**INVESTIGATION OF SOME
SELECTED LANDSLIDES
IN 2000
(VOLUME 2)**

GEO REPORT No. 130

**SECTION 1:
DETAILED STUDY OF
THE 24 AUGUST 2000
LANDSLIDE ON FILL
SLOPE NO. 15NE-B/FR123
BELOW SHEK O ROAD**

**This report was originally produced in July 2001
as GEO Landslide Study Report No. LSR 5/2001**

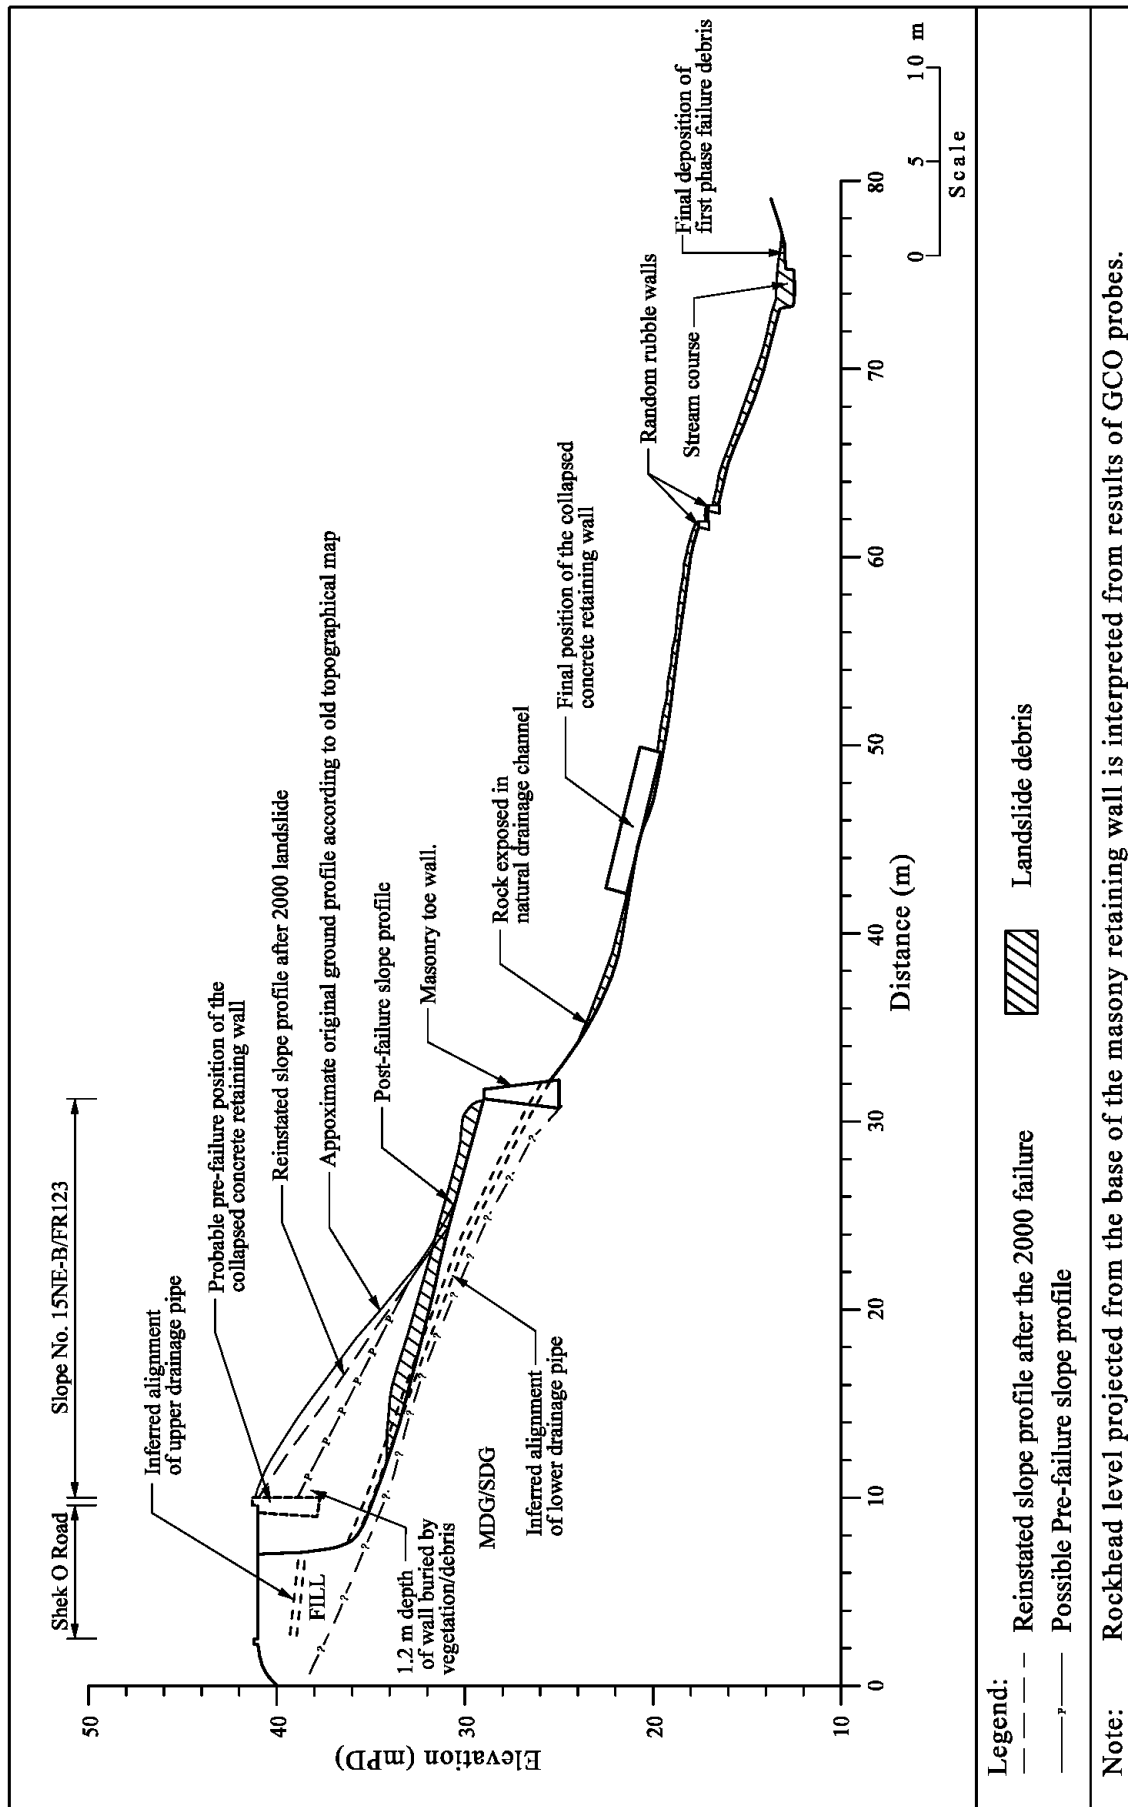
Figure 5 - Cross Section A - A through the Landslide

Since no inlets could be identified on site for the two 350 mm outer diameter clay drain-pipes observed at the site, CCTV surveys were carried out to examine the internal condition of the pipes, to try to locate the pipe inlets and to determine whether the pipes were operational prior to the 2000 landslide. Traces of the probable pipe alignments based on the survey are shown on Figures 4 and 5.

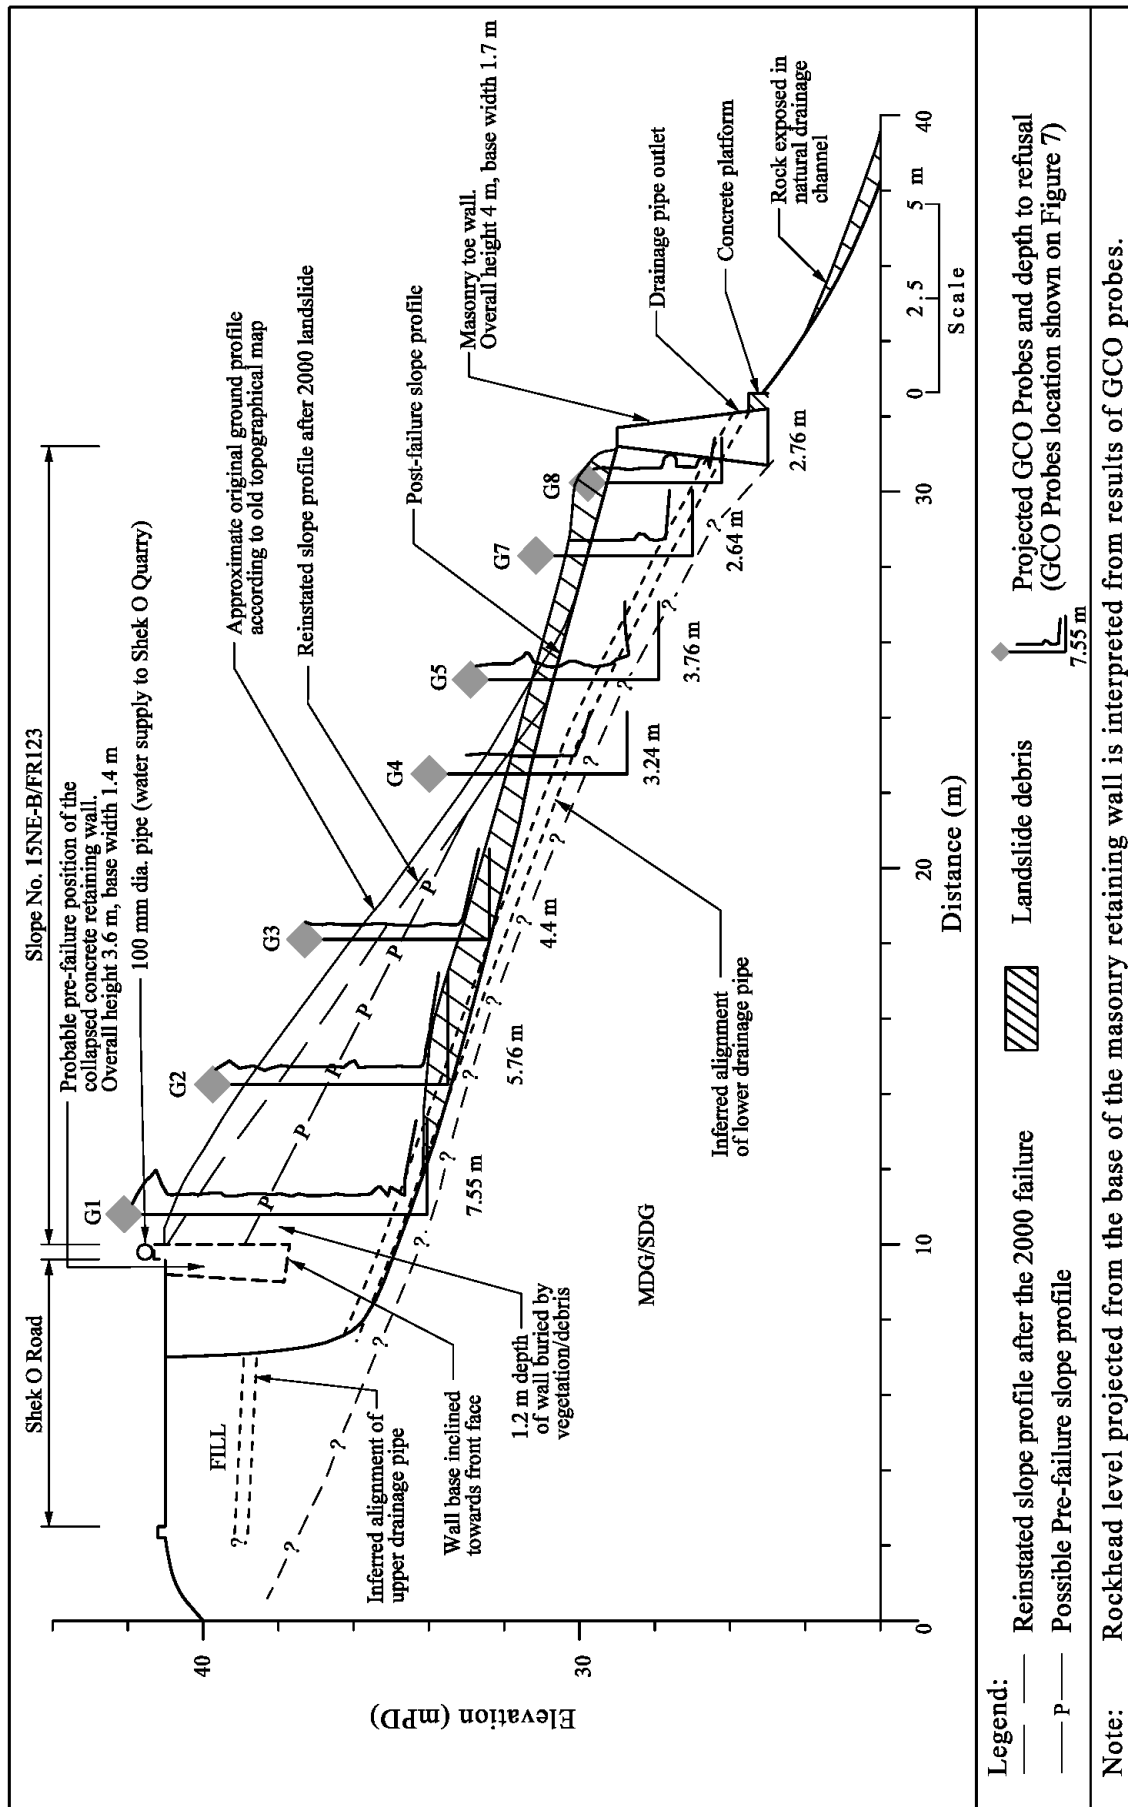
Figure 6 - Detailed Cross Section B-B through the Landslide

The 300 mm internal diameter vitrified clay pipe at the base of the masonry toe wall, with an outlet level of 25.57 mPD (Figure 6 and Plate 9), was surveyed to a length of about 20 m. Due to the pipe being inclined upwards from the point of entry at between 20° and 25° from the horizontal, it was not possible to push the CCTV equipment further at this point.

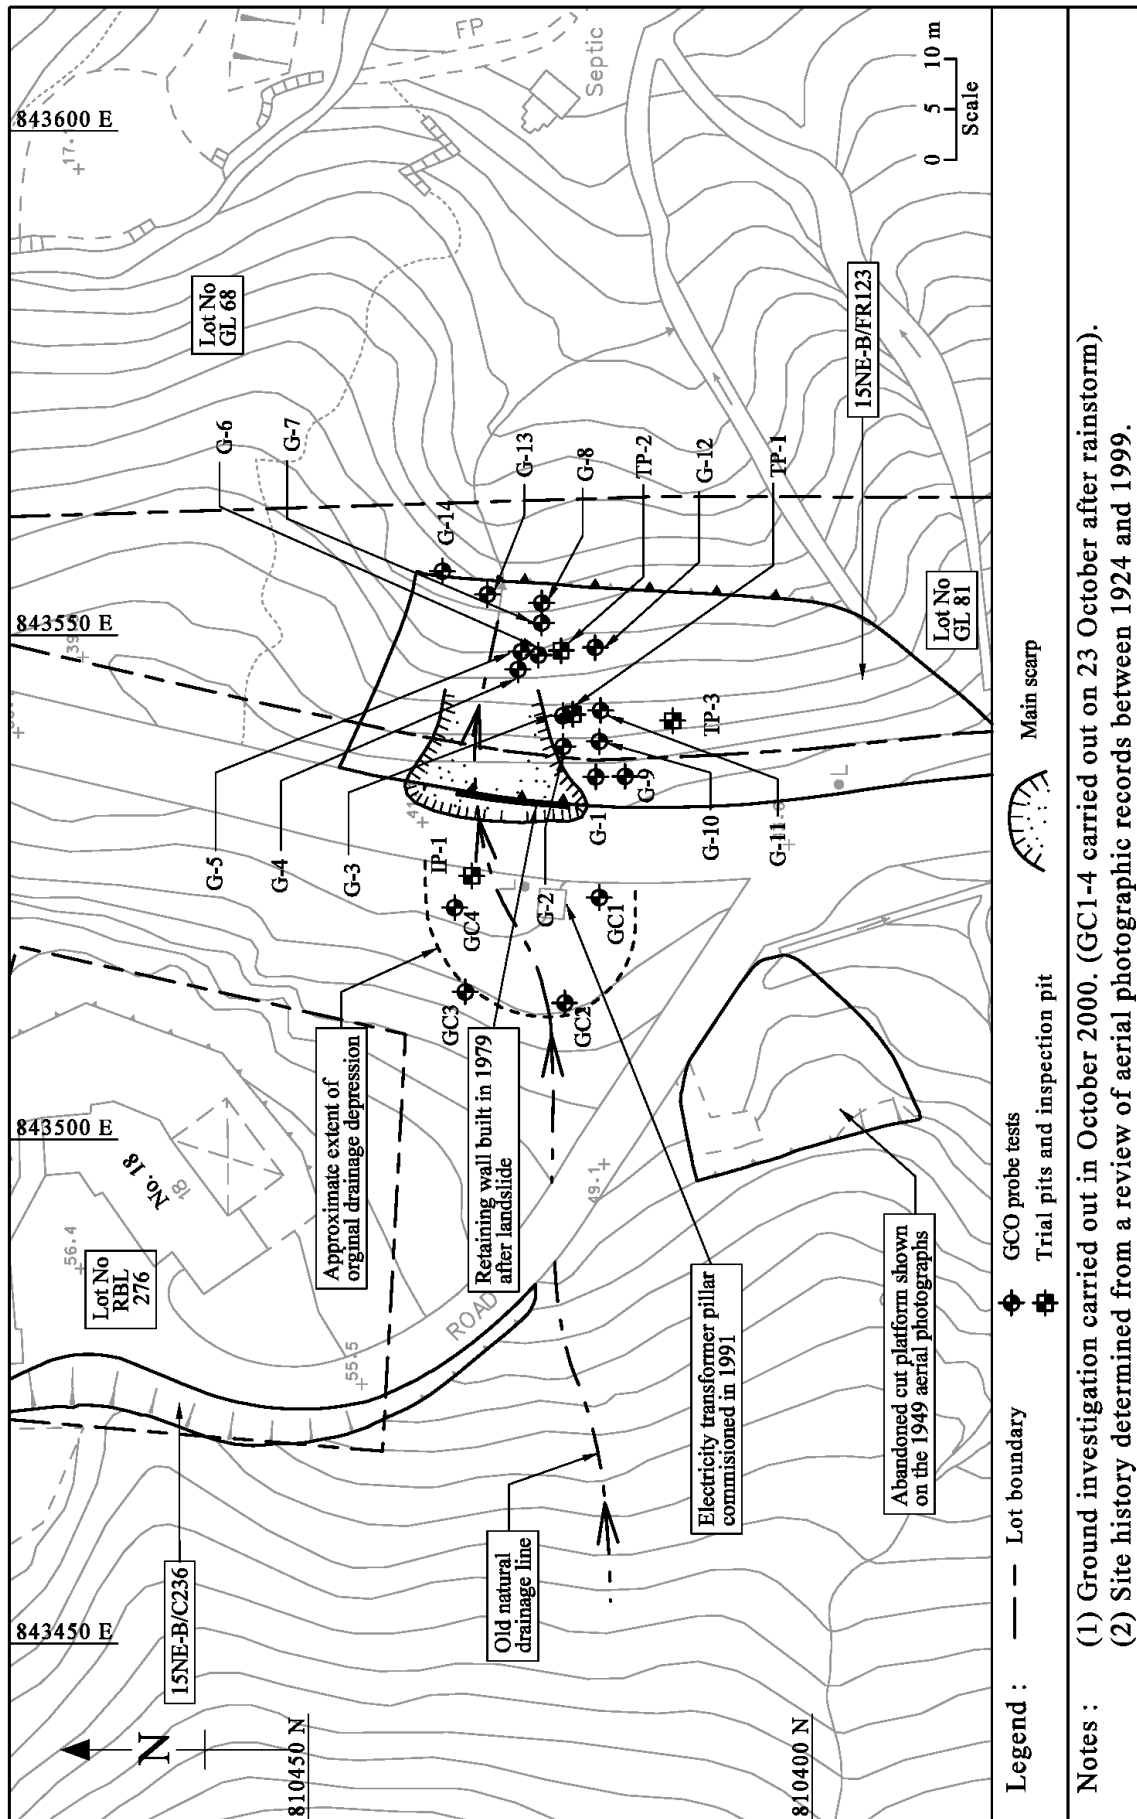
Figure 7 - Ground Investigation and Site History

On 23 October 2000, after a rainstorm, four GCO probe tests were carried out on the western side of Shek O Road around the location of the electricity transformer pillar (Figure 7). A summary of the GCO probe test results is presented in Table C2 of Appendix C. The tests were carried out to verify the thickness and insitu density of the fill within that area. GCO probe test GC1 was carried out at the location where ponded water had been observed. Below the top 0.5 m of loose fill (between 0.5 m to 1.0 m below ground level), the probe fell under its own weight. The probe test results showed the loose nature of the fill up to 4.1 m below ground level where it met refusal. The other three GCO probe test results confirmed the loose nature of the fill and that the thickness (typically 2 m to 4 m) is less than that on the opposite side of Shek O Road. The GCO probe tests GC2 and GC3 carried out furthest west from Shek O Road met refusal at much shallower depths, probably indicating a decreasing fill thickness at higher elevations within the natural drainage line.

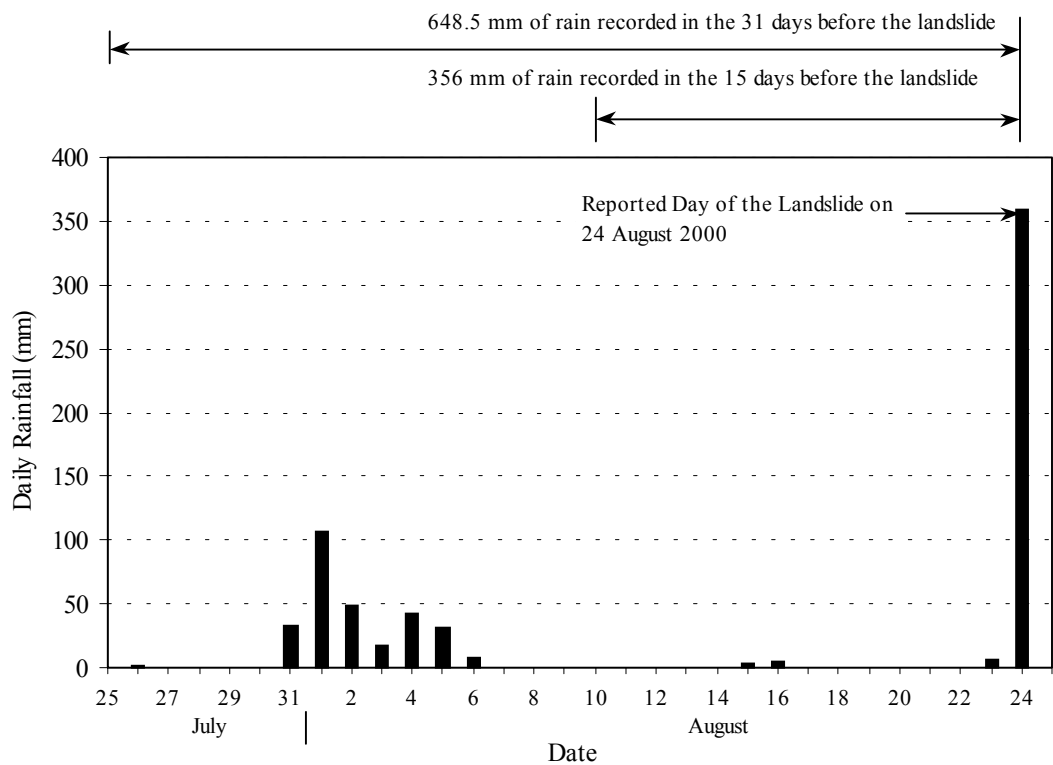
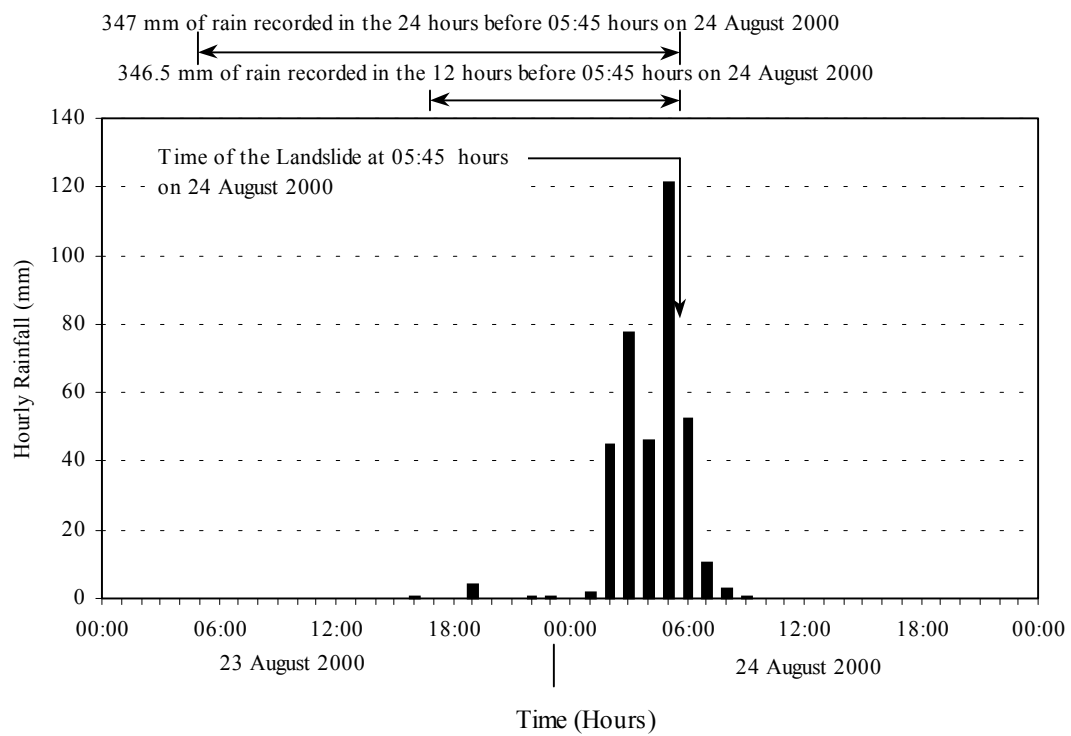
Figure 8 - Rainfall Recorded at GEO Raingauge No. H28

The daily rainfall recorded by the raingauge for one month preceding the landslide, together with the hourly rainfall, are presented in Figure 8. This shows that the rainstorm on 24 August 2000, was the most severe within the month, with a peak hourly rainfall of 126.5 mm recorded between 04:00 hours and 05:00 hours on 24 August 2000. Between 05:45 hours and 08:00 hours, subsequent to the landslide, a further 16.5 mm of rainfall was recorded. No further rainfall was recorded by raingauge No. H28 on 24 August 2000.

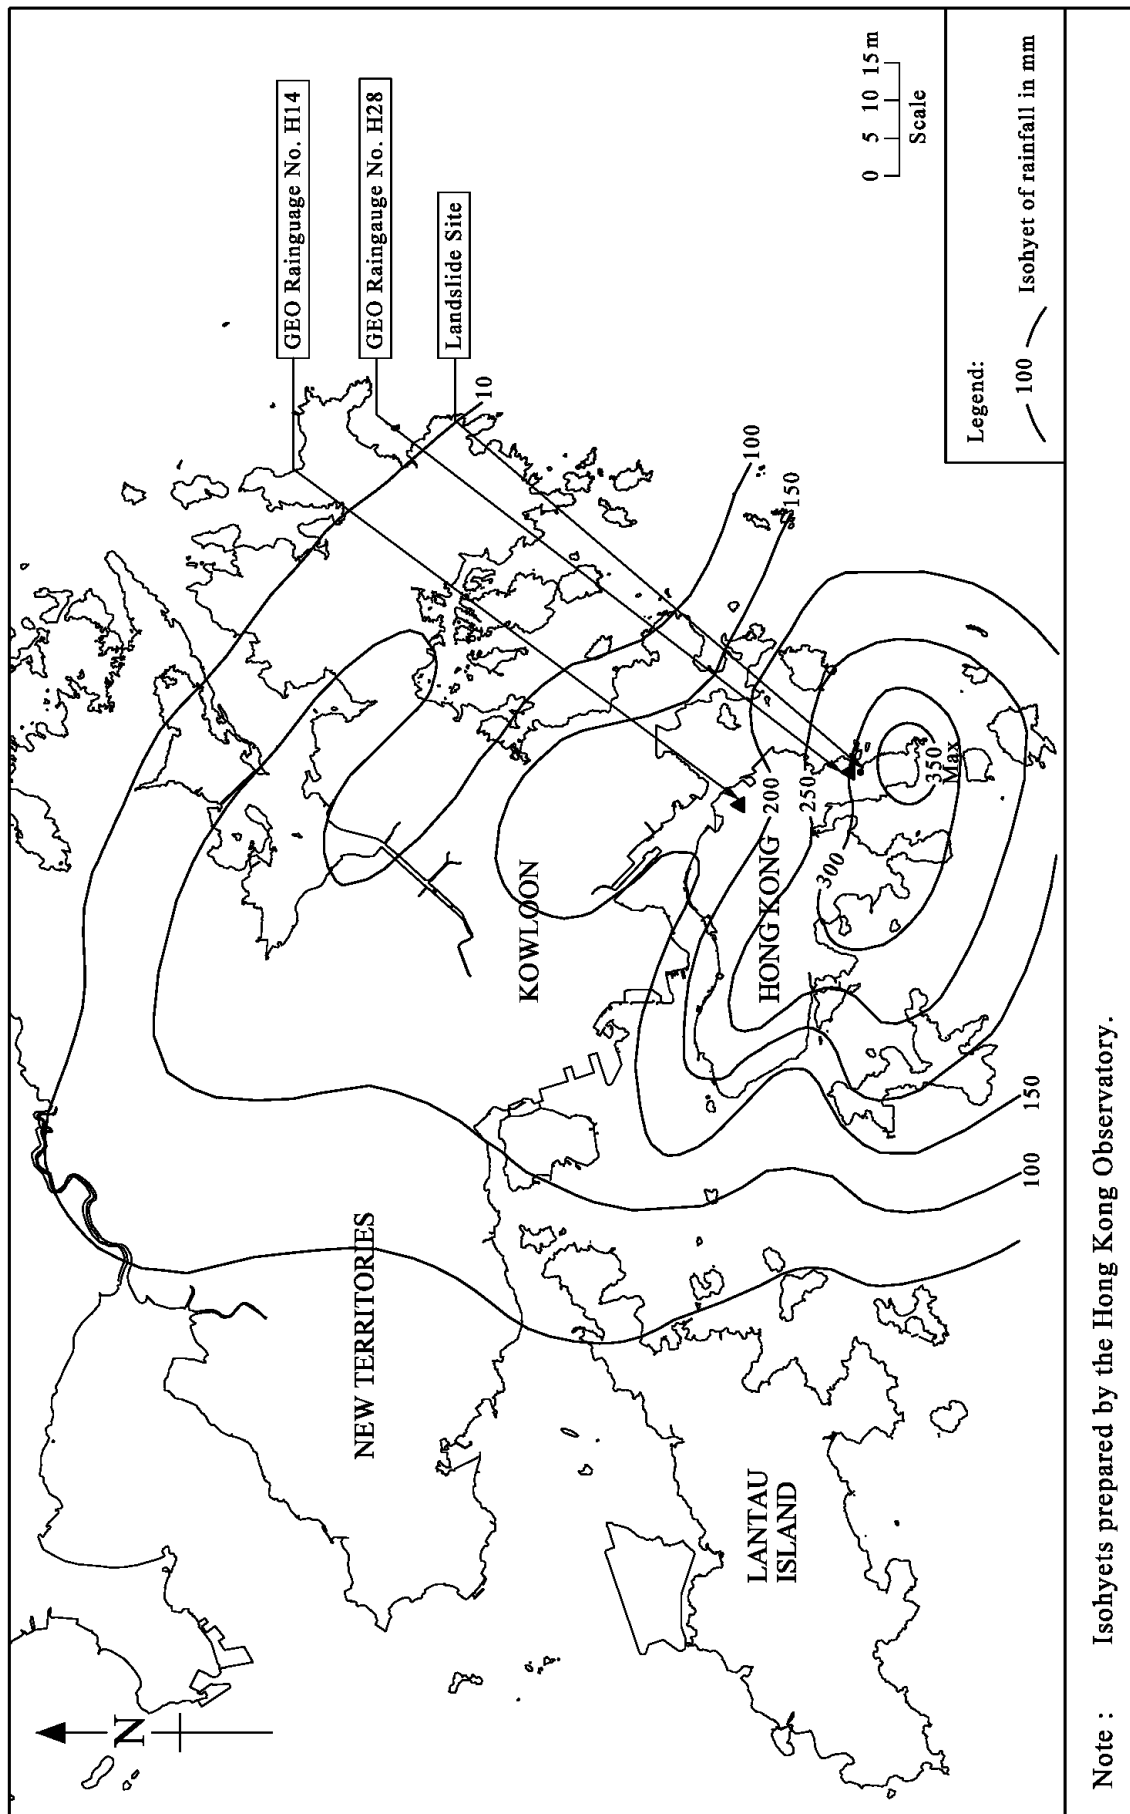
Figure 9 - Isohyets of Rainfall from 00:00 Hours to 05:45 Hours on 24 August 2000

Isohyets of rainfall for the period between 00:00 hours and 05:45 hours on 24 August 2000 (Figure 9) indicate that the Shek O area experienced the heaviest rainfall in Hong Kong (over 300 mm). A Black Rainstorm Warning Signal was issued at 03:05 hours and lowered at 05:55 hours.

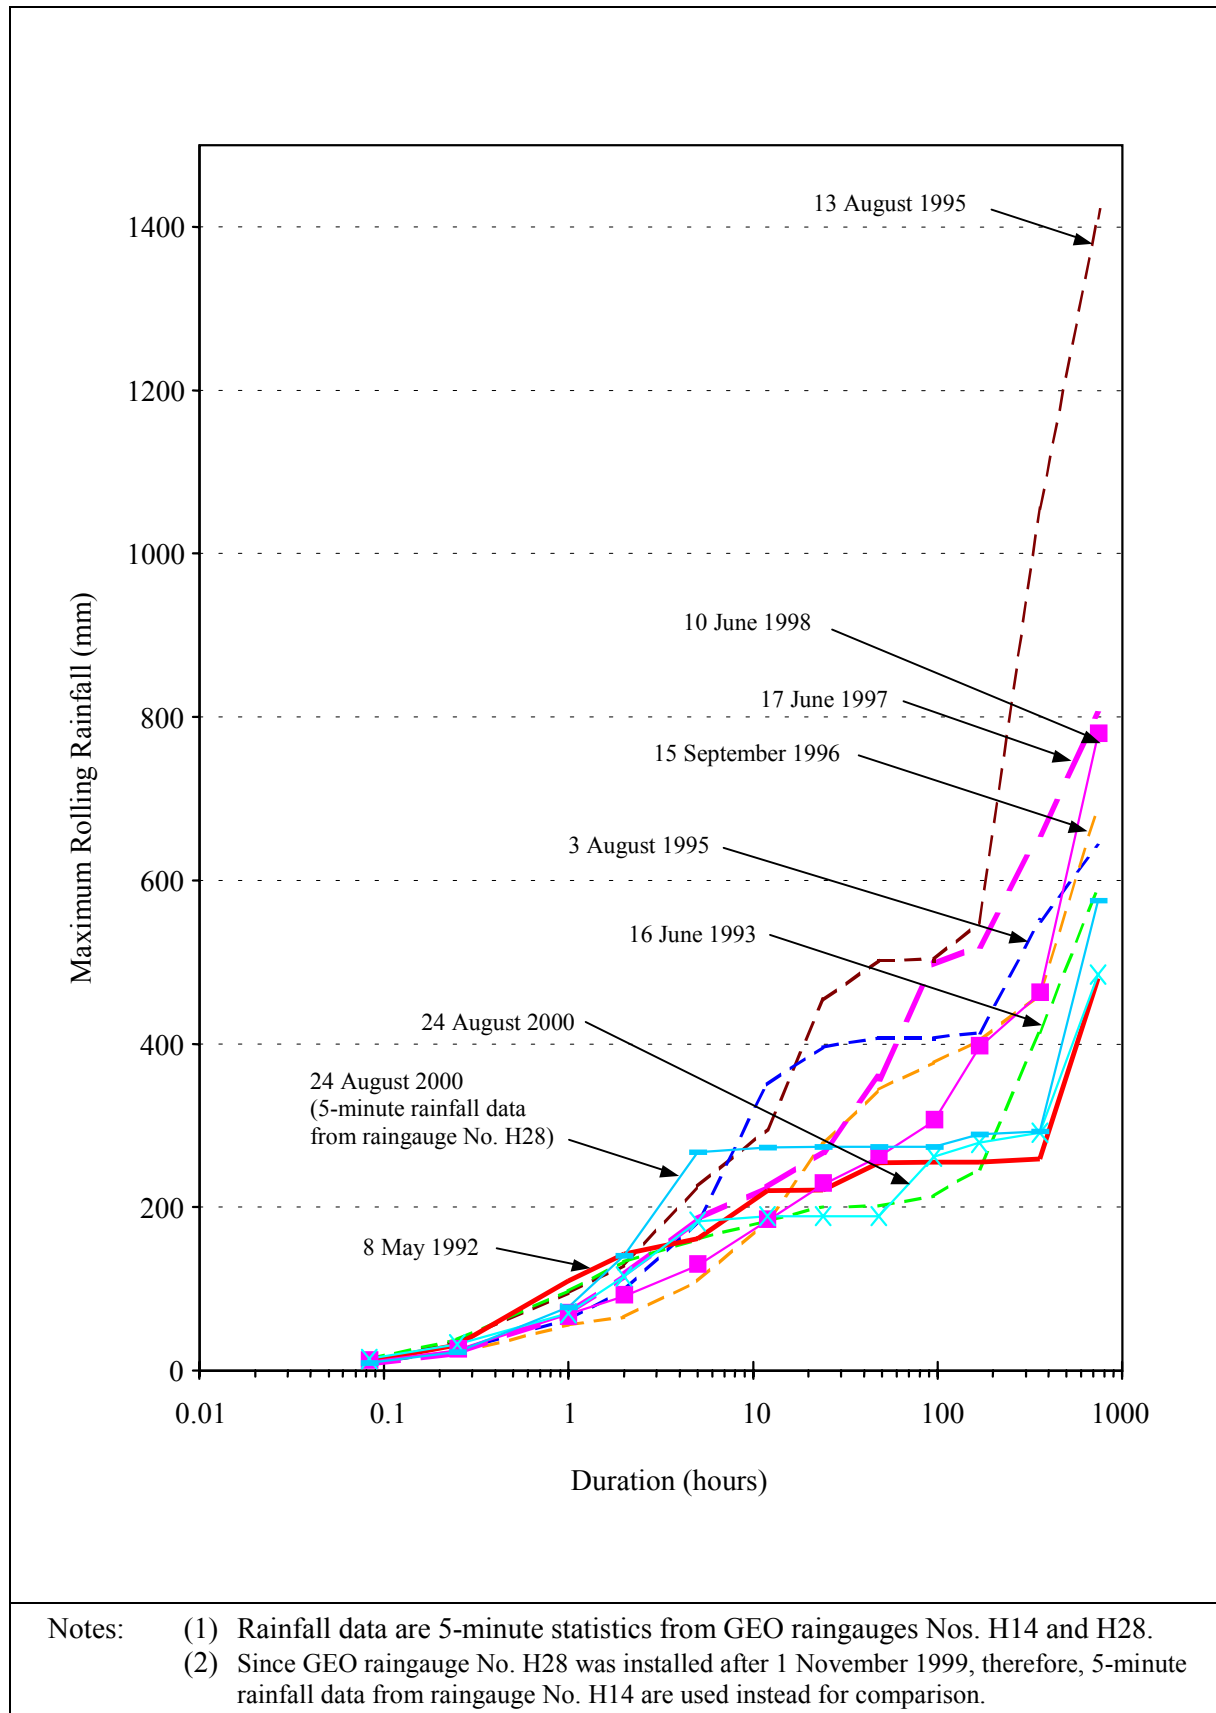
Figure 10 - Maximum Rolling Rainfall for Selected Major Rainstorms at GEO Raingauge Nos. H14 and H28

No. H14, which is located at Wo Hing House, Hing Wah Estate and is about 3.7 km northwest of the site, has been used for the rainfall analysis. Figure 10 compares data for the 24 August 2000 rainstorm recorded by raingauge Nos. H28 and H14, with that of other past major rainstorms recorded by raingauge No. H14. The 24 August 2000 rainstorm recorded by raingauge No. H28 was more severe than any previously significant rainstorms recorded by raingauge No. H14, between 2 and 8 hours duration, since installation of raingauge No. H14 in 1983. This comparison is however indicative only because other factors (especially possible regional influences) have not been accounted for.
