**SECTION 2:
DETAILED STUDY OF
SELECTED LANDSLIDES
ON SLOPE NO. 11NE-D/C45
HIU MING STREET
KWUN TONG**

Halcrow China Limited

**This report was originally produced in August 2001
as GEO Landslide Study Report No. LSR 7/2001**

1. INTRODUCTION

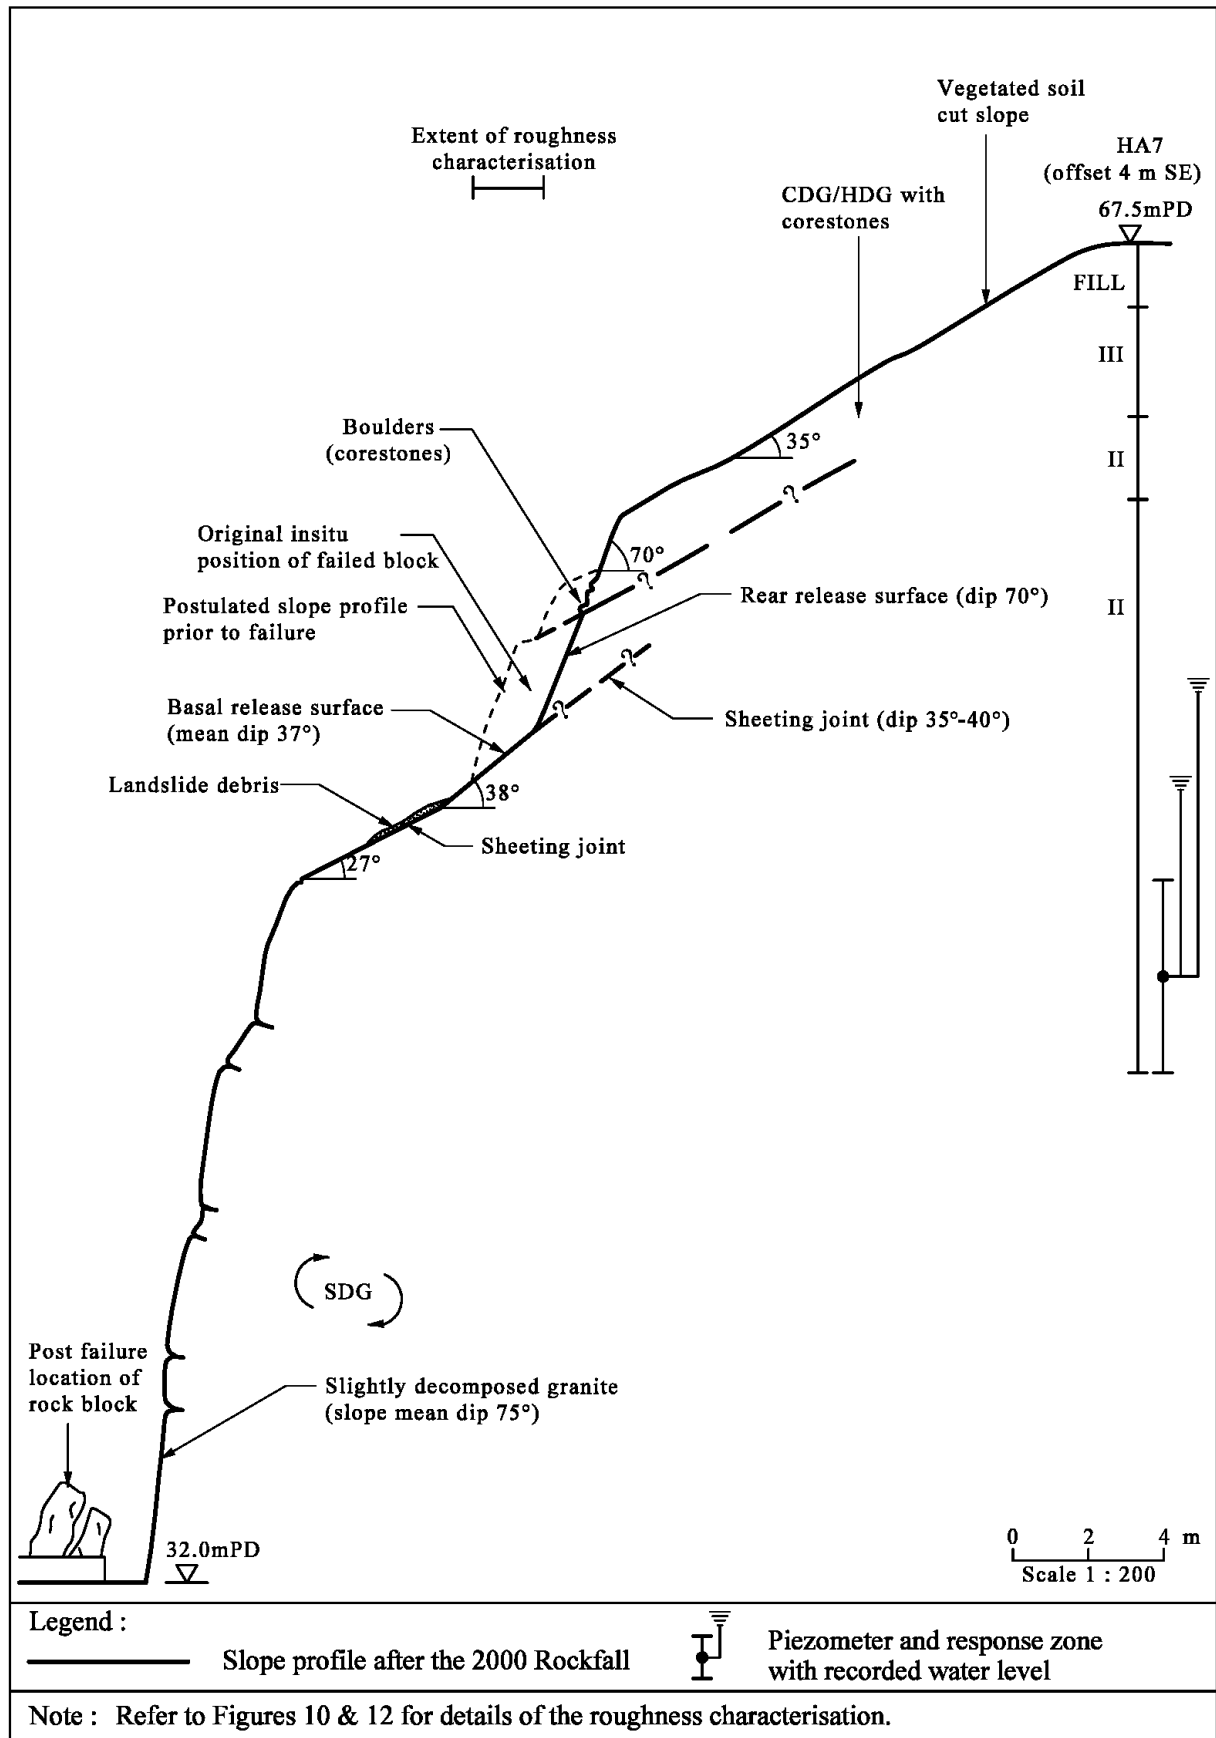
Figure 4 - Cross-section 1-1 through the 2000 Rockfall

The piezometer in borehole HA7 was installed at a depth of 17.50 m (59 mPD) with a response zone from 17 m to 22.2 m below ground level (bgl). The tip of the piezometer is 15.5 m below the rockhead (defined as Grade III or better rock). Groundwater at between 12 m and 14.5 m bgl was recorded during the monitoring period (Figure 4).

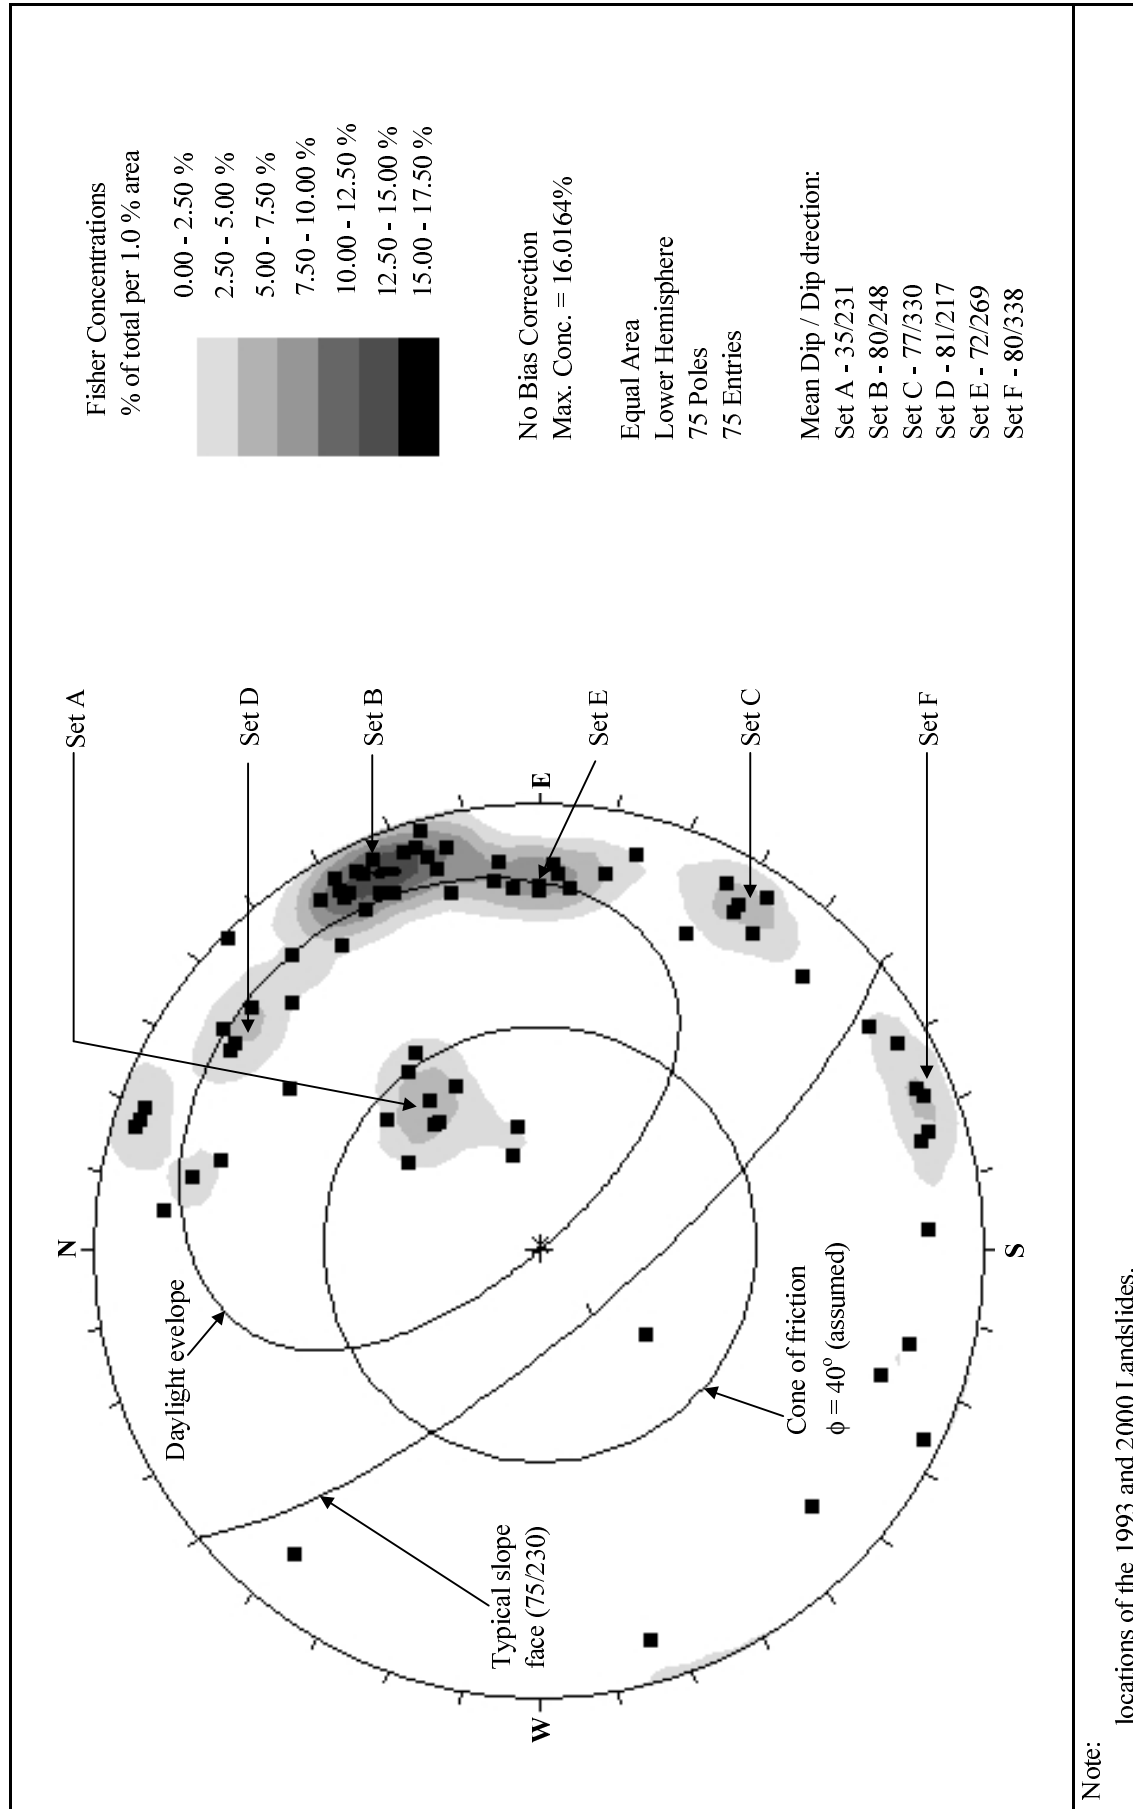
Figure 15 - Stereonet of the Measured Orientations of Discontinuities at Slope Nos. 11NE-D/C44 and 11NE-D/C45

A rock joint survey was carried out along the toe of slope No. 11NE-D/C45 and adjacent slope No. 11NE-D/C44 with the primary purpose of determining whether the basal release surface of the 2000 landslide could be identified elsewhere on the slope and what variability in inclination, particularly localised steepening, could be observed. Six pole concentrations were identified, labelled Sets A to F, in Figure 15. A preliminary stereonet assessment of the rock joint data, indicates that both planar and wedge failure mechanisms are kinematically possible. Observations at the rock slope during the rock joint survey show that potential rock wedges have been identified in previous assessments (e.g. B&P, 1980) and potential failure mitigated against through installation of rock bolts.

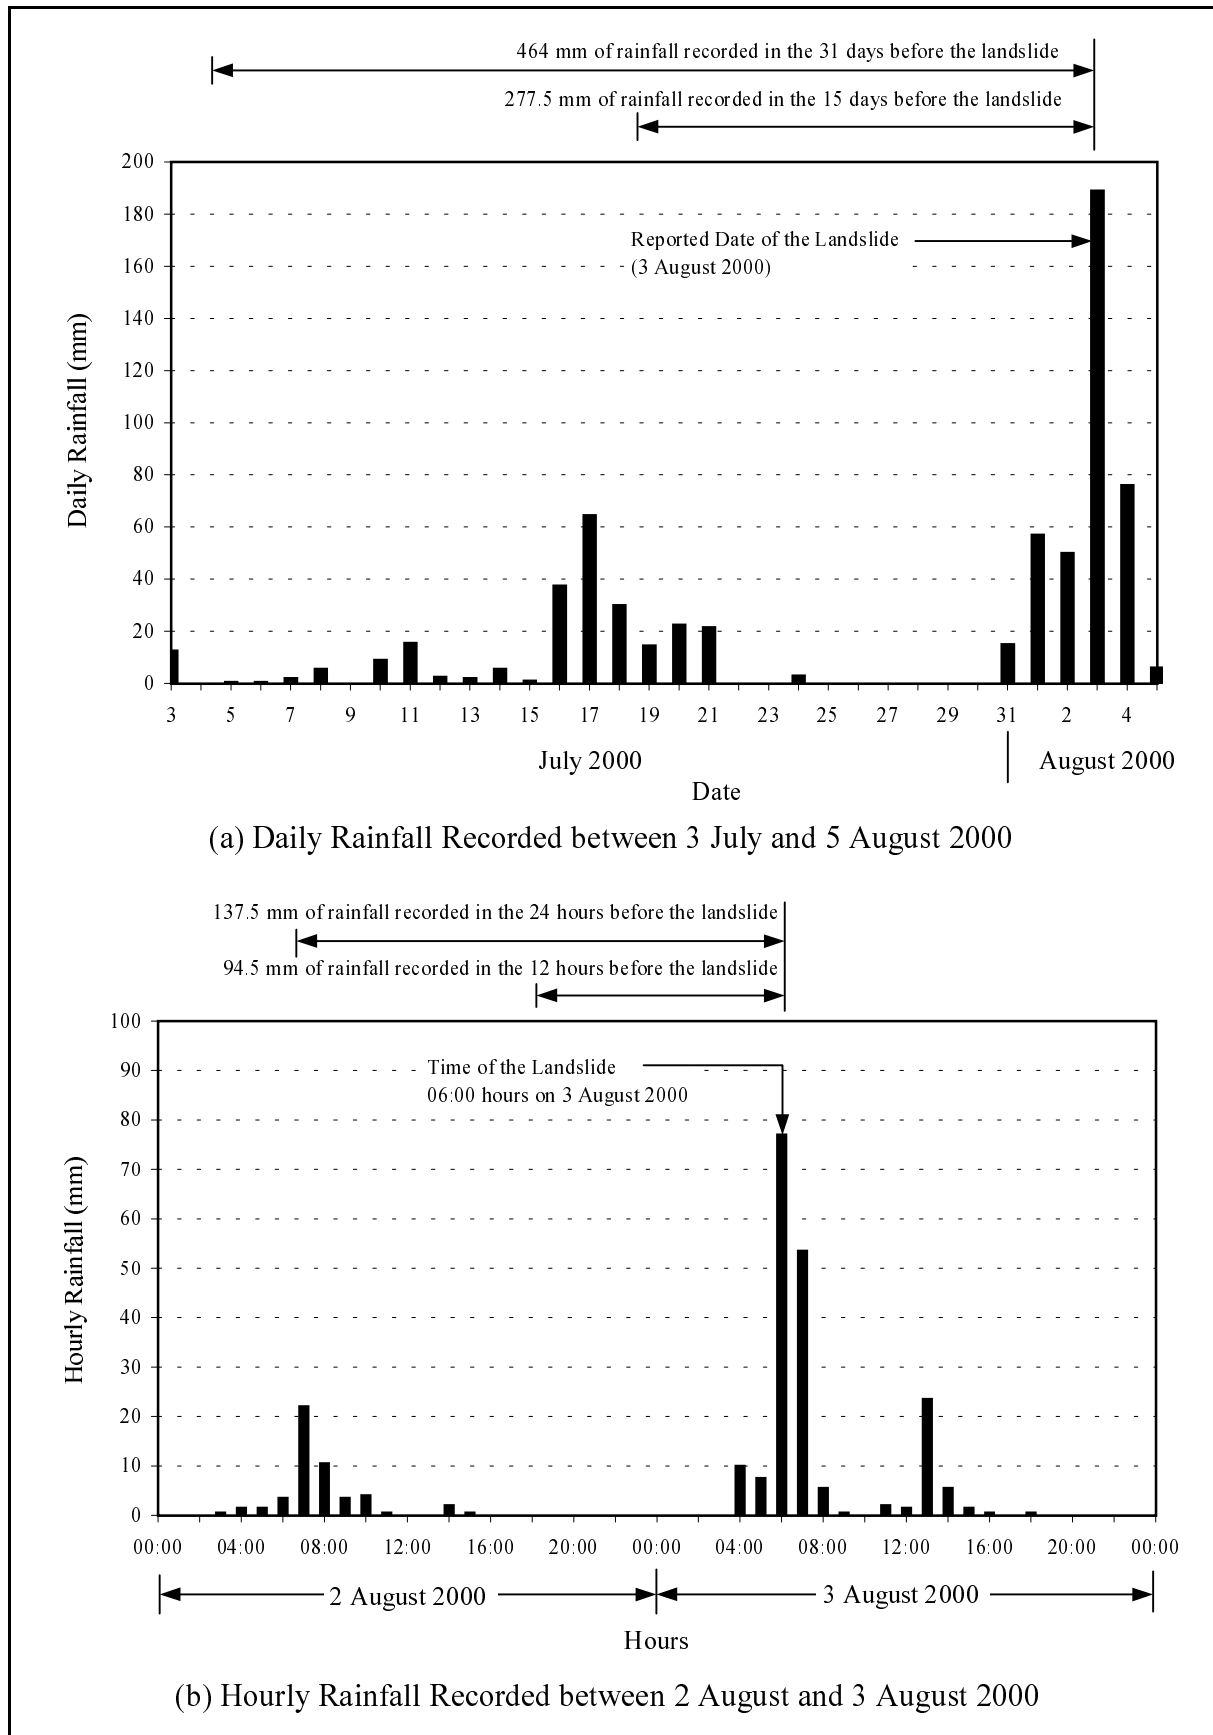
Figure 16 - Daily and Hourly Rainfall Recorded at GEO Raingauge No. K03 in August 2000

The daily rainfall recorded by raingauge No. K03 over a period of one month preceding and three days following the incident is presented in Figure 16. For the purposes of rainfall analysis, it is assumed that the landslide occurred at 6:00 hours on 3 August 2000, which is defined by the eye-witness accounts (Section 4.1).

Hourly rainfall recorded at raingauge No. K03, between 2 August and 3 August 2000 is also presented in Figure 16. The hourly rainfall data show a rainfall peak of 77 mm between 05:00 hours and 06:00 hours on 3 August 2000. Table 2 presents the estimated return periods for the maximum rolling rainfalls recorded at GEO raingauge No. K03, for various durations based on historical rainfall data recorded at the Hong Kong Observatory (Lam & Leung, 1994). The one-hour maximum rolling rainfall between 05:00 hours and 06:00 hours on 3 August 2000 was the most severe compared with the other selected durations, with a corresponding return period of about three years.

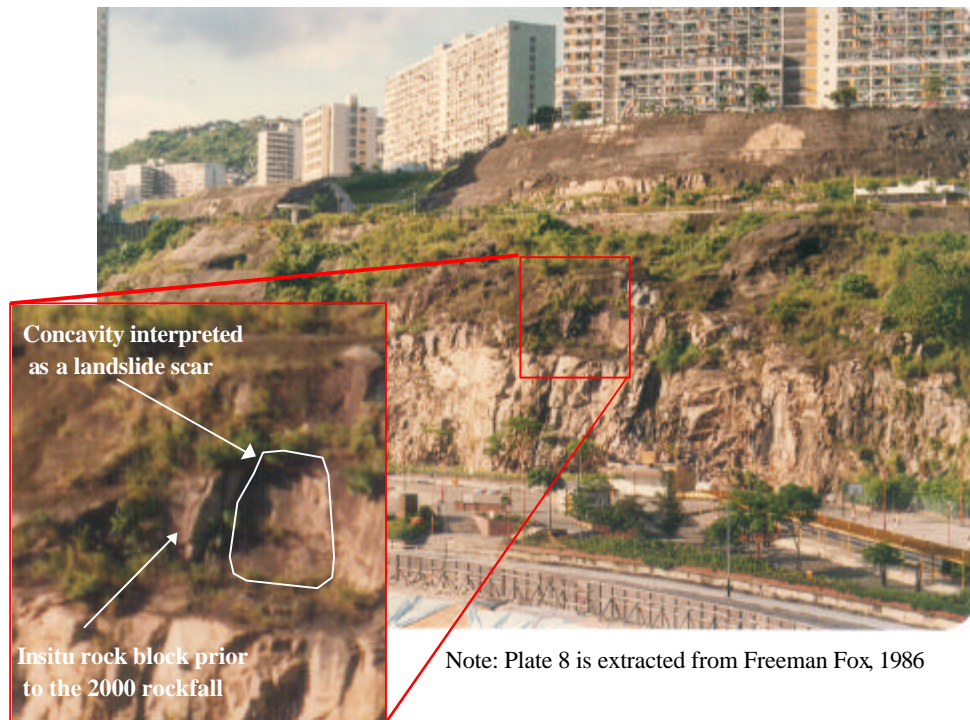
Plate 8 - View of the Location of the 2000 Rockfall Taken about 15 Years before the Failure (Photograph Taken in July 1985)

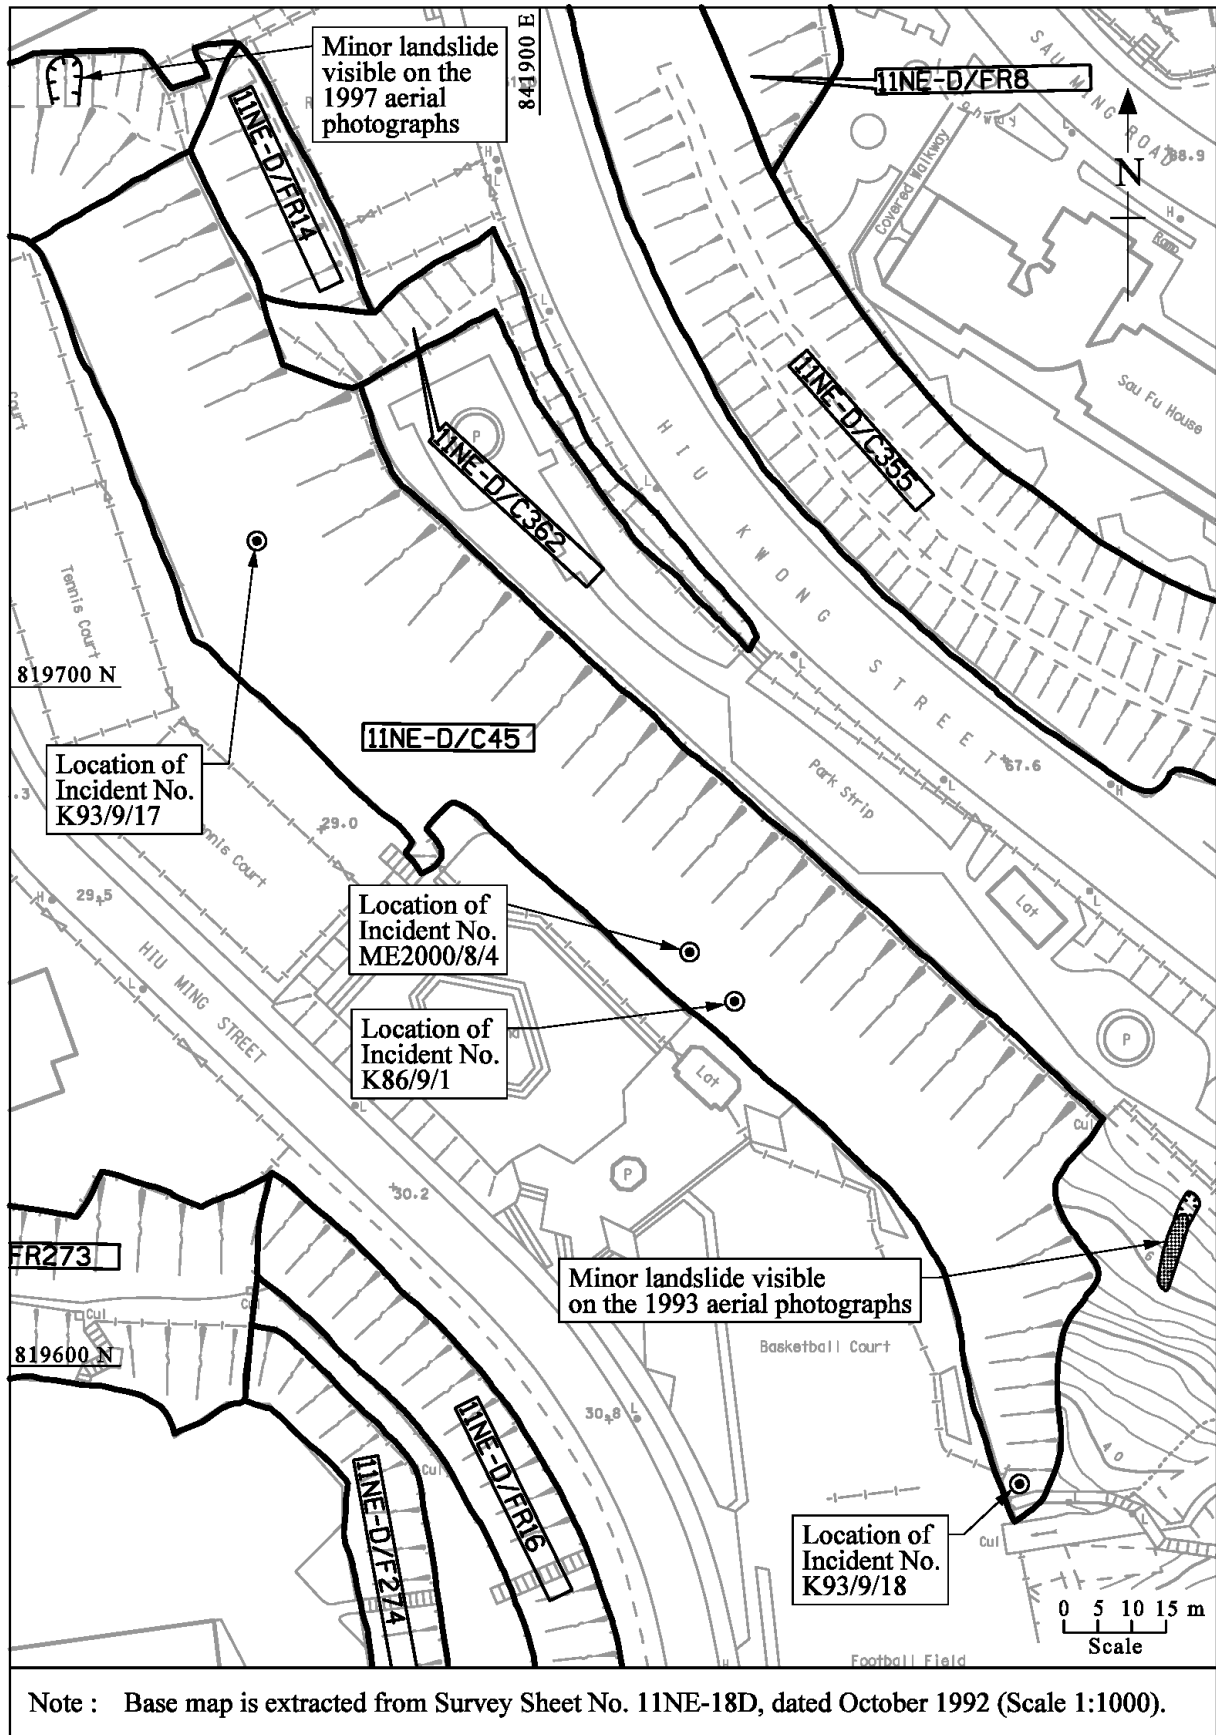
Figure A1 - Location Plan Showing Locations of Previous Instabilities

1997	A light toned area, interpreted as a minor shallow failure, is visible above the adjacent slope (Slope No. 11NE-D/C44) to the north of the subject feature (Figure A1). Much of the upper section of the slope is densely vegetated with relatively mature trees and shrubs.
1998	No significant visible change.
1999	The upper section of the feature is almost totally obscured by dense vegetation, otherwise no significant change is visible.

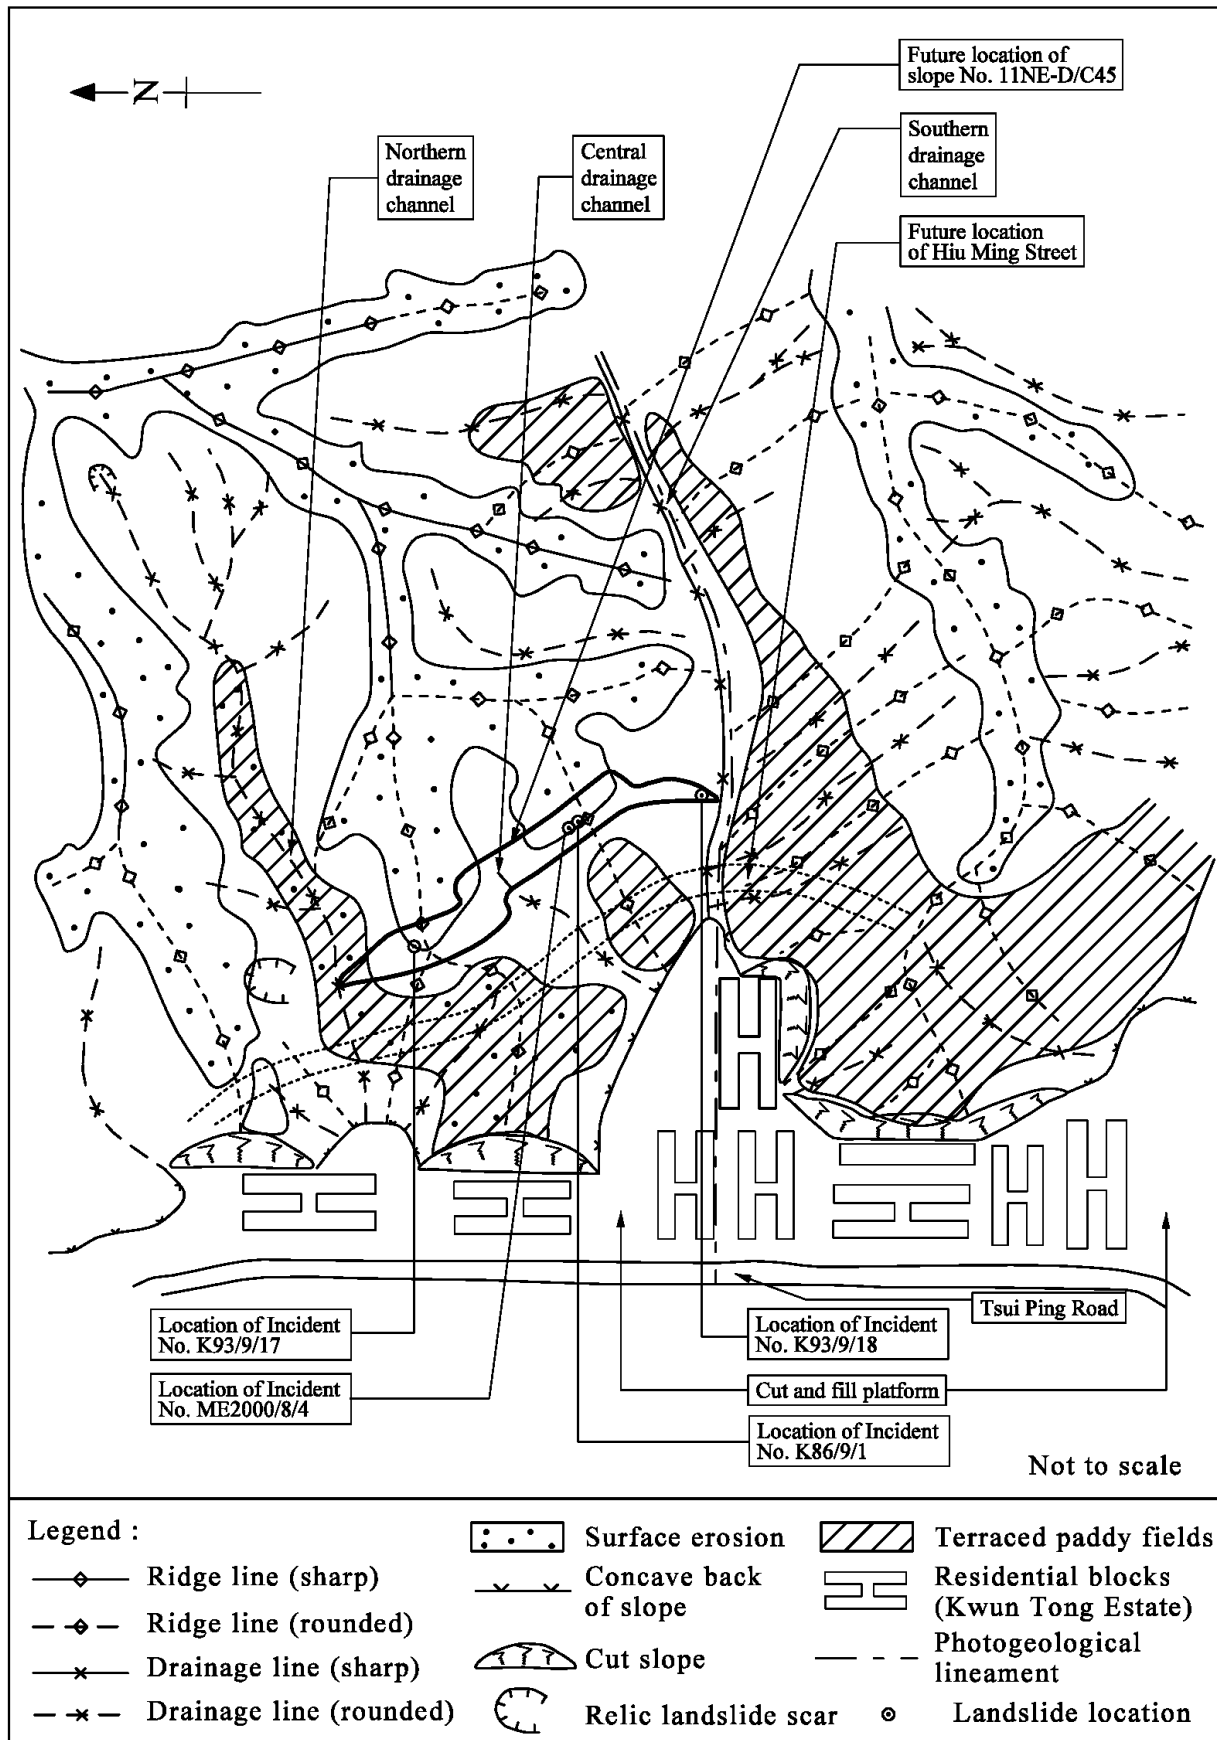
Figure A2 - Aerial Photographic Interpretation
Based on Photographs Taken in 1963

The locations of the four landslide incidents are also marked on Figure A2. The three rock failures all occurred on or close to the west to east trending ridgelines.
