**INVESTIGATION OF SOME  
SELECTED LANDSLIDES  
IN 2000  
(VOLUME 3)**

**GEO REPORT No. 131**

# **SECTION 1: DETAILED STUDY OF THE 24 AUGUST 2000 LANDSLIDE NEAR 2B BOWEN ROAD**

This report presents the findings of a detailed study of a landslide (GEO Incident No. HK2000/08/006) which occurred on 24 August 2000 involving unregistered fill on the hillside adjacent to No. 2B Bowen Road on Hong Kong Island. Debris from the landslide, with an estimated volume of 120 m<sup>3</sup>, entered the adjacent nullah and was transported downstream for a long distance beyond the landslide site (up to about 250 m on plan) to reach Hong Kong Park below Kennedy Road.

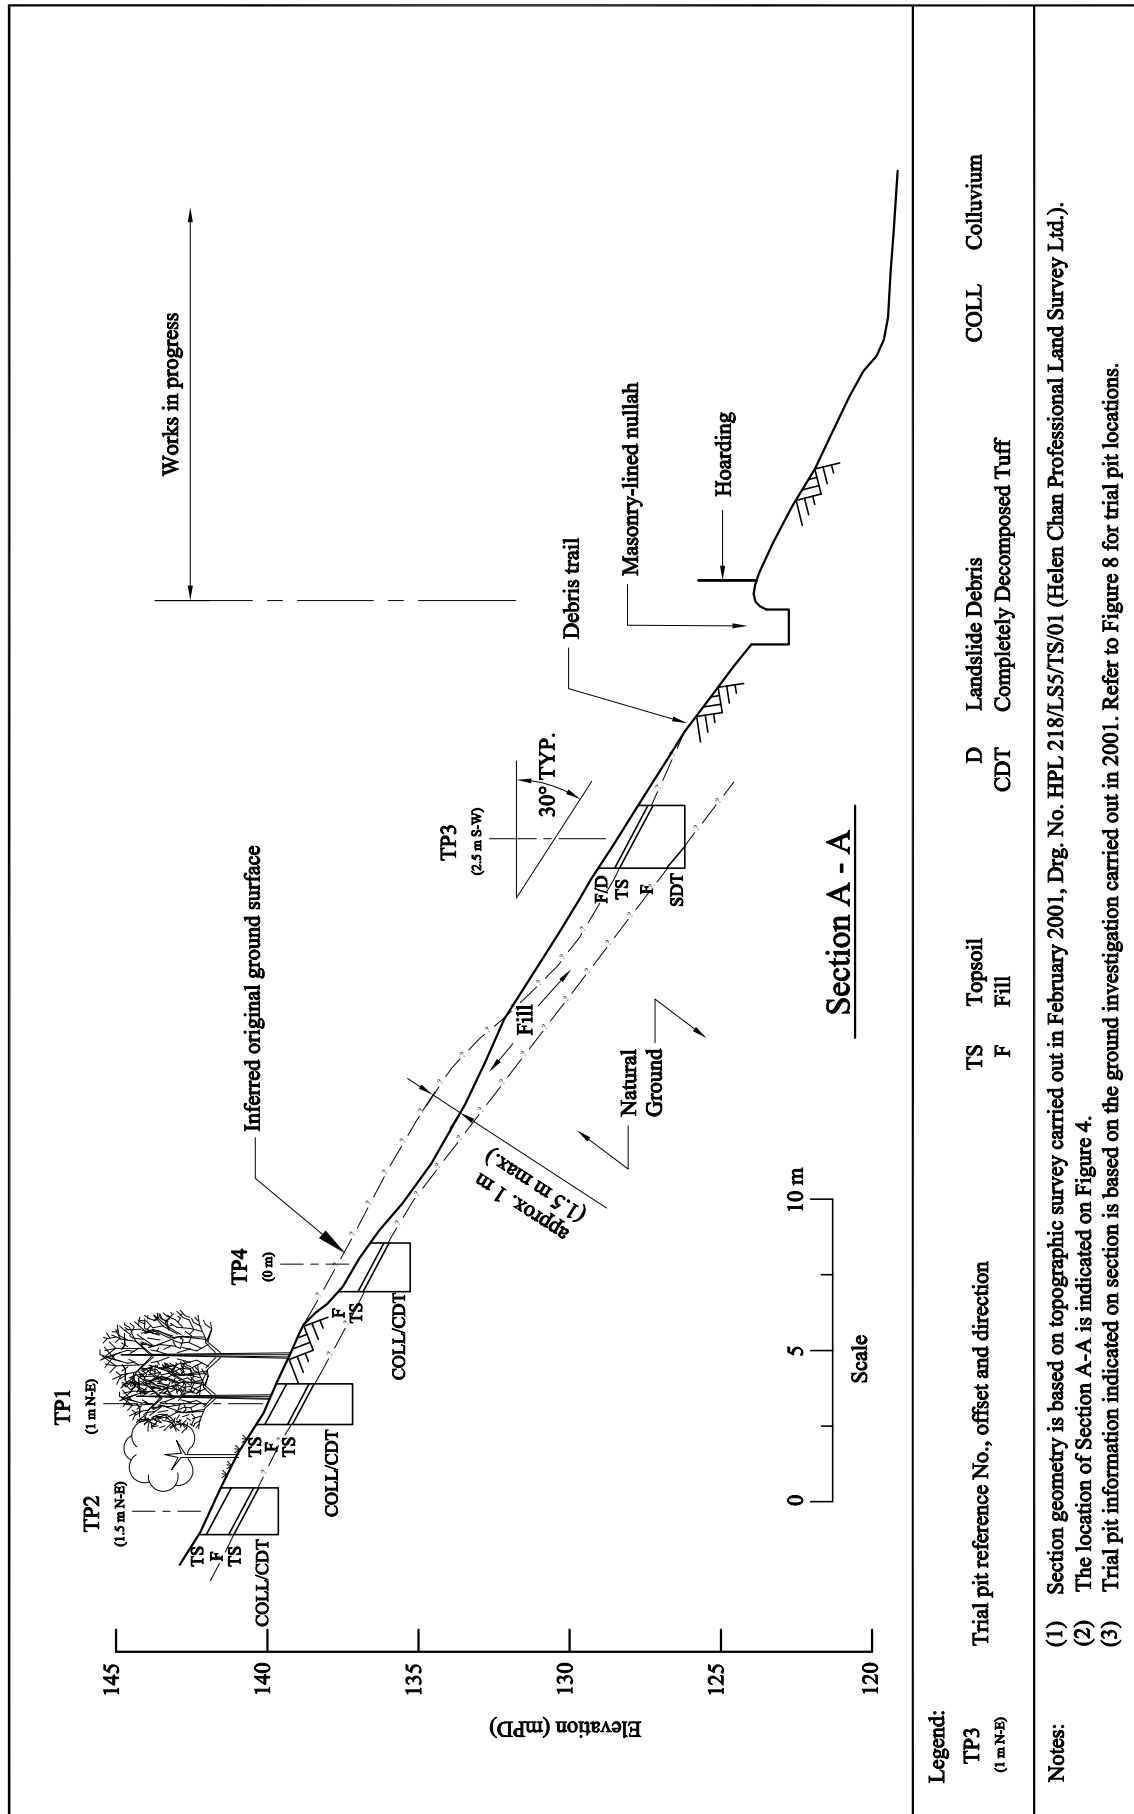
Figure 5 - Section A - A through the Landslide

A geological section through the landslide site is presented in Figure 5.

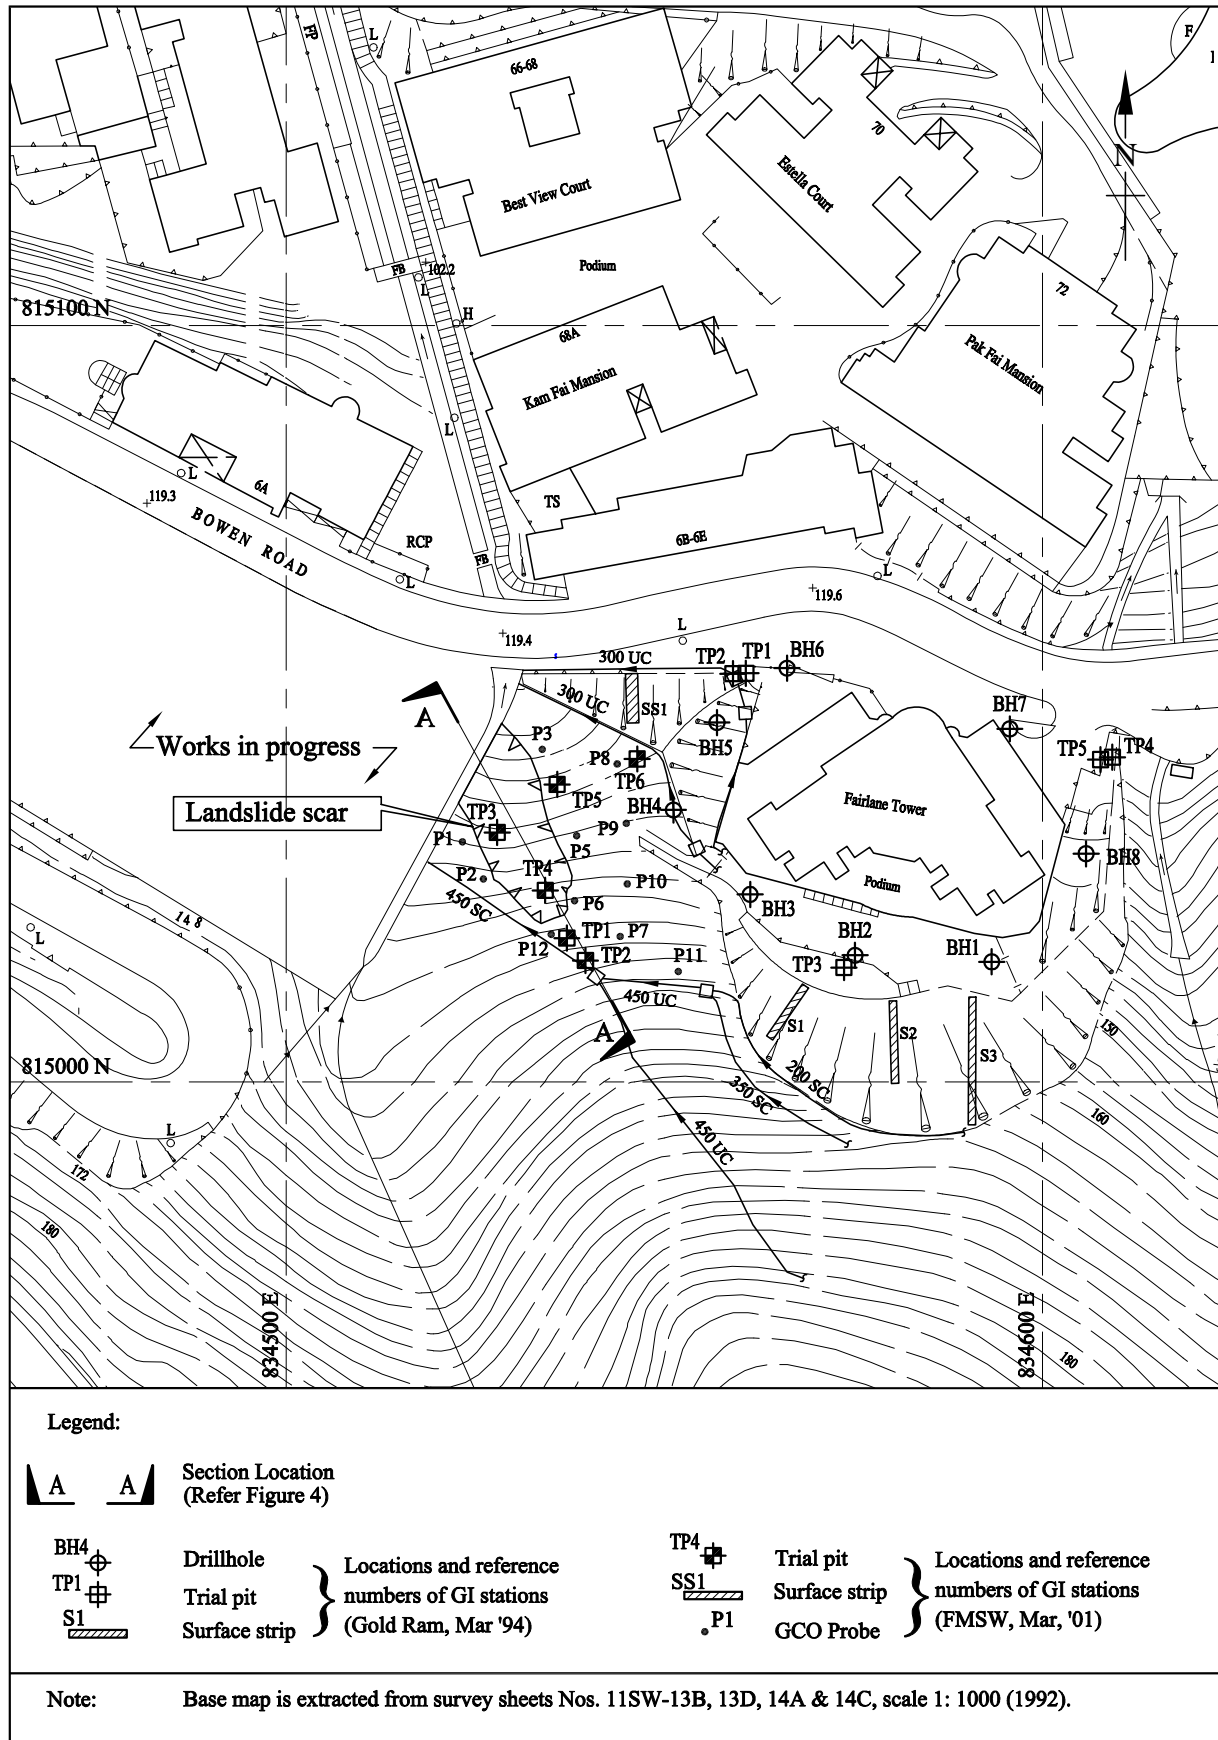
Figure 6 - Ground Investigation Stations

The report presents monitoring data from piezometers installed at drillholes BH1 to BH3, BH5, BH7 and BH8 (Figure 6). Piezometer tips were located within Grade V to Grade III tuff, about 0.8 m above to 2.7 m below rockhead and at depths of 7 m to 15 m below ground surface. Monitoring was carried out from 24 March 1994 to 30 April 1994 during which time water levels generally remained about 1 m to 3 m above rockhead, with BH7 recording the highest water level of 6 m below ground surface.

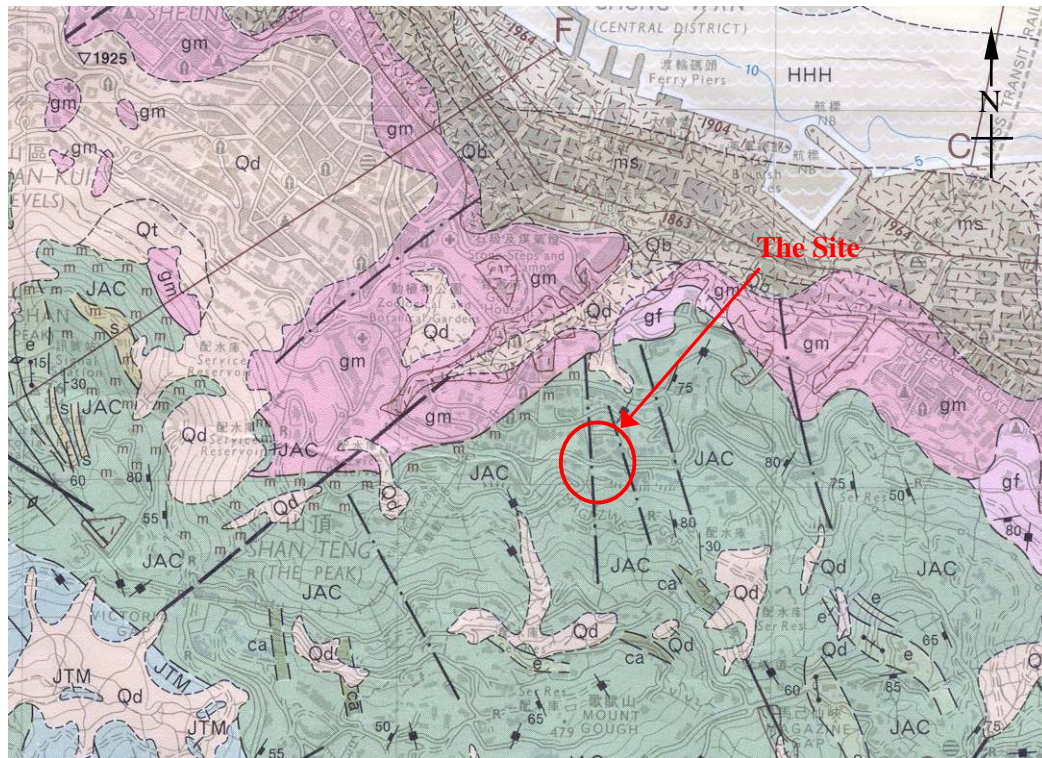
Figure 7 - Solid and Superficial Geology of the Landslide Site

Sheet 11 of the Hong Kong Geological Survey 1:20 000 scale map series HGM20 (GCO 1986) indicates that the solid geology of the landslide site and its surroundings is fine ash vitric tuff from the Ap Lei Chau Formation of the Repulse Bay Volcanics Group (Figure 7). Two NNW-trending photogeological lineaments are indicated on the map which coincide with the natural drainage lines defining the spur feature containing the landslide site.

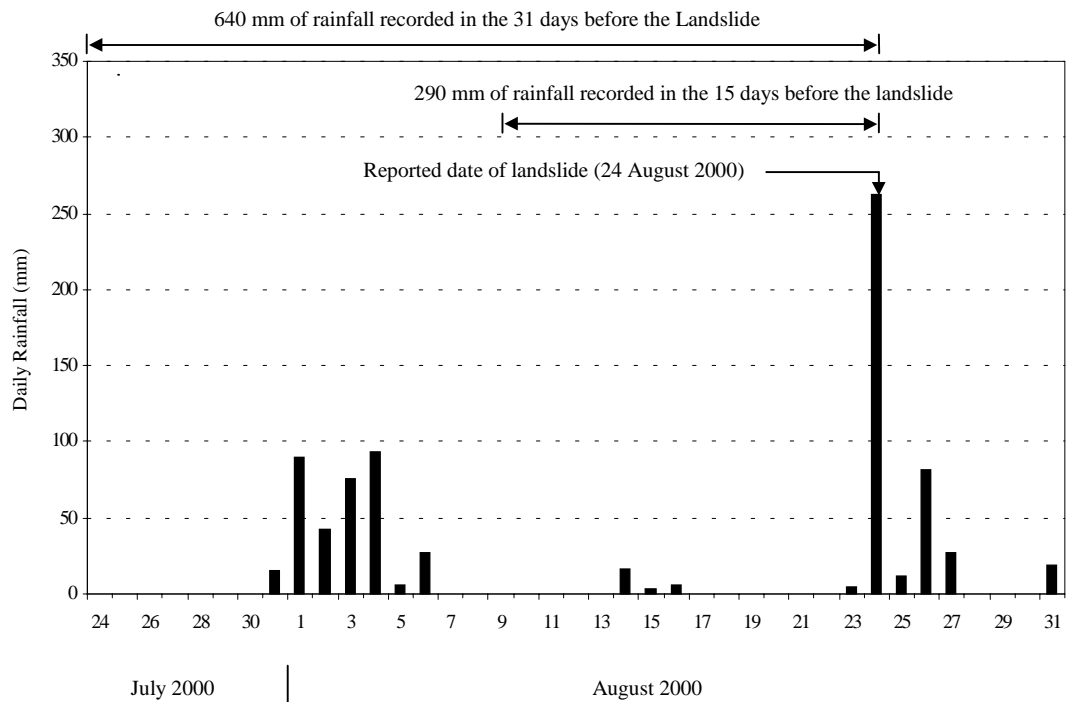
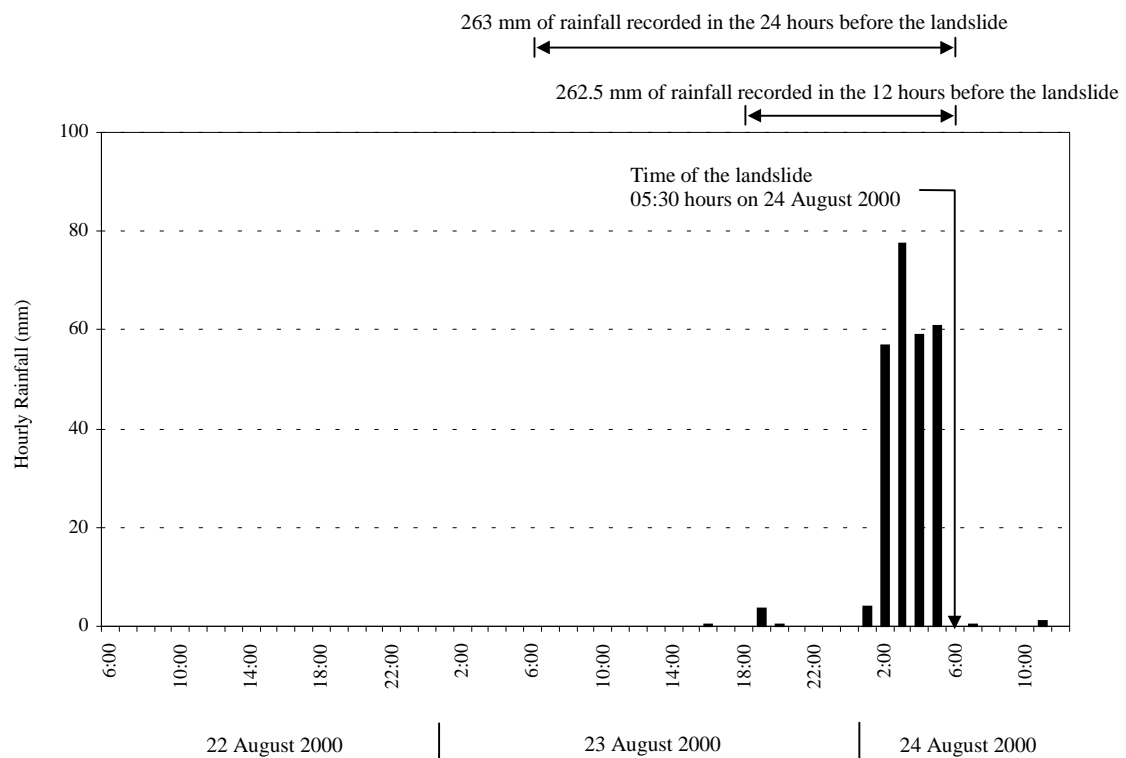
Figure 8 - Rainfall Recorded at GEO Raingauge No. H17

The daily rainfall for the period of one month preceding and seven days following the landslide, together with hourly rainfall for 48 hours before and 6 hours following the landslide, are given in Figure 8. The daily rainfall record shows that the storm was concentrated on 24 August 2000, with the hourly data indicating peak rainfall intensities from 2:00 a.m. to 6:00 a.m., generally in the range of 60 mm/hr to 80 mm/hr. About 260 mm of rainfall was recorded in the four hours prior to the failure.

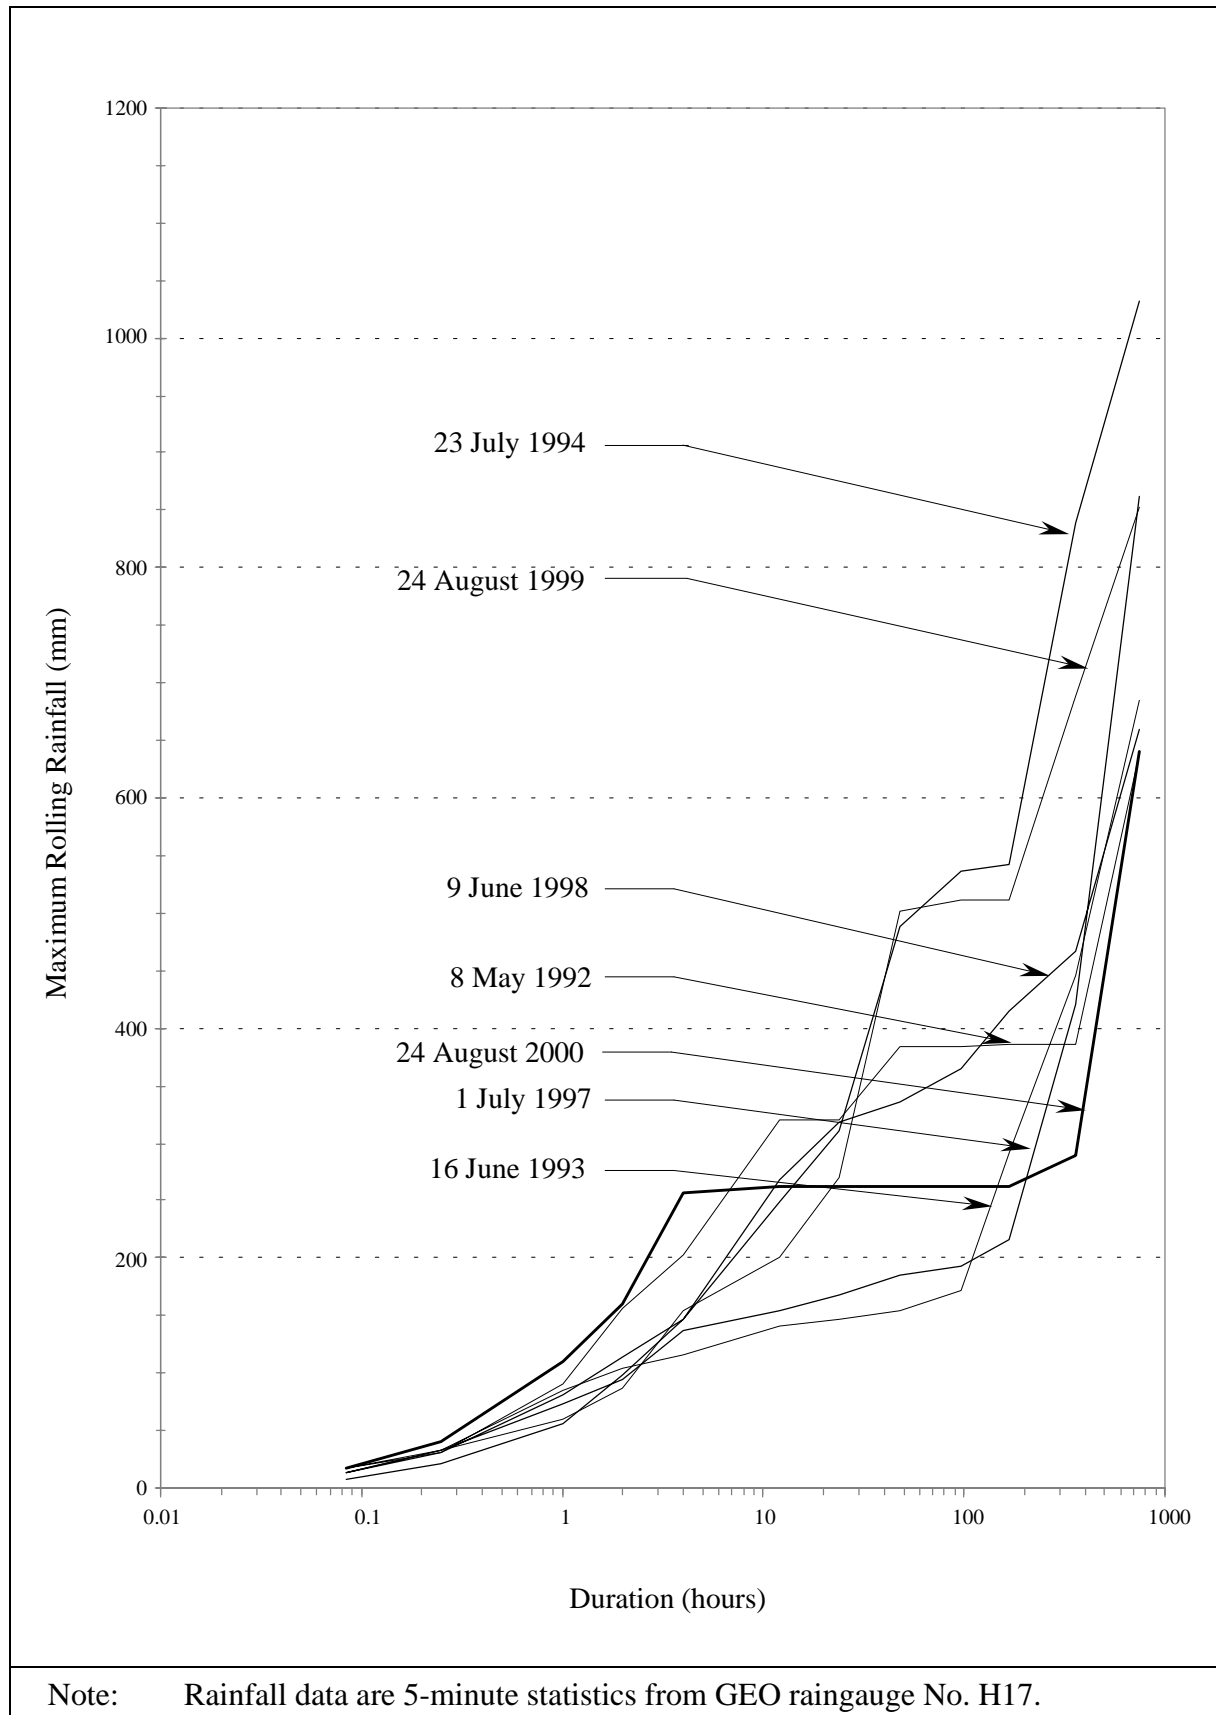
Figure 9 - Maximum Rolling Rainfall Preceding the Landslide and Selected Previous Major Rainstorms Recorded at GEO Raingauge No. H17

Table 2 presents the estimated return periods for the maximum rolling rainfall for various durations based on historical rainfall data at the Hong Kong Observatory (Lam & Leung, 1994). The 4-hour maximum rolling rainfall (257.5 mm) was the most severe, with a return period of about 50 years. A comparison of the severity of the August 2000 rainstorm and other historical major rainstorms recorded by raingauge No. H17 is presented in Figure 9. This shows that the August 2000 rainstorm was the most severe for durations up to 4 hours since installation of the raingauge in the mid-1980's.

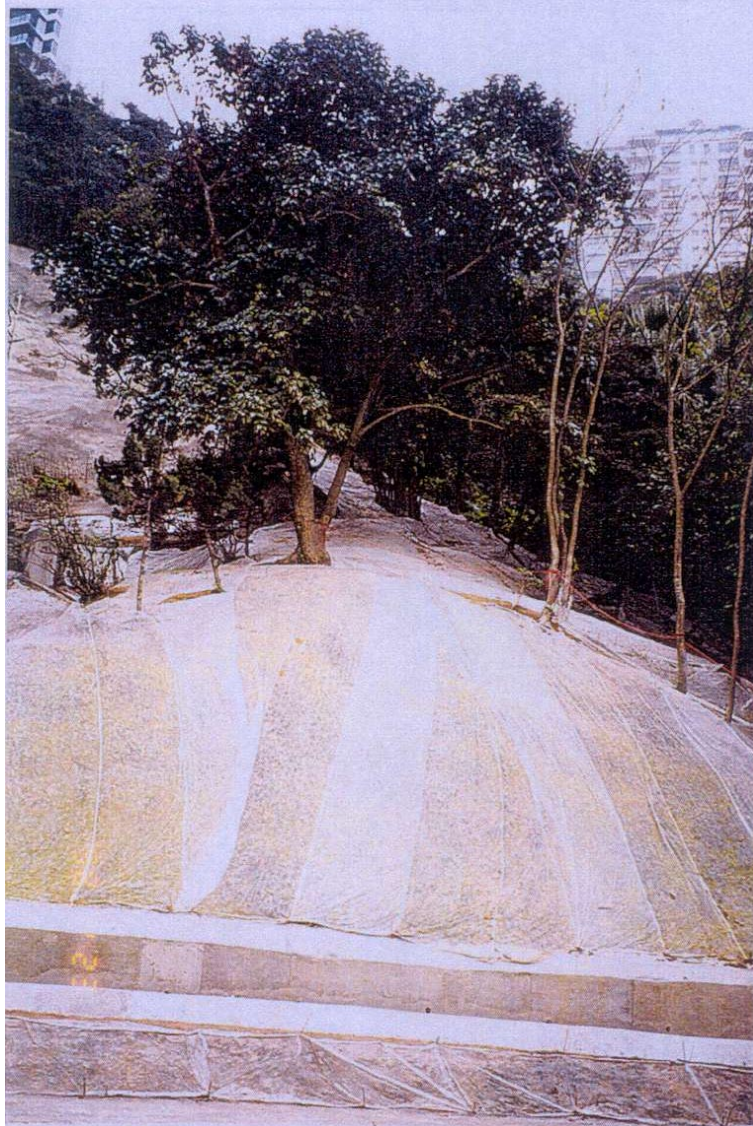
Plate 3 - View South from Bowen Road towards Newly Hydroseeded Slope No. 11SW-B/C179 and Western “Green Hatched Black” Area (Extract from CMW (1998b))

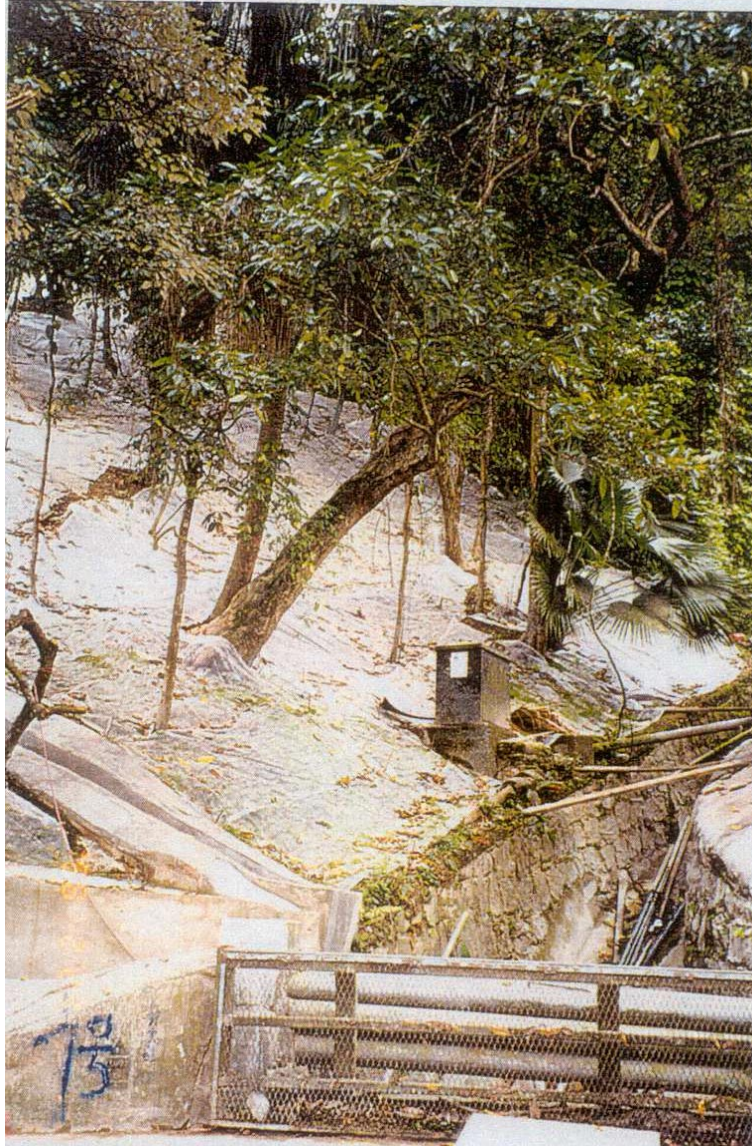
Plate 4 - View South from Bowen Road towards Newly Hydroseeded Western "Green Hatched Black" Area above Nullah (Extract from CMW (1998b). Note Gas Supply Utility Box Adjacent to Nullah, as Shown in Plate 2)

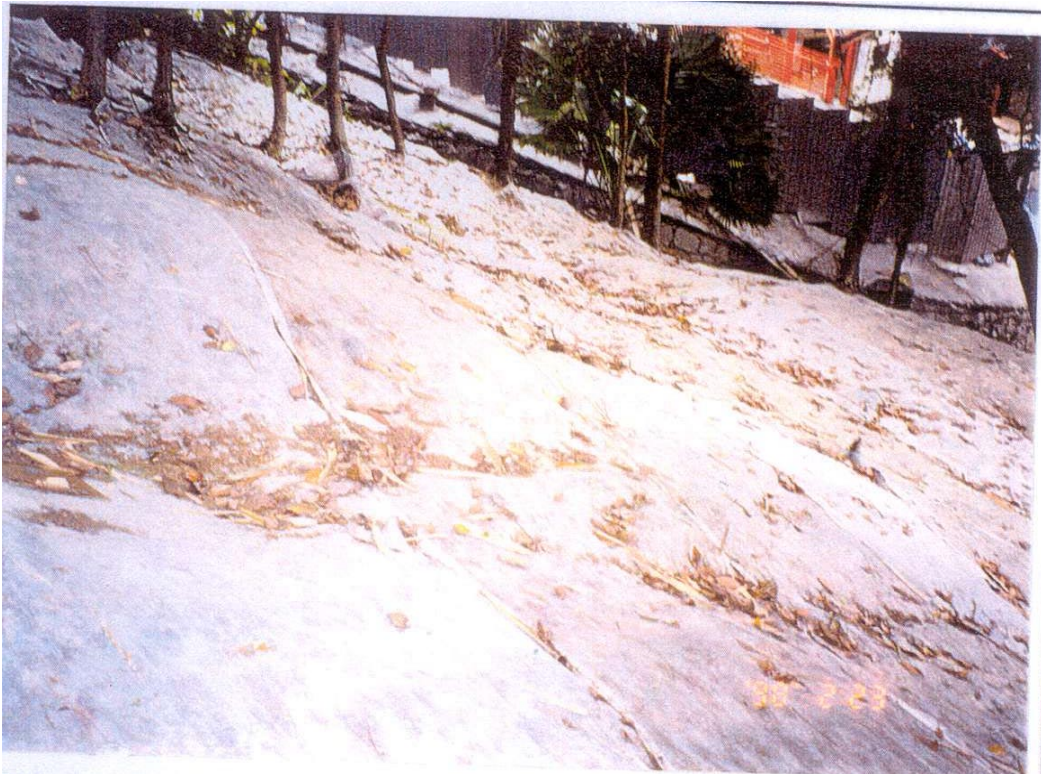
Plate 5 - View Northwest towards Nullah across Location of August 2000 Landslide Scar Showing Newly Hydroseeded Western “Green Hatched Black” Area (Extract from CMW (1998b))
