A STUDY ON PAST FAILURES OF TRENCH EXCAVATIONS

GEO REPORT No. 137

J.S.M. Kwong

**GEOTECHNICAL ENGINEERING OFFICE
CIVIL ENGINEERING DEPARTMENT
THE GOVERNMENT OF THE HONG KONG
SPECIAL ADMINISTRATIVE REGION**

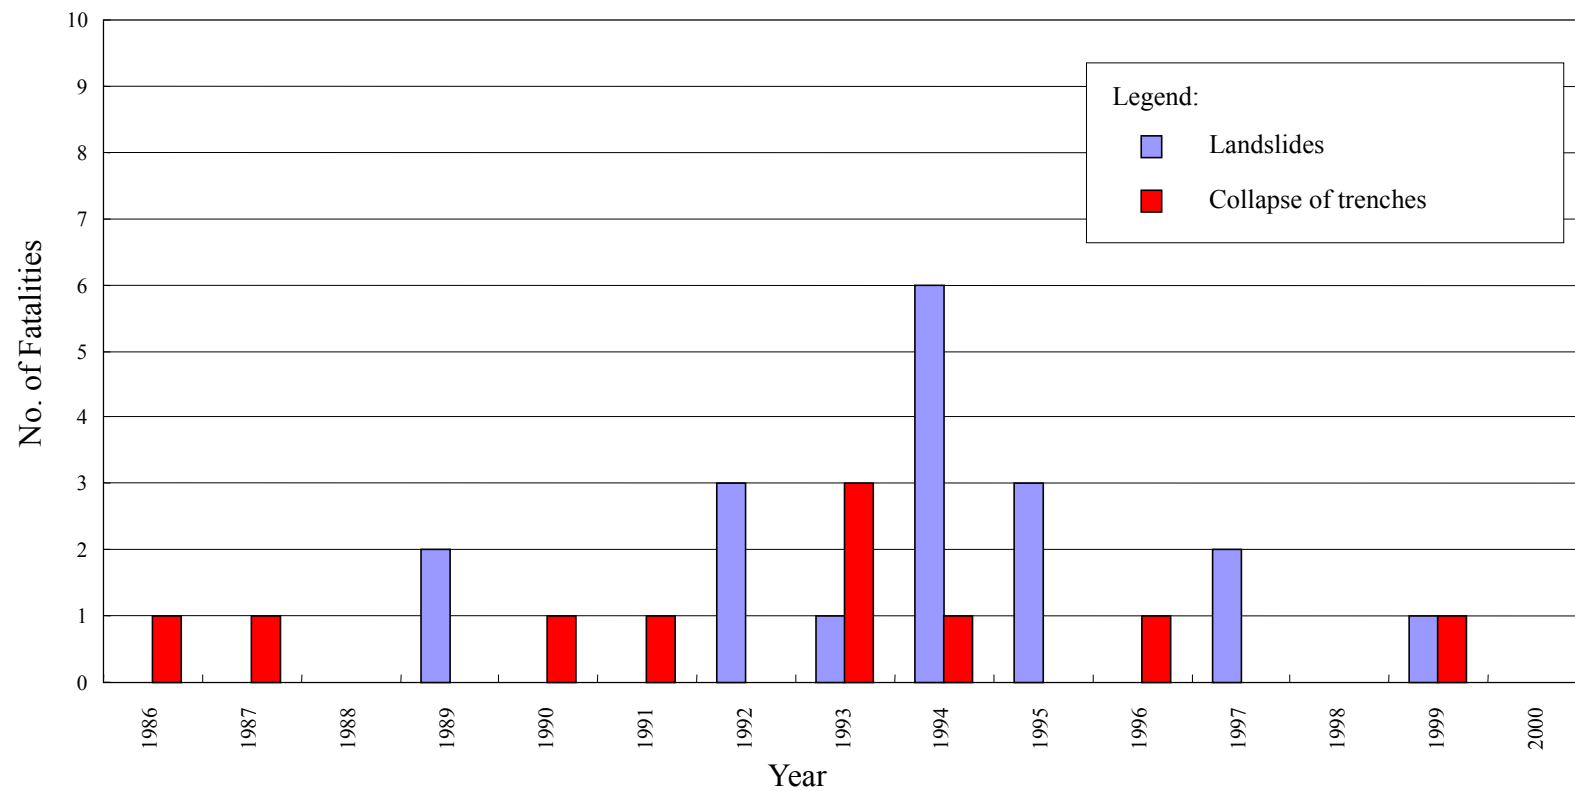
Figure 1 - Statistic on Fatalities Relating to Geotechnical Failures

Lo (2000) collated data on the number of fatalities resulting from landslides. These data, for years between 1986 and 2000, are plotted in Figure 1 together with those resulting from trench excavations. Although the number of fatalities due to trench excavations is lower than that due to landslides, it certainly is not as low as many may perceive. The safety issue relating to trench excavations warrants more attention than currently received.

Note: A trench-induced collapse of retaining wall (Case No. 1) in 1966 resulted in six deaths.

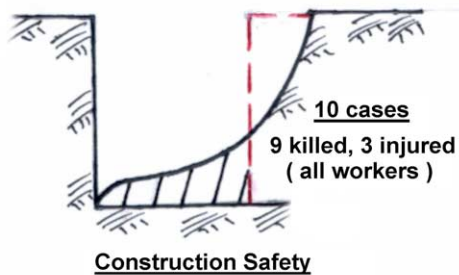
1. Collapse of Trenches

The trench-induced geotechnical failures are categorized into three types (illustrated in Figure 2), namely, collapse of trench, collapse of slope below trench and collapse of slope above trench.

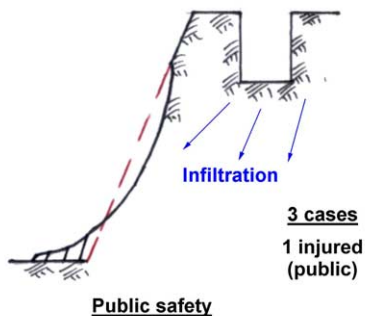
a. Trench at slope crest

*Due to infiltration into slopes
from trenches

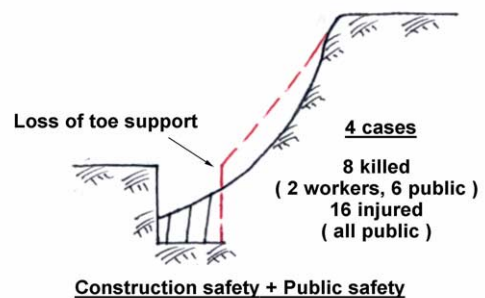
b. Trench at slope toe

* Due to loss of toe support
