**DETAILED STUDY  
OF THE 25 JUNE 2001  
ROCKFALL INCIDENT ON  
SLOPE NO. 11SE-A/C561  
ABOVE KING'S ROAD**

**GEO REPORT No. 150**

**Fugro Maunsell Scott Wilson Joint Venture**

**This report was originally produced in March 2002  
as GEO Landslide Study Report No. LSR 3/2002**

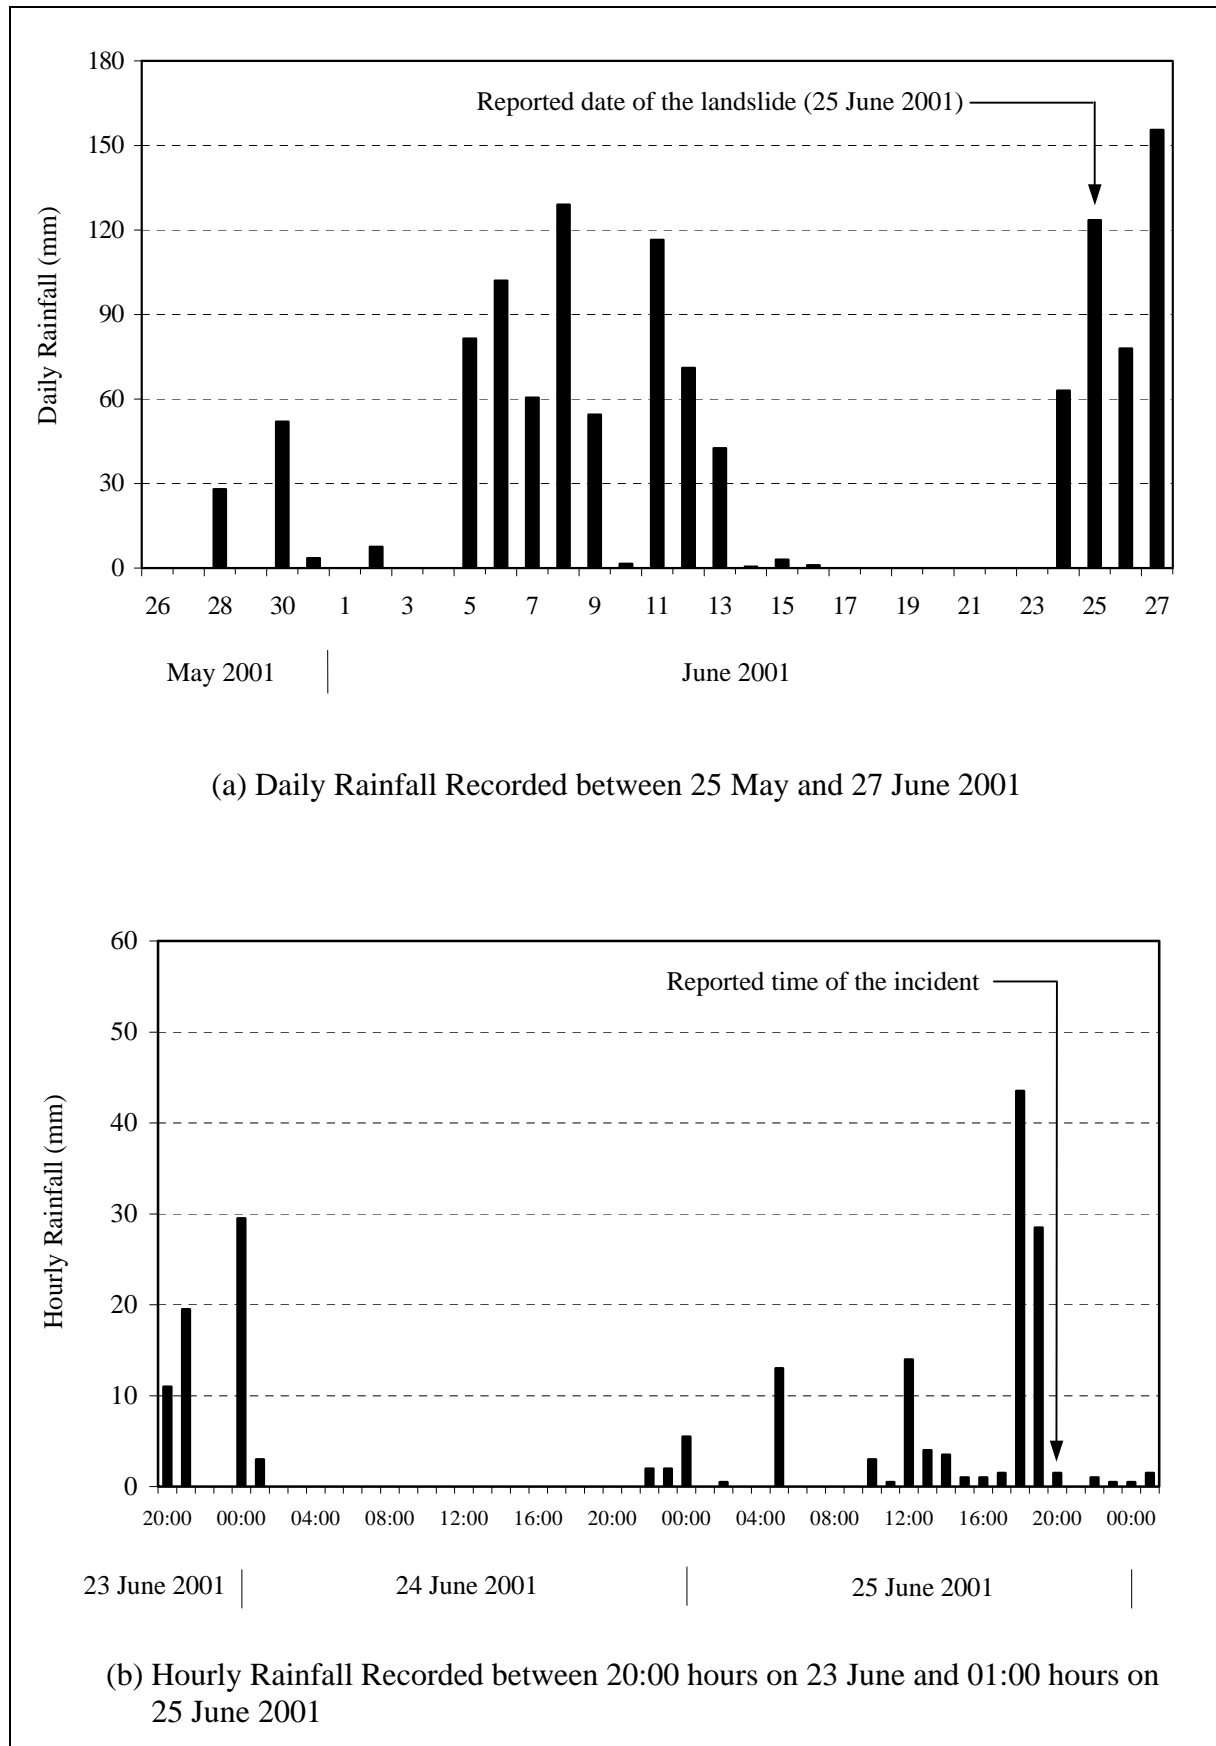
Figure 6 - Rainfall Recorded at GEO Raingauge No. H09

The daily rainfall for the period of one month preceding and two days following the incident, together with hourly rainfall for 48 hours before and 5 hours following the incident are given in Figure 6. The daily rainfall record shows that heavy rainfall was recorded over the two days prior to the rockfall, with the hourly data indicating that the highest rainfall intensities, in the range of about 30 mm/hr to 45 mm/hr, were recorded in the 2 hours prior to the rockfall.
