**DETAILED STUDY
OF THE 9 JUNE 2001
ROCKFALL INCIDENT
AT SLOPE NO. 11NW-A/C58
AT CASTLE PEAK ROAD
BELOW WAH YUEN CHUEN**

GEO REPORT No. 151

Maunsell Geotechnical Services Ltd.

**GEOTECHNICAL ENGINEERING OFFICE
CIVIL ENGINEERING AND DEVELOPMENT DEPARTMENT
THE GOVERNMENT OF THE HONG KONG
SPECIAL ADMINISTRATIVE REGION**

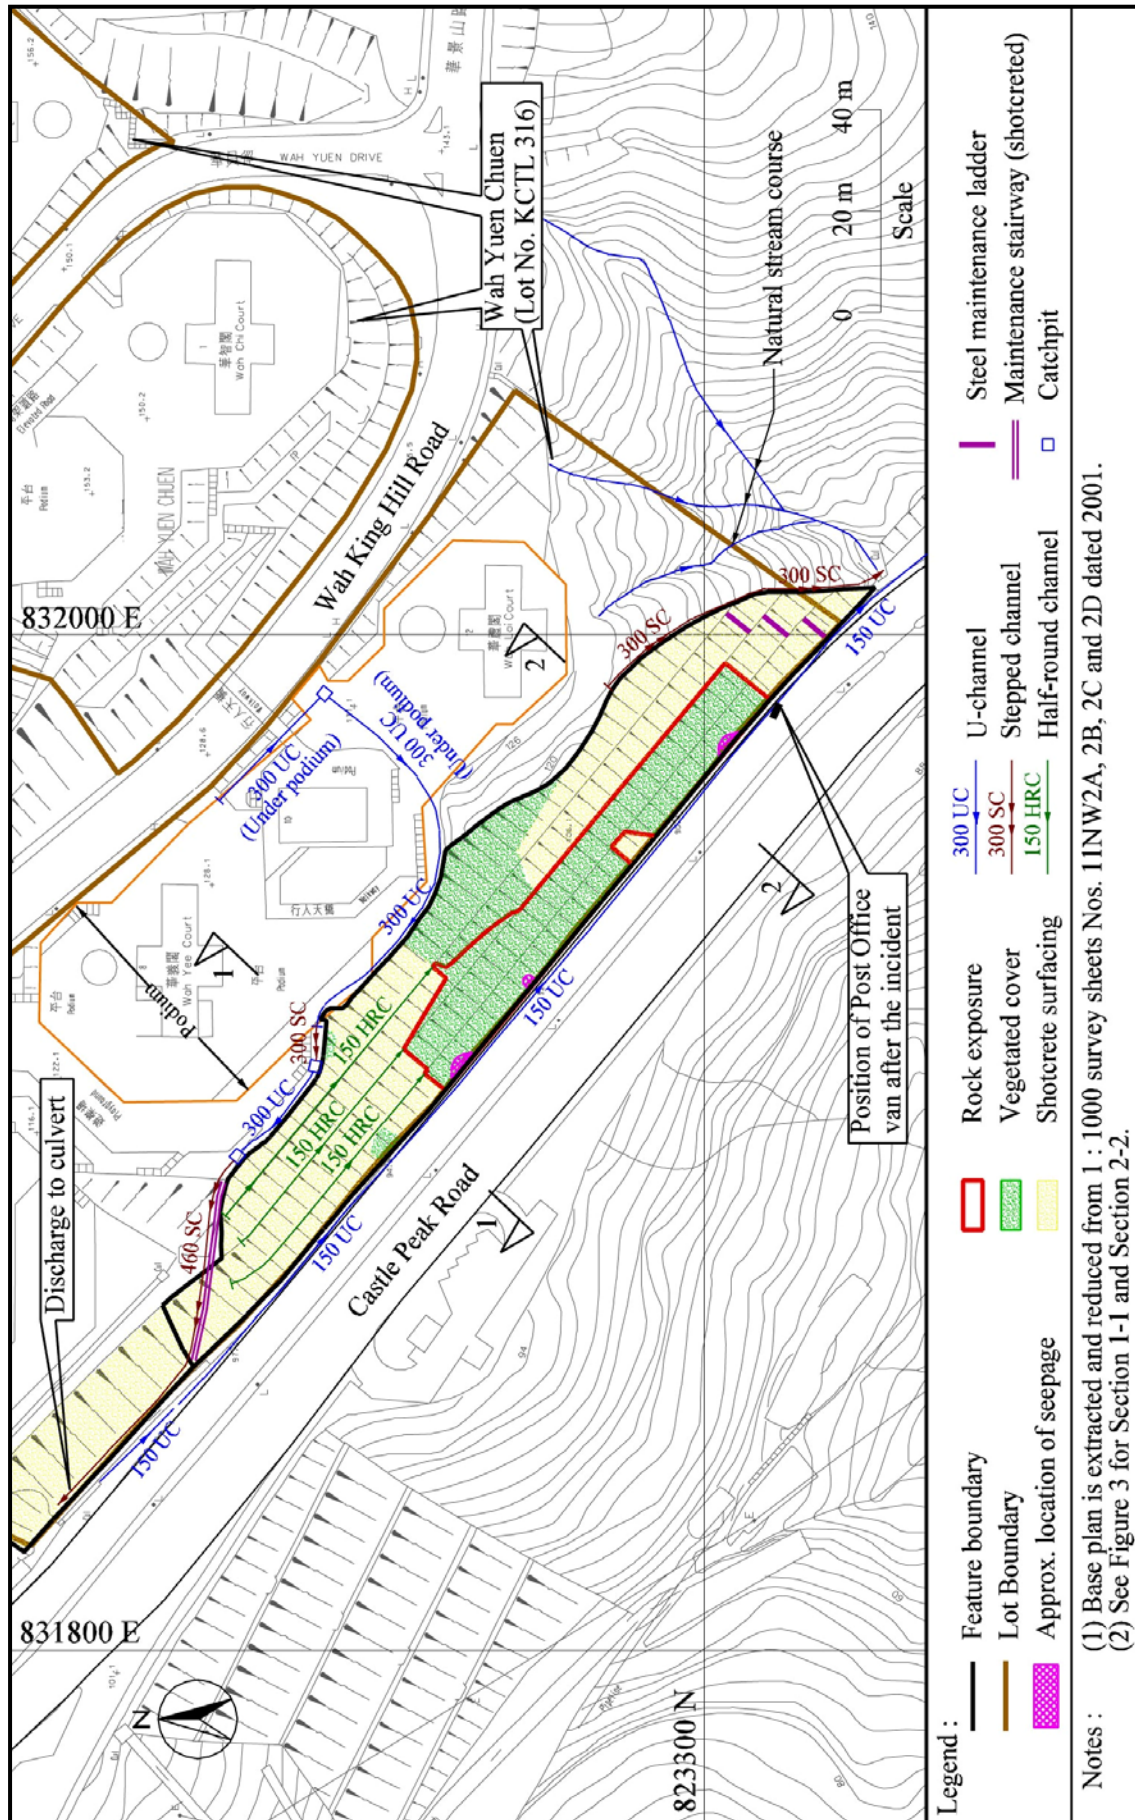
Figure 2 - General Plan Showing Site Observations

Unplanned vegetation covering much of the exposed rock portion and all the berms of slope No. 11NW-A/C58 was observed (Plate 5 and Plates 22 to 26). MGSL's observations of the size and direction of the drainage channels are shown on Figure 2. Most of the half-round channels on berms were partly blocked by unplanned vegetation (Plate 27). MGSL also noted that the surface channels on the berms of the northwest portion of the slope apparently discharge directly onto the exposed rock face (Plate 28).

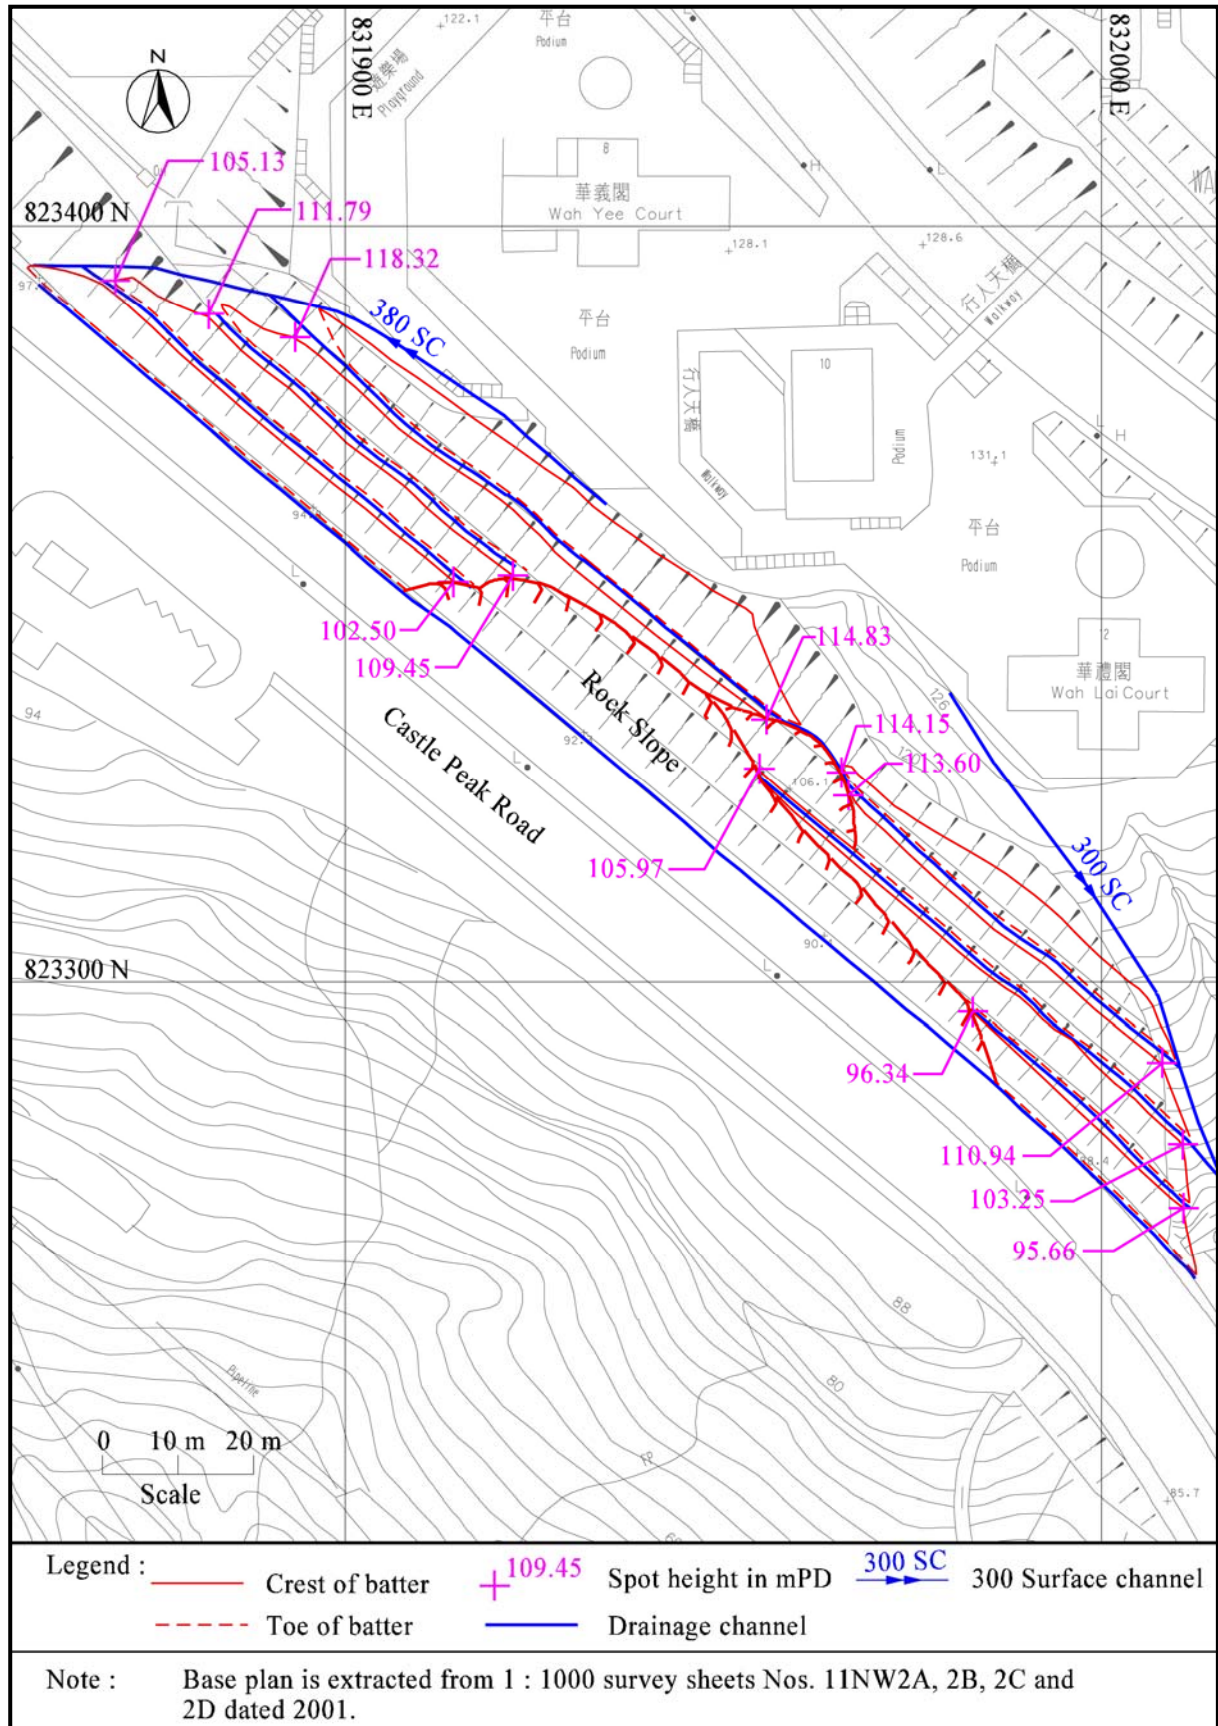
Figure 8 - Slope Drainage Plan Based on Information Extracted from Site Formation Plan Submitted to the BOO by Wong Ouyang & Associates (1978)

The drawings, which accompanied the site formation submission, show the layout plan of slope No. 11NW-A/C58 and include some detail of spot heights along the berms. Figure 8 shows the relevant information on slope drainage provisions from the drawings. The drawing indicates that the drainage channels on the first and second berms were not continuous for approximately 85 m and 40 m respectively across the exposed rock portion of the slope while the drainage channel on the third berm ran across the entire slope. Based on the spot levels shown on the approved drawing, the first and second berm channels at the northwest portion of the slope appear to fall towards the southeast and discharge surface runoff directly onto the exposed rock portion of the slope. Fugro’s geotechnical report did not contain any proposals for drainage works on slope No. 11NW-A/C58.

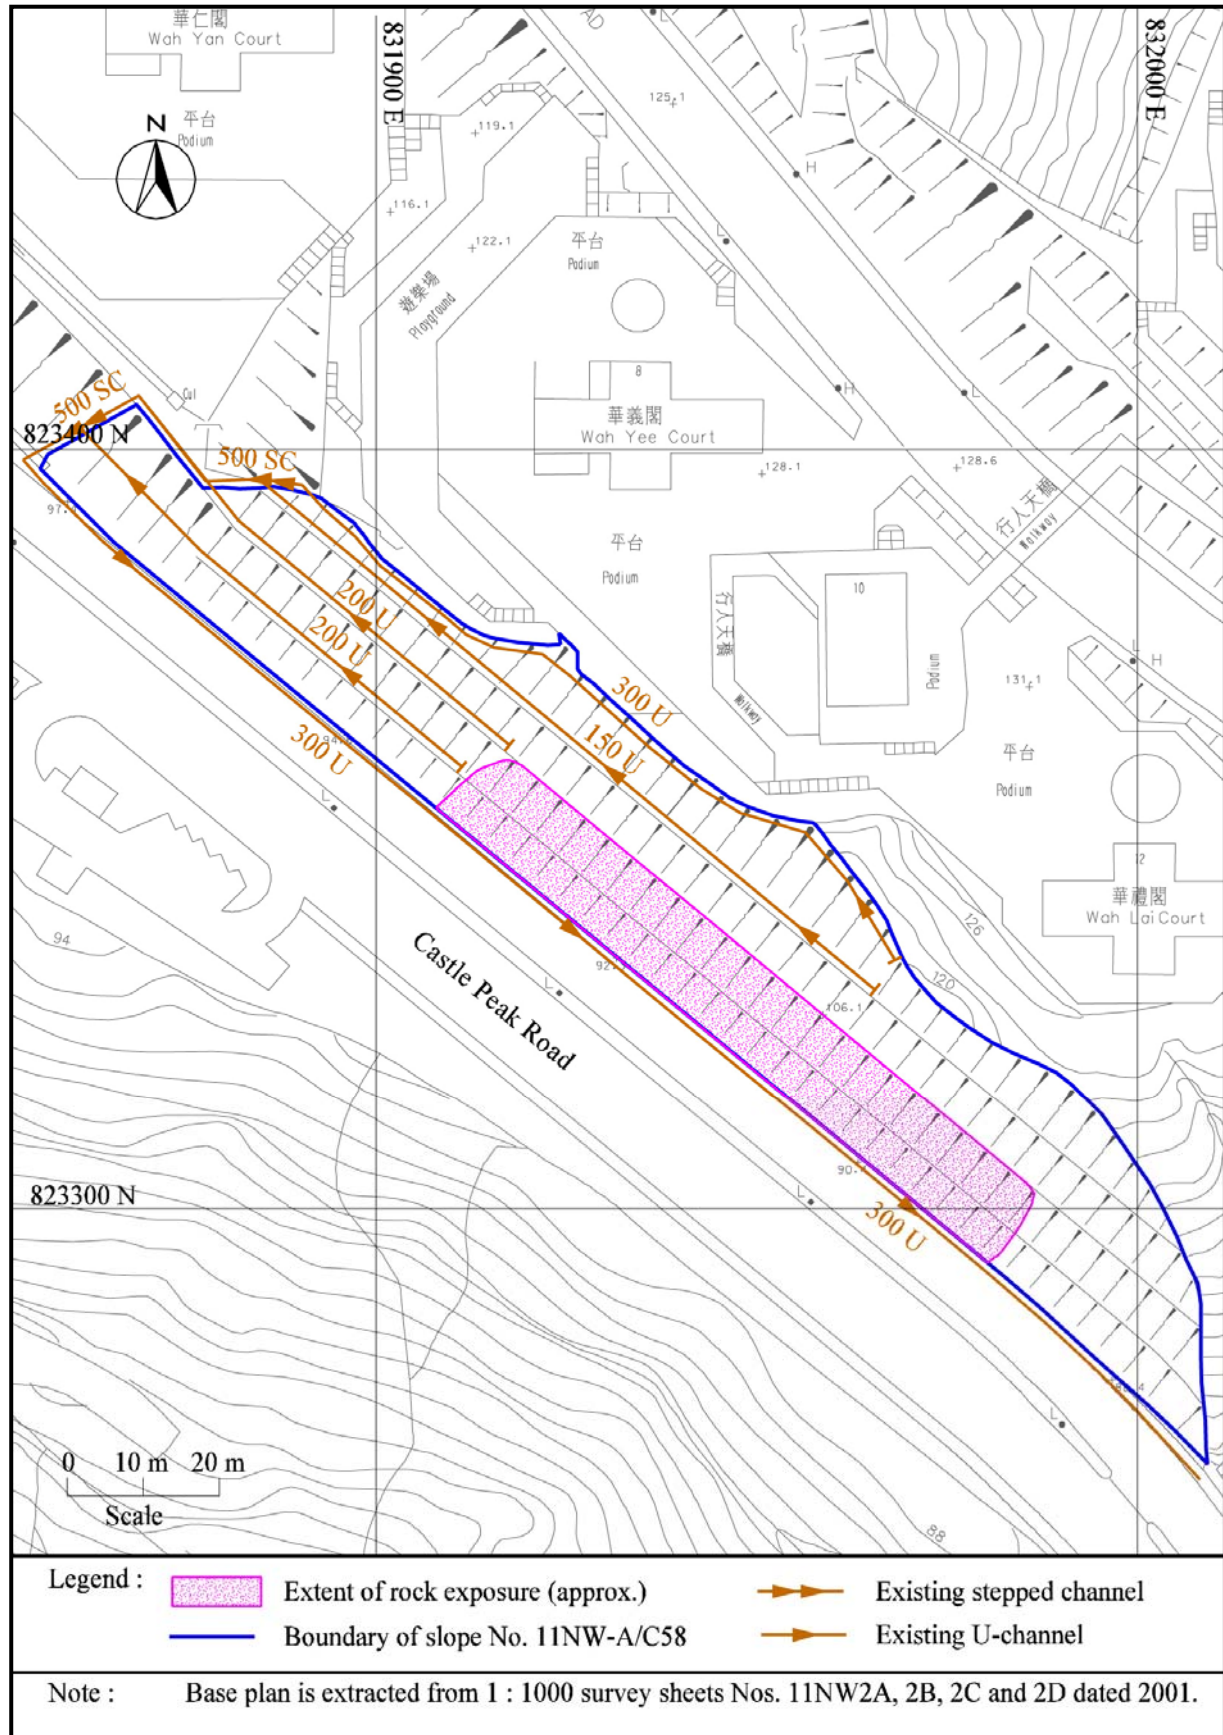
Figure 9 - Slope Drainage Details Based on Information from Stage 2 Study by Halcrow Asia Partnership

Photographs taken by HAP in mid-1997 (Plate 11) show extensive new shotcrete on the northwest and southeast portions of slope No. 11NW-A/C58. HAP's observations of the surface drainage are shown in Figure 9. HAP noted that the surface drainage channels on all three berms to the northwest of the exposed rock portion drain towards the northwest. These observations are inconsistent with the post-failure site observations made by MGSL (see Section 2.1) that the drainage channels on the northwest portion of the slope drain to the southeast and onto the exposed rock portion of the slope (Figure 2). On the southeast portion of the slope, HAP observed no drainage on any of the berms, which is consistent with MGSL's observations (see Section 2.1), whereas W&O's approved site formation plan (Figure 8) shows drains on each of the berms with spot heights that indicate falls towards the southeast. It is possible that the drains on the southeast portion of the slope have been concealed by the shotcreting applied in 1997 (see Section 2.4.1). For the central, exposed rock slope portion, HAP noted "A small number of shrubs and unplanned vegetation were present".

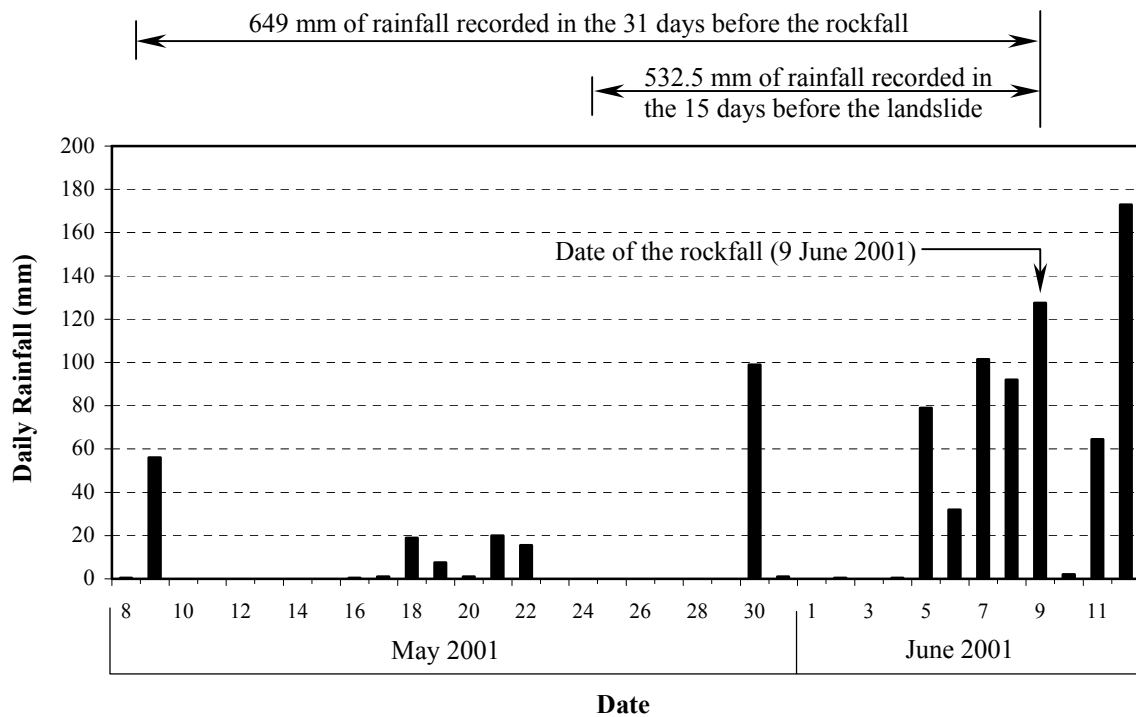
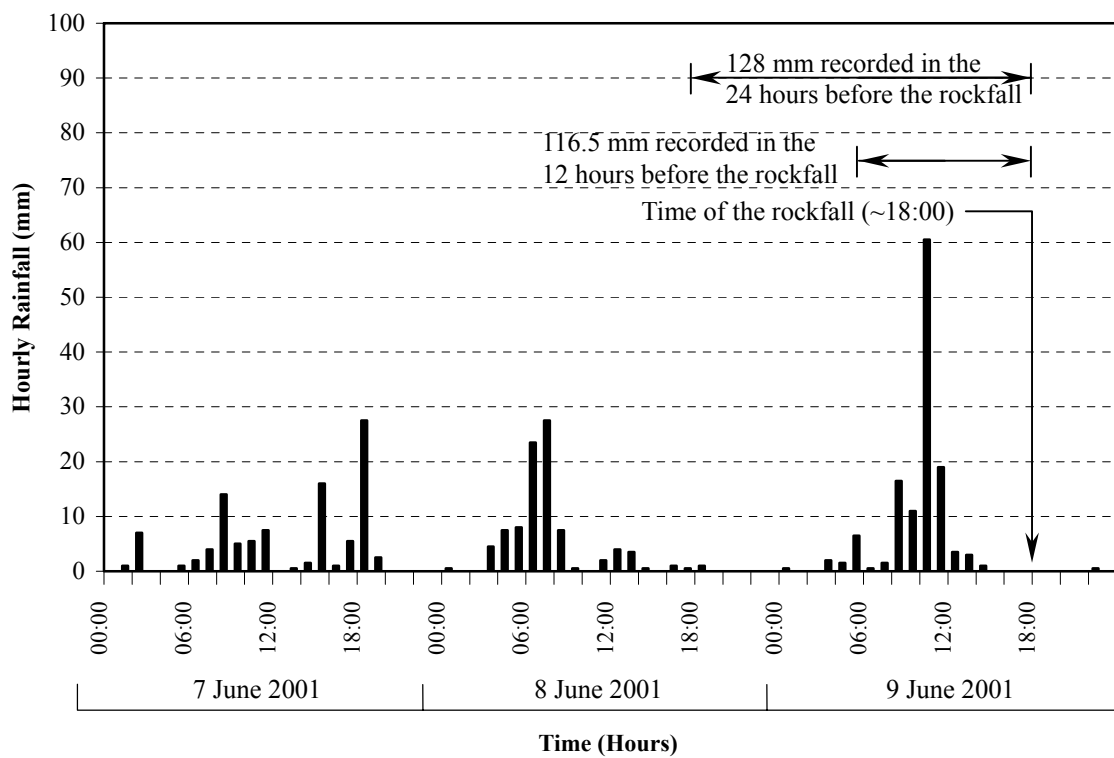
Figure 10 - Daily and Hourly Rainfall Recorded at GEO Raingauge No. N04 for June 2001

The nearest GEO automatic raingauge No. N04 (which has been in service since September 1978) to the rockfall site is located at Kai Kwong Lau, Cho Yiu Estate, about 640 m to the southwest of the site (Figure 1). The daily rainfall recorded in May and June 2001, together with the hourly rainfall from 7 to 9 June 2001, is shown in Figure 10.

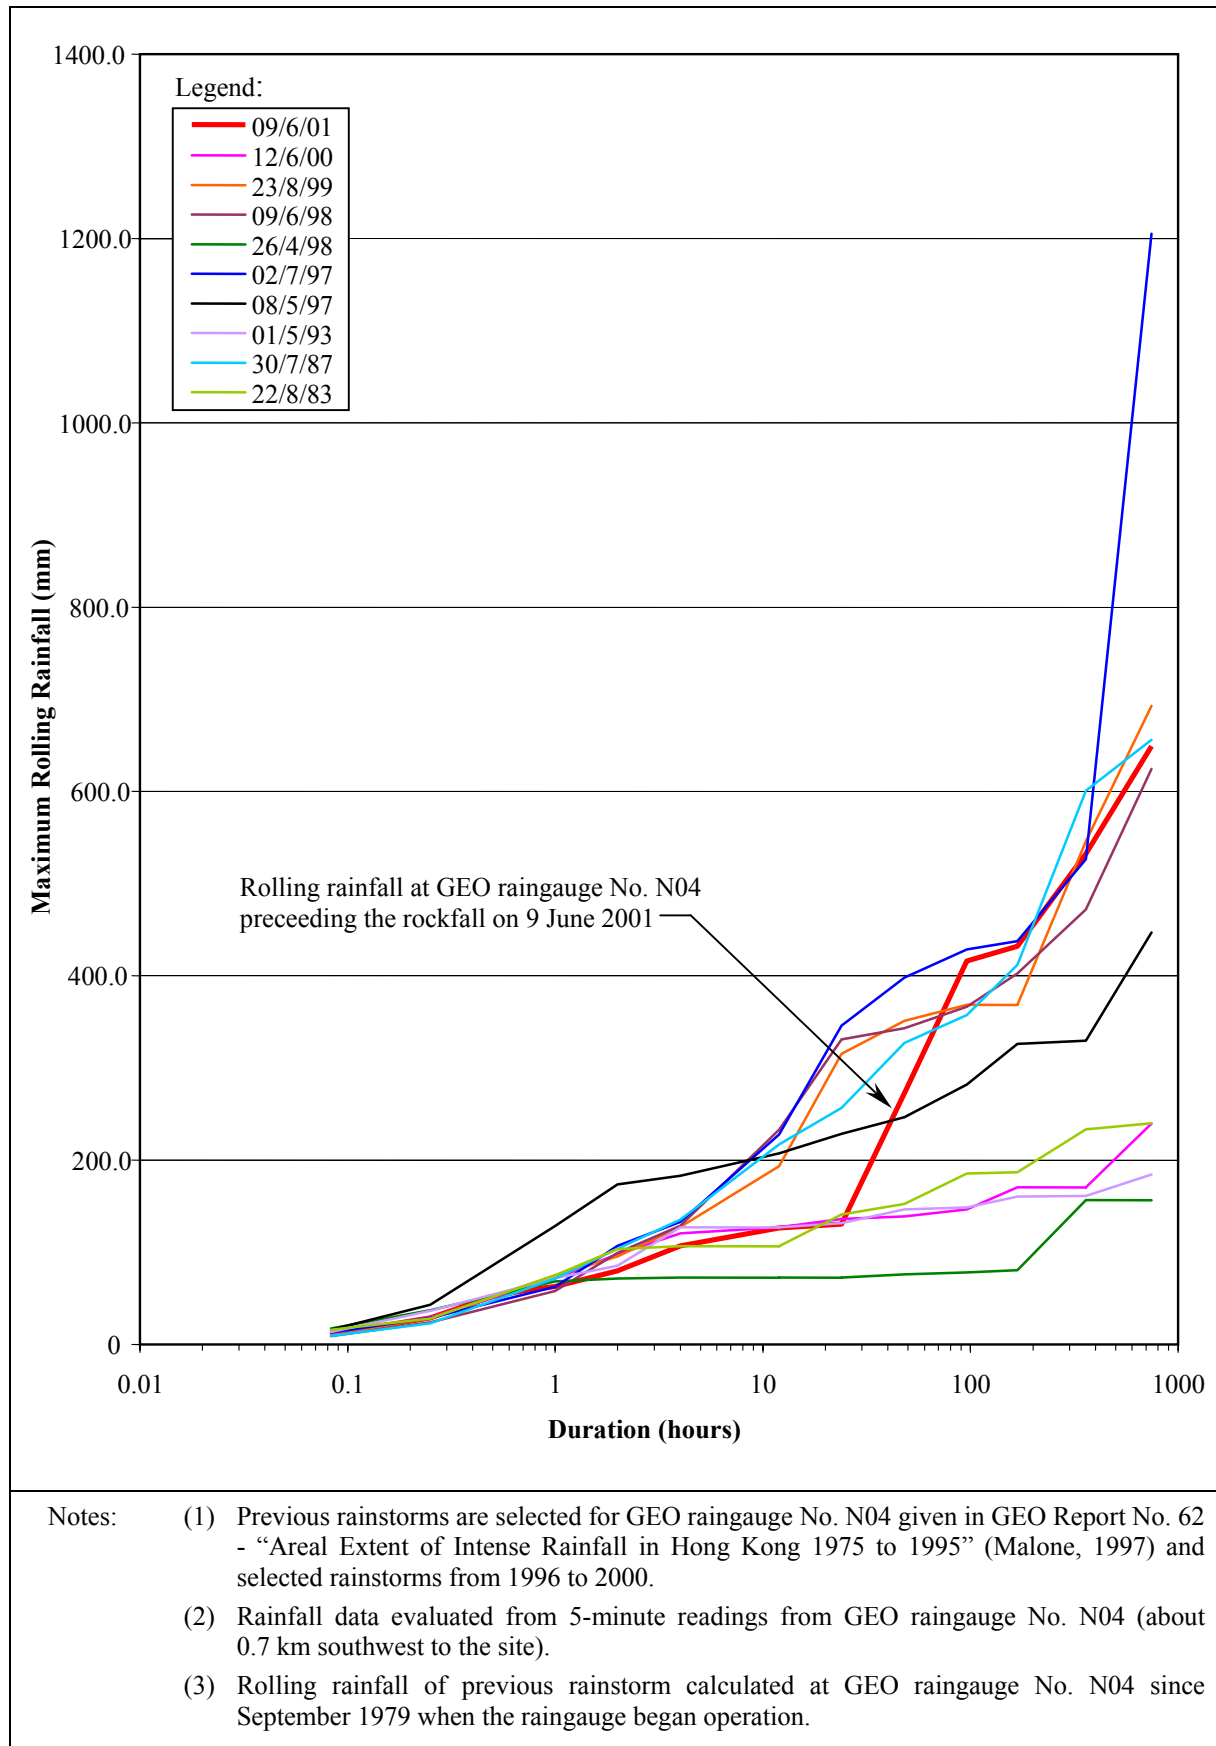
Figure 11 - Maximum Rolling Rainfall for Previous Major Rainstorms at GEO Raingauge No. N04

The maximum rolling rainfalls for the rainstorm on 9 June 2001 have been compared with the previous available data on severe rainstorms since automatic raingauge No. N04 became operational in September 1978 (Figure 11). The maximum rolling rainfalls for the rainstorm on 9 June 2001 were not exceptionally heavy compared with previous rainstorms.

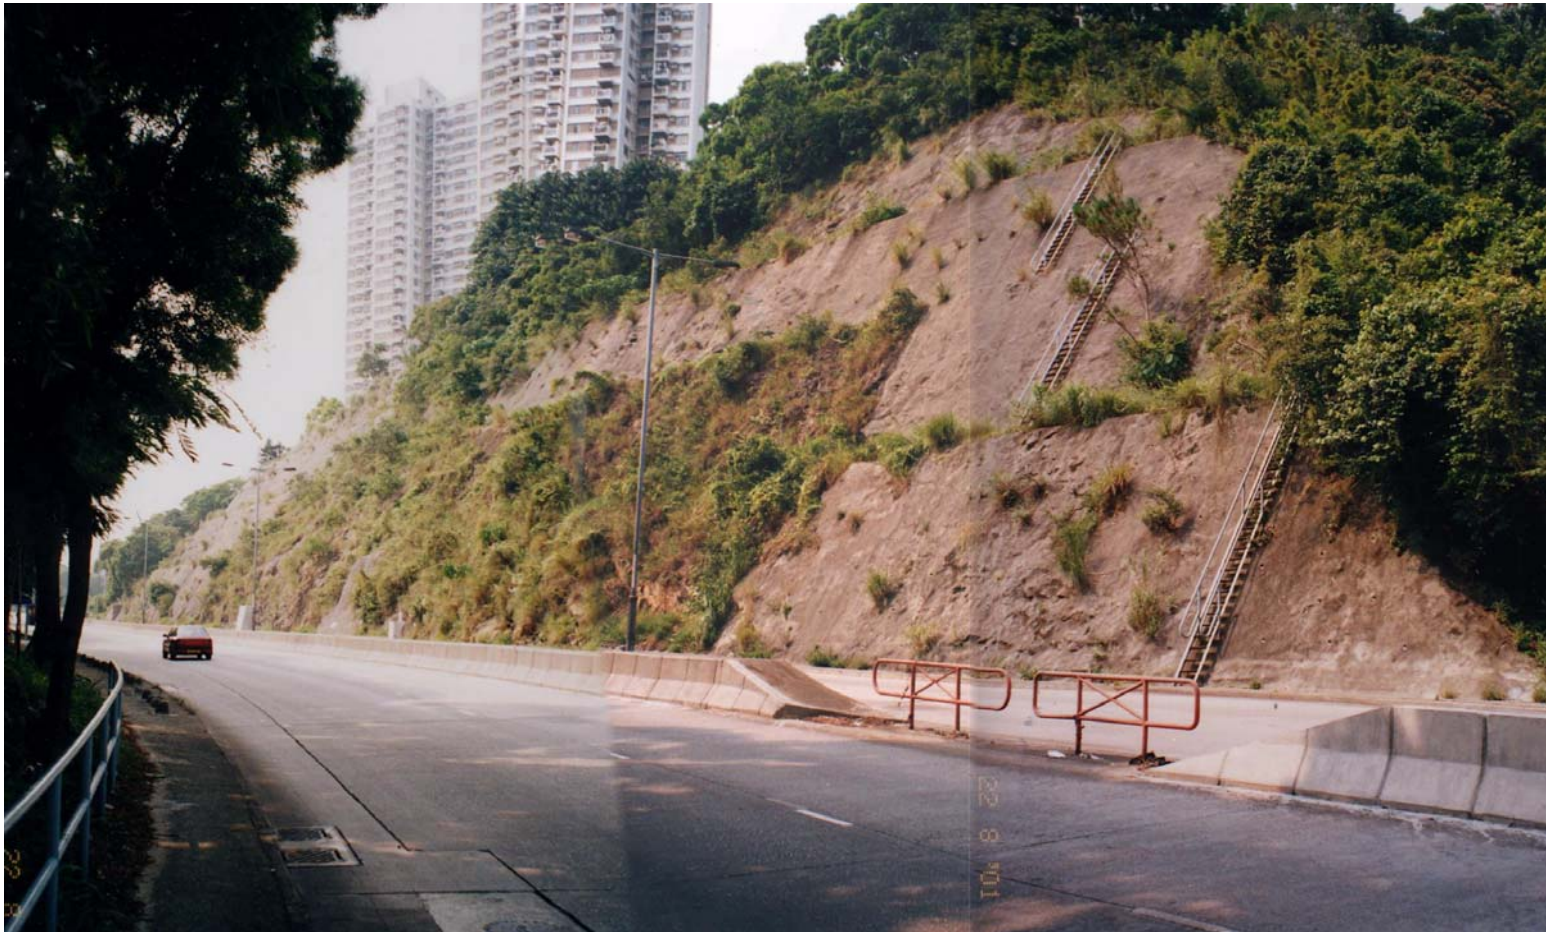
Plate 4 - General View of Slope No. 11NW-A/C58 in 2001 (Photograph taken on 22 August 2001)

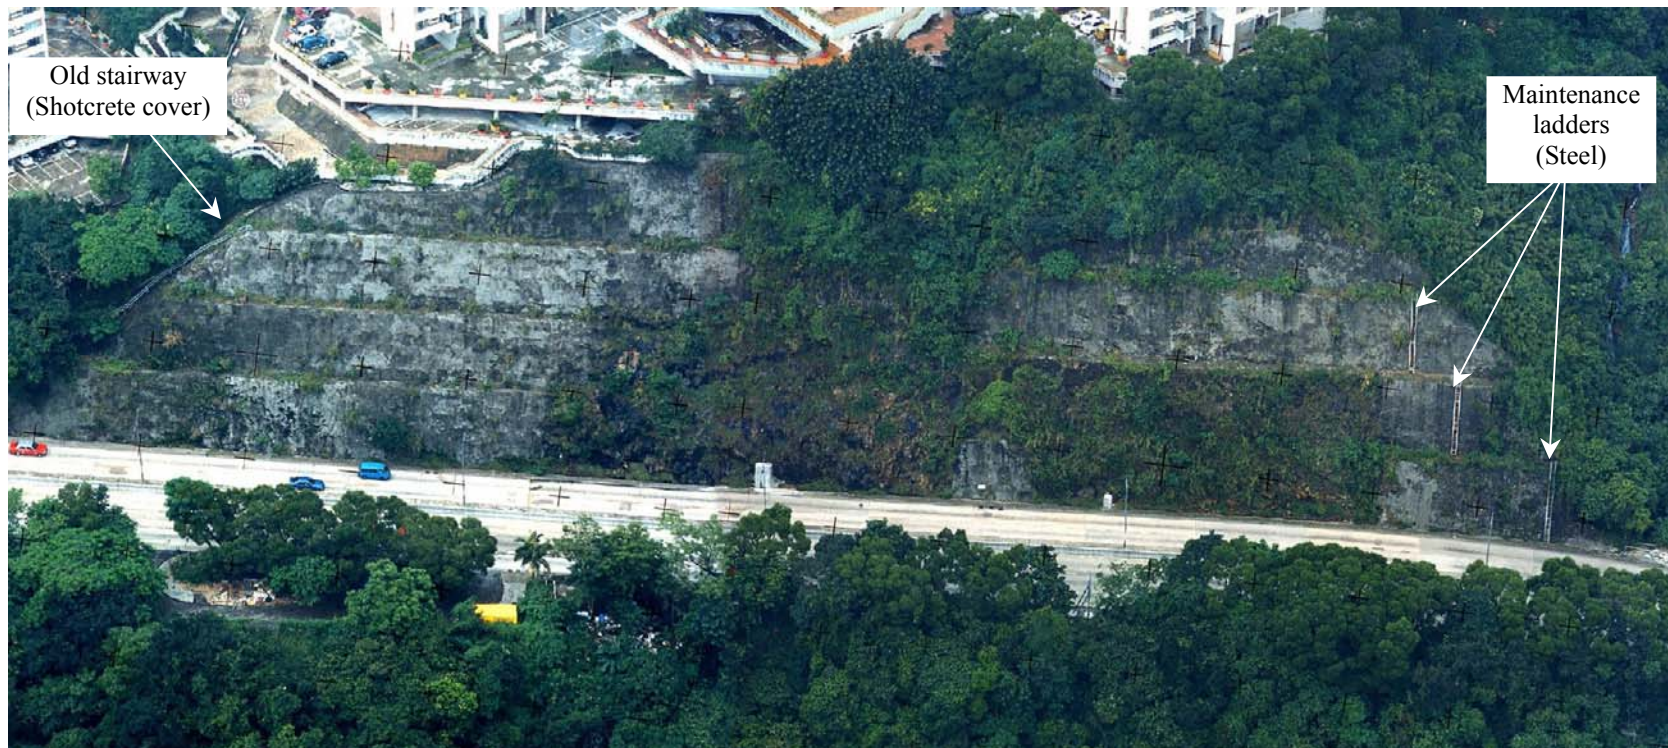
Plate 5 - General View of Slope No. 11NW-A/C58 in 2001 showing Development of Wah Yuen Chuen at Crest
(Photograph taken on 7 September 2001)

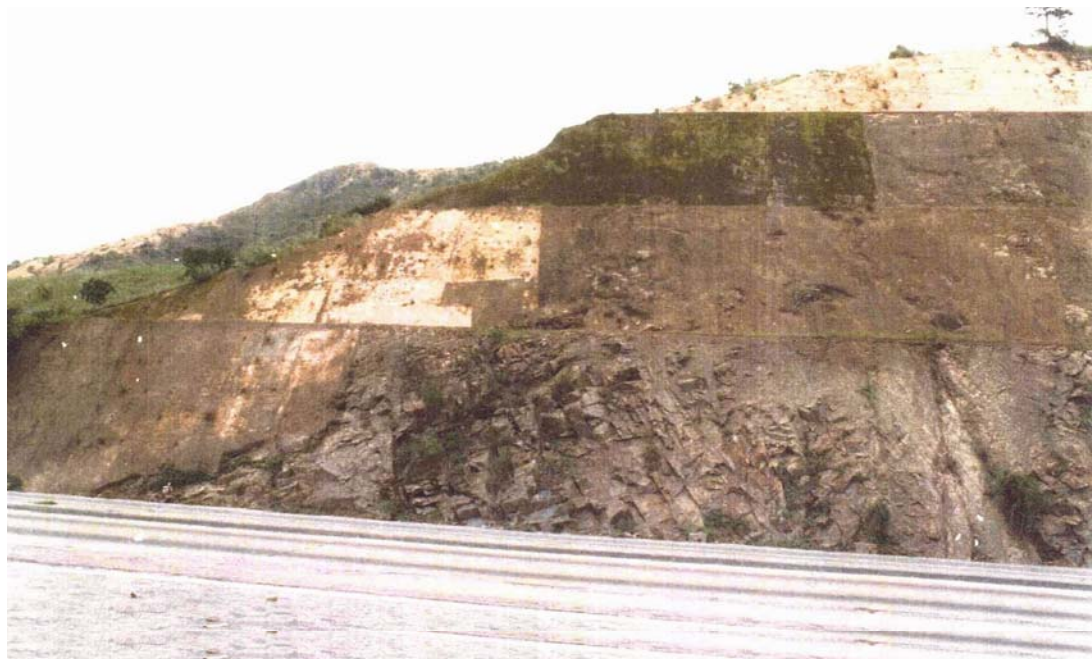
Plate 7 - View of Northwest Portion of Slope No. 11NW-A/C58 in 1977 (Photograph taken by B&P in June 1977)

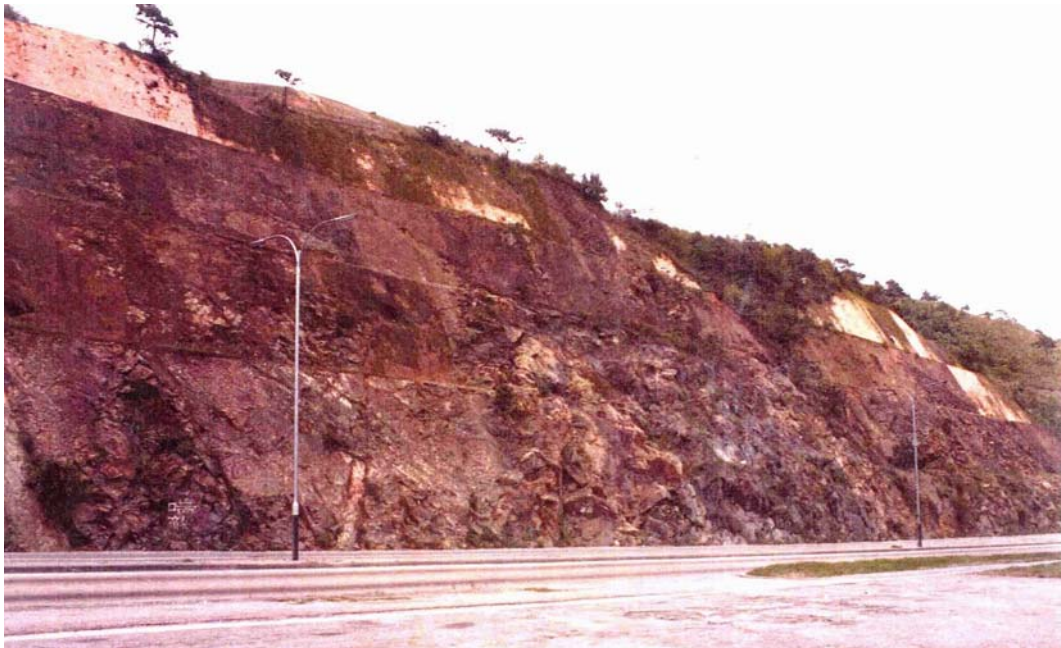
Plate 8 - View of Central and Southeast Portion of Slope No. 11NW-A/C58 in 1977 (Photograph taken by B&P in June 1977)

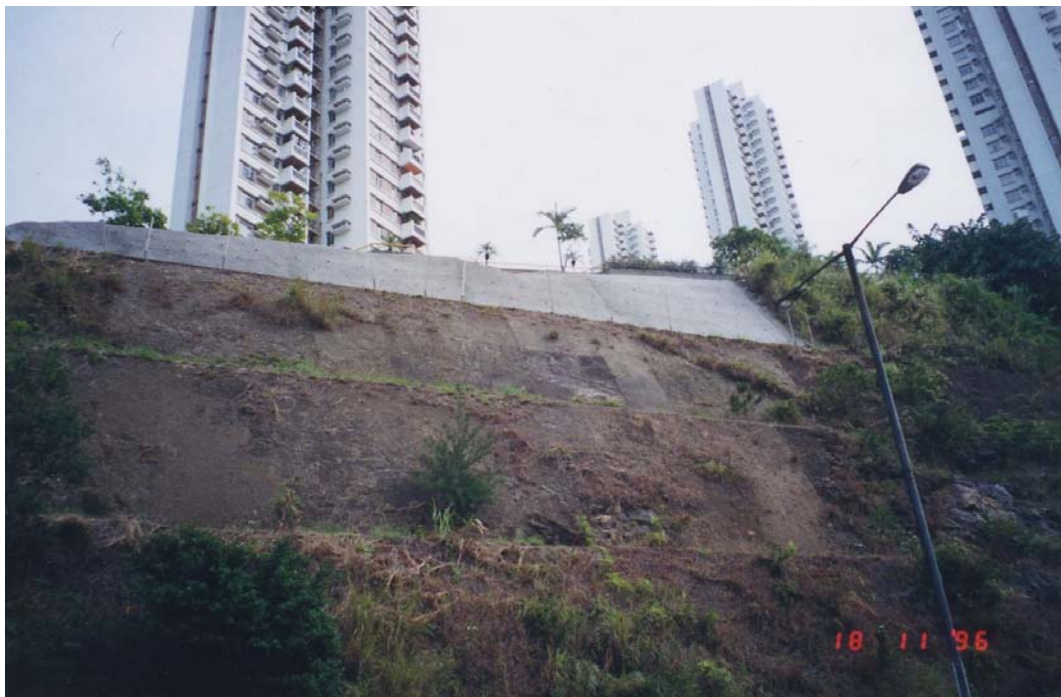
On 28 October 1996, HyD informed the GEO that they would shortly shotcrete slope No. 11NW-A/C58 (see Section 2.4.1). The GEO’s Design Division inspected the slope in November 1996 just after the commencement of the shotcreting works. The GEO inspection record noted seepage along joints on the exposed rock portion of the slope below the second berm. No record of loose rock blocks was mentioned in the GEO’s inspection record. Areas of unplanned vegetation on the exposed rock portion of the slope are shown in the accompanying photographs (Plate 10) and indicated in a sketch attached to the inspection record.

Plate 9 - General View of New Shotcrete at Fourth Batter at Northwest Portion of Slope No. 11NW-A/C 58 within the Private Portion in 1996 (Photograph taken by GEO on 18 November 1996)

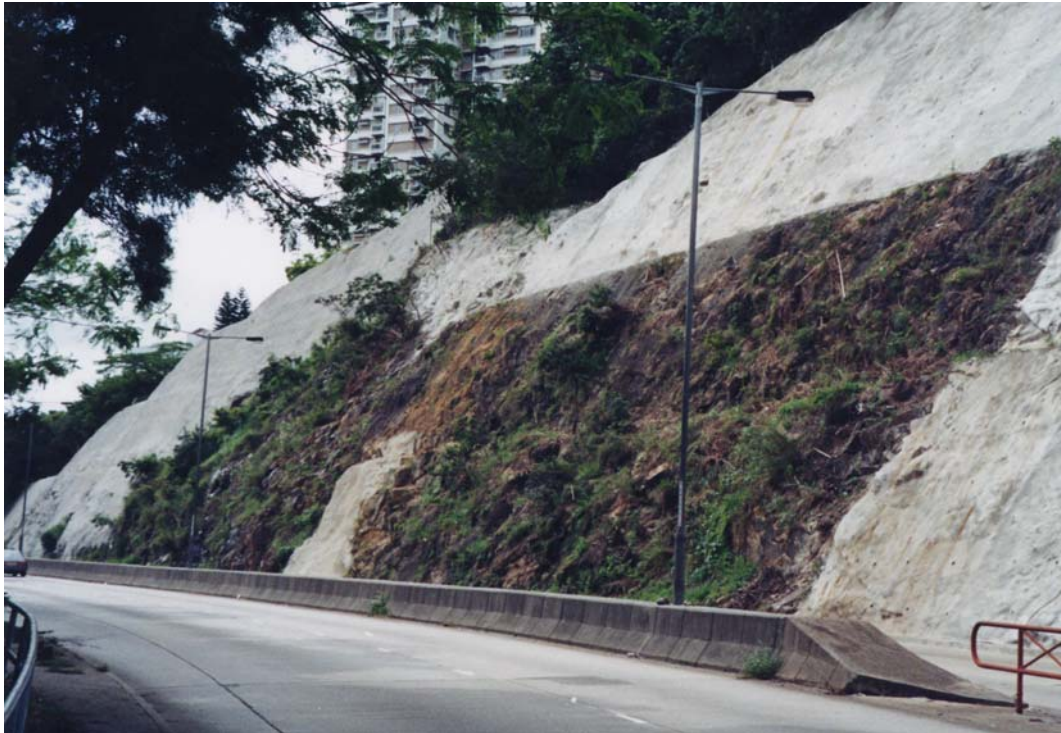
Plate 12 - General View of Slope No. 11NW-A/C58 in 1997
(Photograph taken by HAP on 14 July 1997)

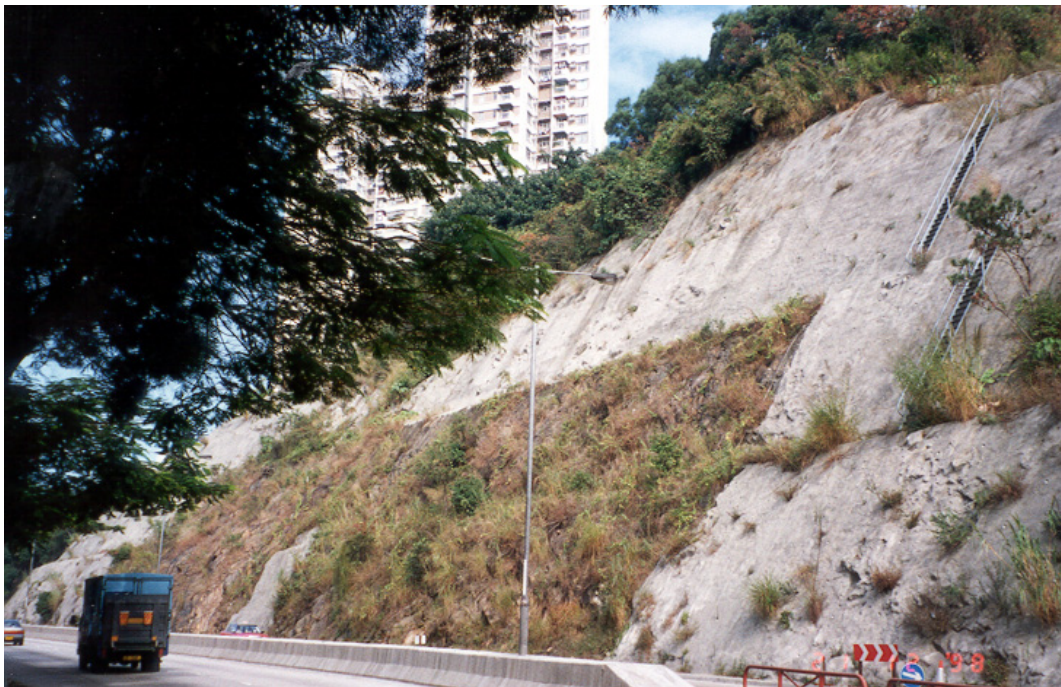
Plate 13 - General View of Slope No. 11NW-A/C58 in 1998
(Photograph taken by HyD on 21 December 1998)

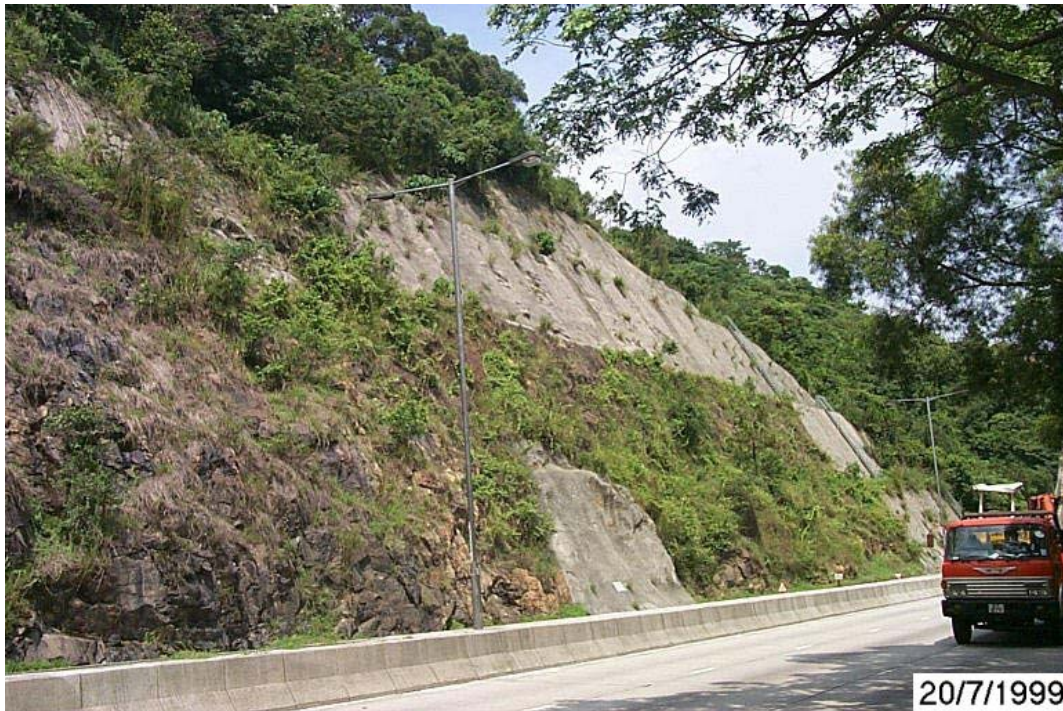
Plate 14 - General View of Slope No. 11NW-A/C58 in 1999
(Photograph taken by GEO on 20 July 1999)

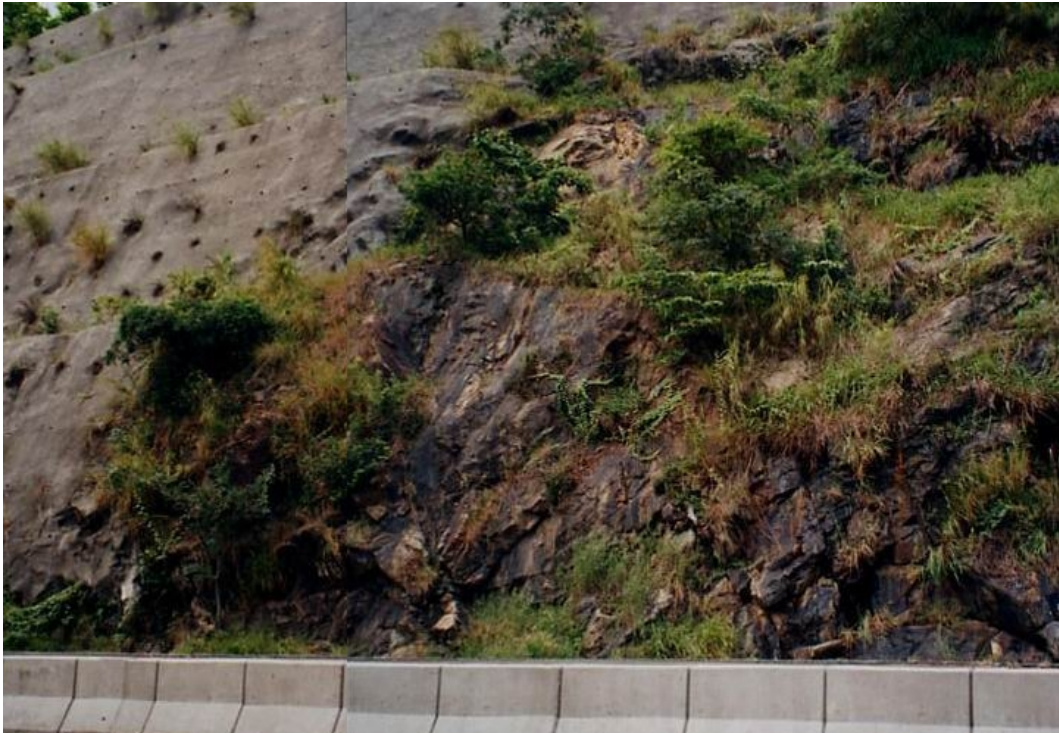
Plate 25 - View of Northwest End of Exposed Rock Portion of Slope No. 11NW-A/C58 (Photograph taken on 14 August 2001)

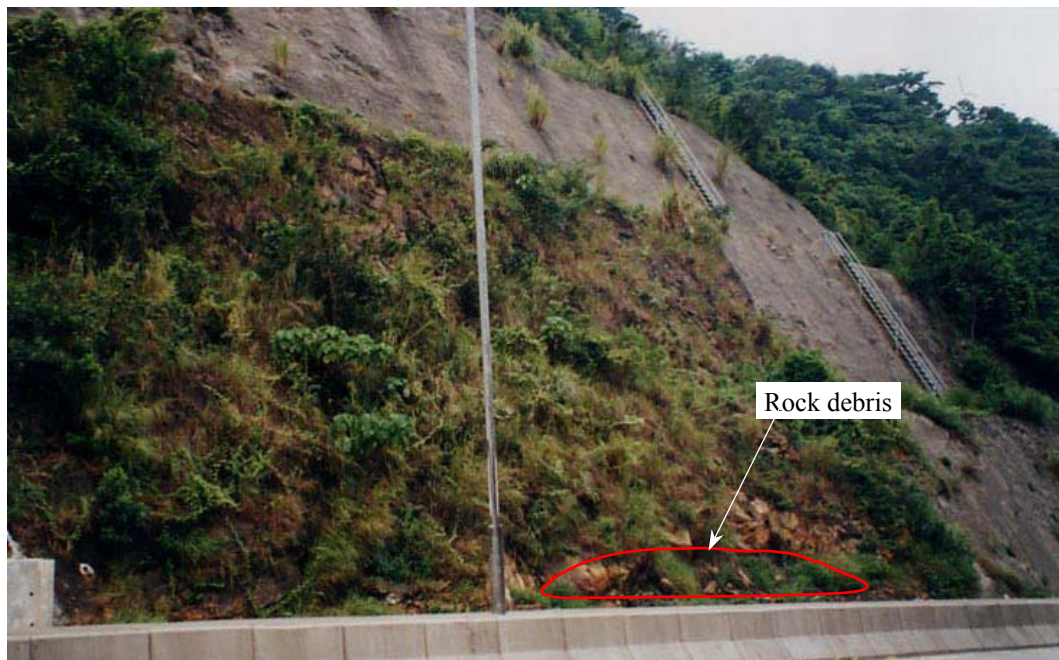
Plate 26 - View of Southeast End of the Exposed Rock Portion of Slope No. 11NW-A/C58 (Photograph taken on 14 August 2001)
