**DETAILED STUDY OF
THE 14 DECEMBER 2001
WASHOUT INCIDENT
BELOW POKFIELD ROAD,
KENNEDY TOWN**

GEO REPORT No. 152

Fugro Maunsell Scott Wilson Joint Venture

**GEOTECHNICAL ENGINEERING OFFICE
CIVIL ENGINEERING AND DEVELOPMENT DEPARTMENT
THE GOVERNMENT OF THE HONG KONG
SPECIAL ADMINISTRATIVE REGION**

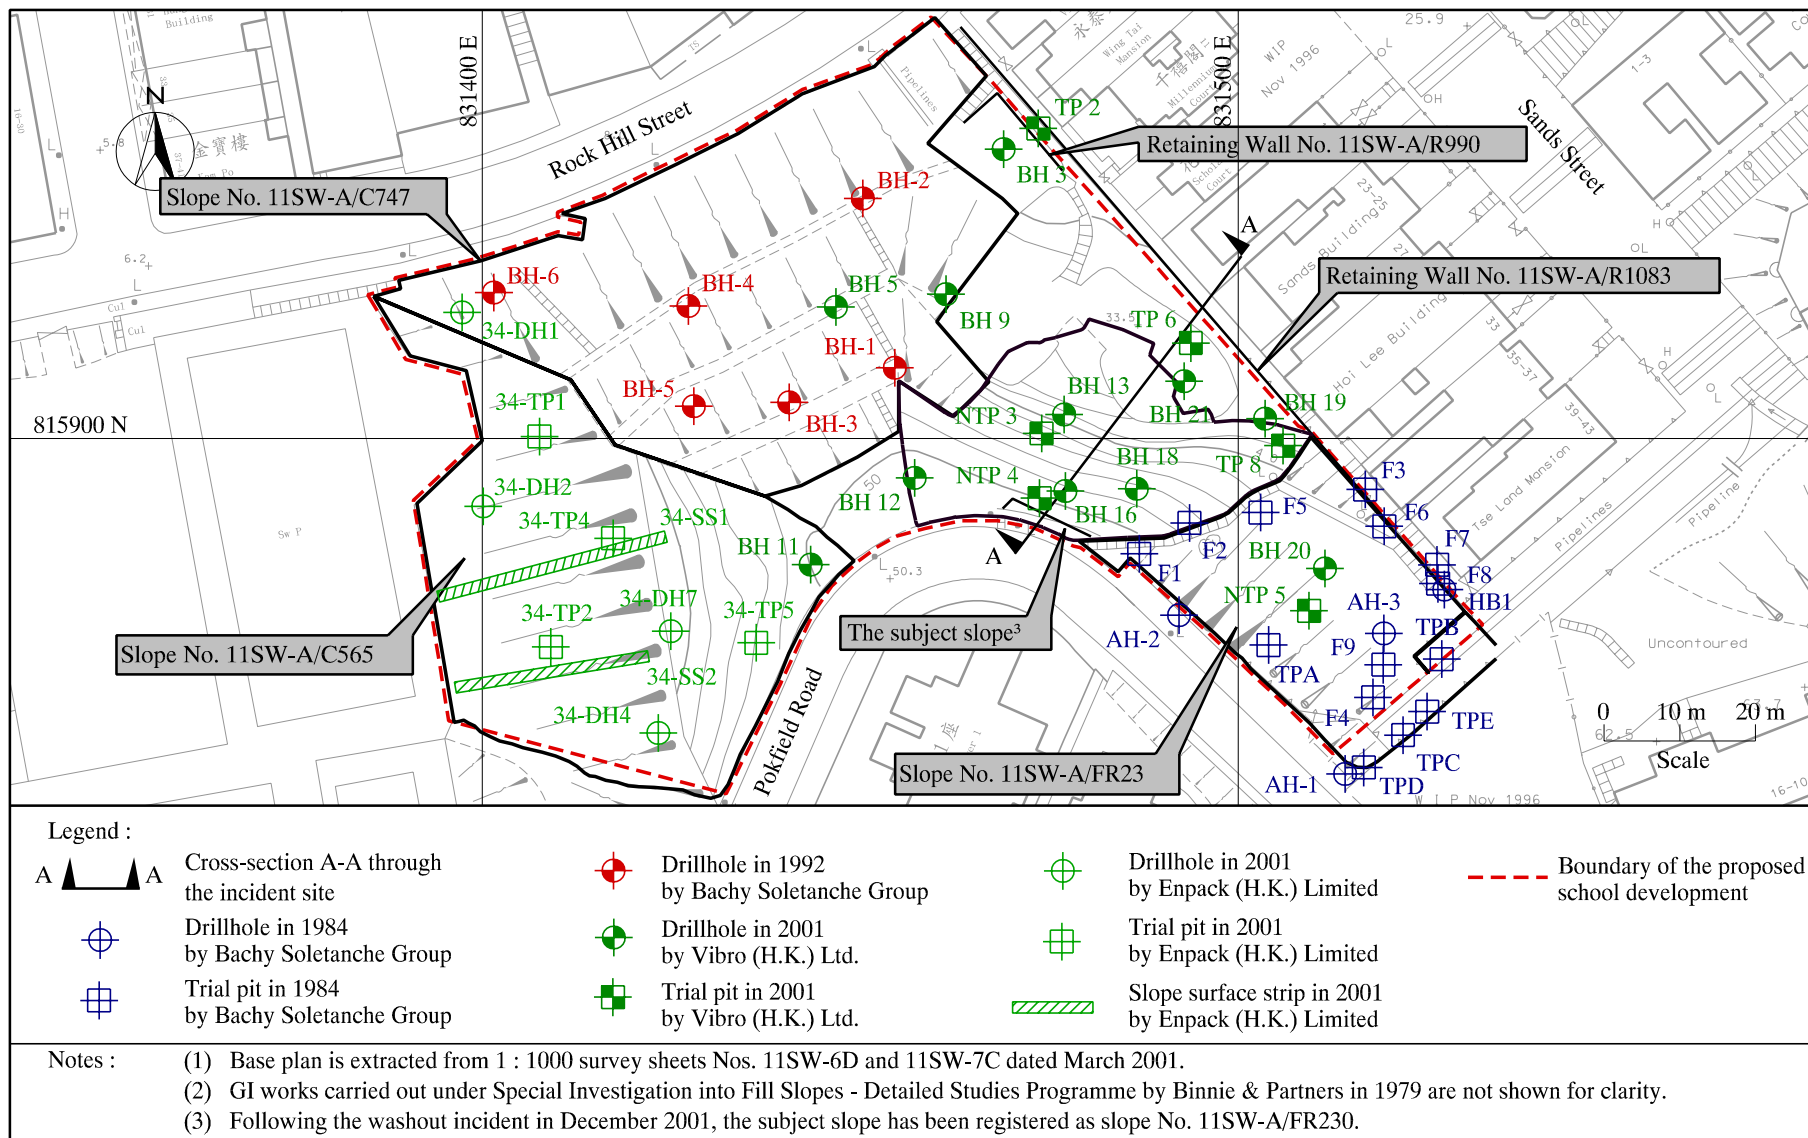
Figure 6 - Plan of Previous Ground Investigation

In 1992, six drillholes were put down by Bachy Soletanche Group over the area corresponding to the present slope No. 11SW-A/C747 for the geotechnical design in connection with the Rock Hill Street Extension project (Figure 6). None of these drillholes encountered fill.

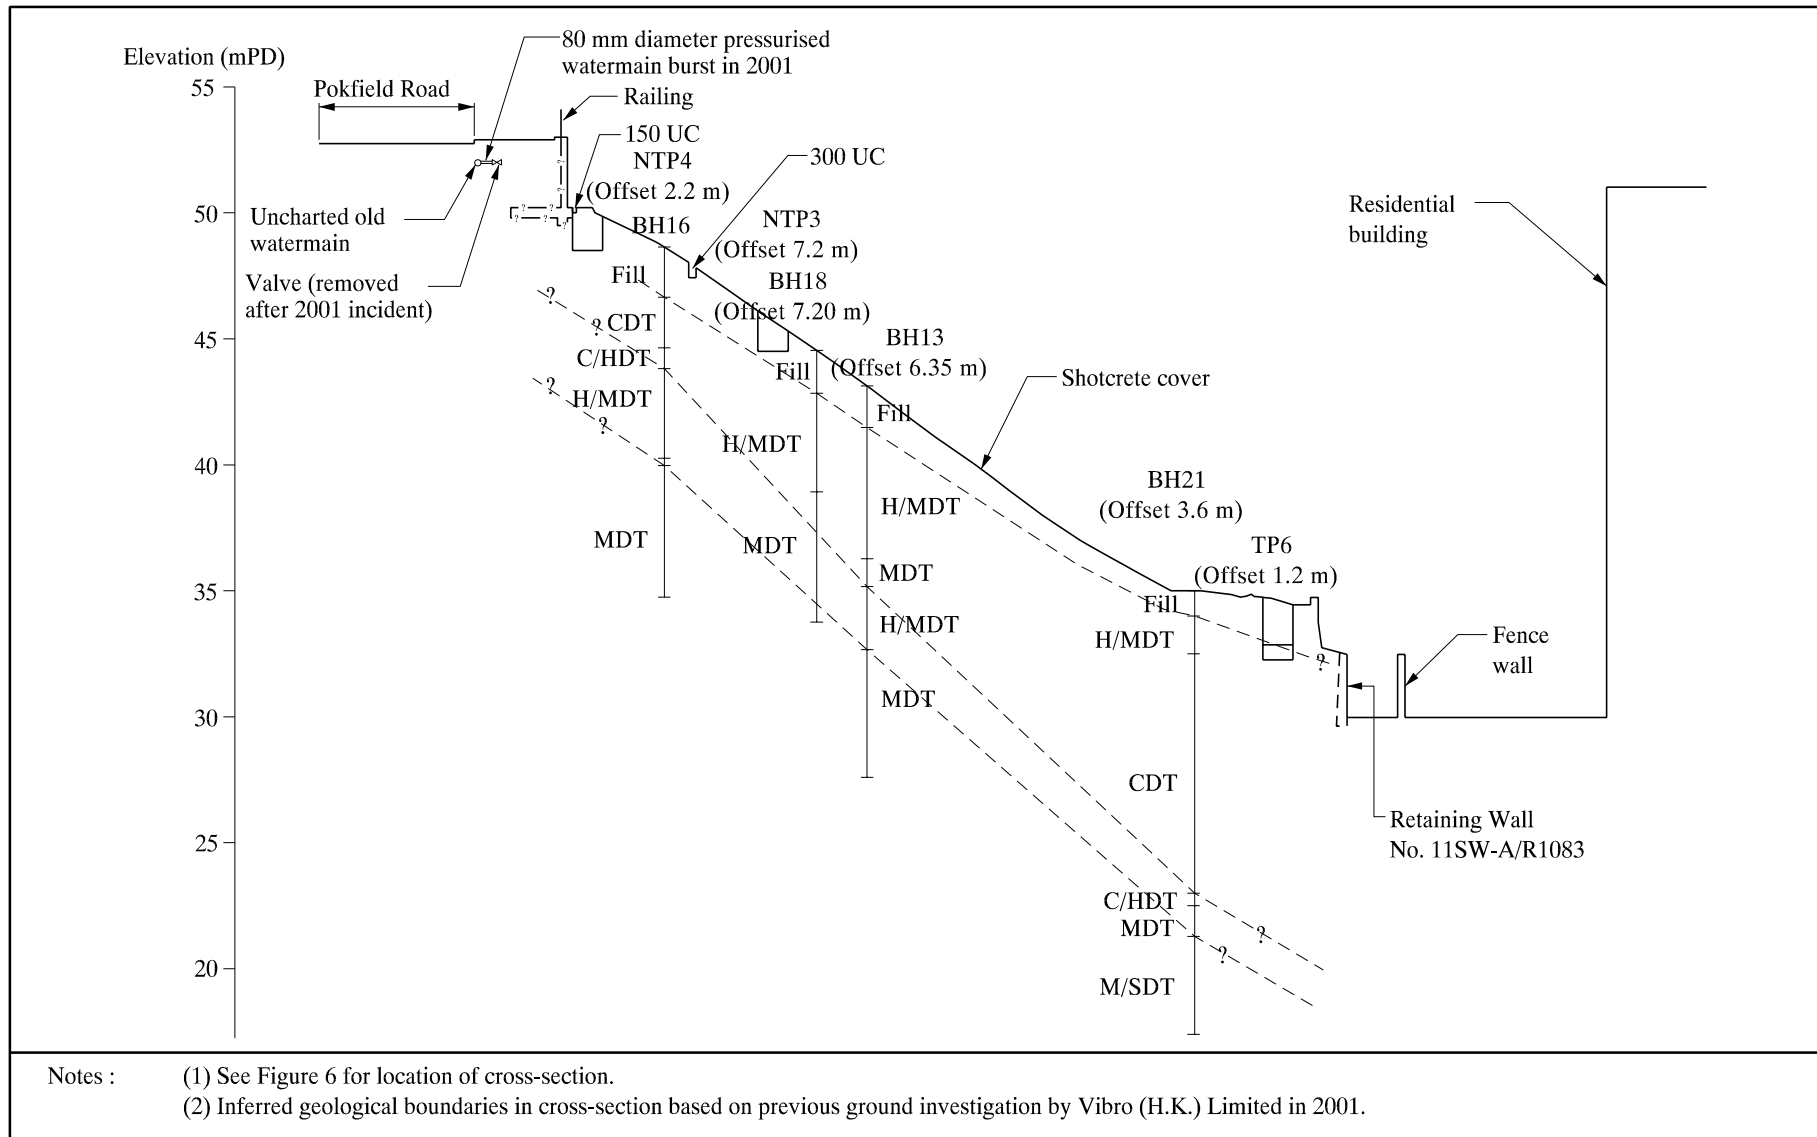
Figure 7 - Cross-section A-A through the Incident Site

A geological cross section through the location of the 2001 washout incident based on the available GI information is given in Figure 7.

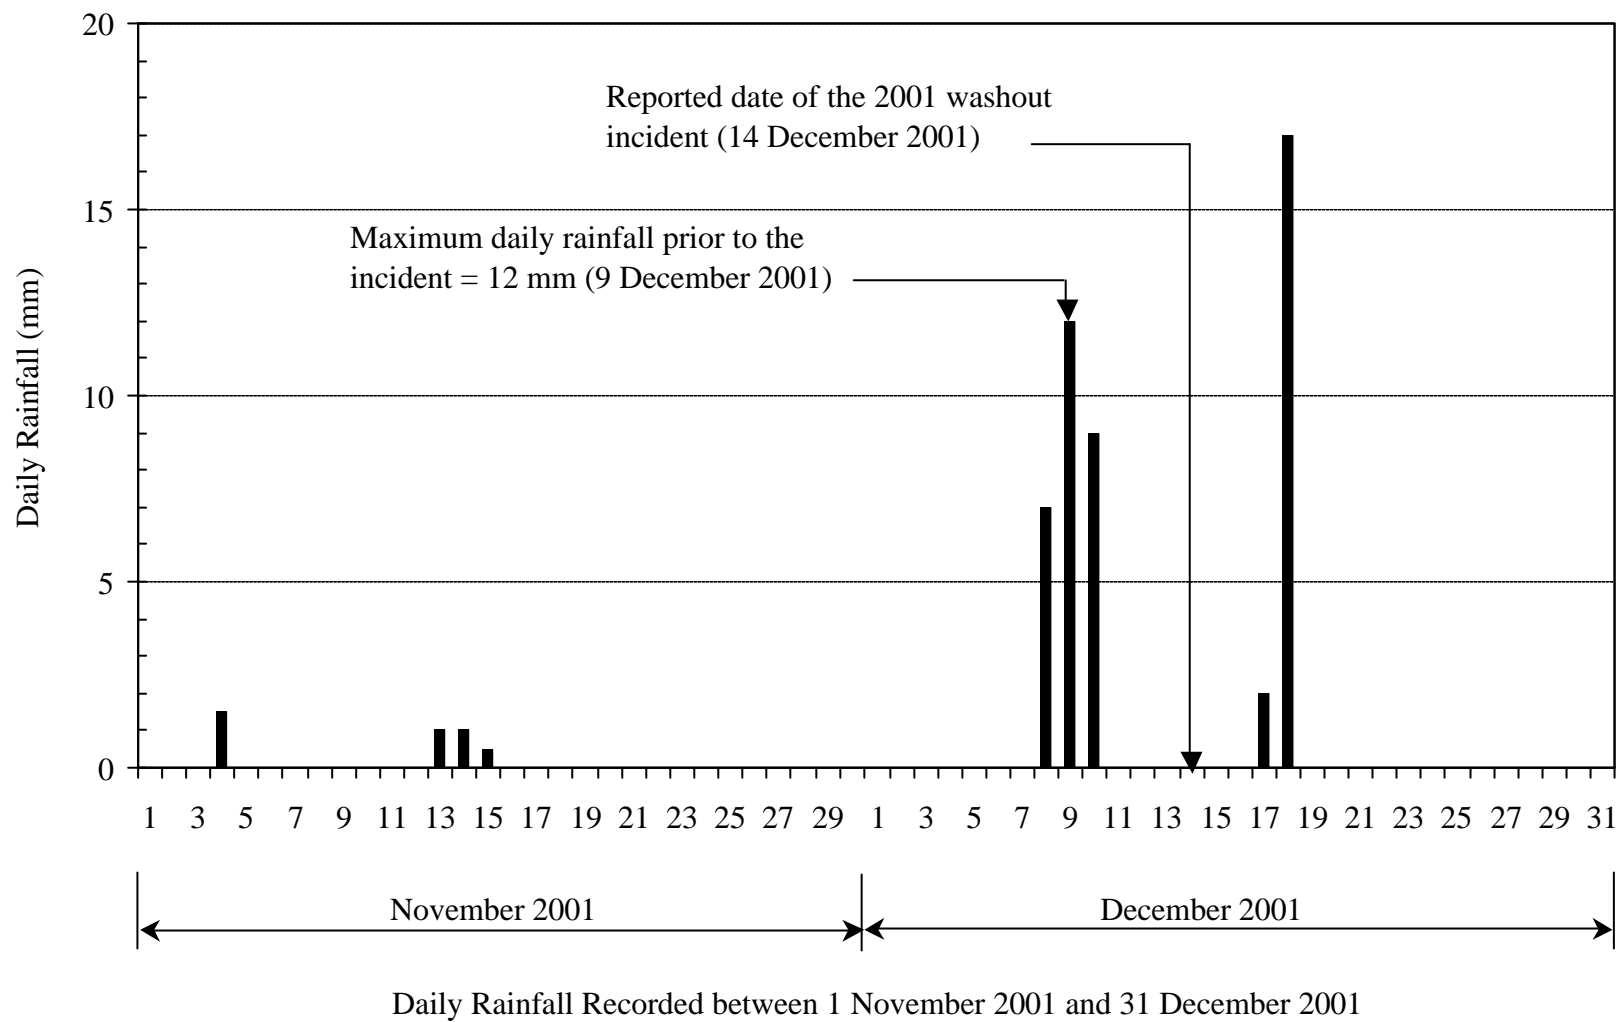
Figure 9 - Rainfall Recorded at GEO Raingauge No. H02

The nearest GEO automatic raingauge (No. H02) to the subject slope is located at Kwun Lung Lau Estate, Lun Wah Street, about 300 m to its southwest. The daily rainfall for the period six weeks preceding and two weeks following the incident is presented in Figure 9. The records show that there was very little rainfall in the month before the incident. No rainfall was recorded in the three days before the burst of the old watermain.
