**DETAILED STUDY OF
THE SEPTEMBER 2001
LANDSLIDE ON THE HILLSIDE
BELOW KWUN PING ROAD,
NORTH OF TSZ WAN SHAN**

GEO REPORT No. 153

Maunsell Geotechnical Services Ltd.

**This report was originally produced in December 2002
as GEO Landslide Study Report No. LSR 10/2002**

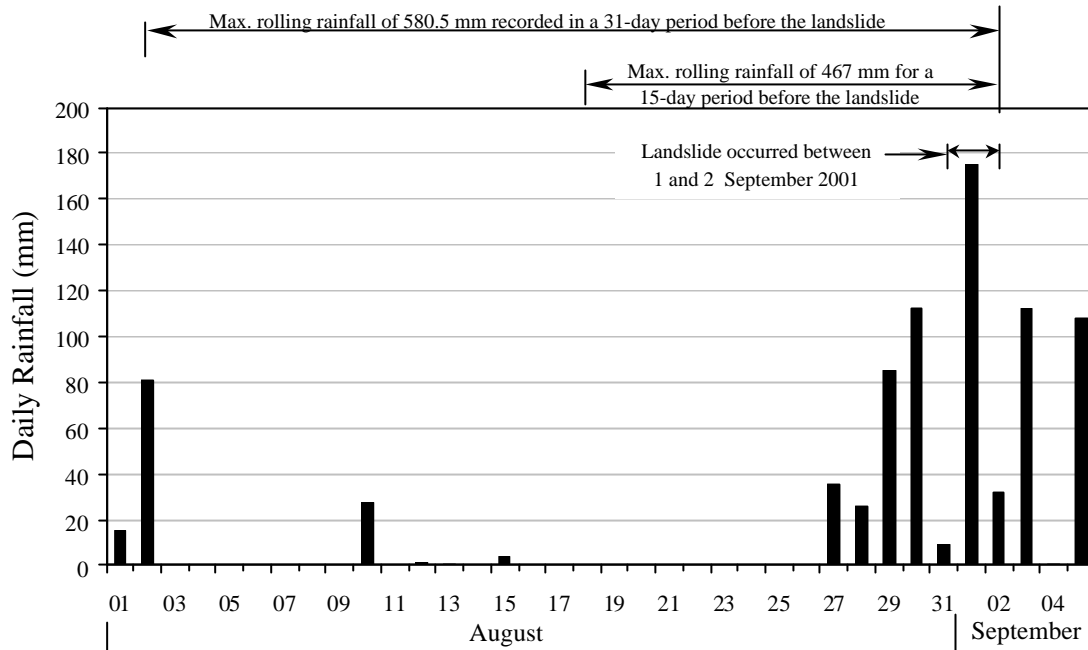
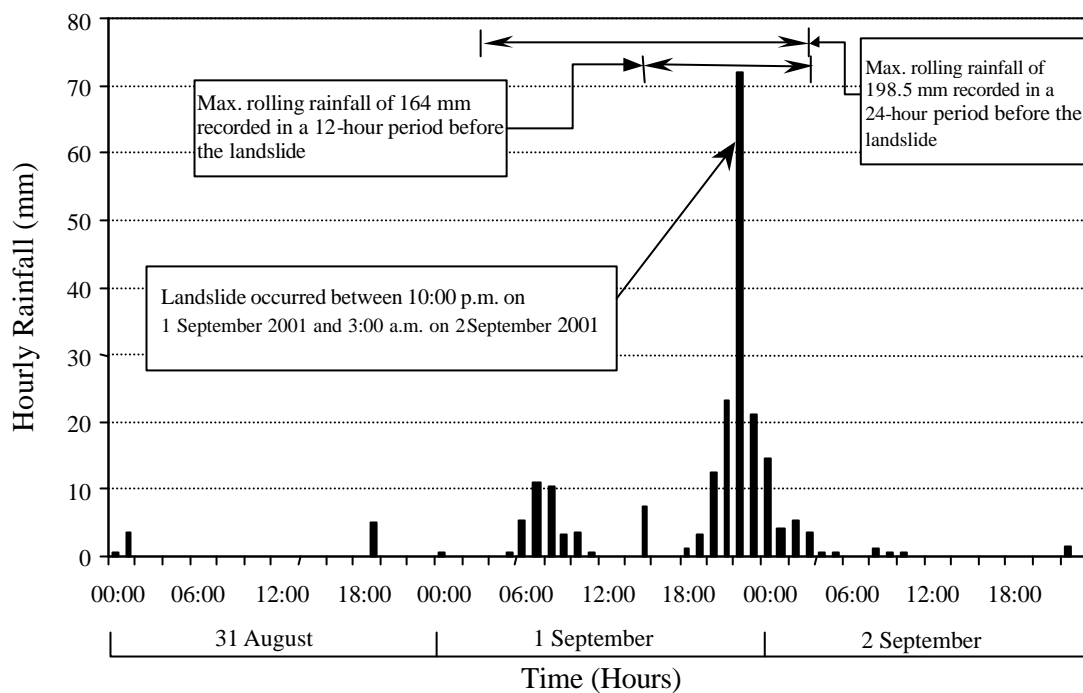
Figure 8 - Daily and Hourly Rainfall Recorded at GEO Raingauge No. K07

The daily rainfall recorded by raingauge No. K07 over the preceding month and three days following the incident is presented in Figure 8. The hourly rainfall readings for the period between 31 August and 2 September 2001 are also shown in Figure 8. The peak hourly rainfall of approximately 72 mm, was recorded in the 24-hour period preceding the September 2001 landslide. For the purpose of rainfall analysis, the landslide was assumed to have occurred before 3:00 a.m. of 2 September 2001 when the rain had almost ceased and the hourly rainfall dropped below 5 mm.

(a) Daily Rainfall Recorded at GEO Raingauge No. K07 between 1 August and 5 September 2001

(b) Hourly Rainfall Recorded at GEO Raingauge No. K07 between 31 August and 2 September 2001

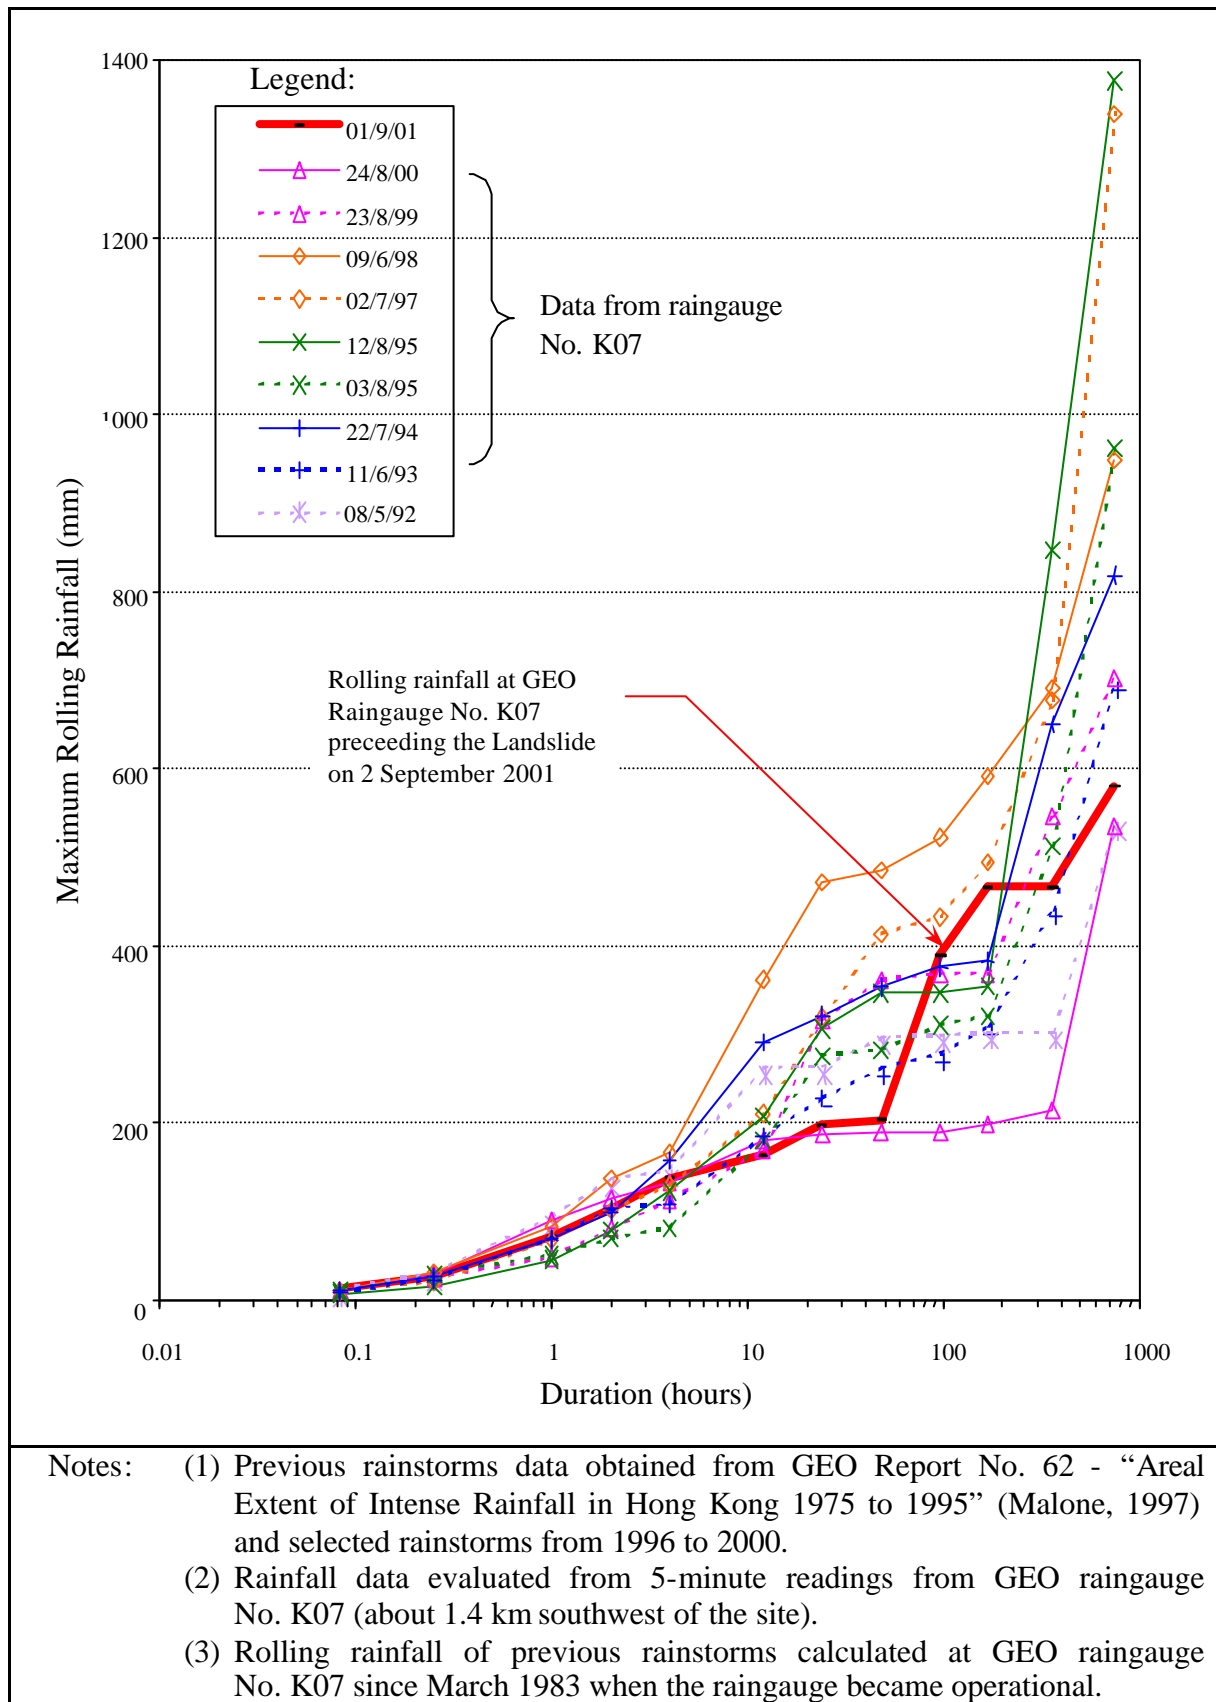
Figure 9 - Maximum Rolling Rainfall for Previous Major Rainstorms at GEO Raingauge No. K07

A comparison of the patterns of selected past major rainstorms recorded at raingauge No. K07 between 1992 and 2001 is presented in Figure 9. The rolling rainfall indicates that the rainstorm on 2 September 2001 was not exceptionally heavy compared with previous rainstorms.
