DETAILED STUDY OF THE 1 SEPTEMBER 2001 DEBRIS FLOW ON THE NATURAL HILLSIDE ABOVE LEI PUI STREET

GEO REPORT No. 154

Maunsell Geotechnical Services Ltd.

This report presents the findings of an investigation into the landslide (GEO Incident No. 2001/09/0057), which occurred on 1 September 2001 above Lei Pui Street, Shek Lei Estate, Kwai Chung. The debris flow was triggered by a landslide involving about 250 m³ of rock and soil on the steep natural hillside above a 25 m high cliff. The landslide debris and entrained material with an estimated maximum volume of 780 m³ was deposited mainly within the lower part of the hillside and an active construction site, situated about 10 m above Lei Pui Street. About 50 m³ of outwash material was deposited on Lei Pui Street and the Shek Lei Estate. The landslide demolished two squatter structures which had been vacated about two hours before the event and Lei Pui Street was closed for 3 days. No casualties were reported.

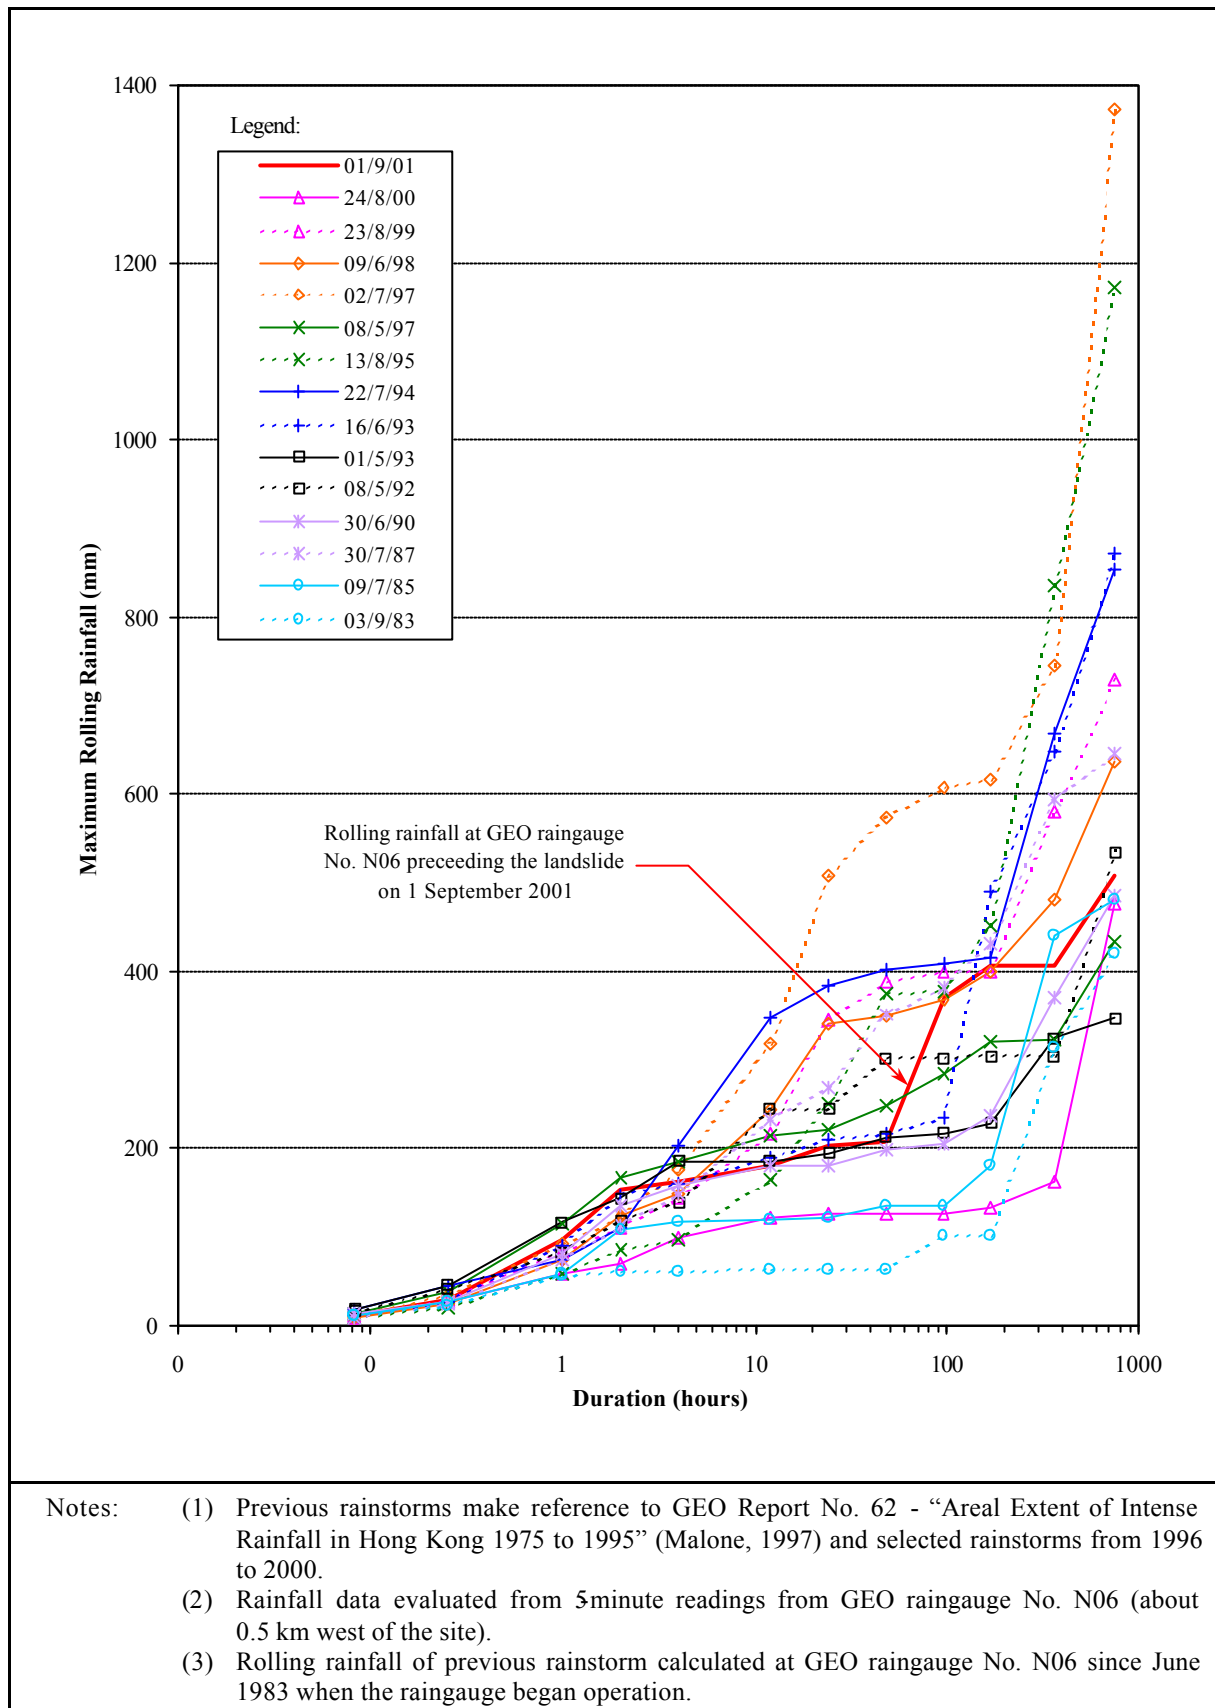
Figure 17 - Maximum Rolling Rainfall for Previous Major Rainstorms at GEO Raingauge No. N06

The maximum rolling rainfall for the rainstorm on 1 September 2001 has been compared with the previous available data on severe rainstorms recorded by raingauge No. N06 since it became operational in June 1983 (Figure 17). The maximum rolling rainfall for the 1 September 2001 rainstorm prior to 10:50 p.m. is comparable to that of the previous most severe rainstorms recorded at raingauge No. N06 for durations of between 2 hours and 3 hours. After 8:30 p.m. on 1 September 2001, the highest 15 minute rainfall intensities were 30 mm between 10:15 p.m. and 10:30 p.m. and 28 mm between 10:30 p.m. and 10:45 p.m. (Figure 18).

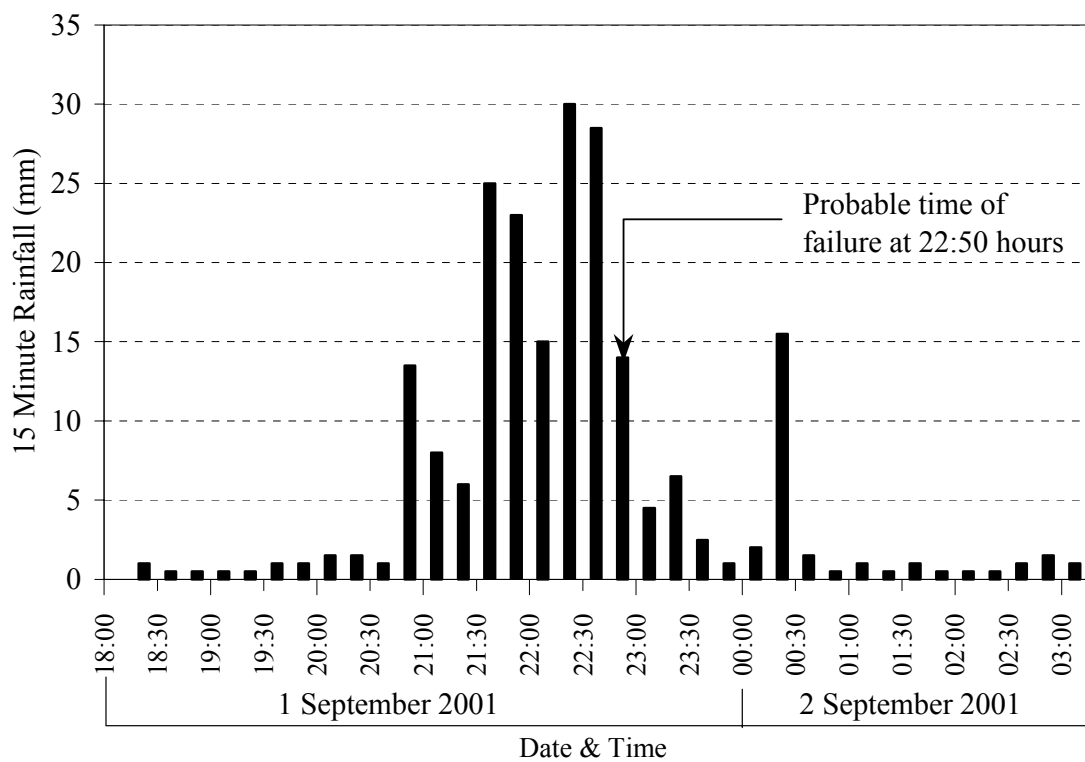
Figure 18 - 15 Minute Rainfall Intensities at GEO Raingauge No. N06

line and the evacuation of the residents of squatter structures Nos. RTW/7E/156 and RTW/7E/158, it is possible that a part of the source area failed prior to the main debris flow event. The most intense rainfall was recorded between 10:15 p.m. and 10:45 p.m. (Section 7), very shortly before the debris flow which most probably occurred at about 10:50 p.m. (Figure 18).

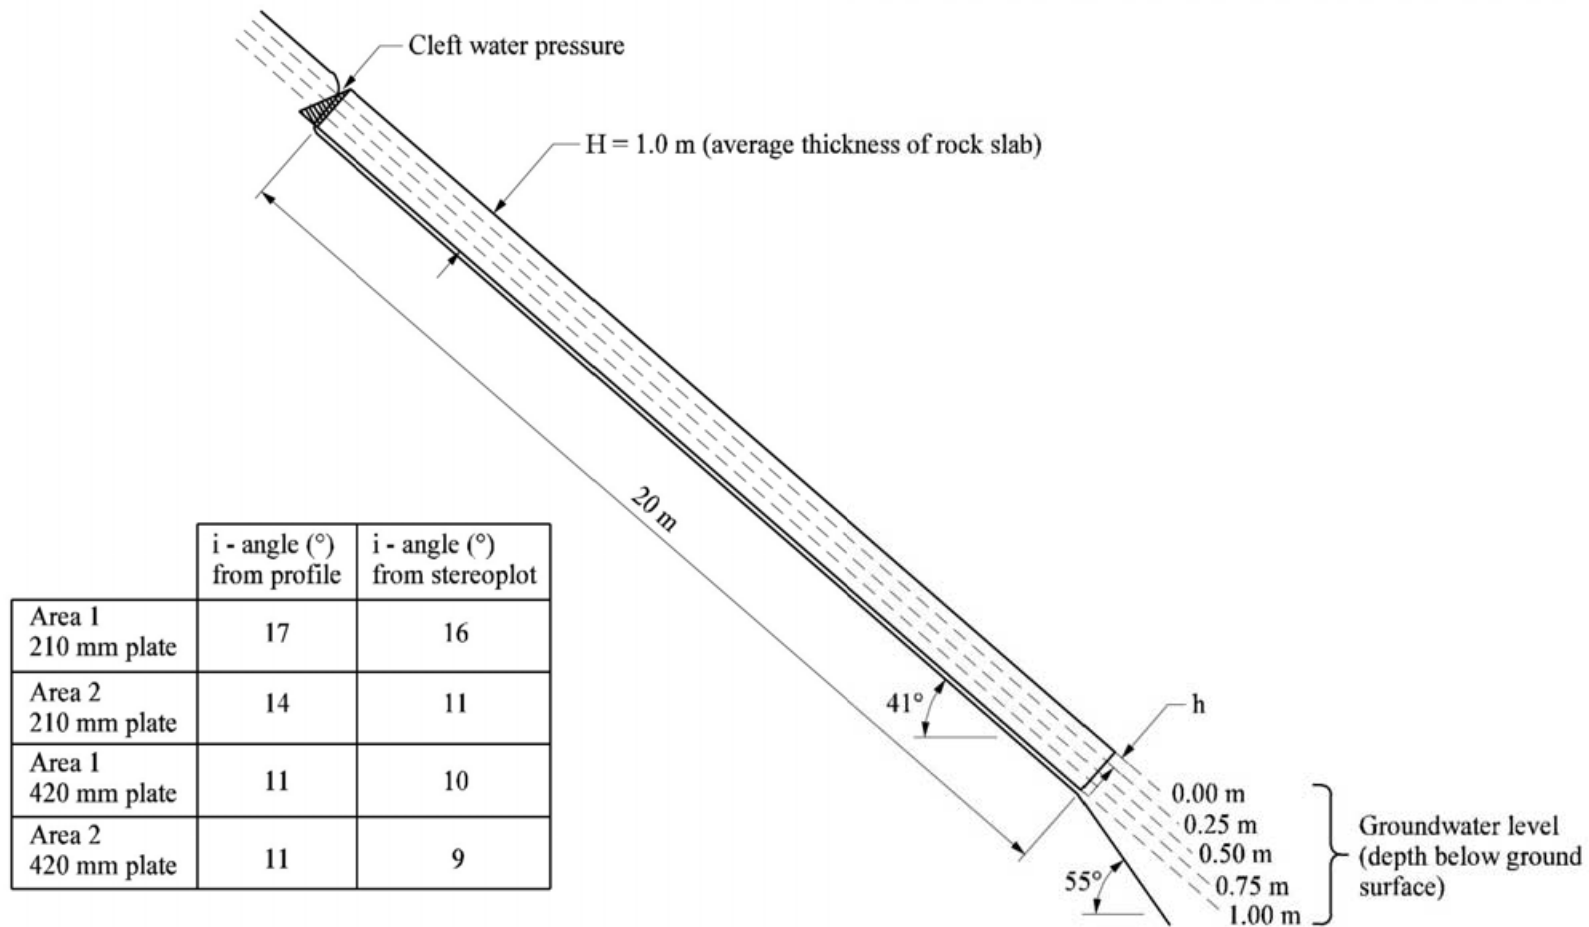
Figure 19 - Simplified Section Adopted for Stability Analysis

The analyses were based on data obtained from the post-failure ground investigation, laboratory testing, site observations and measurements. A cross-section of the source area, range of groundwater levels and joint roughness angles adopted in the analyses are shown in Figure 19. For the purposes of the analysis, a 1 m thick by 12 m wide by 20 m long rock slab dipping at 41° was assumed. A range of heights of water table was assumed to simulate the possible range of groundwater conditions at the time of failure. The influence of possible cleft water pressure within the rock joints immediately behind the scarp of the failure was also examined.

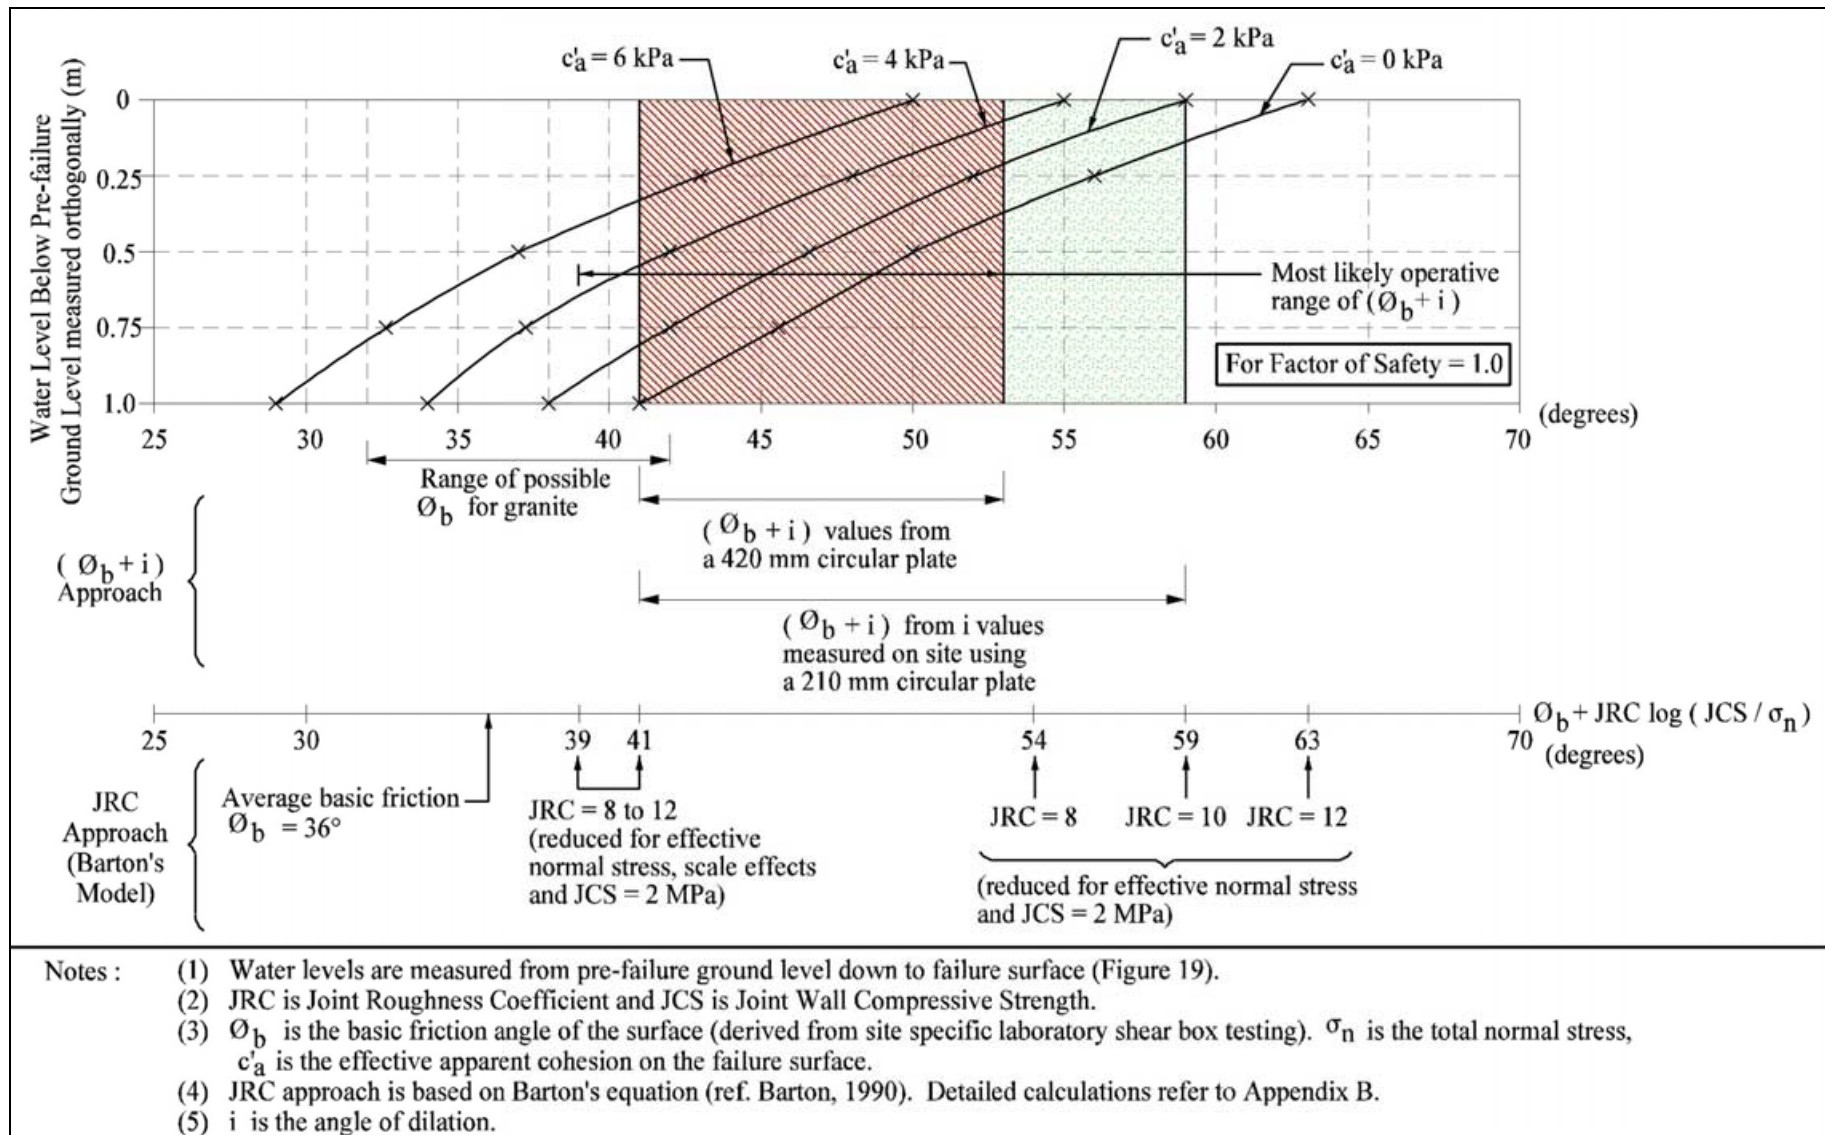
Figure 20 - Results of Stability Analysis

The results of the analyses are presented in Figure 20 for a range of effective friction angles (ϕ') and apparent cohesion c'_a .

The results of the analyses shown in Figure 20 indicate that for a high groundwater condition, failure could occur with either a high angle of friction ($\phi_b + i$) or a high apparent cohesion (c'_a). Alternatively, failure could occur with a combination of relatively modest friction and apparent cohesion values under high groundwater conditions.

of friction will be between 39° and 53° as indicated in Figure 20. This range has mainly been derived by adding the range of 'I' values derived from the 420 mm plate measurements to the possible range of basic angle of friction which lies between 32° and 42° . The values from the 420 mm plate measurements were used instead of the values obtained from the 210 mm plate because the aperture of the sheeting joints is generally wide and infill extensive. Consideration of the lowest angle of friction (39°) derived from the calculations in Appendix B using Barton's method with correction for scale effects has also been given in setting the lower bound angle of friction at 39° . Assuming fully saturated conditions and an operating range of apparent friction angle of between 39° and 53° , failure could occur within a range of apparent cohesion between 3 kPa and 10 kPa.

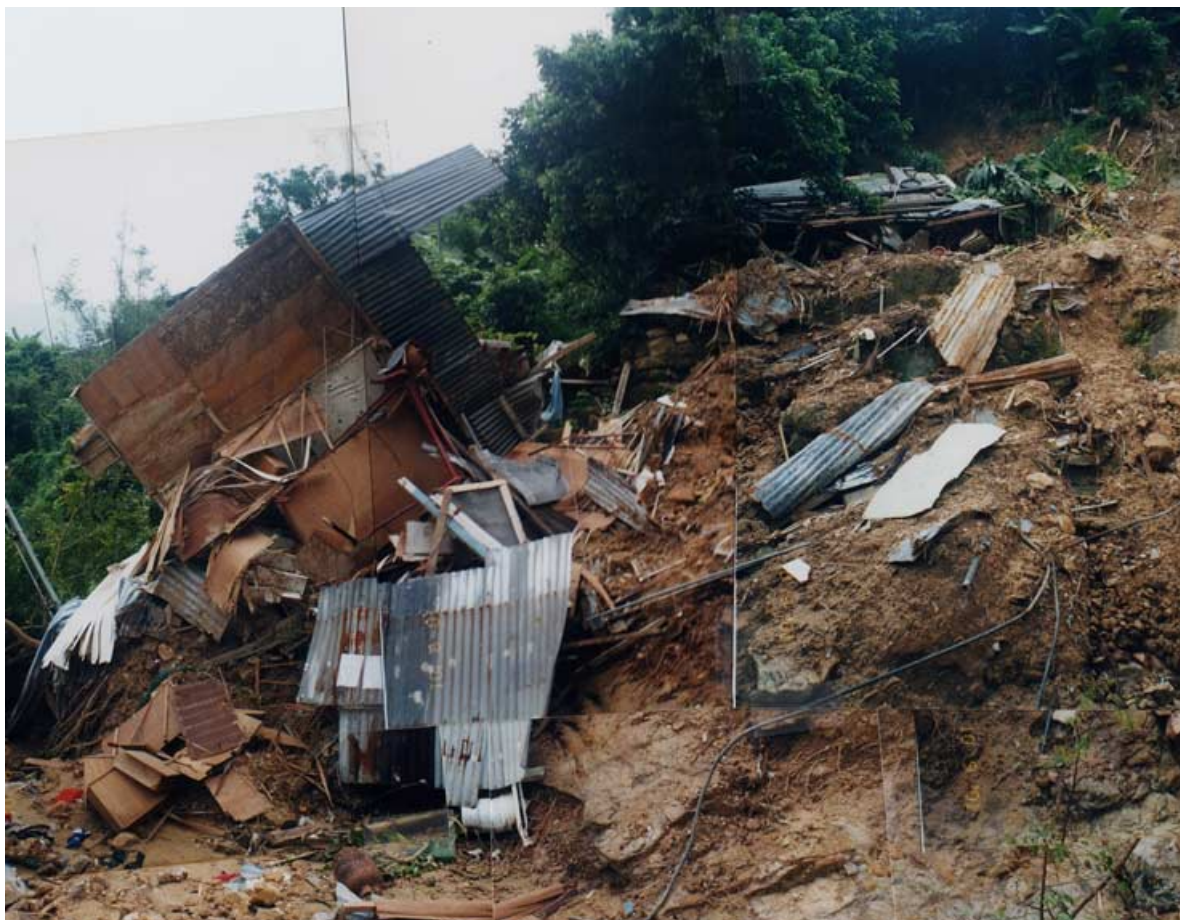
Plate 4 - View of Destroyed Squatter Structures Nos. RTW/7E/156 and RTW/7E/158
(Photograph taken on 4 September 2001)

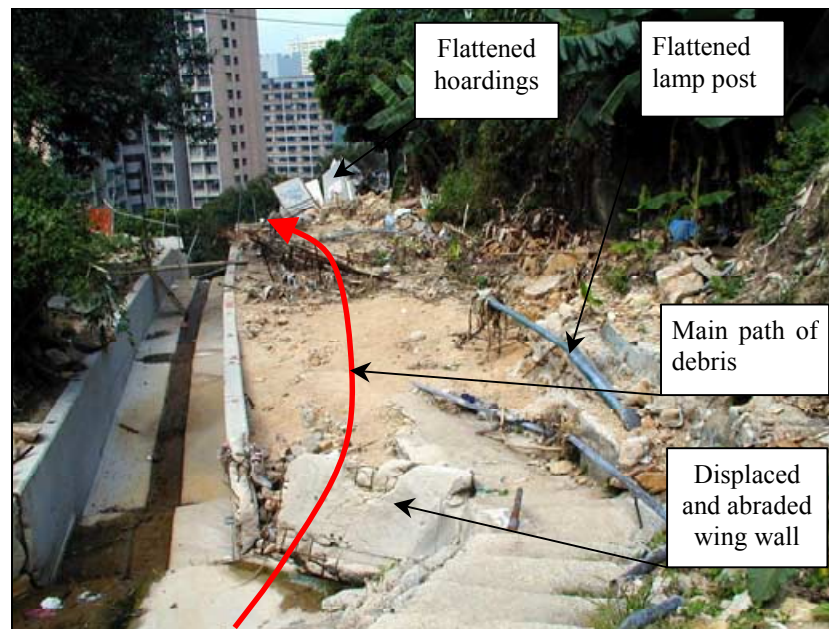
Plate 9 - Upper Concrete Channel above Active Construction Site after the 1 September 2001 Landslide (Photograph taken on 17 October 2001)

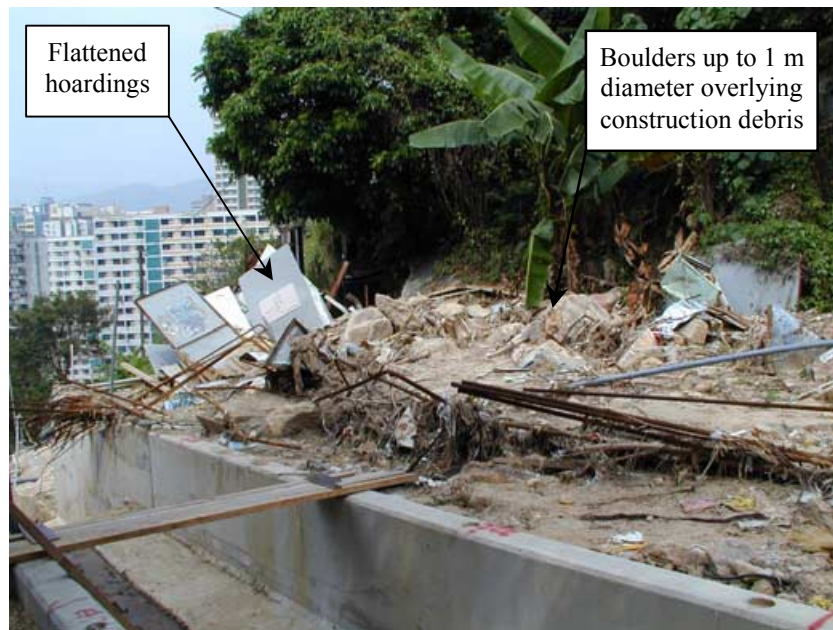
Plate 10 - Bouldery Debris near Downstream End of Upper Concrete Channel
(Photograph taken on 21 October 2001)

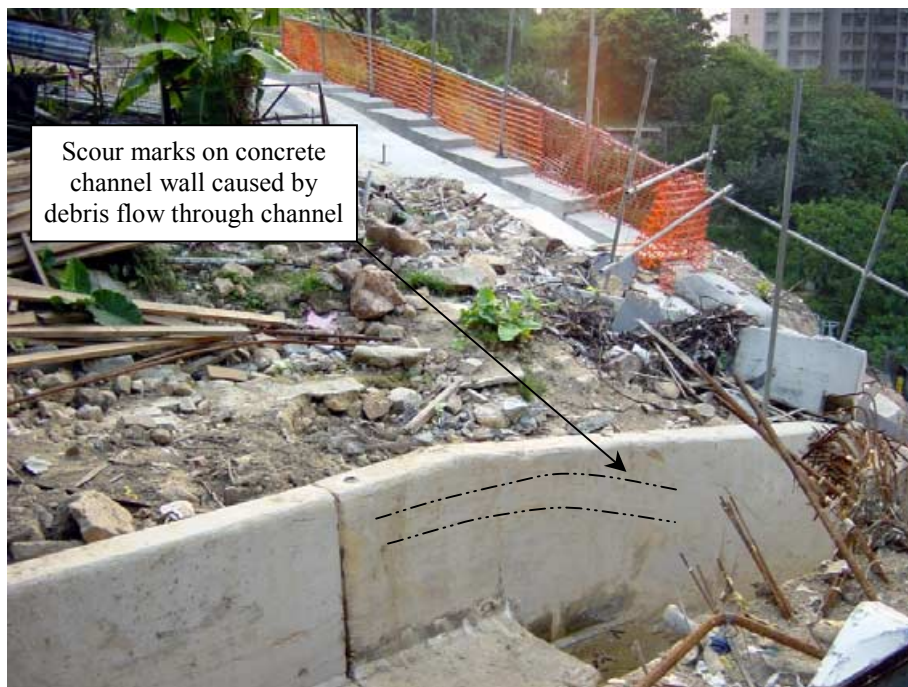
Plate 24 - View of the Concrete Channel above the Active Construction Site Showing Scour Marks on the Wall Face Indicating the Debris Trajectory
(Photograph taken on 18 October 2001)

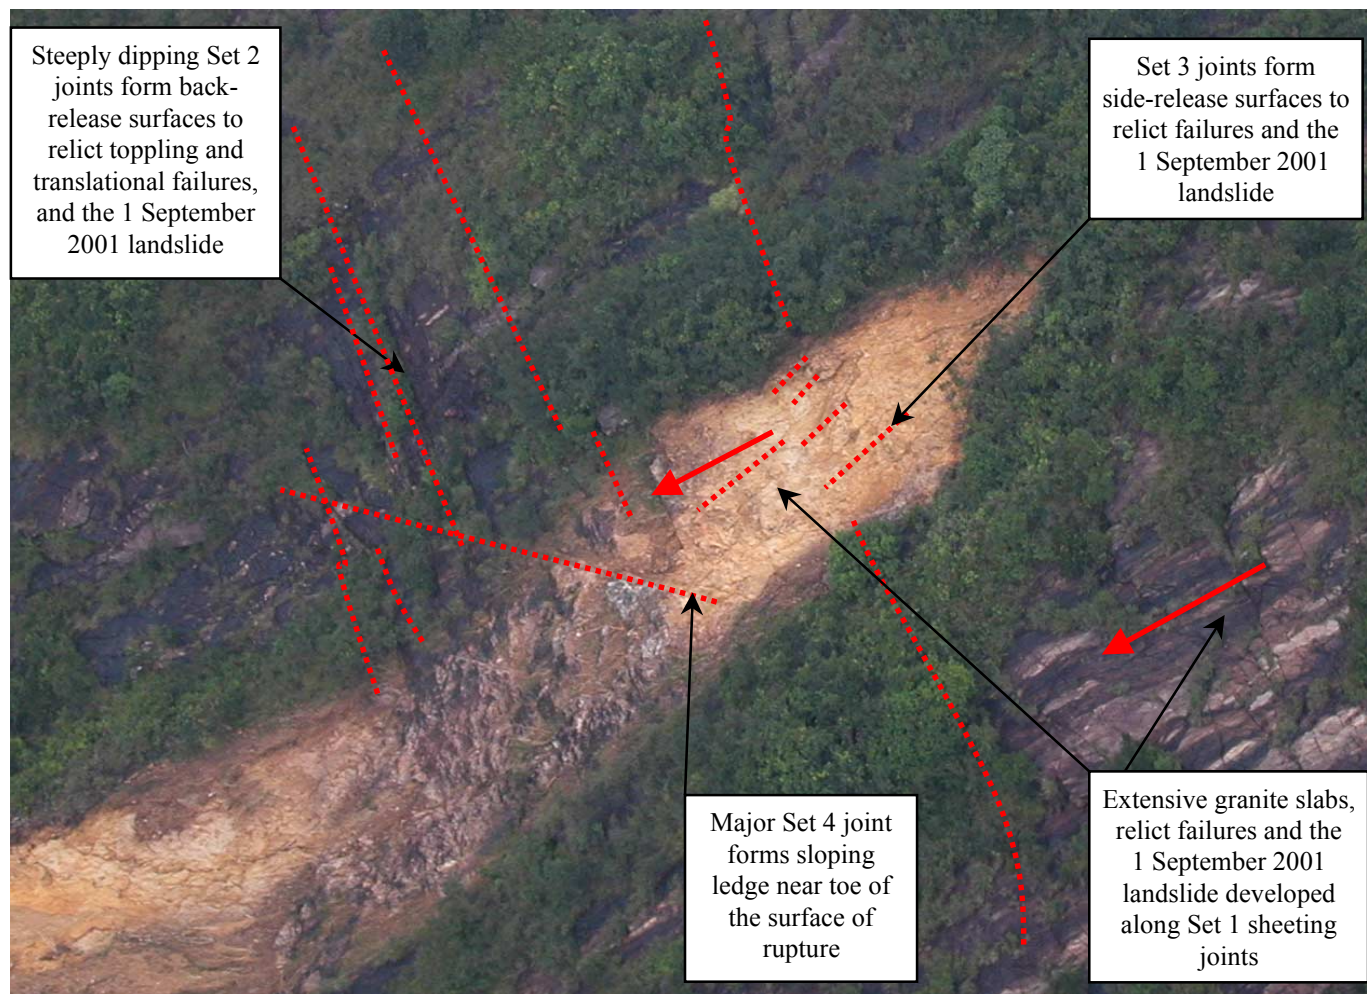
Plate 25 - Main Structural Controls near Source Area
(Photograph taken on 10 September 2001)

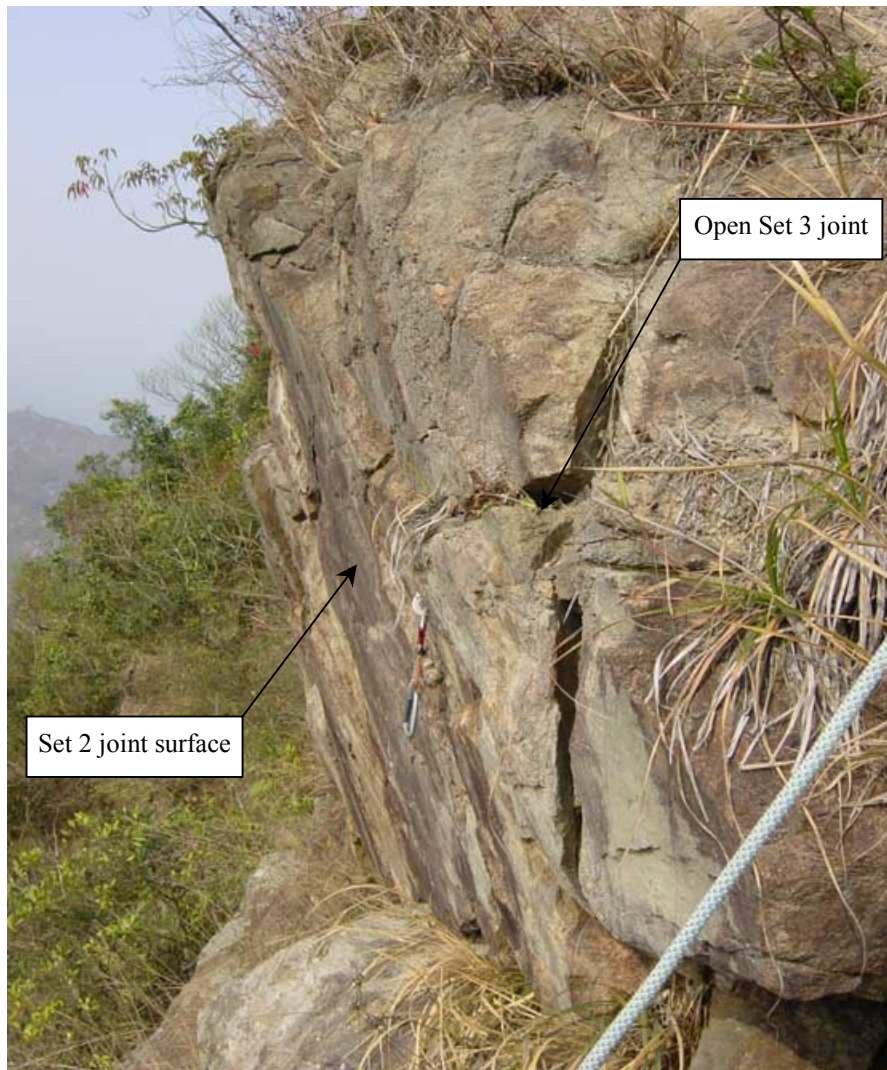
Plate 26 - Dilated Joints in Rock Face above Source Area
(Photograph taken on 4 January 2002)

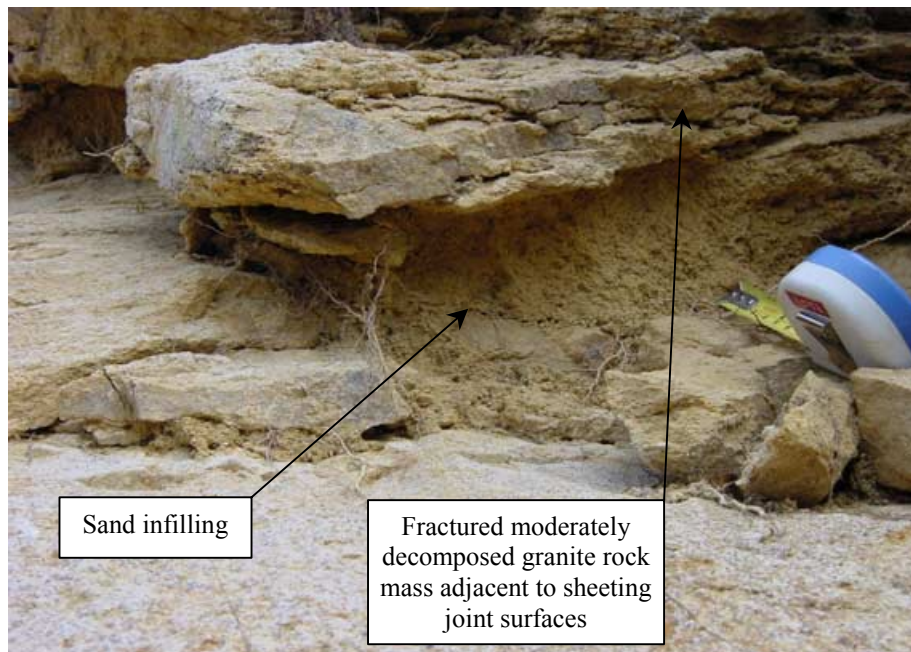
The granite slabs exposed in the flanks of the scar are moderately to slightly decomposed and have a maximum thickness of about 1 m along the north flank and about 0.3 m along the south flank. The slabs are separated from each other by up to 100 mm of highly to completely decomposed granite and structureless silty sand that contains soil pipes up to about 50 mm across (Plates 29 and 30).

Plate 30 - View of Dilation and Infilling of Sheeting Joints in Left Flank of Source Area
(Photograph taken on 21 October 2001)

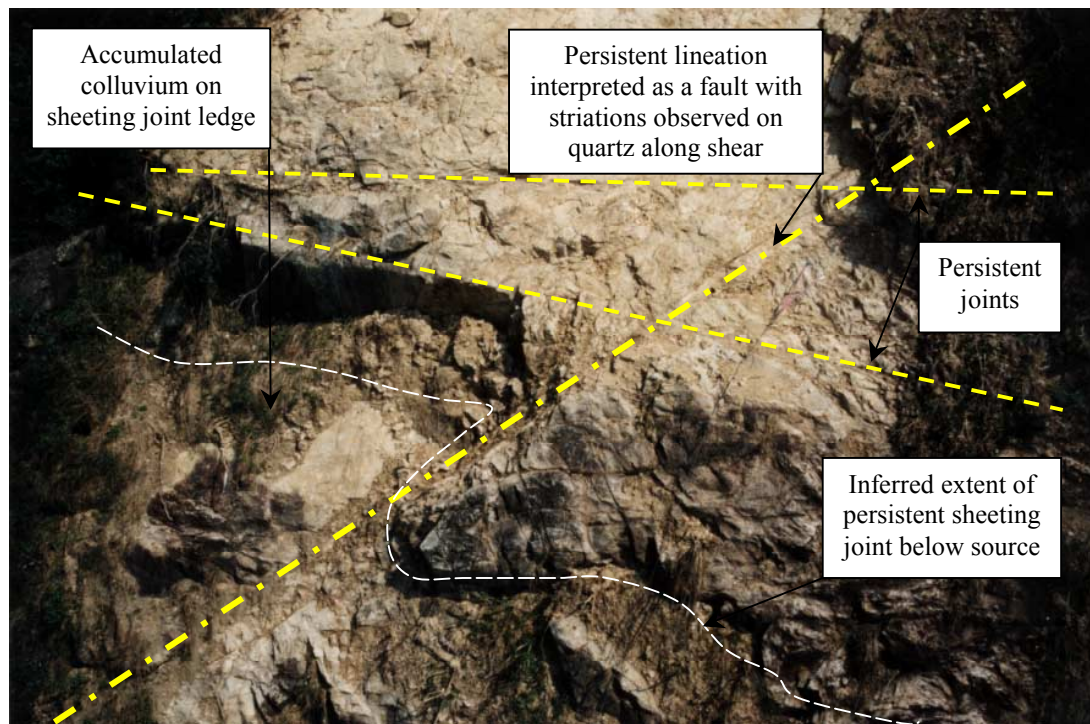
About 1.5 m below the edge of the landslide source is a prominent sheeting joint which extends below the full width of the scar (Plate 31 and Figures 8 to 10). Below the north portion of the scar, recent colluvium has accumulated on the joint surface, below a major Set 2 toppling joint. The Set 2 joint continues through the rock mass in the south portion of the scar, and crosses a major Set 4 shear which is infilled with striated quartz. The Set 4 shear runs for at least 50 m across the exposed cliff face and surface of rupture (Figure 8 and Plate 25). The fault breccia encountered in the inclined drillhole No. DH1, adjacent to a 20 mm thick shear plane inclined at 60° to the drillhole axis, may represent the Set 4 shear as indicated on Section B-B in Figure 10.

Plate 31 - Oblique Aerial View of the Lower Source Area and Upper Cliff
(Photograph taken on 16 October 2001)

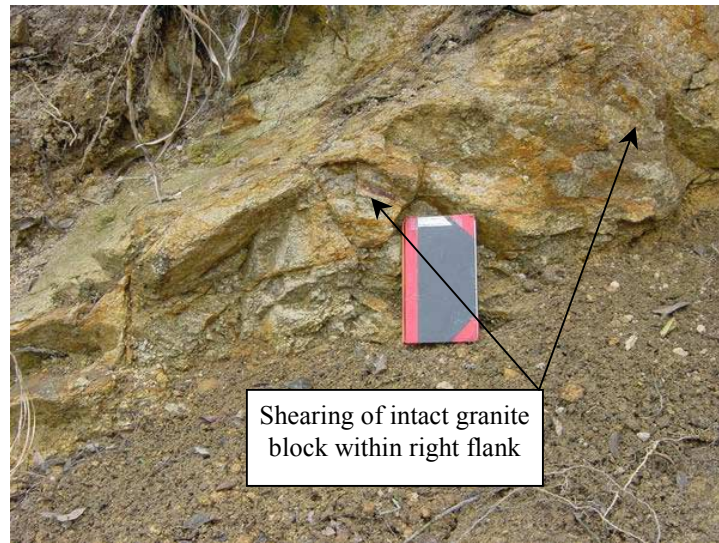
Some evidence of shearing through interlocking blocks was noted in both flanks of the surface of rupture (Figure 8 and Plates 32 and 33). In particular, some corners of moderately decomposed blocks and also some surfaces up to 200 mm in length show no surface staining and have powdery surfaces that appear to have been created by recent shearing (Plate 32). Many of the remaining rock blocks in the flanks are partly dislodged and form a very rough profile to the sides of the landslide scar (Plate 33).

Plate 32 - View of the Lower Right Flank of the Source Area
(Photograph taken on 24 May 2002)

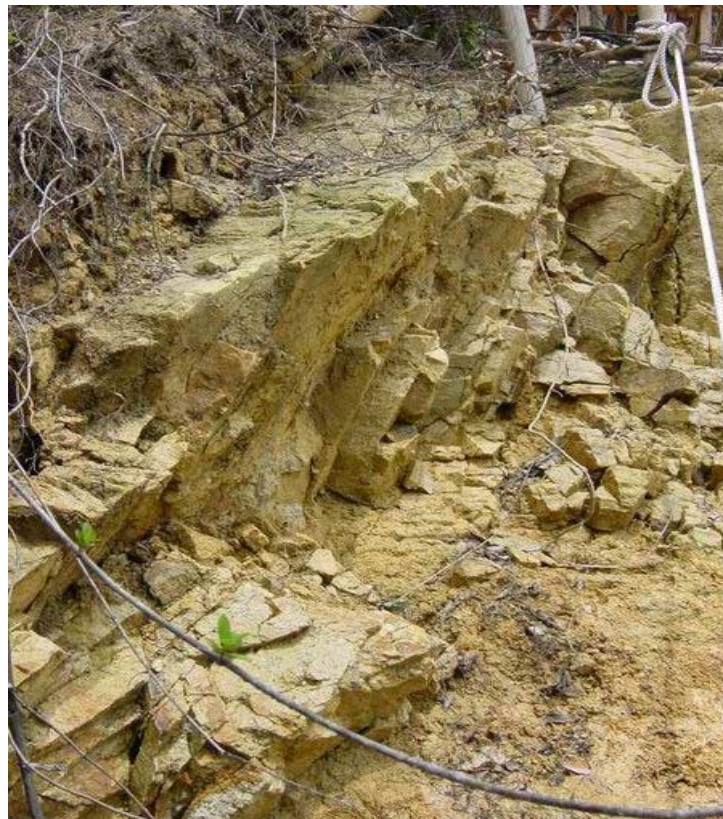
Plate 33 - View of the Right Flank of the Source Area
Showing Stepped Nature of Granite Joints
with Probable Block Interlocking
(Photograph taken on 24 May 2002)

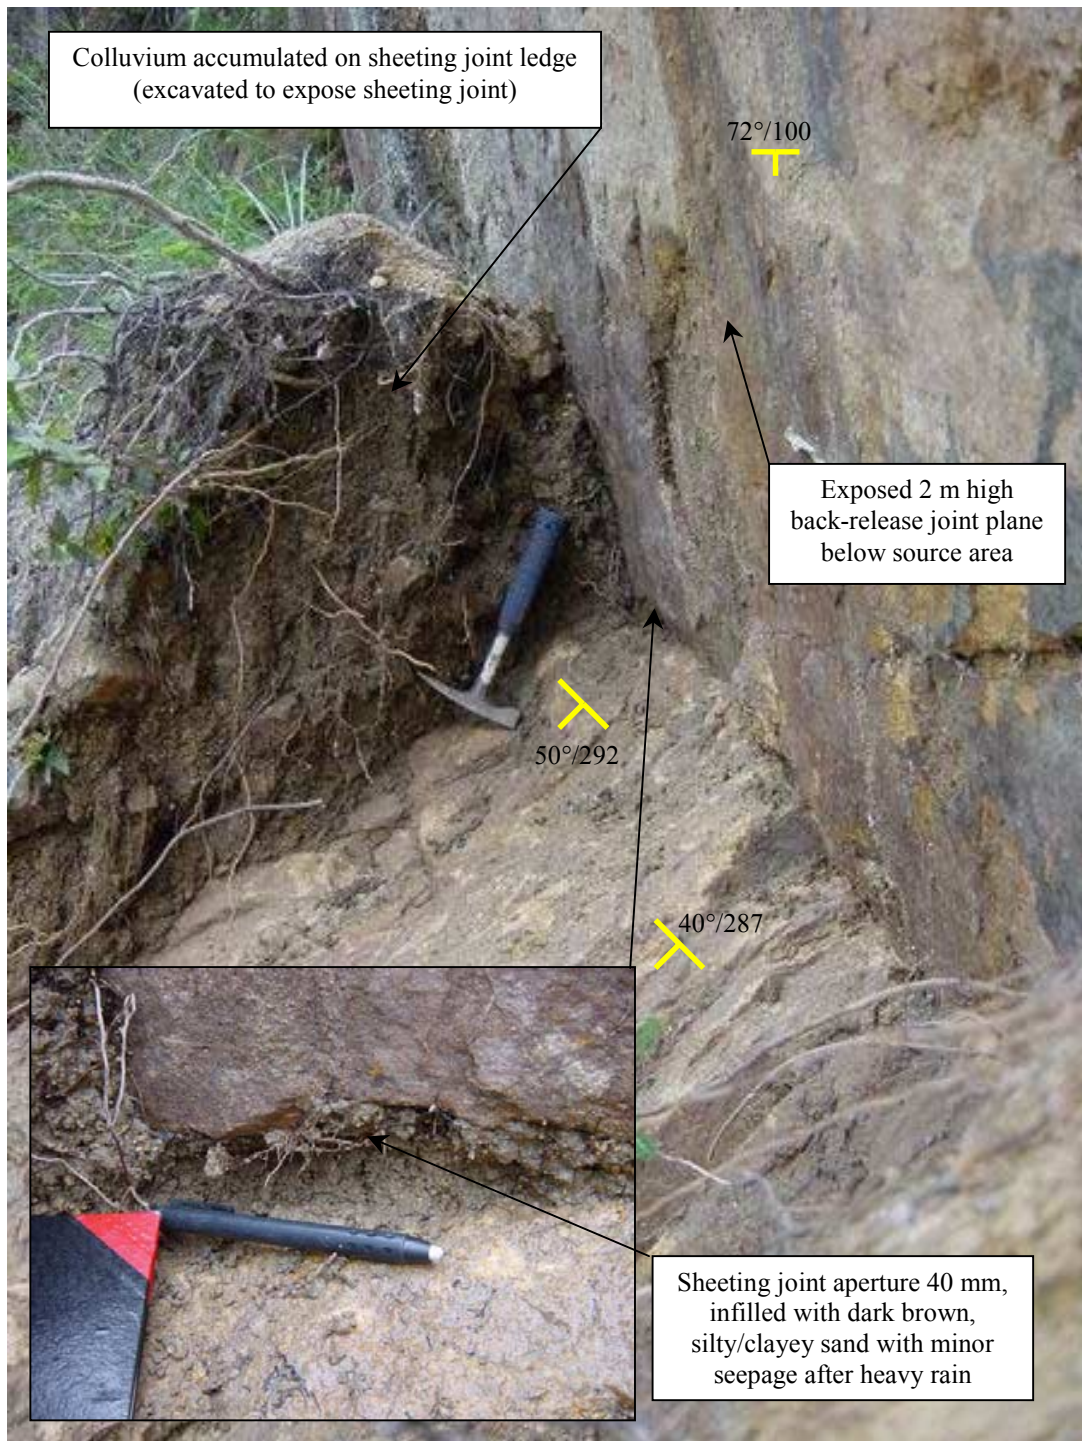
The catchment directly above the landslide source has an area of about 3500 m² (Figure 14), and the convex (in plan) nature of the terrain does not lend itself to concentration of surface run-off into the landslide source area. When inspected from the foot of the cliff below the source on 4 September 2001, no seepage could be detected from the source area. However, abundant seepage could be observed from within the rock slabs adjacent to and above the landslide in the weeks following the rainstorm of 1 September 2001. After direct access to the source area had been established, erosion pipes up to 50 mm across and seepage (after heavy rain) were observed from the surface of rupture and the underlying sheeting joints (Plates 34 and 35).

Plate 34 - View of the Sheeting Joint Ledge below the Source Area
(Photograph taken on 24 May 2002)
