**DETAILED STUDY OF THE
22 MAY 2002 ROCKFALL
INCIDENT ON SLOPE
NO. 11NE-A/C284 AT
SHATIN PASS ROAD
TSZ WAN SHAN**

GEO REPORT No. 156

Halcrow China Limited

**This report was originally produced in October 2002
as GEO Landslide Study Report No. LSR 9/2002**

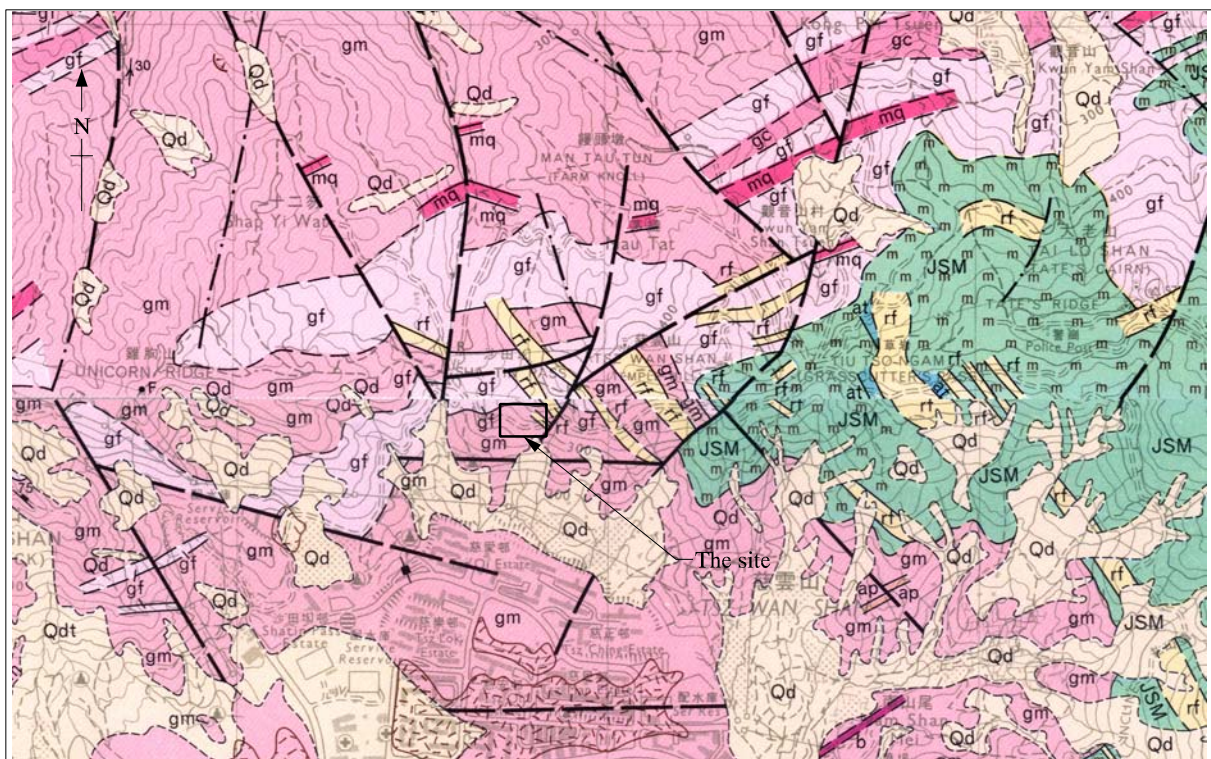
Figure 3 - Solid and Superficial Geology of the Landslide Site

The drainage line to the east of the location of the recent rockfall is interpreted as a fault on the published geological map of the site (Figure 3). The field inspection by HCL found evidence of possible faulting within the exposed rock forming the bed of the drainage line, viz. a series of 50 mm to 100 mm thick quartz veins within a 0.5 m to 1.0 m wide shear zone. The zone affected by the possible faulting is less than 1 m wide and does not appear to affect slopes Nos. 11NE-A/C284 and 11NE-A/C281. No obvious signs of intrusion of dykes could be observed on these slopes. The spacing of sub-vertical joints was noted to decrease towards the location of the drainage line.

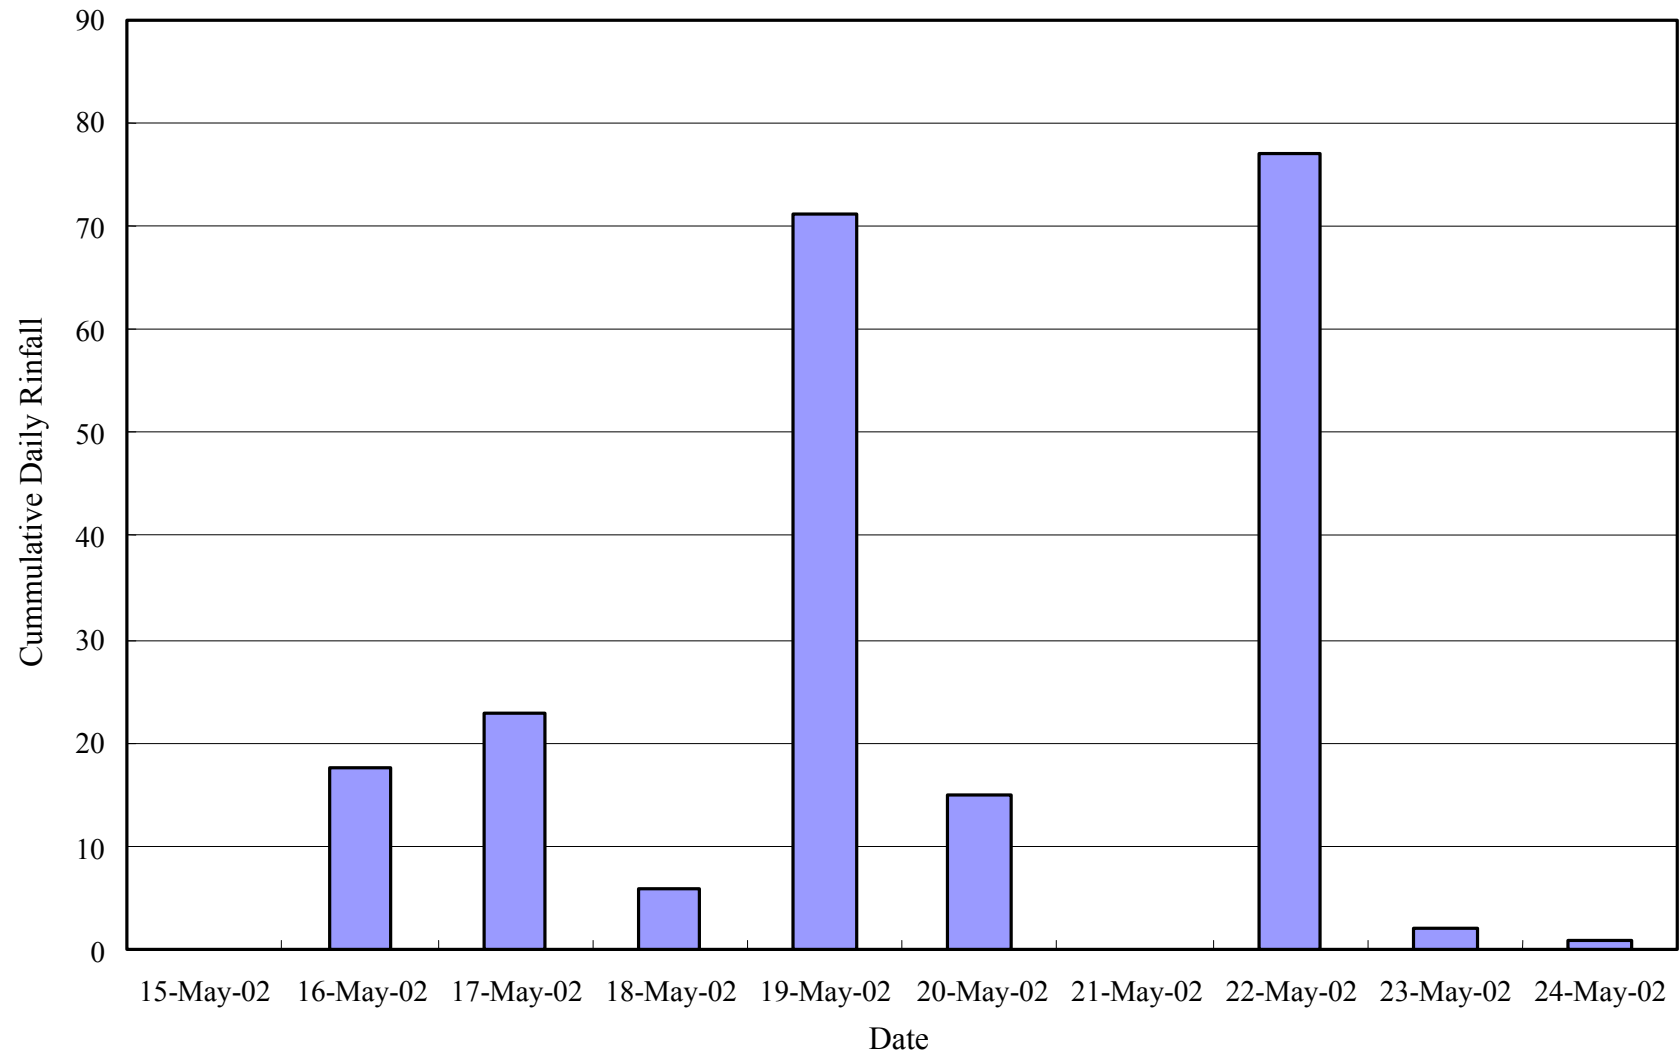
Figure 5 - Daily Rainfall Summary for Raingauge No. K07 in 2002

It is noted that 14 mm of rainfall was recorded in two days preceding the May 2002 rockfall (Figure 5). However, the highest daily rainfall was 71 mm on 19 May 2002 (i.e. 3 days before the incident). The flow rate of seepage observed by HCL from the pocket of cobbles and boulders exposed at the crest of the back scarp, was about 1 litre/min on 24 May 2002 and about 2 litres/min on 30 May 2002. The total rainfall recorded over this period is about 3 mm. It is possible that there may have been a delayed response of the subsurface groundwater flow and the build-up of a transient cleft water pressure behind the “loose block”, which may be a contributory factor of the May 2002 rockfall incident. The rainfall preceding the rockfall was not particularly heavy and the corresponding return period was about one year.

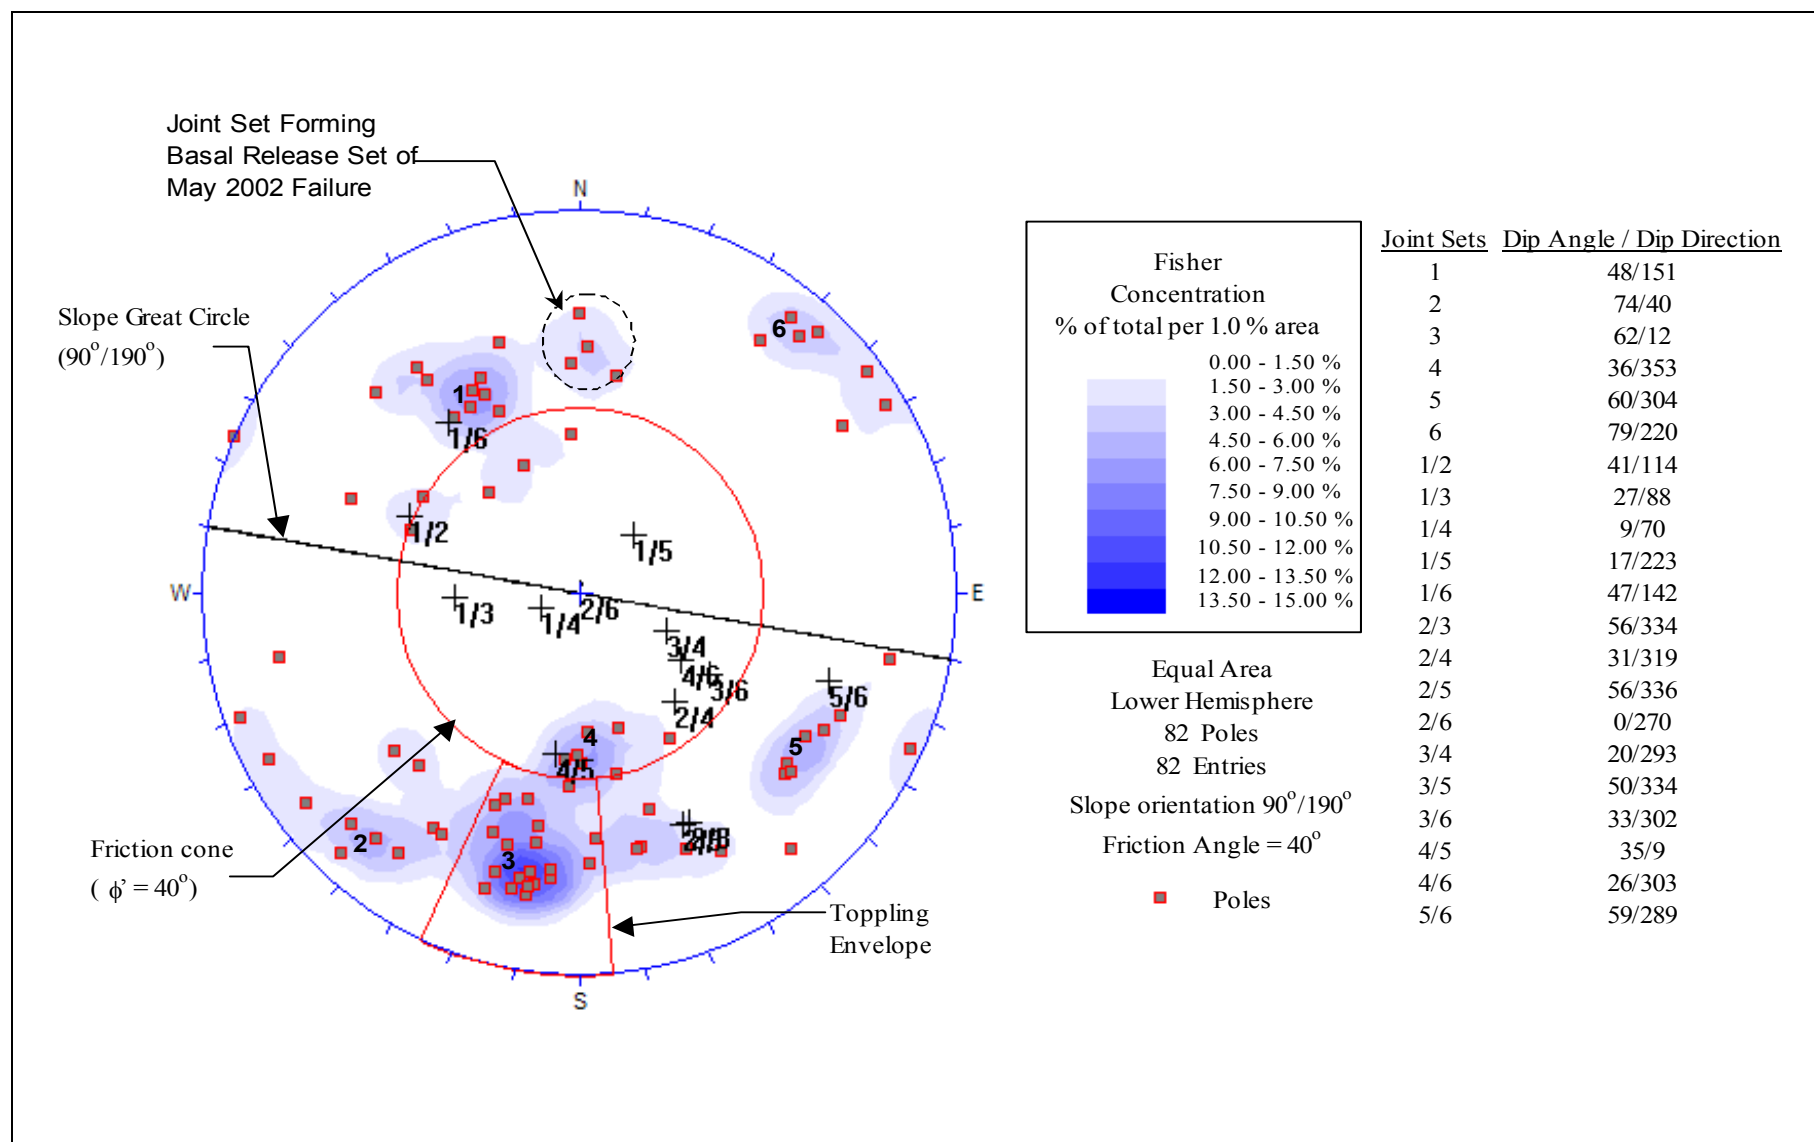
Figure 9 - Stereoplot of Joint Orientations from Detailed Mapping Near the May 2002 Rockfall

A scan-line survey was carried out by HCL for the whole length of the subject slope. Furthermore, a more detailed rock joint mapping was carried out in the vicinity of the May 2002 rockfall location, which covers the eastern-most 30 m of the slope. Stereoplots of rock joint data collected from the scan-line survey and the rock joint mapping are presented in Figures 9 and 10 respectively. It is noted from the stereoplots that there is generally little variation in the distribution of joint orientations along the subject slope. The adversely orientated joints forming the basal release (sliding) surface of the recent failure is shown in Figure 9. Although similar orientated joints were identified occasionally at various locations along the subject slope (Figure 10), they were limited in persistence and would not form a pervasive joint set within the rock mass. Based on the kinematic analysis of the rock joints, it is possible that toppling and wedge failure modes could occur on the subject slope (Figures 9 and 10). As shown in Plate 15, the joint set for potential toppling is well developed at the central portion of the subject slope.

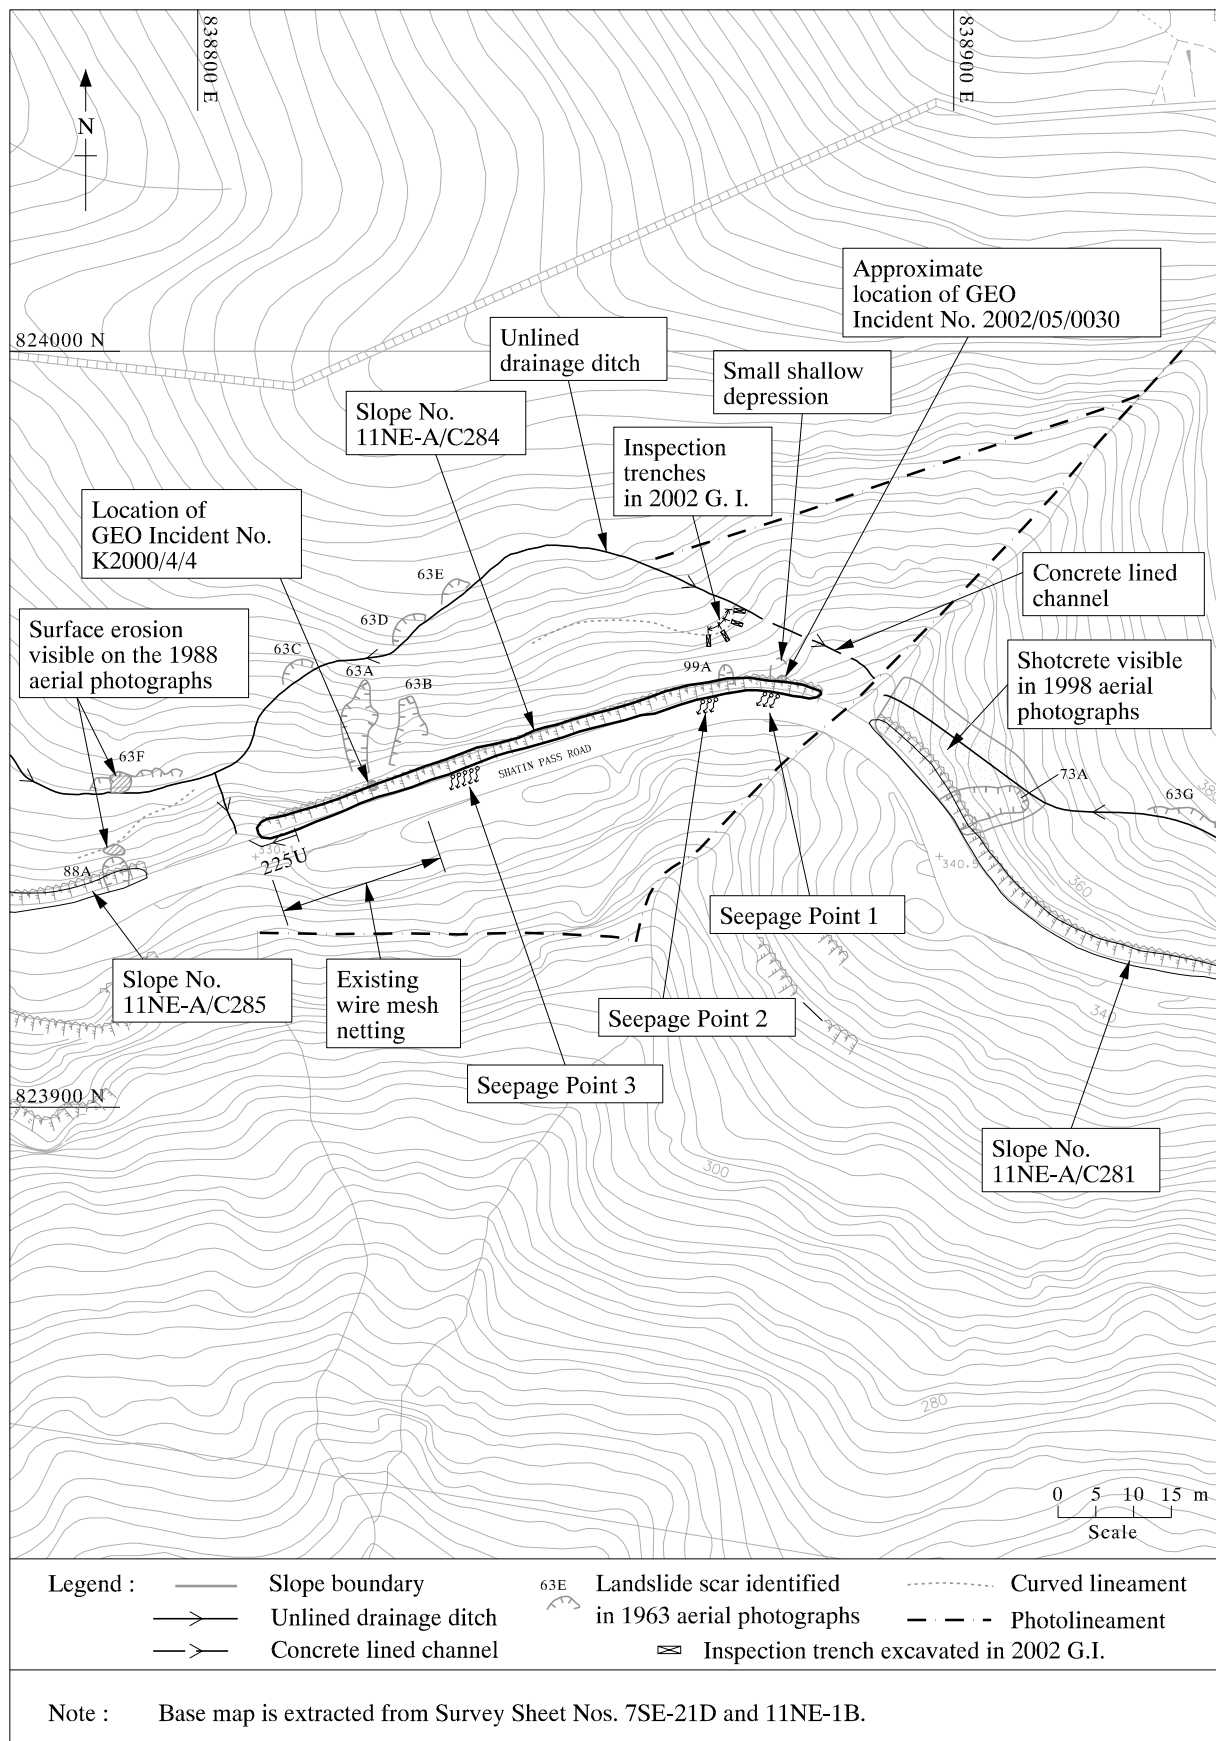
Figure A1 - Feature Identified During the API

23 October 1998 A48436-A48438 4000'	<p>A footpath located about 60 m above the crest of the subject slope is under construction.</p> <p>A fresh area of shotcrete about 20 m by 10 m has been placed over the western end of slope No. 11NE-A/C281.</p> <p>The natural hillside above the subject slope has recovered from the earlier hillfires and is covered in dense grass and small shrubs. The hillside below Shatin Pass Road is generally densely wooded.</p> <p>Possible seepage was observed at Seepage point 3 (Figure A1).</p>
27 October 1999 A50529-A50530 4000'	<p>At the crest of the rock slope a light toned area (about 4 m by 4 m) is visible about 5 m west of the location of the recent rockfall. This is probably a minor failure or an area recently shotcreted (marked as 99A on Figure A1).</p> <p>The footpath above the crest of the slope has been completed.</p> <p>Possible seepage was observed at Seepage points 1 and 3 (Figure A1).</p>

Date of Photograph GEO Photo No(s) Altitude	Observations
11 December 1999 CN25305- CN25306 4000'	No significant change visible to the subject slope. Possible seepage was observed at Seepage points 1 and 3 (Figure A1).
2000 CN27560 4000'	Single photograph. No significant change visible to the subject slope. Possible seepage was observed at Seepage points 1, 2 and 3 (Figure A1).
21 January 2001 RW0854-RW0856 16000'	Infrared high altitude photographs. Due to high altitude and aspect of photographs, no significant detail of the slope can be identified.
