**DETAILED STUDY OF  
THE 23 MARCH 2002  
ROCKFALL INCIDENT  
AT SLOPE NO. 11NW-A/C61  
AT CASTLE PEAK ROAD,  
KWAI CHUNG**

**GEO REPORT No. 157**

**Maunsell Geotechnical Services Limited**

**GEOTECHNICAL ENGINEERING OFFICE  
CIVIL ENGINEERING AND DEVELOPMENT DEPARTMENT  
THE GOVERNMENT OF THE HONG KONG  
SPECIAL ADMINISTRATIVE REGION**

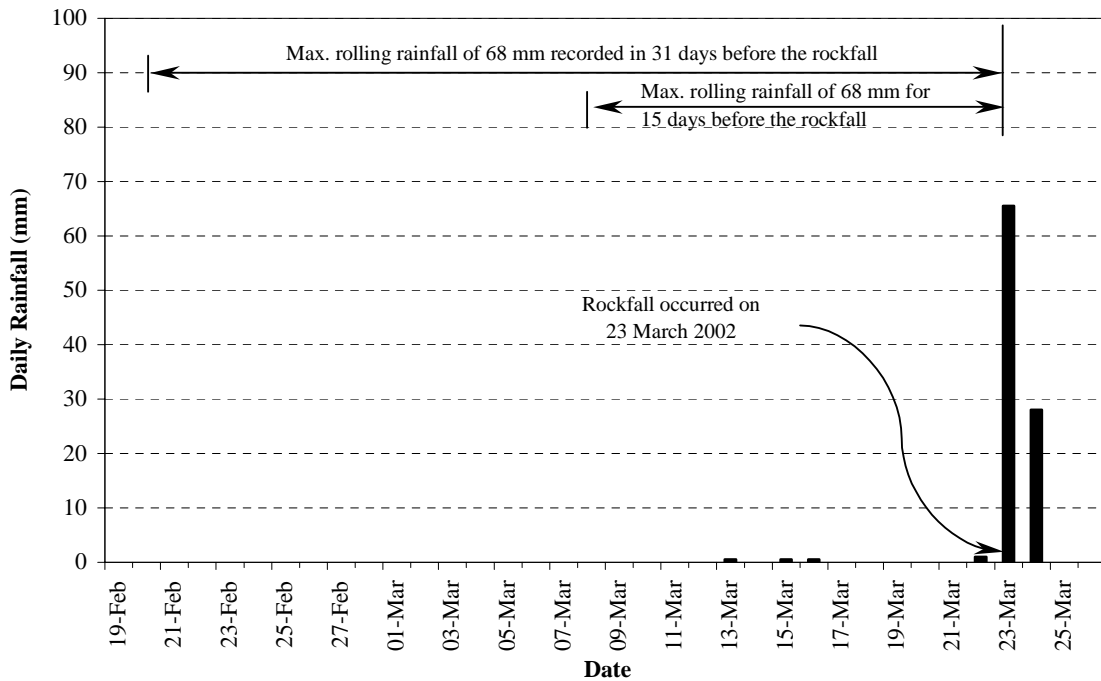
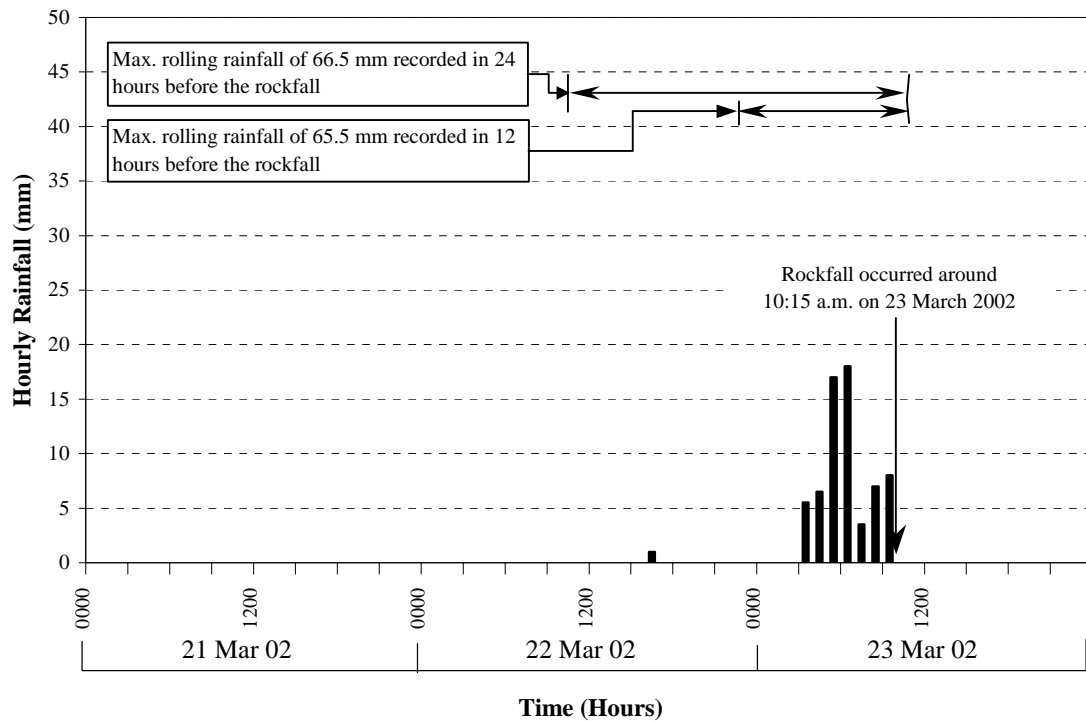
Figure 8 - Rainfall Recorded at GEO Raingauge No. N04 for the March 2002 Rainstorm

The daily rainfall recorded by the raingauge over the preceding month and the three days following the incident is presented in Figure 8. The hourly rainfall readings for the period between 21 March and 23 March 2002 are also shown in Figure 8. The peak hourly rainfall of approximately 18 mm was recorded between 6:00 a.m. and 7:00 a.m. in the 24-hour period preceding the 23 March 2002 rockfall incident.

(a) Daily Rainfall Recorded at GEO Raingauge No. N04 from 19 February to 26 March 2002

(b) Hourly Rainfall Recorded at GEO Raingauge No. N04 from 21 to 23 March 2002

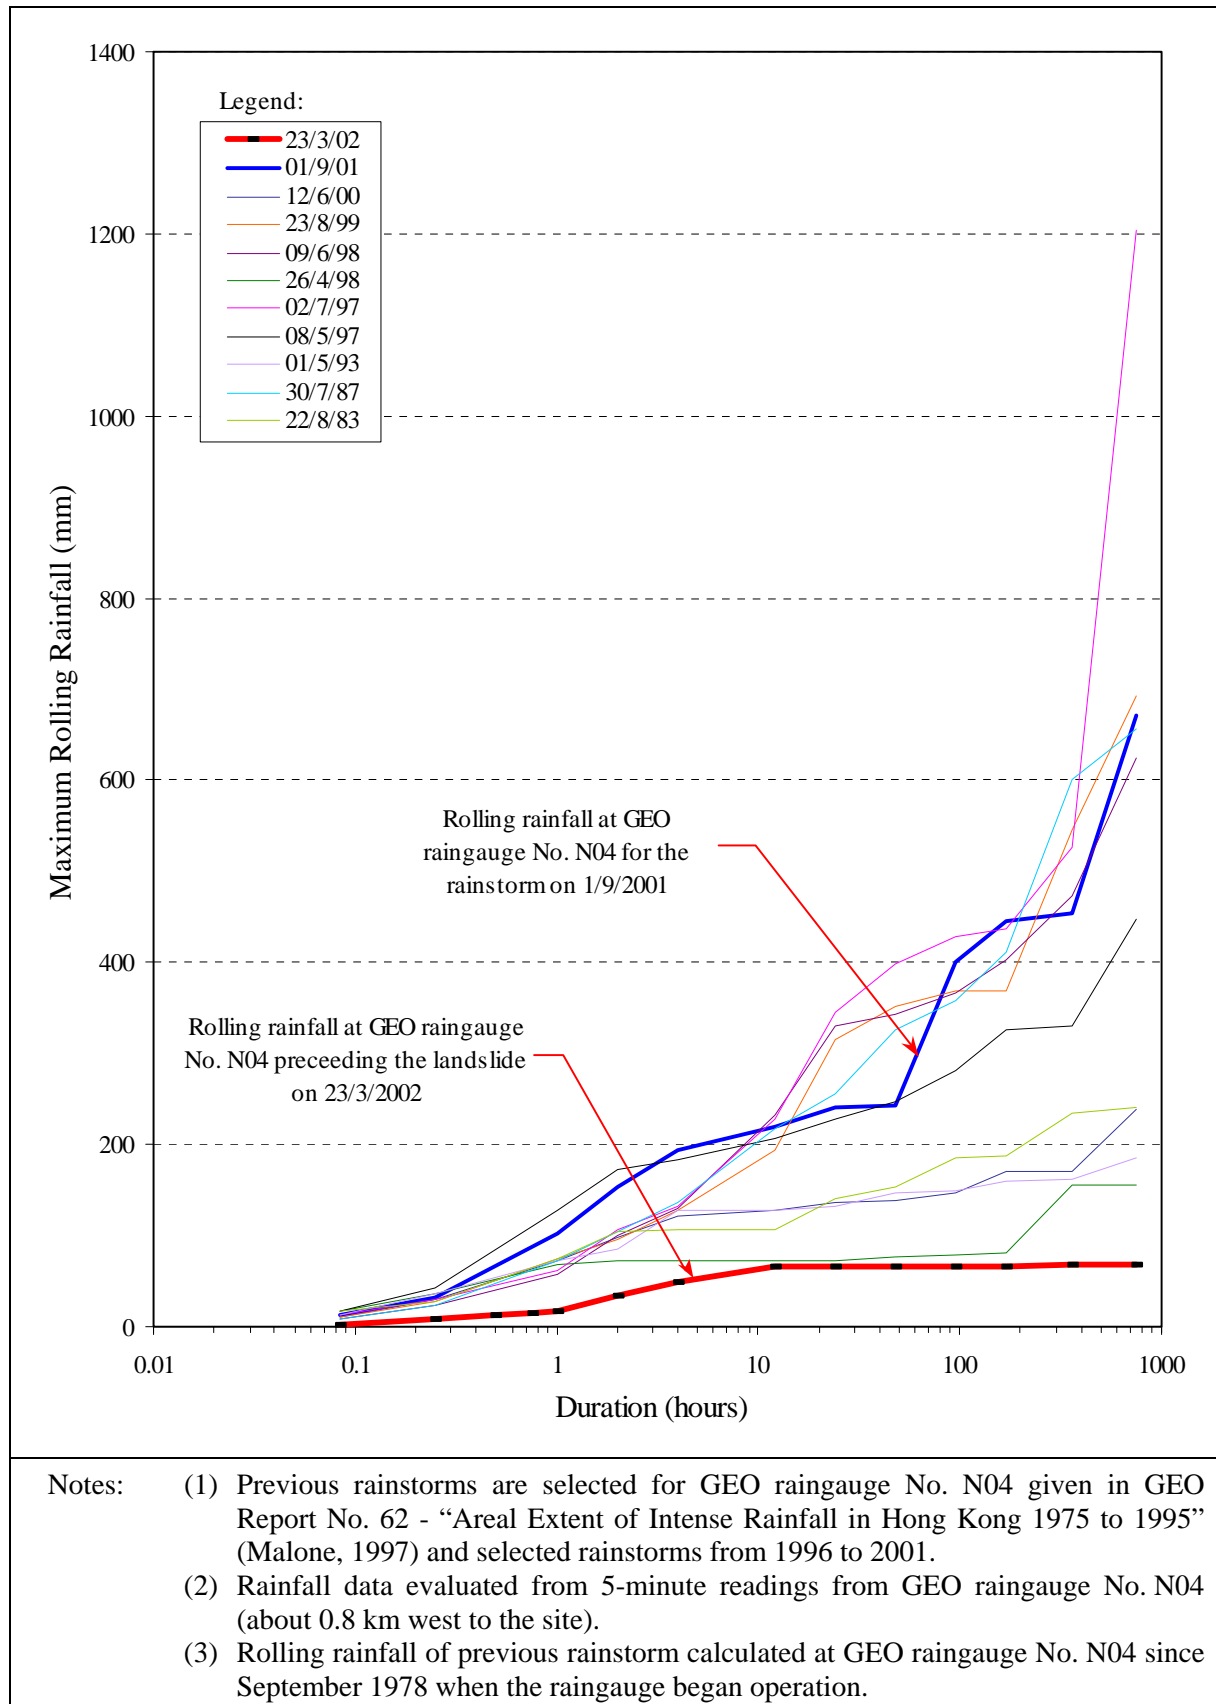
Figure 9 - Maximum Rolling Rainfall for Previous Major Rainstorms at GEO Raingauge No. N04

The results of an analysis of the return periods of the intensities of the previous rainfall records between the completion date of the works, 30 June 2000, and the date of the rockfall incident, are given in Table 2. The most severe rainfall in this period was recorded on 1 and 2 September 2001. The results show that the rainfall return periods for durations were more than 2 years and the critical rainfall duration was for 2 hours, which corresponds to a return period of 13 years (Table 2). A comparison of the patterns of selected past major rainstorms recorded at raingauge No. N04 since it became operational in September 1978 is presented in Figure 9. The maximum rolling rainfall indicates that the rainstorm on 23 March 2002 was much less severe than the 1 September 2001 rainstorm and other rainstorms experienced since the completion of the slope upgrading works in 2000.
