**DETAILED STUDY OF
THE 1 SEPTEMBER 2001
LANDSLIDE ON SLOPE
NO. 11NE-B/FR249 BELOW
NO. 56 DENON TERRACE,
TSENG LAN SHUE, SAI KUNG**

GEO REPORT No. 159

Maunsell Geotechnical Services Limited

**This report was originally produced in May 2003
as GEO Landslide Study Report No. LSR 3/2003**

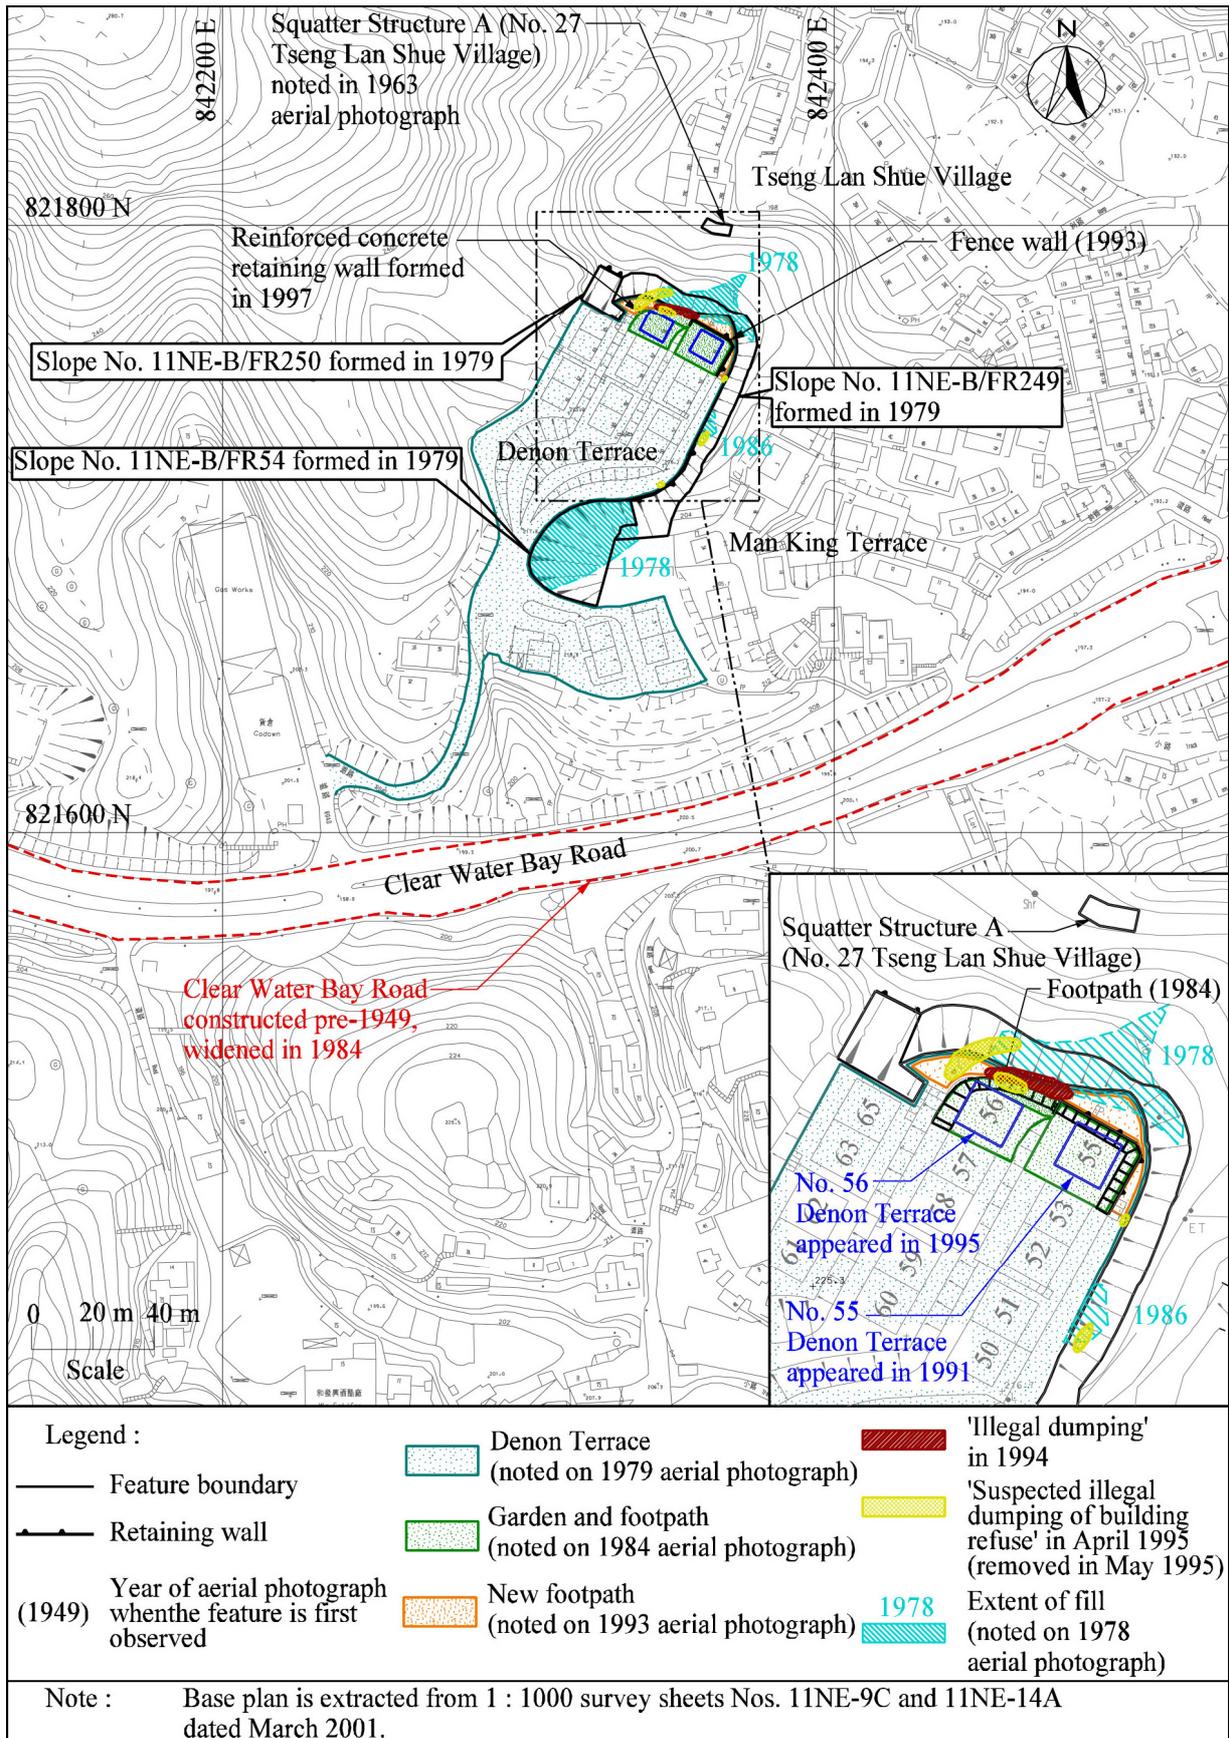
Figure 5 - Site History

A brief account of the site development history has been established from a review of relevant documentation and observations from aerial photographs taken between 1949 and 2001 (Figure 5). Details of the Aerial Photograph Interpretation (API) are presented in Appendix A.

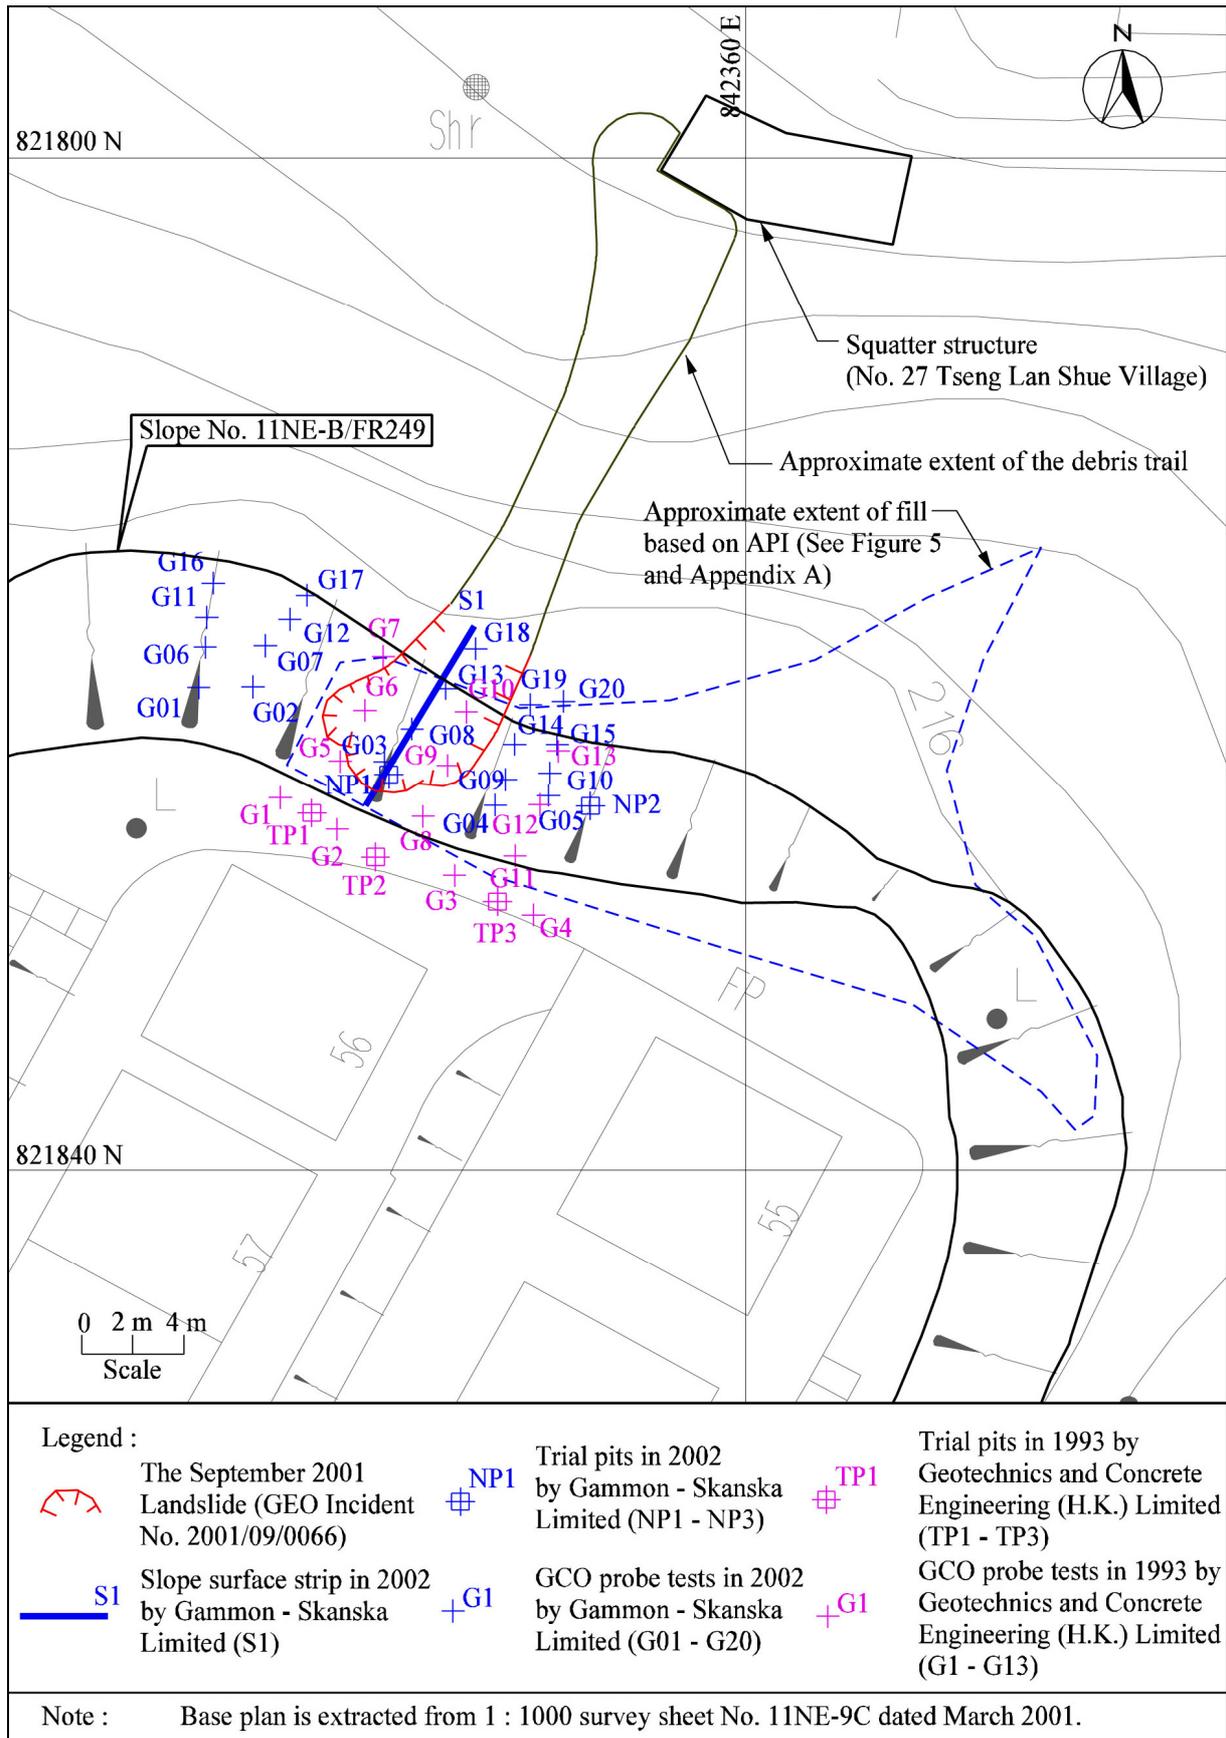
Figure 7 - Ground Investigation Plan

As part of this detailed study, a ground investigation (Figure 7) comprising two trial pits (Nos. NP1 and NP2), one slope surface strip (No. S1) and 20 GCO probes tests (Nos. G1 to G20) was carried out by Gammon Skanska Limited in August 2002 under the supervision of MGSL. The objectives of the ground investigation were to determine the near-surface ground conditions at the landslide site.

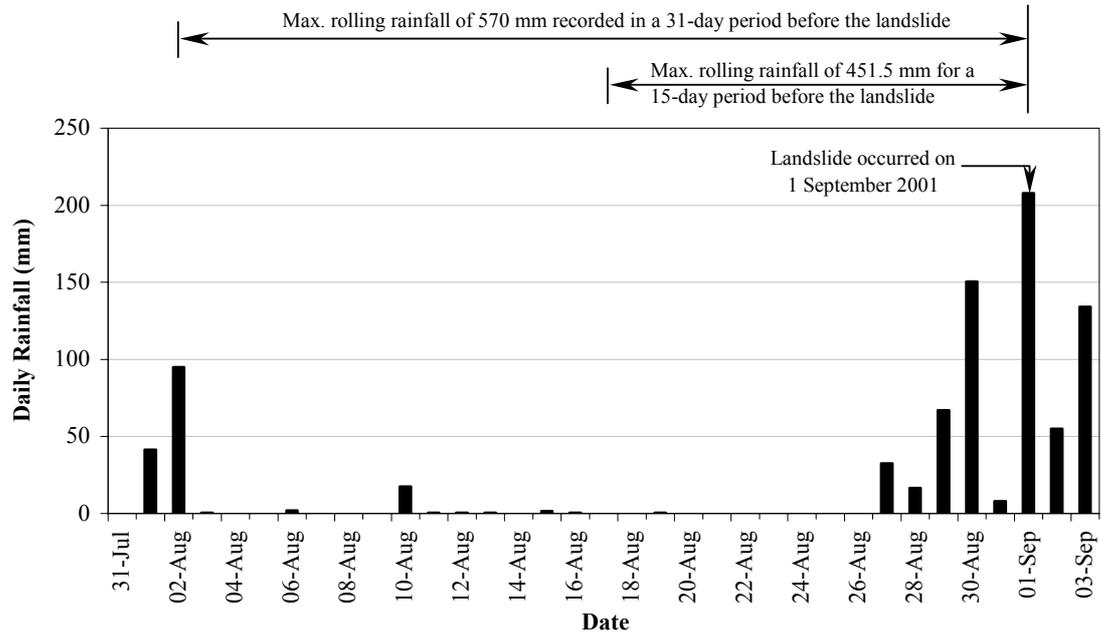
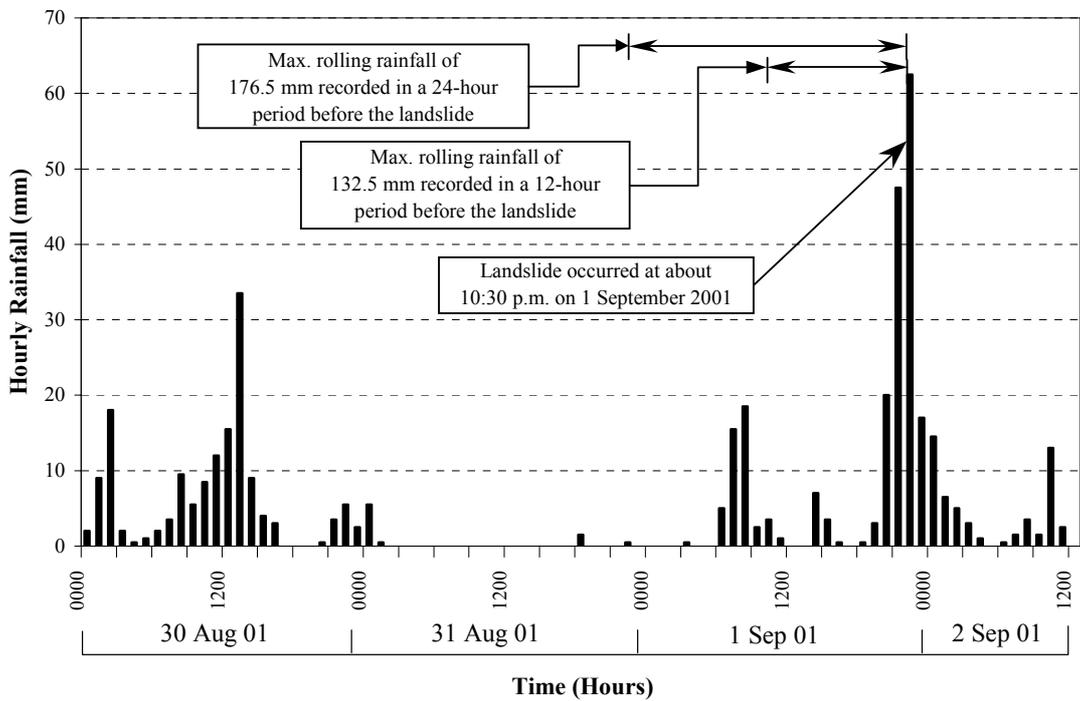
Figure 10 - Daily and Hourly Rainfall Recorded at GEO Raingauge No. N08

days following the incident, together with the hourly rainfall data for the period between mid-night on 30 August and mid-day on 2 September 2001 is presented in Figure 10. The peak hourly rainfall of approximately 63 mm was recorded between 10:00 p.m. and 11:00 p.m. on 1 September 2001. Rainfall recorded by raingauge No. K04 over the above period exhibited a similar pattern to the data received from raingauge No. N08 although the rainfall was less intense.

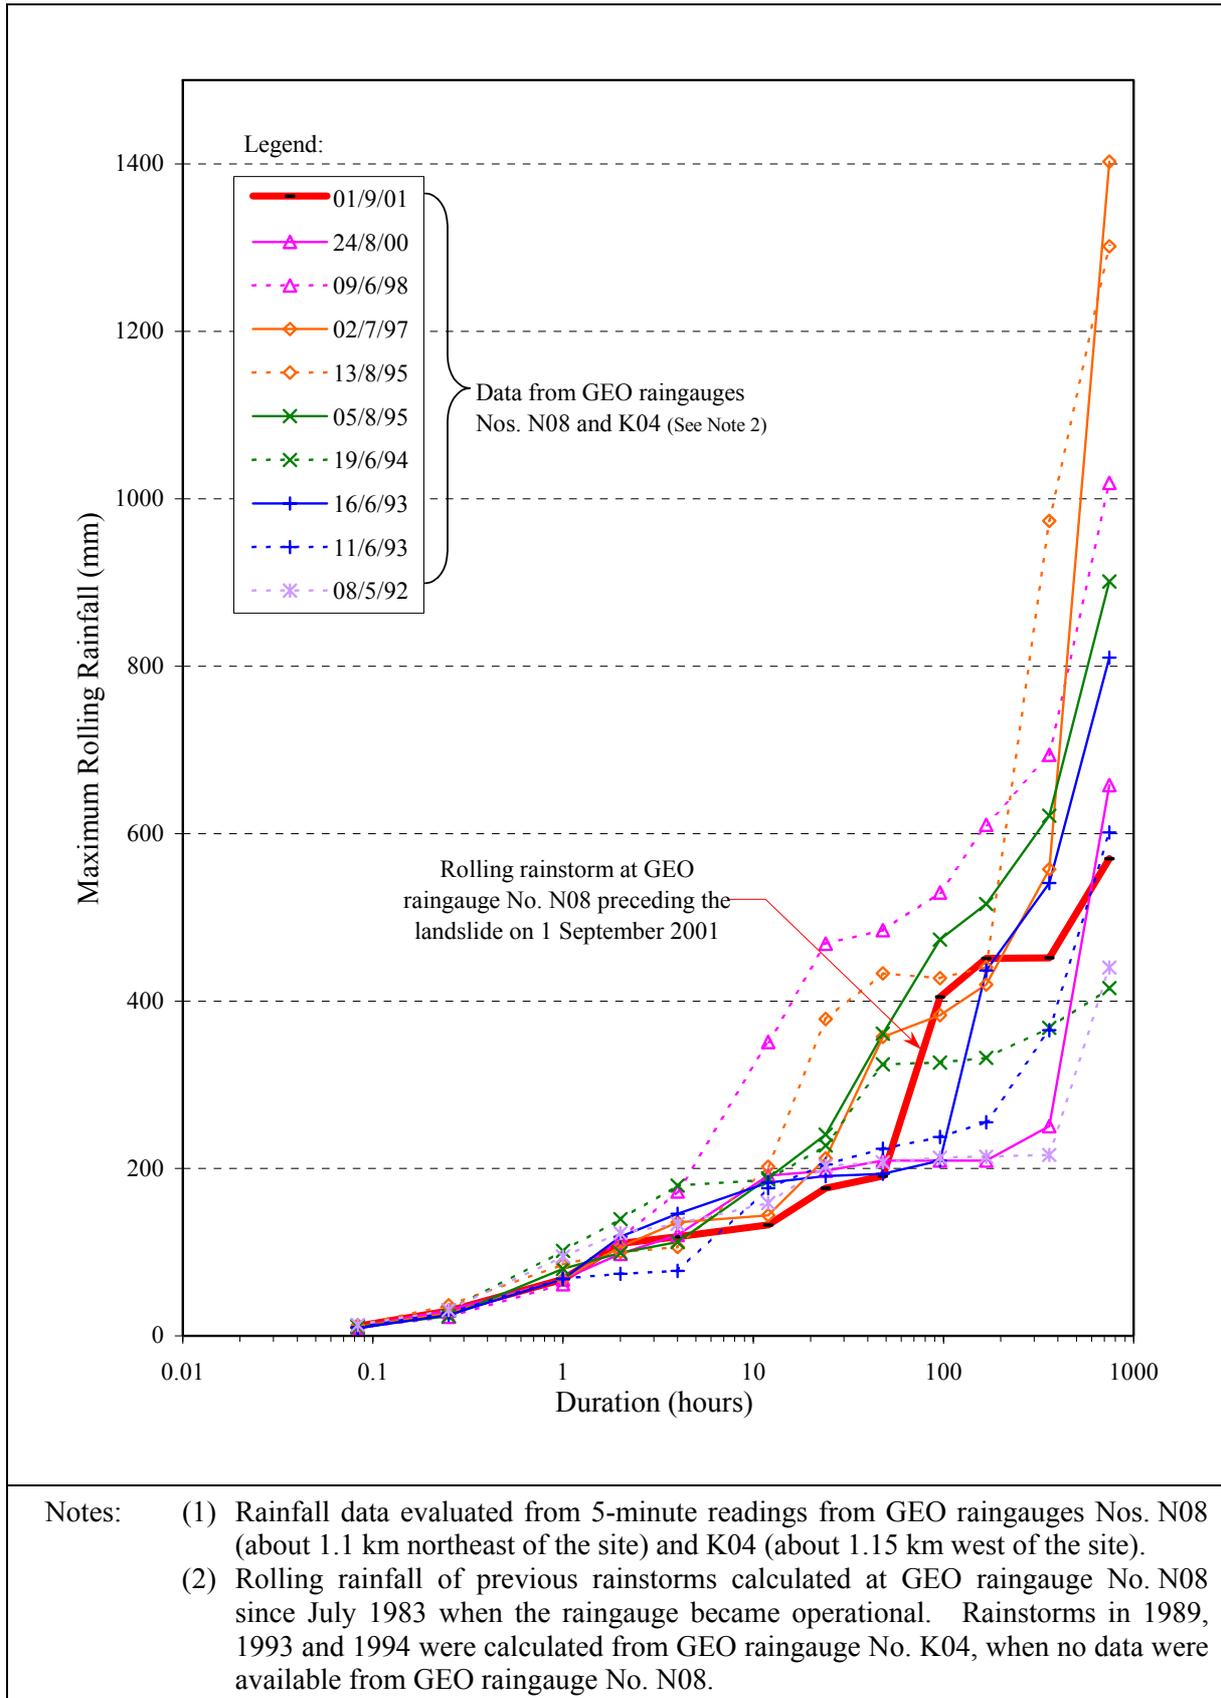
Figure 11 - Maximum Rolling Rainfall for Previous Major Rainstorms at GEO Raingauges Nos. K04 and N08

A comparison of the patterns of selected past major rainstorms recorded at raingauge No. N08 between 1992 and 2001 is presented in Figure 11. However since no data were available from GEO raingauge No. N08 for the years 1989, 1993 and 1994, data from GEO raingauge No. K04 were used in the comparison. The rolling rainfall indicates that the rainstorm on 1 September 2001 was not exceptionally heavy as compared with the previous rainstorms.

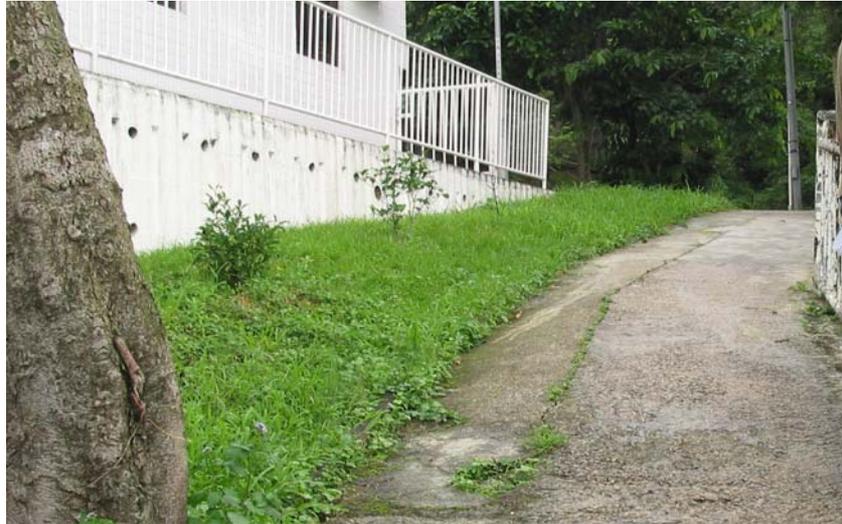
Plate 2 - View of the Concrete Paved Footpath at the Crest of Slope No. 11NE-B/FR249 above the Landslide Site (Photograph taken on 4 June 2002)

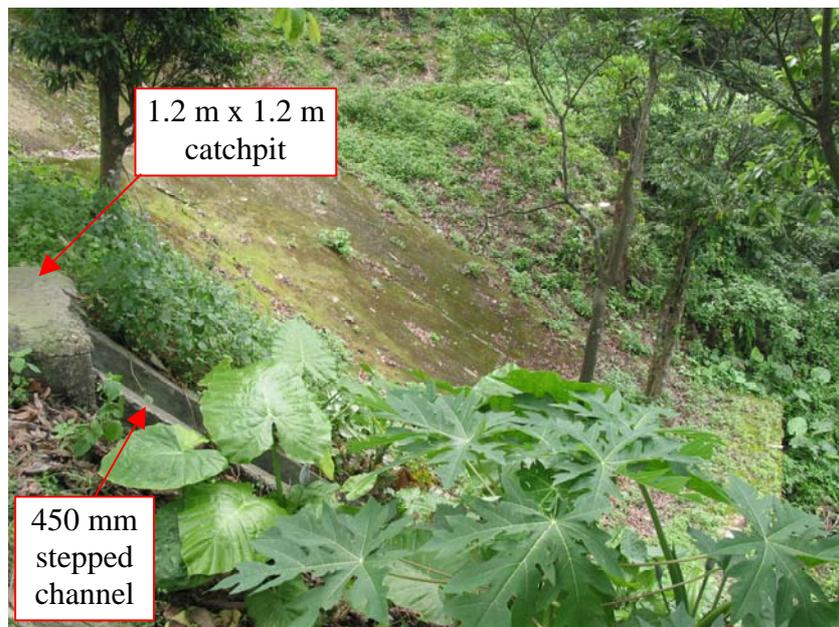
Plate 3 - General View of Slope No. 11NE-B/FR250 (Photograph taken on 4 June 2002)

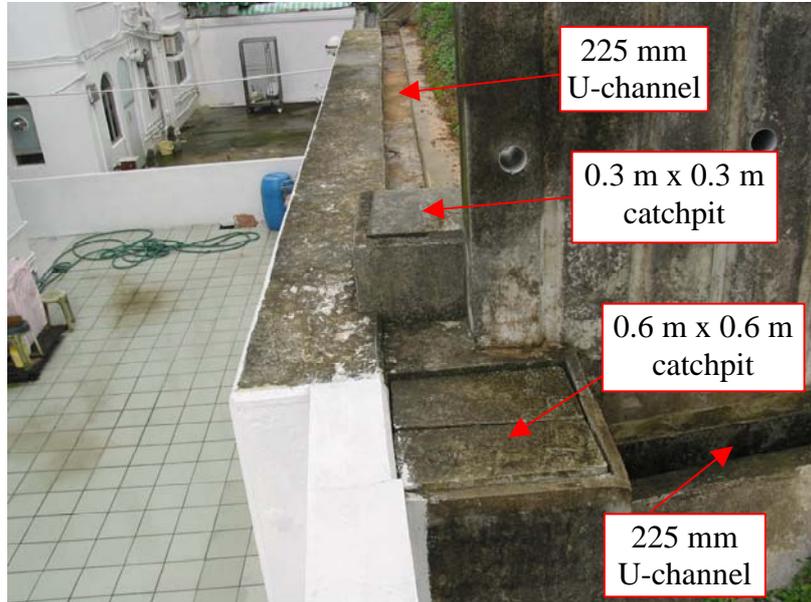
Plate 4 - View of the Catchpits at the East Corner of No. 56 Denon Terrace
(Photograph taken on 22 May 2002)

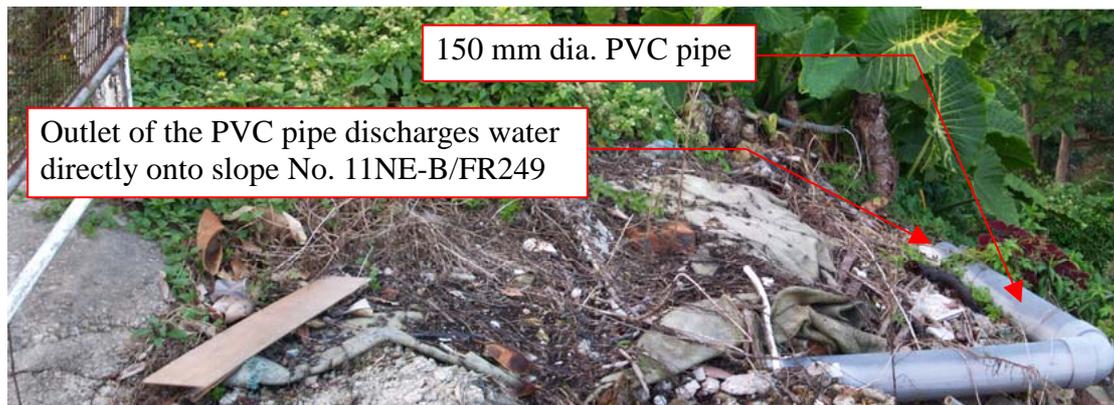
Plate 5 - View of the 150 mm Diameter PVC Pipe on Slope No. 11NE-B/FR249
(Photograph taken on 21 December 2001)

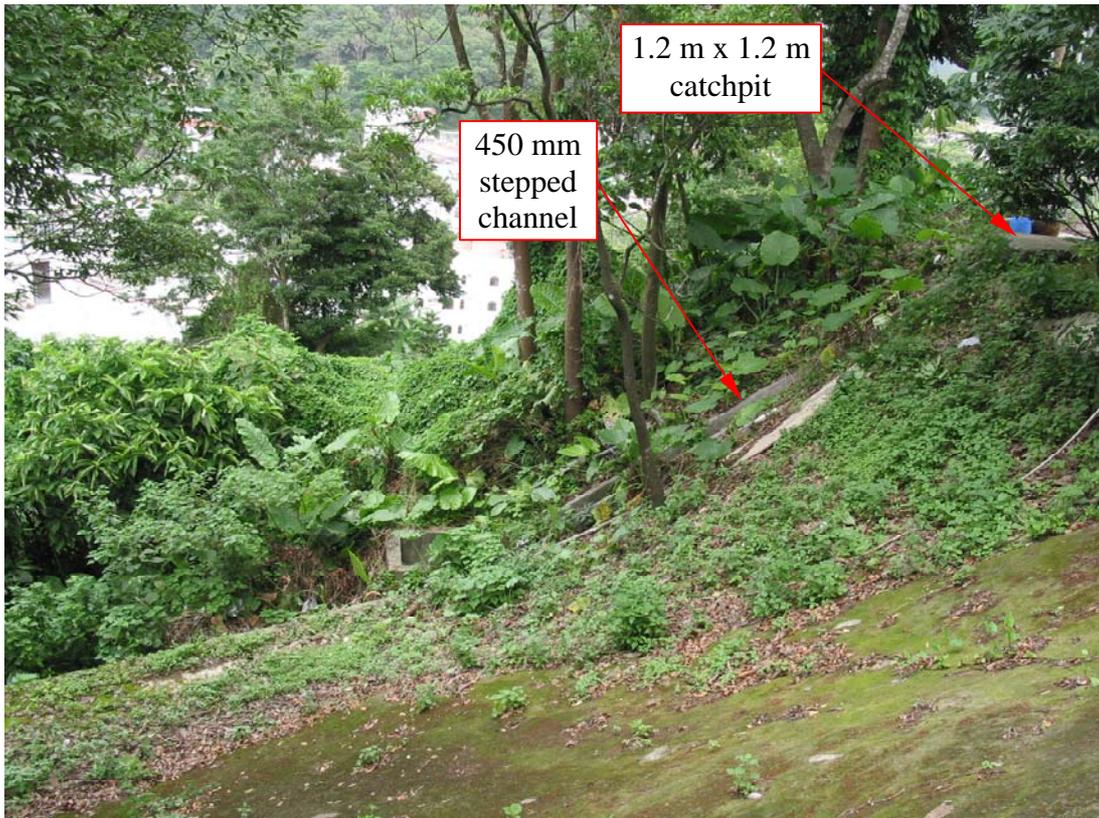
Plate 6 - View of the 450 mm Stepped Channel on Slope No. 11NE-B/FR250
(Photograph taken on 4 June 2002)

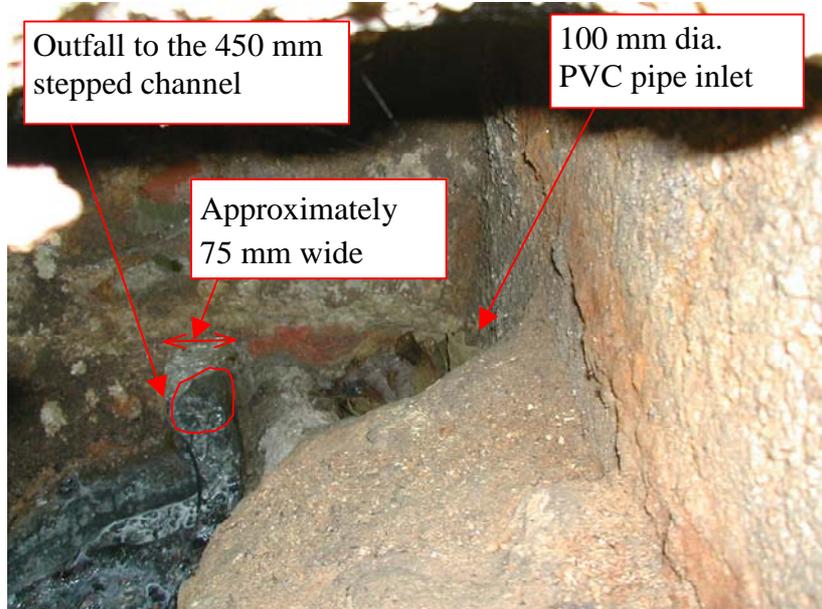
Plate 7 - View inside the 1.2 m x 1.2 m Catchpit at the Crest of Slope No. 11NE-B/FR249 (Photograph taken on 24 September 2002)

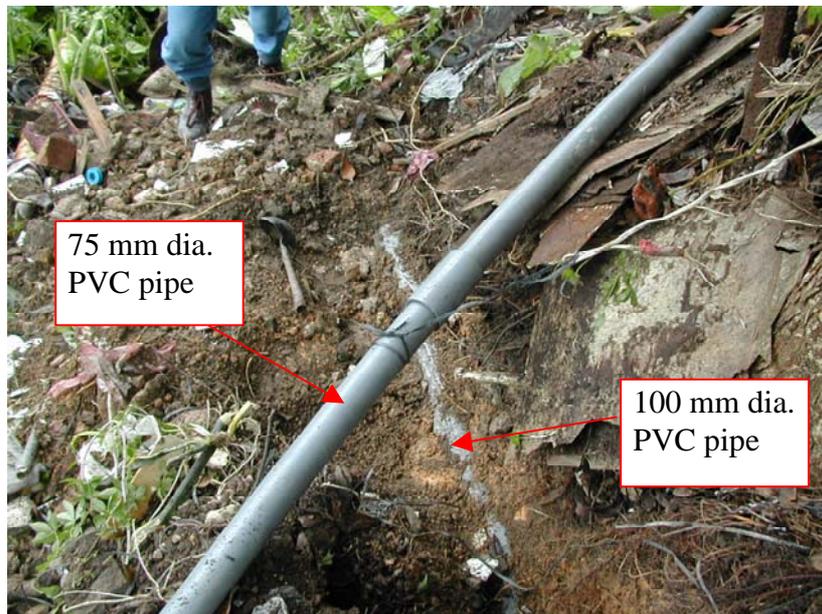
Plate 8 - View of the Buried 100 mm Diameter PVC Pipe and the 75 mm Diameter PVC Pipe on the Hillside (Photograph taken on 24 September 2002)

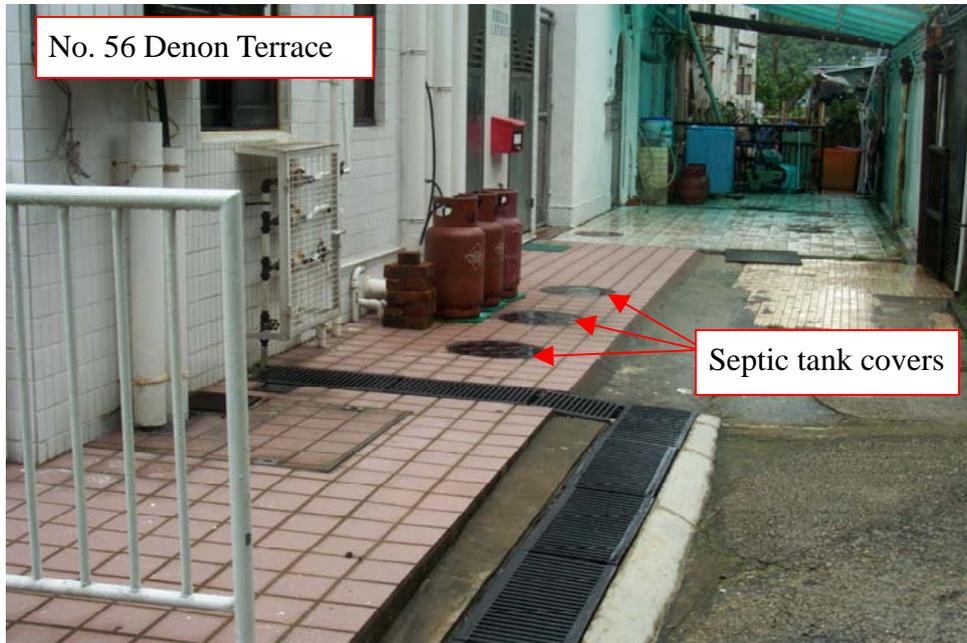
Plate 9 - View of Septic Tank Location Adjacent to No. 56 Denon Terrace
(Photograph taken on 20 June 2002)

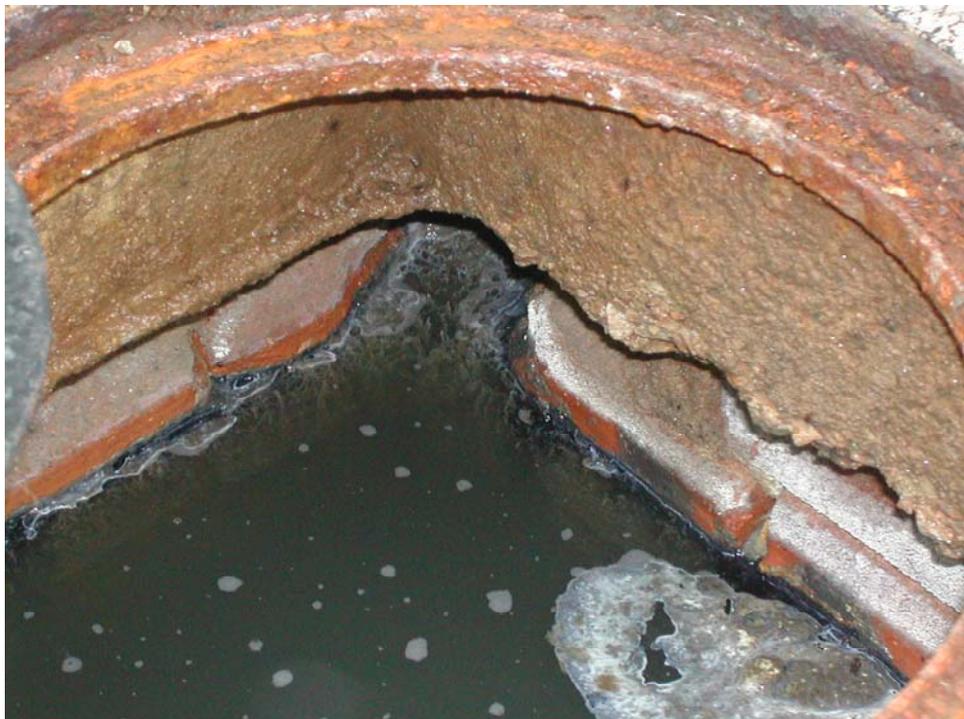
Plate 10 - View of the Septic Tank Outlet to the 75 mm Diameter
PVC Pipe (Photograph taken on 24 September 2002)

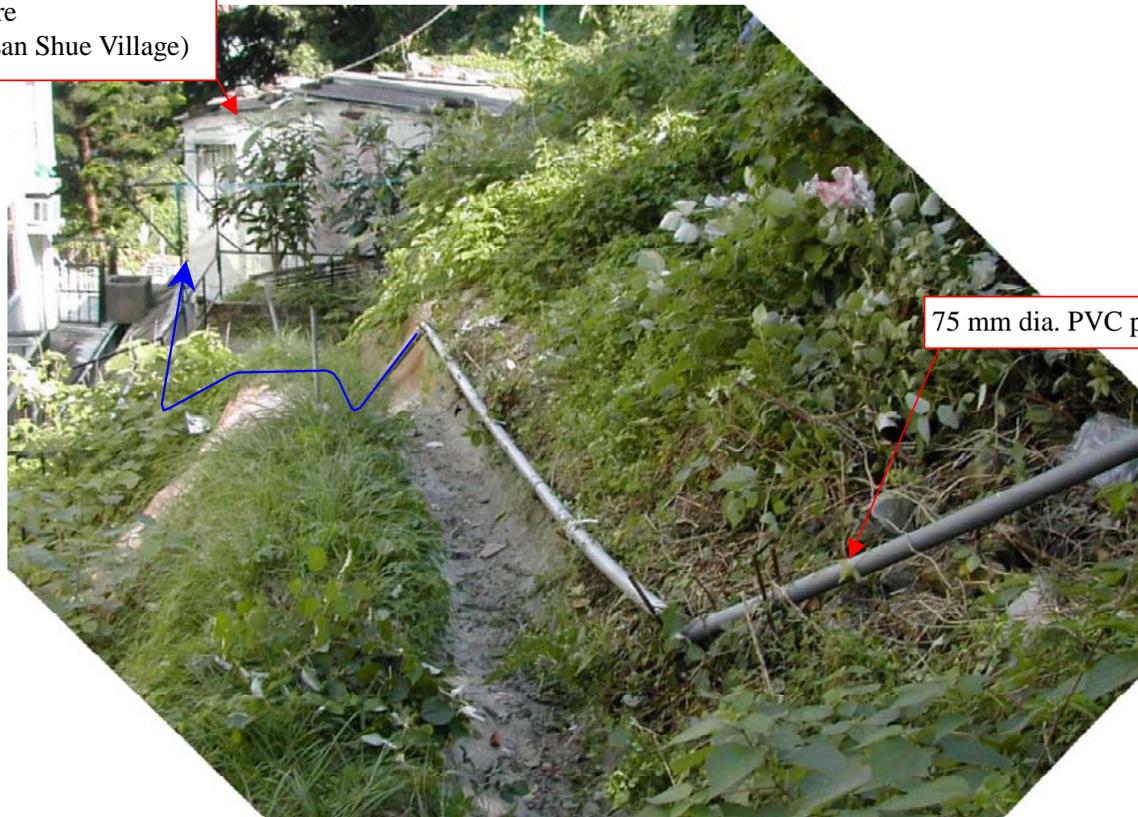
Plate 11 - View of the 75 mm Diameter PVC Pipe near Squatter Structure (No. 27 Tseng Lan Shue Village)
(Photograph taken on 9 October 2002)

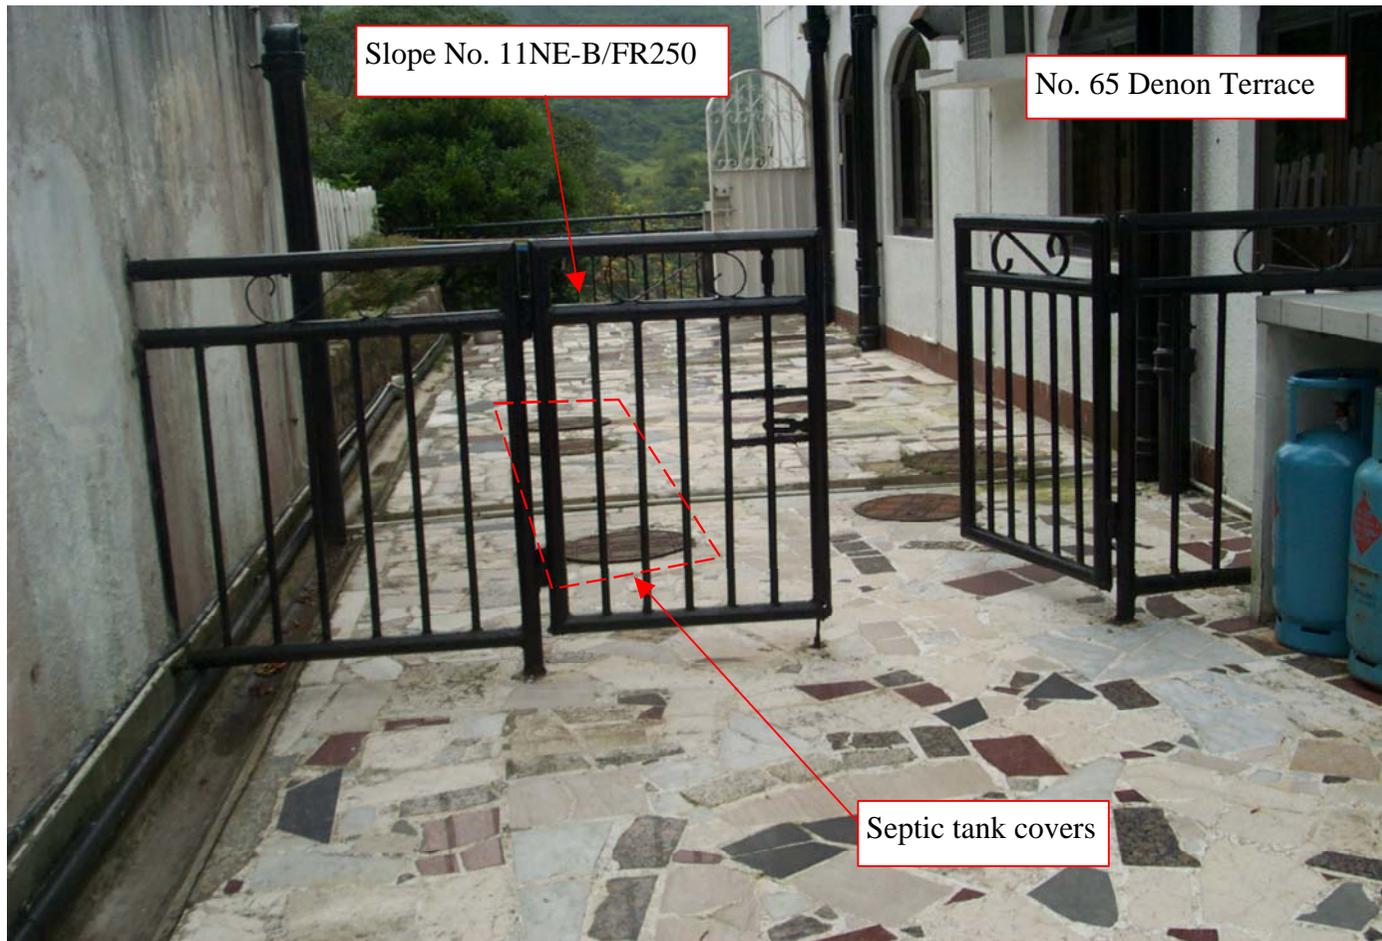
Plate 12 - View of the Septic Tank Location Adjacent to Nos. 63 and 65 Denon Terrace
(Photograph taken on 9 October 2002)

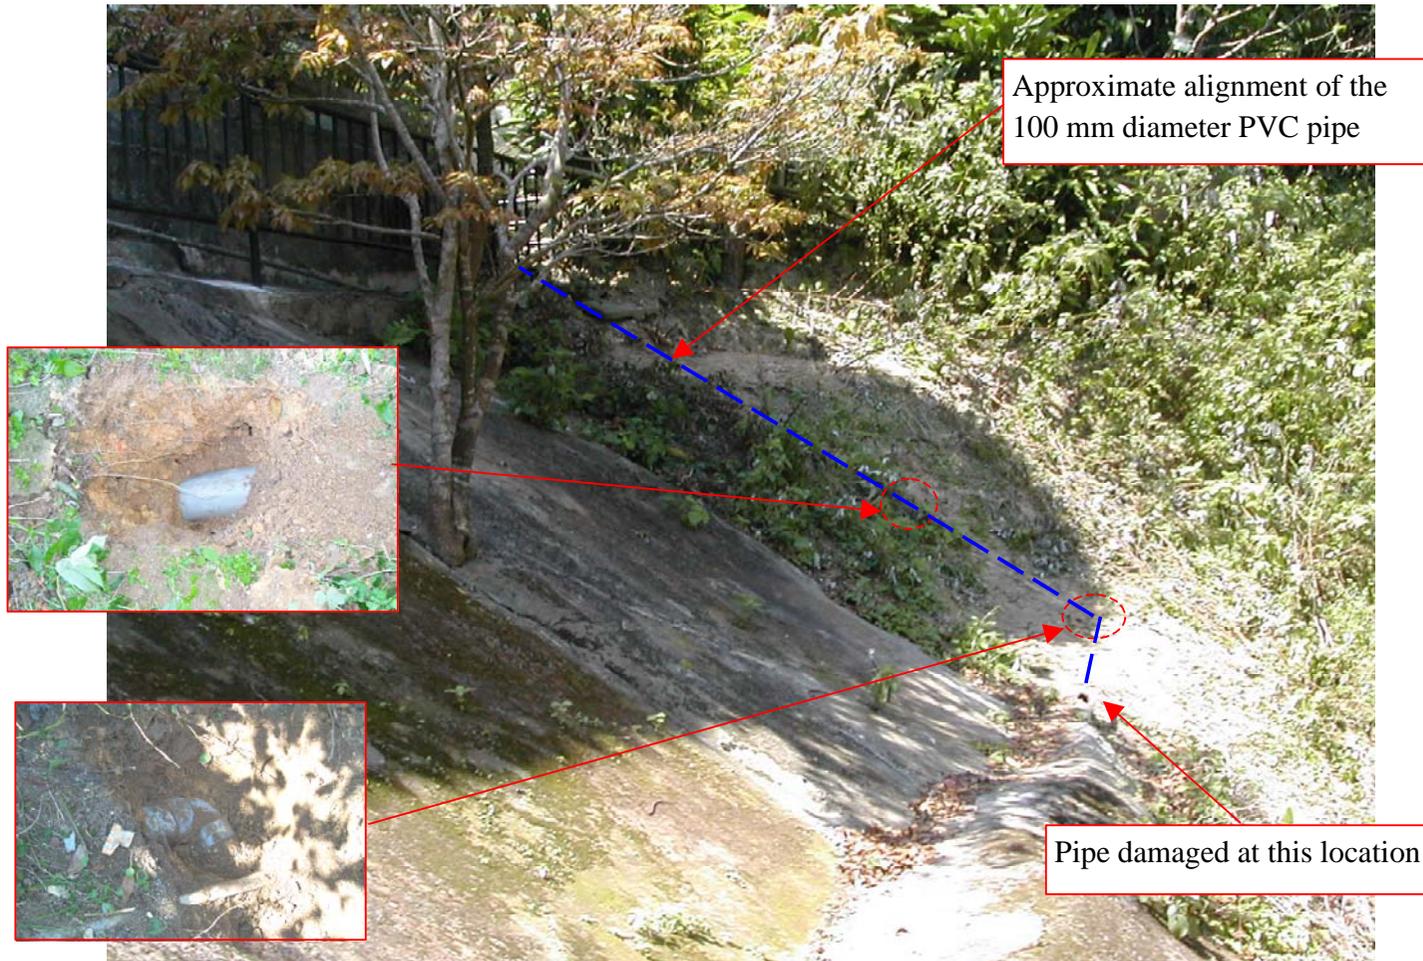
Plate 13 - View Showing the Approximate Alignment of the 100 mm Diameter PVC Pipe on Slope No. 11NE-B/FR250
(Photograph taken on 9 October 2002)
