**DETAILED STUDY OF  
THE 16 SEPTEMBER 2002  
LANDSLIDE ON SLOPE  
NO. 11NE-D/C18 AT  
CHA KWO LING TSUEN,  
FAN WA STREET, LAM TIN**

**GEO REPORT No. 160**

**Maunsell Geotechnical Services Limited**

**This report was originally produced in August 2003  
as GEO Landslide Study Report No. LSR 7/2003**

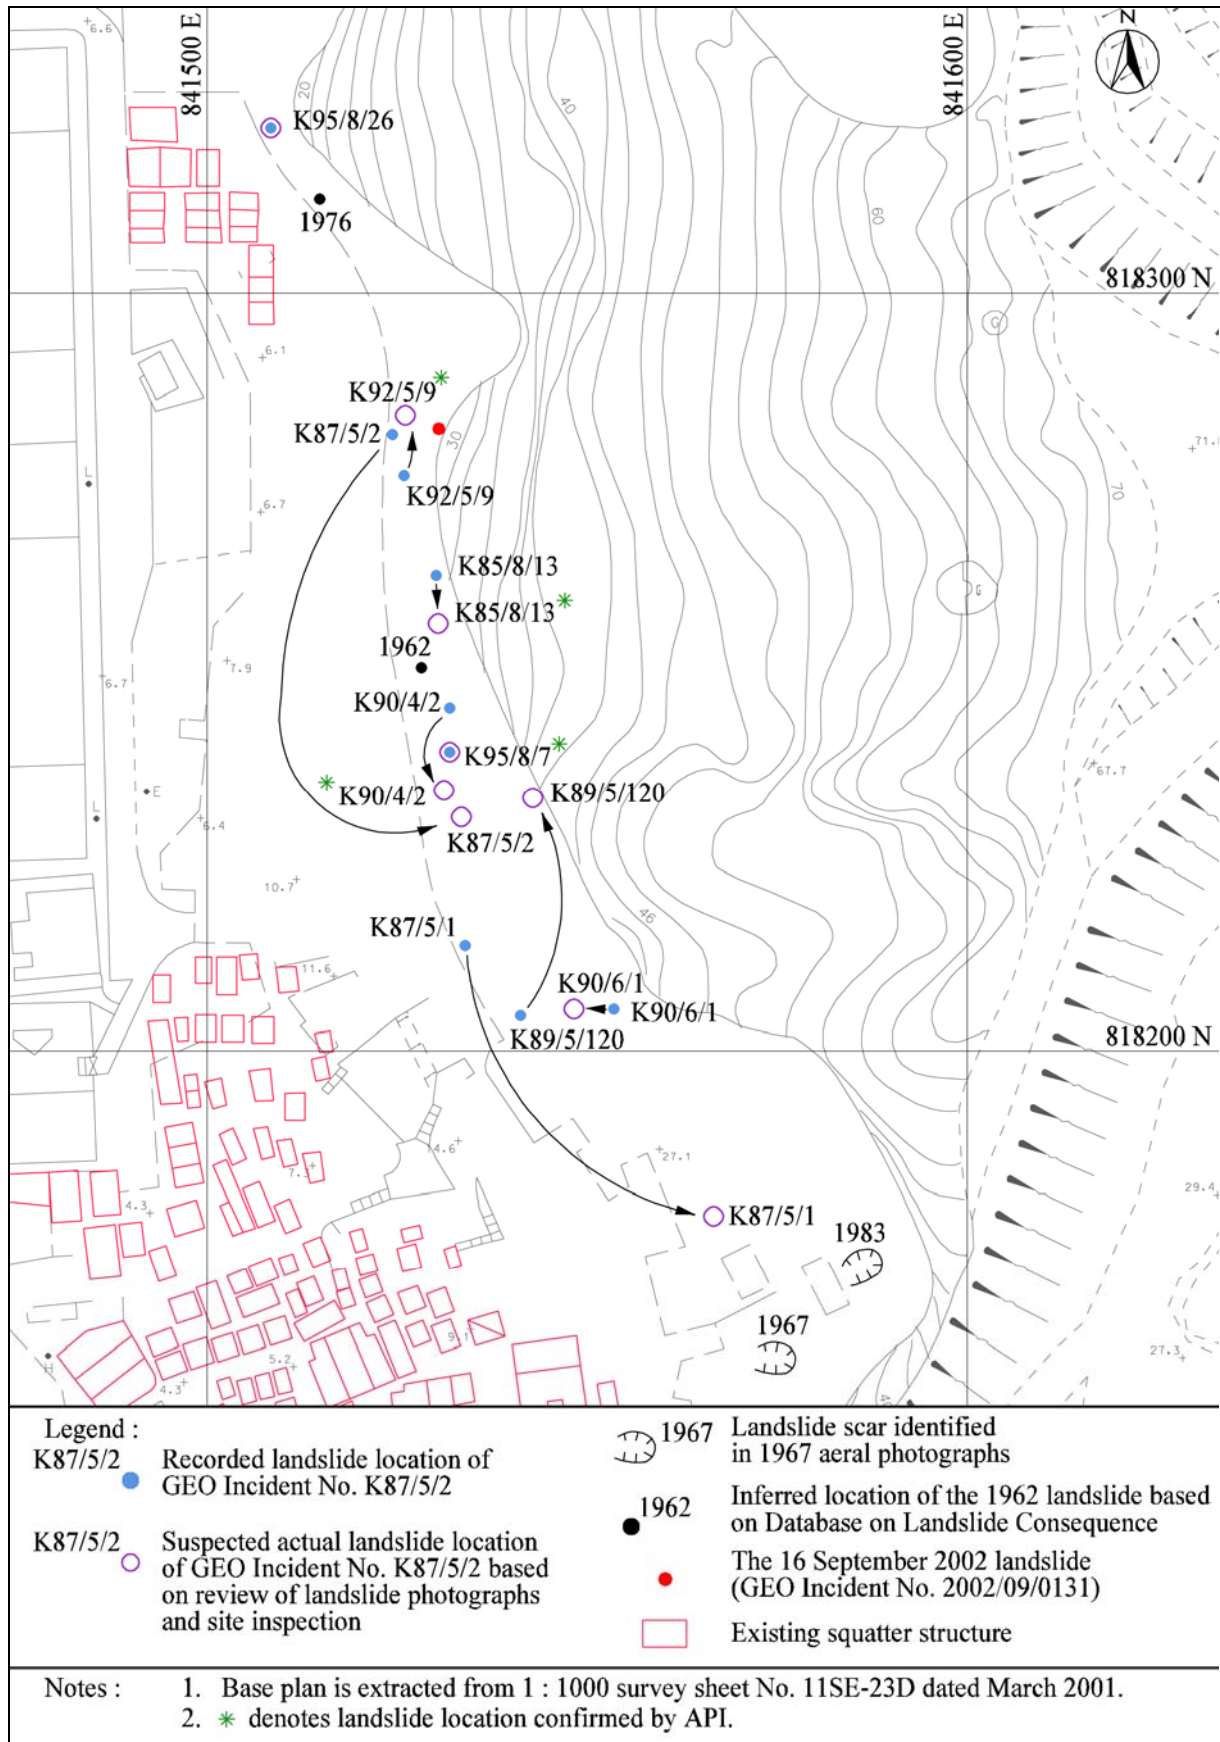
Figure 8 - Past Instability

<p>Note: Locations of the incidents are shown in Figures 8 and 14.</p>

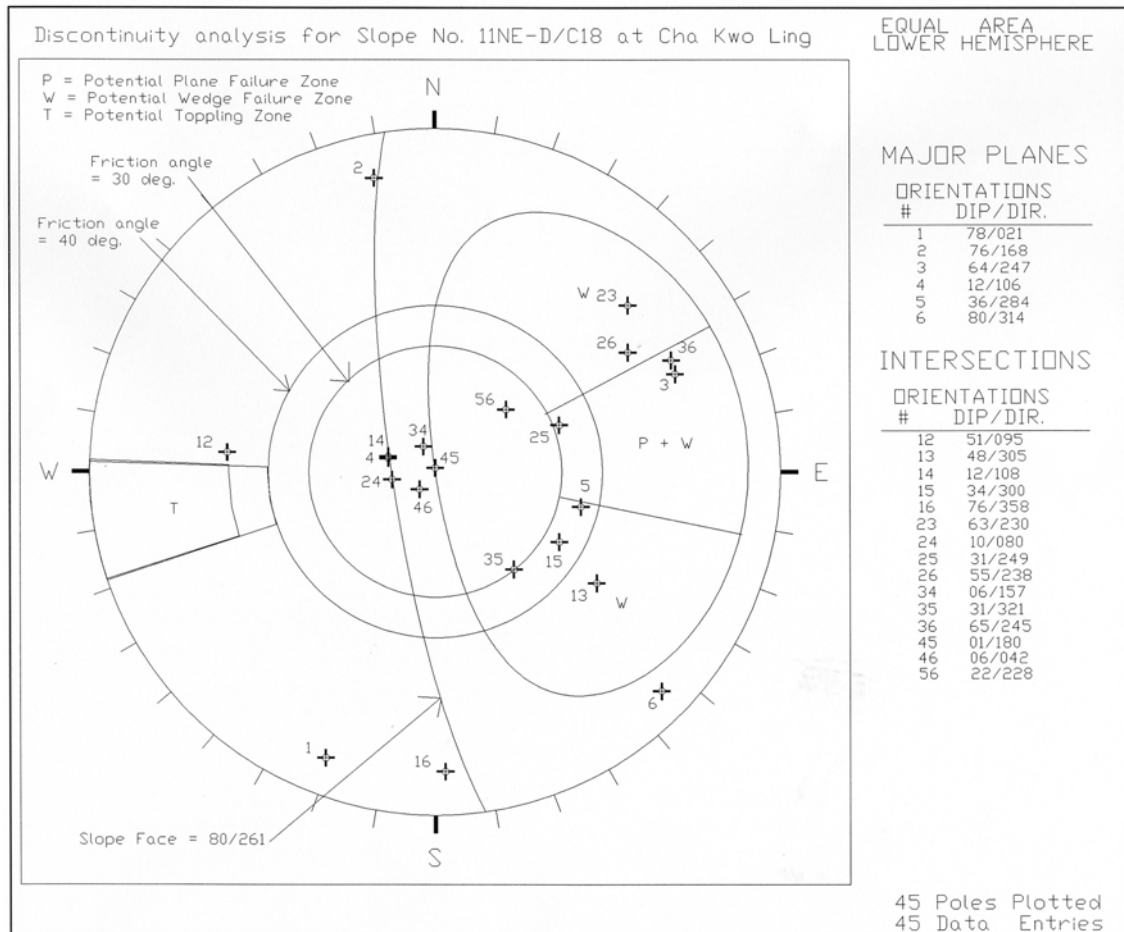
Figure 11 - Major Joint Planes at the Landslide Location

- Notes:
- (1) # 1 and # 2 represent Joint Set J1 (Steeply dipping, side release surfaces)
  - (2) # 3 represents Joint Set J2 (steeply dipping, back release surfaces)
  - (3) # 4 represents Joint Set J3 (shallow dipping, favourable orientation)
  - (4) # 5 represents Sheeting Joints (moderately dipping, unfavourable orientation)

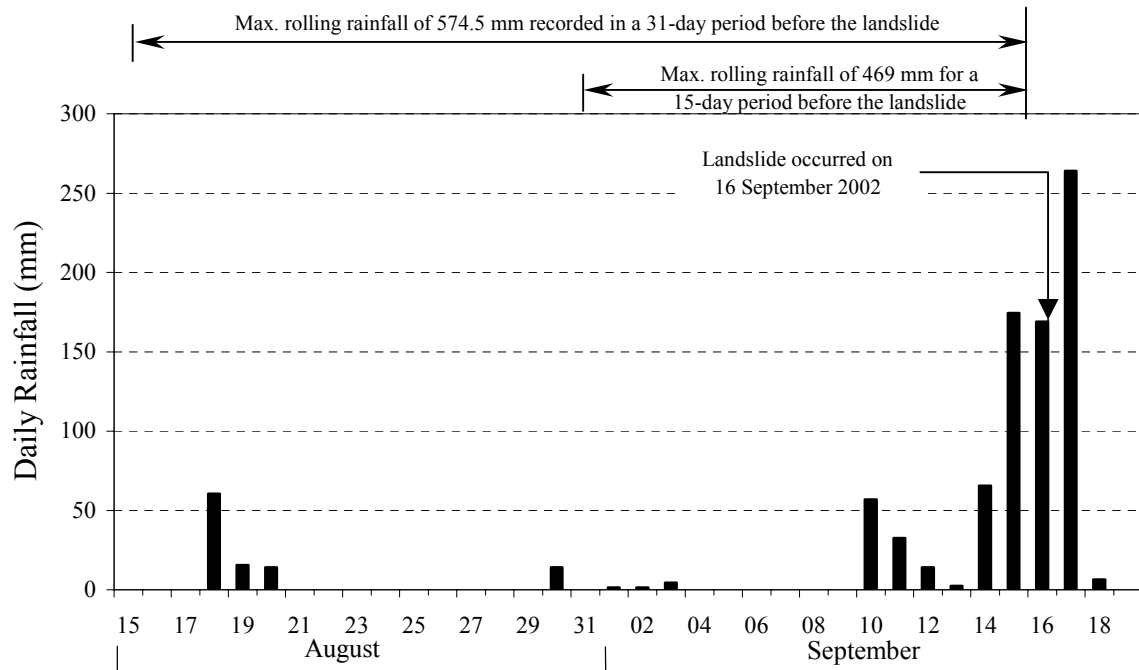
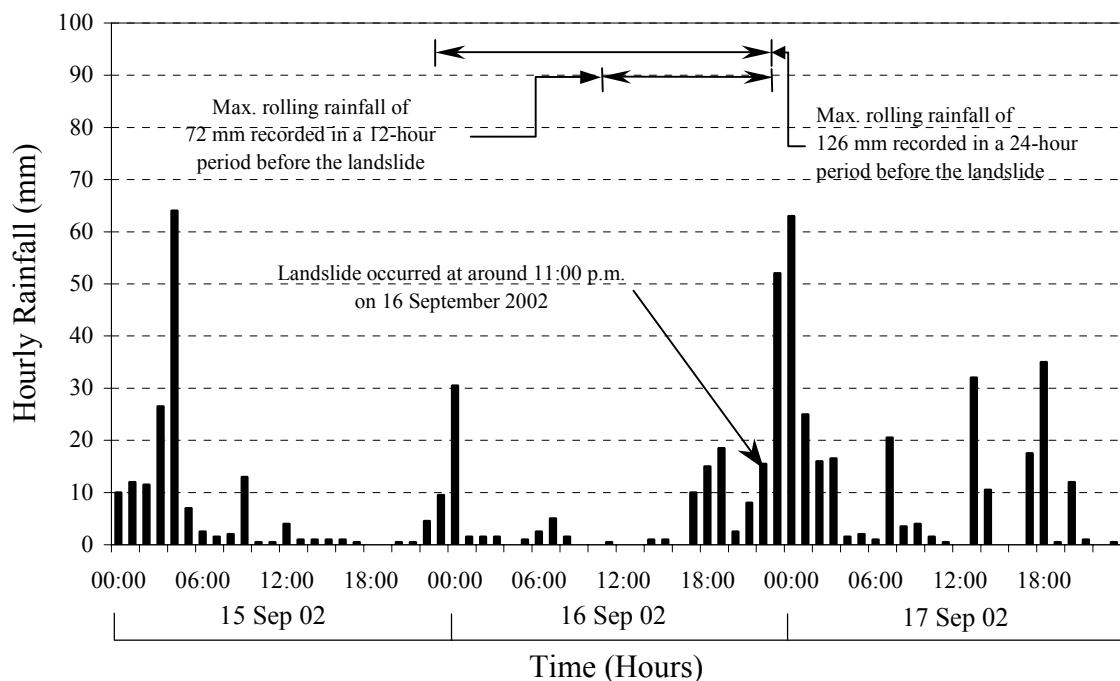
Figure 12 - Daily and Hourly Rainfall Recorded at GEO Raingauge No. K08

The daily rainfall recorded by raingauge No. K08 over the month preceding and two days following the landslide incident is presented in Figure 12. The hourly rainfall readings for the period between 15 and 17 September 2002 are also shown on Figure 12. The peak hourly rainfall relevant to the landslide incident (approximately 63 mm) was recorded between midnight and 1.00 a.m. on 17 September 2002.

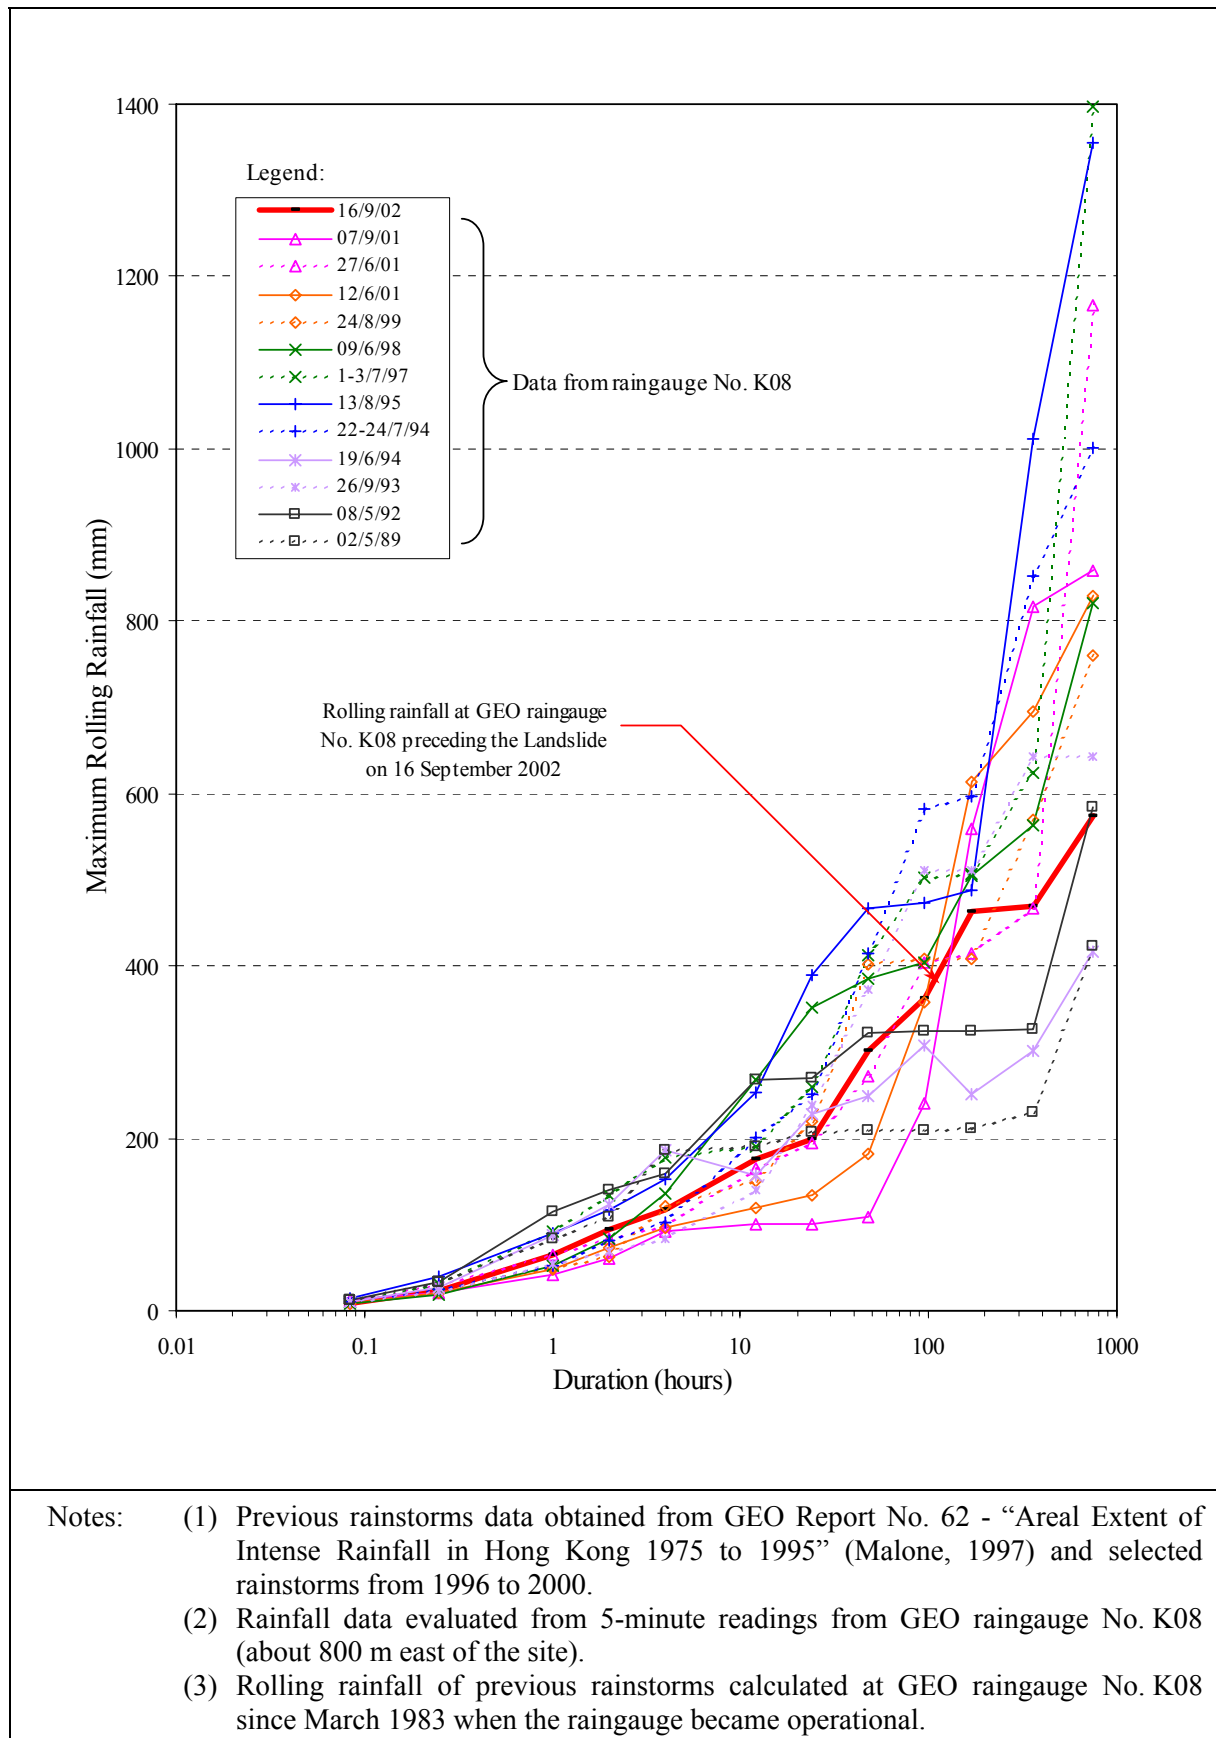
Figure 13 - Maximum Rolling Rainfall for Previous Major Rainstorms at GEO Raingauge No. K08

A comparison of the patterns of nine selected past major rainstorms recorded at raingauge No. K08 between 1986 and 2002 is presented in Figure 13. The rolling rainfall preceding the 16 September 2002 landslide is less severe than the previous rainstorms.

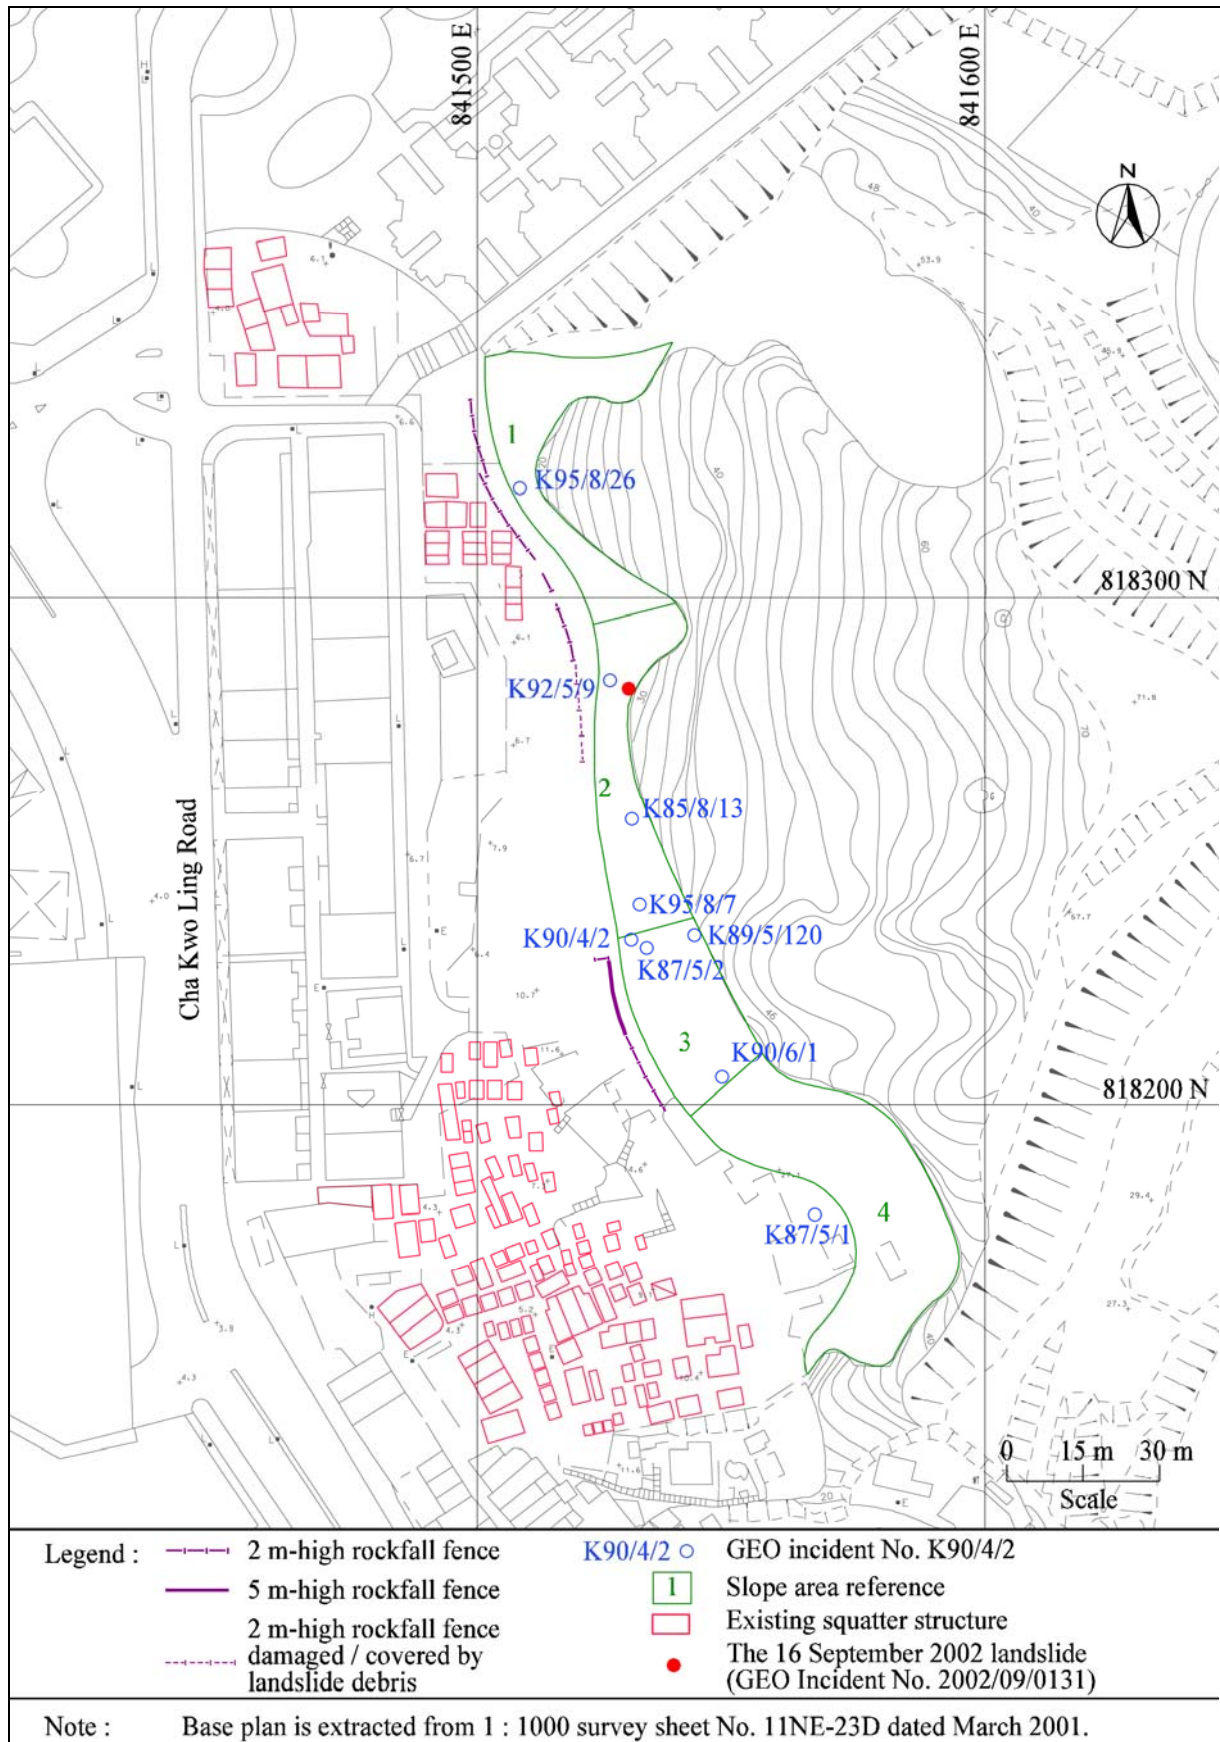
Figure 14 - Slope Areas and Previous Landslide Incidents

Several of the past landslides at the subject slope have been small in volume (< 30 m<sup>3</sup>) and form spatial clusters that appear to identify zones susceptible to instability (Figure 14). To date, the large-scale, sheeting joint-controlled failure on 12 August 1995 (1,000 m<sup>3</sup>) and the sheeting joint-controlled failure on 16 September 2002 (30 m<sup>3</sup>) have been confined to Area 2. In Areas 1, 3 and 4, previous failures are characterised by small-scale rockfalls, which appear to have been controlled by the geological structure of joint sets J1 and J2 in conjunction with local variations in orientation of the slope face.

Area 2 is associated with all the contributory factors listed in Section 6.1 above, most notably the sheeting joints and associated seepage. The sheeting joints are adversely orientated, dipping out of the slope face at about 25° to 35° and may be laterally extensive (possibly tens of metres to the south and about 20 m to the north of the 16 September 2002 landslide). Owing to the limited access and the dense unplanned vegetation in parts of the slope (see Plate 12), the persistence of these discontinuities could not be assessed in detail. However, the possibility that they may continue for a substantial distance cannot be ruled out. The joints are typically very widely spaced and infilled with Grade V granite with an aperture width of up to 300 mm. Depending on factors such as shear strength of the joints and their persistence within the slope, permeability and potential for build-up of water pressure, together with the presence of sub-vertical release joints, there is potential for future large-scale landsliding on sheeting joints as well as small-scale toppling and sliding in Area 2. No obvious signs of distress or mass movement were observed during the present study. Open space currently exists at the slope toe of Area 2 and the consequence-to-life in the event of minor failures in this locality is unlikely to be high.

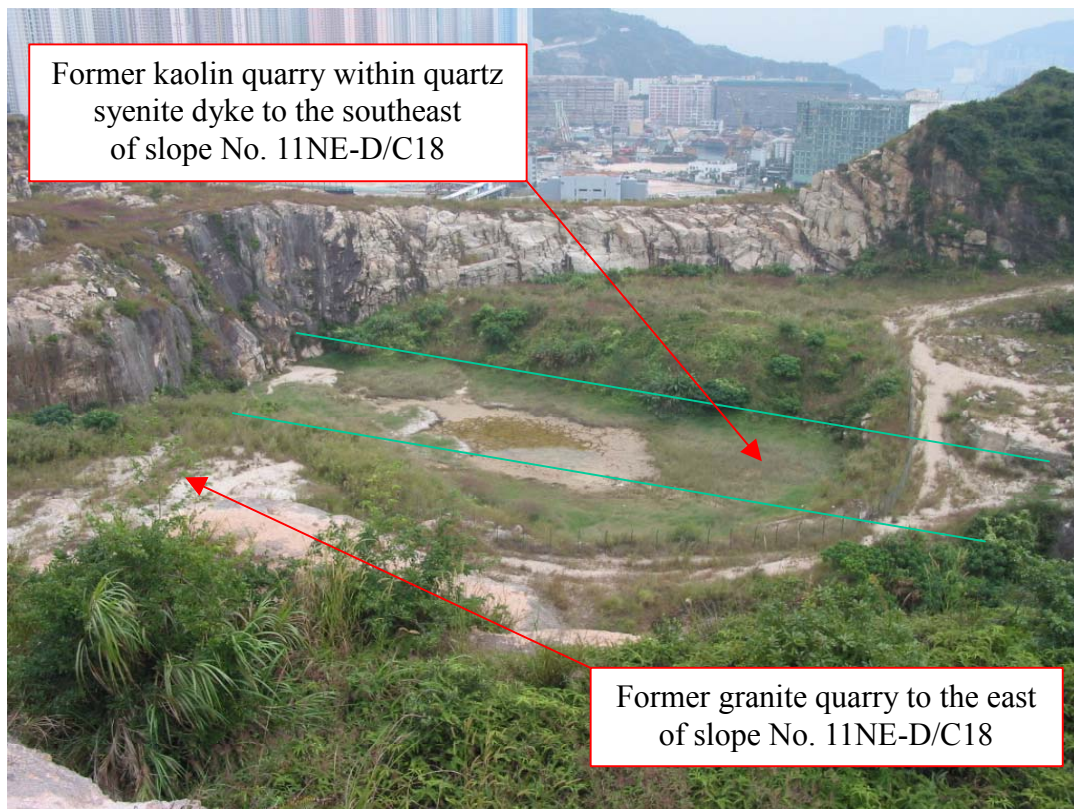
Plate 4 - View of Former Quarries to the East of Slope No. 11NE-D/C18  
(Photograph taken on 27 November 2002)
