**DETAILED STUDY OF THE
28 NOVEMBER 2002
ROCKFALL ABOVE
YIP HING STREET,
WONG CHUK HANG**

GEO REPORT No. 164

Halcrow China Limited

**This report was originally produced in October 2003
as GEO Landslide Study Report No. LSR 9/2003**

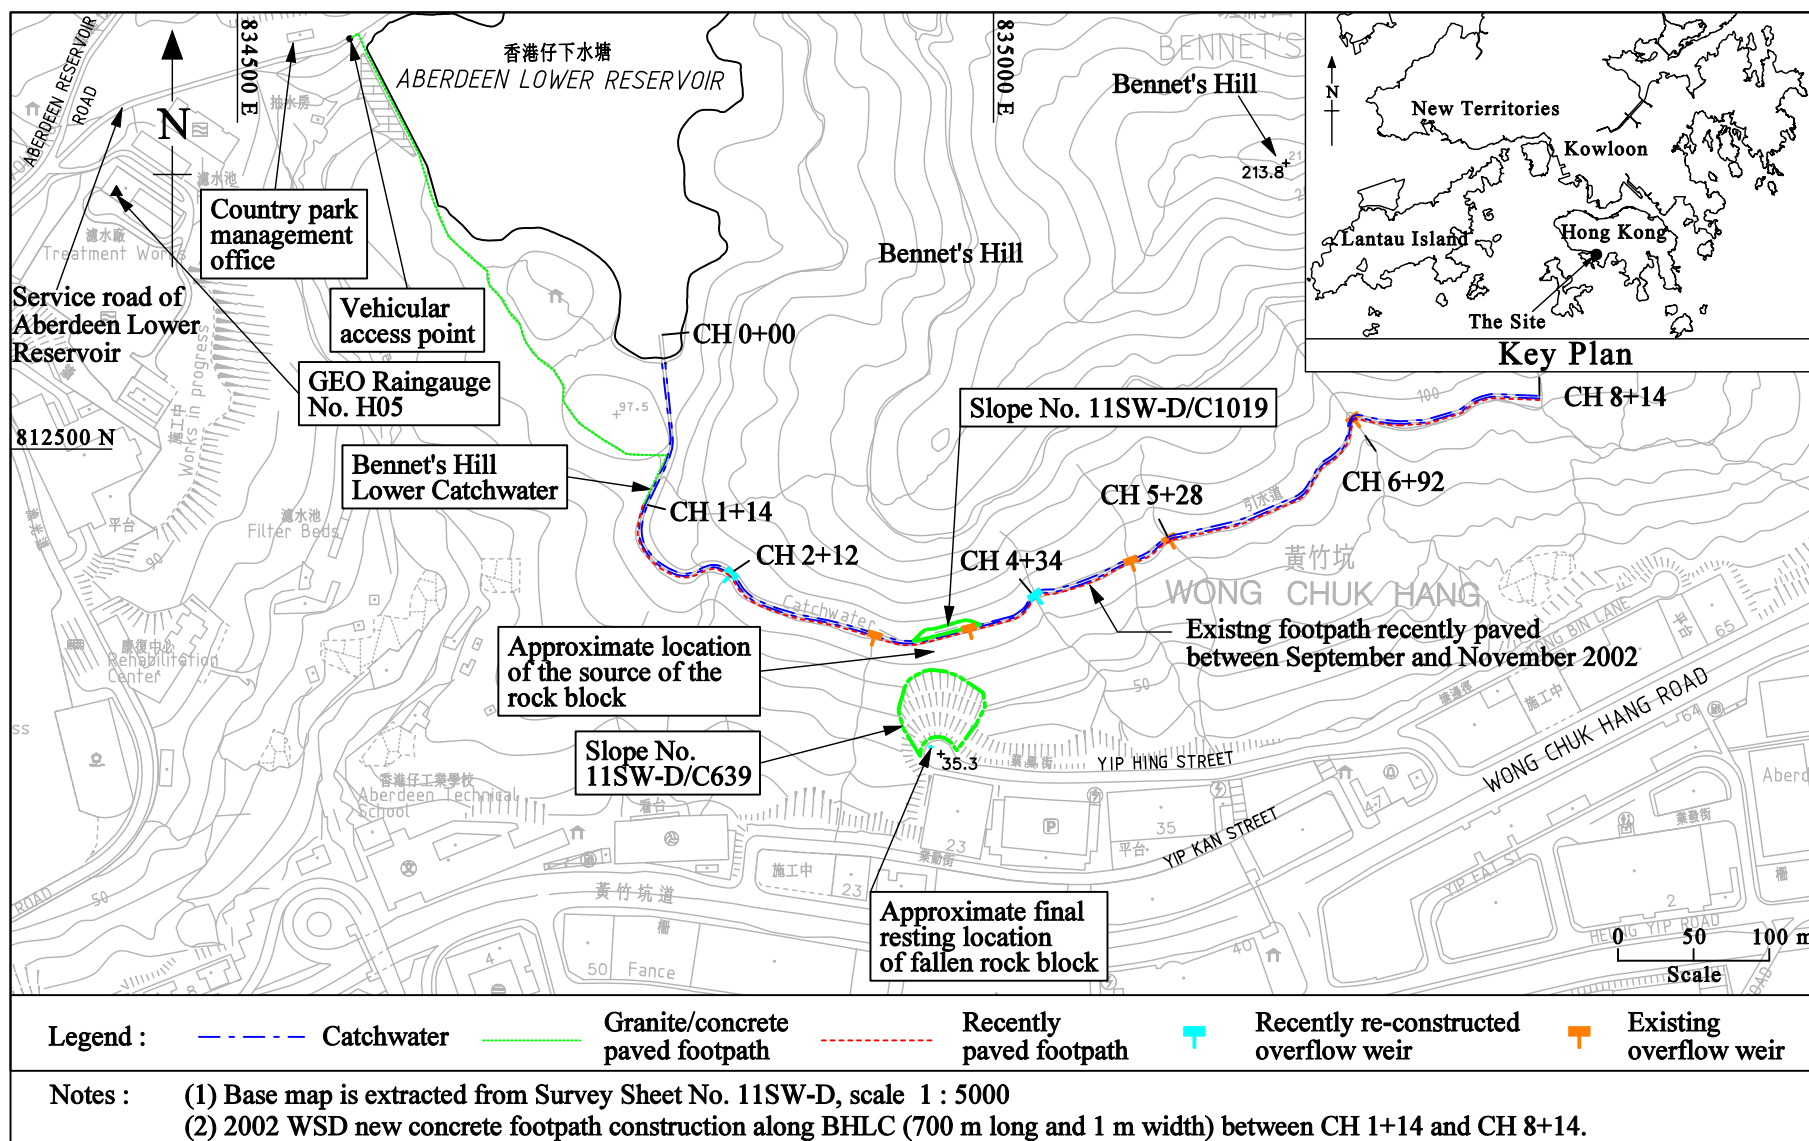
Figure 1 - Site Location Plan

A site location plan is shown in Figure 1. The site is a south-facing hillslope on the

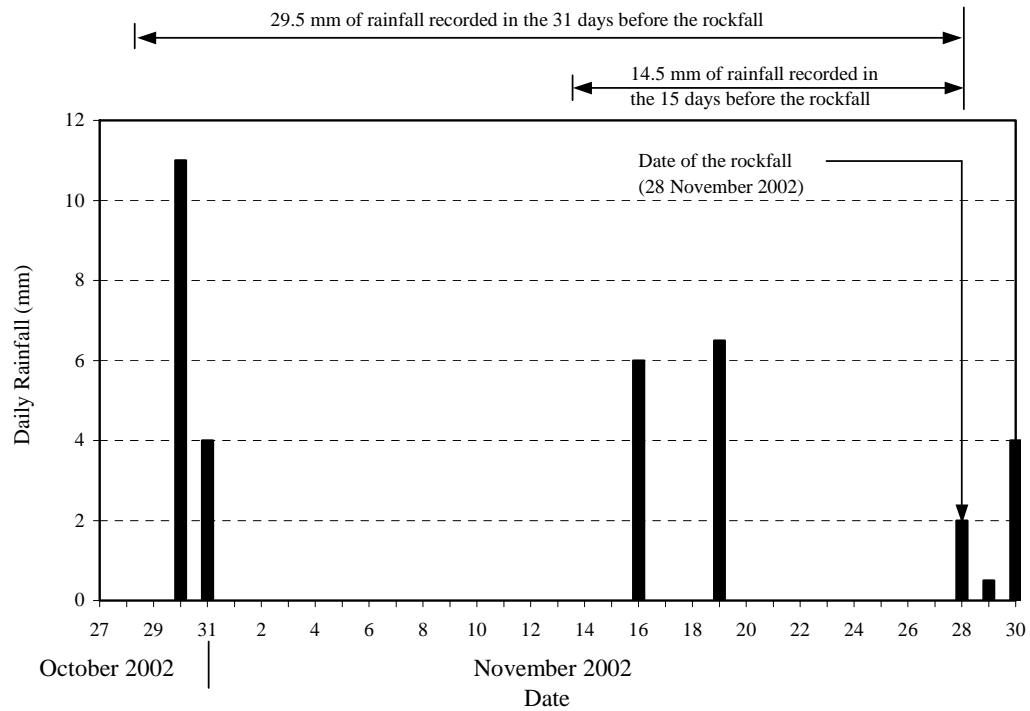
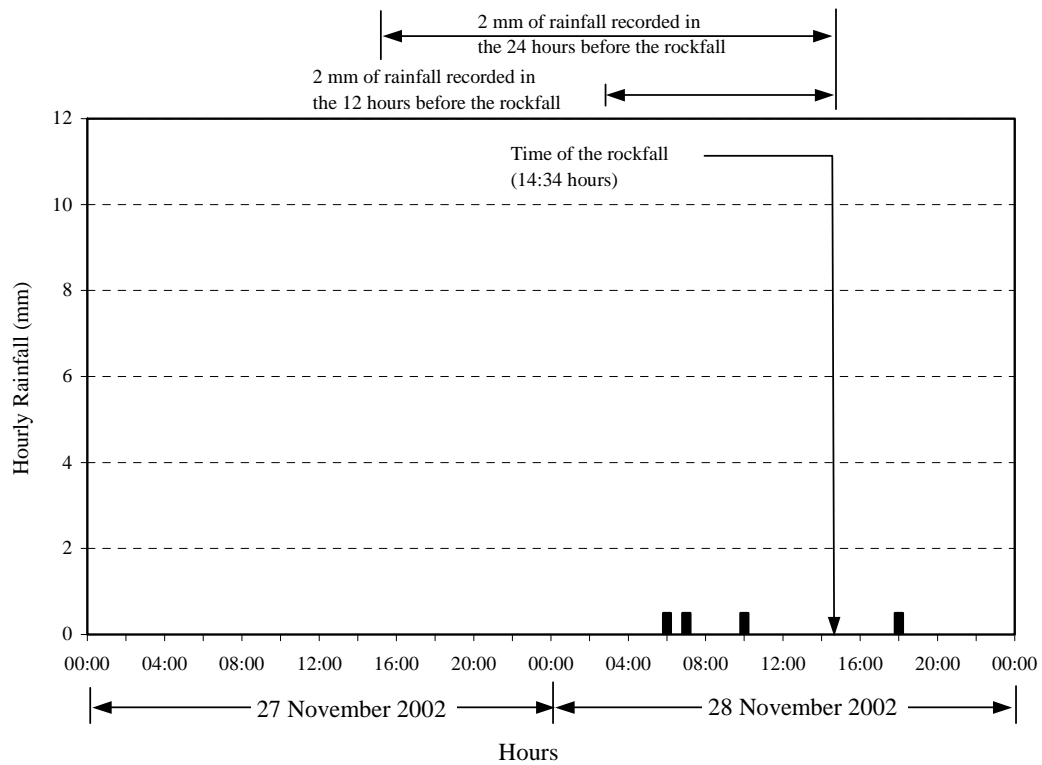
Figure 4 - Daily and Hourly Rainfall Recorded at GEO Automatic Raingauge No. H05 in November 2002

The nearest GEO automatic raingauge (No. H05) to the Study Site is located at Aberdeen Treatment Works, Aberdeen Reservoir Road, about 620 m northwest of the natural hillside above slope No. 11SW-D/C639 (Figure 1). The daily rainfall records of raingauge No. H05 in the preceding month and 24 hours prior to the incident are presented in Figure 4. This shows that within the 31 days preceding the incident, about 29.5 mm of rainfall was recorded.

(a) Daily Rainfall Recorded between 27 October and 30 November 2002

(b) Hourly Rainfall Recorded between 27 November and 28 November 2002

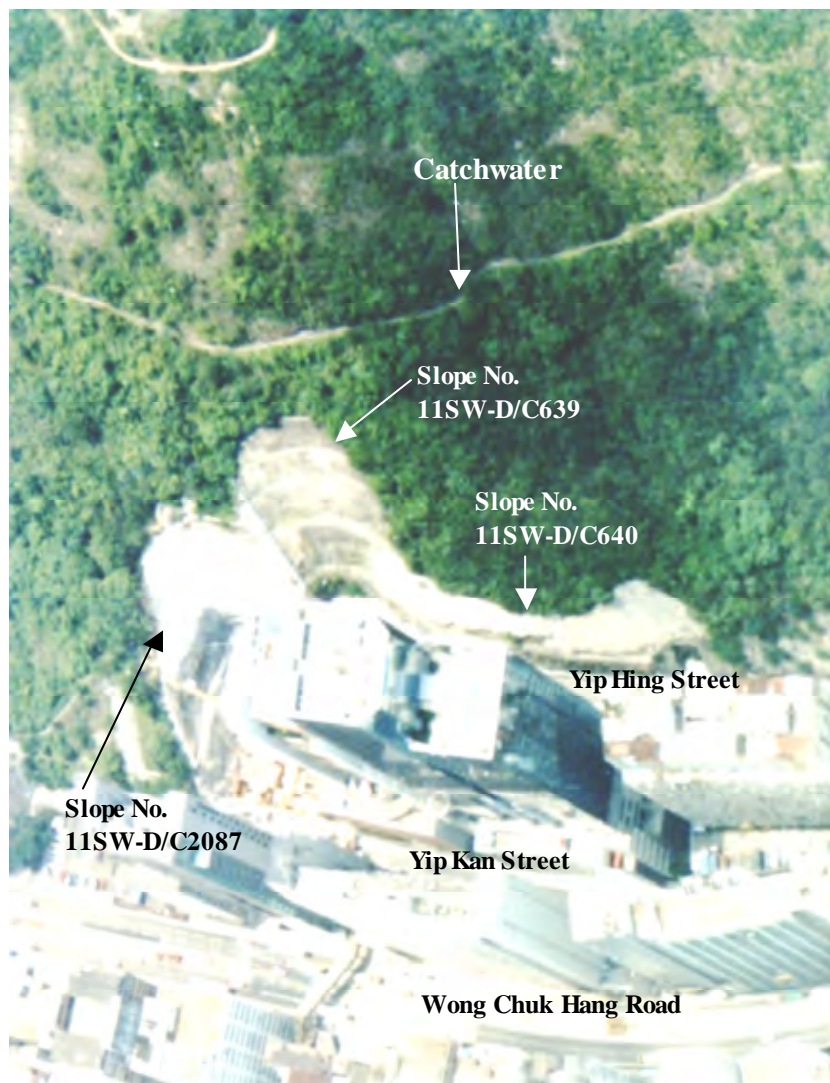
Plate A1 - 2001 Aerial Photograph of the Site

24 May 2001 CW31151- CW31152 4500'	Medium clarity, stereoscopic coverage of entire site. No significant changes were observed.
