# **GEOLOGICAL CHARACTERISATION OF THE LAI PING ROAD LANDSLIDE**

**GEO REPORT No. 166**

**N.P. Koor & S.D.G. Campbell**

**GEOTECHNICAL ENGINEERING OFFICE  
CIVIL ENGINEERING AND DEVELOPMENT DEPARTMENT  
THE GOVERNMENT OF THE HONG KONG  
SPECIAL ADMINISTRATIVE REGION**

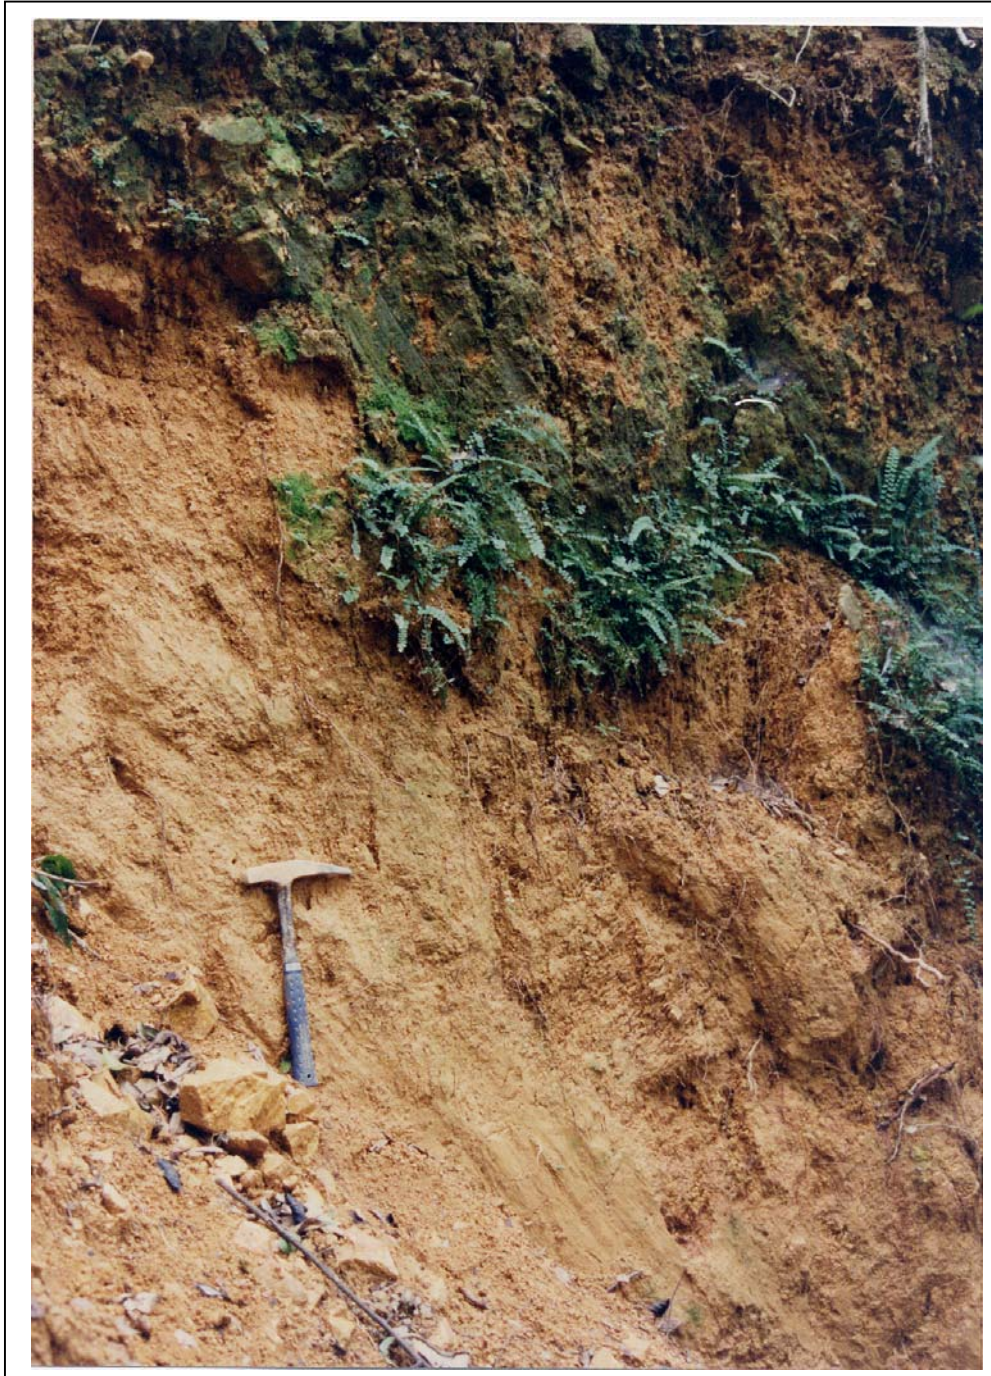
EG 97/117/22

Frontispiece: The Main Scarp of the Composite Landslide with Two Generations of Slickensides and a Distinct Vegetation Line of Ferns and Moss Indicating at Least Two Phases of Landslide Development

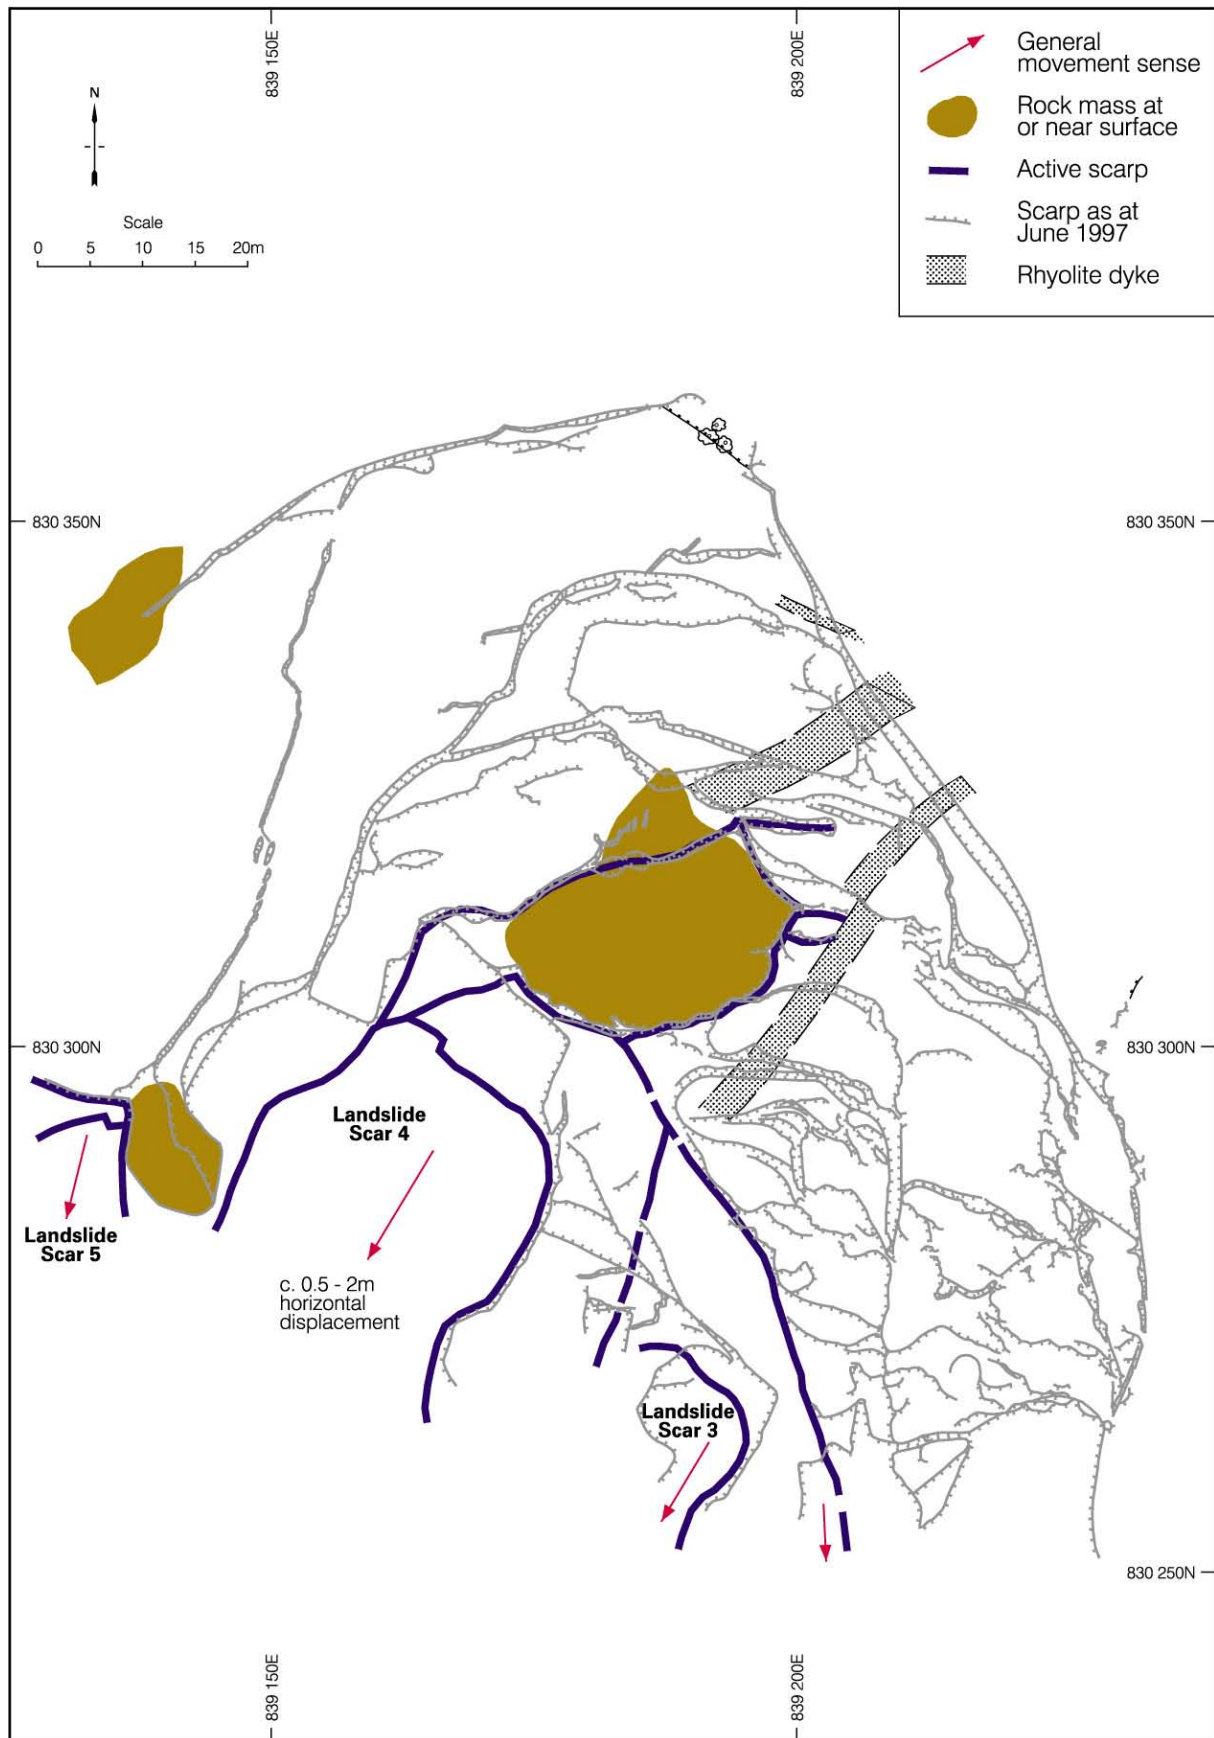
Figure 16 - Composite Landslide Displacement Model - Pre-October 1979

A synthesis of evidence for the evolution of the scarps is presented in Figures 16, 17 & 18. At least three broad phases of movement are inferred:

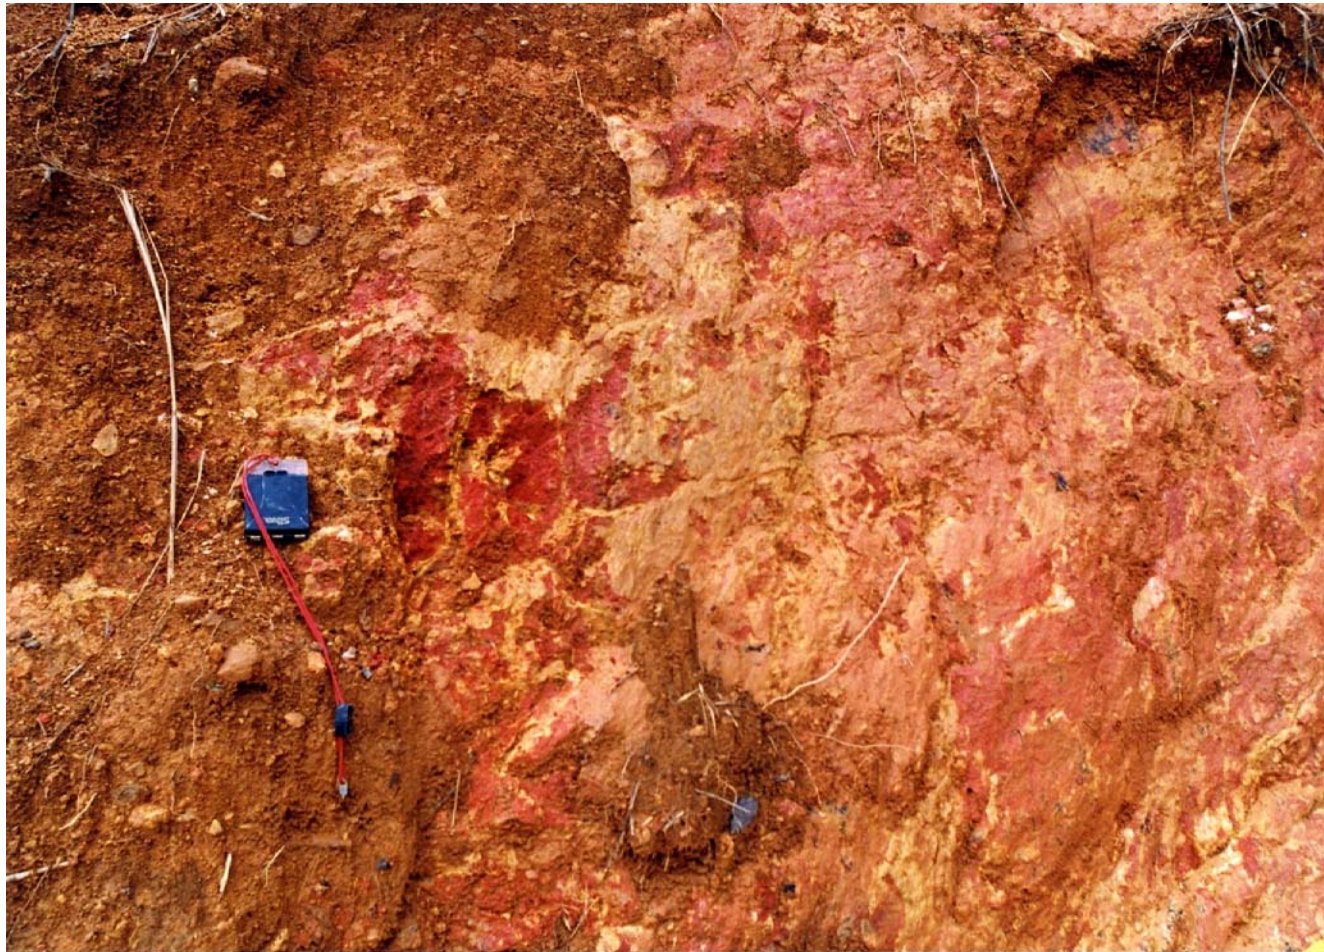
GS 97/108/21

A zone of intense alteration within the saprolite can be traced from north-west to south-east across landslide scars 4, 3 and 2. The zone is characterised by a deep red to reddish pink coloration (iron and manganese staining), and the common development of white to buff, kaolin-infilled relict joints, with some dark brown manganiferous deposits (Plate 7a & 7b). The kaolin infills are up to 30 mm thick. The altered zone appears to dip into the hillside, towards the north-north-east at c. 25-40°, and in the same general direction as the fabric and stratification within the tuff. A discontinuous rhyolite intrusion (sill?) is also emplaced along the zone of alteration in landslide scar 4 (Drawing No. EG 499). Although many of the alteration features of the zone are consistent with weathering of the tuff and rhyolite, the zone may be one of pre-existing hydrothermal alteration. The altered tuff is extremely weak, and when broken down by finger pressure its constituents initially feel silt sized. However, with further pressure the altered tuff quickly becomes very clayey and greasy and appears to release some water.

Plate 7(a) - Intensely Altered Coarse Ash Crystal Tuff Exposed in Landslide Scar 4A (Plate Location Shown on Drawing EG503) (Taken on 6/8/97)

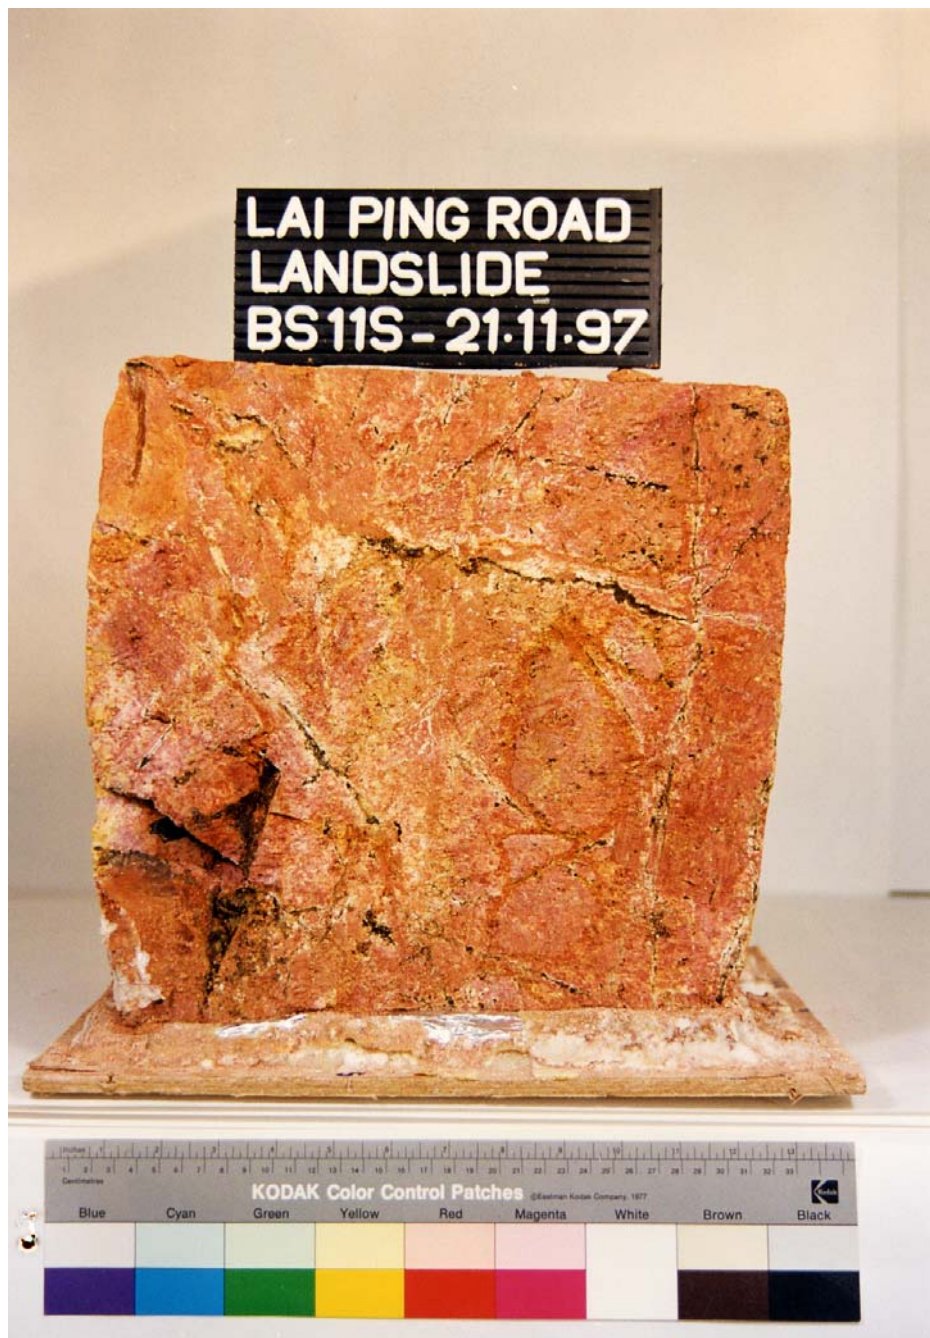
EG 97/147/04

Plate 7(b) - Southern Face of Block Sample 11 - Intensely Altered Tuff -  
Note Contorted Relict Joints Infilled with White Kaolin and  
Manganiferous Deposits (Plate Location Shown on Drawing  
EG503) (Taken on 21/11/97)

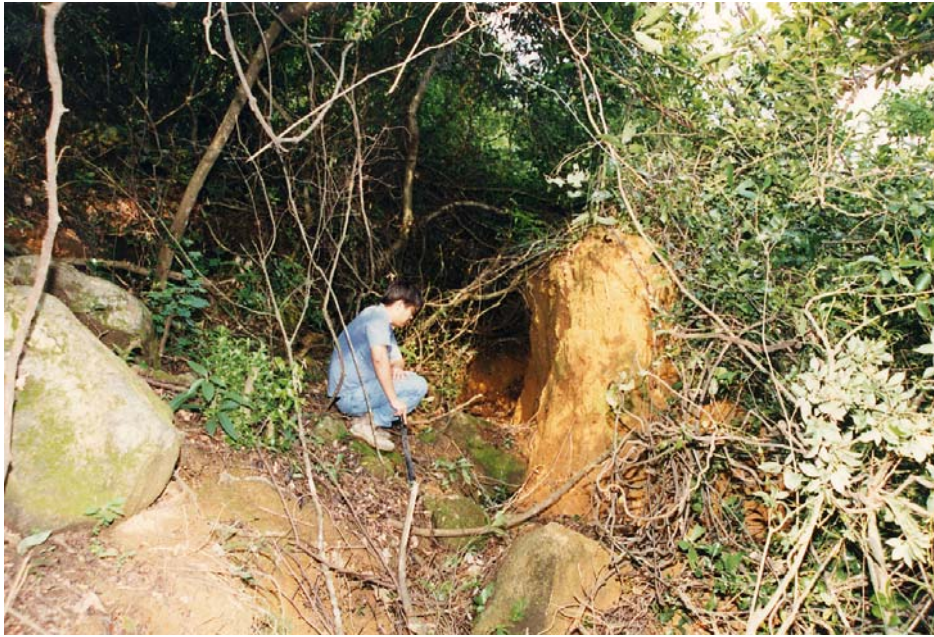
GS 97/119/35

Plate 9 - Heaved Block of Saprolite or “Pop-Up Structure” within Main and Minor Scarp Complex (Plate Location Shown on Drawing EG503)  
(Taken on 3/9/97)

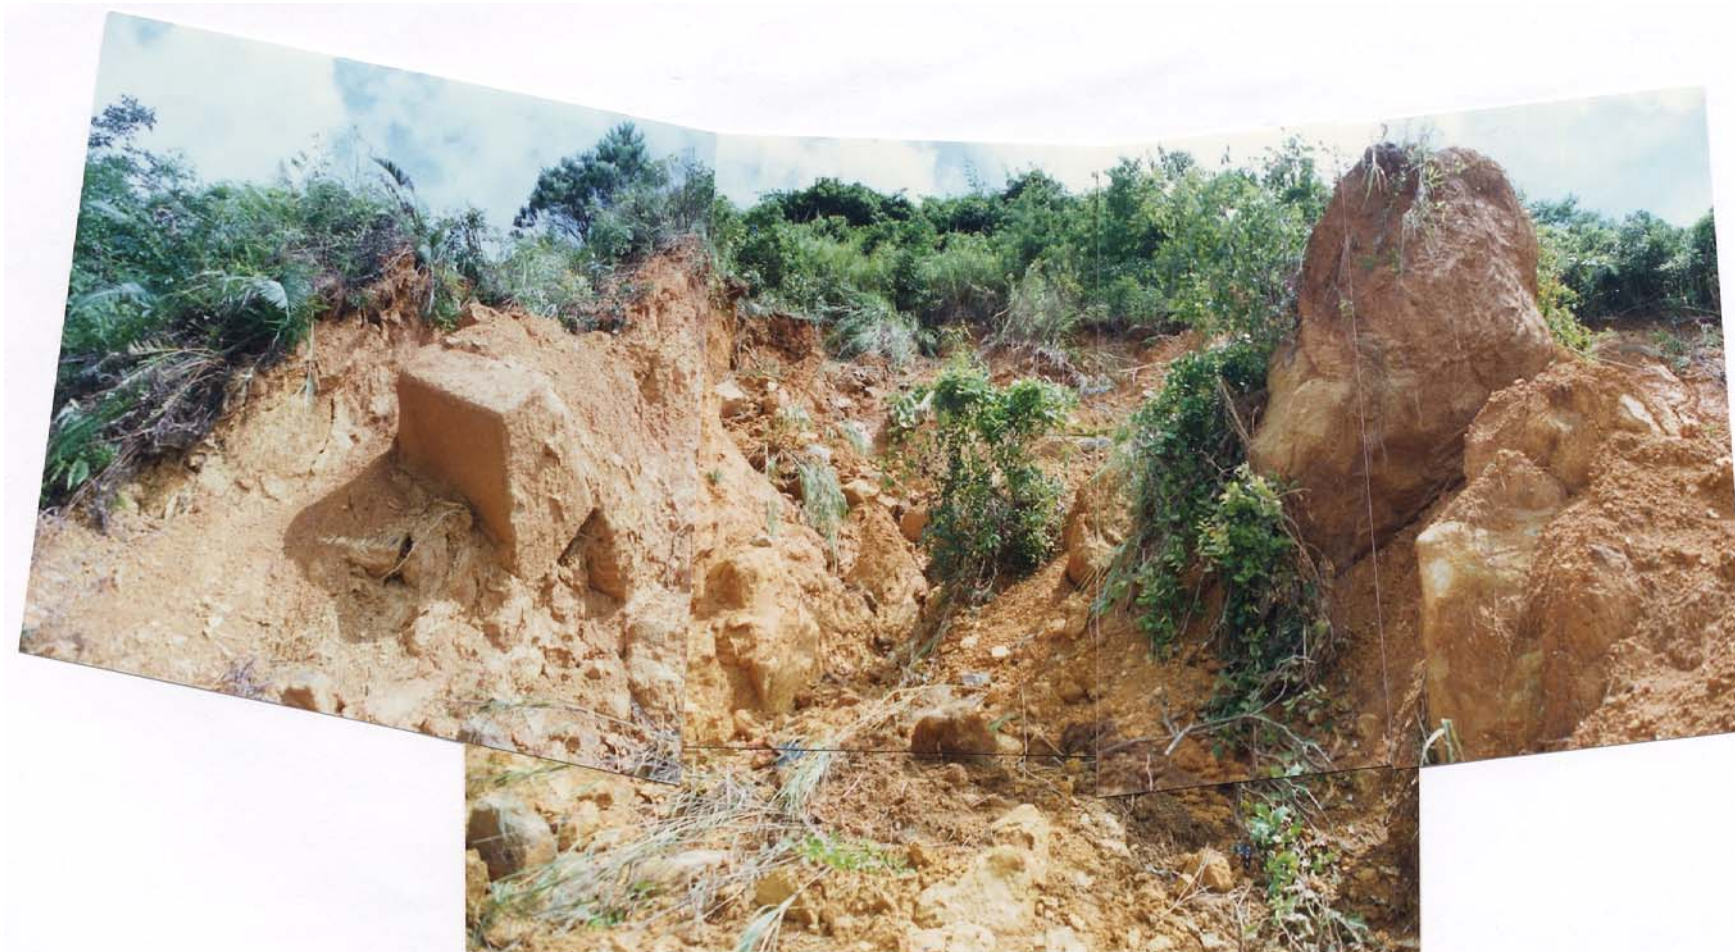
GS 97/22/2 - 5

(b) Landslide scar 2 (Plate 14) is located within the original cut slope, apart from its extreme north-east corner, and is a re-activation of instability initiated in 1979 (Figure 5). The main scarp is irregular in plan, being about 12 m wide and 35 m long. The crest drainage U-channel of the original cut slope feeds directly into the failure scar. The main scarp is sub-vertical to vertical along the crown and right hand flank and between 0.5 m and 4 m high. The left hand flank is up to 3 m high and inclined at 45° and forms part of the steep ridge separating landslide scars 1 and 2 (Drawing No. EG 499). The landslide occurred in residual soil and completely decomposed tuff with large corestones, some of which have been rotated in the down slope direction (Plate 15). A zone of intensely altered tuff outcrops in both flanks. Locally, made ground, up to 1 m thick, is present in the main scarp (Plate 16). Below the main scarp, steep gullies have been eroded into the saprolite forming prominent ridges, up to 1 m high. No distinct surfaces of rupture were observed.

Plate 14 - View of Landslide Scar 2 Looking Up Towards the Main Scarp (Plate Location Shown on Drawing EG503) (Taken on 14/7/97)

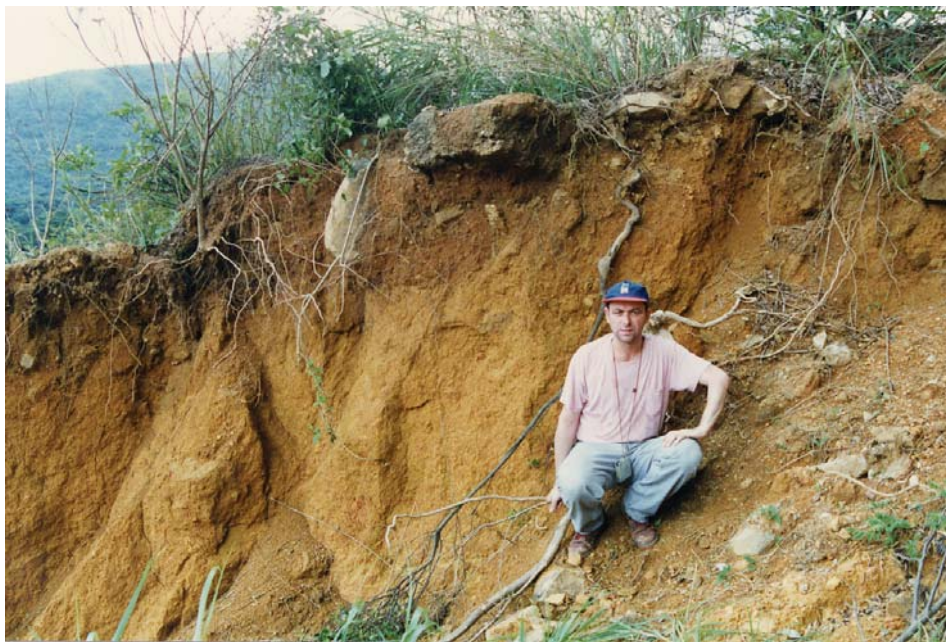
Plate 16 - Made Ground Exposed in the Main Scarp of Landslide Scar 2 (Plate Location  
Shown on Drawing EG503) (Taken on 7/8/97)  
GS 97/93C/14

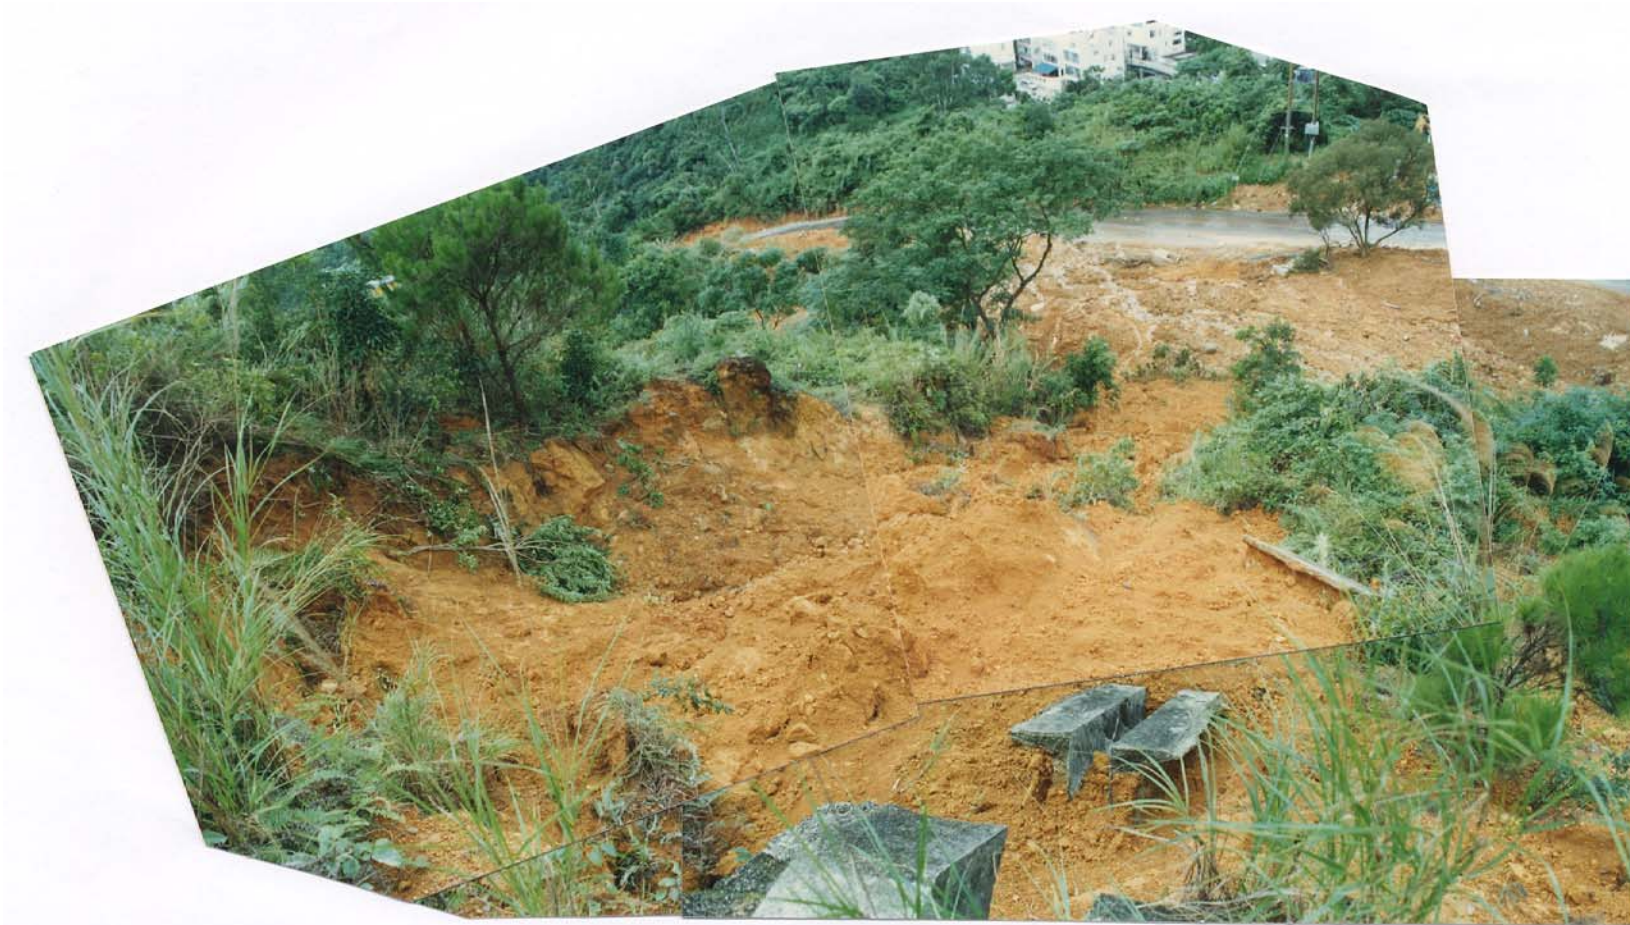
GS 97/54/7 - 10

(c) Landslide scar 3 is located within the original cut slope about 18 m from its toe (Plate 17). The landslide is a reactivation of a 1978 or 1979 landslide (Figure 5) and can be clearly seen in the photograph of the site taken in October 1979 (Plate 18). The scarp, which resembles an inverted L in plan, is sub-vertical and up to 2 m high. At the crown, the main scarp is about 10 m long. The left hand flank is linear and 17 m long. There is no well defined right hand flank, and the landslide debris extends north-west of a prominent north-south ridge within the failure scar (Drawing No. EG 499). A north-west trending tension

Plate 17 - View of Landslide Scar 3 Looking Down Towards the Left Hand Flank (Plate Location Shown on Drawing EG503) (Taken on 7/7/97)

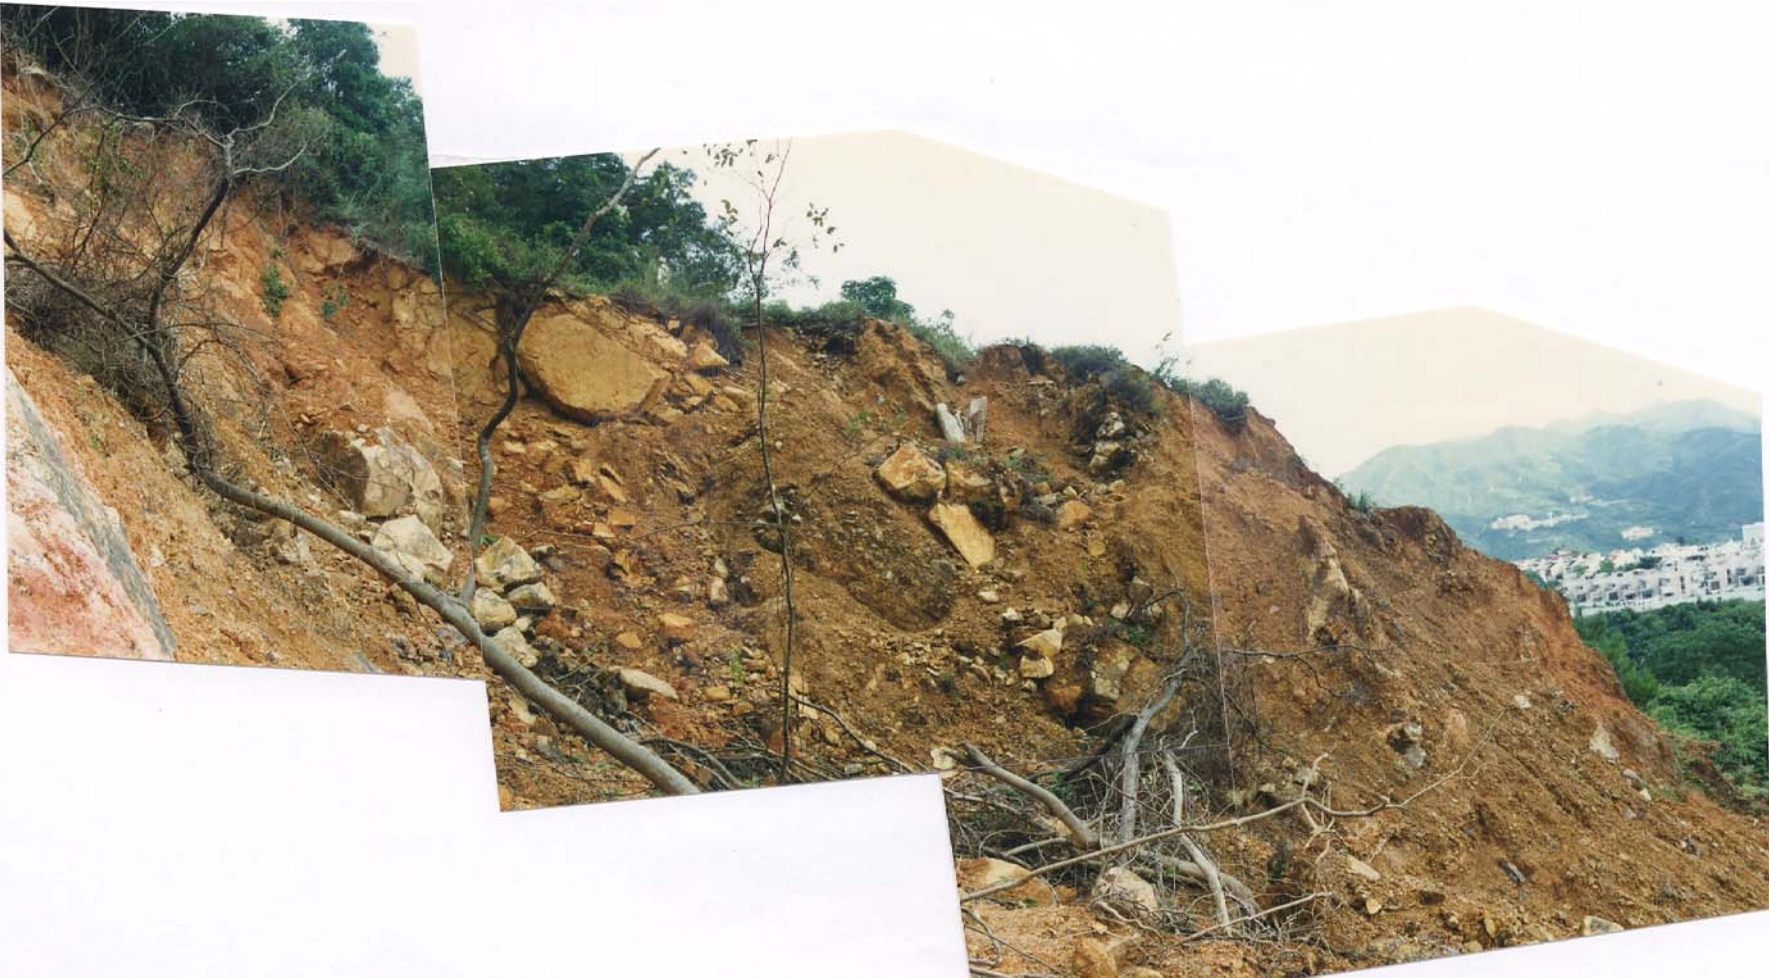
GS 97/108C/23 - 25

Plate 22 - Left Hand Flank of Landslide Scar 4 Showing Disrupted Rock Mass (Plate Location Shown on Drawing EG503) (Taken on 6/8/97)

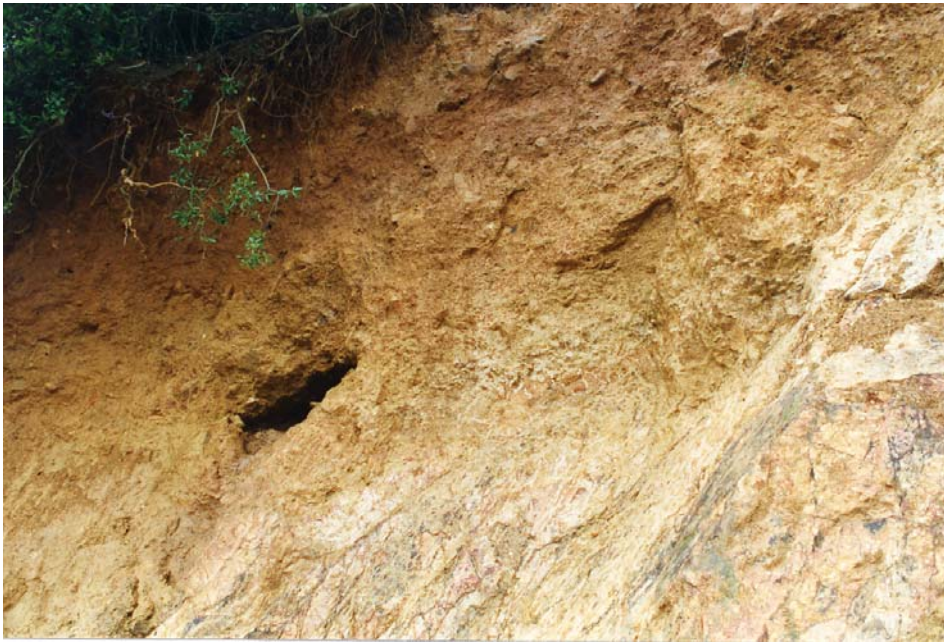
Plate 28(a) - A Large 1.5 m Wide Soil Pipe at the Old Colluvium-New Colluvium Interface Exposed in the Main Scarp of Landslide Scar 5 - Note Slight Seepage (Plate Location Shown on Drawing EG503) (Taken on 7/7/97)  
GS 97/53/07

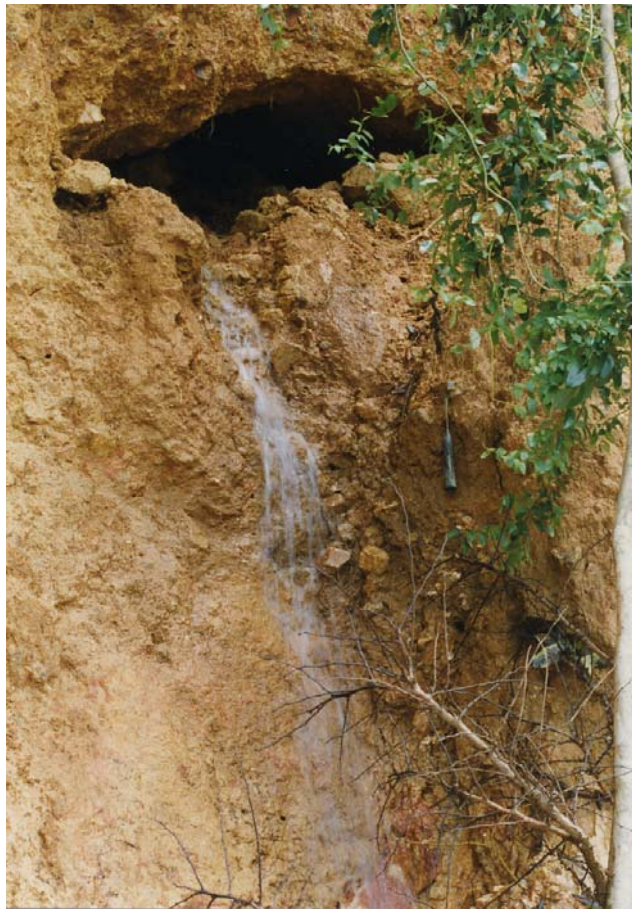
Plate 28(b) - Soil Pipe with Medium Flow (Plate Location Shown on Drawing EG503) (Taken on 8/8/97)  
GS 97/107C/30

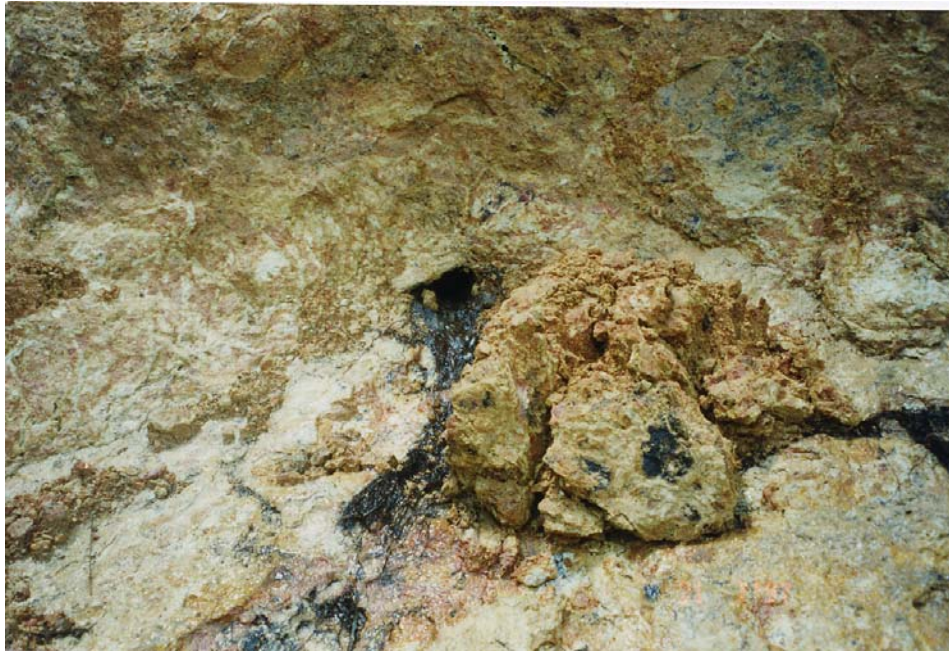
EG 97/97/36

Plate 29 - Small 40 mm Diameter Soil Pipes at the Old Colluvium-Saprolite Interface Exposed in Landslide Scar 5 (Plate Location Shown on Drawing EG503) (Taken on 21/7/97)

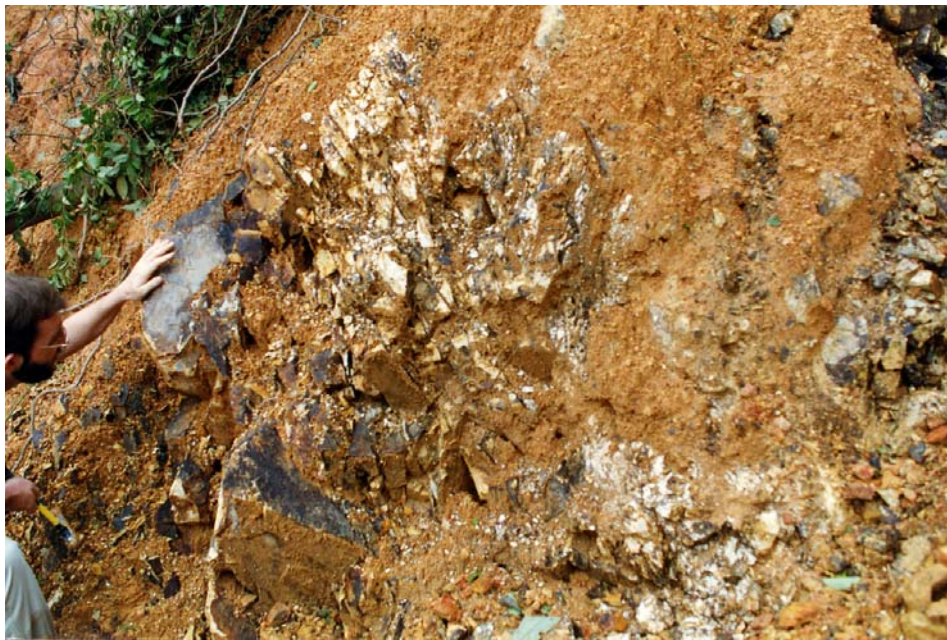
Plate 30 - Rhyolite Dyke Exposed in Landslide Scar 4 - Note Very Closely Spaced Joints with White Kaolin Infill (Plate Location Shown on Drawing EG503) (Taken on 7/7/97)

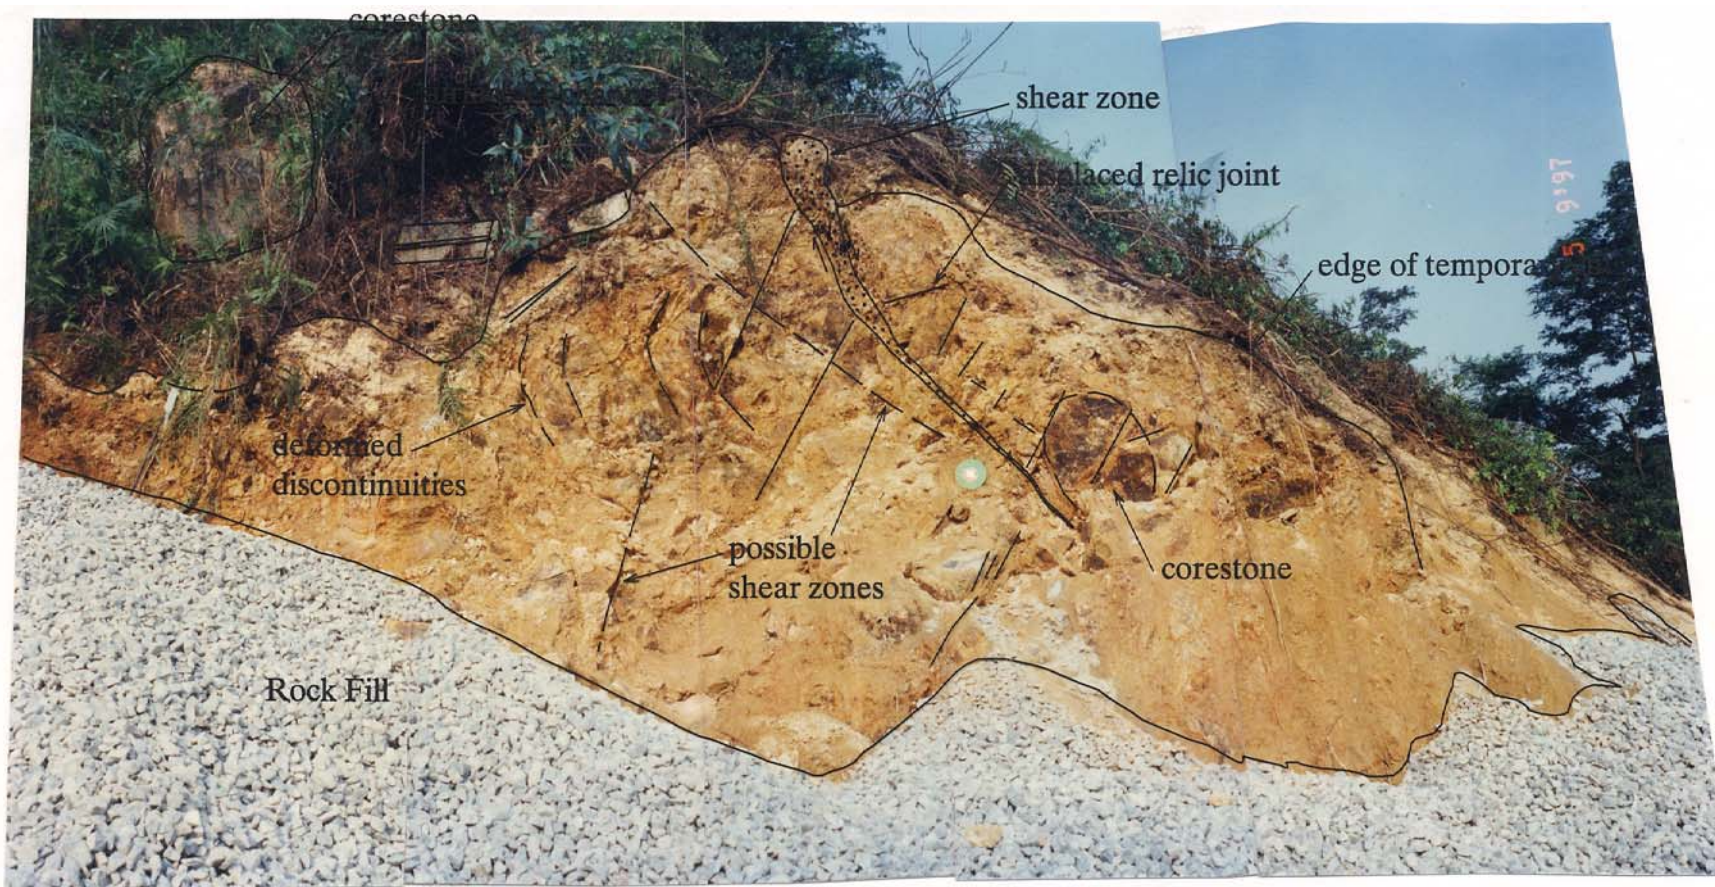
EG 97/112/9 - 13

Plate 31 - Temporary Cut in the Left Hand Flank of Landslide Scar 4 Exposing an Inclined Brittle Dilating Shear Plane within the Partially Weathered Rock Mass (Plate Location Shown on Drawing No. EG503) (Taken on 5/9/97)

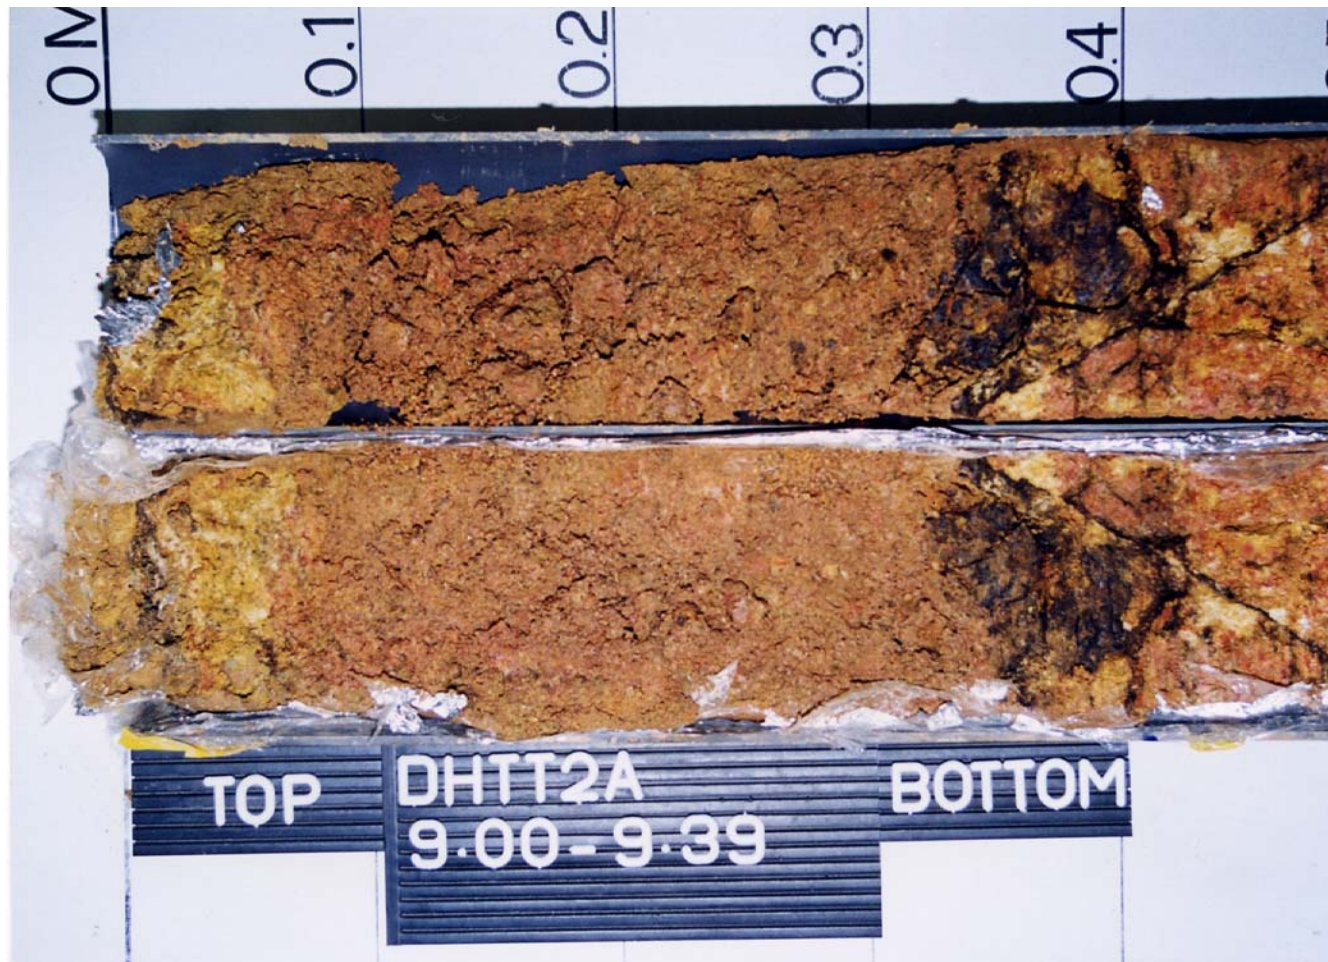
EG 97/18/15

Plate 34 - Close-Up of Split 4CMLC Core from Drillhole TT2A Showing an Anomalous Zone within Grade V Saprolite Interpreted as Being either an Infilled Soil Pipe or a High Permeability Shear Zone (Taken on 6/5/98)

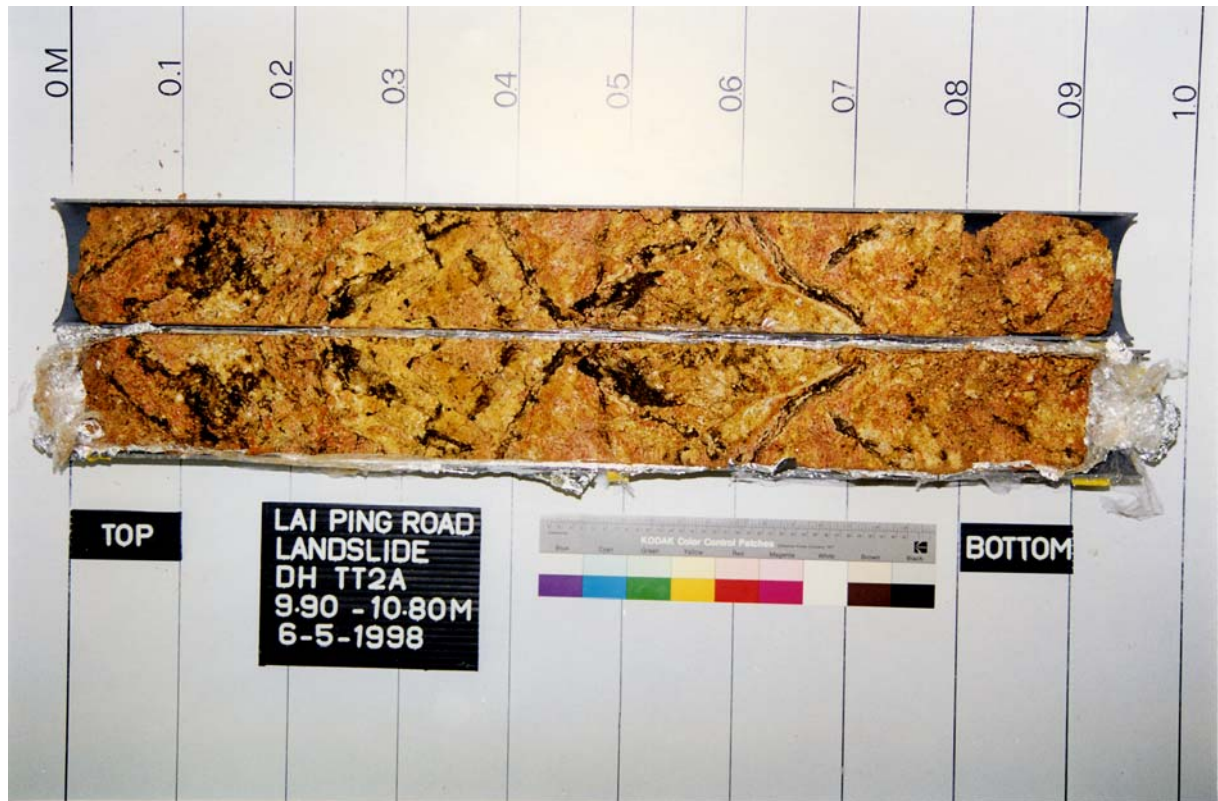
Plate B2 - Drillhole TT2A - Split 4CMLC Core 9.90 m to 10.80m. Typical Completely Decomposed Tuff.

9.90 m to 10.80 m. Extremely weak yellowish-brown mottled reddish-pinkish-brown, white and black and streaked black completely decomposed coarse ash TUFF with very closely-spaced, rough planar, extremely narrow,  $70^\circ$  joints infilled with manganiferous deposits and white clay (kaolin).  $30^\circ$  -  $40^\circ$  moderately spaced joint set with up to 10mm of intercolated white clay and manganiferous deposits between 10.30 m and 10.60 m (clayey SILT with much angular coarse quartz sand and fine angular gravel).

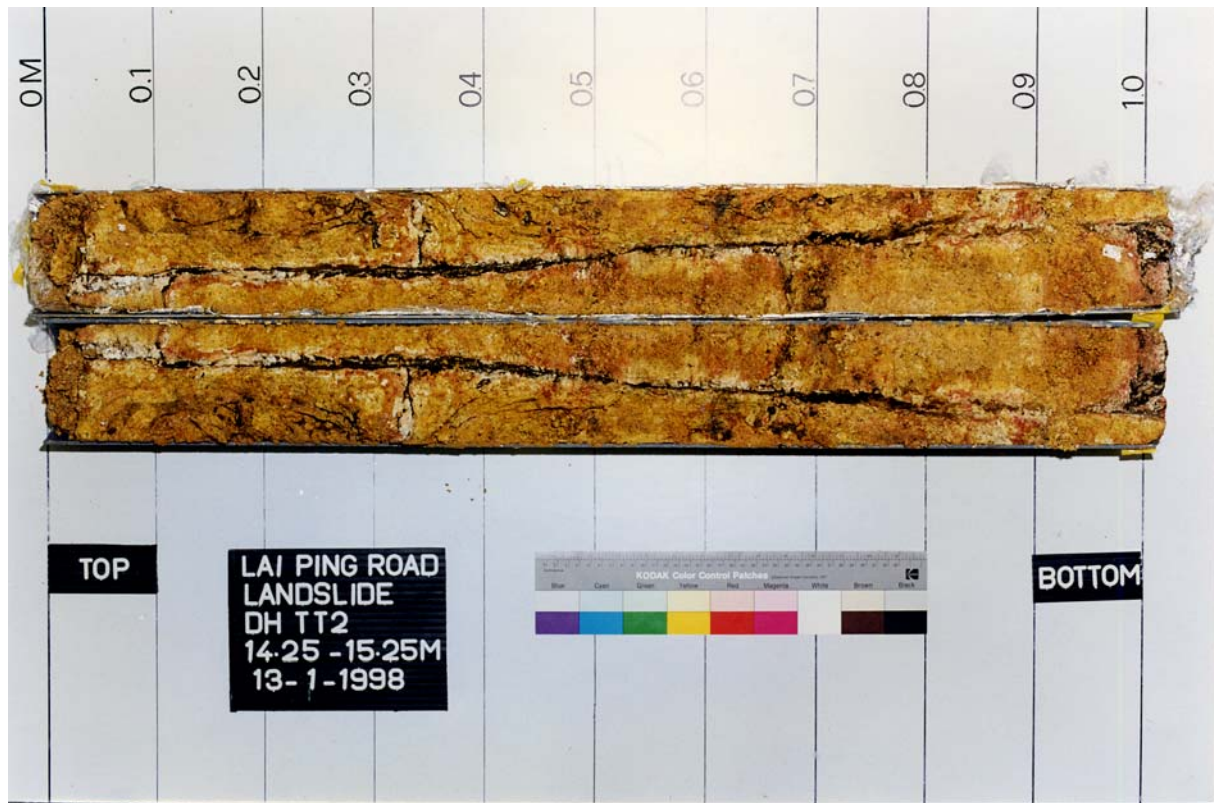
Plate B3 - Drillhole TT2 - Split 4CMLC Core 14.25 m to 15.25 m. Typical Sub-vertical Joint in Completely Decomposed Tuff.

14.25 m to 15.25 m. Extremely weak yellowish-brown mottled pinkish-red and white, completely decomposed coarse ash TUFF (clayey SILT with much angular coarse quartz sand and fine angular gravel). with sub-vertical slickensided undulating, narrow joint with up to 18 mm of white clay (kaolin) and 1 mm manganiferous deposit infill at 14.25 m to 14.55 m with managniferous deposits becoming dominant below 14.55 m. At 15.00 m, 3 mm of manganiferous deposits and no kaolin. Occasional sub-horizontal joints displaced along main sub-vertical joint.

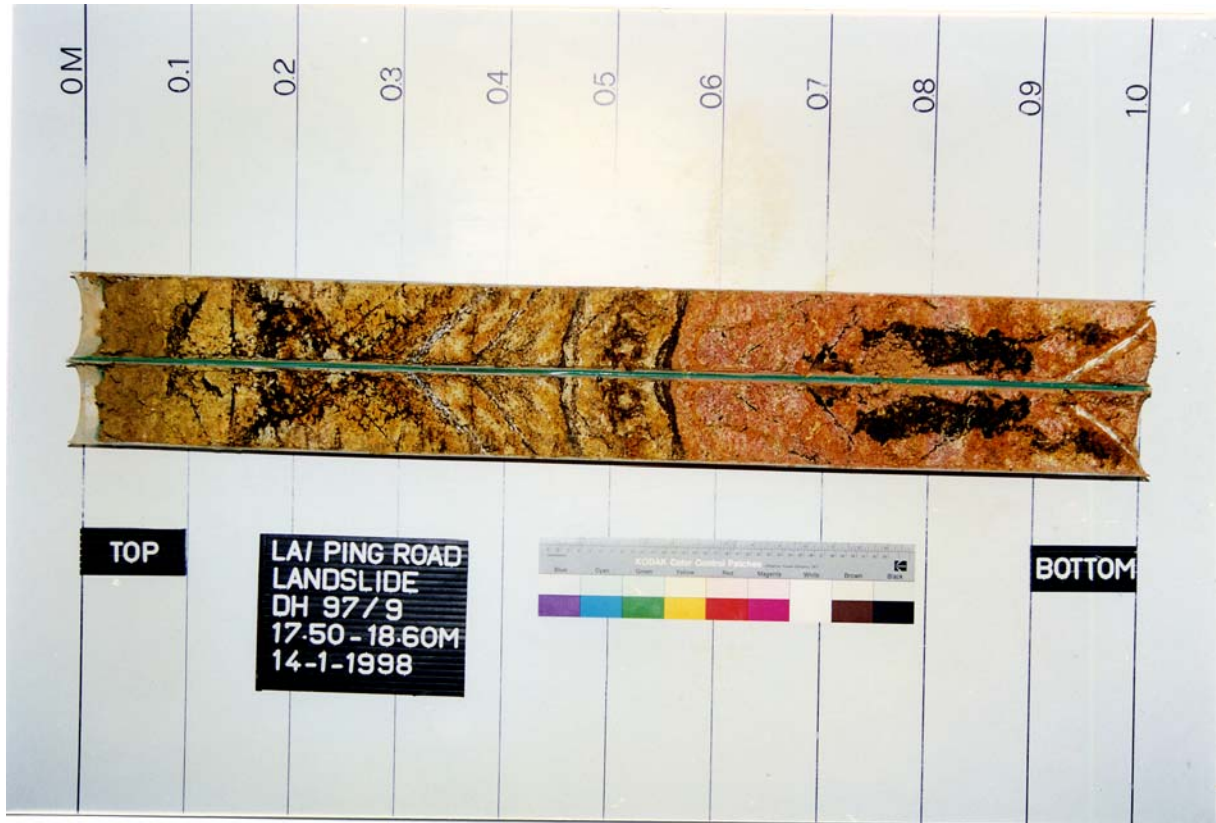
Plate B4 - Drillhole DH 97/9 - Split Maizier 17.50 m to 18.60 m. Sharp Junction between Completely Decomposed Tuff and Highly Altered Completely Decomposed Tuff.

18.05 m to 18.60 m. Extremely weak reddish-purple mottled white, ginger and dark brown and spotted grey completely decomposed coarse ash TUFF (Highly Altered Tuff - stiff silty CLAY) with very closely-spaced 40° to 70° very narrow relic joints infilled with white clay (kaolin) and manganiferous deposits. Where present the kaolin surrounds the manganiferous joint infill deposits.
