# **GEOLOGICAL CHARACTERISATION OF THE LAI PING ROAD LANDSLIDE**

**GEO REPORT No. 166**

**N.P. Koor & S.D.G. Campbell**

**GEOTECHNICAL ENGINEERING OFFICE  
CIVIL ENGINEERING AND DEVELOPMENT DEPARTMENT  
THE GOVERNMENT OF THE HONG KONG  
SPECIAL ADMINISTRATIVE REGION**

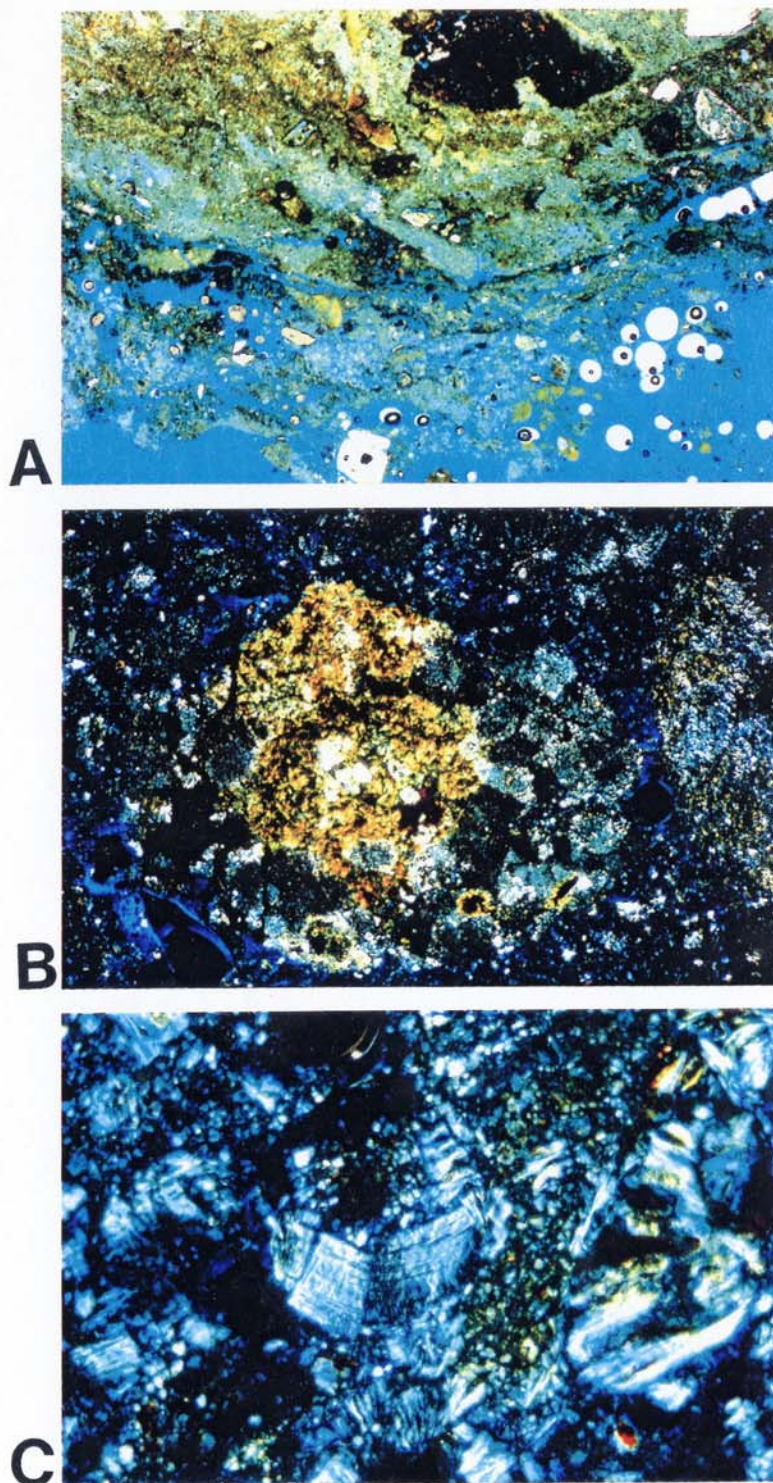
crystals (flakes) stacked on 00l, up to 1.0 mm thick, and in places these have also been deformed (Plate 1C). Deformation of the books has resulted in the bending and fracturing of the planar kaolinite crystals which are replaced by anastomosing intergrowths of a fibrous mineral, possibly halloysite, and granular ferromanganese minerals (Plate 2A). Ferromanganese minerals also occur as clasts and as a replacement of the clay matrix.

1A. Sample BS5/A5/D. Lai Ping Road landslide. Optical photomicrograph of clay-rich saprolite with dark-brown fragments of ferromanganese minerals. The clay is impregnated with blue-stained resin (plane-polarized light; field width 9 mm).  
1B. Sample BS5/A5/D. Lai Ping Road landslide. Optical photomicrograph of igneous grain partially replaced by intergrowths of yellow-brown biotite (cross-polarized light; field width 4.5 mm).  
1C. Sample BS5/A5/D. Lai Ping Road landslide. Optical photomicrograph of deformed kaolinite 'books' in the clay matrix. (cross-polarized light; field width 1.1 mm).

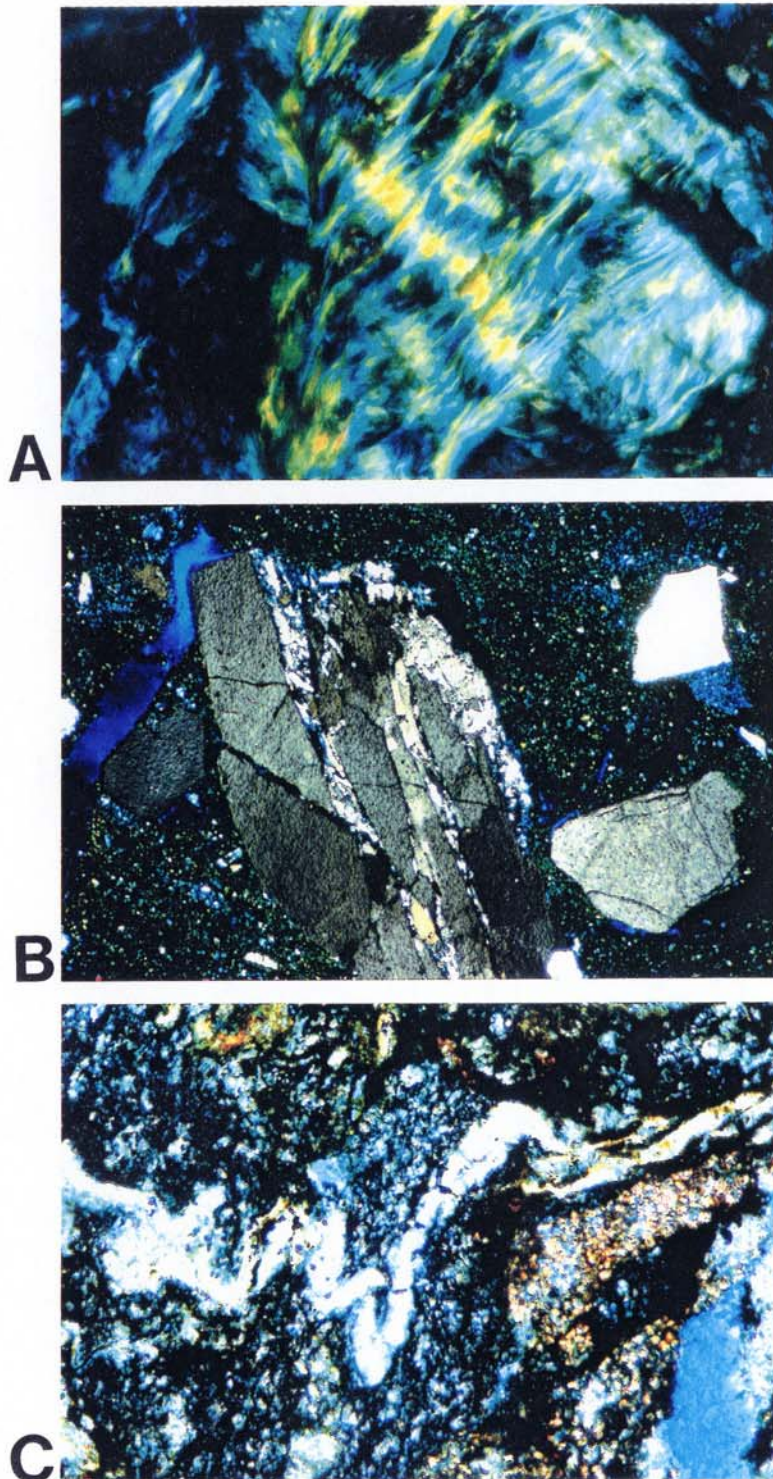
A kaolinized volcanoclastic rock containing portions of a slip clay and associated clay gouge. Volcanic quartz grains (<4.0 mm) constitute approximately 25% of the sample, and are commonly fractured and polygonised, and a few have developed a mortar texture of finely comminuted grains between larger grains (Plate 2B). Much of the fine-grained quartz (<0.1 mm) in the matrix appears to have developed by comminution of larger grains. Heavily kaolinised alkali feldspar grains (<3.0 mm) and a few lava fragments together account for 6% of the sample. The clay matrix, forming over 60% of the sample, consists of mostly random intergrowths of kaolinite and halloysite. Kaolinite 'books' are typically equant and up to 1.0 mm thick, but deformed books are also found showing sinuous shapes (Plate 3A). Deformed kaolinite plates are replaced by anastomosing intergrowths of a fibrous mineral which is possibly halloysite (Plate 3B). Many of the kaolin-rich areas in the clay matrix appear to be disrupted or deformed veins (Plate 2C), typically consisting of a kaolin fill with wall linings of ferromanganese minerals.

2A. Sample BS5/A5/D. Lai Ping Road landslide. Optical photomicrograph showing replacement of planar kaolinite crystals in a book by fibrous ?halloysite. Clay minerals are stained yellow by ferromanganese mineral (cross-polarized light; field width 0.45 mm).

2B. Sample BS7/A7/C. Lai Ping Road landslide. Optical photomicrograph of deformed quartz grain showing mortar texture (cross-polarized light; field width 4.5 mm).

2C. Sample BS7/A7/C. Lai Ping Road landslide. Optical photomicrograph of deformed kaolin-filled vein (cross-polarized light; field width 1.1 mm).

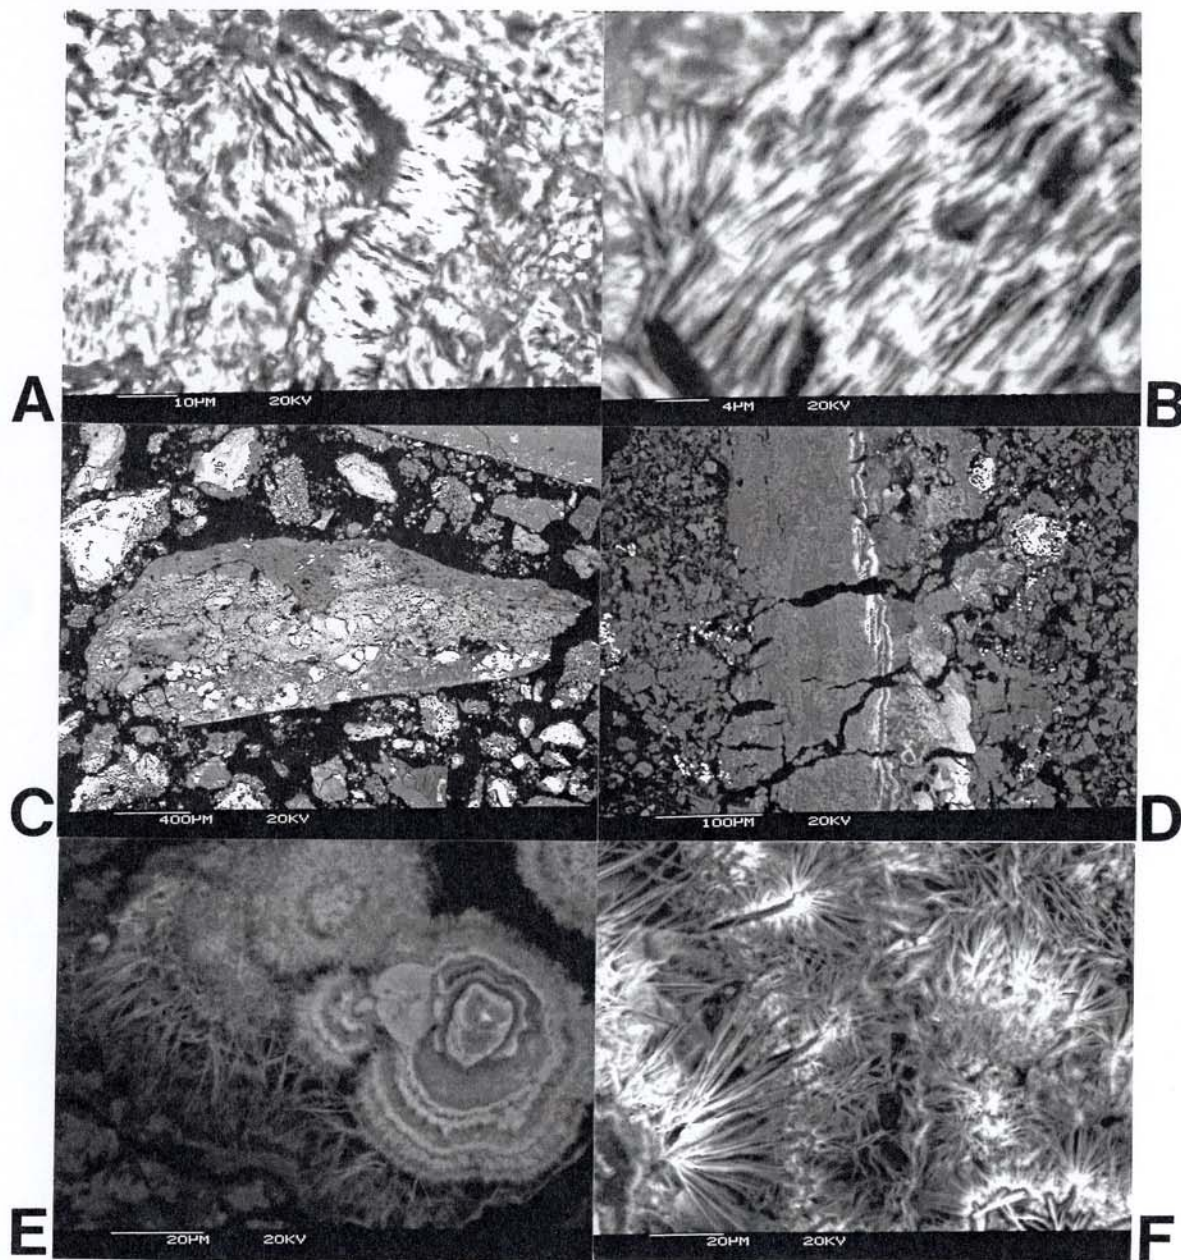
3A. Sample BS7/A7/C. Lai Ping Road landslide. Backscattered secondary electron photomicrograph of deformed kaolinite book in the clay matrix.

3B. Sample BS7/A7/C. Lai Ping Road landslide. Backscattered secondary electron photomicrograph of deformed book-like kaolinite plates partially replaced by fibrous ?halloysite.

3E. Sample BS8/A8/B. Lai Ping Road landslide. Backscattered secondary electron photomicrograph of Mn-oxide showing concentric growth of thin platy crystals.

3F. Sample BS8/A8/B. Lai Ping Road landslide. Backscattered secondary electron photomicrograph of Mn-oxide showing radial clusters of thin platy crystals.

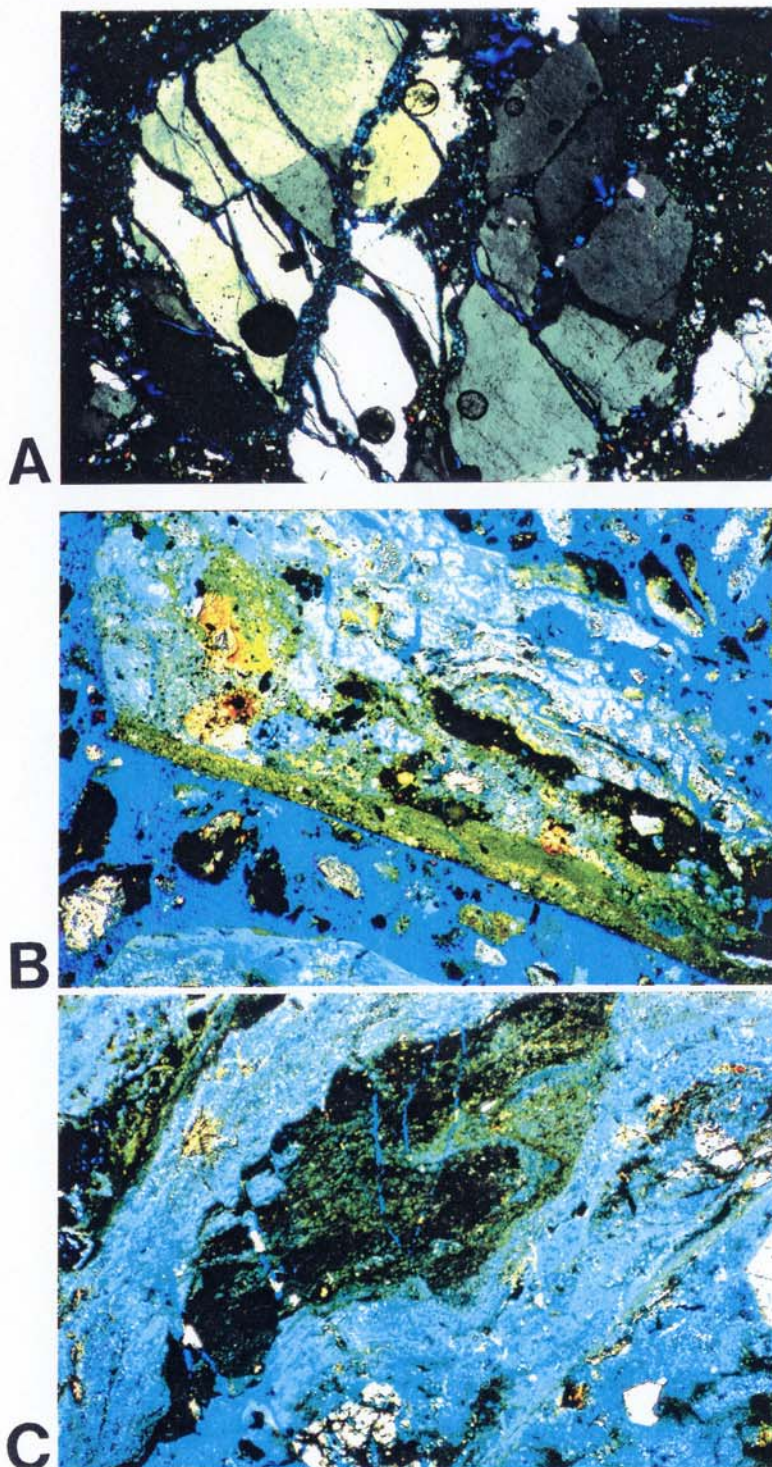
components (Plate 4B). The structure of these compound fragments suggest that the movement responsible of the formation of orientated domains in the slip clay was followed by a static interval when fluids percolated along the slip plane and precipitated thin laminae and clusters of Fe-oxyhydroxides and Mn-oxides (Plate 3D). Thin veins (<0.5 mm) with Mn-oxide fills also cut the sample and commonly give rise to brown or yellow staining in the adjacent clay. In detail the Mn-oxides show patterns of concentric growth with thin platy crystals generally showing a radial arrangement (Plates 3E and 3F). Modification of the orientated kaolin clay (kaolinite?) forming slip clay fragments also appears to have taken place during a static interval, resulting in random fibrous overgrowths on the orientated domains (Plate 6A). These may represent halloysite formed by hydration of kaolinite in response to fluid percolation along a slip plane. Similar fibrous overgrowths are well developed on kaolin books in the matrix of the sample (Plate 6B). In detail some end sections of these fibres appear to be curved (Plate 6C), suggesting that they represent the rolled or tubular morphologies of halloysite, possibly modified by collapse in the SEM vacuum.

The thin section contains part of a clay gouge associated with two or more early slip planes developed in a highly altered volcanoclastic protolith. Tension fractures developed in the protolith are enhanced by staining from ferromanganese minerals (Plate 4C). Strained and fractured quartz grains (<5.0 mm) are the largest relicts of the protolith and form up to 10% of the sample (Plate 5A). A few relict grains of alkali feldspar and lava are also preserved but are highly kaolinized. Clay minerals account for approximately 80% of the sample, and mostly form random intergrowths of kaolin books with overgrowths of fibrous halloysite (Plate 6D). Orientated clay microfabrics are found in the slip clays developed along the slip planes and are associated with impersistent laminae of ferromanganese minerals; brown

- 4A. Sample BS8/A8/B. Lai Ping Road landslide. Optical photomicrograph of highly fractured quartz phenocryst with blue-stained clay filling cracks (cross-polarized light; field width 4.5 mm).

- 4B. Sample BS8/A8/B. Lai Ping Road landslide. Optical photomicrograph of a compound slip clay fragment in the clay matrix. The folded bluish-white kaolin with associated dark-brown Mn-oxide is an early slip clay; the green-stained kaolin is a later slip clay. Resin is deep blue (plane-polarized light; field width 4.5 mm).

- 4C. Sample BS12/B1/A. Lai Ping Road landslide. Optical photomicrograph of an early clay gouge with associated slip planes. Slip clays form green-stained diagonal lines bottom right and top left. Dark-brown ferromanganese minerals stain a detached and disrupted slip clay fragment in the gouge (centre). Thin tensional veins cut the fragment and quartz grains (plane-polarized light; field width 9 mm).

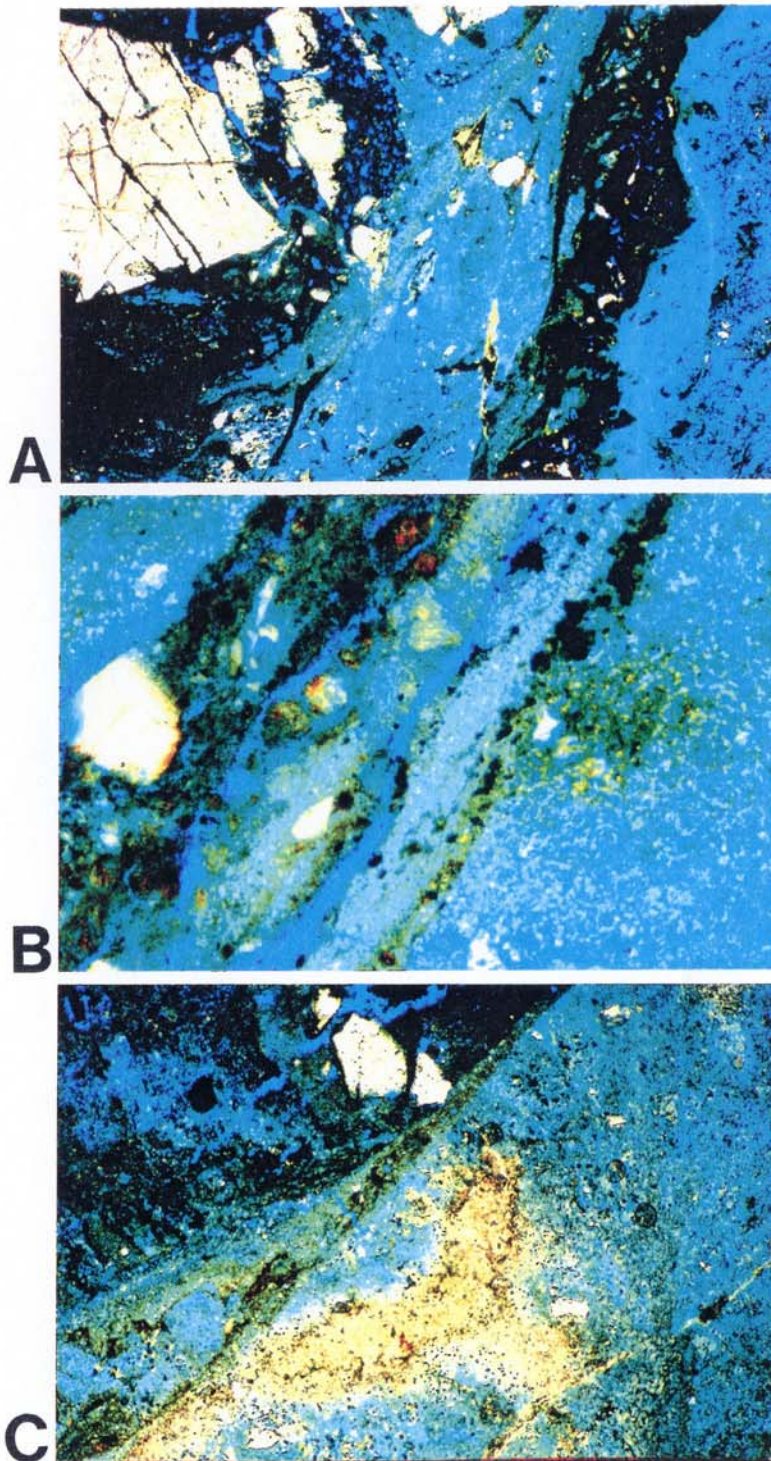
5A. Sample BS12/B1/A. Lai Ping Road landslide. Optical photomicrograph of a fractured quartz grain in a clay gouge. Dark-brown ferromanganese minerals with thin green-stained clays attached are slip clay fragments. Blue-stained kaolin forms the matrix of the gouge. (plane-polarized light; field width 9 mm).

5B. Sample BS12/B1/A. Lai Ping Road landslide. Optical photomicrograph of a slip plane. Slip clays are pale-blue or green-stained in association with dark-brown laminae of ferromanganese minerals. Resin is deep blue. (plane-polarized light; field width 1.1 mm).

5C. Sample BS12/B1/A. Lai Ping Road landslide. Optical photomicrograph of a slip plane. Tensional veins (bottom right) formed normal to the slip plane are filled with ferromanganese minerals (plane-polarized light; field width 4.5 mm).

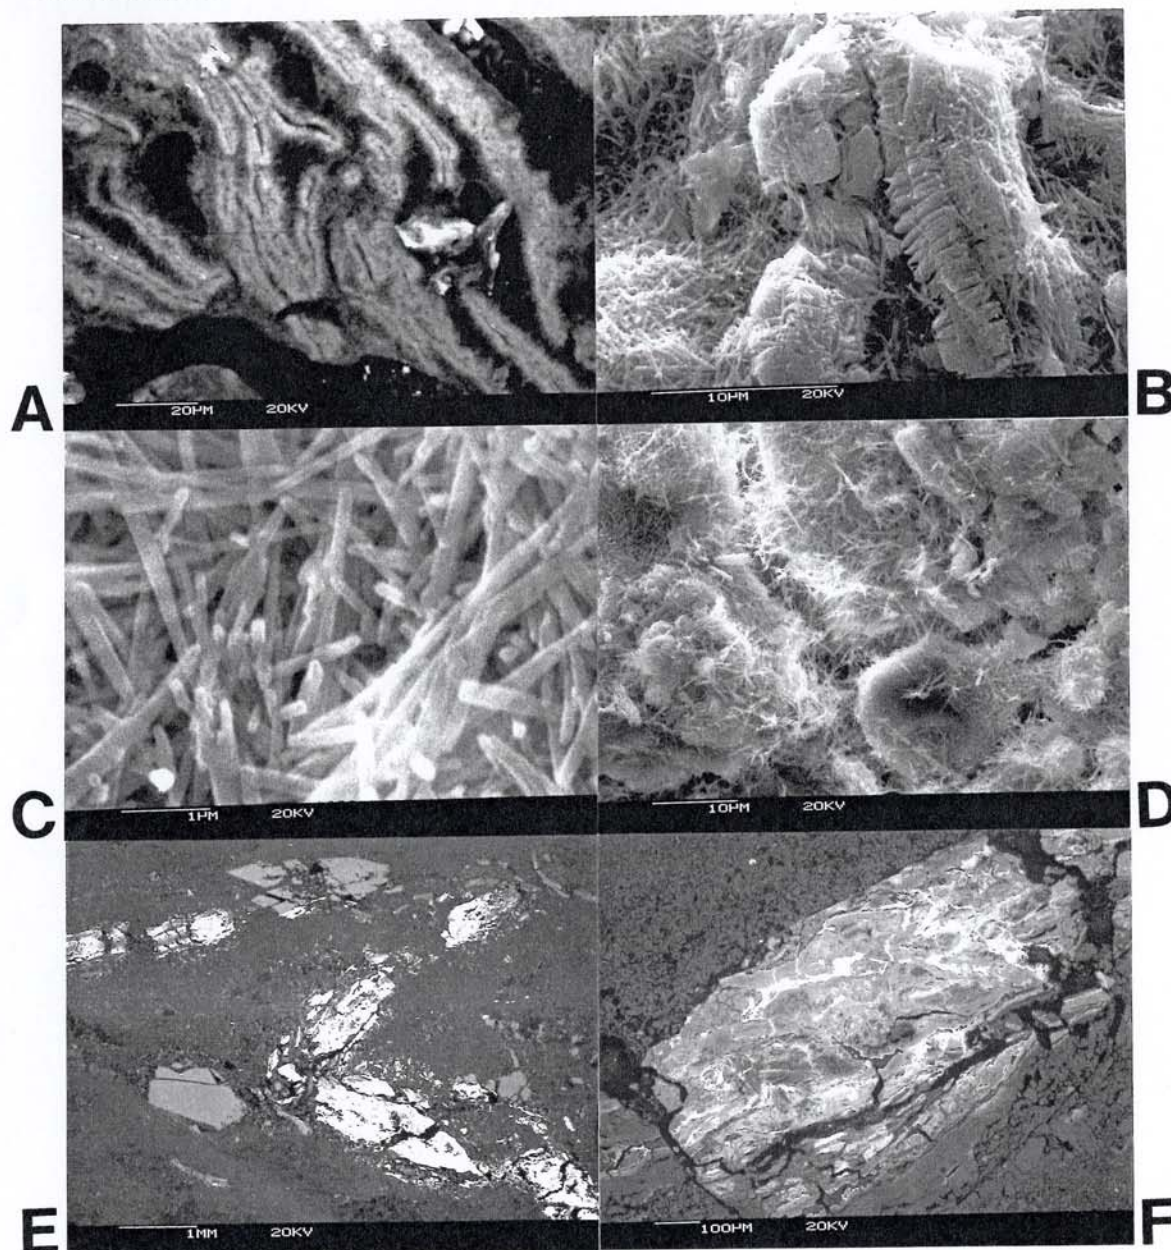
Within the gouge, slip clay fragments consisting of kaolin and ferromanganese laminae have been deformed and disrupted (Plate 6E). Some are compound fragments showing internal deformation of the slip clay and associated Mn-oxide (Plate 6F). Fe-oxyhydroxides are also found in the fragments, in clusters of radiating platy crystals (Plate 9A). Granules of a Ce-rich mineral (?carbonate) are associated with some Fe-oxyhydroxide clusters (Plate 9B). The appearance and structure of the clay fragments in the gouge suggest that they are pre-existing slip clays or tension gash fills which were detached and deformed by earlier movements on a slip plane.

6A. Sample BS8/A8/B. Lai Ping Road landslide. Backscattered secondary electron photomicrograph of orientated domains of kaolin clay with overgrowths of fibrous halloysite.

6B. Sample BS8/A8/B. Lai Ping Road landslide. Backscattered secondary electron photomicrograph of kaolinite books with overgrowths of fibrous halloysite.

6E. Sample BS12/B1/A. Lai Ping Road landslide. Backscattered secondary electron photomicrograph showing deformed and disrupted ferromanganese laminae (bright grey) and quartz grains (mid-grey).

6F. Sample BS12/B1/A. Lai Ping Road landslide. Backscattered secondary electron photomicrograph of a compound slip clay fragment. Folded and disrupted slip clay comprising mid-grey kaolin and bright grey Mn-oxide formed early. Later slip clay and Mn-oxide is undeformed (bottom right of fragment).

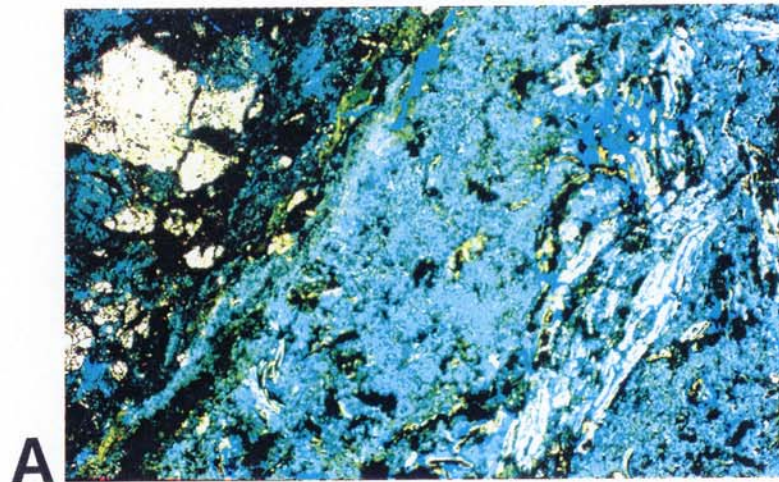
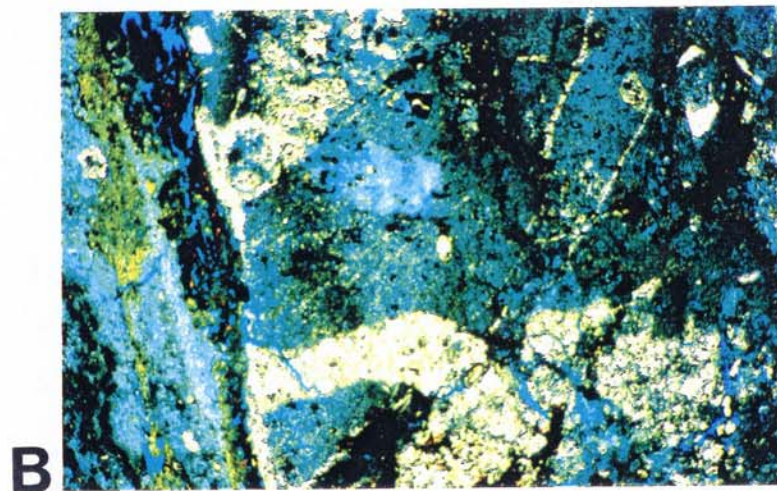
7A. Sample BS12/B1/B. Lai Ping Road landslide. Optical photomicrograph showing a pale blue clay gouge with slip clay fragments. The blue-green clay (top left) forms part of a slip plane against a quartz-rich protolith stained dark-brown by ferromanganese minerals (plane-polarized light; field width 9 mm).

7B. Sample BS12/B1/B. Lai Ping Road landslide. Optical photomicrograph of quartz-filled tensional veins in the protolith, normal to a slip plane (subvertical, left of field). Two quartz-filled veins have also formed along the slip plane together with dark-brown ferromanganese laminae (plane-polarized light; field width 4.5 mm).

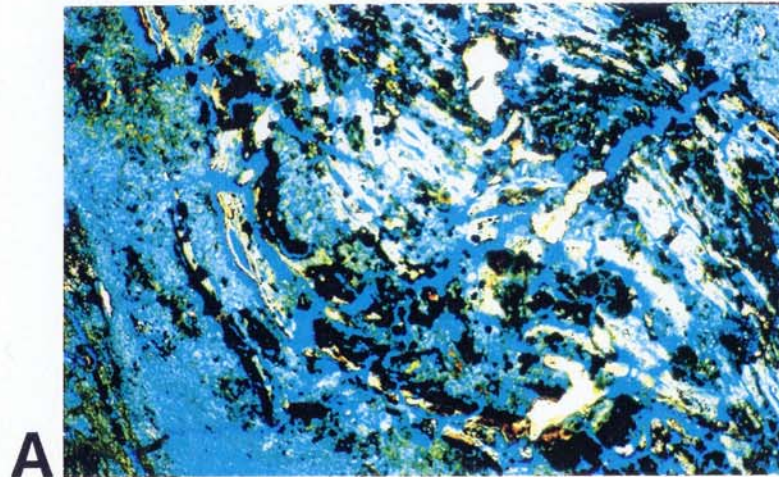
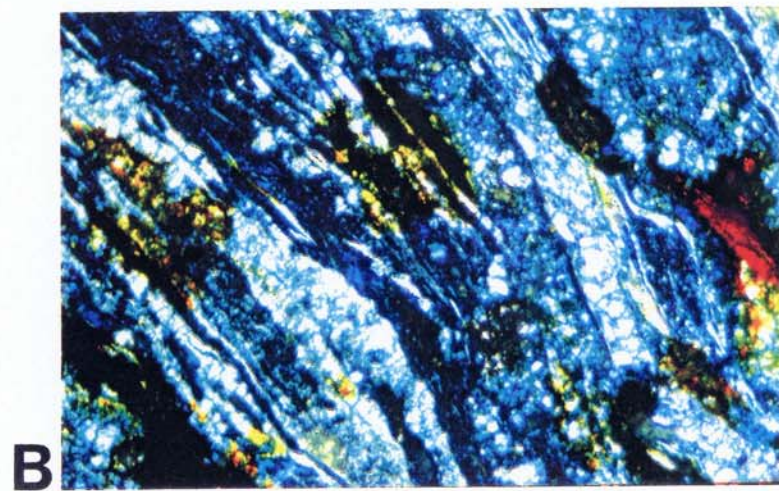
8A. Sample BS12/B1/B. Lai Ping Road landslide. Optical photomicrograph showing contorted slivers of slip clay consisting of whitish or pale-blue orientated domains of kaolin with dark-brown ferromanganese minerals (plane-polarized light; field width 4.5 mm).

8B. Sample BS12/B1/B. Lai Ping Road landslide. Optical photomicrograph of slip clay. Dark blue orientated domains of kaolin minerals alternate with whitish or pale-blue random domains. Brown and yellow staining is from ferromanganese minerals (cross-polarized light; field width 1.1 mm).

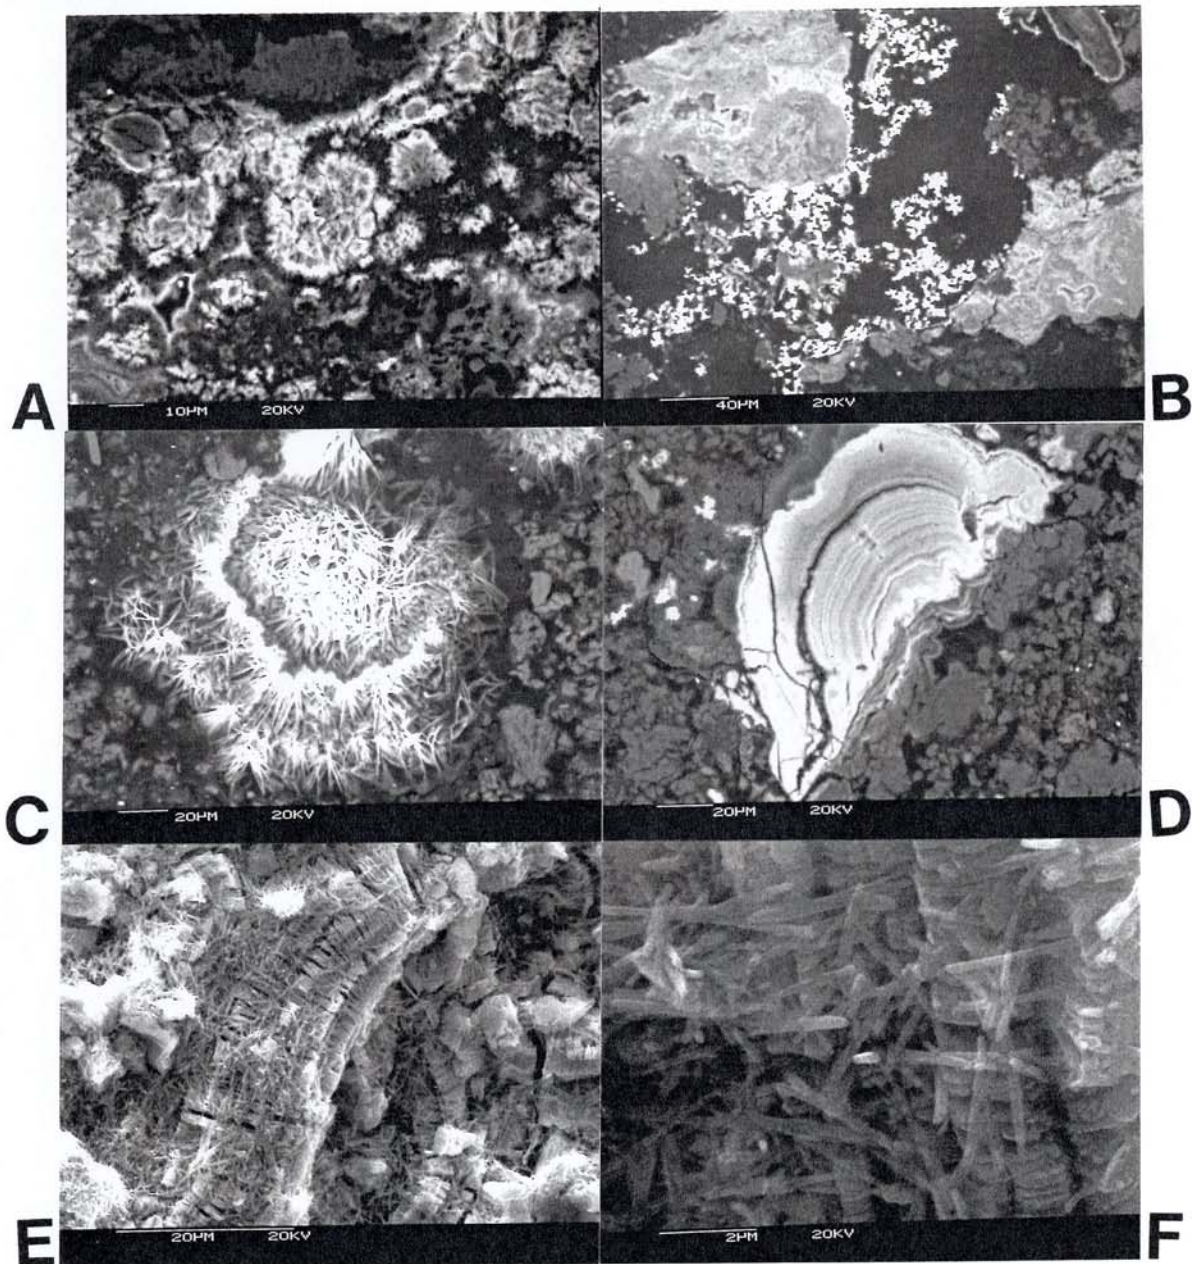
- 9A. Sample BS12/B1/A. Lai Ping Road landslide. Backscattered secondary electron photomicrograph of Fe-oxyhydroxide forming clusters of radiating platy crystals in slip clay fragments.

- 9B. Sample BS12/B1/A. Lai Ping Road landslide. Backscattered secondary electron photomicrograph of Ce-rich mineral forming granules in slip clay fragment.
