**REPORT ON THE
DEBRIS FLOW AT
SHAM TSENG SAN TSUEN
OF 23 AUGUST 1999**

**FINDINGS OF
THE INVESTIGATION**

GEO REPORT No. 169

Fugro Maunsell Scott Wilson Joint Venture

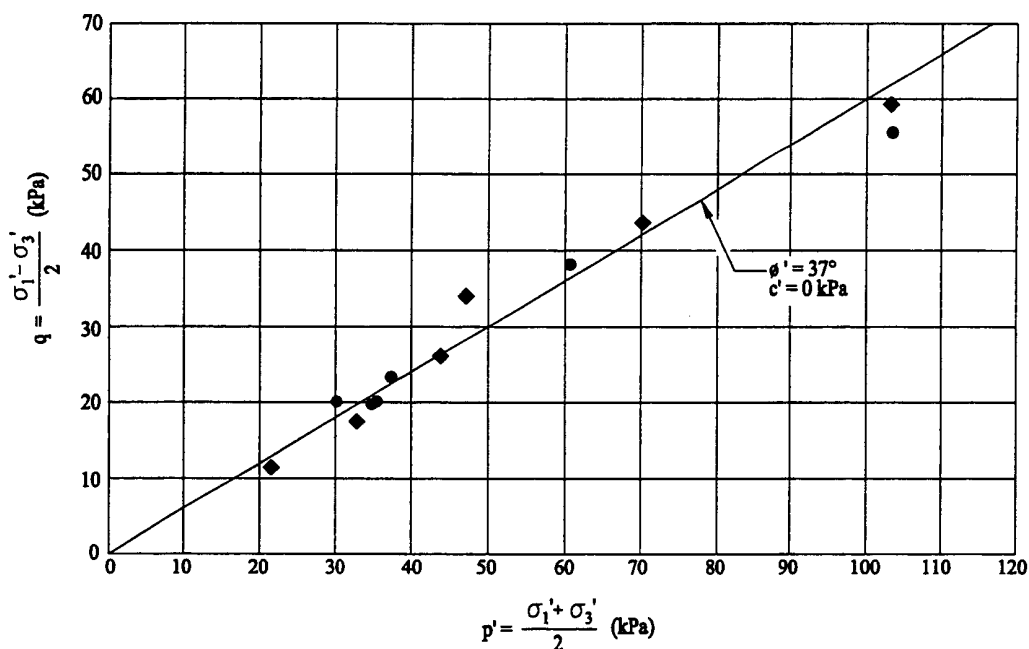
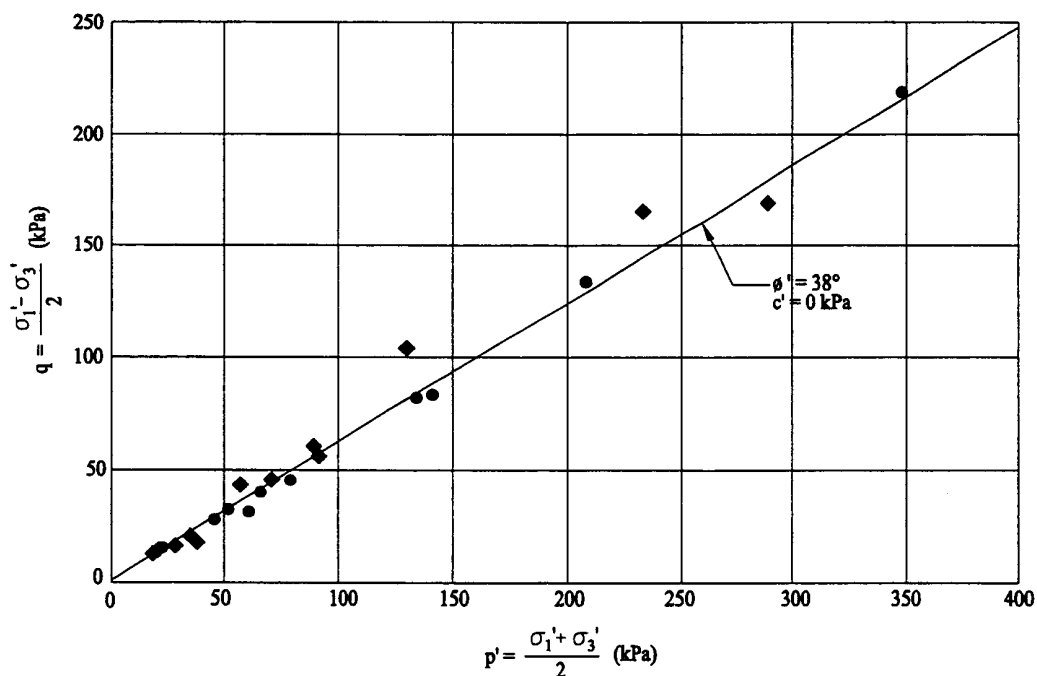
Figure 23 - Triaxial Compression Test Results for Colluvium and Completely Decomposed Granite

The shear strength properties of the surface colluvium and CDG were assessed by consolidated undrained triaxial compression tests using samples recovered from the Landslide A site. The results of the tests are presented in Figure 23. The angle of shearing resistance (ϕ') of the surface colluvium and CDG are 37° and 38° respectively, with zero cohesion (c'). However, the actual mass shear strength of the surface, bouldery colluvium, which contains 30% to 50% of moderately weathered clasts of cobbles and boulders, will be somewhat higher. No undisturbed samples suitable for testing were retrieved from the dense weathered colluvium but it appears from field inspections that its strength will be comparable to that of the underlying CDG.

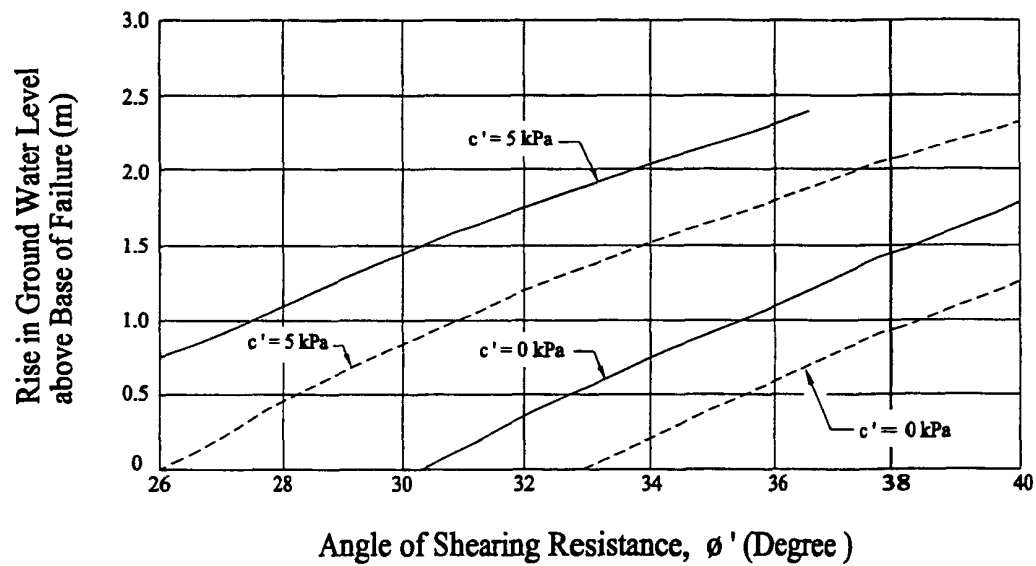
Figure 24 - Results of Theoretical Stability Analyses

The results of the analyses are presented in Figure 24 for a range of shear strength parameters of $c' = 0$ to 5 kPa and $\phi' = 32^\circ$ to 40° . As noted before, the mass shear strength of the colluvium is likely to be higher than matrix shear strength because of the presence of cobbles and boulders. The results indicate that for the likely ranges of shear strength parameters, a perched water table of about 1 m to 2 m above the base of the failure would have been sufficient for failure to occur. This is consistent with the field observations and the hydrogeological setting of the sites, suggesting that the supporting theoretical analysis are credible.

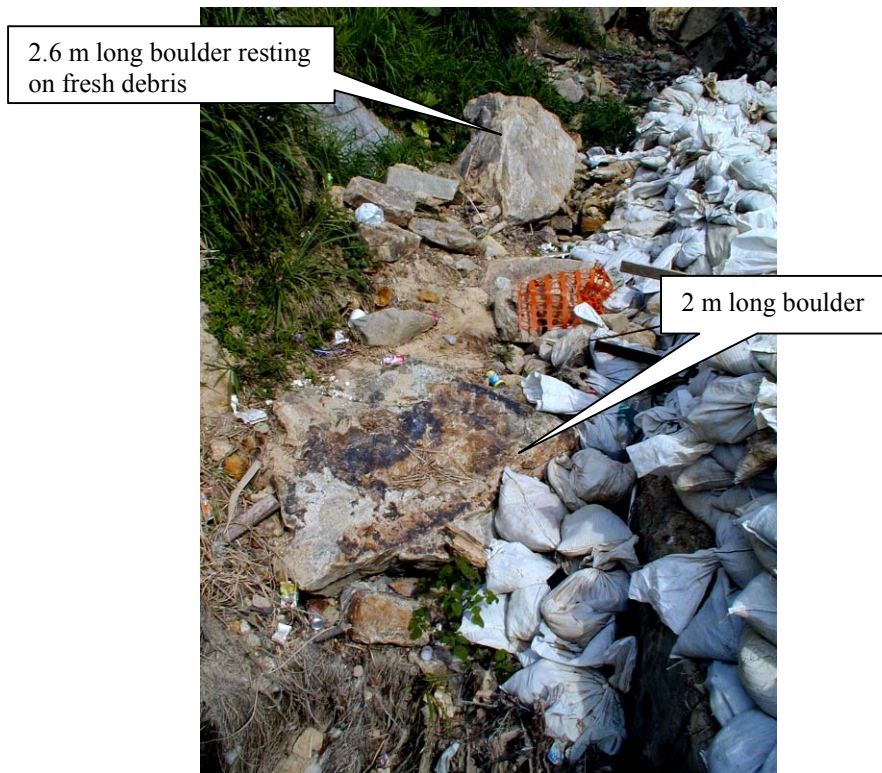
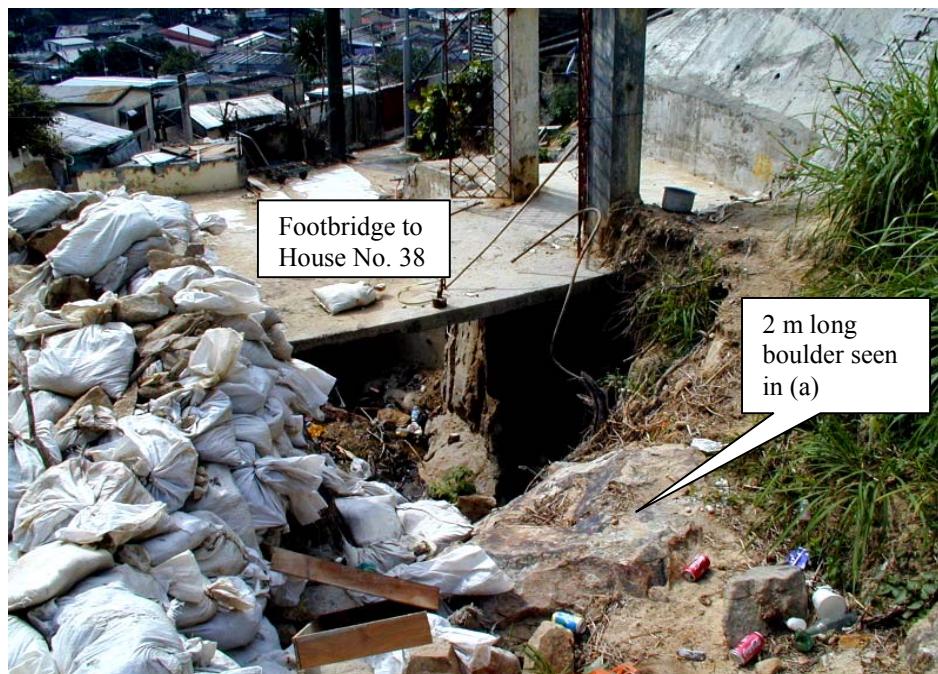
Plate 4 - Nullah Upstream of Footbridge to House No. 38
(Photographs Taken on 8 December 1999)

(a) Nullah upstream of footbridge to House No. 38 infilled with fresh boulders

(b) Nullah partially cleared

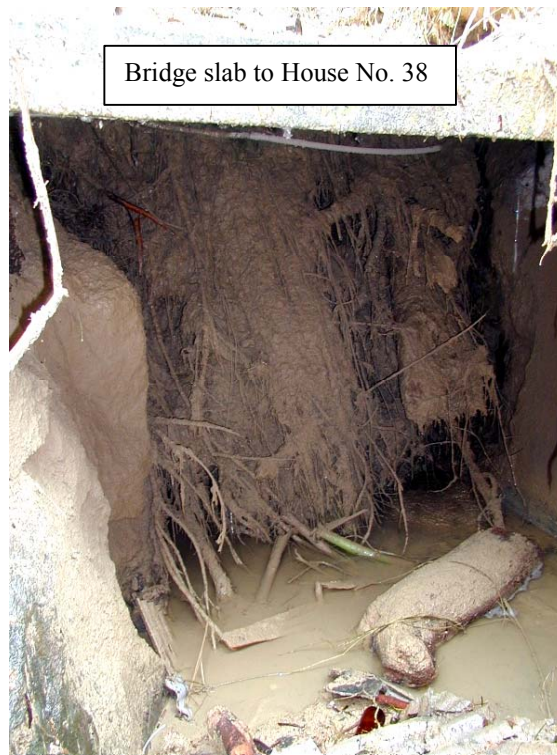
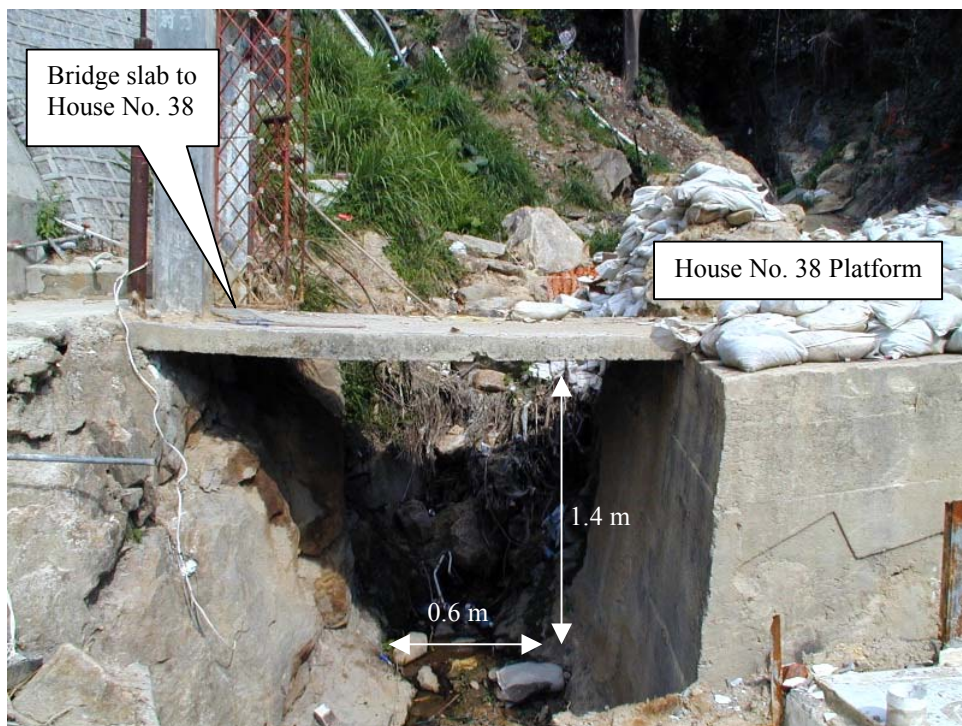
Plate 6 - Nullah at Footbridge to House No. 38

(a) Nullah beneath footbridge to House No.38 totally blocked by fresh vegetation and boulders (Photograph taken on 24 August 1999)

(b) Nullah partially cleared (Photograph taken on 8 December 1999)

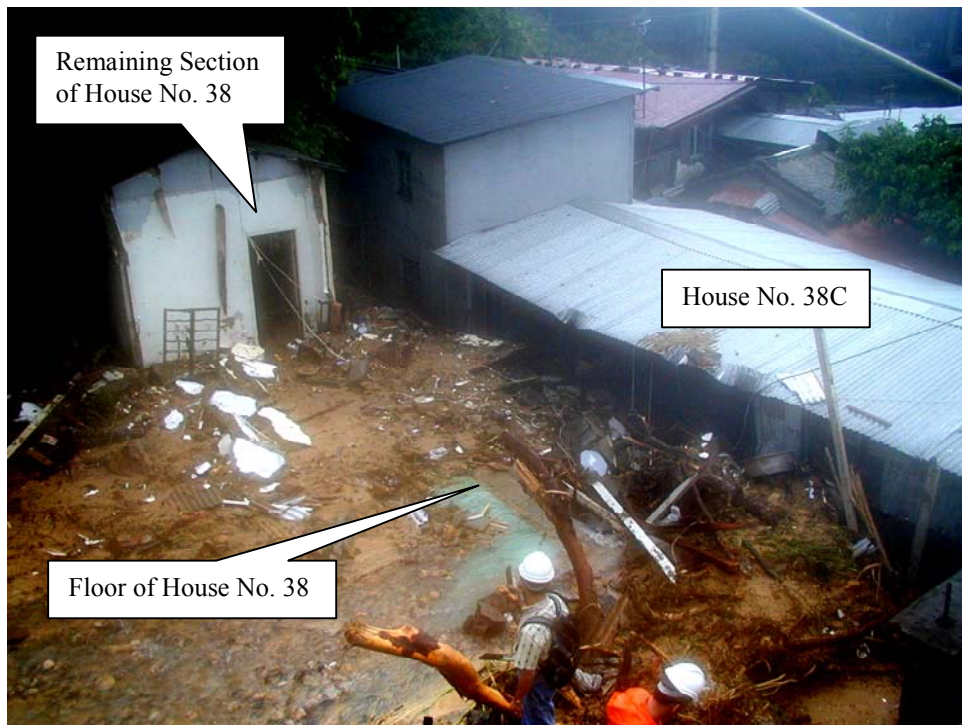
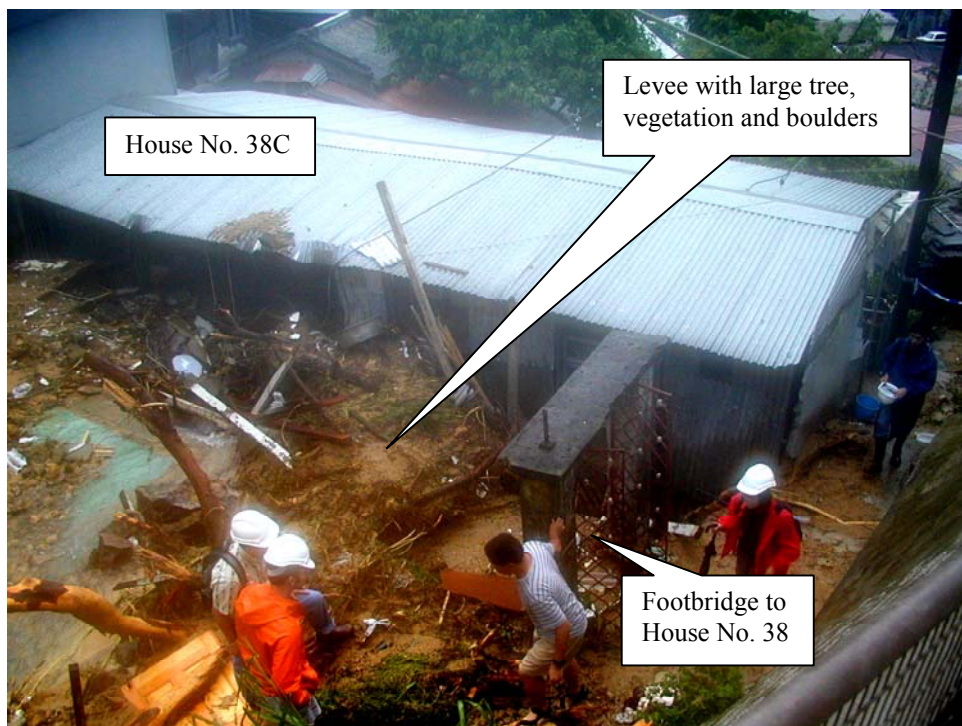
(a) Remains of House No. 38

(b) Bridge and levee at House No. 38

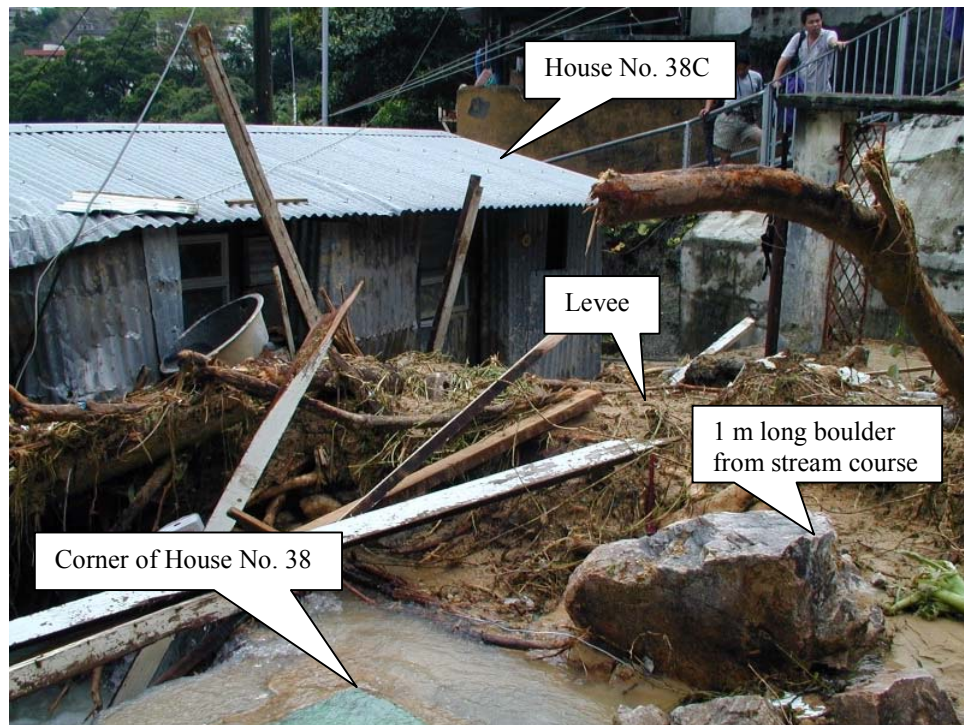
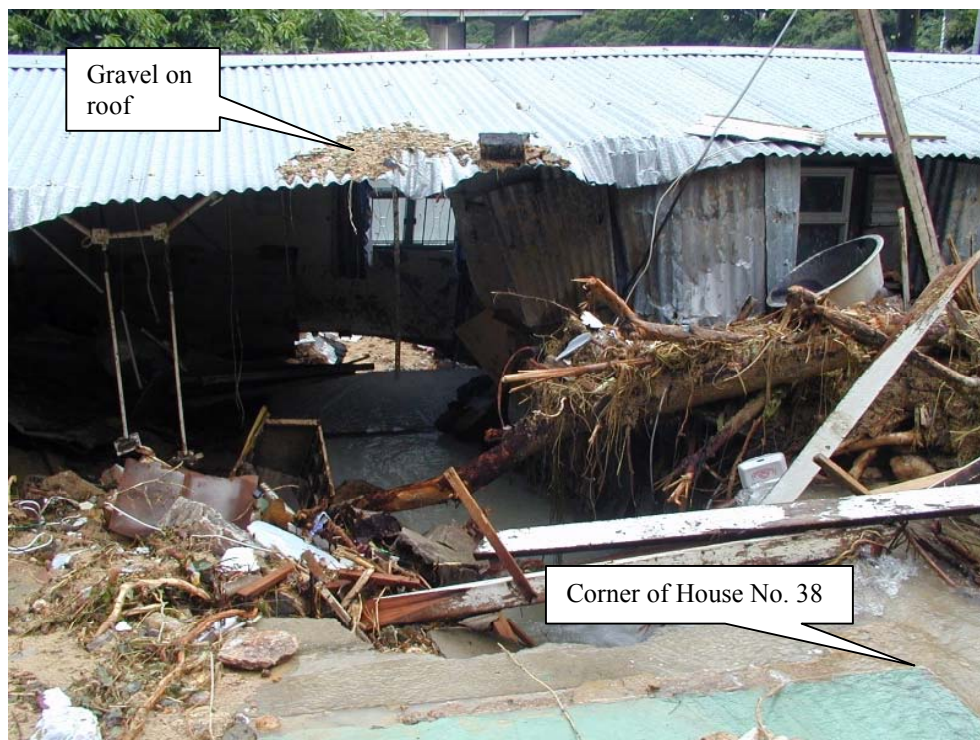
(a) Levee against House No. 38C with large tree, vegetation and boulders

(b) Path of debris flow through House No. 38C

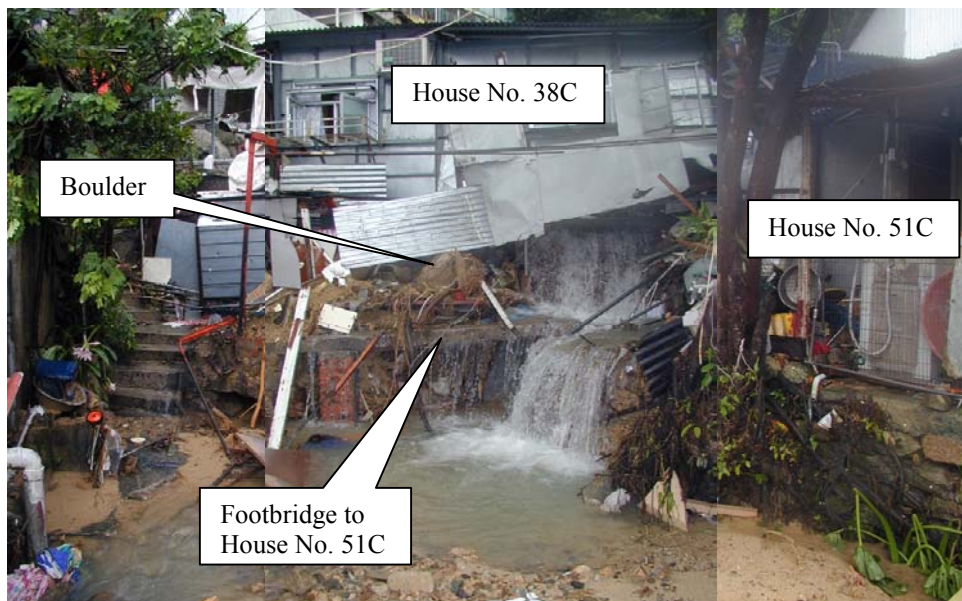
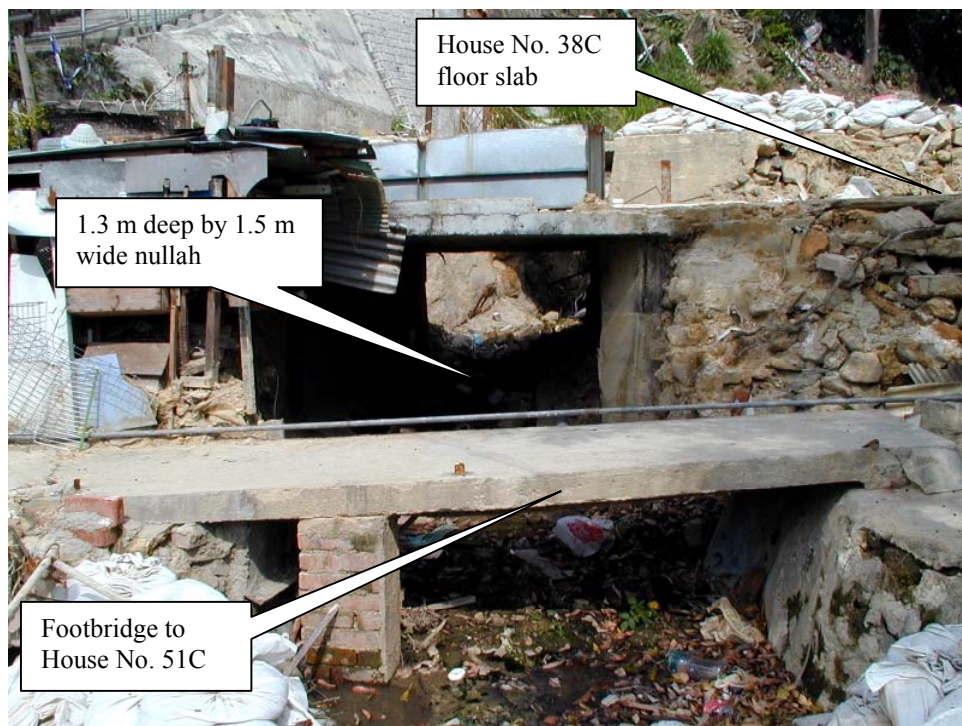
(a) View looking upstream to House No. 38C from position where the deceased was located (Photograph Taken on 24 August 1999)

(b) Nullah after clearance of House No. 38C (Photograph Taken on 8 December 1999)

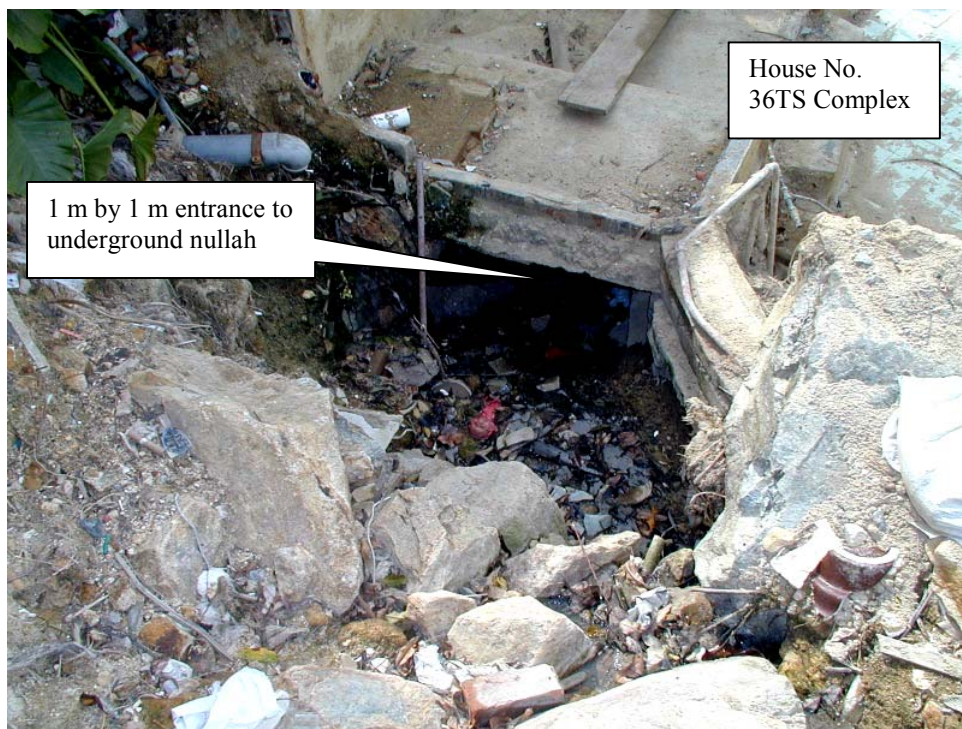
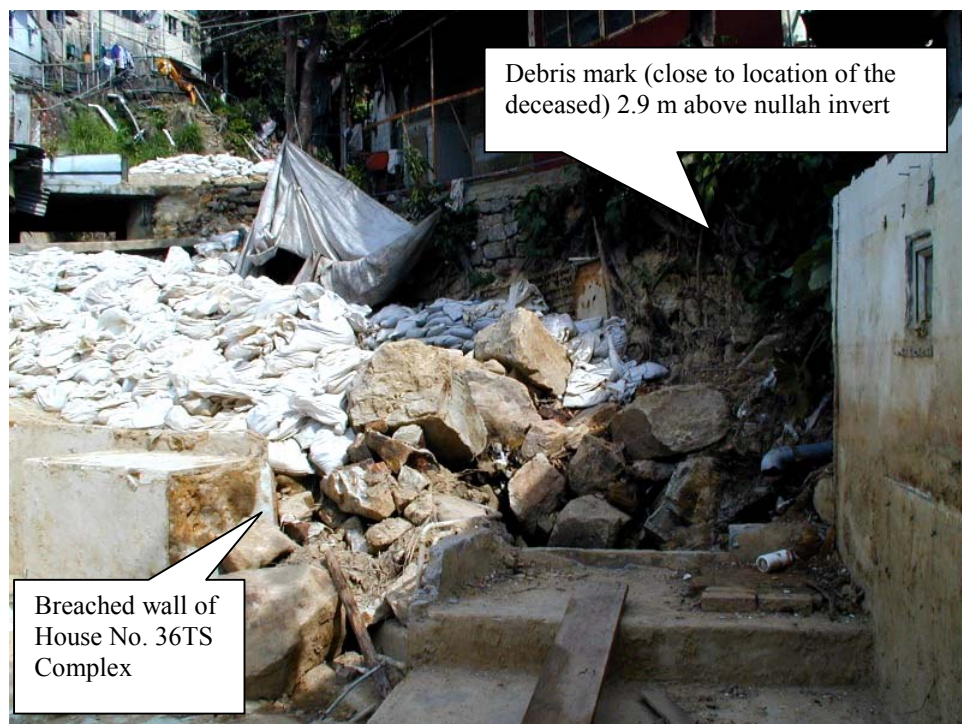
Plate 10 - Boulder-choked Nullah at Entrance to Underground Section at the House No. 36TS Complex (Photographs Taken on 8 December 1999)

(a) Partially cleared fresh boulders at entrance to underground nullah

(b) Fresh boulders up to 0.8 m across choking nullah above House No. 36TS Complex

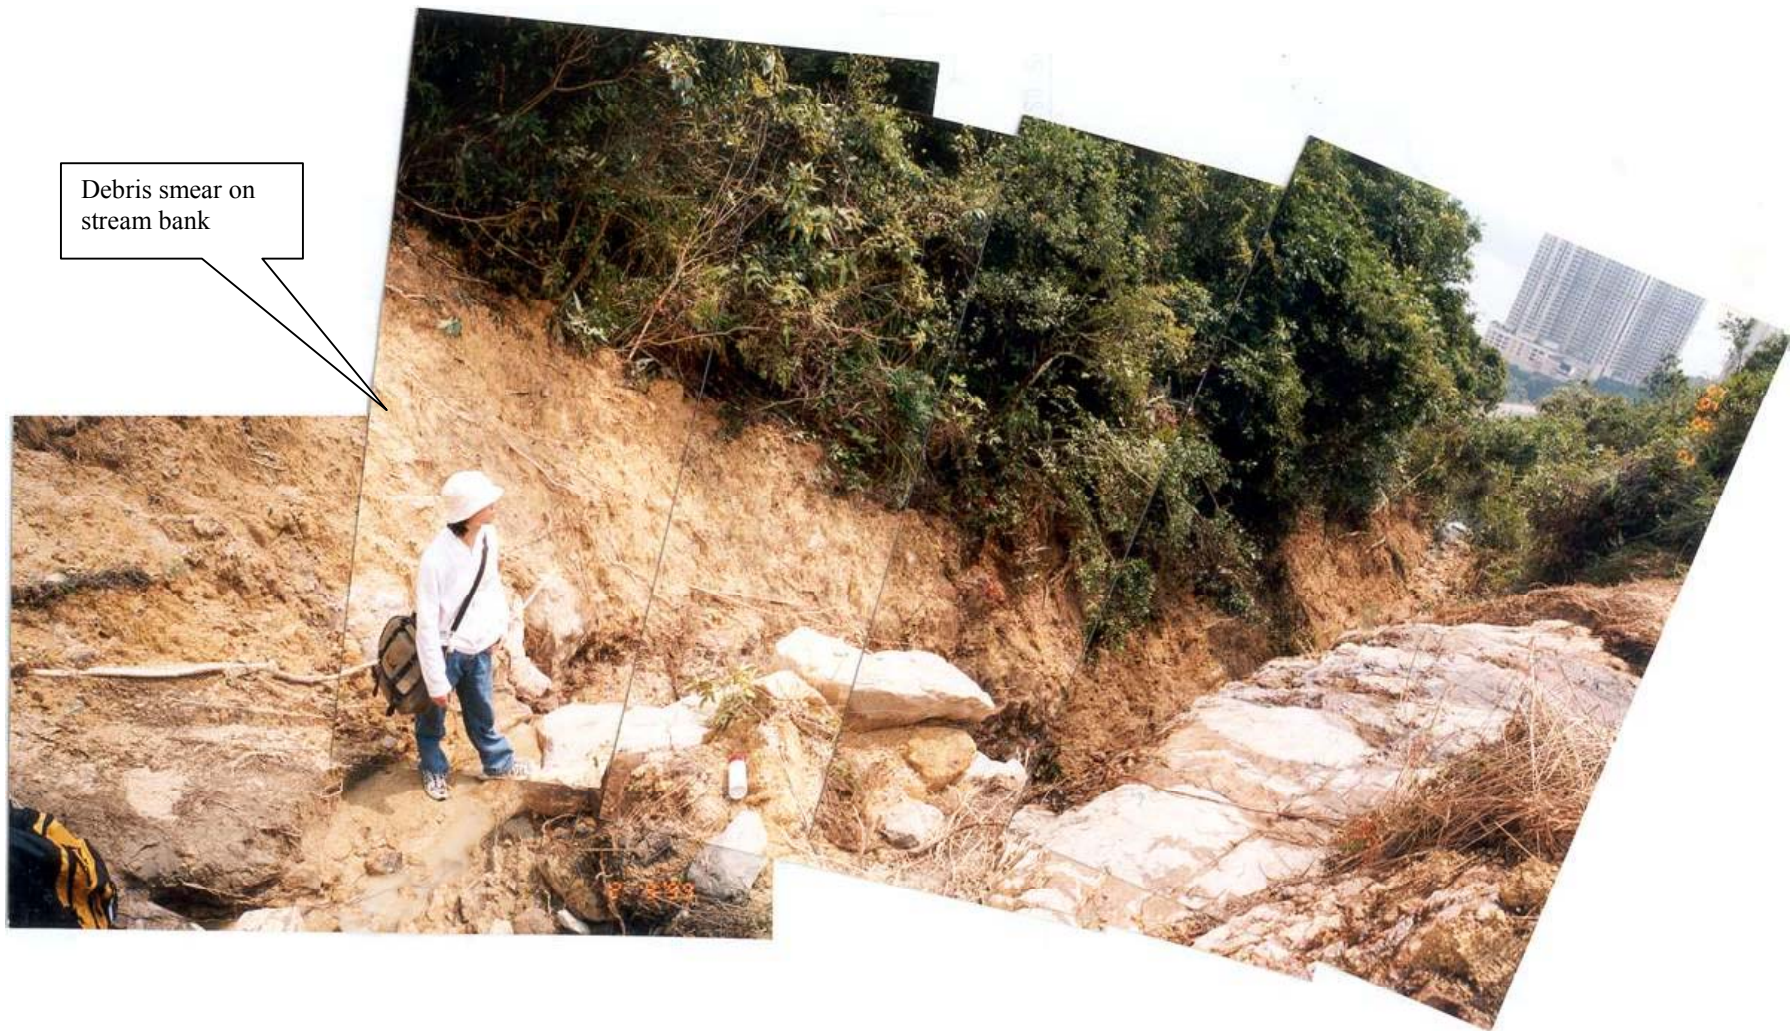
Plate 11 - Debris Trail from Top of 5 m High Waterfall at Chainage 45 to Top of Steep Section at Chainage 80
(Photograph Taken on 2 September 1999)

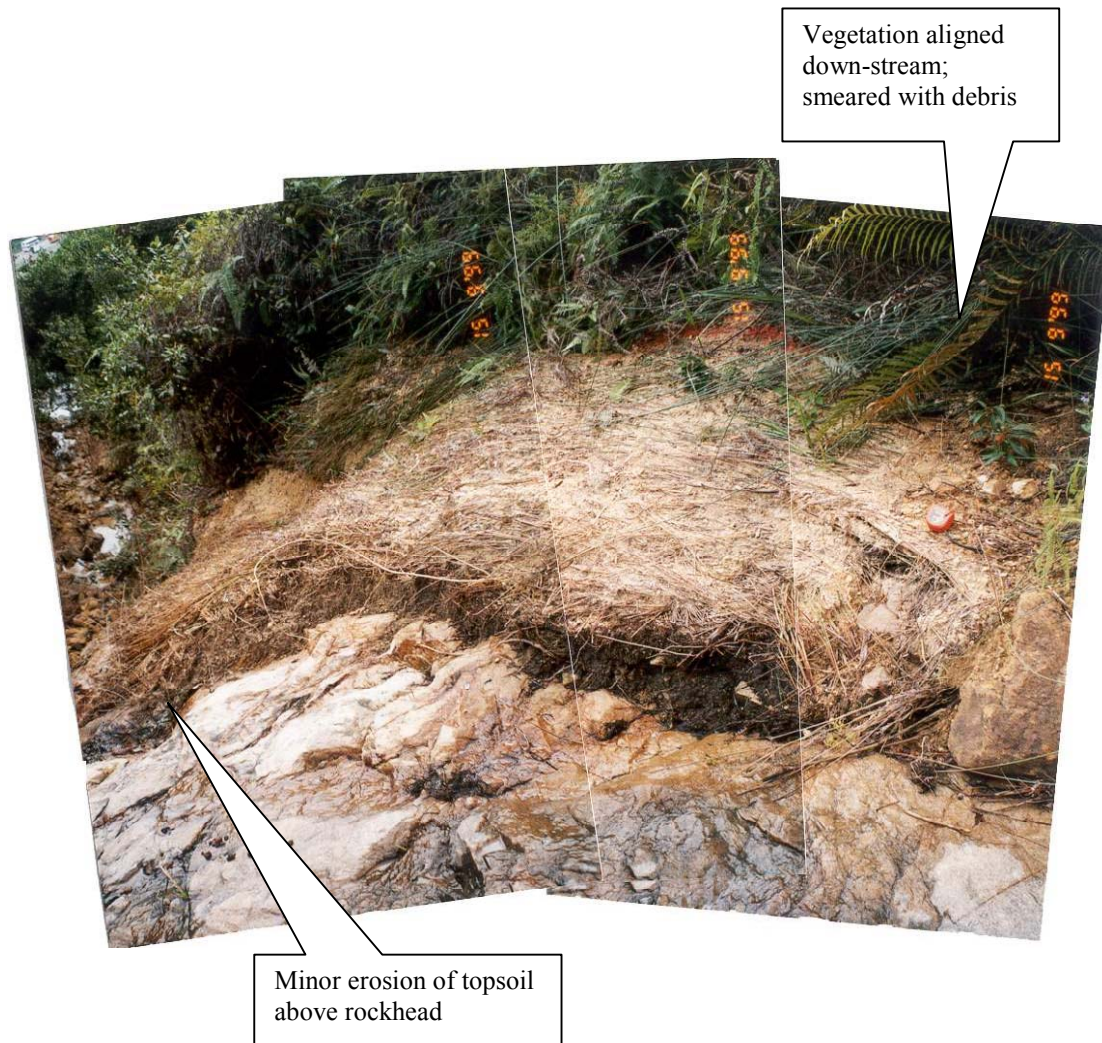
Plate 12 - Debris Trail on West Bank of Stream Course at Chainage 45
(Photograph Taken on 15 September 1999)

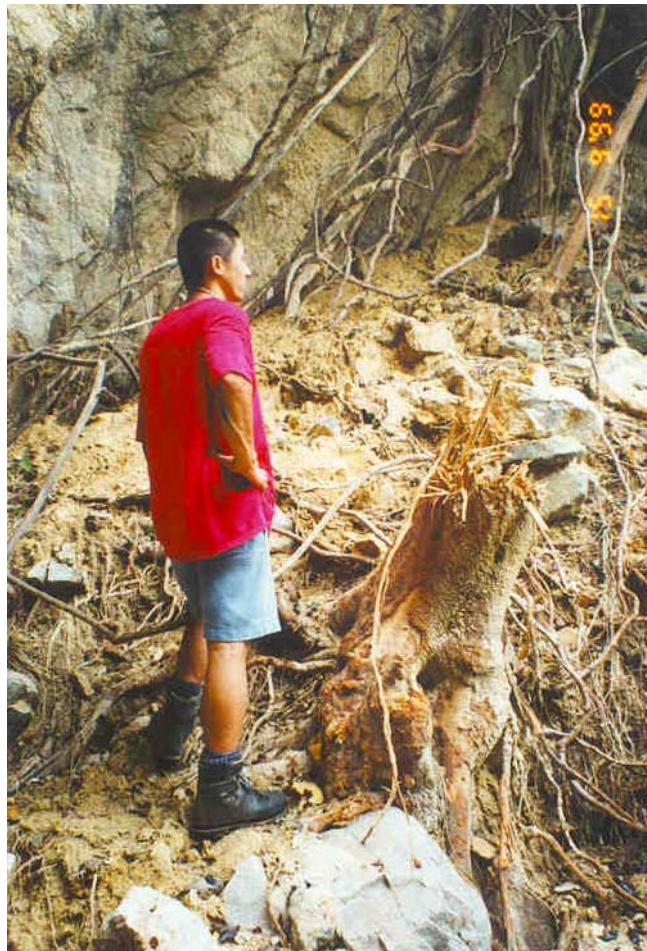
Plate14 - Severed 0.4 m Diameter Tree Stump at Foot of 10 m High Waterfall
at Chainage 110 (Photograph Taken on 15 September 1999)

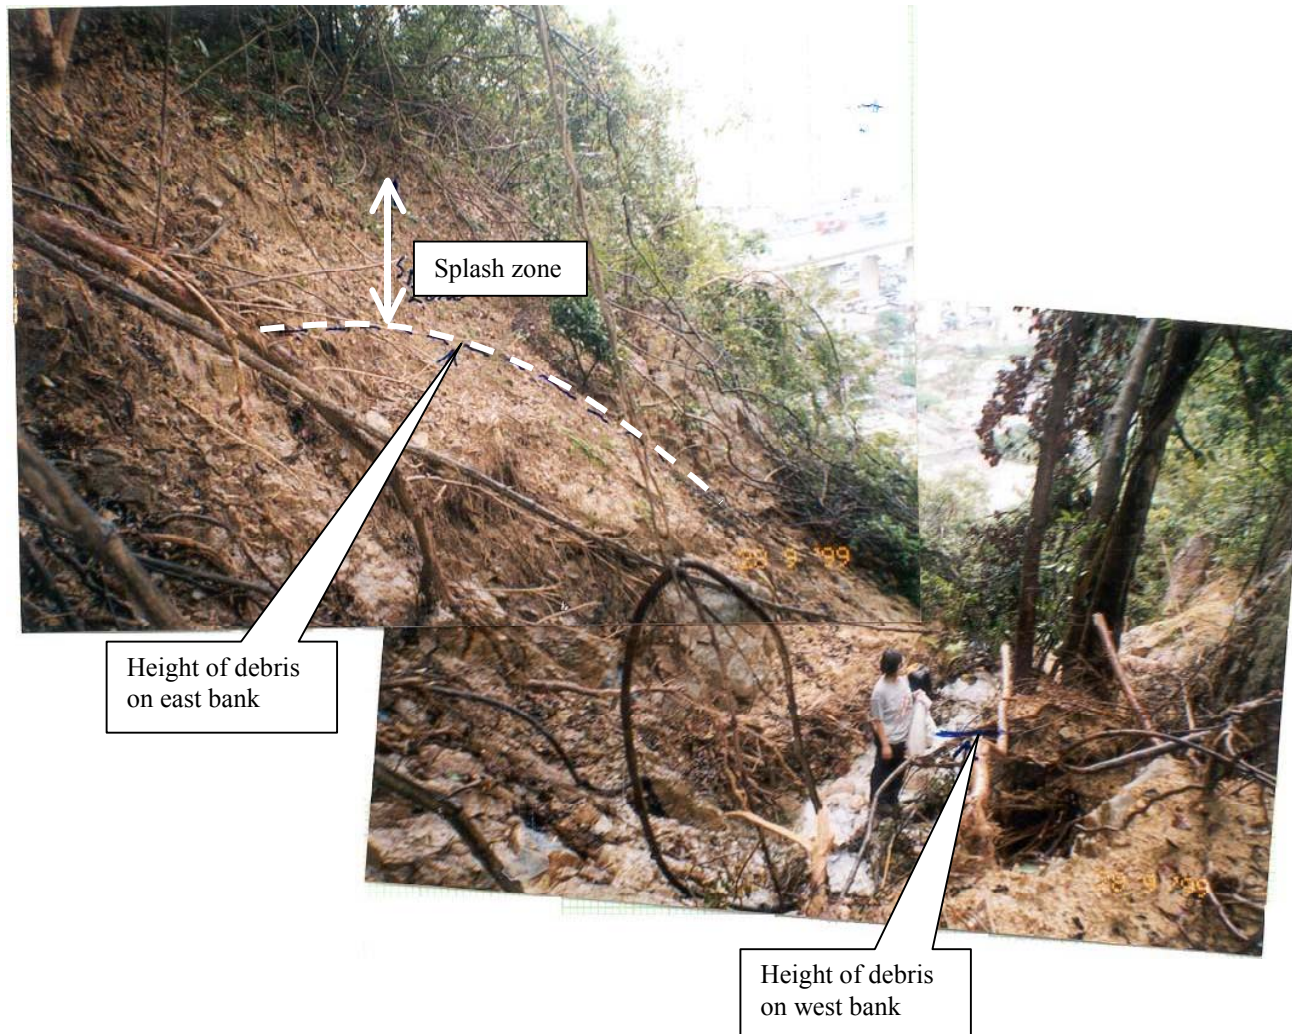
Plate 15 - Superelevation of Debris Marks at Chainage 121 Below 10 m High Waterfall (Photograph Taken on 8 September 1999)

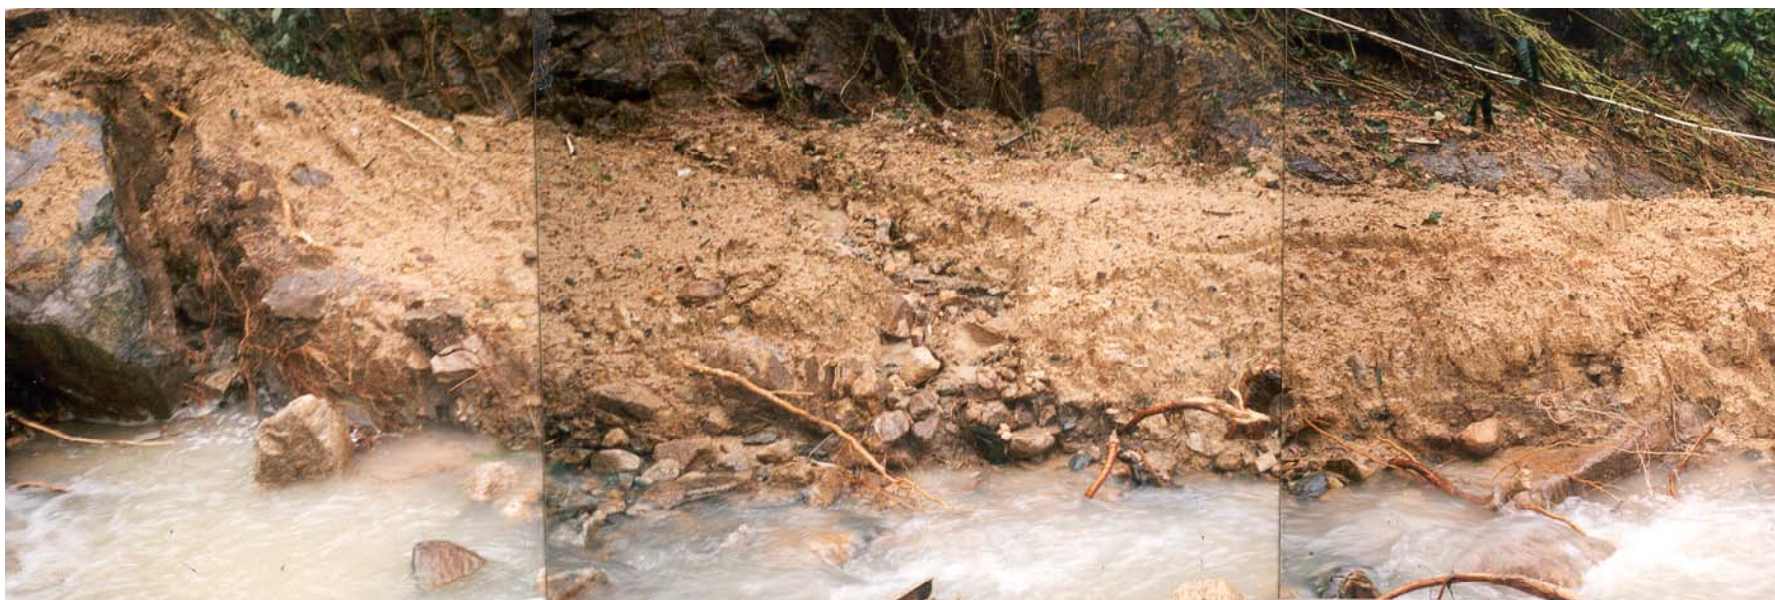
Plate 18 - Fresh, Silty Debris Overlying Old Debris (Angular Cobbles) near Site of the Kitchen Structure to House No. 38 (Photograph Taken on 25 August 1999)

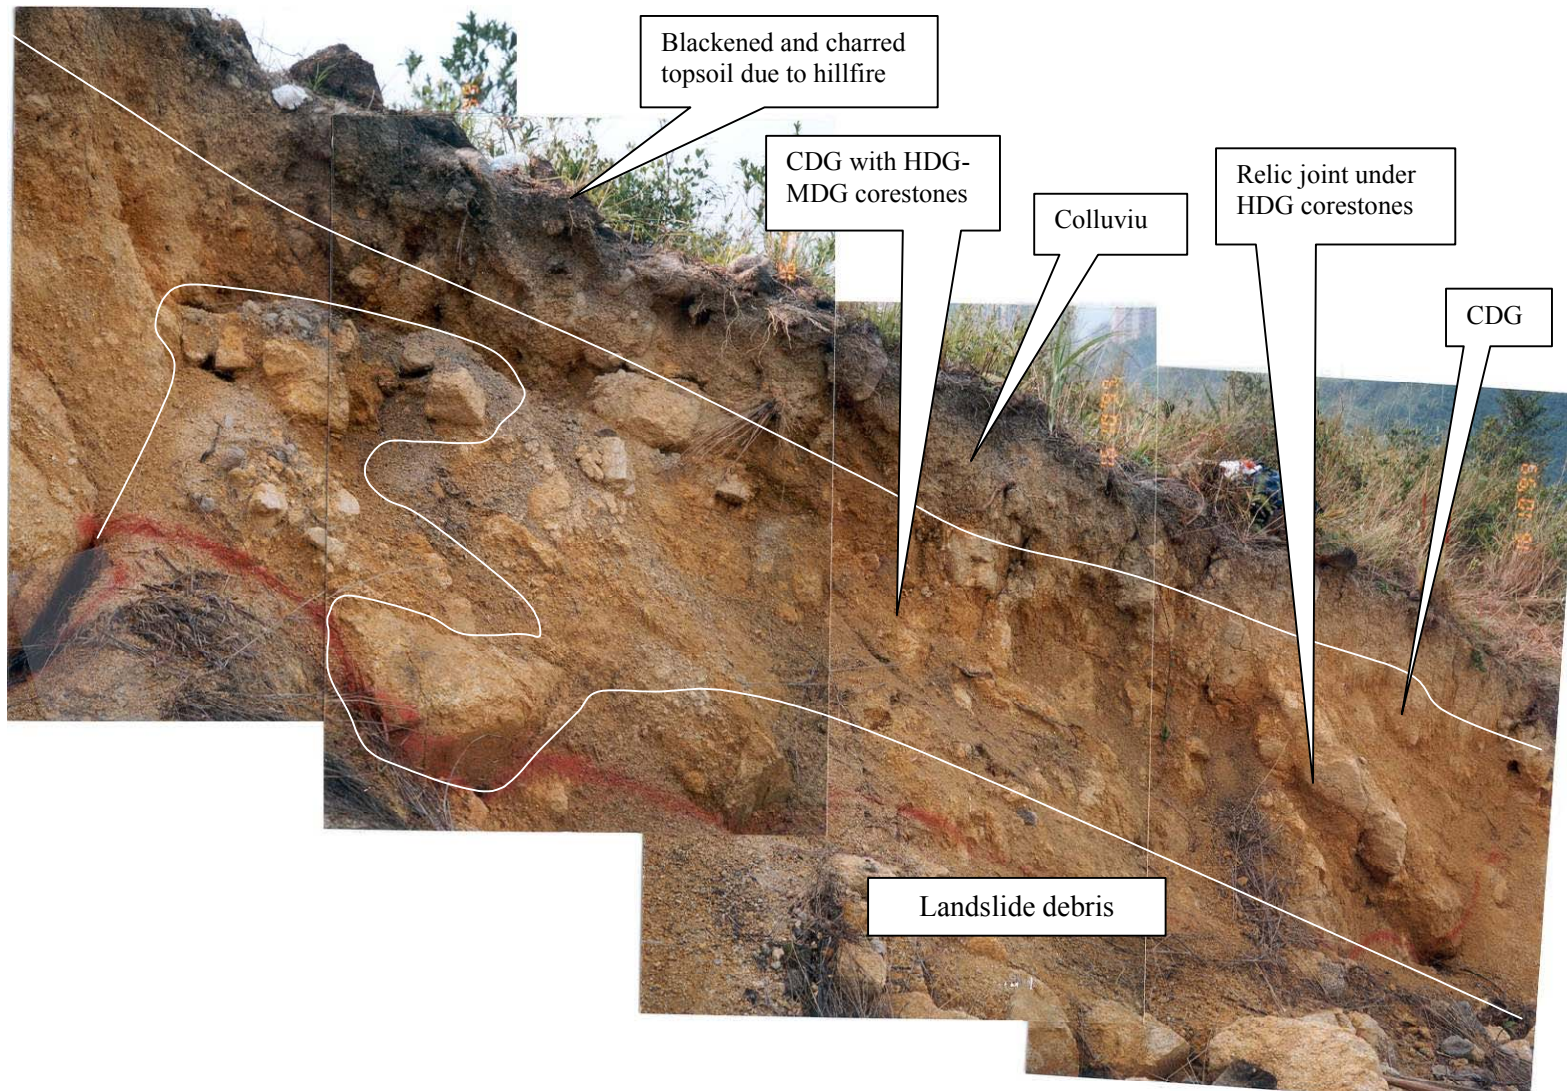
Plates 24 and 25 show the geology in the southern flank of Landslide A. Here, completely decomposed granite (CDG), containing highly to moderately decomposed corestones, overlies the insitu highly to moderately decomposed (PW 30/50) rock mass. Behind the main scarp, colluvium between 0.1 m and 0.3 m in thickness overlies the PW 30/50 material. In front of the main scarp, the thickness of the colluvium gradually increases downslope to a depth of about 1.2 m.

The topsoil, which is generally less than 200 mm thick, has been blackened and charred across the sites of landslides A to D by the 1995/1996 hillfire. This has resulted in the topsoil consisting of a very loose, silty sand with negligible cohesive properties and very poor root system development. Patches of blackened bare earth and blackened boulders are present around the scarps and flanks of the landslides (Plates 24 to 26).

Plate 24 - Details of Upper Portion of Southern Flank of Landslide A (Photograph Taken on 16 October 1999)

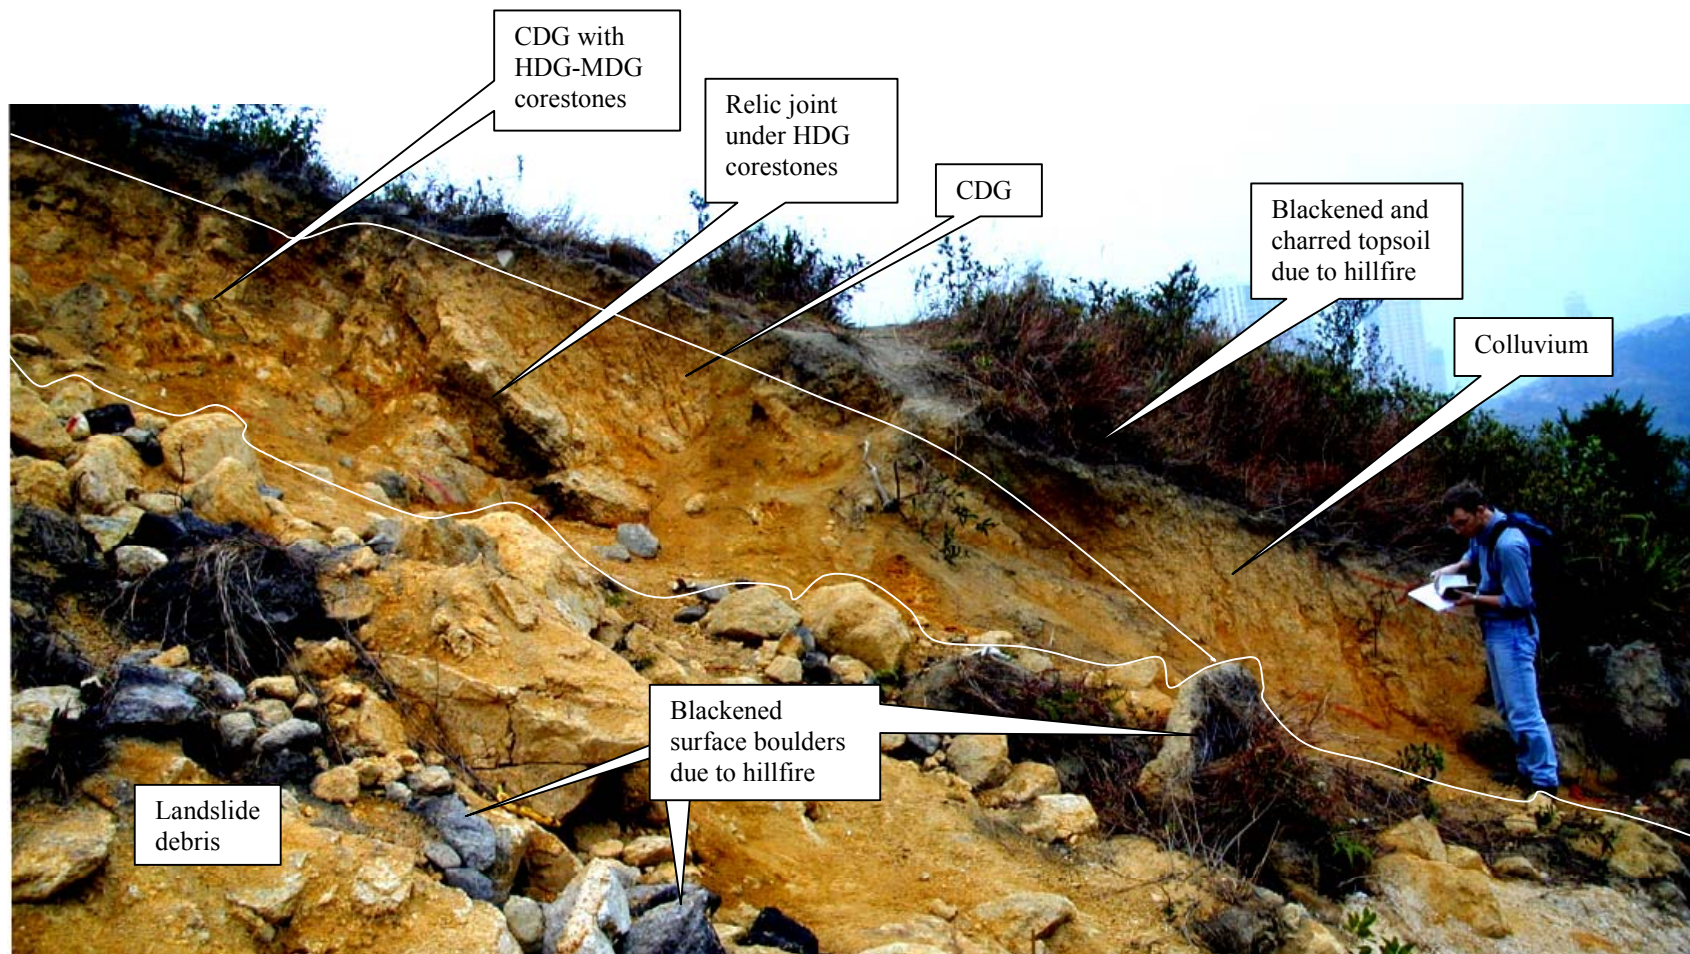
Plate 25 - Details of Upper to Middle Portion of Southern Flank of Landslide A (Photograph Taken on 16 December 1999)

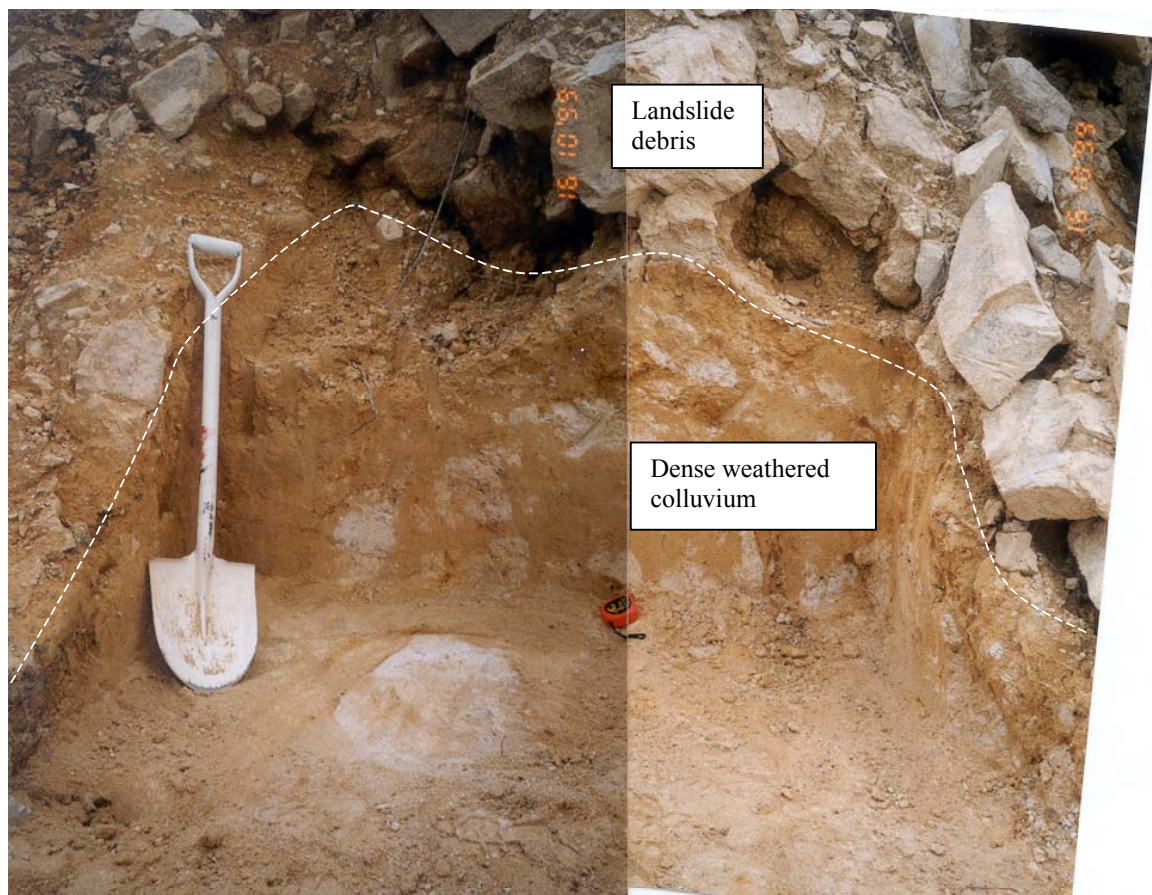
Plate 28 - Details of Landslide Debris Overlying Dense Weathered Colluvium
at Location of Portable Triple-tube Sampler Hole No. PTTS 5
(Photograph Taken on 16 October 1999)

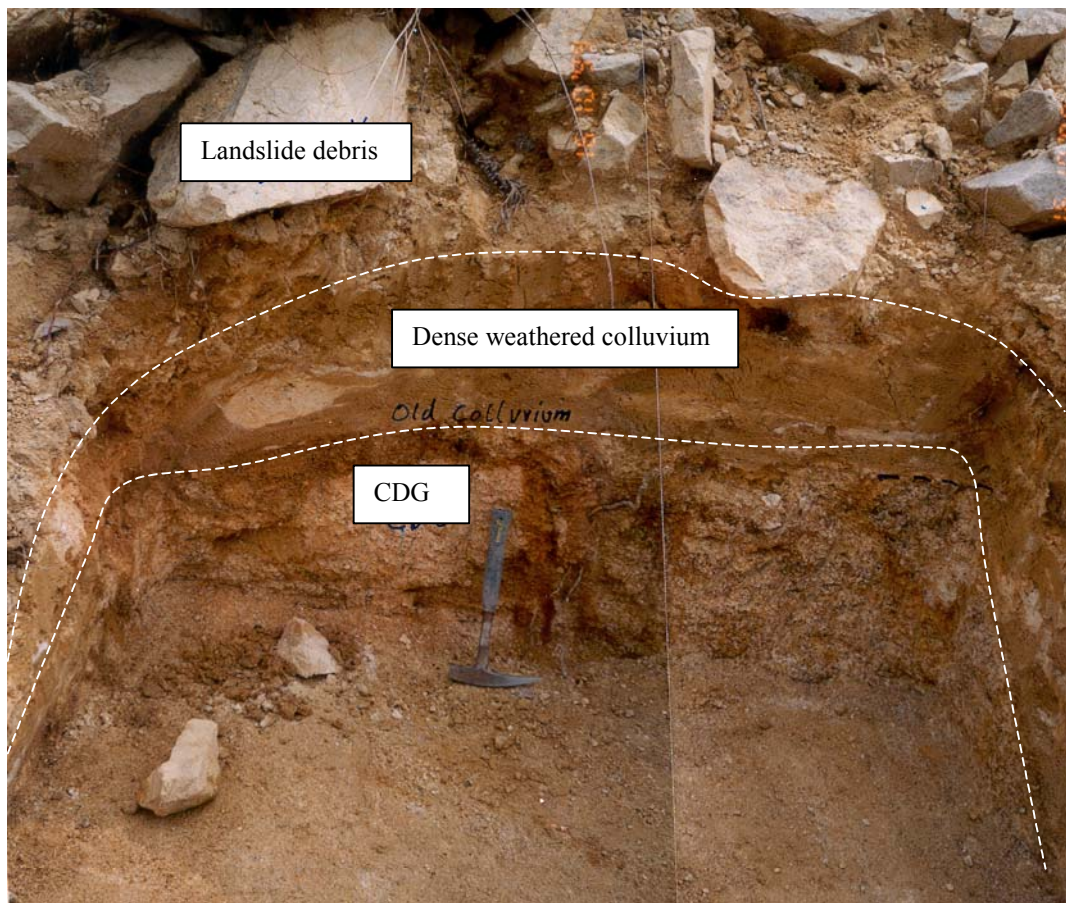
The landslide debris near the northern flank of Landslide A comprises moderately to slightly decomposed boulders up to 2.5 m across. The boulders could have been derived from secondary failure of the PW 90/100 rock mass, following initial failure of the colluvium in front. The trial pits for PTTS 5 and PTTS 6(A) indicate that the landslide debris directly overlies dense weathered colluvium up to 0.5 m thick, which in turn overlies insitu CDG (Plates 28 and 29). This colluvium is similar to that in Trial Pits TP3 and TP4 described above. No rupture surfaces can be identified below, within or above this dense weathered colluvium and no rupture surfaces are present in the continuous drillhole cores.

Plate 29 - Details of Landslide Debris/Dense Colluvium/CDG Sequence at
Location of Portable Triple-tube Sampler Hole No. PTTS 6(A)
(Photograph Taken on 16 October 1999)
