**REPORT ON THE
DEBRIS FLOW AT
SHAM TSENG SAN TSUEN
OF 23 AUGUST 1999**

**FINDINGS OF
THE INVESTIGATION**

GEO REPORT No. 169

Fugro Maunsell Scott Wilson Joint Venture

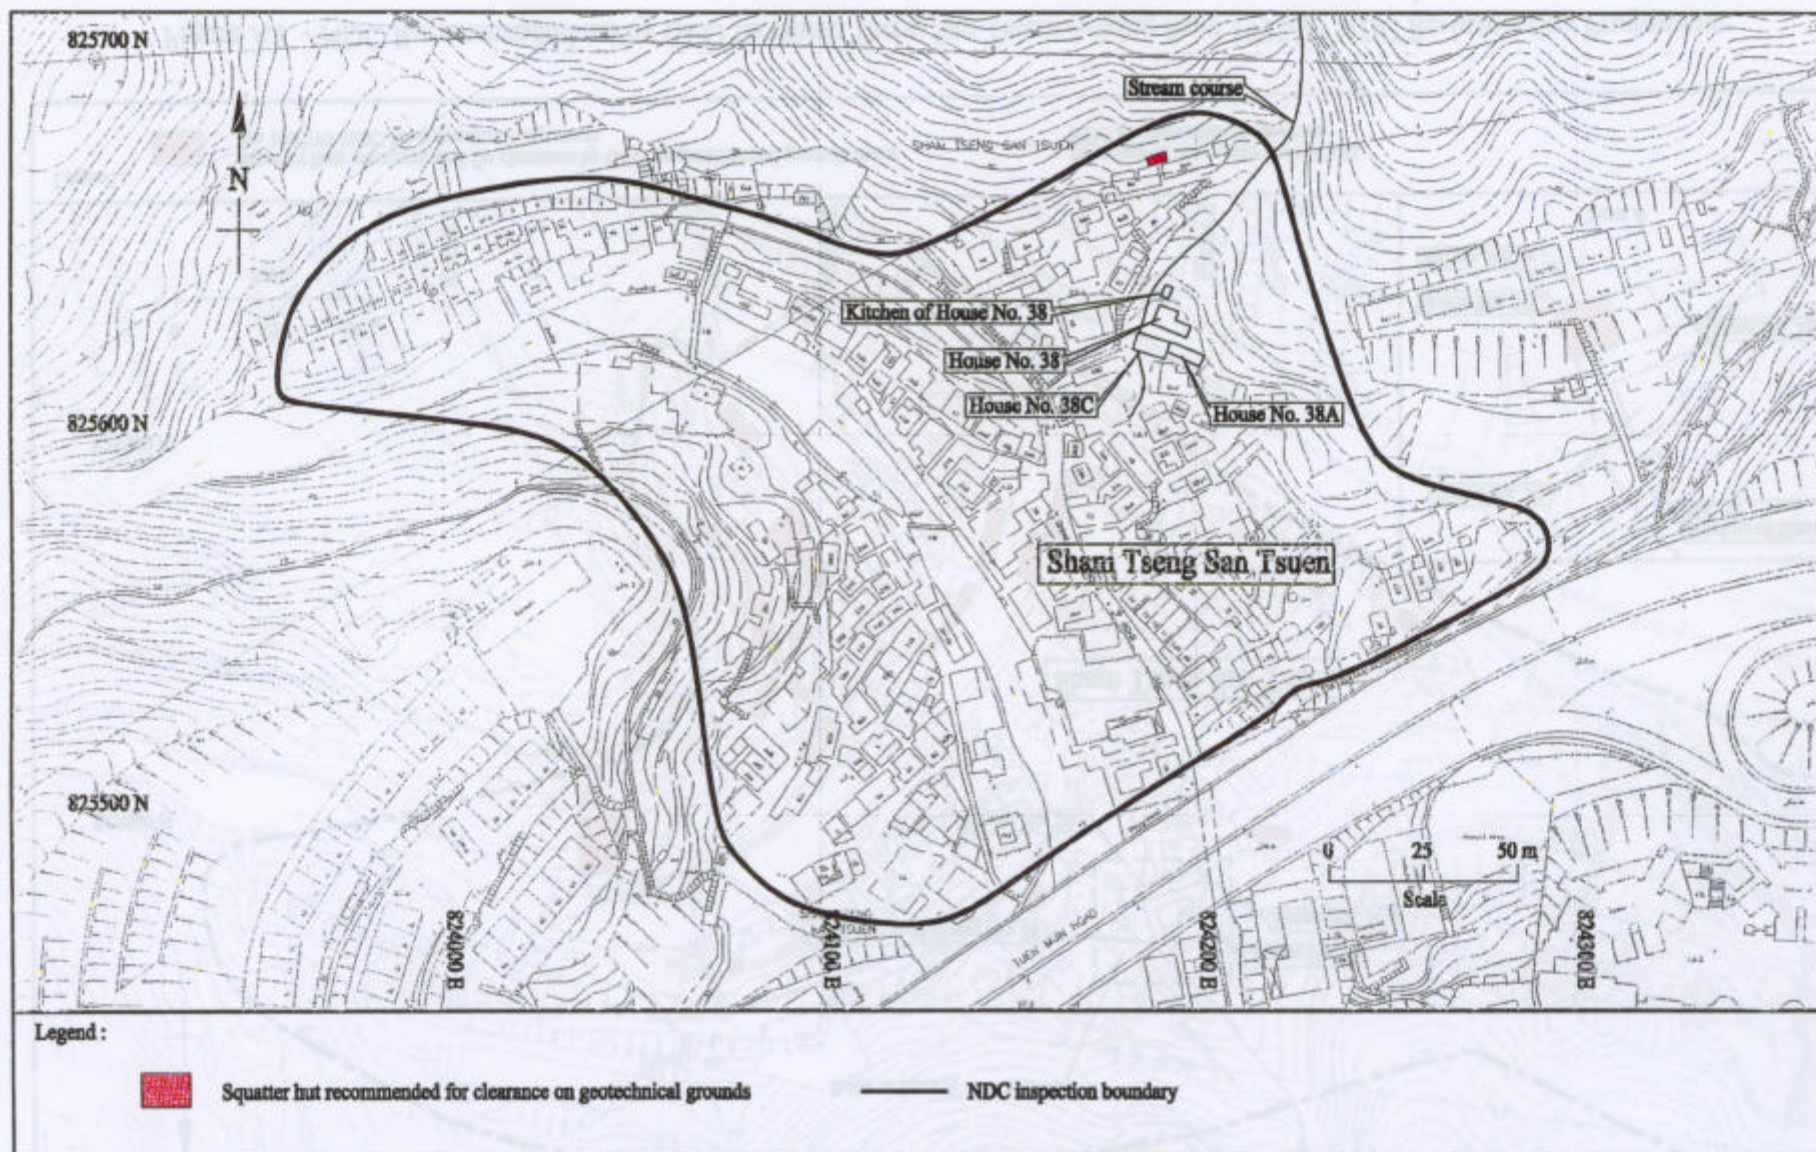
In April 1988, the GEO carried out an inspection of Sham Tseng San Tsuen under the NDC Programme. Clearance recommendations on slopes safety grounds were subsequently given by the GEO the HD (Figure A1). Houses Nos. 38C and 38 together with the kitchen structure of House No. 38, which were located within the NDC inspection boundaries, had not been recommended for clearance at that time.

Figure A1 - Recommendations for Squatter Clearance Made by GEO Following NDC Inspections in 1988

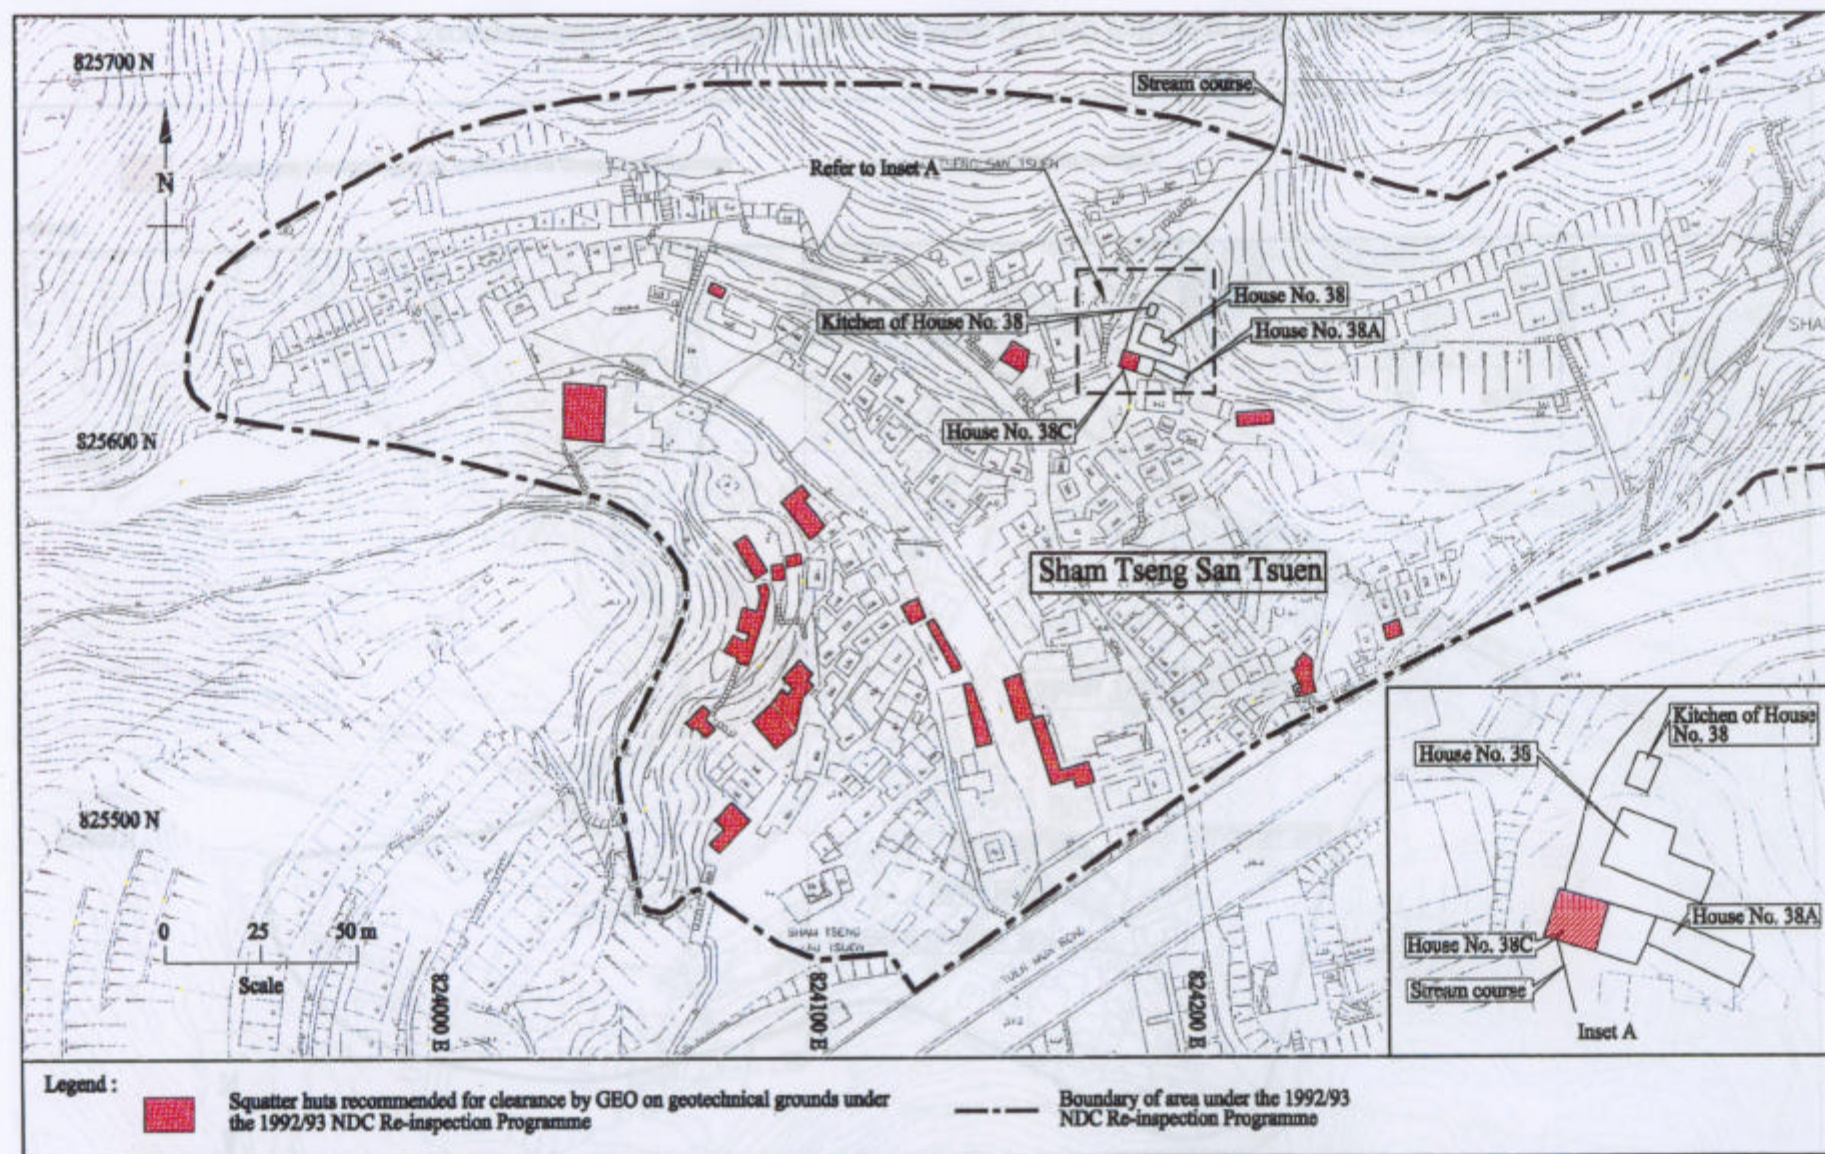
In May 1992, the GEO undertook to re-inspect all of the previously inspected New Territories squatter villages under the NDC Programme. Site inspection at Sham Tseng San Tsuen were carried out between 1 December and 11 December 1992, under the 1992/93 NDC Re-inspection Programme. The western-most part of the House No. 38C (reference no. TW4/93/A/62) was recommended for clearance because it was considered to be a “flimsy structure on watercourse” (Figure A2). House No. 38 and its kitchen structure were not recommended for clearance. The NDC recommendation was passed to the HD on 16 December 1992. The concerned part of House No. 38C had not been cleared when the 23 August 1999 debris flow incident occurred.

Figure A2 - NDC Recommendations by GEO for Sham Tseng San Tsuen Arising from 1992/93 NDC Re-inspection Programme

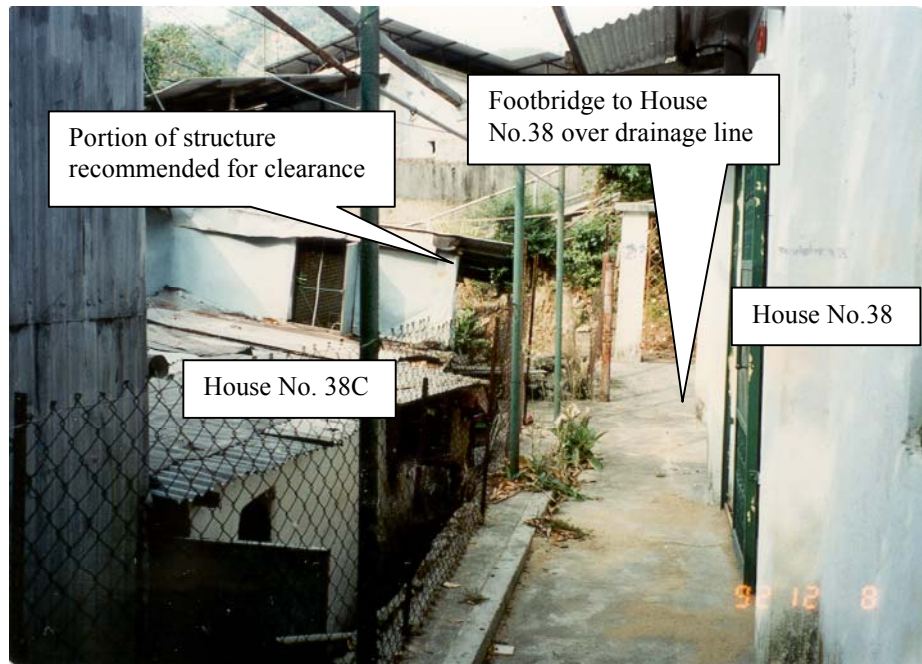
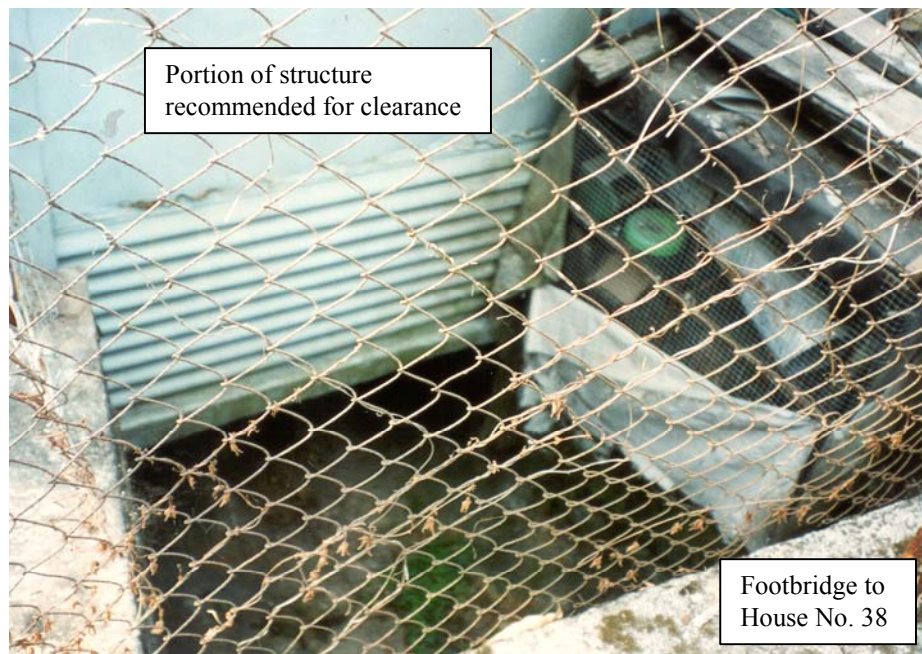
Plate A1 - Portion of Structure Recommended for Clearance at House No.38C, Sham Tseng San Tsuen (Photographs Taken during NDC Re-inspection on 8 December 1992)
