REVIEW OF NOTABLE LANDSLIDE INCIDENTS DURING SLOPE WORKS

GEO REPORT No. 171

H.W. Sun & H.M. Tsui

**GEOTECHNICAL ENGINEERING OFFICE
CIVIL ENGINEERING AND DEVELOPMENT DEPARTMENT
THE GOVERNMENT OF THE HONG KONG
SPECIAL ADMINISTRATIVE REGION**

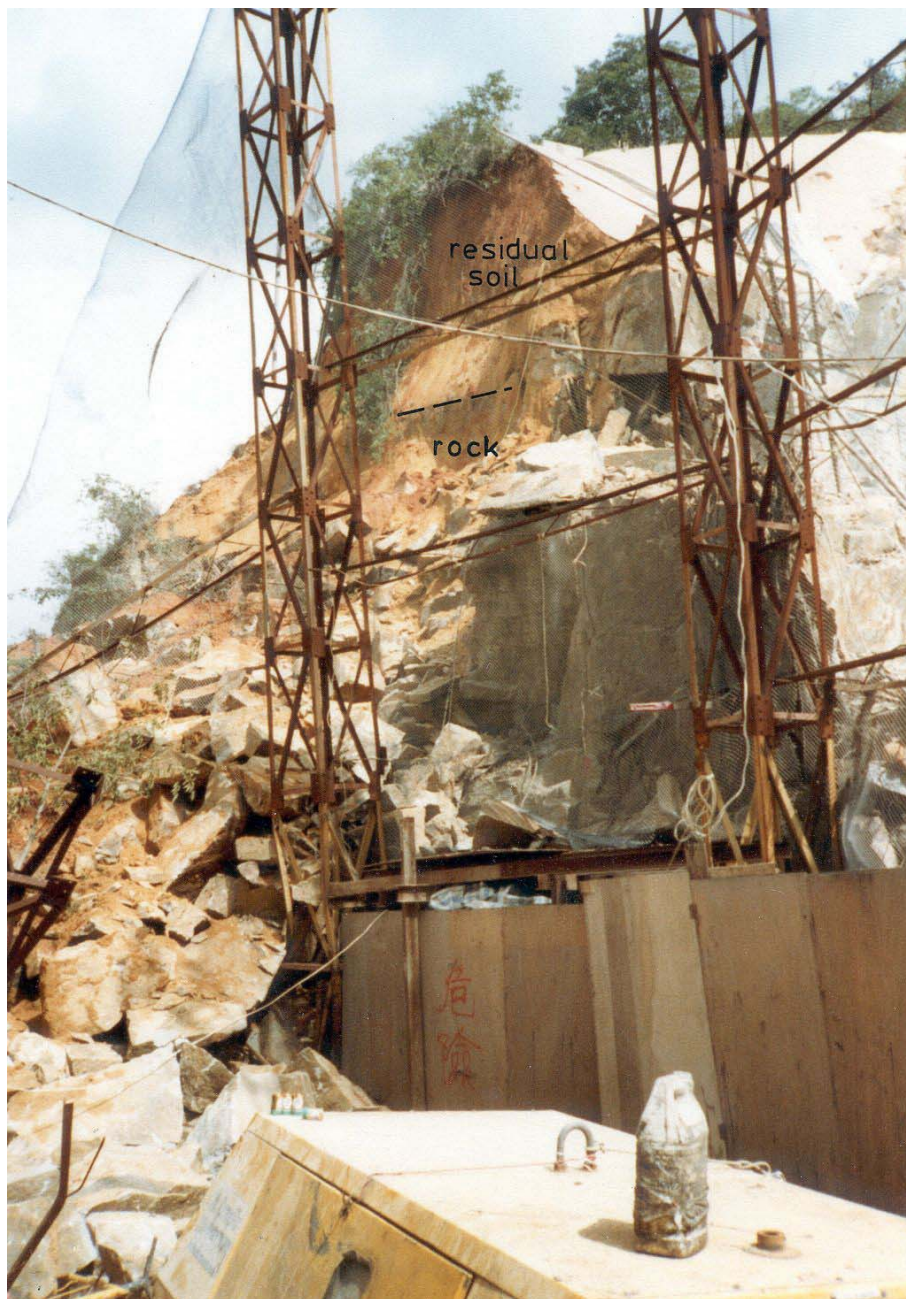
Plate 1 - The 12 July 1981 Incident at Yip Kan Street, Hong Kong

Note: General view of the landslide

The failure occurred on an approximately 16 m high soil and rock cut slope on a dry Sunday night, a week after heavy rainfall associated with tropical storm Lynne. The failure involved a composite landslide mobilised on daylighting, continuous chlorite coated rock joints dipping at 20° to the horizontal out of the slope through monzonite, together with slumping of an overlying residual soil layer. The failure volume was approximately 1,235 m³ and contained individual blocks of rock up to 10 m³. Direct shear testing confirmed that the angle of friction on the chlorite coated joints could be as low as 17° at low normal stress levels.

It is apparent that disturbance due to blasting and perhaps cleft water pressure developed during tropical storm Lynne was sufficient to cause the initial movements. The failure was then a matter of gradual deterioration followed by final detachment.

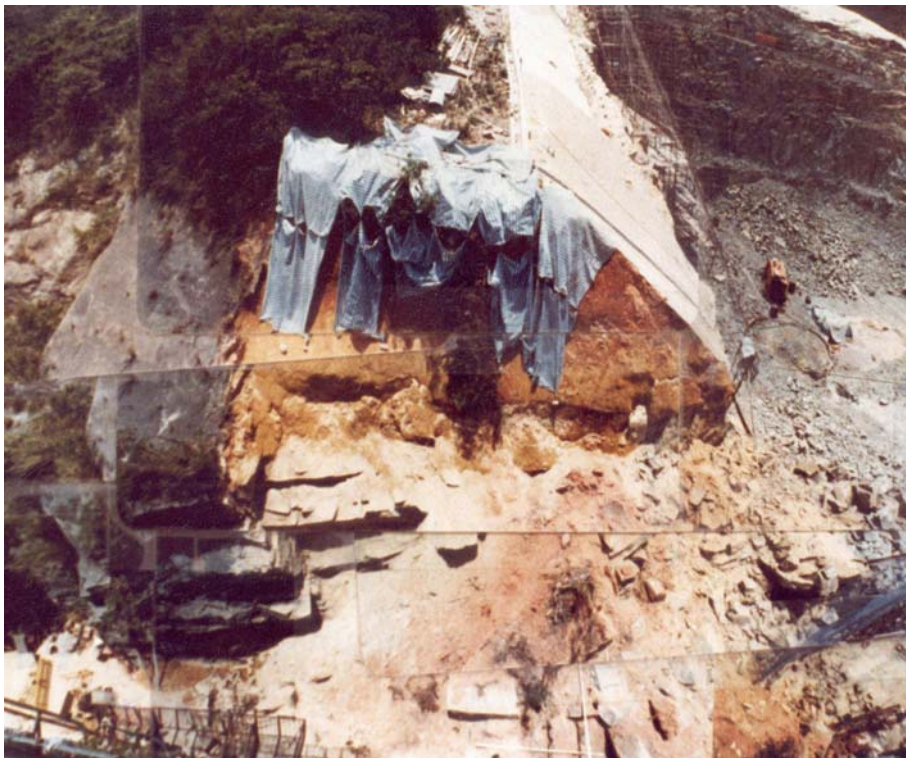
Plate 2 - The 12 July 1981 Incident at Yip Kan Street, Hong Kong

Note: Bird's eye view of the landslide

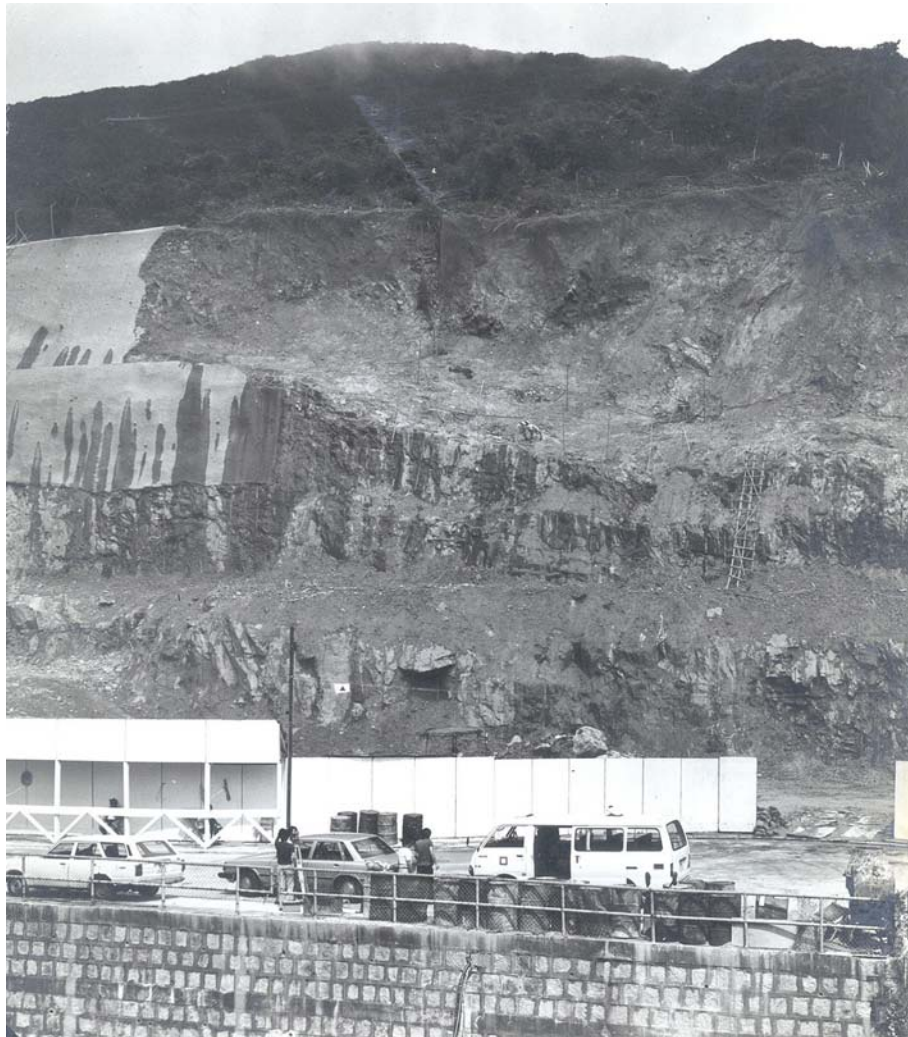
Plate 3 - The 29 May 1982 Incident at South Bay Close, Repulse Bay

Note: General view of the landslide

Two major landslides involving sliding failures occurred on a partially completed rock cut slope within an active construction site for a private residential development project. The first failure occurred on 29 May 1982 following an estimated 525 mm of rainfall on the day. The landslide involved approximately 3,800 m³ of closely jointed weathered rock which failed along a persistent, rough but thickly infilled daylighting discontinuity over an approximate length of 70 m. The landslide debris deposited at the slope toe was maximum 17 m thick. A second landslide (700 m³) occurred to the south of the previous detachment on 17 August 1982 after an estimated 500 mm rainfall on the day.

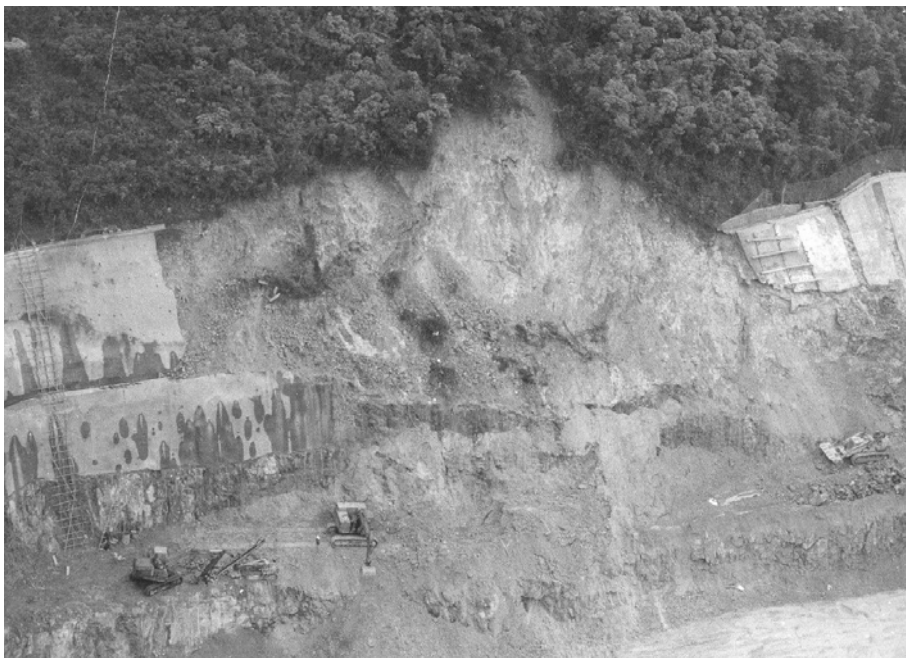
Plate 4 - The 29 May 1982 Incident at South Bay Close, Repulse Bay

Note: General view of the landslide

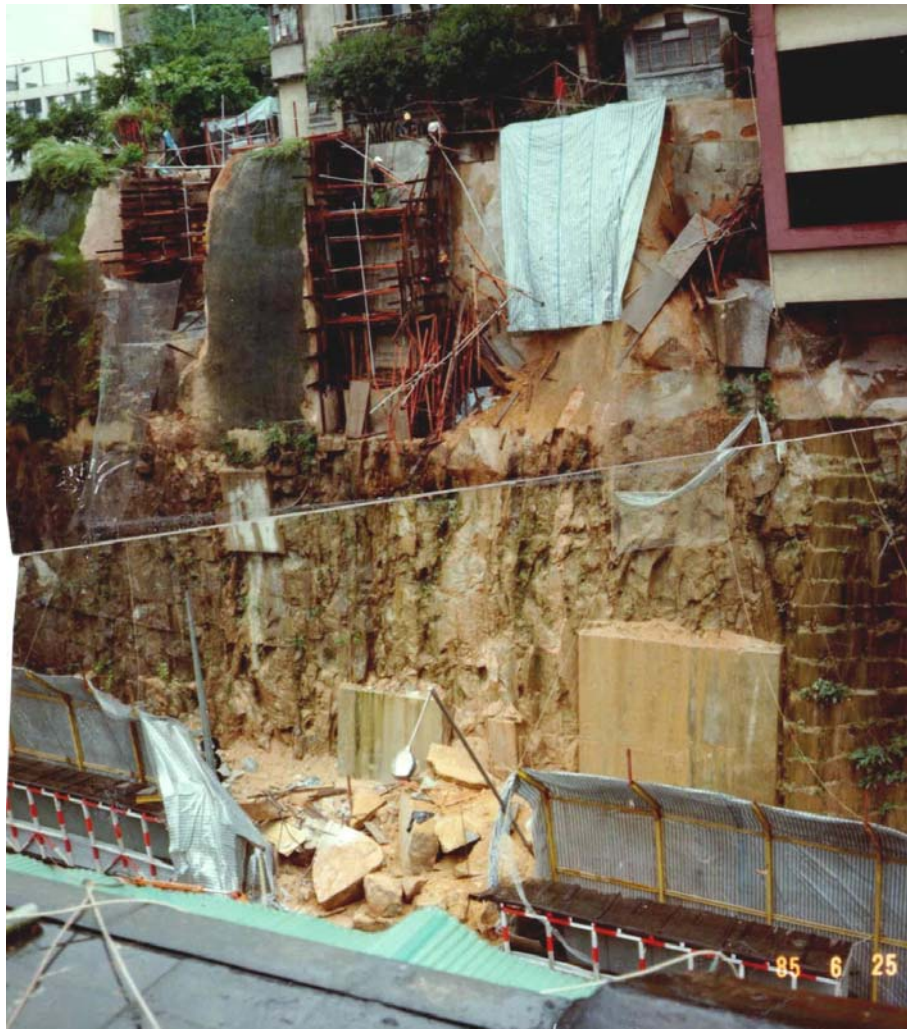
Plate 5 - The 25 June 1985 Incident at King's Road, Hong Kong

Note: General View of the Landslide Site

The rockfall occurred soon after heavy rainfall on a soil/rock cut slope where excavation works at the crest at about 22 m above King's Road were being carried out. The failure involved the sliding of granite blocks along adverse joints in decomposed granite. The slipped mass comprising large rock fragments up to 5 m³ demolished a 7 m long safety fence erected at the slope toe on King's Road. The volume of debris was estimated to be about 70 m³. Two westbound lanes and the pedestrian pavement of King's Road were blocked. This failure was a planar slide on unfavourably orientated joints partly coated with kaolin. Very slight seepage was observed on the scar during post-failure inspection by the GCO on the same day of the failure. The failure was probably triggered by heavy rainfall which resulted

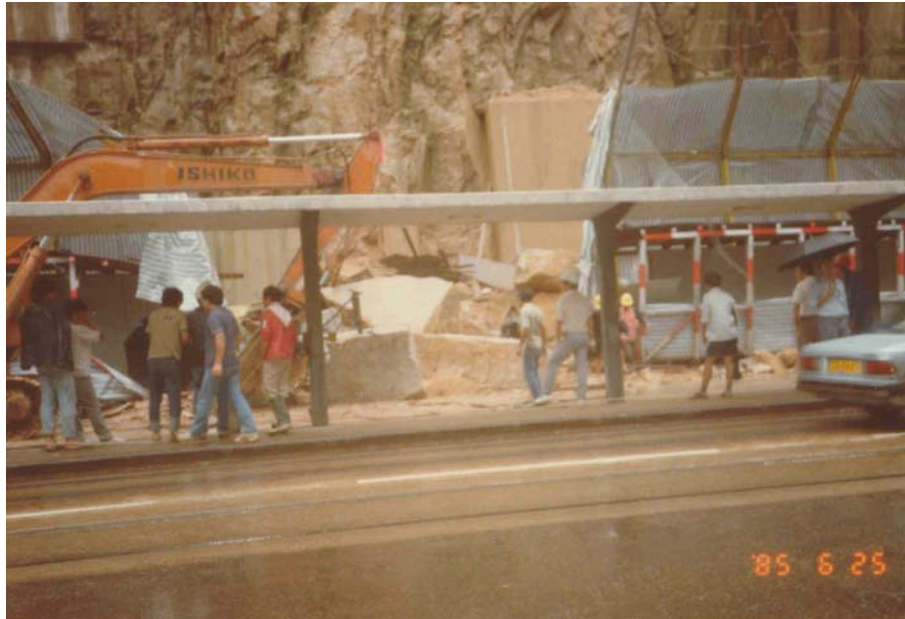
Plate 6 - The 25 June 1985 Incident at King's Road, Hong Kong

Note: Slipped mass comprising large rock blocks up to 5 m³ demolished a safety fence erected at the slope toe on King's Road

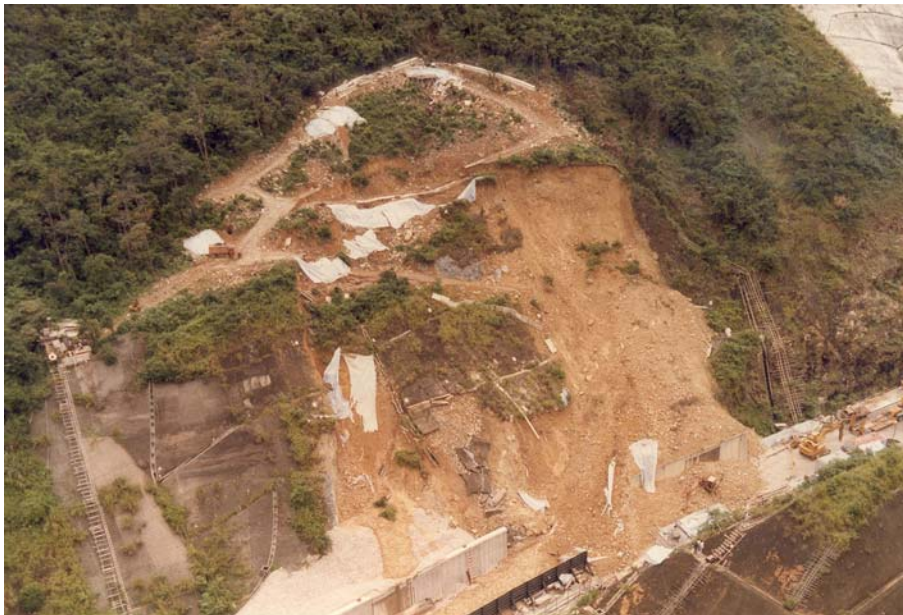
Plate 8 - The August 1985 Incident at Tin Wan Hill Road, Hong Kong

Note: General view of the landslide

The incident occurred on a 37 m high cut slope when permanent stabilisation works were being constructed in 1985. Slope movements began after the formation of the cut slope in 1963. Slope remedial works including regrading, surface protection and subsurface drainage were carried out on a number of occasions between 1968 and 1982. Further instabilities were observed in October 1983 and permanent slope stabilisation works were designed by the GCO. The works consisted of a reinforced concrete retaining wall at the slope toe, trimming of the slope face and installation of 20 m maximum length horizontal drains and surface drainage channels. Site works began in early 1985 and slope movement was re-activated in June 1985 following heavy rainfall. The slope movement accelerated in July 1985 during excavation near the slope toe for the construction of the toe retaining wall. The slope was stabilised temporarily by placing rock fill at the slope toe. Following intense rainfall on 26 and 27 August 1985, the instability progressed further upslope with the formation of new tension cracks up to

9 m deep and failure of the near-surface materials. Rapid slope movement of up to 800 mm per day was recorded between 26 and 29 August 1985. On three occasions about 100 m³ to 200 m³ of material detached from the steep colluvial cut face which had been standing at about 56° and the landslide debris was deposited on both lanes of Tin Wan Hill Road. There was no reported casualties.

Further instability occurred on 6 September 1985. The landslide was investigated by the GCO (Irfan, 1986). Failures occurred in the colluvium as well as along relict failure surfaces in the deeply weathered profile. The slope has a complex geological and hydrogeological setting, involving effects of shear and fault zones and adversely orientated discontinuities with weak, slickensided infill. Slope deterioration occurred over the years involving opening up of the subvertical joints. The total volume of the unstable groundmass was estimated to be about 19,200 m³.

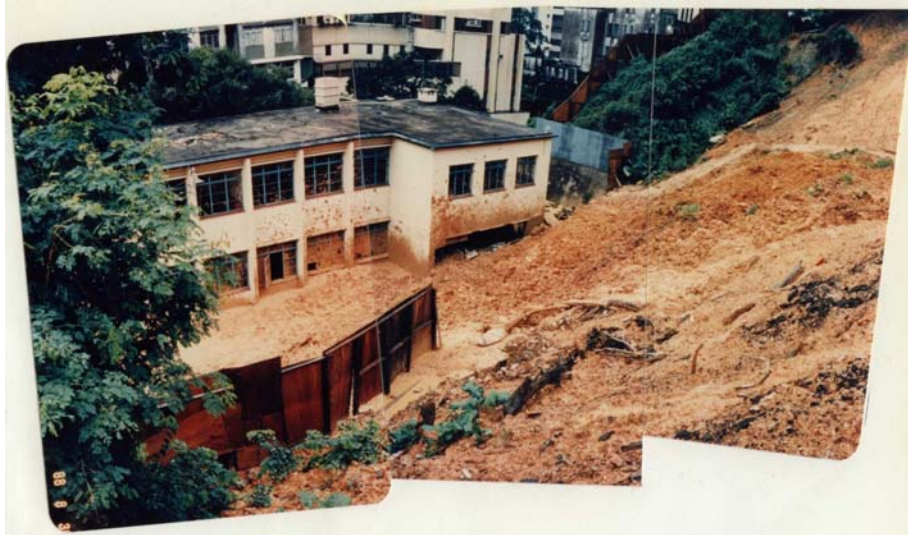
Plate 15 - The 31 August 1988 Incident at North of Island Road Government School

Note: General view of the landslide debris in the school yard

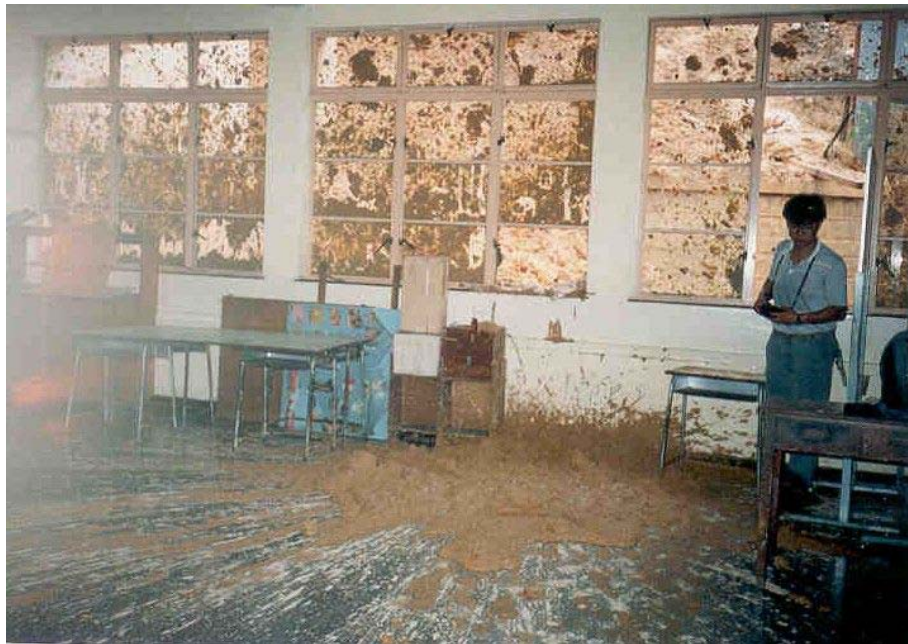
Plate 16 - The 31 August 1988 Incident at North of Island Road Government School

Note: Landslide debris flooded into a room on the ground floor of the school

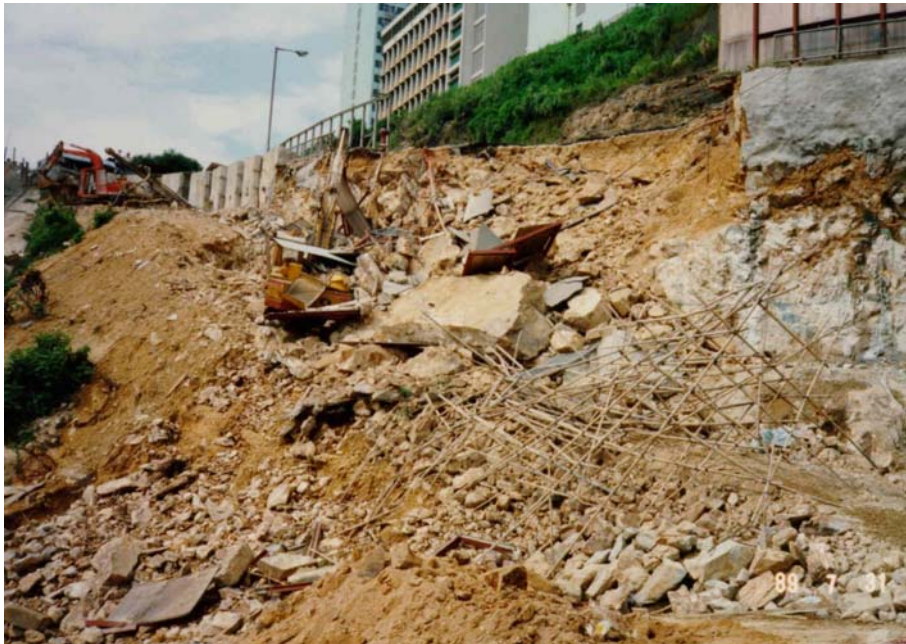
Plate 17 - The 31 July 1989 Incident at Kwai Shing Engineering Centre, Kwai Chung

Note: General view of the landslide

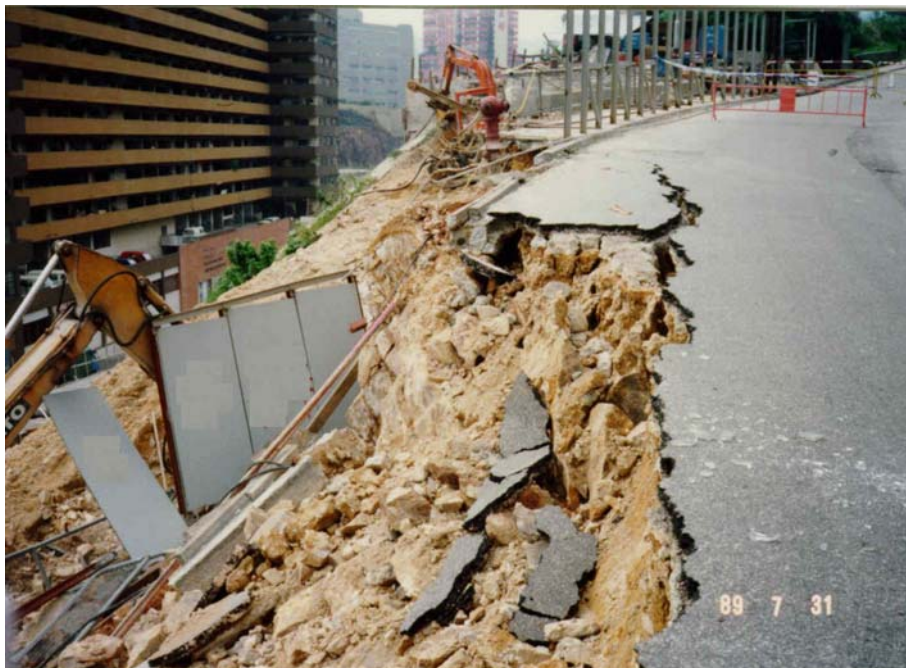
Plate 18 - The 31 July 1989 Incident at Kwai Shing Engineering Centre, Kwai Chung

Note: One lane of Kwai Shing Circuit was closed as a result of the landslide

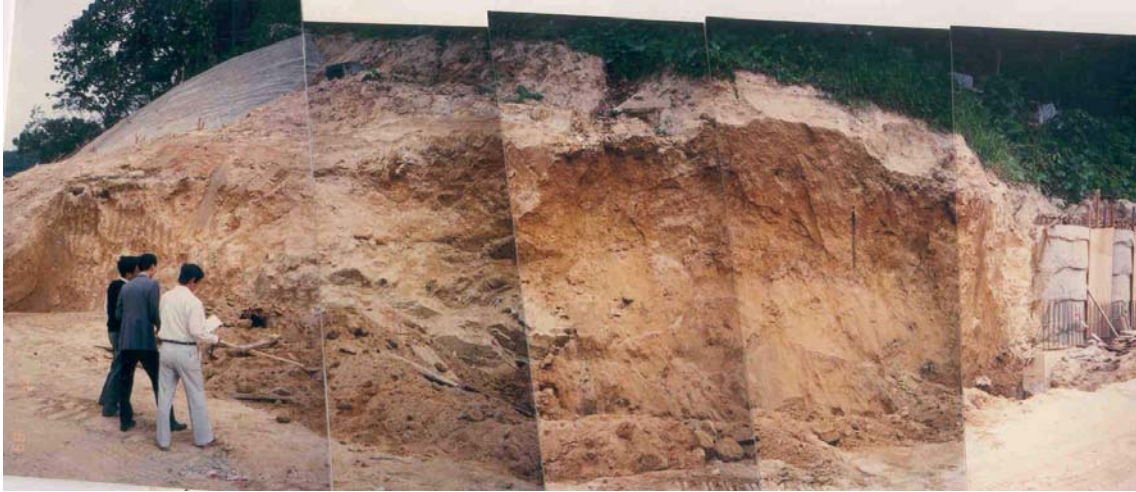
Plate 19 - The 24 November 1989 Incident at Victoria Road, Hong Kong

Six days later, a landslide of about 5 m³ occurred on the temporary cut slope (see Plate 19) and caused injuries to two site workers.

Note: The failed mass, about 5 m^3 , slid into the trench excavated for the retaining wall foundation construction

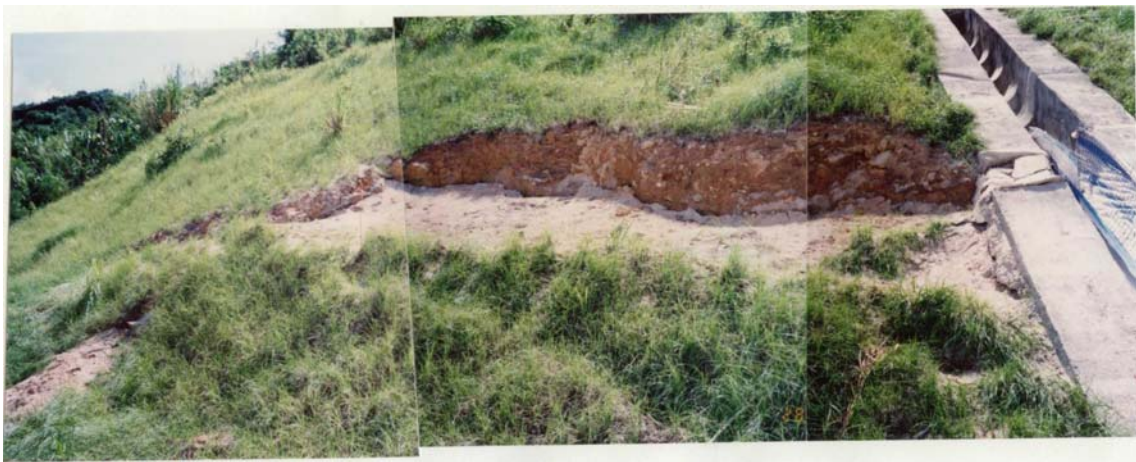
Plate 22 - The November 1989 and April 1992 Incidents at Siu Sai Wan, Hong Kong

Note: View of a sealed-up tension crack

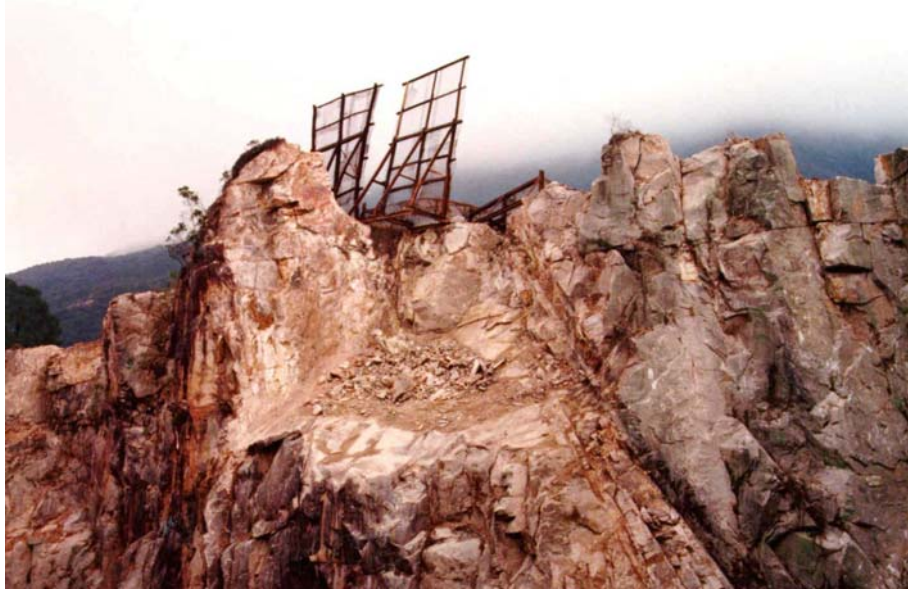
Plate 25 - The 28 February 1991 Incident at Shau Kei Wan East Housing Development Site

Note: A close view of the source of failure

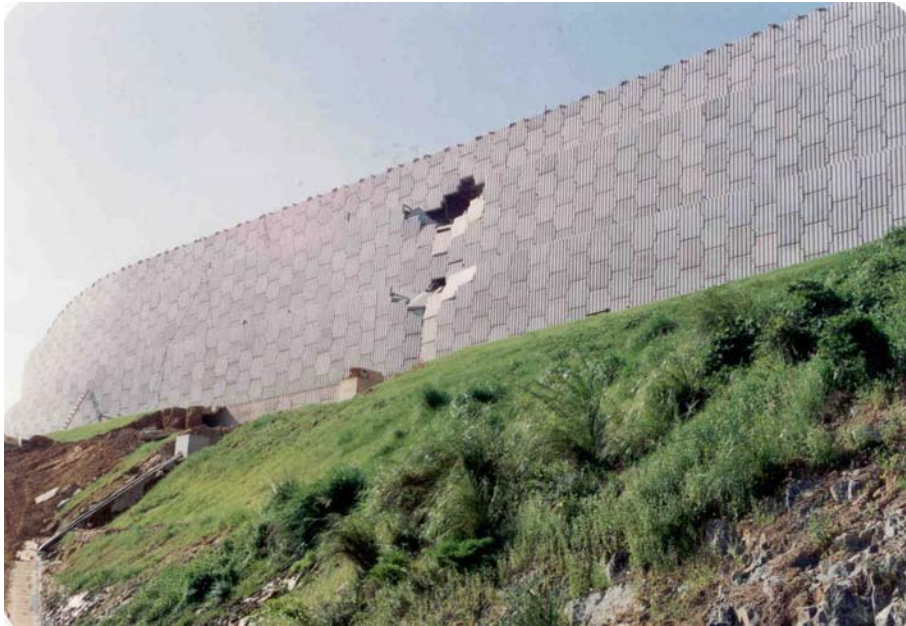
Plate 27 - The 16 June 1995 Incident at Northwest Tsing Yi

Note: Front view of the damaged facing panels of the reinforced fill wall

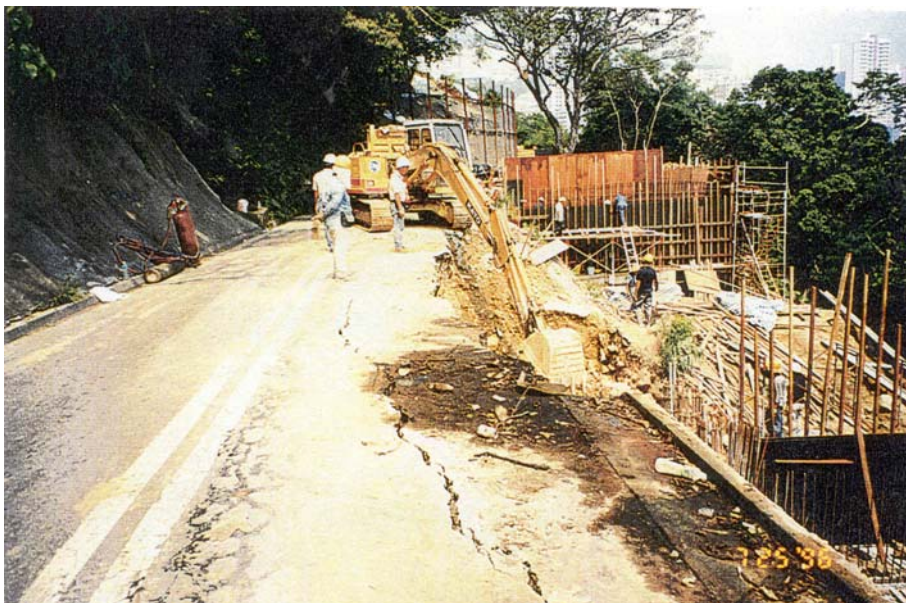
Plate 28 - The 25 July 1996 Incident at Victoria Road, Pok Fu Lam

A major landslide (about 75 m³) occurred within a construction site near No. 212 Victoria Road at about 8:00 a.m. on 25 July 1996. The landslide occurred on a sub-vertical temporary soil cut slope for the construction of a retaining wall on the downhill side of Victoria Road as part of a road improvement project managed by the Highways Department. The temporary cut was about 10 m in height with an average slope angle of 80°. The landslide debris was trapped behind the partially completed concrete retaining wall and caused complete closure of Victoria Road for two days (see Plate 28). The failure was probably caused by inadequate temporary support to the sub-vertical soil cut which was formed in the wet season. It was noted in a GEO file note that no rainfall was recorded in the 24 hour period preceding the failure and that the incident was believed not to be caused by heavy rainfall.

Note: Debris was trapped behind the partially completed concrete retaining wall

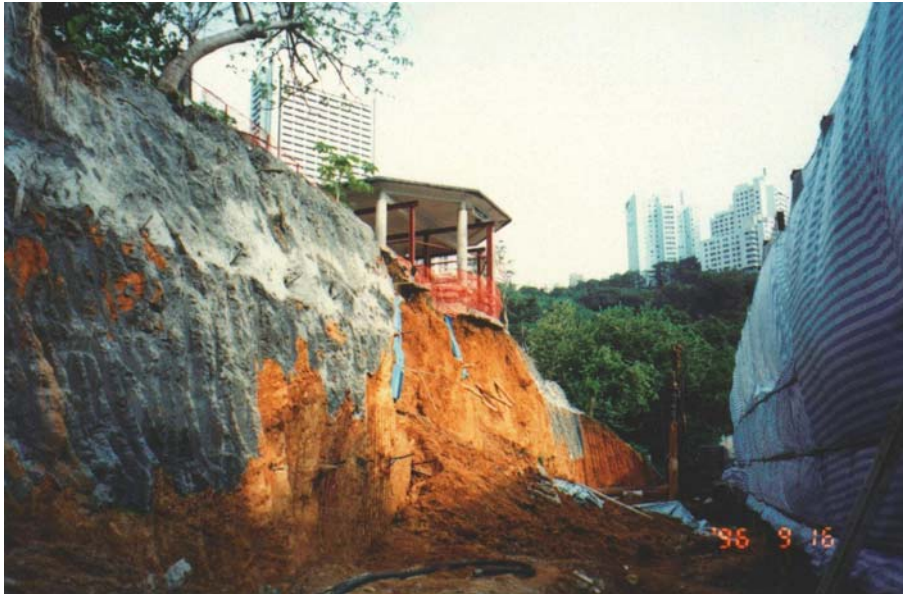
Plate 29 - The 14 September 1996 Incident at Victoria Road, Pok Fu Lam

Note: The landslide resulted in the partial closure of the cemetery behind the slope crest

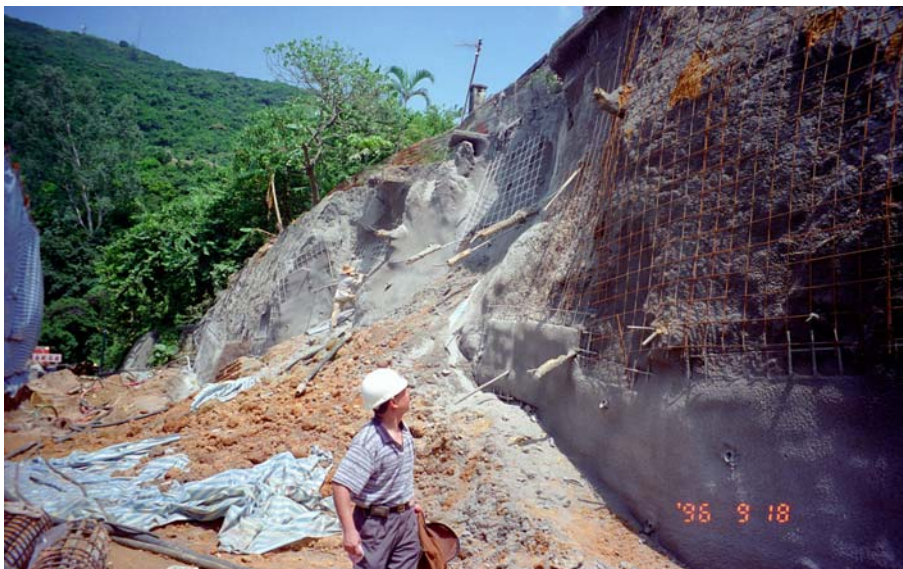
Plate 30 - The 14 September 1996 Incident at Victoria Road, Pok Fu Lam

The third landslide (Incident No. HK 96/9/3) occurred near the Chinese Christian Cemetery and involved a failure volume of about 45 m³ on an 8 m high sub-vertical temporary soil cut slope with soil nails. At the time of failure, two rows of the soil nails had been installed at the top portion of the slope but the soil nail heads had not yet been constructed (see Plate 29). The landslide resulted in partial closure of the cemetery behind the slope crest (see Plate 30). The inspection carried out by the Special Projects Division of the GEO noted that a large amount of surface water could have flowed towards the slope crest, ponded behind the parapet and overflowed onto the slope. It was also reported that the grouting between the soil nail steel bars and the soil was possibly poor. Two nails at the back scarp of the landslide were inspected by digging about 0.2 m into the scarp around the nails and no grout was found between the bars and the surrounding soil (see Plate 31). Inspection of the nails exposed at the scarp also revealed little grout cover to the underside of the steel bars, which might indicate that the bars did not have sufficient centralisers in the drillholes. In addition, the grout appeared to be fairly weak and could easily be broken up by "knocking with a hammer".

Note: Two rows of soil nail heads not installed at the top portion of the slope at the time of failure

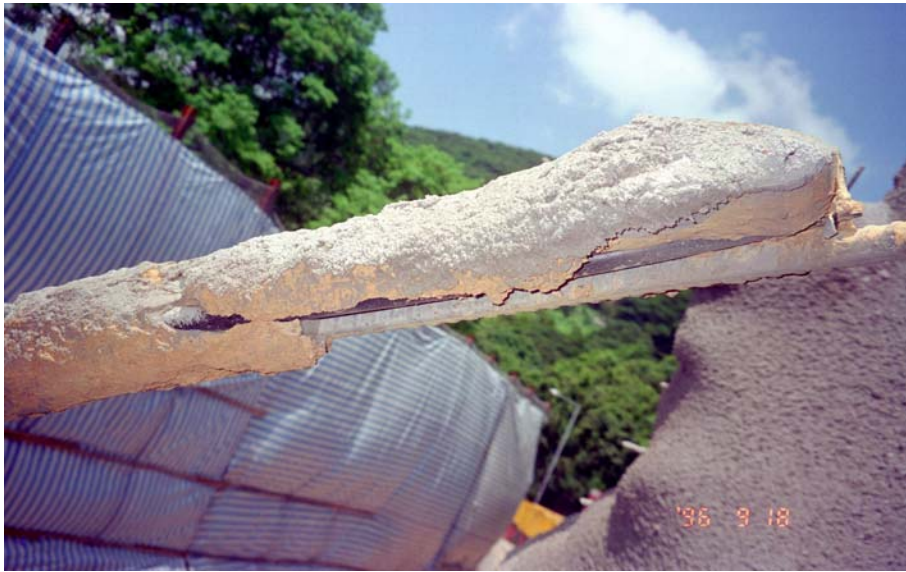
Plate 31 - The 14 September 1996 Incident at Victoria Road, Pok Fu Lam

Note: Poorly constructed grouting between the soil nail steel bars and the surrounding soil

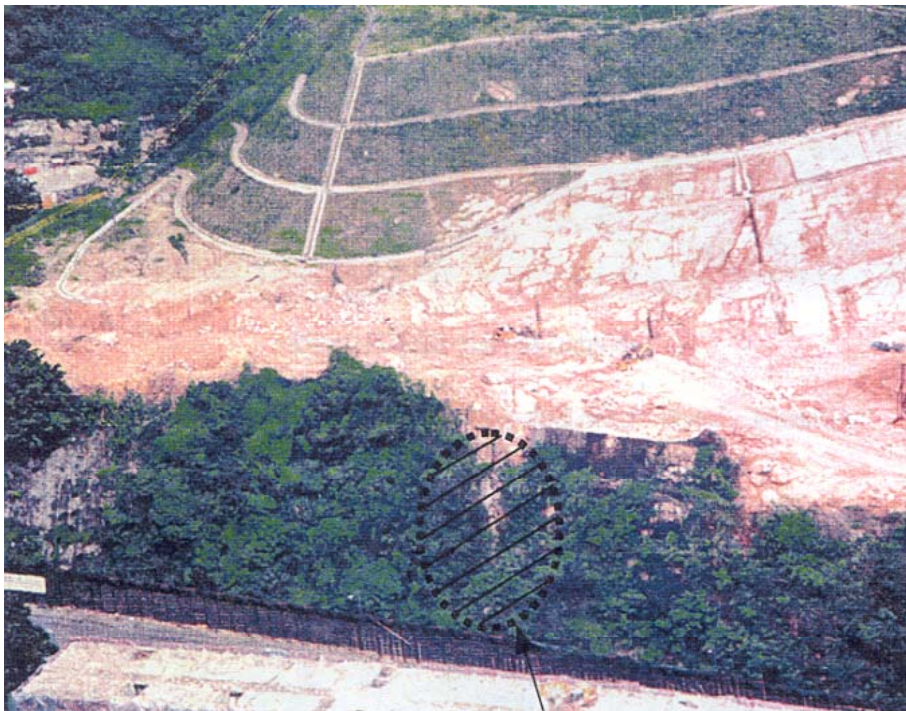
The portion of the
slope failed on
4 December 1997

A major rockfall occurred on a rock slope along Sau Mau Ping Road at about 2:20 p.m. on 4 December 1997, when site formation works for a public housing development were being carried out under the supervision of resident site staff managed by the consultant. A view of the site three months before the failure occurred is presented in Plate 32. The failure happened during or immediately following blasting at the east portion of the slope. The failure volume was about 1,000 m³ and the detached rock mass destroyed a section of a 7.1 m high rockfall protective fence erected along the slope toe (see Plate 33). The detached rock mass blocked the entire four lanes of Sau Mau Ping Road, covering 25 m of its length. The metal hoarding on the far side of the road was punched through at several locations. This section of Sau Mau Ping Road was temporarily closed to traffic and the area was cleared of people at the time of the blast and there was no reported injury. The road was subsequently closed for 17 days.

Note: View of the failure site about three months before the failure

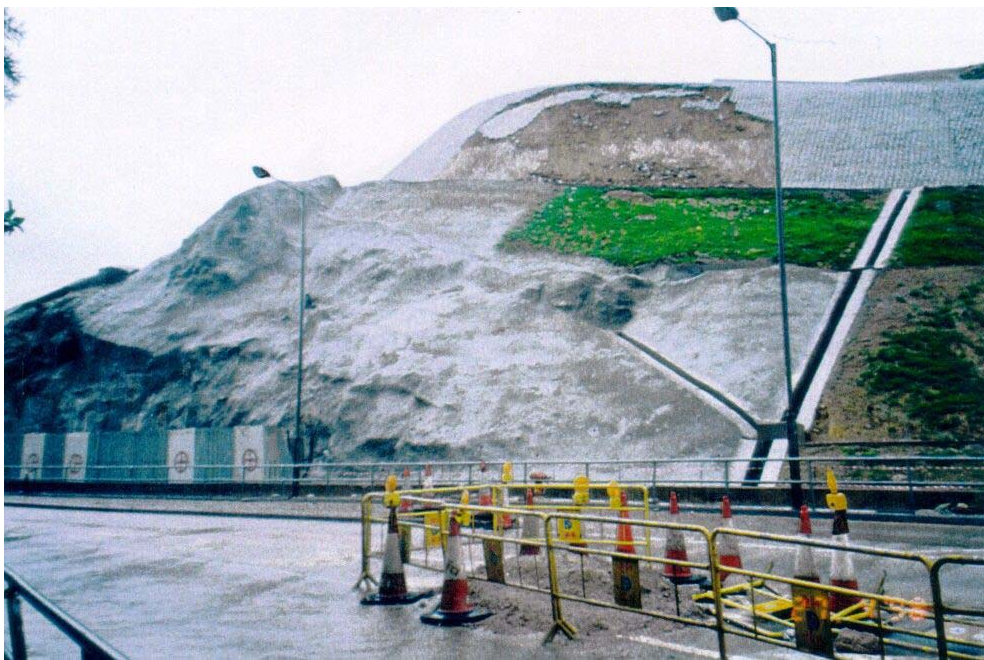
Plate 34 - The 27 April 1998 Incident at Po Lam Road

This incident occurred at about 12:00 p.m. on 27 April 1998 during relatively light rain and involved the failure (about 26 m³) of a reinforced fill embankment which was under construction (see Plate 34). The works formed part of a Government site formation project under a design and build contract with the site works supervised by resident site staff engaged by the Client Department. The majority of the debris from the failure came to rest on the berm below but some of the facing blocks from the reinforced fill embankment reached the road at the toe of the slope.

Note: General view of the landslide

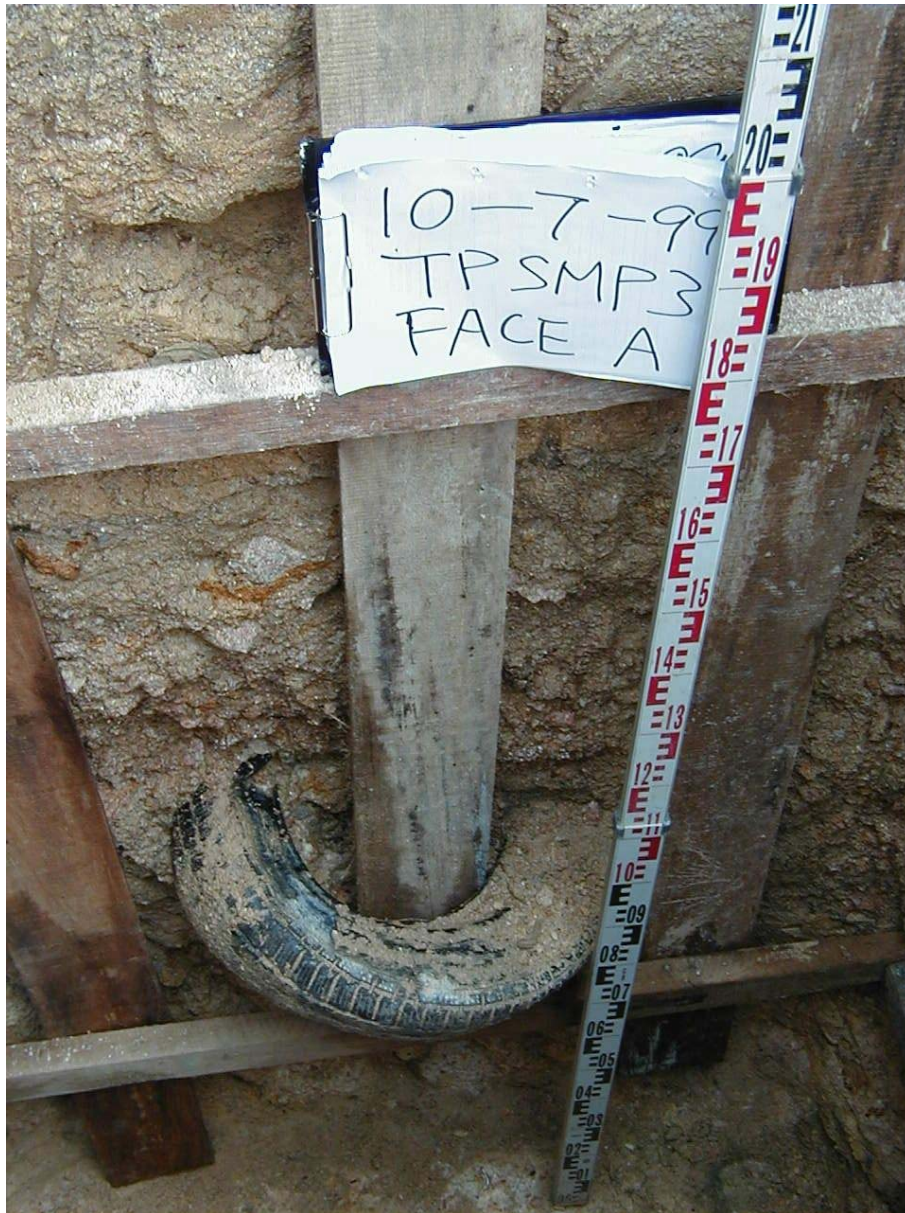
Plate 35 - The 27 April 1998 Incident at Po Lam Road

Follow-up investigation was also carried out on an adjacent newly recompacted fill slope and a rock slope treated with stabilisation measures under the same project. In the fill slope, foreign materials including an old car tyre (see Plate 35) were encountered and that the state of compaction of the fill did not conform to the required standard. In the rock slope, it was found that some of the rock dowels were not properly grouted and that some were of shorter length than the design length.

Note: A car tyre was encountered in the fill material

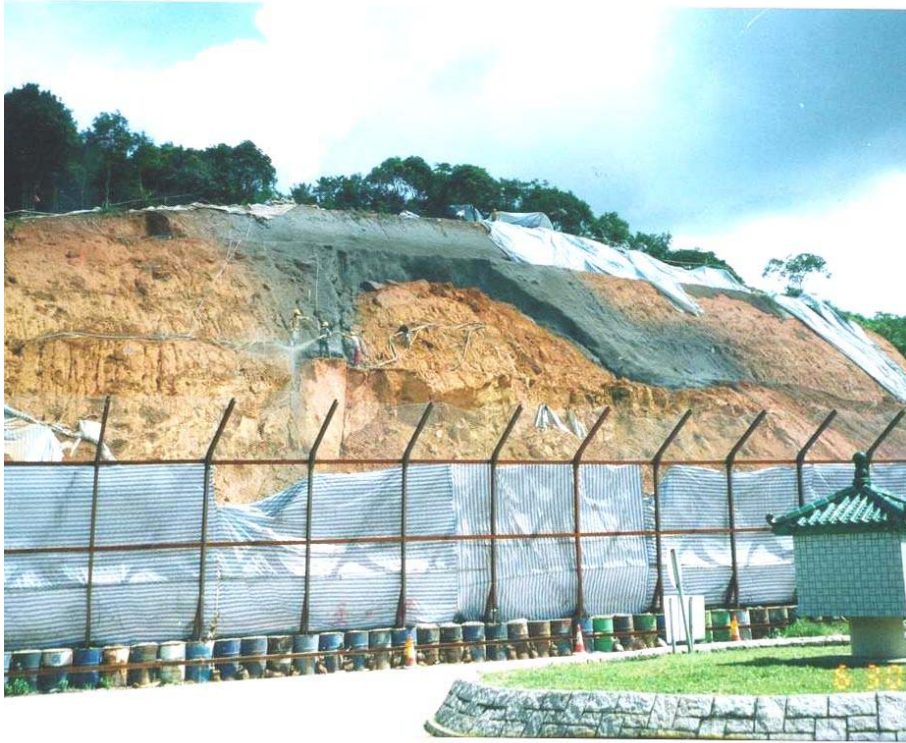
Plate 36 - The June 1998 Incidents at Junction of Sai Sha Road and Tai Mong Tsai Road

Between 4:00 p.m. and 6:00 p.m. on 9 June 1998, a landslide occurred on the northern portion of a temporary soil nailed cut slope within an LPM site during heavy rainfall. On the following afternoon, a second landslide, probably a delayed response to the rainstorm on 9 June 1998, occurred at the lowest 6 m of the southern portion of the cut slope. This southern landslide extended progressively upslope to the full slope height of 24 m by 29 June 1998. The total volume of the landslides was about 2600 m³ (see Plate 36). Debris from the landslides was deposited at the toe of the slope within the construction site and part of the displaced material remained on the slope. No casualties were reported as a result of the landslides.

A detailed investigation of the landslides was carried out by GEO's landslide investigation consultant (FSWJV, 1999). The ground conditions at the site were complex with persistent relict infilled discontinuities, high and complex groundwater regime and, possible subsurface drainage concentration due to the presence of a depression in the rockhead, history of major failures, etc. The actual groundwater condition during the construction of the works was more severe than that assumed in the design of the temporary works which were programmed to be carried out in the dry season. In the event, the works were delayed and critical slope works had to be carried out in the wet season but the corresponding design assumption in relation to the groundwater conditions was not reviewed. The detailing of the temporary soil nail heads only incorporated small (150 mm) steel plates and in addition, some of the heads for the temporary, as well as permanent nails had not been constructed at the time of the failure (see Plate 37). This meant that soil nail failure in the active zone dominated, which was exacerbated by the progressive deterioration of the condition of the active zone through cracking as a result of rainfall and inadequate surface confinement.

Note: General view of the landslide

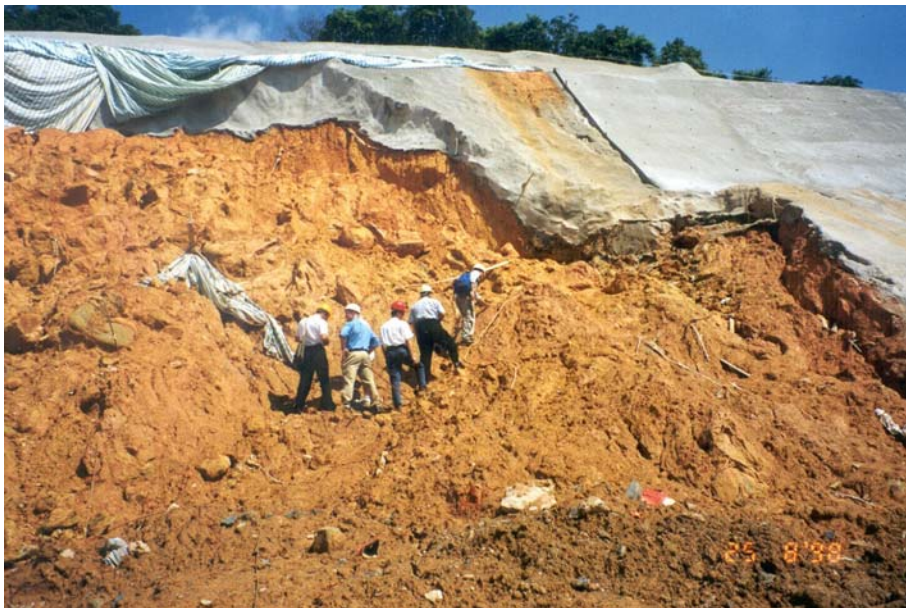
Plate 37 - The June 1998 Incidents at Junction of Sai Sha Road and Tai Mong Tsai Road

Note: General view of the landslide

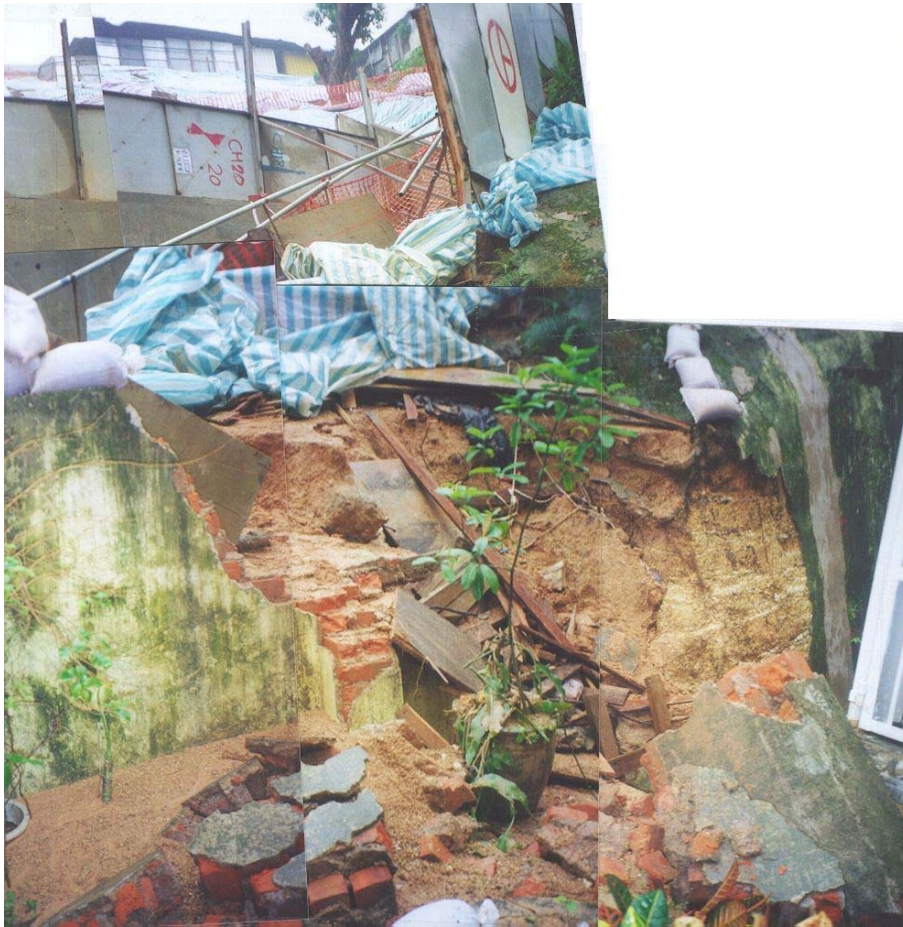
Plate 38 - The 3 April 2000 Incident behind No. 279 Prince Edward Road West

The incident occurred at around 8:00 p.m. on 3 April 2000 at an active LPM site and involved the collapse of a 1.5 m high brick wall just outside the site during heavy rainfall (see Plates 38 and 39). A loose fill slope above the unregistrable brick wall was being upgraded by means of recompaction under the supervision of a consultant to the GEO. No casualties were reported as a result of the incident but all of the 12 units of a residential building below the toe of the fill slope had to be temporarily evacuated.

Note: General view of the landslide

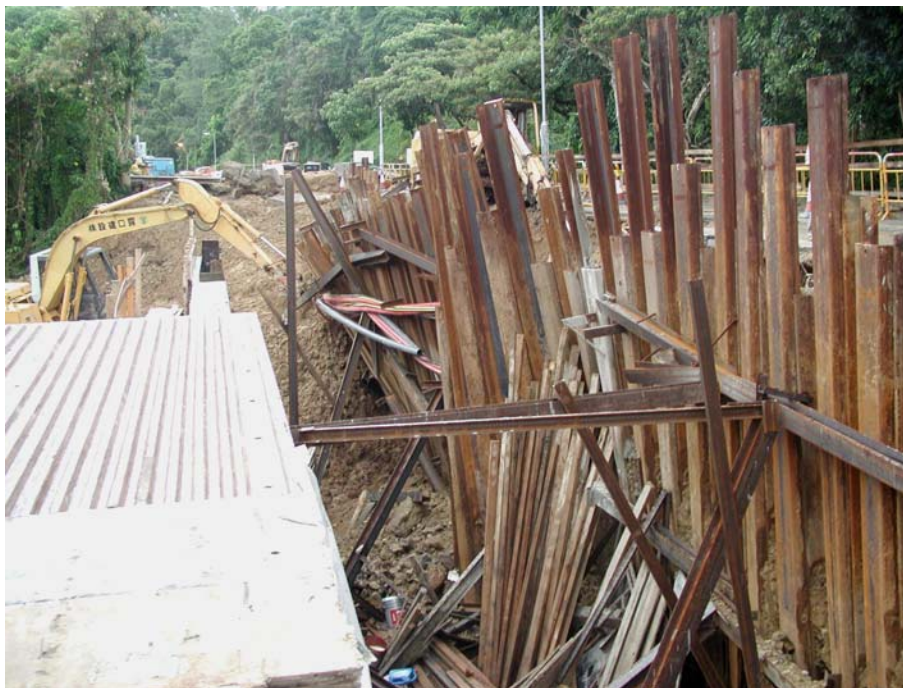
Plate 41 - The 24 August 2000 Incident below Lung Ha Wan Road

Sometime before 6:30 a.m. of 24 August 2000, a temporary sheet pile wall failed during heavy rainfall causing major subsidence of Lung Ha Wan Road. The temporary cut was to enable the construction of a reinforced concrete retaining wall as part of the Highways Department's road widening works project supervised by resident site staff managed by the consultant. The failure resulted in the closure of Lung Ha Wan Road until the afternoon of 25 August 2000. The incident involved significant deformation and tilting, by up to 30° from the vertical, of an approximately 5.5 m high, 20 m long portion of the sheet pile wall (see Plates 40 and 41). The volume of failed groundmass behind the sheet pile wall was estimated to be 200 m³. No casualties were reported as a result of the incident.

Note: Lateral support system provided to the sheet pile wall

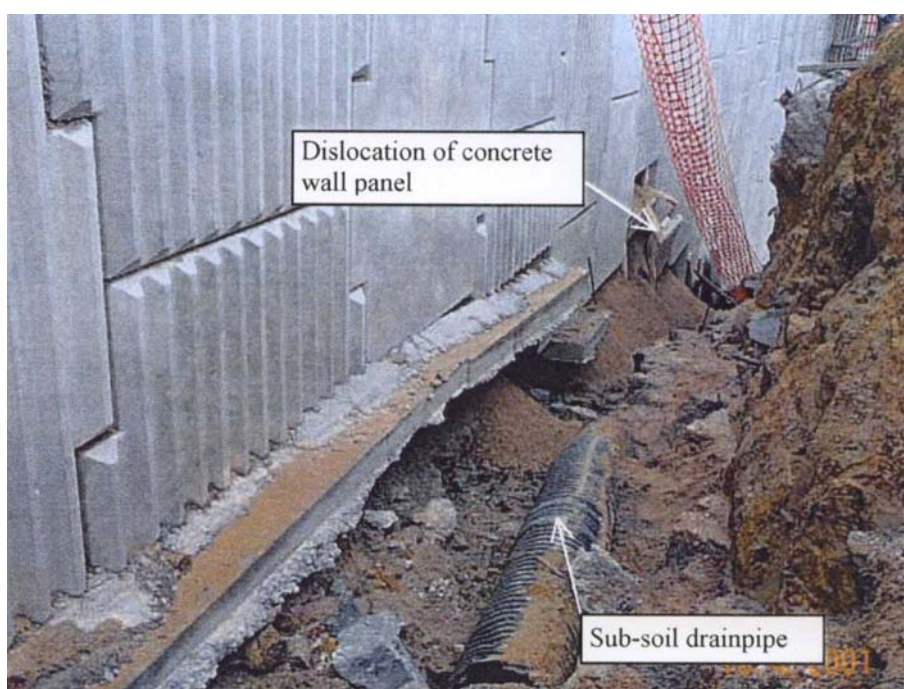
Plate 42 - The 9 April 2001 Incident at Tsing Yi Northern Coast Road Site
above Tam Kon Shan Road

A washout failure (about 35 m³) occurred at approximately 6:00 p.m. on 9 April 2001 during heavy rainfall within the construction site of the Tsing Yi North Coastal Road project of the Highways Department. The construction was supervised by Highways Department's in-house supervisory staff and geotechnical design advice was given by the Advisory Division of the GEO. The incident involved a reinforced fill wall which was being constructed. The foundation of the wall was undermined by concentrated surface runoff following heavy rainfall, resulting in significant distress/deformation of the wall. Landslide debris was deposited on Tam Kok Shan Road below resulting in temporary closure of the road. Also, the undermining of the partly completed reinforced fill wall resulted in wall movement (see Plates 42 and 43).

Note: Undermining of the reinforced fill wall
