REVIEW OF NOTABLE LANDSLIDE INCIDENTS DURING SLOPE WORKS

GEO REPORT No. 171

H.W. Sun & H.M. Tsui

**GEOTECHNICAL ENGINEERING OFFICE
CIVIL ENGINEERING AND DEVELOPMENT DEPARTMENT
THE GOVERNMENT OF THE HONG KONG
SPECIAL ADMINISTRATIVE REGION**

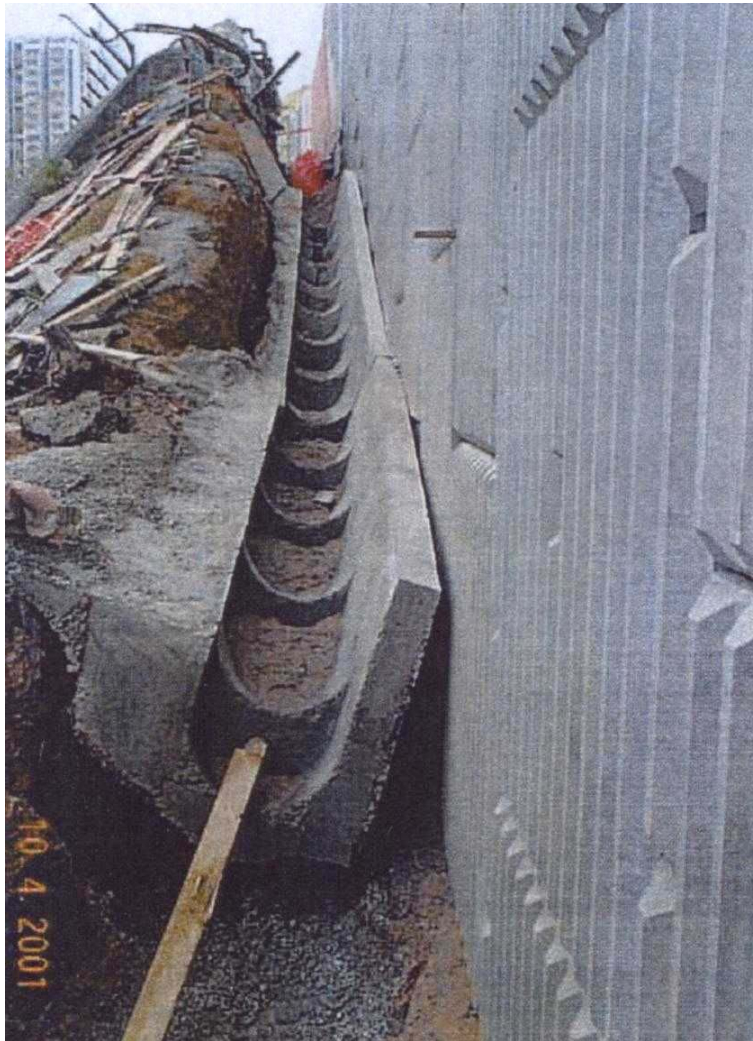
Plate 43 - The 9 April 2001 Incident at Tsing Yi Northern Coast Road Site
above Tam Kon Shan Road

Note: Dislocation of a stepped channel in front of the reinforced fill wall

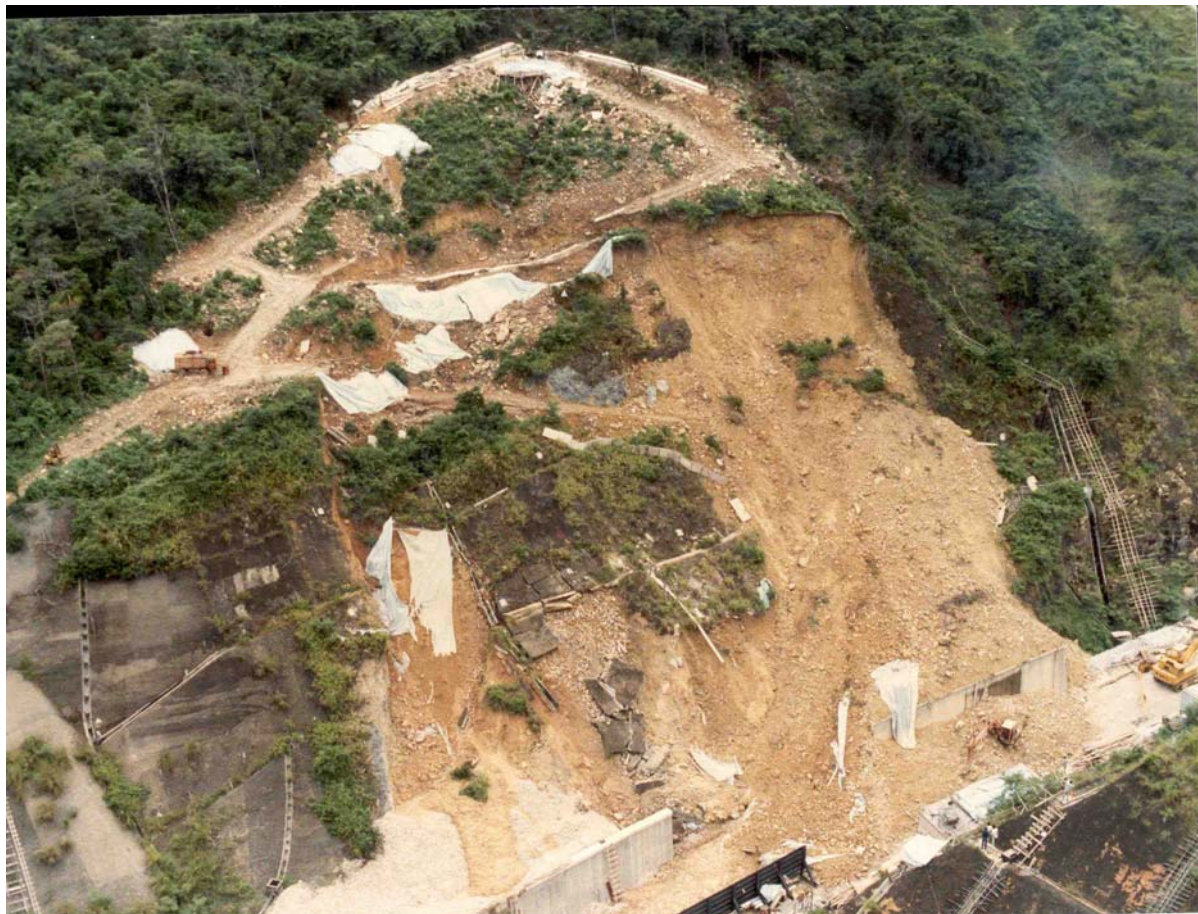
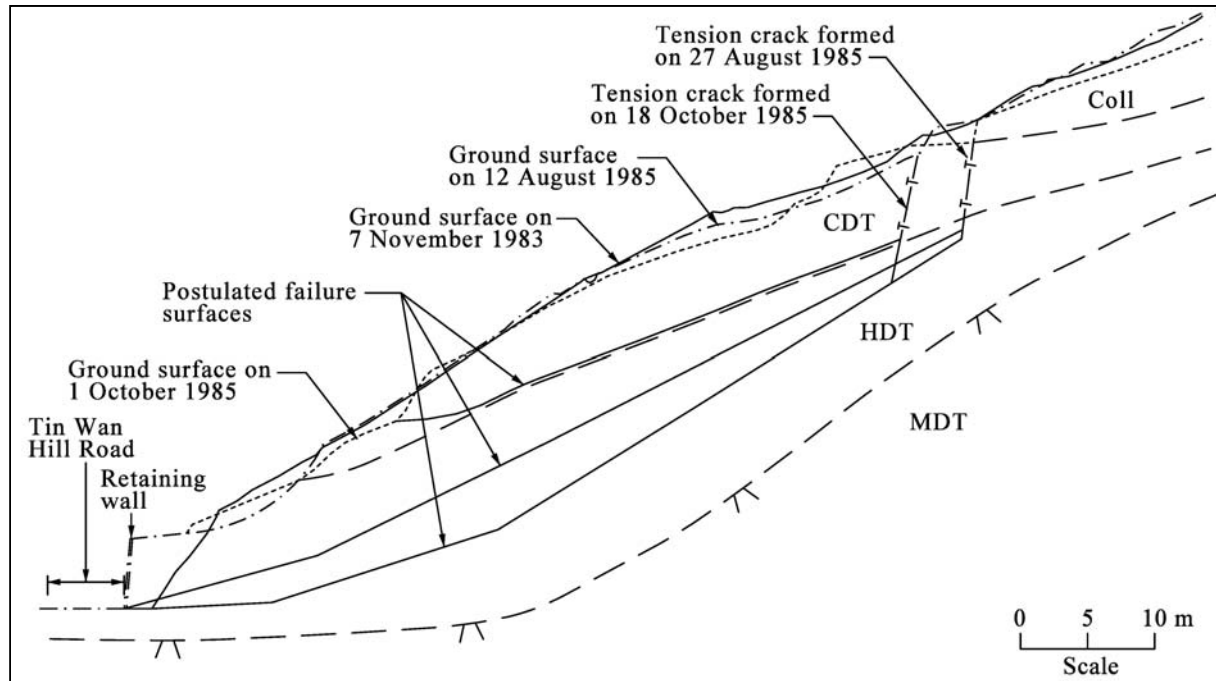
**Case No. 5 - The August and September 1985 Incidents at Tin Wan Hill Road, Hong Kong
(Sheet 2 of 2)**

The incident occurred on a 37 m high cut slope when permanent stabilisation works were being constructed in 1985. Slope movements began after the formation of the cut slope in 1963. Slope remedial works including regrading, surface protection and subsurface drainage were carried out on a number of occasions between 1968 and 1982. Further instabilities were observed in October 1983 and permanent slope stabilisation works were designed by the GCO. The works consisted of a reinforced concrete retaining wall at the slope toe, trimming of the slope face and installation of 20 m maximum length horizontal drains and surface drainage channels. Site works began in early 1985 and slope movement was re-activated in June 1985 following heavy rainfall. The slope movement accelerated in July 1985 during excavation near the slope toe for the construction of the toe retaining wall. The slope was stabilised temporarily by placing rock fill at the slope toe. Following intense rainfall on 26 and 27 August 1985, the instability progressed further upslope with the formation of new tension cracks up to

9 m deep and failure of the near-surface materials. Rapid slope movement of up to 800 mm per day was recorded between 26 and 29 August 1985. On three occasions about 100 m³ to 200 m³ of material detached from the steep colluvial cut face which had been standing at about 56° and the landslide debris was deposited on both lanes of Tin Wan Hill Road. There was no reported casualties.

Further instability occurred on 6 September 1985. The landslide was investigated by the GCO (Irfan, 1986). Failures occurred in the colluvium as well as along relict failure surfaces in the deeply weathered profile. The slope has a complex geological and hydrogeological setting, involving effects of shear and fault zones and adversely orientated discontinuities with weak, slickensided infill. Slope deterioration occurred over the years involving opening up of the subvertical joints. The total volume of the unstable groundmass was estimated to be about 19,200 m³.

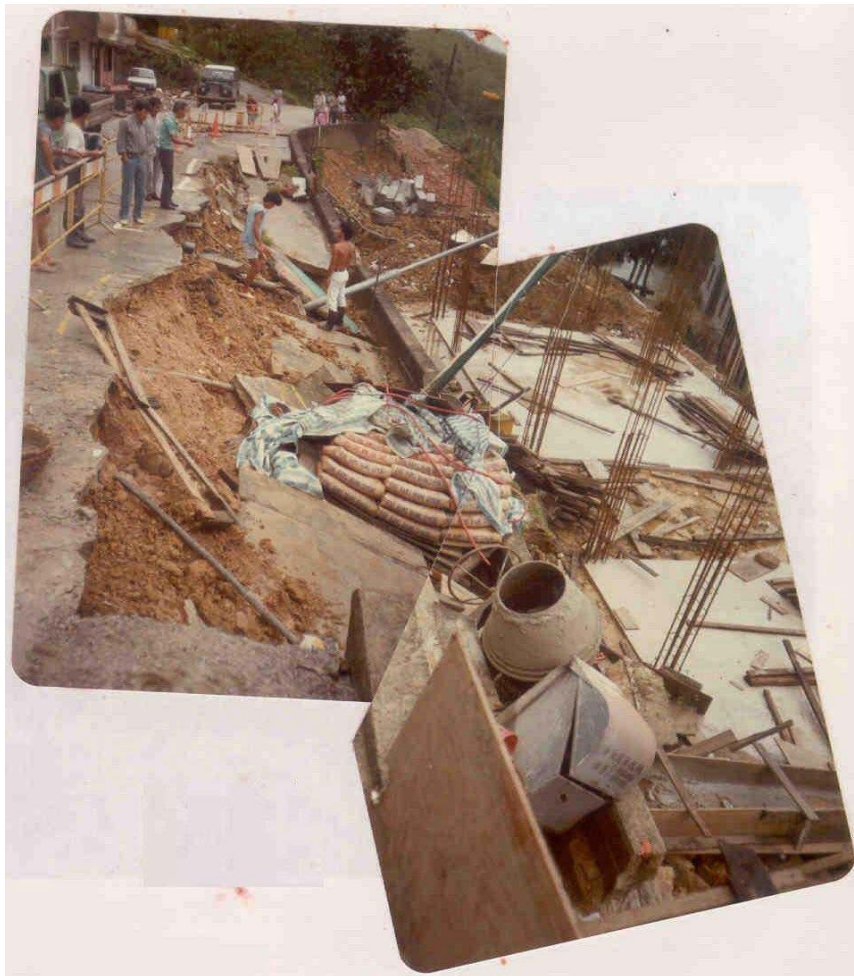
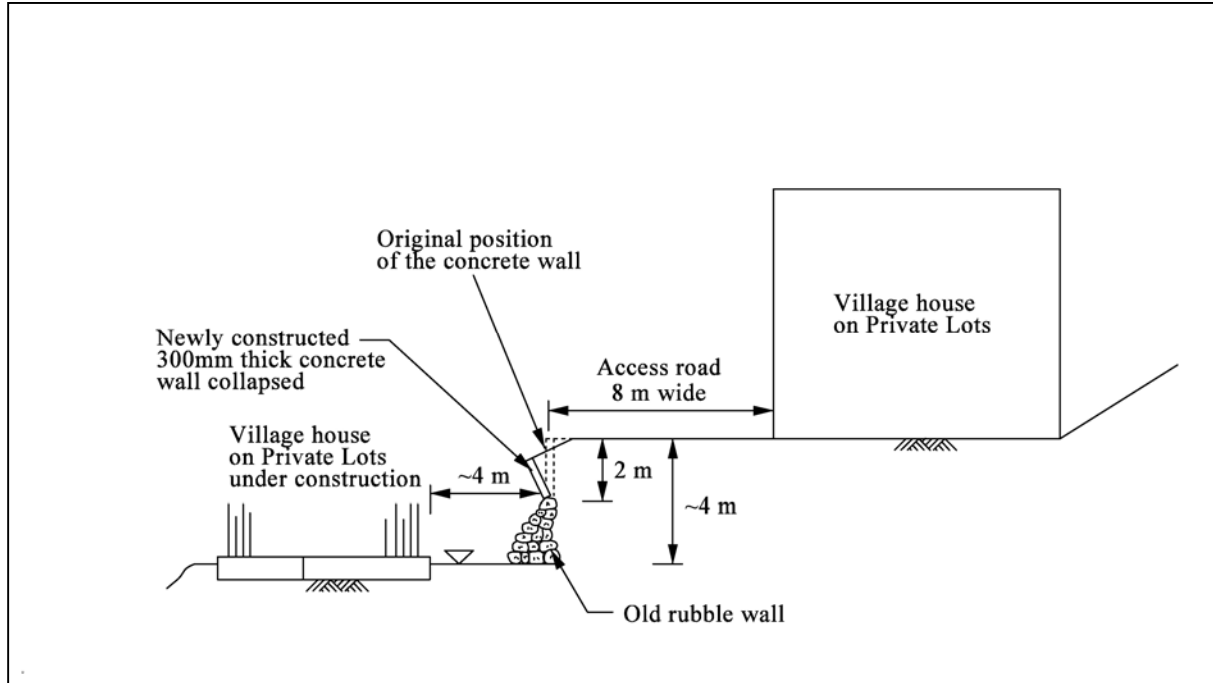
Case No. 6 - The 6 September 1985 Incident at No. 3-6 Pak Shek Terrace, Pak Shek Wo, Sai Kung (Sheet 2 of 2)

The failure occurred during heavy rainfall, involved the collapse of a 24 m long section of a 3 to 4 m high retaining wall, comprising a 2 m high, 300 mm thick concrete wall founded on top of a 1 to 2 m high rubble wall. This retaining wall supported an 8 m wide access road and immediately below it was an active construction site for two small village houses on a 15 m wide platform. At the time of the failure, three parked cars together with about 40 bags of cement and a small drum concrete mixer were on the access road near the crest of the concrete wall. They all fell down with the debris into the construction site. The volume of the debris was about 100 m³. A large flow of water from a hole on the remaining uncollapsed portion of the wall was observed. A PVC pipe running

perpendicular to the wall was also broken behind the collapsed wall and was discharging water into the area of the failure. The access road was subsequently closed. The failure was probably due to surcharge from the parked cars and construction materials, and possibly leaking water carrying services. Heavy rainfall during the day of the failure, may have led to a rise in groundwater level and could have been a contributory factor, noting that there was no weepholes provided on the collapsed section of the wall. Based on the post-failure inspection by the GCO, the concrete wall itself was considered inherently unstable as it was founded on a wall of uncertain stability and was too thin to be a proper retaining structure.

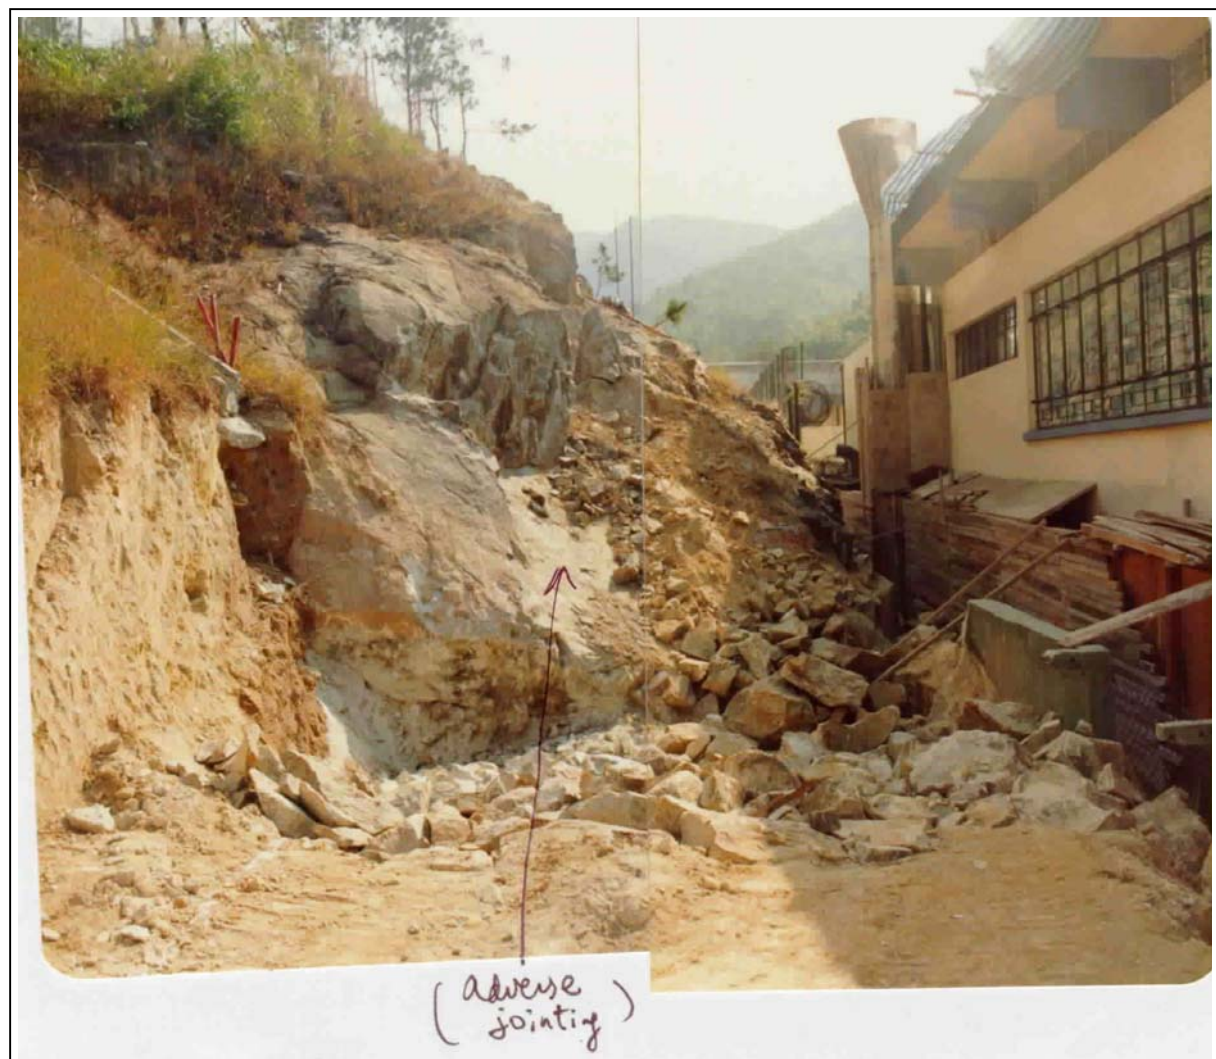
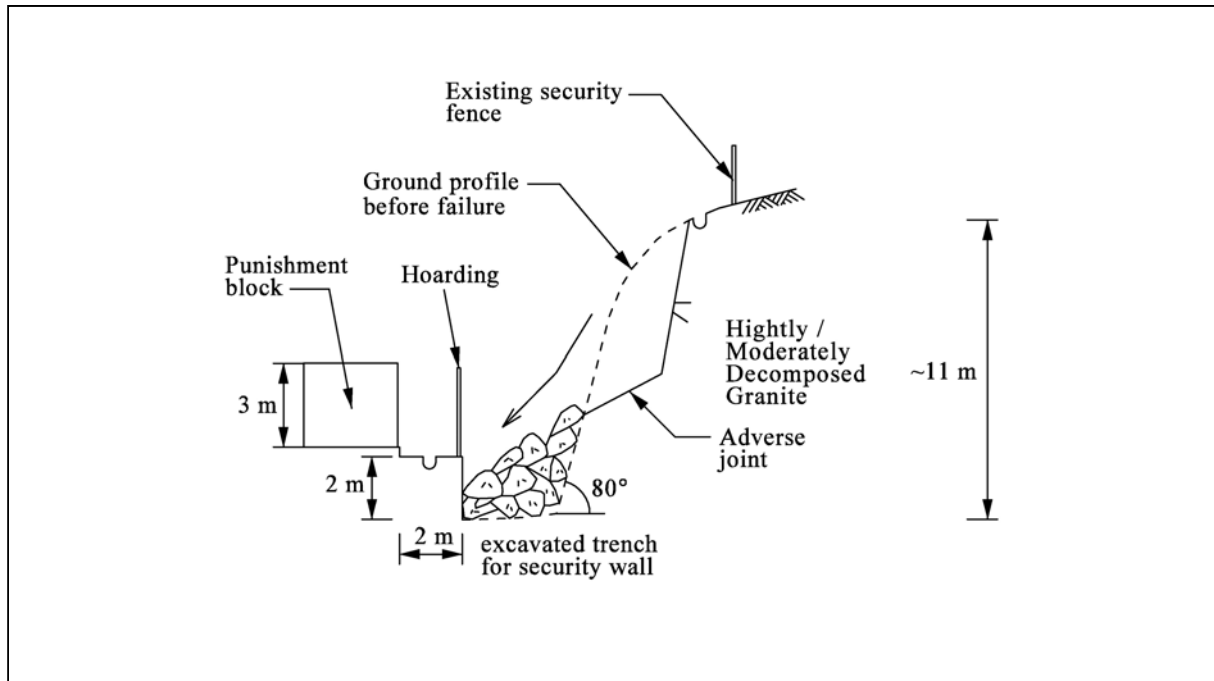
**Case No. 7 - The 4 December 1986 Incident at Tai Lam Centre for Women, Tai Lam Chung
(Sheet 2 of 2)**

The failure occurred on an 80° temporary cut slope which had been formed to allow the construction of security wall along the hillside boundary of the Tai Lam Women's Prison, Tai Lam Chung. There was no rainfall on the day of the failure but some moderate rainfall 2 days earlier.

About 24 hours prior to the failure, a less extensive slip had been observed by the Resident Site Staff on the temporary cut slope, and at the same time a 5 mm wide and 5 m long tension crack was identified above the crest of the failure scar. A geotechnical engineer from Arch SD visited the site on the same day and advised the Resident Site Staff of the potential instability of the temporary cut slope and the need for urgent precautionary measures. On the following day, the temporary cut

slope failed along an adversely dipping rock joint. The failed debris of about 400 m³ came to rest in a 2 m deep trench at the toe of the slope which had been excavated to facilitate the construction of the security wall foundation. Part of the punishment block of the Prison, located at about 2 m from the excavated trench, was also evacuated.

The failure was probably caused by over-steepened and unsupported excavation, and the presence of unfavourable orientated rock joints.

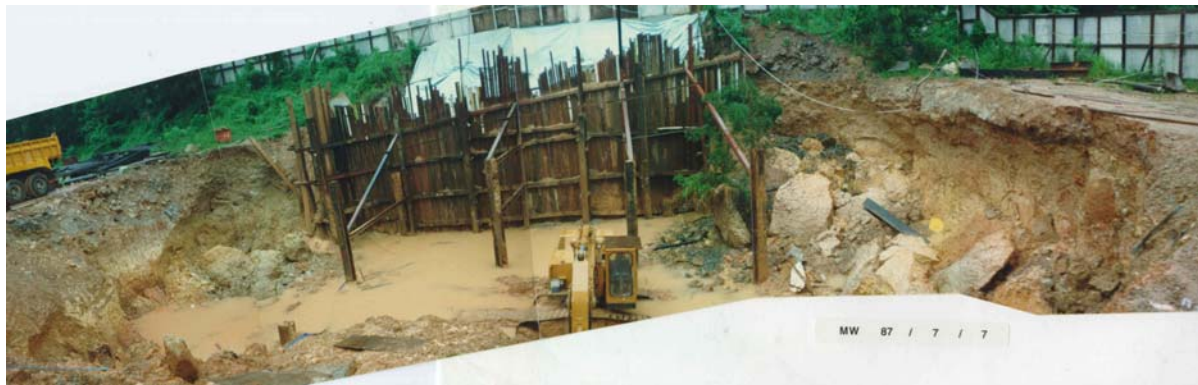
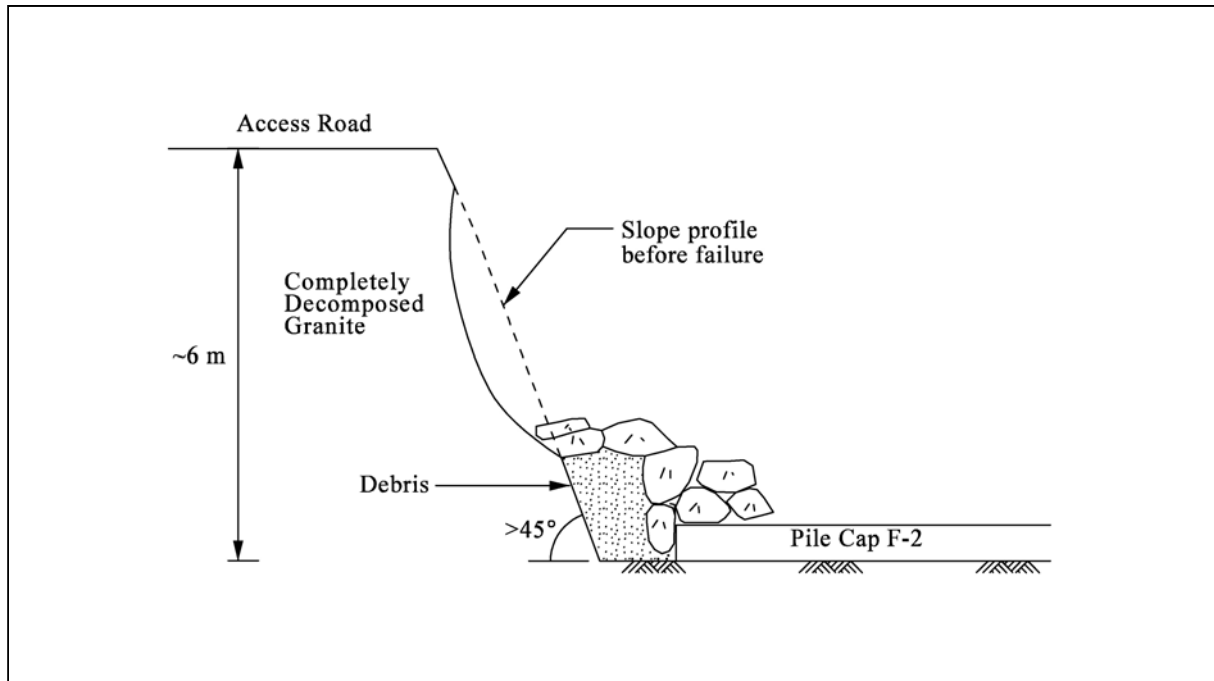
**Case No. 8 - The 27 July 1987 Incident at Fairview Garden, Wai Tsuen Road, Tsuen Wan
(Sheet 2 of 2)**

Two failures occurred during heavy rainfall on a building construction site in Tsuen Wan where a 6 m deep excavation for a pile cap was being carried out. The first failure occurred on the unsupported south-eastern face of the excavation when 8 workers were working in the excavation, releasing about 45 m³ of soil debris and as a result 2 workers were injured. Another worker who escaped injury in this initial collapse was also injured when he went to assist with the rescue.

The second failure occurred four hours later on the north-western face of the excavation and releasing soil debris of about 30 m³. This failure affected an existing slope which supported Texaco Road North above the northern face of the excavation. One lane of the road was closed as a precautionary measure.

The causes of the two failures were probably due to the over-steepening of the excavation faces and lack of temporary support. Rapid increase in groundwater pressure due to rain infiltration might also have contributed to the failures.

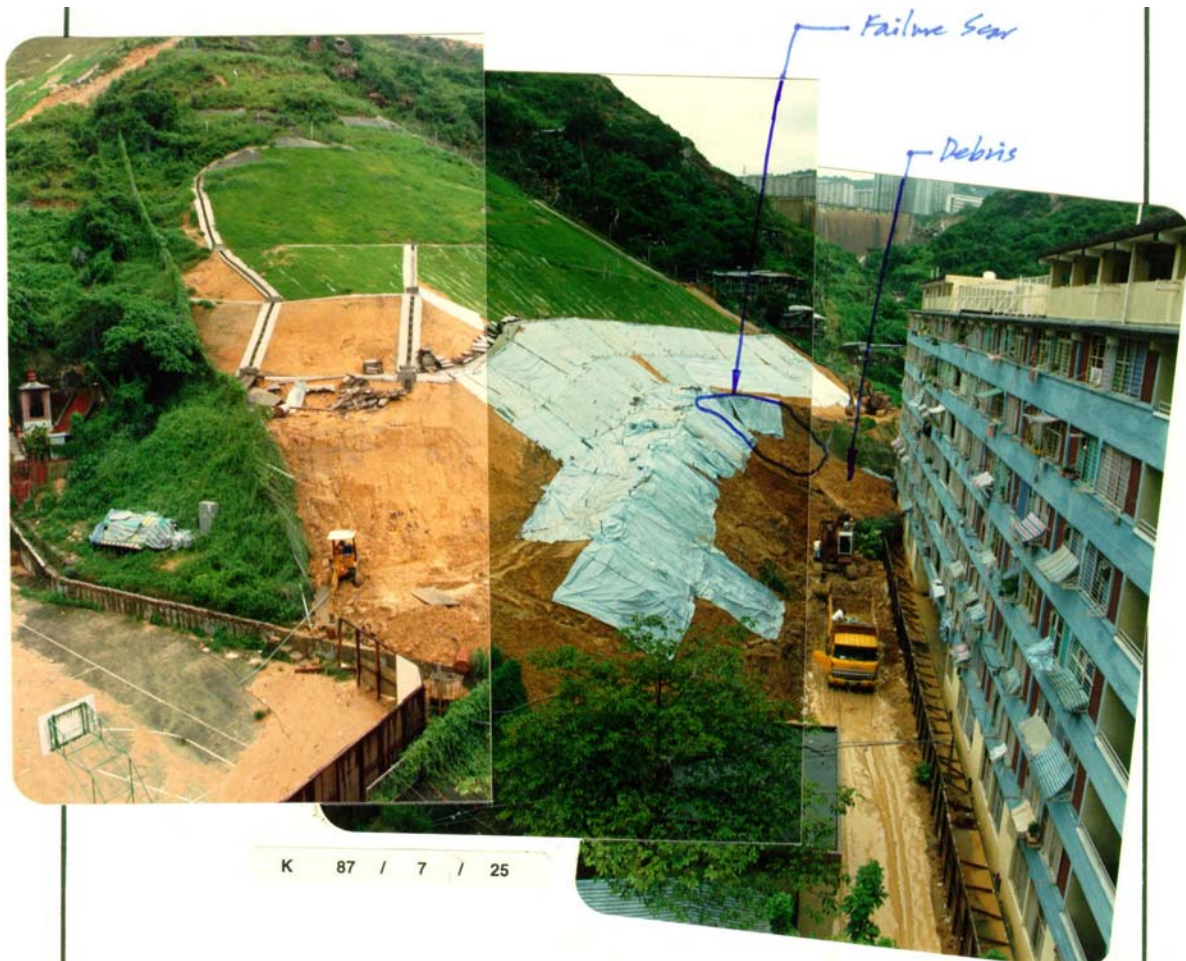
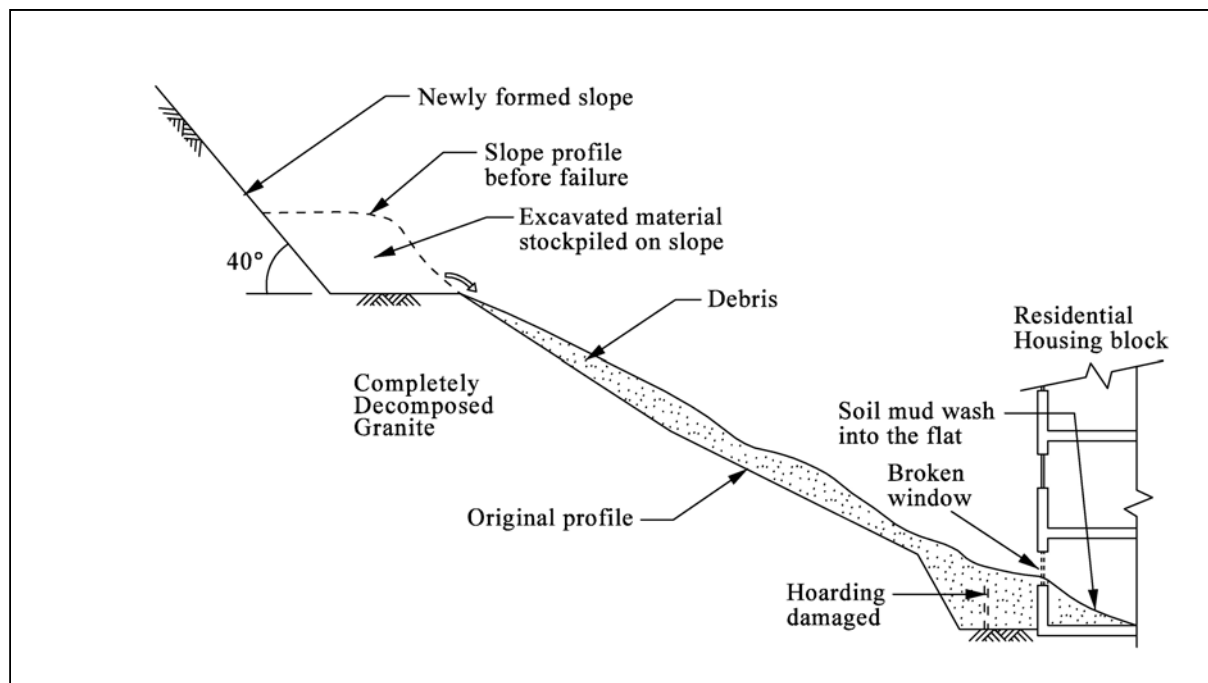
**Case No. 9 - The 30 July 1987 Incident behind Block 10, Jordan Valley Estate, Kowloon
(Sheet 2 of 2)**

The landslide occurred during heavy rainfall on 30 July 1987 at about 2:30 a.m., on stockpiles of excavated materials on the lower batter of a soil cut slope behind Block 10, Jordan Valley Estate. At the time of failure, the slope was being upgraded under the LPM Programme. The failure involved sliding down of excavated materials which was stockpiled on the lowermost batter of the cut slope to form a temporary access ramp. The debris with a volume of about 300 m³ damaged the hoardings and safety fence at the toe of the cut slope and came to rest against the housing block. Part of the external building wall, windows and doors of several flats on the ground floor were damaged by the landslide debris and some debris was washed into residential flats. No casualties were reported but the landslide caused temporary evacuation of 20 flats of the housing block.

The failure was probably caused by infiltration of water during heavy rainfall into the excavated material stockpile. The improper location of the stockpile might also have been a contributory factor to this severe consequence failure.

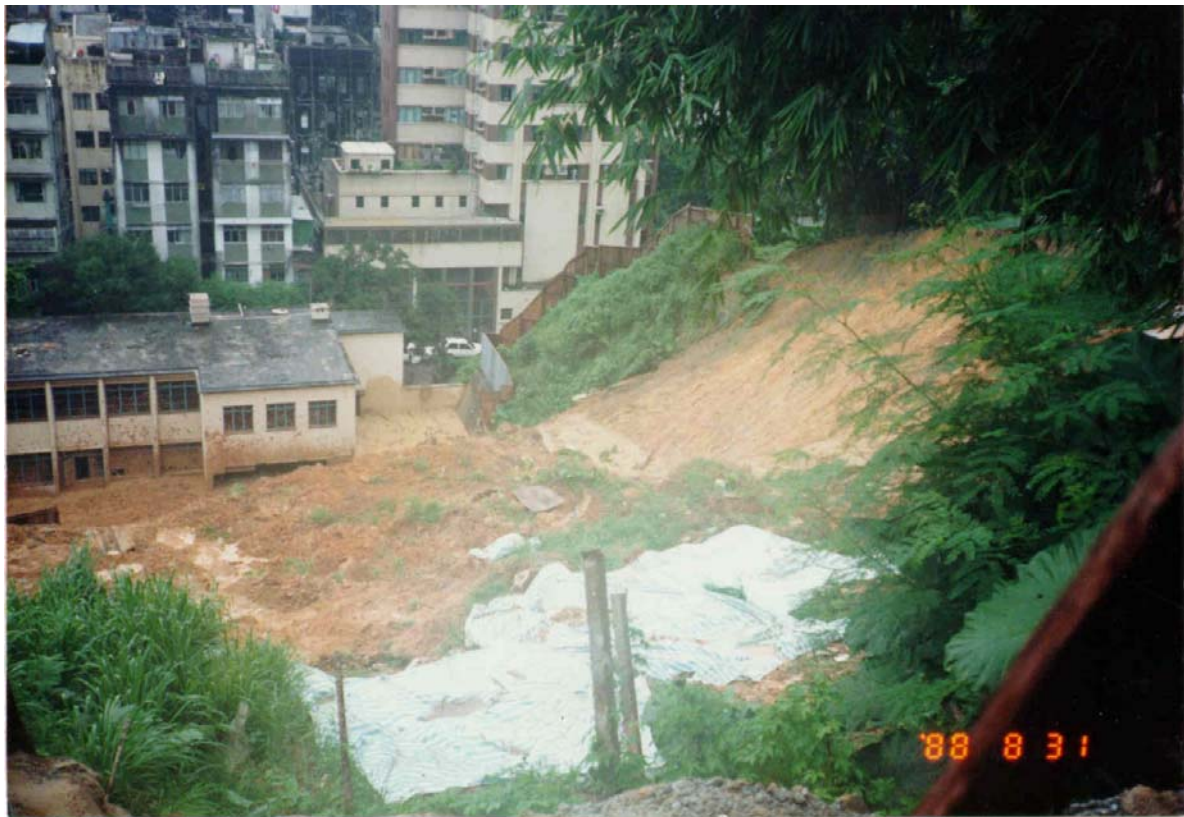
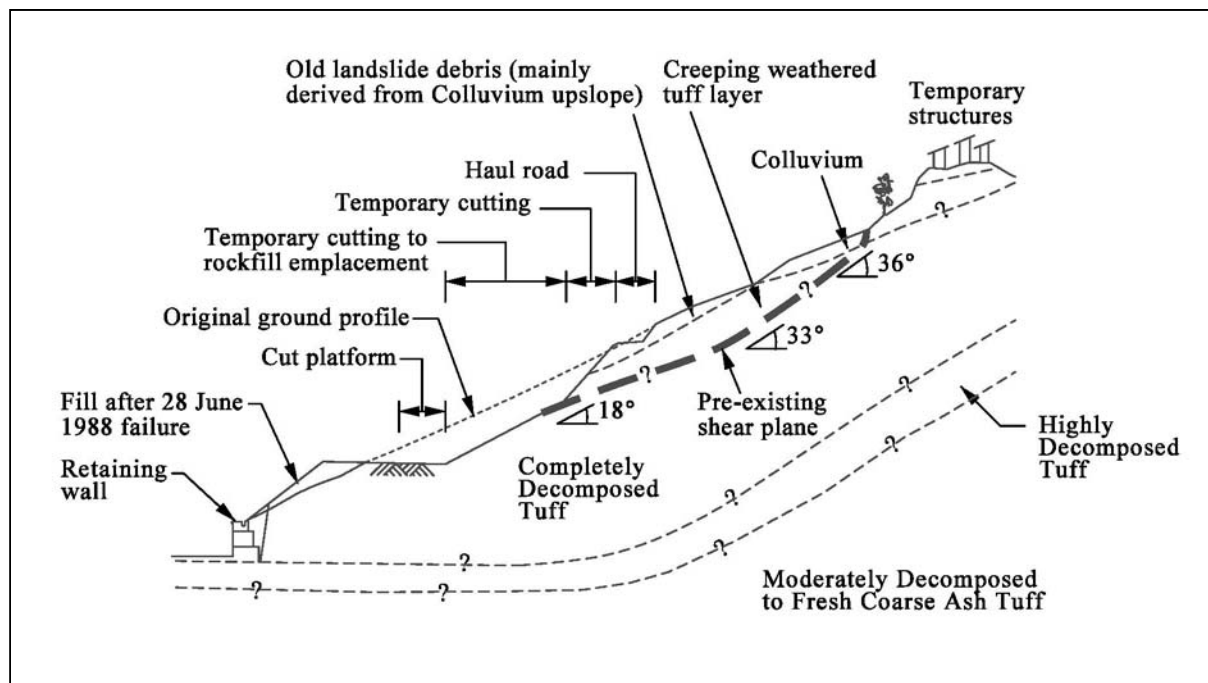
Case No. 10 - The 28 June 1988 and 31 August 1988 Incidents at North of Island Road Government School (Sheet 2 of 2)

Two failures occurred above Island Road Government School, at a 25 m high soil cut slope with an average gradient of 25°, which was being upgraded under the LPM Programme. On 28 June 1988 after a prolonged period of rain, the first failure occurred on the upper portion of the slope involving 100 m³ of soil debris. A 17 m long and up to 1 m deep tension crack of approximately crescent shape developed on the slope face near the crest of the slope. Ten squatter huts at the crest were subsequently permanently evacuated and the school playground behind the school was also closed off. The failure was probably caused by rapid infiltration due to removal of vegetation on the slope.

Following the first failure, the original upgrading works for this slope had been revised to replacing the top 3 m of soil with rockfill.

The second failure, involving about 800 m³ of debris, occurred during moderate rain on 31 August. The debris piled up against the rear wall of the school building causing the collapse of a screen wall of a ground floor workshop. The debris also flowed into the workshop and the surrounding area of the school. Eight rooms in the school were temporarily closed. According to Special Project Report No. 4/89, the second failure was caused by removal of toe support and a moderate rise in groundwater pressure due to rapid infiltration from the slope face stripped of vegetation and previous instability in the form of creep. As suggested by the post-failure investigation by the GCO, the second failure was found to have occurred along an irregular surface of a pre-existing shear plane which was formed as a result of rupture of a weathered tuff layer due to creep.

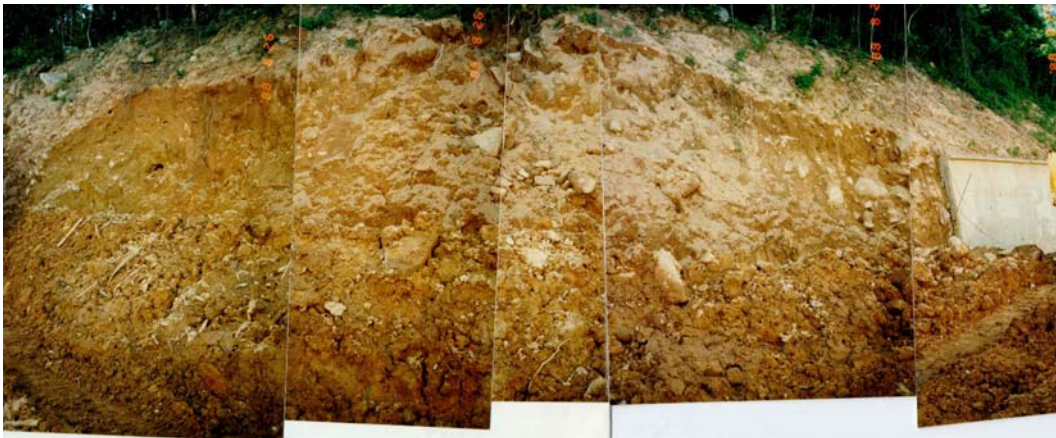
First failure

The first failure occurred to the south of a partly completed retaining wall and involved a failure mass of about 65 m³. About 8 days later, a second failure occurred to the north of the first failure and involved soil debris of about 10 m³. A number of natural soil pipes with very significant seepage flows were observed on the failure scars at both locations after the failures. The two failures resulted in the

The causes of the two failures were probably the over-steepening of the temporary cut slope and lack of temporary support. Rapid increase in groundwater pressure due to seepage flows from the natural soil pipes also probably contributed to the failures.

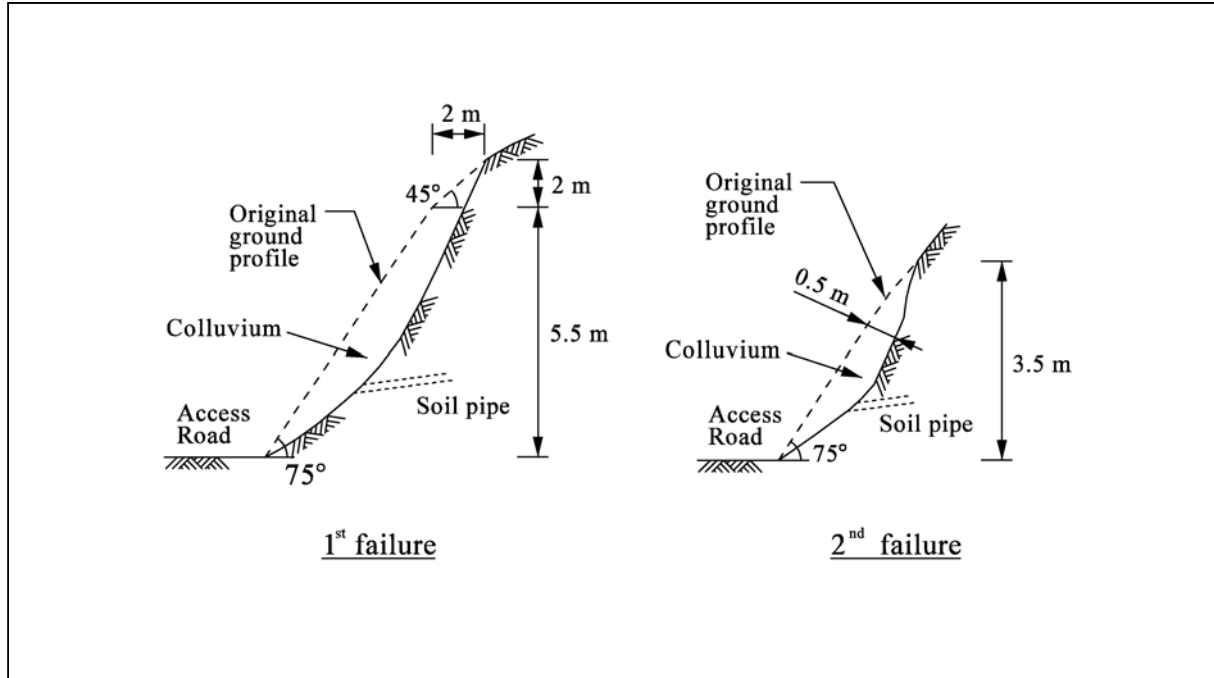
Case No. 11 - The Incident at Tai Wan, Sai Kung (Sheet 2 of 2)

Two landslides occurred in mid-August 1988 during a prolonged period of rainfall. They occurred in a temporary sub-vertical cut slope which was to provide access and to facilitate the construction of a retaining wall, as part of the site formation works for a private building development. The cut slope was formed before the design was accepted by the GCO.

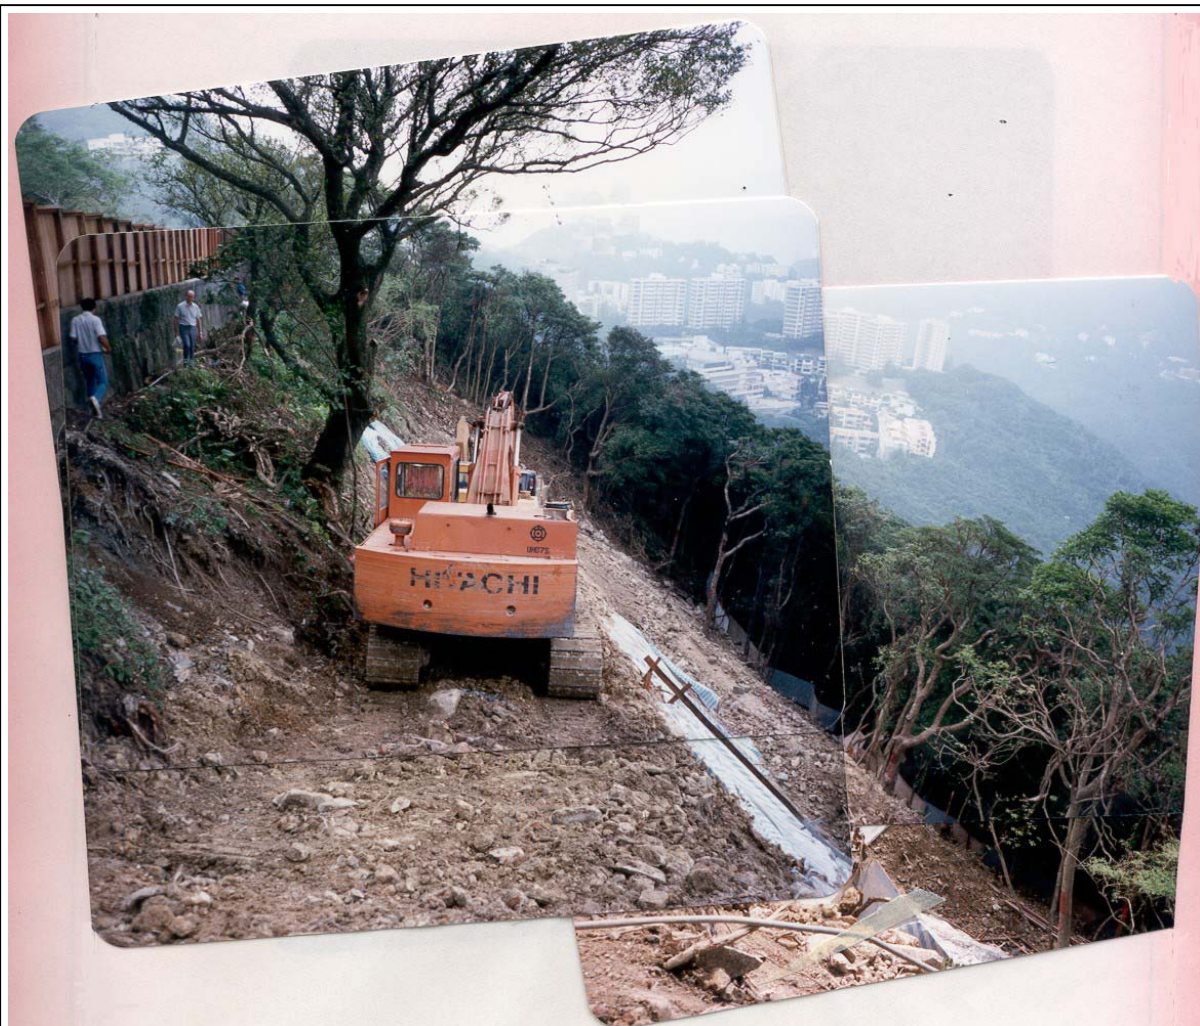
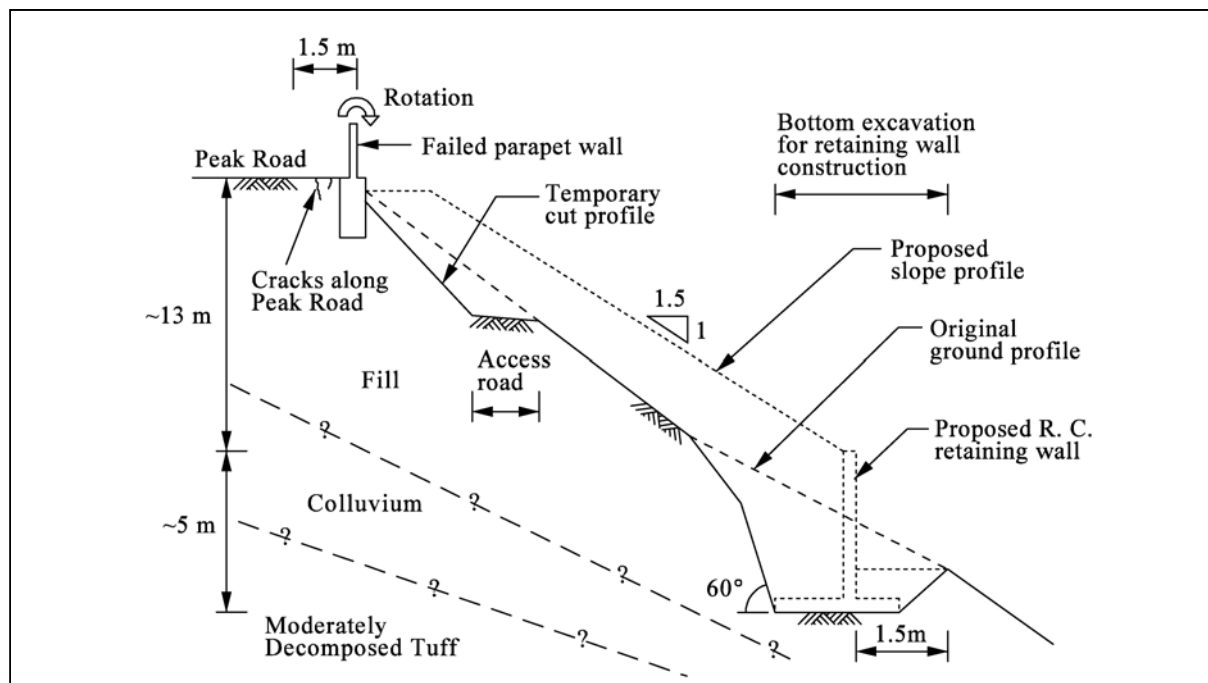
Case No. 12 - The 29 July 1989 Incident at Peak Road, Hong Kong (Sheet 2 of 2)

The failure involved severe cracking on Peak Road and significant movements of a parapet wall along the crest of a fill slope on the downhill side which at the time was being upgraded under the LPM Programme. The slope upgrading works included the construction of a 5 m high reinforced concrete cantilevered retaining wall along the slope toe and recompaction of the top 3 m of loose fill.

Cracks on Peak Road were initially observed on 29 July 1989. The cracking was seen to have worsened subsequently, with a maximum crack width of 5 mm being observed on 2 August 1989. The parapet wall was measured to have moved 16 mm vertically and 12 mm horizontally between 31 July 1989 and 2 August 1989.

The failure resulted in the closure of the uphill lane of Peak Road.

A subsequent investigation into the failure by the GCO suggested that the stability conditions of the parapet wall were well below standard even before the works were started, and that the observed cracking on Peak Road and the movements of the parapet wall were triggered by the LPM construction activities.

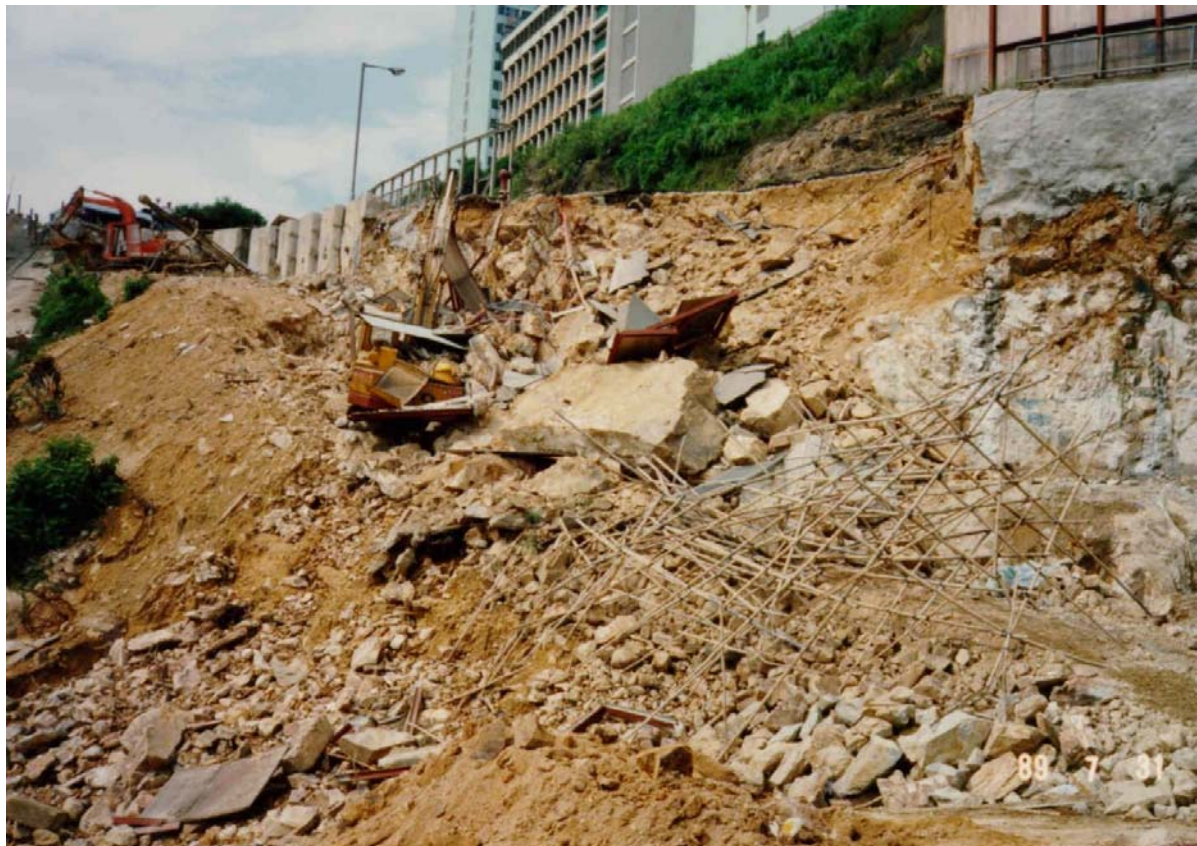
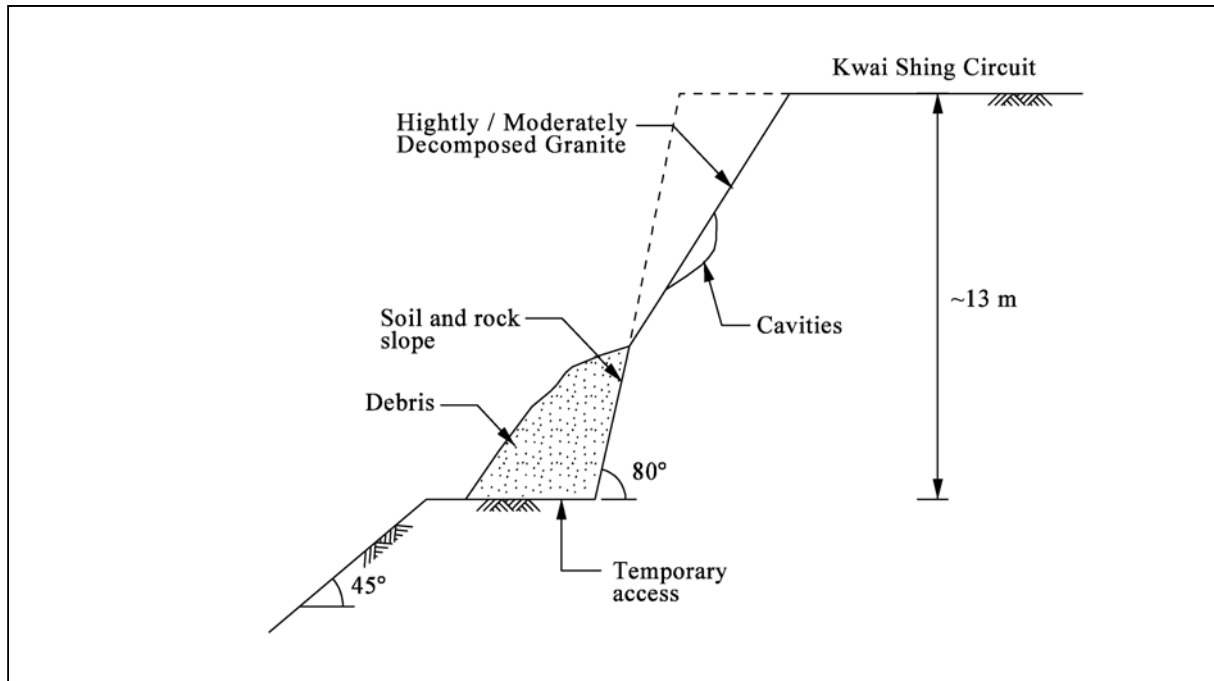
**Case No. 13 - The 31 July 1989 Incident at Kwai Shing Engineering Centre, Kwai Chung
(Sheet 2 of 2)**

The failure occurred on a dry day, on an 80° temporary rock cut slope which was being formed as part of the site formation for Kwai Shing Engineering Centre along Kwai Shing Circuit (KSC). The failure involved a rock slide of about 50 m³ along a 45° plane near the crest of the rock cut slope. Cavities were observed in the backscar, water was seen flowing from a fire hydrant on KSC and an underground power line was found broken. No groundwater was observed. As a result of the landslide, one person was injured and one lane of KSC was closed for 7 months.

were observed on the cut slope on 27 July 1989, four days before the incident. The contractor was instructed by the consultant on 28 July 1989 to carry out precautionary works, comprising grouting up of the cavities and provision of additional rock bolts. These stabilisation works had not been carried out up to the time of failure which resulted in one person being injured.

The failure was probably due to the presence of unfavourable orientated open joints in the rock cut slope.

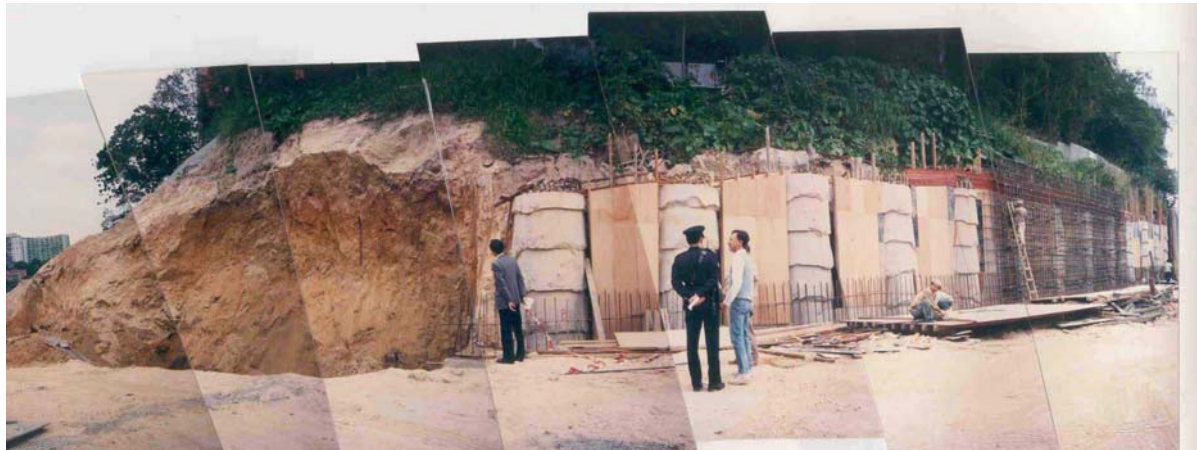
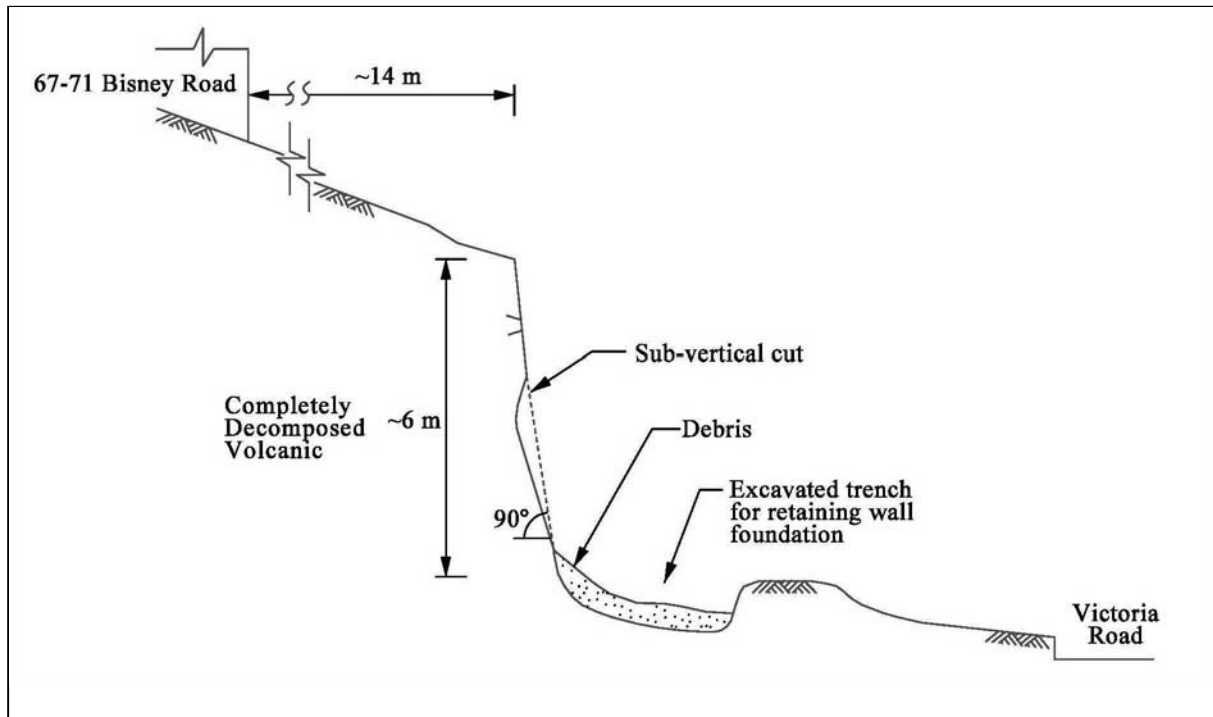
**Case No. 14 - The 24 November 1989 Incident at Victoria Road, Hong Kong
(Sheet 2 of 2)**

The failure occurred on a sub-vertical temporary cut for a cantilevered retaining wall construction below 67-71 Bisney Road, as part of a road improvement project. The failure mass, about 5 m³ of soil, slid into a trench excavated at the toe of the temporary cut slope for the retaining wall foundation construction. The temporary cut was about 6 m high without any temporary supporting measures. Two workers were injured as a result of the failure.

The main trigger of this failure was the over-steepness of the temporary cut and the lack of temporary support. The open cut method for the retaining wall construction adopted by the contractor deviated from the approved “alternate bay” method. The Engineer’s Representative had reminded the contractor via a memo 6 days before the

failure, regarding the observed non-compliance of construction method and requested the contractor to submit detailed engineering design and drawings for the temporary cut for approval.
