REVIEW OF NOTABLE LANDSLIDE INCIDENTS DURING SLOPE WORKS

GEO REPORT No. 171

H.W. Sun & H.M. Tsui

**GEOTECHNICAL ENGINEERING OFFICE
CIVIL ENGINEERING AND DEVELOPMENT DEPARTMENT
THE GOVERNMENT OF THE HONG KONG
SPECIAL ADMINISTRATIVE REGION**

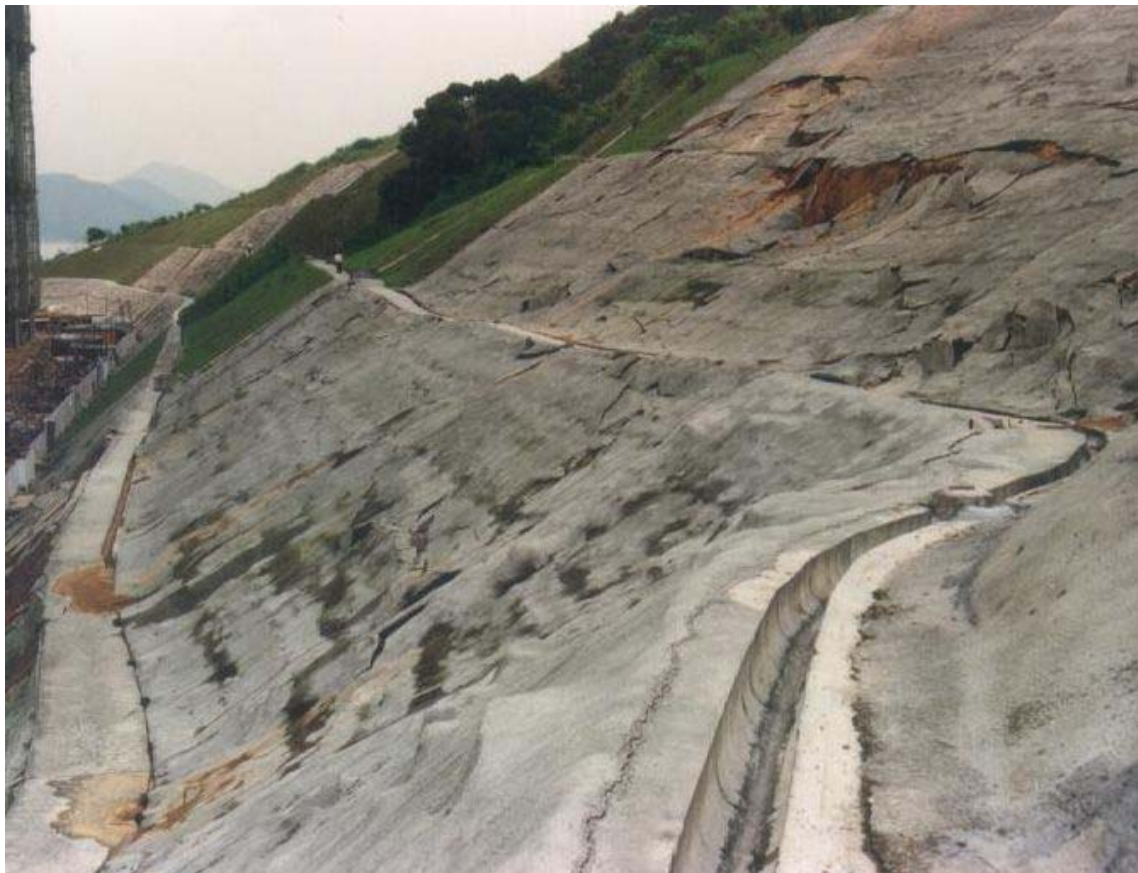
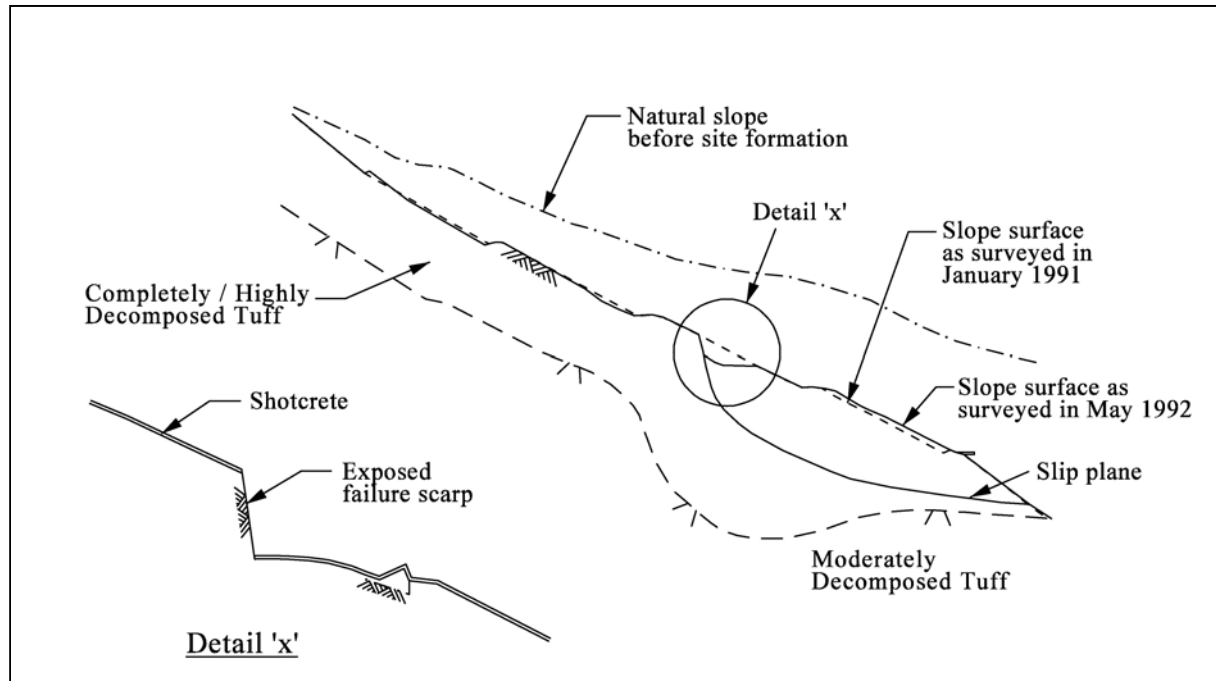
**Case No. 15 - The November 1989 and April 1992 Incidents at Siu Sai Wan, Hong Kong
(Sheet 2 of 2)**

Signs of distress involving tension cracks were observed in a 47 m high soil/rock cut slope during site formation works in late November 1989. The bottom batter of the slope was cut at a gradient of 72° and the upper batters were formed from 34° to 45° . An investigation by the GEO suggested that the mode of instability was related to stress relief as a result of slope formation, leading to toppling of blocks of soil bounded by predominantly sub-vertical relict joints. Remedial measures involved re-grading the slope to a flatter gradient of 30° , together with surface drainage measures and shotcreting. Parts of the slope in the southern end adjacent to a rock slope was revised from unsupported cut to soil nails. The remedial works was completed in early 1991.

No signs of distress were reported on the slope until April 1992, a failure was observed to be taking place progressively. Most of the displaced ground mass remained on the slope. The failure was reported in detail in the GEO Special Project Report No. SPR 3/93. The mechanism of failure was diagnosed to be probably associated with deep-seated failure of a thick profile of hydrothermally altered relict-jointed tuff. The principal cause of the failure was believed to be a combination of high pore water pressure, low mass strength of soils and a relatively large thickness of completely weathered rock. The major factors in the failure were not considered in the original design nor when the cut slope was redesigned following the November 1989 failure.

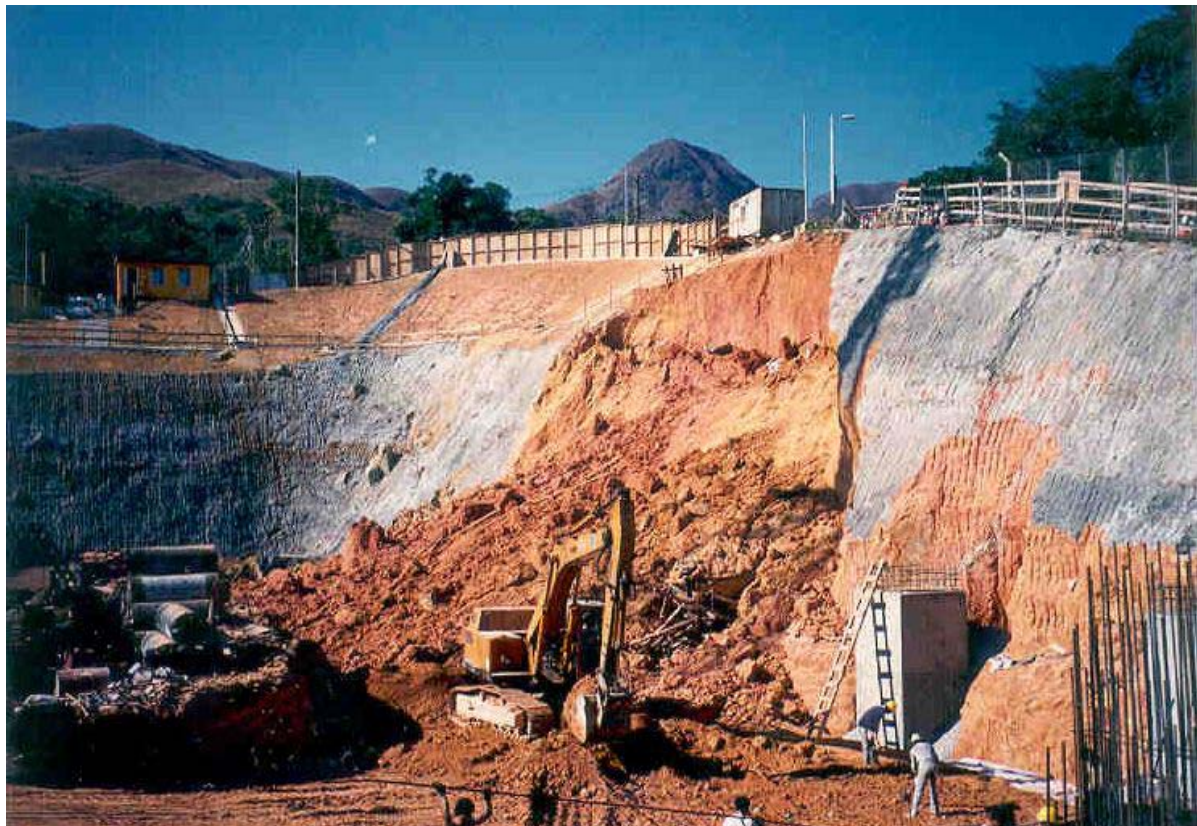
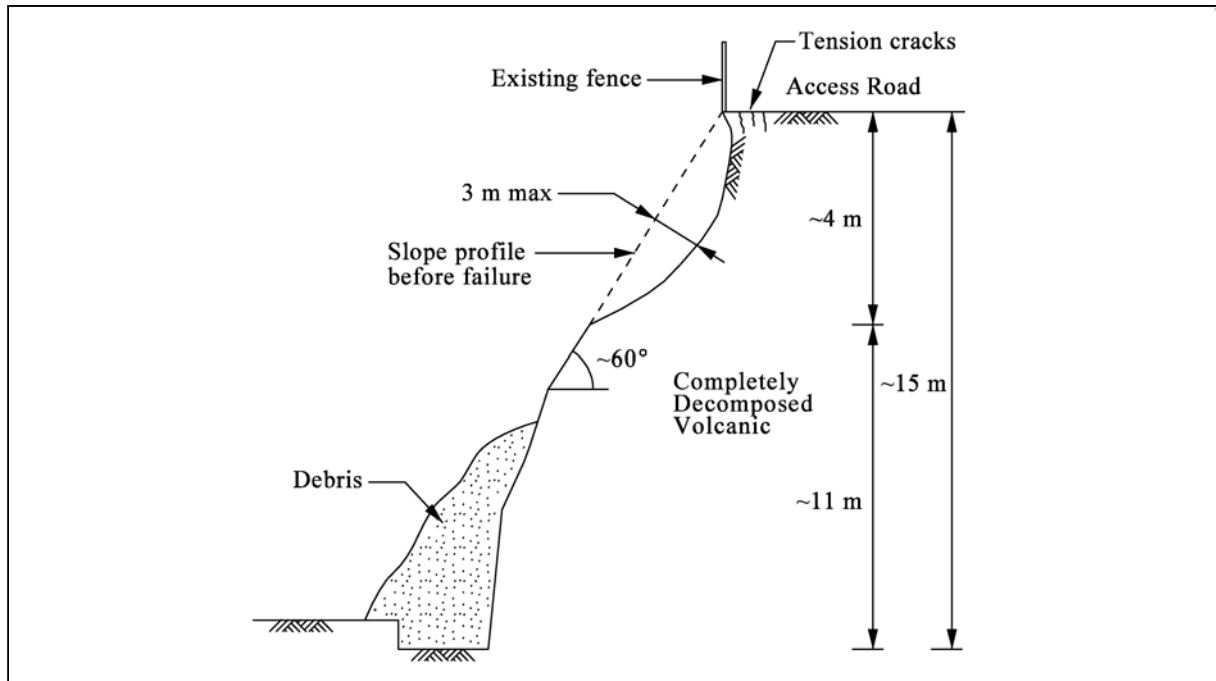
**Case No. 16 - The 10 January 1990 Incident at Po Lo Che Service Reservoir Site, Sai Kung
(Sheet 2 of 2)**

The failure occurred during dry weather in January 1990 at the crest of a 15 m high, 60° steep temporary cut slope in completely weathered volcanics when it was being formed for the construction of a service reservoir. The failure debris was about 400 m³. A sub-vertical scar, about 4 m high, was exposed at the crest of the slip. Major tension cracks up to 150 mm wide developed at the slope crest adjacent to the slip scar. A section of the village access road pavement at the crest was slightly undermined and half width of the access road was closed as a result of the failure.

The cause of the failure was probably due to the over-steepening of the temporary cut in CDV material with relict joints. The GCO had inspected the temporary cut slope a few weeks before the failure occurred,

and had expressed their concern in writing to WSD about the potential instability of the cut slope. However, the contractor disagreed and argued at the time that the cut slope was stable. The works continued until failure occurred on 10 January 1990.

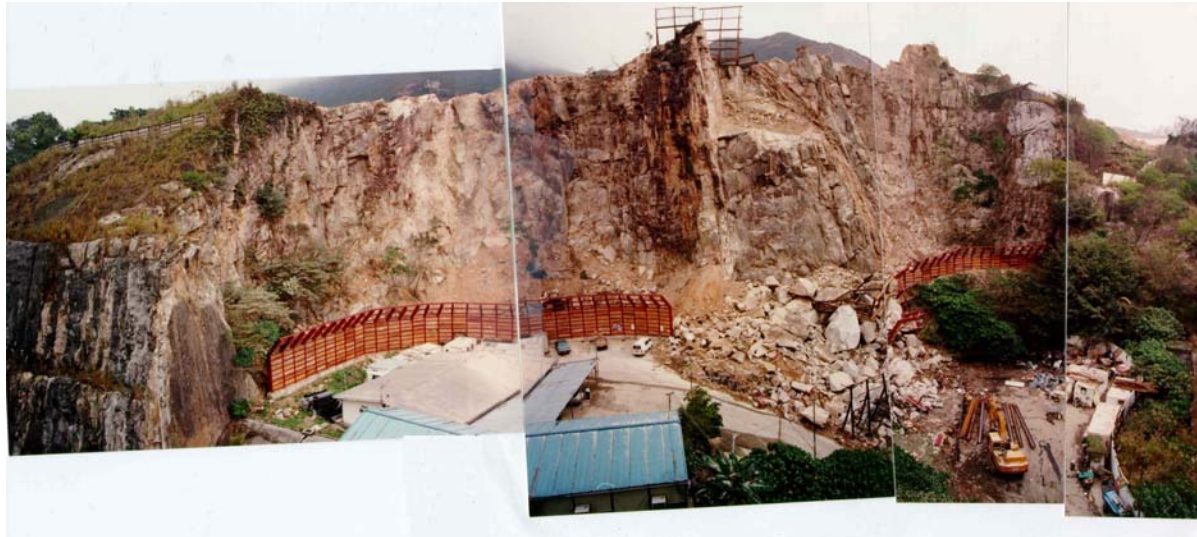
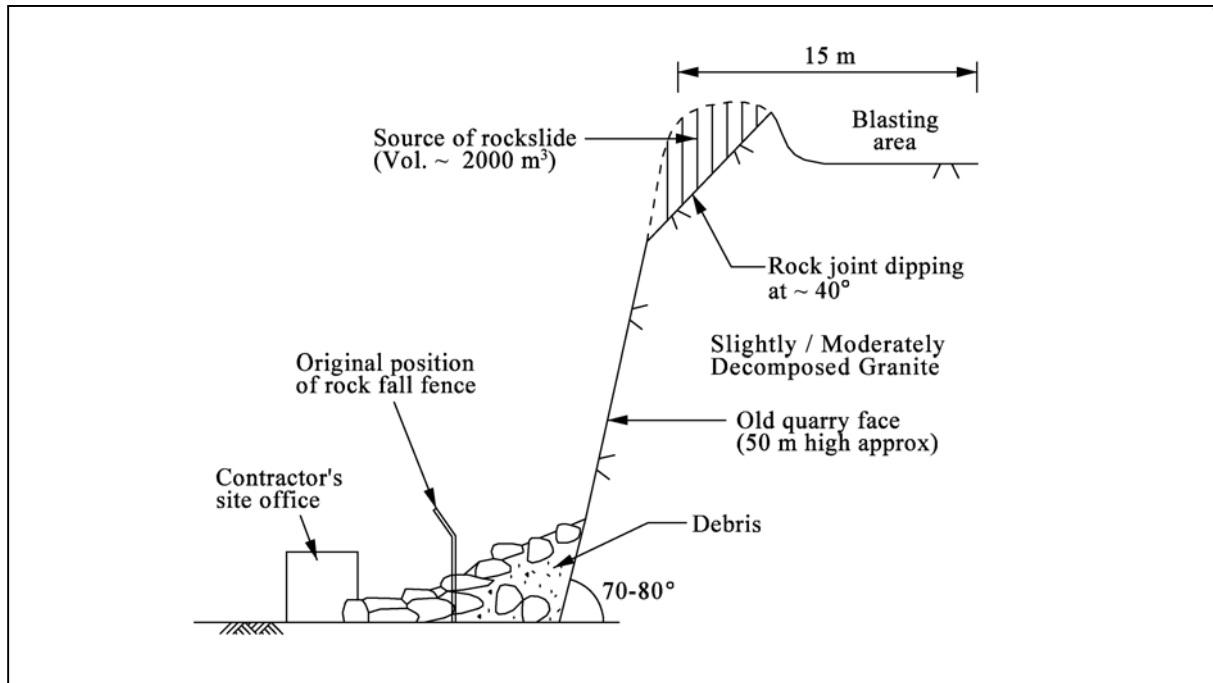
Case No. 17 - The 28 February 1991 Incident at Shau Kei Wan East Housing Development Site (Sheet 2 of 2)

The failure occurred during dry weather near a 50 m high disused quarry face. At the time of failure, blasting was taking place at the crest of the rock slope as part of the site formation works for the adjacent housing development. The failure was reported to have occurred within one minute of a blast which took place within 15 m from the blasting area. About 2000 m³ of rock block was dislodged and fell onto the works area located at the toe of the quarry face. Six container office units and four vehicles parked nearby were damaged as a result of the landslide. The failure also caused the closure of two primary schools for three days, slight injury to one worker from a nearby garage and the closure of the northern end of Hoi Ching Street until completion of the site formation works behind the quarry face.

The failure was a planar slide on an unfavourably orientated discontinuity and was triggered by the blasting at the quarry crest. Rainfall was not a factor in this landslide.

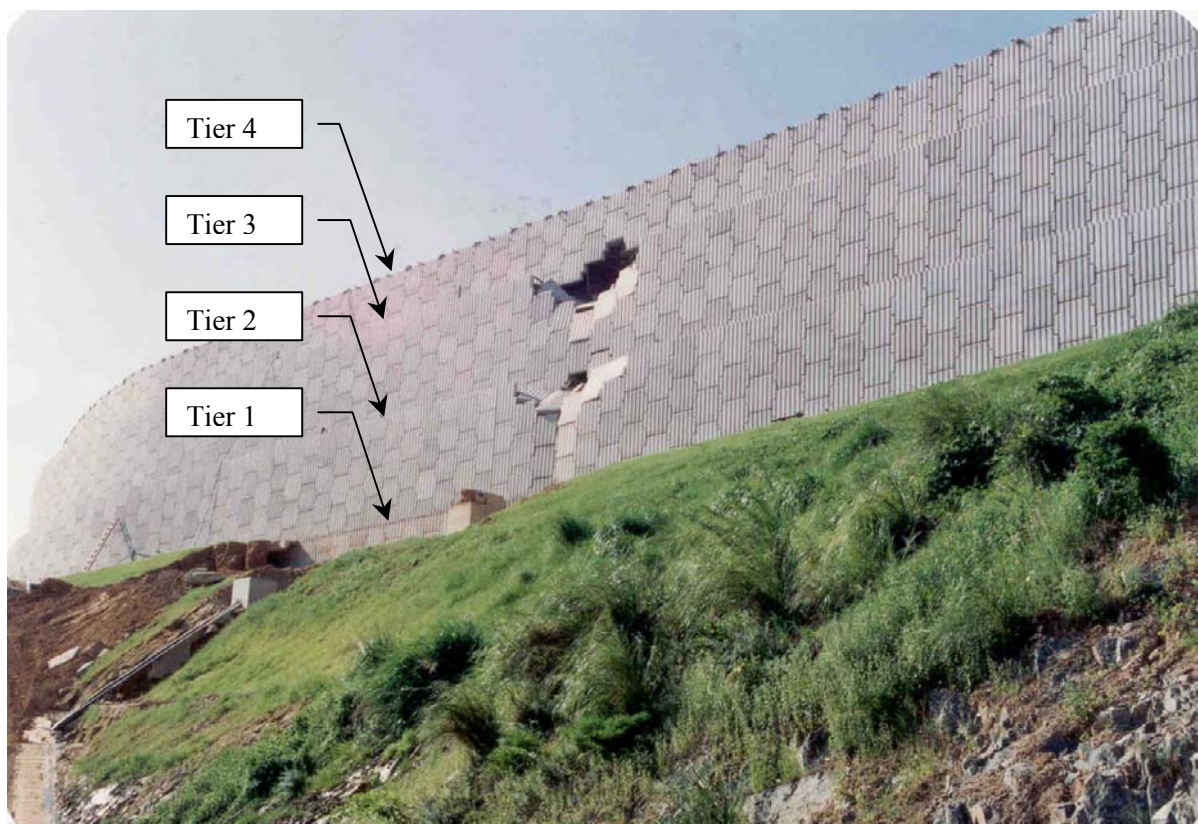
Case No. 18 - The 16 June 1993 Incident in Northwest Tsing Yi (Sheet 2 of 2)

The failure occurred during heavy rainfall on a 6-tier, about 36 m high, reinforced fill wall (No. 1) which was under construction as part of the Advanced Earthworks in Northwest Tsing Yi (under HyD's Works Contract No. HY/91/21). At the time of failure, the wall construction had reached the forth tier (about 24 m high), behind the top of which was a large platform (with no protection against direct infiltration) formed for the upper tiers construction of the wall. Along the edge of the platform, adjacent to the natural hillside, an earth bund was formed to provide a temporary drainage channel to direct and discharge the stormwater runoff from the hillside. About 1 hour prior to the failure, the channel was found to be blocked by boulders and water overspilled onto the platform area and the reinforced fill wall below. It was reported that the failure was initiated at the base of Tier 2, with a loss of fill material under the Tier 2 levelling slab. This resulted

in the formation of a void into which the Tier 2 levelling slab settled. The fill from behind the facing panel also moved down and displaced the top ties of Tier 1 over the erosion scar. Following the loss of fill material at the base of Tier 2, the fill material above then moved down behind the panels, displaced the ties and pulled the panels out of position. At Tier 3, the base levelling slab failed completely due to the loss of material below, and one half-size base panel then dislodged, creating a hole through which a large quantity of fill material was washed out. This caused a cone-shaped cavity right up to the top of the wall and major disruption to the panels adjoining the void, which either fell into the cavity or were pulled there by the displacement of their ties. The failure was probably caused by the high water level built up within the fill material, resulting in piping at the base of Tier 2 and the subsequent collapse of parts of Tiers 3 and 4.

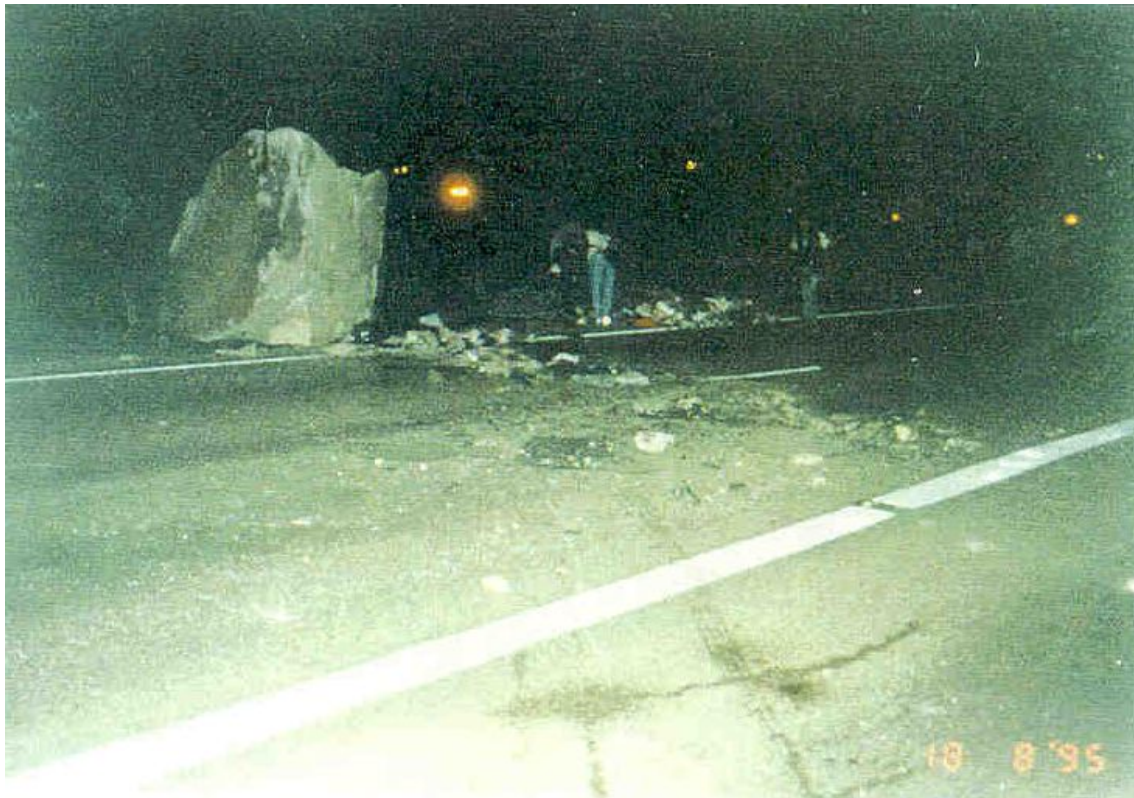
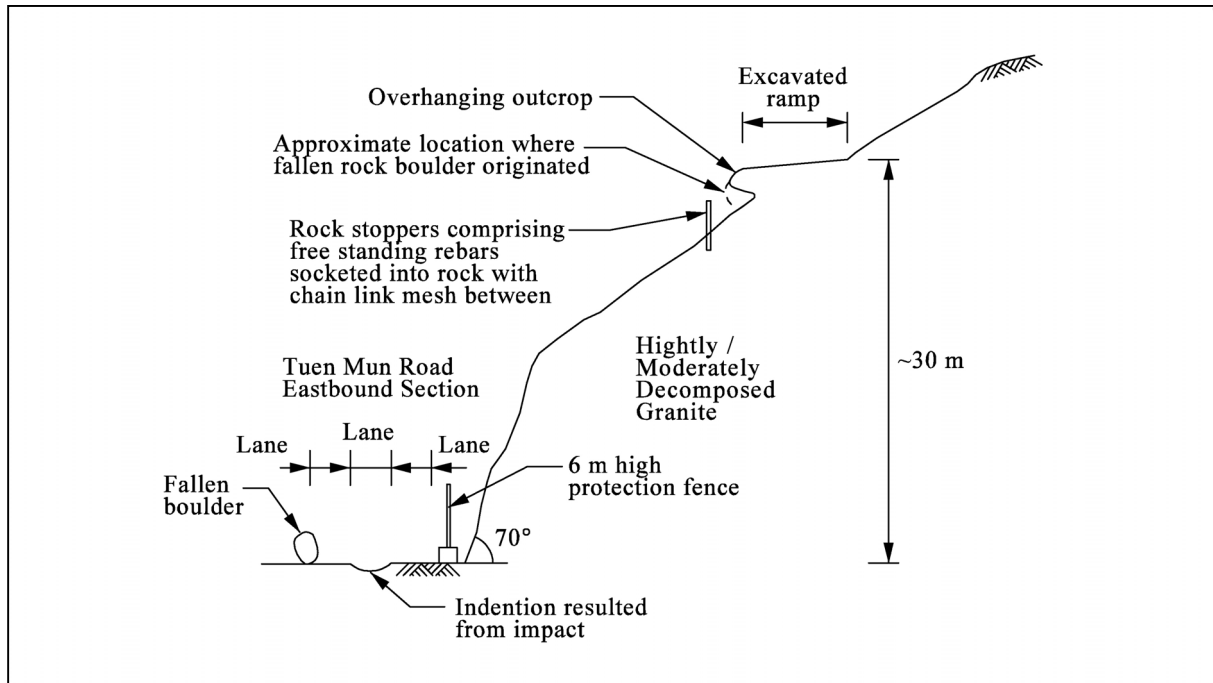
**Case No. 19 - The 18 August 1995 Incident at Siu Lam, Tuen Mun Highway, N.T.
(Sheet 2 of 2)**

Date of Failure:	18 August 1995	Consequences:	1 fatality and 1 injury to members of the public, 3 east-bound lanes of Tuen Mun Hwy temporarily closed, major rock cuts for Tai Lam section of the Improvement to Tuen Mun Road Project suspended
Weather at Date of Failure:	Partly cloudy, fair		
Feature Affected:	6SW-D/C18		
Type of Work:	Road improvement works		
Client:	Government	Type of Supervision:	Full-time supervision by Resident Site Staff
Failure Volume/ Materials	10 m ³ of rock		
Type of Failure:	Rockfall

The rockfall occurred during scaling works on a rock outcrop some 30 m above the Tuen Mun Highway. The excavation works were part of Highways Department's Improvement to Tuen Mun Road Project which was being carried out under a design-and-built contract. The rockfall involved falling of a rock block of about 2 m x 2 m x 2.5 m in size from the overhanging rock outcrop at the crest of the slope onto the highway below outside the site boundary. The detached rock block rolled and landed in the middle eastbound lane of the highway and was hit by a van before coming to rest at the edge of the outer lane. This failure caused one fatality and one injury to members of the public, the closure of three eastbound lanes, and the suspension of rock cuts for the Tai Lam section of the project for about eleven

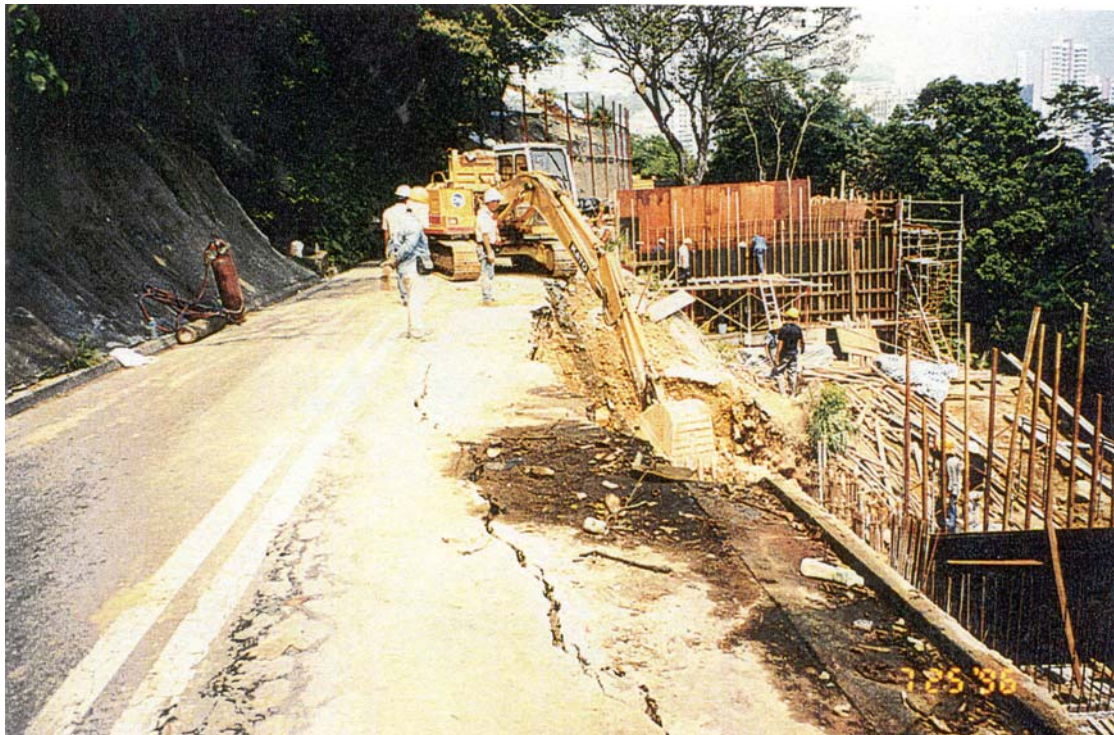
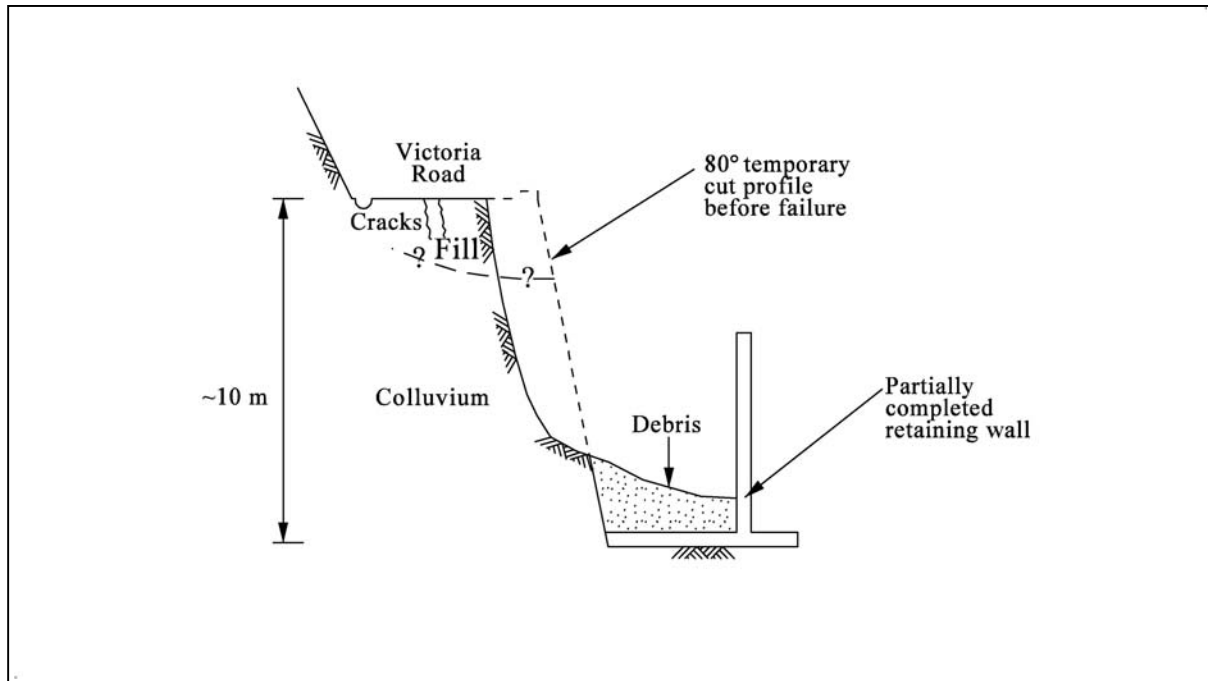
**Case No. 20 - The 25 July 1996 Incident Near 212 Victoria Road, Hong Kong
(Sheet 2 of 2)**

Date of Failure:	25 July 1996	Failure Volume/ Materials	75 m ³ of fill and colluvium
Weather at Date of Failure:	Dry	Type of Failure:	Landslide
Feature Affected:	11SW-C/R544	Consequences:	Complete closure of Victoria Road for 2 days
Type of Work:	Road improvement works	Type of Supervision:	Full-time supervision by Resident Site Staff
Client:	Government

The failure occurred during a dry day, at an 80° temporary cut for a retaining wall construction below Victoria Road, as part of Highways Department's Victoria Road Improvement Project Stage II Phase I. The failed mass, estimated to be 10.5 m wide, 4 m long and 1.8 m deep, came to rest behind the partially completed retaining wall. The temporary cut was about 10 m high without any temporary hard surface protection or support. Cracks were formed in the carriageway of Victoria Road parallel to the crest of the temporary cut. No temporary measures to divert surface runoff away from the temporary slope surface were provided. The failure resulted in complete closure of Victoria Road for two days. The temporary works were designed by the contractor, checked by the Independent Checking Engineer and

accepted by the consultant. GEO had expressed their concern on the over-steepened and unsupported temporary cut after a site visit in March 1996, about four months before the failure, and about the level of geotechnical control on site following a further three landslides which occurred on 14 September 1996.

The weather at the time of the failure was fine and no rainfall was recorded in the 24 hours preceding the failure. This failure was probably caused by over-steepness of the temporary cut without any temporary support.

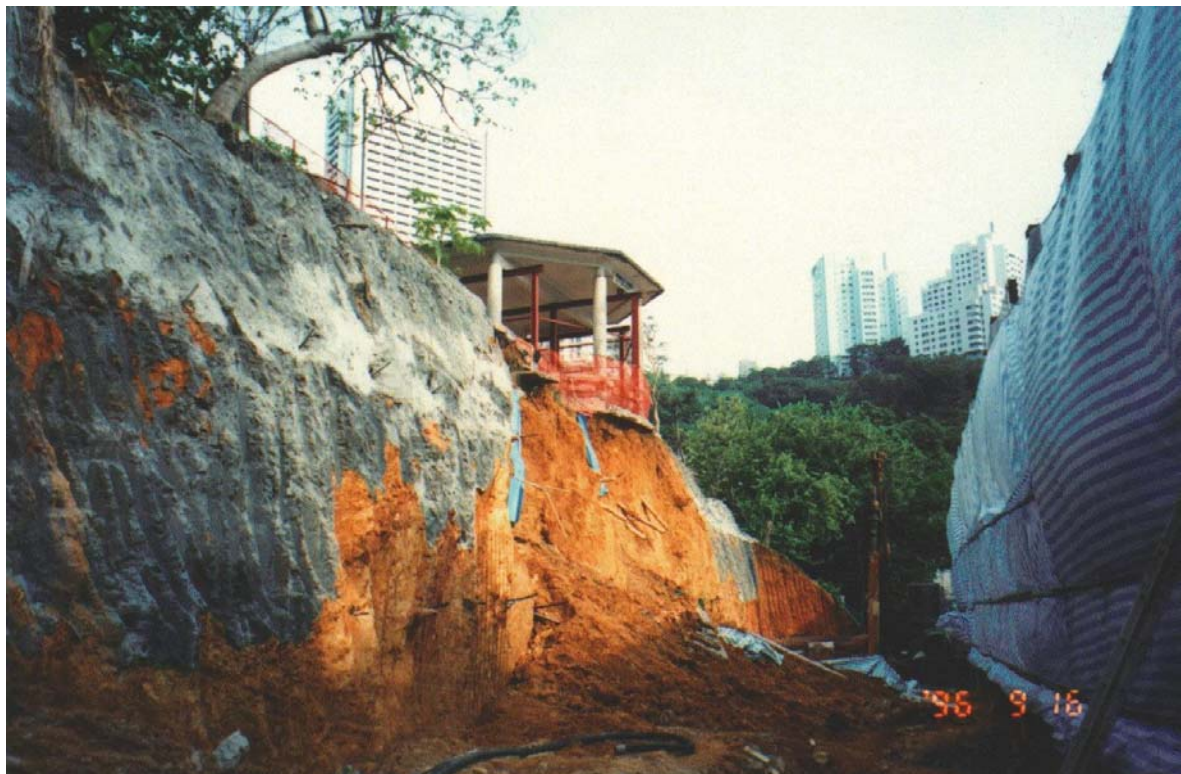
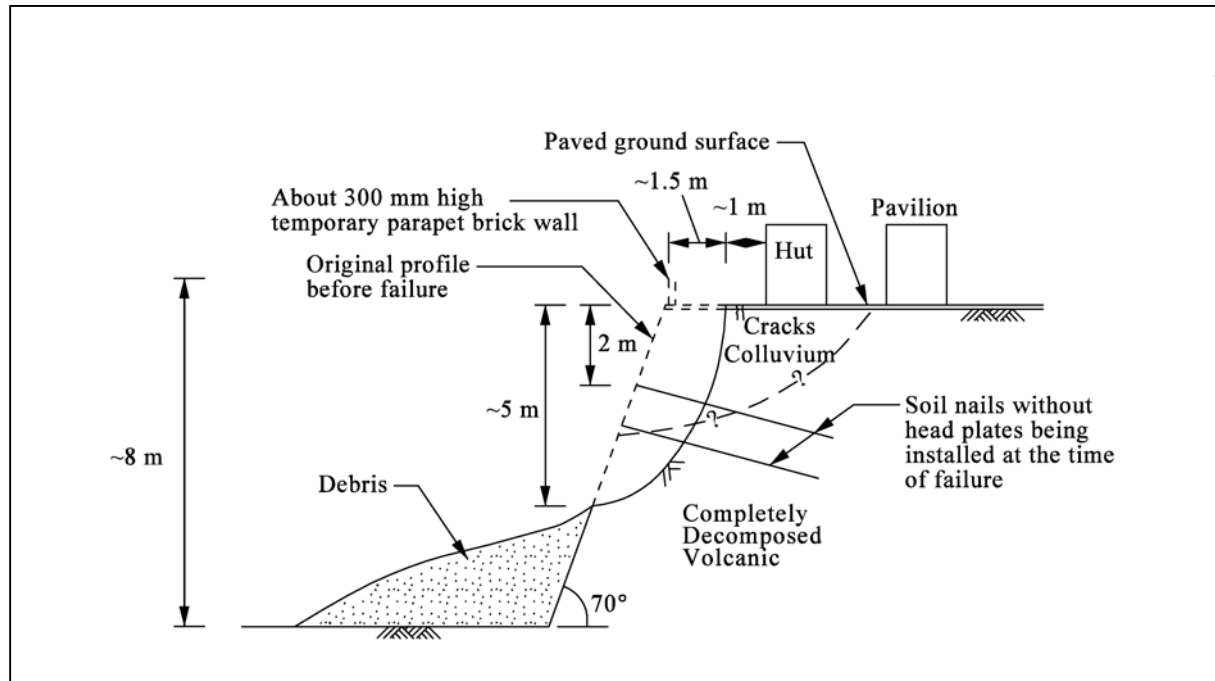
Case No. 21 – The 14 September 1996 Incident near the Junction of Victoria Road and Sandy Bay Road (Sheet 2 of 2)

Basic Data			
Date of Failure:	14 September 1996	Failure Volume/:	45 m ³ of colluvium and CDV
Weather at Date of Failure:	Heavy rainfall	Materials	
Feature Affected:	11SW-C/C186	Type of Failure:	Landslide
Type of Work:	Road improvement works	Consequences:	Temporary evacuation of 1 hut and 1 pavilion, partial closure of the Chinese Christian Cemetery
Client:	Government	Type of Supervision:	Full-time supervision by Resident Site Staff

The failure occurred during heavy rainfall on an 8 m high sub-vertical temporary soil cut slope with soil nails for the construction of a reinforced concrete retaining wall, as part of Victoria Road Improvement Project. Two rows of widely-spaced soil nails had been installed at the top portion of the cut slope at the time of failure, but the nail heads had not yet been constructed. The cut slope failed with the debris sliding down leaving the nails in position at the scarp. The volume of the failure debris was about 45 m³. It was observed by the GEO staff during a post-failure inspection that grouting between the steel bars and the surrounding soil in the soil nails had been poorly constructed. Cracks about 20 mm wide were noted on the paved surface over the slope crest. One hut and one pavilion near the crest were evacuated and the

Chinese Christian Cemetery behind the slope was partially closed as a result of the landslide. The landslide was probably caused by ingress of surface water into the temporary cut slope, thereby resulting in wetting and erosion of the soil, and possible development of seepage pressure. The contributory factors to the failure were considered to include convergent flow and heavy discharge of surface water into the slope, the absence of nail heads, the top row of soil nails being too low below the crest, wide nail spacing, and lack of surface protection to the temporary cut face.

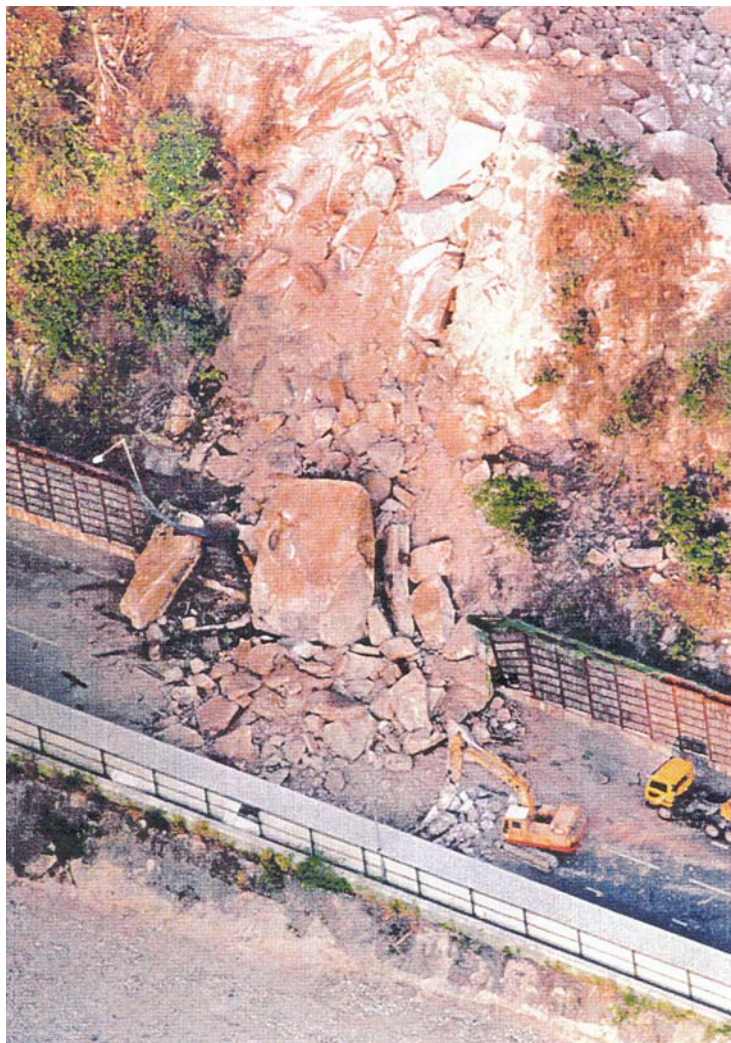
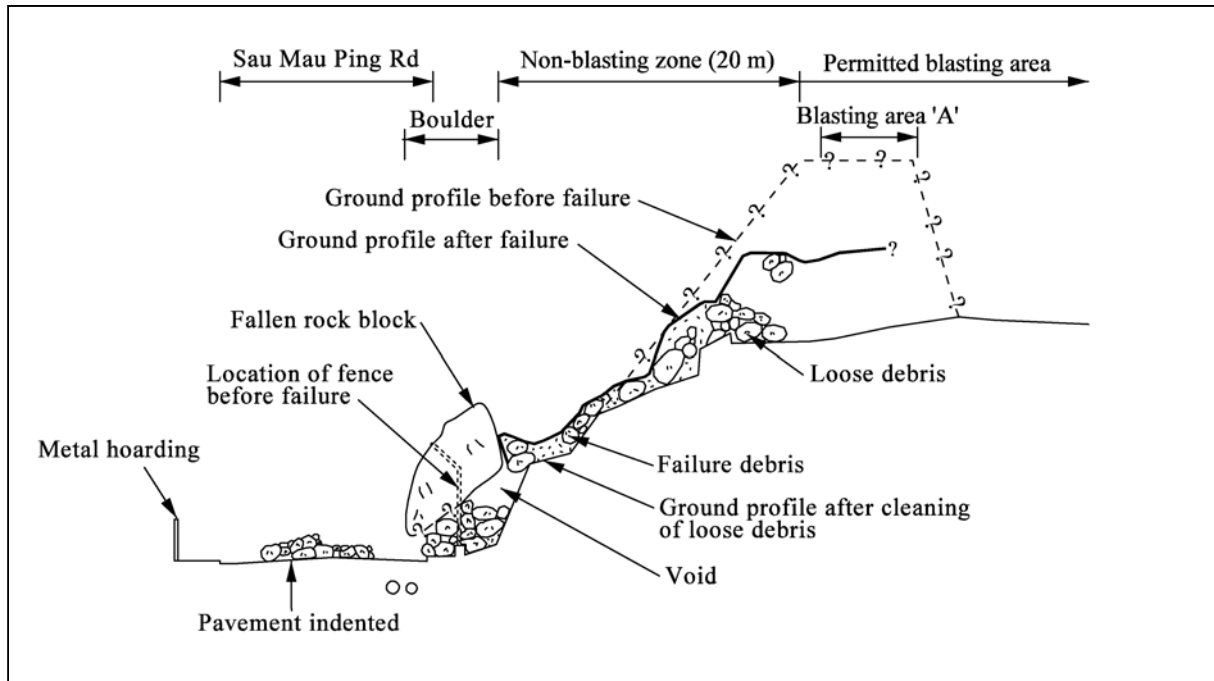
**Case No. 22 - The 4 December 1997 Incident at Sau Mau Ping Road, Kowloon
(Sheet 2 of 2)**

Date of Failure:	4 December 1997	Failure Volume/ Materials	1,000 m ³ of rock
Weather at Date of Failure:	Fine	Type of Failure:	Landslide
Feature Affected:	11NE-D/C7	Consequences:	Closure of Sau Mau Ping Road for 17 days
Type of Work:	Site formation works	Type of Supervision:	Full-time supervision by Resident Site Staff
Client:	Government

The failure occurred on a 25 m high rock slope adjacent Sau Mau Ping Road. The rock slope was located at the lower part of slope No. 11NE-D/C7, the top portion of which was being removed under on-going site formation works. The failure happened a few seconds after blasting had taken place behind the crest of the slope. As a normal safety precaution measure, the road section was closed to the traffic and was kept clear of people during blasting. The volume of the failure debris was about 1000 m³ and contained some large angular blocks of rock, the largest being about 150 m³. The debris destroyed a section of the protective fence erected along the toe of the slope and completely blocked Sau Mau Ping Road for a length of 25 m. The metal hoarding on the far side of the road was punched through at several locations. The failure

According to the detailed landslide study by the GEO (GEO Report No. 94), blasting was carried out at a close distance to the crest of the failed slope and the amount of explosives used was found to have exceeded the permitted value. The slope failure was caused by the shock waves and gas pressures generated by the blast which took place close to the crest of the slope.

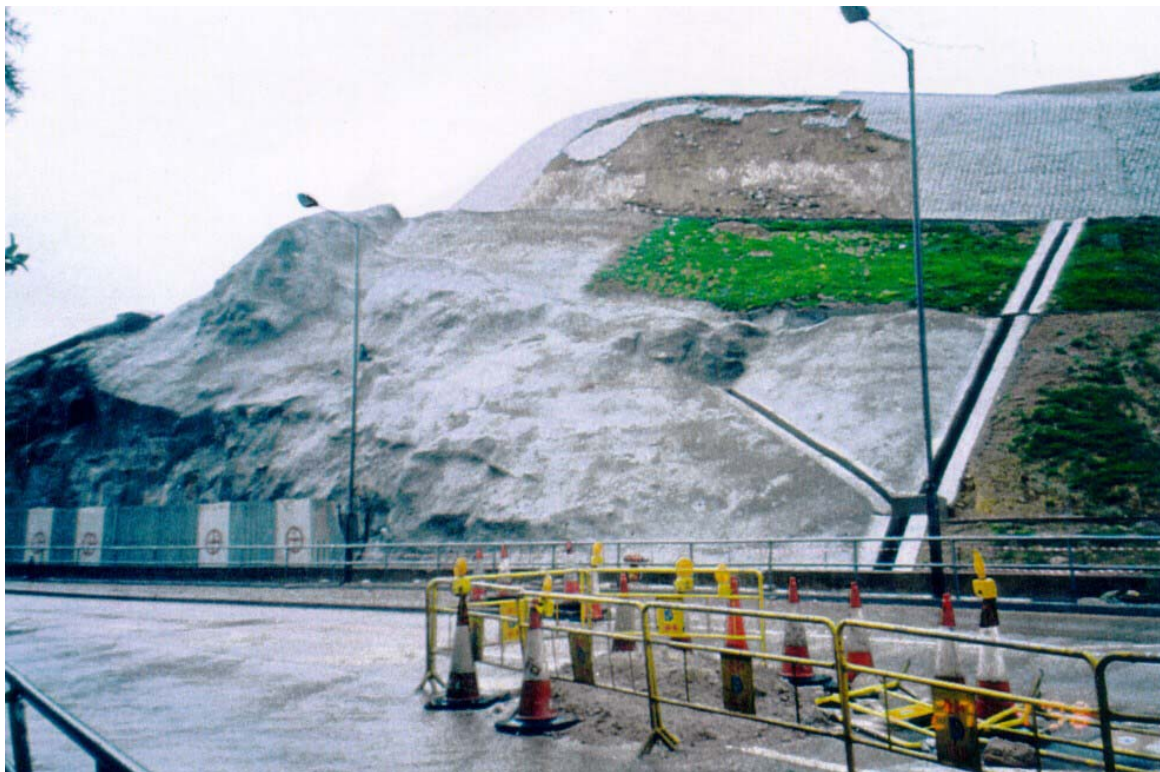
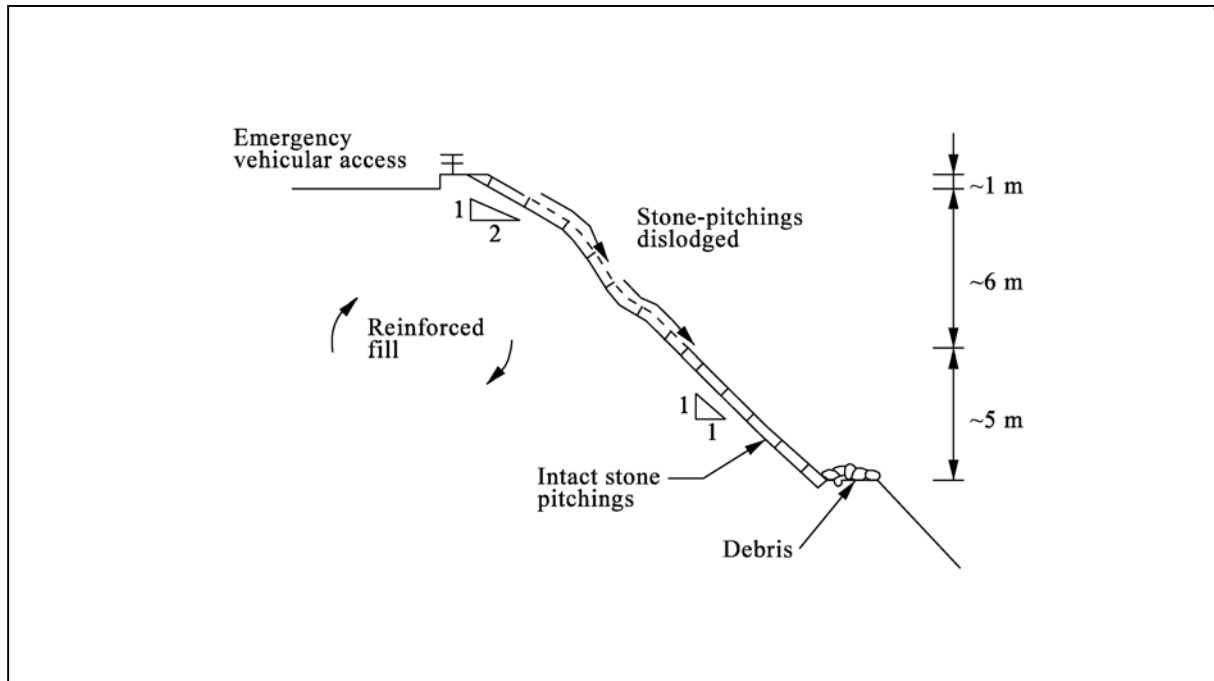
Case No. 23 - The 27 April 1998 Incident at Po Lam Road (Sheet 2 of 2)

Date of Failure:	27 April 1998	Failure Volume/ Materials	26 m ³ of fill and facing blocks
Weather at Date of Failure:	Light rain	Type of Failure:	Landslide
Feature Affected:	Not applicable	Consequences:	Temporary road closure for entire 3 lanes of major road (closed for 3 days)
Type of Work:	Reinforced fill embankment	Type of Supervision:	Full-time supervision by Resident Site Staff
Client:	Government

The landslide occurred during relatively light rain, on a reinforced fill embankment under construction for a Government site formation project. The embankment was about 12 m in height with a slope angle of 45°, except for the upper about 1 m which was locally inclined at 26° to the horizontal. The surface of the slope was protected with stone facing. The failure involved deformation of soil mass over an area of 7 m by 11.5 m and a tension crack sub-parallel to and about 2 m below the embankment crest. The deformed soil mass, about 20 m³ in volume, remained substantially on the embankment and about 6 m³ of debris slid onto a berm below. A few facing blocks travelled as far as the road at the toe of the slope, resulted in three lanes of the road being closed for three days.

The post-failure investigation concluded that the failure was probably due to poor horizontal positioning or absence of geogrids, which left a zone of unreinforced fill behind the facing blocks. Testing also showed that some of the fill had not been compacted to the required standard. The effects of rain infiltration and poor workmanship of the stone facing construction are also considered contributory factors to the failure. The works were being supervised by full-time resident site staff engaged by the Client Department.

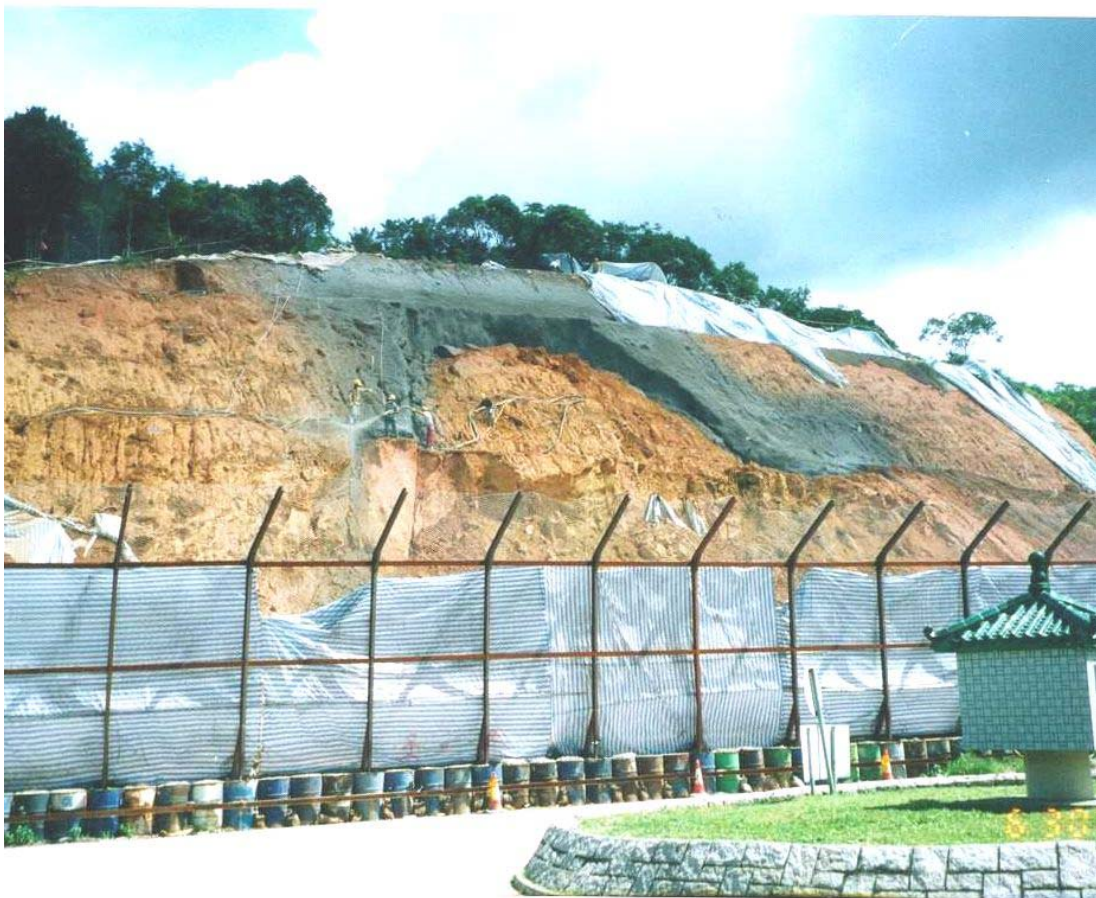
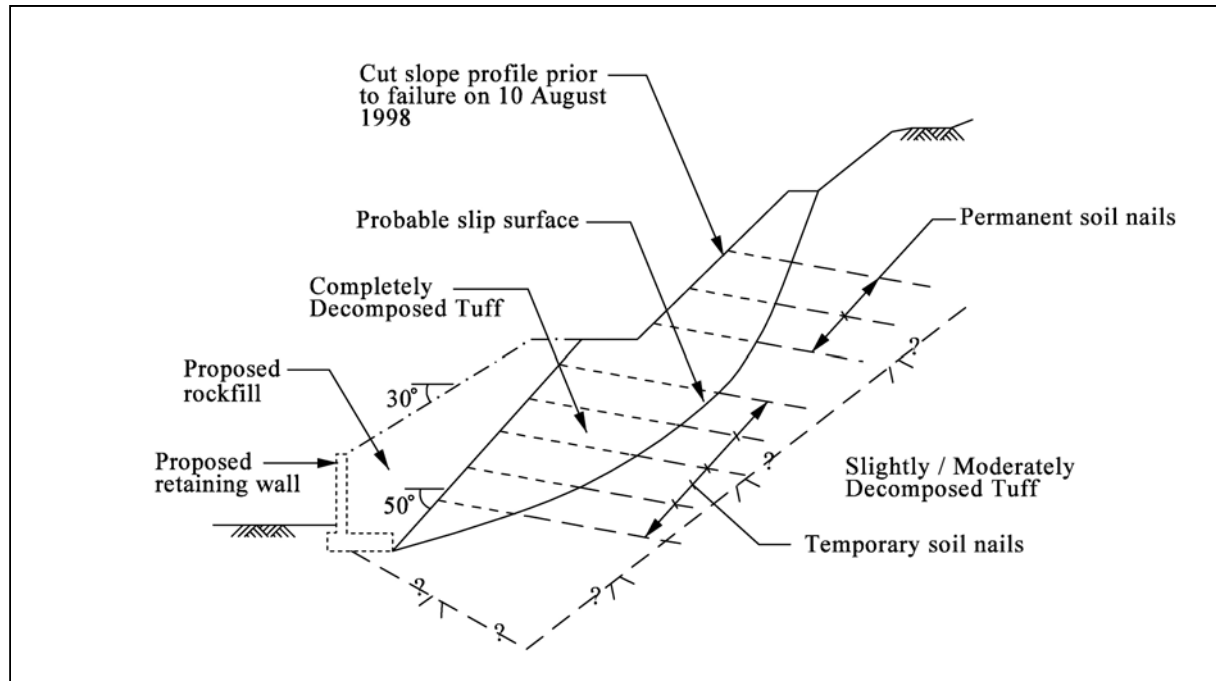
Case No. 24 - The 9 and 10 June 1998 Incidents at Junction of Sai Sha Road and Tai Mong Tsai Road (Sheet 2 of 2)

Date of Failure:	9 and 10 June 1998	Failure Volume/ Materials	900 m ³ of soil (1 st) 1,700 m ³ of soil (2 nd)
Weather at Date of Failure:	Heavy rainfall	Type of Failure:	Landslide
Feature Affected:	8SW-A/C8	Consequences:	Landslide debris deposited within the construction site
Type of Work:	Slope upgrading works	Type of Supervision:	Full-time supervision by Resident Site Staff
Client:	Government

The two landslides occurred consecutively on a soil cut slope where LPM works were in progress, which included the construction of a RC retaining wall at the slope toe with rockfill behind the wall backfilled up to about 2 thirds of the slope height. Permanent soil nails were proposed in the upper third of the slope and temporary soil nails were included in the design to reinforce a 50° temporary cut to provide space for the RC wall construction. Both landslides occurred when the soil nails were being installed during the temporary works stage. No casualties were reported as a result. The landslides were caused by the groundwater conditions much more severe than those assumed in the temporary works design, which relied on the works being carried out during the dry season. The construction was delayed and temporary

slope works had to be carried out during the wet season, hence exposing the temporary slopes to conditions not being envisaged and allowed for in the original design, and such effects also not subsequently being assessed in construction reviews. The absence of some of the nail heads at the time of failure and the nail head detailing incorporating small (150 mm square) steel plates, were probably not effective in providing support to the temporary slopes.
