REVIEW OF NOTABLE LANDSLIDE INCIDENTS DURING SLOPE WORKS

GEO REPORT No. 171

H.W. Sun & H.M. Tsui

**GEOTECHNICAL ENGINEERING OFFICE
CIVIL ENGINEERING AND DEVELOPMENT DEPARTMENT
THE GOVERNMENT OF THE HONG KONG
SPECIAL ADMINISTRATIVE REGION**

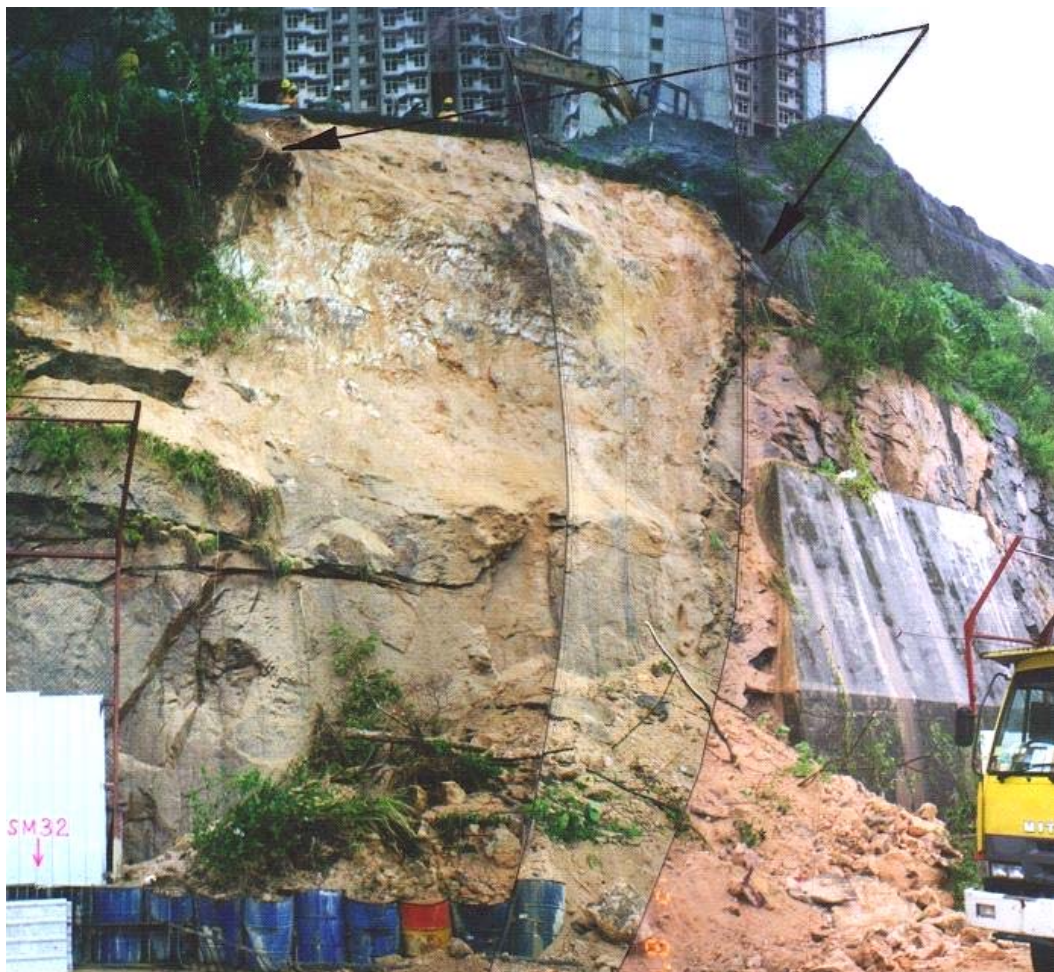
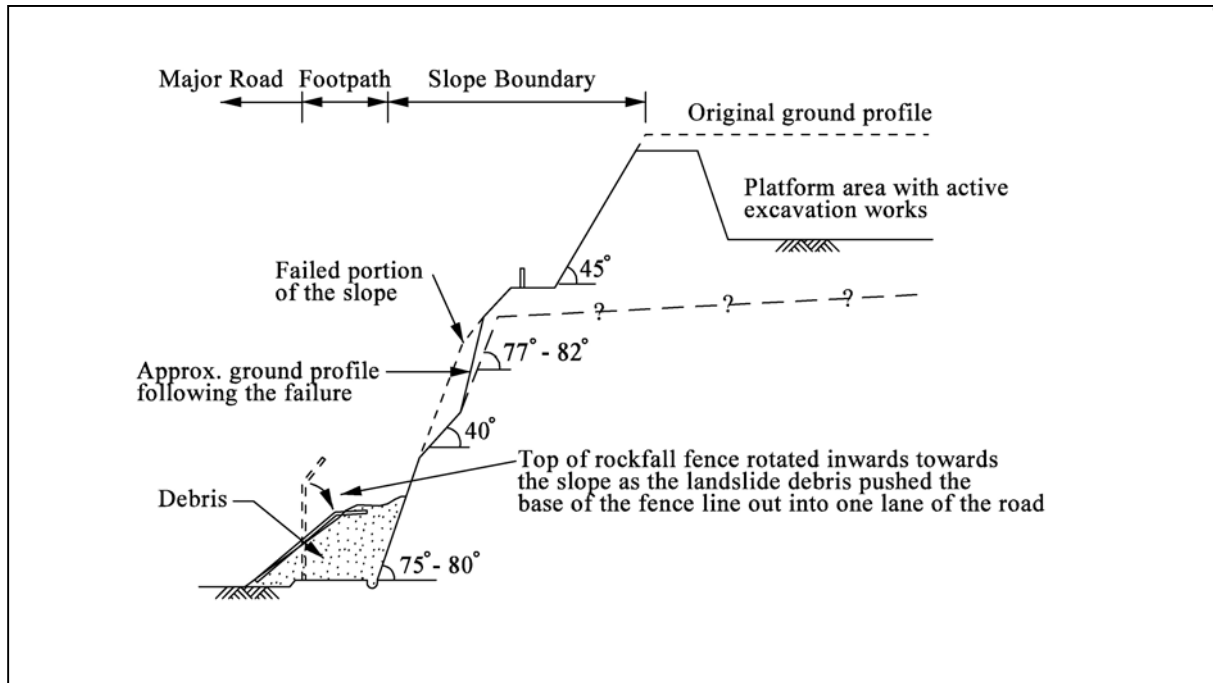
Case No. 25 - The 12 August 1999 Incident at a Private Development Site (Sheet 2 of 2)

Date of Failure:	12 August 1999	Failure Volume/ Materials	25 m ³ of soil/rock debris
Weather at Date of Failure:	Light rainfall	Type of Failure:	Landslide
Feature Affected:	Not applicable	Consequences:	Road closed for about 12 hours
Type of Work:	Excavation works at crest of slope in progress	Type of Supervision:	AP/Geotechnical Consultant's staff
Client:	Private Developer

The landslide involved the failure of a 25 m high slope previously upgraded under the 1988/89 LPM Programme. At the time of the failure, the slope was within an active construction site and excavation works were in progress at the crest of the slope. The landslide resulted in temporary closure of a major road.

protective measures against direct infiltration across the formation being excavated above the slope where the landslide occurred. Intense weathering and clay infilled discontinuities were present locally within the cut slope at the failure location.

The landslide was triggered by moderate rainfall (estimated maximum return period of less than 2 years). The rainstorm was less severe than other rainstorms experienced at the site in the past. The cause of the landslide is probably related to recent changes in the site setting associated with the active construction site. Observations made shortly after the landslide revealed that there were no proper drainage provisions or precautionary

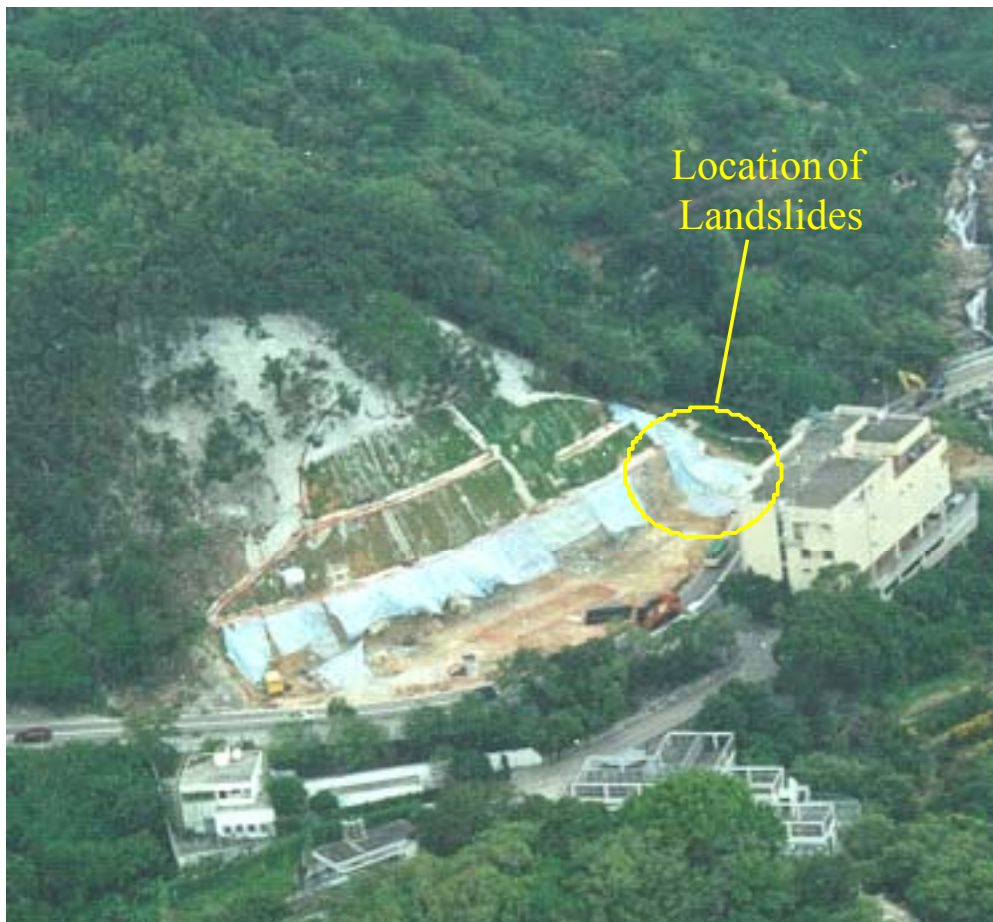
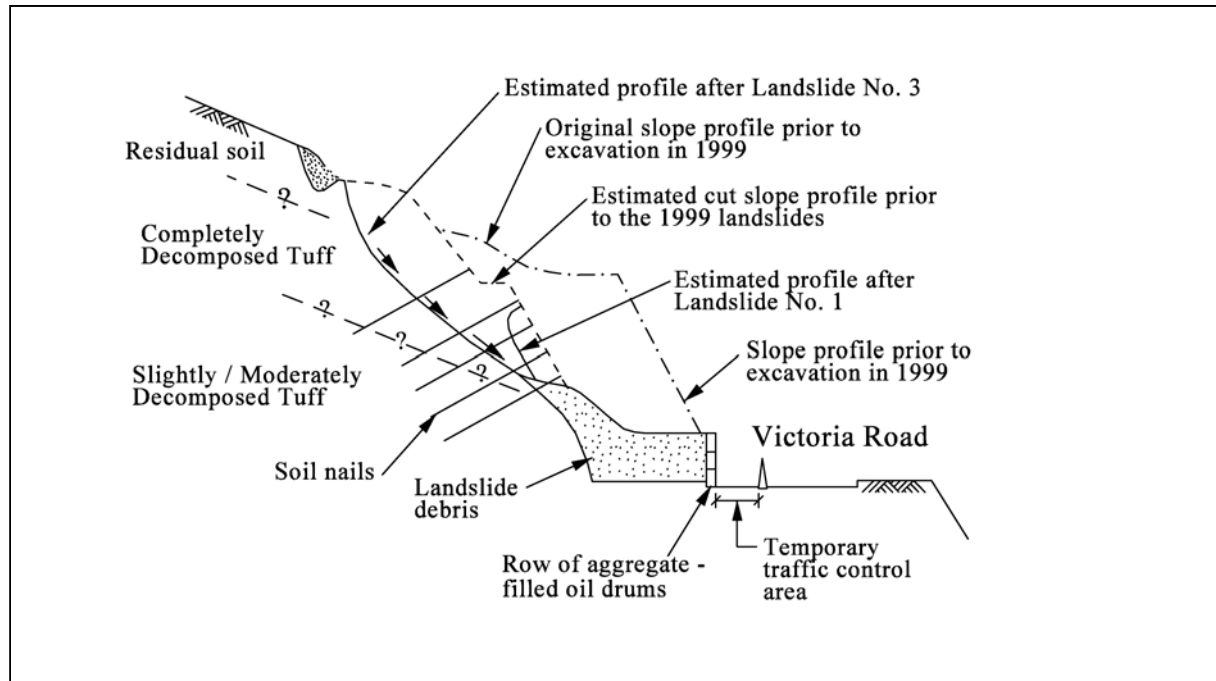
Case No. 26 - The 23 and 24 August 1999 Incidents at Victoria Road Opposite the Access Road to the Pok Fu Lam Kennels (Sheet 2 of 2)

Basic Data			
Date of Failure:	<i>23 & 24 August 1999</i>	Failure Volume/ Materials	<i>40 m³ of decomposed volcanic rock</i>
Weather at Date of Failure:	<i>Moderate rainfall</i>	Type of Failure:	<i>Landslide</i>
Feature Affected:	<i>Not applicable</i>	Consequences:	<i>Washout debris covered Victoria Road</i>
Type of Work:	<i>Road widening, slope works in progress</i>	Type of Supervision:	<i>Full-time supervision by Resident Site Staff</i>
Client:	<i>Government</i>

Three landslide incidents occurred at a 10 m high section of a cut slope where slope works were being carried out at the time of failure and soil nails had been installed (but with the nail head lattice structure yet to be constructed). Most of the debris was impeded by aggregate-filled oil drums placed at the slope toe but washout debris covered both lanes of Victoria Road. No casualties were reported as a result of the landslide.

The rainfall that triggered the failures was moderate (estimated maximum return period of about 4 years). Contributory factors to the failures included blockage of surface water drainage provisions, inadequate surface protection against infiltration, and presence of erosion pipes and open joints (exposed in the landslide scar).

There were also adverse geological features (i.e. steep orthogonal relict joints forming the side release surfaces, a shallowly to moderately-inclined relict joint dipping out of the slope face forming the basal surface of rupture and the possible presence of a fault through the cut slope). The absence of structural nail heads at the time of failure would probably have prevented the nailed slope from acting effectively as an integrated mass.

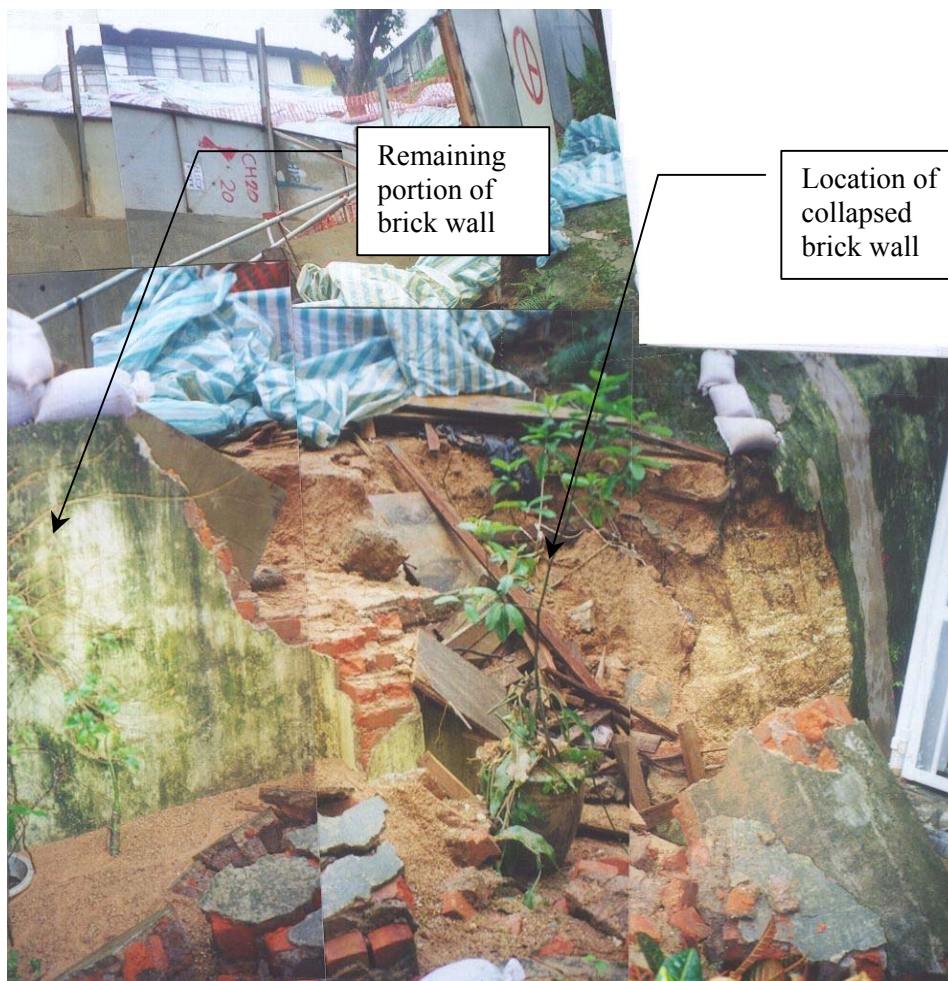
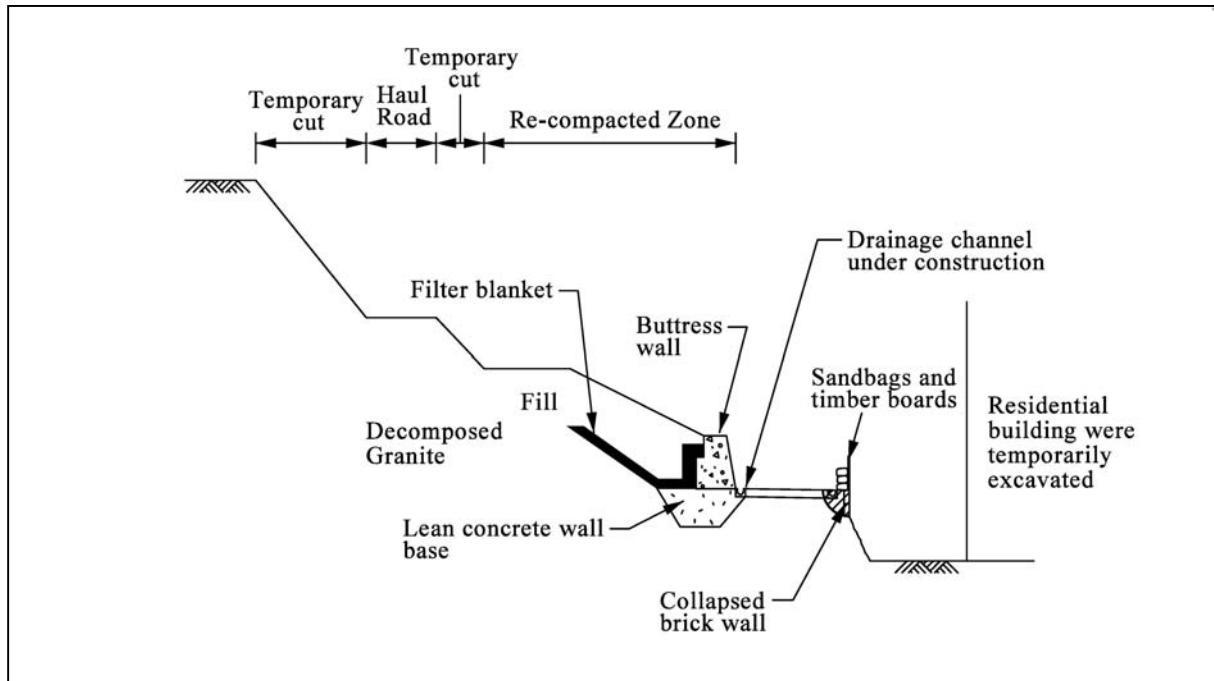
**Case No. 27 - The 3 April 2000 Incident behind No. 279 Prince Edward Road West
(Sheet 2 of 2)**

Date of Failure:	<i>3 April 2000</i>	Failure Volume/ Materials	<i>6 m³ of debris</i>
Weather at Date of Failure:	<i>Fairly heavy rainfall</i>	Type of Failure:	<i>Washout and collapse of brick wall</i>
Feature Affected:	<i>11NW-D/FR183</i>	Consequences:	<i>Residential building temporarily evacuated</i>
Type of Work:	<i>Slope upgrading works</i>	Type of Supervision:	<i>Full-time supervision by Resident Site Staff</i>
Client:	<i>Government</i>

The incident occurred at around 8:00 p.m. on 3 April 2000 at an active LPM site and involved the collapse of a 1.5 m high brick wall just outside the site during heavy rainfall. A loose fill slope above the unregistrable brick wall was being upgraded by means of recompaction under the supervision of a consultant to the GEO. No casualties were reported as a result of the incident but all of the 12 units of a residential building below the toe of the fill slope had to be temporarily evacuated.

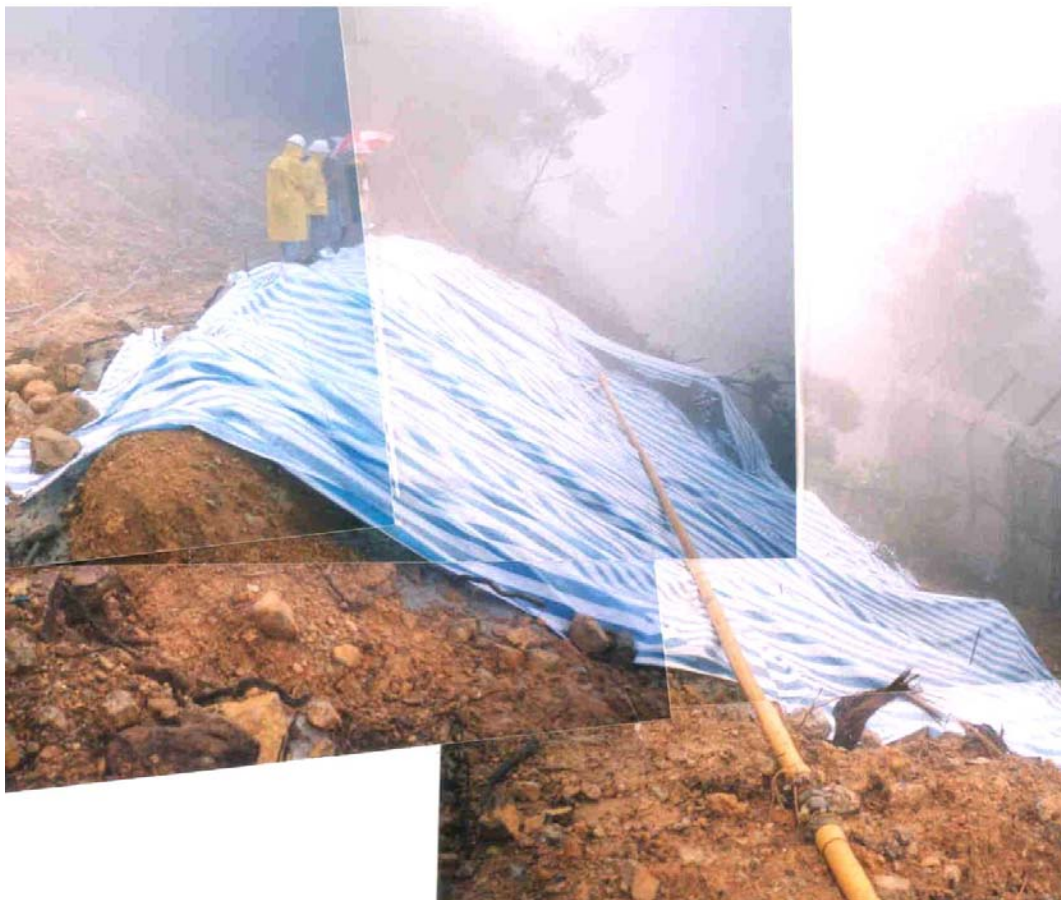
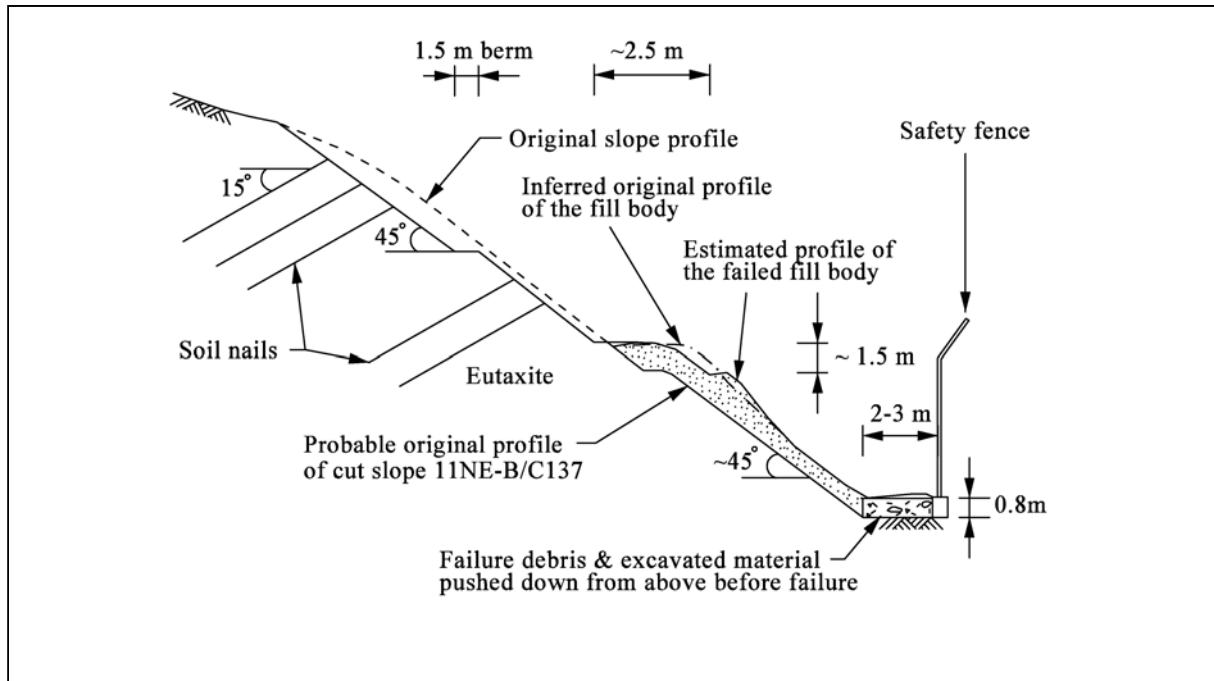
Case No. 28 - The 23 April 2000 Incident at Clear Water Bay Road (Sheet 2 of 2)

Date of Failure:	<i>23 April 2000</i>	Failure Volume/ Materials	<i>50 m³ of fill</i>
Weather at Date of Failure:	<i>Moderate rainfall</i>	Type of Failure:	<i>Washout</i>
Feature Affected:	<i>11NE-B/C137</i>	Consequences:	<i>Temporary road closure</i>
Type of Work:	<i>Road improvement works</i>	Type of Supervision:	<i>Full-time supervision by Resident Site Staff</i>
Client:	<i>Government</i>

The incident involved the failure of a loose fill body perching on a cut slope, which was being upgraded under a road improvement project. The failure debris was all contained within the boundary of the active construction site. No casualties were reported as a result of the incident.

The loose fill body involved in the failure was formed by end-tipping of materials over the cut slope in providing a platform for drilling of the proposed soil nails. Also, materials excavated from the upper slope were pushed over the haul road onto the lower slope and trucked away at the slope toe. There were no temporary or permanent drainage provisions at the time of the incident. The fill body slumped and partly slipped during the incident.

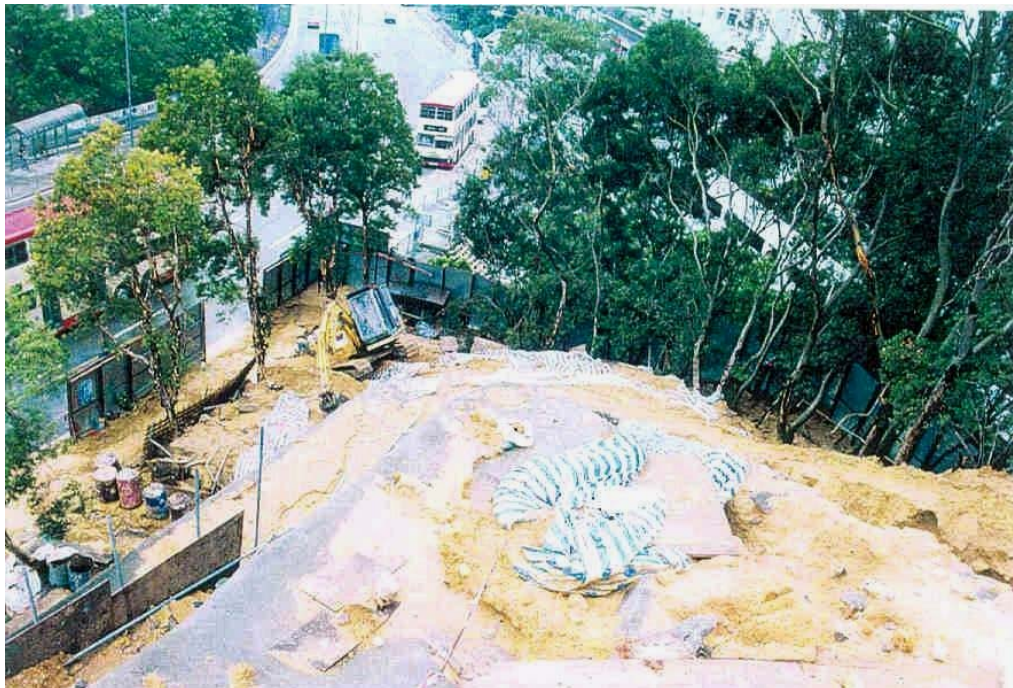
Case No. 29 - The 12 June 2000 Incident at Ching Hong Road, Tsing Yi (Sheet 2 of 2)

Date of Failure:	12 June 2000	Failure Volume:/ Materials	35 m ³ of soil
Weather at Date of Failure:	Black rainstorm warning	Type of Failure:	Washout
Feature Affected:	10NE-B/C2	Consequences:	Washout debris covered the public road, no road closure
Type of Work:	Slope upgrading works	Type of Supervision:	Full-time supervision by Resident Site Staff
Client:	Government

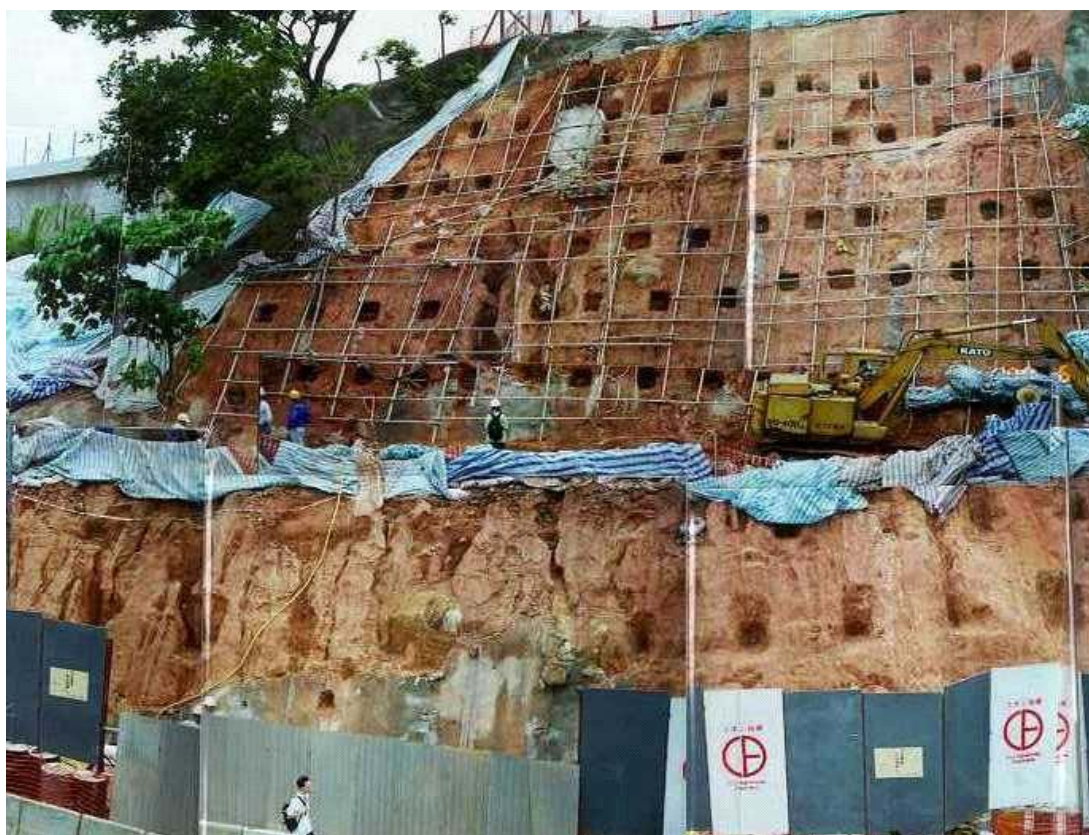
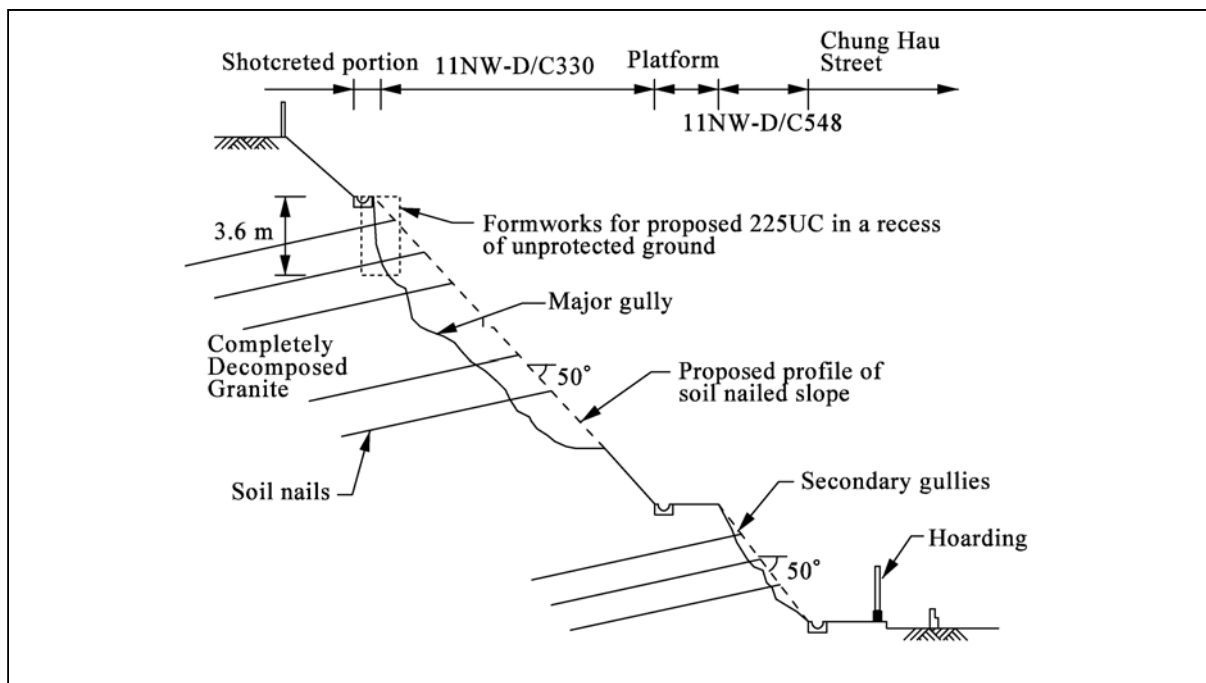
**Case No. 30 - The 12 June 2000 Incident at Chung Hau Street, Ho Man Tin
(Sheet 2 of 2)**

Date of Failure:	12 June 2000	Failure Volume/ Materials	30 m ³ of fill
Weather at Date of Failure:	Moderate rainfall	Type of Failure:	Washout
Feature Affected:	11NW-D/C330 and C548	Consequences:	Debris deposited within the site boundary
Type of Work:	Slope upgrading works	Type of Supervision:	Full-time supervision by Resident Site Staff
Client:	Government

The incident involved a washout failure on a cut slope during rainfall, which was being upgraded under the LPM Programme. Majority of the washout debris remained within the boundary of the active construction site. No casualties were reported as a result of the incident.

Located above the cut slope was a WSD service reservoir, around which was a perimeter drain. Part of the surface water collected by this perimeter drain was designed to discharge off site via a system of permanent drains on the cut slope. At the time of the washout failure, part of the permanent drains on the cut slope was being replaced. The original concrete channels had been demolished leaving unlined trenches. At the time of the incident surface water from the perimeter

drain in the WSD compound discharged off site into the incomplete drainage system on the slope, and this resulted in the washout failure.

A similar washout failure, but less severe, occurred at the same location about 2 months before the incident, indicating that the drainage provisions had been inadequate for some time.

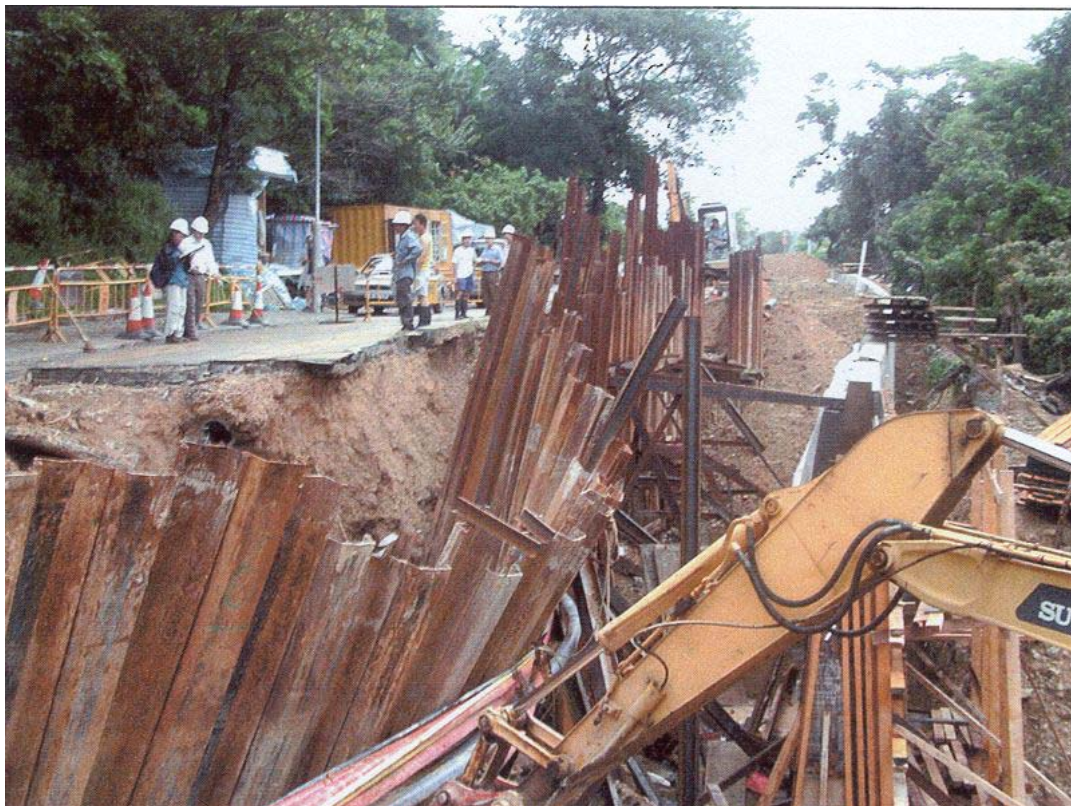
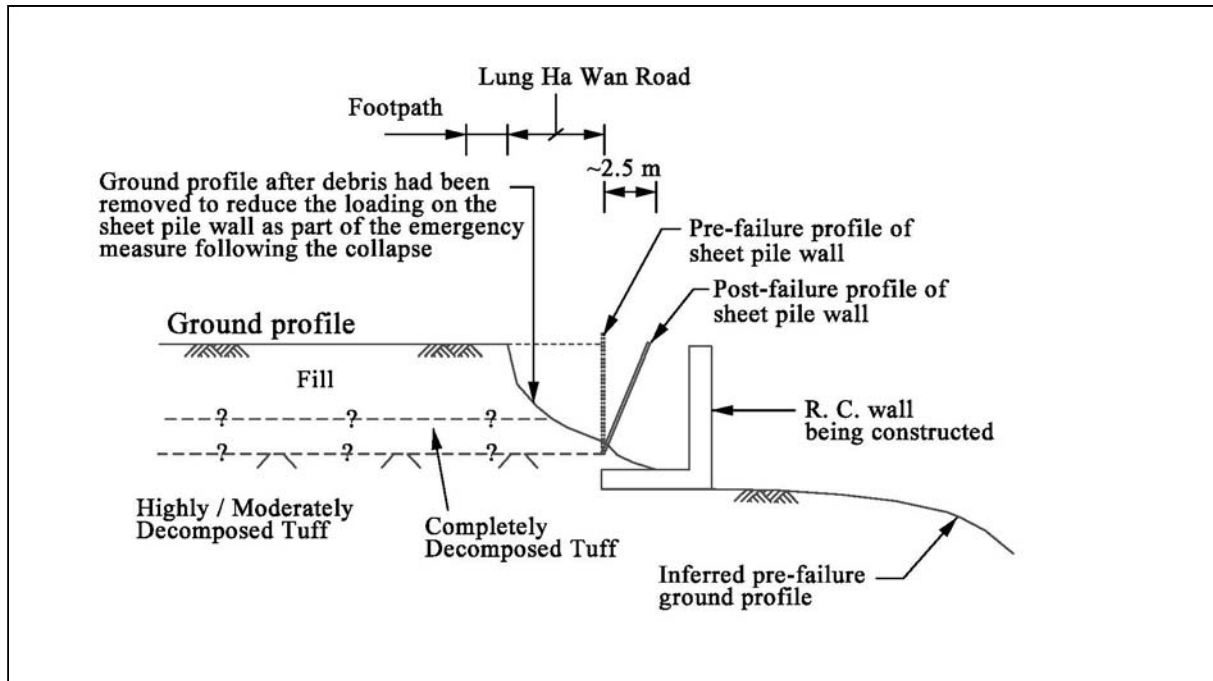
Case No. 31 - The 24 August 2000 Incident Below Lung Ha Wan Road (Sheet 2 of 2)

Date of Failure:	24 August 2000	Failure Volume/ Materials	200 m ³ of fill
Weather at Date of Failure:	Heavy rainfall	Type of Failure:	Sheet pile failure
Feature Affected:	Not applicable	Consequences:	Temporary road closed for two days
Type of Work:	Road widening, sheeting in progress	Type of Supervision:	Full-time supervision by Resident Site Staff
Client:	Government

The incident occurred during heavy rainfall on a road improvement works site. A section of a 55 m long temporary sheet pile wall collapsed resulting in the closure of Lung Ha Wan Road for two days. No casualties were reported as a result of the incident. The sheet pile wall was being constructed to provide temporary support to Lung Ha Wan Road during the construction of a new reinforced concrete retaining wall to widen the road.

The failure of the wall was probably due to the build-up of groundwater pressure behind the wall and inadequate lateral support provided to the wall. Build up of groundwater pressure was considered likely to have been associated with the driving of the sheet pile wall through, and blockage of, a reinforced concrete culvert

The temporary sheet pile wall system was designed by the contractor and was certified by an Independent Checking Engineer. The design was also accepted by the Engineer. However, the construction of the sheet pile wall did not conform to the approved design drawings. The Resident Site Staff had previously observed the non-conformities of the shoring system for the wall and repeatedly warned the contractor over the 6-month period preceding the failure. No action was taken by the contractor and the works proceeded despite the non-conformities.

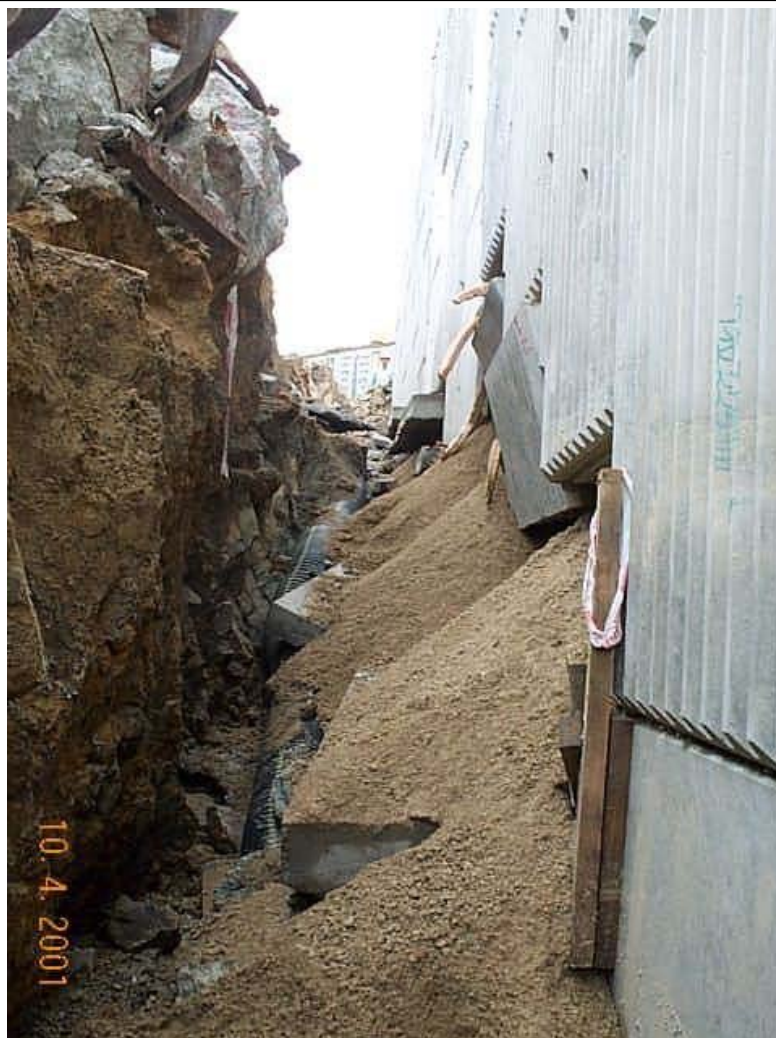
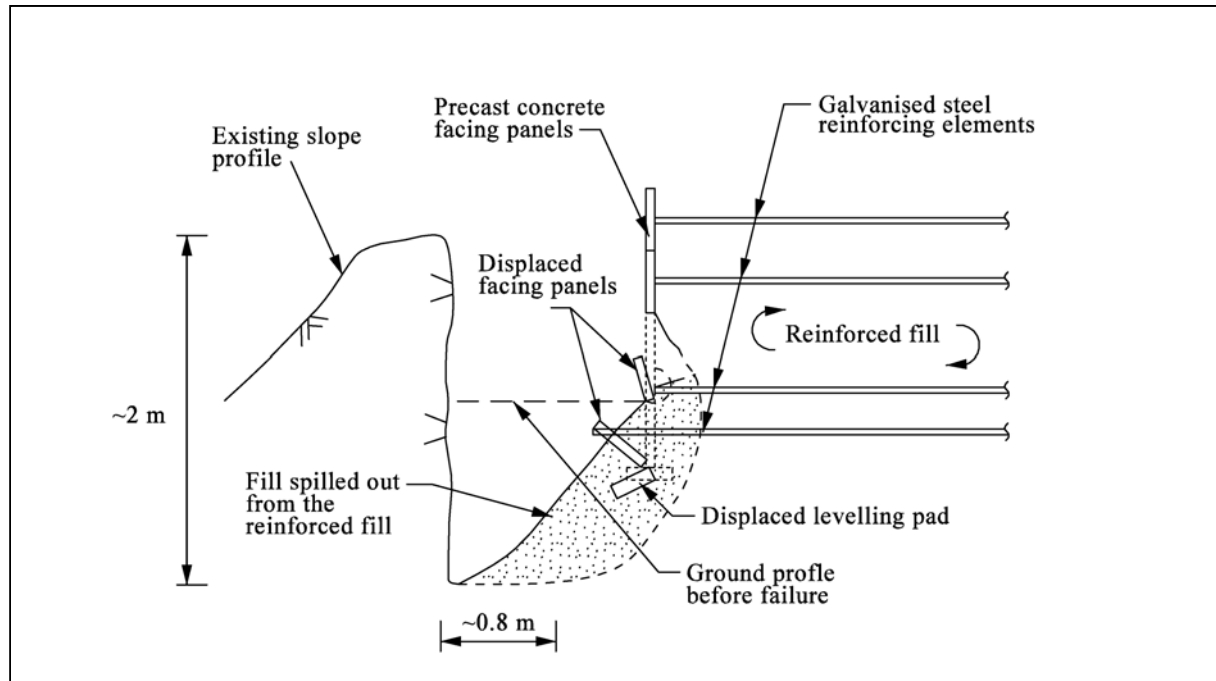
Case No. 32 - The 9 April 2001 Incident at Tsing Yi Northern Coast Road Site above Tam Kok Shan Road (Sheet 2 of 2)

Basic Data			
Date of Failure:	9 April 2001	Failure Volume/ Materials	35 m ³ of fill
Weather at Date of Failure:	Heavy rainfall (Amber Rainstorm)	Type of Failure:	Washout
Feature Affected:	Reinforced fill wall failure	Consequences:	Temporary Tam Kon Shan Road closure and a large section of the reinforced fill wall was reconstructed
Type of Work:	Reinforced fill wall for road construction		
Client:	Government	Type of Supervision:	Full-time supervision by Resident Site Staff

The incident occurred during heavy rainfall during construction of a reinforced fill wall which was part of the works for a road construction project. The reinforced fill wall was being constructed to support a link road to connect the proposed carriageway of Tsing Yi Northern Coast Road to Tam Kon Shan Road. The foundation of the reinforced fill wall was undermined by concentrated surface runoff resulting in significant distress and movement of the wall. Out wash material was deposited on Tam Kok Shan Road and the road was closed for two hours.

surface runoff flow eroded part of the compacted fill behind the wall as well as the ground material beneath the wall foundation. The failure of the wall was probably due to lack of an adequate system of temporary drainage.
