REPORT ON THE SHEK KIP MEI LANDSLIDE OF 25 AUGUST 1999

GEO REPORT No. 181

**Fugro Maunsell Scott Wilson Joint Venture
&
Professor J. B. Burland**

**GEOTECHNICAL ENGINEERING OFFICE
CIVIL ENGINEERING AND DEVELOPMENT DEPARTMENT
THE GOVERNMENT OF THE HONG KONG
SPECIAL ADMINISTRATIVE REGION**

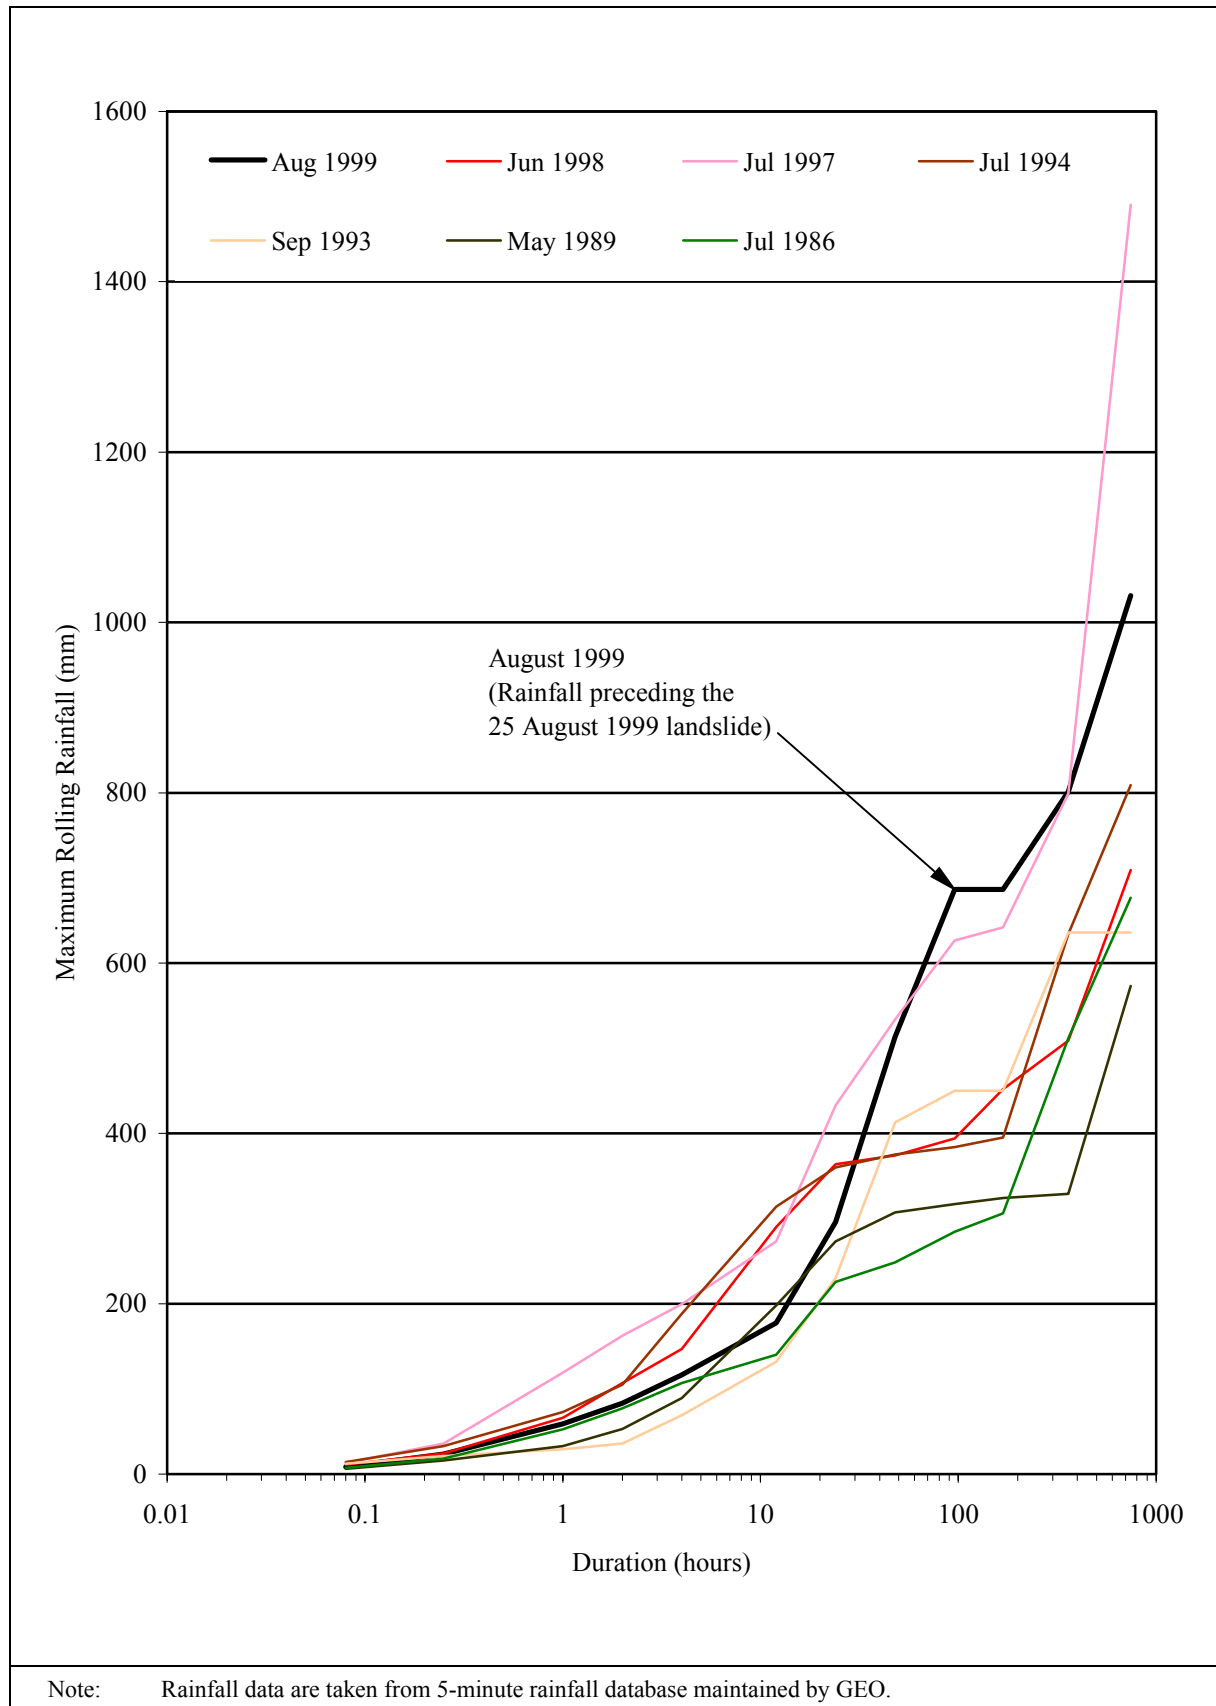
Figure 14 - Maximum Rolling Rainfall at GEO Raingauge No. K06 for Major Rainstorms between 1982 and 1999

The August 1999 rainstorm was comparable to the severe rainstorm in July 1997 (Figure 14), when no major instability similar to that of 25 August 1999 was noted at that time. This also suggests that the slope may have been subjected to deterioration such that the slope became more vulnerable to the effects of rainfall.

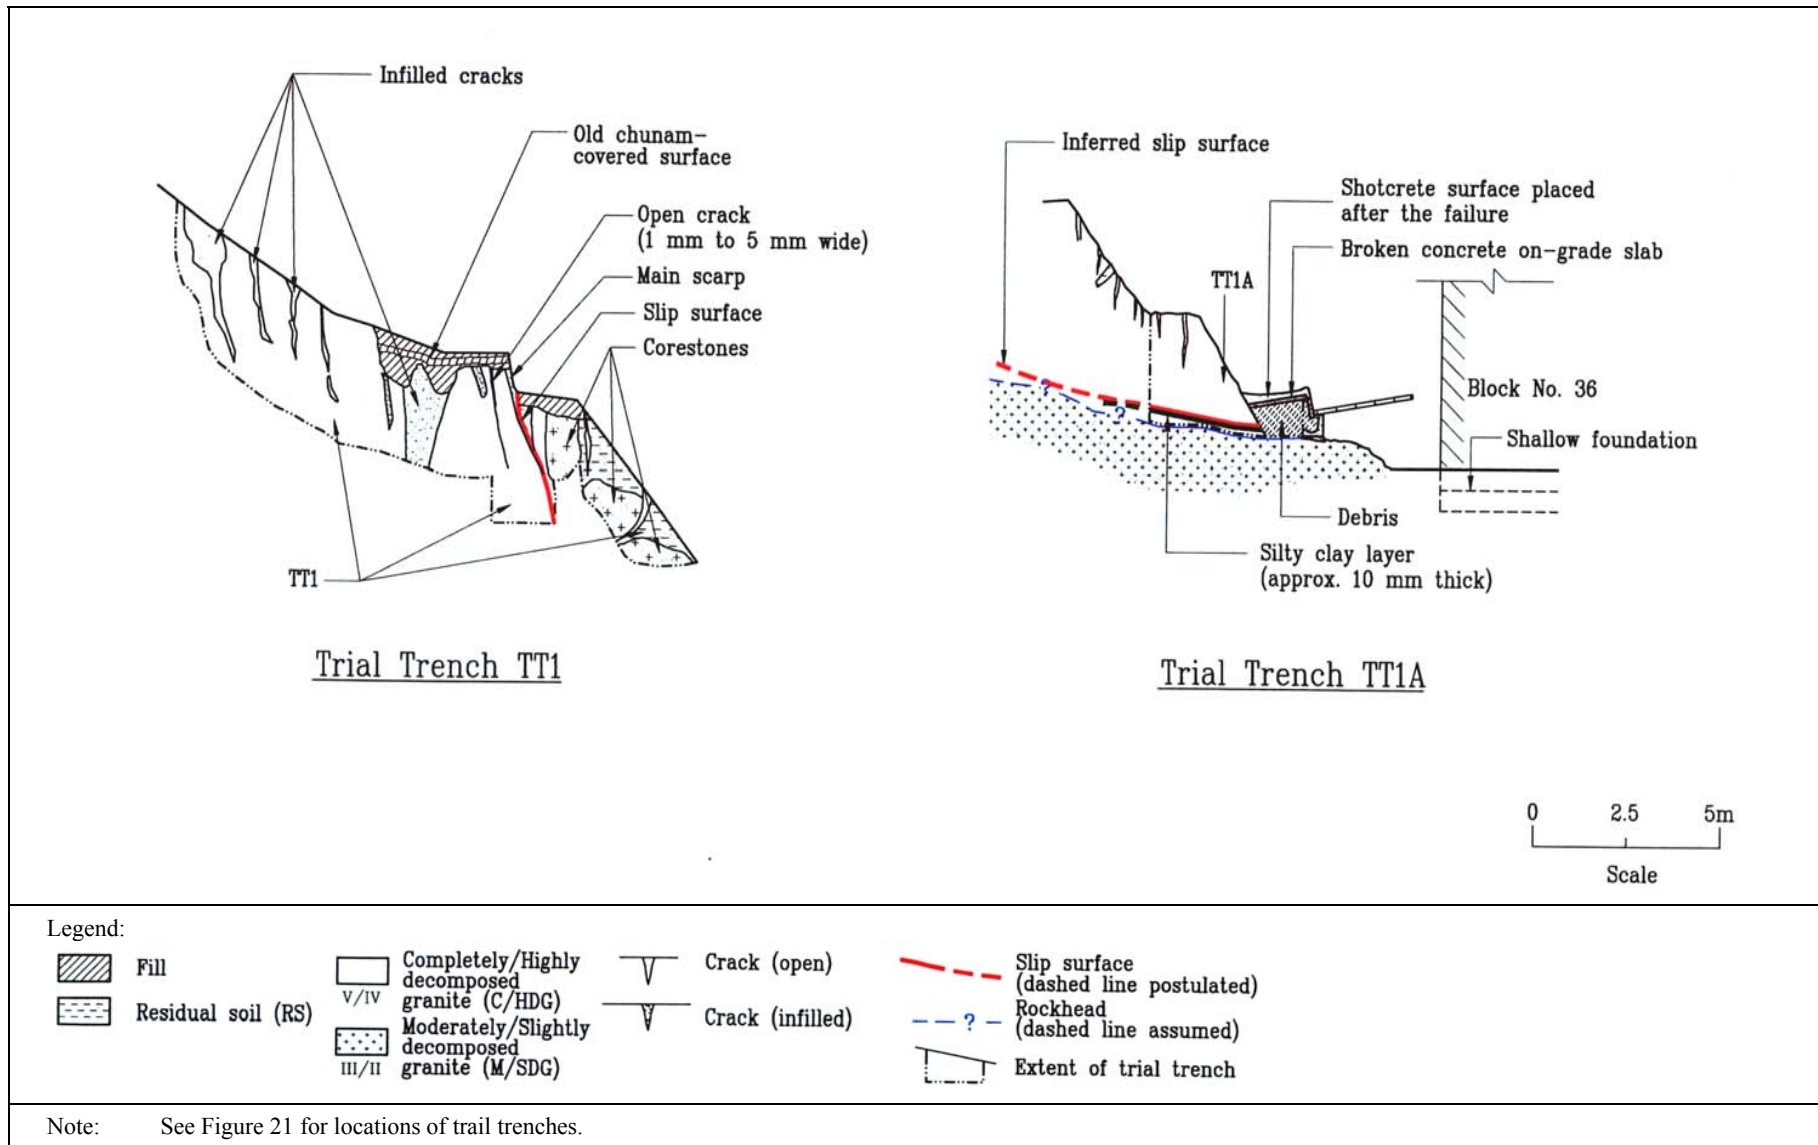
Figure 22 - Main Observations in Trial Trenches at Section 1-1

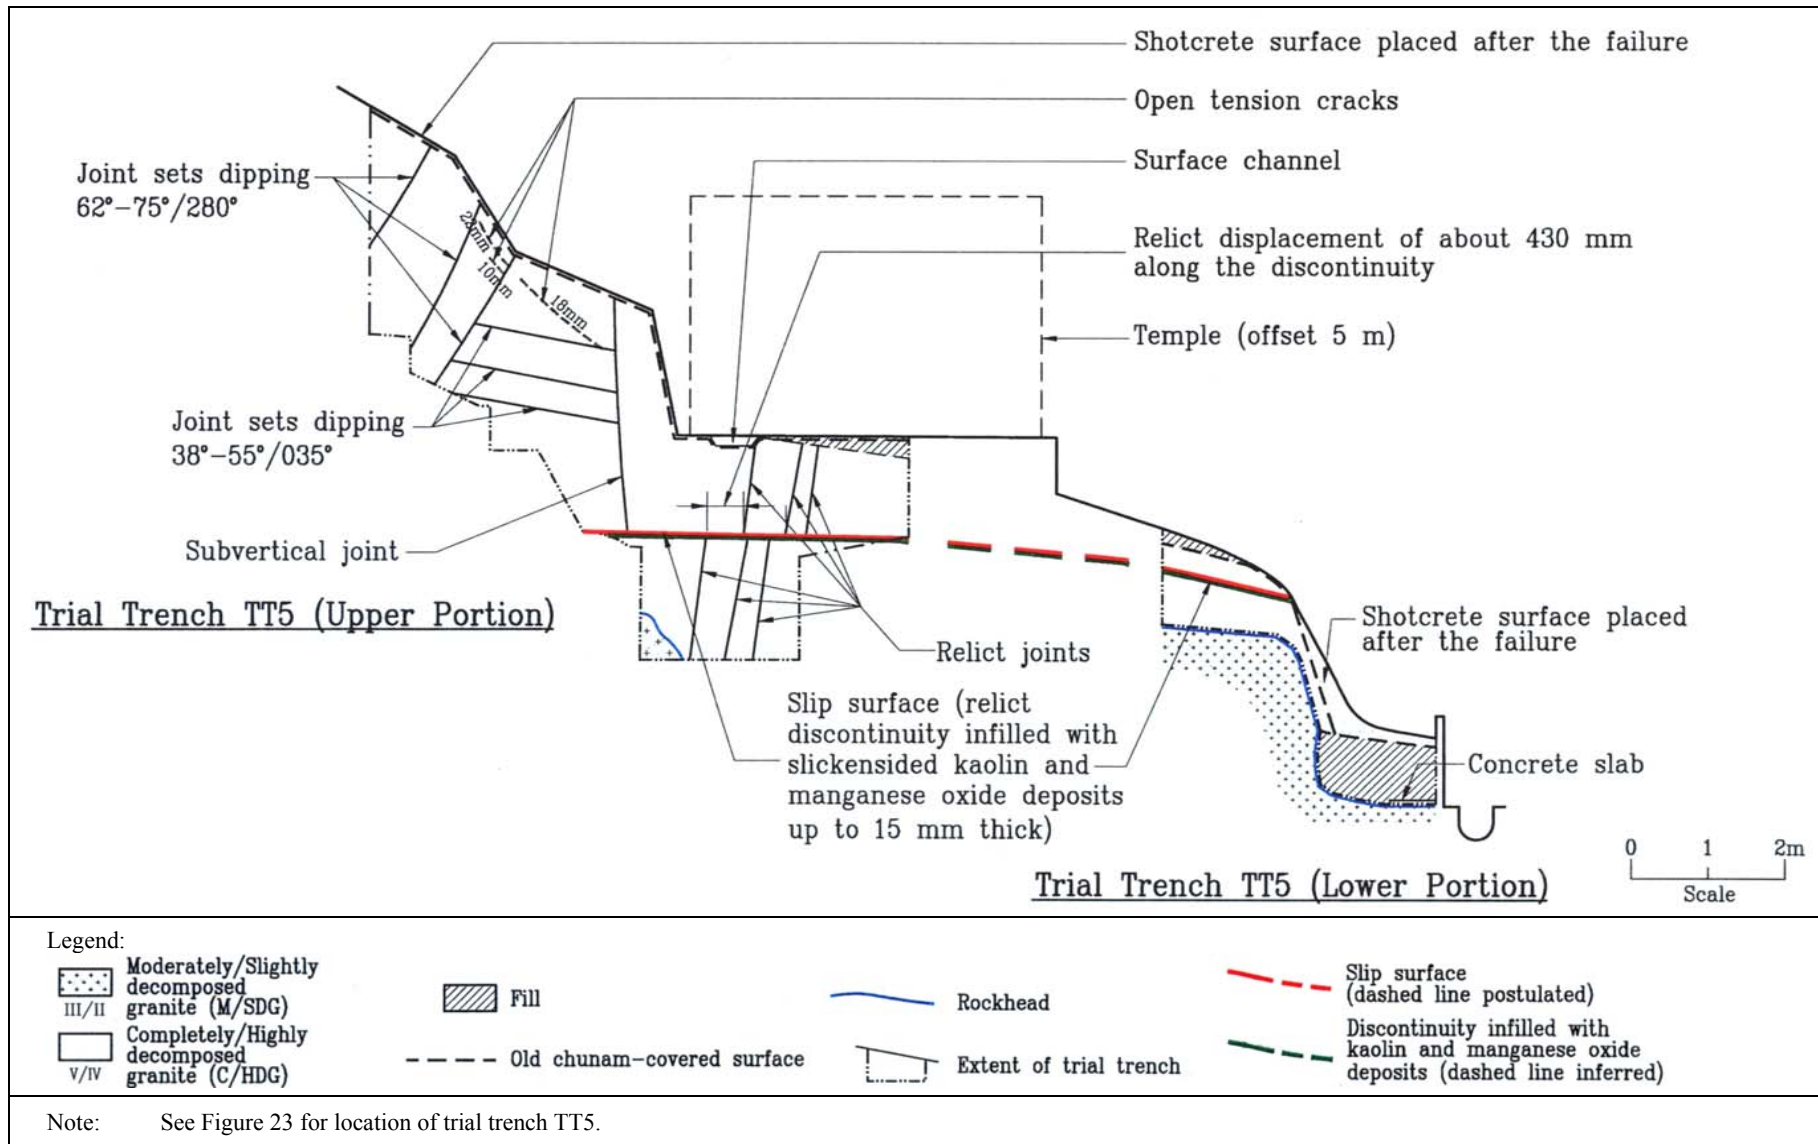
Figure 24 - Main Observations in Trial Trenches at Section 2-2

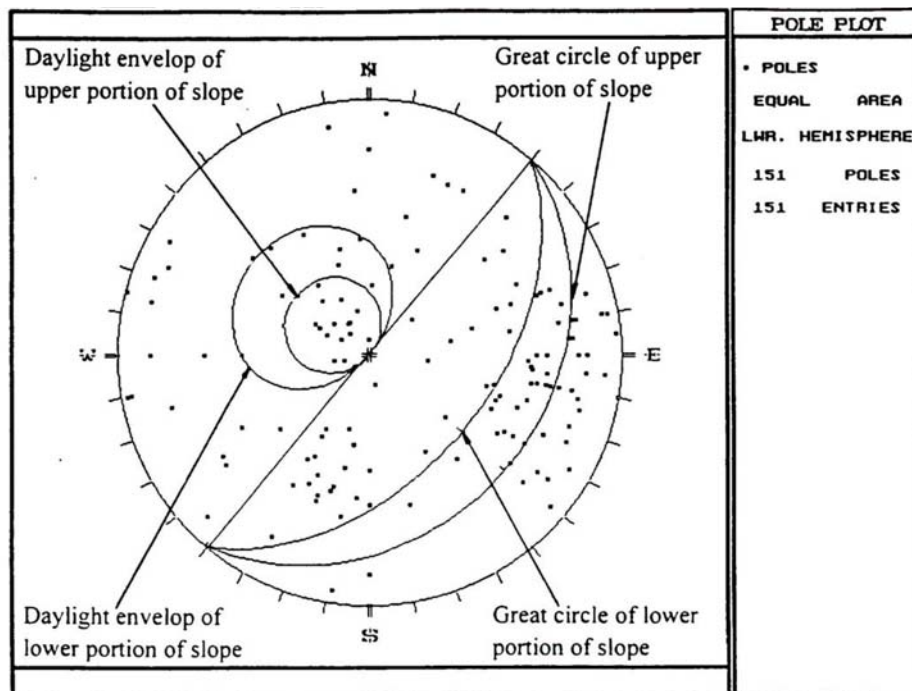
(a) Relict Discontinuities Infilled with Kaolin and Manganese Oxide Deposits

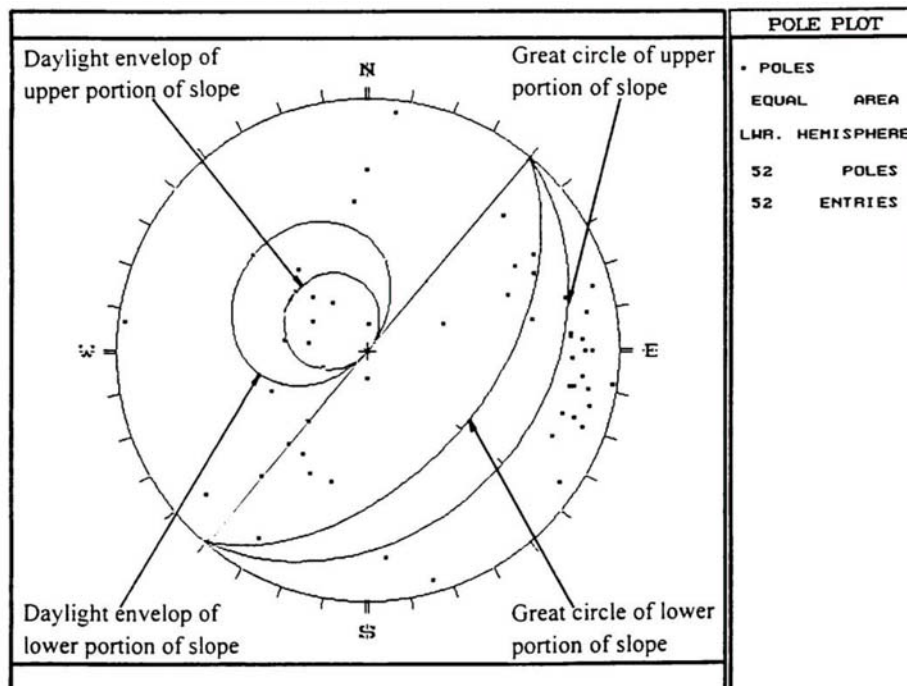
(b) Slickensided Relict Discontinuities Infilled with Kaolin and Manganese Oxide Deposits

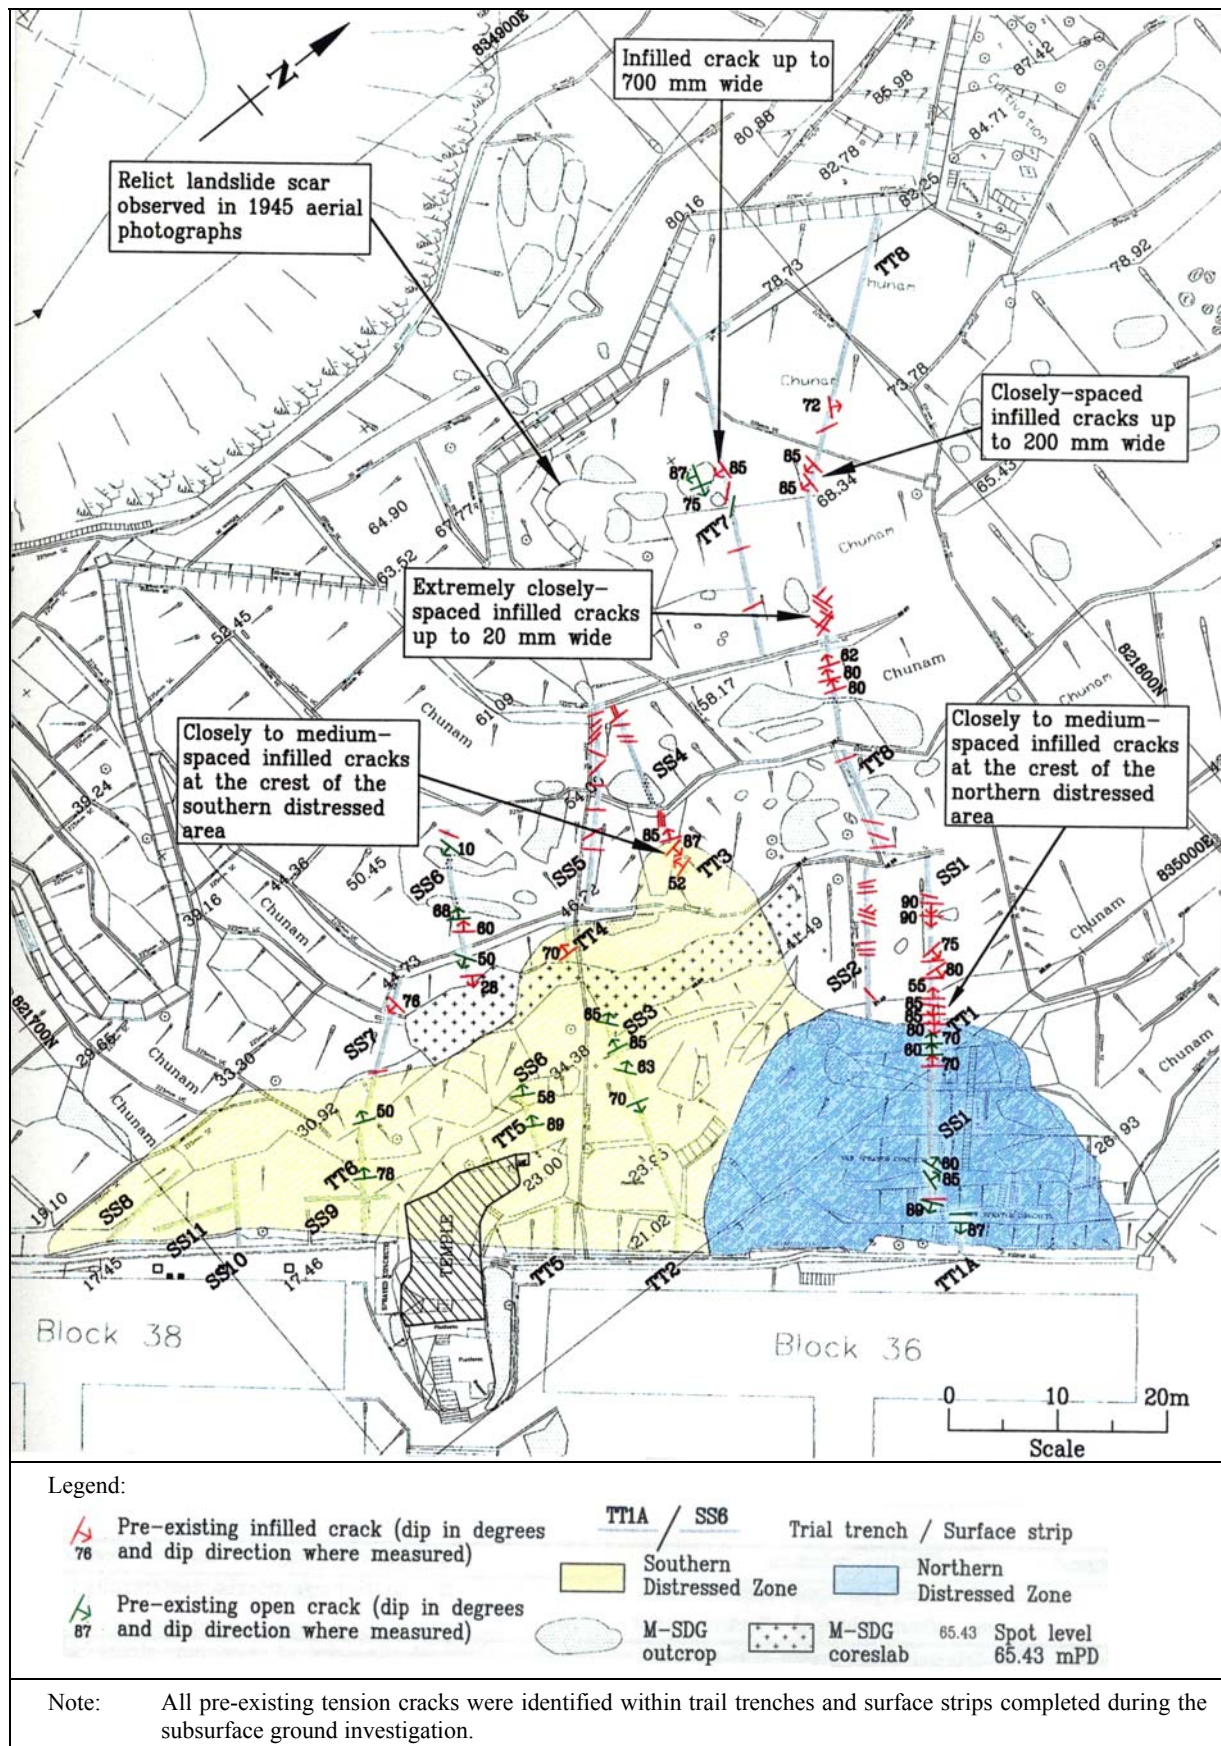
Figure 28 - Locations of Pre-existing Tension Cracks

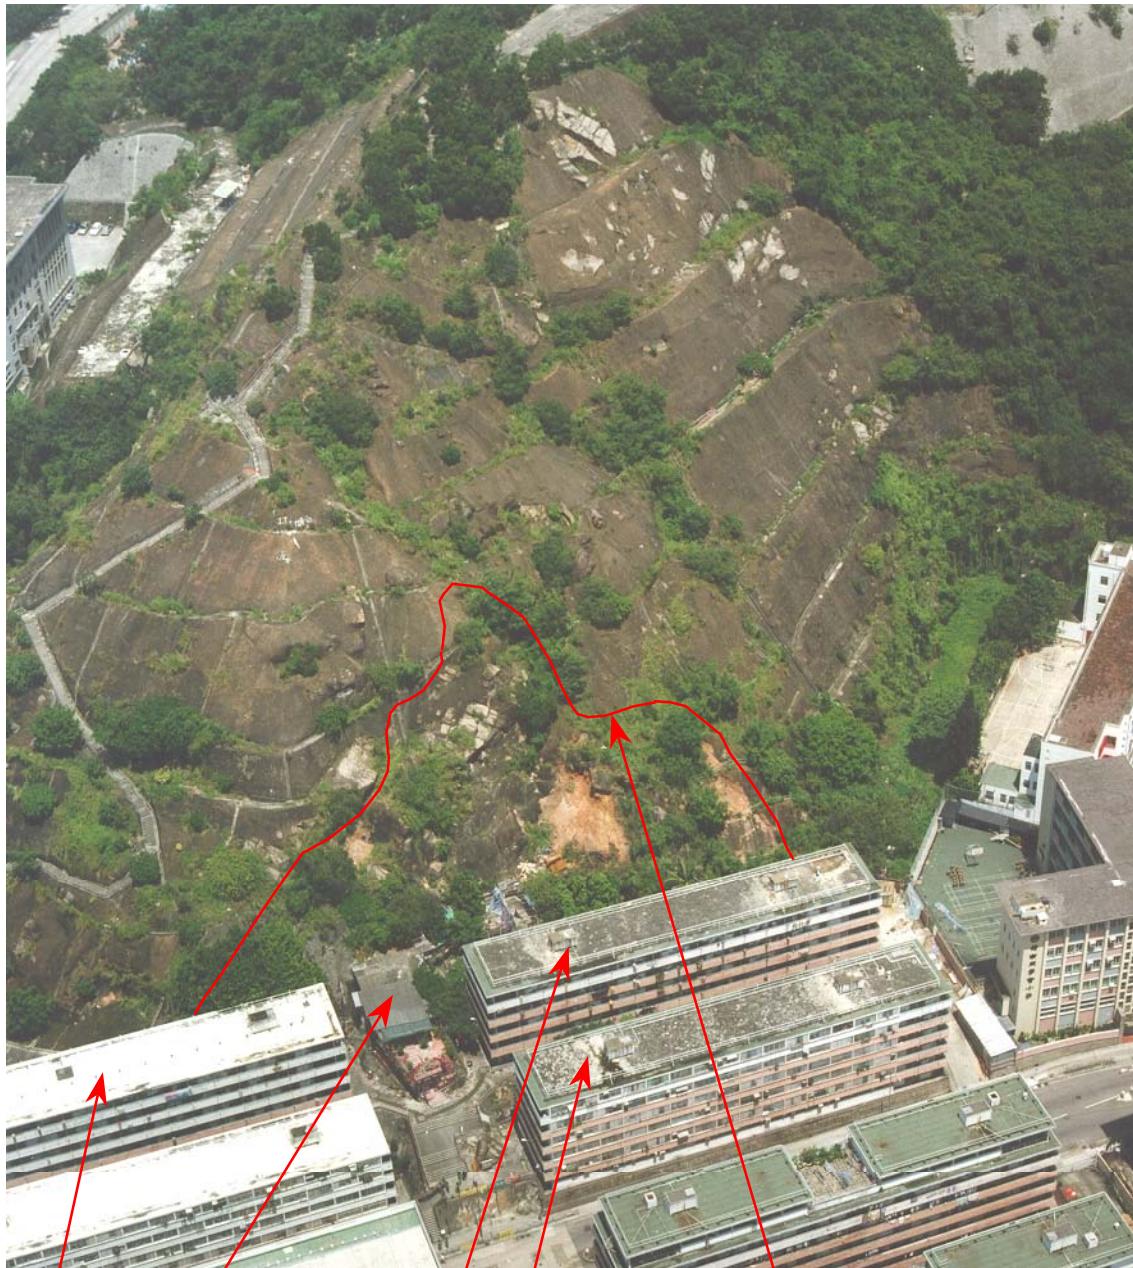
Plate 1 - Oblique Aerial View of the Landslide Site (Photograph Taken on 26 August 1999)

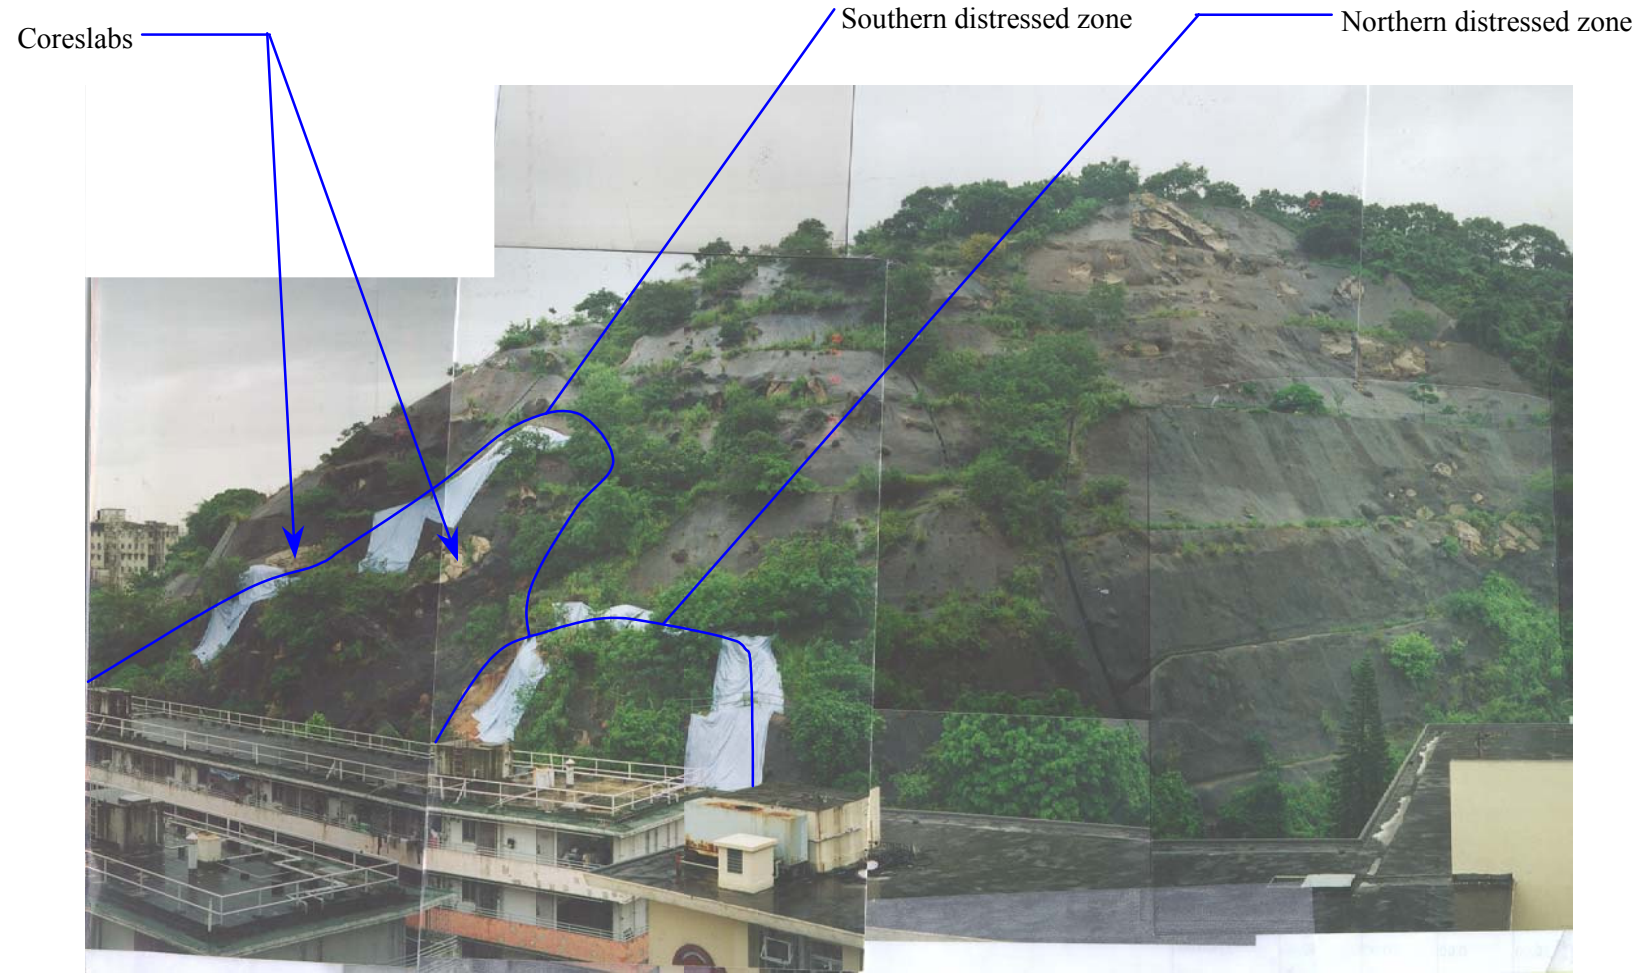
Plate 2 - General View of the Distressed Slope (Photograph Taken on 28 August 1999).
See Figure 34 for location.

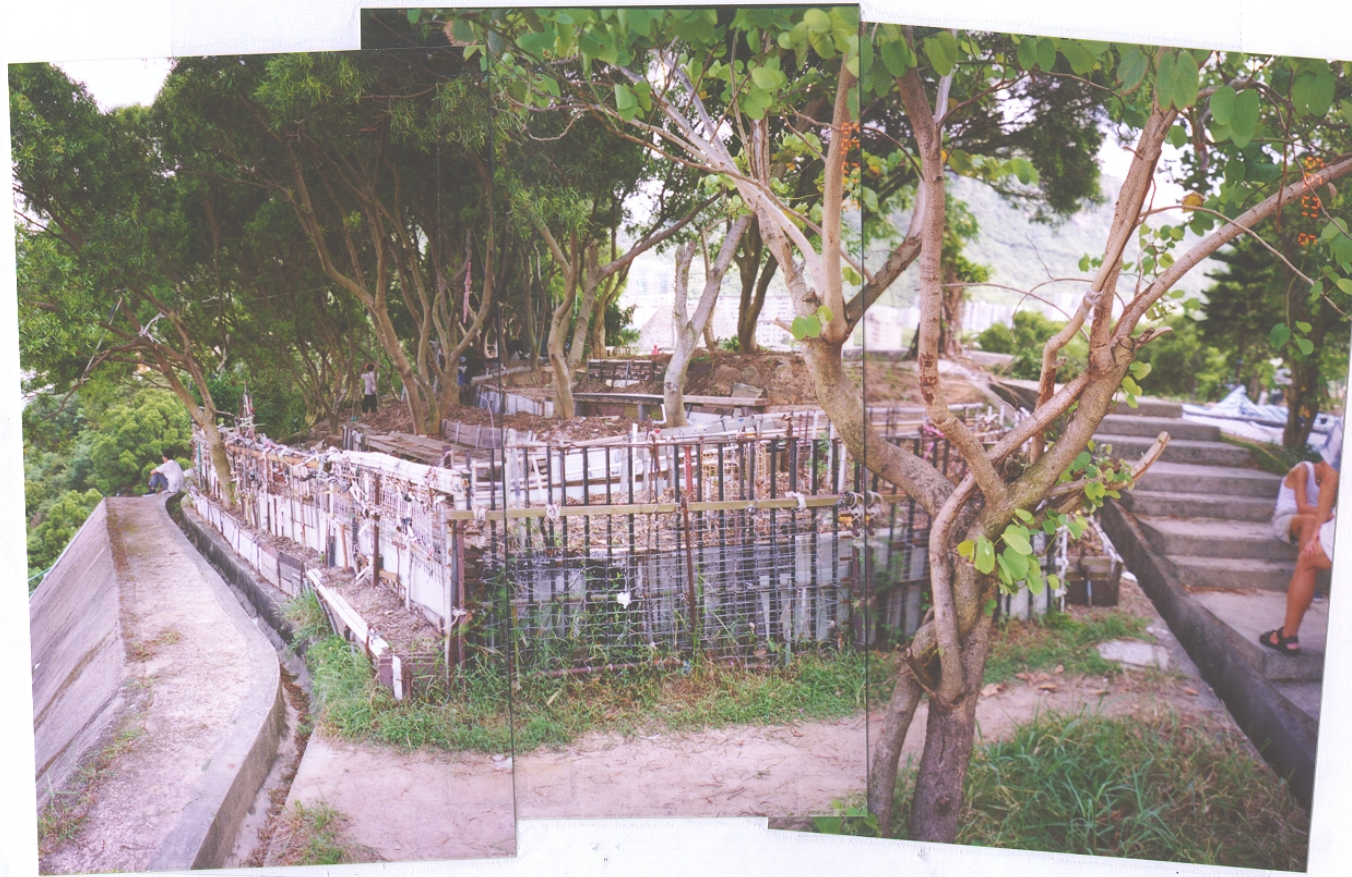
Plate 3 - View of the Unauthorized Cultivation Area at the Hilltop above the Distressed Slope
(Photograph Taken on 10 September 1999). See Figure 34 for location.

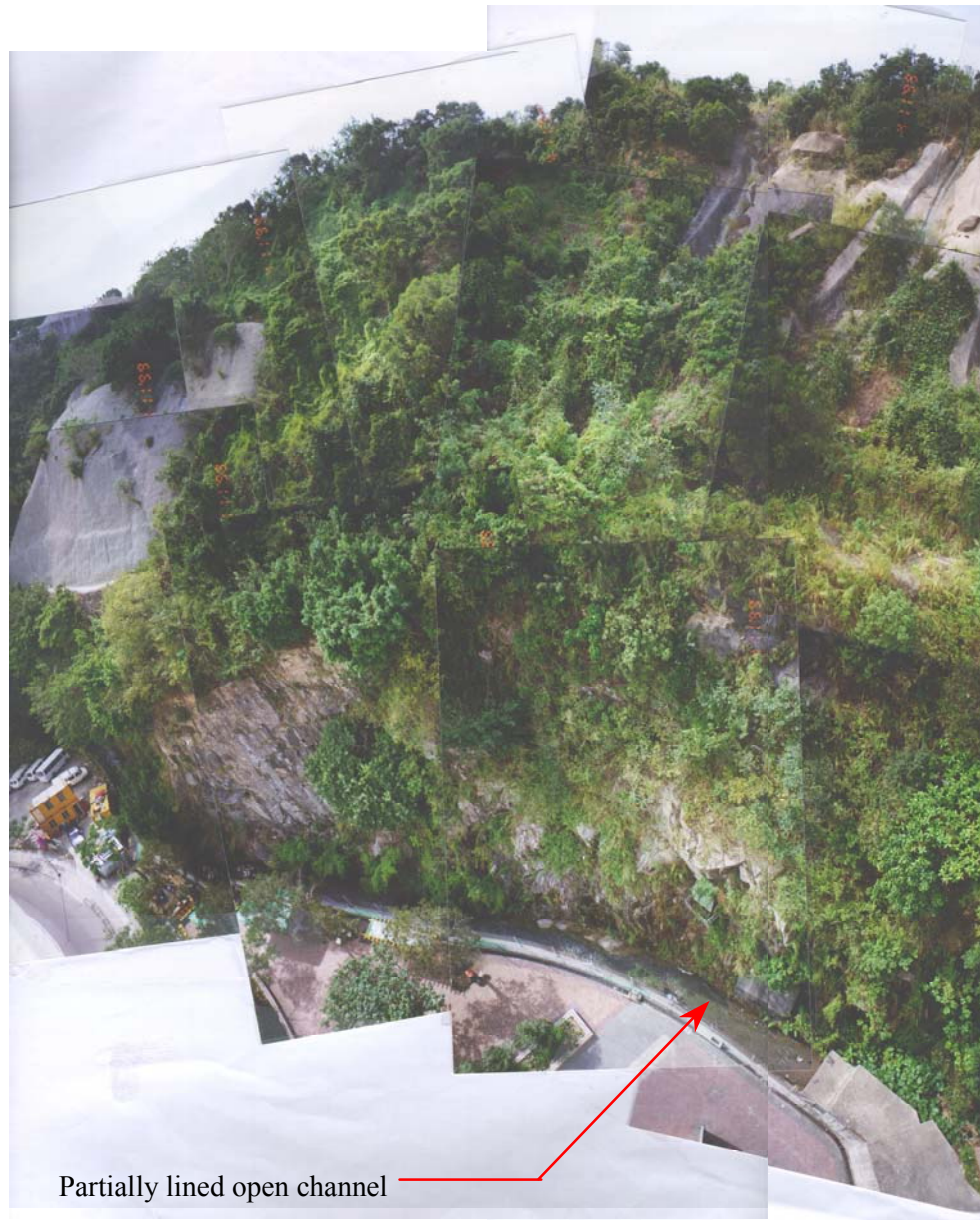
Plate 4 - View of Slope No. 11NW-B/C582 and the Partially Lined Open Channel along the Toe (Photograph Taken on 4 November 1999). See Figure 34 for location

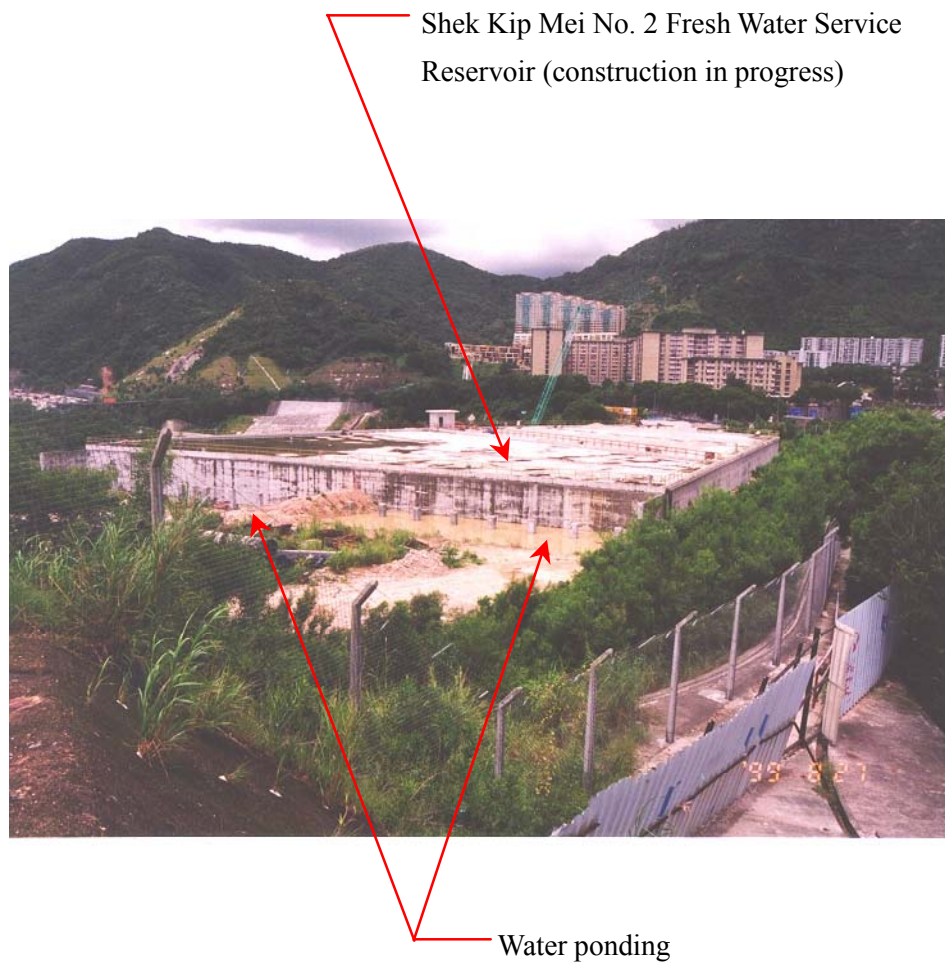
Plate 5 - View of the WSD Service Reservoir Construction Site at the Hilltop to the North of the Distressed Slope (Photograph Taken on 27 August 1999). See Figure 34 for location.

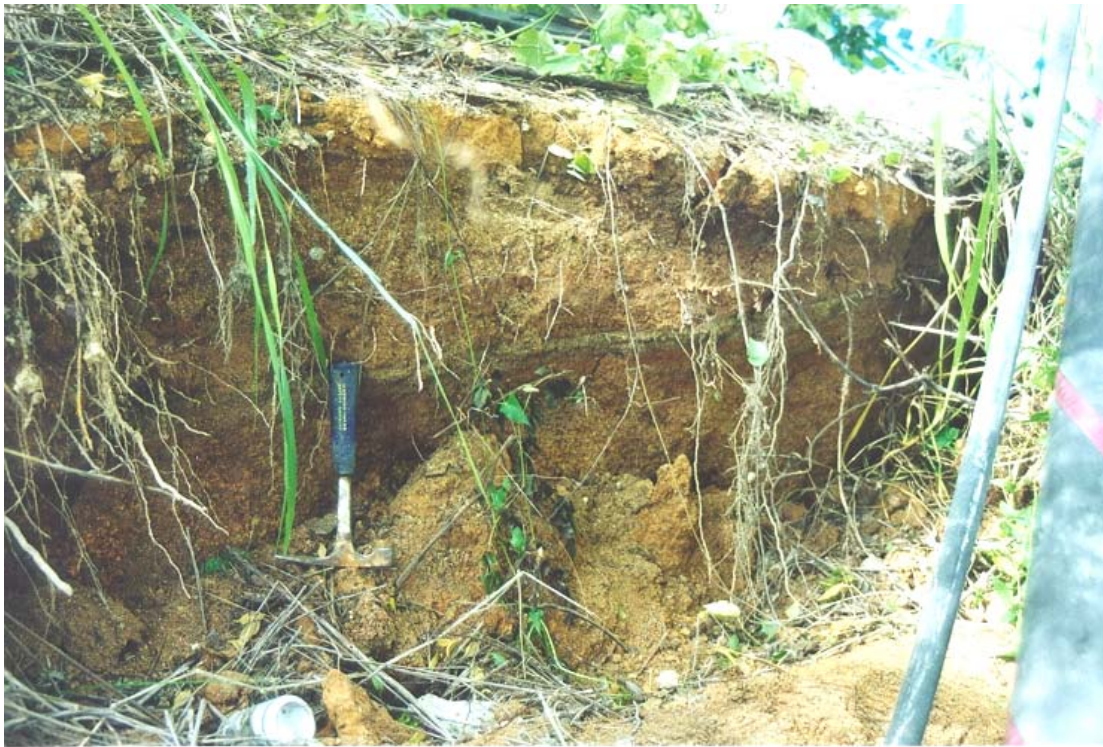
Plate 7 - Main Scarp at the Northern Distressed Zone (Photograph Taken by Hong Kong Geological Survey on 31 August 1999). Hong Kong Geology Survey Archive No. GS99/080C/21. See Figure 34 for location.

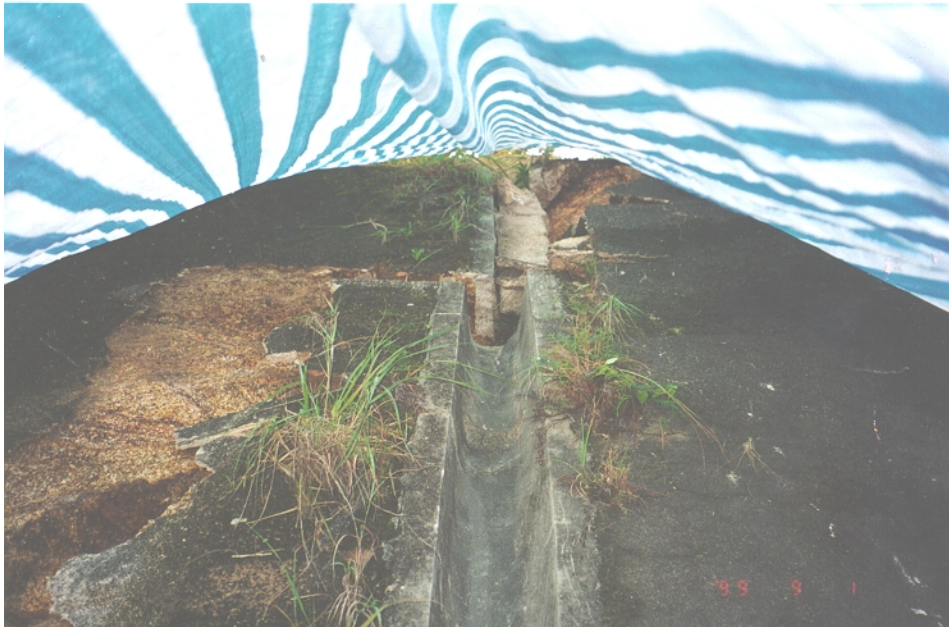
Plate 12 - Right Lateral Displacement across a Drainage Channel (Photograph Taken on 1 September 1999). See Figure 34 for location

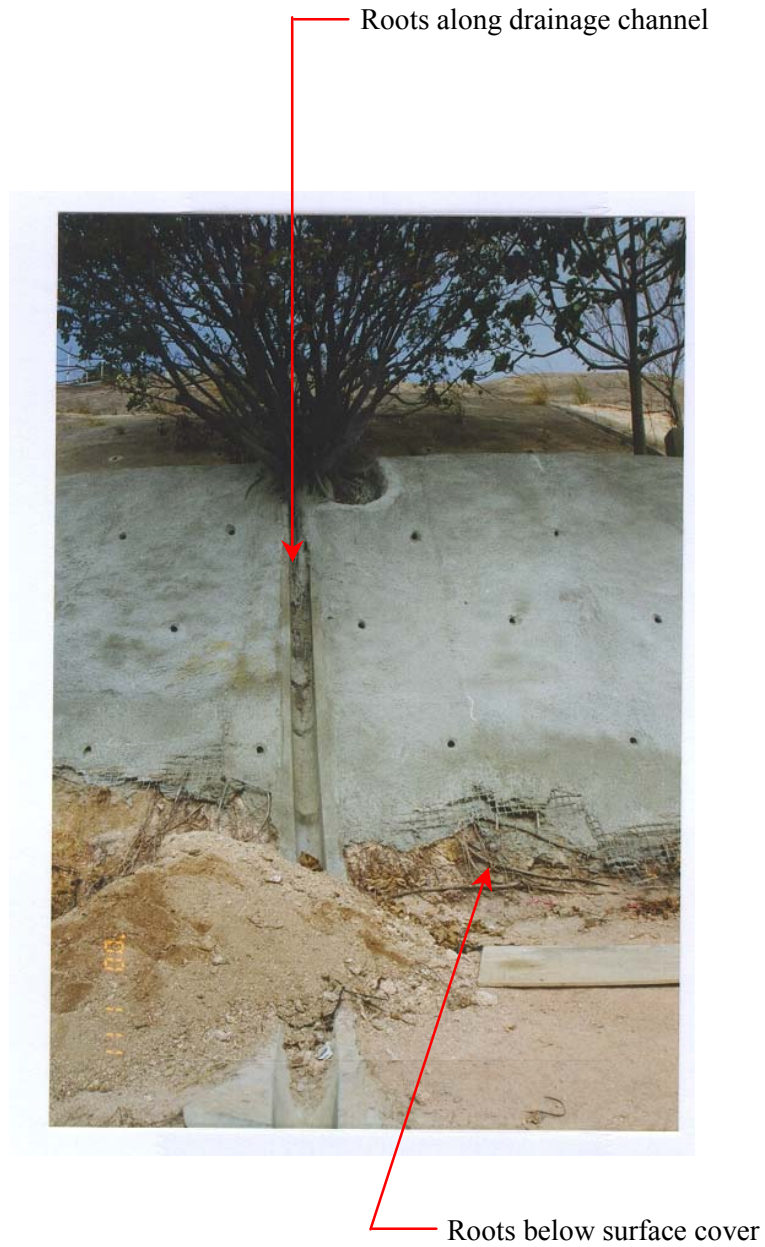
Plate 17 - Tree Roots along Surface Channel and between the Surface Cover and the Soil beneath (Photograph Taken on 11 January 2000).
See Figure 34 for location.

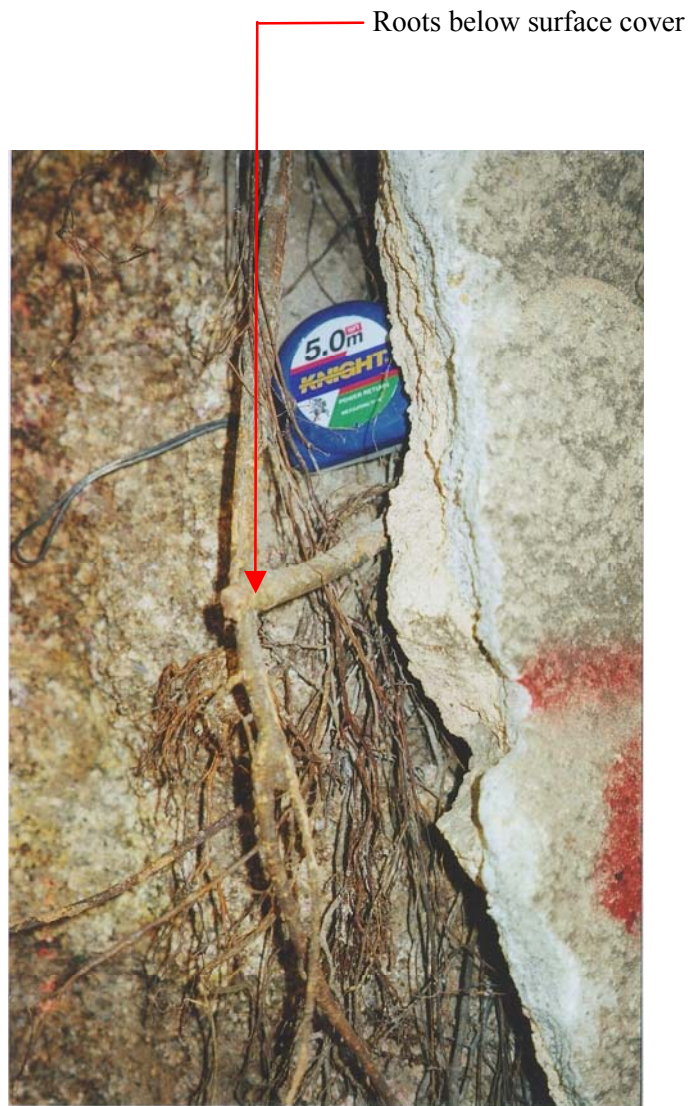
- (j) Post-landslide observations of water ponding on parts of the exposed surface of the WSD's reservoir site, between 27 August and 30 August 1999, during which time there was no significant reduction in water level within the ponded area.
- (k) Pre- and post-landslide observations that various parts of slope No. 11NW-B/C90 had unplanned trees and grass, especially along old drainage lines and within concrete drainage channels (Plates 17 and 29) and weepholes. Voids were noted between the cracked chunam cover and the soil beneath (Plate 30), most notably where tree roots had penetrated, forcing the chunam cover away from the slope (Plate 18).

Plate 18 - Tree Roots beneath the Surface Cover (Photograph Taken on 14 December 1999). See Figure 34 for location.

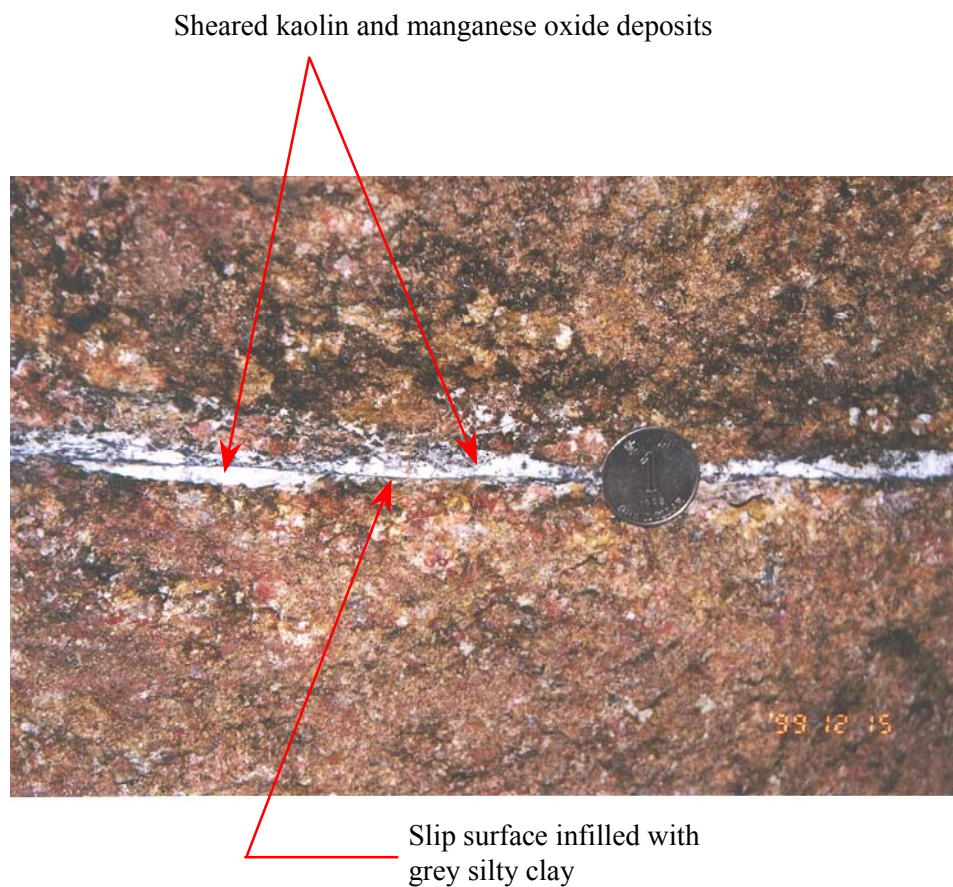
Plate 24 - Close-up View of the Slip Surface within the Sub-horizontal Discontinuity Infilled with Kaolin and Manganese Oxide Deposits at Trial Pit No. AP6 at the Toe of the Southern Distressed Zone (Photograph Taken on 15 December 1999). See Figure 34 for location.

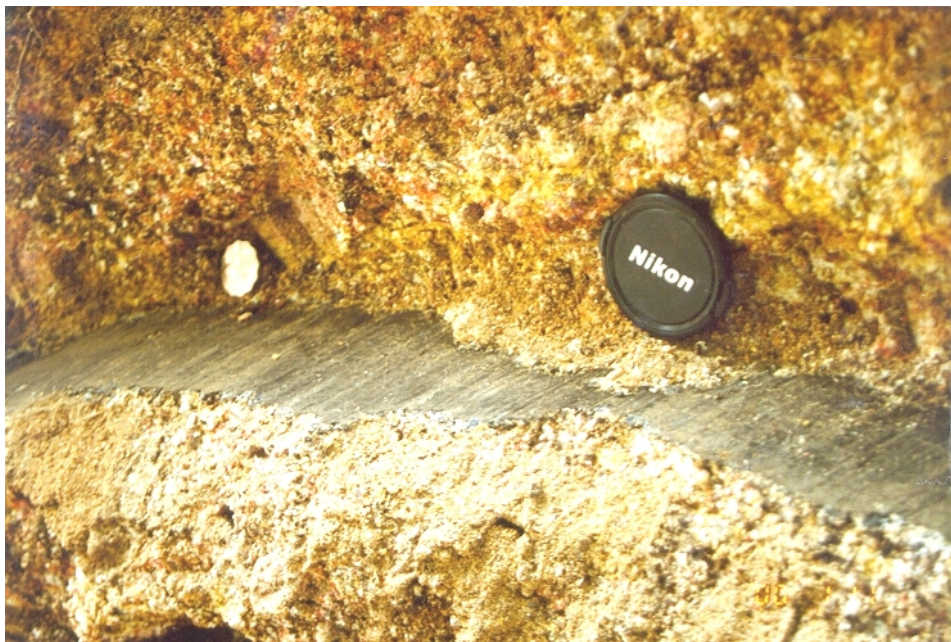
Plate 25 - Laterally-persistent Discontinuity Infilled with Slickensided Kaolin and Manganese Oxide Deposits at Surface Stripping No. SS11 (Photograph Taken on 11 January 2000). See Figure 34 for location.

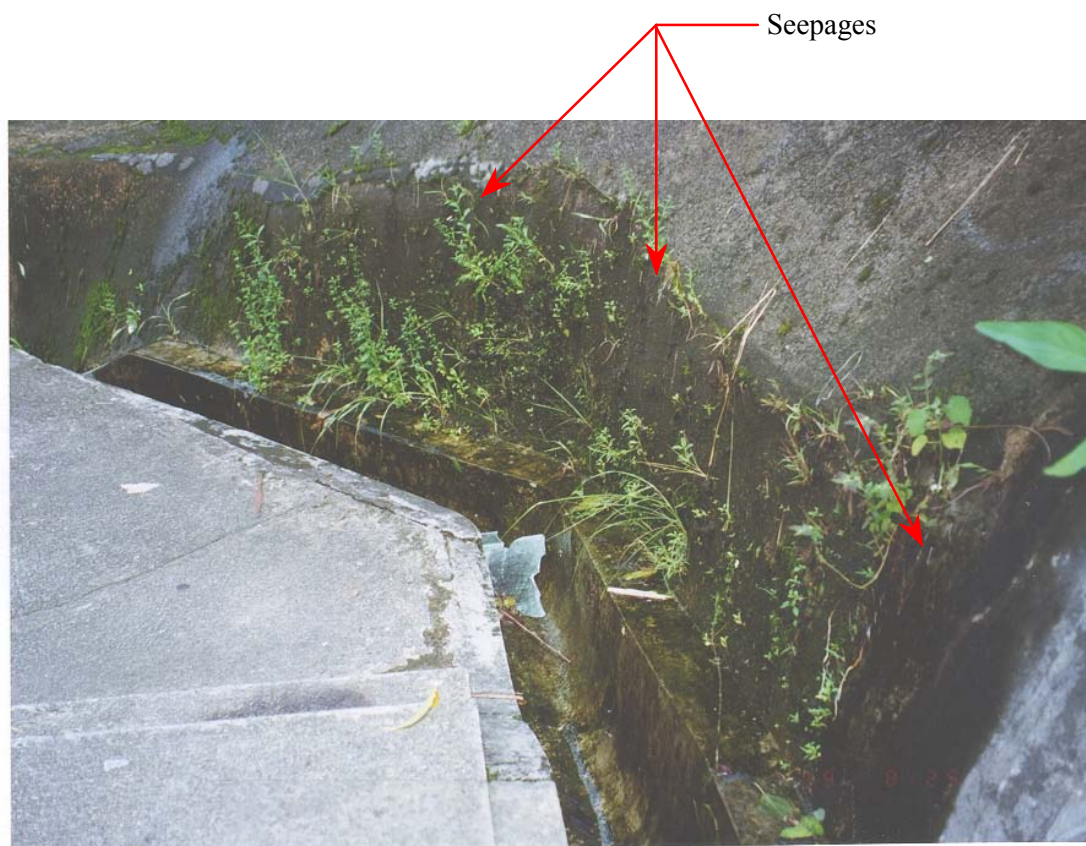
- (e) Post-landslide observations of seepages from some of the horizontal drains in slope No. 11NW-B/C91, and at the interface between rock outcrop and the chunam-covered soil portion towards the toe of this slope, and also along the staircase on slope No. 11NW-B/C68 (Figure 3, Plates 27 and 28). Seepage was also noted from horizontal drillhole No. H2 which was drilled at the southern portion of slope No. 11NW-B/C91, i.e. close to the landslide site.

Plate 28 - Seepage at Slope No. 11NW-B/C68 (Photograph Taken on 25 August 1999). See Figure 34 for location.
