REPORT ON THE SHEK KIP MEI LANDSLIDE OF 25 AUGUST 1999

GEO REPORT No. 181

**Fugro Maunsell Scott Wilson Joint Venture
&
Professor J. B. Burland**

**GEOTECHNICAL ENGINEERING OFFICE
CIVIL ENGINEERING AND DEVELOPMENT DEPARTMENT
THE GOVERNMENT OF THE HONG KONG
SPECIAL ADMINISTRATIVE REGION**

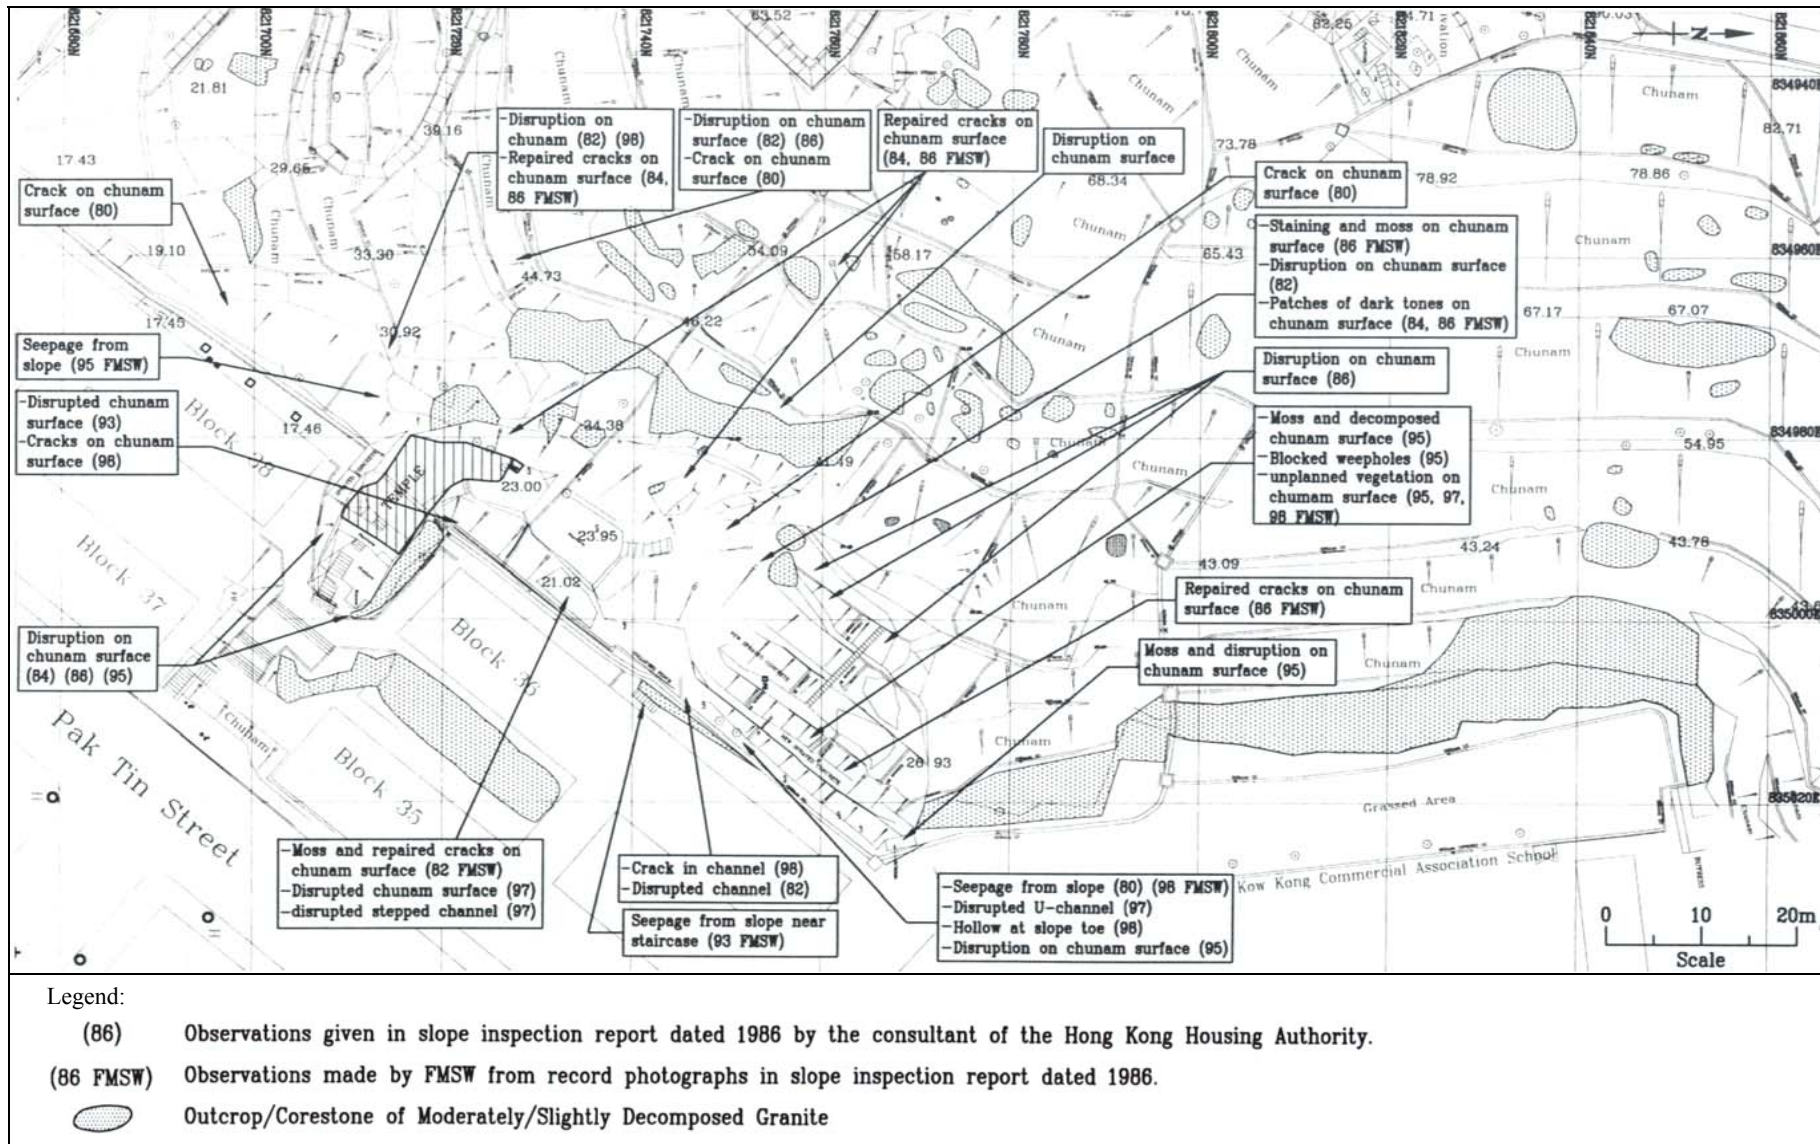
Figure A5 - Summary of Key Observations from Previous Slope Inspection Reports

General Observations	Ref.	Recommendations	Ref.	Remarks	Ref.
Annual Geotechnical Inspection (Inspection Date: January 1980) (Binnie & Partners (Hong Kong) (B&P), 1980)					
<u>Observations given in inspection report</u> - "Cracking with preferred orientation" in southern portion and mid-height of central portion of slope - "Seepage at toe" of northern portion - "Surface is overgrown with boulders and rubbish" in lower central portion	Photos Nos. 22a,27a,26a, 28a,23a & 24a (B&P,1980)	- Improve access - Seal cracks to act as telltales - Clear blocked channels	Sheet 1 (B&P,1980)	- Inspection covers the full extent of slope No. 11NW-B/C90	Sheet 2 (B&P,1980)
<u>Observations interpreted by FMSW</u> - Unplanned vegetation on slope surface in lower central portion	Photo No. 23a (B&P,1980)				
Annual Geotechnical Inspection (Inspection Date: June 1982) (Binnie & Partners (Hong Kong) (B&P), 1982)					
<u>Observations given in inspection report</u> - "Berm channel of inadequate capacity" in upper central portion - "Erosion on slope surface" in upper southern portion <u>Lower southern portion</u> - "Local disruption of chunam surface due to root action" - "Disrupted stepped channel on berm" - "Disruption at toe surface" - "Disruption of chunamed surface" - "Minor vegetation behind stepped channel" - "Disruption of chunam, minor vegetation and boulders on surface" - "Minor vegetation and disruption of chunamed surface"	Photos Nos. 6a,14a,24a, 25a,26a,7a, 8a, 9a,13a,10a, 12a,16a, 21a,27a,15a, 17a,18a,20a, 22a, 23a & 28a (B&P,1982)	- Repair disrupted chunamed surfaces - Seal cracks in chunam & concrete - Provide concrete surfacing - Clear channels - Improve access for inspection - Remove random vegetation - Remove loose boulders and debris on slope surface - Monitor the movement of cracks in chunam surface	Sheet 1 (B&P,1982)	- Inspection covers the full extent of slope No. 11NW-B/C90 - The report stated that "The slope [No. 11NW-B/C90] has been resurfaced in December 1981"	Sheet 1 (B&P,1982) Sheet 2 (B&P, 1982)

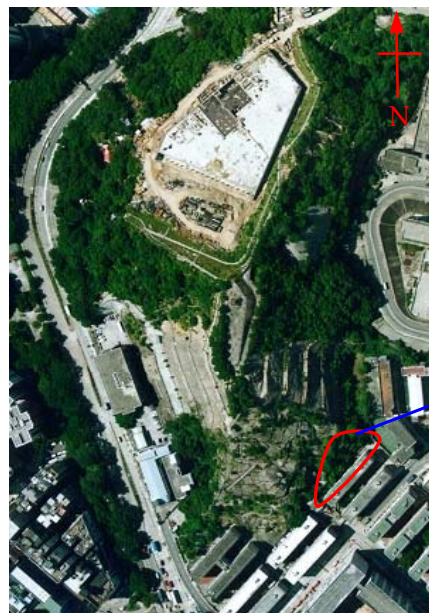
(c) 1998
Dense vegetation noted above
and within the area of distress
in 1999
