PERFORMANCE ASSESSMENT OF GREENING TECHNIQUES ON SLOPES

GEO REPORT No. 183

B.L.S. Lui & Y.K. Shiu

**GEOTECHNICAL ENGINEERING OFFICE
CIVIL ENGINEERING AND DEVELOPMENT DEPARTMENT
THE GOVERNMENT OF THE HONG KONG
SPECIAL ADMINISTRATIVE REGION**

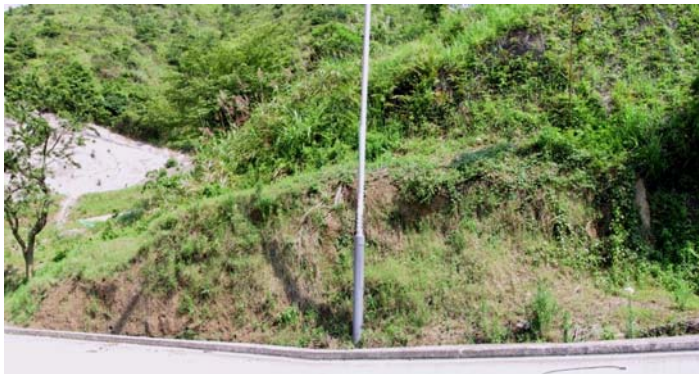
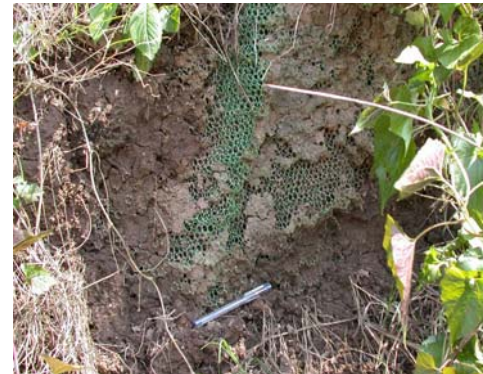
Figure 1 - Details of Biocrete

- A mixture of soil, concrete and organic fibre is sprayed onto the slope surface (Thickness not mentioned in supplier's brochure). Soil and fertilizer are embedded in the mixture in the form of "bio-capsules".
- A layer of PVC mesh, which has not been mentioned in supplier's brochure, was noted on site embedded in the soil mixture.
- Though not mentioned in the supplier's brochure, the usual landscaping treatment is hydroseeding grass seeds.

the mulch/soil mix on the two slopes inspected (Plates 1a to 1c). The cracked surface on slope C104 was extensive, covering more than 30% of the slope surface area. The mulch/soil mix layer was hard and dry, and had disintegrated at local areas, probably owing to the addition of cement additives. No reinforcing element is specified in the manufacturer's brochure. However, a layer of PVC mesh was found embedding within the mulch/soil mix. It probably serves to reinforce the mulch/soil mix. The mesh was however weak and brittle. On both slopes, the soil mix had detached locally, exposing the PVC mesh (Plate 1d). No erosion control mat was provided to the surface of the mulch/soil mix.

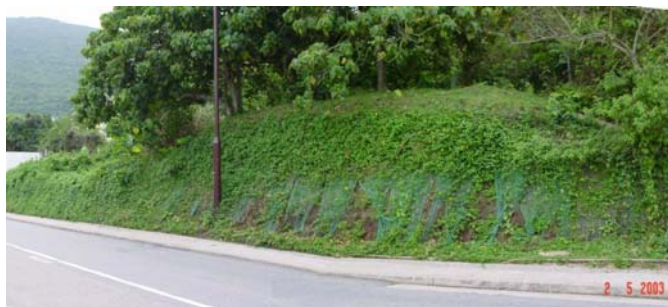
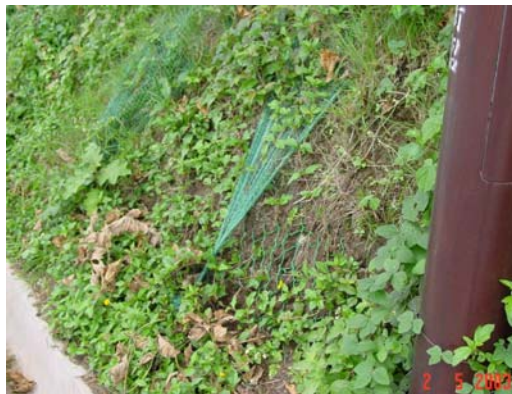
Figure 2 - Details of Hong Kong Mulching

- A layer of 3-D PVC coated wire mesh is fixed on slope surface by a row of steel anchors along slope crest at 1.2 m c/c spacing and by sub-anchors on every 100 m² of slope face.
- Soil mix containing soil, binding agent and seeds is sprayed on the wire mesh and slope surface to a minimum thickness of 50 mm.
- The finished slope surface is covered by a layer of degradable erosion control mat, usually coir mesh, which is fixed with U-pins on soil mix surface (Not shown in section for clarity).

The two slopes were inspected for engineering assessment. Degradable erosion control mat was specified in the manufacturer's brochure for use in the system. However, a layer of non-degradable mat was noted on site. Detachments of mulch/soil mix and the erosion control mat were noted along the toes of the slopes up to a height of about 1.5 m above slope toe, exposing the steel mesh which was originally covered under the mulch (Plate 2). The condition of the system above this level was satisfactory. As the two sites are located in remote area, the system detachment may be caused by cows when they eat the vegetation as judged by the contrast between the dense vegetation coverage at higher level of the slopes and the poor condition at toe levels of the two slopes (Plate 3).

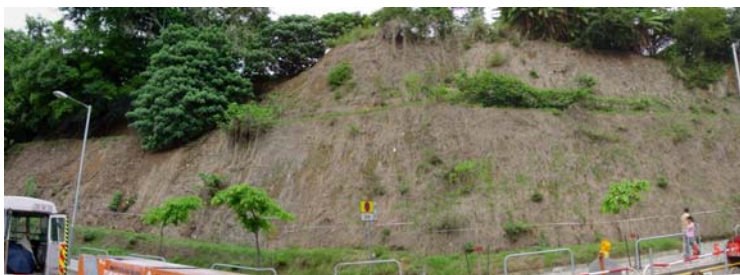
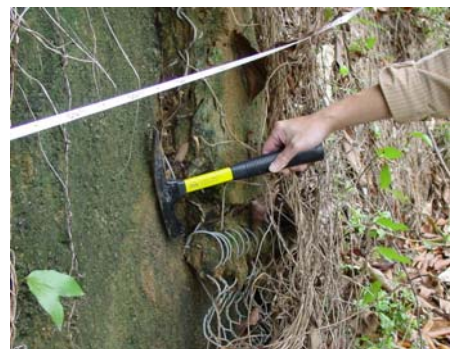
Figure 3 - Details of NFY Hydro-Mulching

- A layer of 3-D PVC coated wire mesh is anchored on to slope surface by fixing pins at 2 m c/c spacing.
- Mulching mix consisting of fertilizer and moisture retaining agent with a minimum thickness of 75 mm is then sprayed on the wire mesh and slope surface. The final face is covered with a degradable erosion control mat, which is fixed by plastic strips (not shown in section for clarity).
- The usual landscape treatments are hydroseeding grass seeds and/or planting creepers.

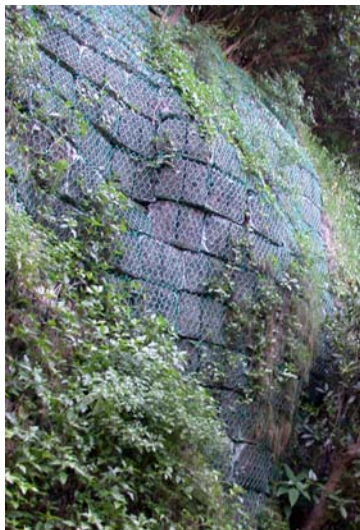
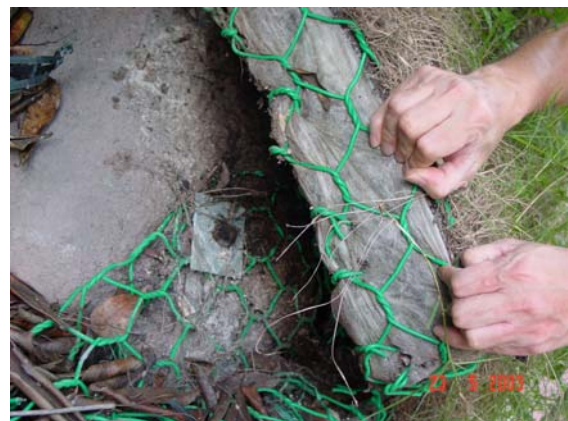
Figure 13 - Details of NFY Mulching Panel

For both the Instant Evergreen System and NFY Mulching Panel, the small isolated panels of soil mix tend to dry up quickly and result in unhealthy plant growth with time. Vegetation growing on the individual panels is therefore more susceptible to desiccation during dry season. The large exposed surface areas of the panels may lead to a high rate of surface evaporation. In some cases, the weak soil mix in the panels disintegrated as a result of desiccation (Plate 13a). Thus, if *Wedelia trilobata* (三裂葉蟛蜞菊) or other ground covering plants are able to establish and maintain a dense coverage, they may help retain soil moisture. Without a dense vegetation cover, the wire mesh forming the gabions for the product are very visible and may not be visually pleasing. Drought tolerant species may have a higher chance of healthy growth in a longer term. In addition, surface erosion was noted locally on the mulch/soil mix of NFY Mulching Panel (Plate 13c).

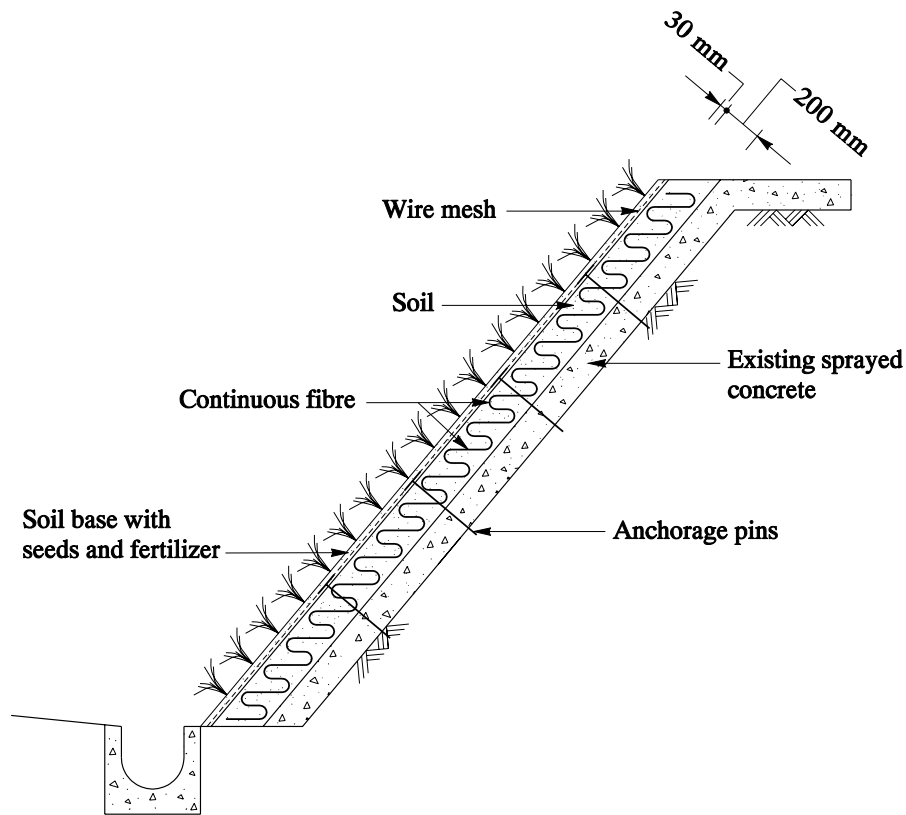
Figure 15 - Details of Geofiber

- Soil and continuous fiber (polyester) are sprayed onto slope surface to form a layer of “reinforced” soil about 200 mm thick.
- A layer of wire mesh is placed on top of the geofiber body by anchorage pins at 1.5 m spacing, followed by a layer of 30 mm-thick soil base mixed with seeds and fertilizer on the surface.

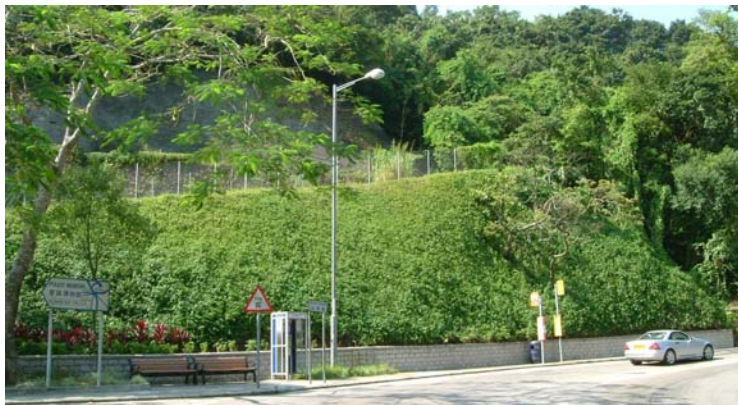
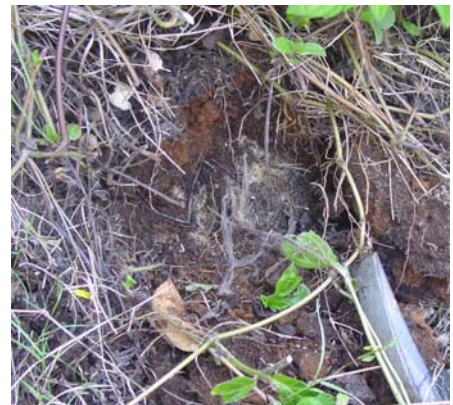
Overall view of slope treated with Geofiber

Close-up view

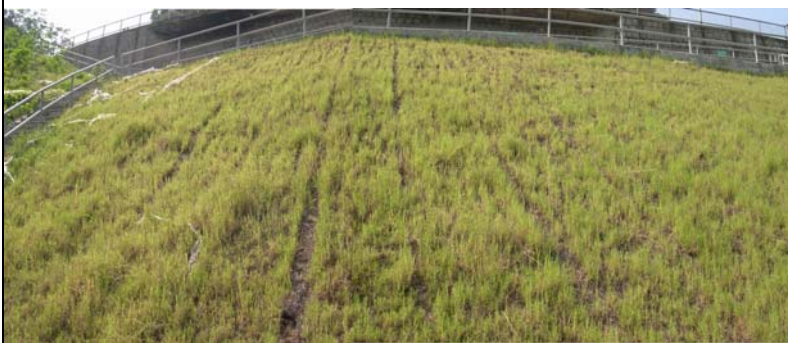
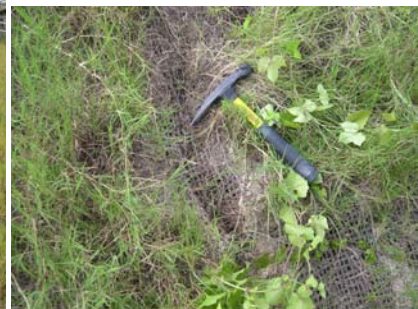
Figure 18 - Details of Coir

Overall view of slope applied with Coir

Close-up view

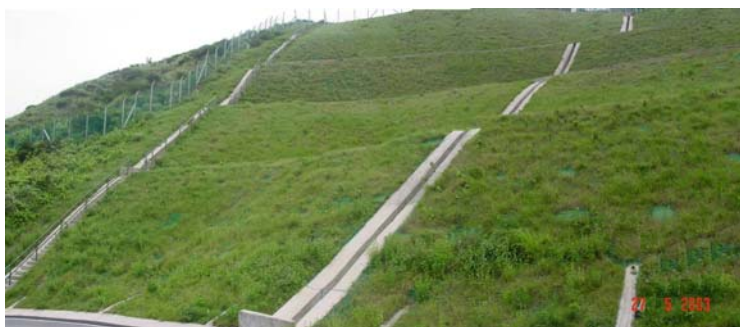
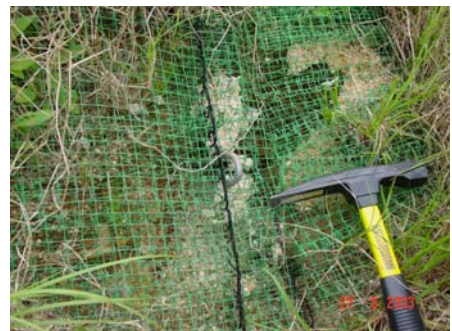
Figure 23 - Details of Multimat

Overall view of slope applied with Multimat

Close-up view

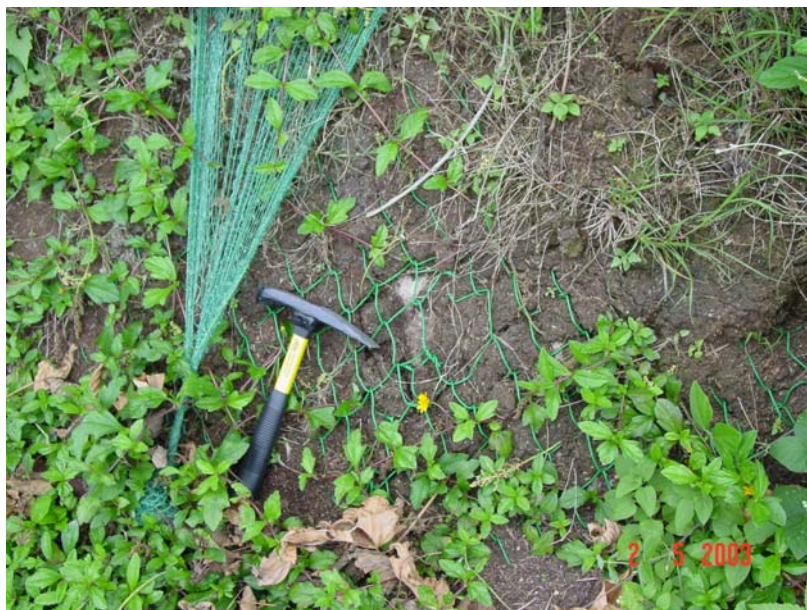
Plate 2a

Observations: Detachment of mulch/soil mix
Slope No.: 8SW-B/C95
Location: Tai Mong Tsai, Sai Kung
Date of Inspection: 2 May 2003

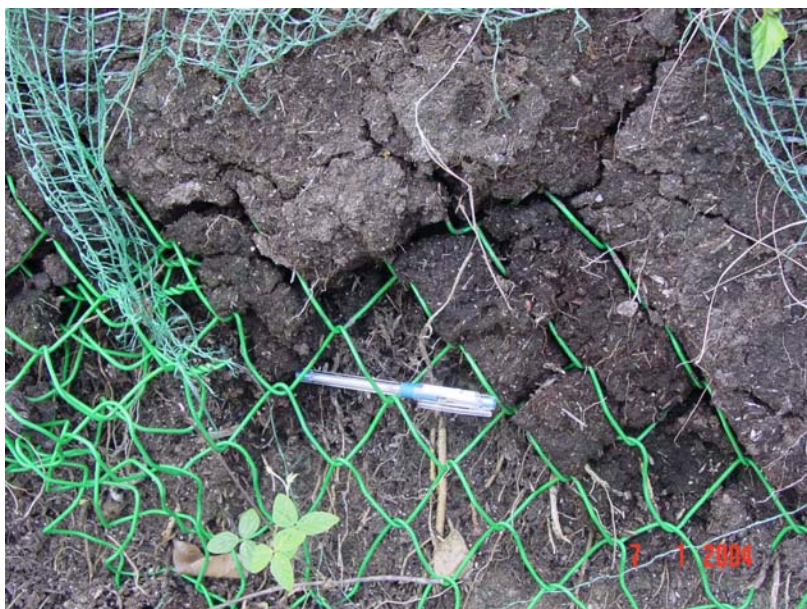
Plate 2b

Observations: Detachment of mulch/soil mix, exposing the wire mesh
Slope No.: 8SW-B/C46
Location: Yan Yee Road, Sai Kung
Date of Inspection: 7 January 2004

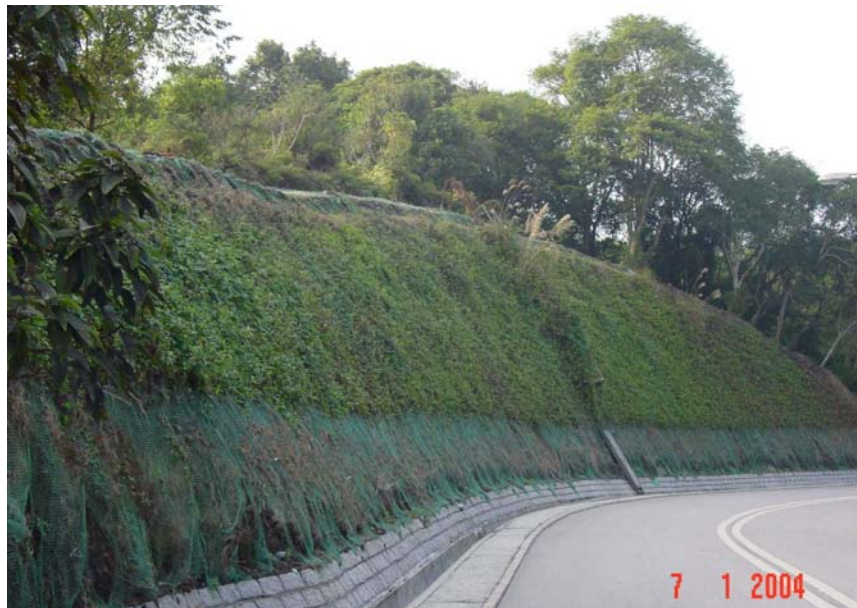
Plate 3b

Observations: Difference in vegetation coverage on upper and lower parts of slope
Slope No.: 8SW-B/C46
Location: Yan Yee Road, Sai Kung
Date of Inspection: 7 January 2004

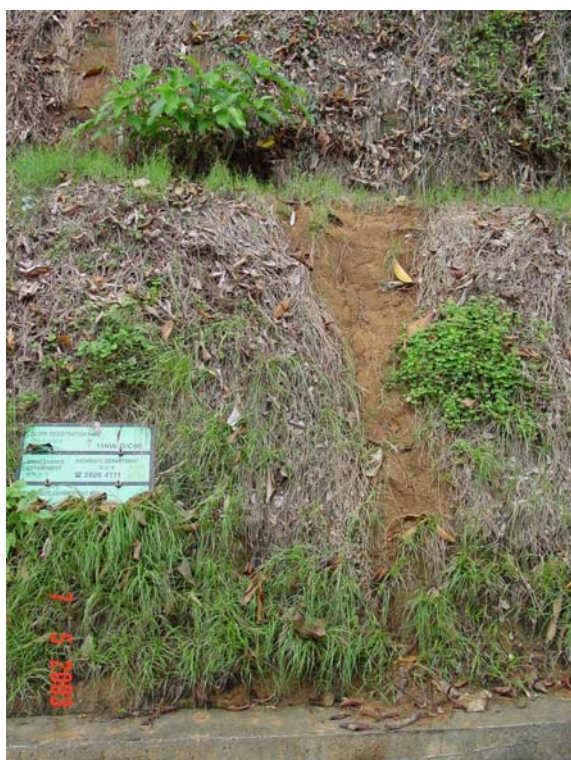
Plate 5a

Observations: Surface erosion
Slope No.: 11NW-D/C90
Location: Homantin
Date of Inspection: 7 May 2003

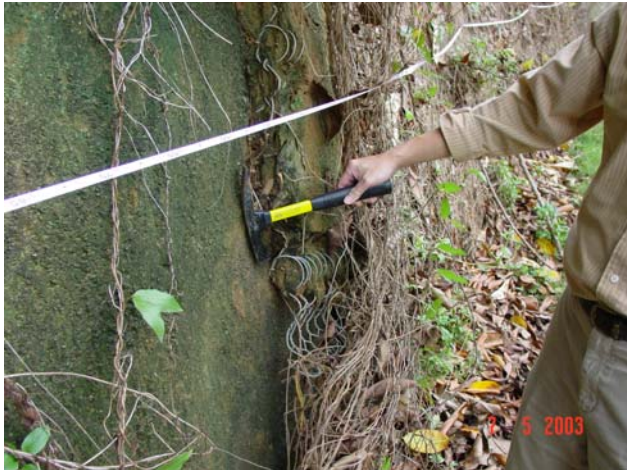
Plate 5c

Observations: Edge of system subject to surface erosion
Slope No.: 11NW-D/C90
Location: Homantin
Date of Inspection: 7 May 2003

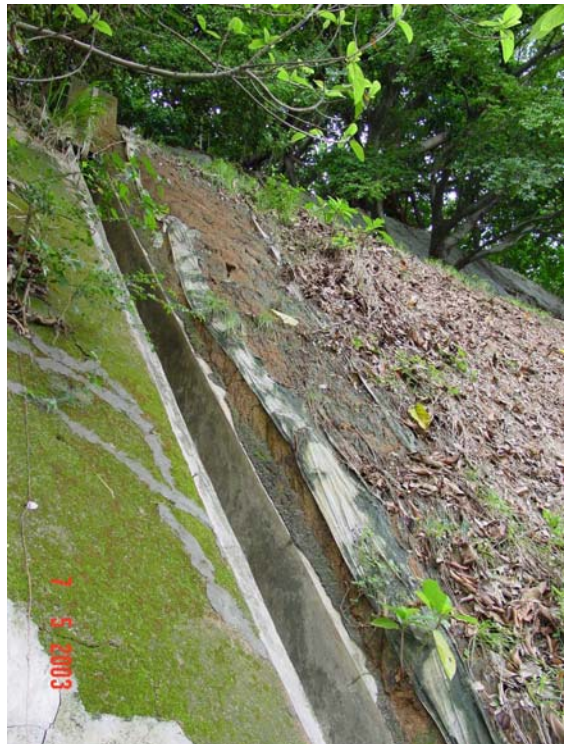
Plate 5d

Observations: Edge of system near stepped channel subject to surface erosion
Slope No.: 11NW-D/C90
Location: Homantin
Date of Inspection: 7 May 2003

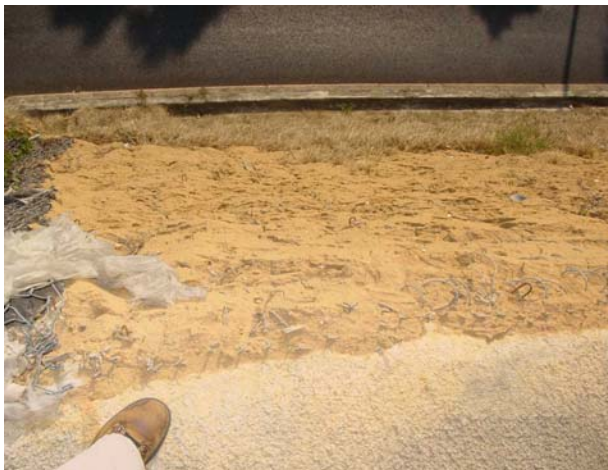
Plate 5e

Observations: Surface erosion on mulch/soil mix (view from berm on slope face)
Slope No.: 11SW-D/C105
Location: Deep Water Bay Road
Date of Inspection: 17 December 2003

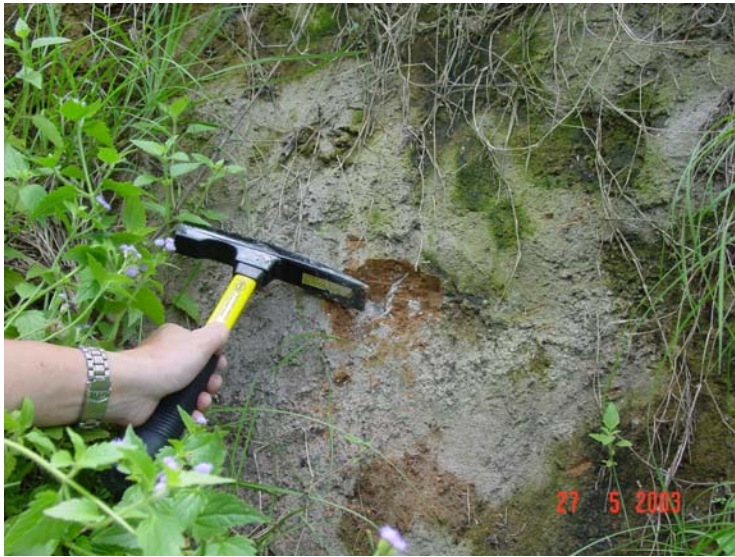
Plate 6a

Observations: Bare surface on
hard soil mix
Slope No.: 11NE-A/C357
Location: Jat's Incline
Date of Inspection: 27 May 2003

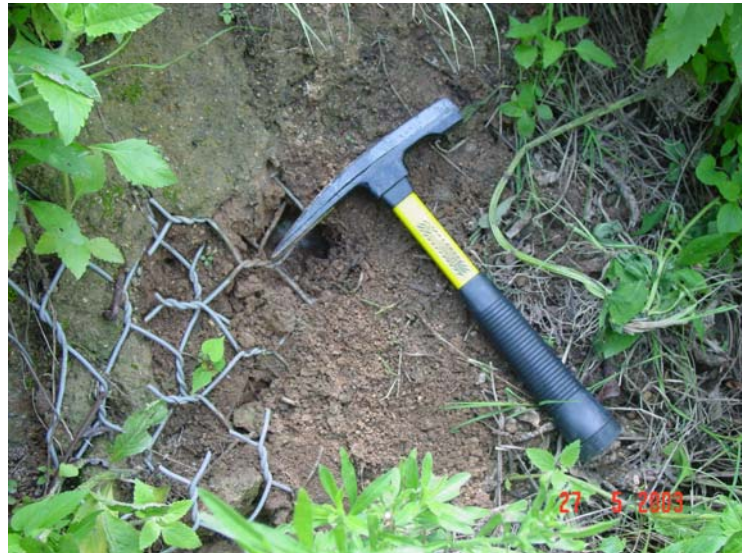
Plate 6b

Observations: Detachment of
soil mix
Slope No.: 11NE-A/C357
Location: Jat's Incline
Date of Inspection: 27 May 2003

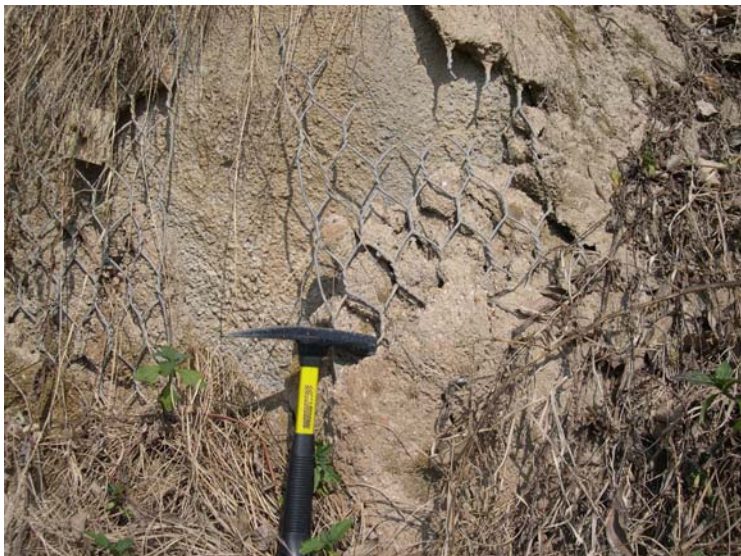
Plate 6c

Observations: Detachment of
mulch/soil
mix, exposing
the wire mesh
Slope No.: 11NW-A/C123
Location: Caldecott Road
Date of Inspection: 16 December
2003

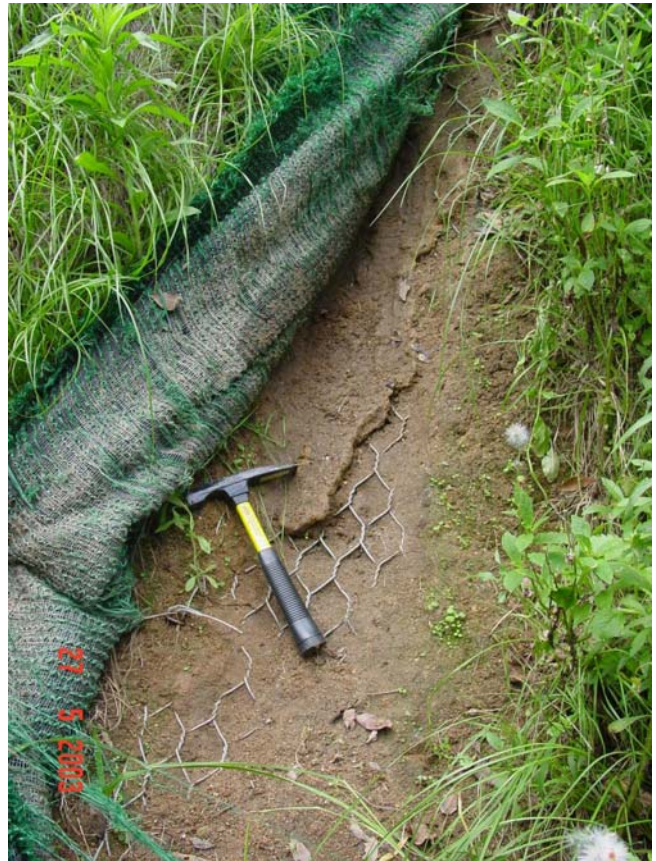
Plate 6d

Observations: Inadequate anchorage of
erosion control mat
Slope No.: 11NE-A/C357
Location: Jat's Incline
Date of Inspection: 27 May 2003

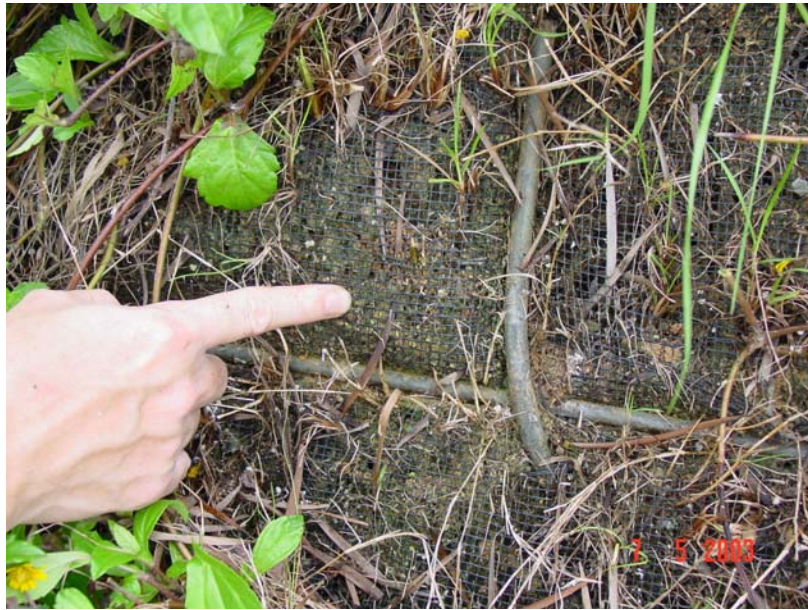
Plate 7a

Observations: Horizontal bracing in the form of steel bars on system surface
Slope No.: 11NW-D/C130
Location: Chung Hau Street, Homantin
Date of Inspection: 7 May 2003

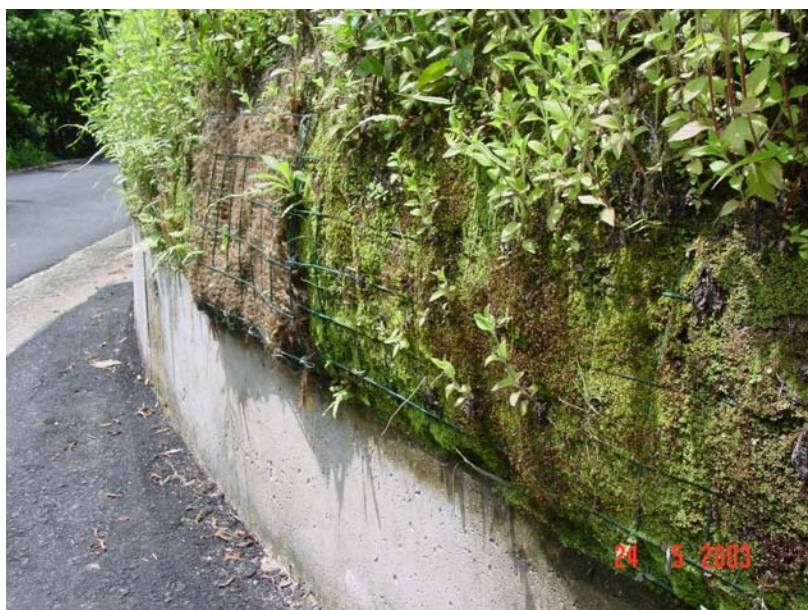
Plate 8a

Observations: Bulging of soil mix
Slope No.: 11SE-A/C487
Location: Mount Parker Road
Date of Inspection: 24 May 2003

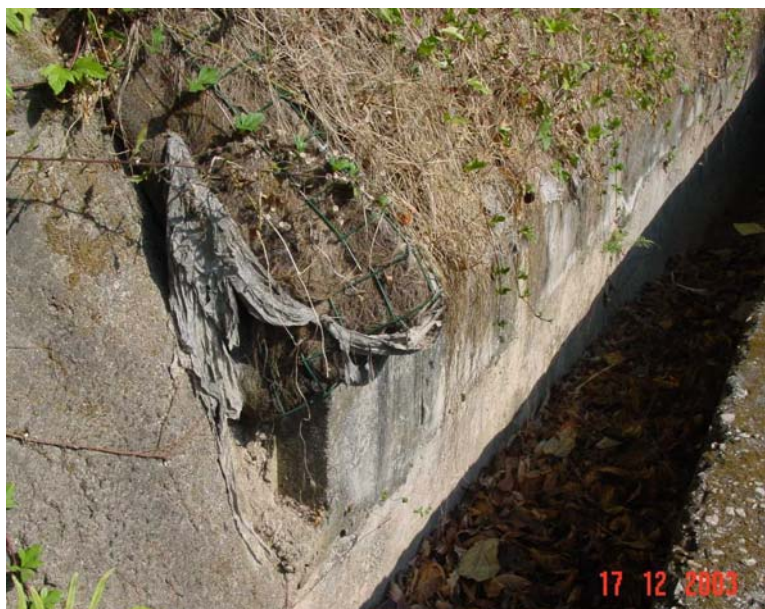
Plate 8b

Observations: Minor bulging of soil mix above concrete kerb
Slope No.: 11SW-D/C117
Location: Nam Fung Road
Date of Inspection: 17 December 2003

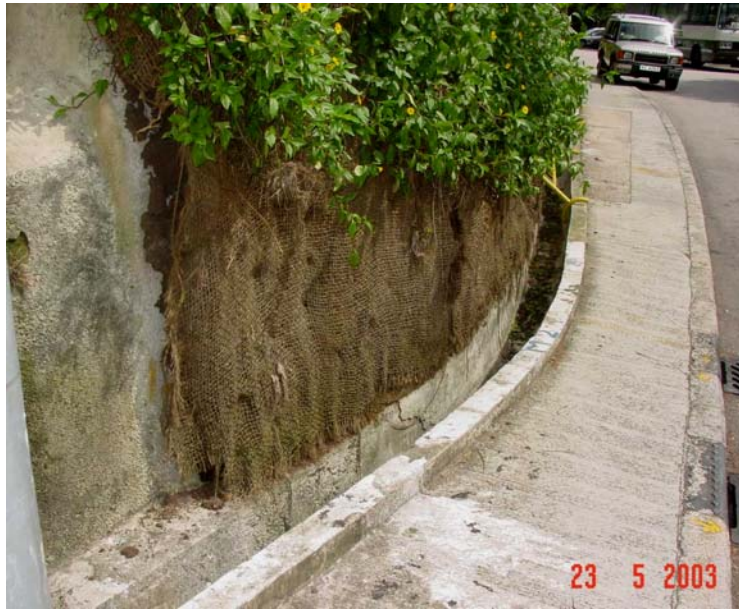
Plate 10a

Observations: Steeply inclined slope profile
Slope No.: 11SE-C/C166
Location: Mount Butler
Date of Inspection: 23 May 2003

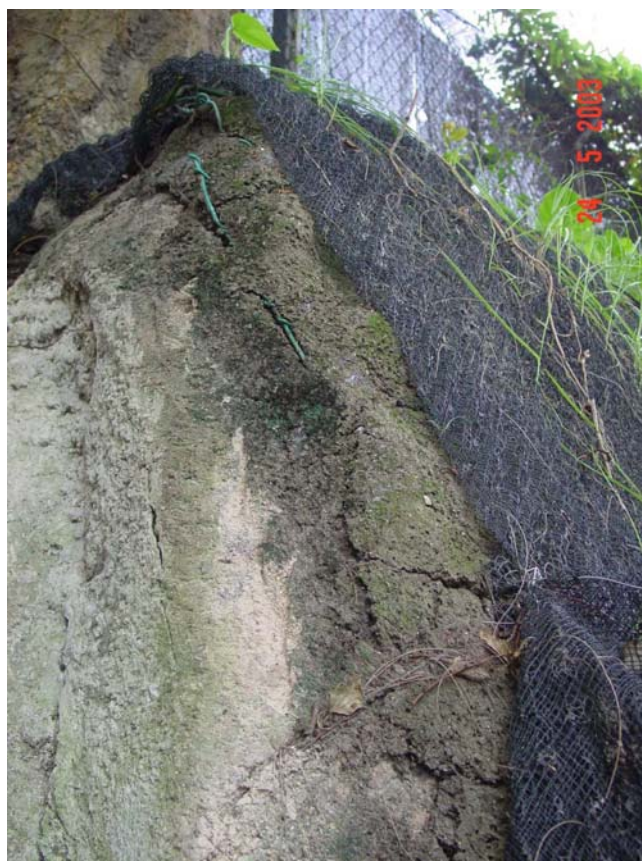
Plate 11a

Observations: Edge of system subject
to surface erosion
Slope No.: 15NE-C/C3
Location: Stanley
Date of Inspection: 24 May 2003

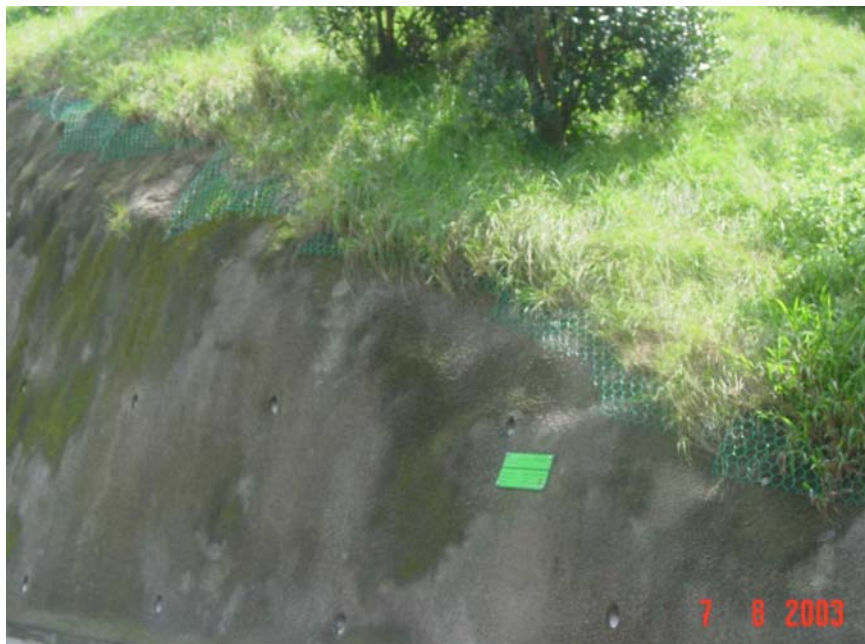
Plate 11b

Observations: System Over-hanging
Slope No.: 15NE-B/C232
Location: Shek O
Date of Inspection: 7 August 2003

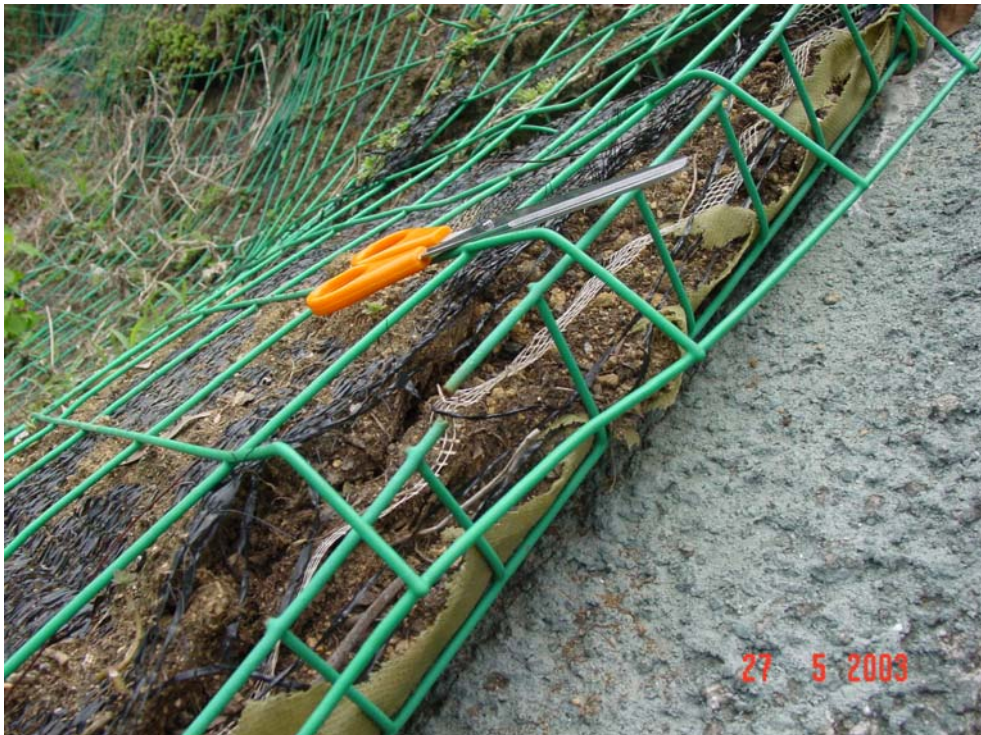
Slope No.: 11NE-D/C366
Location: Lam Tin
Date of Inspection: 27 May 2003

Plate 12 - Lining of Geotextiles for Panels on a Slope with Instant Evergreen System

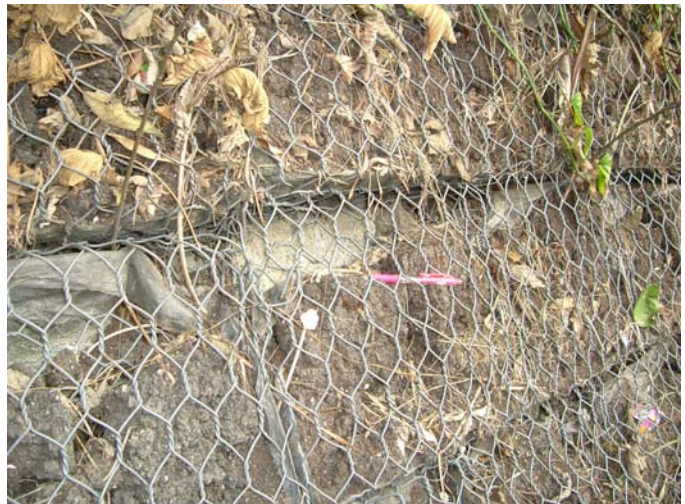
Plate 13b

Observations: Erosion of mulch/soil mix out of the gabion
Slope No.: 11SW-A/C139
Location: Pokfulam Road
Date of Inspection: 27 December 2003

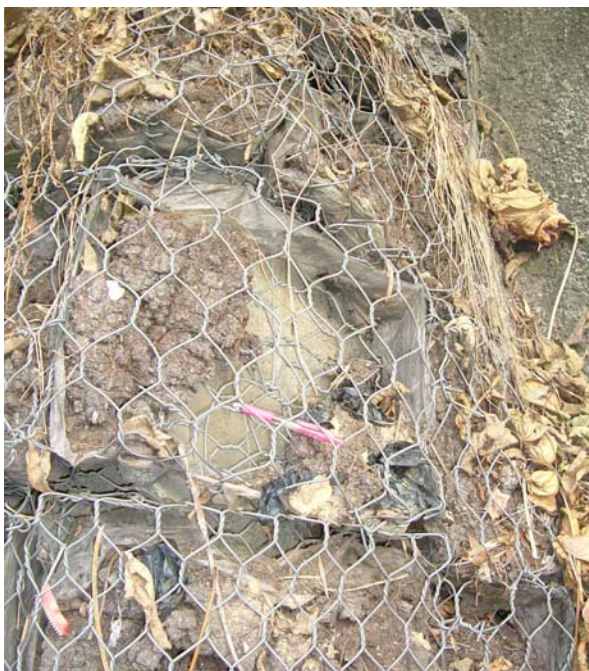
Plate 13c

Observations: Erosion of mulch/soil mix out of the gabion at the edge of system
Slope No.: 11SW-A/C139
Location: Pokfulam Road
Date of Inspection: 27 December 2003

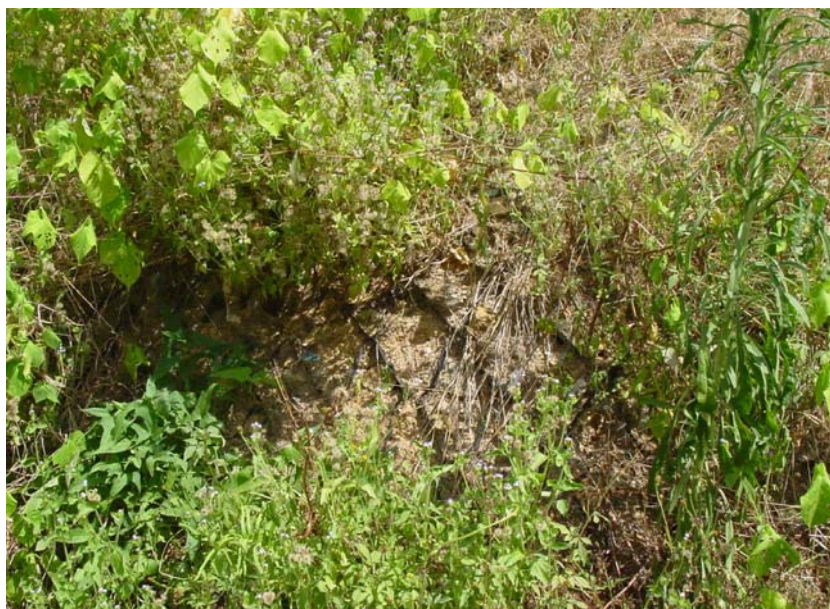
Plate 14b

Observations:	Erosion on slope with Terra Cell
Slope No.:	11NE-D/C815
Location:	Tiu Keng Leng
Date of Inspection:	17 July 2003

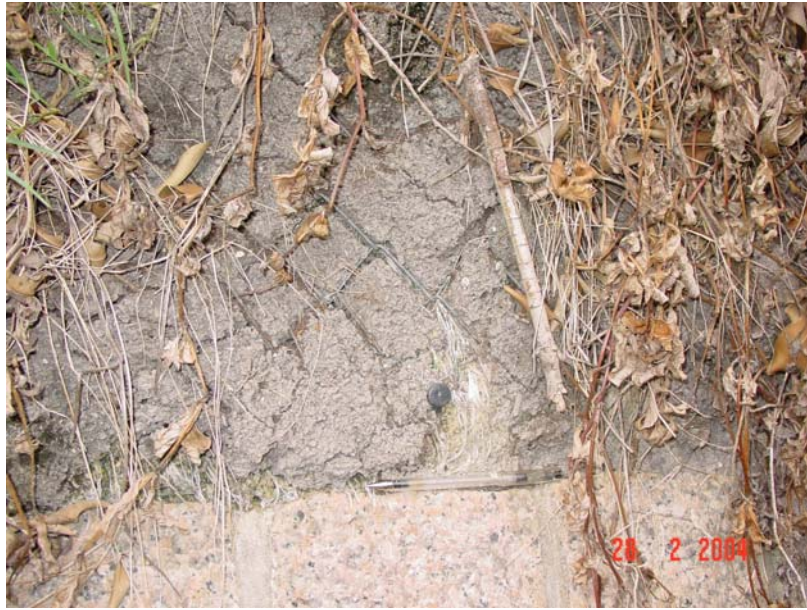
Plate 15a

Observations: Detachment of surface mulch, exposing the wire mesh and the fiber underneath
Slope No.: 11SW-B/C24
Location: Stubbs Road
Date of Inspection: 28 Feb 2004

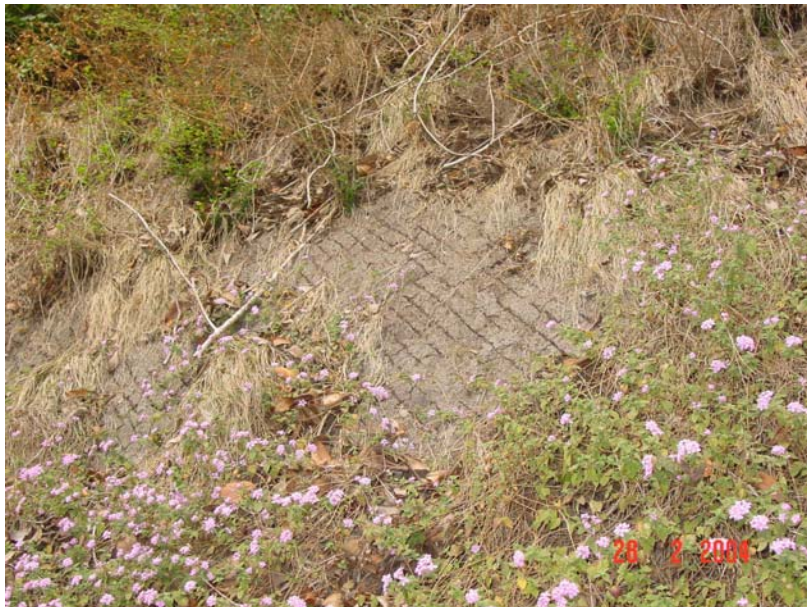
Plate 15b

Observations: Detachment of surface mulch in a large extent
Slope No.: 11SW-B/C24
Location: Stubbs Road
Date of Inspection: 28 Feb 2004

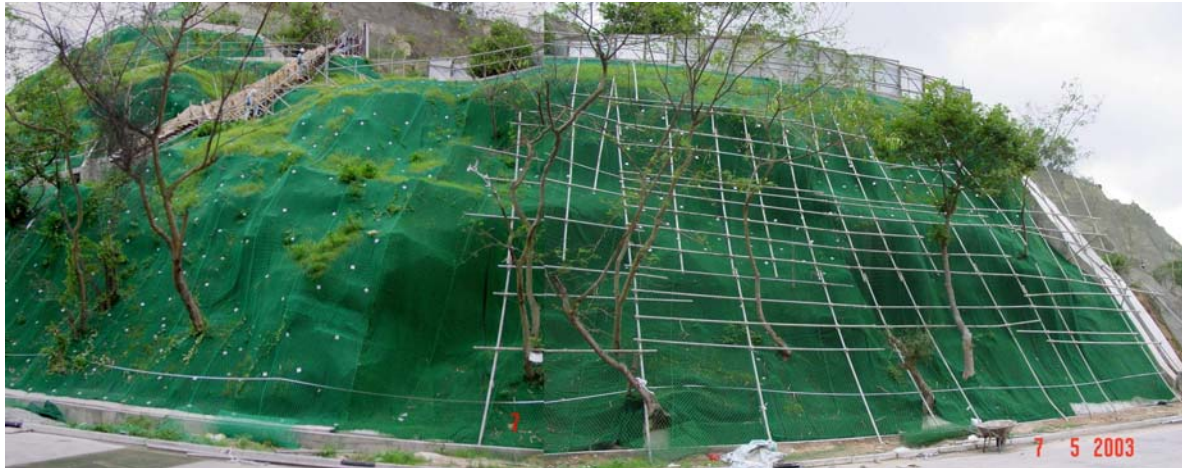
Plate 16a

Observations: Erosion control mat covering slope with Soil Guard
Slope No.: 11NW-D/C403
Location: Homantin
Date of Inspection: 7 May 2003

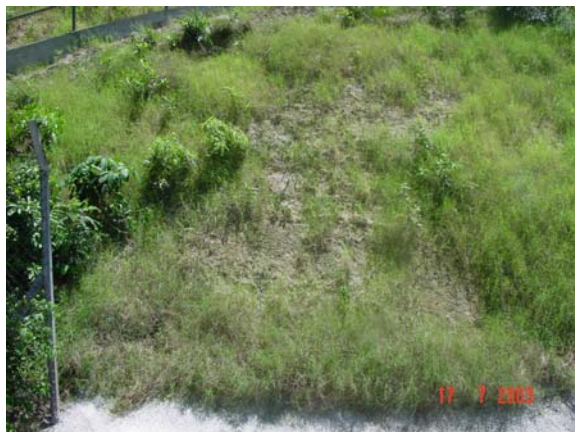
Plate 16b

Observations: Erosion on slope with Soil Guard
Slope No.: 11NW-B/C504
Location: Beacon Hill
Date of Inspection: 17 July 2003

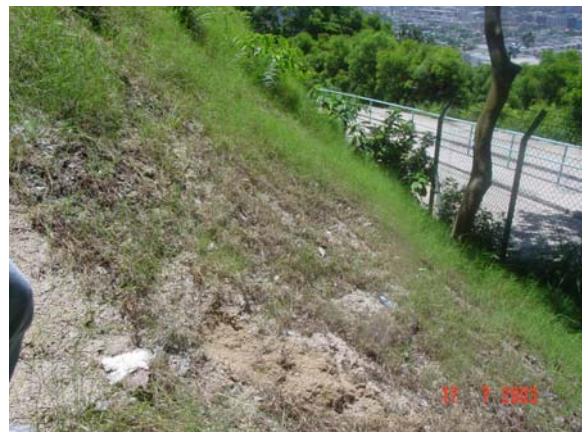
Plate 16c

Observations: Erosion at crest of slope with Soil Guard
Slope No.: 11NW-B/C504
Location: Beacon Hill
Date of Inspection: 17 July 2003

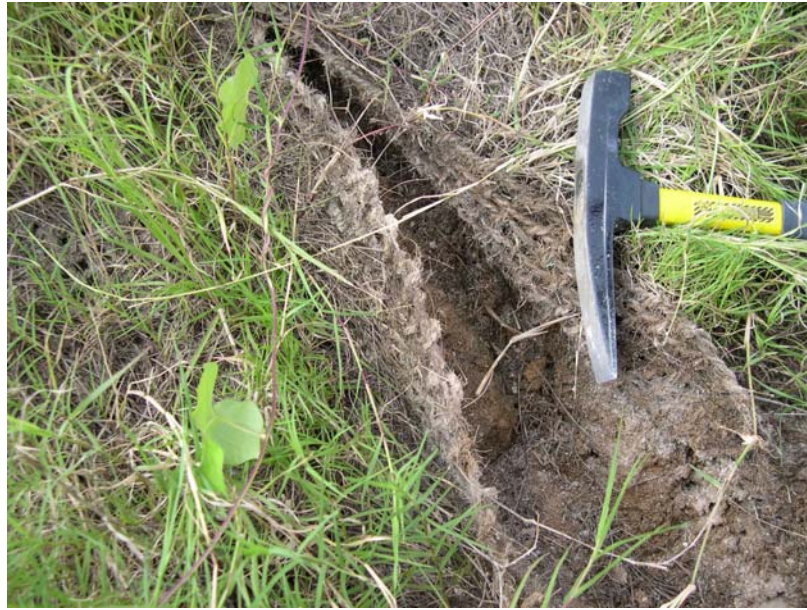
Plate 17a

Observations: Erosion gullies formed along the lapping of two mats
Slope No.: 11NW-D/FR40
Location: Homantin
Date of Inspection: 21 May 2003

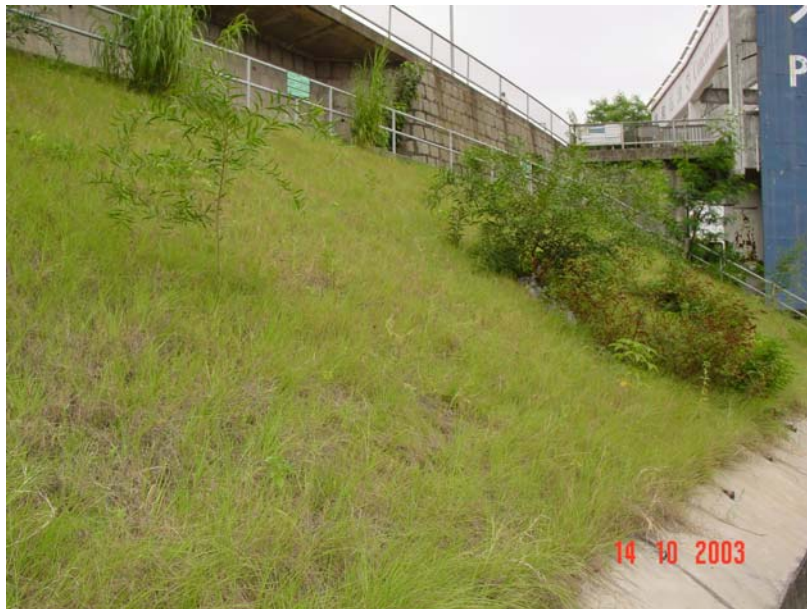
Plate 17b

Observations: Vegetation established on the lapping paths of two mats
Slope No.: 11NW-D/FR40
Location: Homantin
Date of Inspection: 16 October 2003

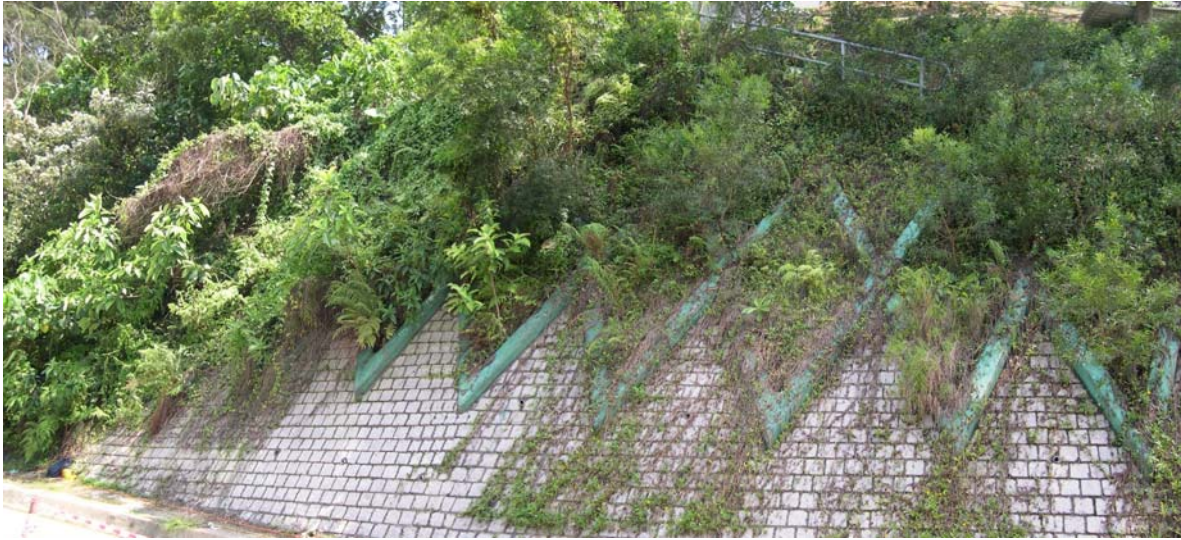
Plate 20a

Observations: Miramat TM8 on slope with grillage beams
Slope No.: 7SW-D/C22
Location: Lower Shnig Mun Road
Date of Inspection: 21 May 2003

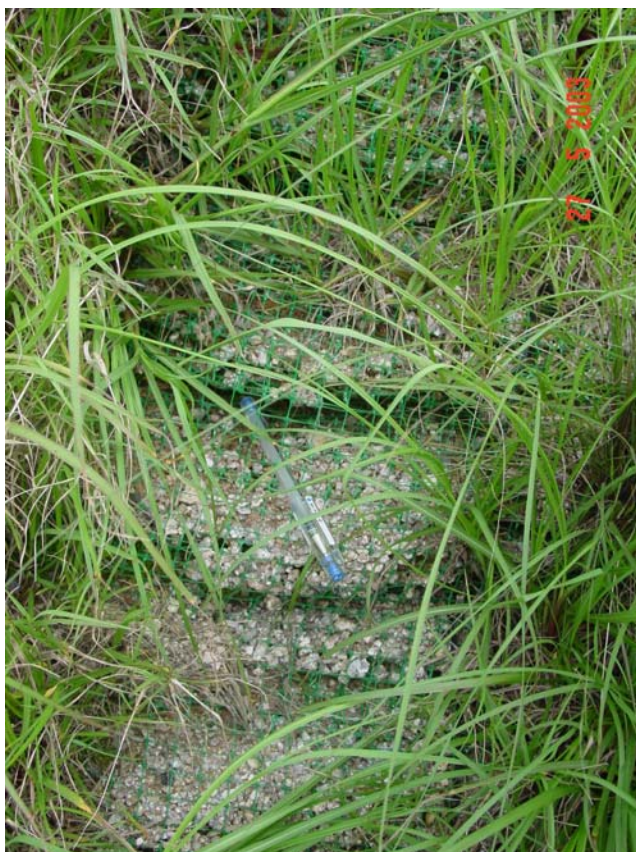
Plate 21a

Observations: Filling material on
Multimat
Slope No.: 7SE-C/C42
Location: Fei Ngo Shan Road
Date of Inspection: 27 May 2003

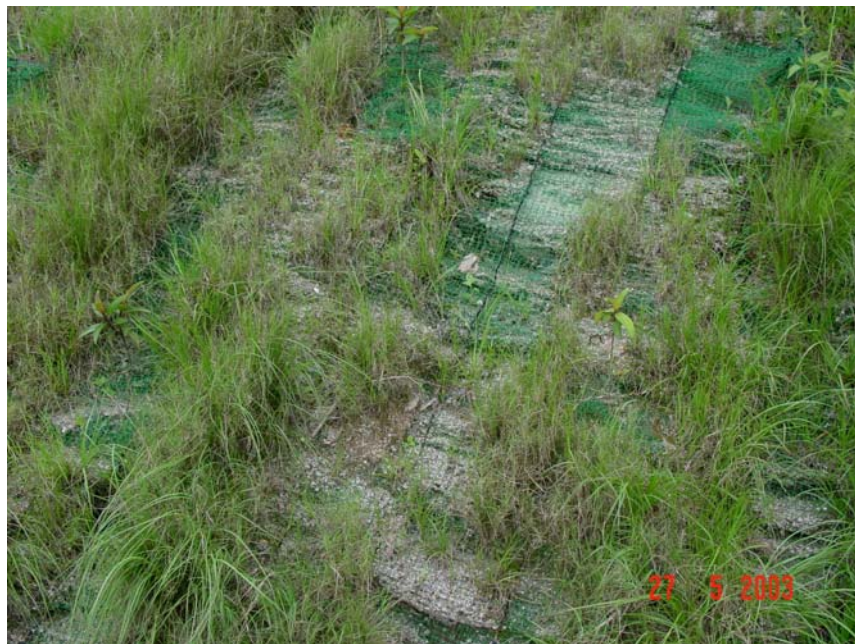
Plate 21b

Observations: Filling material on Multimat eroded away
Slope No.: 7SE-C/C42
Location: Fei Ngo Shan Road
Date of Inspection: 27 May 2003

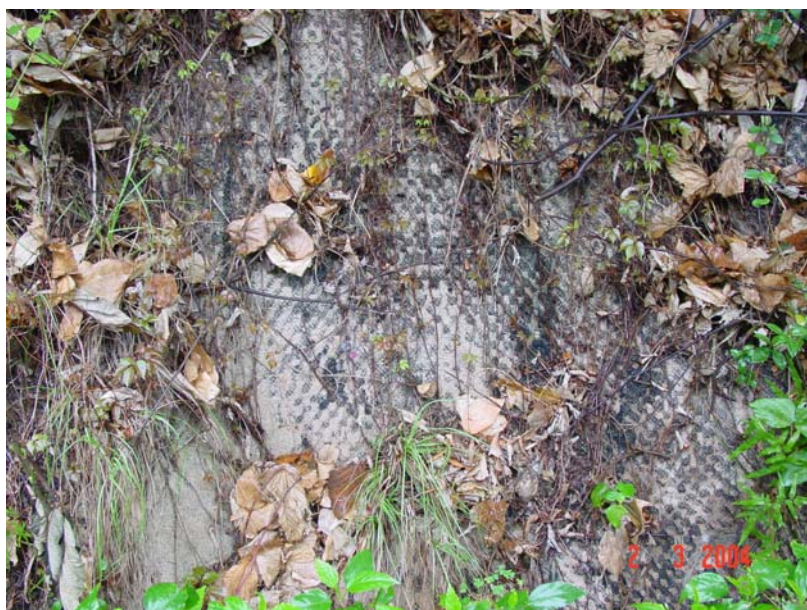
Plate 22a

Observations: Minor erosion on slope surface
Slope No.: 7SE-D/C13
Location: Hiram's Highway
Date of Inspection: 2 March 2003

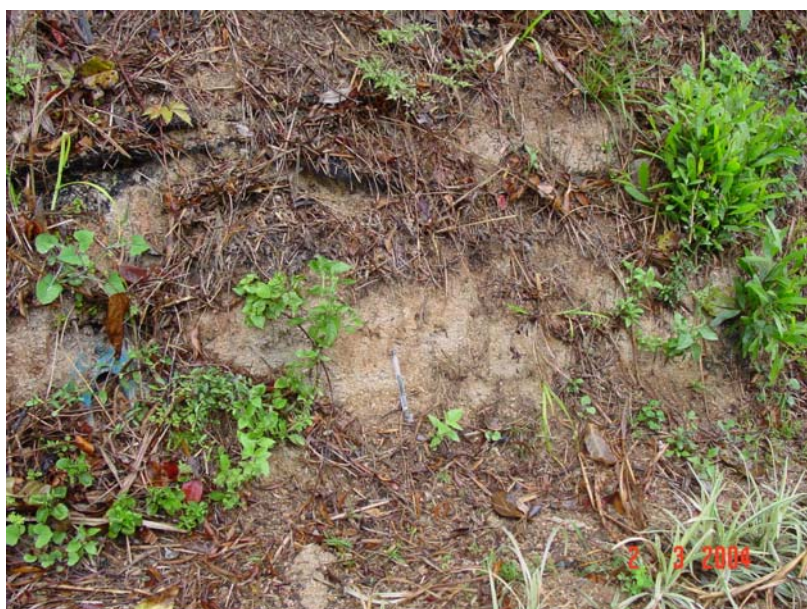
Plate 22b

Observations: Erosion on slope surface
Slope No.: 7SE-D/C53
Location: Hiram's Highway
Date of Inspection: 2 March 2003

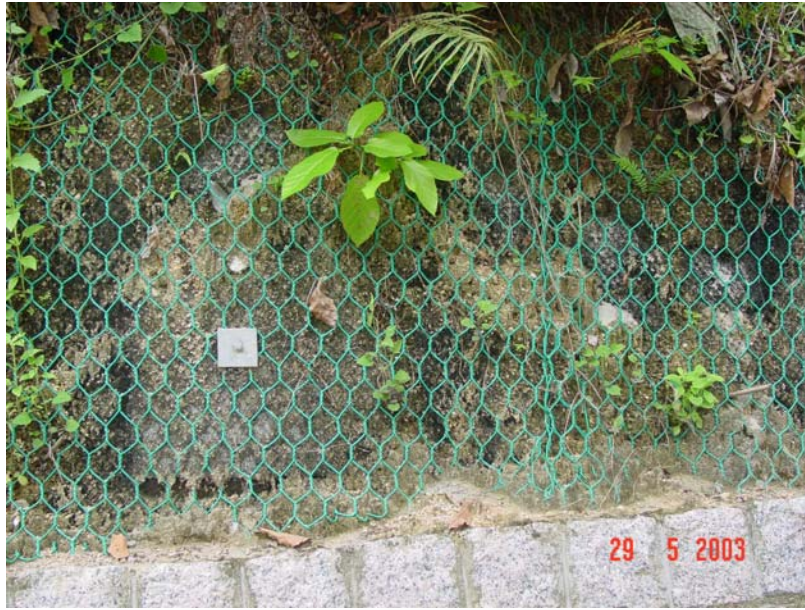
Plate 23a

Observations: Erosion at slope applied with Enkamat
Slope No.: 3SE-D/C74
Location: Bride's Pool Road
Date of Inspection: 29 May 2003

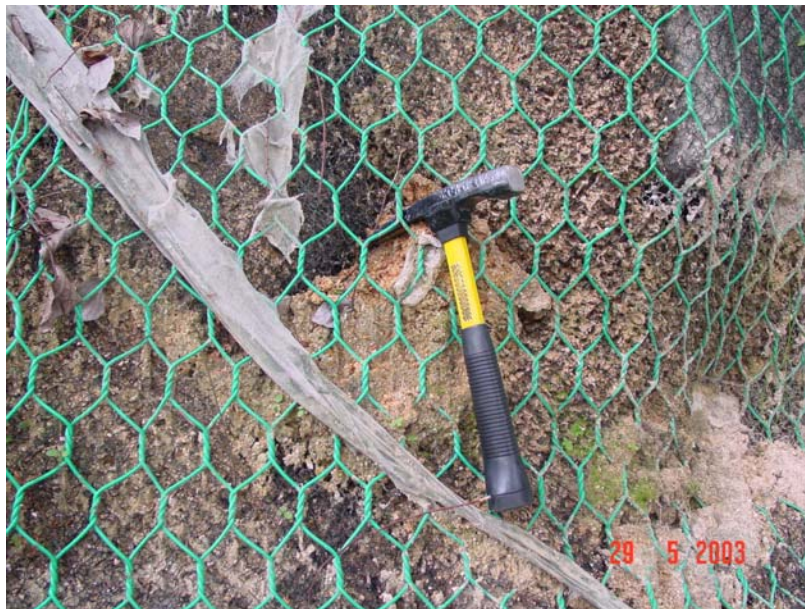
Plate 23b

Observations: Eroded material at slope applied with Enkamat trapped by wire mesh
Slope No.: 3SE-D/C74
Location: Bride's Pool Road
Date of Inspection: 29 May 2003
