PERFORMANCE ASSESSMENT OF GREENING TECHNIQUES ON SLOPES

GEO REPORT No. 183

B.L.S. Lui & Y.K. Shiu

**GEOTECHNICAL ENGINEERING OFFICE
CIVIL ENGINEERING AND DEVELOPMENT DEPARTMENT
THE GOVERNMENT OF THE HONG KONG
SPECIAL ADMINISTRATIVE REGION**

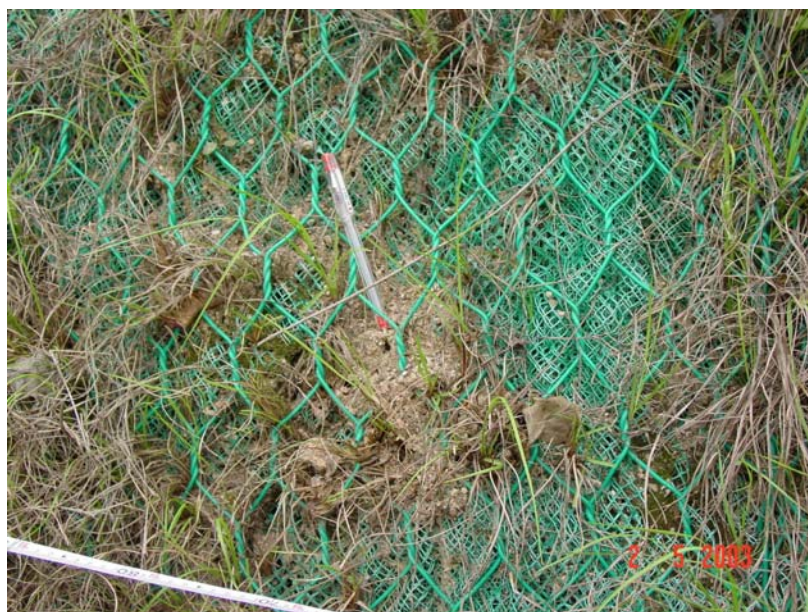
Slope No.: 6SE-C/C28
Location: Tsing Lung Tau
Date of Inspection: 8 March 2004

Plate 24 - Steel Wire Mesh and Multimat not Securely Anchored at Slope Toe

The slope C28 was inspected in March 2004 for engineering assessment. No sign of weakening in strength of the mats was noted. The steel wire mesh and mat were anchored securely on the slope and were in good contact with the soil surface, except at local areas at the slope toe (Plate 24). No apparent sign of erosion was noted on the slope.

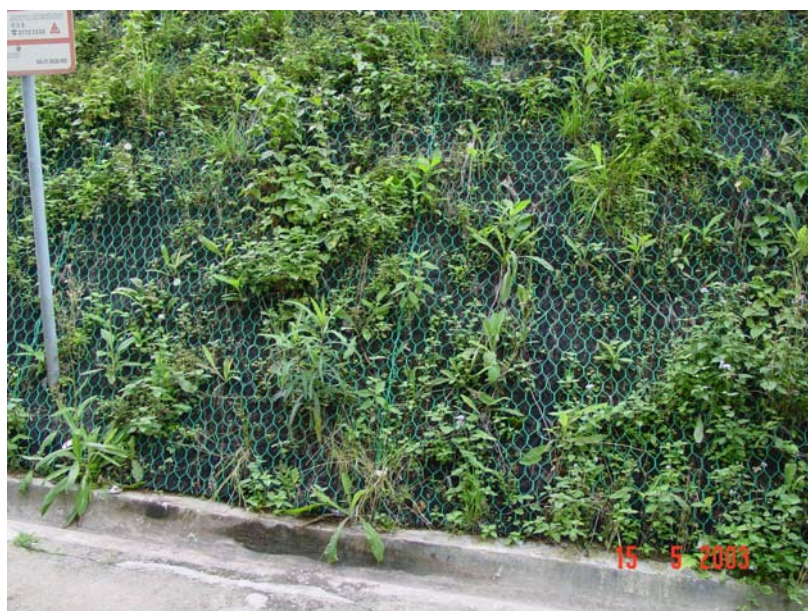
Plate 25a

Observations: Eroded material at slope applied with Tensarmat/EM4 trapped by wire mesh
Slope No.: 8SW-B/C74
Location: Tai Mong Tsai, Sai Kung
Date of Inspection: 2 May 2003

Two slopes no. 8SW-B/C74 and 11SW-C/C82 were inspected for engineering assessment. The average slope angles for slopes C74 and C82 are 60° and 50° respectively. The mat on slope C74 had lost strength and become brittle, illustrating that it might not be adequately ultra violet stabilized. Minor erosion occurred on Slope C74 and the eroded soil was trapped by the mat and the wire mesh (Plate 25a). There was no sign of weakening in the strength of the mats nor sign of erosion on the other slope (Plate 25b). The mats were noted to have conformed to the soil surface and securely pegged on both slopes.

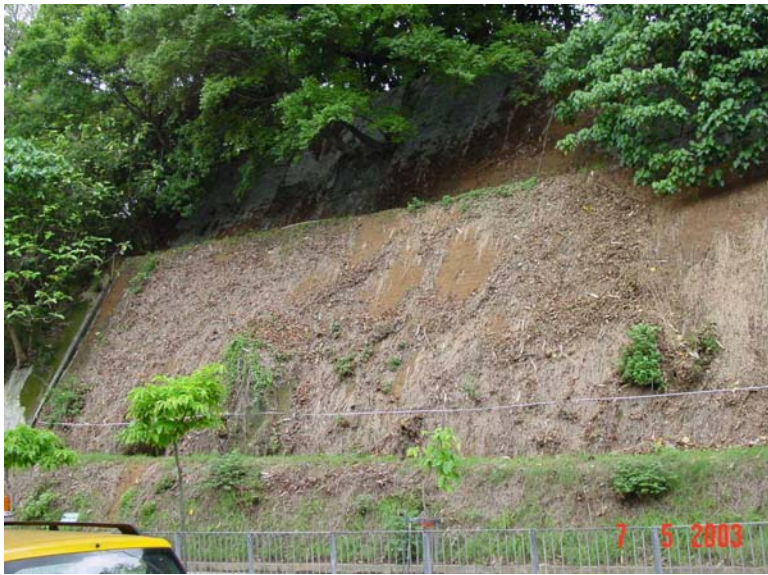
Plate 25b

Observations: No sign of erosion apparent
Slope No.: 11SW-C/C82
Location: Pokfulam Road
Date of Inspection: 15 May 2003

Plate 25 - Slopes Applied with Tensarmat/EM4 with Steel Wire Mesh

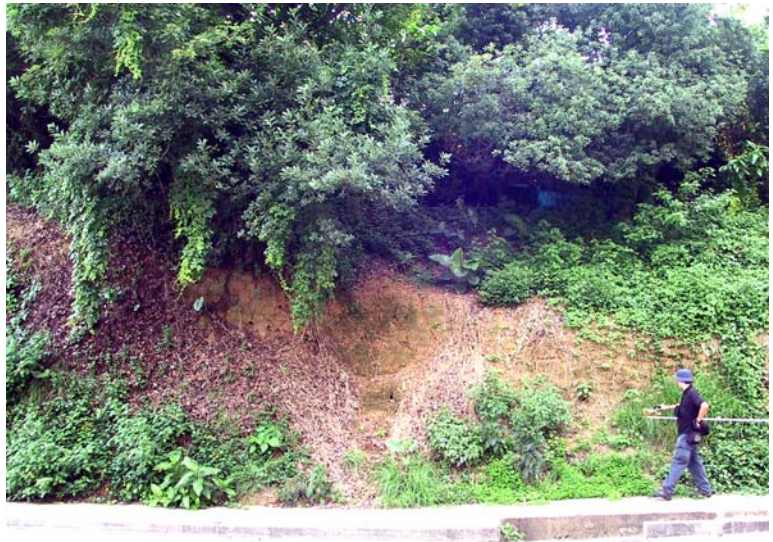
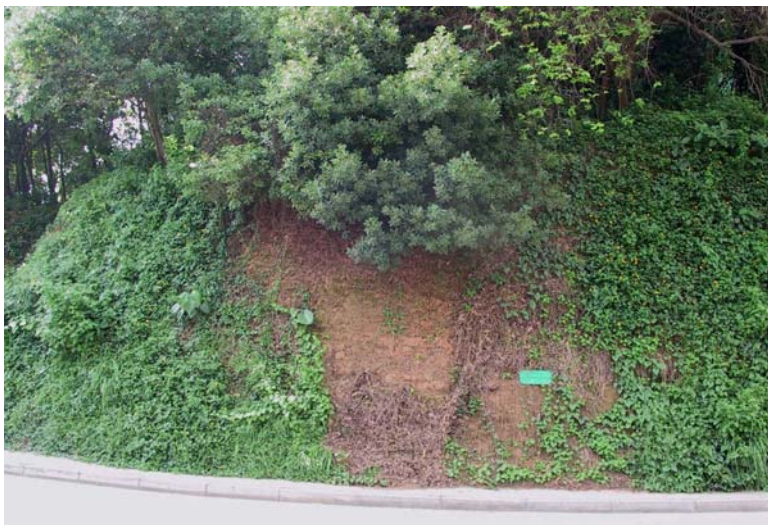
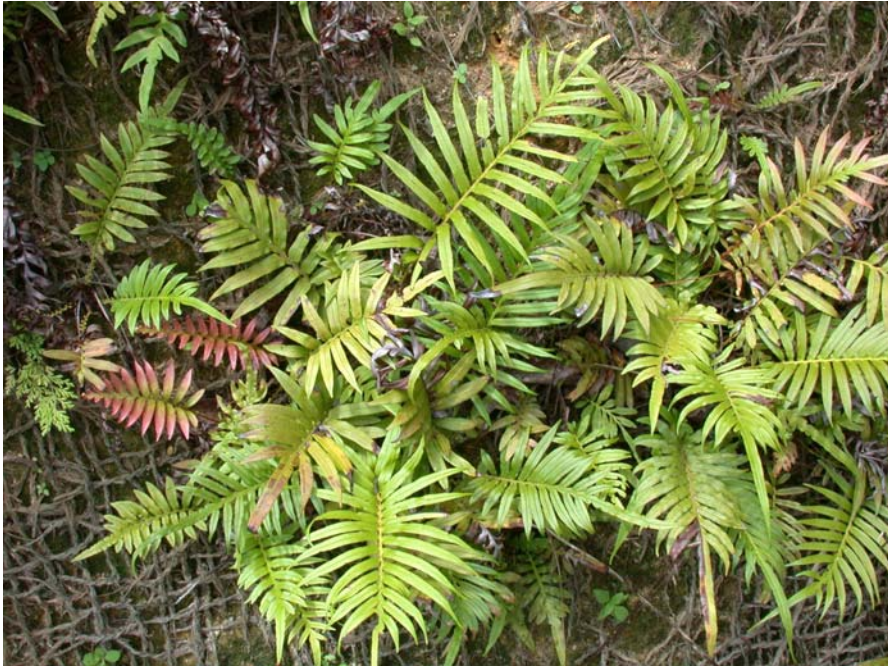
Plate 26 - Surface Erosions below Tree Canopies

Slope No.: 11NW-D/C90
Location: Homantin
Date of Inspection: 7 May 2003

Slope No.: 6SE-B/C256
Location: Route Twisk
Date of Inspection: 22 May 2003

The surface of the soil mix is protected with a layer of temporary degradable erosion control mat. During the site inspections, the mats on all the slopes had almost completely decomposed. Surface erosion was observed on slope C90 at various locations (Plates 5a and 5b). The vertical edges of the system on this slope were noted to be exposed (Plate 5c) and subject to surface erosion, especially those adjacent to stepped channel (Plate 5d). Surface erosion was also noted locally on slope C105 (Plate 5e), covering less than 10% of the total slope surface. Serious surface erosions were observed at areas directly under the canopies of existing trees at slopes C90 and C256 (Plate 26).

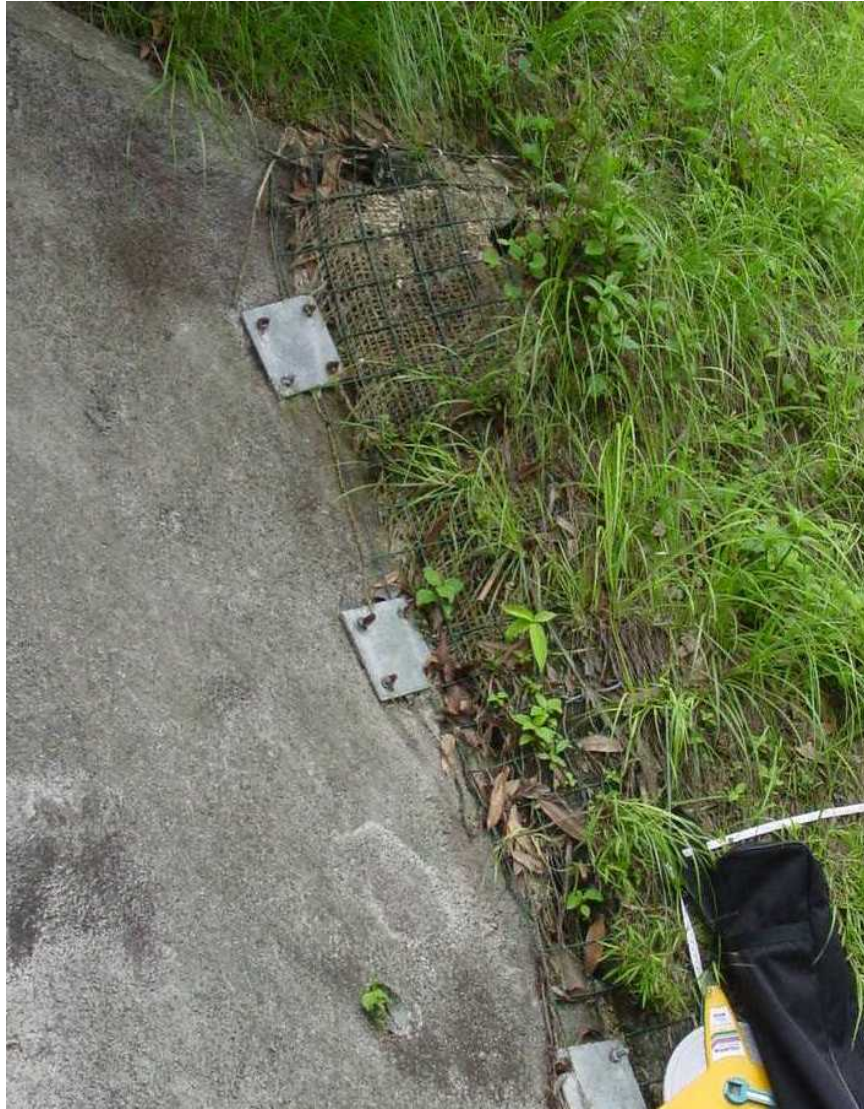
Plate 30 - Protection at the Edge of Soil Panel

Plate 30 shows a view of a properly protected edge.

Slope No.: 11SE-A/C487
Location: Mount Parker
Date of Inspection: 24 May 2003

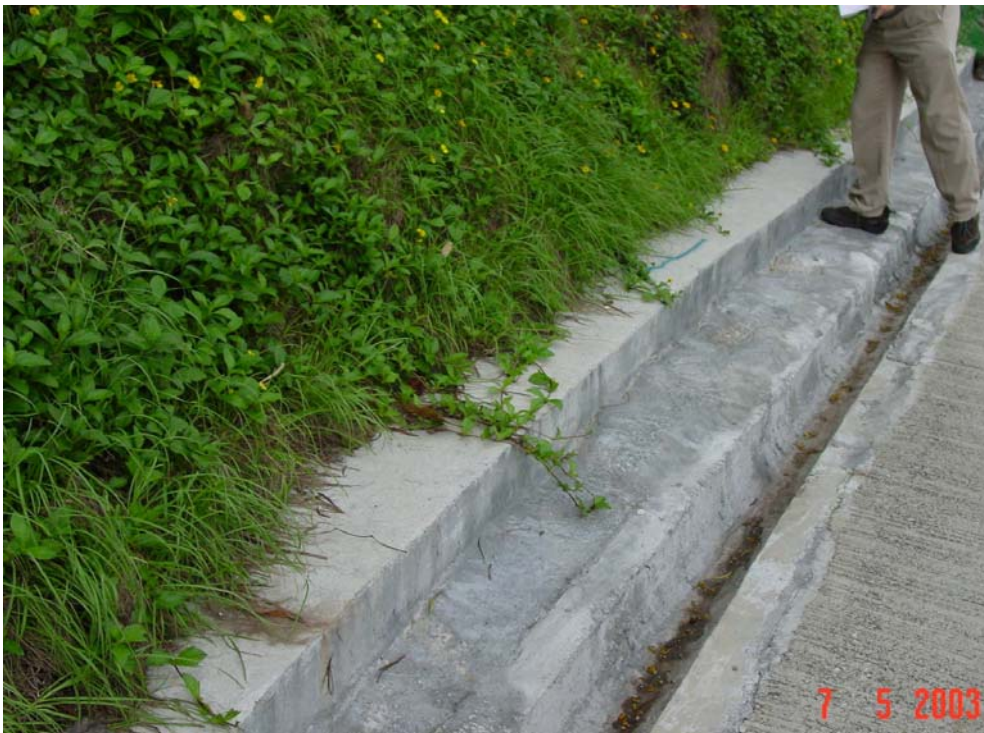
Plate 31 - Concrete Kerb As Toe Support for Greening System

Slope No.: 11NW-D/C130
Location: Homantin
Date of Inspection: 7 May 2003

- (f) Sufficient channels should be provided at slope crest and berms to drain surface runoff, and prevent the soil/mulch mix of the greening products from surface erosion.
- (g) Concrete kerb or planter wall should be provided as far as practicable in order to support the toe of the soil/mulch layers and to avoid downslope movement of the soil/mulch. Plate 31 shows an example of such support.
- (h) It is recommended that openings should be formed in the existing concrete cover to enable direct contact between the soil/mulch and the soil underneath the concrete through the openings. This would allow more moisture and nutrients to be obtained from the soil.
