**DETAILED STUDY OF THE  
5 MAY 2003 AND 13 JUNE 2003  
LANDSLIDES ON  
SLOPE NO. 6NE-B/C8  
FAN KAM ROAD, PAT HEUNG**

**GEO REPORT No. 190**

**Maunsell Geotechnical Services Limited**

**This report was originally produced in February 2004  
as GEO Landslide Study Report No. LSR 1/2004**

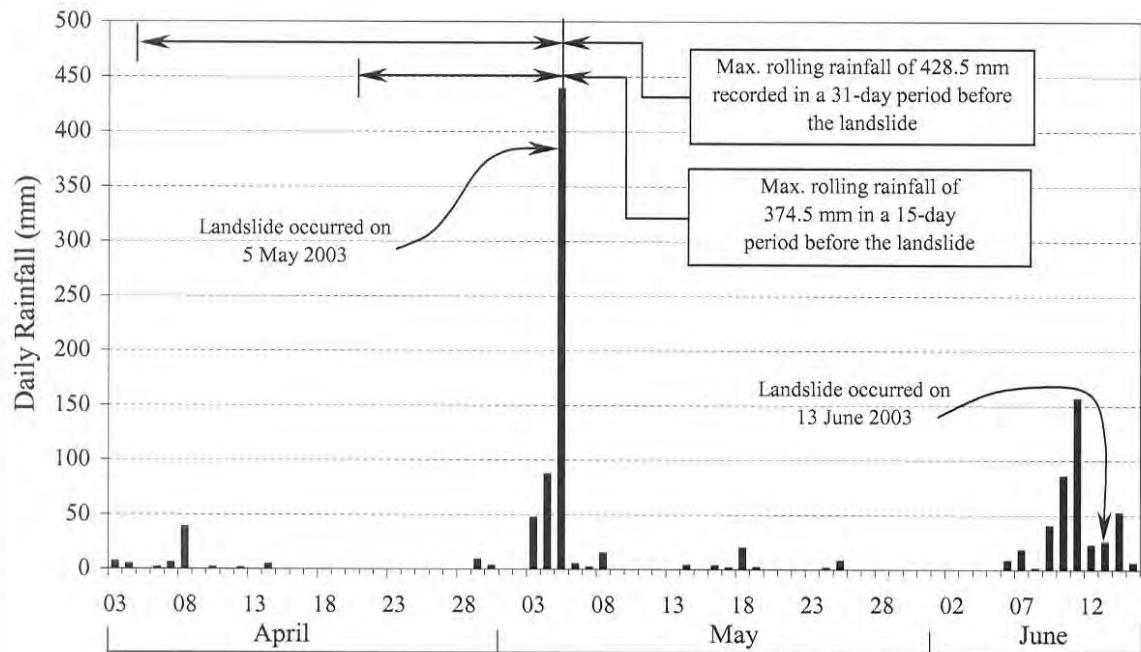
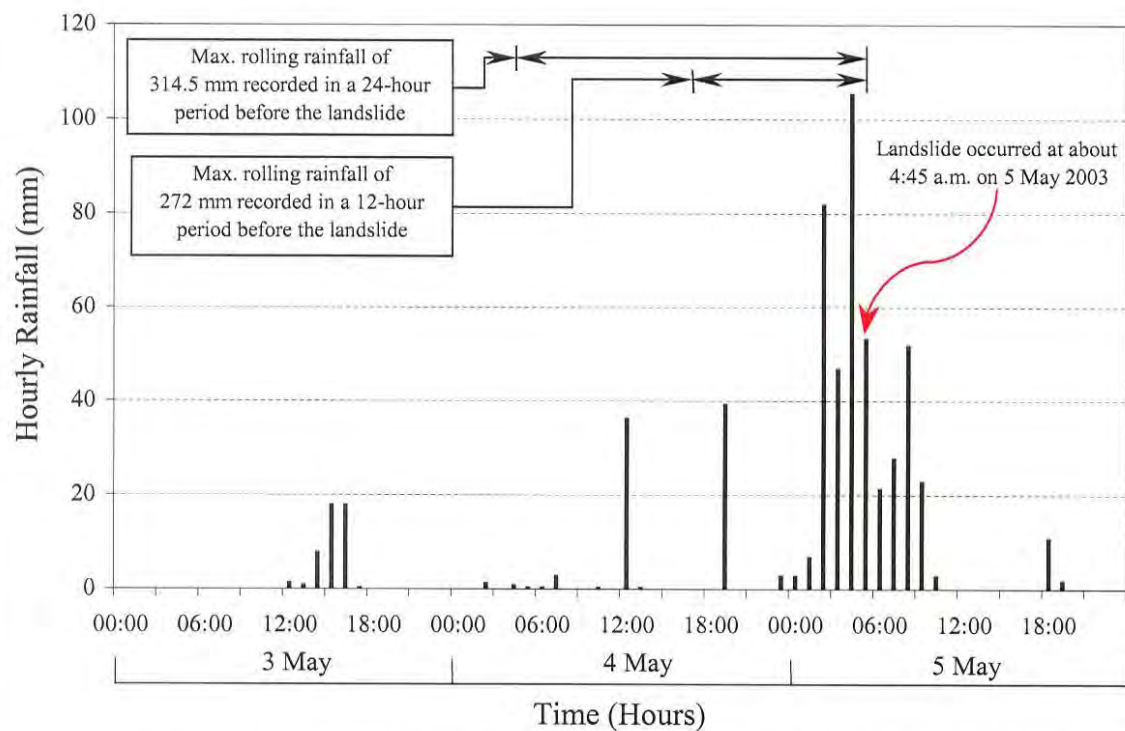
Figure 10 - Daily and Hourly Rainfall Recorded at GEO Raingauge No. N36

The daily rainfall recorded by raingauge No. N36 over the month preceding the 5 May 2003 landslide and two days following the 13 June 2003 landslide incident, together with the hourly rainfall readings for the period between 3 and 5 May 2003, are presented in Figure 10. The rain was heavy on the morning of 5 May 2003 between 2:10 a.m. and 10:00 a.m. The 24-hour and 12-hour rainfall before the landslide was 314.5 mm and 272 mm respectively. The maximum 1-hour rolling rainfall was recorded as 118 mm between 3:45 a.m. and 4:45 a.m. on 5 May 2003 (Table 1).

presented in Figure 10. The daily rainfall recorded on 12 and 13 June 2003 was less than 25 mm.

(a) Daily Rainfall Recorded at GEO Raingauge No. N36 between 3 April 2003 and 15 June 2003

(b) Hourly Rainfall Recorded at GEO Raingauge No. N36 between 3 May 2003 and 5 May 2003

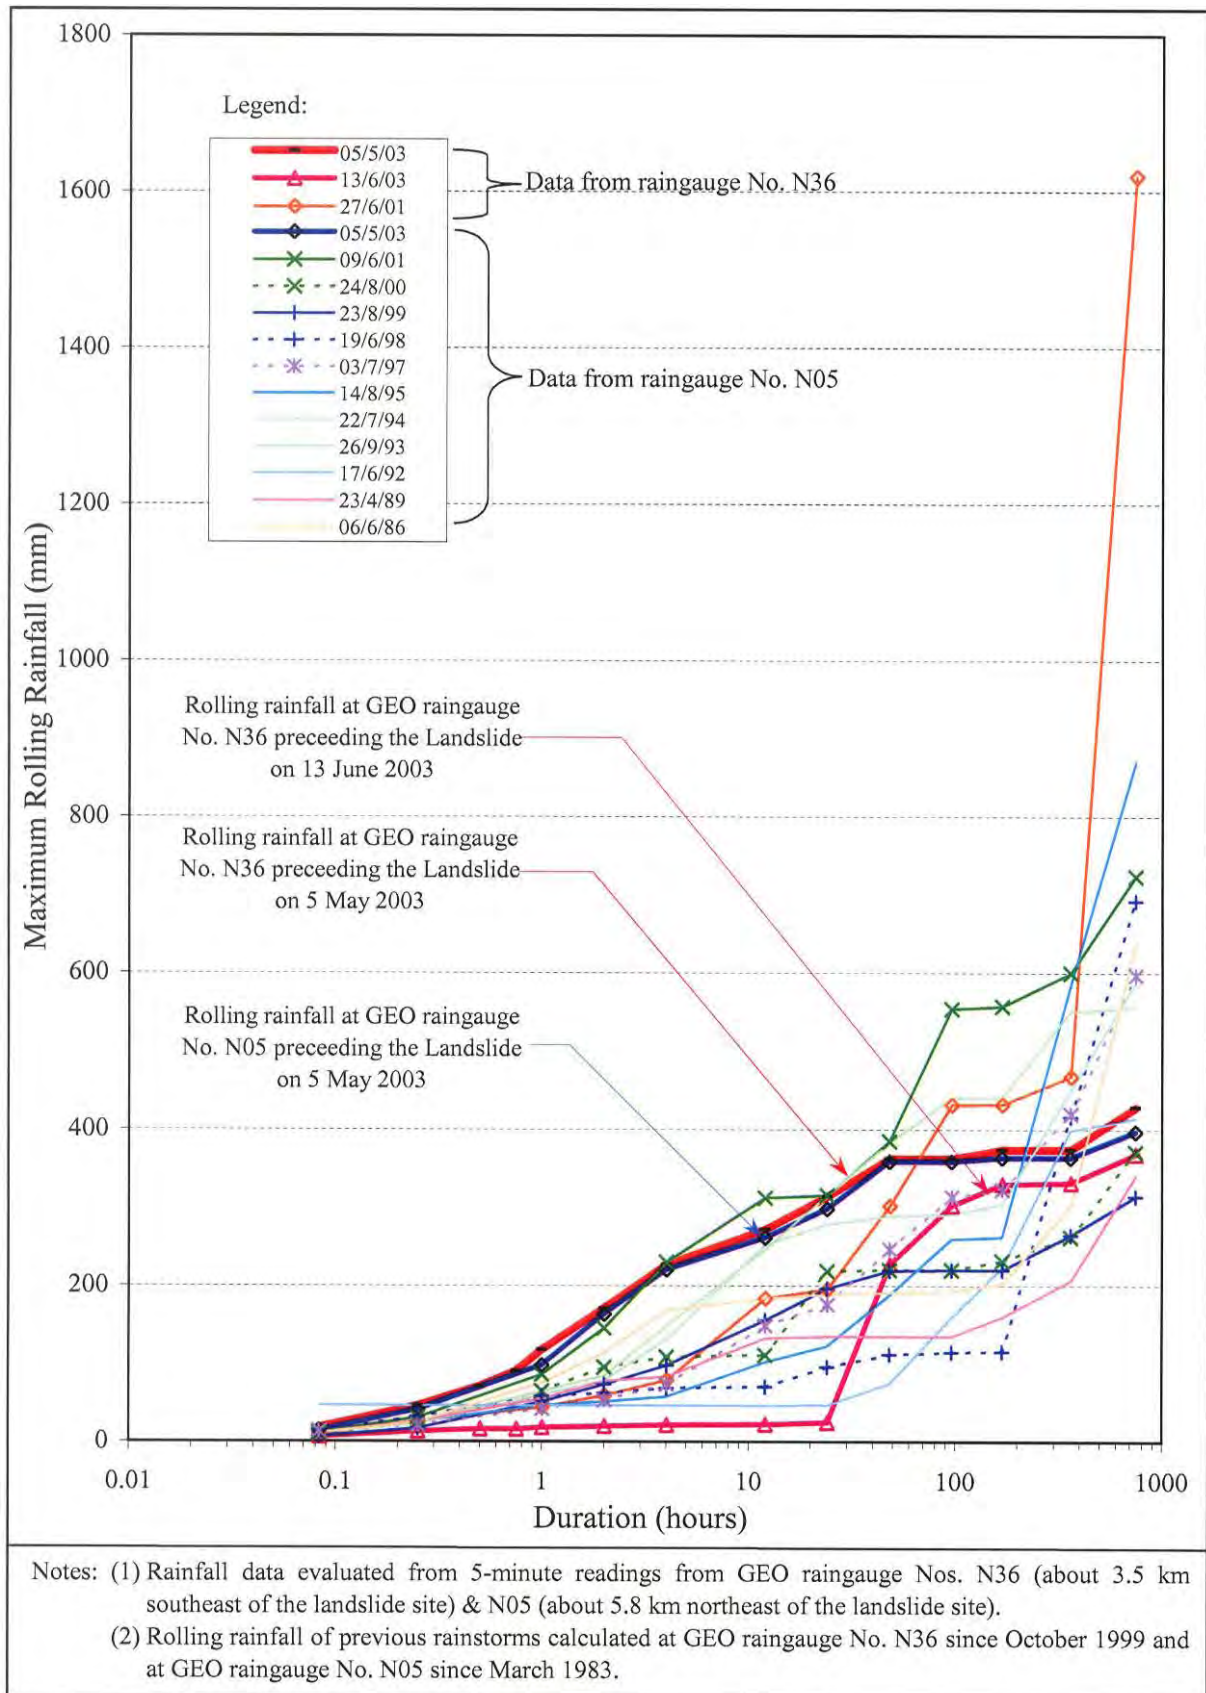
Figure 11 - Maximum Rolling Rainfall for Previous Major Rainstorms at GEO Raingauges Nos. N36 and N05

The maximum rolling rainfalls for the rainstorm on 5 May 2003 have been compared with that of the past major rainstorms between 1983 and 2001 recorded by raingauge No. N05 (which began operation in March 1983 and is located about 5.8 km to the northeast of the landslide) and No. N36 (which began operation in October 1999) (see Figure 11). The maximum rolling rainfall for the rainstorm prior to 4:45 a.m. on 5 May 2003 exceeds that from previous rainstorms for durations up to 4 hours (Figure 11).

Analysis of the return periods of the rainfall intensities preceding the 13 June 2003 landslide is given in Table 2. The results show that the return periods for the maximum rolling rainfall for the various durations considered are less than 2 years, which indicates that the rainfall was not heavy. The rainfall analysis also confirmed that the cut slope had experienced more intense rainstorms in the past than that preceding the 13 June 2003 landslide (Figure 11).

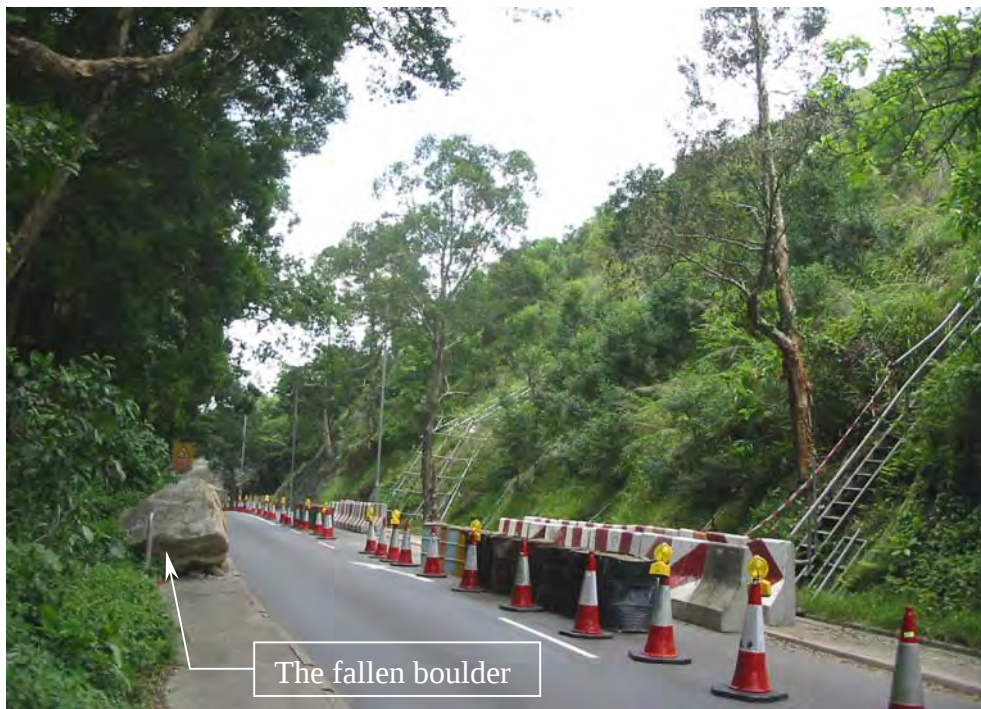
Plate 3 - General View of Slope No. 6NE-B/C8 and the Fallen Boulder  
(Photograph taken on 16 May 2003)

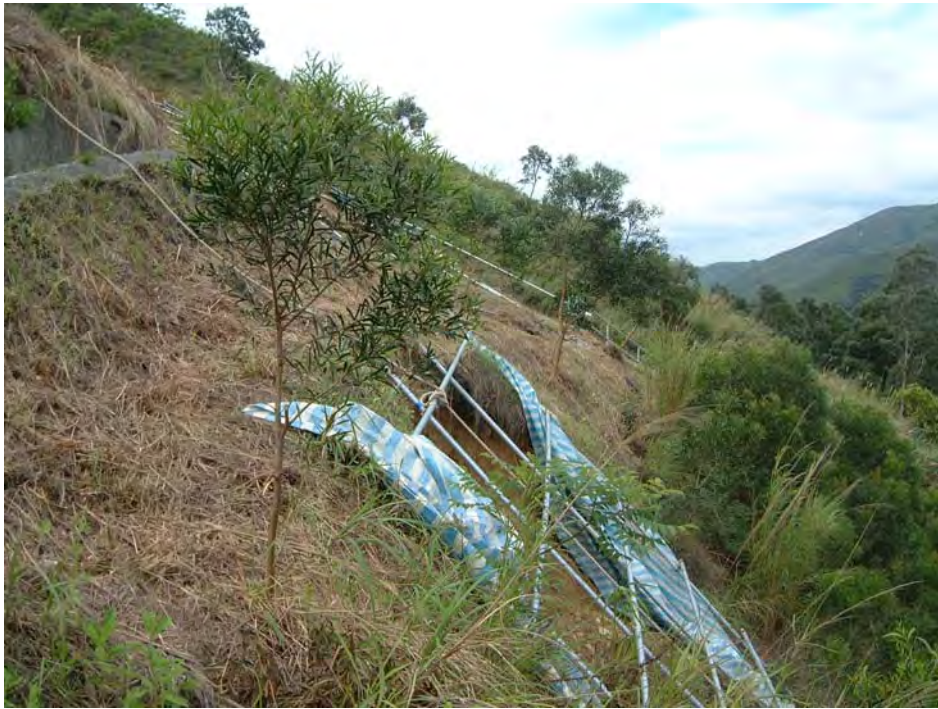
Plate 4 - Side View of the Area Immediately above the 5 May 2003 Landslide Site  
(Photograph taken on 16 May 2003)

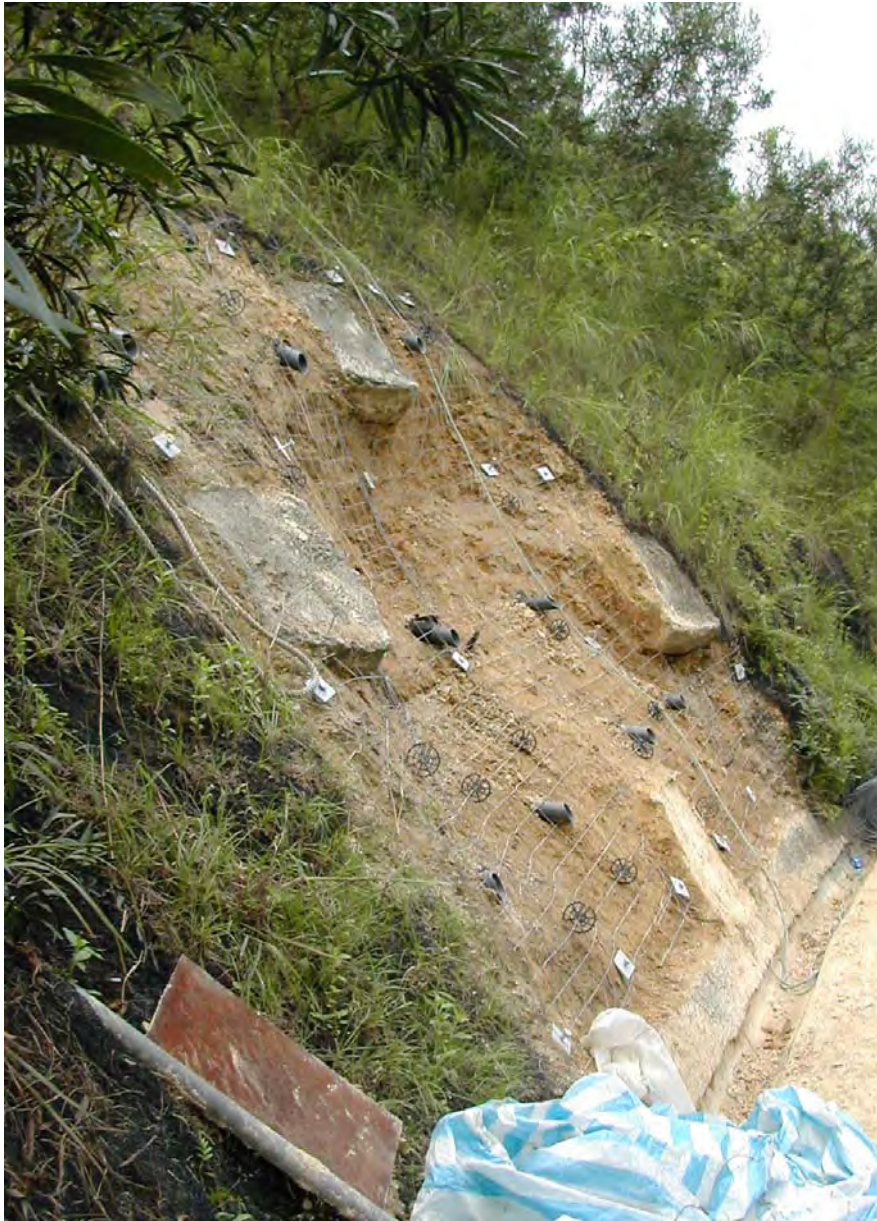
The landslide scar, which was located on the 50° to 55° steep portion of slope No. 6NE-B/C8, measured about 3 m wide by 2.8 m high by 0.4 m deep and was delineated by three soil nail heads (Figure 9 and Plate 14).

Plate 14 - View of the 13 June 2003 Landslide Following Surface Preparation for Urgent Repair Works (Photograph taken on 19 June 2003)

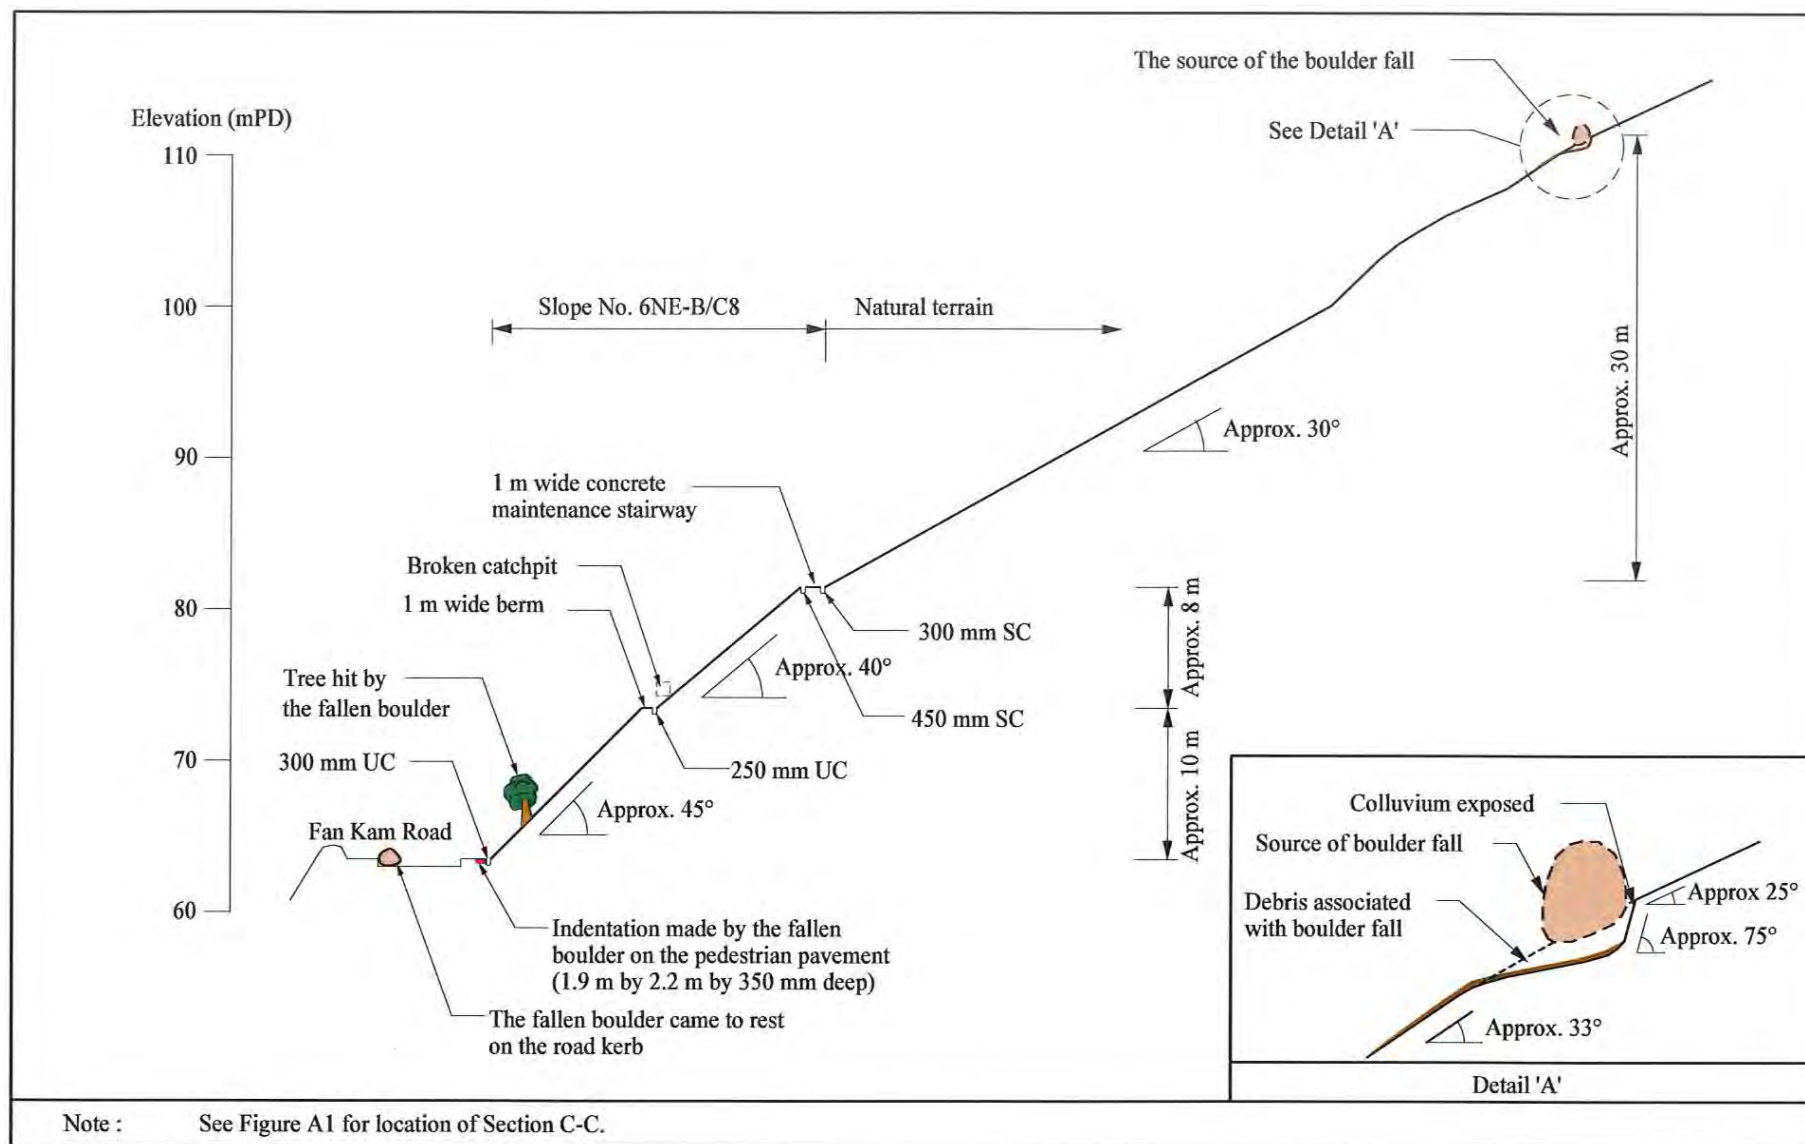
Figure A3 - Section C-C through the 5 May 2003 Boulder Fall Site

The fallen boulder (4.2 m<sup>3</sup>) was moderately to slightly decomposed (Grade II/III) coarse ash tuff and measured approximately 1.4 m by 1.5 m by 2 m (Plate A4). Based on the extent of soil staining on the surface of the boulder, the boulder was likely to have been embedded into the natural hillside to a depth of between 100 mm and 200 mm before detachment (Plate A4). Also, it is probable that the boulder was positioned with its longest dimension (about 2 m) across the hillside, with about 1 m protruding above the surface of the hillside (see Figure A3).

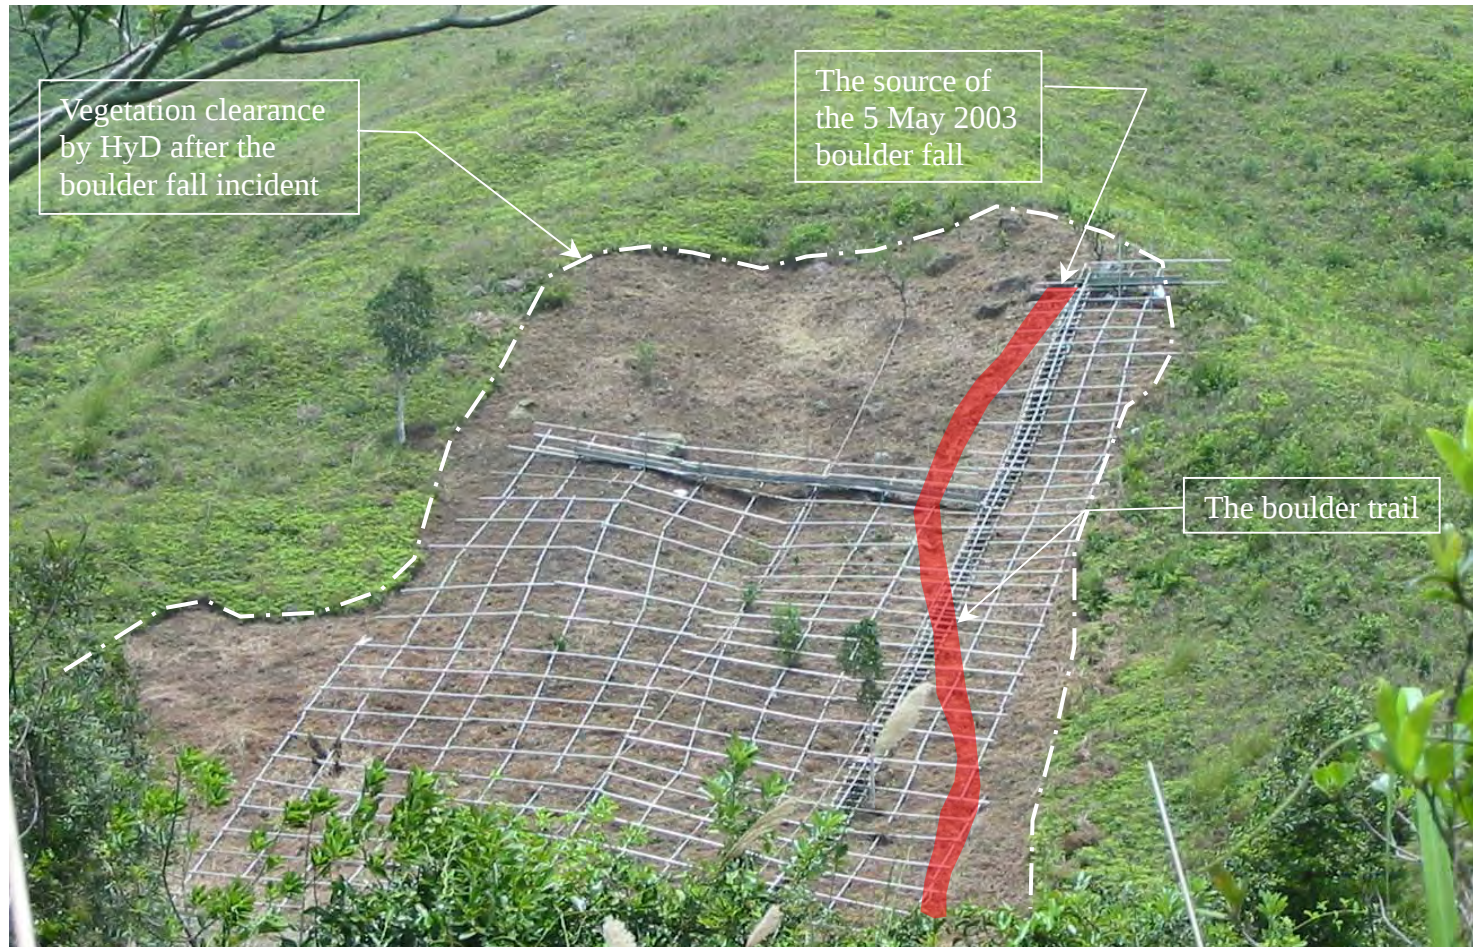
Plate A1 - General View of the Source of the 5 May 2003 Boulder Fall and the Upper Section of the Boulder Trail  
(Photograph taken on 16 May 2003)

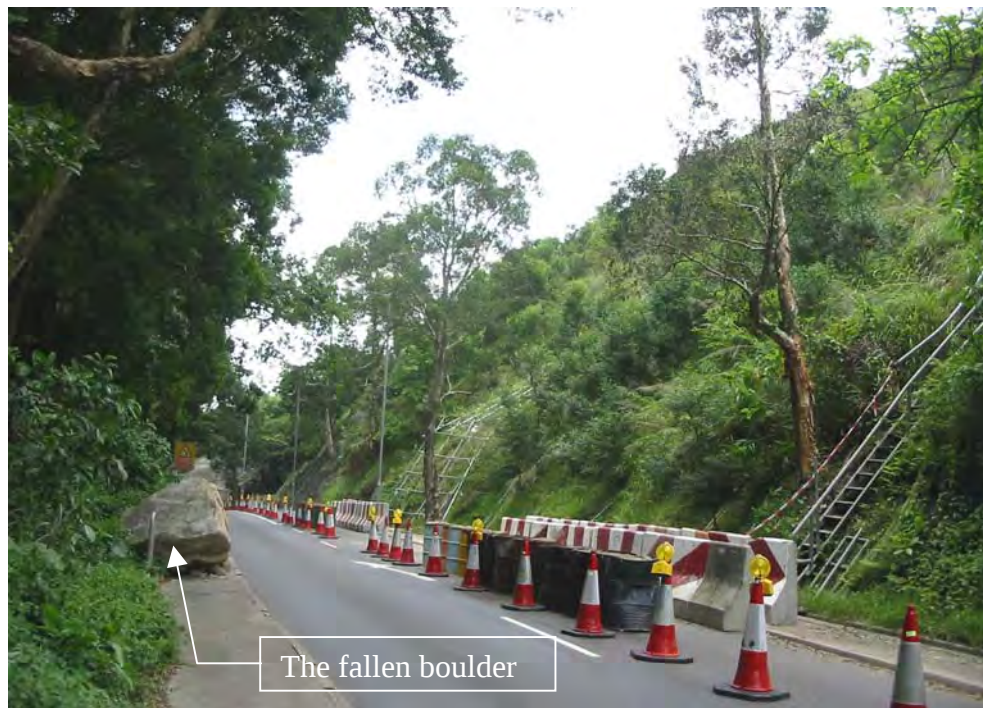
Plate A2 - General View of Slope No. 6NE-B/C8 and the Fallen Boulder  
(Photograph taken on 16 May 2003)

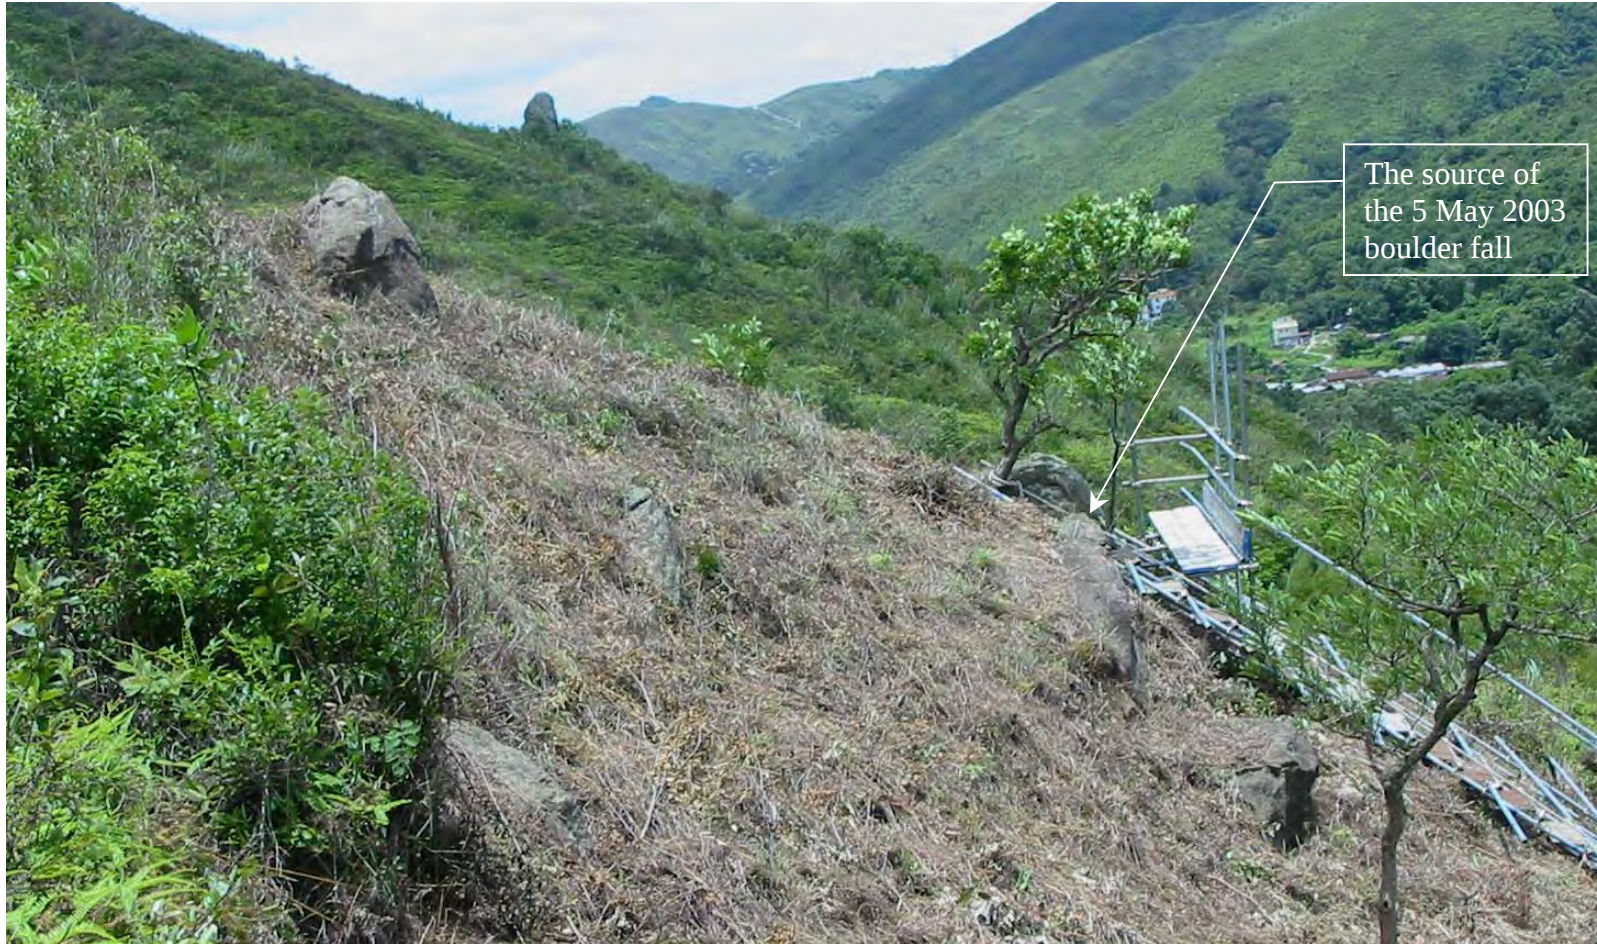
Plate A3 - Side View of the Natural Hillside above the Source of the 5 May 2003 Boulder Fall after Vegetation Clearance  
(Photograph taken on 16 May 2003)

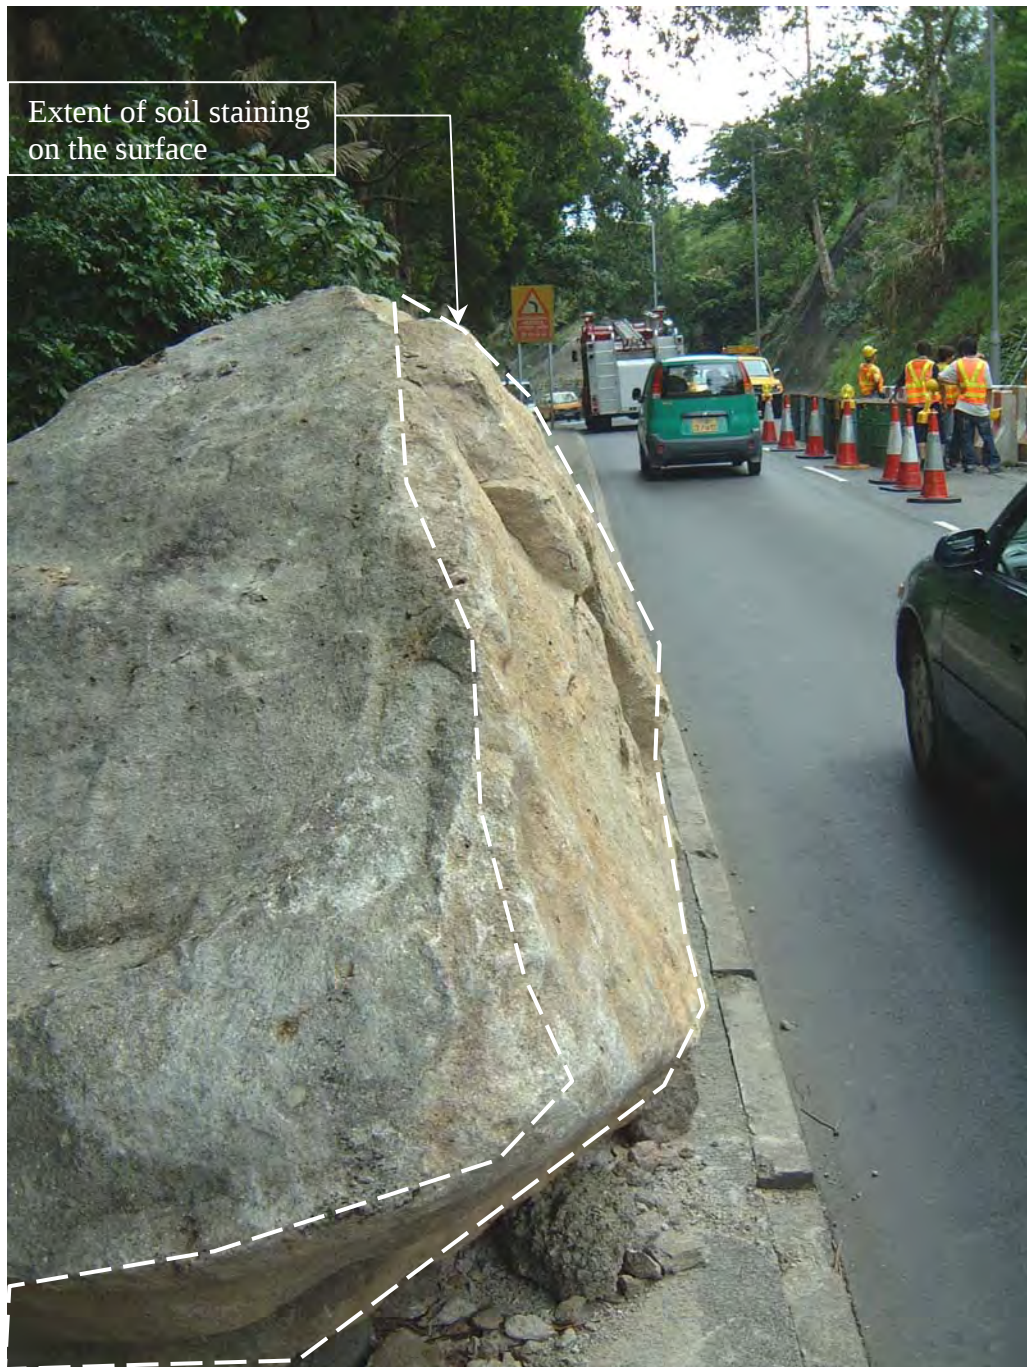
Plate A4 - Close-up View of the Fallen Boulder (Photograph taken on 16 May 2003)

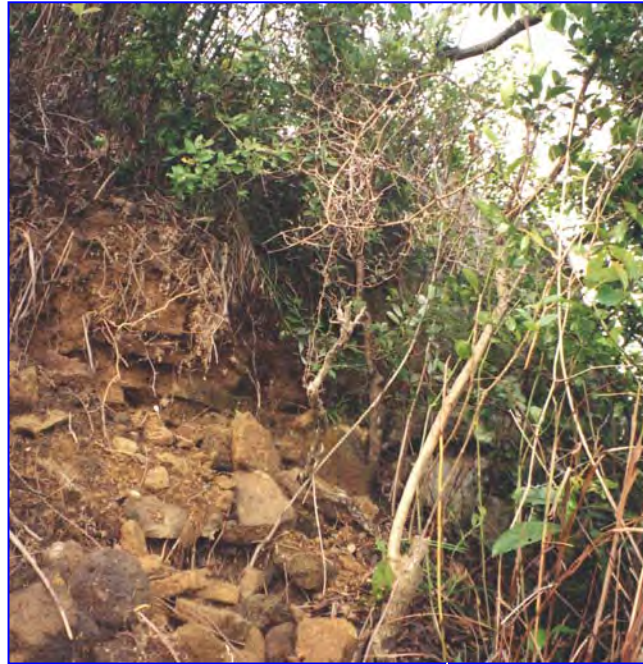
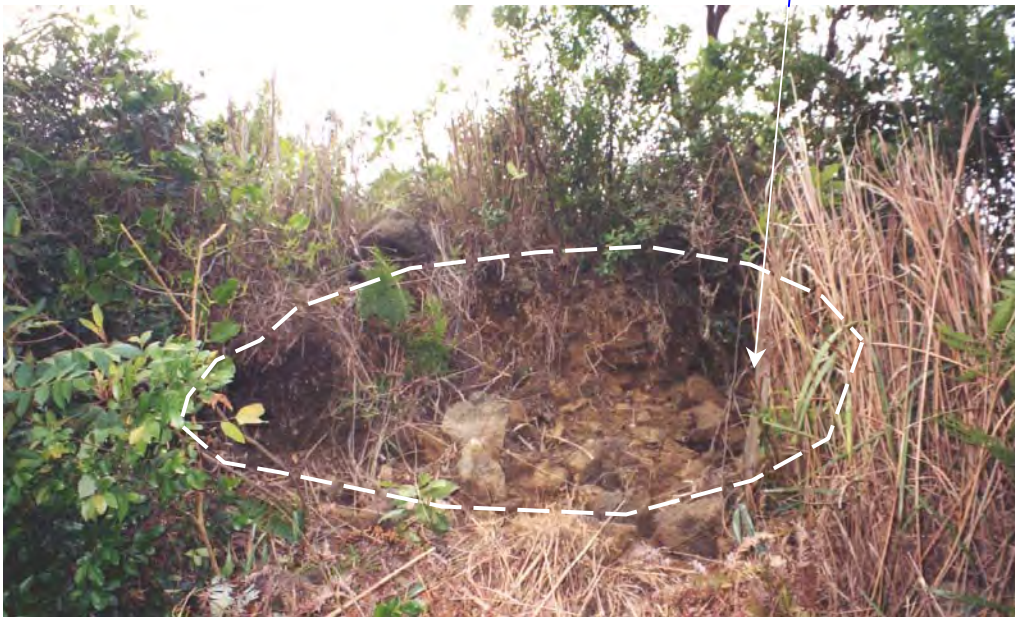
The fallen boulder left a depression/void at its source area which measured about 2.5 m by 1 m (Plate A5). No major tree roots were found within the depression/void. Smaller boulders with sizes ranging from about 0.5 m to 1 m were found immediately above the source area of the fallen boulder (Plate A6).

Plate A5 - View of the Source of the 5 May 2003 Boulder Fall  
(Photograph taken on 6 May 2003)

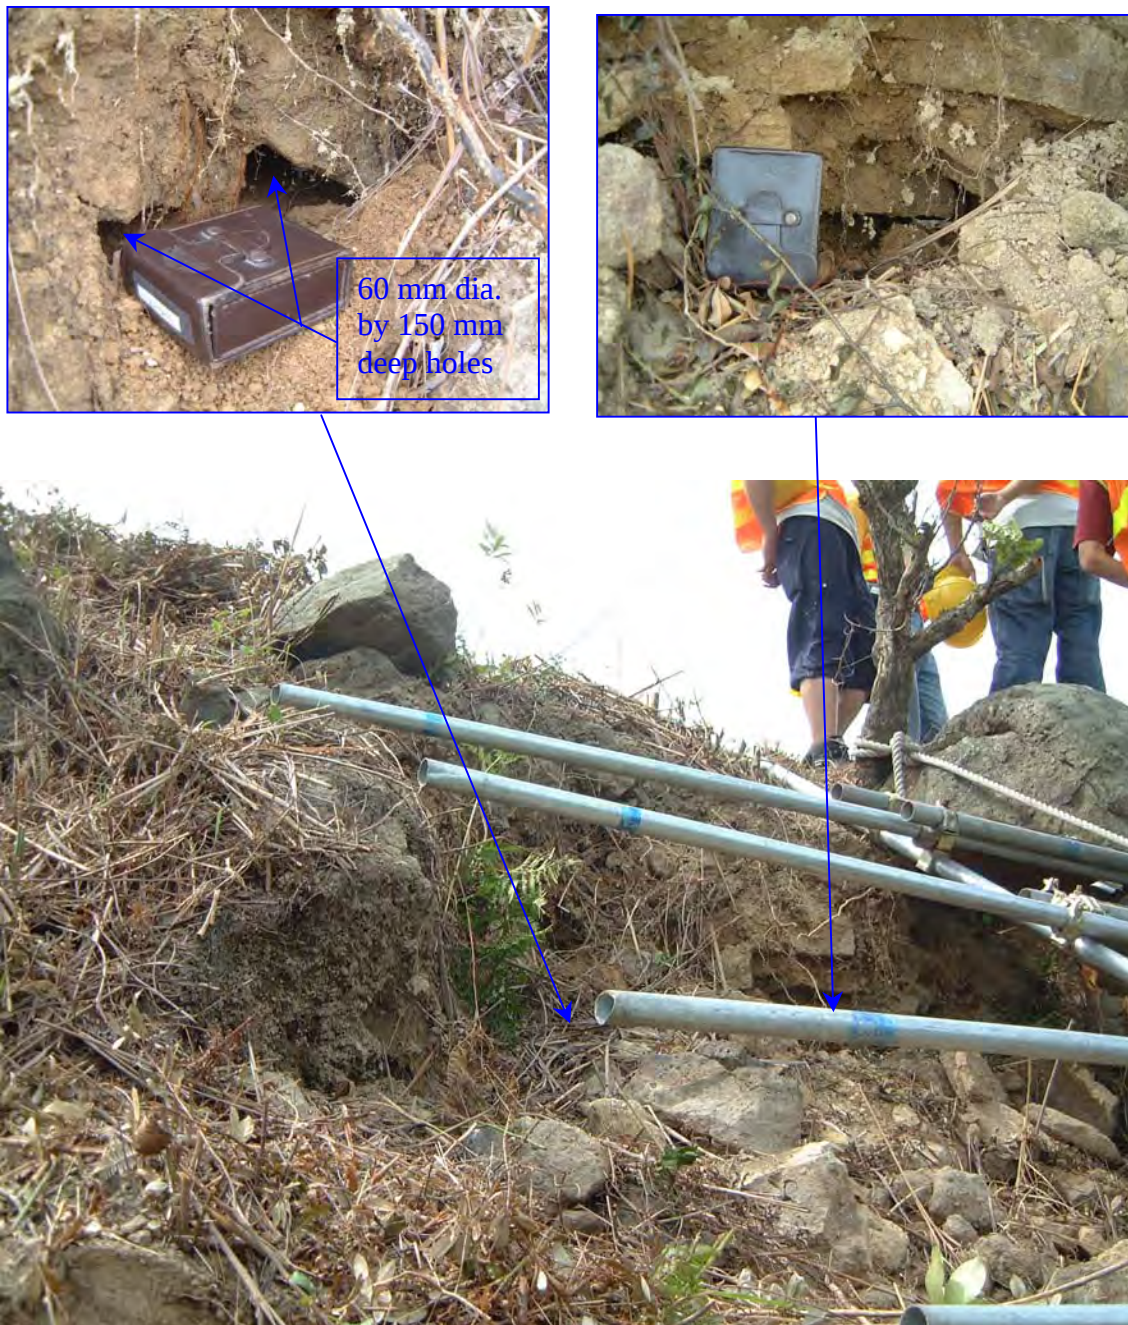
Plate A6 - Close-up View of the Source of the 5 May 2003 Boulder Fall after Vegetation Clearance (Photograph taken on 16 May 2003)

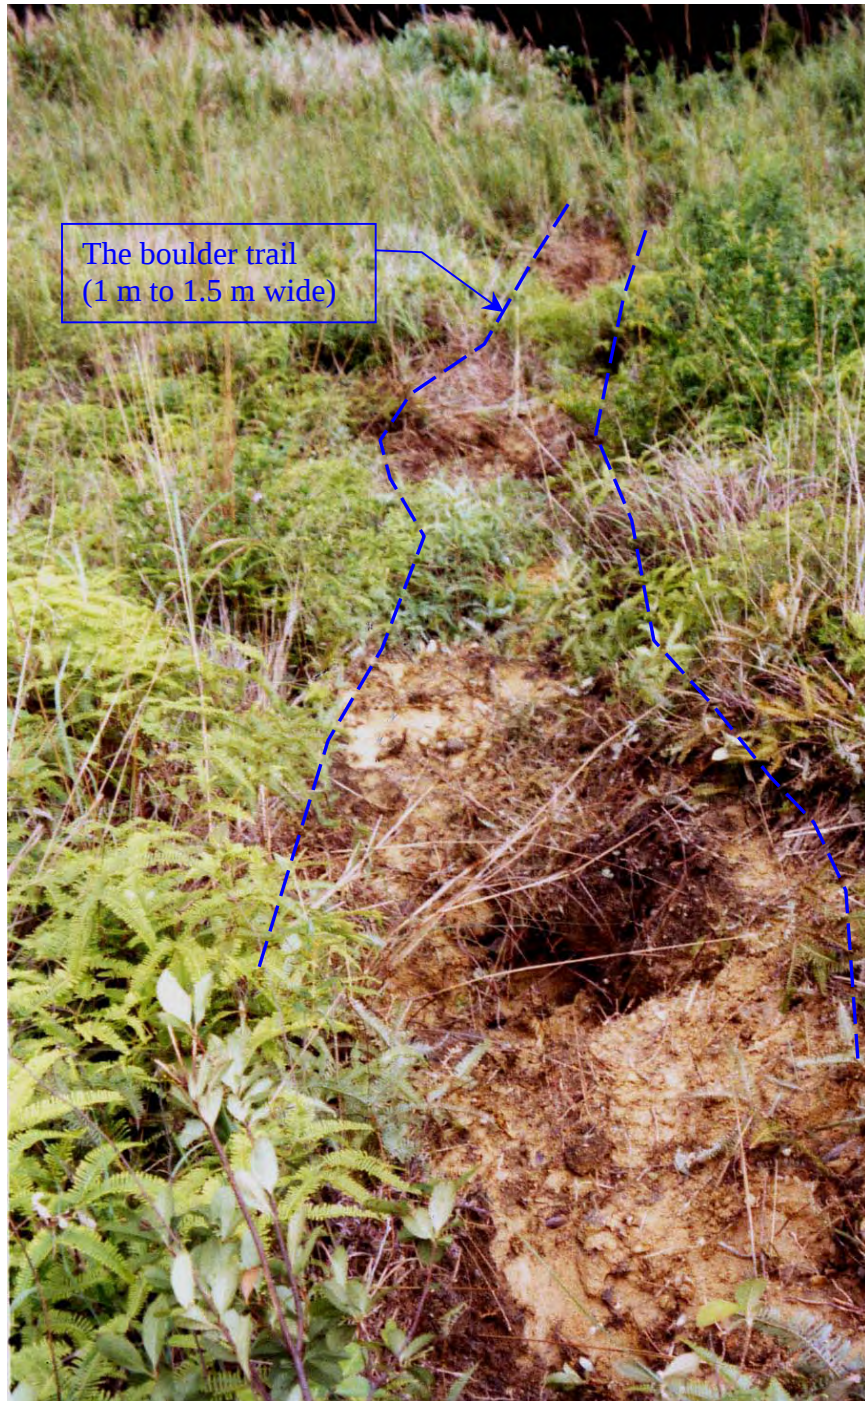
Plate A7 - Close-up View of the Boulder Trail Looking Downhill  
(Photograph taken on 6 May 2003)

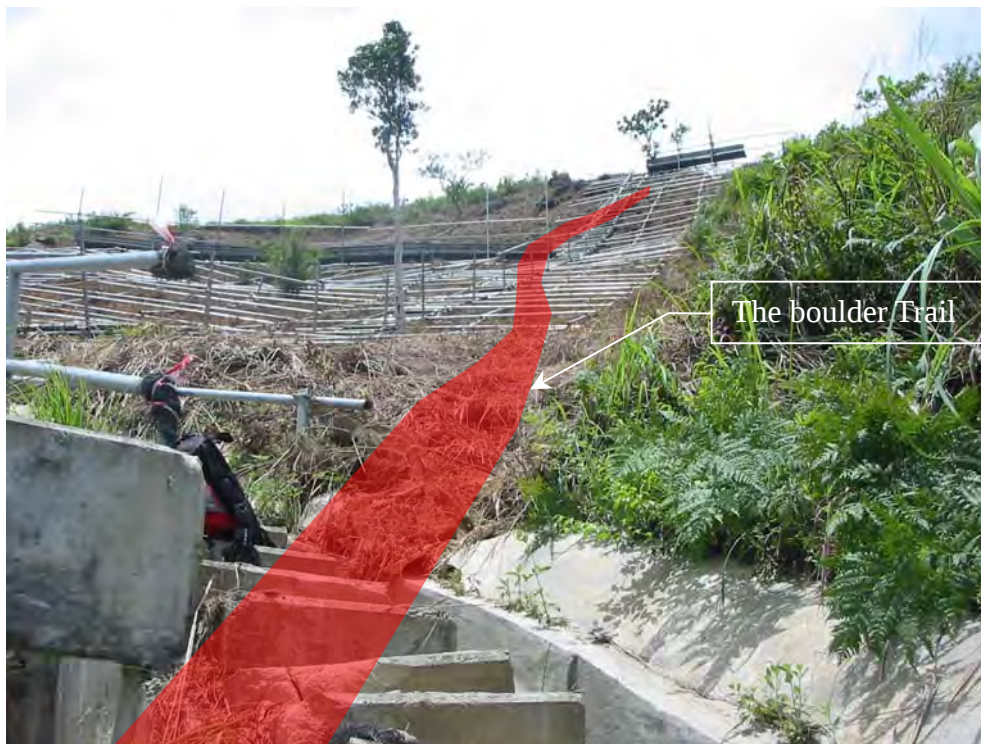
Plate A8 - The Boulder Trail Looking Uphill (Photograph taken on 16 May 2003)
