**DETAILED STUDY
OF THE 6 JUNE 2003
ROCKFALL INCIDENT ON
SLOPE NO. 11NE-C/C71
AT KUNG LOK ROAD
KWUN TONG**

GEO REPORT No. 192

T.H.H. Hui

**GEOTECHNICAL ENGINEERING OFFICE
CIVIL ENGINEERING AND DEVELOPMENT DEPARTMENT
THE GOVERNMENT OF THE HONG KONG
SPECIAL ADMINISTRATIVE REGION**

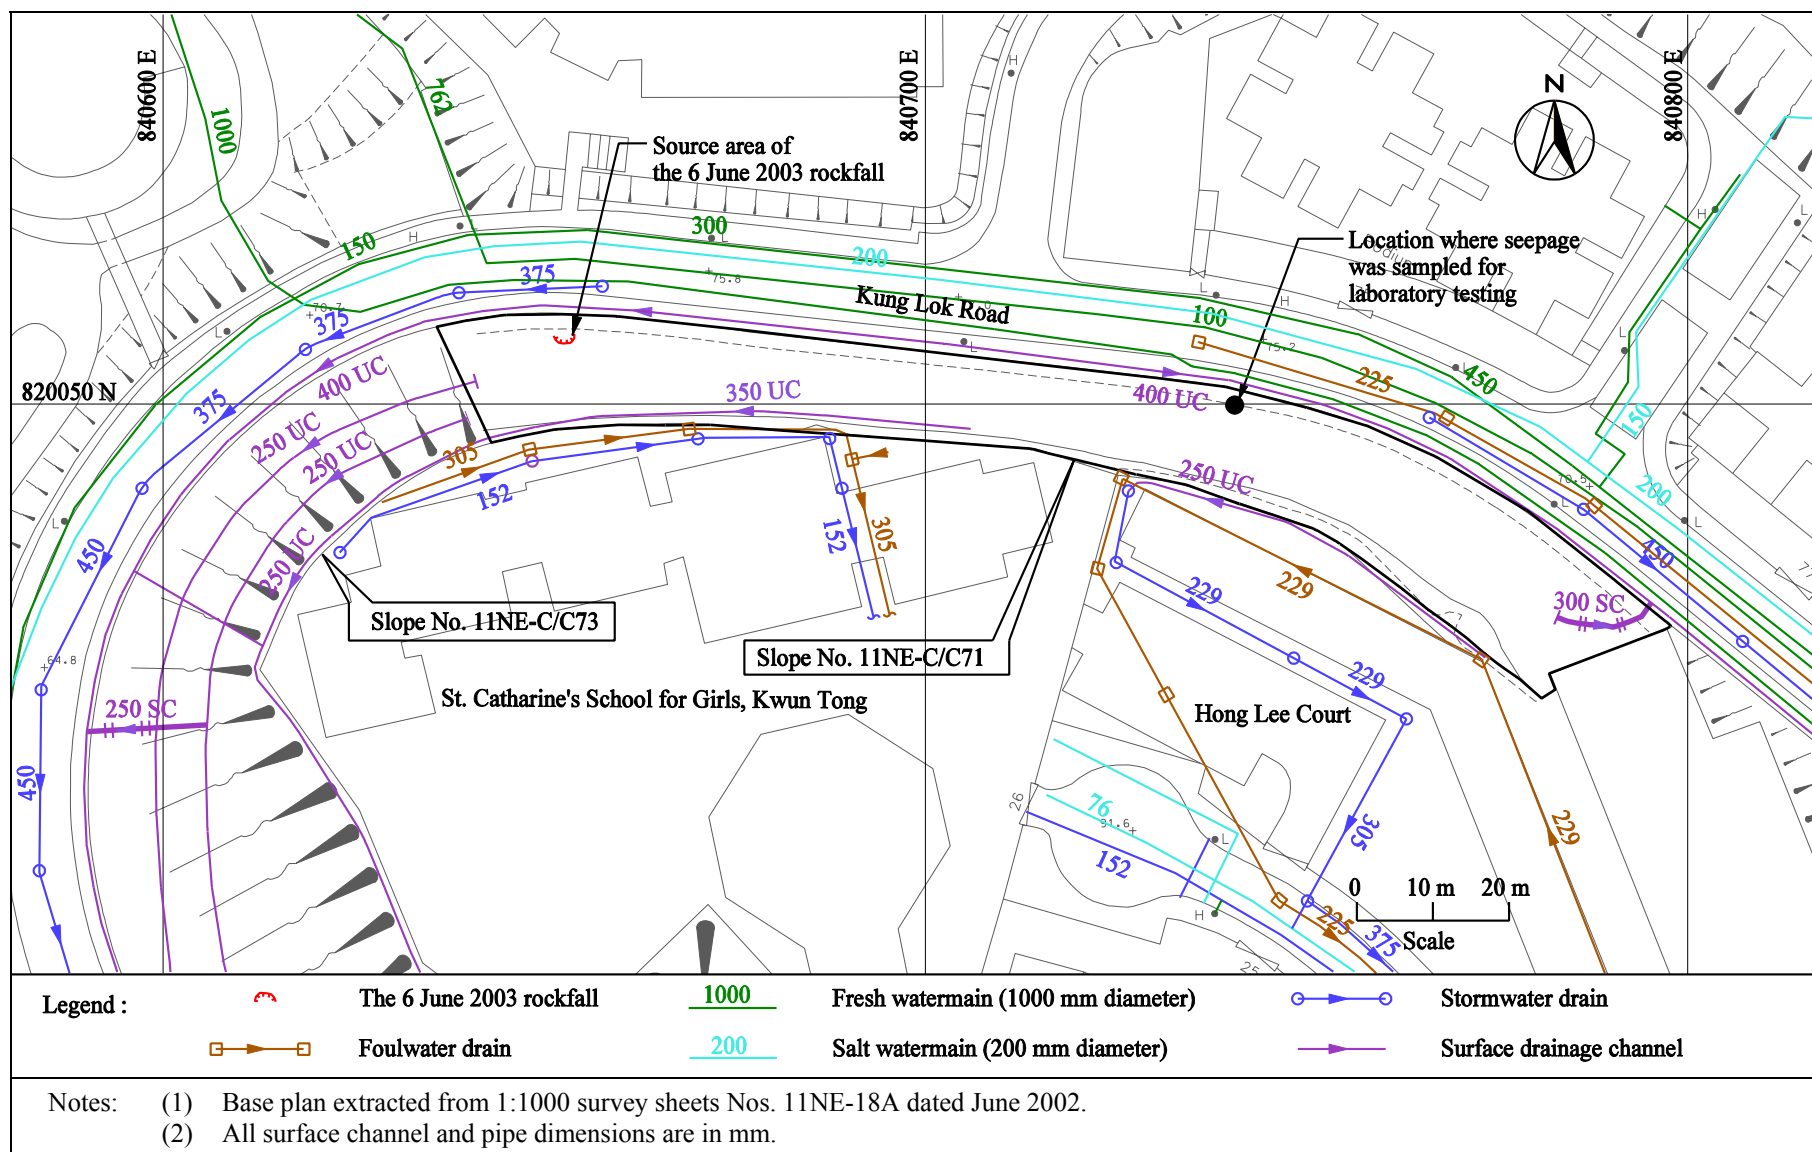
Figure 3 - Locations of Water-carrying Services

Since the seepage rate at the western portion of the slope was too low for collection of water sample, water samples were only collected from the eastern portion of the slope for chemical tests at the Public Works Central Laboratories. Results of laboratory tests indicate that the seepage at the eastern portion of the slope had a chloride ion concentration of 854 mg/l and an E.Coli bacteria concentration of 180 cfu/100 ml, which are much higher than that typically found in potable water (i.e. chloride ion concentration of 16 mg/l and E.Coli bacteria concentration of 0 cfu/100 ml, based on information given by the WSD). According to the Public Works Central Laboratory, the seepage is “not a typical unpolluted rain water”. It is possible that the seepage may be related to leakage of foul water drains at the slope crest (Figure 3).

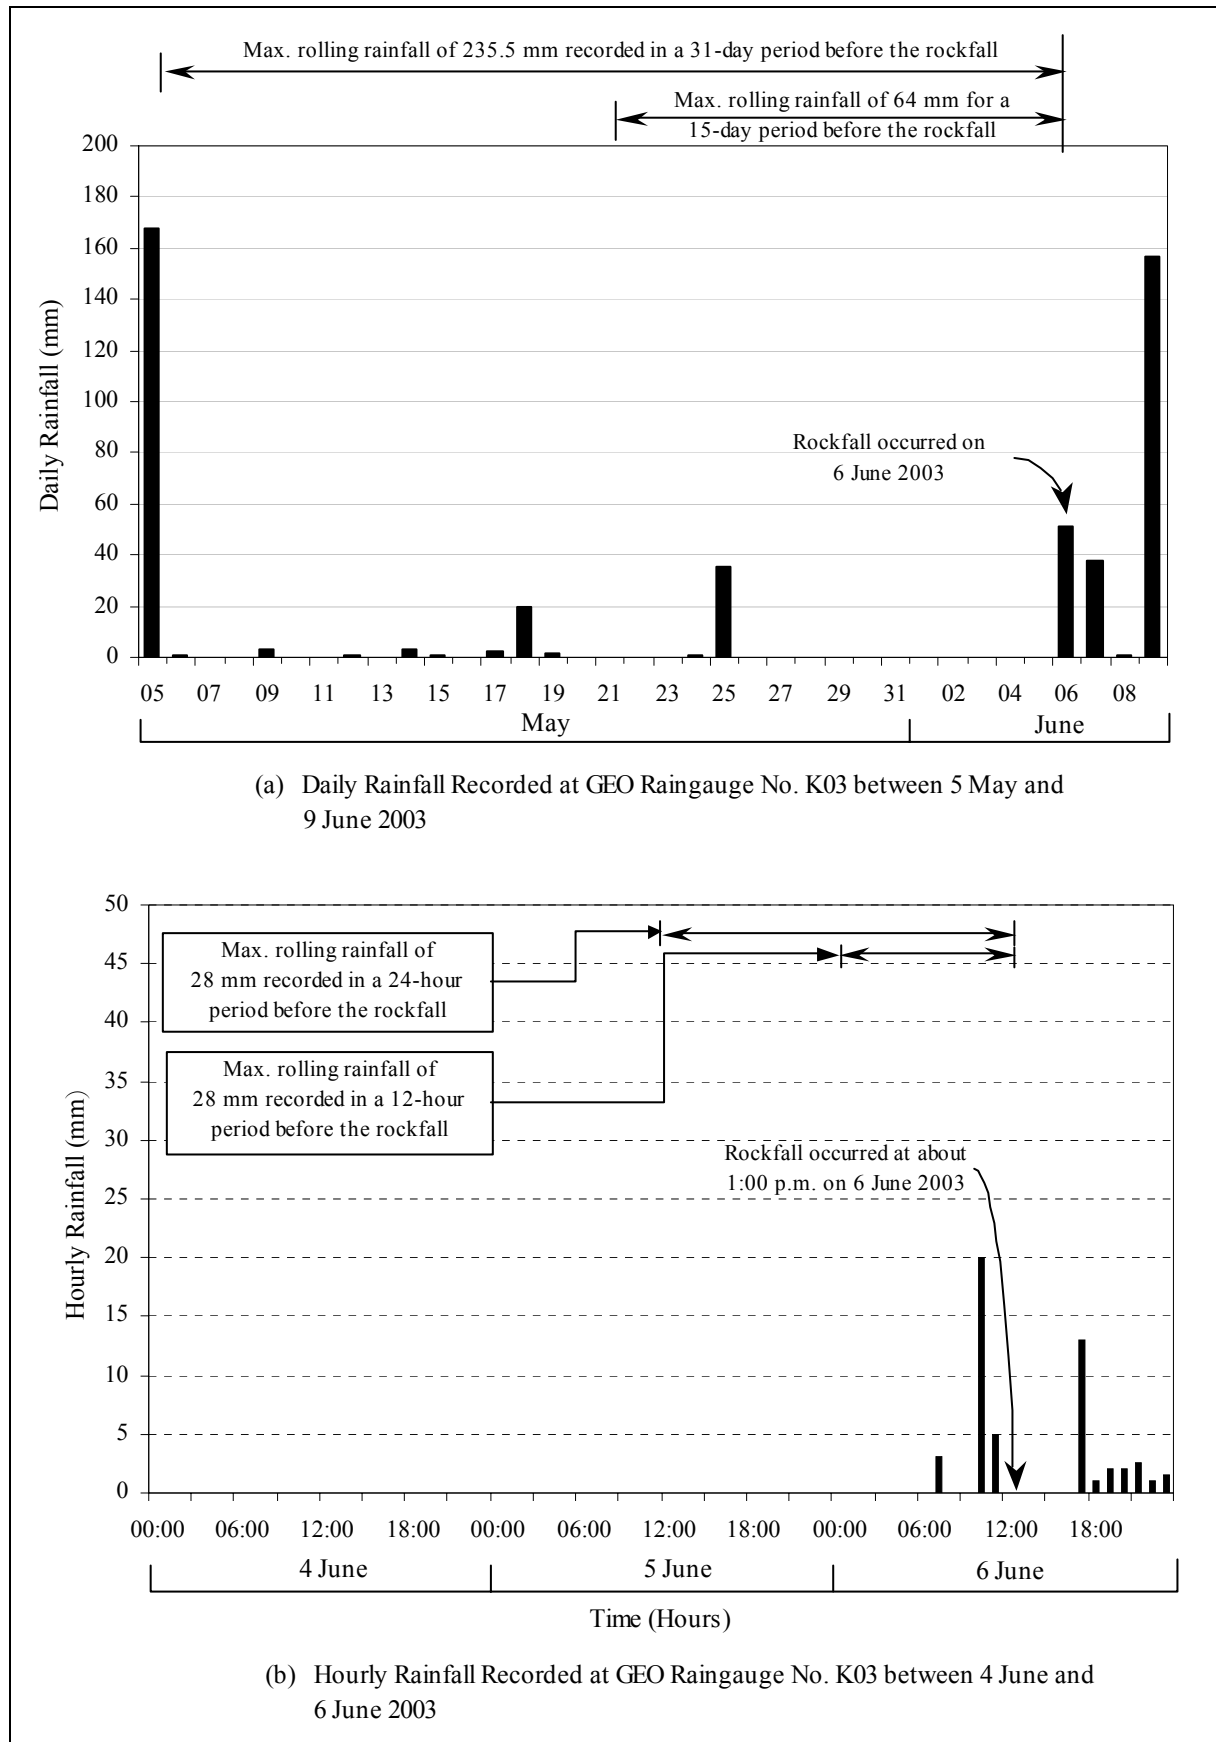
Figure 11 - Daily and Hourly Rainfall Recorded at GEO Raingauge No. K03

The daily rainfall over the preceding month and three days following the incident, together with the hourly rainfall data for the period between 4 and 6 June 2003, is presented in Figure 11. The daily rainfall record shows that relatively light rainfall occurred during the 12 hours preceding the rockfall, with the maximum 1-hour rolling rainfall of about 20 mm between 10:15 a.m. and 11:15 a.m. on 6 June 2003. Table 1 presents the estimated return periods for the maximum rolling rainfall for various durations recorded by raingauge No. K03 with reference to historical rainfall data at the Hong Kong Observatory in Tsim Sha Tsui (Lam & Leung, 1994). The results show that the return period of the 6 June 2003 rainstorm was less than 2 years.

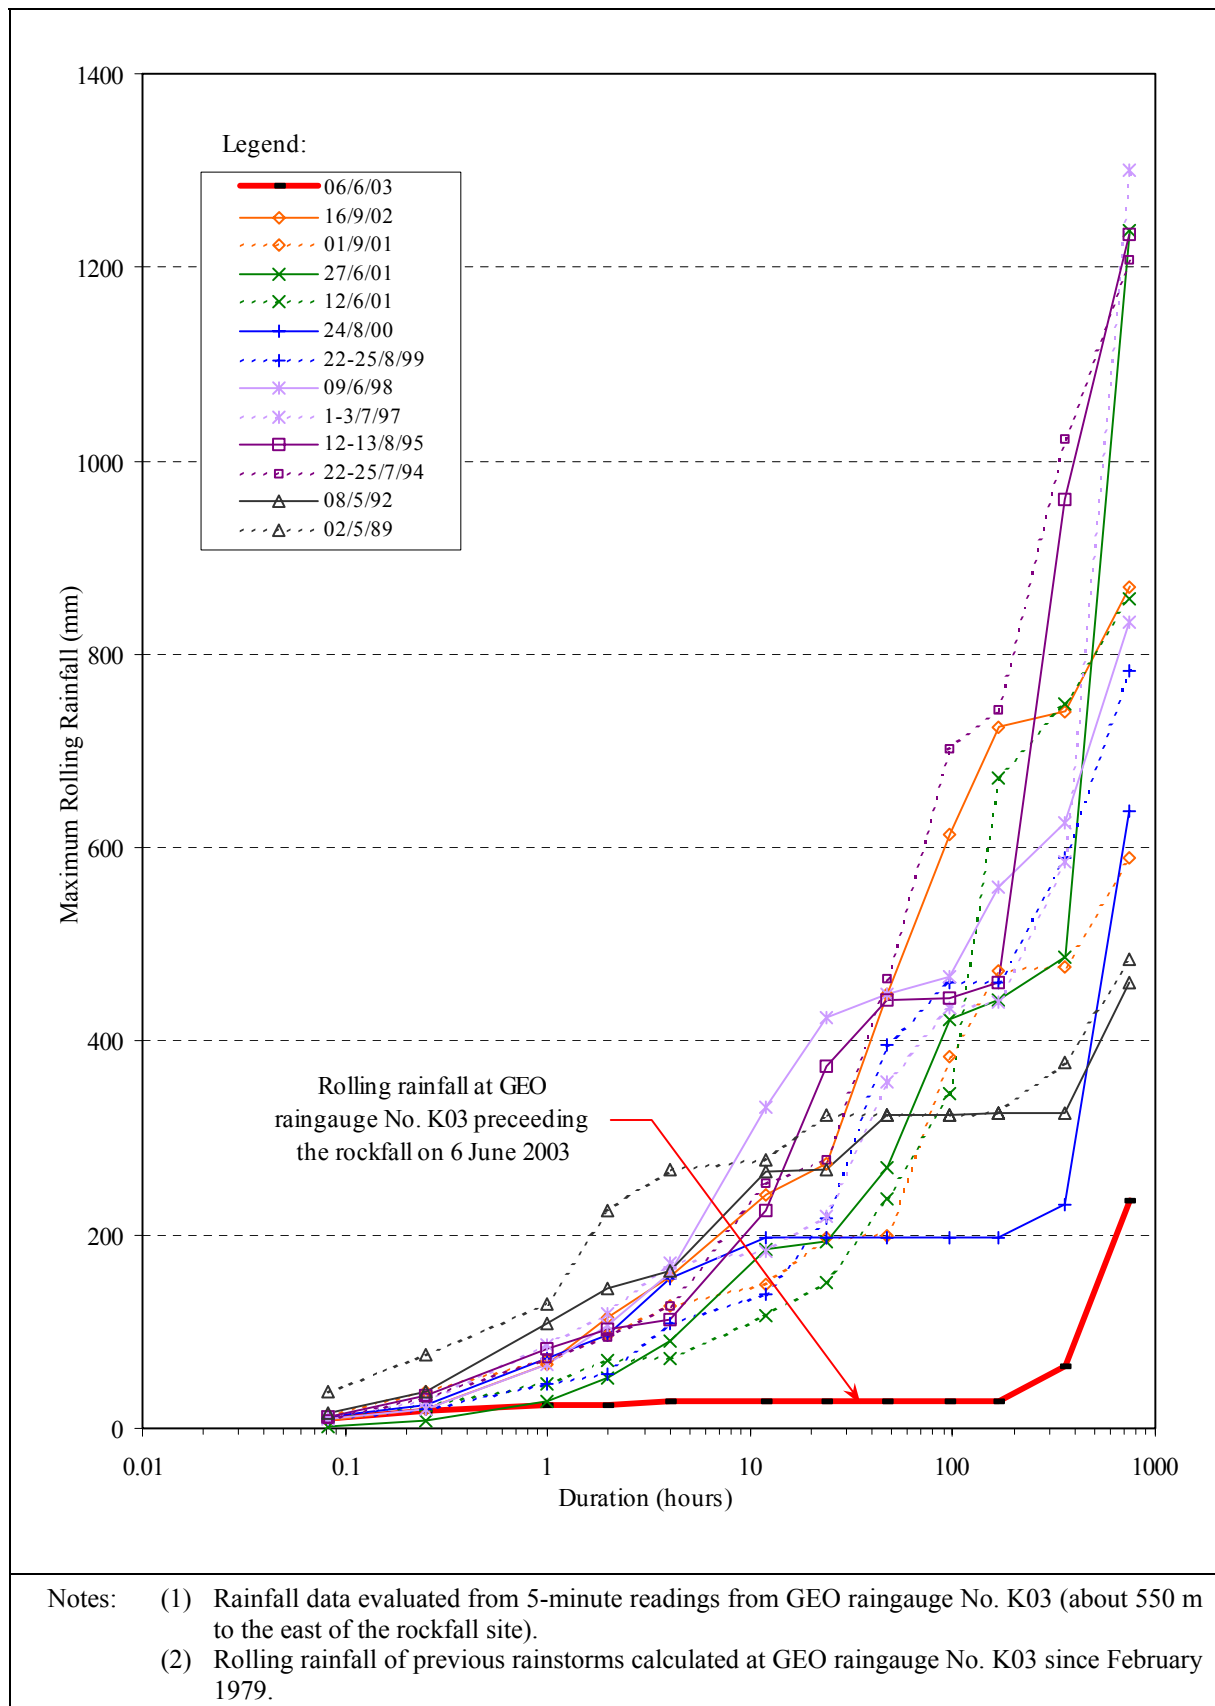
Figure 12 - Maximum Rolling Rainfall for Previous Major Rainstorms at GEO Raingauge No. K03

The maximum rolling rainfall for the rainfall on 6 June 2003 has been compared with that of the past major rainstorms between 1983 and 2001 recorded by raingauge No. K03. The maximum rolling rainfall indicates that the rainfall on 6 June 2003 was not particularly severe as compared with the previous rainstorms (Figure 12).
