**THE 5 MAY 2003
DEBRIS FLOW AT
KAU LUNG HANG SHAN
TAI PO**

GEO REPORT No. 196

Maunsell Geotechnical Services Limited

**This report was originally produced in February 2005
as GEO Landslide Study Report No. LSR 2/2005**

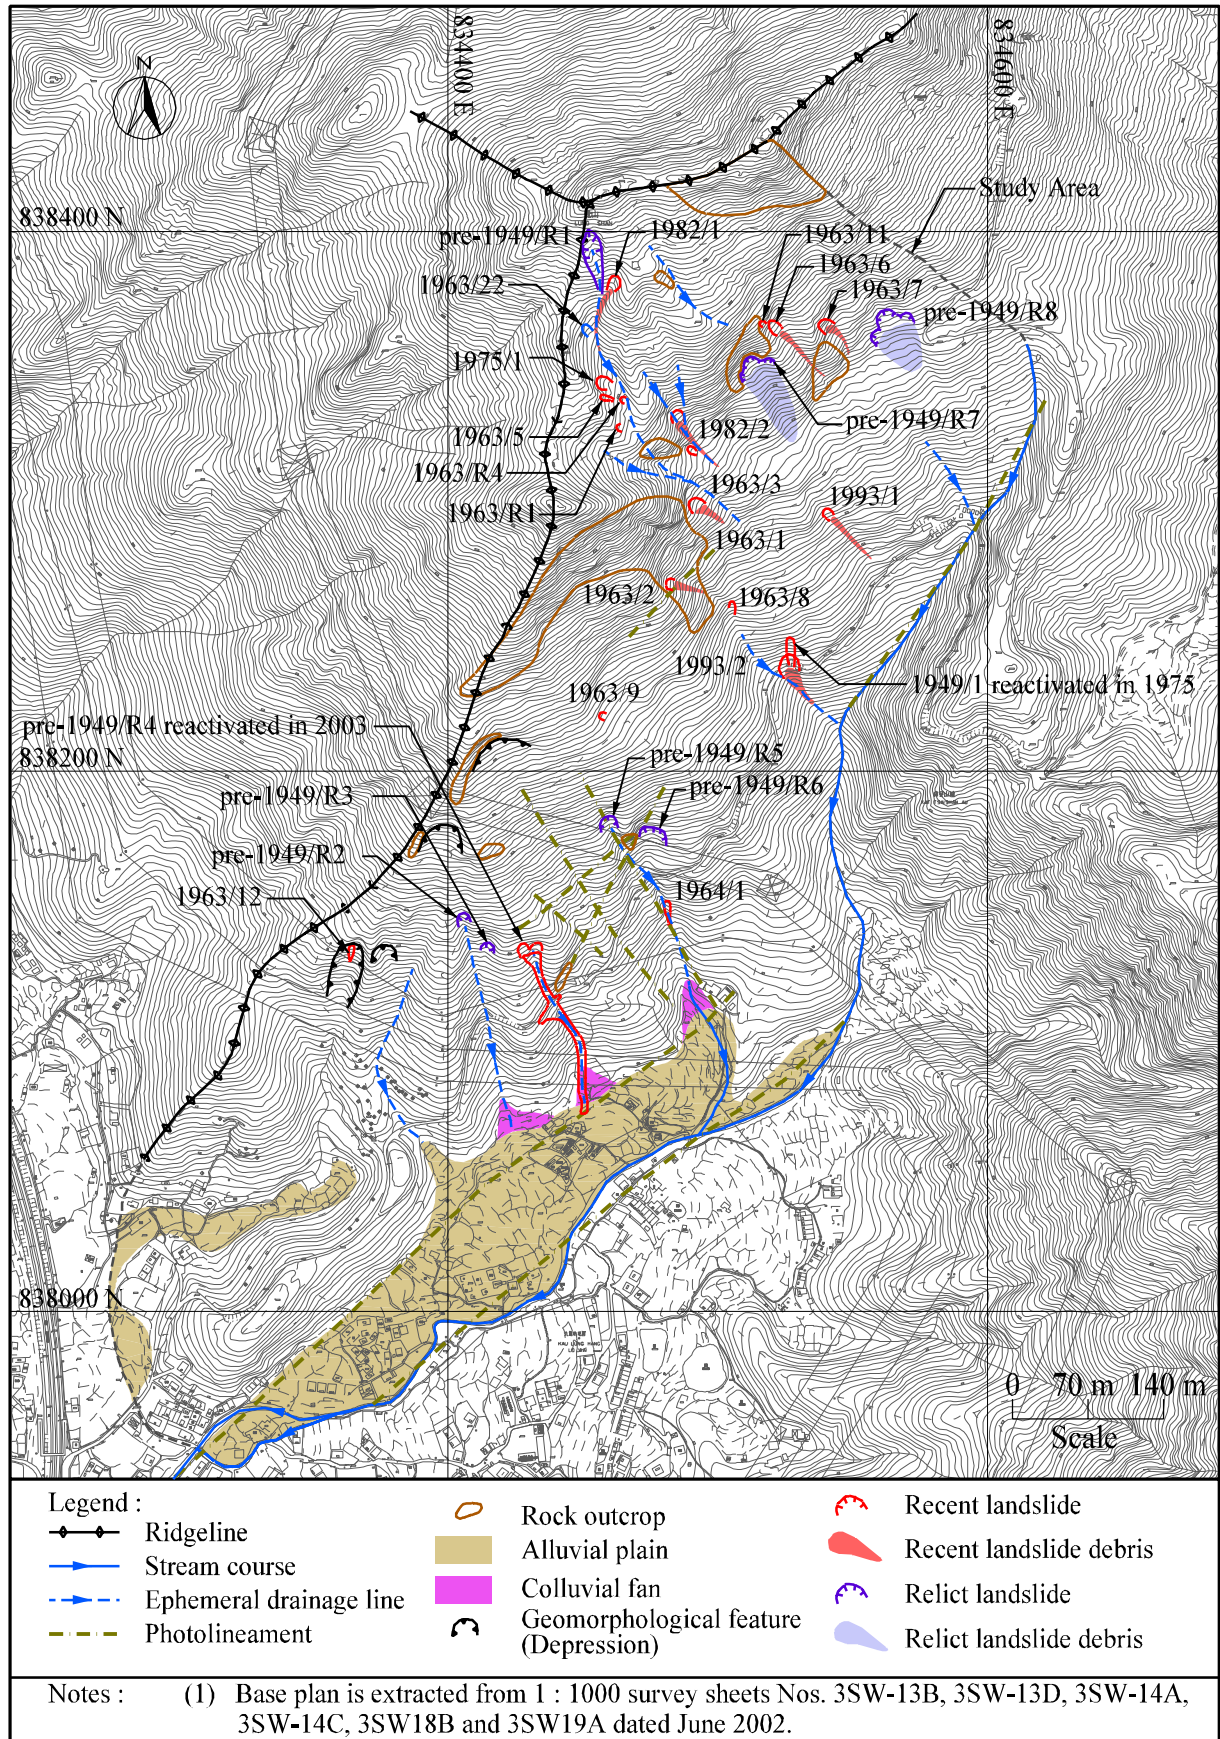
Figure 3 - Aerial Photograph Interpretation

Few landslides were recorded in the NTLI database near the 5 May 2003 landslide site. However, several relict landslides (with the presence of concave depressions) were identified by the detailed low-level API carried out for this study (Figure 3). These generally have a similar setting to the subject landslide, i.e. below a break in slope and at the head of, or adjacent to, a drainage line. Therefore, any attempt at prediction of magnitude-frequency relationship of such landslides, or the susceptibility of the hillside, would require detailed low-level API to establish a more accurate landslide inventory. The presence of colluvial

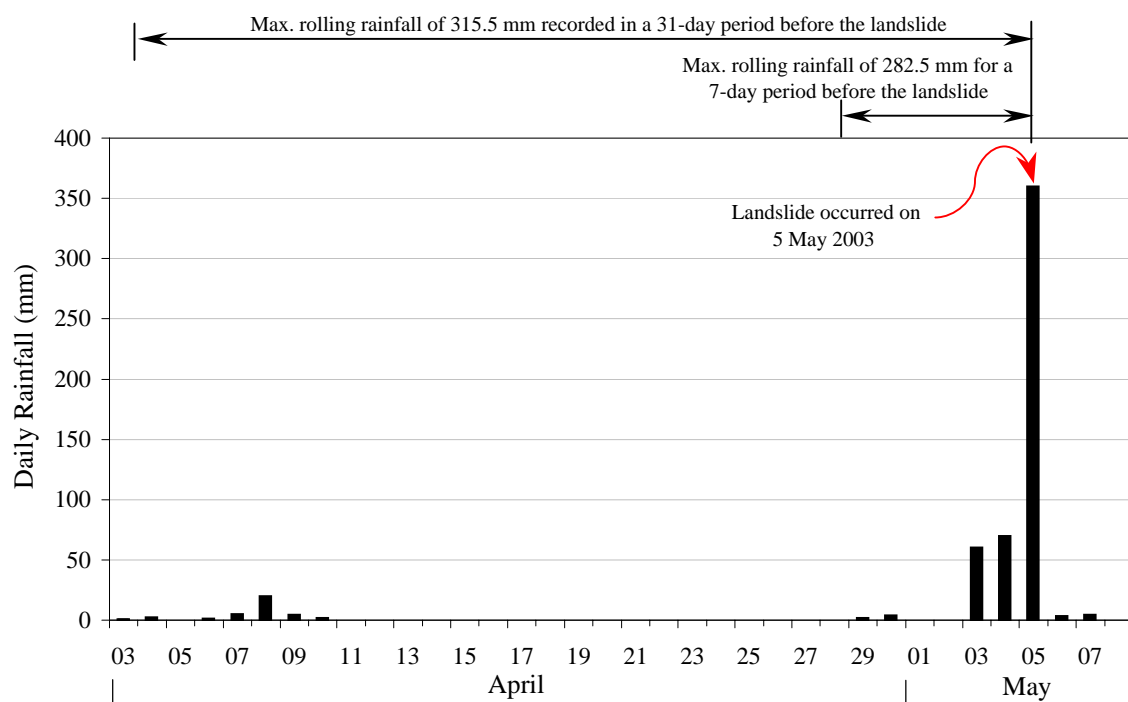
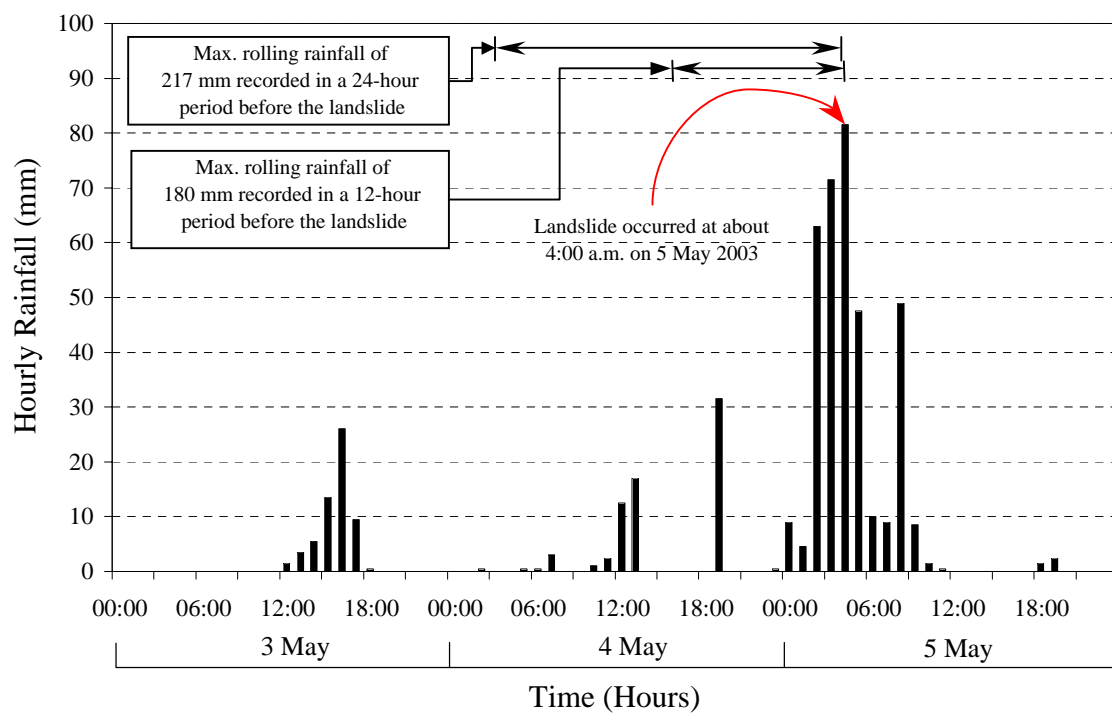
Figure 13 - Daily and Hourly Rainfall Recorded at GEO Raingauge No. N05

The daily rainfall recorded by raingauge No. N05 over the month preceding the incident, together with the hourly rainfall data for the period between 3 and 5 May 2003, are presented in Figure 13. The rain was heavy on the morning of 5 May 2003 between 2:10 a.m. and 10:00 a.m. The 24 hour and 12 hour rainfall before the landslide was 217 mm and 180 mm respectively. The maximum 1-hour rolling rainfall was recorded as 98 mm between 2:30 a.m. and 3:30 a.m. on 5 May 2003.

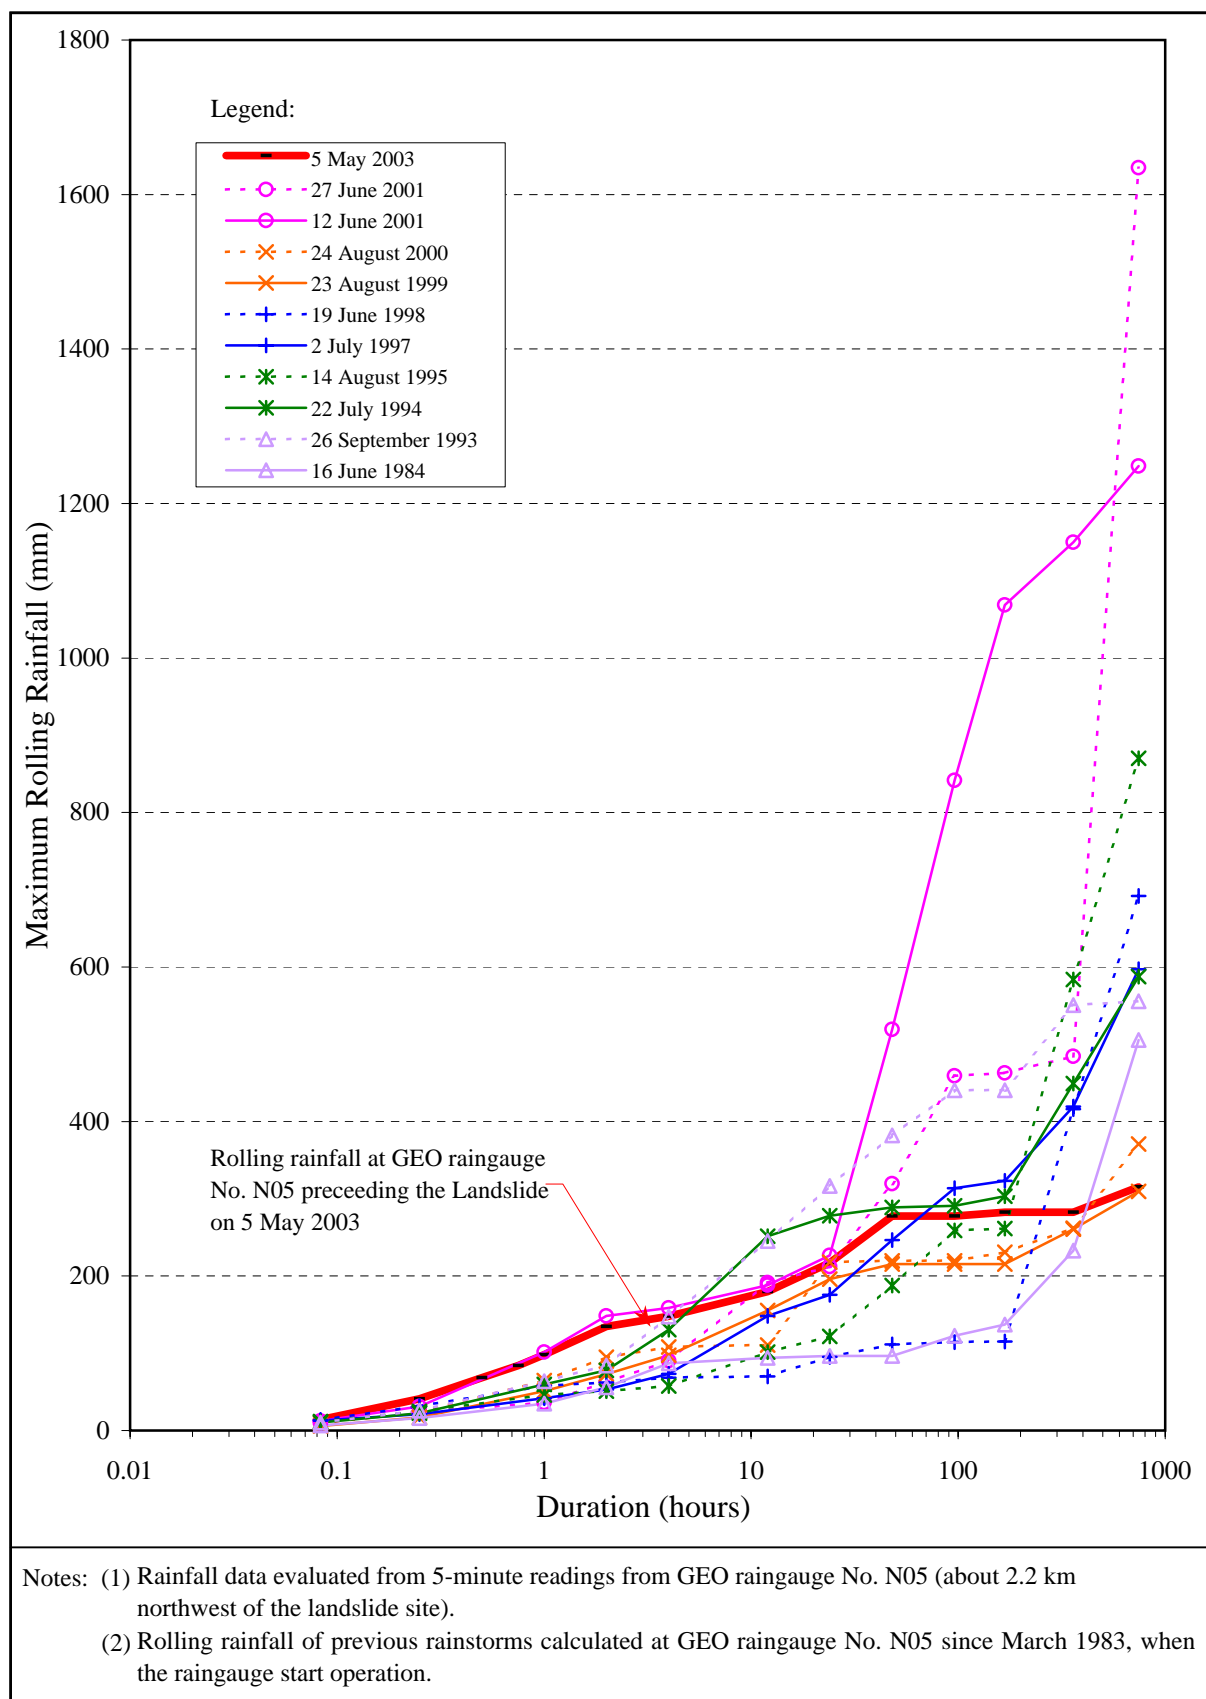
Figure 14 - Maximum Rolling Rainfall for Major Rainstorms at GEO Raingauge No. N05

The maximum rolling rainfall for the rainstorm on 5 May 2003 has been compared with the past major rainstorms between 1983 and 2002 recorded by raingauge No. N05, which came into operation in March 1983 (Figure 14). The maximum rolling rainfall for the

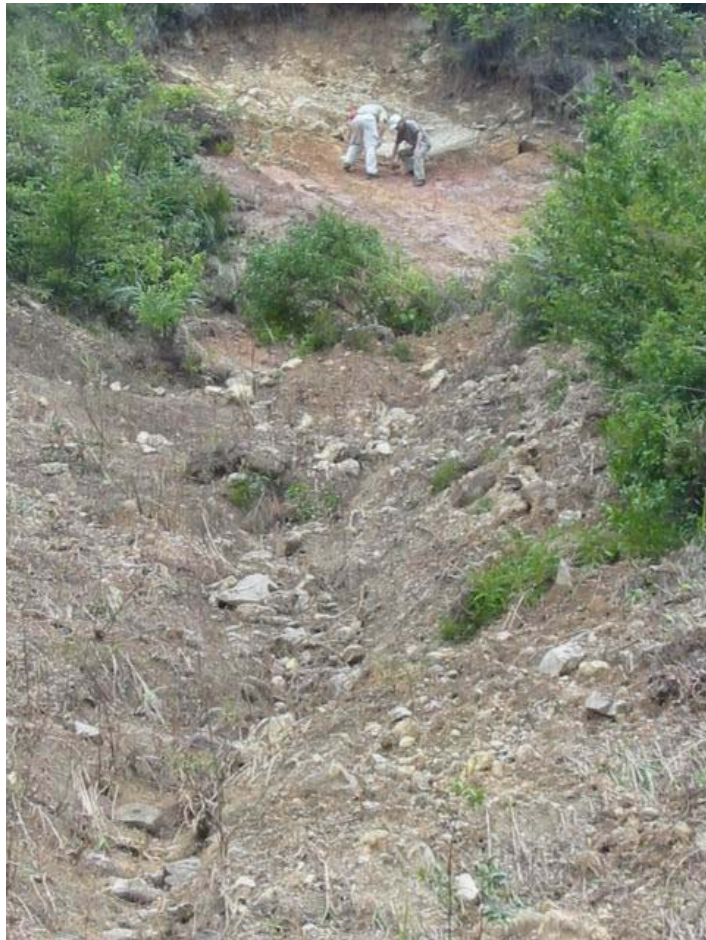
Plate 15 - View of the Source Area from the Debris Trail
(Photograph taken on 16 May 2003)

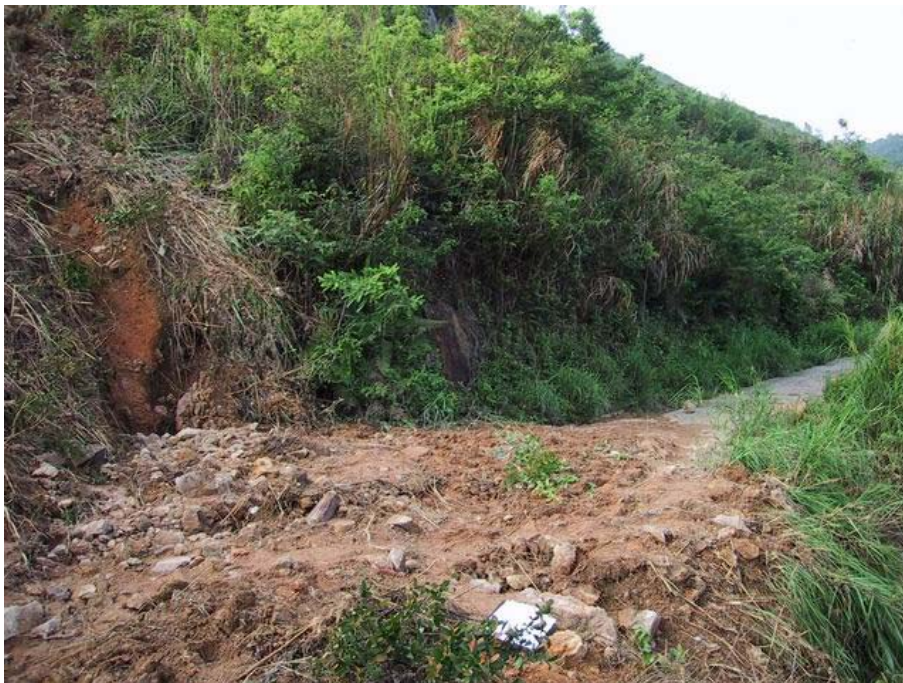
Plate 18 - View of the Landslide Debris on the Access Road
(Photograph taken on 9 May 2003)

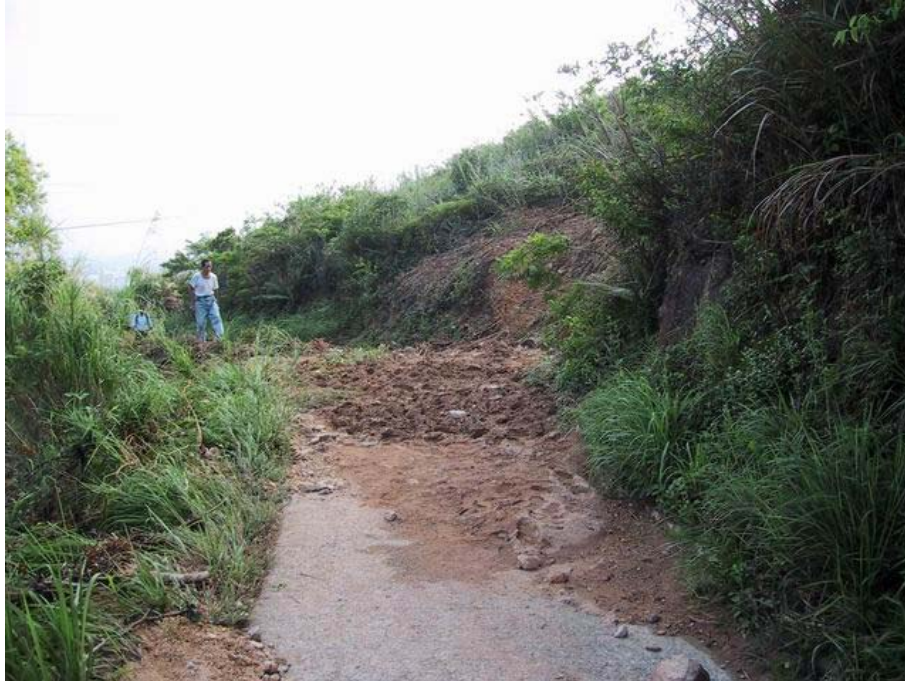
Plate 19 - View of the Landslide Debris on
the Access Road Looking West
(Photograph taken on 9 May 2003)

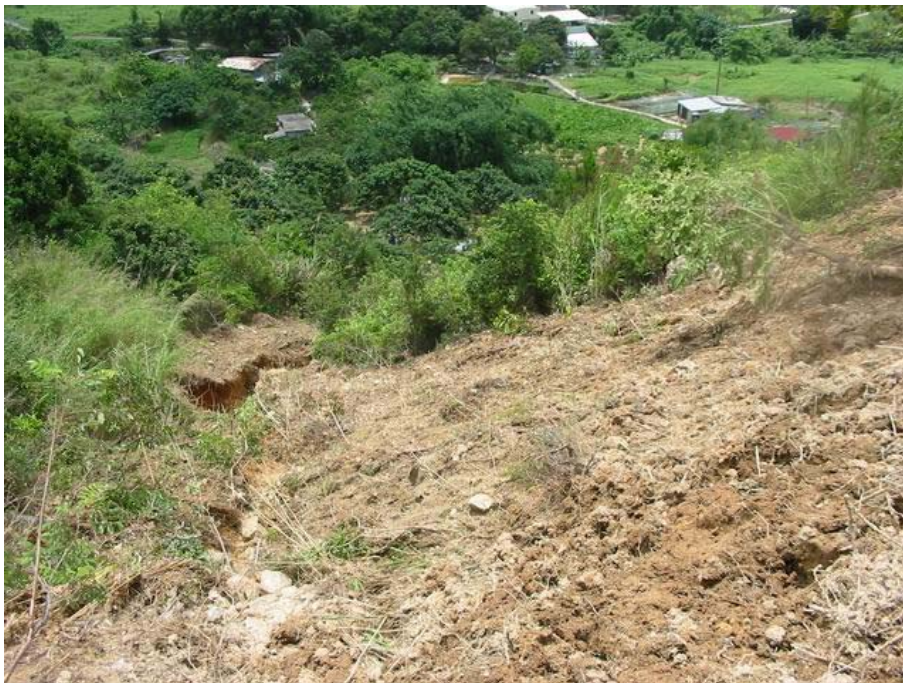
Plate 20 - View of the Debris Trail Looking
Downslope from the Access Road
(Photograph taken on 16 May 2003)

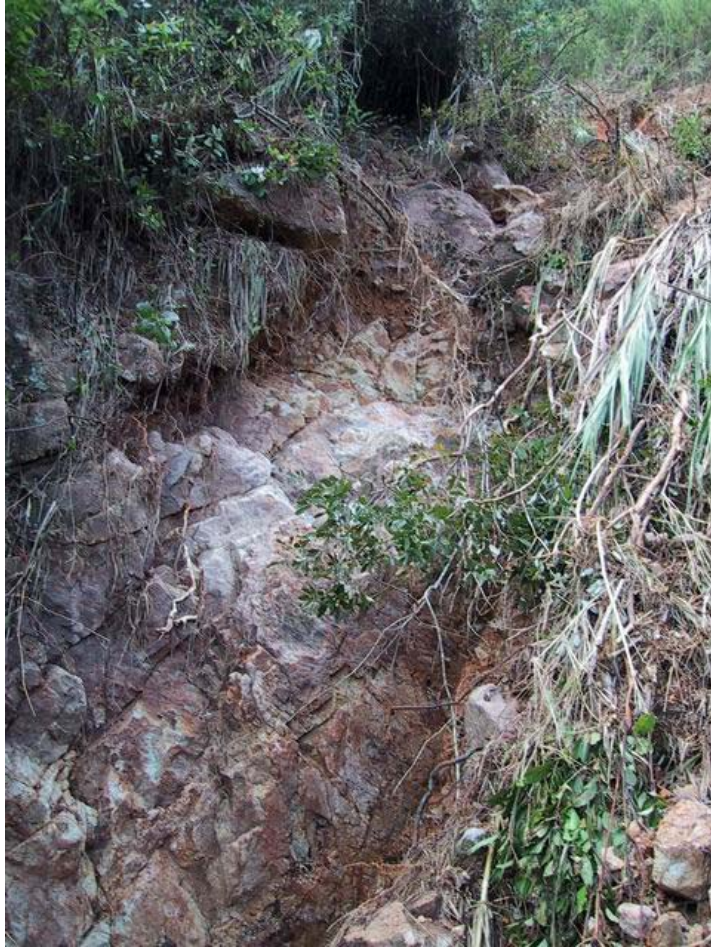
Plate 23 - Exposed Rock Within the Drainage Line/Gully below the Access Road
(Photograph taken on 9 May 2003)

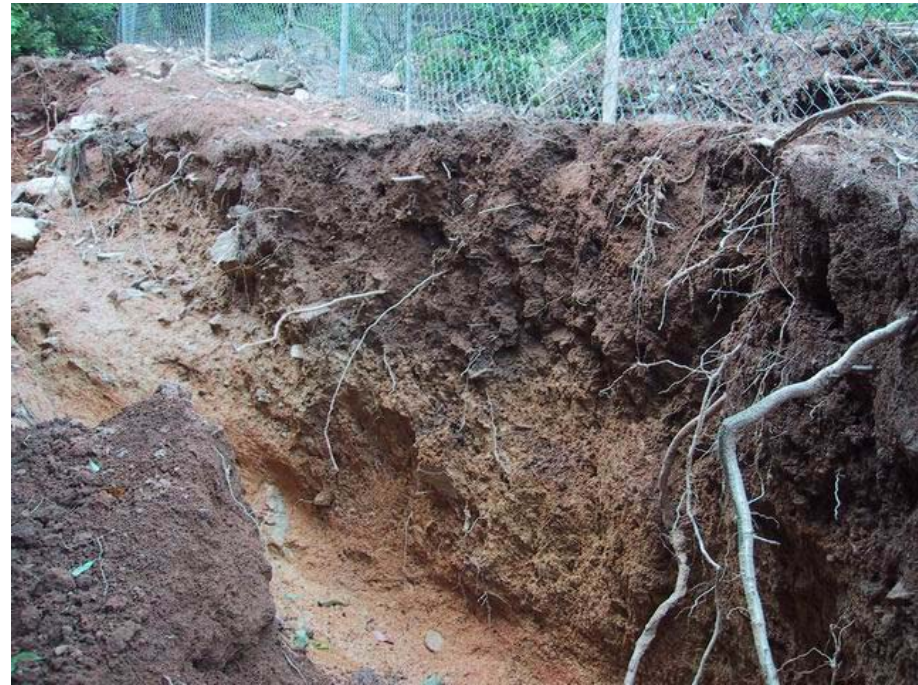
Plate 28 - View of Exposed Soil Profile Within the Incised Gully
Adjacent to the Orchard at Chainage CH 123
(Photograph taken on 9 May 2003)

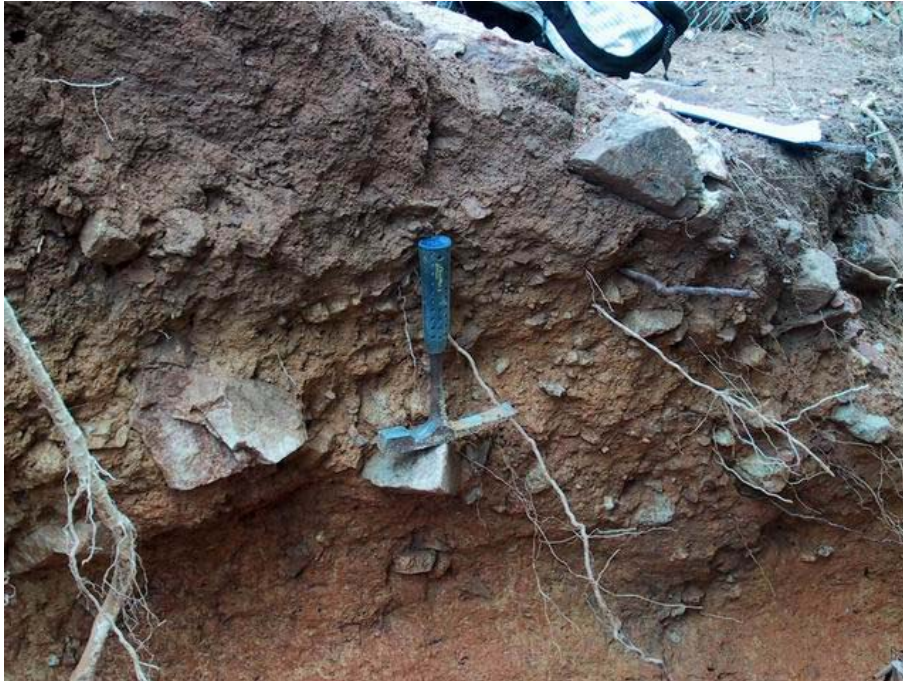
Plate 29 - Close-up View of Colluvium Within the Incised Gully at Chainage CH 123
(Photograph taken on 9 May 2003)

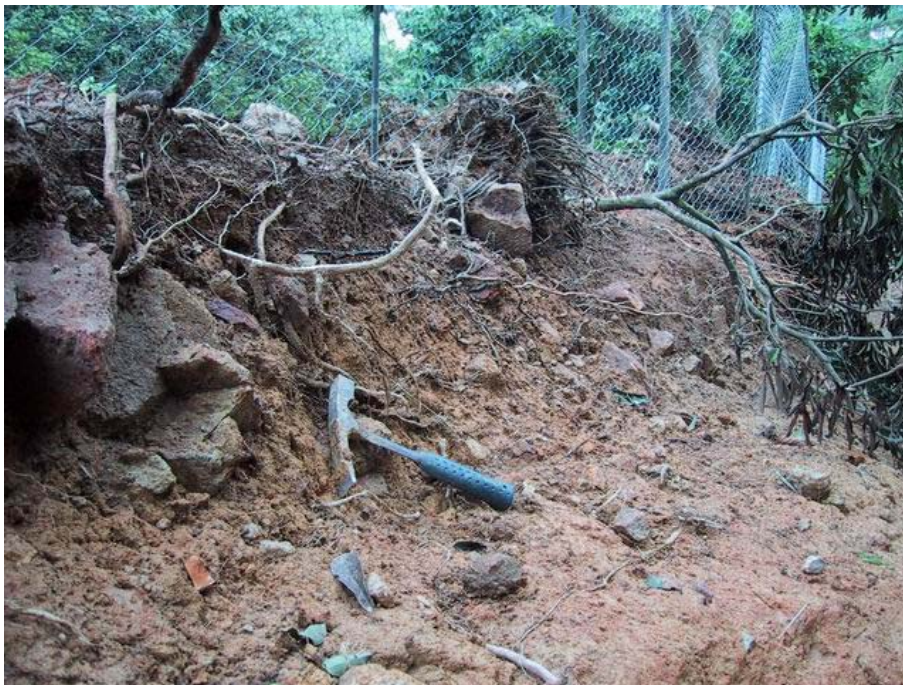
Plate 30 - Close-up View of Colluvium Exposed at the Flanks of the Drainage Line at Chainage CH 125
(Photograph taken on 9 May 2003)

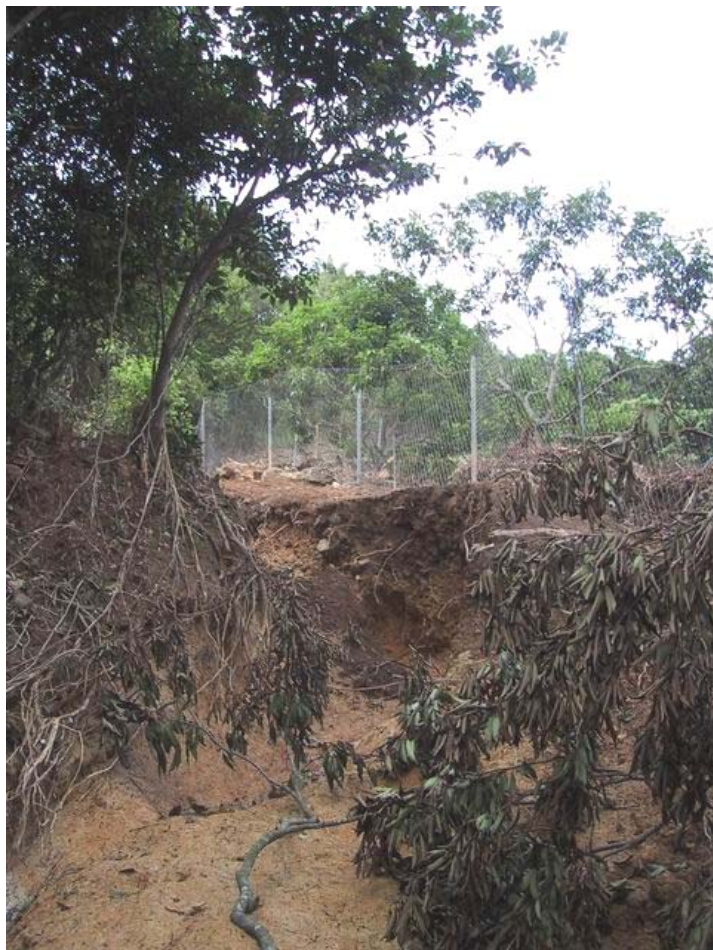
Plate 33 - General View of the Drainage Line Near the Landslide Toe Area at Chainage CH 130
(Photograph taken on 9 May 2003)

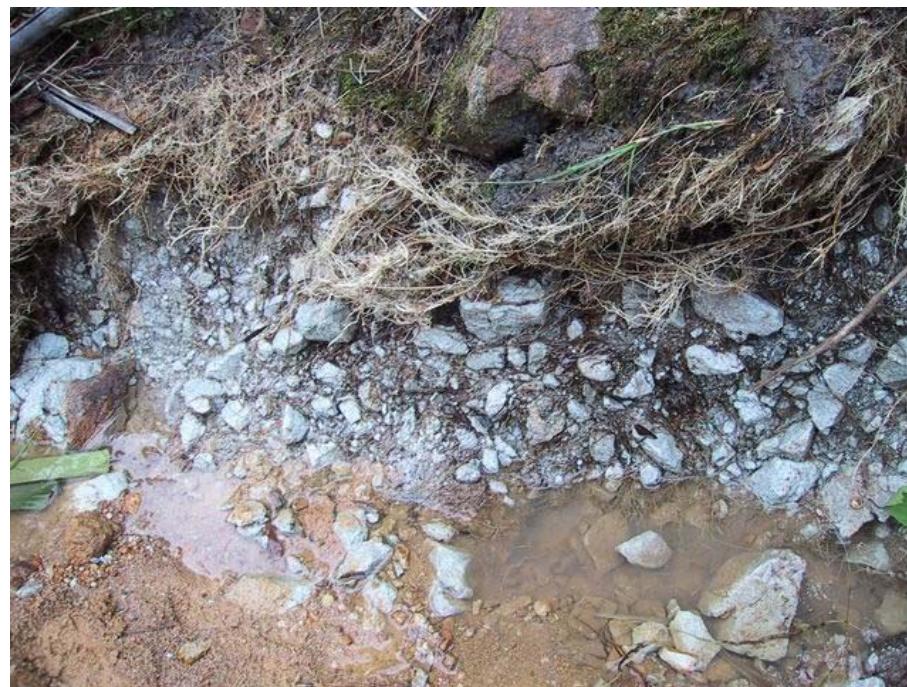
Plate 34 - Alluvium with a Kaolin Matrix Found Within the Drainage Line Near the Toe of the Landslide
(Photograph taken on 9 May 2003)

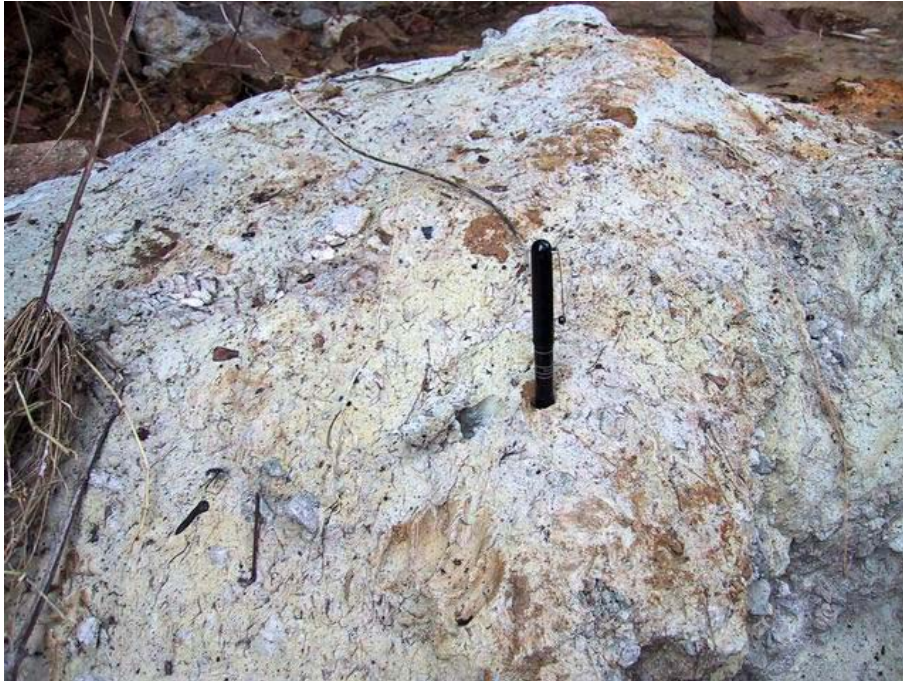
Plate 35 - Decomposed Coarse Ash Tuff With Kaolin Rich Matrix Found Near the toe of the Debris Trail
(Photograph taken on 9 May 2003)

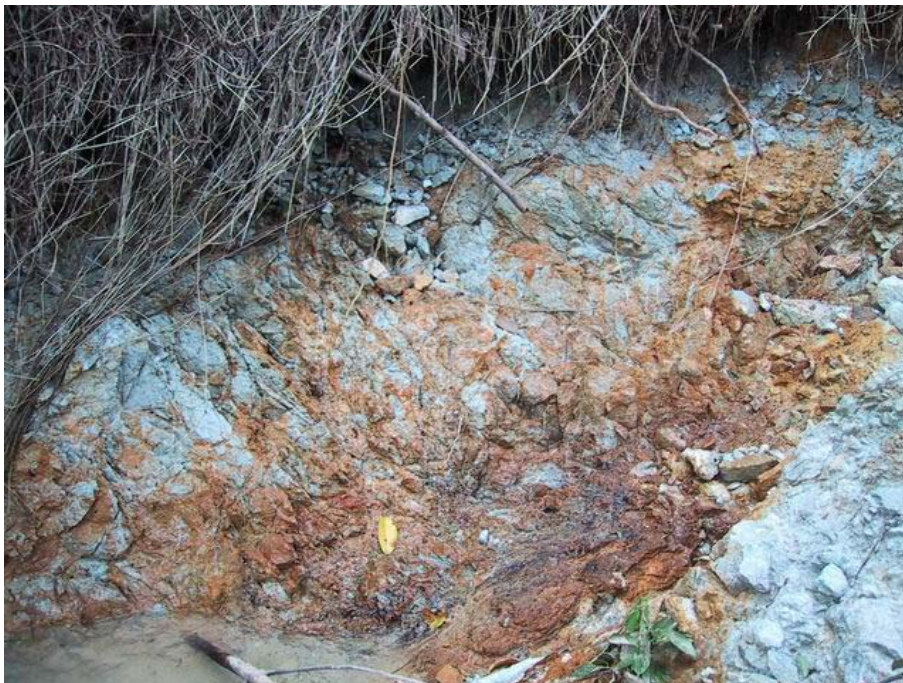
Plate 36 - Insitu Decomposed Coarse Ash Tuff Found within the Drainage Line/Debris Trail Near the Toe of the Landslide at Chainage CH 135
(Photograph taken on 9 May 2003)

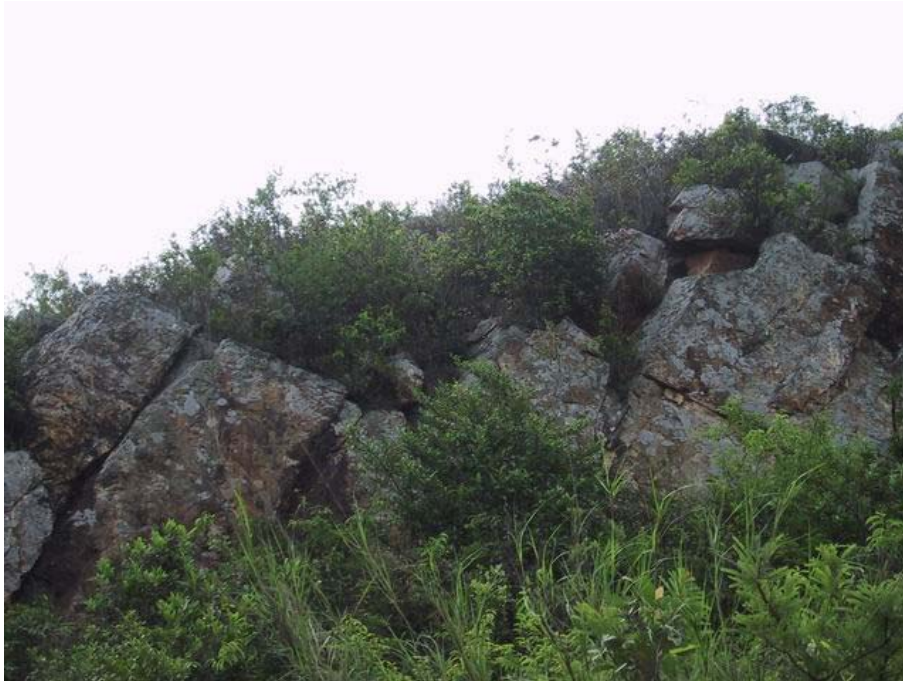
Plate 37 - View of the Rock Outcrop (Coarse Ash Tuff) at About 30 m Southeast of the Landslide Source Area
(Photograph taken on 16 May 2003)

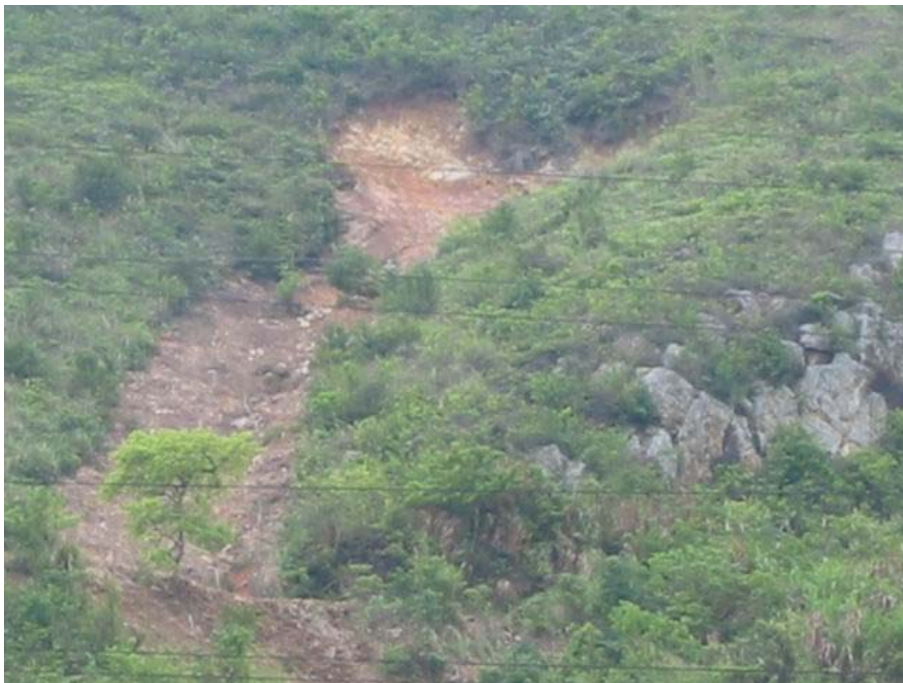
Plate 38 - Close-up View of the Landslide Source Area and Debris Trail
(Note joints in the outcrop on the right have similar strike to those within the source area. Photograph taken on 12 May 2003)

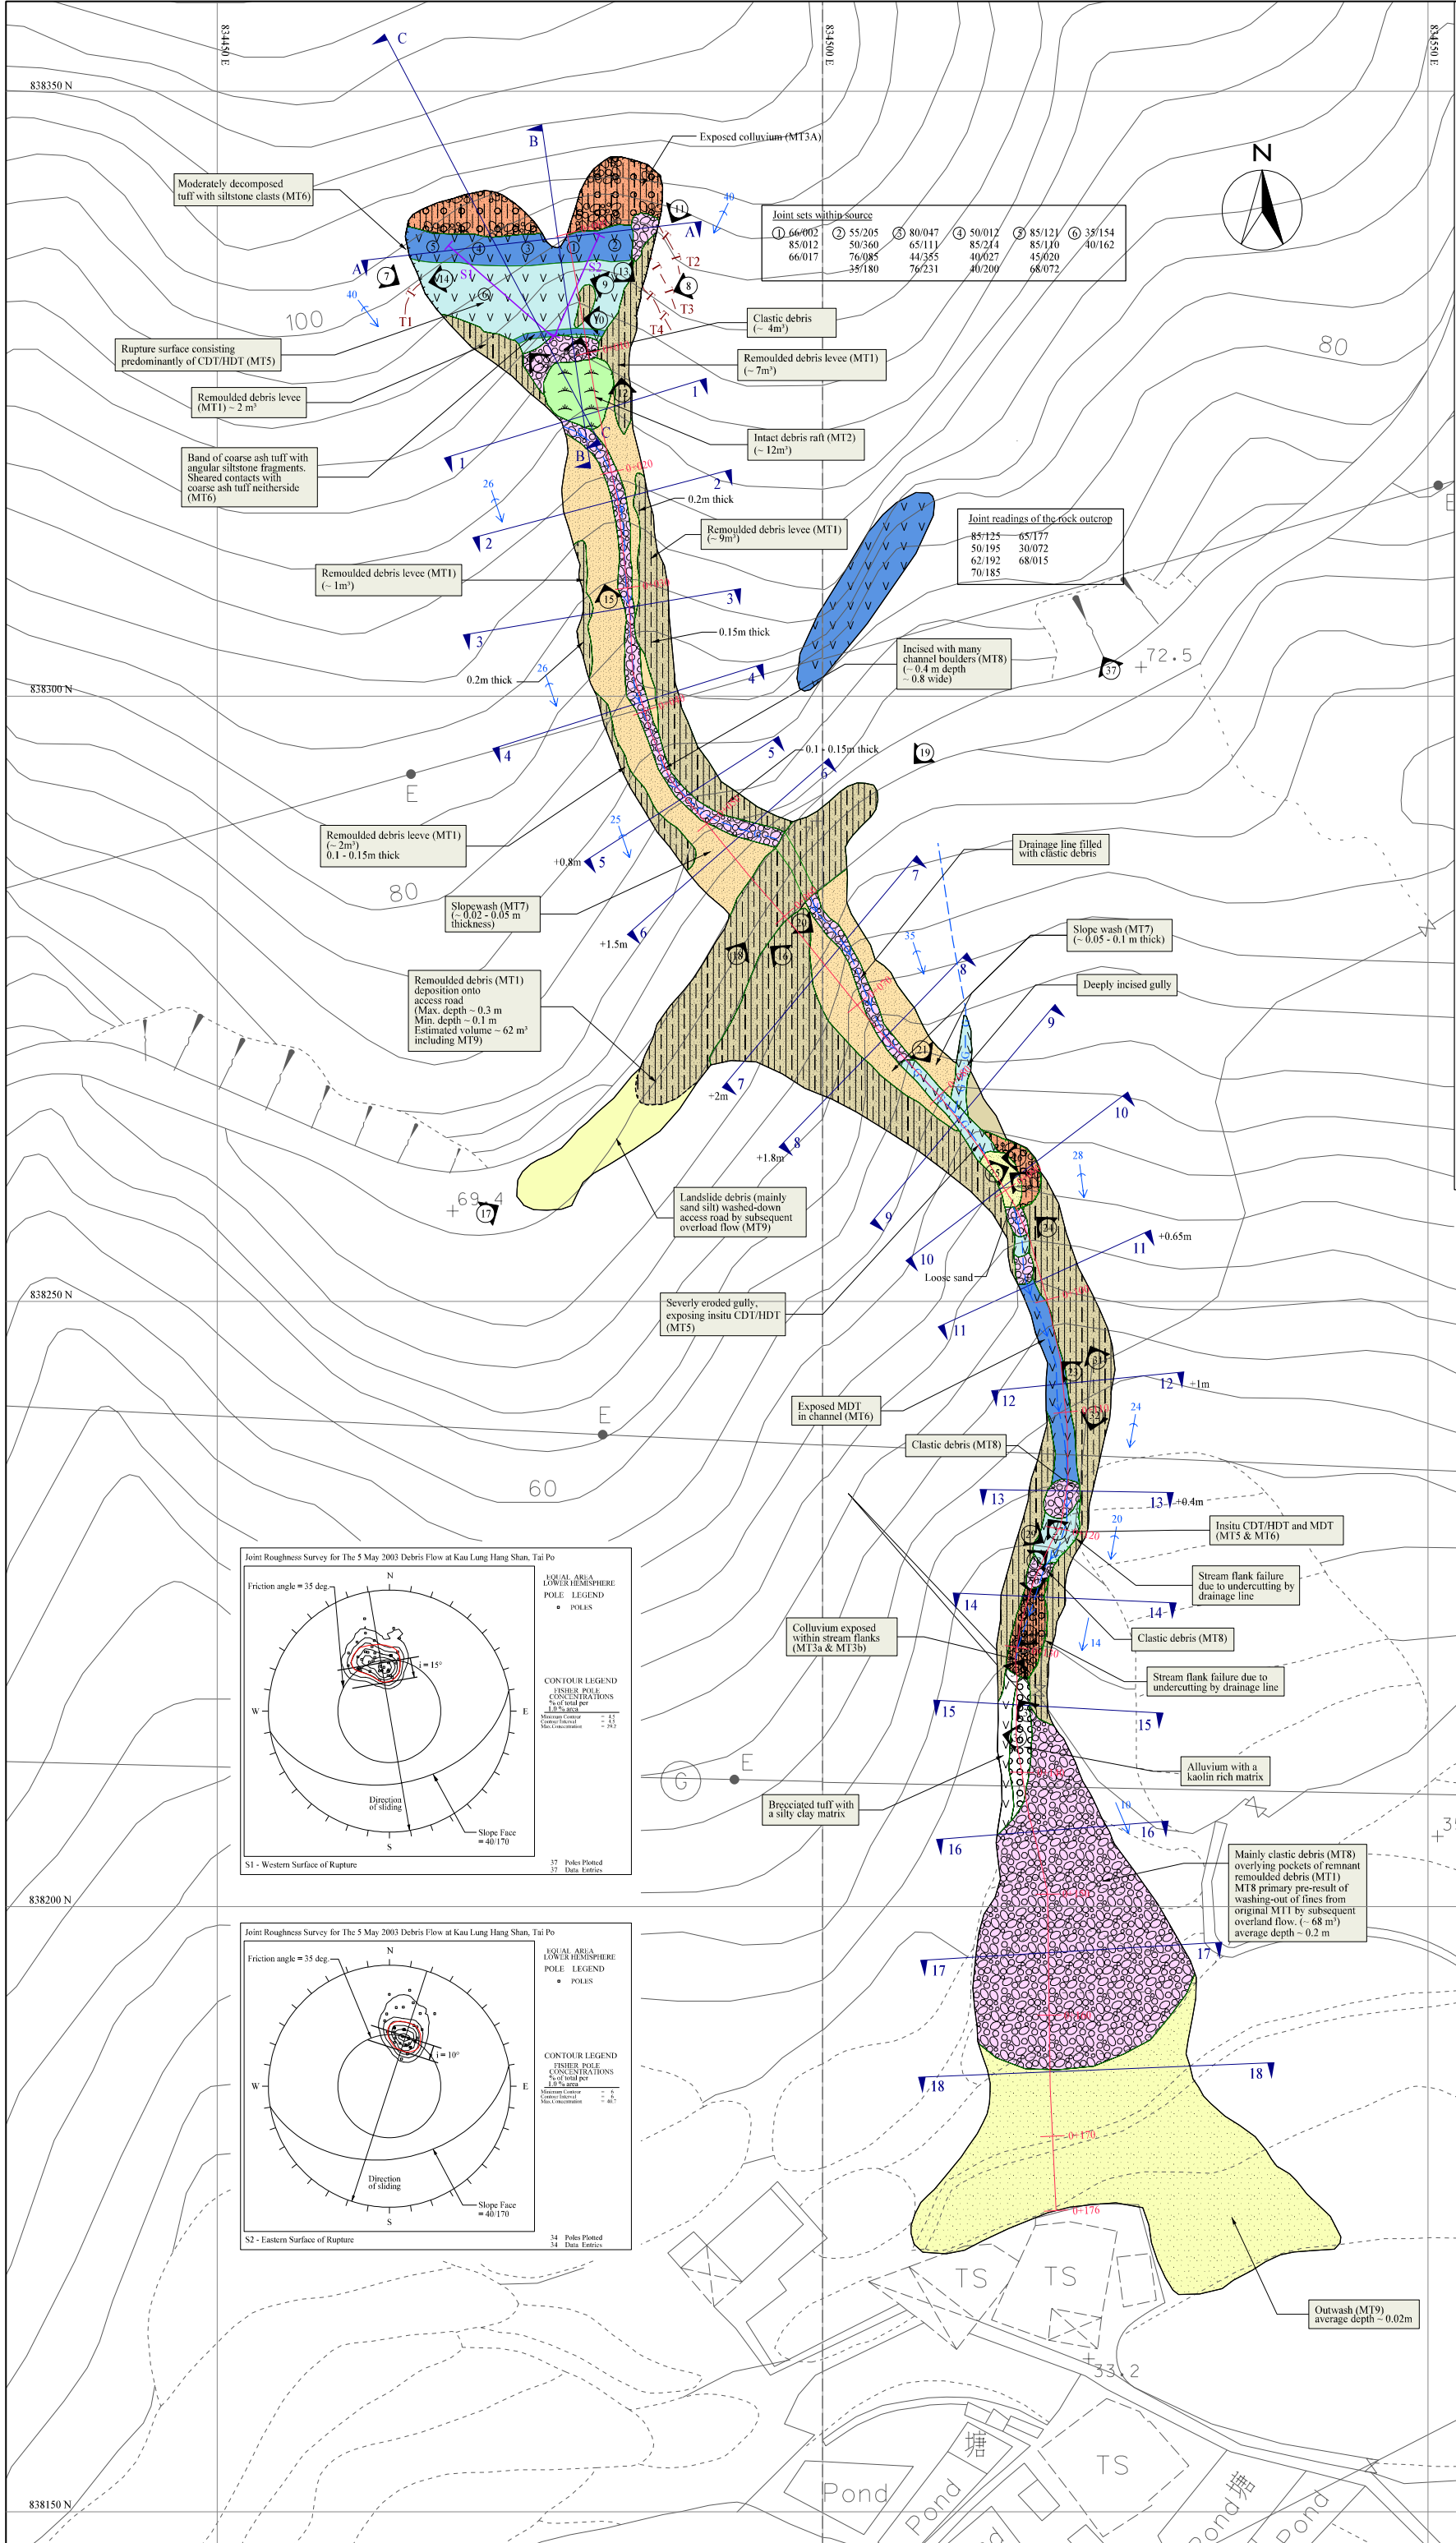
1 The Debris Flow Scar Materials and Mass Balance

(2) The roughness of the surface of rupture was surveyed along two chainage lines (S1 and S2) and the measurements were taken at 0.3 m spacing.
