**THE 25 AUGUST 2003
ROCKFALL ON SLOPE NO.
7SW-C/C362 AT ROUTE TWISK
NEAR TSUEN KAM
INTERCHANGE TSUEN WAN**

GEO REPORT No. 200

Maunsell Geotechnical Services Limited

**GEOTECHNICAL ENGINEERING OFFICE
CIVIL ENGINEERING AND DEVELOPMENT DEPARTMENT
THE GOVERNMENT OF THE HONG KONG
SPECIAL ADMINISTRATIVE REGION**

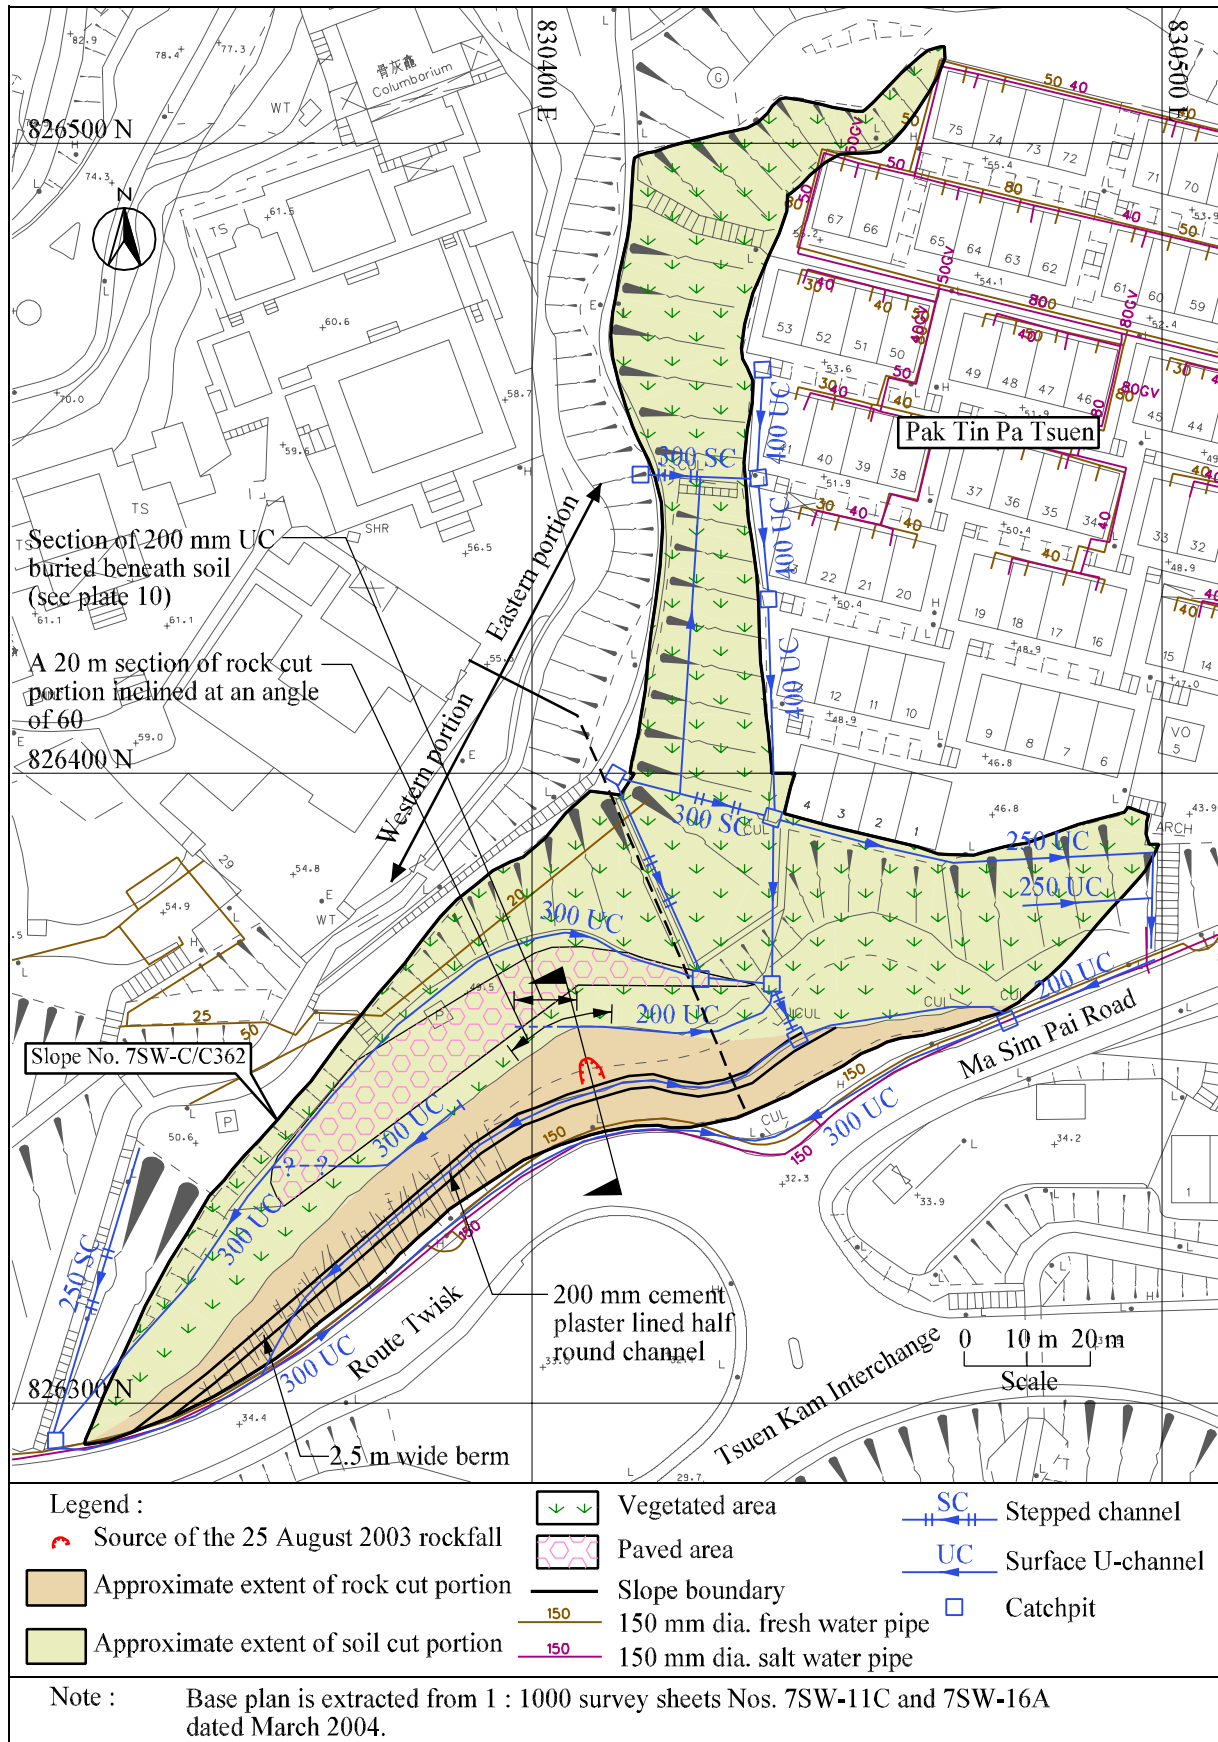
Figure 2 - Site Layout Plan

Surface drainage provisions on the rock cut portion mainly comprise a 200 mm wide crest U-channel running along the eastern part of the slope and a 300 mm U-channel running along the slope toe (Figure 2). A 200 mm wide half-round channel has also been provided on the intermediate berm (Figure 2 and Plate 5).

According to the Slope Maintenance Responsibility Information System of the Lands Department, slope No. 7SW-C/C362 is of mixed maintenance responsibility (MR) (Figure 2). The western slope portion (where the August 2003 rockfall occurred) is under the MR of the Leisure and Cultural Services Department (LCSD), while the eastern slope portion is under the MR of the Architectural Services Department (Arch SD). Arch SD is the maintenance agent for the entire area of slope No. 7SW-C/C362.

According to the GEO incident report, the rockfall incident occurred on the rock cut portion of slope No. 7SW-C/C362 at about 9 a.m. on 25 August 2003. The source of the rockfall was located within the second slope batter near the crest of the rock cut portion, just below a paved garden/sitting-out area (Figures 2 and 3).

Both the crest channel and half-round berm channel in the vicinity of the August 2003 rockfall were almost completely blocked with vegetation (Plates 5 and 6). Also, a section of the crest channel (about 8 m long) was completely buried by soil of up to about 0.3 m thick and covered extensively with tree roots (Figure 2 and Plate 10). No signs of seepage were observed on slope No. 7SW-C/C362 during MGSL's inspections.

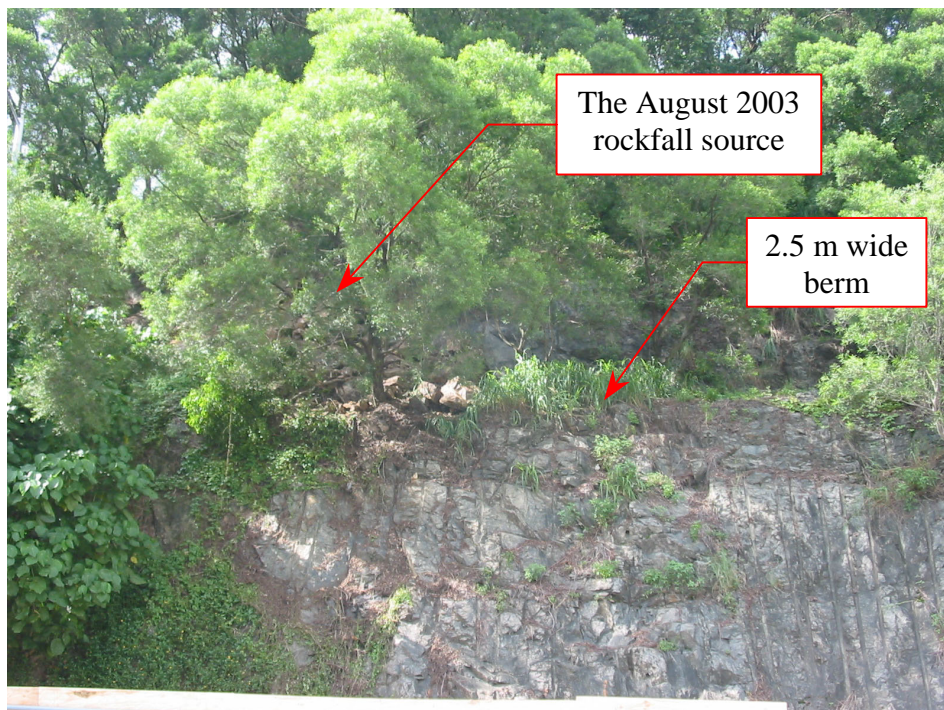
Plate 4 - General View of the Rock Portion of Slope No. 7SW-C/C362
(Photograph taken on 26 August 2003)

The rock cut portion of the slope is sparsely vegetated with some local shrubs (Plates 4 and 5). There are a number of trees in the vegetated area above the landslide scar and isolated trees on the rock cut portion of the slope (Plate 1). Tree roots of 10 mm to 20 mm diameter were exposed within the upper part of the basal sliding plane and adjacent to the source of the rockfall (Plates 5 and 9).

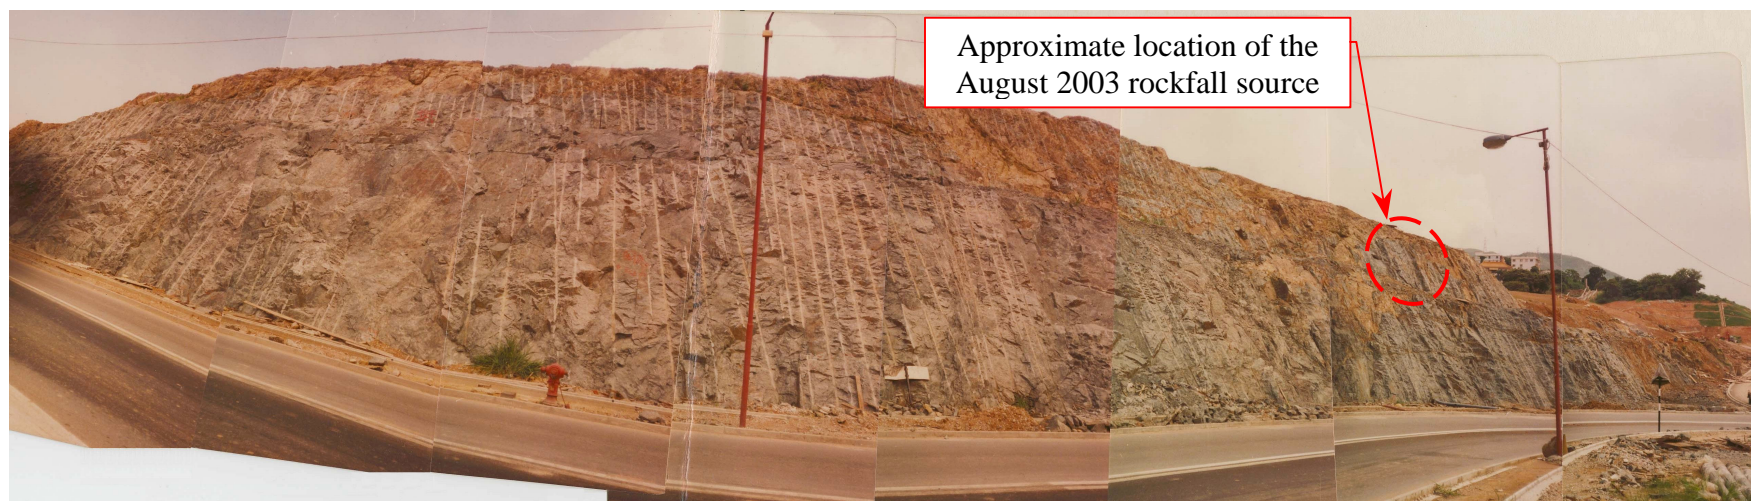
Plate 7 - General View of the Excavated Slope Face in 1981
(Photograph taken by GCO on 10 September 1981)

The slope formation works were completed in September 1981 (Plates 7 and 8). No potential wedge instability was reported by SWKP on the rock cut portion. SWKP noted that “the constructed slopes are considered stable and no remedial works other than scaling of loose rock are anticipated”.
