REVIEW OF THE JUNE 2004 WASHOUT INCIDENT ON SLOPE NO. 10SW-D/C97 AT ADDICTION TREATMENT CENTRE, HEI LING CHAU

GEO REPORT No. 201

Fugro Scott Wilson Joint Venture

**This report was originally produced in May 2005
as GEO Landslide Study Report No. LSR 6/2005**

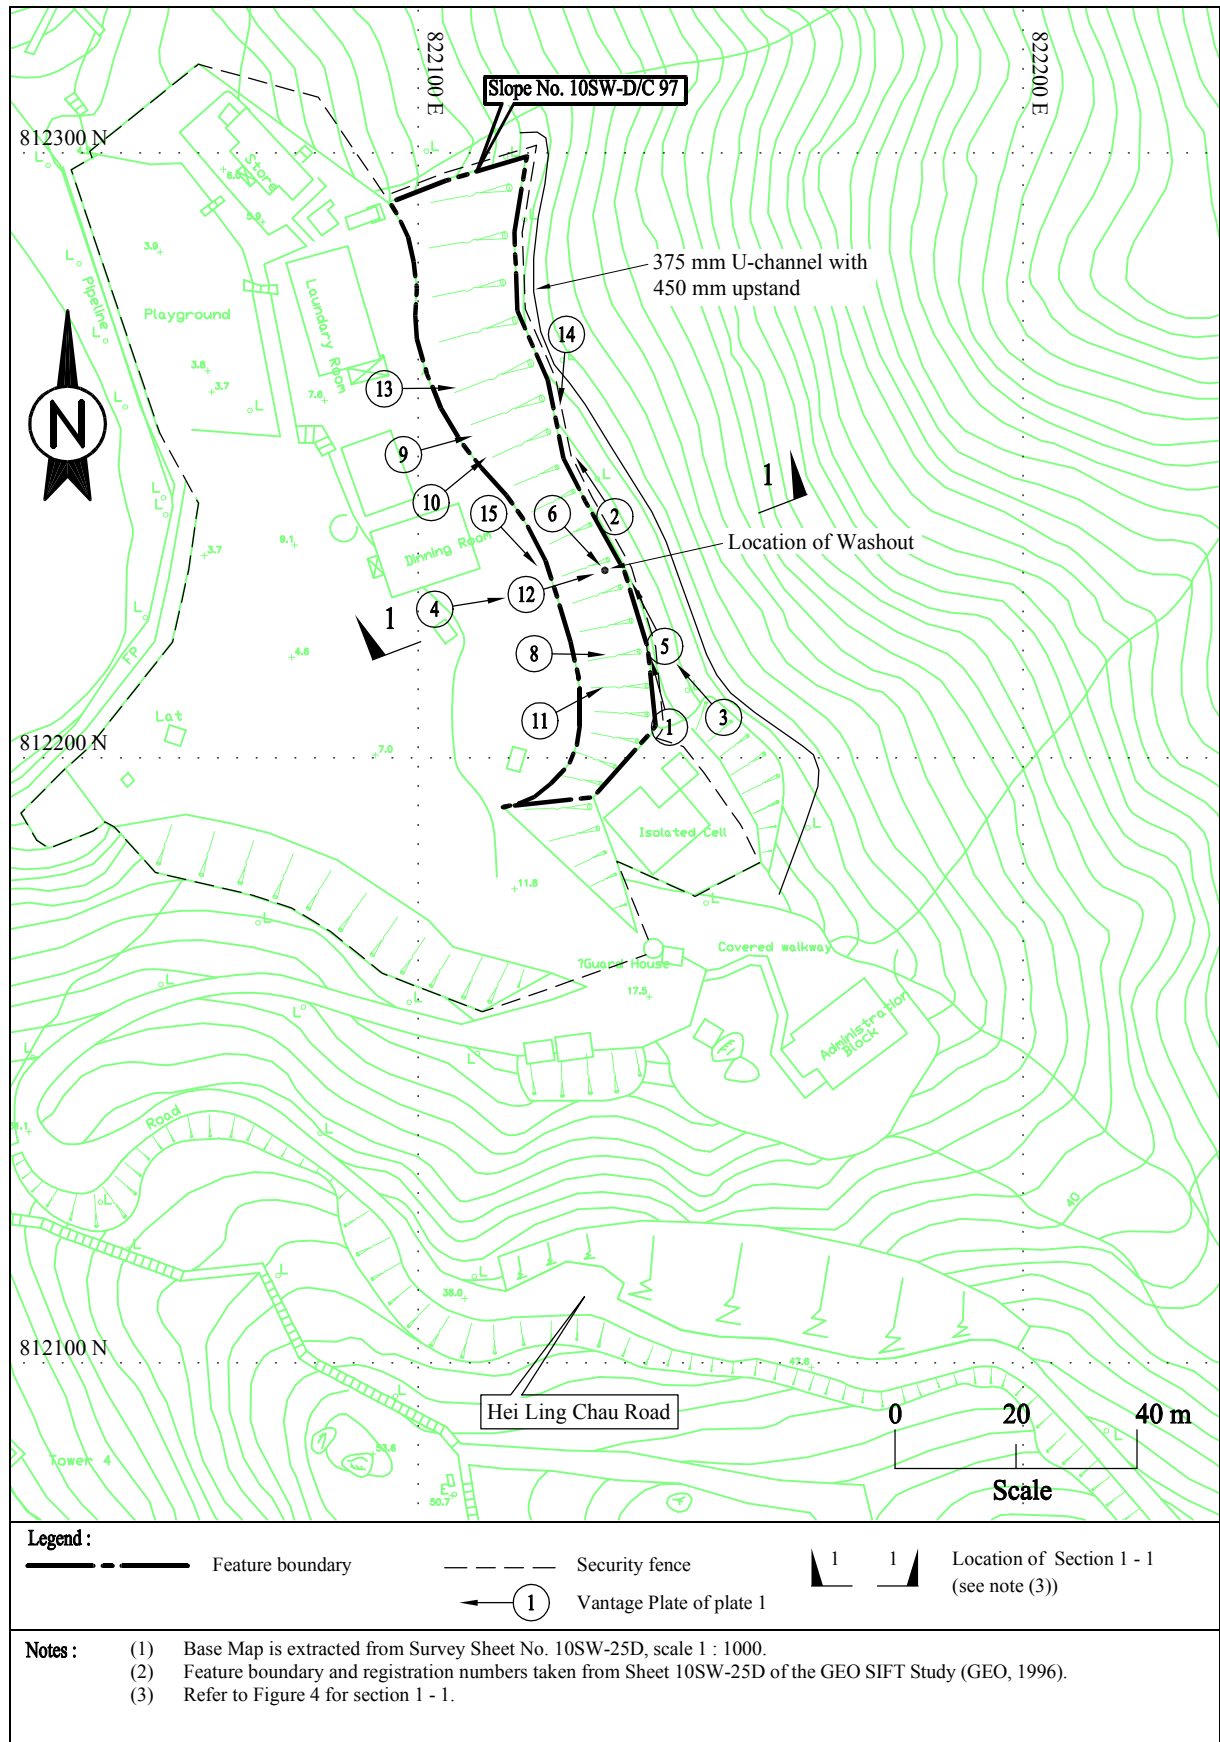
Figure 2 - Site Plan

Slope No. 10SW-D/C97 is located along the eastern boundary of the women's compound and comprises a westerly facing soil nailed cut slope about 115 m long and from 38° to 50° steep, with height varying from 2 m at the southern end to 13 m at the northern end (Figure 2). The slope face is covered by "Tensar-Mat" erosion control mat with no wire mesh, which supports a low cover of vegetation comprising mostly grass (Plate 1). Prescriptive raking drains are installed along the lower portion of the slope face. There is a 1.5 m wide berm at the slope crest, along which is a 4 m high steel mesh security fence (Plate 2).

The June 2004 washout (Plate 4) occurred at a soil nail head located in the central portion of the slope (see Figure 2), about 7.5 m above the slope toe. A cross-section through

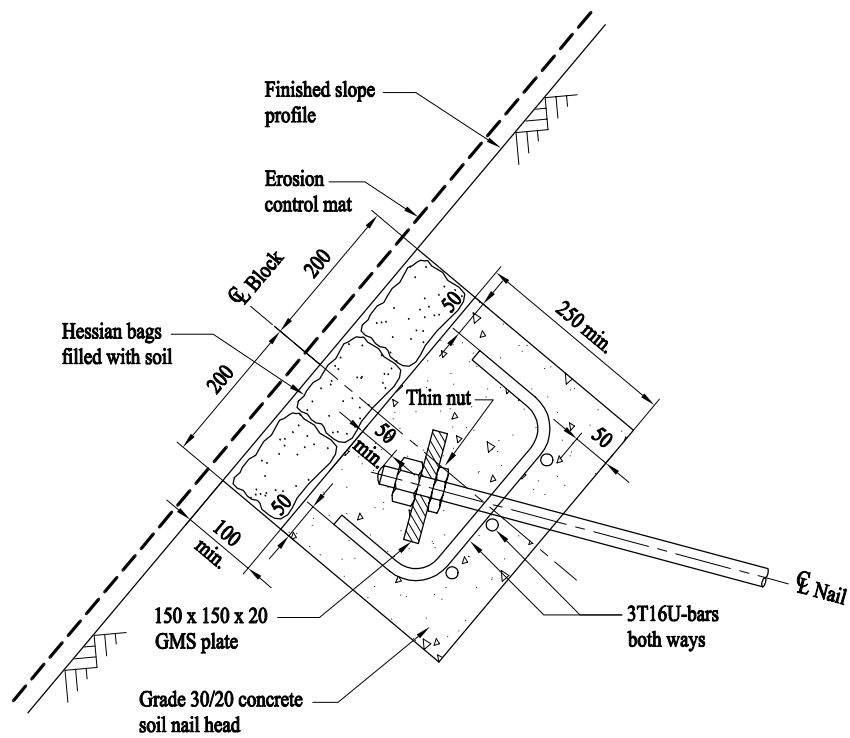
Figure 3 - Soil Nail Head Detail for Slope No. 10SW-D/C97

No significant re-profiling of the slope face was carried out as part of the slope upgrading works. The arrangement at the soil nail heads involved the head being formed below the slope surface level to a depth of 100 mm and covered with soil-filled hessian bags prior to placement of the erosion control mat (Figure 3).

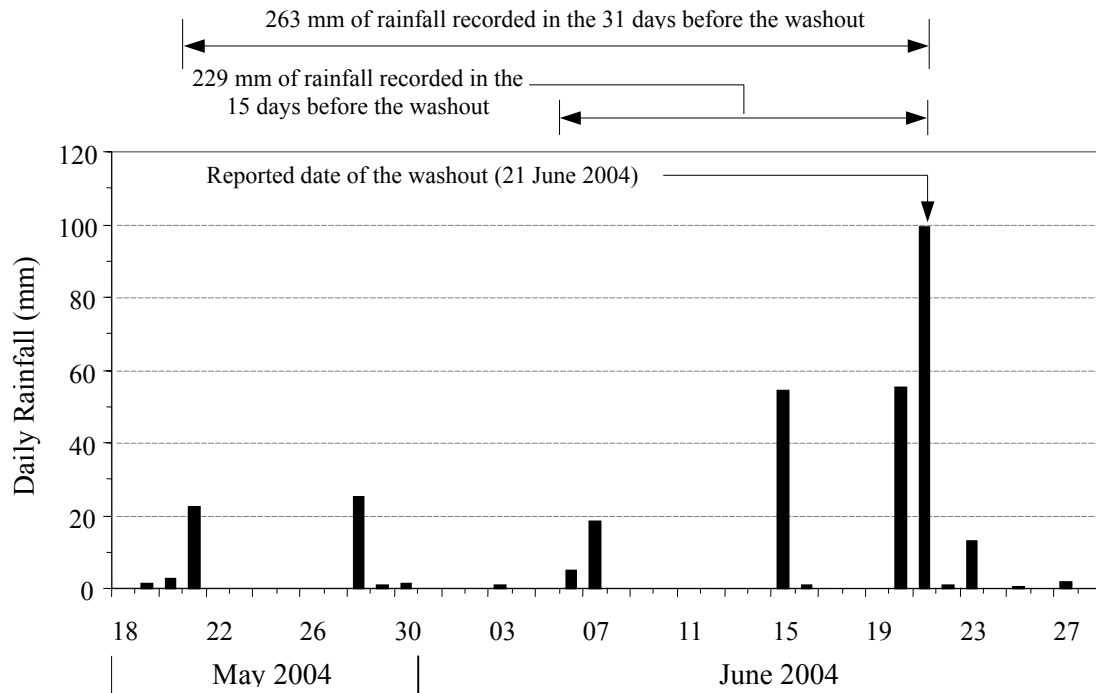
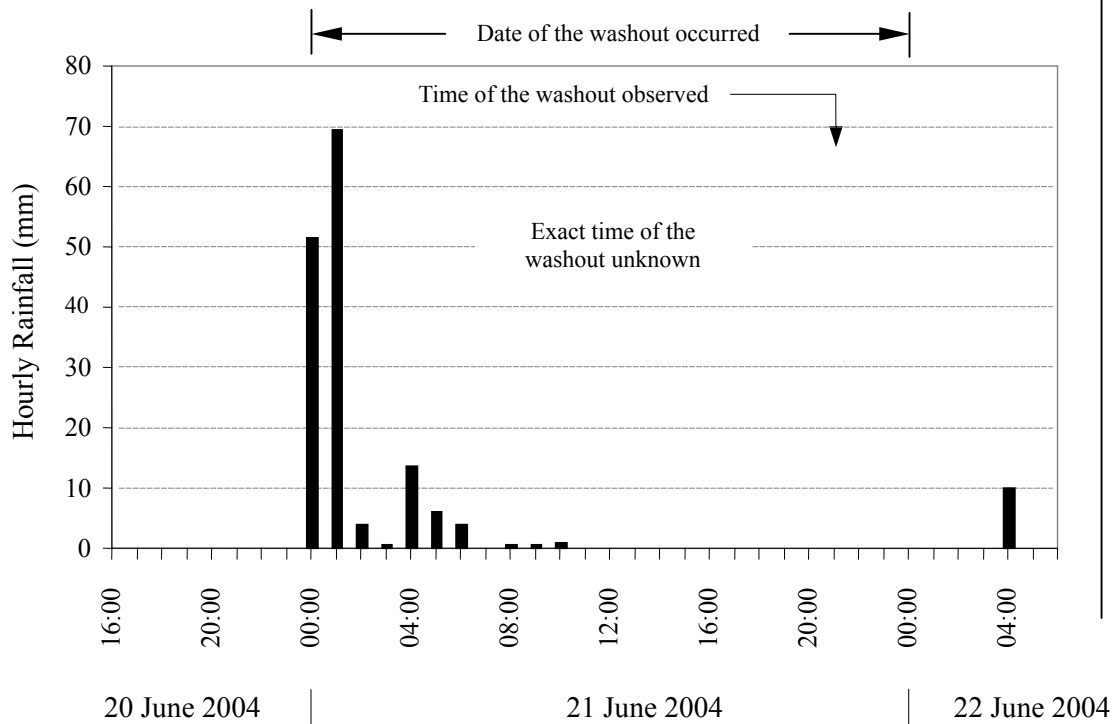
Figure 5 - Rainfall Recorded at GEO Raingauge No. N25

The nearest GEO automatic raingauge (No. N25) to the site is located at the Peng Chau Indoor Recreation Centre, Peng Chau about 4 km north of the site (Figure 1). The daily rainfall records of raingauge No. N25 for the period prior to the June 2004 washout incident are presented in Figure 5. These indicate that about 150 mm of rainfall occurred in the 24-hour period prior to the failure. Based on historical rainfall data at the Hong Kong Observatory (Lam & Leung, 1994), the corresponding return period of the rainfall recorded prior to the 21 June 2004 washout is about 7 years (Table 2).

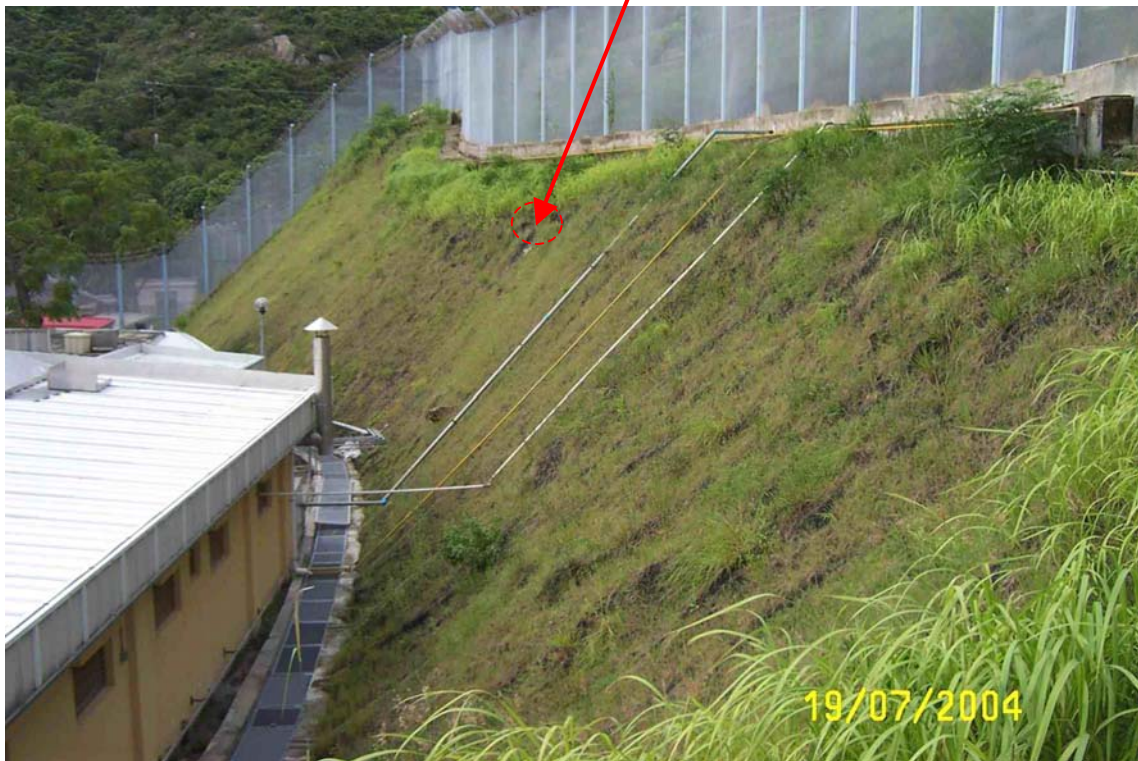
Location of washout

Plate 1 - General View of Slope No. 10SW-D/C97 from South
(Photograph taken on 19 July 2004)

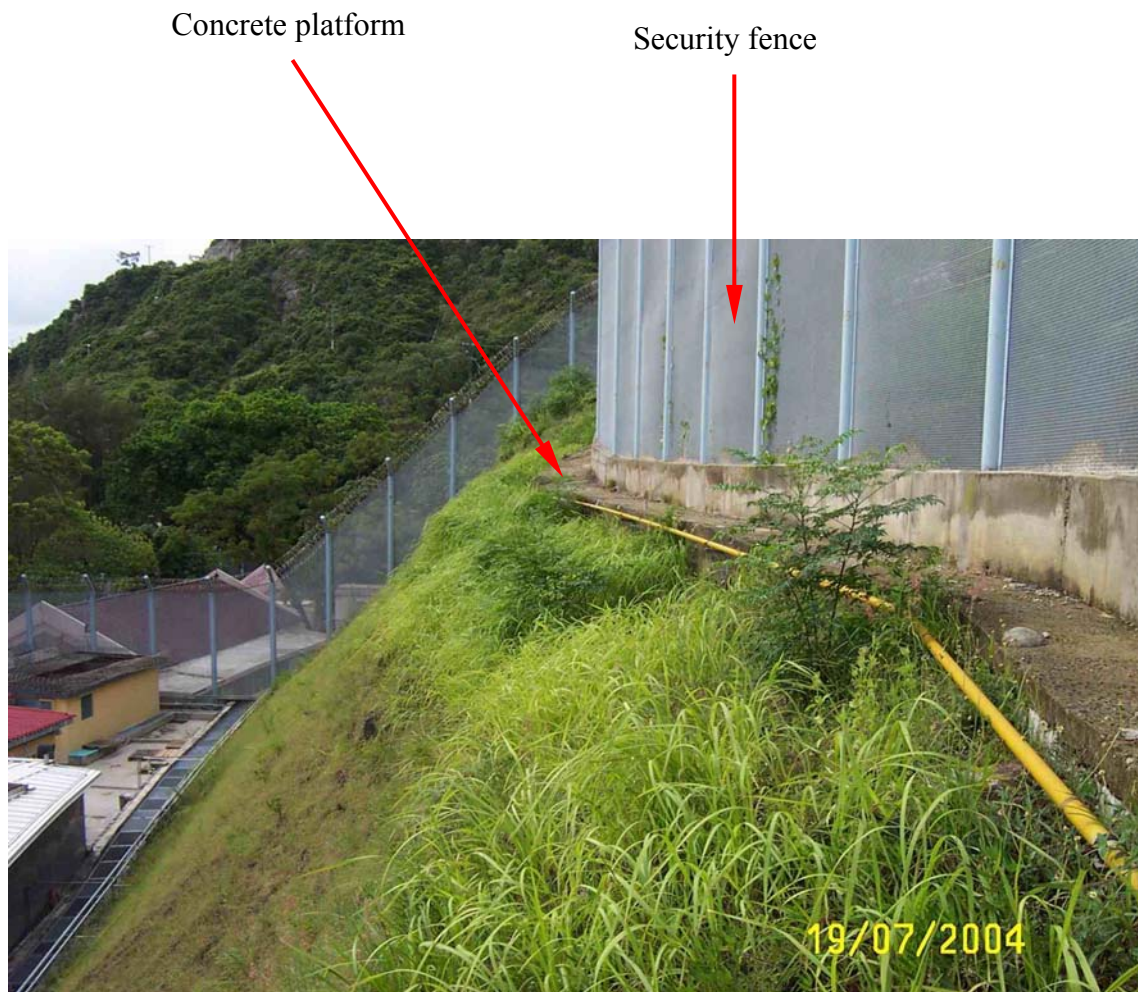
Plate 2 - General View of the Upper Portion of Slope No. 10SW-D/C97
(Photograph taken on 19 July 2004)

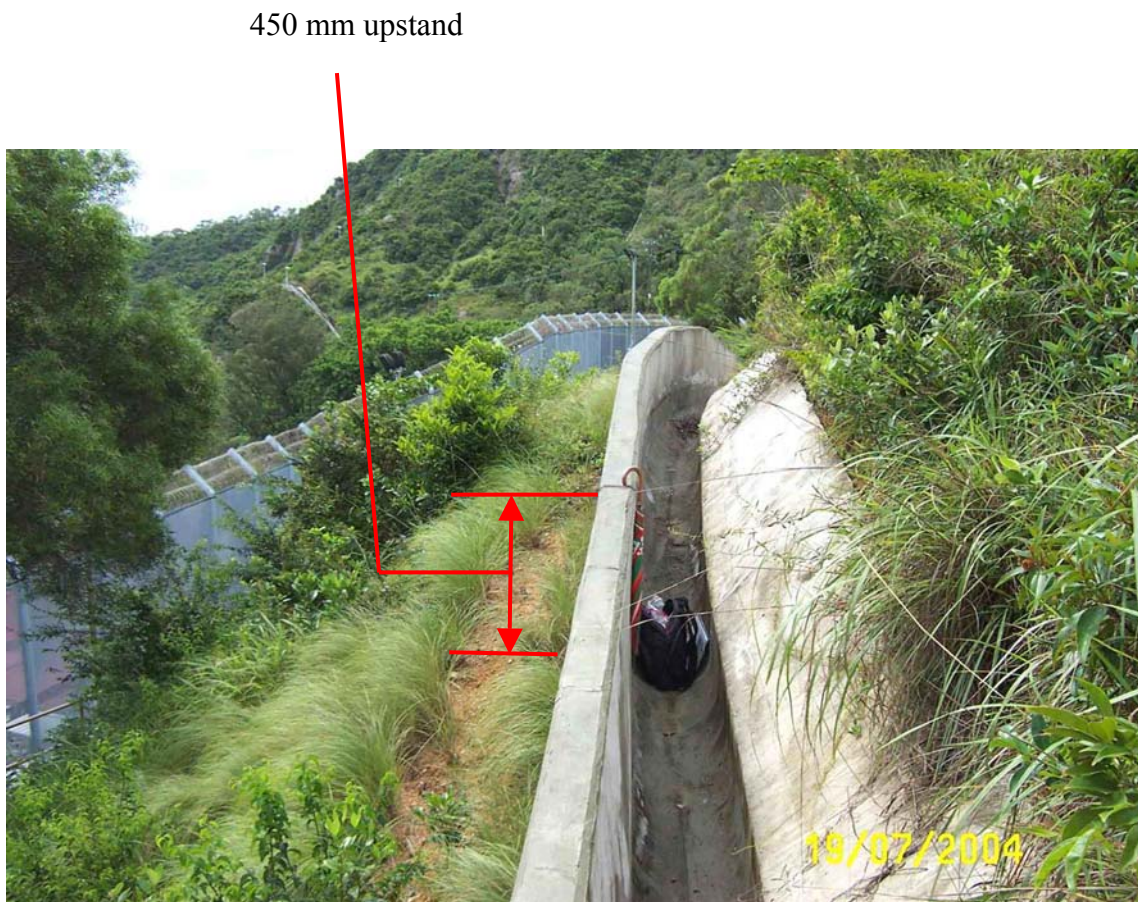
Beyond the security fence, the local topography comprises heavily vegetated natural hillside with a slope angle of about 35°, the lower 8 m of which has been cleared and re-vegetated in association with the recent slope upgrading works. Formation of the crest berm has resulted in a maximum 1 m high 70° soil cut at the transition with the natural hillside. The upper extent of the re-vegetated area is defined by a 375 mm U-channel (Plate 3). The downslope wall of the channel has been extended upwards by about 450 mm.

Plate 3 - General View of the 375 mm U-Channel Located Upslope of the Crest Berm of Slope No. 10SW-D/C97 Showing 450 mm Upstand on Channel Wall (Photograph taken on 19 July 2004)

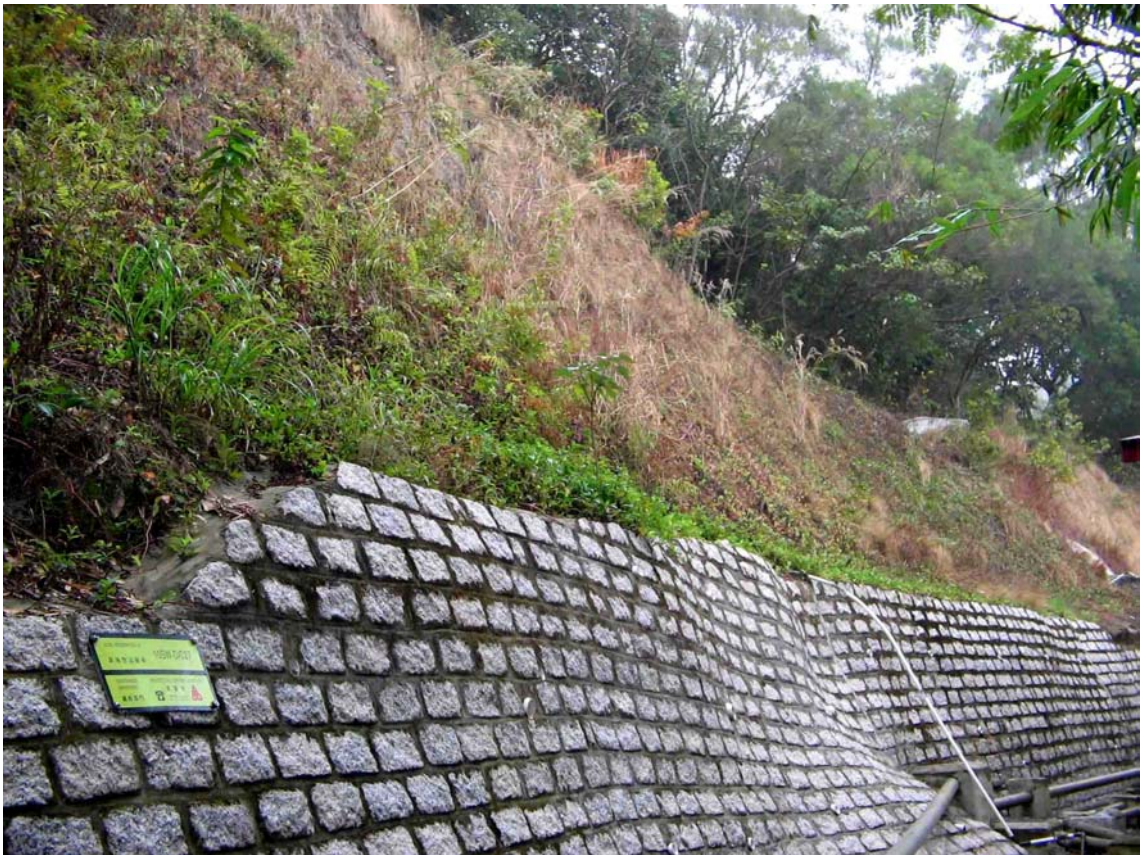
Slopes Nos. 10SW-D/C27, 10SW-D/C35 and 10SW-D/C139 (Plates 16, 17 and 18) incorporate a wire mesh netting lying over the erosion control mat. This appeared to have provided a barrier against trimming tools and mitigated the abrasive effects of pedestrian access, as in all cases, the erosion control mat was found to be in good condition, with no obvious signs of damage (Plates 19, 20 and 21).

Plate 16 - General View of Slope No. 10SW-D/C27
(Photograph taken on 11 March 2005)

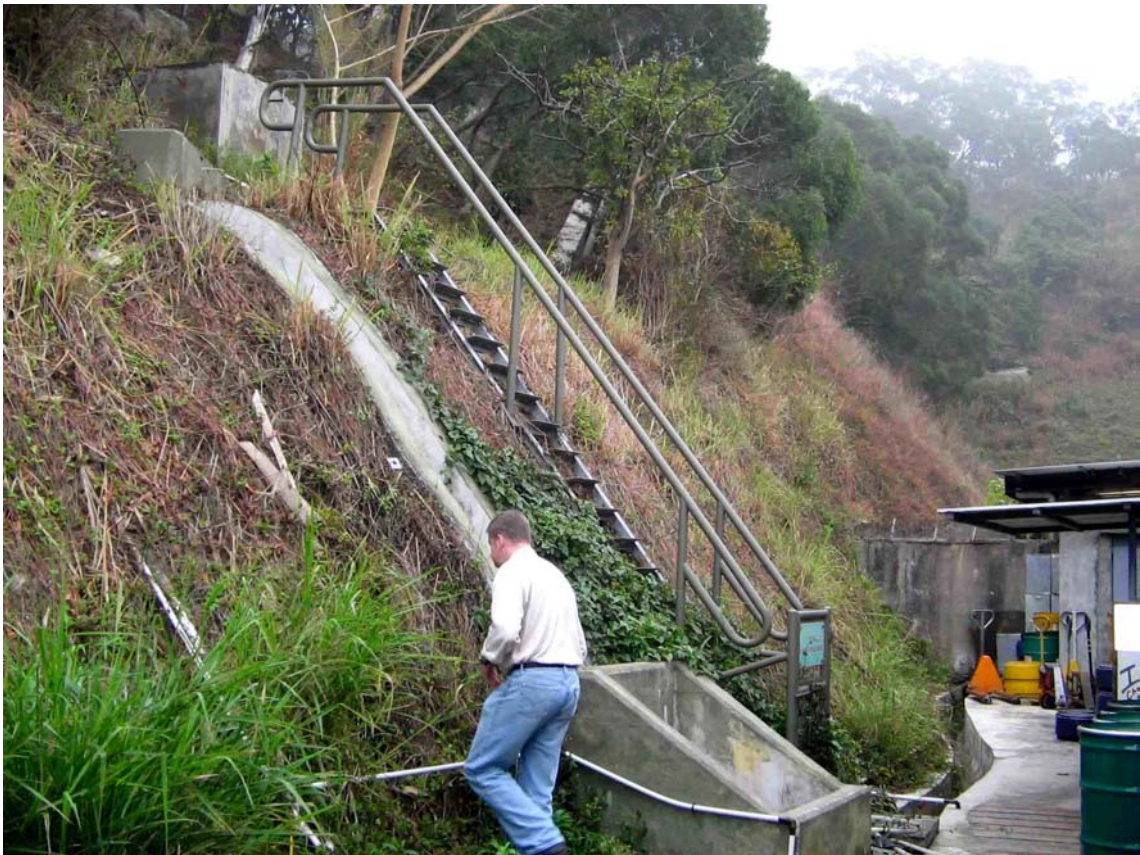
Plate 17 - General View of Southwesterly Facing Portion of Slope No. 10SW-D/C35
(Photograph taken on 11 March 2005)

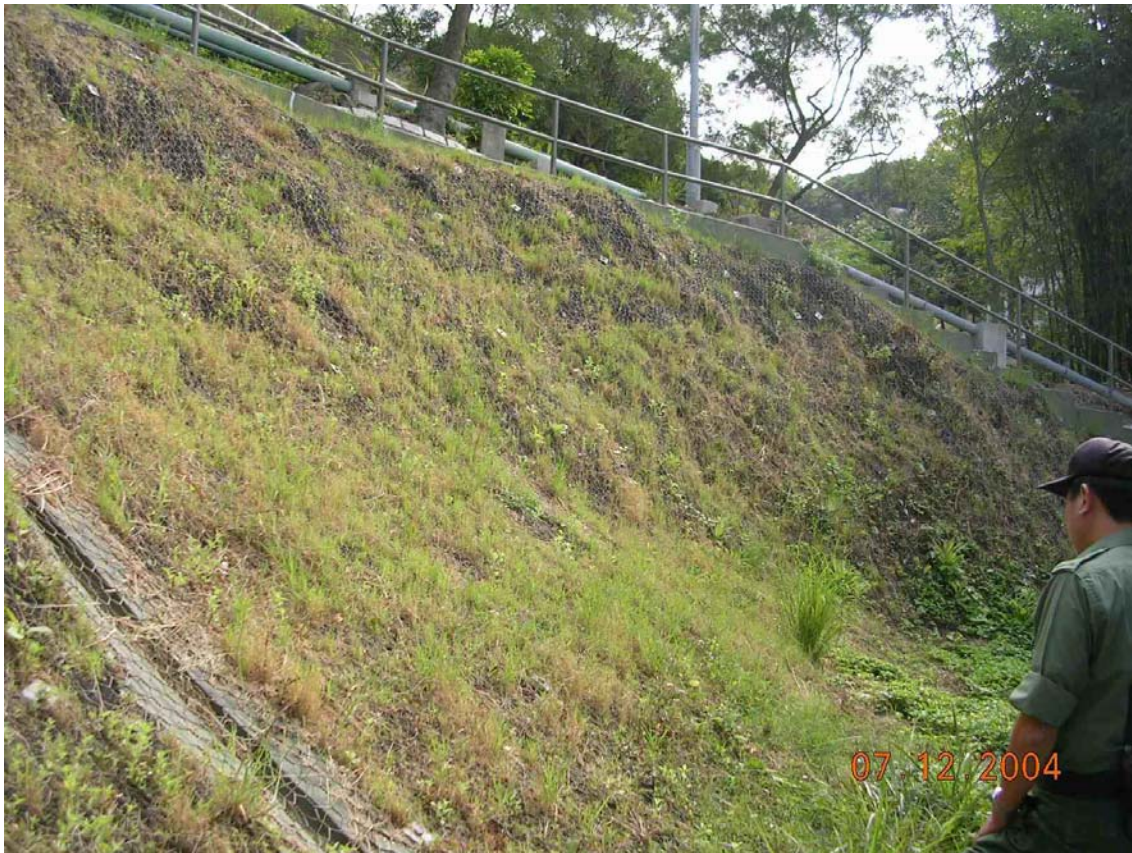
Plate 18 - General View of Slope No. 10SW-D/C139
(Photograph taken on 7 December 2004)

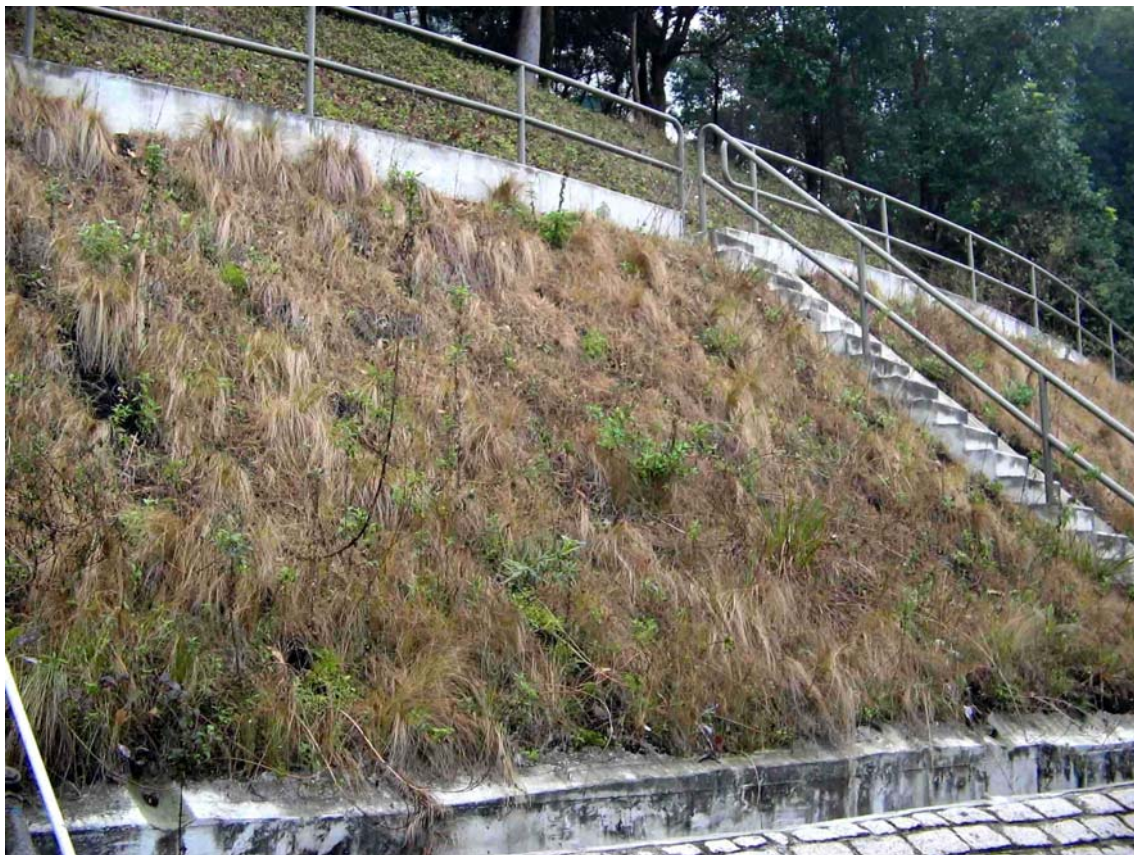
The erosion control mats on slopes Nos. 10SW-D/C28, 10SW-D/C101 and 10SW-D/C102 (Plates 22, 23 and 24), which did not incorporate wire mesh netting, all showed signs of having been cut after placement (Plates 25, 26 and 27), although to a lesser extent than that observed on slope No. 10SW-D/C97 where the June 2004 landslide incident occurred. A factor in the condition of the erosion control mat for these slopes appeared to be the choice of different vegetations, as the 'creeper' type vegetation cover applied to the upper batter of slope No. 10SW-D/C28 and also slope No. 10SW-D/C27 (Plates 28 and 19 respectively) formed a network of stems on the erosion control mat that did not appear to be removed during vegetation trimming (underway on slope No. 10SW-D/C28 at the time of inspection by FSW in March 2005), whilst the grass cover on the lower batter of slope No. 10SW-D/C28 and slope No. 10SW-D/C102 had been trimmed down to the erosion control mat.

Plate 22 - General View of Slope No. 10SW-D/C28
(Photograph taken on 11 March 2005)

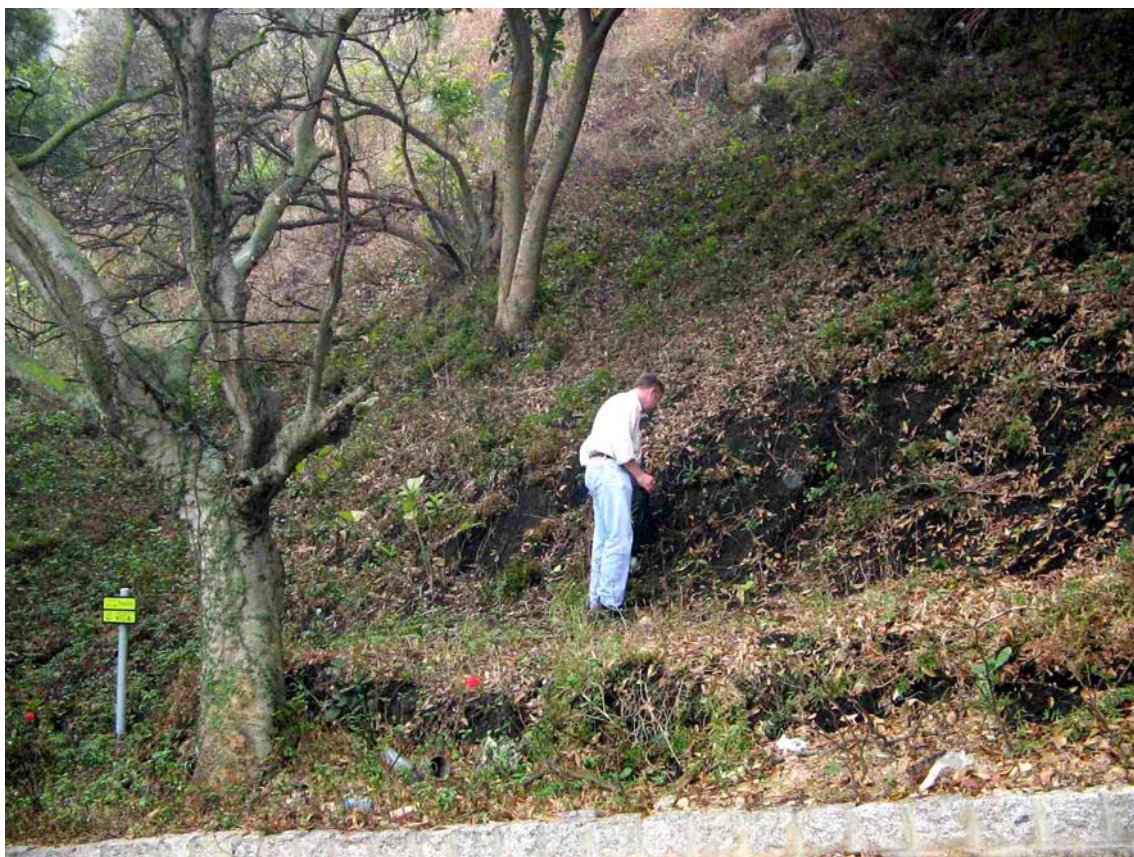
face of slope No. 10SW-D/C101 (Plates 23 and 29), which appeared to be hindered by the extensive tree cover and resulting leaf litter, as well as the gap between the erosion control mat and the underlying ground surface over significant areas. These two features probably further limited the amount of sun light reaching the slope face and reduce vegetation growth.

Plate 23 - General View of Southwestern Portion of Slope No. 10SW-D/C101
(Photograph taken on 11 March 2005)

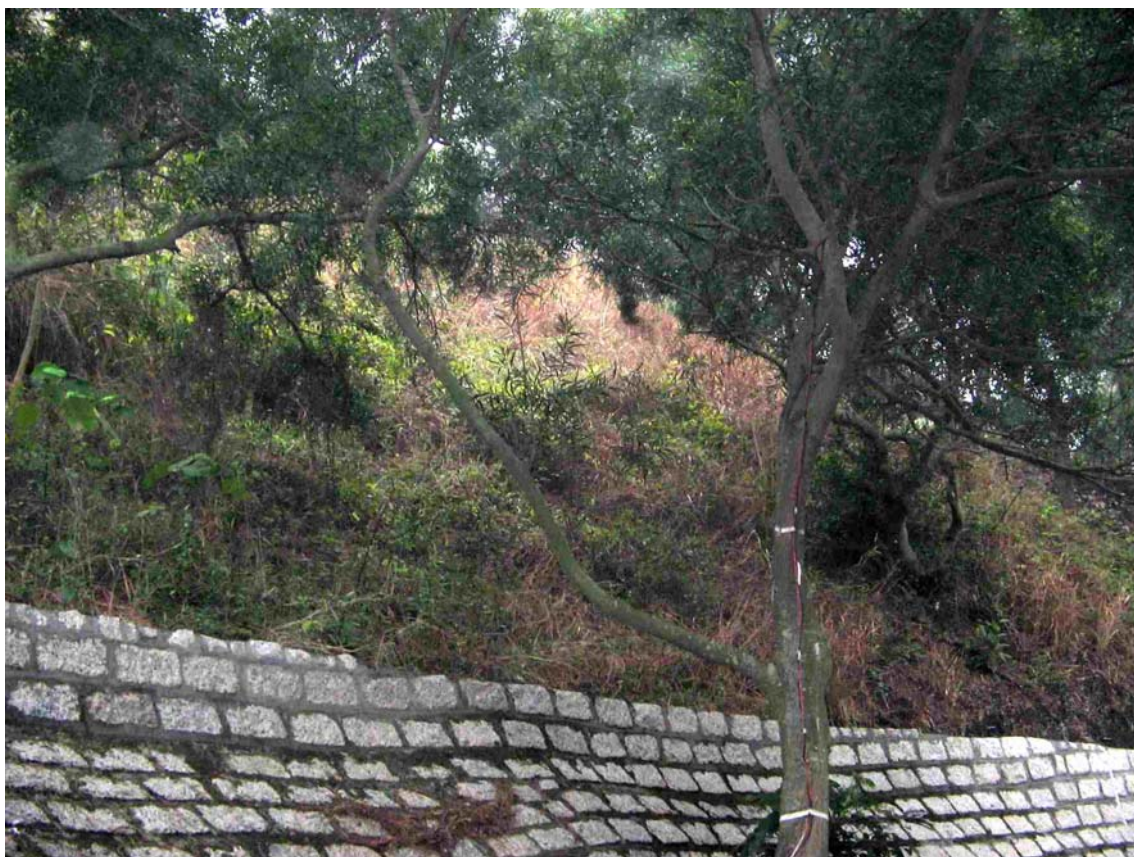
Plate 24 - General View of Slope No. 10SW-D/C102
(Photograph taken on 11 March 2005)

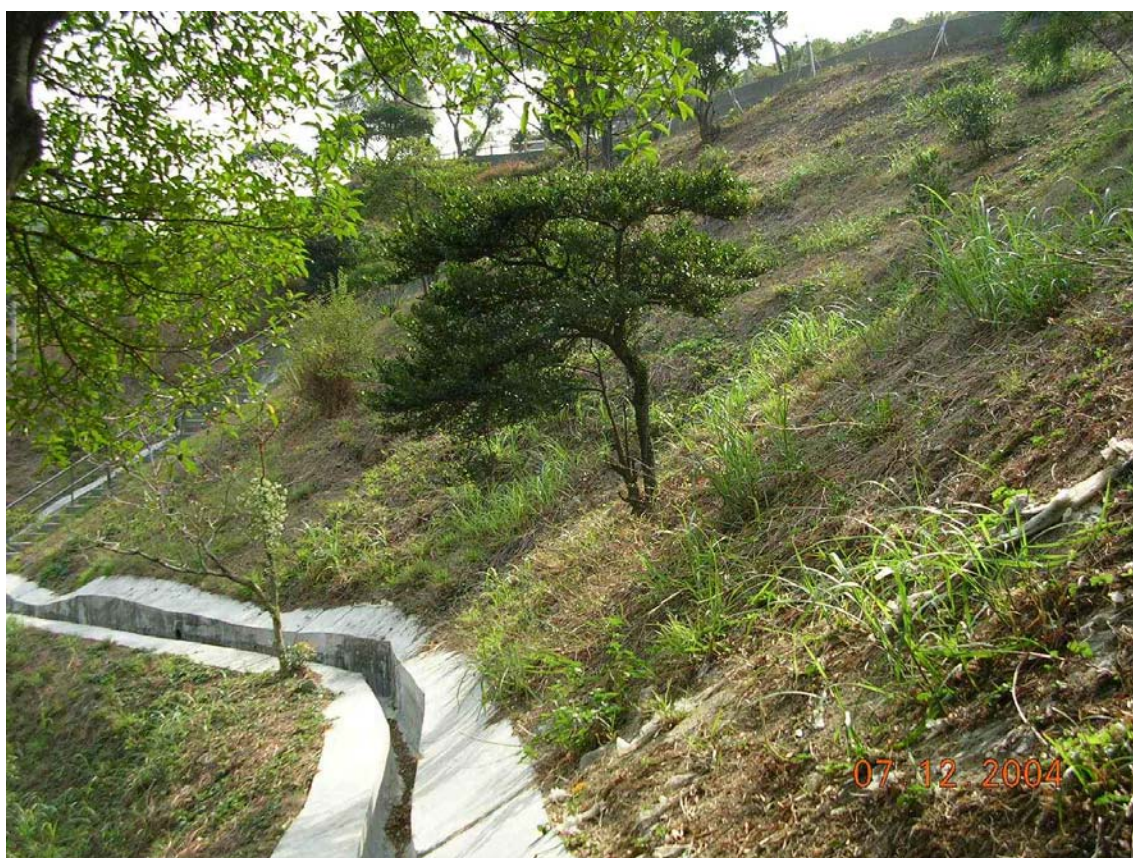
At the time of the inspection by FSW of slope No. 10SW-D/F55 in December 2004, which did not incorporate wire mesh netting or erosion control matting at the slope face, the majority of the slope face had recently undergone vegetation trimming (Plate 30). A small portion of the eastern end of the feature retained a dense cover of grass and creeper vegetation (Plate 31). A number of areas on the slope face were completely stripped of vegetation, exposing the topsoil below (Plates 32 and 33).

Plate 30 - General View of Slope No. 10SW-D/F55
(Photograph taken on 7 December 2004)

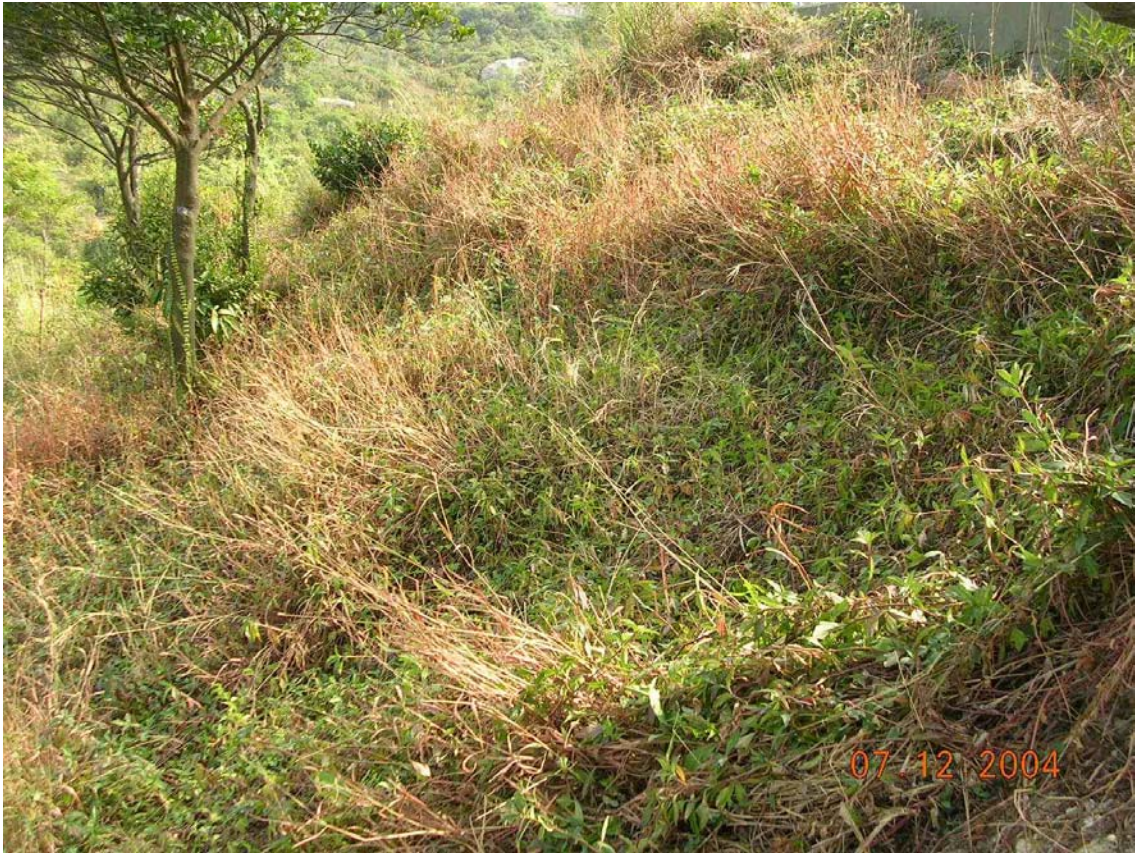
Plate 31 - View of Eastern Portion of Slope No. 11SW-D/F55 not Subject to Vegetation Trimming (Photograph taken on 7 December 2004)
