# **VOLUME 3: DETAILED STUDY OF SELECTED NATURAL TERRAIN LANDSLIDES AT CLOUDY HILL**

**HALCROW CHINA LIMITED**

**This report was originally produced in July 2003  
as GEO Landslide Study Report No. LSR 6/2003**

**Landslide Investigation Consultancy Agreement No. CE 2/2000**  
**Landslide Reconnaissance Field Proforma – Cloudy Hill**

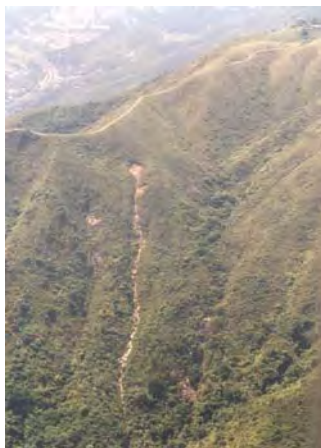
Photo. No. CH00C Date 09/07/01 (Looking W)

| ( ) Man-made disturbance | (X) Tension cracks (Minor) | ( ) Post failure widening |
| ( ) Evidence of previous movement | (X) Deterioration of rock mass | ( ) Seepage |
| ( ) Within scar of relict failure | (X) Infilled joints | (X) Erosion pipes |

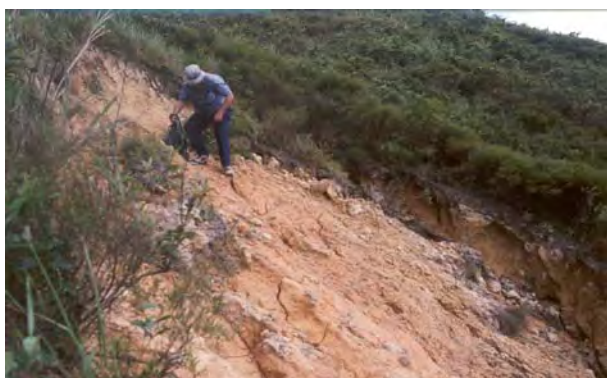
Photo. No. CH01ACLOSENIK Date 09/08/01 (Looking E)      Photo. No.      Date / / (Looking )

Many pipes approximately 30 mm diameter      Some quartz Veins  
 Much post-failure gullying

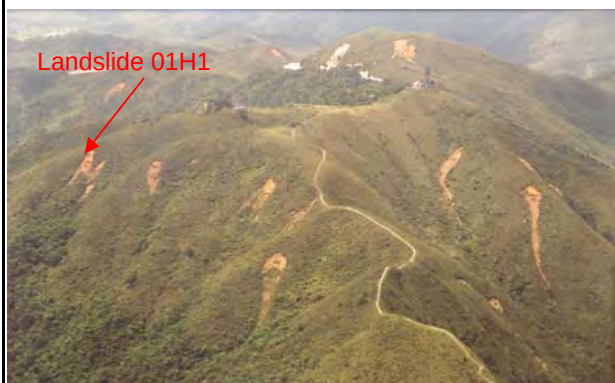
Photo. No.CH00&01 Date 09/08/01 (Looking N)

Numerous quartz veins over surface of rupture  
Controlled by local thick deposits of colluvium

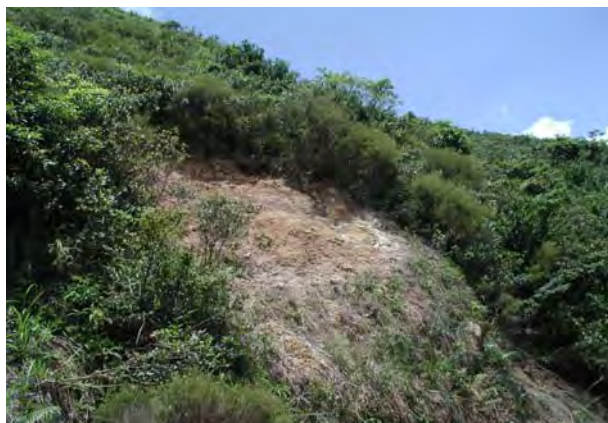
Photo. No.P8090018 Date 09/08/01 (Looking E)

Step observed near toe of landslide is possible crown of previous landslide

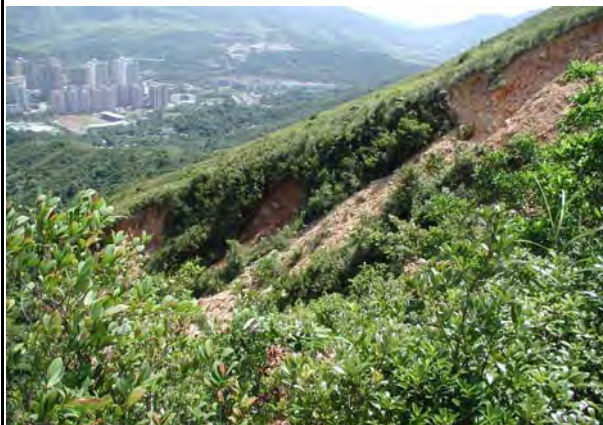
Photo. No.P8090045 Date 09/08/01 (Looking W)

Widening of very large (150 m x 100 m x 5 m) pre-existing failure  
Potential hazard to developments at base of drainage channel

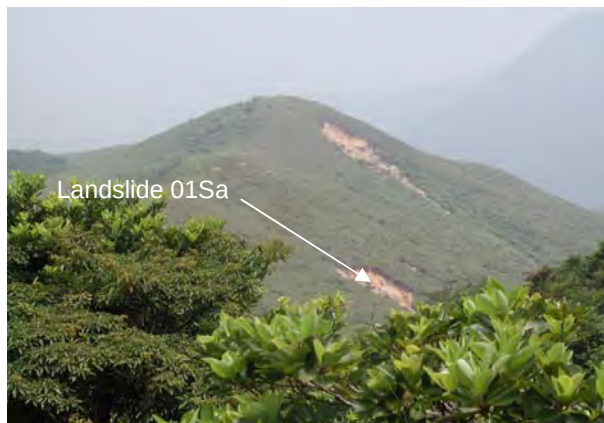
Photo. No. P8220057 Date 22/08/01 (Looking N)

Landslide 01Sa →
