REVIEW OF SLOPE SURFACE DRAINAGE WITH REFERENCE TO LANDSLIDE STUDIES AND CURRENT PRACTICE

GEO REPORT No. 210

T.H.H. Hui, H.W. Sun & K.K.S. Ho

**GEOTECHNICAL ENGINEERING OFFICE
CIVIL ENGINEERING AND DEVELOPMENT DEPARTMENT
THE GOVERNMENT OF THE HONG KONG
SPECIAL ADMINISTRATIVE REGION**

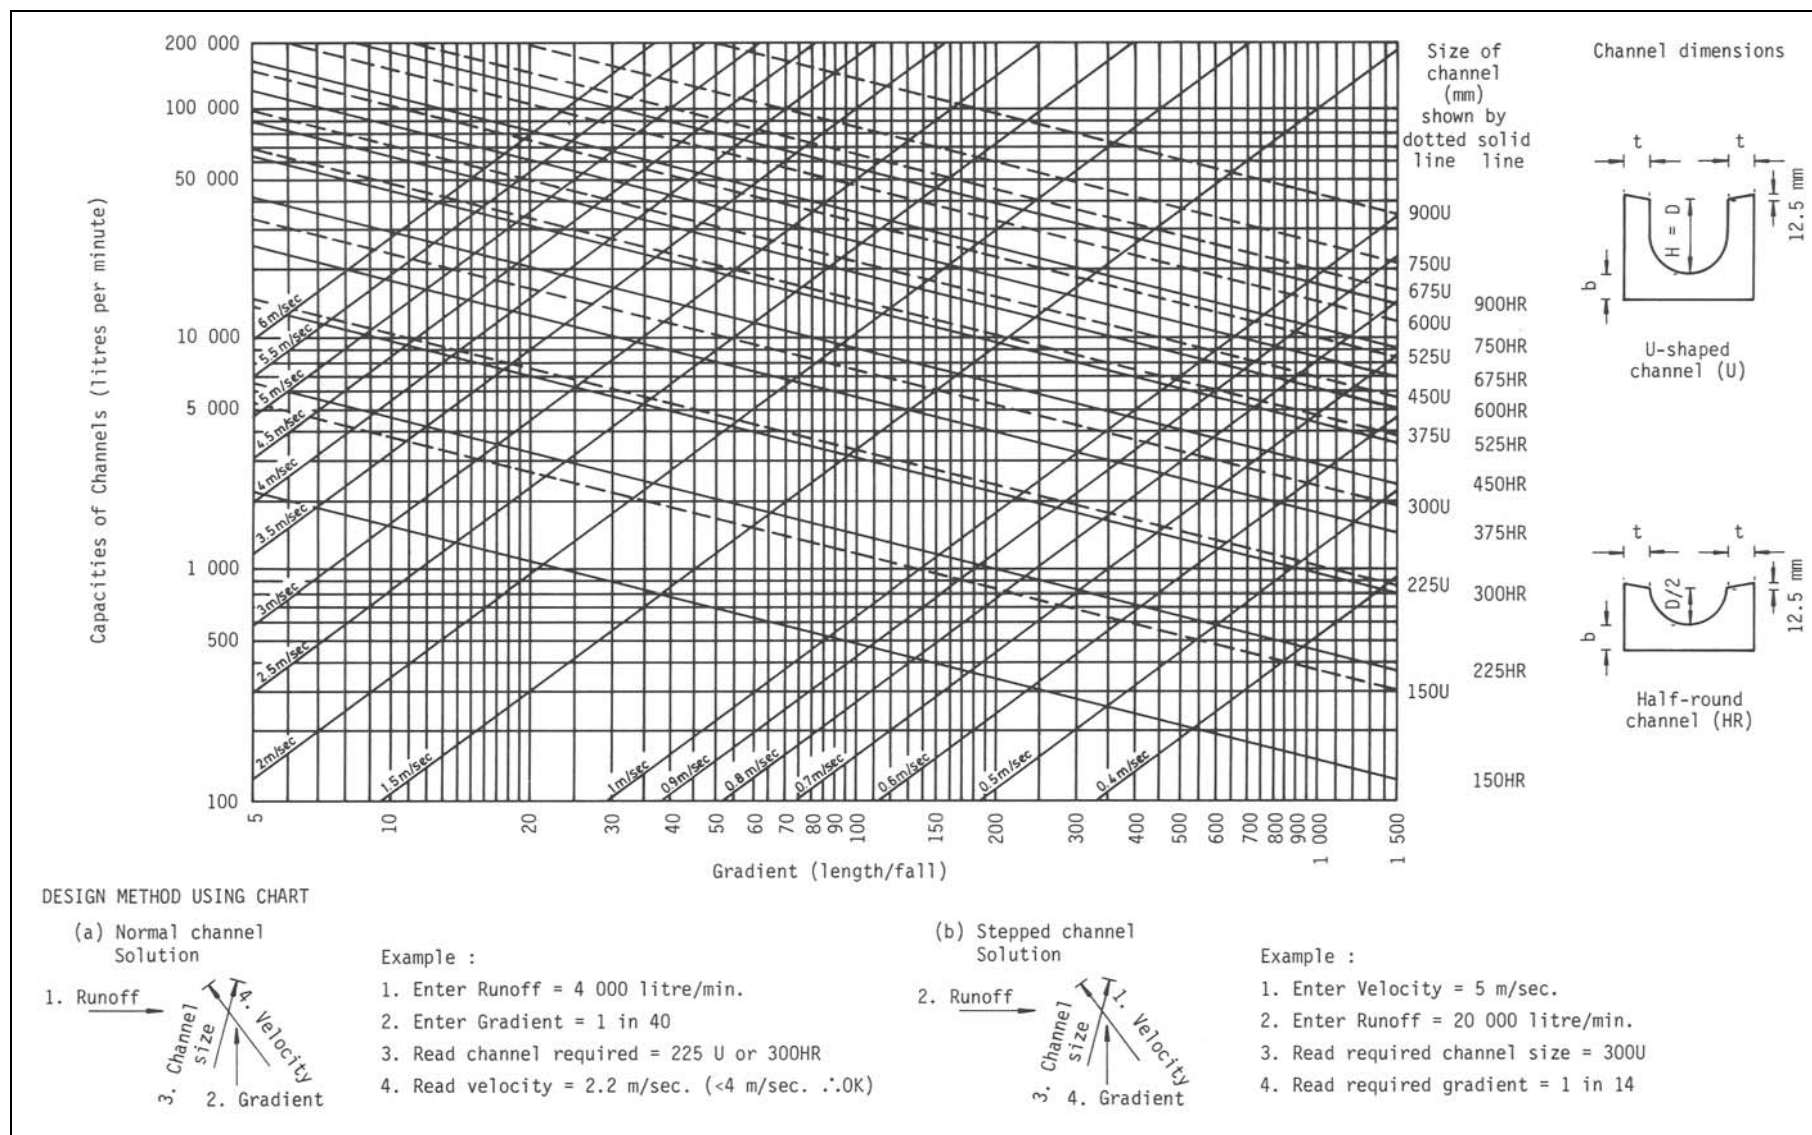
Figure 12 - Chart for the Rapid Design of Channels (Reproduced from Figure 8.7 of GCO (1984))

The design methodology of stepped channels is currently under review by the Standards and Testing Division of the GEO. A noteworthy aspect concerns the interpretation of the design charts given in Figures 8.7 and 8.8 of GCO (1984), which are reproduced as Figures 12 and 13 respectively. In the sizing of a stepped channel, the example given in Figure 8.7 of GCO (1984) notes that a stepped channel should be taken as an U-channel in using the design chart. However, there is a grey area when reference is made to Figure 8.8 of GCO (1984) in establishing the corresponding design channel depth, as this is to be based on the assumption of a half-round channel instead of an U-channel.

The ramification of the above is illustrated by way of a simple example in the following. For a required channel capacity of 20,000 litres per minute and a design flow velocity of 5 m/sec, a 300 mm U-channel, with a gradient of 1 in 14, is needed in accordance with Figure 12. By reference to Figure 13, the corresponding design channel depth would be 350 mm (incorporating a splash allowance of 200 mm and an effective depth of the channel section corresponding to a half-round channel, instead of an U-channel pursuant to Section A-A in Figure 13). If the effective depth of the channel section were instead taken to correspond to an U-channel in Figure 13, then the design channel depth would become 500 mm. On the other hand, if a consistent assumption were to be made that the two corresponding design charts are to be used for half-round channels, then with the above example, the required channel size would become 450 mm, with a design channel depth of 575 mm (incorporating, in this case, a splash allowance of 350 mm). Thus, making consistent assumptions in the use of the design methodology in GCO (1984) would result in a larger-sized stepped channel as compared with that based on the current recommended methodology.

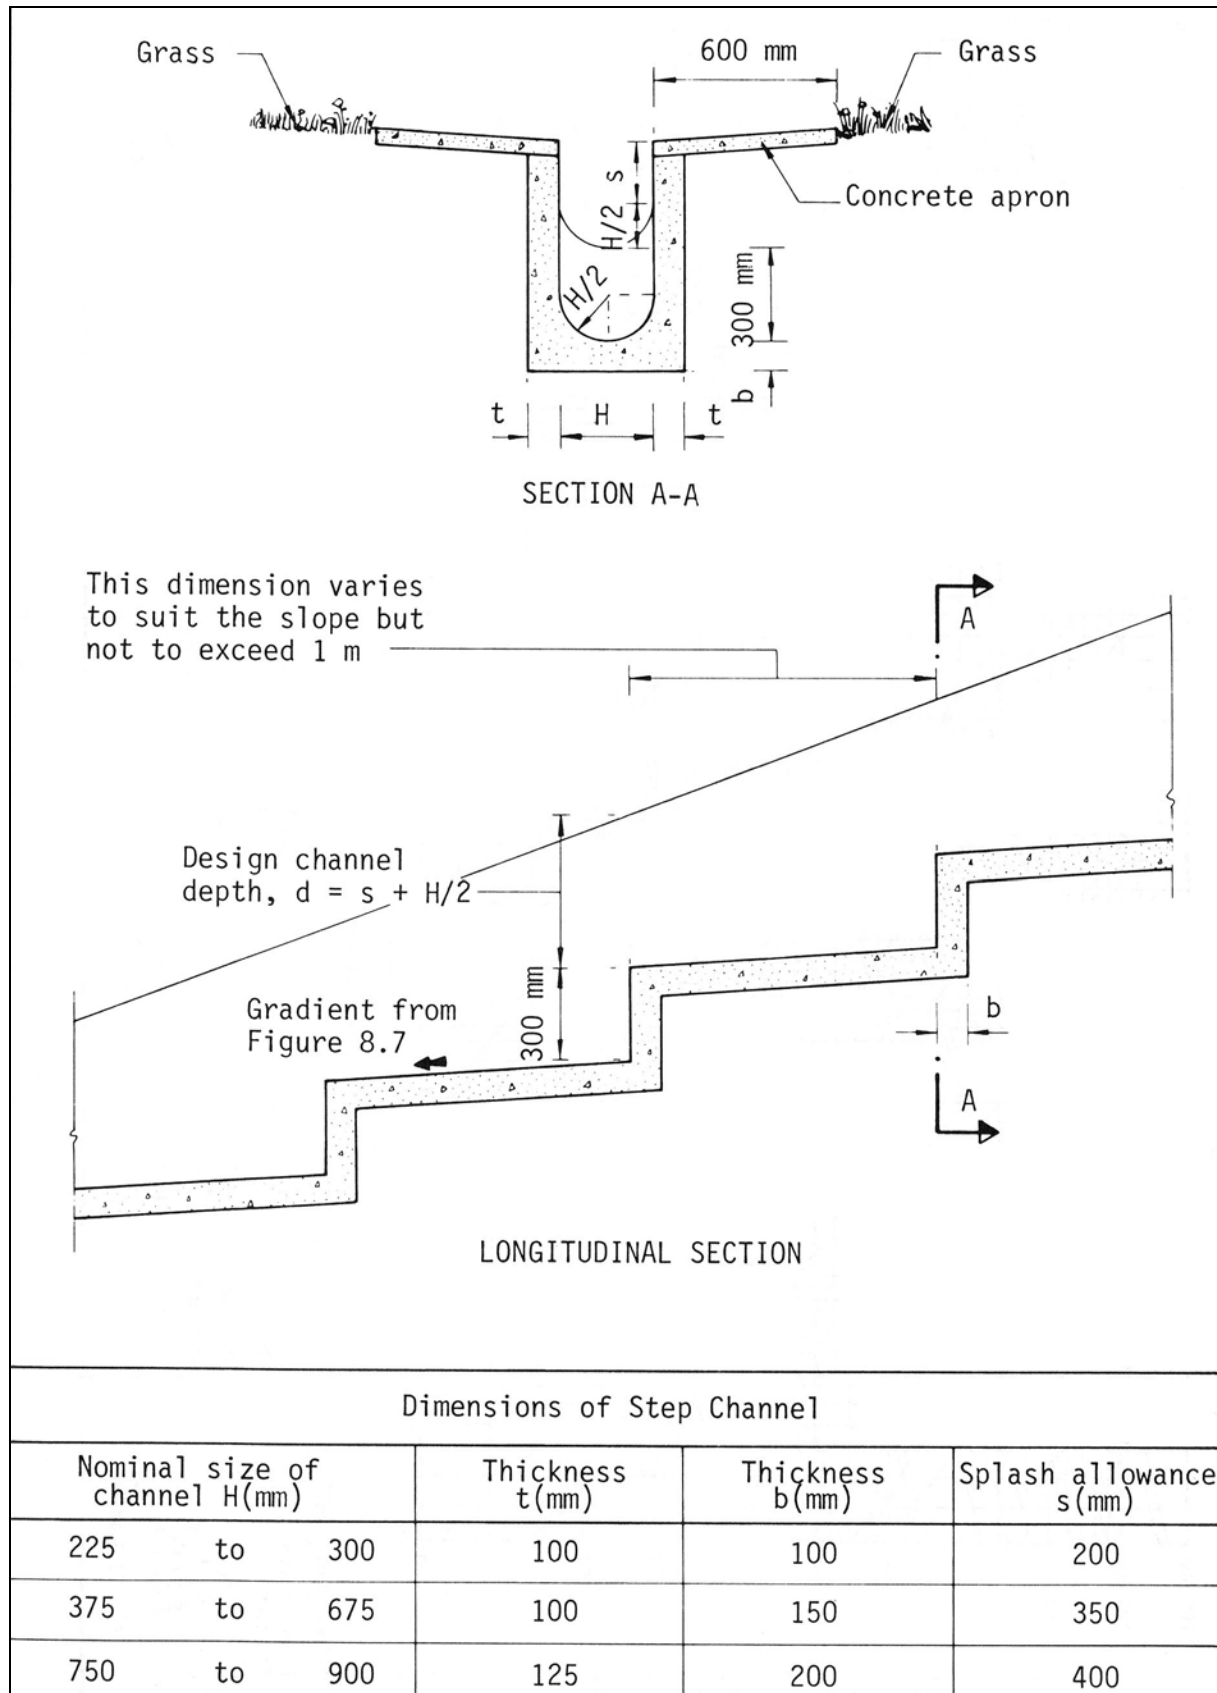
Figure 13 - Typical Details of Stepped Channel (Reproduced from Figure 8.8 of GCO (1984))

Reference to the two corresponding figures in the First Edition of the Geotechnical Manual for Slopes (GCO, 1979) indicates a discrepancy at that time between the cross section (which suggests a design channel depth of $(H/2 + s)$ as per a half-round channel, where H is the nominal size of the channel and s is the splash allowance), and the longitudinal section (which suggests a design channel depth of $(H + s)$, as per an U-channel). This discrepancy was removed in GCO (1984), which suggested a design channel depth corresponding to $(H/2 + s)$ for a half-round channel, instead of $(H + s)$ as per an U-channel. Given the way the previous minor discrepancy was rectified, the outcome is a smaller design channel depth and a consequential inconsistency between Figures 8.7 and 8.8 in GCO (1984), which assume an U-channel and a half-round channel respectively.

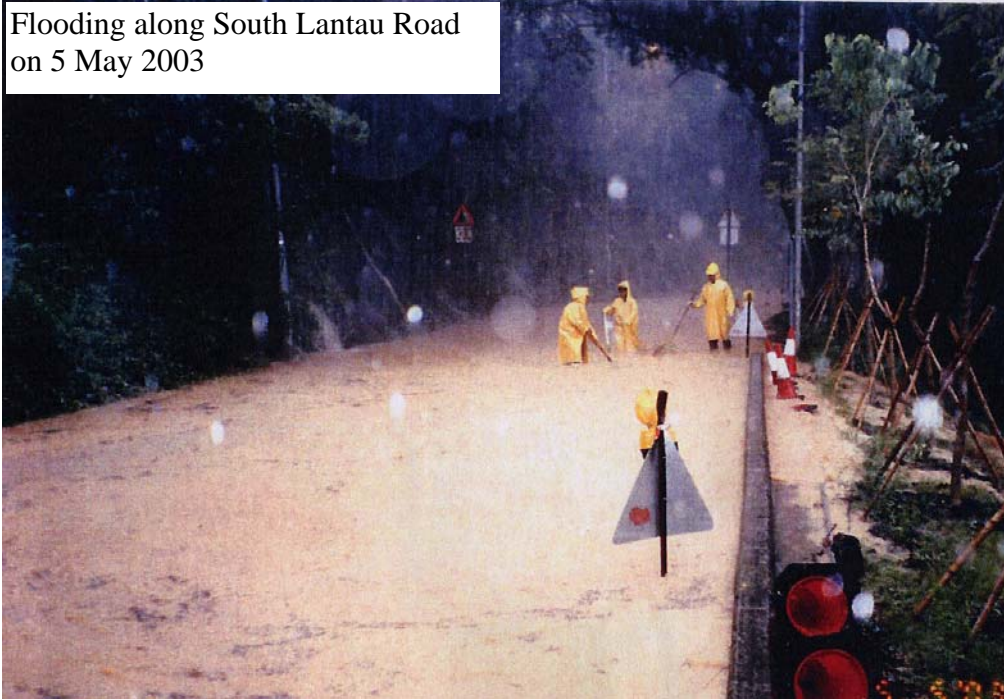
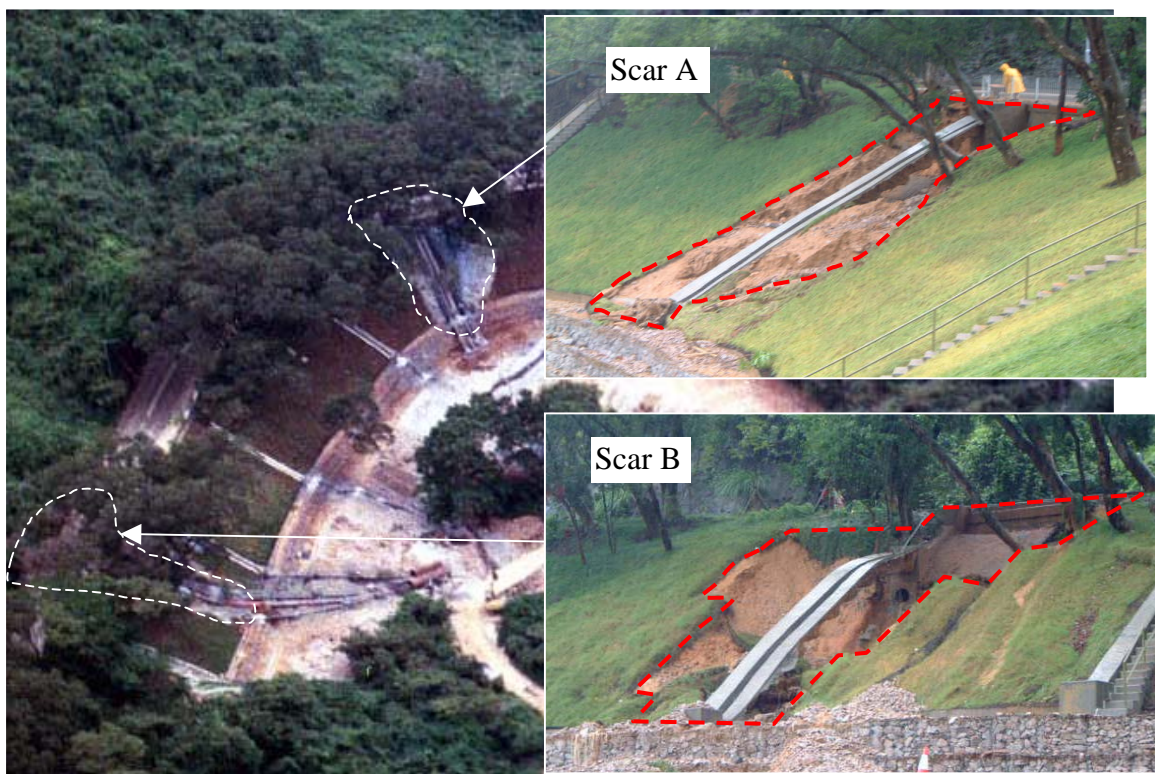
Plate 1 - The 5 May 2003 Washout Failures on a Fill Slope below South Lantau Road

Flooding along South Lantau Road
on 5 May 2003

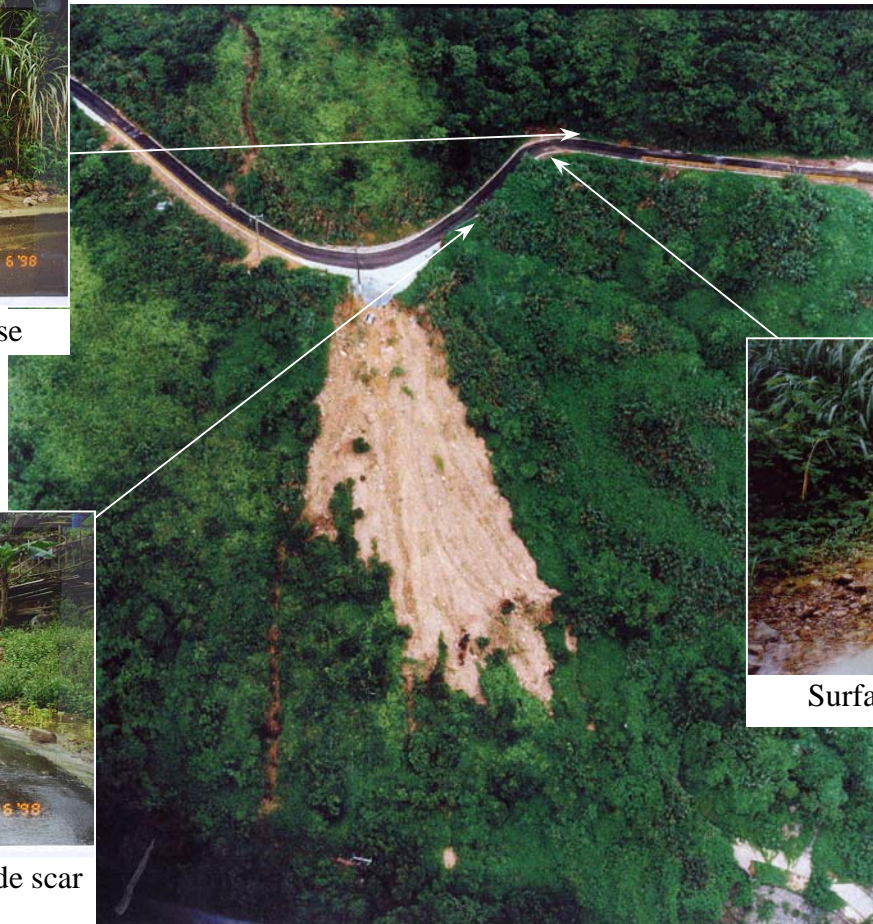
Overflow from streamcourse

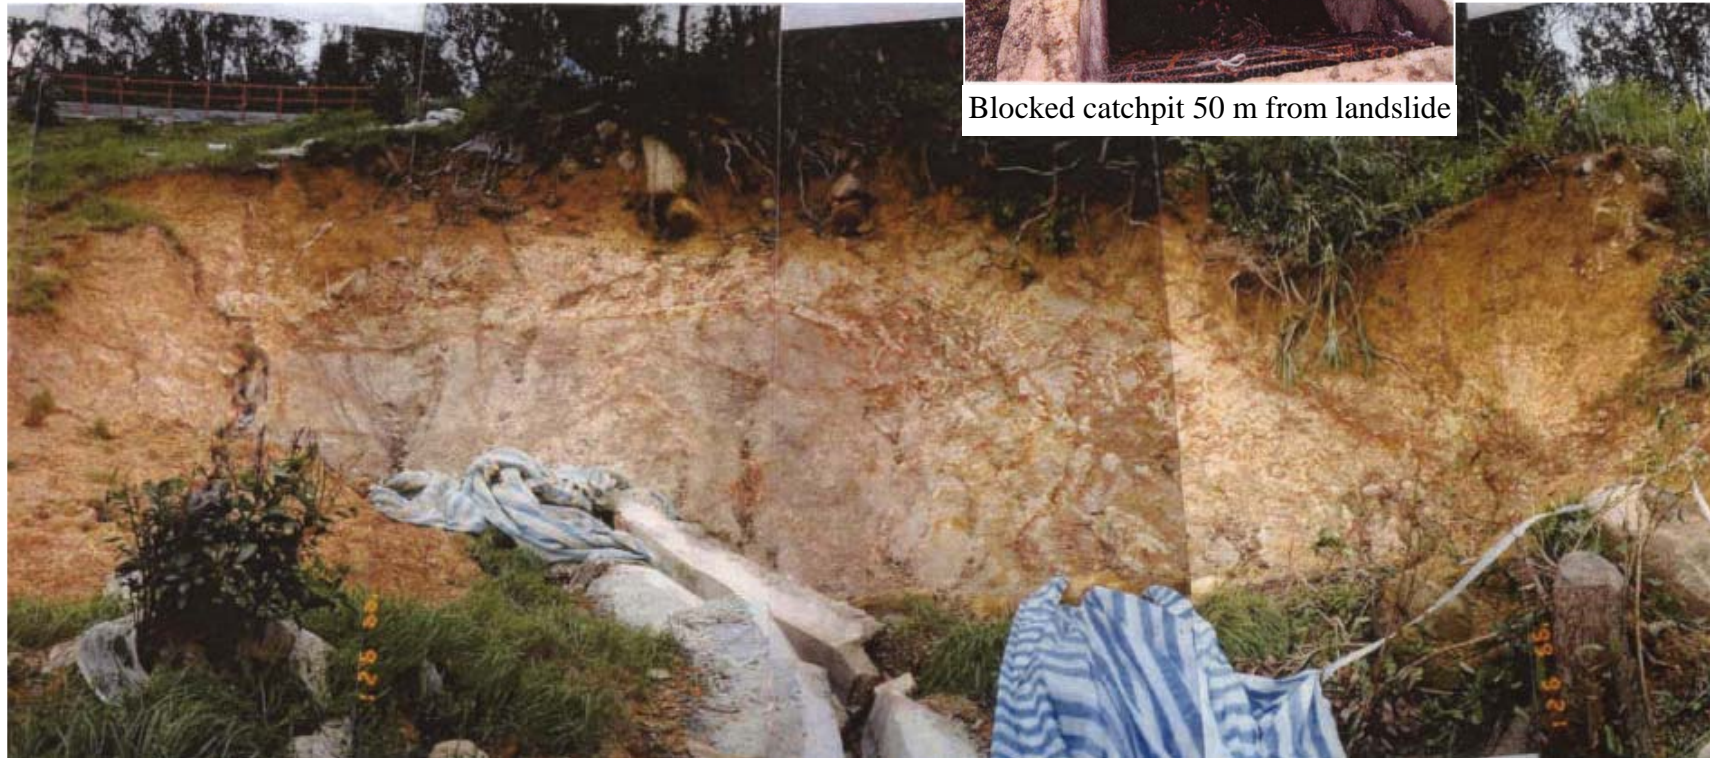
Plate 12 - The 23 August 1999 Landslide on a Cut Slope below Yin Hing Temple, Lantau

Blocked catchpit 50 m from landslide

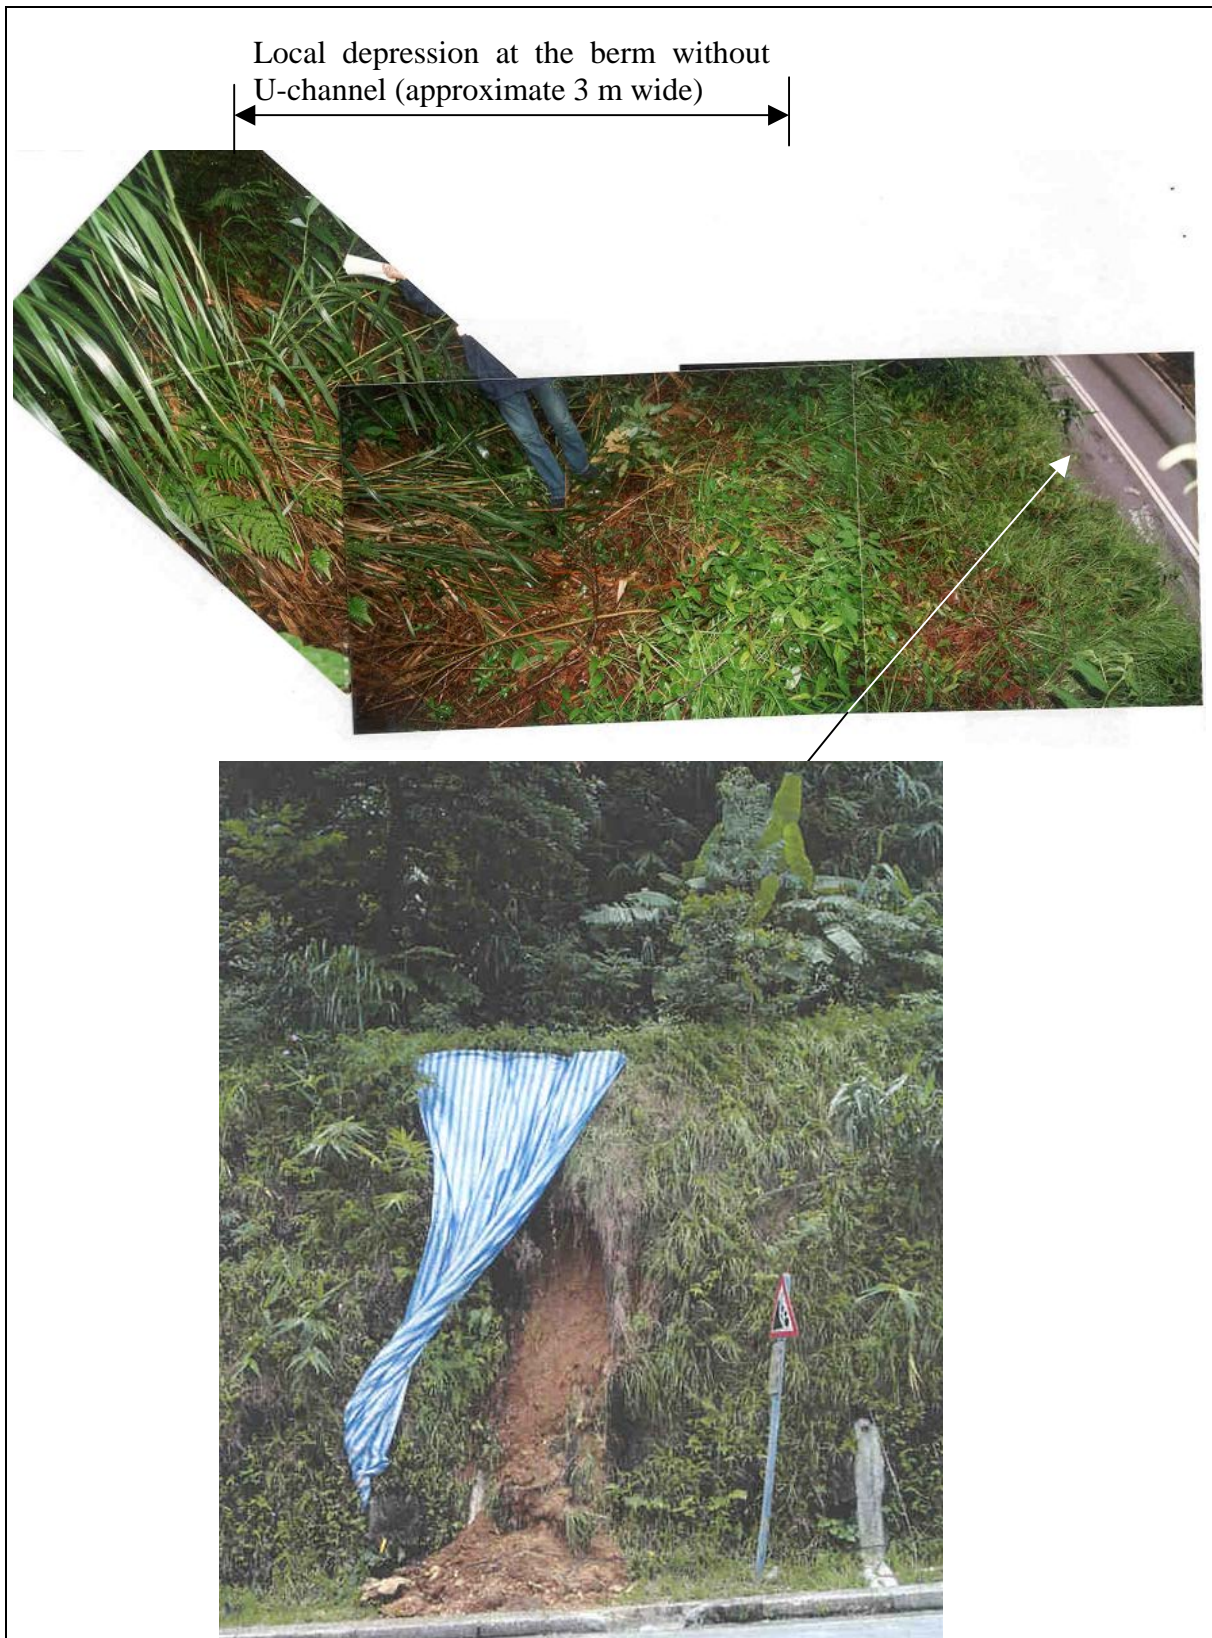
Plate 13 - The June 2001 Landslide on a Cut Slope at Route Twisk

This incident involved a minor landslide (about 3 m³) that occurred on a newly upgraded soil cut slope. As part of the slope upgrading works, the pre-existing hard surface cover was replaced with a vegetated cover (see Figure 9 and Plate 13). No surface drainage channel was provided on a 3 m wide vegetated berm above the location of the landslide to intercept potential surface runoff from the upper slope batter.

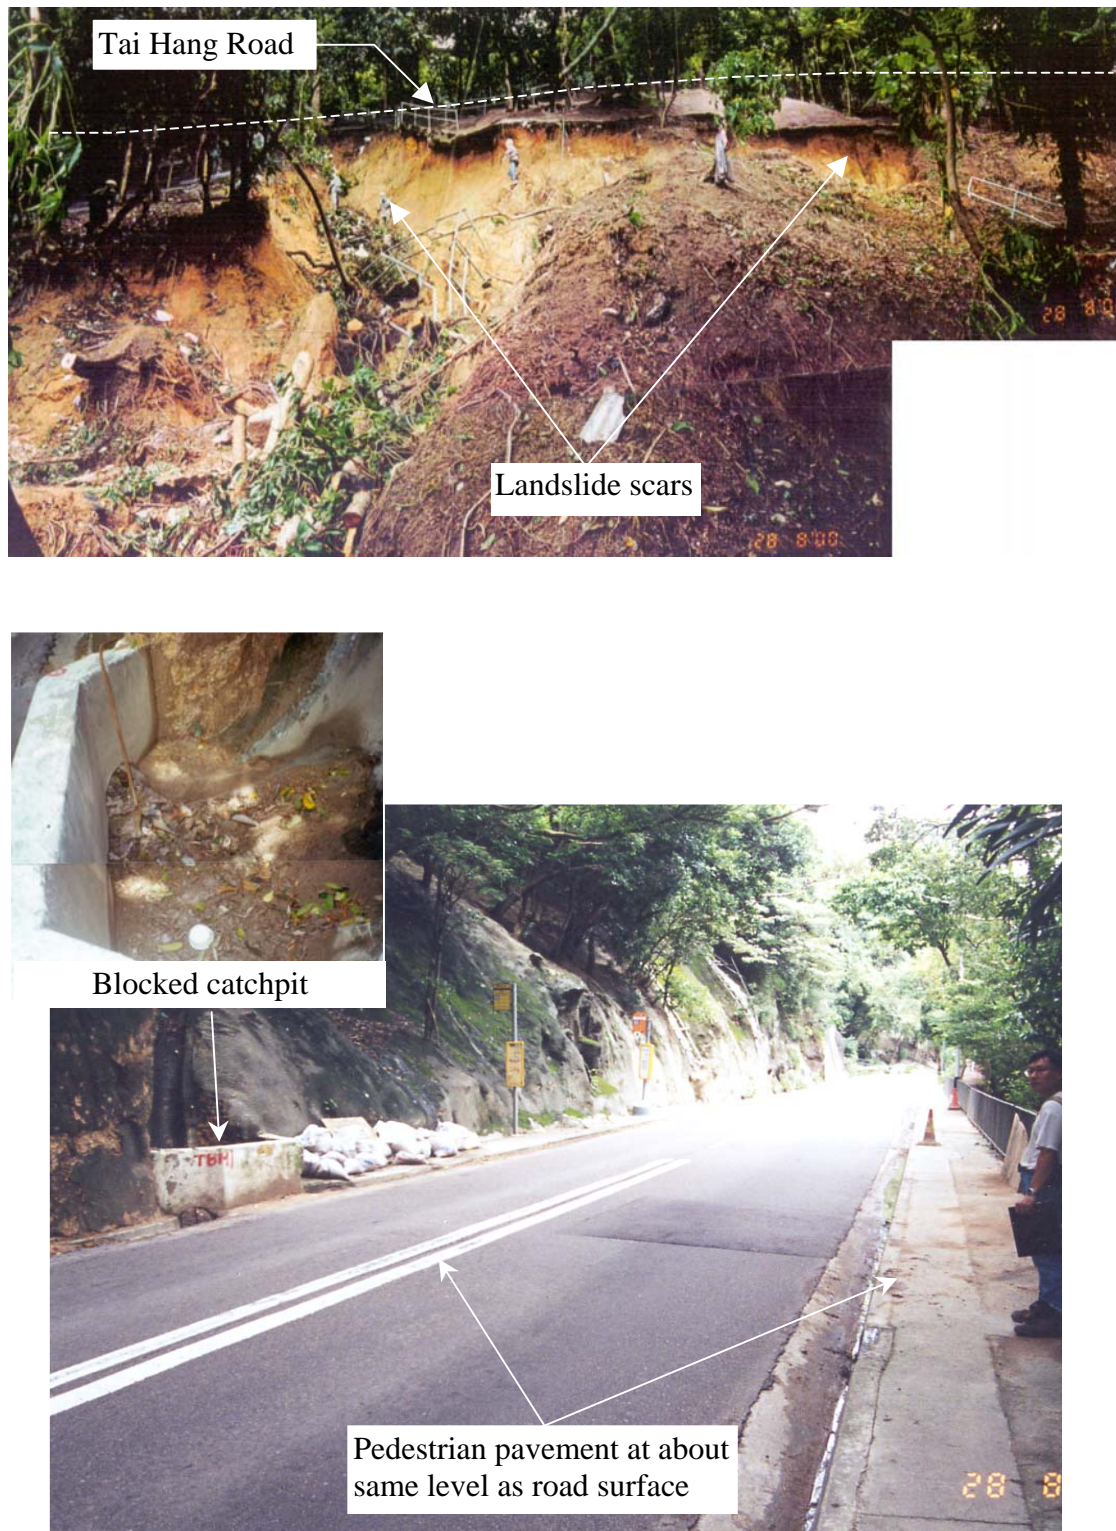
Plate 14 - The 24 August 2000 Landslide on a Disturbed Hillside below Tai Hang Road

This case involved a total of five landslides (failure volumes ranging from 10 m³ to 250 m³) that occurred on disturbed terrain (comprising a cleared squatter area) below Tai Hang Road. Most of the landslide debris was deposited on a natural drainage line and the outwash material was carried downslope to a carpark of a private residential building at the toe of the hillside (see Figure 10 and Plate 14).

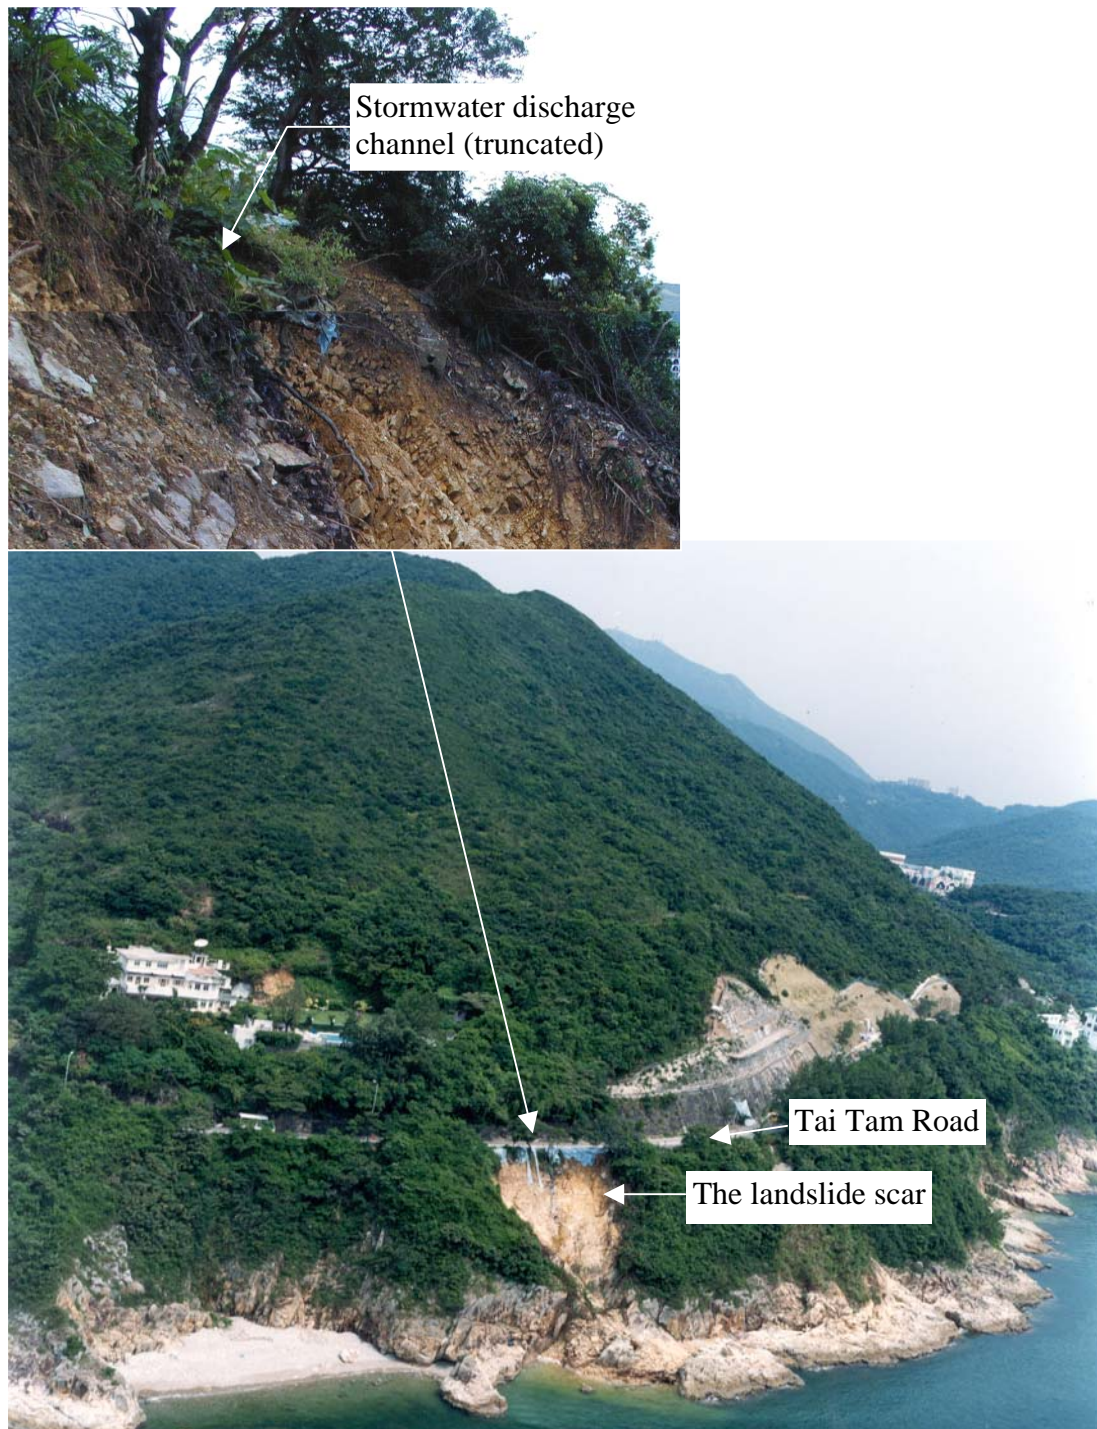
Plate 15 - The 24 August 2000 Landslide on a Natural Hillside below Tai Tam Road

This case involved a major landslide (about 700 m³) that occurred on a hillside below Tai Tam Road (see Figure 11 and Plate 15). No casualty or significant damage to property was caused in the incident.
