**DETAILED STUDY OF THE  
20 AUGUST 2005 LANDSLIDE  
ON SLOPE NO. 11SW-D/C543  
ABOVE MIDDLE GAP ROAD  
WANCHAI GAP**

**GEO REPORT No. 211**

**FUGRO SCOTT WILSON JOINT VENTURE**

**This report was originally produced in November 2006  
as GEO Landslide Study Report No. LSR 8/2006**

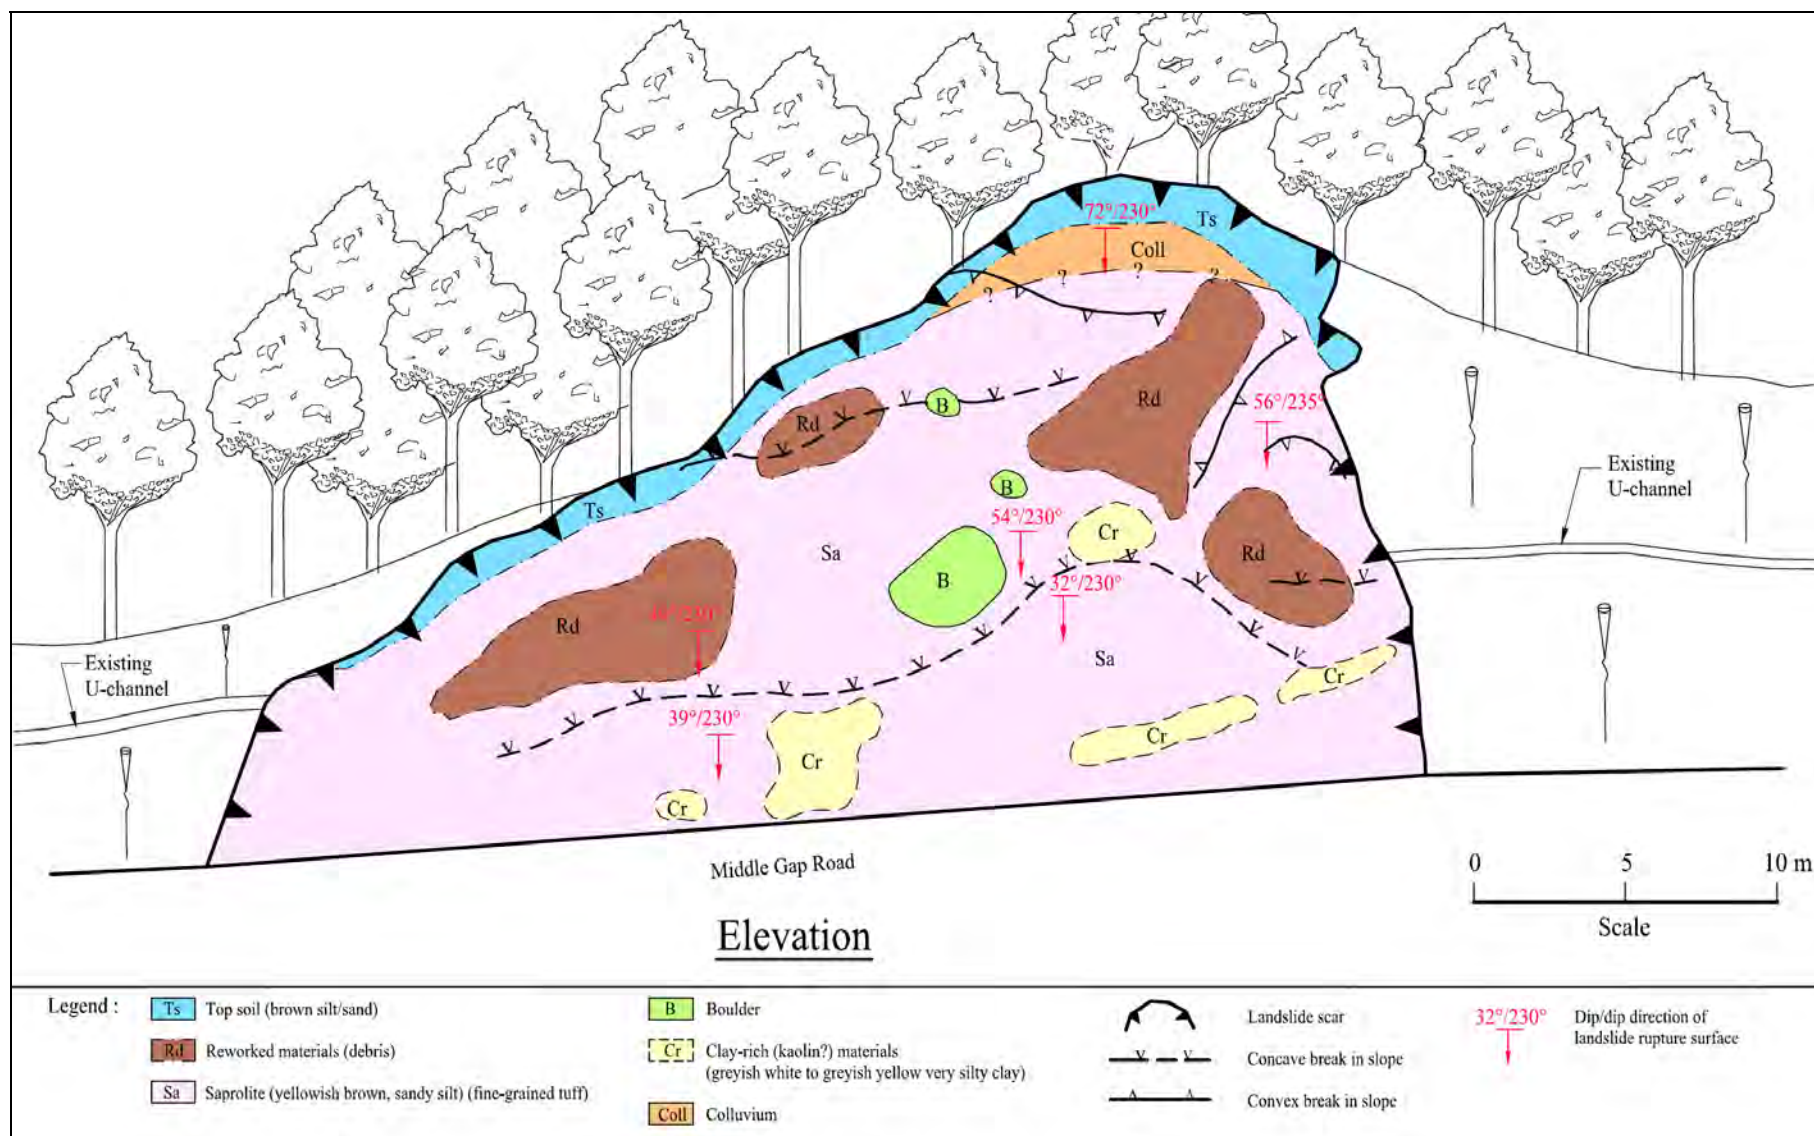
Figure 8 - Mapping of the Landslide Scar

The following pertinent observations were recorded from the field mapping, as presented in Figure 8:

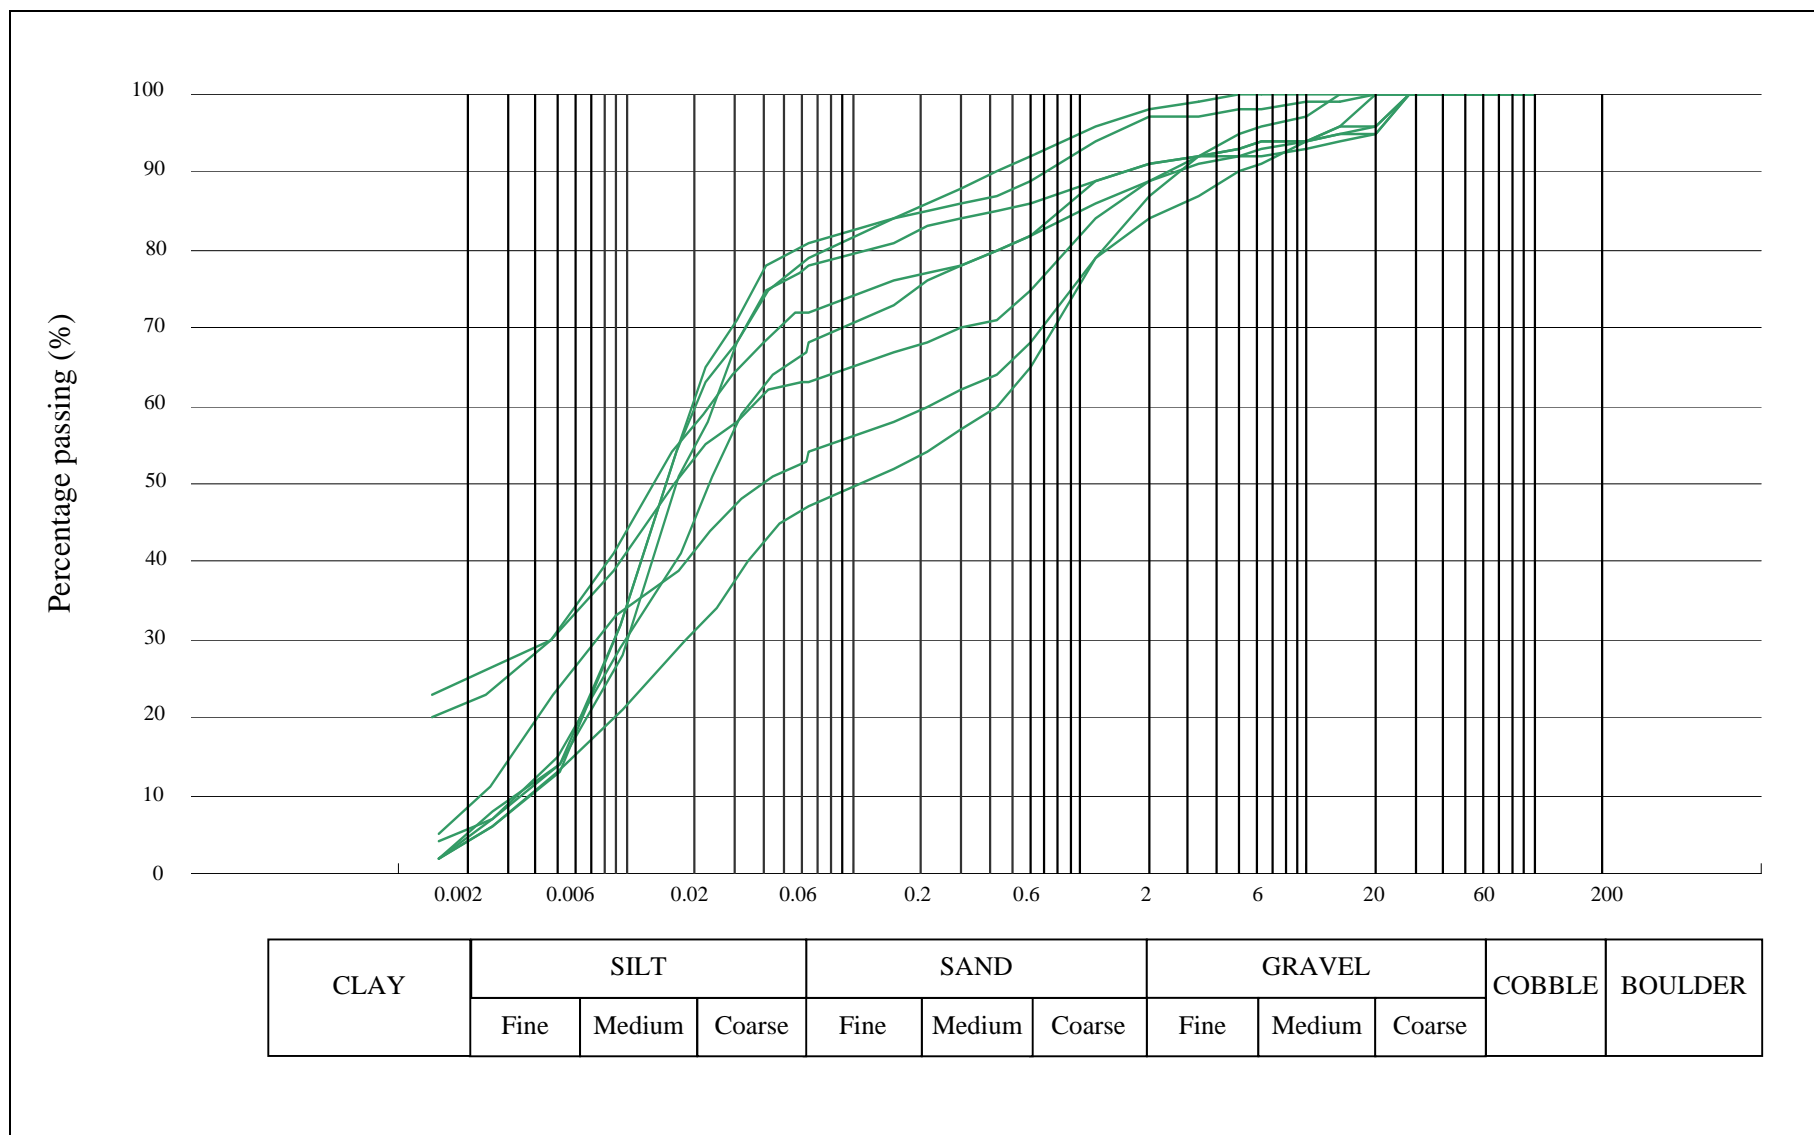
Figure 13 - Particle Size Distribution of Colluvium

The particle size distribution of the colluvium indicates that this material comprises a clayey, sandy SILT with some gravel to a gravelly SAND/SILT (Figure 13). This material generally falls within the intermediate plasticity range in the plasticity chart with a Plasticity Index of 16% to 18% and a Liquid Limit of 38% to 40% (Figure 14).

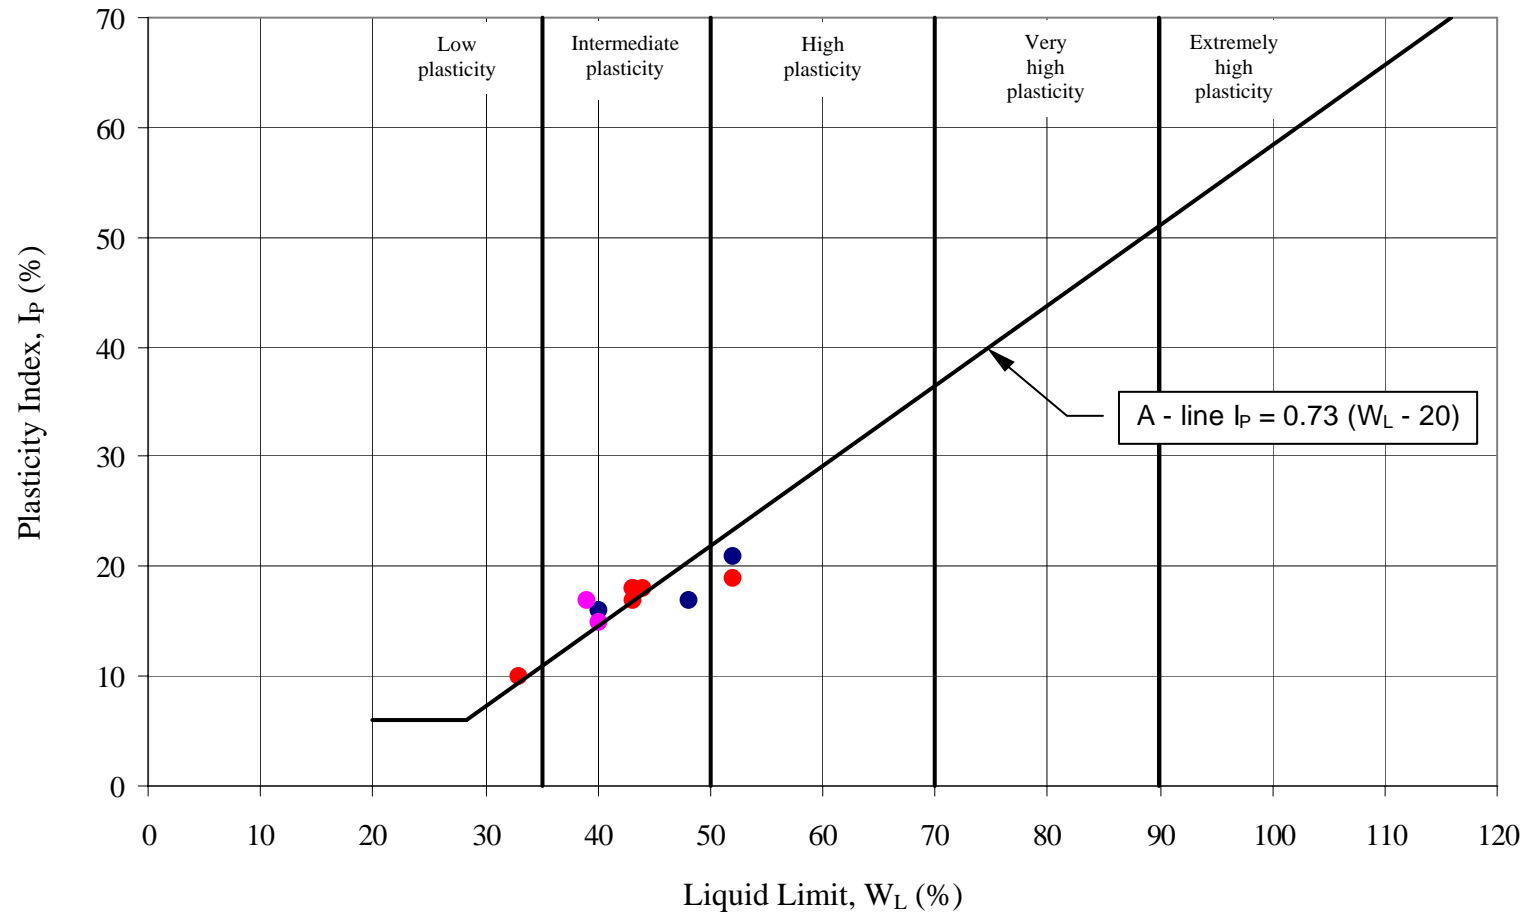
Figure 14 - Plasticity Chart for Colluvium, Completely Decomposed Tuff and Kaolinised Tuff

The particle size distribution of the completely decomposed tuff samples recovered in the zone above the landslide scar indicates that this material comprises a clayey, sandy SILT with some gravel to a silty, sandy GRAVEL (Figure 15). This material generally falls within the plasticity range from low to high in the plasticity chart with a Plasticity Index of 10% to 19% and a Liquid Limit of 33% to 52% (Figure 14). Samples recovered from the kaolinised material in the lower portion of the landslide scar comprise a sandy SILT with some gravel (Figure 16), with fines falling into the intermediate to high plasticity range in the plasticity chart with a Plasticity Index of 16% to 21% and a Liquid Limit of 40% to 52% (Figure 14).

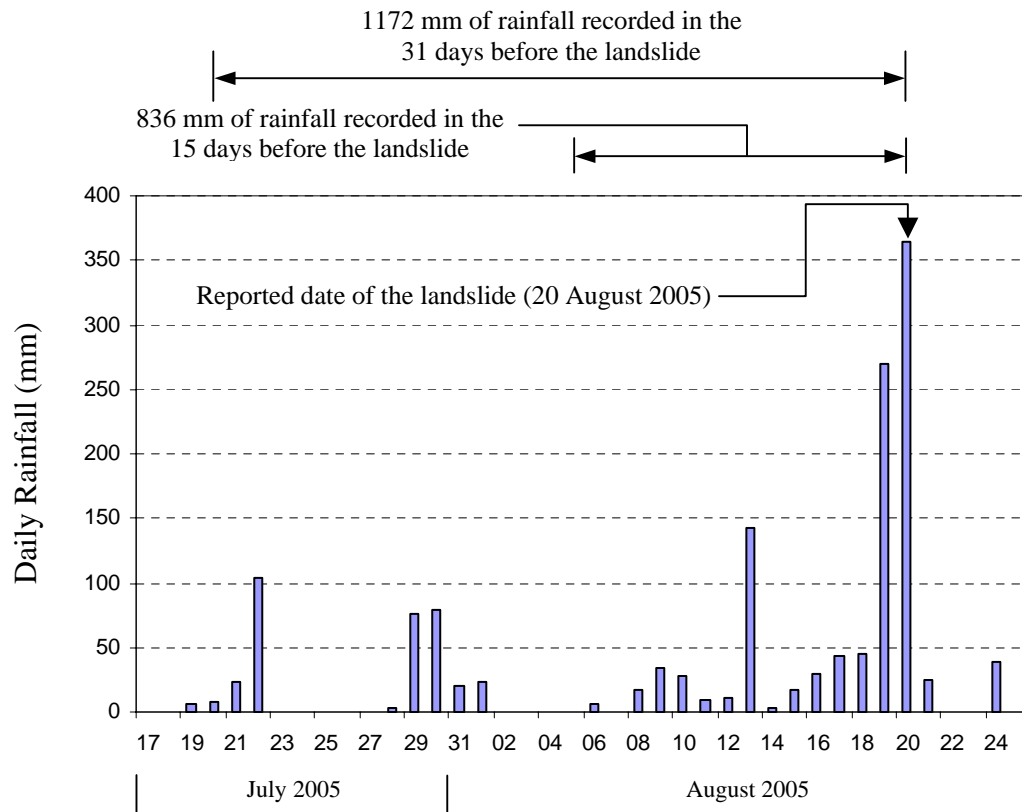
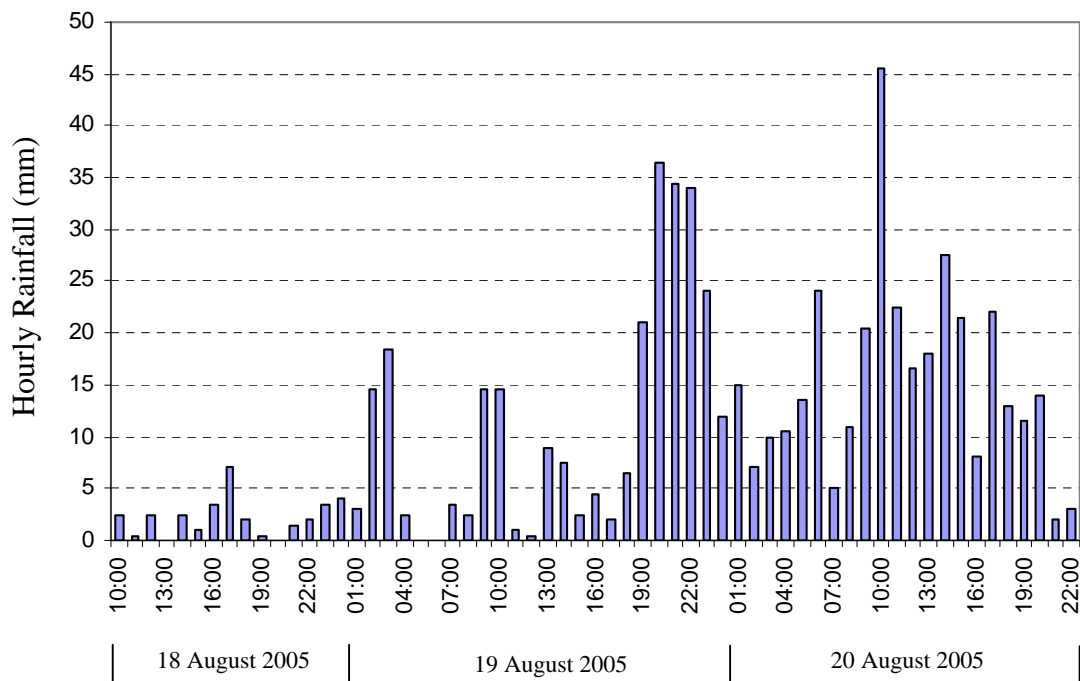
Figure 18 - Rainfall Recorded at GEO Raingauge No. H17

The daily rainfall recorded by raingauge No. H17 over the month preceding the landslide, together with the hourly rainfall readings for the period between 10:00 a.m. on 18 August 2005 and 10:00 p.m. on 20 August 2005, are presented in Figure 18. The 24-hour and 12-hour rainfall before the landslide was 375.5 mm and 242 mm respectively. The maximum 1-hour rolling rainfall was recorded as 46 mm between 9:05 a.m. and 10:05 a.m. on 20 August 2005.

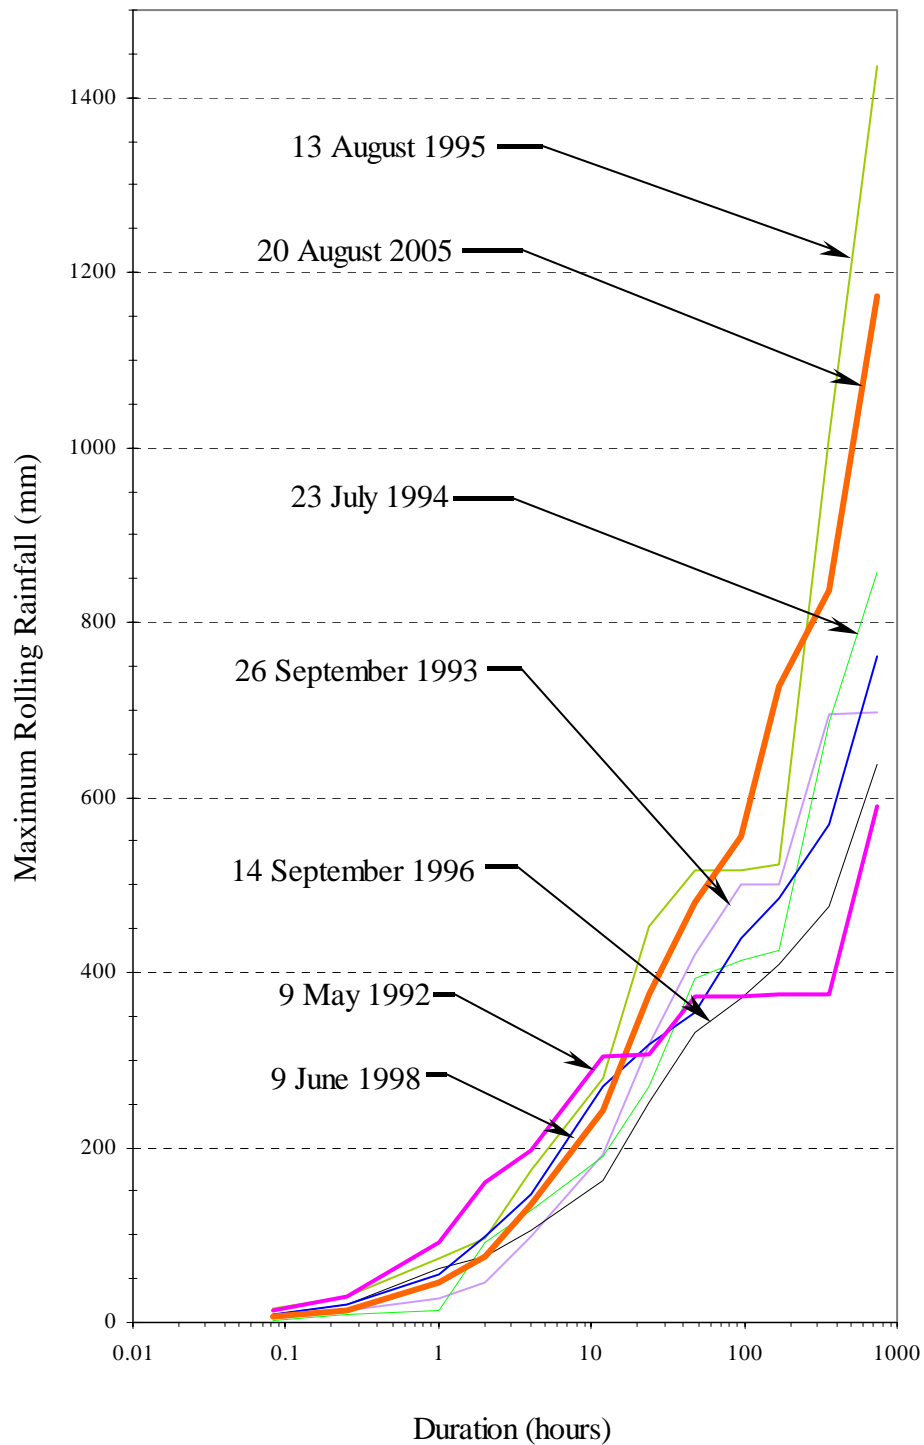
Figure 19 - Maximum Rolling Rainfall Preceding the Landslide and Selected Previous Major Rainstorms Recorded at GEO Raingauge No. H17

The maximum rolling rainfall for the rainstorm in August 2005 has been compared with the past major rainstorms between 1992 and 1998 recorded by raingauge No.H17, which came into operation in mid-1980s (Figure 19). This shows that the rainfall preceding the August 2005 landslide is the most severe for the 4-day and 7-day duration. While the maximum rolling rainfall for the rainstorm in August 2005 is comparable to the severe rainstorms recorded between 1992 and 1998 for durations longer than 7 days, it is not particularly severe for short duration rainfalls (< 2 days).

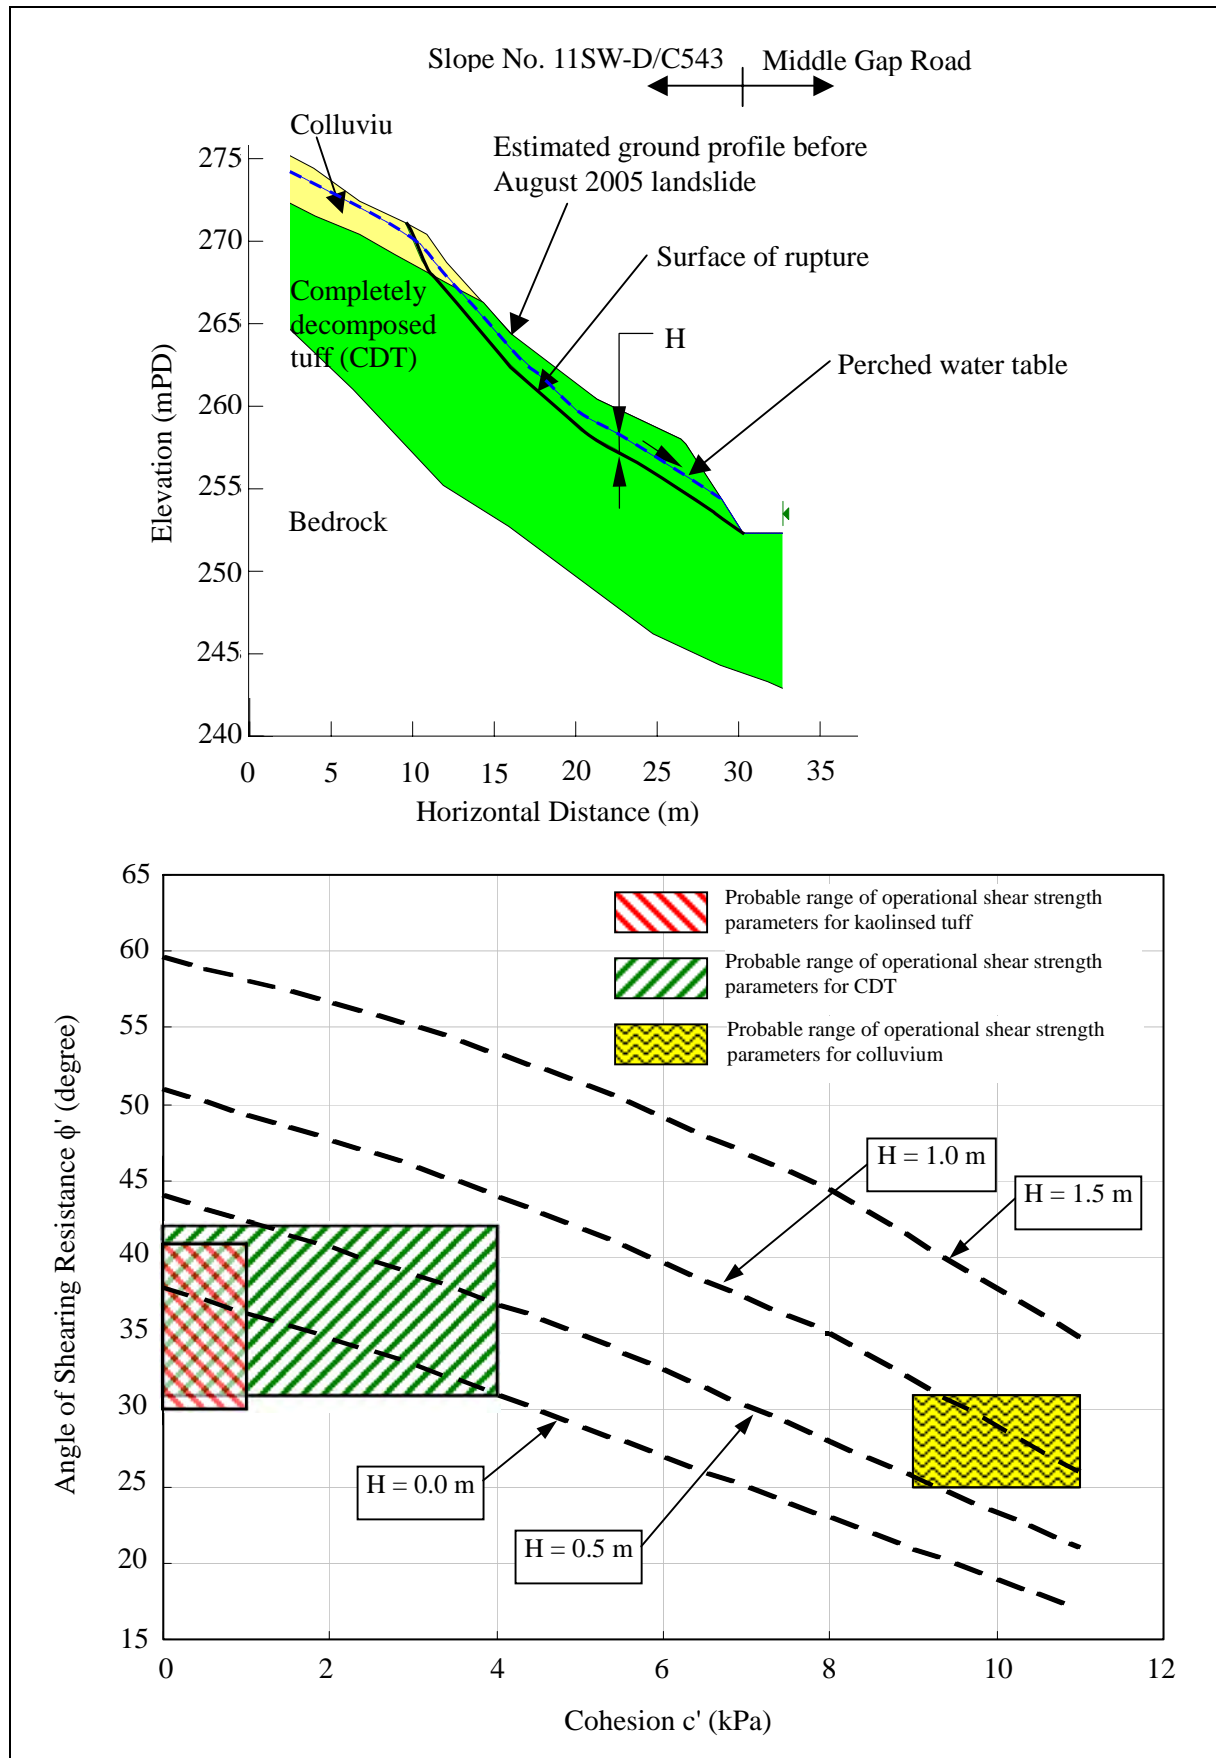
Figure 20 - Results of Theoretical Stability Analysis

The cross-section through the landslide included in the stability analyses was based on Section A-A presented in Figure 7. The pre-failure slope profile was based on topographic survey plans, photographic records and inference using engineering judgement. The geometry of the surface of rupture and the ground profile was based on site measurements by FSW, post-failure topographic survey by the Survey Division of CEDD and the site-specific ground investigation. The idealised inferred section adopted in the analyses is presented in Figure 20.

The results of the analyses are presented in Figure 20. For a factor of safety of unity, the analyses suggest that failure could have been brought about by the development of a transient ground water pressure corresponding to a water level of about 1 m above the surface of rupture.

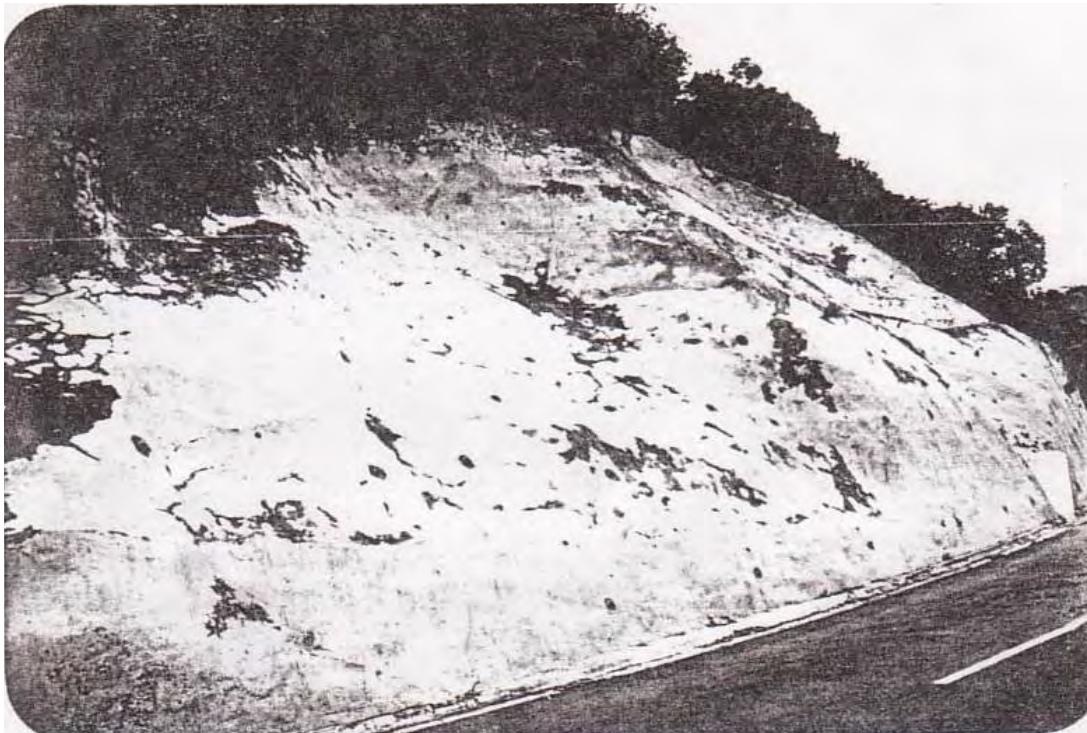
Plate 4 - Record Photograph of Slope No. 11SW-D/C543 Taken in April 1978  
Showing Slope Geometry Modified by Previous Instability  
(Photograph extracted from Binnie & Partners (HK) Phase I  
Re-appraisal of Cut & Natural Slopes & Retaining Walls)

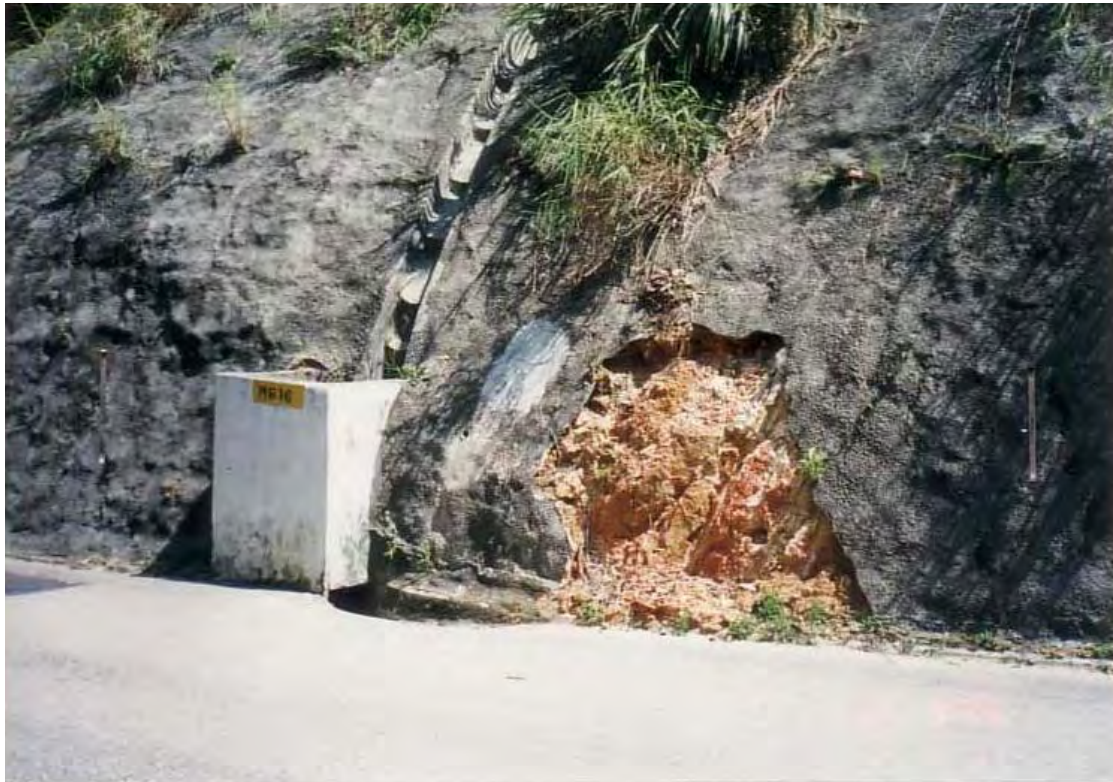
Plate 5 - Record Photograph of Slope No. 11SW-D/C543 Taken in August/September 1995 Showing Small Detachment from Central Portion of Slope (Photograph taken by Highways Department in August/September 1995)

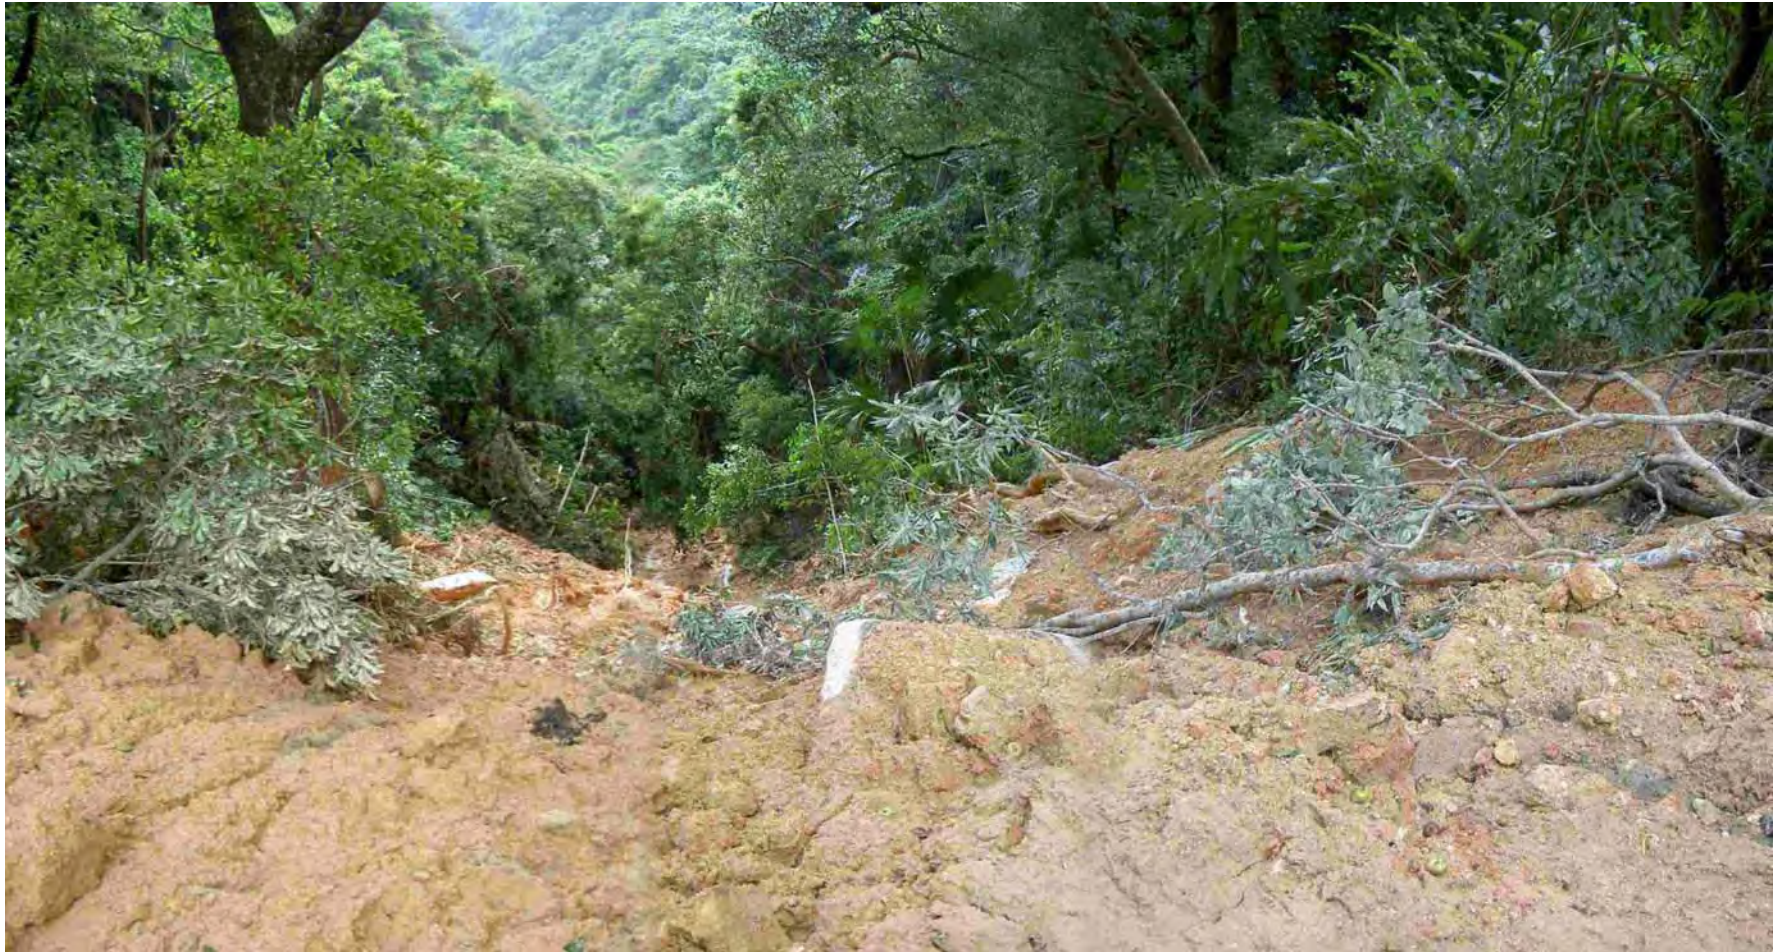
Plate 18 - View West Down Drainage Line below Mount Cameron Road Showing Extent of Debris Runout

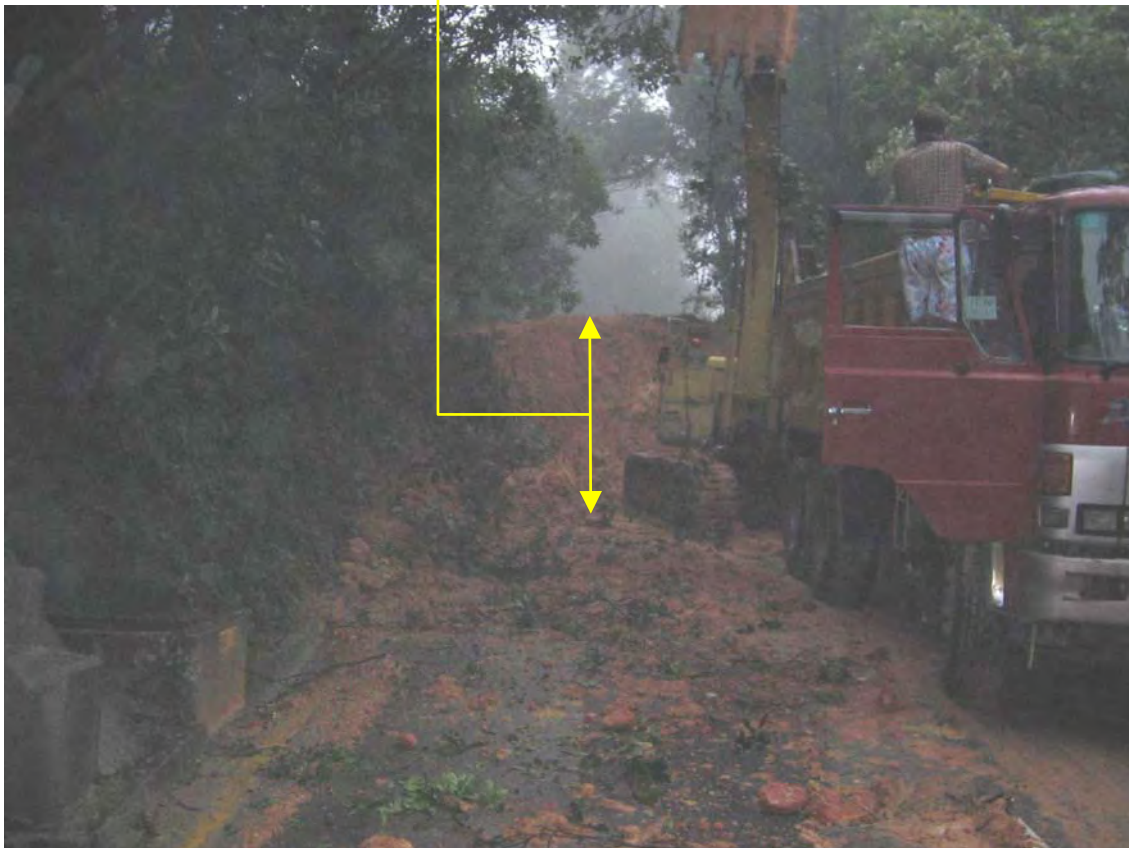
Plate 19 - Debris Mound on Middle Gap Road

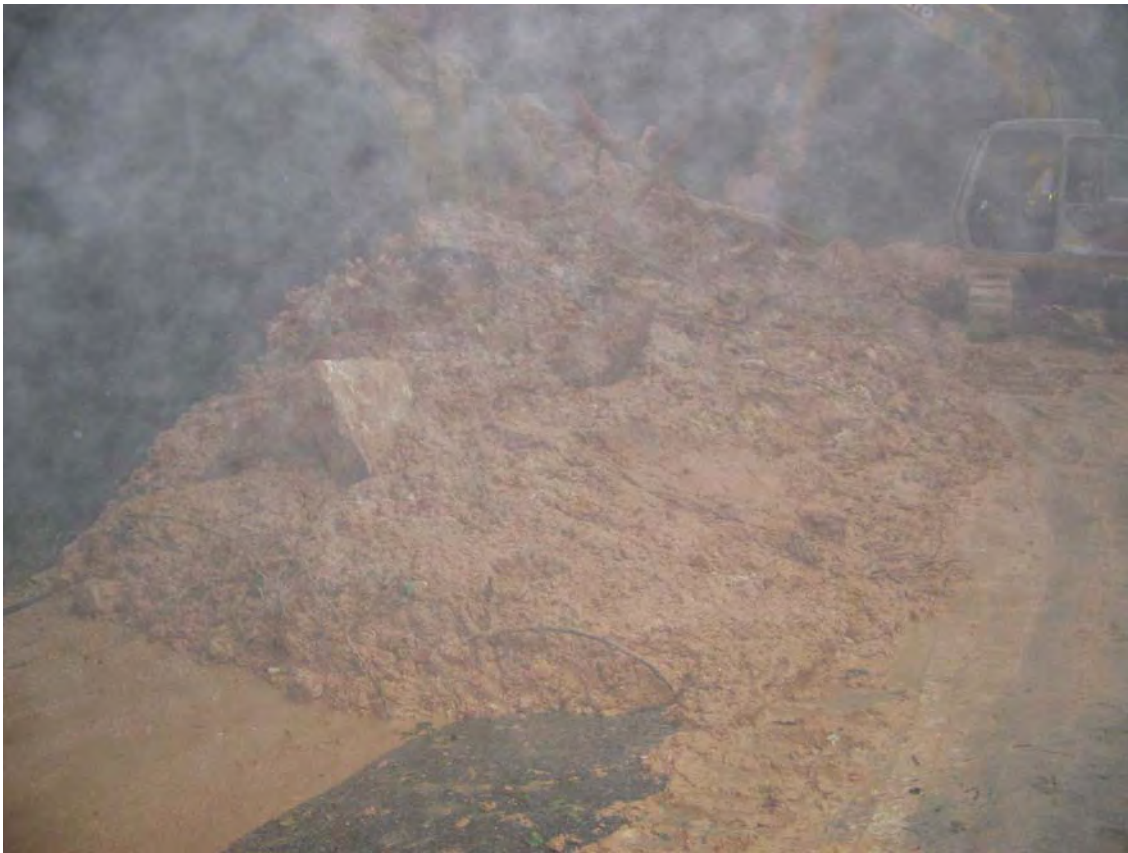
Plate 20 - Debris Mound on Mount Cameron Road

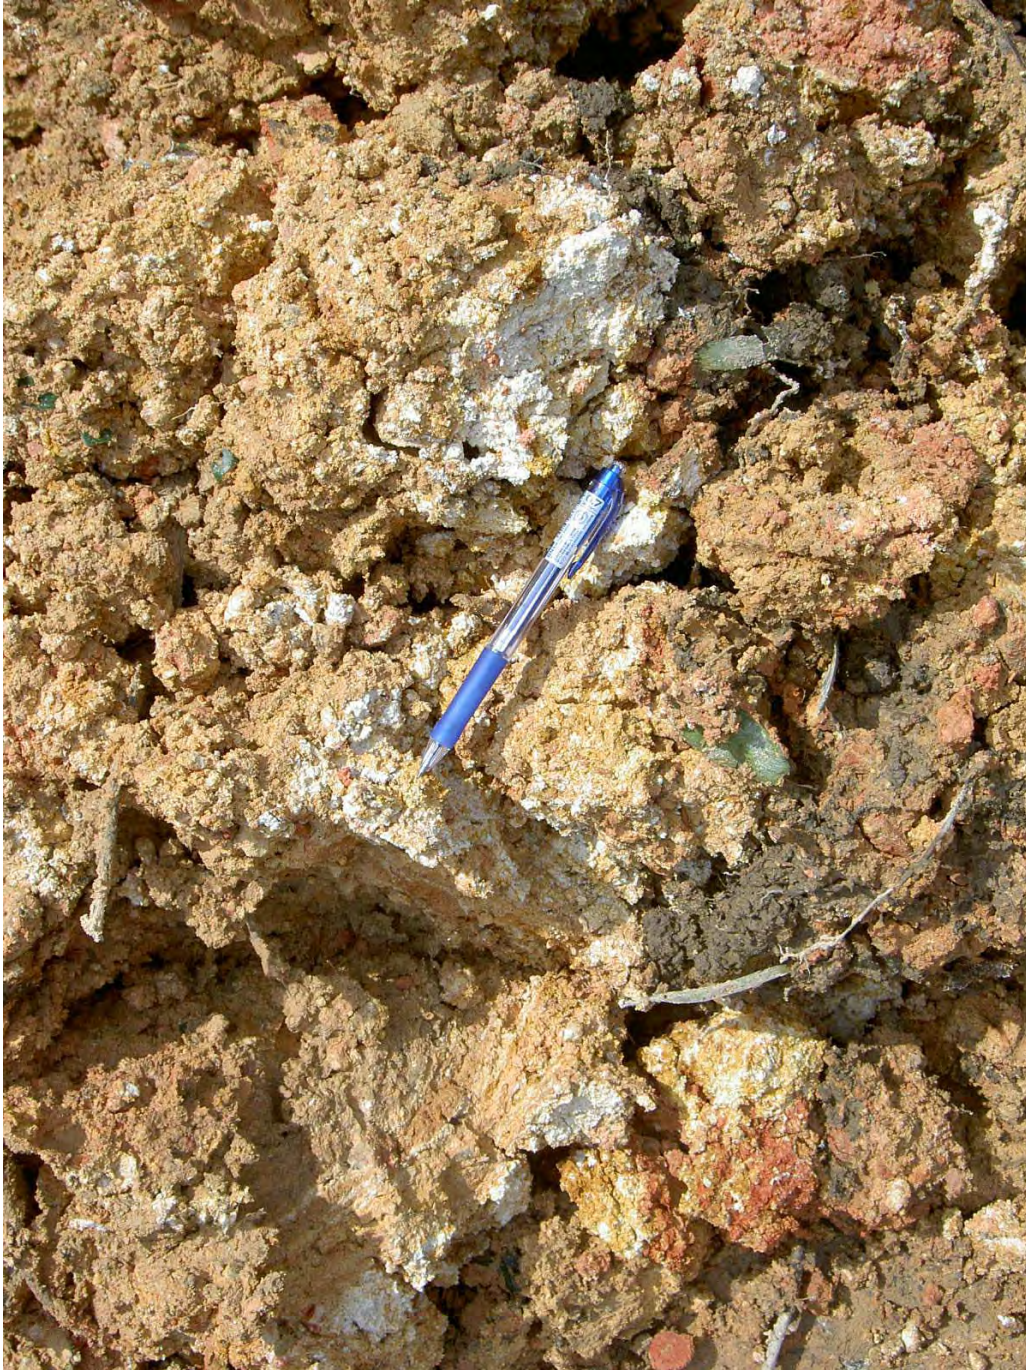
Plate 23 - Example of Kaolin-like Material Identified in Landslide Debris

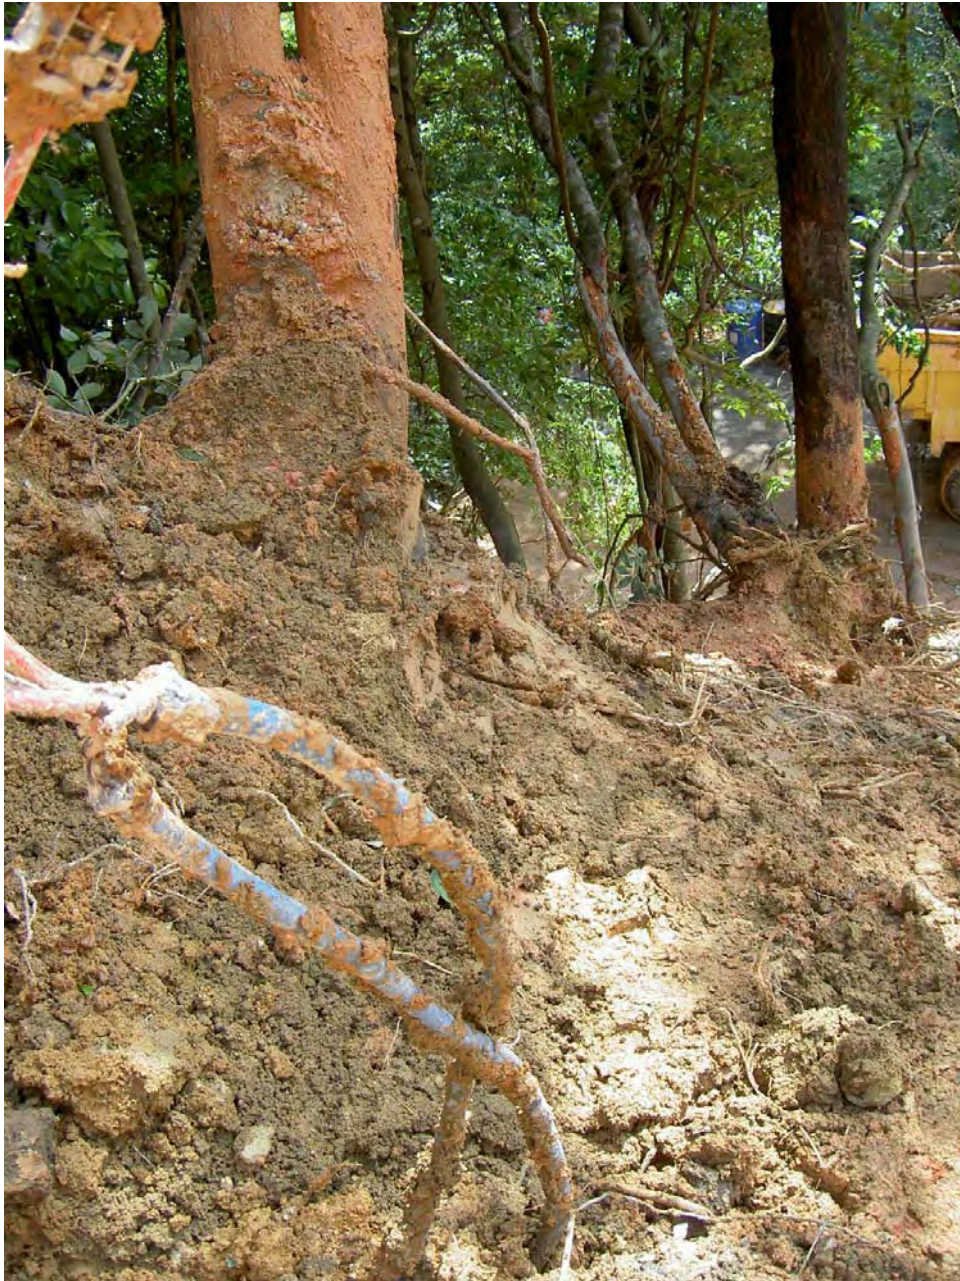
Plate 24 - View East from Mount Cameron Road Showing Scarring on Trees Providing Indication of Thickness of Debris Mass During the Landslide

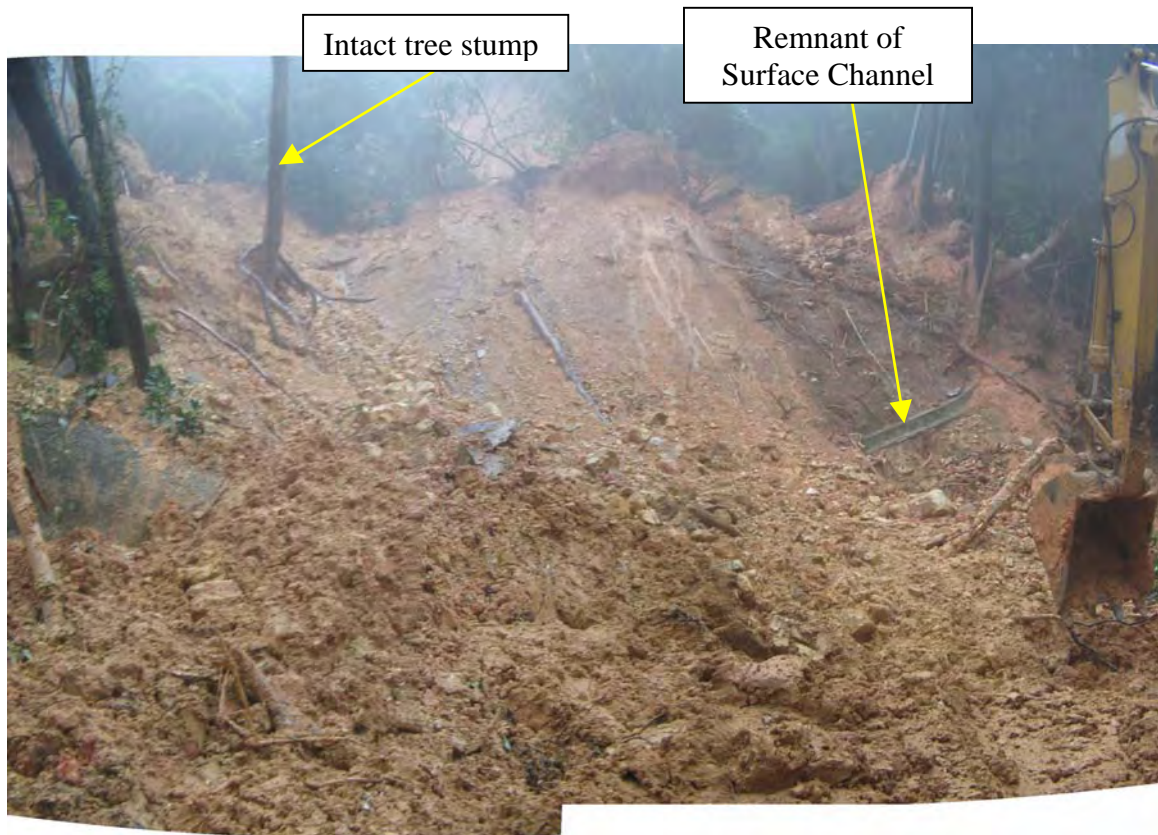
Plate 25 - View East from Mount Cameron Road Showing Sloping Ground in Debris Trail with Intact Tree Stumps and Remnants of Surface Channel

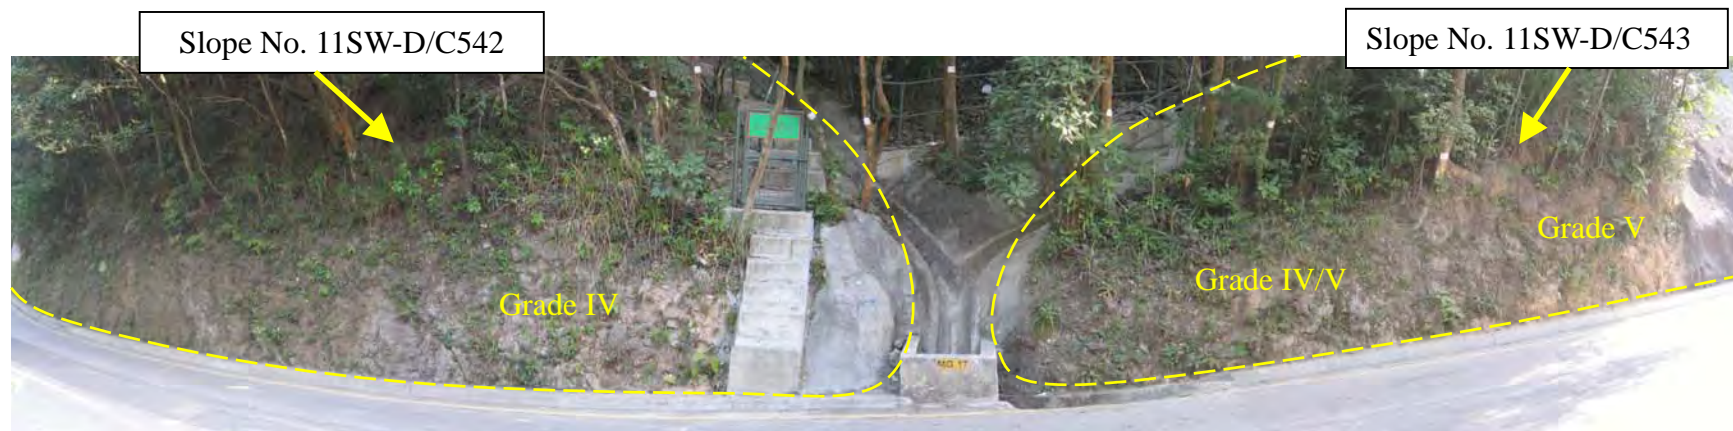
Plate 26 - View across Northern Extent of Slopes Nos. 11SW-D/C542 and 11SW-D/C543 Showing Weathering Gradient of Exposed Decomposed Volcanics

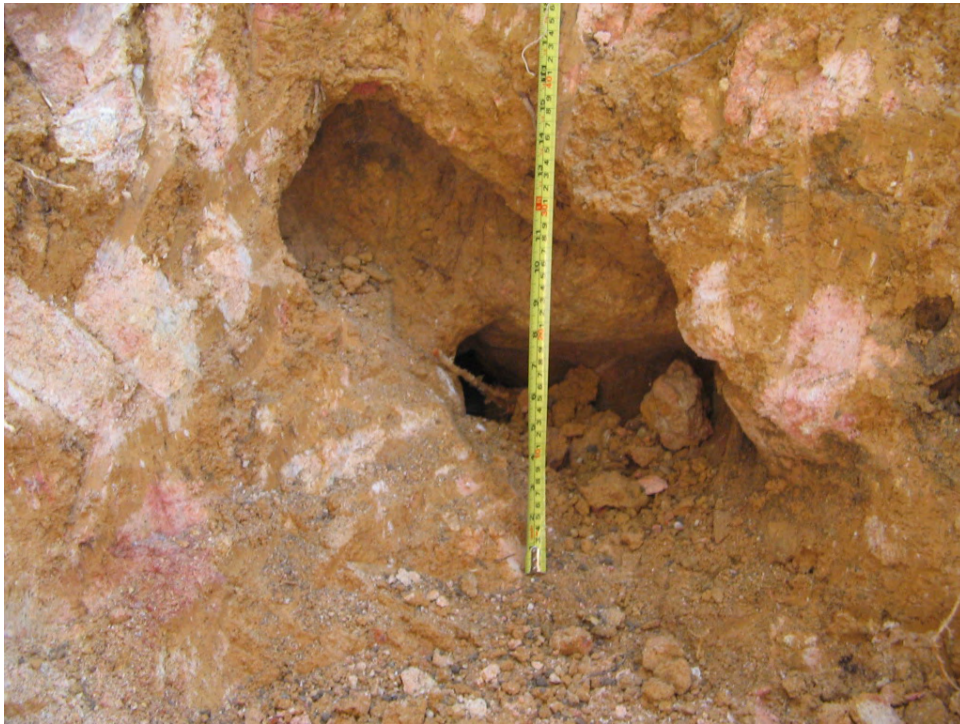
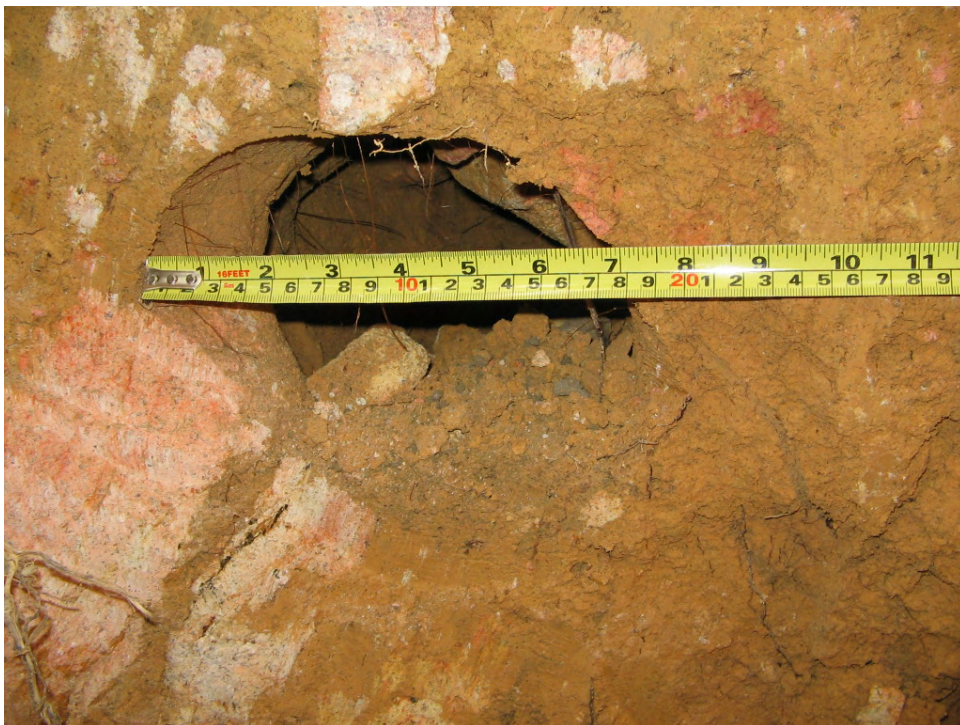
Plate 28 - Soil Pipes within Colluvium in Trial Pit TP1 (Photograph taken on 9 February 2006)
