**DETAILED STUDY OF THE  
20 AUGUST 2005 LANDSLIDE  
ON SLOPE NO. 11SW-D/C543  
ABOVE MIDDLE GAP ROAD  
WANCHAI GAP**

**GEO REPORT No. 211**

**FUGRO SCOTT WILSON JOINT VENTURE**

**This report was originally produced in November 2006  
as GEO Landslide Study Report No. LSR 8/2006**

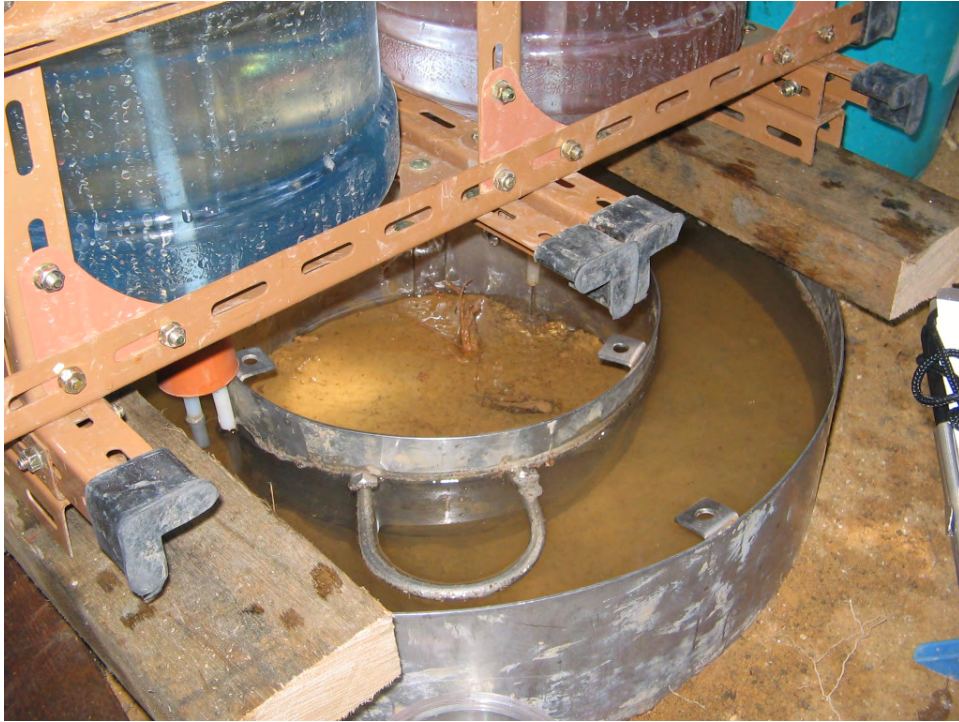
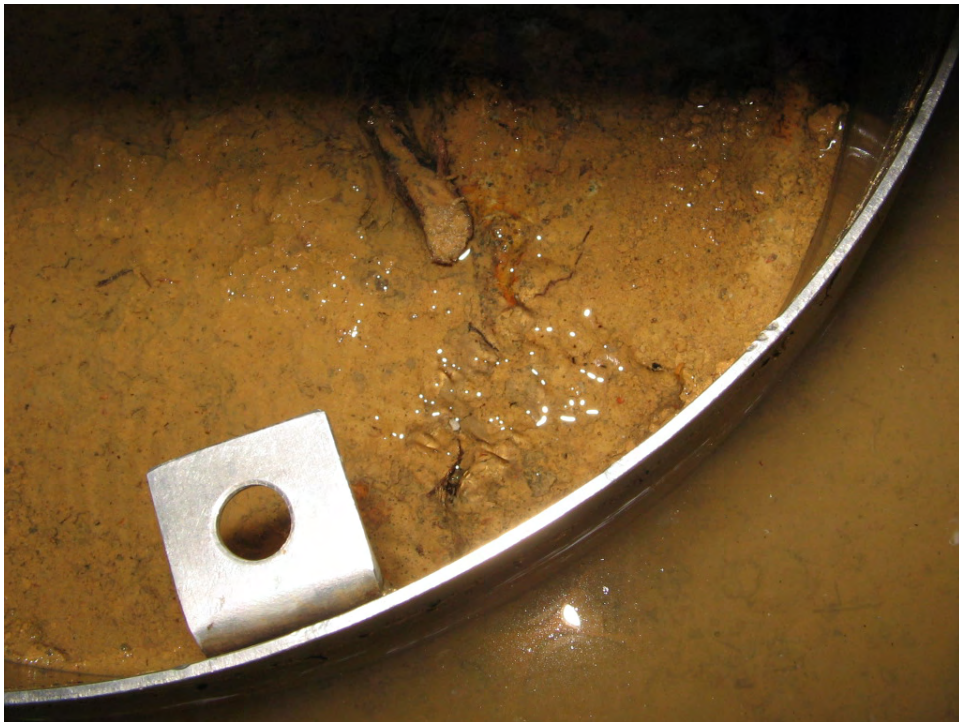
- (a) Soil pipes up to 150 mm diameter were encountered in trial pit TP1 (Figures 9 and 12 and Plate 28) at about 0.8 m depth within the colluvium.
- (b) Soil pipes were also identified in colluvium at 0.4 m depth in trial pit TP1 during double-ring infiltrometer test following sudden loss of water placed within the rings (Plate 29).

Plate 29 - Presence of Soil Pipe Caused Sudden Loss of Water Placed within Inner Ring During Double Ring Infiltrometer Testing in Trial Pit TP1 (Photograph taken on 7 February 2006)

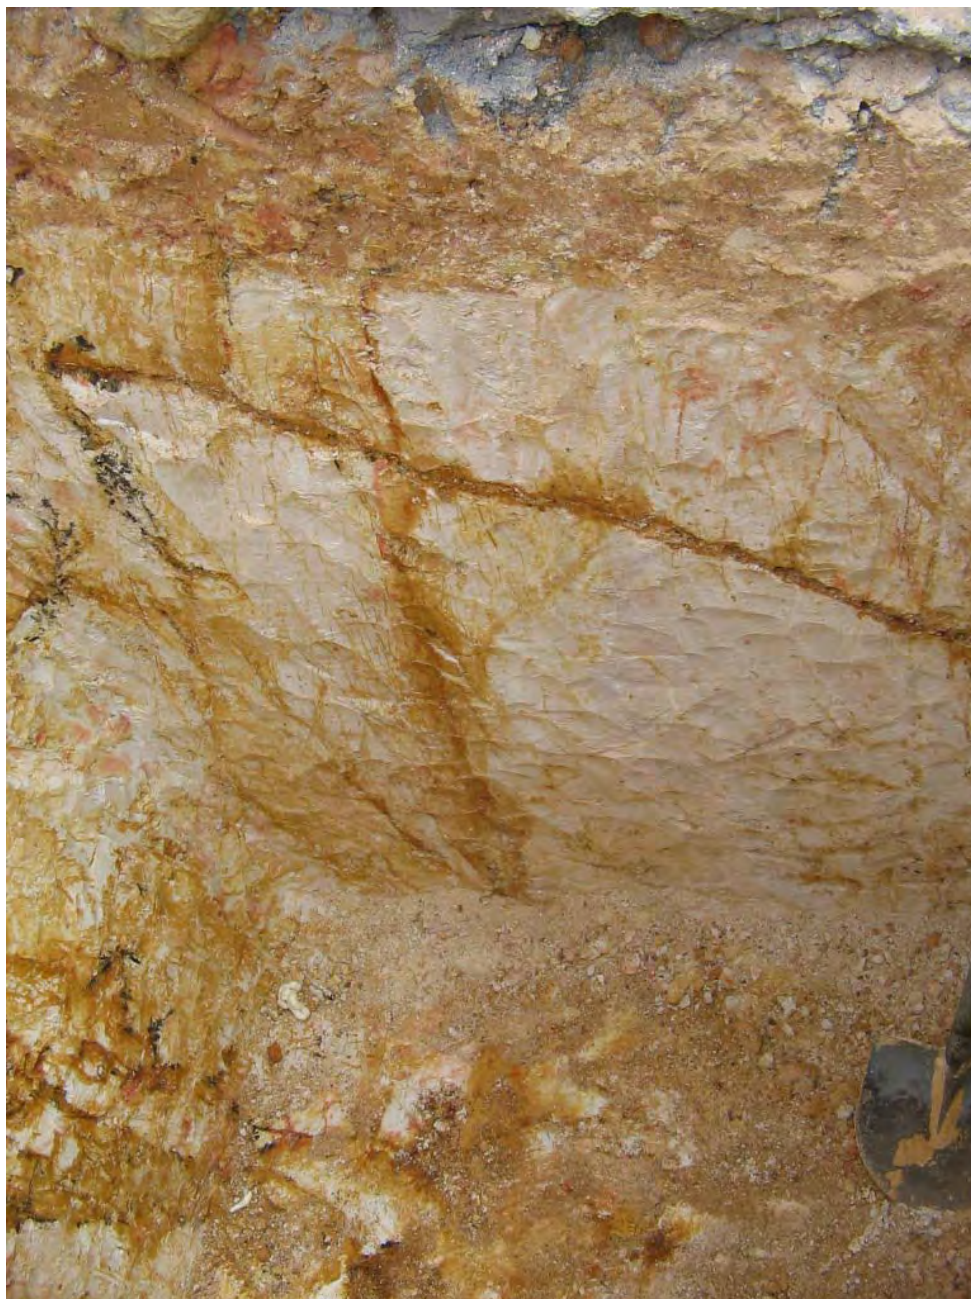
- (e) Extensive kaolinisation of the decomposed tuff, described as light grey, slightly sandy clayey silt with occasional fine gravel with limonite and manganese stained in relict joints, was identified in the lower portion of the scar in trial pits TP5 and TP6, being most distinct in TP5 (Plate 31), which was broadly consistent with the locations identified during the field mapping of the scar (Section 5.2.2). Kaolinisation was also observed to some extent in TP4, situated higher in the scar, though to a much lesser extent and in combination with deposition in relict joints (Plate 32). Mazier samples recovered from drillholes BH2 and BH5 in the lower slope portion also indicated localised kaolinisation of the tuff, ranging in thickness from 0.2 m to 0.5 m (Plate 33). White and buff kaolin of up to 5 mm thick and black mangiferous infills were commonly observed in relict joints (Plate 34).

Plate 31 - Extensive Kaolinisation of Decomposed Tuff in Trial Pit TP5  
(Photograph taken on 13 February 2006)

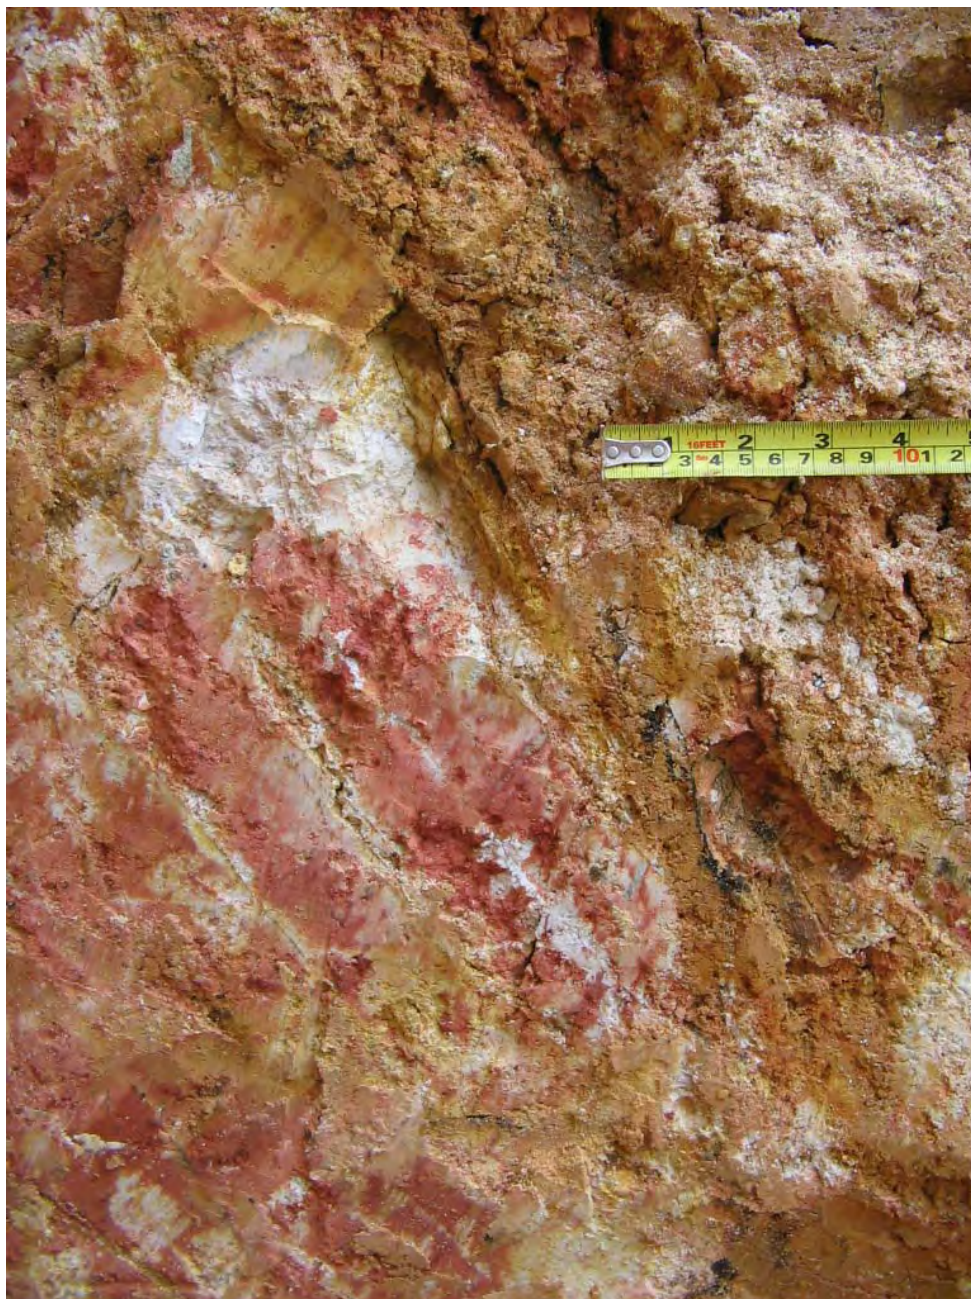
Plate 32 - Kaolin in Relict Joint in Trial Pit TP4 (Photograph taken on 11 February 2006)

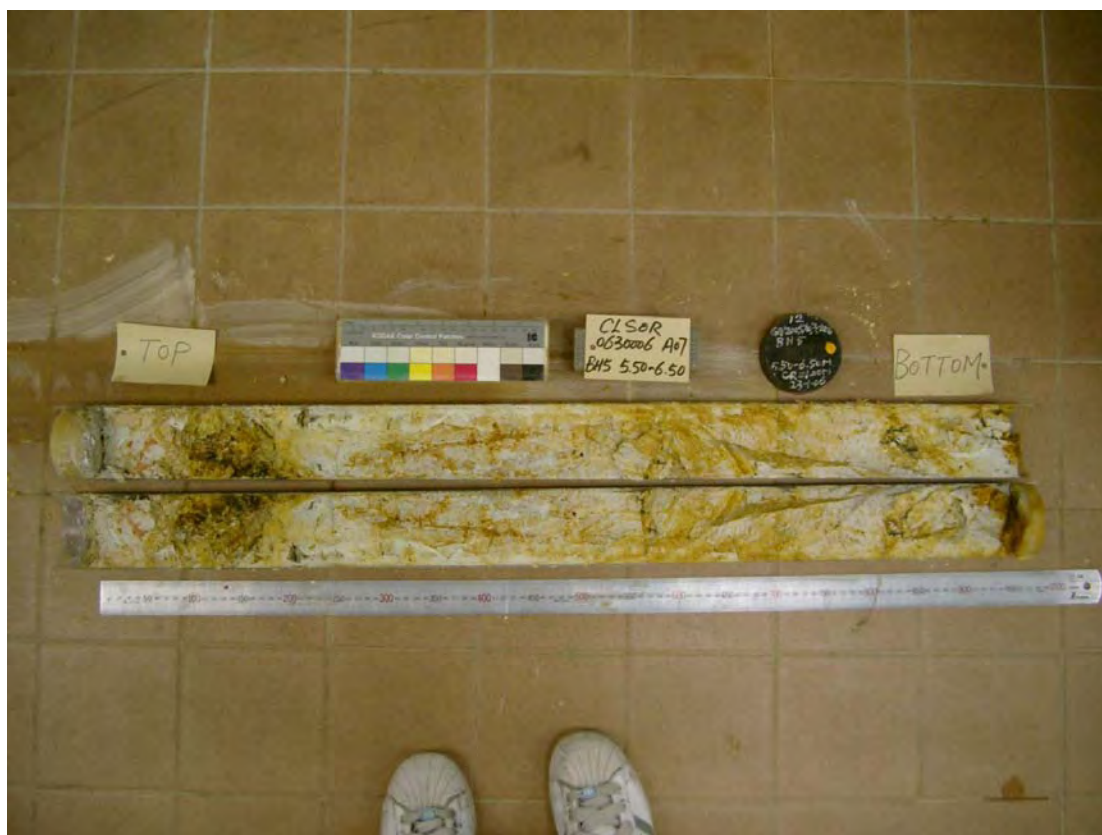
Plate 33 - Kaolinised Tuff in Mazier Sample Recovered from Drillhole BH5  
(Photograph taken on 26 April 2006)
