**REVIEW OF
THE 20 AUGUST 2005
DEBRIS FLOOD AT
LO WAI, TSUEN WAN**

GEO REPORT No. 212

Maunsell Geotechnical Services Limited

**This report was originally produced in October 2006
as GEO Landslide Study Report No. LSR 5/2006**

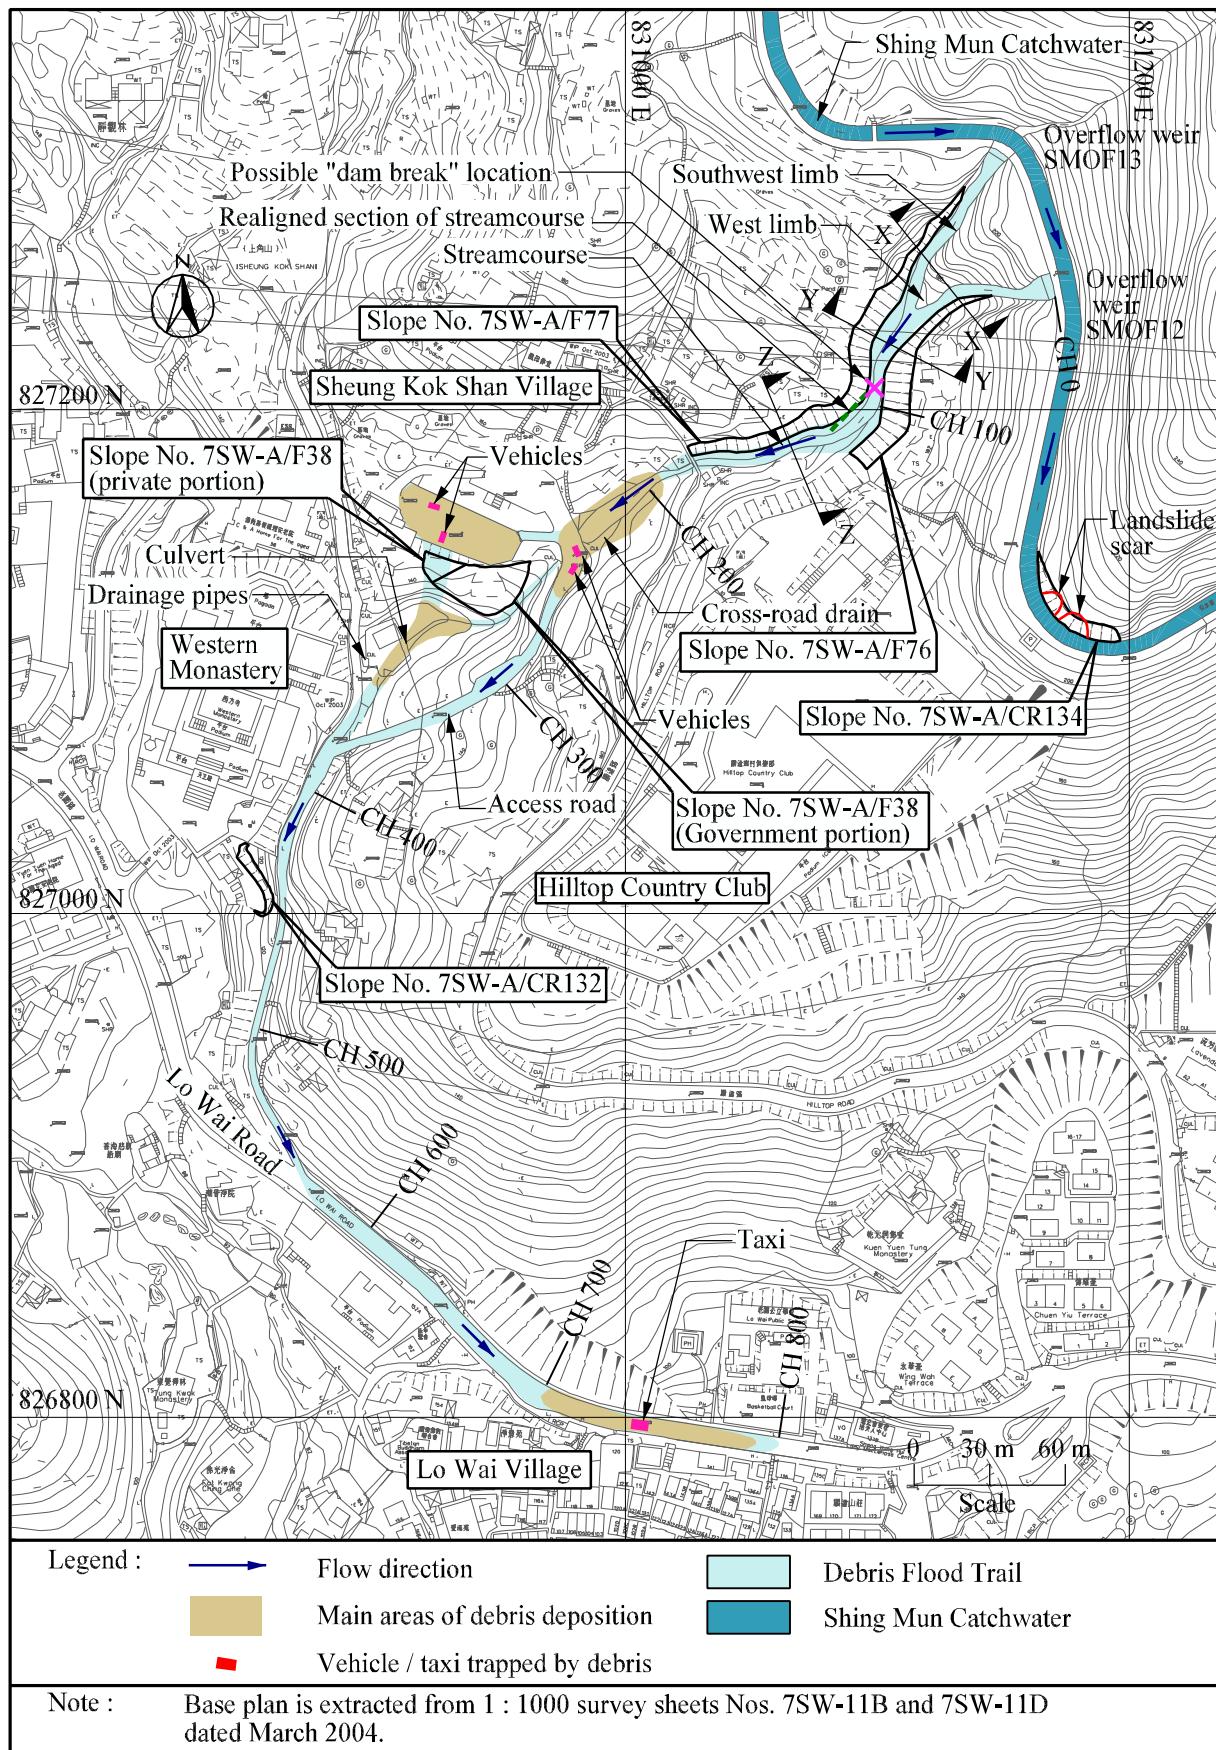
Figure 2 - Debris Flood Trail

The debris flood realigned the streamcourse at chainage CH 100, bypassing an existing bend and cutting into the body of slope No. 7SW-A/F77 (Figure 2).

Three strong pulses of debris flood activity were reported to have taken place on 20 August 2005. Two occurred between 4:00 p.m. and 6:00 p.m. and the third at around 8:00 p.m. The earlier two pulses may be related to the relatively intense rainfall between 3:00 p.m. and 4:00 p.m. and between 5:00 p.m. and 6:00 p.m. respectively (Figure 16). However, there was no obvious increase in rainfall intensity prior to the third pulse both from the hourly rainfall data and from the 15-minute rainfall data. The last pulse could have resulted from a ‘dam break’ at a certain point along the streamcourse, where partial blockage had developed. Such a possible ‘dam break’, if it did occur, could be located at a narrow section along the streamcourse as shown in Figure 2 (see also Plate 46).

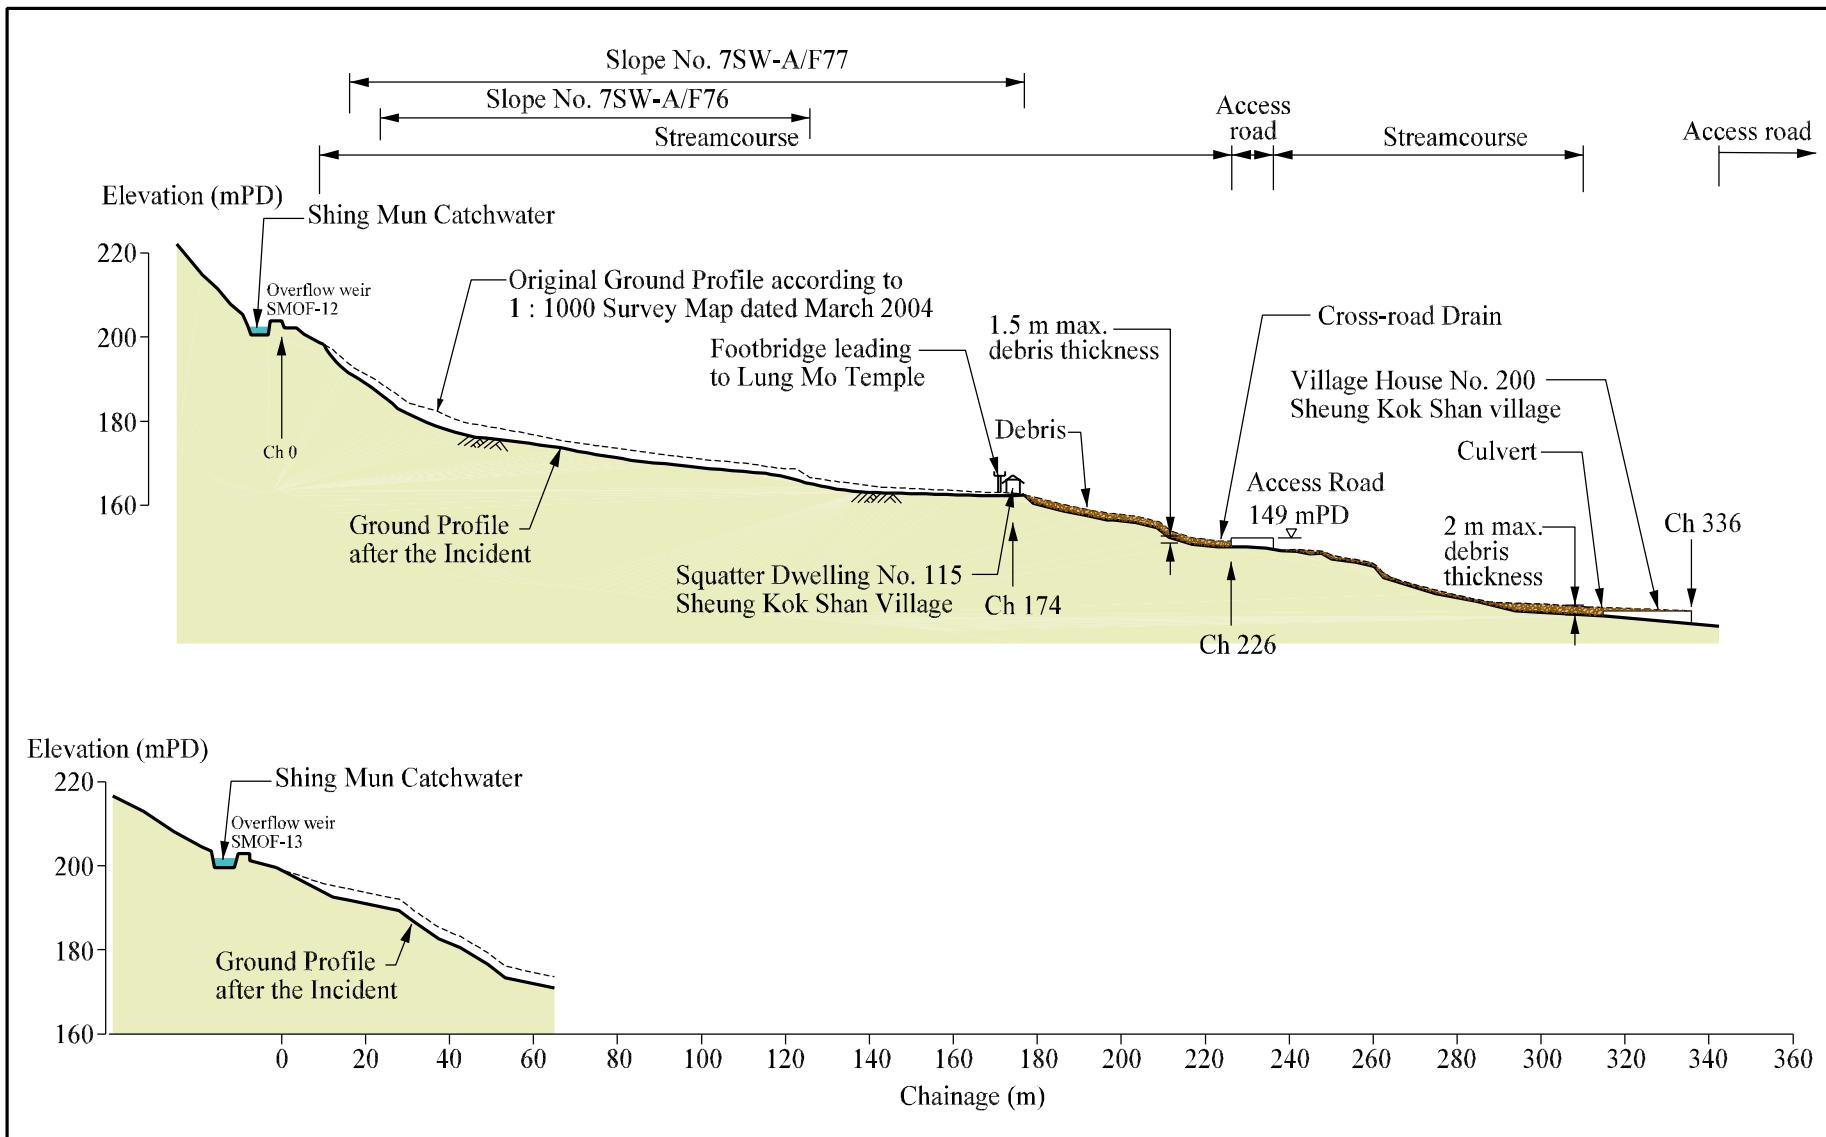
Figure 10 - Longitudinal Section of Streamcourse

The heavy flows from the overflow weirs into the upper limbs of the streamcourse probably built up momentum as a result of the steepness of the streamcourse limbs (in the order of 35°), and the substantial drop in head of about 27 m between the invert levels of the overflow weirs and the level of the stream bed at the confluence of the streamcourse limbs. The stream bed and slopes Nos. 7SW-A/F76 and 7SW-A/F77 comprised loose colluvium that was susceptible to entrainment and undercutting by the flow. As shown in the longitudinal section presented in Figure 10, the depth of entrainment increased along the limbs of the streamcourse.

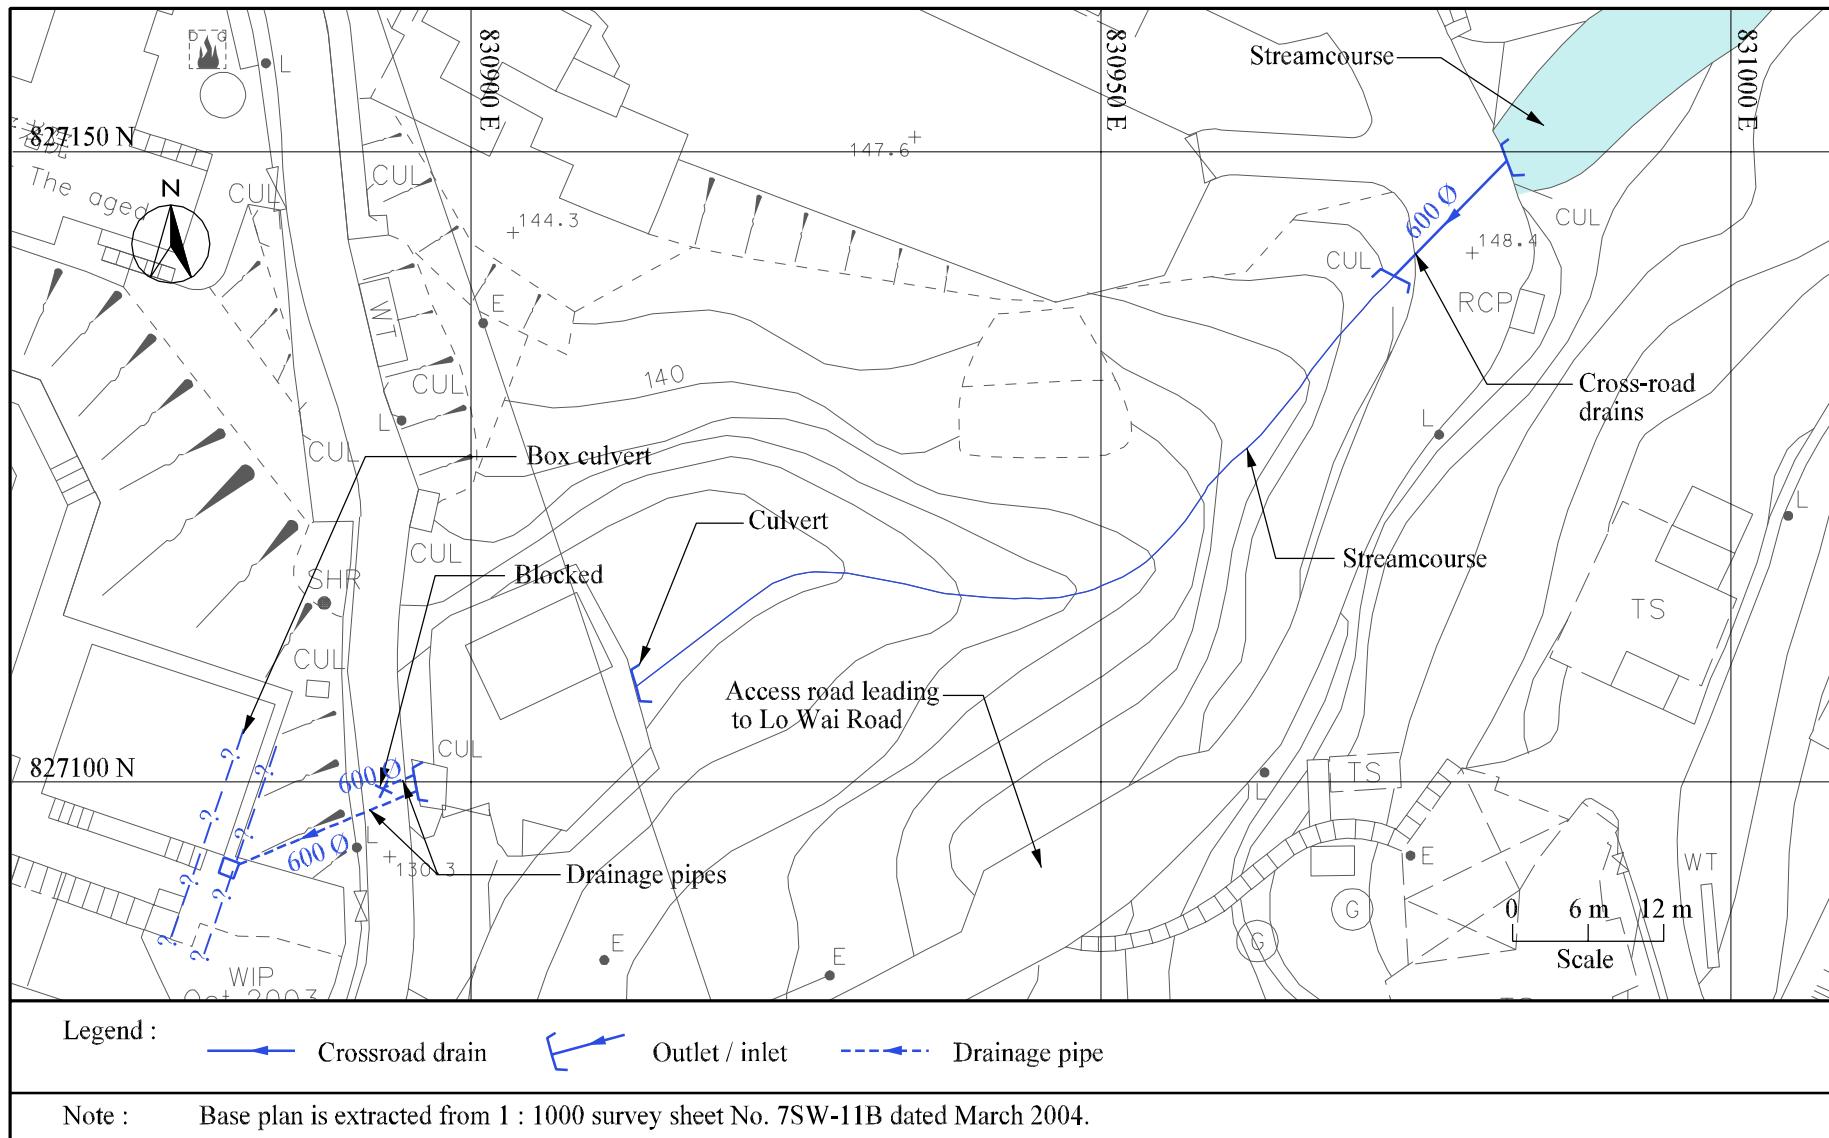
Figure 15 - Alignments of Cross-road Drains and Drainage Pipes by CCTV Survey

The western portion of slope No. 7SW-A/F38, below the car park, was washed out by the debris flood (Plate 40). The scar was about 10 m wide by 23 m long, with a maximum depth of about 1.0 m (corresponding to a volume of about 40 m³). The debris at the toe of the slope contained domestic refuse, tree branches and other detritus. Similar debris had been deposited on the front yard of village house No. 200 (Plate 41), and the culvert beneath the front yard of the house was completely blocked. Plate 42 shows the inlet to the 1.1 m wide by 0.8 m high culvert after clearance. The two drainage pipes on the other side of the front yard were partly blocked at the time of inspection (Plate 43). A CCTV survey was carried out by LIC "Stand-by" CCTV contractor to inspect these two pipes on 6 October 2005. Both pipes are 0.6 m in diameter. One of the pipes was 10.1 m long and clear of debris during the CCTV survey. The pipe was found to be connected to a culvert running to the south and under the Western Monastery. The other pipe was however blocked by soil debris at 1.3 m and further inspection could not be carried out. The alignment of the drains from the CCTV survey are presented in Figure 15.

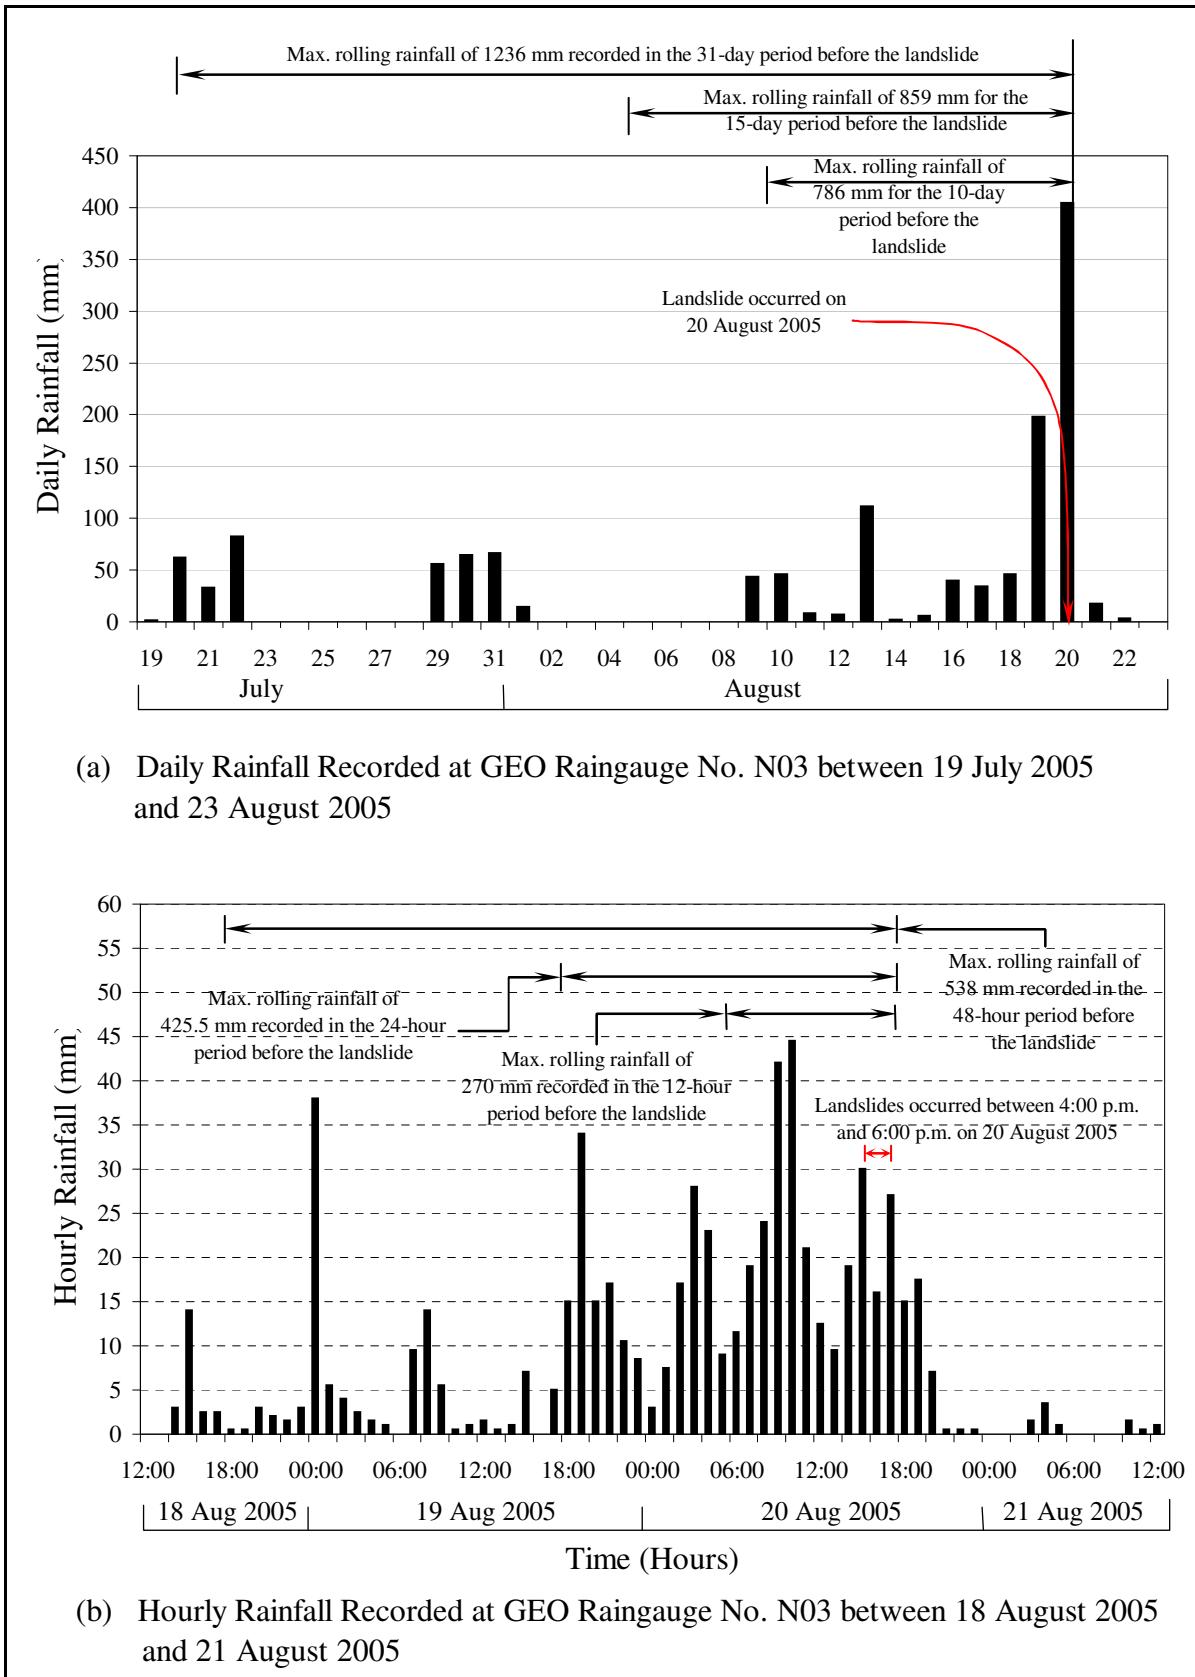
Figure 16 - Daily and Hourly Rainfall Recorded at GEO Raingauge No. N03

The daily rainfall recorded by raingauge No. N03 over the month preceding the incident, together with the hourly rainfall readings for the period of 18 to 21 August 2005, are presented in Figure 16. The rainstorm commenced on the afternoon of 18 August 2005 and intense rainfall was recorded until the evening of 20 August 2005. The maximum 24-hour and 48-hour rolling rainfall before the incident was 425.5 mm and 538 mm respectively. The maximum 1-hour rolling rainfall was recorded as 46 mm between 10 a.m. and 11 a.m. on 20 August 2005 (Table 1).

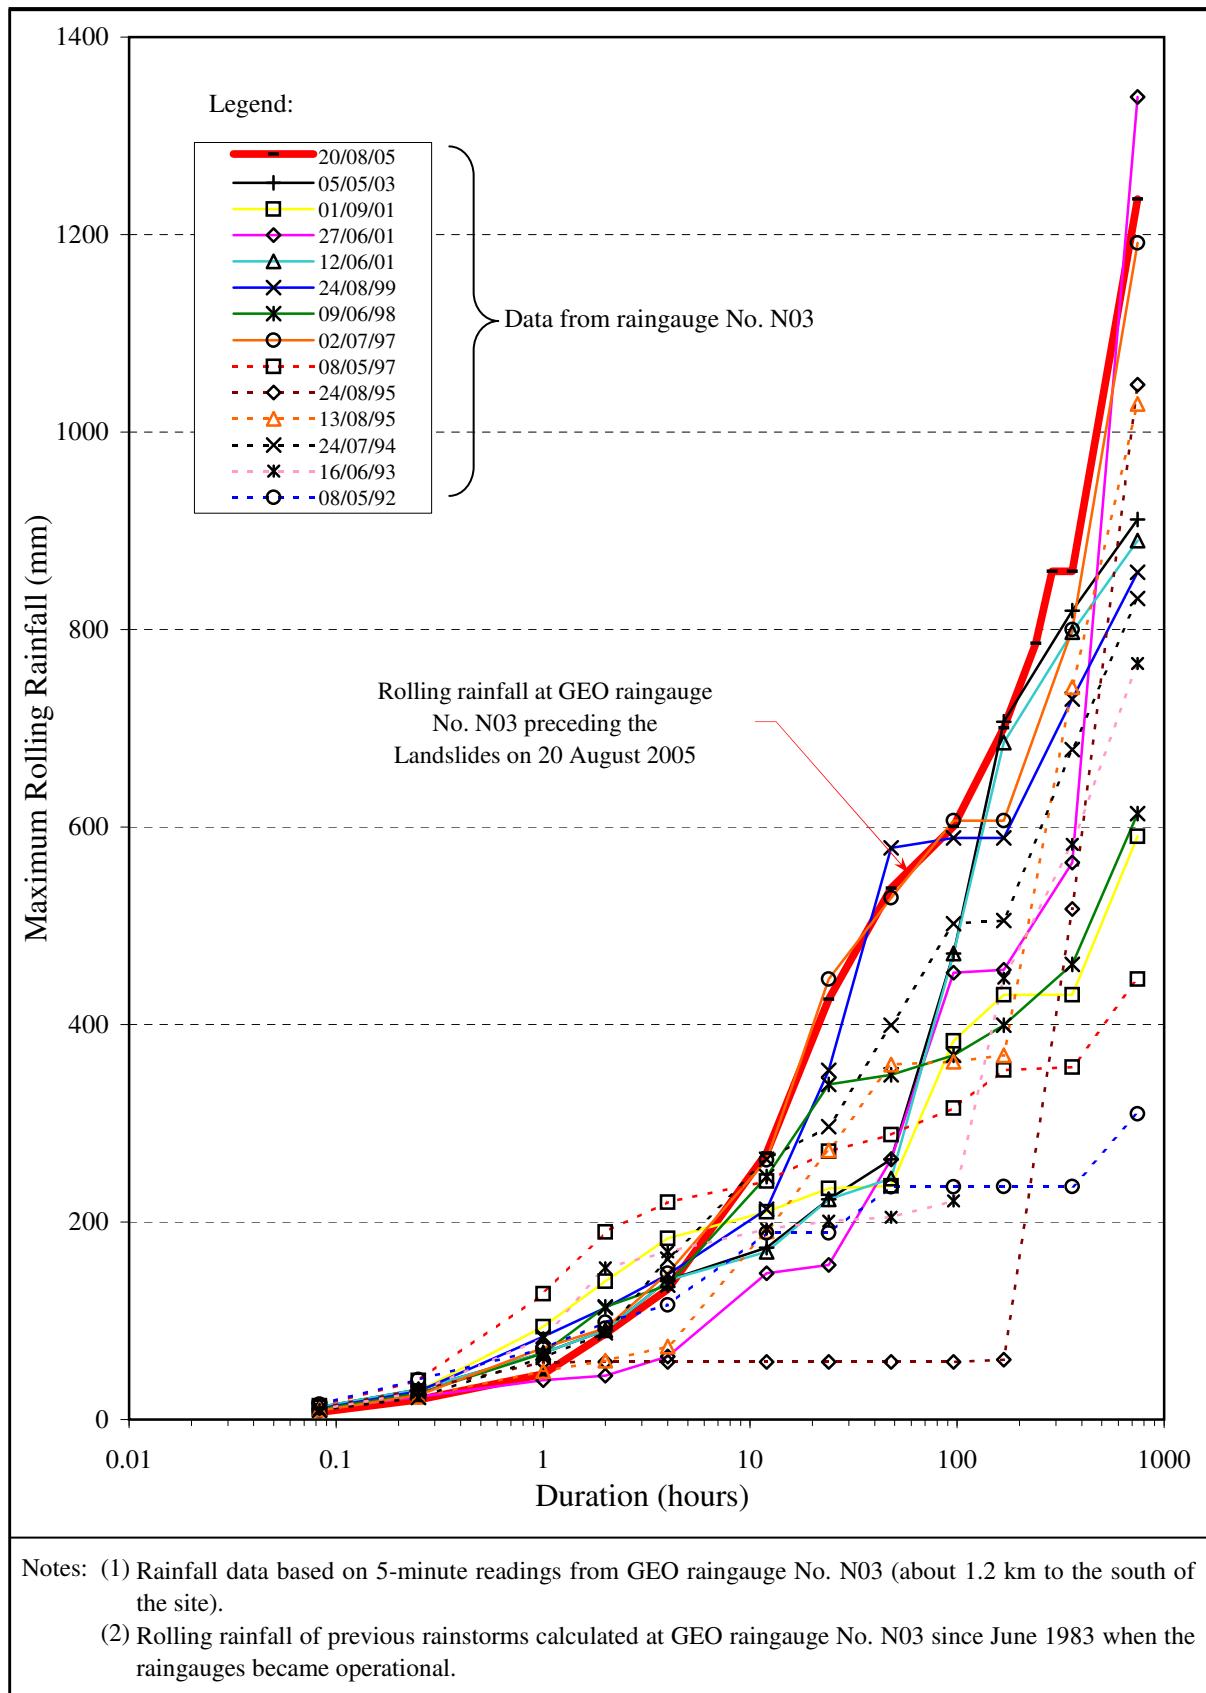
Figure 17 - Maximum Rolling Rainfall for Previous Major Rainstorms at GEO Raingauge No. N03

The maximum rolling rainfall for the August 2005 rainstorm has been compared with the past major rainstorms between 1983 and 2004 recorded by raingauge No. N03, which came into operation in June 1983 (Figure 17).

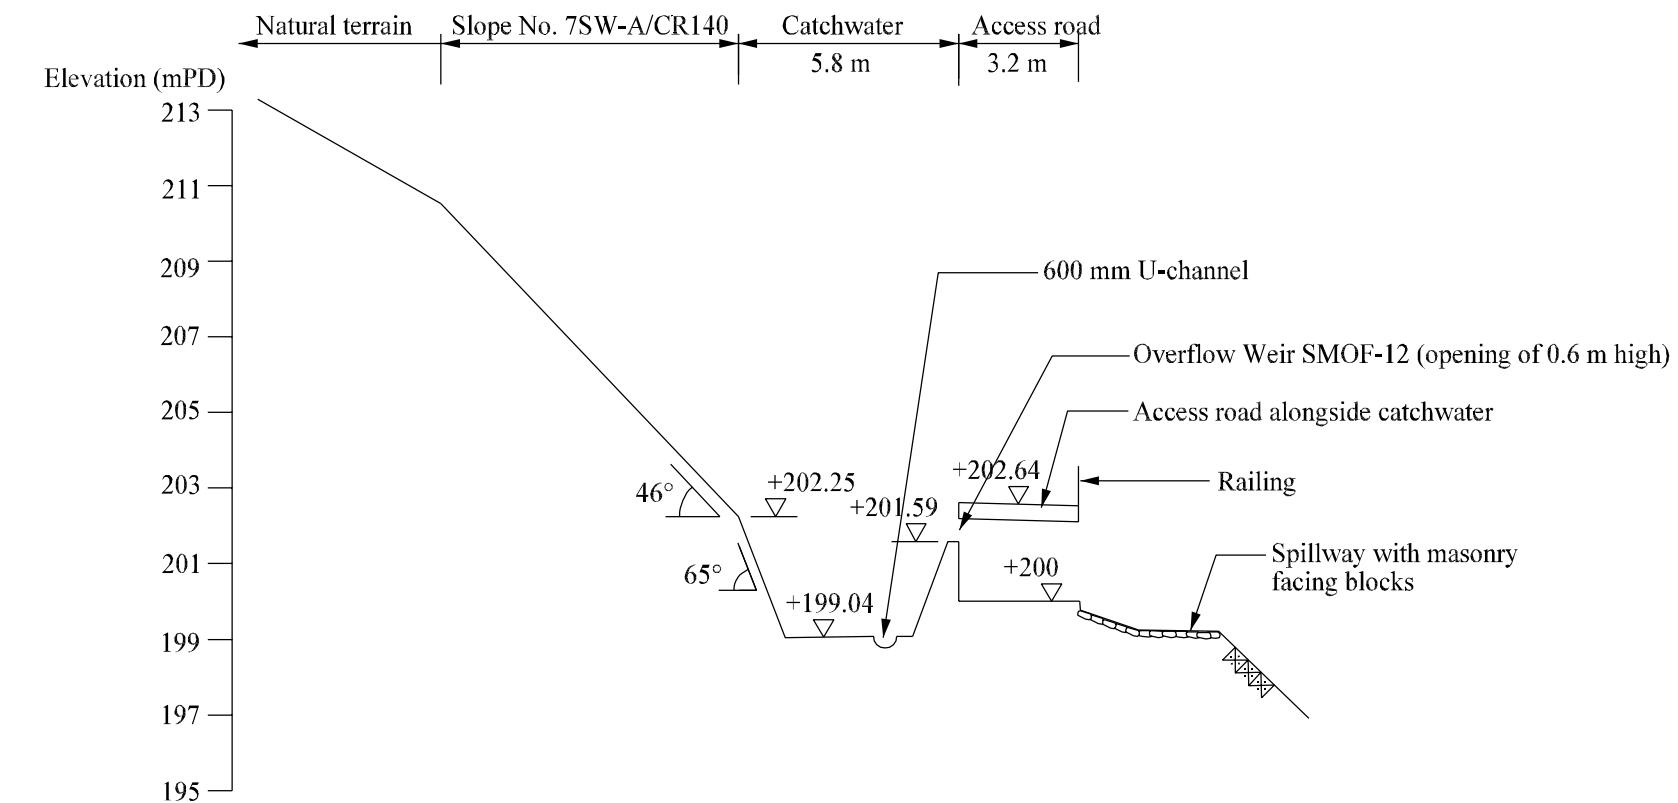
Figure 18 - Cross-section of Overflow Weir SMOF-12

Overflow weirs SMOF-12 and SMOF-13 were surveyed as part of the present study and the cross-sections are presented in Figures 18 and 19 respectively. The invert levels of the openings are at 201.59 mPD and 201.62 mPD for weirs SMOF-12 and SMOF-13 respectively, which are a short distance below the top level of the catchwater channel that typically varies between 202.25 mPD and 202.35 mPD (Figures 20 and 21).

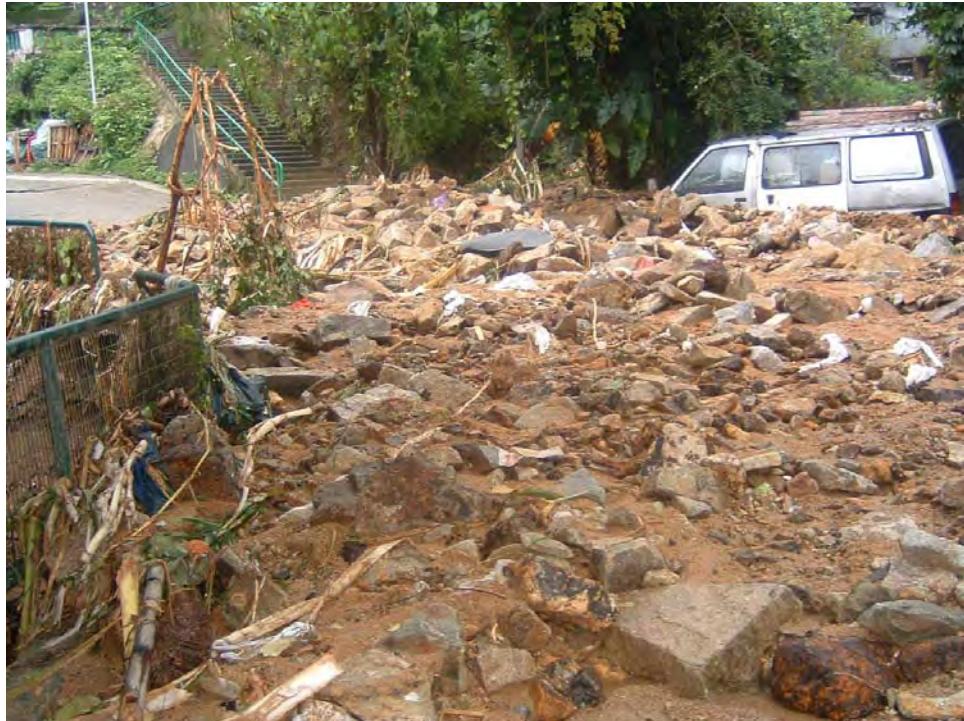
The width of the streamcourse increases in the vicinity of Lung Mo Temple, allowing the debris flood to spread resulting in deposition of some of the cobbles and boulders. Complete blockage of the cross-road drain beneath the access road by washed debris and refuse caused the debris flood to overtop the access road and branch out. This relatively flat area also allowed spreading of the debris flood and further deposition of cobbles and boulders (Plate 5).

Plate 5 - Debris Deposited on Access Road Leading to Lo Wai Road
(Photograph taken on 21 August 2005)

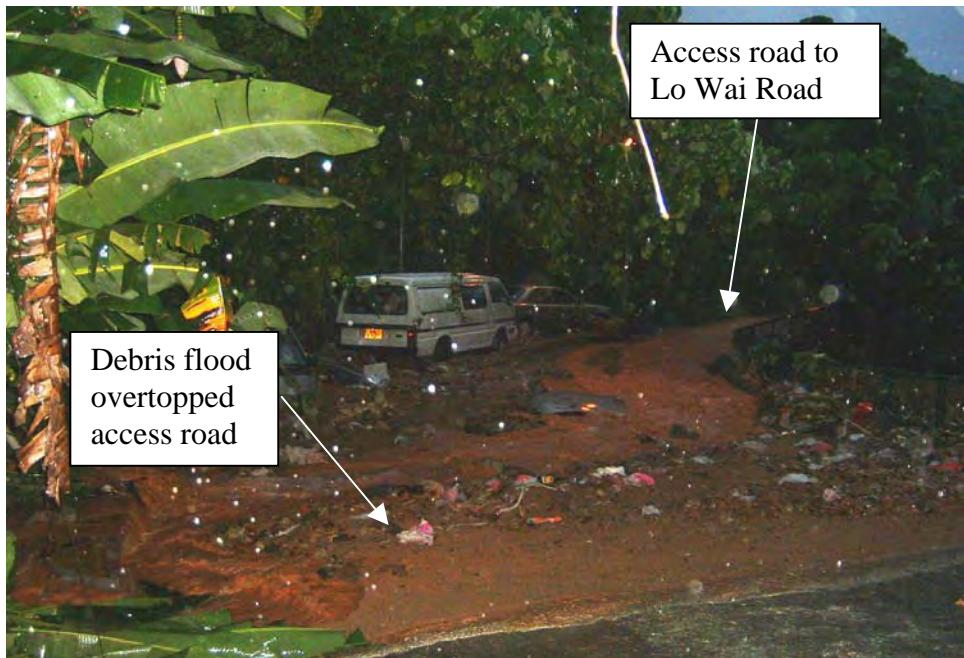
Plate 6 - Debris Flood Overtopped the Access Road
(Photograph taken by local resident on 20 August 2005)

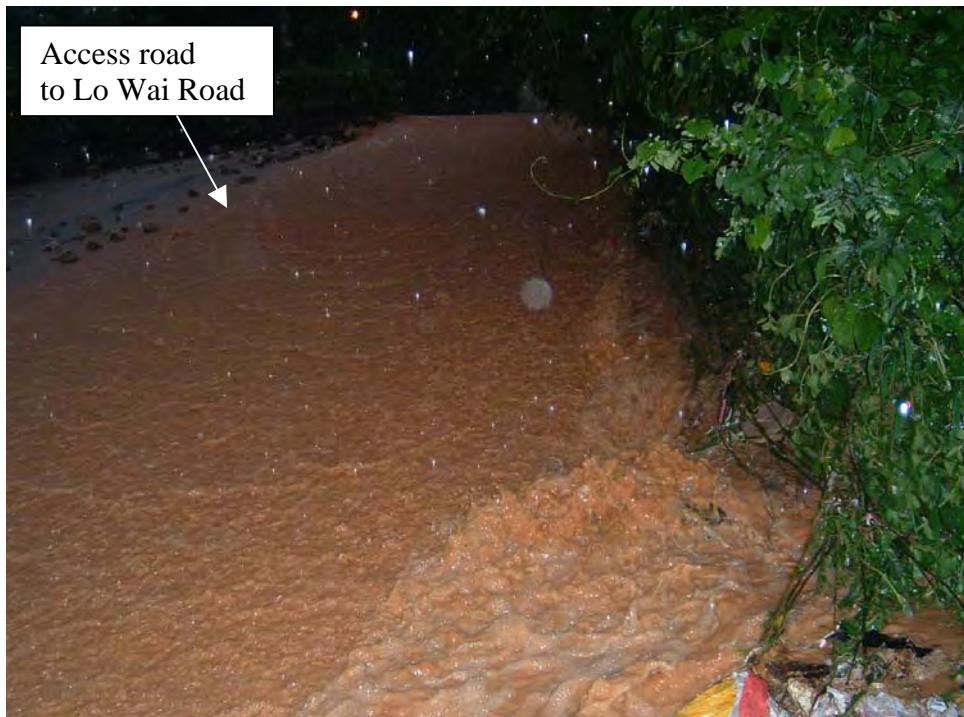
Plate 7 - Debris Flood Flowing along Access Road towards Lo Wai Road
(Photograph taken by local resident on 20 August 2005)

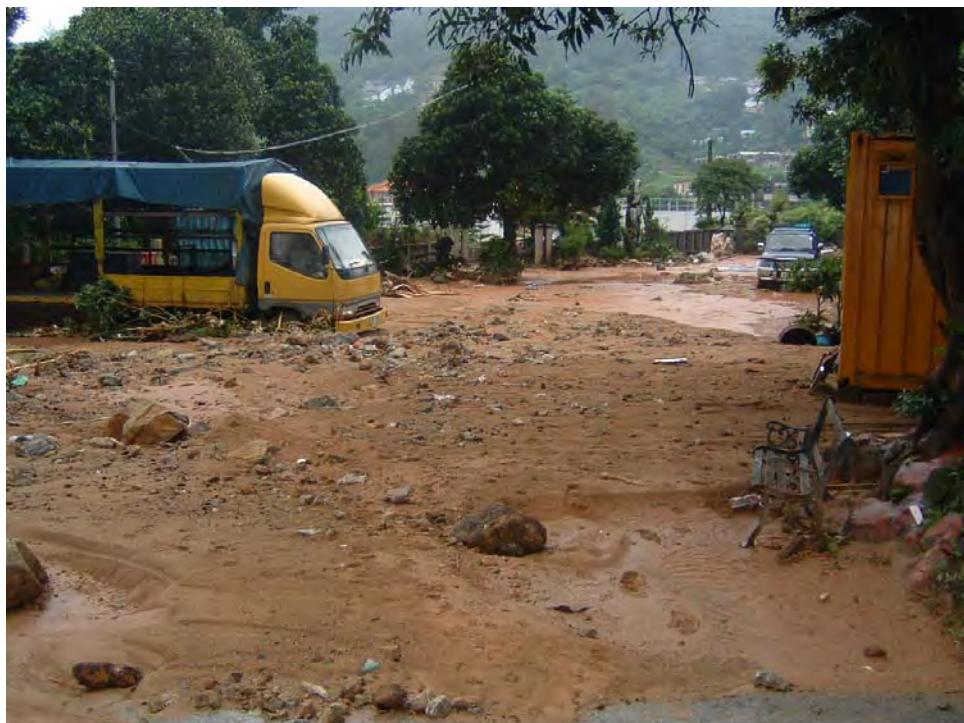
Plate 8 - View of Debris Deposited on the Open Car Park
(Photograph taken on 21 August 2005)

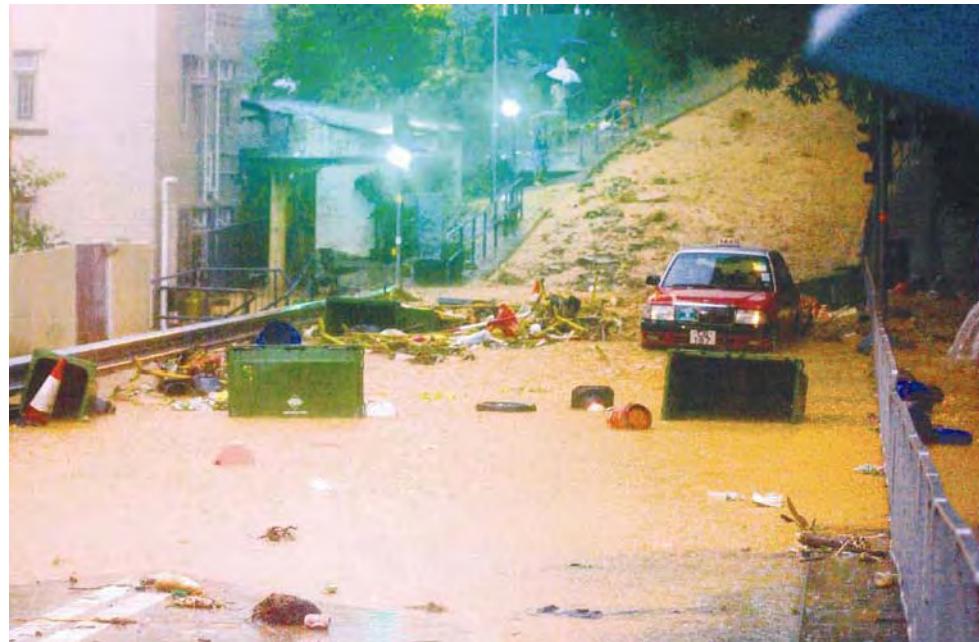
The debris flood continued along Lo Wai Road, where the remaining debris was deposited on a slightly depressed section of the road (Plate 9).

Plate 9 - Taxi Trapped by Debris Deposited on Lo Wai Road
(Photograph taken on 20 August 2005 - Ming Pao Daily News)

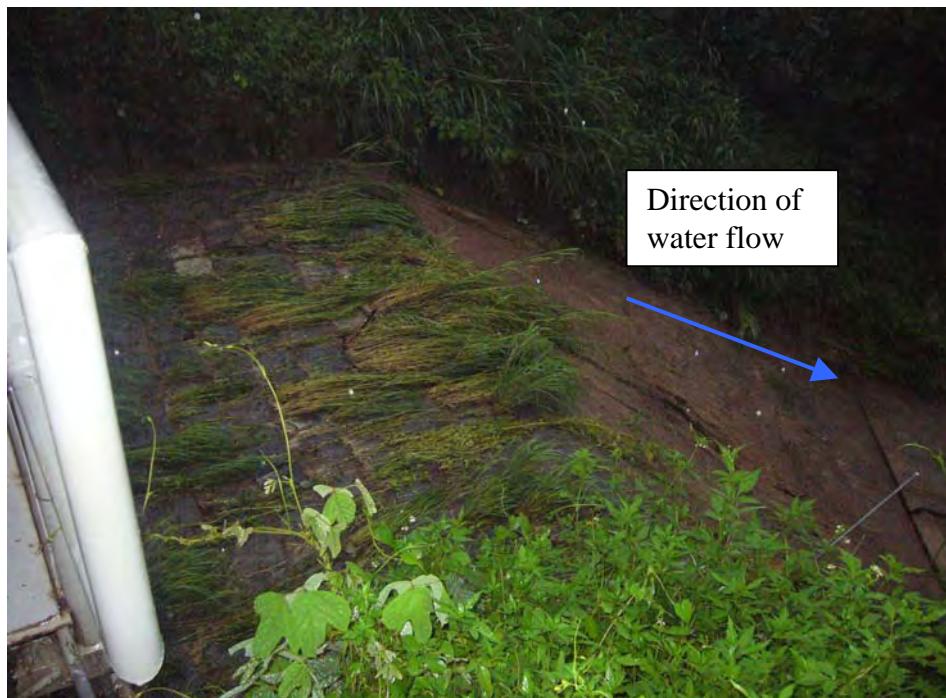
Plate 12 - Masonry Facing Blocks at Spillway
below Overflow Weir SMOF-12
(Photograph taken on 25 August 2005)

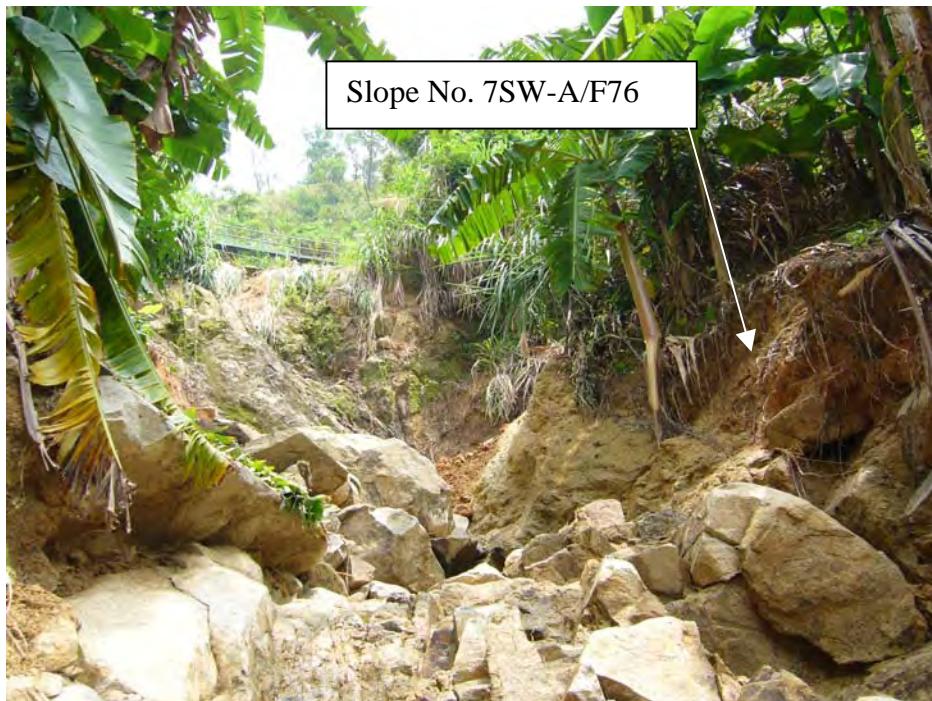
Plate 15 - View of West Limb of the Streamcourse at
Approximate Chainage CH 38 after the Incident
(Photograph taken on 25 August 2005)

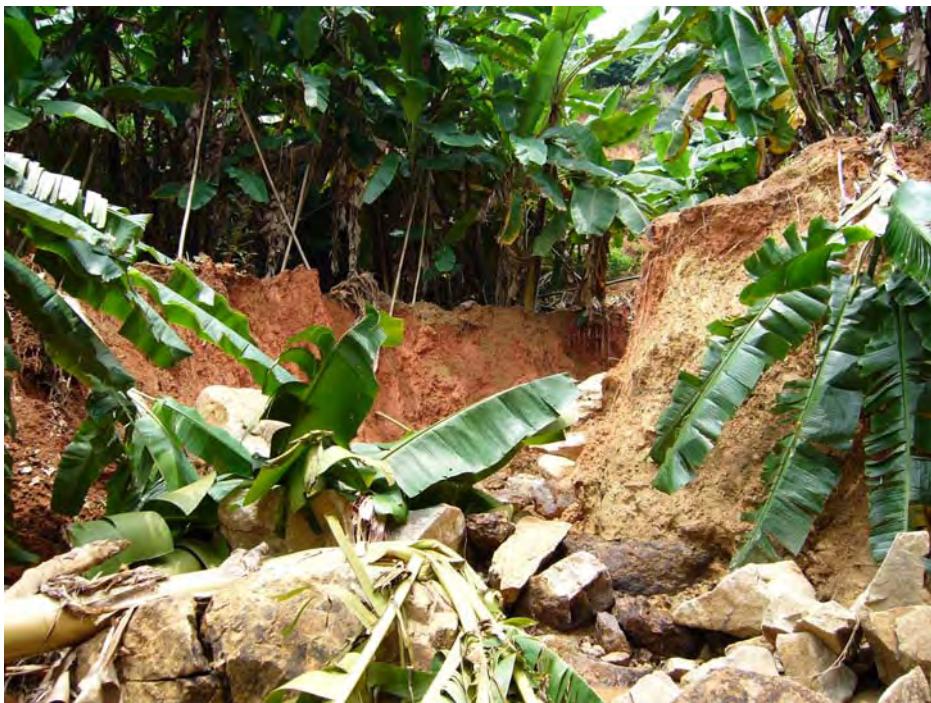
Plate 17 - View of Southwest Limb of the Streamcourse at Approximate Chainage CH 60 after the Incident
(Photograph taken on 25 August 2005)

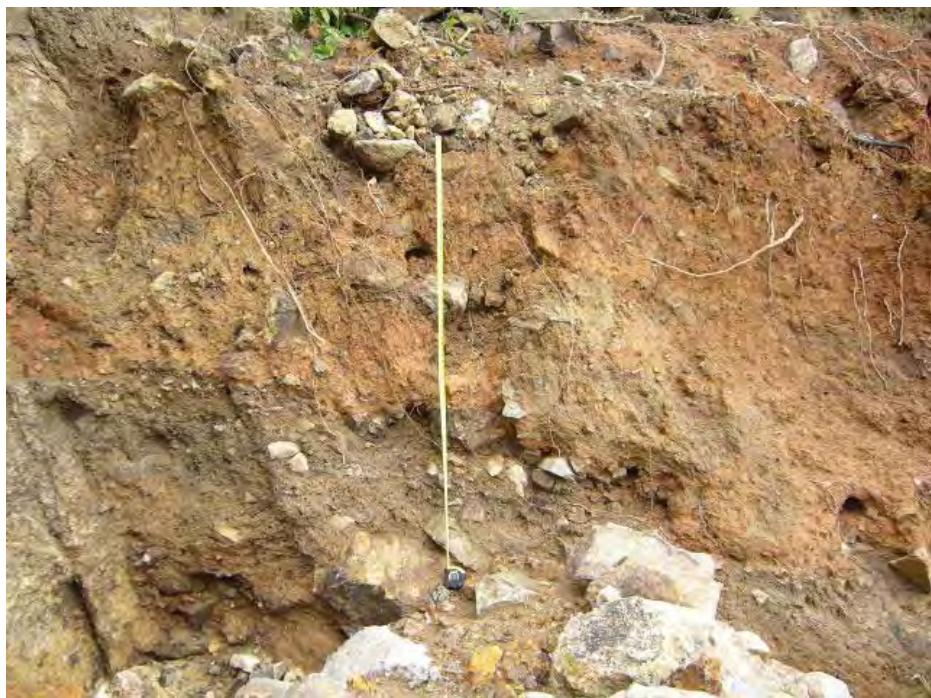
Field mapping revealed that the colluvium located along the streamcourse from the overflow weirs to the confluence of the two limbs can be separated into two to three sub-layers (Plates 18 and 19), indicating that previous occurrence of instability probably took place prior to the 2005 debris flood. This also corroborates the evidence from API.

Plate 18 - Erosion Gully in Southwest Limb with Different Layers of Colluvium
(Photograph taken on 25 August 2005)

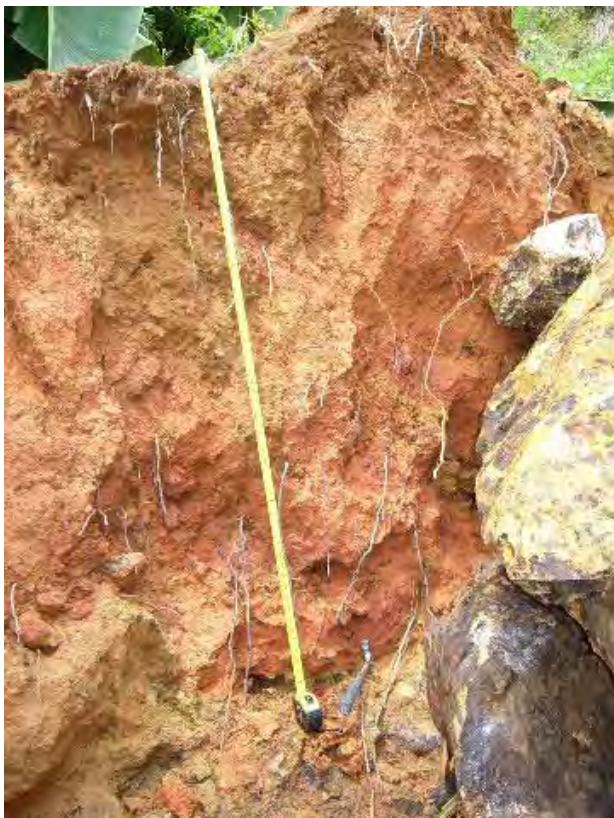
Plate 19 - Younger Colluvium
Overlying Older Colluvium
in Southwest Limb
(Photograph taken on
25 August 2005)

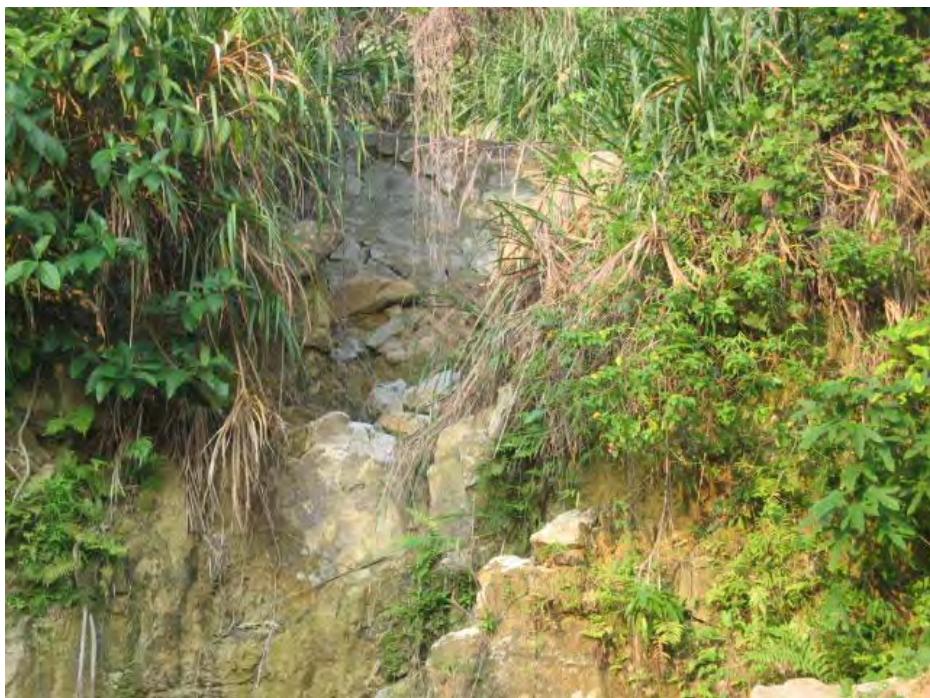
Plate 20 - Highly to Moderately Decomposed Tuff Exposed
below the Spillway of the Southwest Limb
(Photograph taken on 25 August 2005)

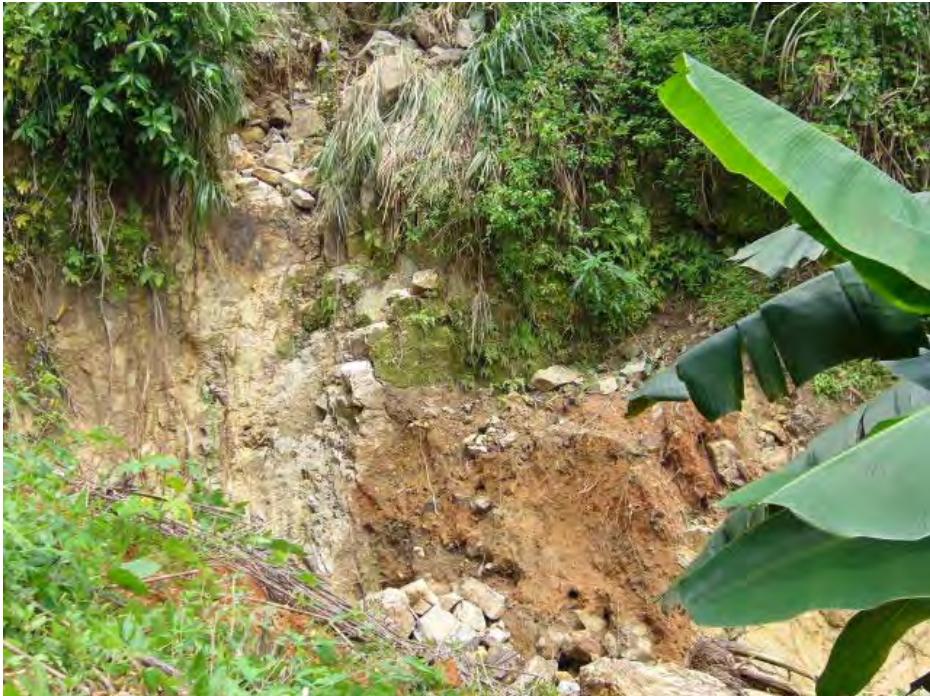
Plate 21 - Moderately Decomposed Tuff Exposed
below the Spillway of the West Limb
(Photograph taken on 25 August 2005)

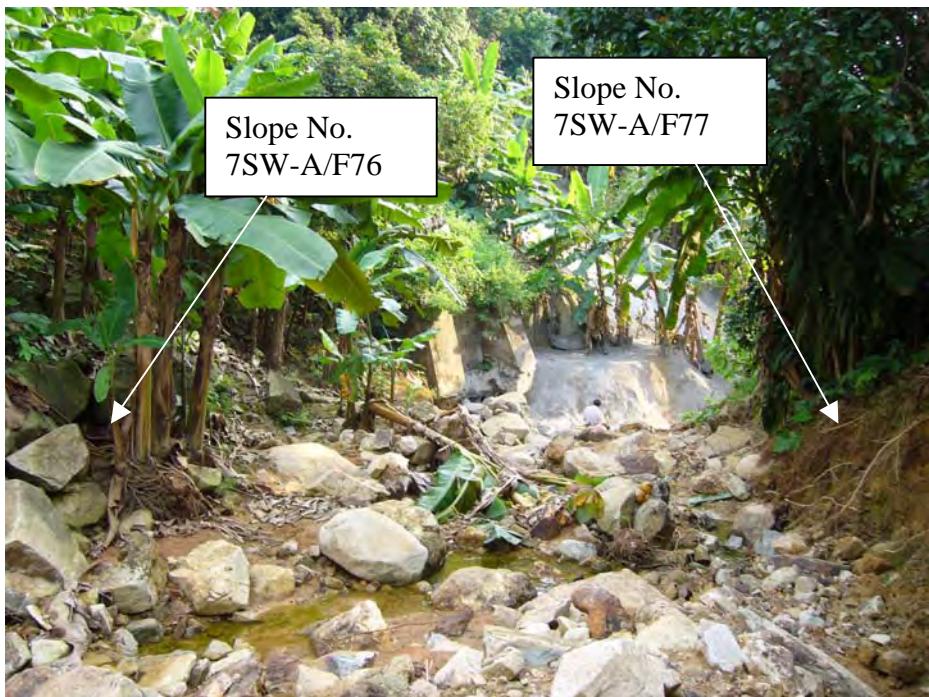
Plate 27 - View of Streamcourse at Approximate
Chainage CH 92 after the Incident
(Photograph taken on 22 September 2005)

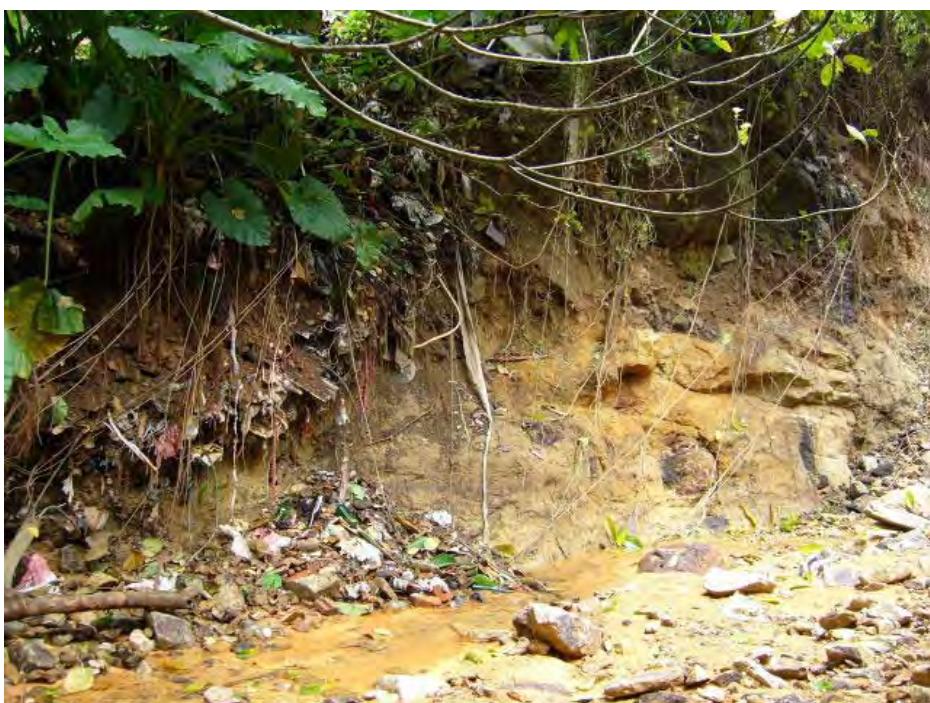
No bedrock was observed along the stream bed after the confluence point except for local areas near chainage CH 110, where a small area of bedrock was exposed at the bottom of the northwest valley side (Plate 28). At the crest of the rock exposure is a layer of dumped fill and domestic refuse (Plate 28).

Plate 28 - Refuse Deposited on Highly to Moderately
Decomposed Tuff at Approximate Chainage CH 110
(Photograph taken on 25 August 2005)
