**REVIEW OF
THE 20 AUGUST 2005
DEBRIS FLOOD AT
LO WAI, TSUEN WAN**

GEO REPORT No. 212

Maunsell Geotechnical Services Limited

**This report was originally produced in October 2006
as GEO Landslide Study Report No. LSR 5/2006**

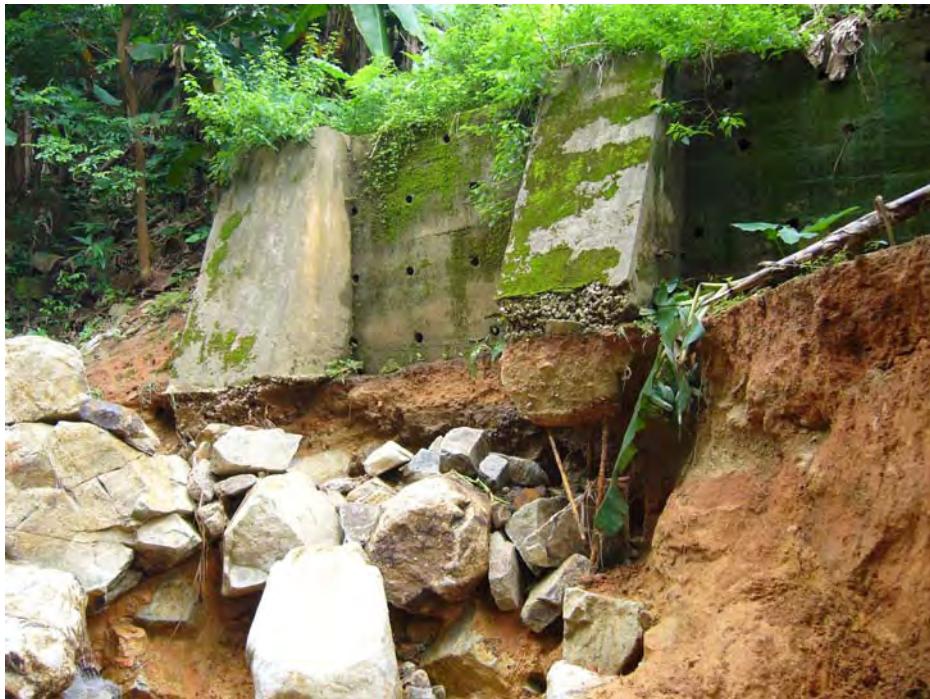
Some of the squatter structures at the crest of slopes Nos. 7SW-A/F76 and 7SW-A/F77 were affected by the debris flood. Squatter structure No. RTW/4AD/119 at approximate chainage CH 110 was undermined (Plate 29) and consequently the structure was permanently evacuated under Category 1 NDC, as recommended by the GEO. Part of squatter structure No. RTW/4AD/125, situated at the crest of slope No. 7SW-A/F76, collapsed. A completely collapsed squatter structure No. RTW/4AD/126, which is located adjacent to the squatter structure No. RTW/4AD/125, was displaced about 10 m towards the streamcourse (Plate 30). Both squatter structures Nos. RTW/4AD/125 and RTW/4AD/126 were permanently evacuated (Category 1 NDC) as recommended by the GEO. The foundation of a retaining structure, which is about 2.5 m high and 20 m to the northwest of squatter structure No. RTW/4AD/125, was also undermined (Plate 31).

Plate 31 - Foundation of a Retaining Structure Exposed
(Photograph taken on 25 August 2005)

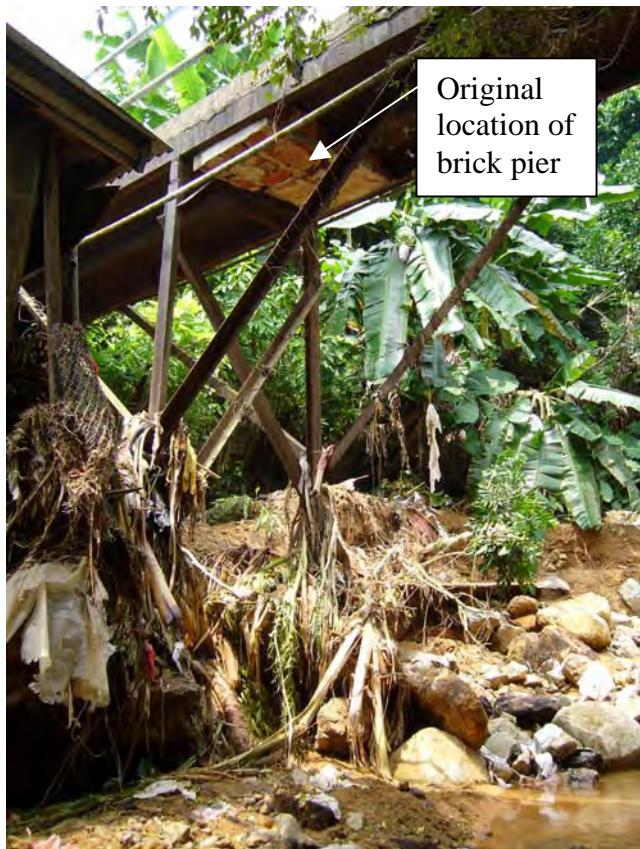
The bridge pier near Lung Mo Temple was swept approximately 10 m down along the streamcourse (Plate 32). Plates 33 and 34 show the original position of the pier. Squatter structure No. RTW/4AD/115 that was situated near the bridge pier (Plate 35) was only slightly damaged by the debris flood, with part of the foundation undermined (Plates 36 and 37). It resulted in another ‘near-miss’ case.

Plate 33 - Original Location of Destroyed Cement-Rendered Brick Pier Providing Partial Support to Footbridge across Streamcourse
(Photograph taken on 25 August 2005)

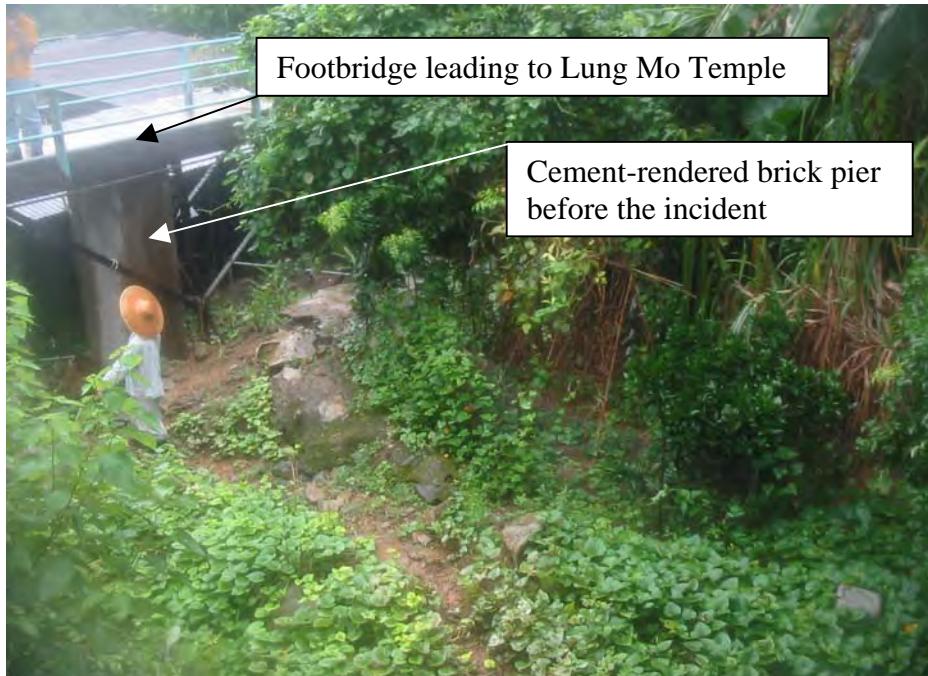
Plate 34 - View of Footbridge and Squatter Structure No. RTW/4AD/115 before the Incident
(Photograph taken on 31 August 2004)

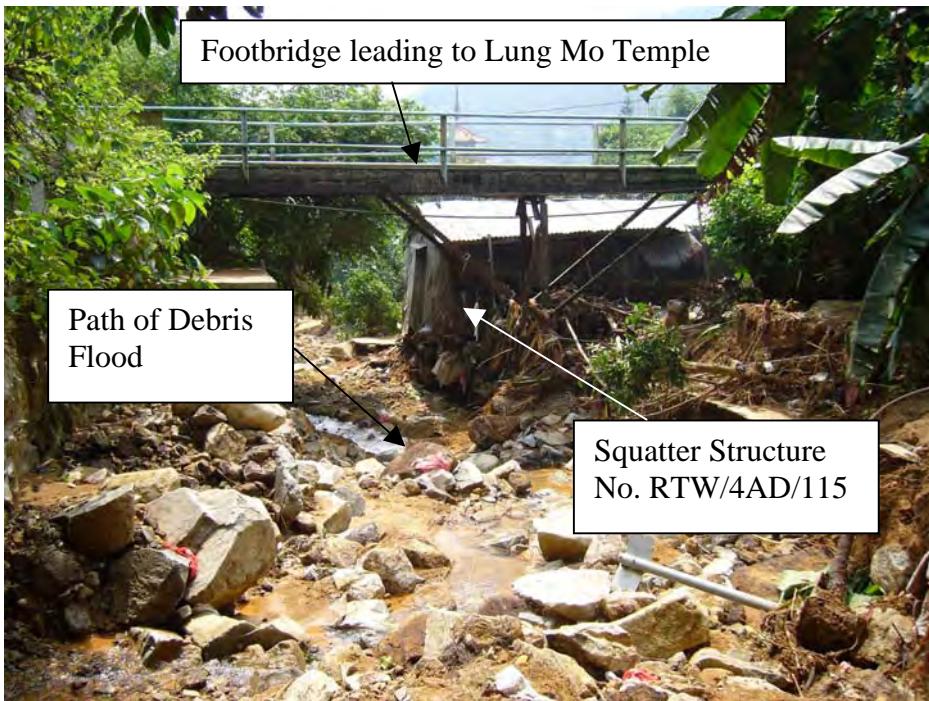
Plate 35 - View of Squatter Structure
No. RTW/4AD/115 and Footbridge
(Photograph taken on 25 August 2005)

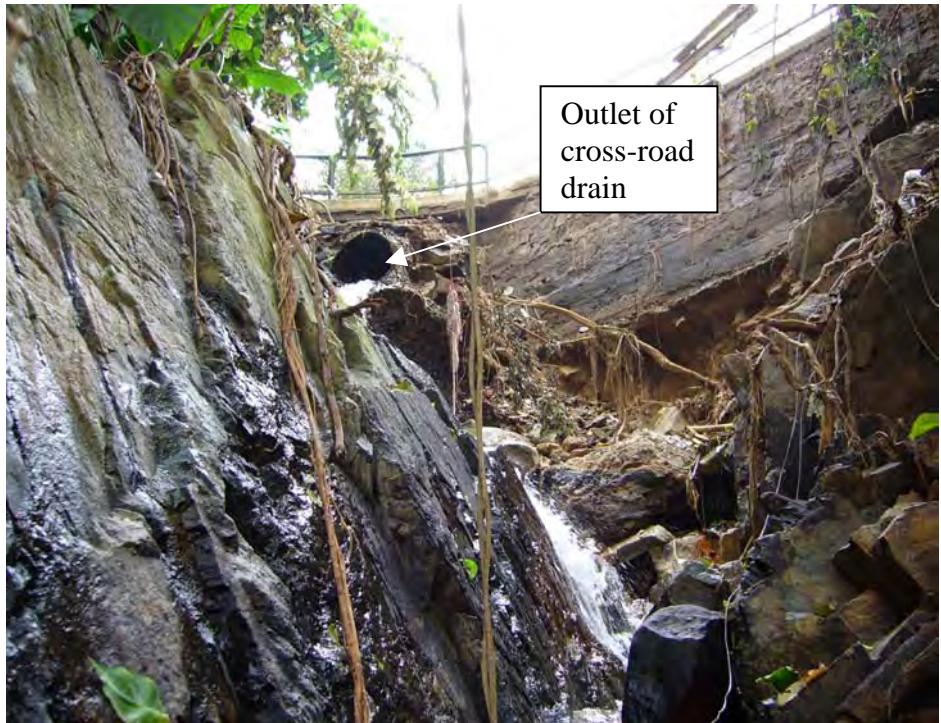
Debris comprising cobbles and boulders was deposited near the junction of the access road and the streamcourse at chainage CH 226 (Plate 5). The cross-road drain beneath the access road was completely blocked by debris and the maintenance condition of the cross-road drain prior to the debris flood incident is not known. Plate 38 shows the condition of the upstream end of the cross-road drain and Plate 39 shows the condition at the downstream end. The relatively small cross-road drain was not capable of catering for such a debris flood. A CCTV survey was carried out on 6 October 2005 to examine the condition of the drain, which was found to be clear of debris and in fair condition. The alignment of the drains from the CCTV survey are presented in Figure 15.

Plate 39 - View of Outlet from Cross-road Drain beneath the Access Road
(Photograph taken on 25 August 2005)

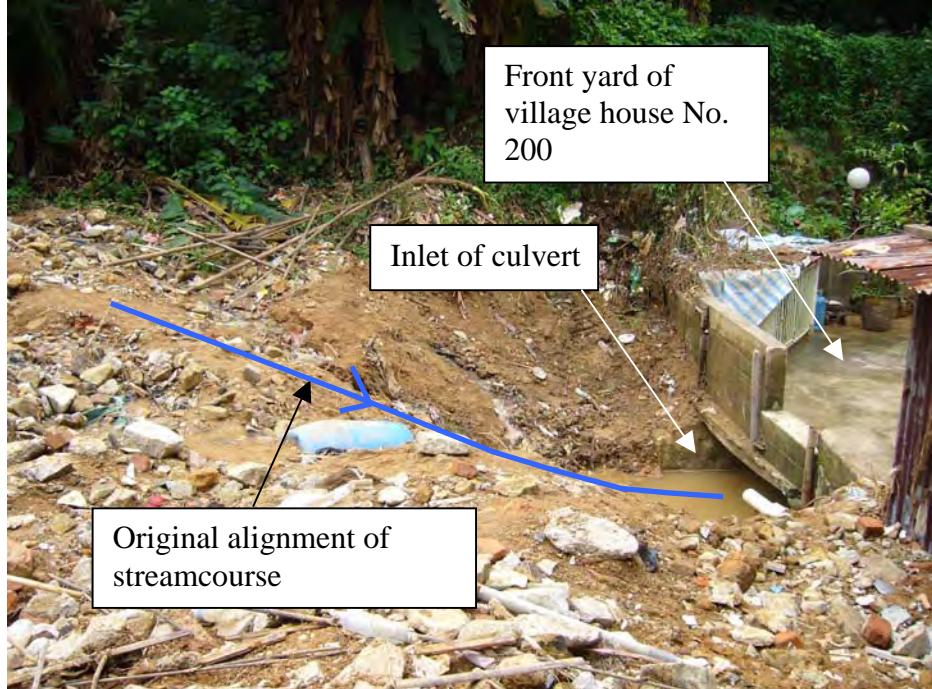
Plate 42 - View of Inlet to Culvert beneath Village
House No. 200 (After Clearance)
(Photograph taken on 25 August 2005)

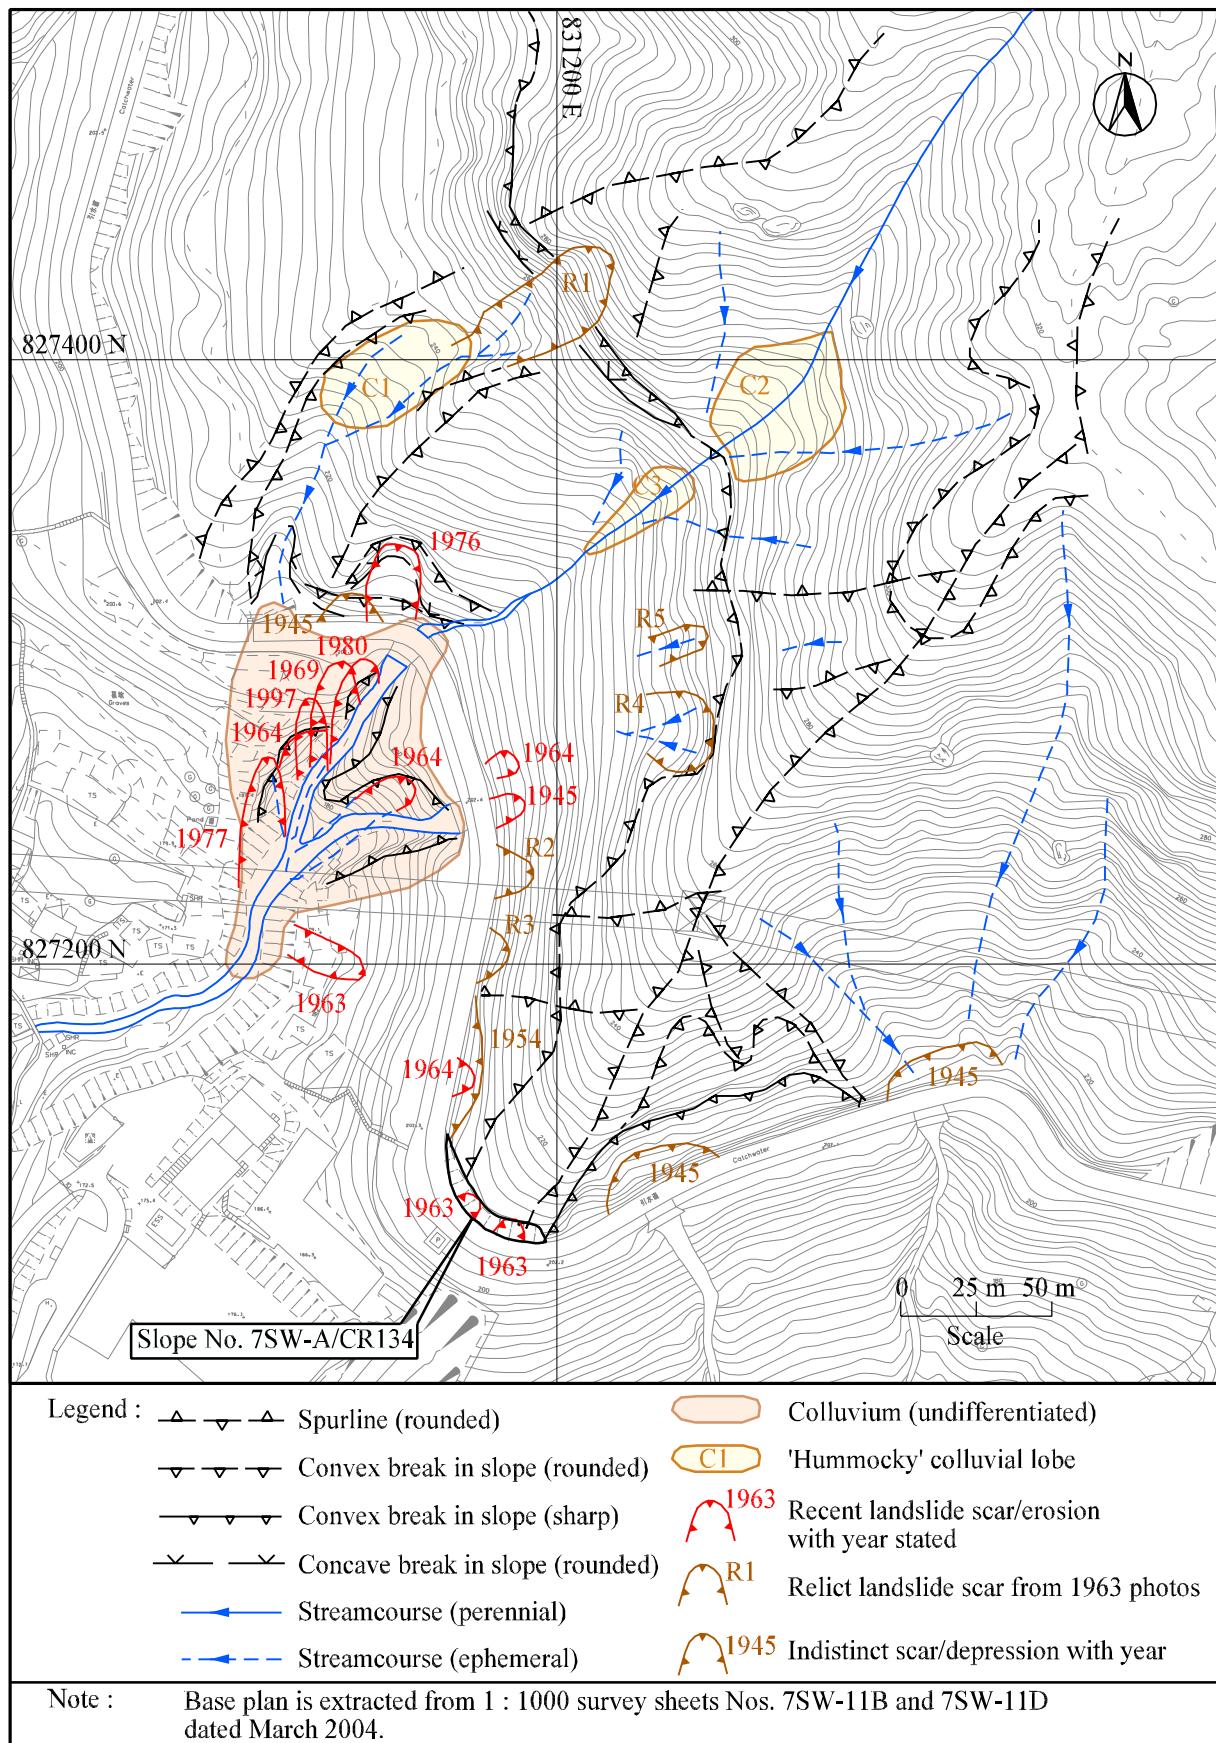
Figure A1 - Past Instabilities and Geomorphology

1954 Areas of high reflectivity, interpreted as erosion and corresponding to areas of localised over-steepening, can be observed immediately downslope from the catchwater adjacent to overflow weirs SMOF-12 and SMOF-13.

An area of over-steepening and relatively high reflectivity can be observed at the south end of slope No. 7SW-A/CR140. It is difficult to ascertain with any certainty the nature and age of this probable erosional feature.
