**REVIEW OF THE  
11 AUGUST 2005 LANDSLIDE  
BELOW BLOCK J OF PRINCESS  
MARGARET HOSPITAL,  
KWAI CHUNG**

**GEO REPORT No. 213**

**Maunsell Geotechnical Services Limited**

**This report was originally produced in November 2006  
as GEO Landslide Study Report No. LSR 7/2006**

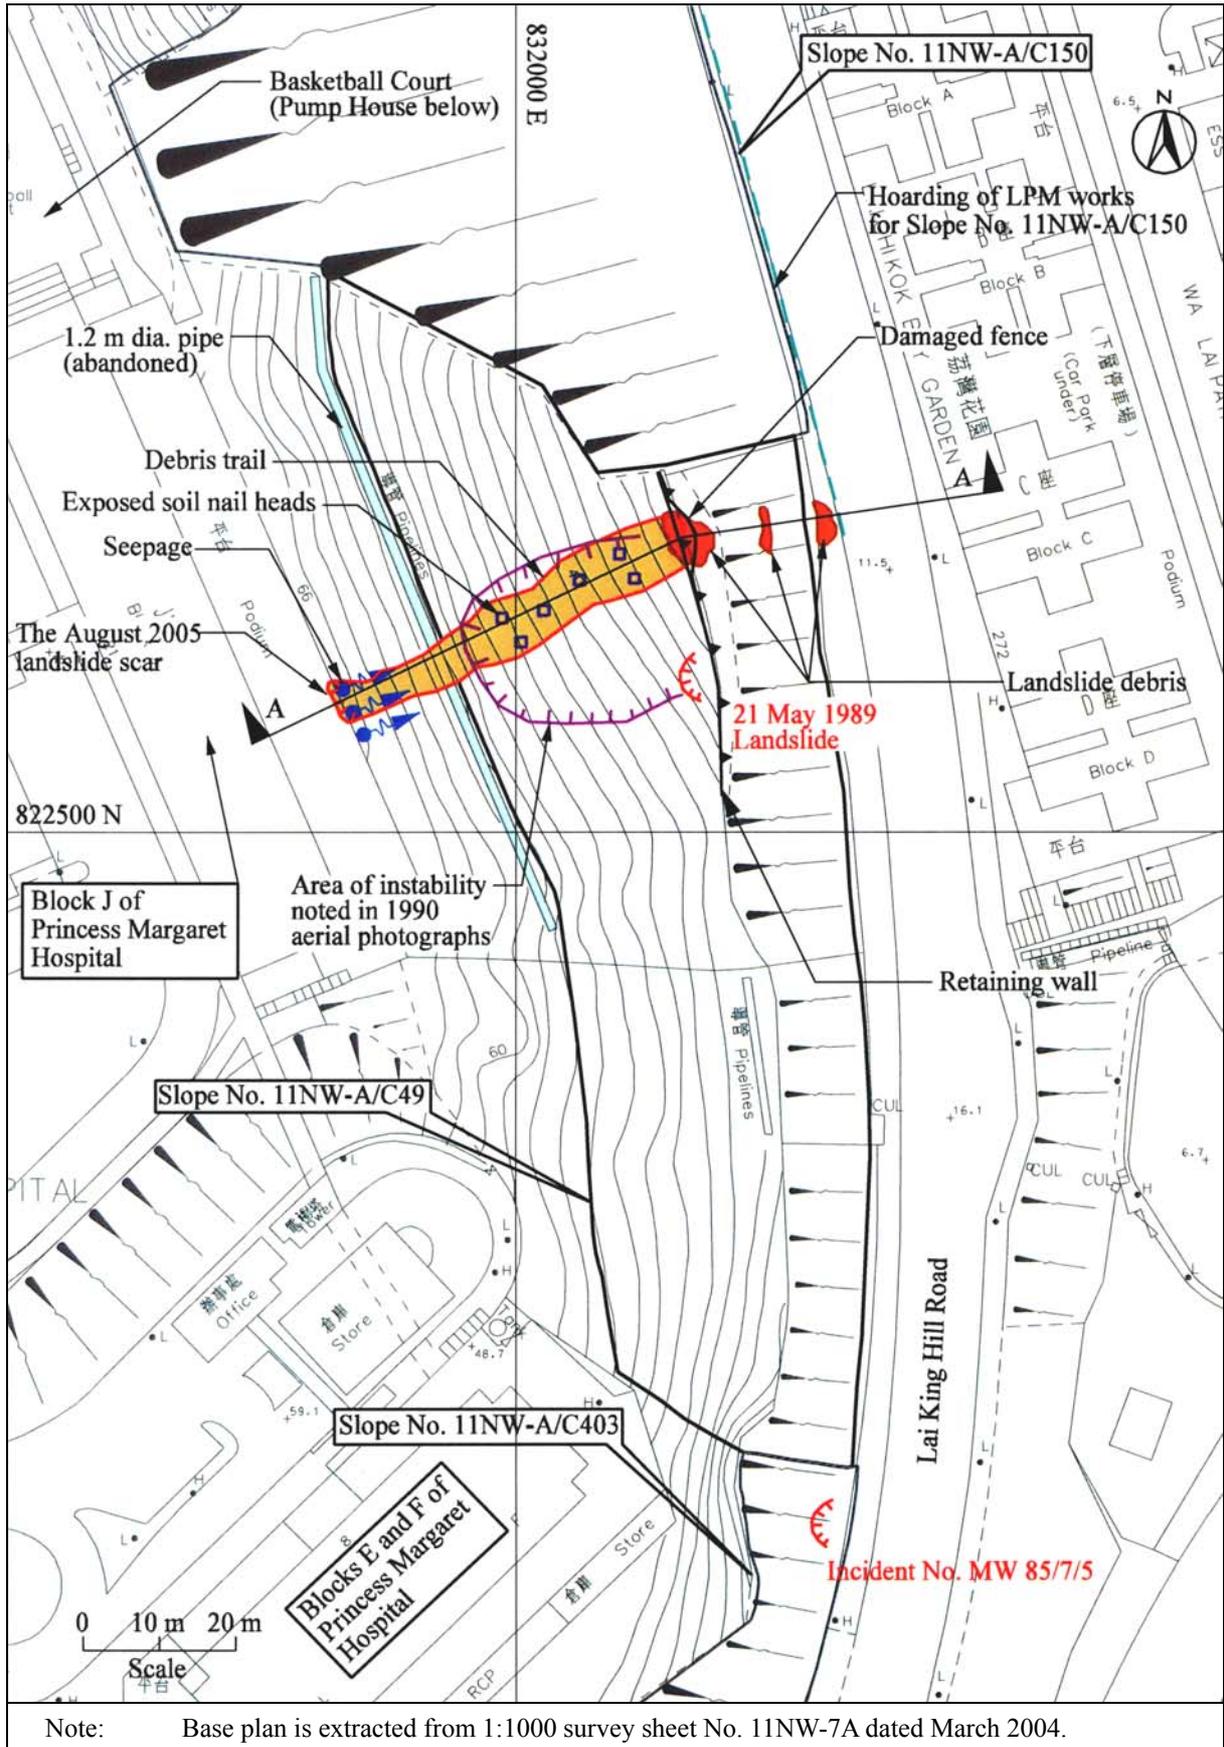
Figure 2 - Site Plan

The 1990 aerial photographs revealed that a patch of bare surface noted on the hillside near the crest of slope No. 11NW-A/C49 might be an area of instability (Figures 2 and A1). However, no records in relation to this instability could be located in the documentary records of the GEO.

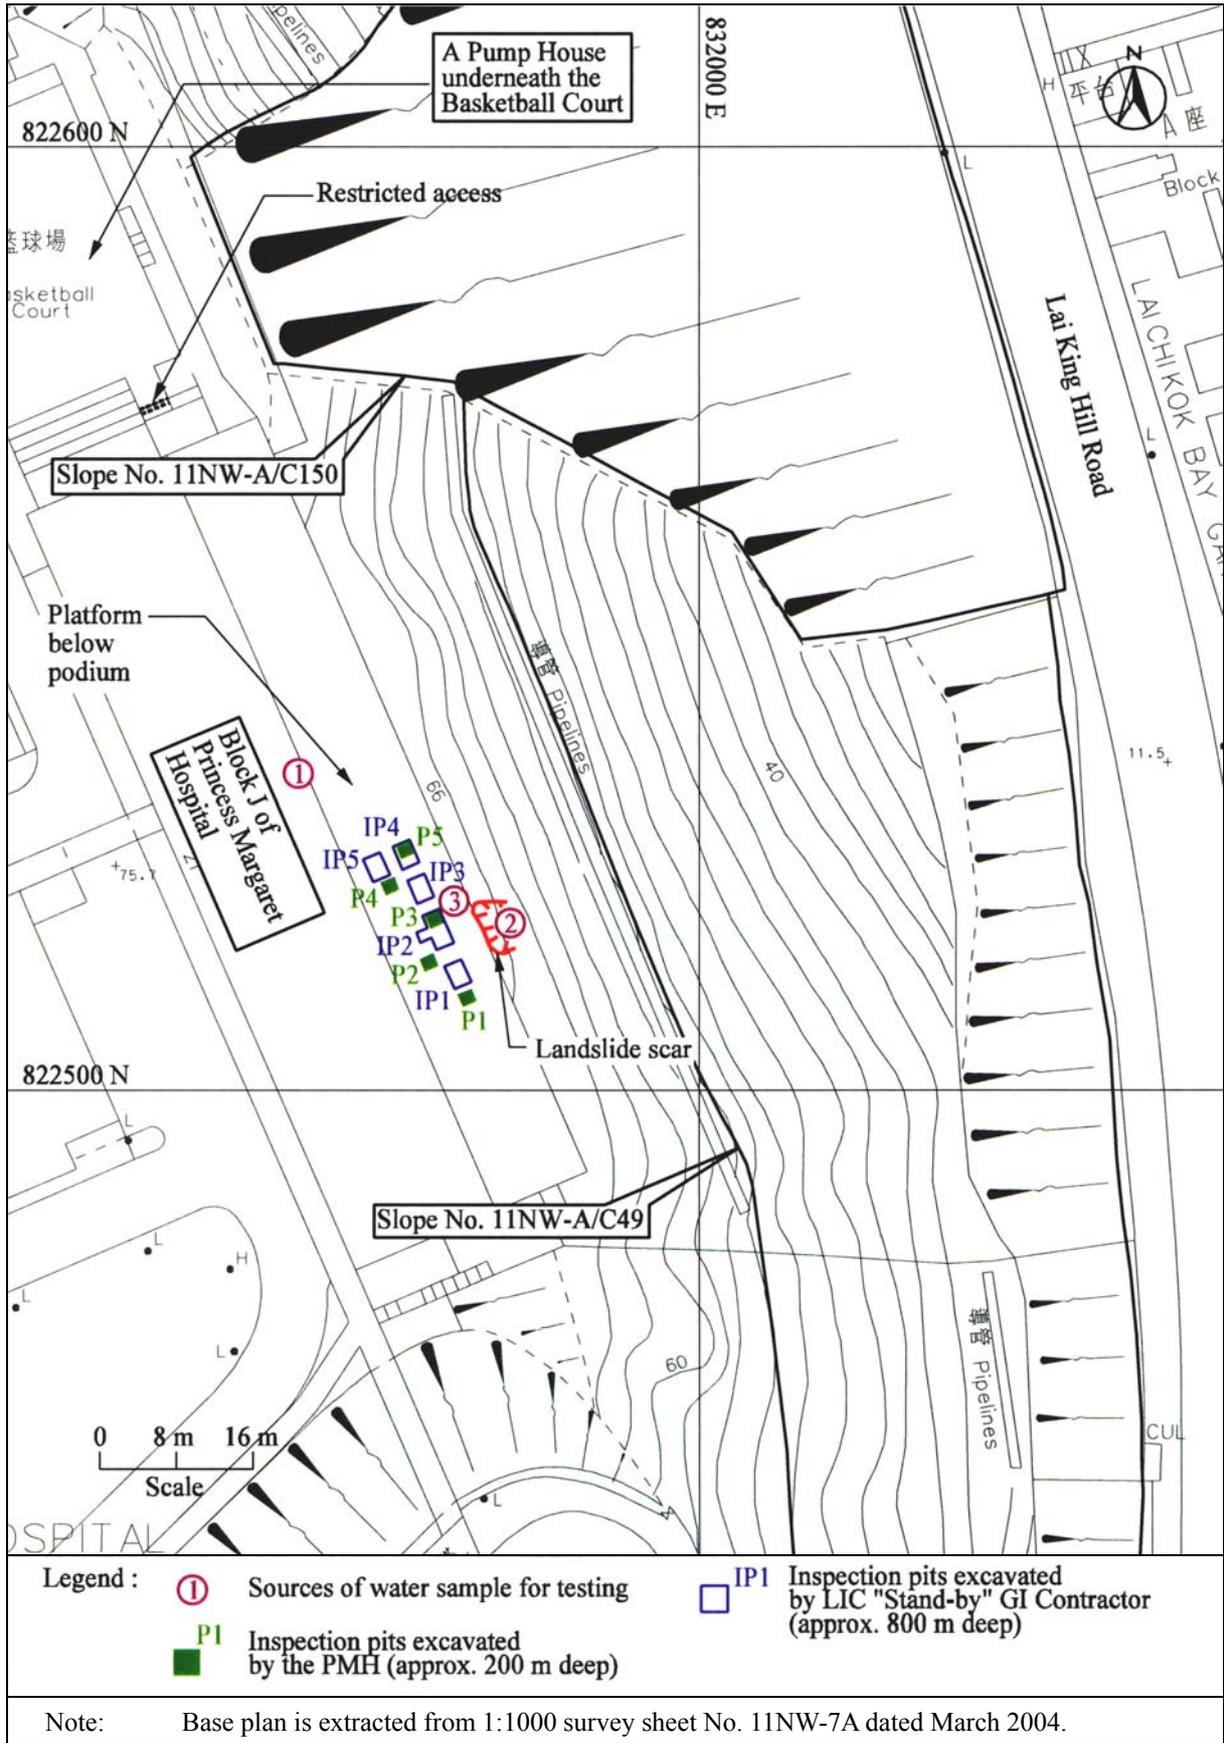
Figure 4 - Location Plan of Inspection Pits and Sources of Water for Sampling

After the landslide, the EMSD, the prevailing maintenance agent to PMH, excavated five inspection pits (Nos. P1 to P5) (Figure 4) on the platform at the crest of the landslide scar on 12 August 2005 to identify and inspect the buried services. Three pipes (one is a 150 mm diameter heavily corroded steel pipe, one is a 200 mm diameter steel pipe and the remaining one is a 100 mm diameter uPVC pipe) were exposed in the pits at a depth of about 200 mm (Plates 6 and 7). No leakage or evidence of void or soil pipe was observed in the inspection pits. No leakage check or closed-circuit television (CCTV) survey of the buried pipes was

In order to locate the suspected leaky water pipe, five inspection pits (IP1 to IP5) at the platform behind the crest of the failed slope were dug by Inter Pacific Limited with the agreement of PMH. The locations of the five inspection pits are shown in Figure 4.

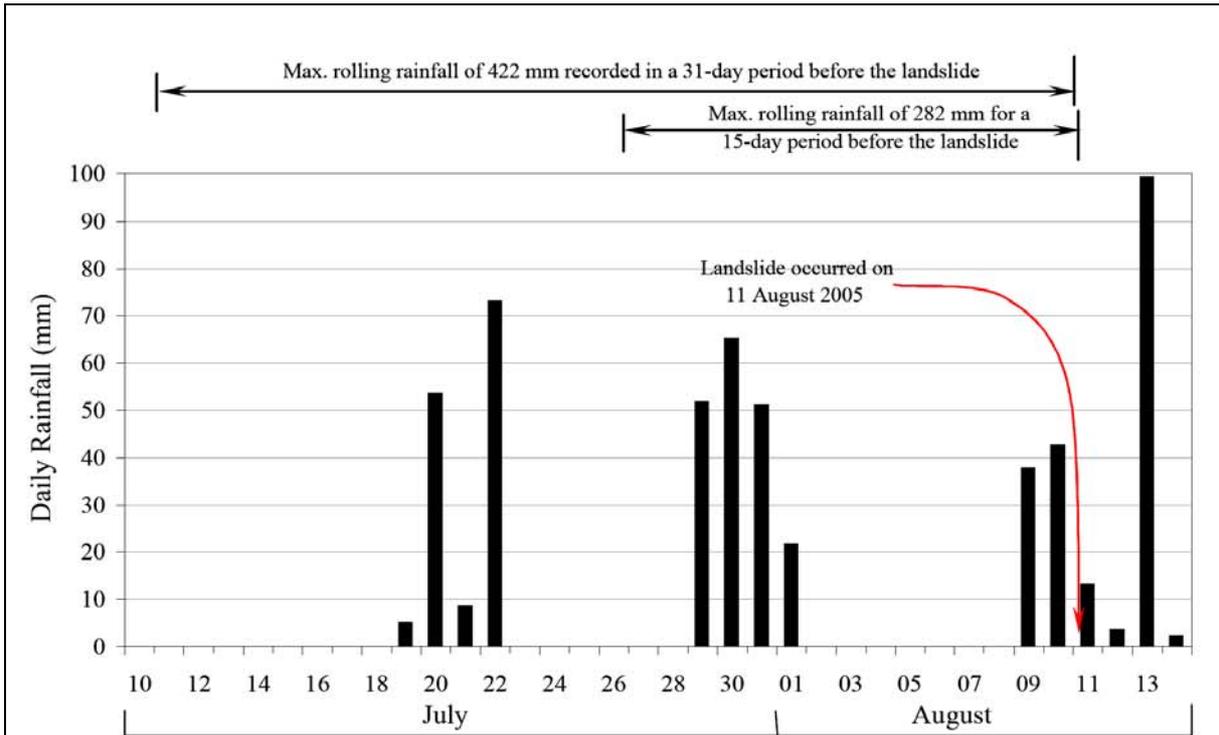
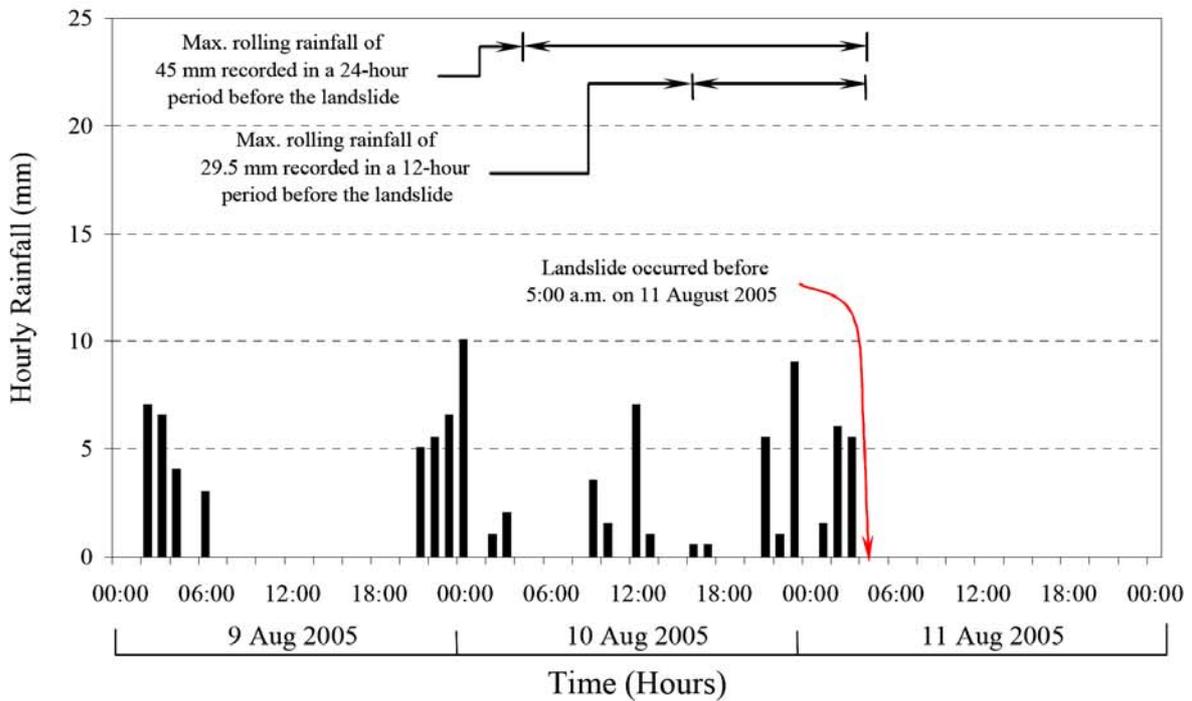
Figure 10 - Daily and Hourly Rainfall Recorded at GEO Rain gauge No. N04

The landslide occurred at about 5:00 a.m. on 11 August 2005. The daily and hourly rainfalls recorded by raingauge No. N04 prior to the August 2005 landslide are presented in Figure 10. The records show that there was only light rainfall before the 11 August 2005 landslide occurred, and the maximum rolling rainfall for one-hour and 24-hour periods are only 9 mm and 45 mm respectively (Table 1).
