**DETAILED STUDY OF THE
20 AUGUST 2005 LANDSLIDE
AT BOWEN ROAD ABOVE
NO. 120 KENNEDY ROAD**

GEO REPORT No. 214

FUGRO SCOTT WILSON JOINT VENTURE

**GEOTECHNICAL ENGINEERING OFFICE
CIVIL ENGINEERING AND DEVELOPMENT DEPARTMENT
THE GOVERNMENT OF THE HONG KONG
SPECIAL ADMINISTRATIVE REGION**

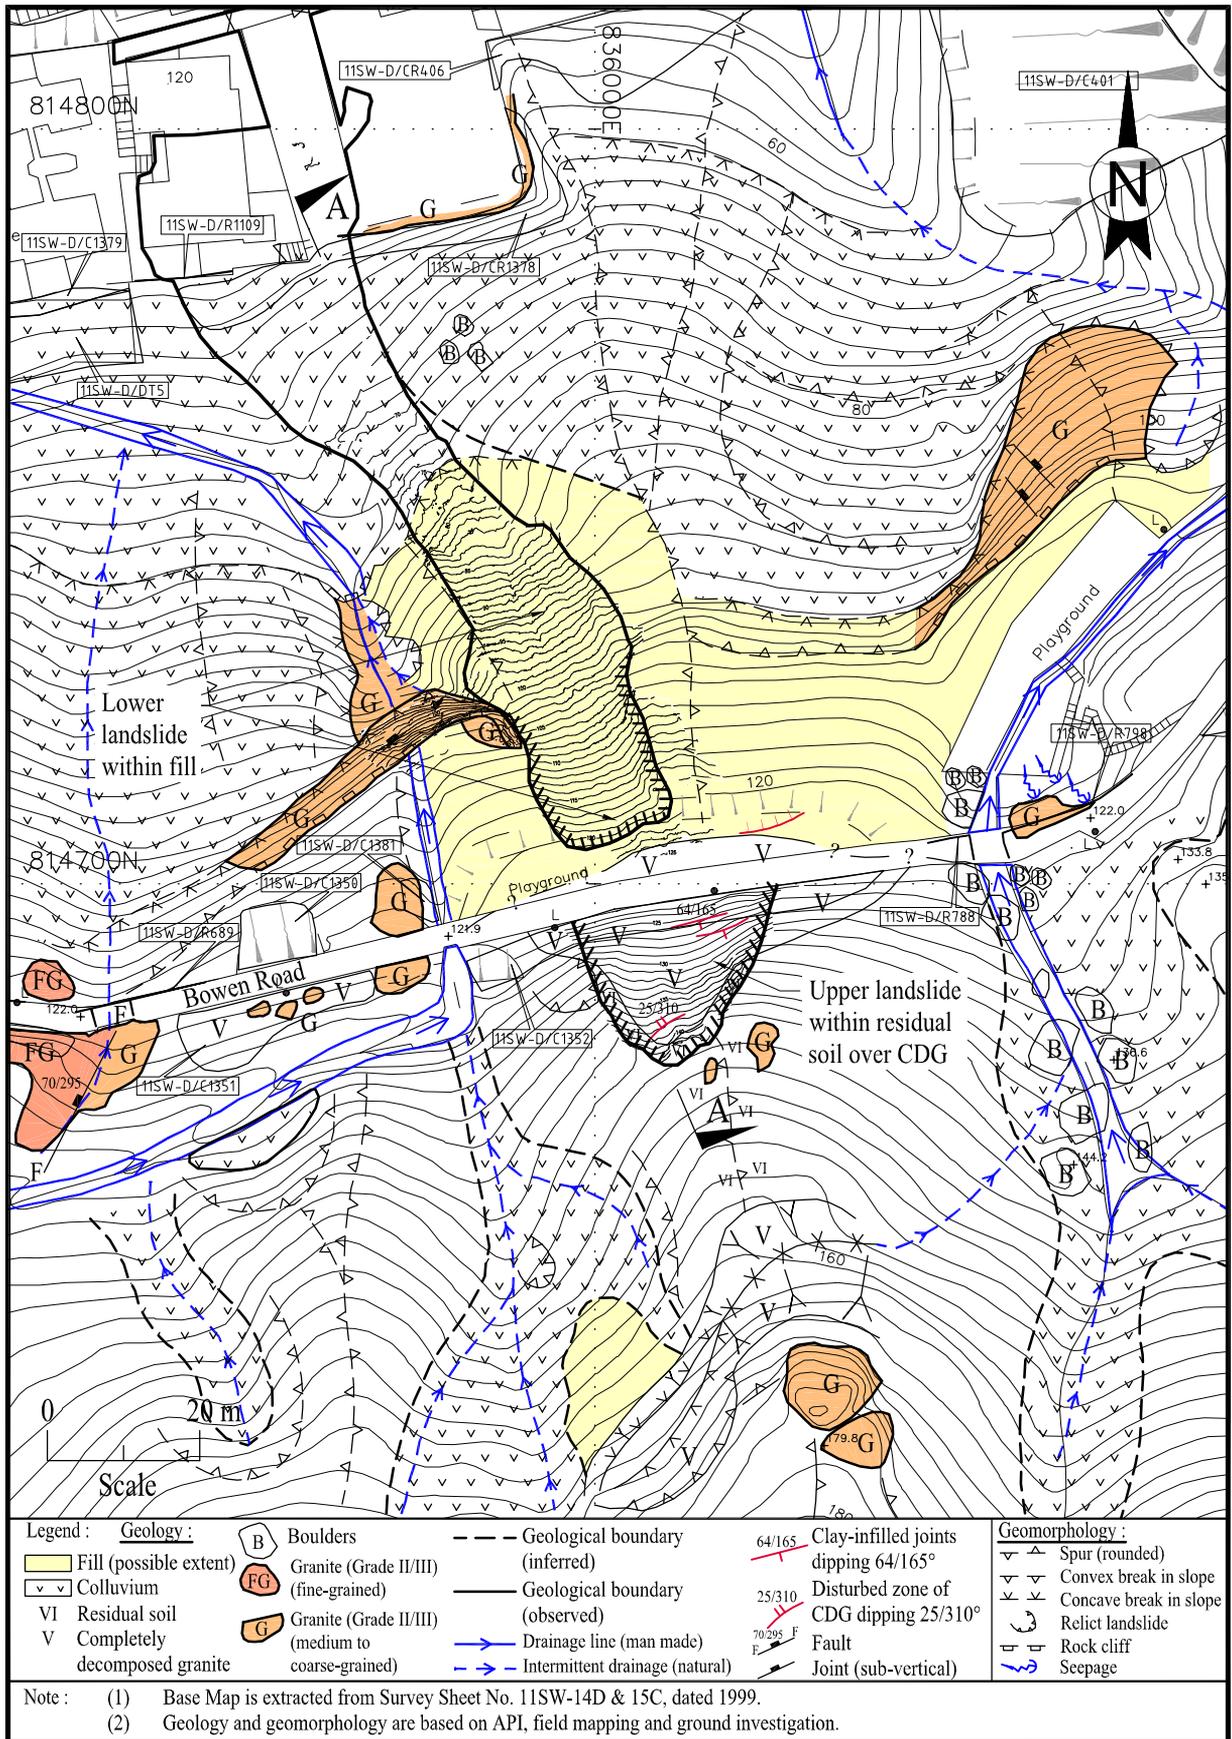
Figure 7 - Geology and Geomorphology

Granite corestones are exposed within CDG in Slopes Nos. 11SW-D/C1351 and 11SW-D/C1352 located either side of the upper landslide (Figure 7). The CDG is covered in some parts with chunam, which is cracked in places. The faulted granite contact is exposed at the boundary of Slopes nos. 11SW-D/C2167 and 11SW-D/C1349 (Figures 4 and 7). Bouldery colluvium is exposed within the major drainage line to the east of the upper landslide (Figure 7).

The tension crack observed on the platform adjacent to Bowen Road (Figures 2 and 7, and Plates 19 and 20) was further investigated by trial pit TP8 (Plate 23), together with slope surface strips SS2a and SS2b. At each location, the crack was noted to be within fill and was poorly developed as compared with the crack observed at ground surface. In trial pit TP8, the crack was observed up to about 0.6 m depth at the rear of a concrete block. The crack was about 30 mm wide and comprised some loose soil infill.

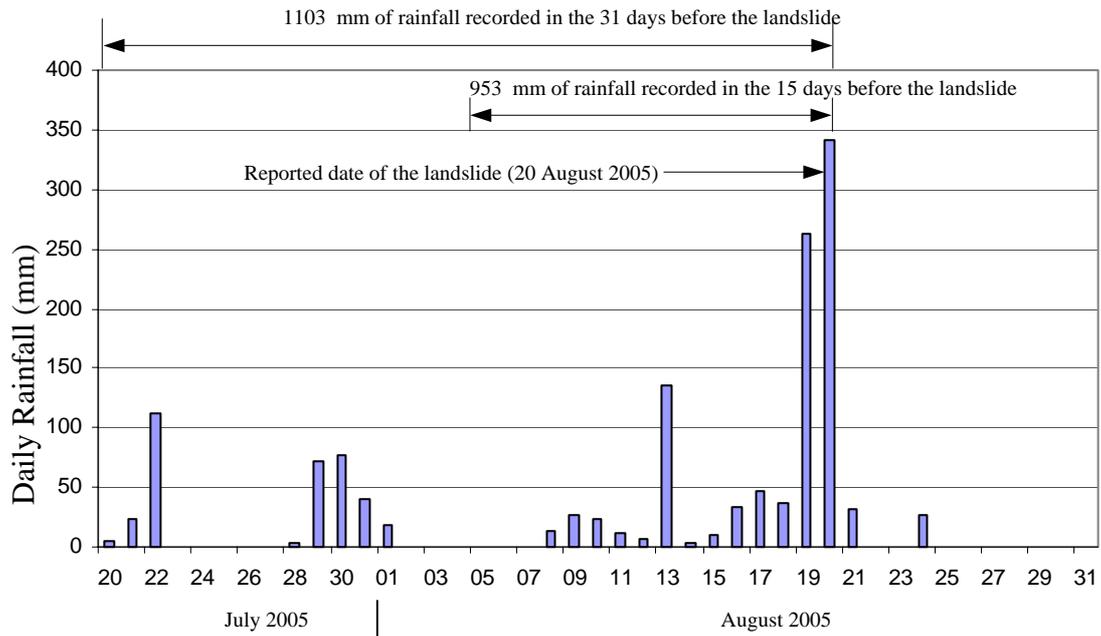
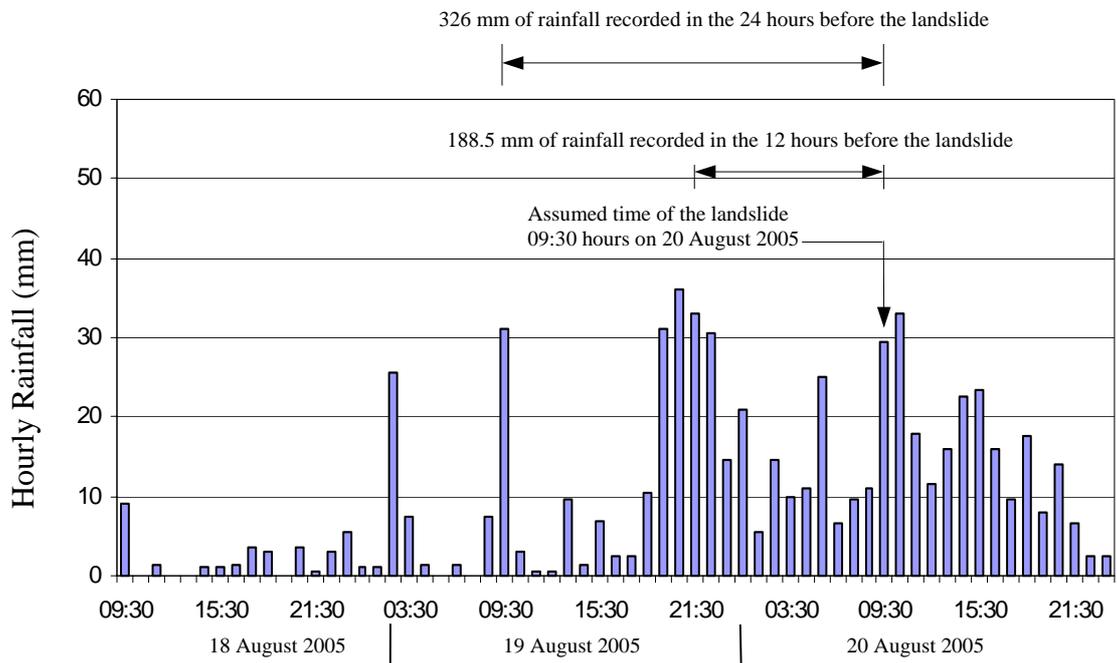
Figure 9 - Rainfall Records of GEO Raingauge No. H06

The daily rainfall recorded by the raingauge between 20 July and 25 August 2005, and the hourly rainfall between 9:30 a.m. on 18 August 2005 and 11:30 p.m. on 20 August 2005 are shown in Figure 9. The 24-hour and 12-hour rainfall before the landslide was 326 mm and 188.5 mm respectively. The maximum 1-hour rolling rainfall was recorded as 36 mm between 8:05 p.m. and 9:05 p.m. on 19 August 2005.

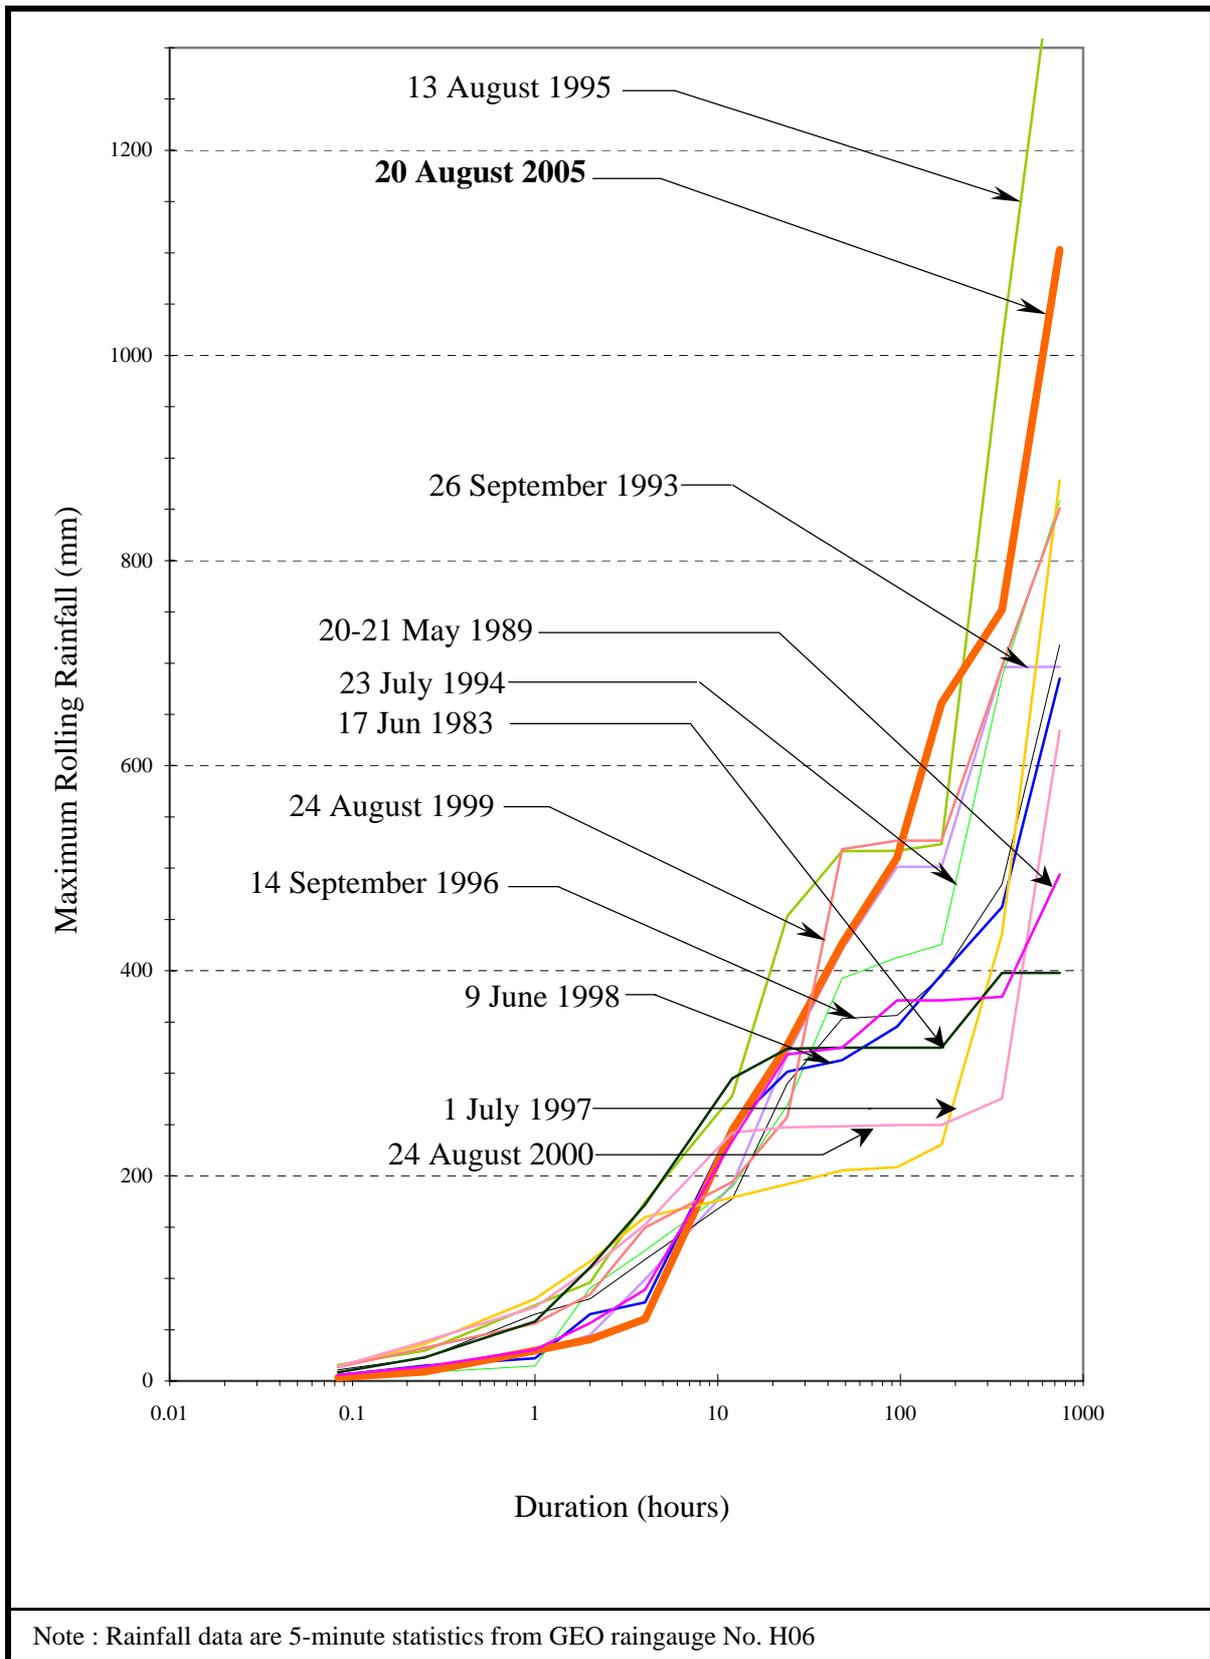
Figure 10 - Maximum Rolling Rainfall Preceding the 20 August 2005 Landslides and Selected Previous Major Rainstorms Recorded at GEO Raingauge No. H06

The maximum rolling rainfall for the rainstorm on August 2005 has been compared with the past significant rainstorms between 1983 and 2000 recorded by raingauge No. H06, which came into operation in 1983 (Figure 10). The results indicate that the August 2005 rainstorm was the most severe in terms of 4-day to 9-day duration rainfall since the installation of the raingauge in 1983.

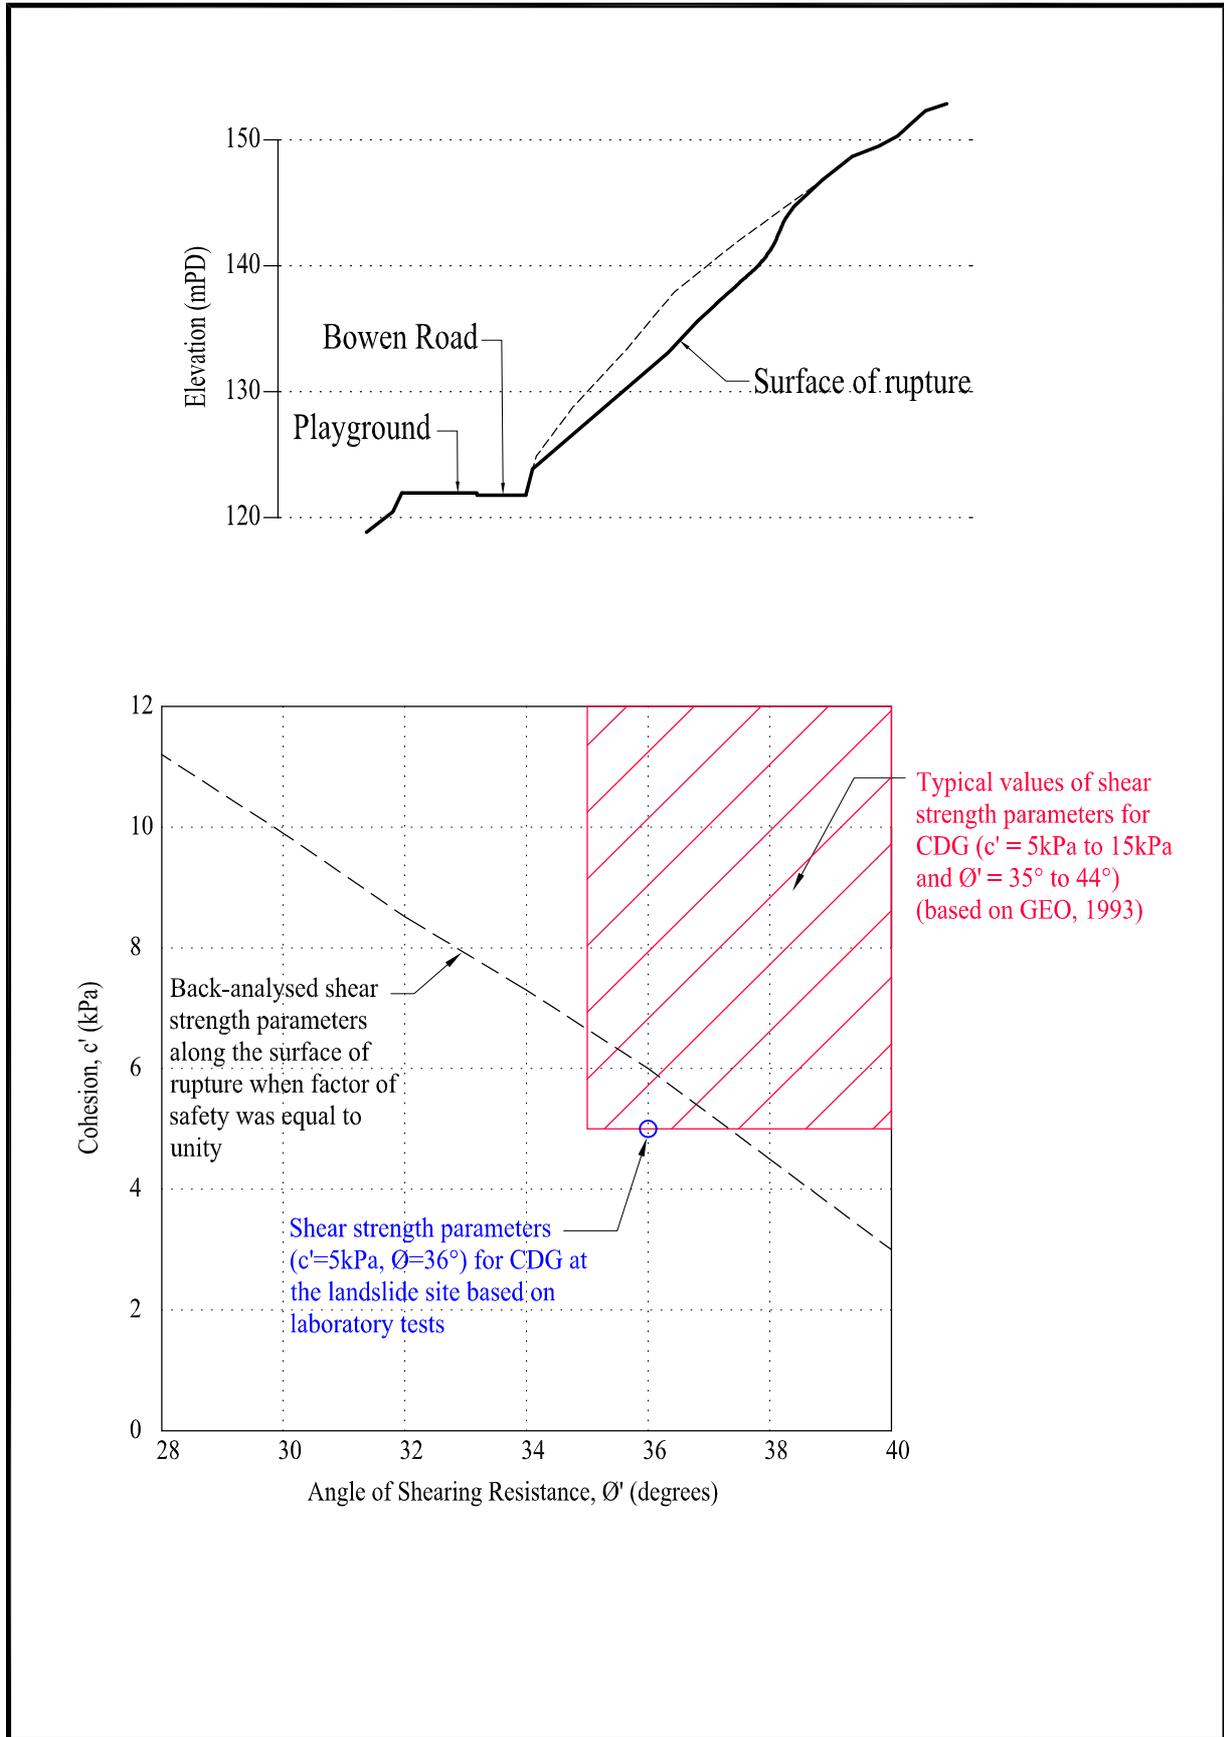
Figure 11 - Results of Theoretical Slope Stability Analyses

The information used in the analyses was obtained from the post-failure ground investigations, fieldwork and laboratory testing, together with site observations and measurements. A representative cross-section of the landslide site is shown in Figure 11. The pre-failure slope profile was established from topographic survey plans, aerial photographic records, the adjoining slope profiles and inference using engineering judgement. The geometry of the rupture surface was determined by site measurements undertaken by FSW and post-failure topographic survey.

The results of the analyses are presented in Figure 11. The results suggest that the slope possessed a factor of safety close to unity prior to the landslide under zero groundwater pressure, when the shear strength parameters for CDG obtained from laboratory tests on samples taken from the site (i.e. $c' = 5$ kPa and $\phi' = 36^\circ$) were adopted. As such, prior to the August 2005 failure, the slope might have been in a marginally stable condition. The results of the analyses reflect the susceptibility of the hillside to rain-induced landslides arising from the reduction of soil suction and the build-up of transient groundwater pressures in the near-surface materials through infiltration and subsurface seepage.

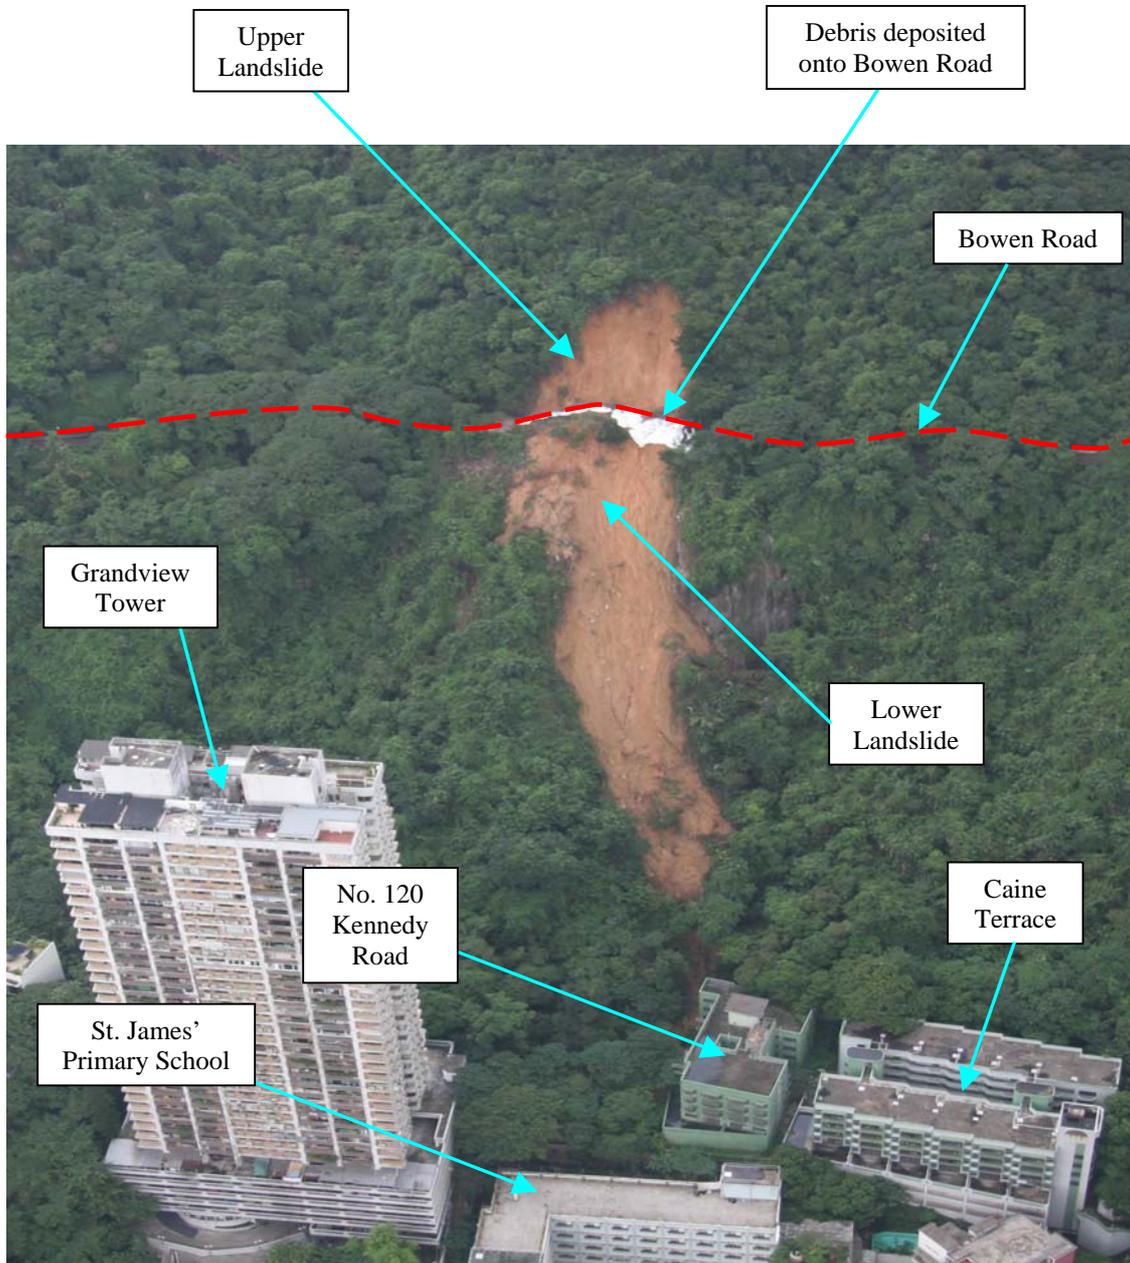
Plate 1 - General View of the Landslide Site (Photograph Taken on 22 August 2005)

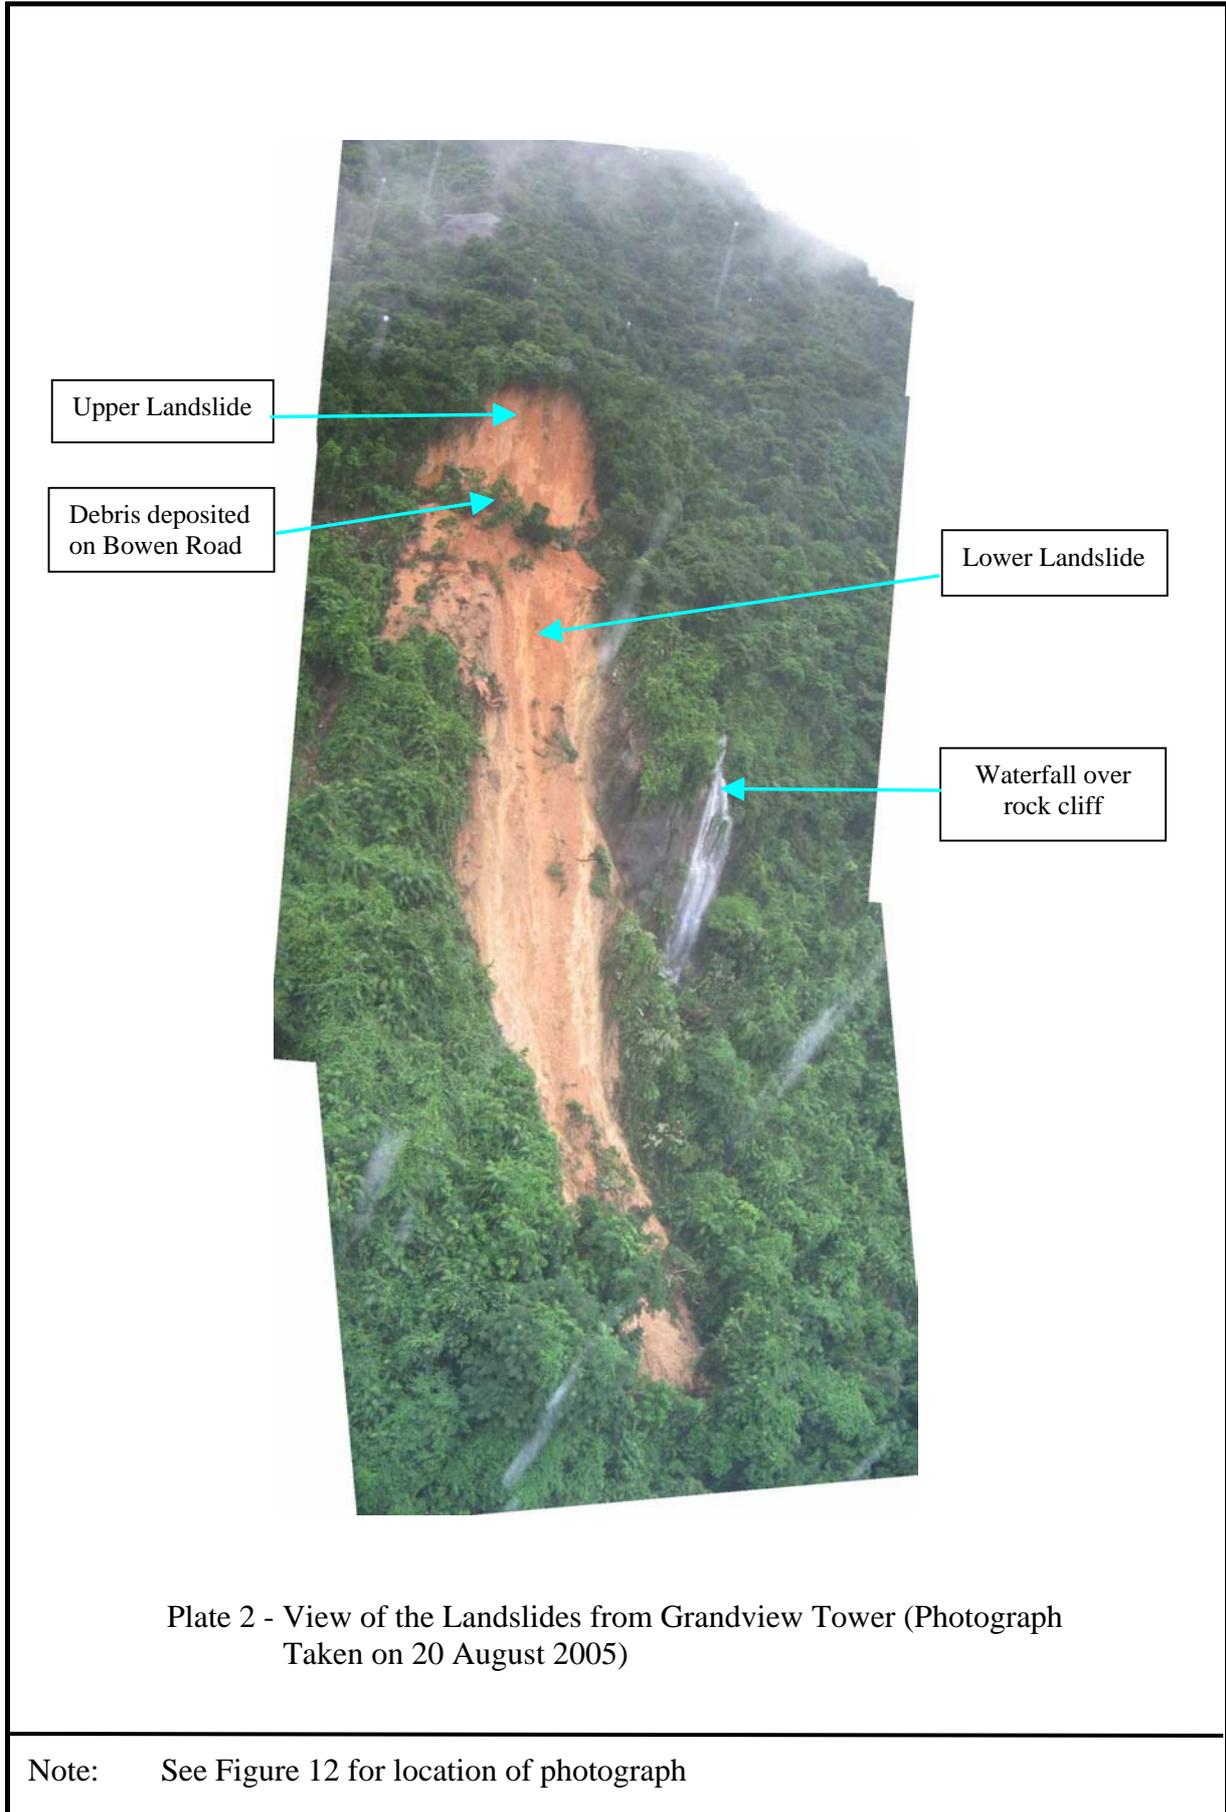
Plate 2 - View of the Landslides from Grandview Tower (Photograph Taken on 20 August 2005)

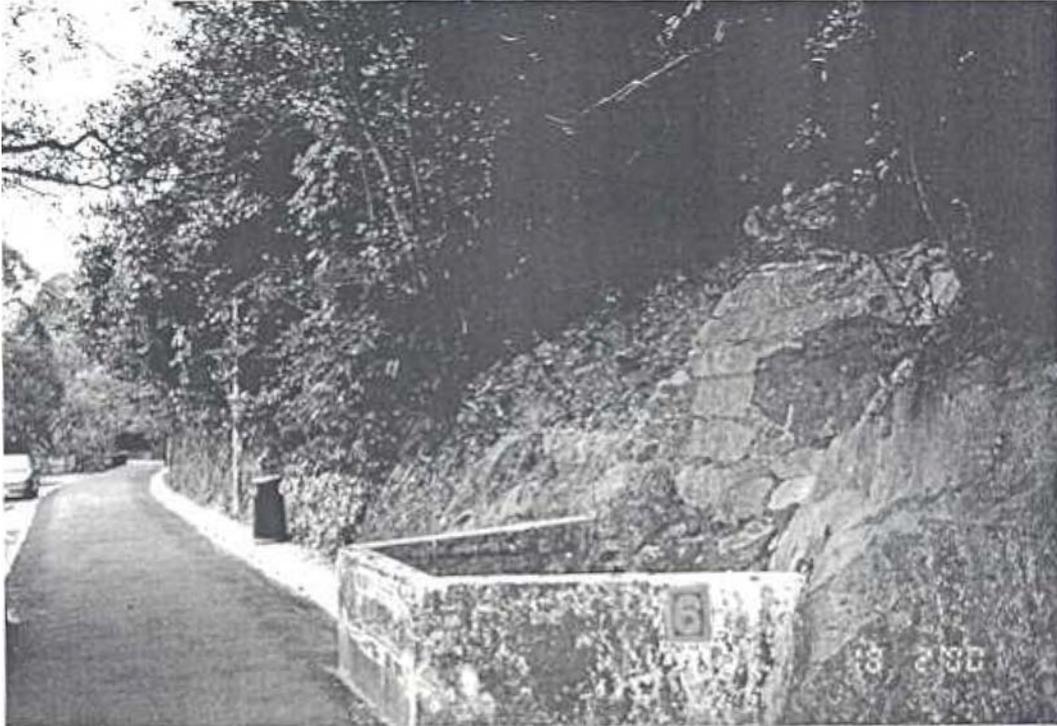
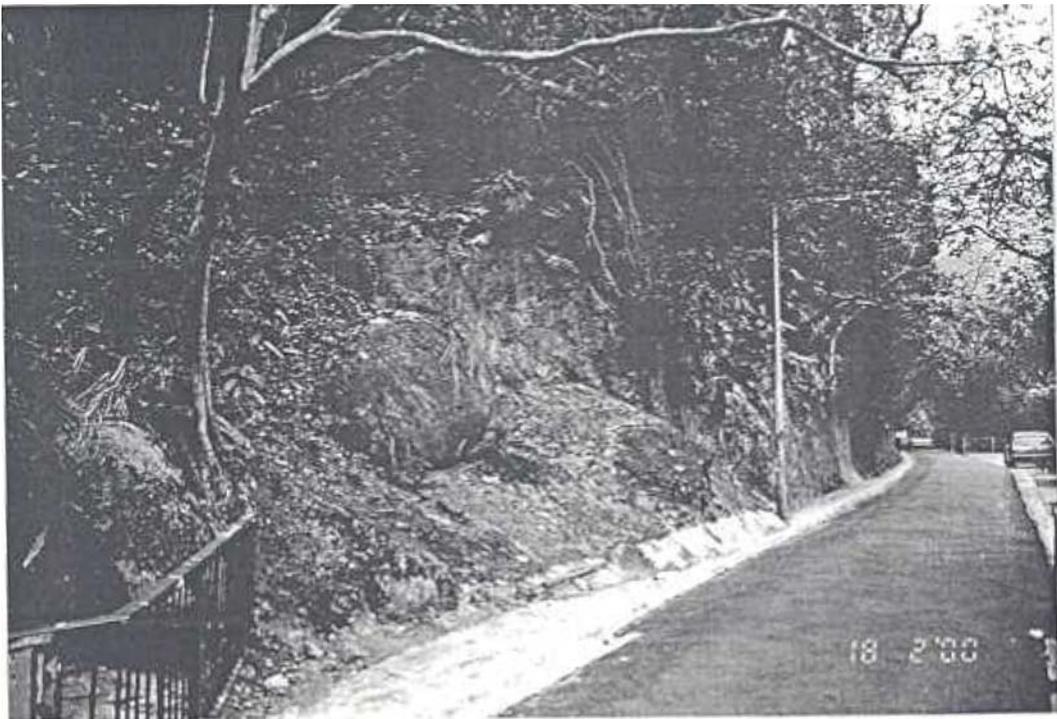
Plate 4 - Record Photographs of Slope No. 11SW-D/C1352 Taken in February 2000

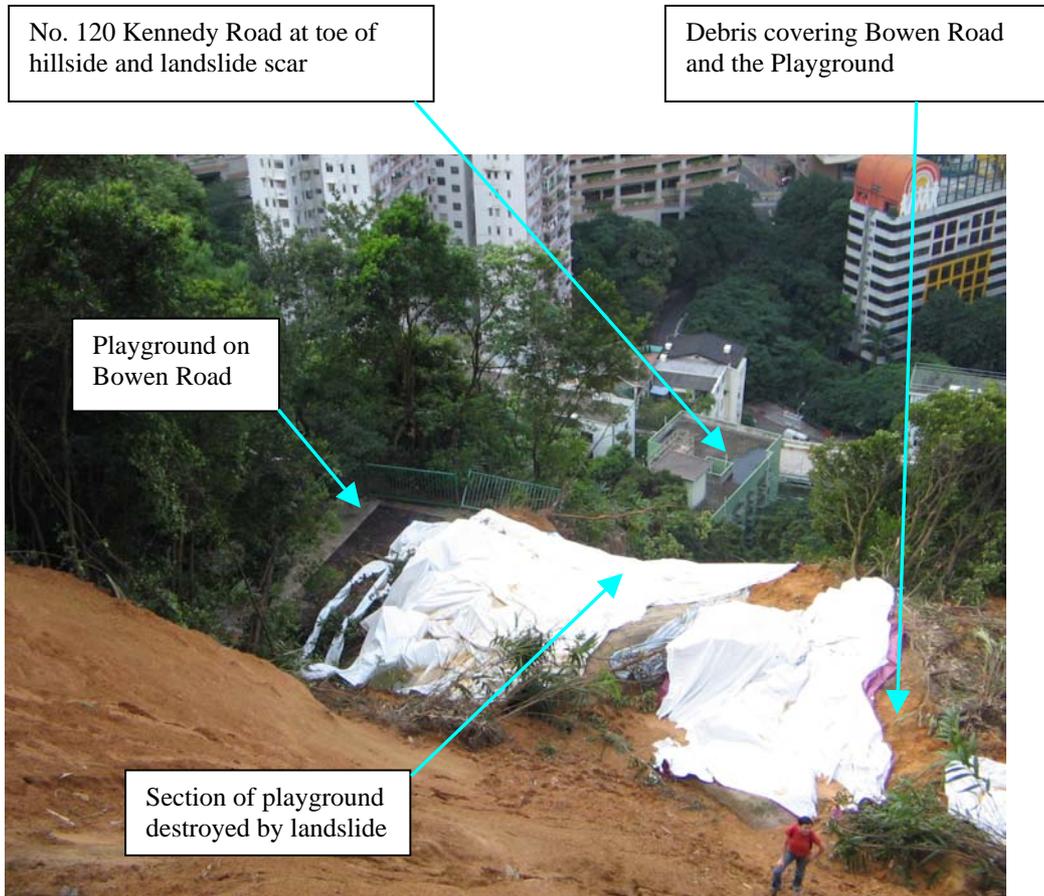
Plate 9 - View from Upper Landslide above Bowen Road (Photograph Taken on 23 August 2005)
