**DETAILED STUDY OF
THE 20 AUGUST 2005
LANDSLIDE ON SLOPE NO.
11NE-A/C153 AT PING TING
ROAD, NGAU CHI WAN**

GEO REPORT No. 215

T.M.F. Lau & K.K.S. Ho

This report presents the findings of a review of a landslide (Incident No. 2005/08/0299) that occurred at the rock portion of a 47 m high soil/rock cut slope No. 11NE-A/C153 at Ping Ting Road, Ngau Chi Wan, at about 2:37 a.m. on 20 August 2005. The landslide involved the detachment of a total of about 36 m³ of rock blocks and soil, and the displacement of a rock wedge, about 12 m wide and 14 m high. Both lanes of Ping Ting Road were temporarily closed. No casualties were reported as a result of the landslide.

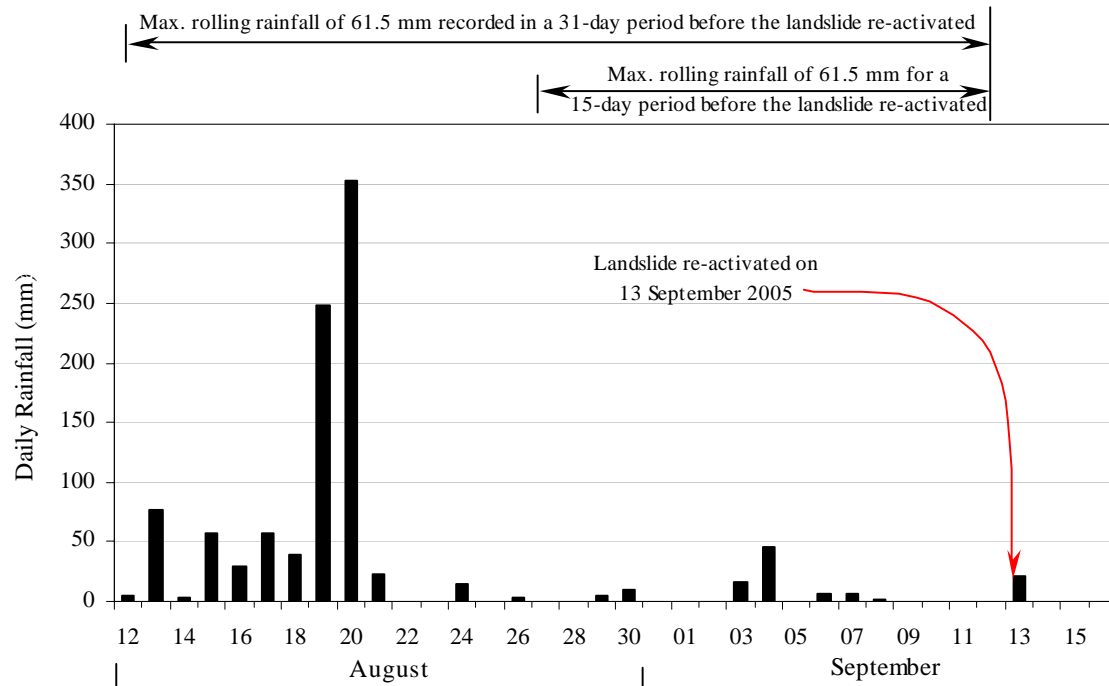
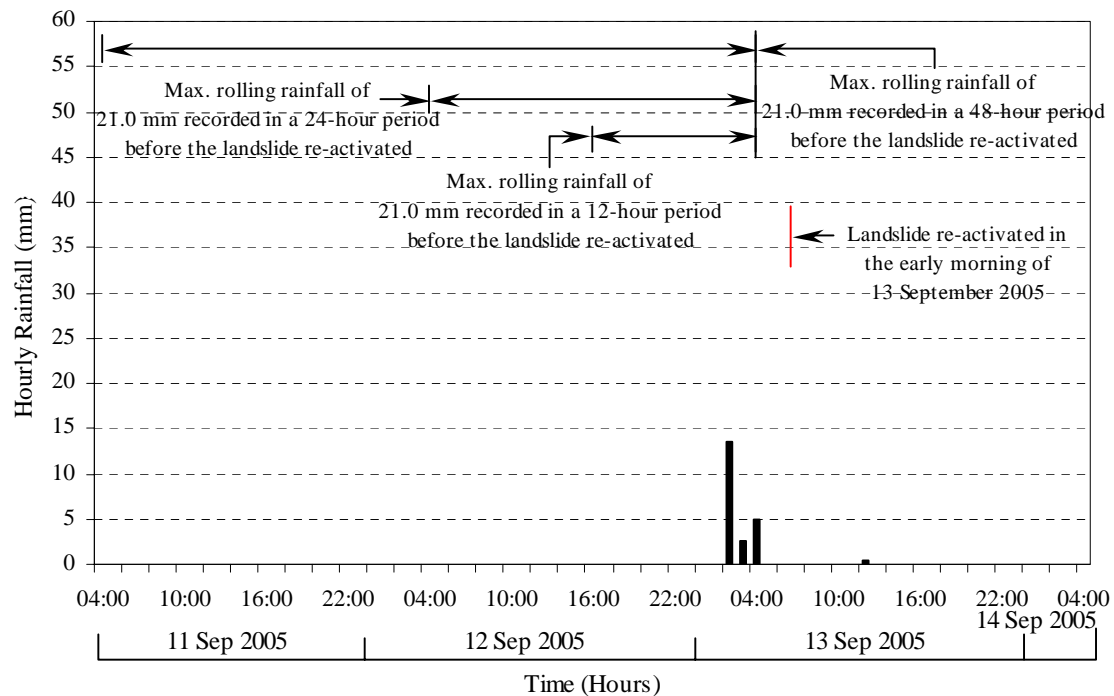
Figure 11 - Daily and Hourly Rainfall Recorded at GEO Raingauge No. K09 Preceding the Re-activated Landslide on 13 September 2005

On the morning of 13 September 2005, further instability of slope No. 11NE-A/C153 occurred at the location of the 20 August 2005 landslide following relatively light rainfall (Figure 11). MGSL inspected the landslide on the morning of 14 September 2005.

The daily rainfall recorded by raingauge No. K09 over the month preceding the landslide on 13 September 2005, together with the hourly rainfall readings for the period of 11 to 14 September 2005, are presented in Figure 11. A short duration rainstorm started on the early morning of 13 September 2005 and rainfall was recorded for less than 3 hours. The maximum 24-hour rolling rainfall before the landslide was 21 mm. The maximum 1-hour rolling rainfall was 13.5 mm between 2:00 a.m. and 3:00 a.m. in the early morning of 13 September 2005 (Table 2). Table 2 presents the estimated return periods for the maximum rolling rainfall for various durations. It can be seen that for rainfall durations

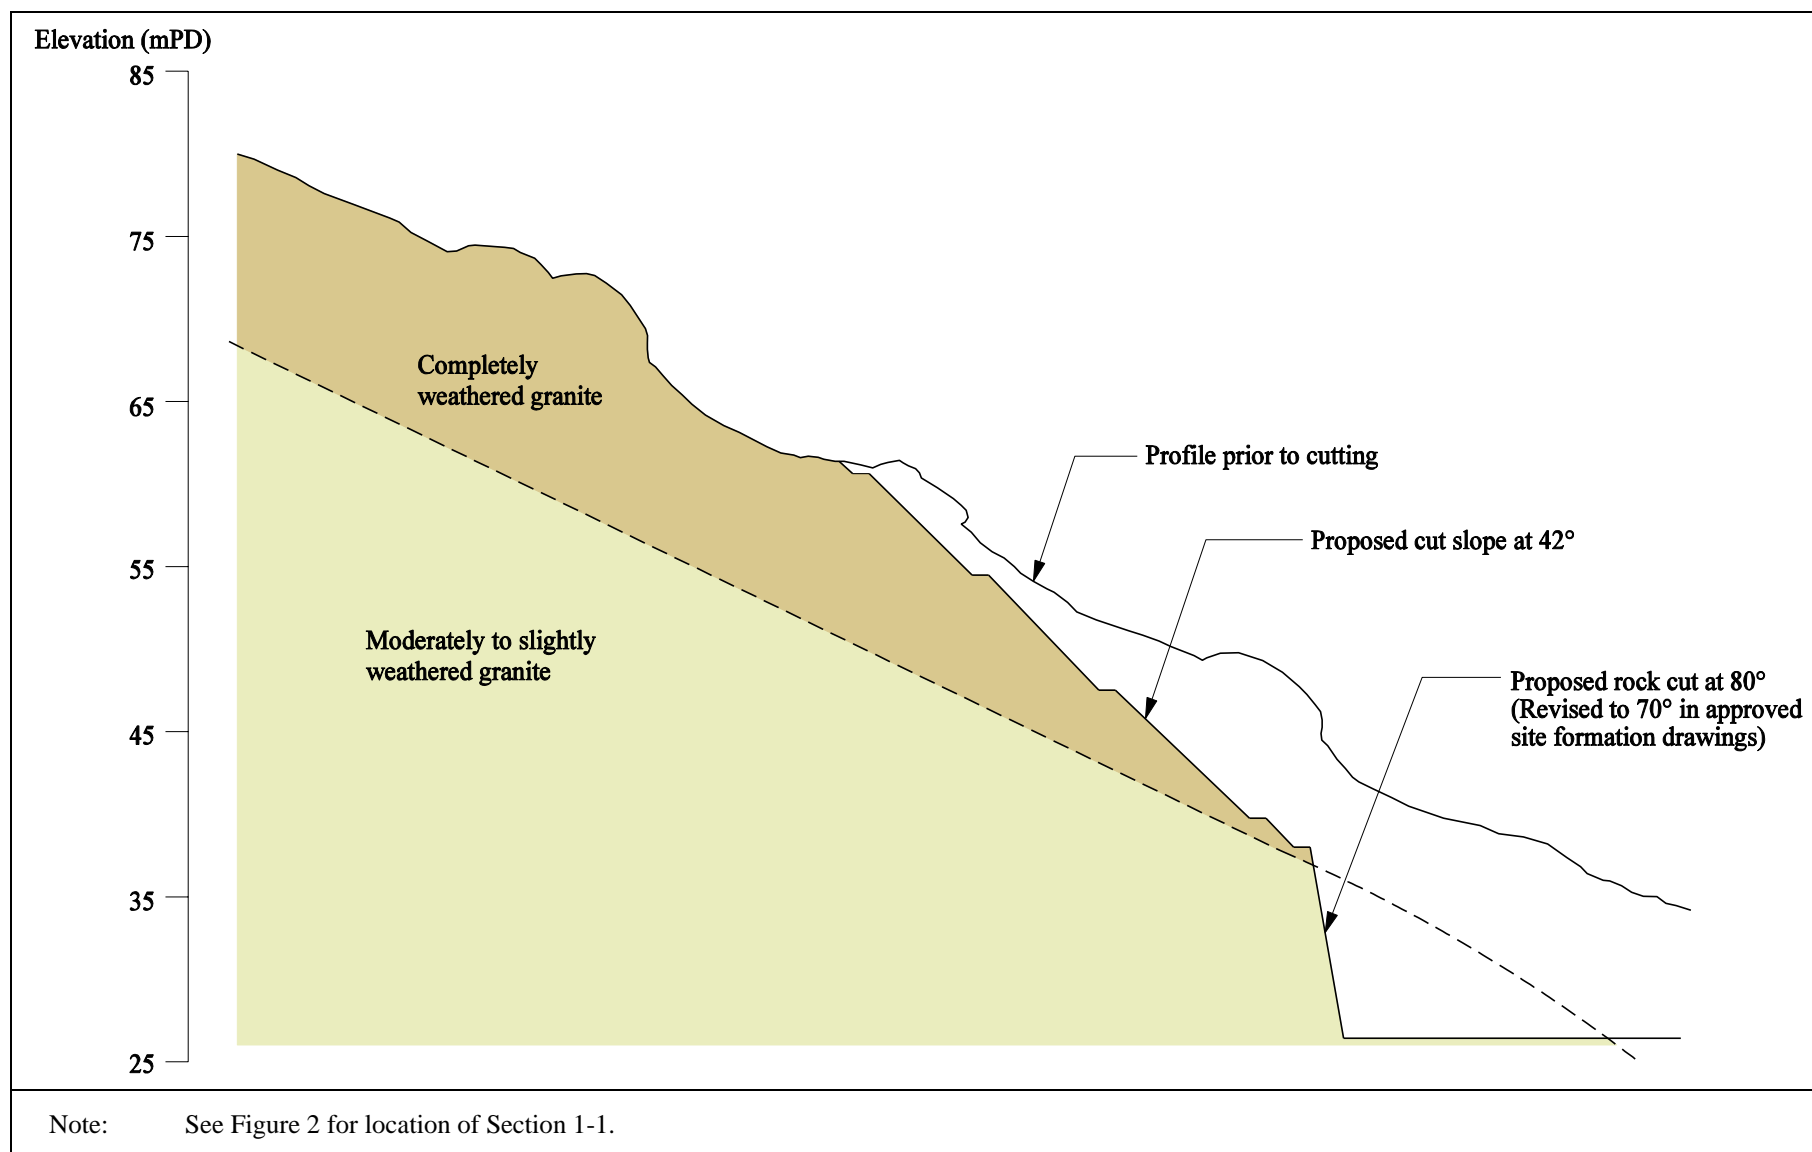
Figure 12 - Geological Section 1-1 Extracted from FHK Design Report (1978)

According to the GI information given in FHK (1978), the natural hillside prior to cutting in the vicinity of the August 2005 landslide site comprised approximately 7 m of completely to highly weathered granite with occasional “boulders”, overlying slightly weathered granite. The slightly weathered granite was described as “Pinkish light grey, medium to coarse-grained, moderately widely spaced joints, slightly weathered GRANITE, very strong”. An inferred geological cross-section of the hillside was presented in FHK (1978) as Section 1-1, which showed a 7 m to 10 m thick layer of completely weathered granite overlying moderately to slightly weathered granite. After forming the slope, the completely weathered granite would have been trimmed and the moderately to slightly weathered granite exposed at the lowermost batter. The extent of the cutting as depicted in Section 1-1 in FHK (1978) is reproduced in Figure 12.

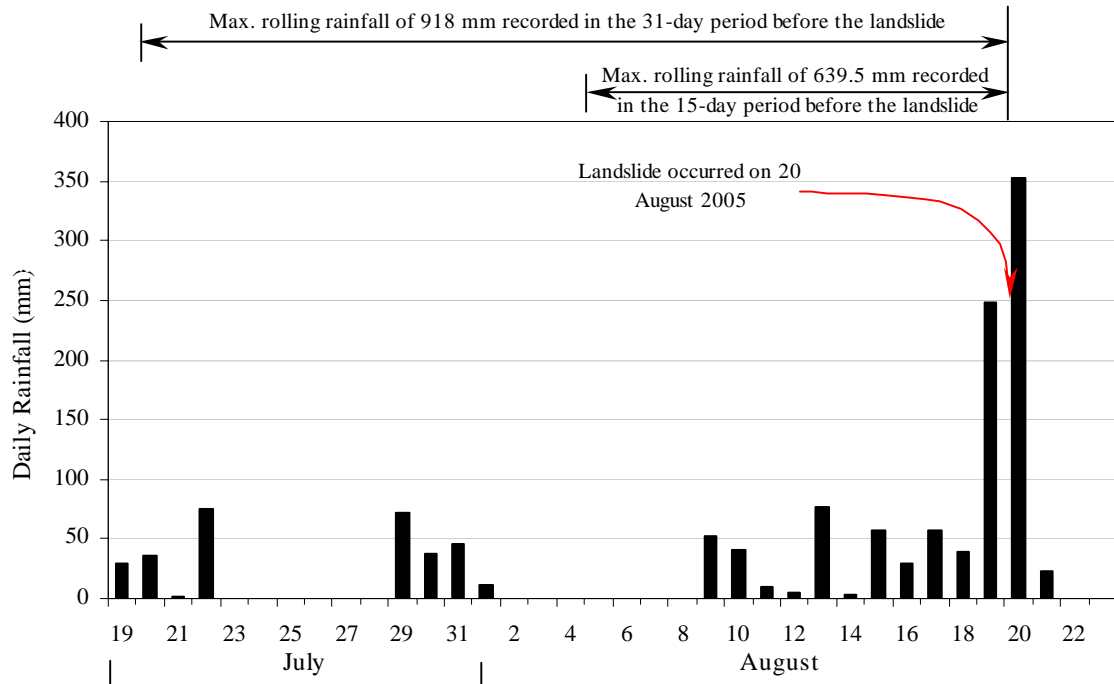
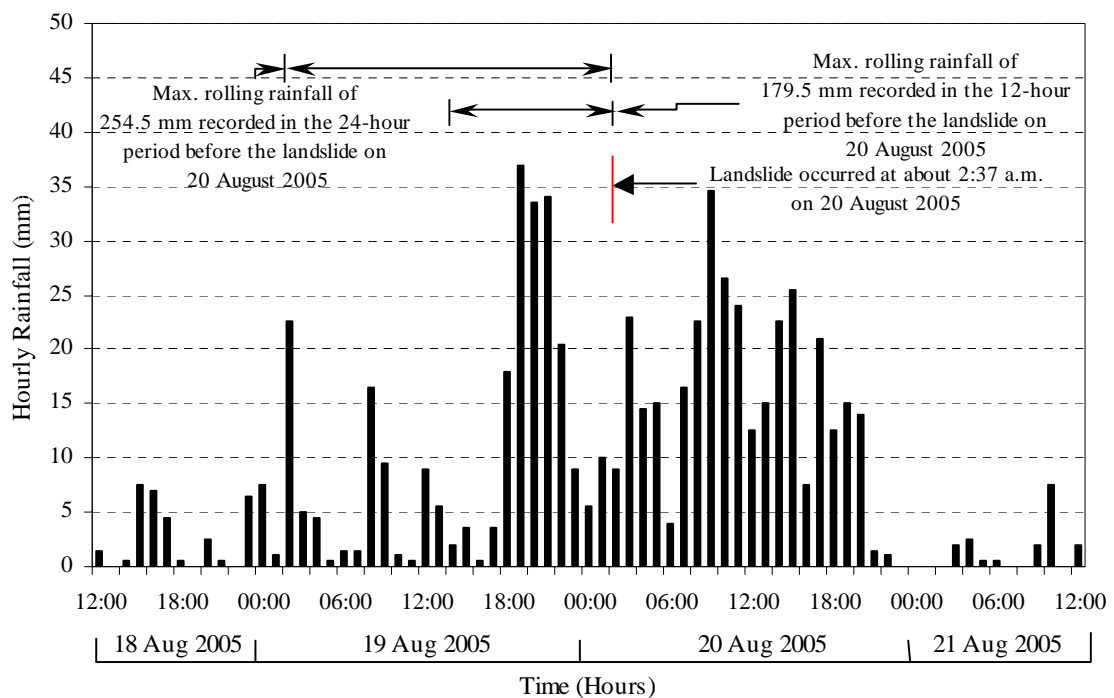
Figure 13 - Daily and Hourly Rainfall Recorded at GEO Raingauge No. K09 Preceding the Landslide on 20 August 2005

The daily rainfall recorded by raingauge No. K09 over the month preceding the 20 August 2005 landslide, together with the hourly rainfall readings for the period of 18 to 21 August 2005, are presented in Figure 13. A rainstorm started on the afternoon of 18 August 2005 and heavy rainfall was recorded until the evening of 20 August 2005. The maximum 24-hour and 48-hour rolling rainfall before the landslide was 255 mm and 307 mm respectively. The maximum 1-hour rolling rainfall was recorded as 44.5 mm between 7:25 p.m. and 8:25 p.m. on the evening of 19 August 2005 (Table 1).

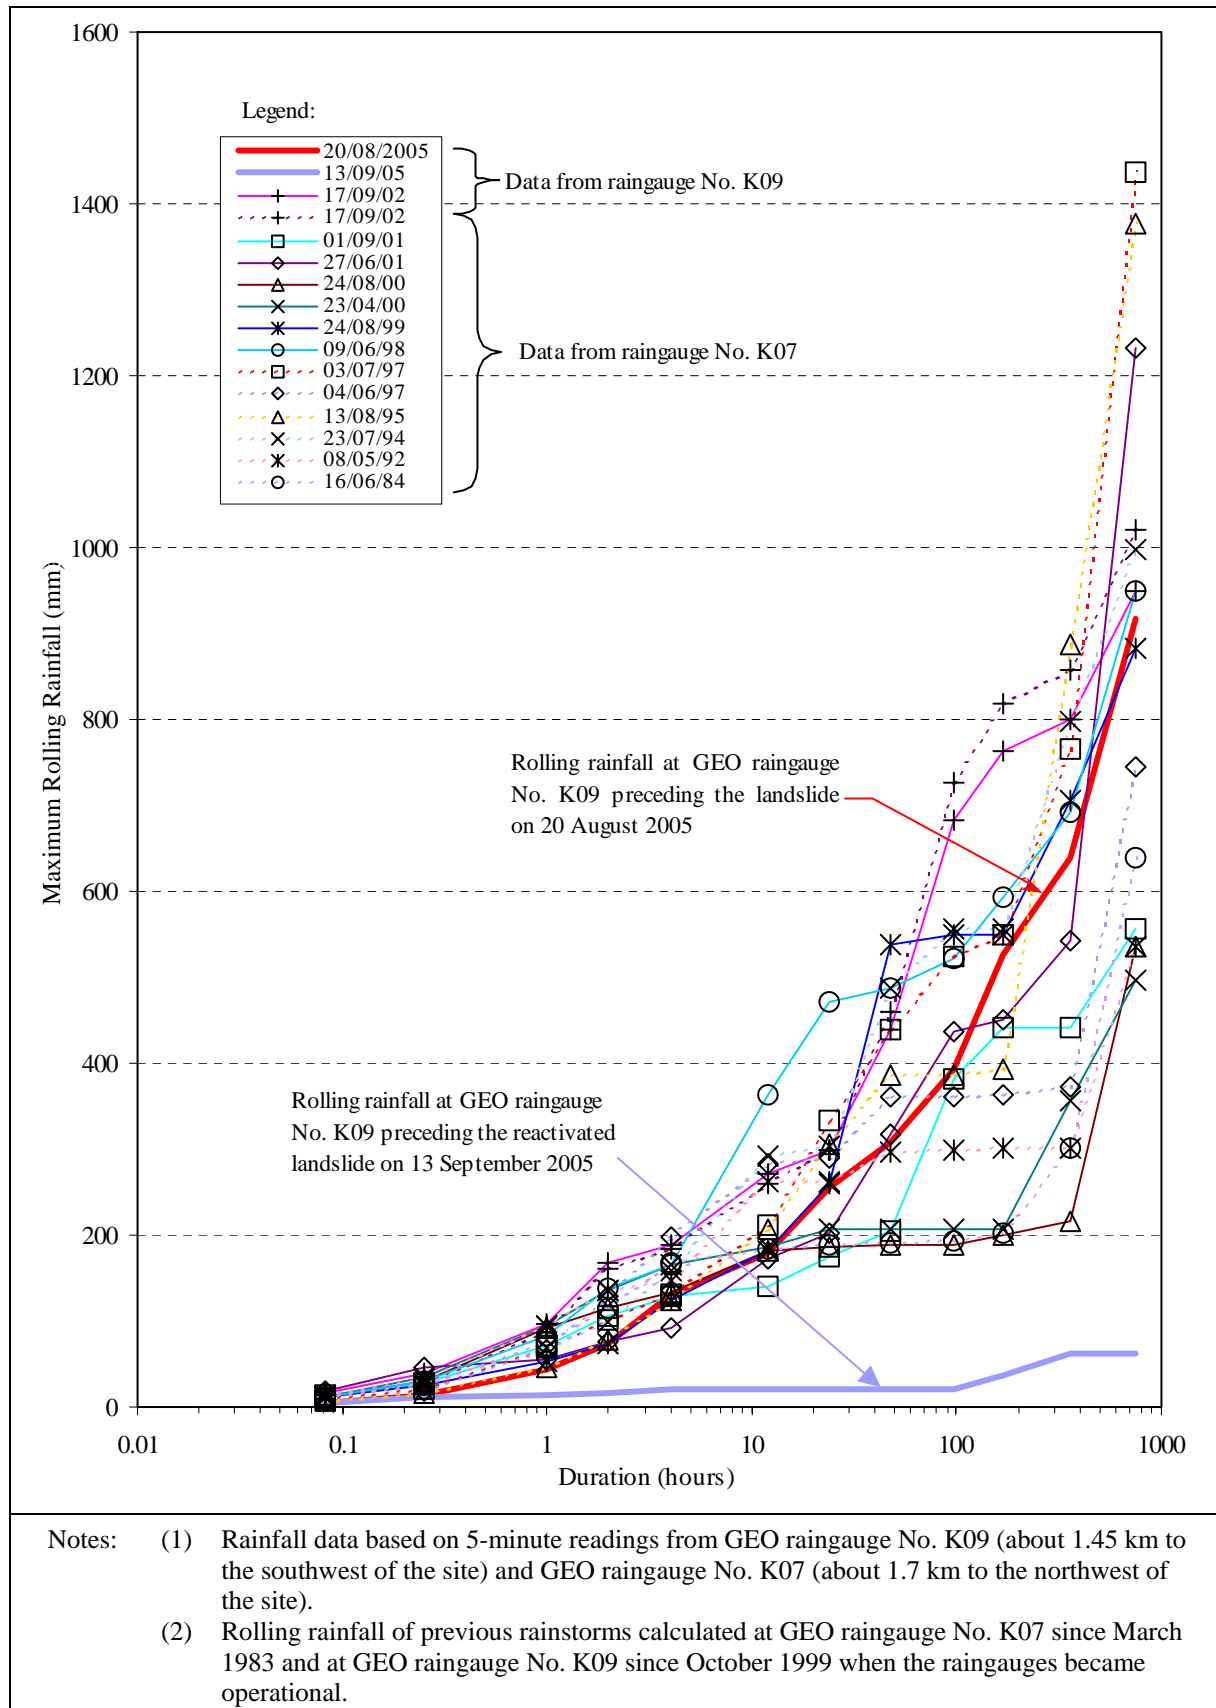
Figure 14 - Maximum Rolling Rainfall for Previous Major Rainstorms at GEO Raingauges Nos. K07 and K09

The maximum rolling rainfall for the August 2005 rainstorm has been compared with the past major rainstorms between 1983 and 2004 recorded by raingauges Nos. K07 and K09, which came into operation in March 1983 and October 1999 respectively (Figure 14). The maximum rolling rainfall for the 19 August 2005 rainstorm is less severe than the past rainstorms recorded between 1983 and 2004.

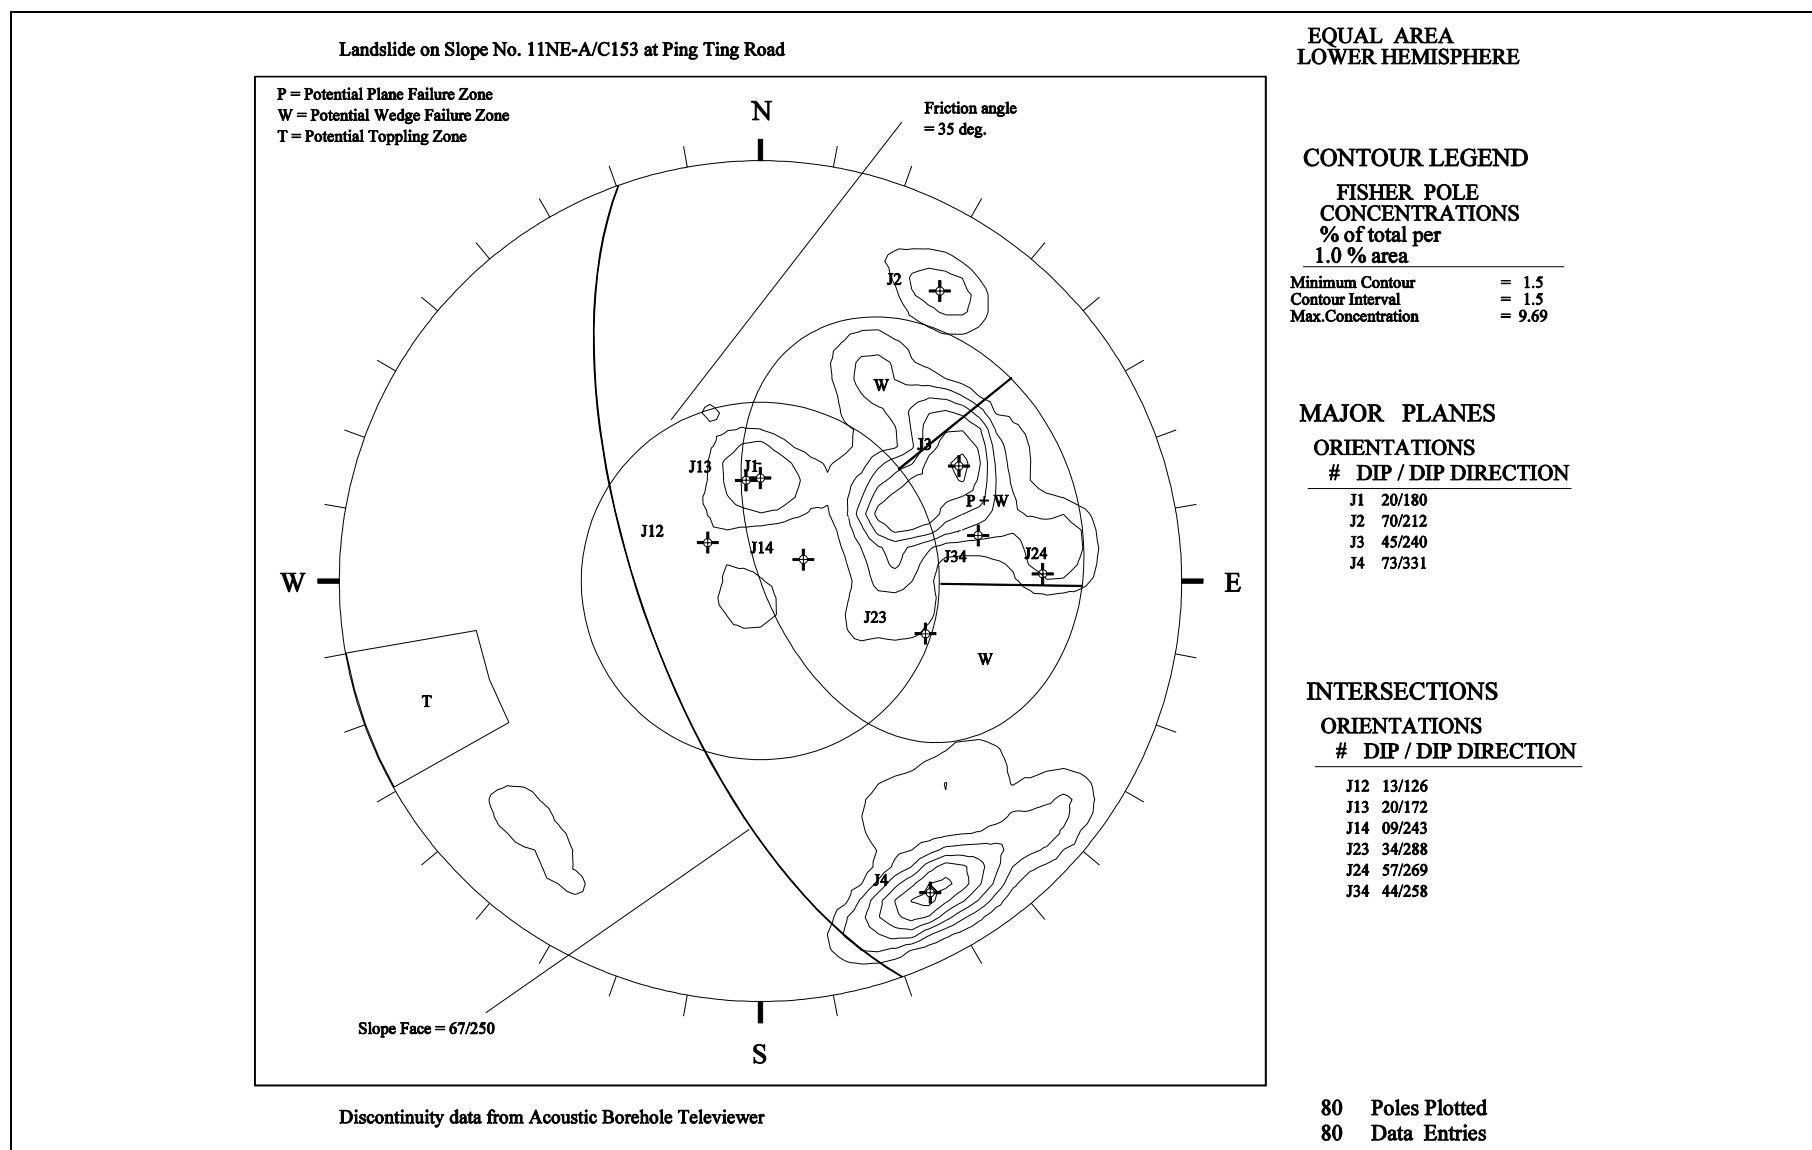
Figure 15 - Stereograph of Rock Joints at Borehole DH3

Televiwer survey was carried out at borehole DH3 within the moderately to slightly decomposed granite (at depths between 14 m and 25 m). Kinematic analysis was carried out on the rock joints obtained from televiwer survey. The results indicate that the joint sets there are marginally daylighting (Figure 15).

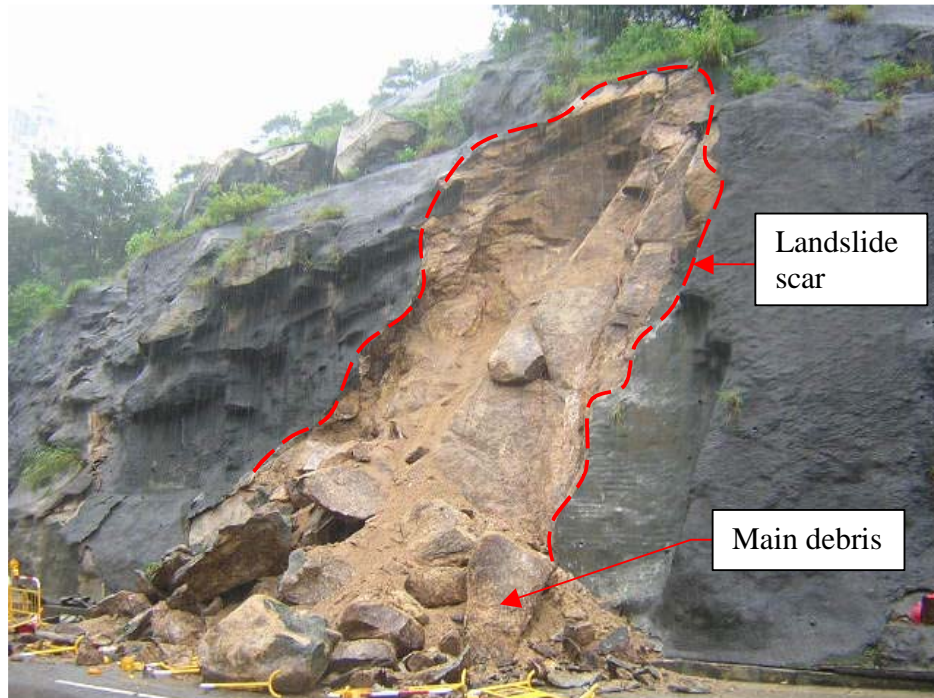
Plate 2 - View of the 20 August 2005 Landslide on Slope No.11NE-A/C153 Looking North (Photograph taken on 20 August 2005)

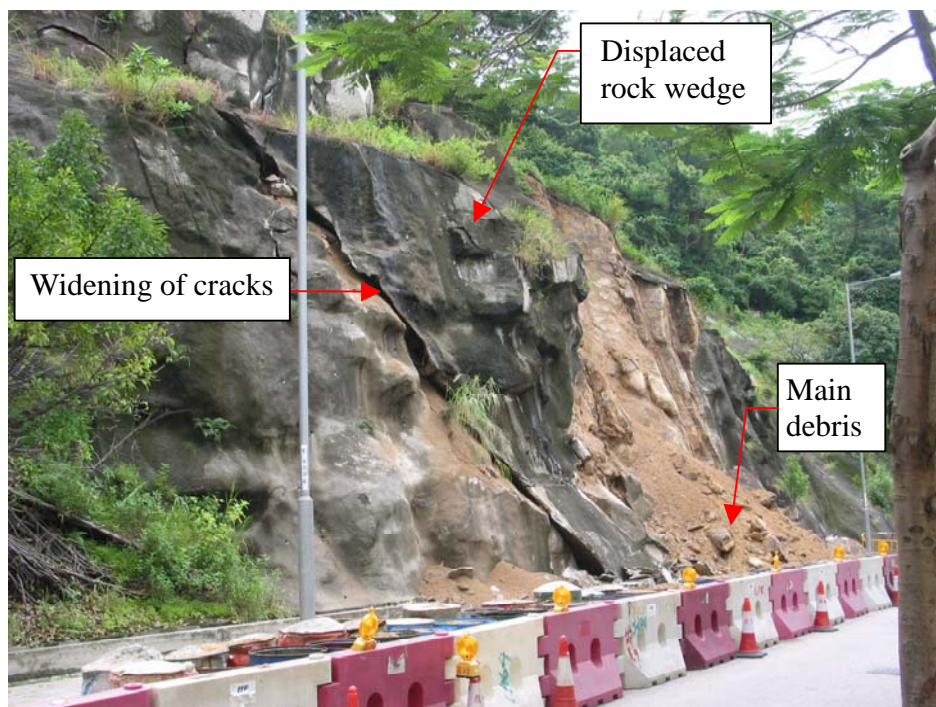
Plate 3 - View of the Reactivated Landslide on Slope
No. 11NE-A/C153 on 13 September 2005 Looking
Southeast (Photograph taken on 13 September 2005)

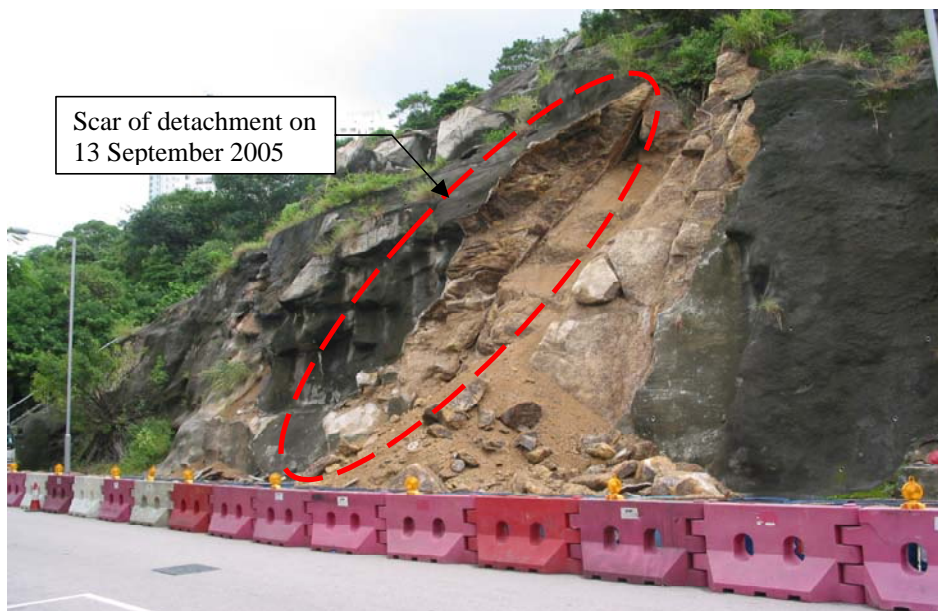
Plate 4 - View of the Reactivated Landslide on Slope
No. 11NE-A/C153 on 13 September 2005 Looking
North (Photograph taken on 13 September 2005)

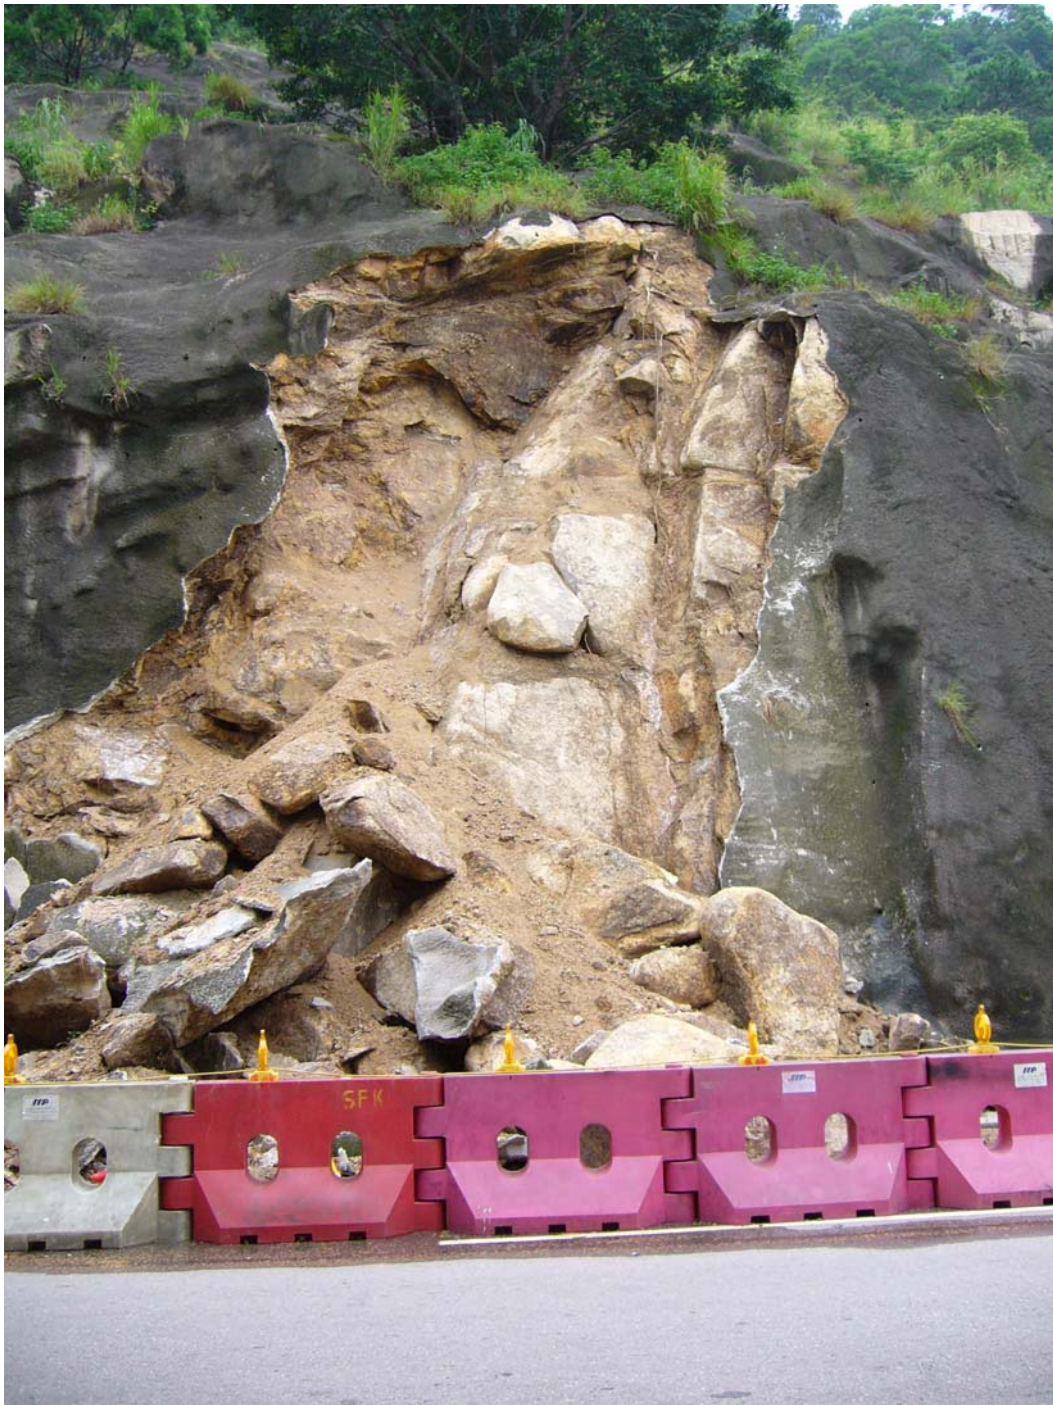
Plate 12 - General View of 20 August 2005 Landslide Scar
(Photograph taken on 25 August 2005)

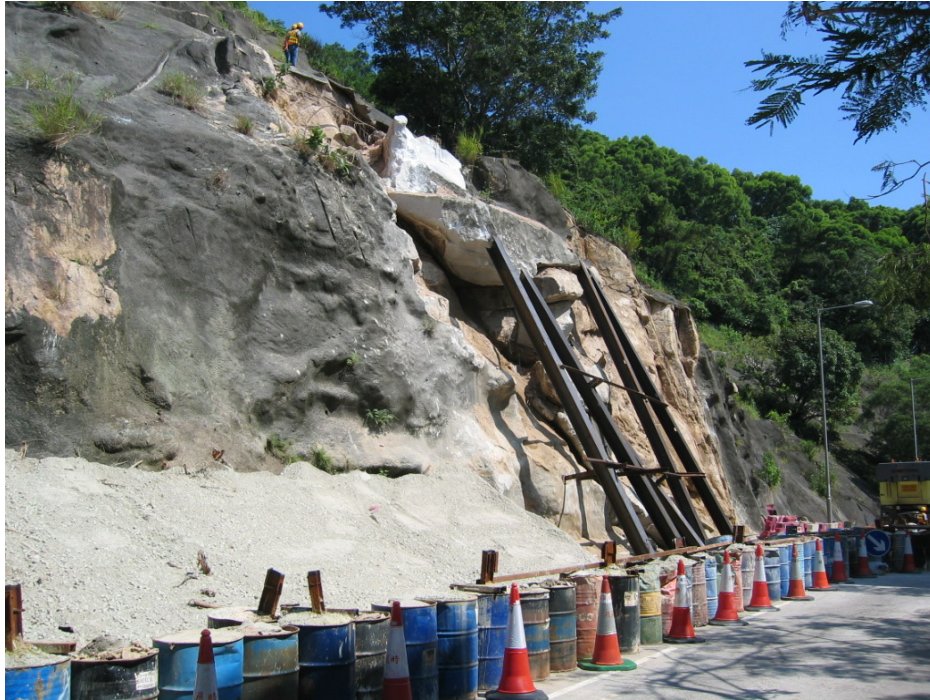
Plate 19 - General View of Urgent Repair Works as at
16 September 2005 Looking Southeast

Between 13 and 16 September 2005, HyD carried out emergency works at the recommendation of the GEO, including the removal of landslide debris and loose rock blocks, to allow re-opening of the northbound lane of Ping Ting Road. During the emergency works, some of the loose rock blocks were observed to exhibit further displacement. Struts were erected by HyD to support the overhanging rock blocks (Plate 19). In mid-September 2005, the Mainland East Division of the GEO advised HyD to construct a mass concrete buttress to support the displaced rock wedge. The buttress was completed by the end of January 2006 (Plate 20).
