**REVIEW OF THE 21 AUGUST 2005
LANDSLIDE ON SLOPES
NOS. 7SE-B/C195 AND 7SE-B/C131
AND THE DISTRESSED HILLSIDE
ABOVE SLOPE NO. 7SE-B/C122 AT
MA ON SHAN UPPER VILLAGE**

GEO REPORT No. 216

Maunsell Geotechnical Services Limited

**This report was originally produced in December 2006
as GEO Landslide Study Report No. LSR 16/2006**

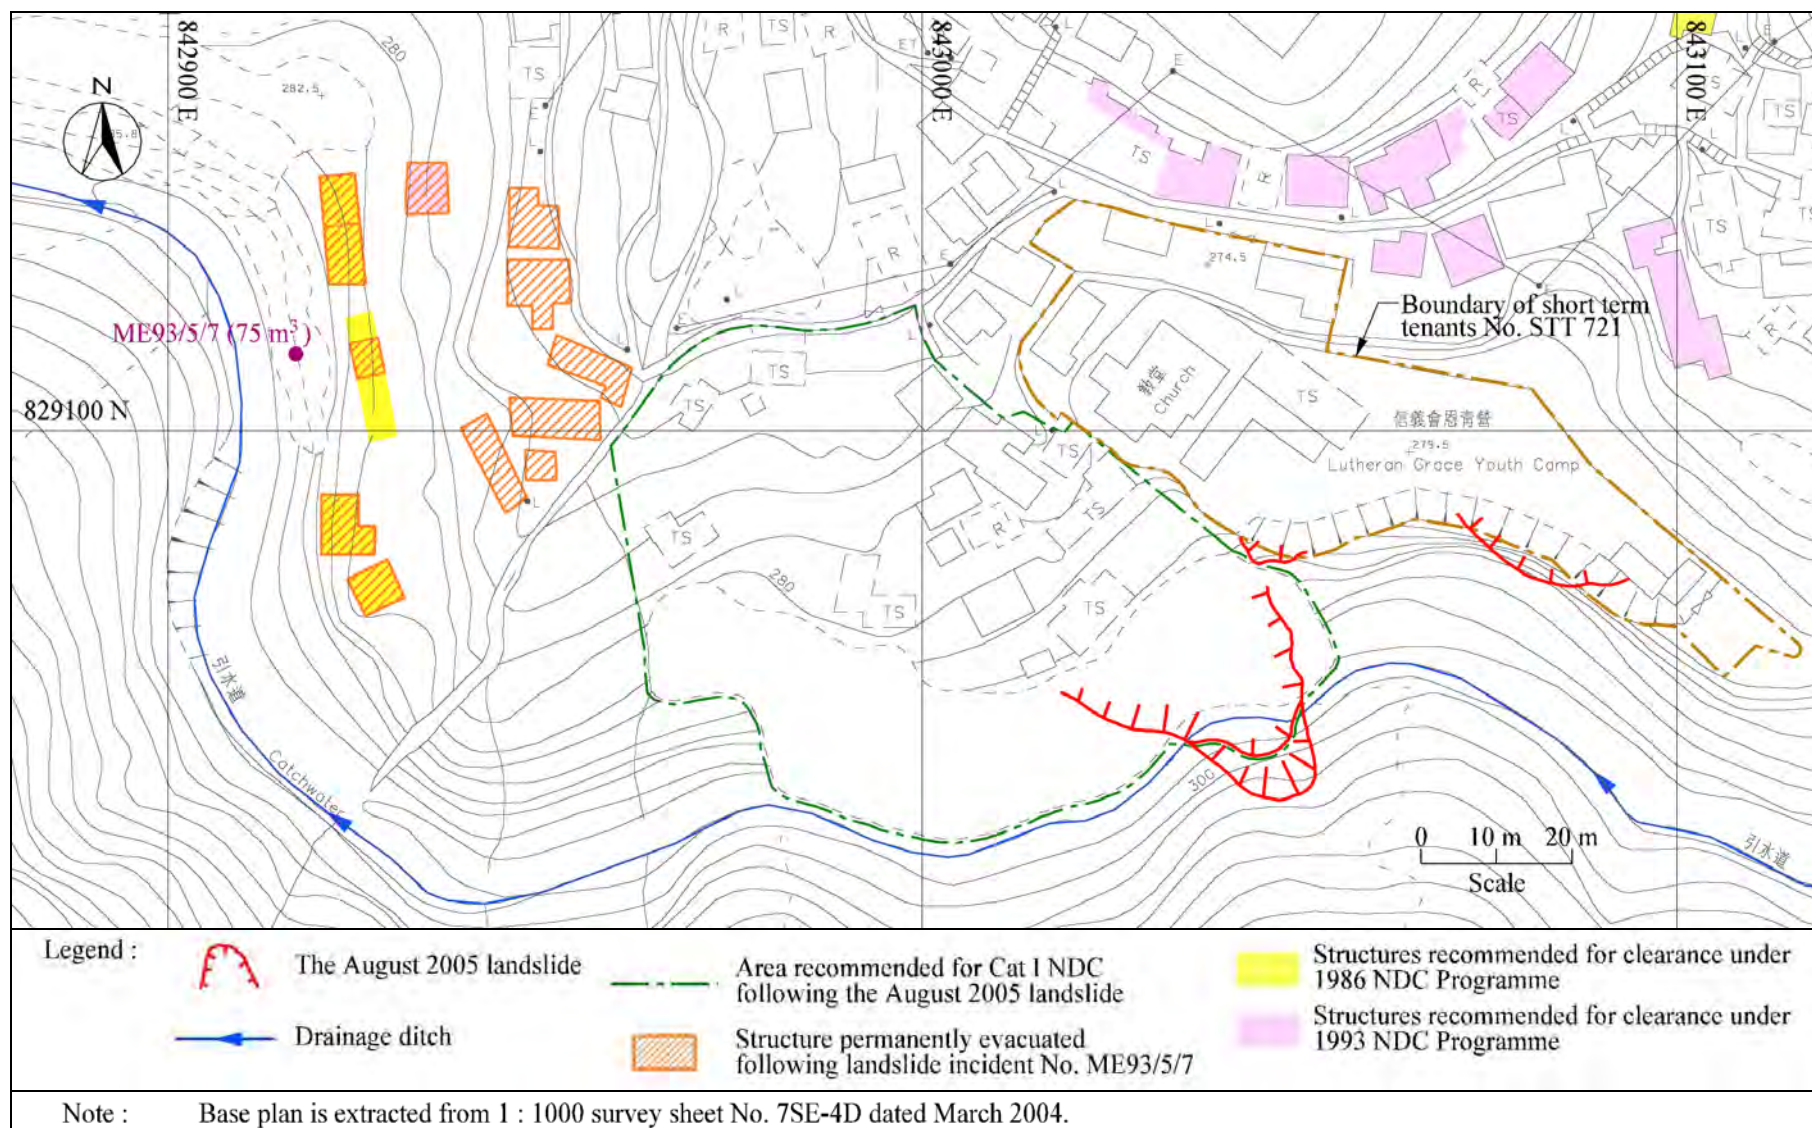
Figure 6 - Recommendation for Non-development Clearance

GEO also recommended Category 1 NDC clearance of a number of registered squatter structures (see Figure 6) in the vicinity of the toe of the August 2005 landslide. The clearance was completed in June 2006.

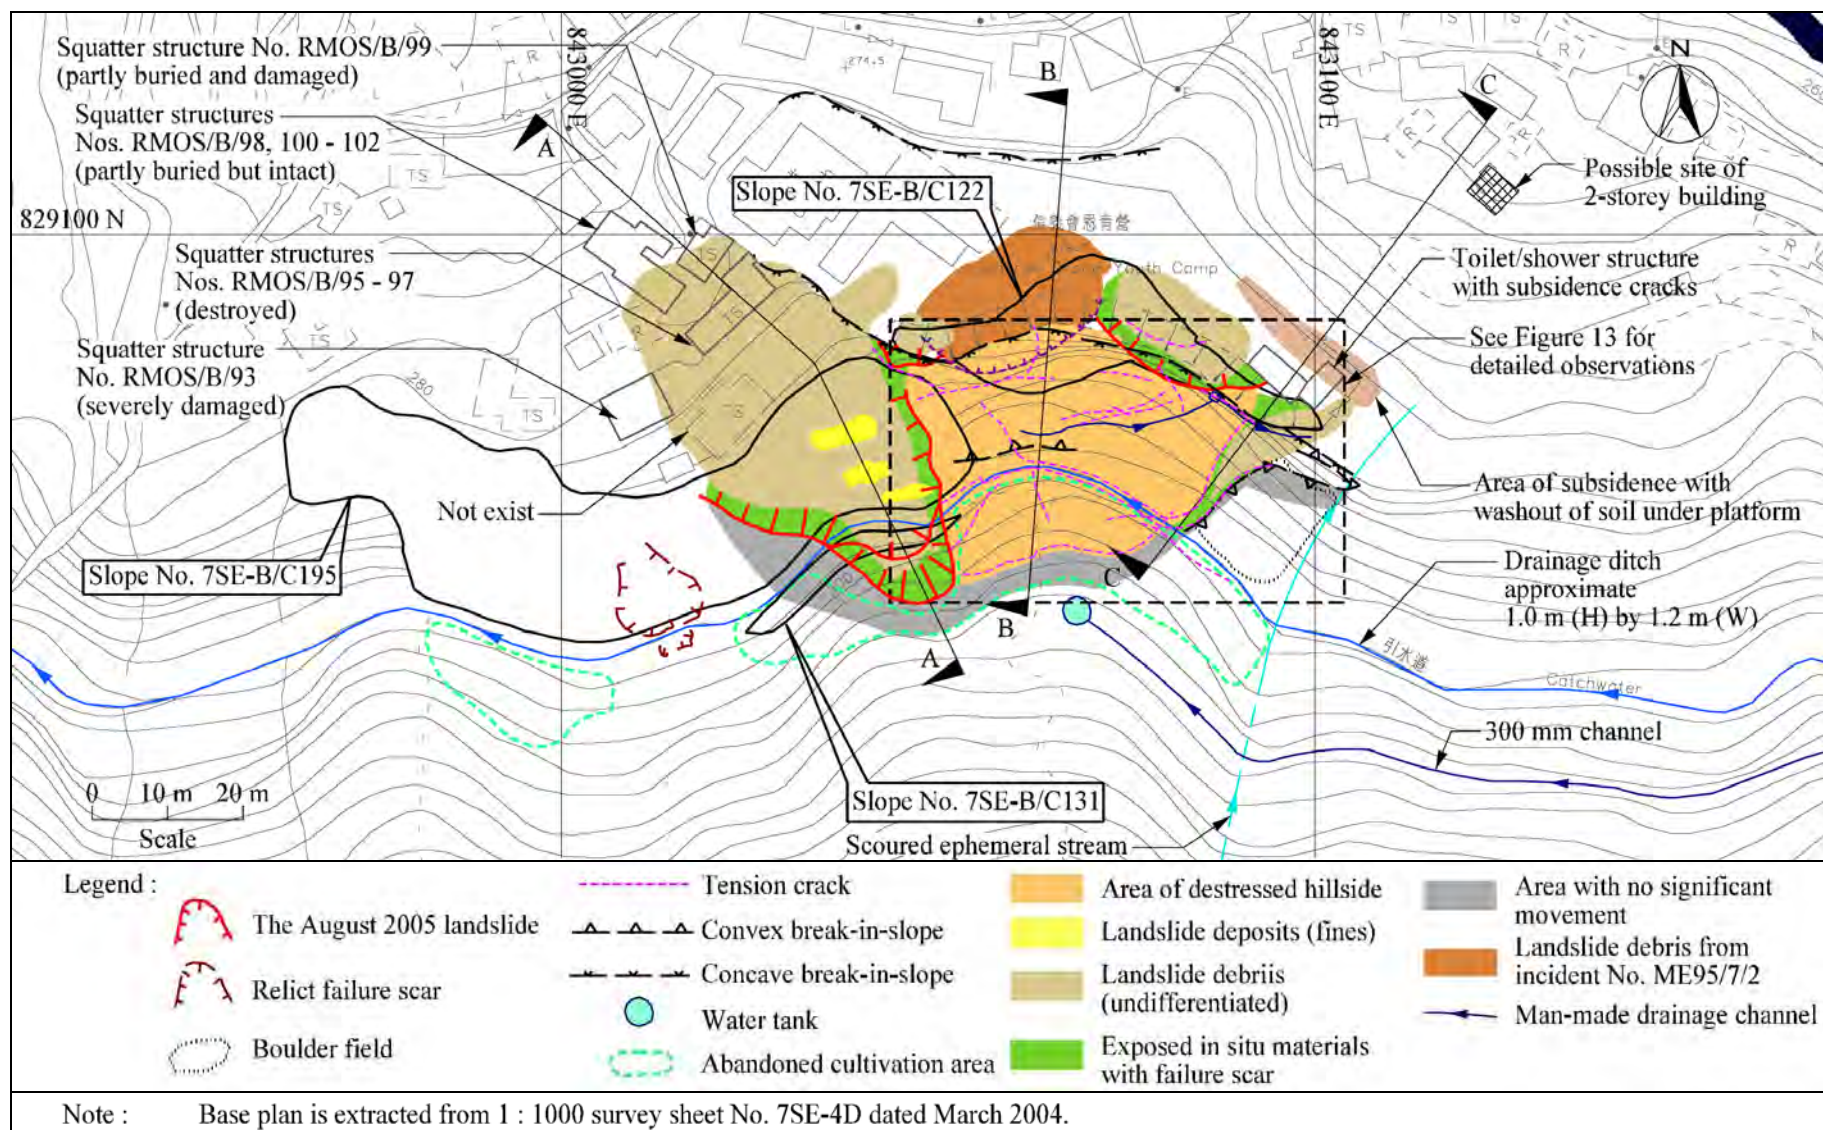
Figure 8 - Field Mapping

(Figure 8 and Plate 30). This landslide had caused the collapse of the downhill side of the drainage ditch, which had been replaced with a mortared rubble wall. The size of the tree (with a trunk of about 50 mm diameter) at the base of the landslide (i.e. within the debris lobe) suggests that the landslide is likely to be quite old, i.e. at least several years. The juxtaposition of this landslide scar and the repaired section of the drainage ditch, suggests that the failure may have been caused by seepage of water from the drainage ditch.

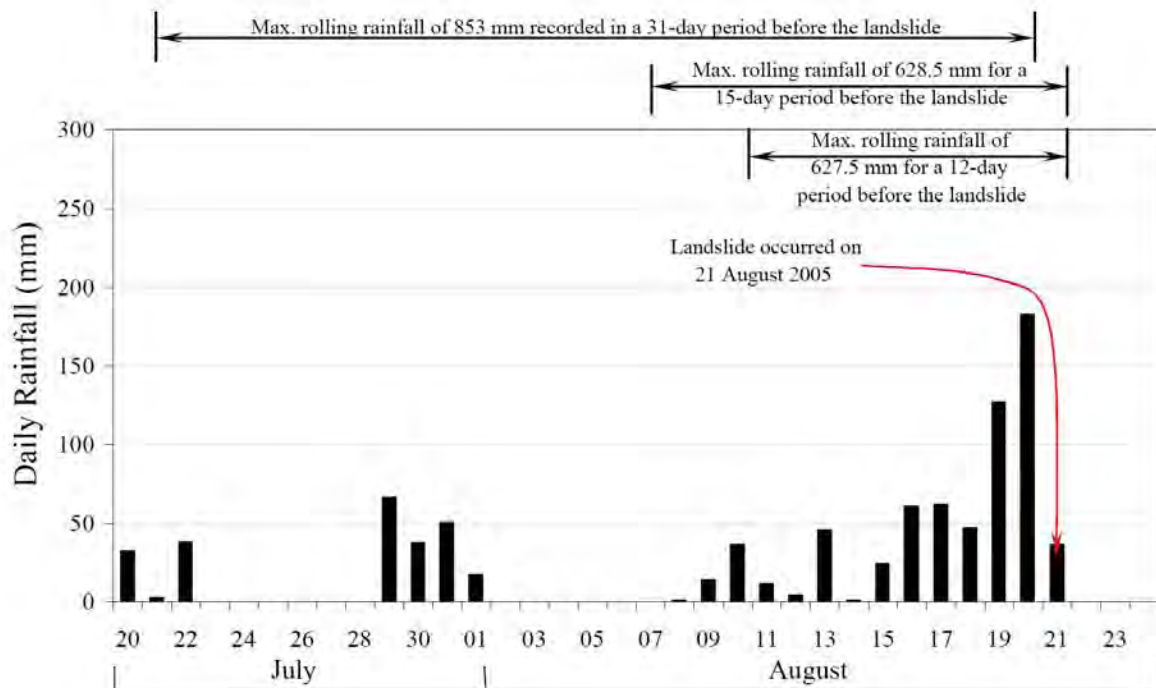
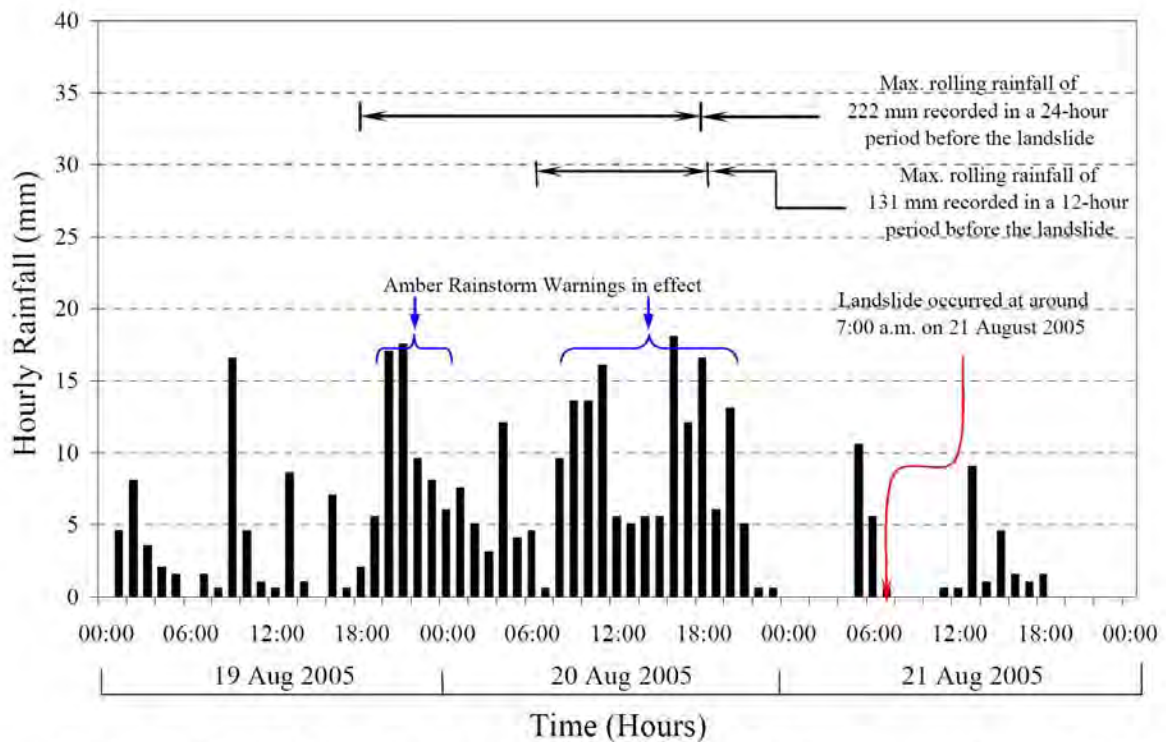
Figure 14 - Daily and Hourly Rainfall Recorded at GEO Raingauge No. N44

According to the Incident Report prepared by the GEO, the landslide occurred at 7:00 a.m. on 21 August 2005. The daily rainfall recorded by raingauge No. N44 over the month preceding the incident, together with the hourly rainfall readings for the period between 19 and 21 August 2005, is presented in Figure 14.

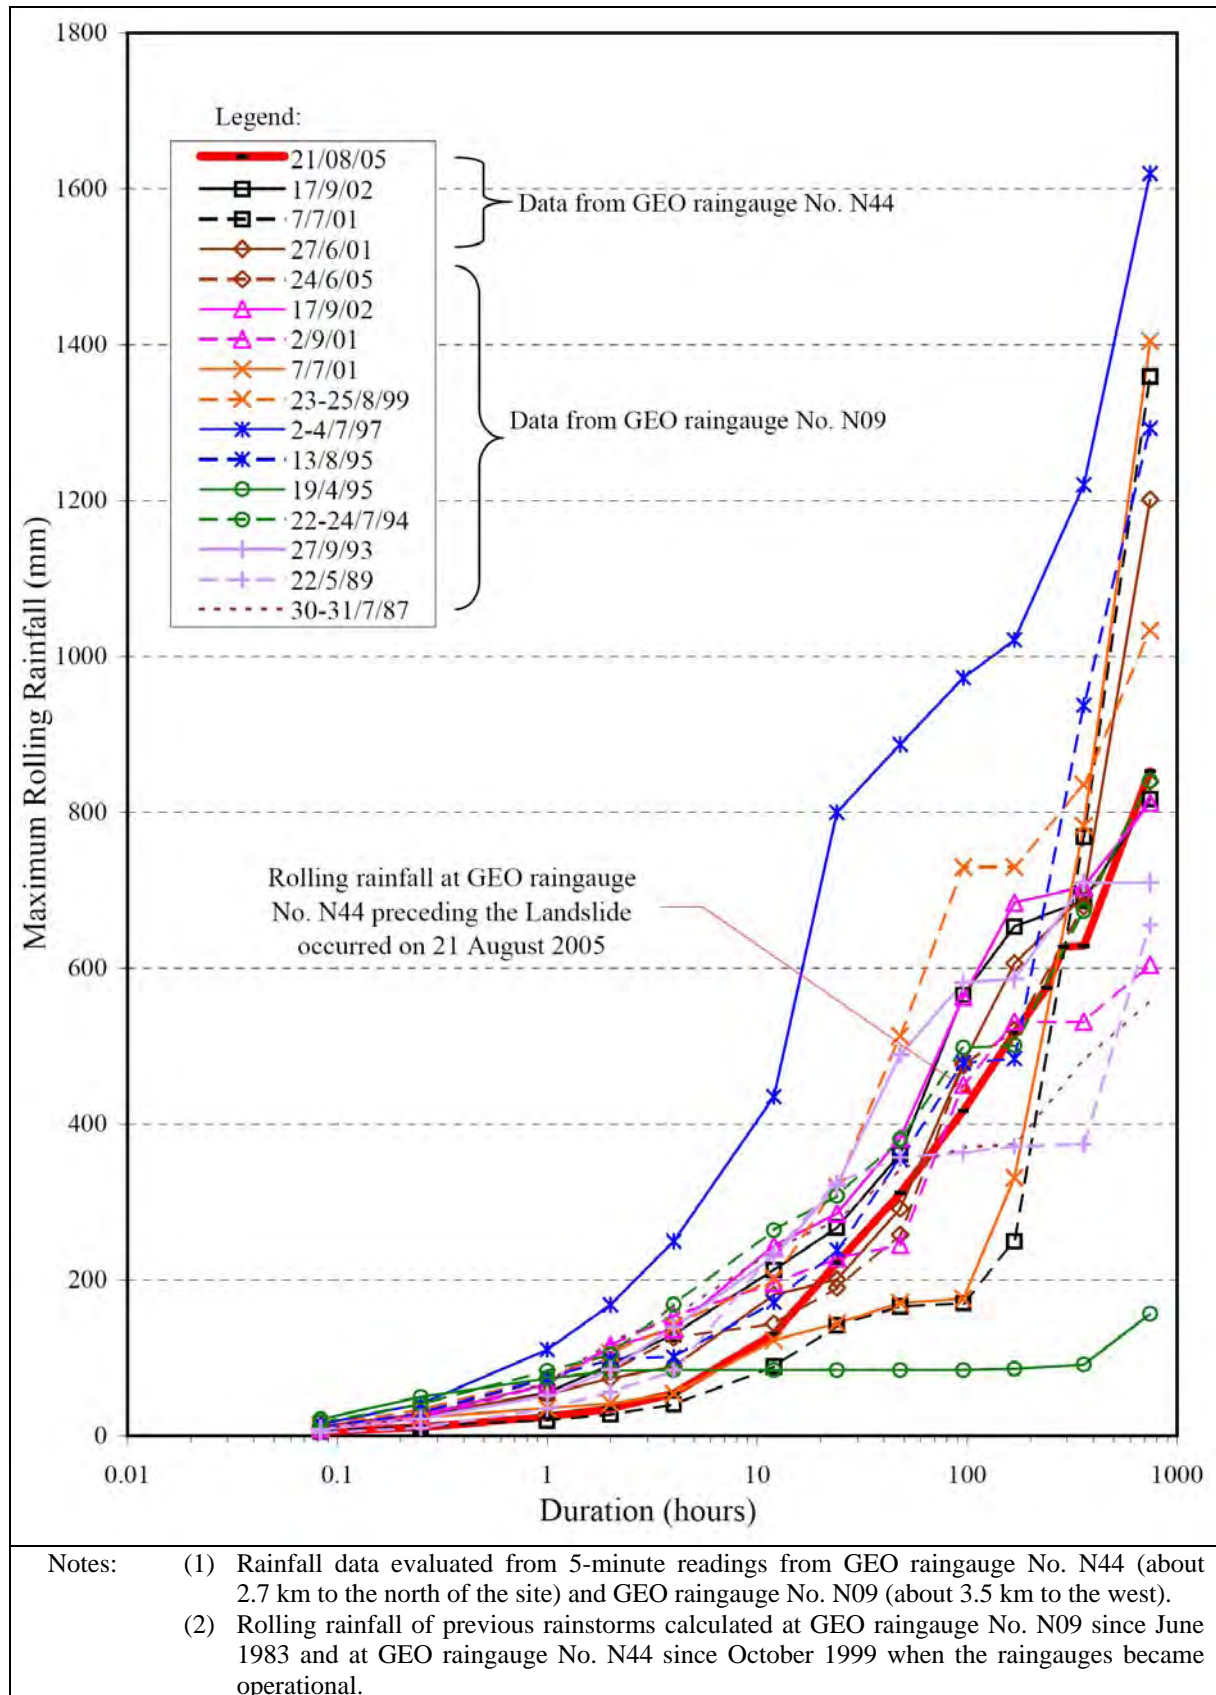
Figure 15 - Maximum Rolling Rainfall for Previous Major Rainstorms at GEO Raingauges Nos. N09 and N44

The maximum rolling rainfall for the August 2005 rainstorm has been compared with the past major rainstorms recorded by raingauges Nos. N09 and N44, which came into operation in June 1983 and October 1999 respectively (Figure 15). It is noted that the August 2005 rainstorm was less severe than previous major rainstorms.
