**DETAILED STUDY OF THE
20 AUGUST 2005 LANDSLIDE
ON SLOPES NOS. 11SE-A/C285,
11SE-C/DT1 AND 11SE-C/DT6
ABOVE TAI HANG DRIVE
HAPPY VALLEY**

GEO REPORT No. 217

**GEOTECHNICAL ENGINEERING OFFICE
CIVIL ENGINEERING AND DEVELOPMENT DEPARTMENT
THE GOVERNMENT OF THE HONG KONG
SPECIAL ADMINISTRATIVE REGION**

**This report was originally produced in March 2007
as GEO Landslide Study Report No. LSR 2/2007**

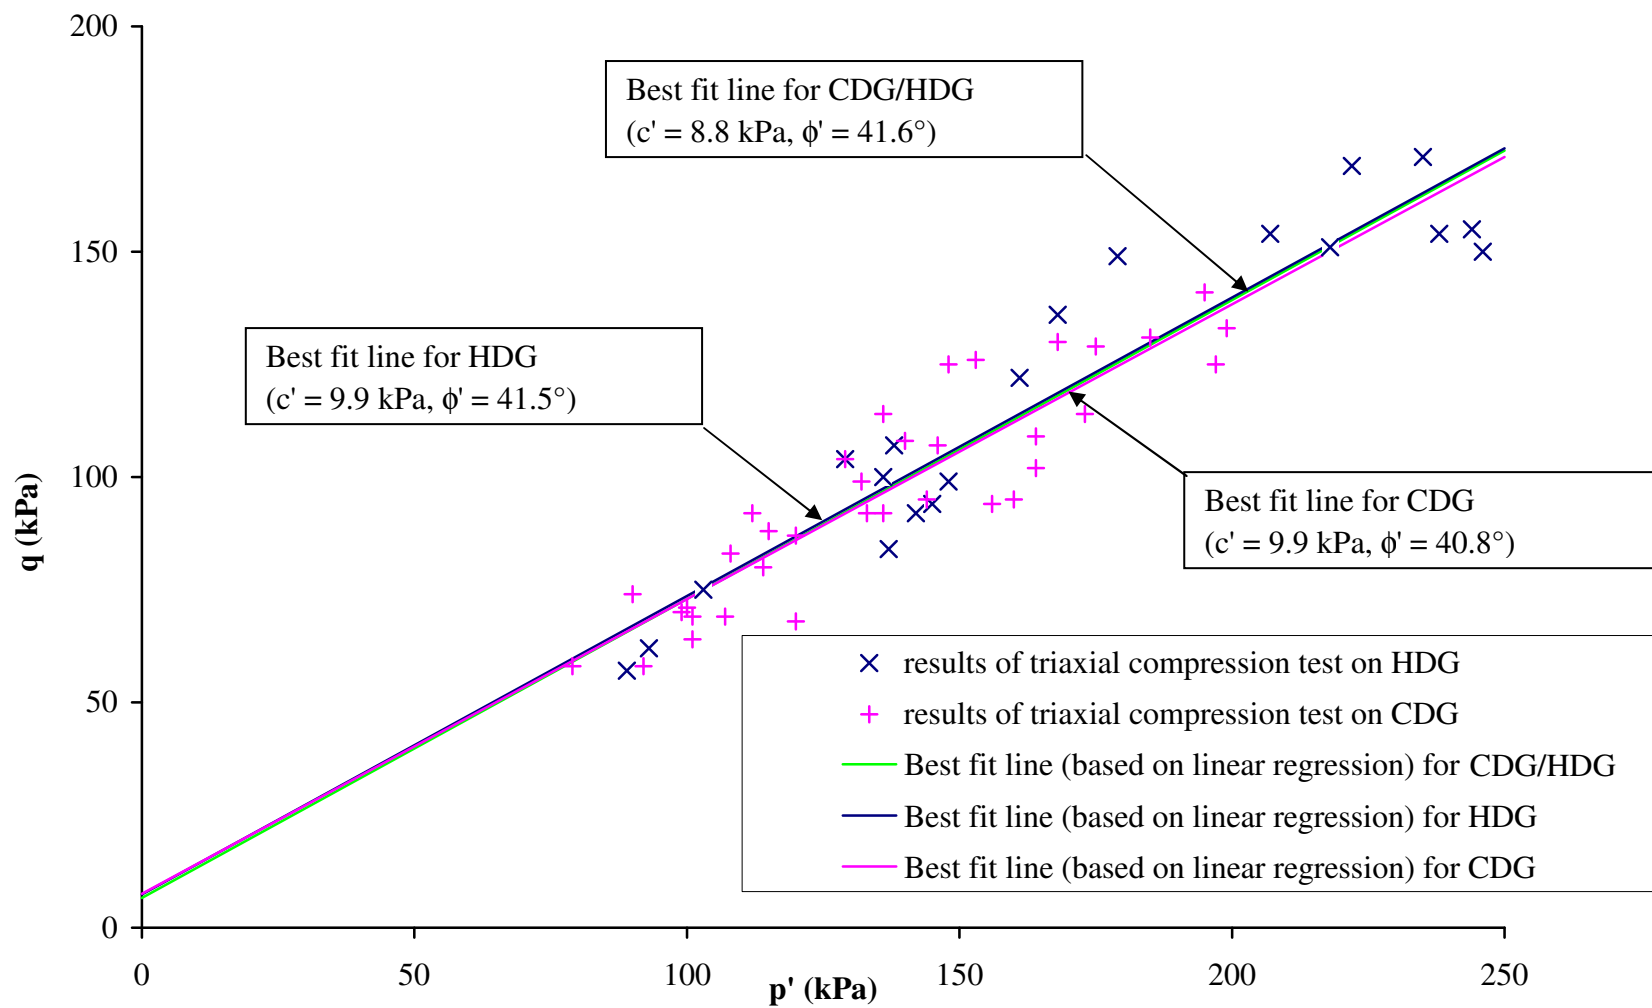
Figure 17 - p' - q Plots for CDG and HDG

Triaxial compression test results on undisturbed samples taken from the strata of CDG and HDG for the appropriate effective stress range (i.e. p' within 200 kPa for CDG and 250 kPa for HDG) indicate that CDG and HDG have similar shear strengths of $c' = 9$ kPa and $\phi' = 42^\circ$ (Figure 17).

The results of the analyses are presented in Figure 20. The analyses indicated that with shear strength parameters of $c' = 9$ kPa and $\phi' = 42^\circ$ for the CDG/HDG (corresponding to the results of laboratory tests, Figure 17), the development of a transient groundwater pressure corresponding to a piezometric level of about 6 m above the surface of rupture, would have been required to initiate failure of the slope. However, for a range of possible lower bound shear strength parameters of c' ranging from 2 kPa to 6 kPa and ϕ' ranging from 30° to 34° for the CDG, the analyses indicated that piezometric levels of about 1 m to 3 m above the surface of rupture would have been required to initiate failure. The lower shear strength parameters and thus, the lower groundwater levels required for failure to occur, are considered to be more appropriate for the 20 August 2005 landslide given the evidence of the failure occurring partly along relict joints and partly within intact CDG.

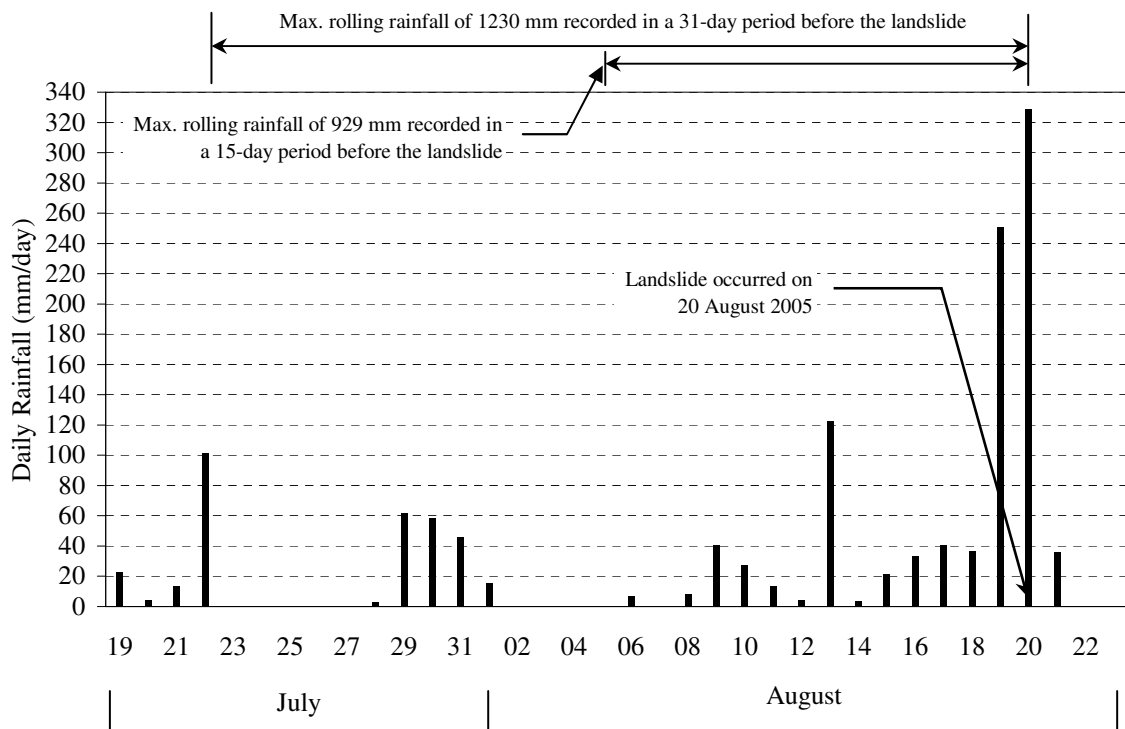
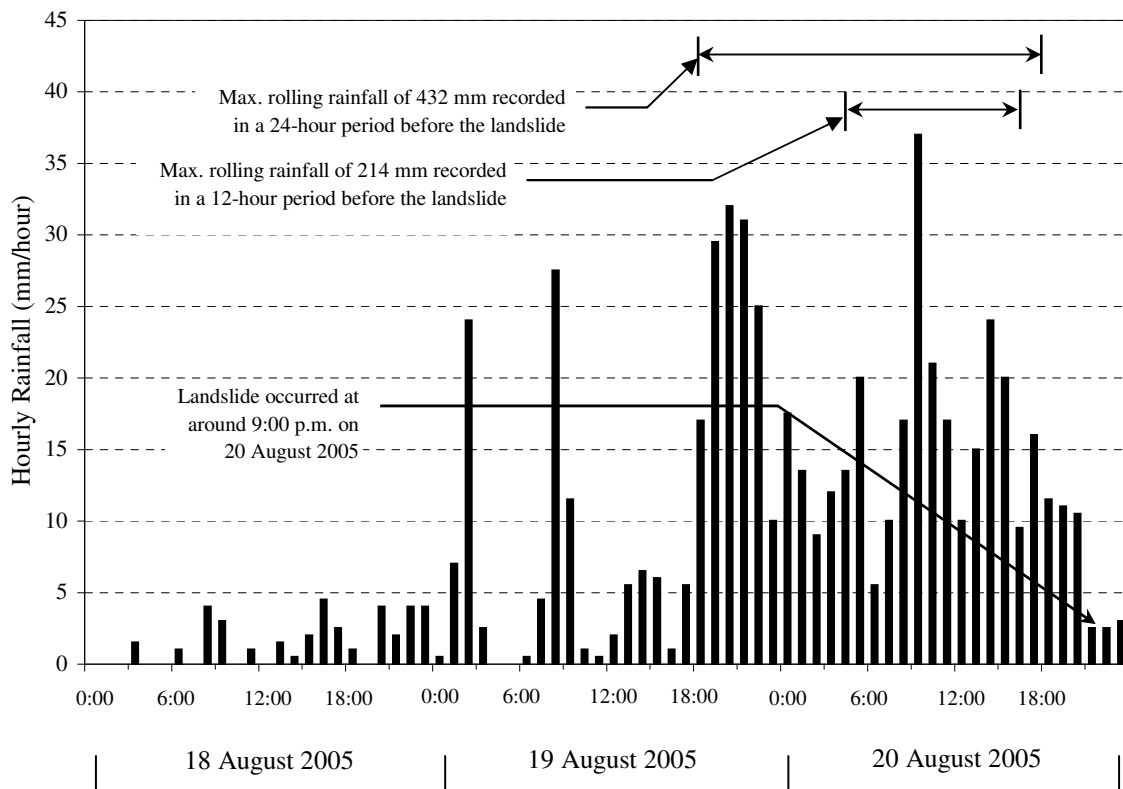
Figure 18 - Daily and Hourly Rainfall Recorded at GEO Raingauge No. H07

The daily rainfall recorded by raingauge No. H07 over the month preceding the 20 August 2005 landslide incident, together with the hourly rainfall readings for the period between 18 and 20 August 2005, are presented in Figure 18. For the purpose of rainfall analysis, the time of the landslide was assumed to be 9:00 p.m., i.e. immediately following a prolonged period (about 24 hours) of rainfall with intensity of between 10 mm/hr and 35 mm/hr.

The 20 August 2005 landslide occurred on a 18 m high, 40° steep predominantly soil portion of an engineered soil and rock cut slope No. 11SE-A/C285 and extended into the DT feature immediately above, following a prolonged period of rainfall (maximum 37 mm/hr, see Figure 18).

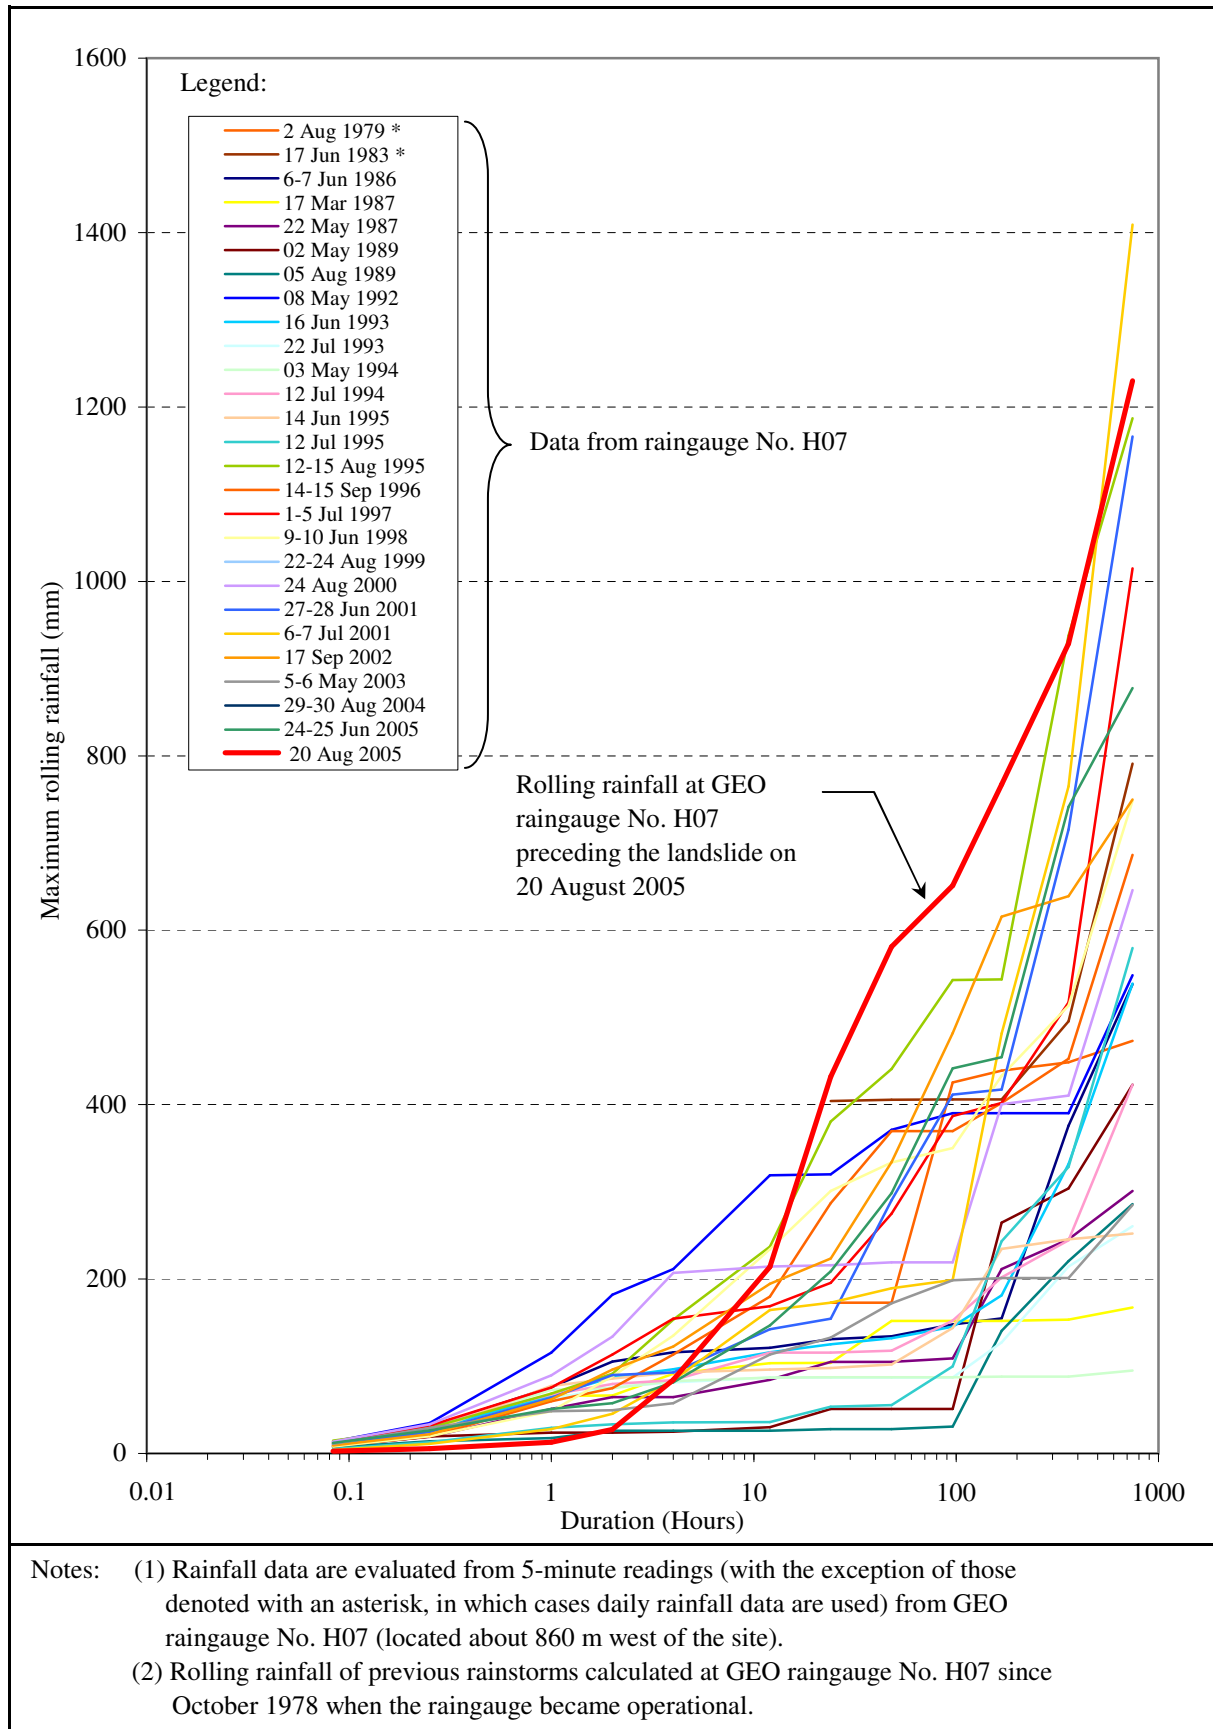
Figure 19 - Maximum Rolling Rainfall for the Rainstorm Preceding the Landslide and Selected Previous Major Rainstorms Recorded at GEO Raingauge No. H07

The maximum rolling rainfall for the rainstorm preceding the August 2005 landslide has been compared with the past major rainstorms between 1978 and 2005 recorded by raingauge No. H07, which came into operation in October 1978 (see Figure 19). It is noted that the maximum rolling rainfall for the rainstorm prior to 9:00 p.m. on 20 August 2005 exceeds that from previous rainstorms for durations of 24 hours, 48 hours, 4 days, 7 days and 15 days.

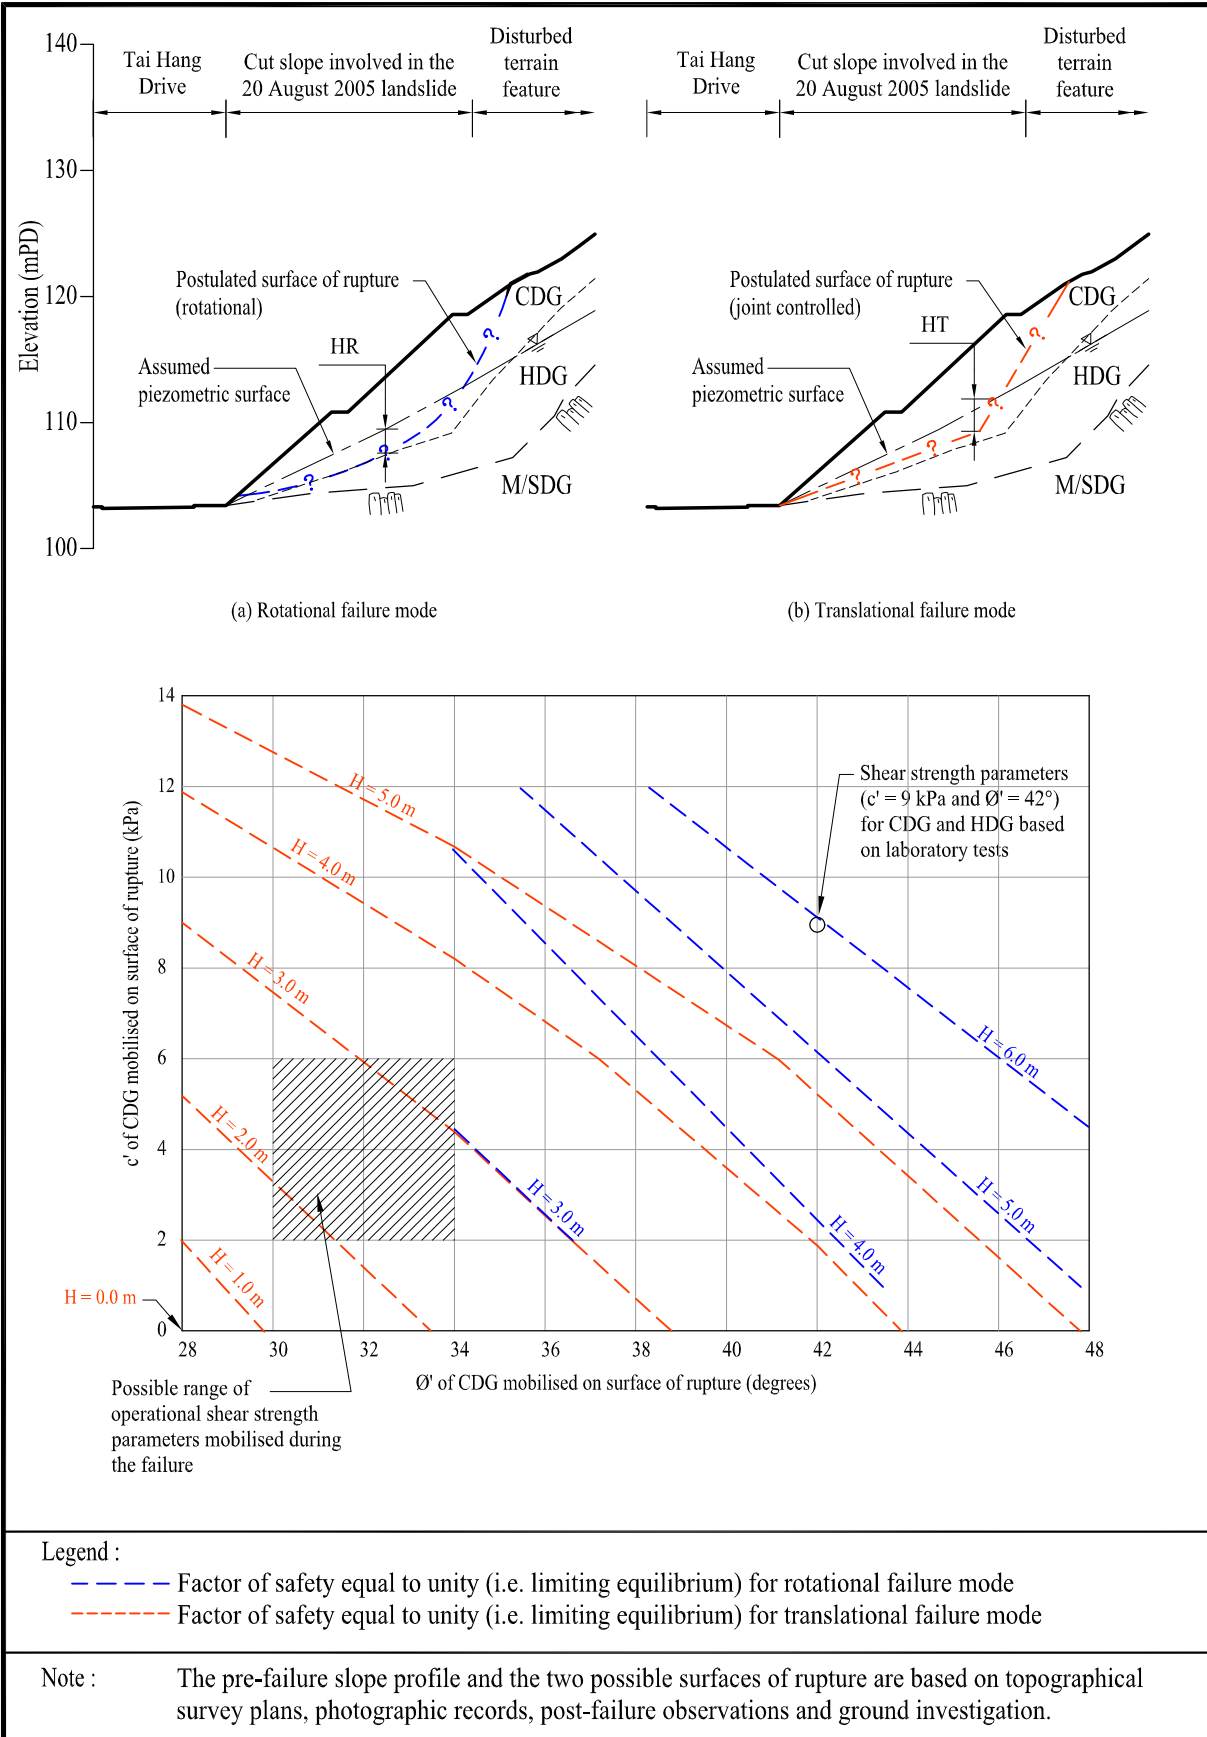
Figure 20 - Summary of Sensitivity Analyses

Cross-sections through the slope included in the stability analyses are shown in Figure 20. The pre-failure slope profile was inferred from topographical survey plans, the approved site formation plans, photographic records and post-failure field observations. The geometry of the likely surface of rupture and ground profile is based on topographical survey, field observations and ground investigation carried out as part of the post-landslide study.

Based on the geological mapping (Figure 12) and the post-landslide ground investigation, the surface of rupture of the 20 August 2005 landslide was interpreted to be partly along relict joints and partly within CDG (with the exception of the top 2.5 m portion, which was within residual soil). Stability analyses were carried out using a range of values of shear strength parameters, which covers the typical range of parameters given for CDG (GEO, 1993), as well as the parameters derived from laboratory testing completed as part of the post-failure ground investigation. Analyses were carried out for both rotational and translational failure models. Various elevated groundwater levels above the surfaces of rupture were assumed for the purpose of the stability analyses.

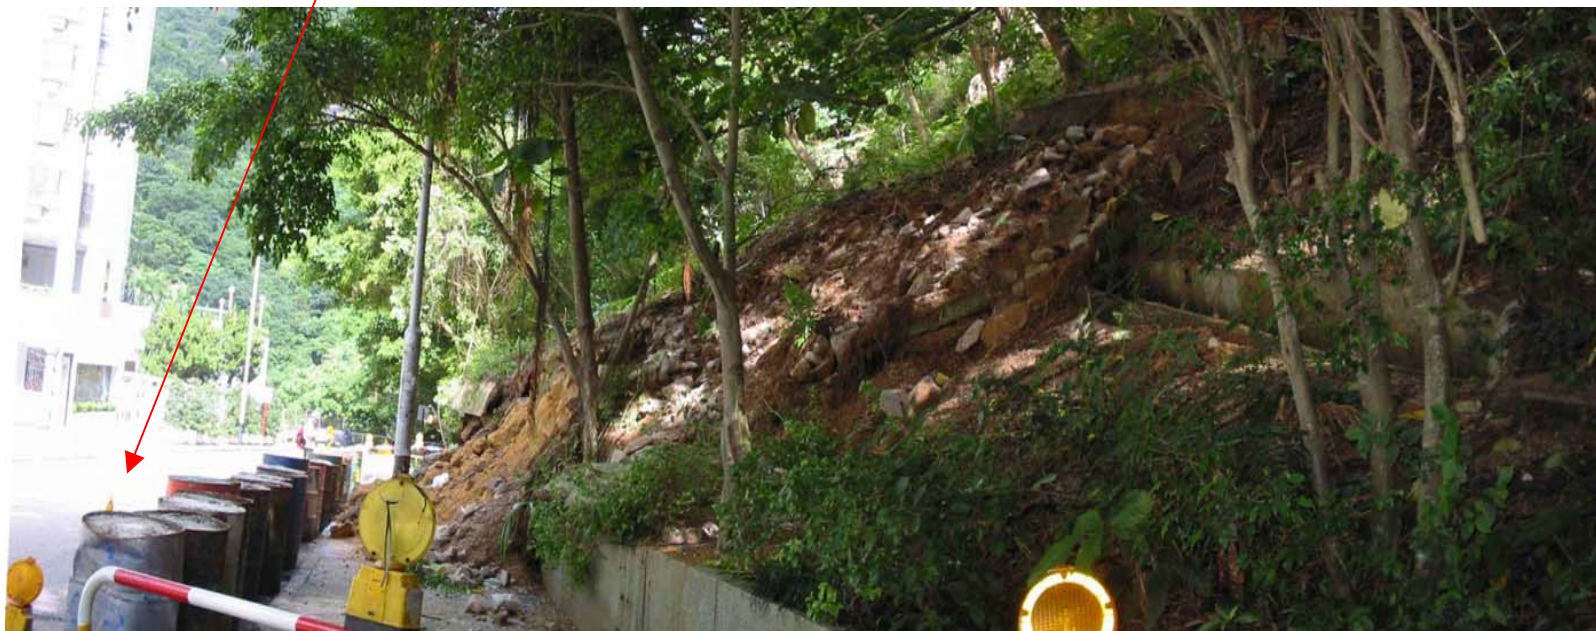
Plate 4 - Side View of the 20 August 2005 Landslide (Photograph taken by FSW on 22 August 2005)

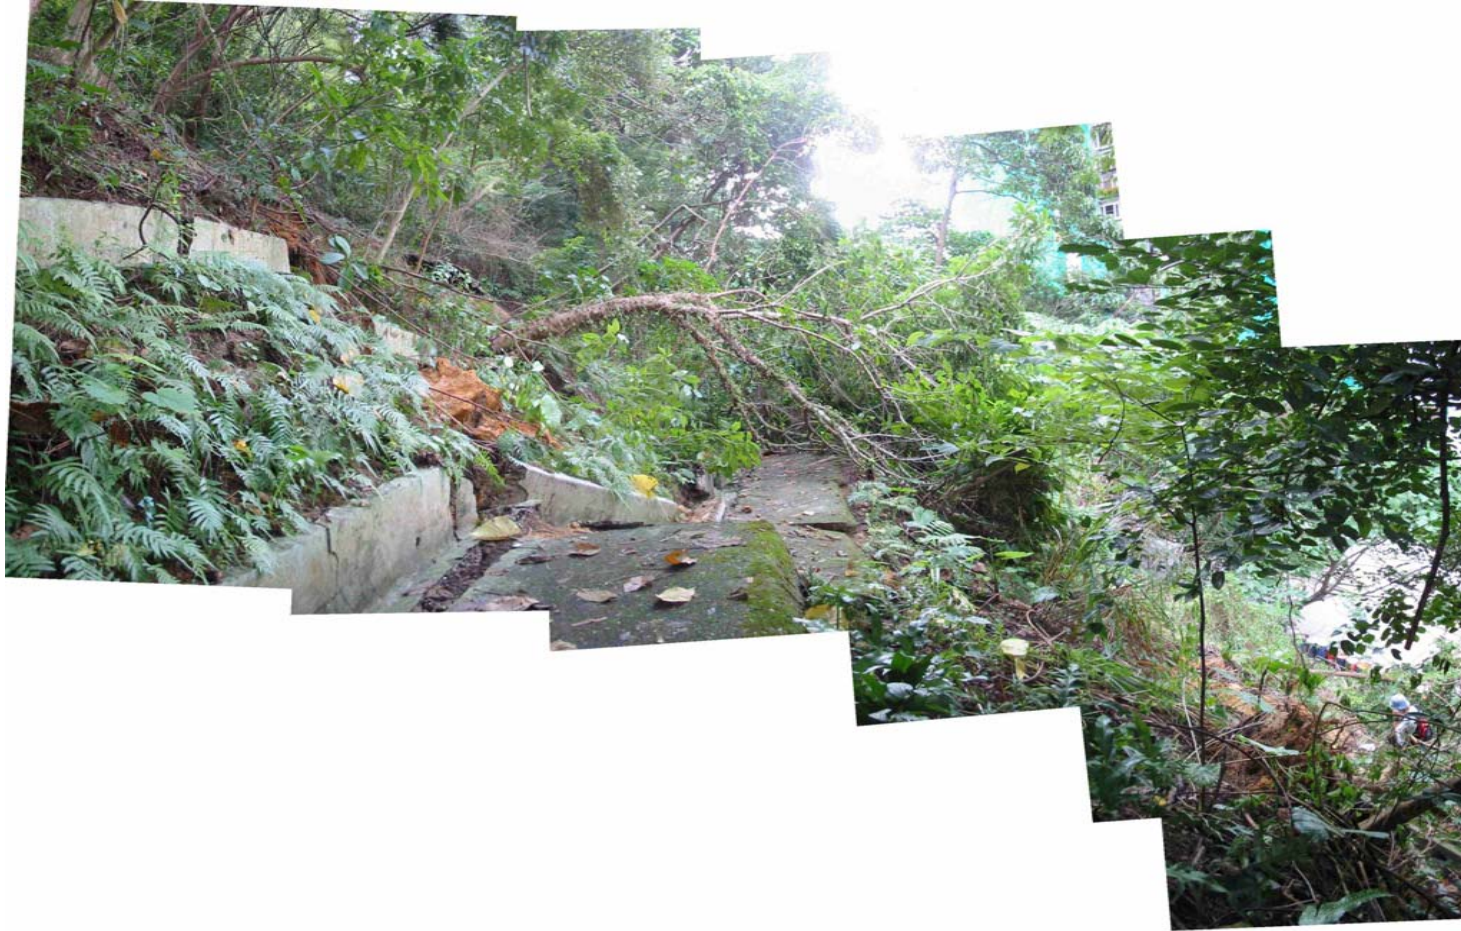
Plate 6 - Side View at the Eastern Flank of the 20 August 2005 Landslide Looking West (Photograph taken by FSW on 22 August 2005)

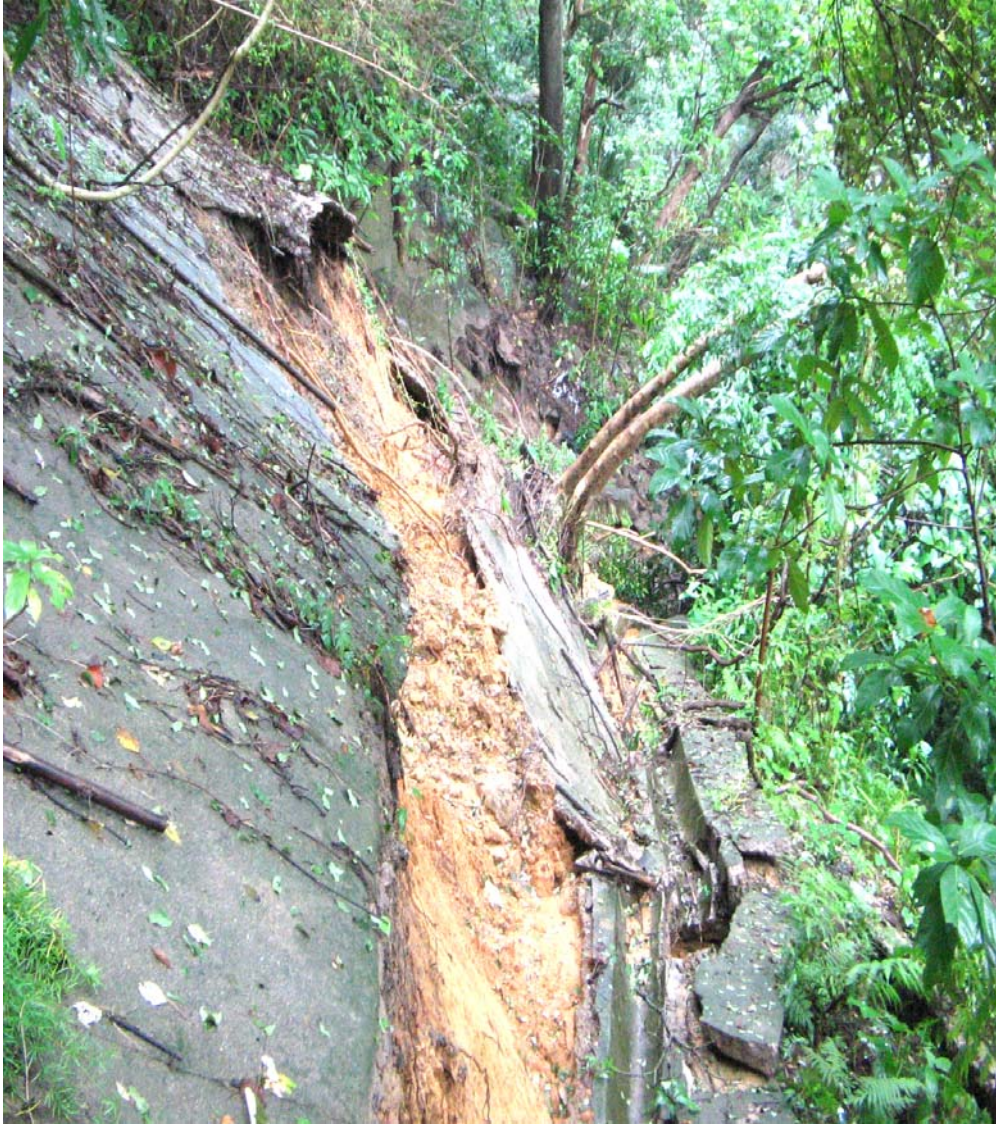
Plate 7 - Side View of the Main Scarp of the 20 August 2005 Landslide
(Photograph taken by FSW on 22 August 2005)

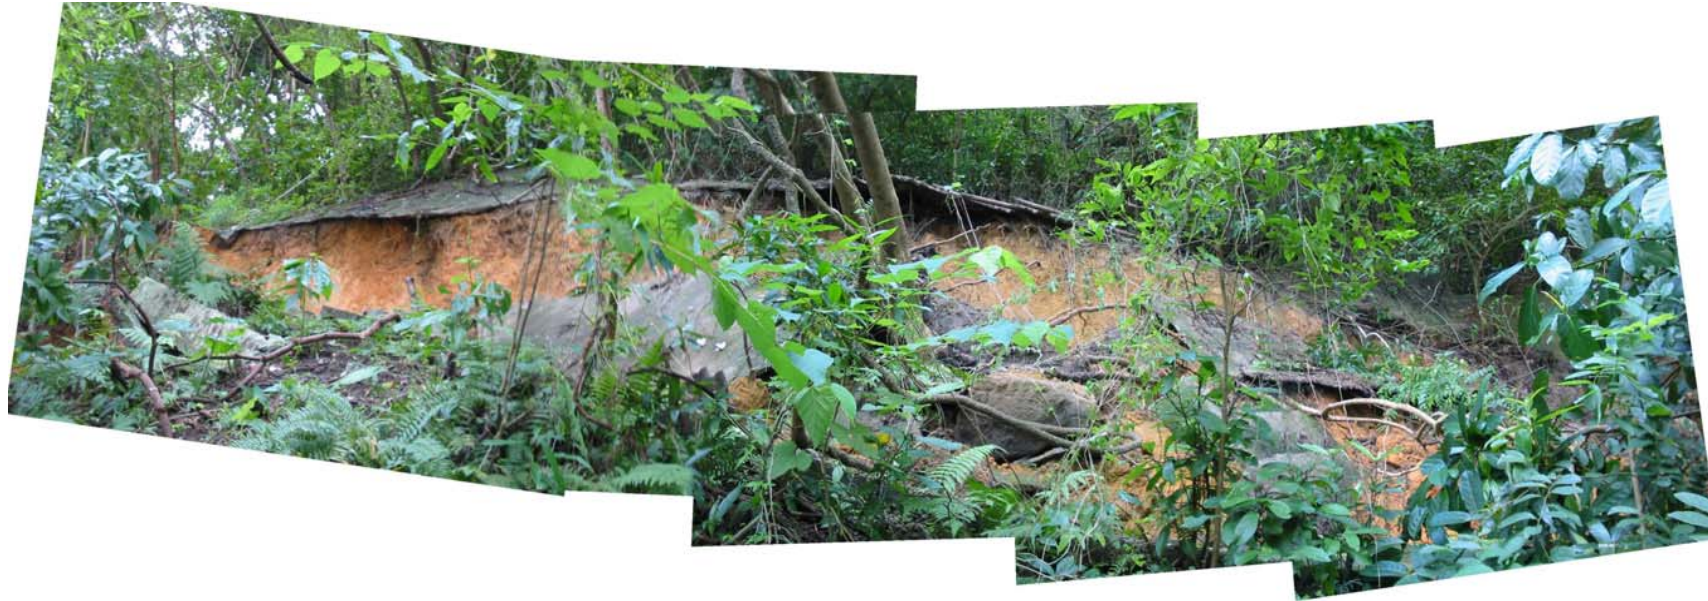
Plate 9 - View of the Main Scarp of the 20 August 2005 Landslide (Photograph taken by FSW on 22 August 2005)

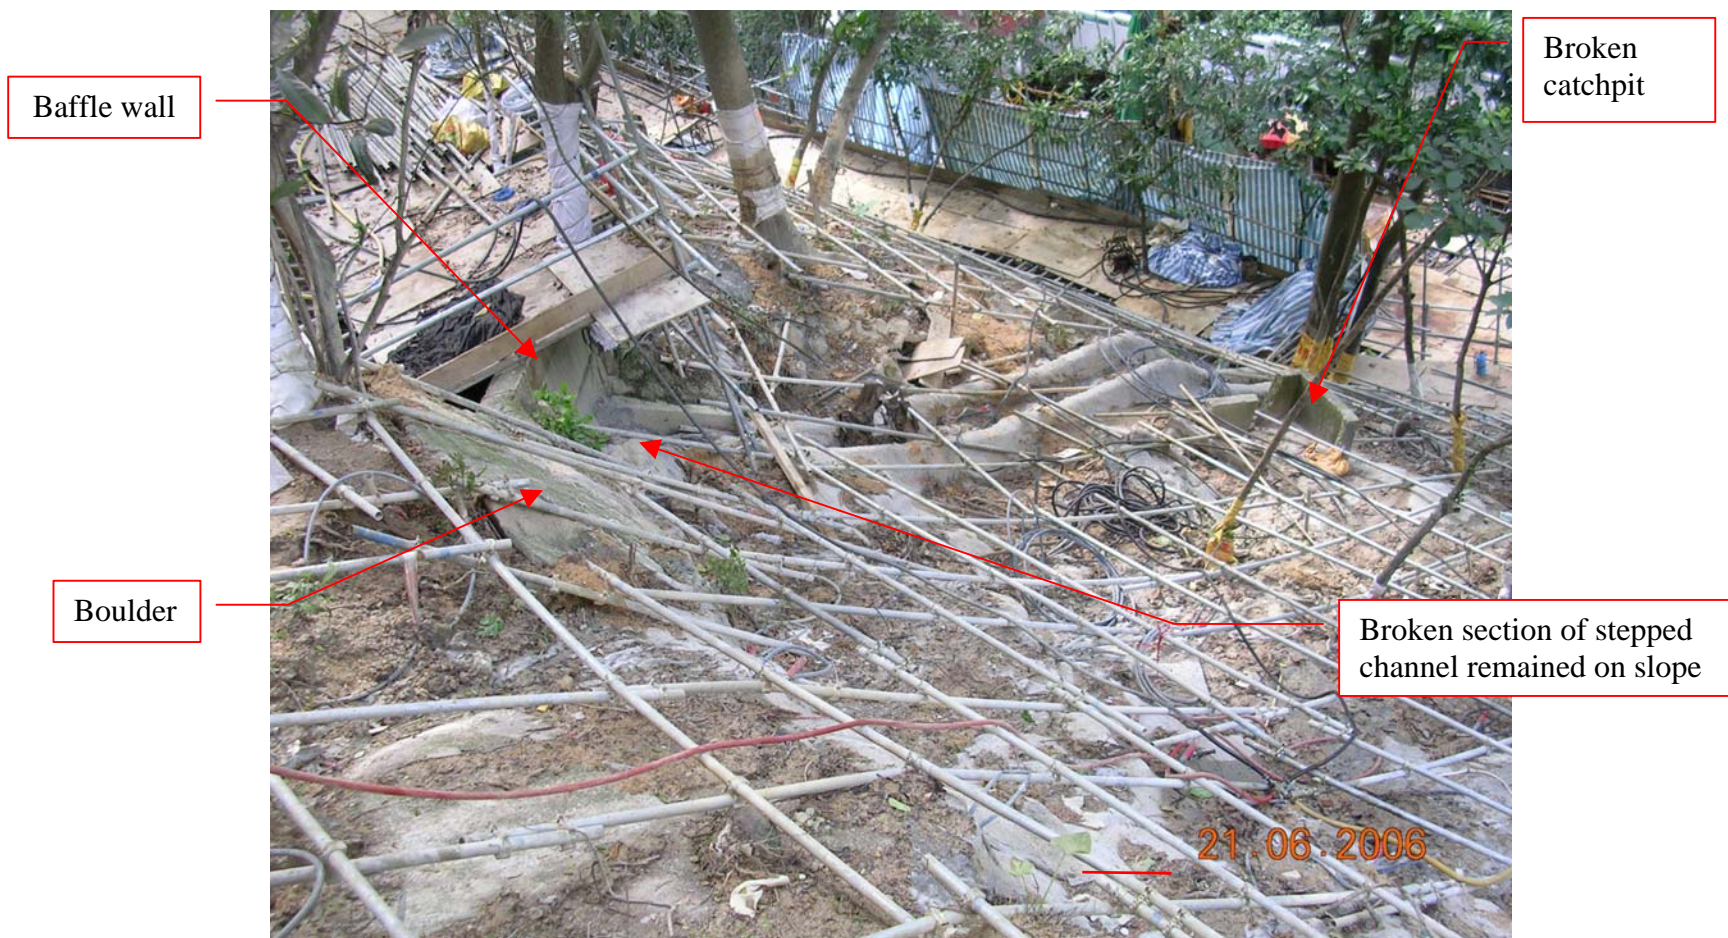
Plate 25 - Side View of the Slope below the Baffle Wall (Photograph taken by FSW on 21 June 2006)

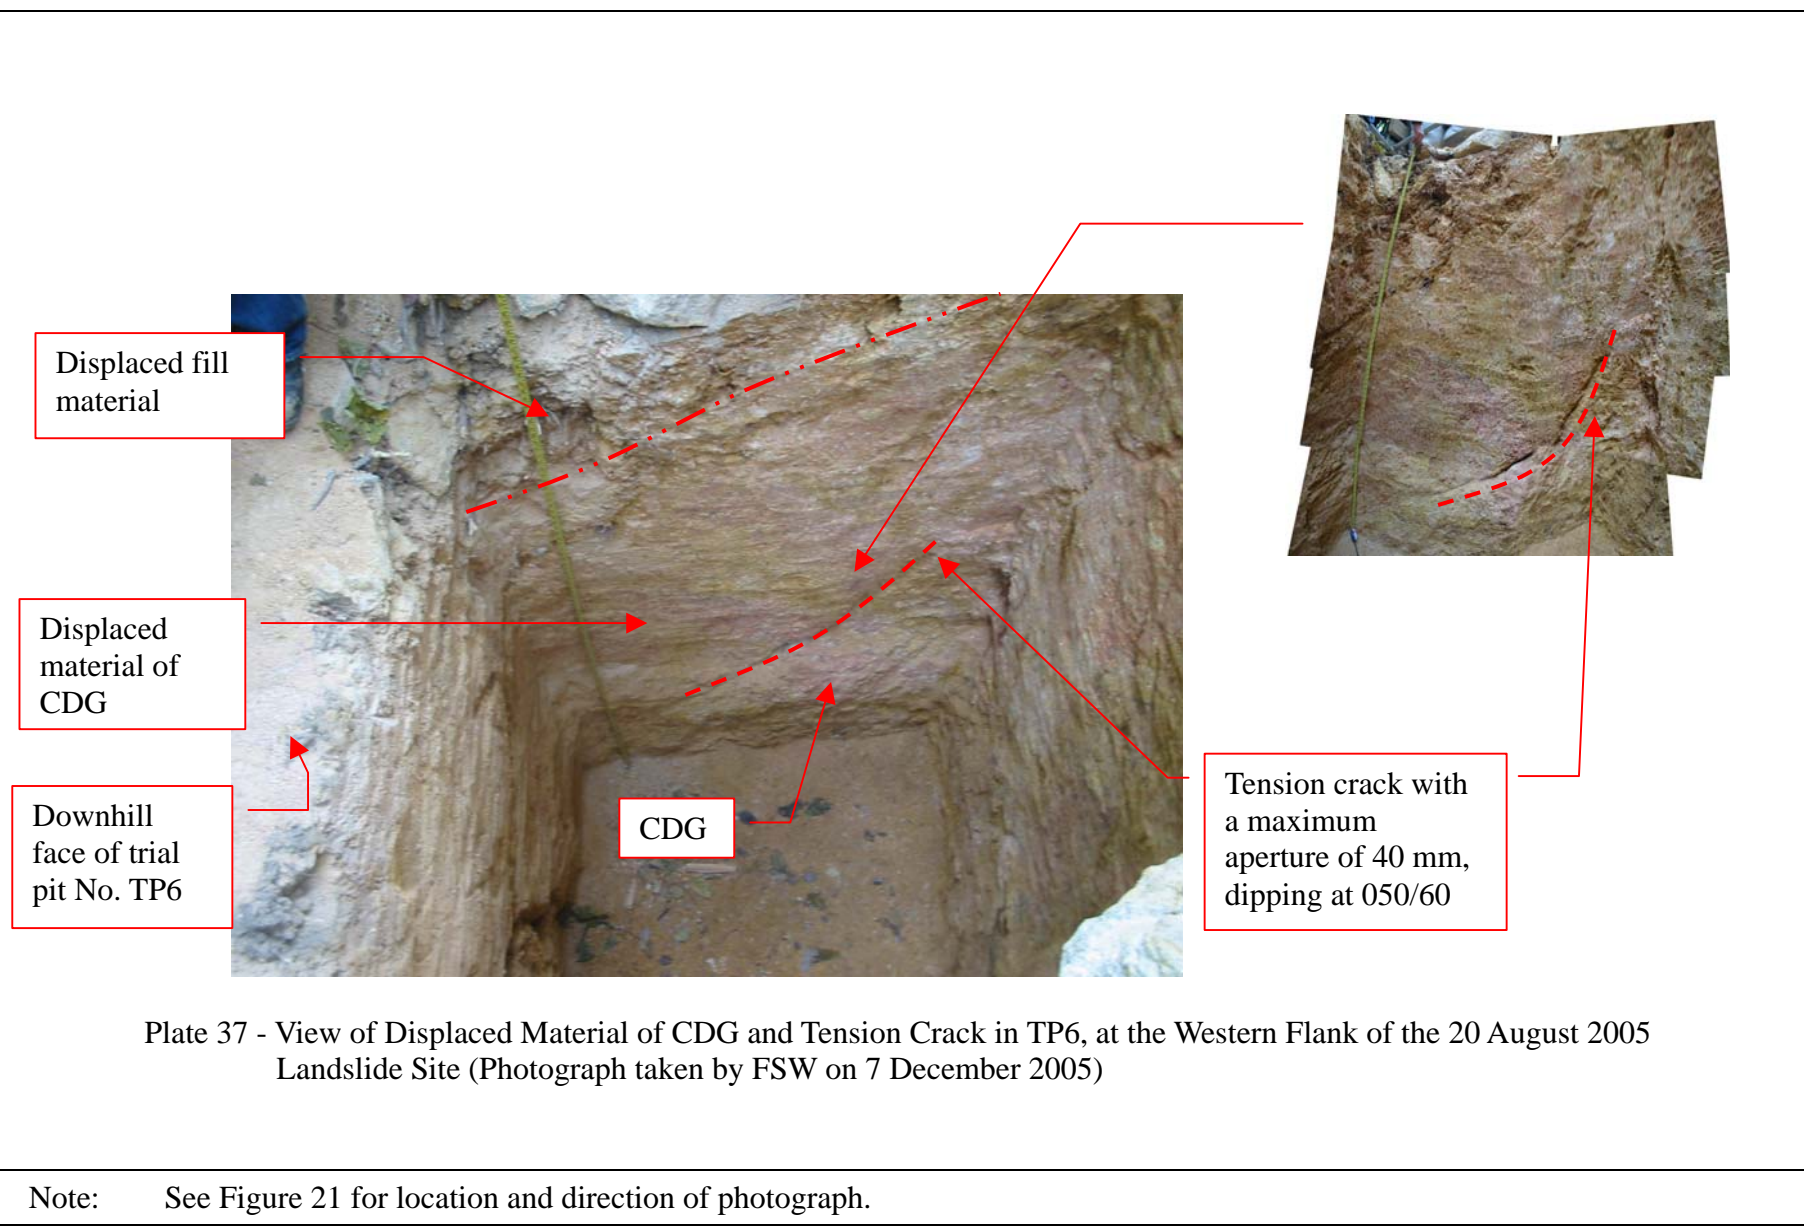
Trial pit No. TP5 sunk at the eastern flank of the landslide (Figure 2) also revealed a 0.5 m thick layer of probably displaced material comprising clayey sandy silt with lenses of CDG overlying bedrock which contains sheeting joints dipping at 30° to 50° out of the slope (Plate 36).

Plate 36 - View of Displaced Material of CDG Overlying Rock at TP5, at the Eastern Flank of the 20 August 2005 Landslide Site (Photograph taken by FSW on 24 November 2005)
