REVIEW OF SELECTED LANDSLIDES INVOLVING SOIL-NAILED SLOPES

GEO REPORT No. 222

F.H. Ng, M.F. Lau, K.W. Shum & W.M. Cheung

**GEOTECHNICAL ENGINEERING OFFICE
CIVIL ENGINEERING AND DEVELOPMENT DEPARTMENT
THE GOVERNMENT OF THE HONG KONG
SPECIAL ADMINISTRATIVE REGION**

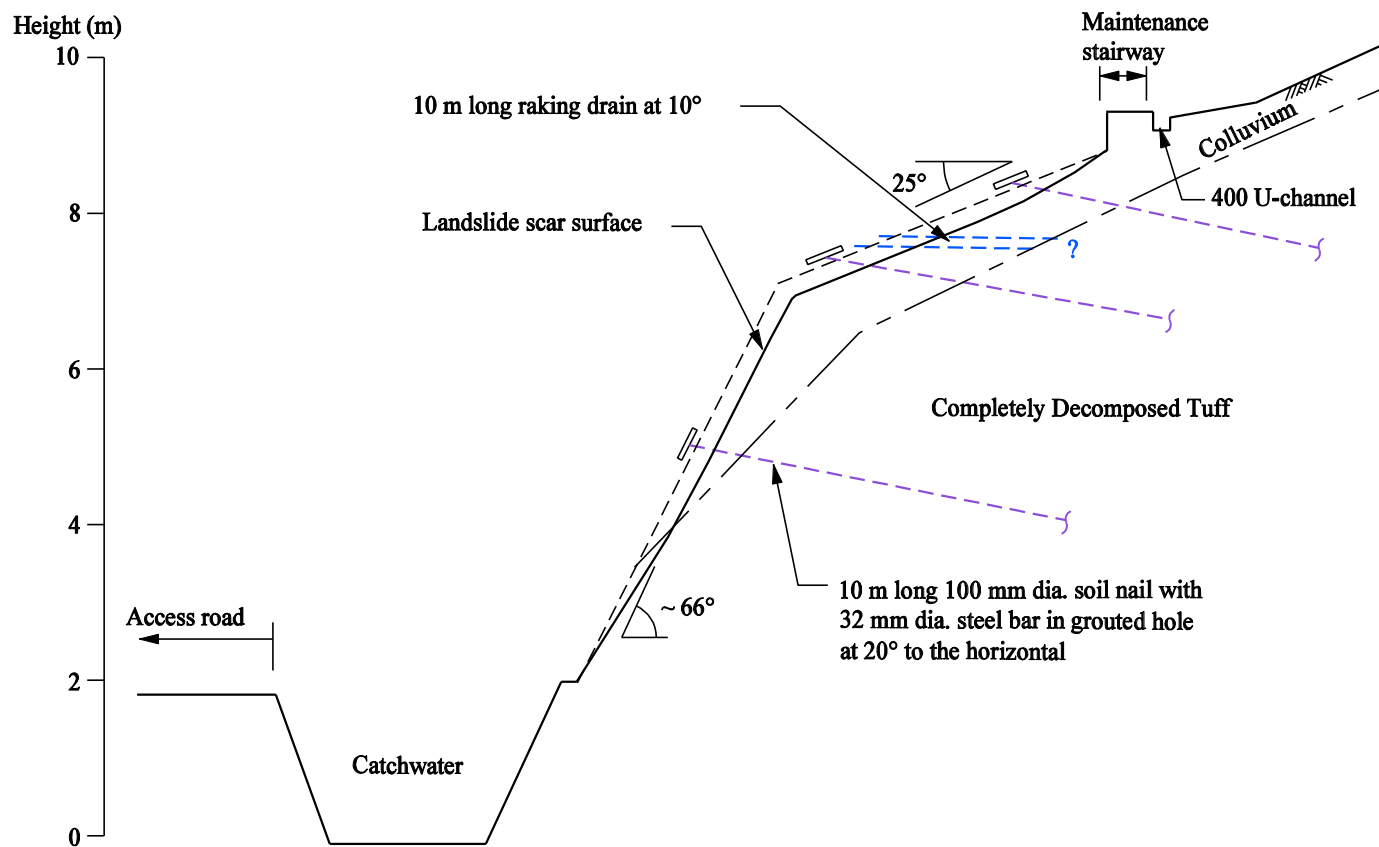
Figure 17 - Section A-A (Slope No. 6SE-D/CR437)

2 m centres horizontal spacing, at an inclination of 20° below the horizontal (Figure 17).

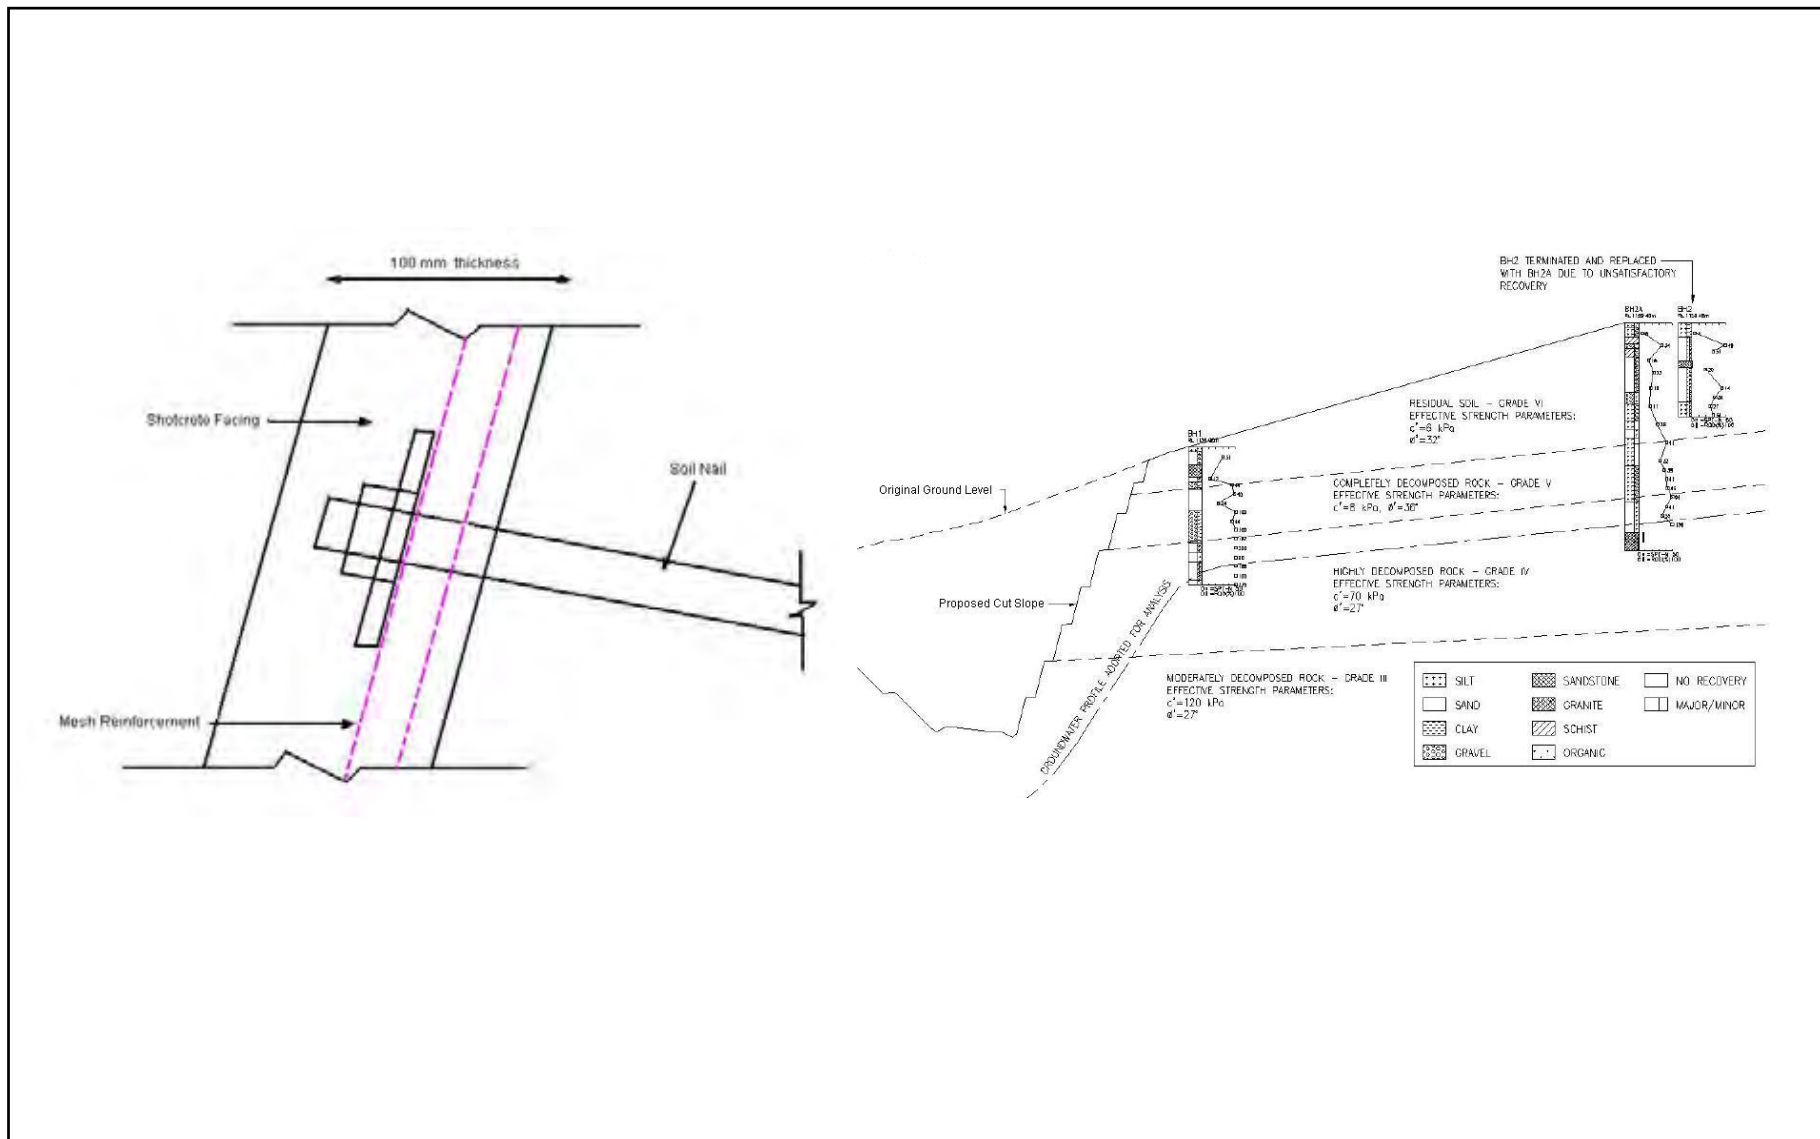
Figure 29 - Cross Section of the 45 m High Soil-nailed Slope and Details of the Guniting Facing (Extracted from Liew & Liong (2006))

The soil-nailed slope comprised a maximum of eight berms, with each of the batters inclined at 76° . The maximum height of the slope was about 45 m. It was reinforced with 12 m long soil nails, except for the highest berm where 6 m long soil nails were installed. Each batter was provided with three rows of soil nails. The horizontal spacing of the soil nails was 1.5 m centres. The slope surface was protected by 100 mm thick gunite (G25) with two layers of A6 mesh reinforcement (Figure 29).

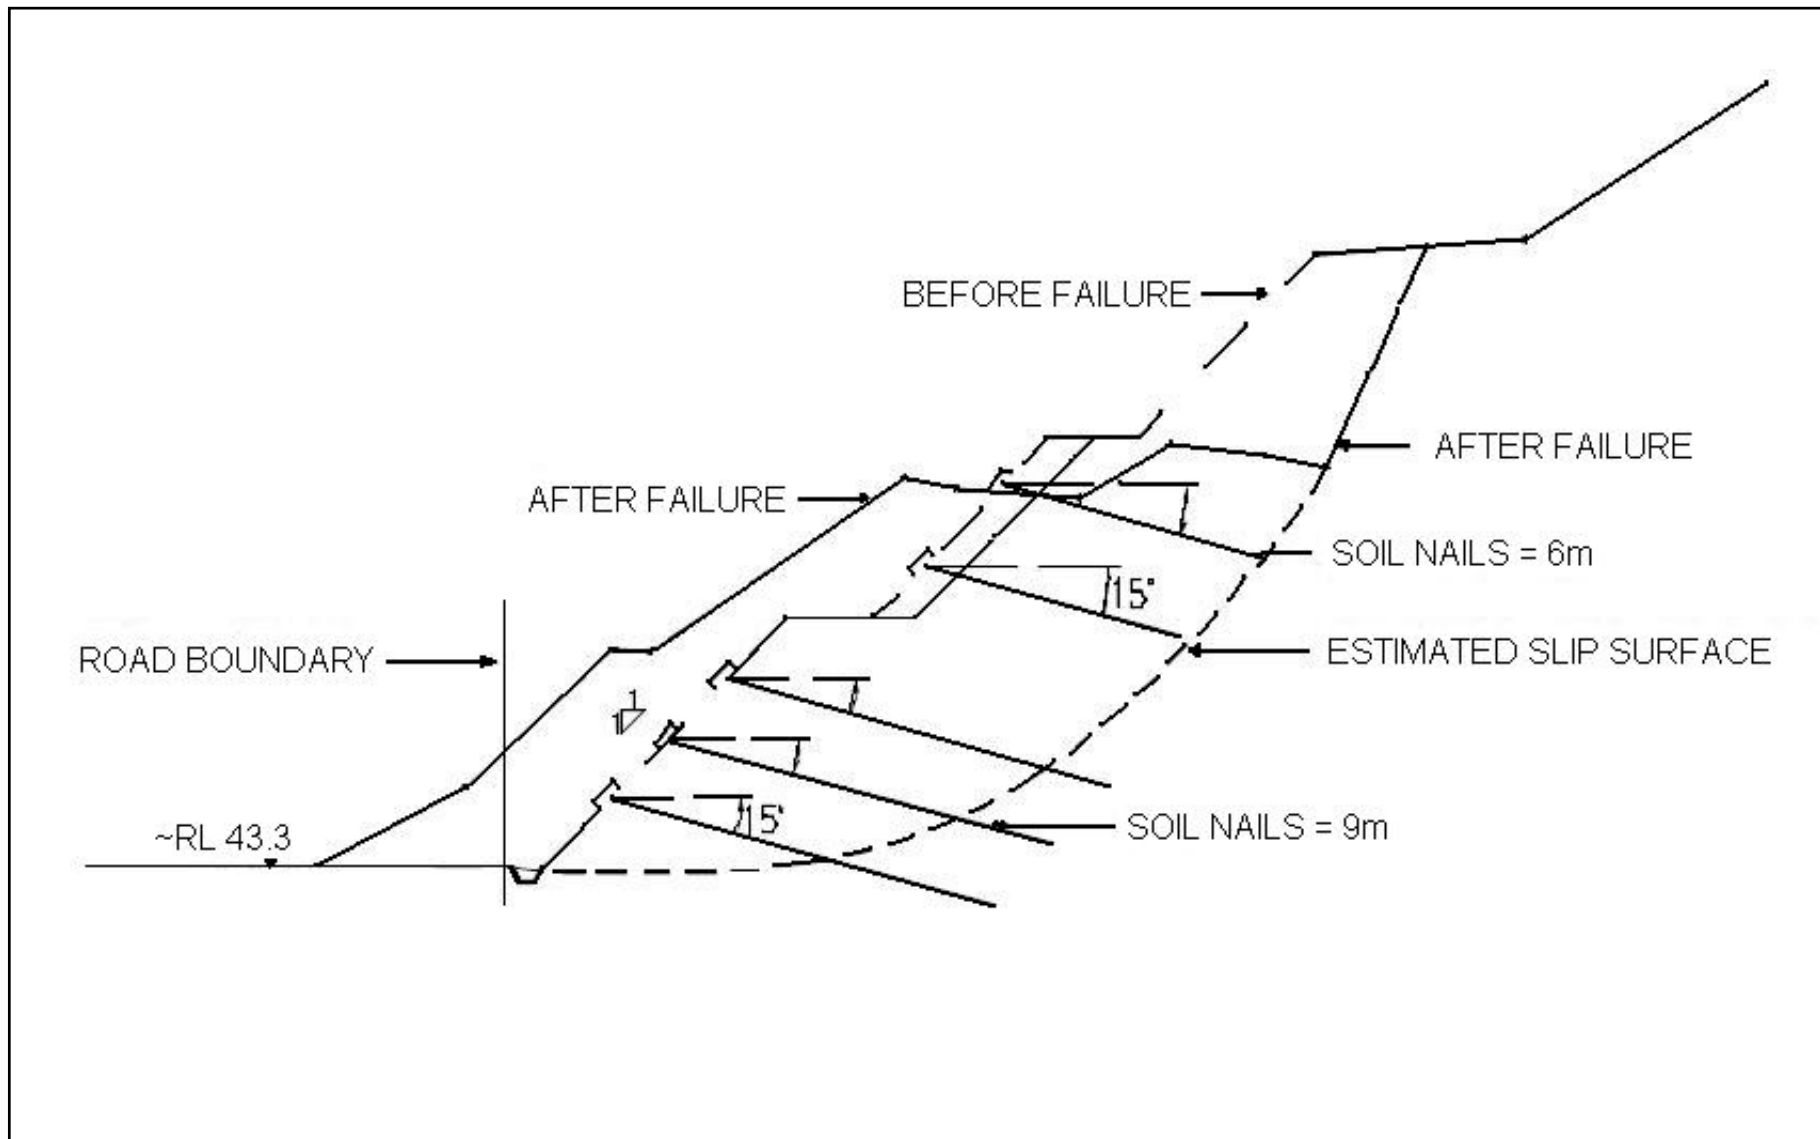
Figure 30 - Cross Section of the 18 m High Soil-nailed Slope (Extracted from Chen(2004))

The soil-nailed portion of the slope was about 16 m high with 3 berms. The lowest and second lowest berms were strengthened by three rows of 9 m long soil nails and two rows of 6 m long soil nails respectively, with a horizontal spacing of 1.5 m to 2 m (Figure 30).

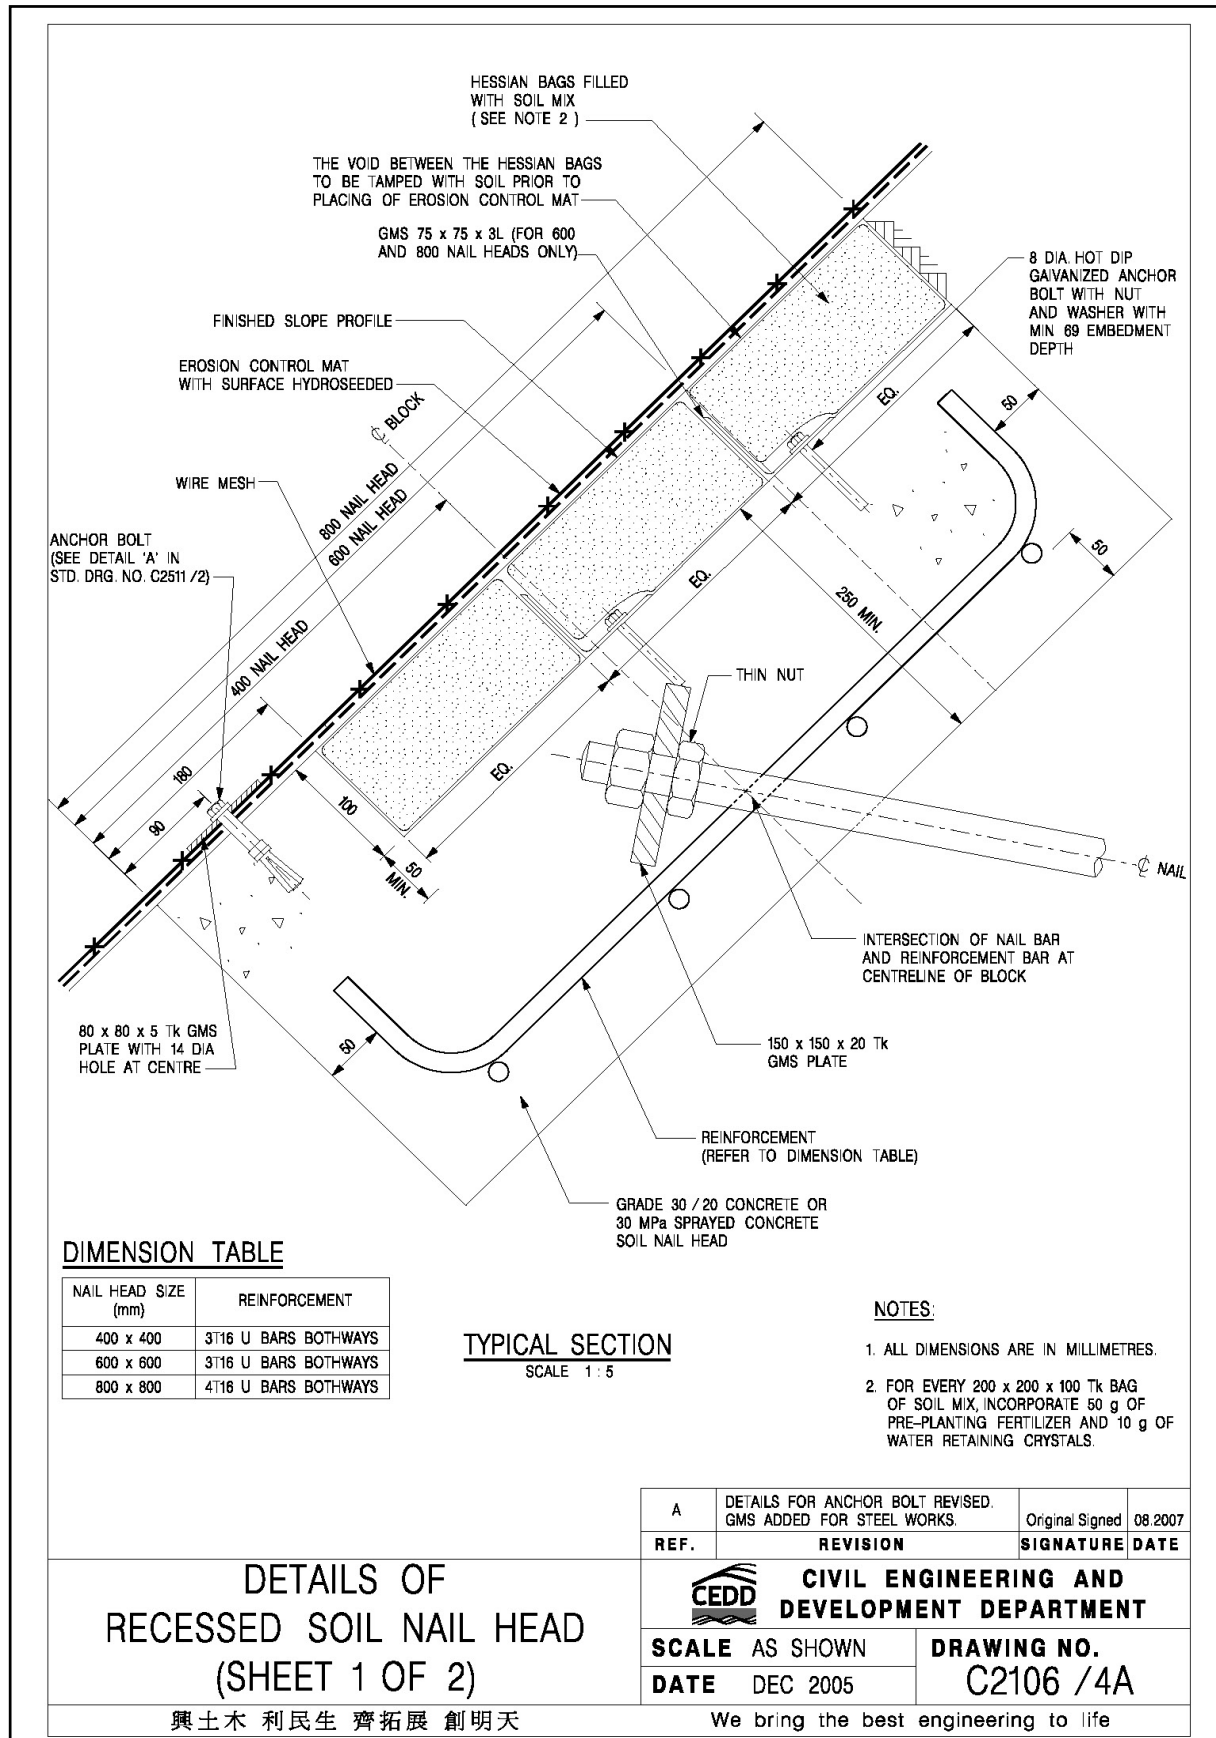
Figure 31 - Details of Recessed Soil Nail Head

From the aesthetics point of view, designers generally tend to favour the use of recessed nail heads. Typical details are shown in a standard drawing issued by CEDD, as reproduced in Figure 31. However, there is another school of thought that does not advocate the use of recessed nail heads for routine applications. Concerns have been raised by some practitioners with regard to the stability of the backfill placed in hessian bags above the concrete nail heads in the long run (viz. hessian would degrade after a few years and the backfill may get washed out, especially for the enlarged nail heads; for many slopes, shrubs and small trees may quickly replace the grass and disguise the nail heads, making the recessed nail heads redundant, which would incur additional costs and time). In principle, the designer should carefully consider, on a case-by-case basis, the need for recessed soil nail heads and the appropriate detailing of the backfill above the recessed heads.
