FINAL REPORT OF THE COMMISSION OF INQUIRY INTO THE RAINSTORM DISASTERS 1972

GEO REPORT No. 229

T.L. Yang, S. Mackey & E. Cumine

**This report is largely based on the Final Report of the Commission
of Inquiry into the Rainstorm Disasters 1972 produced in November 1972**

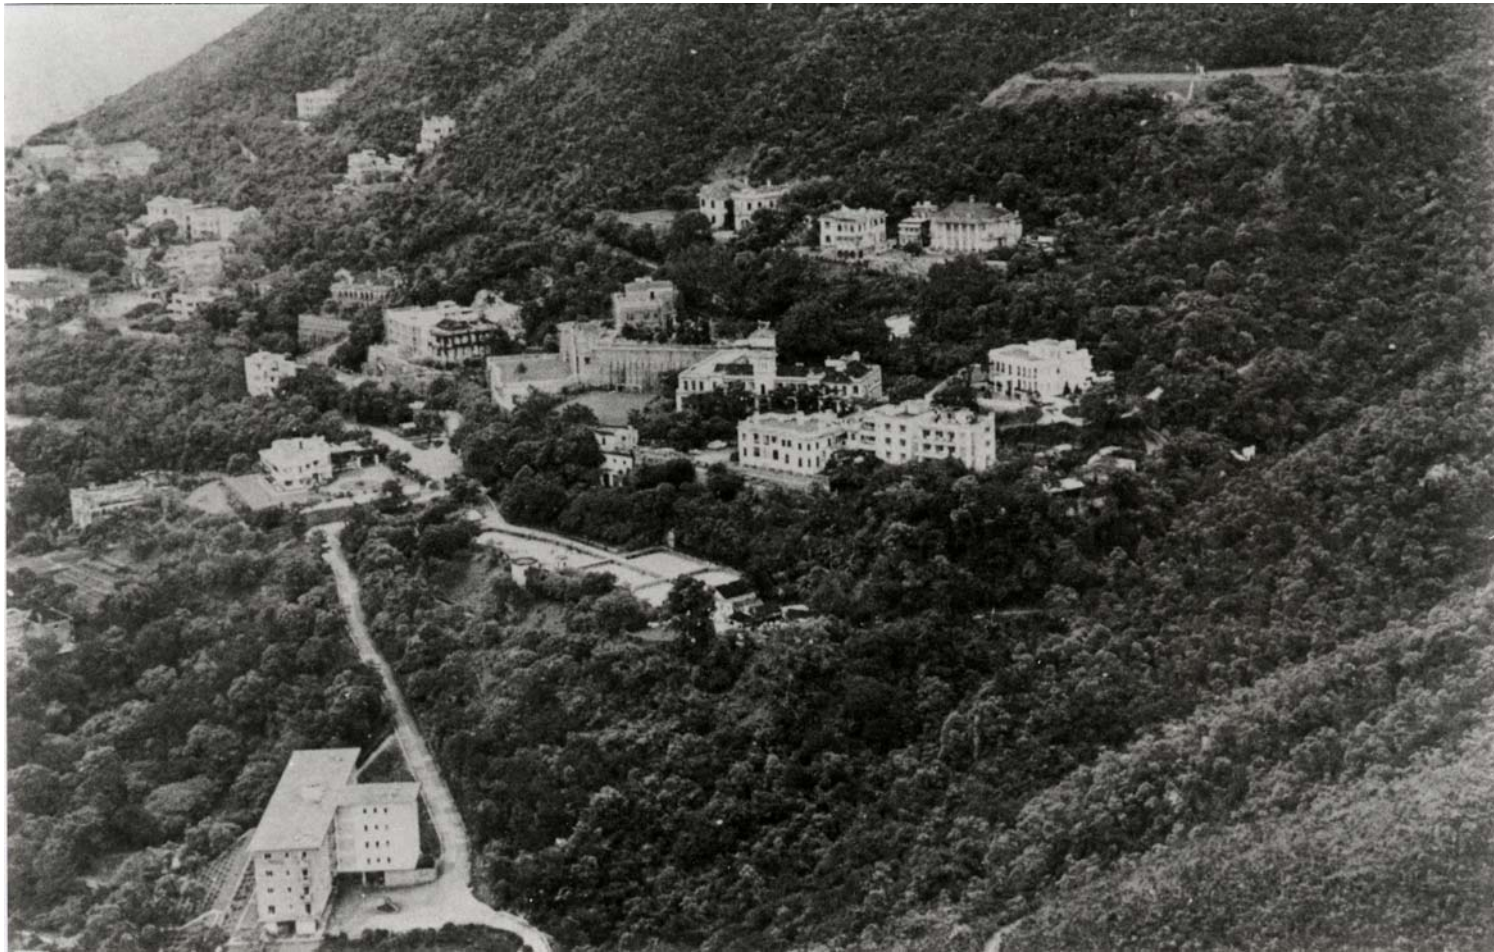
47. Plate 1 shows the type of development in the western part of the Mid-levels prior to 1962, although the photograph was taken considerably later. The character of the neighbourhood had not begun to change. The houses were generally spacious in character and of two or three storeys, with a height not exceeding 35 feet. The height, “design and disposition” of all building developments had to be subject to the “special approval” of the Director of Public Works.

262. The history of redevelopment of I.L. 2260 as presented to us is set out in Chapter III of this Report. However, in spite of much testimony and cross-examination the detailed happenings which occurred on this site over the ten-year period extending from 1962 to 1972 remain something of a mystery. Plate 1 shows the approximate nature and character of the site as it existed prior to 1962 when redevelopment work commenced.

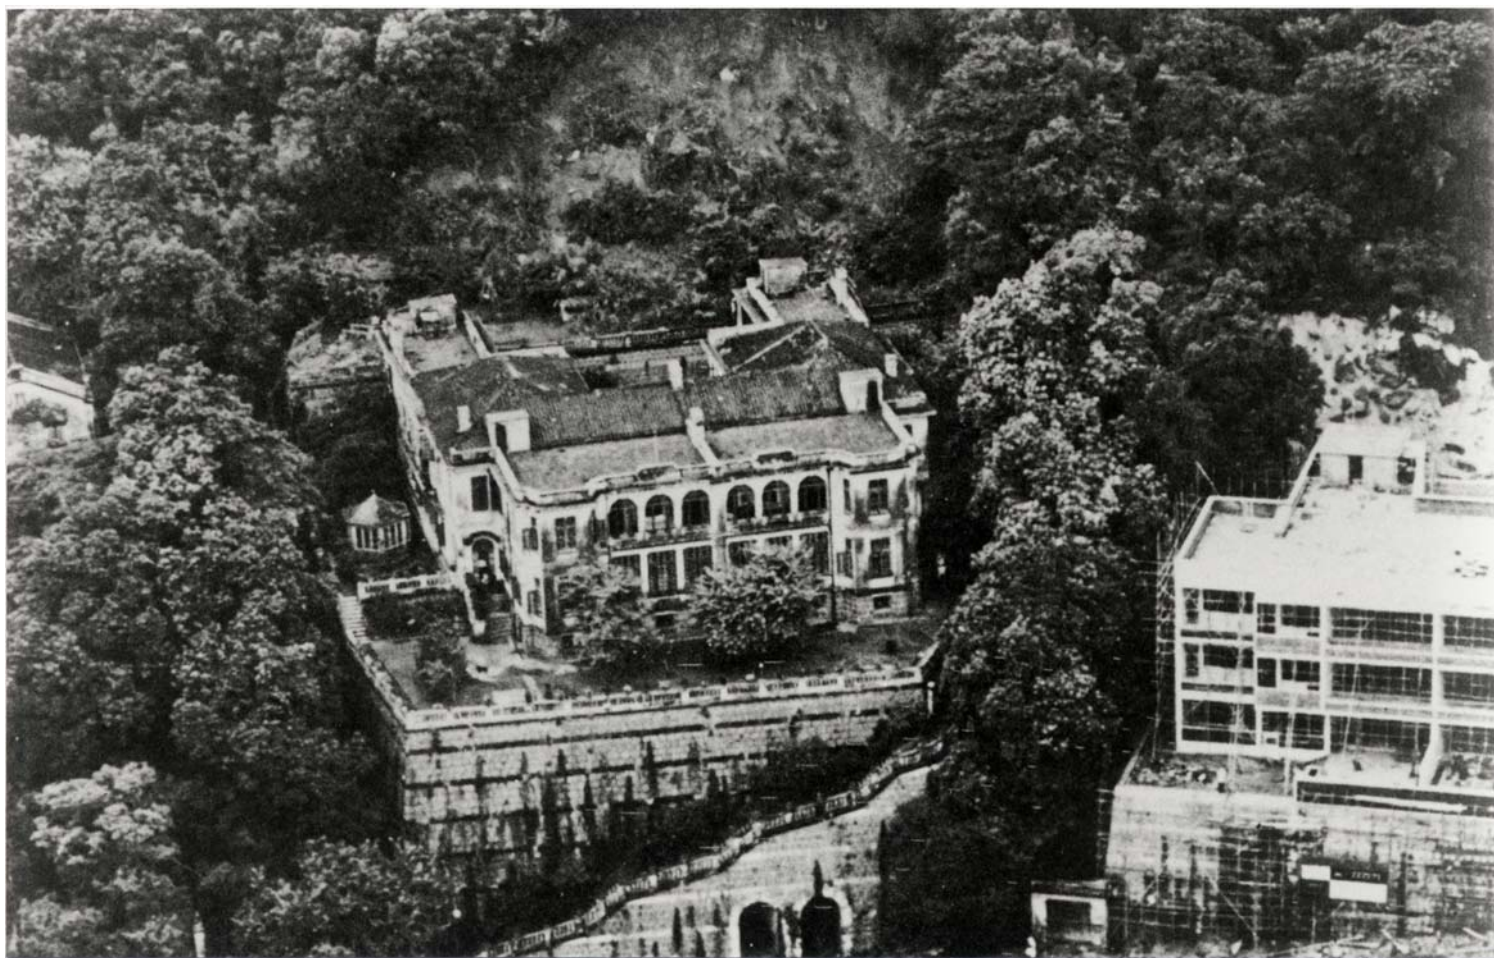
61. The Linton Investment Co., Ltd., with Mr. Linton CHU as Managing Director, acquired the lease of Inland Lot 2260 (here-inafter referred to as I.L. 2260), 51C and 51D, Conduit Road, on October 1, 1962. It was a property of 30,650 square feet, and consisted of a pair of old-style semi-detached "mansions". Plate 2 is a photograph of the property in 1961.

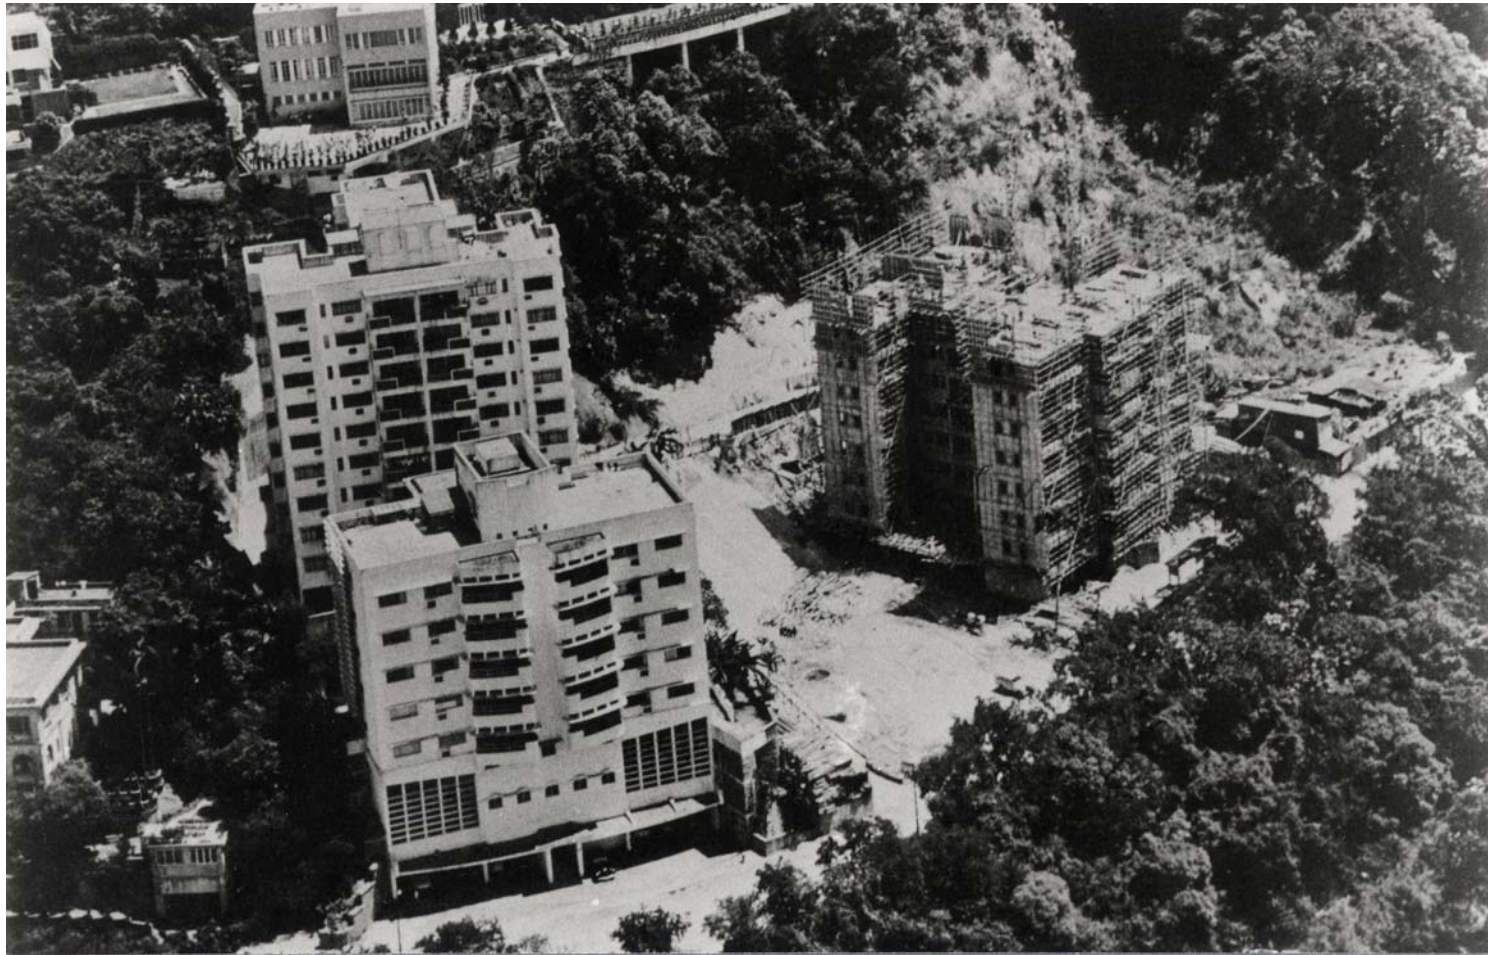
Plate 3

65. Plate 3, which is a photograph of the vicinity of I.L. 2260 taken on May 24, 1970, shows the extent of the cutting of the slope behind I.L. 2260. Berms can be seen extending across the inclined surface which was covered with the remains of chunam plastering. It was a slope which apparently had to be bolstered by a small retaining wall or stone-pitching. The slopes did not show any obvious signs of instability, but did appear to be rather steep in places.

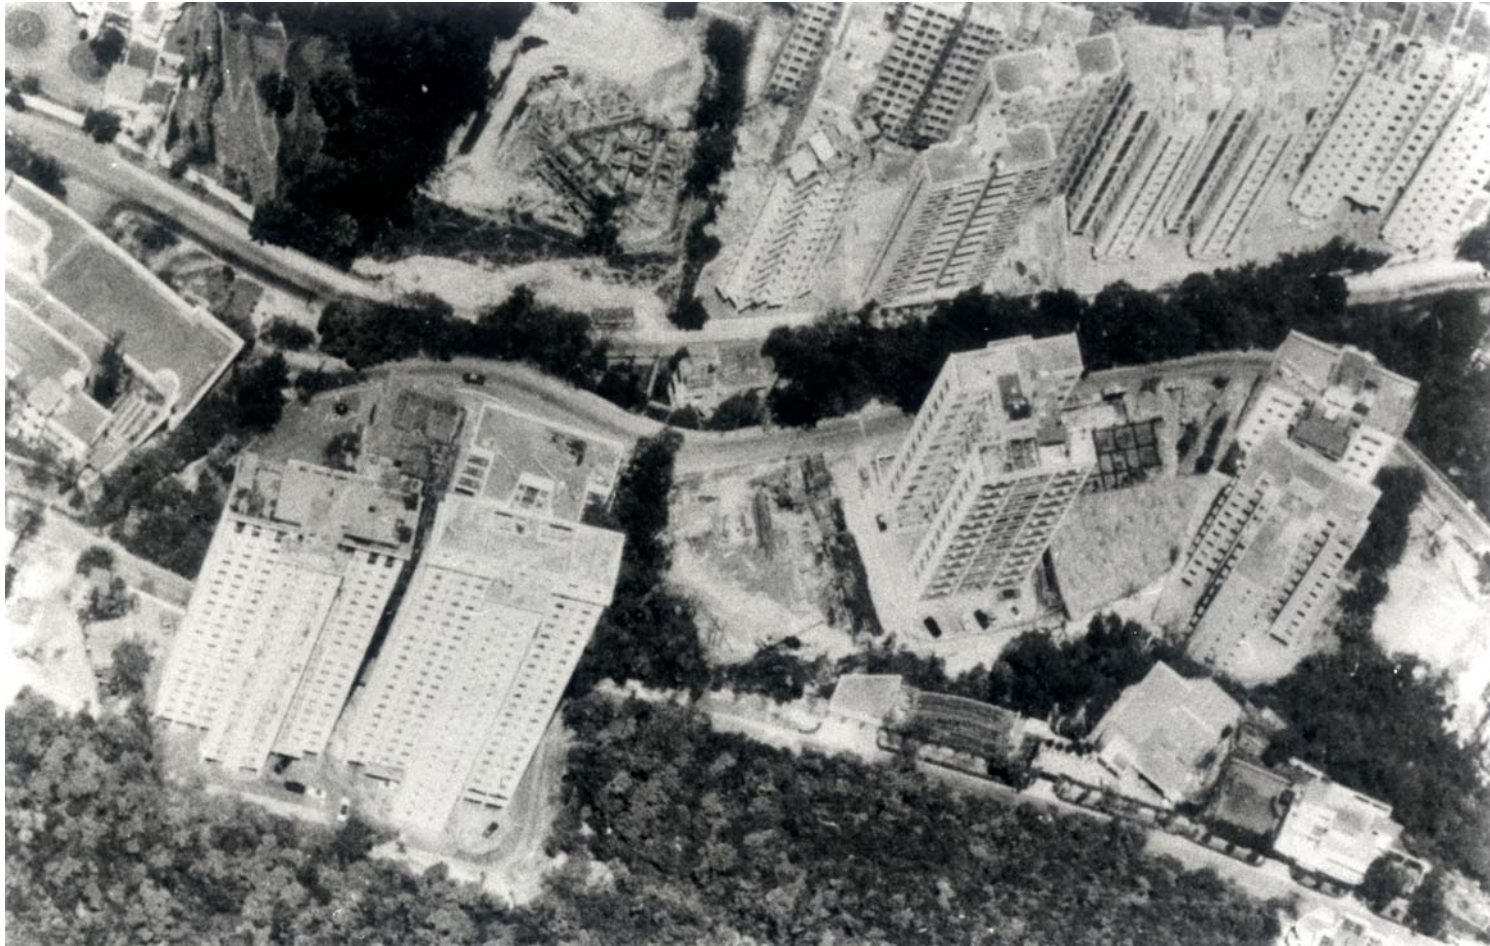
86. Plate 4 is an aerial view of the Mid-levels in March 1972. In that month, the driving of steel sheet piles commenced at I.L. 2260. There was also excavation for the removal of obstructions. By the end of March some 75% of the steel sheet piles had been driven along the eastern half of the base of the slope at the southern face of the site (see Plates

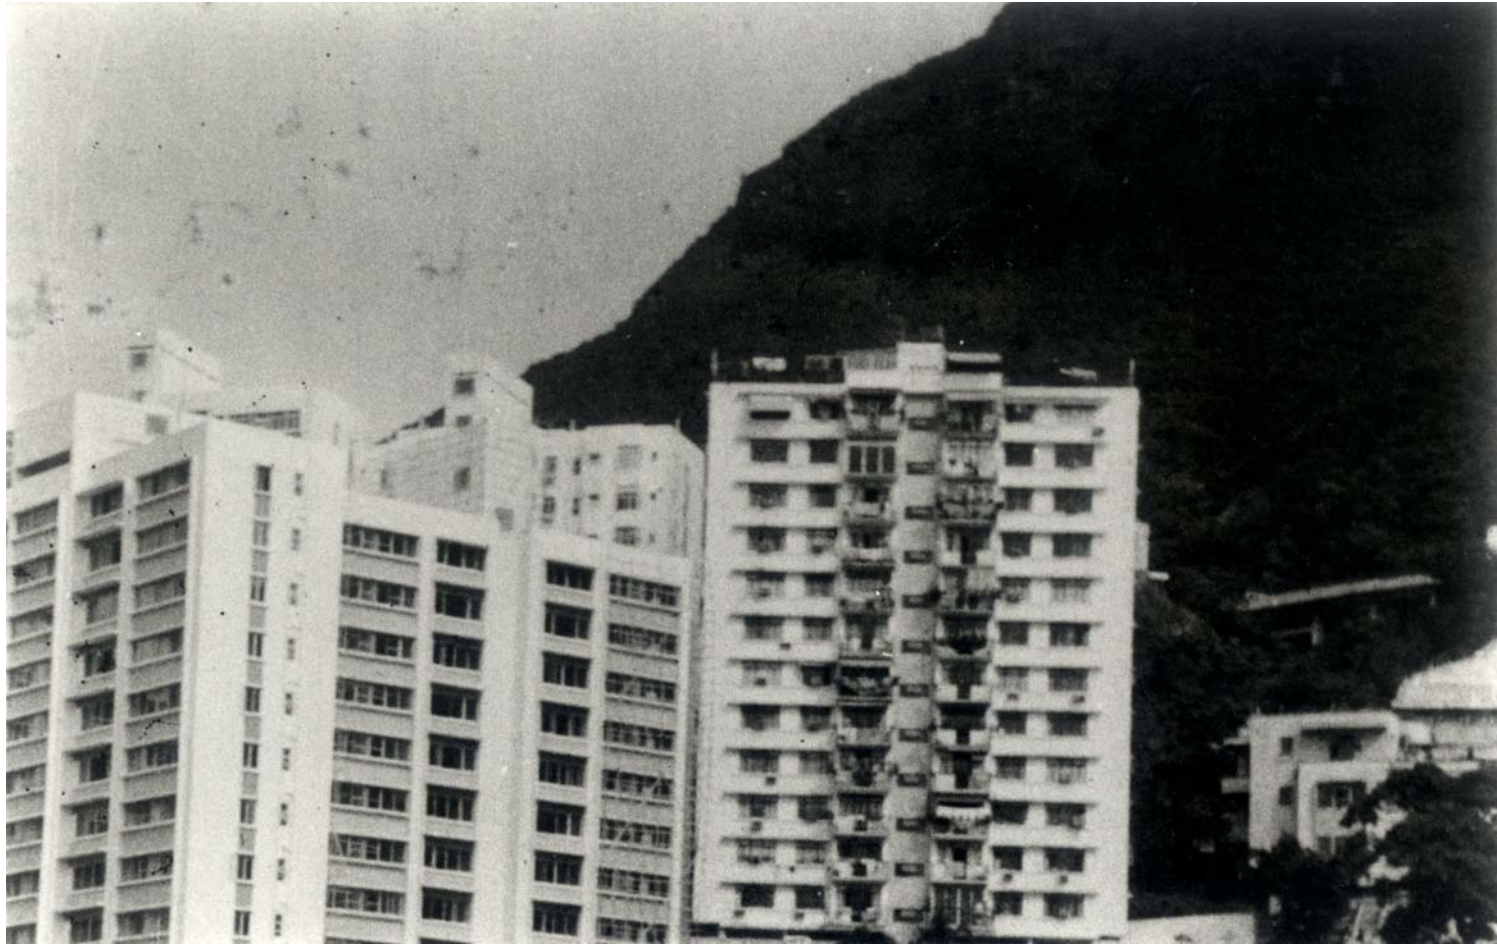
Plate 10

124. Plates 10 and 11, which were taken from the same angle, show the disaster area respectively before and after the major landslide. An aerial view of the disaster area is at Plate 7. Appendix IX is a plan of the disaster area showing the approximate limit of the major landslide (including debris) on June 22, 1972.

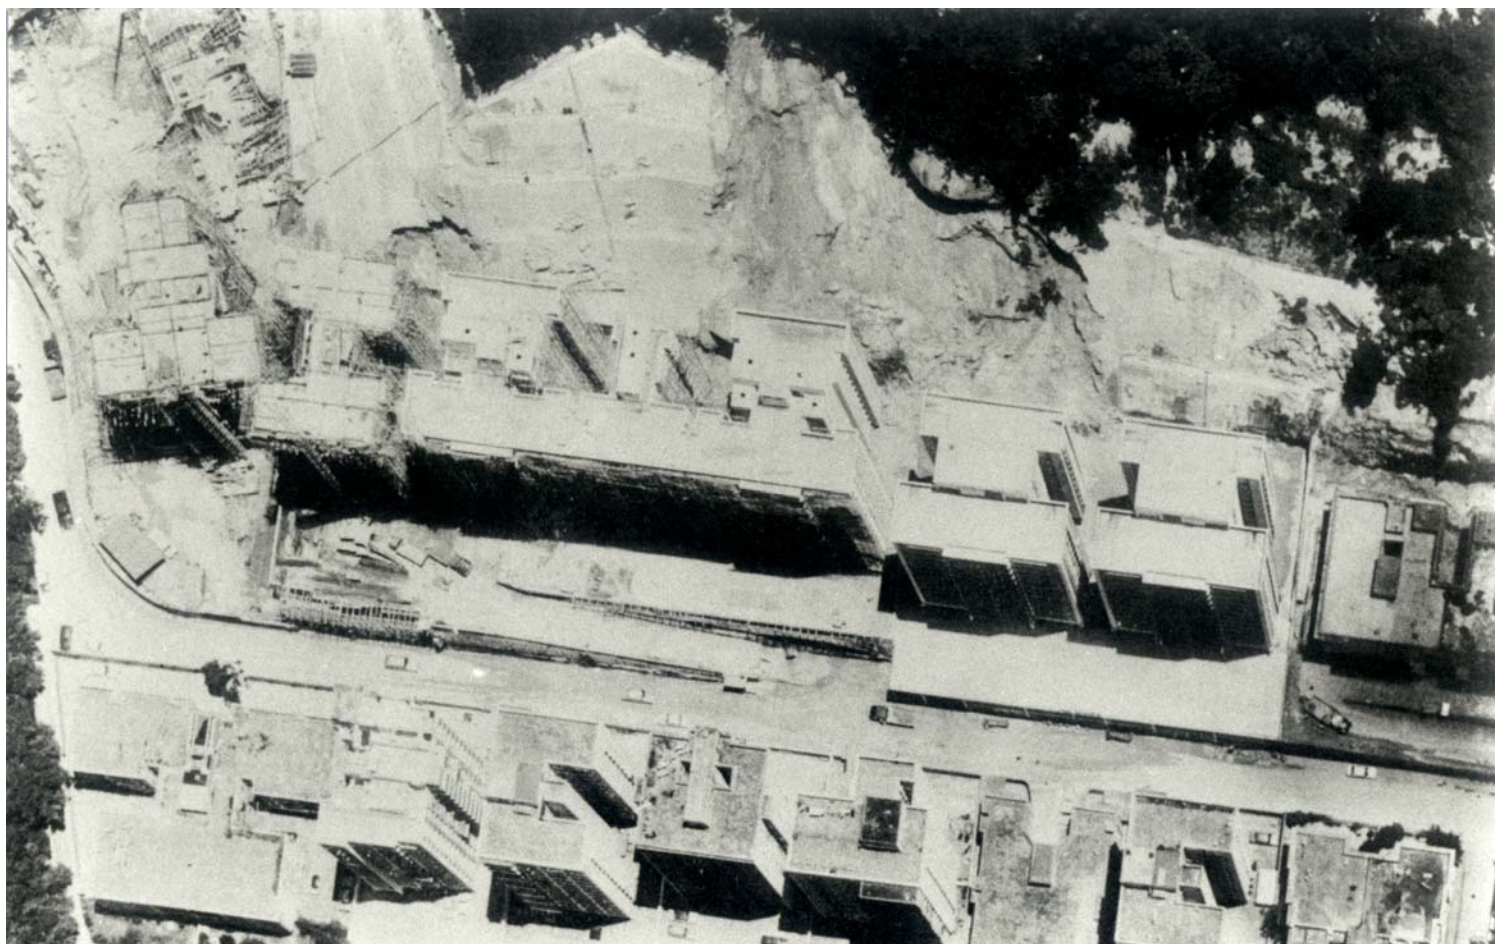
Plate 13

212. Although, in fact, three separate landslips occurred on the same day, the areas of the individual slips merged into one another, leaving a continuous scar on the hillside cutting faces as if a single landslip had occurred (see Plate 13).

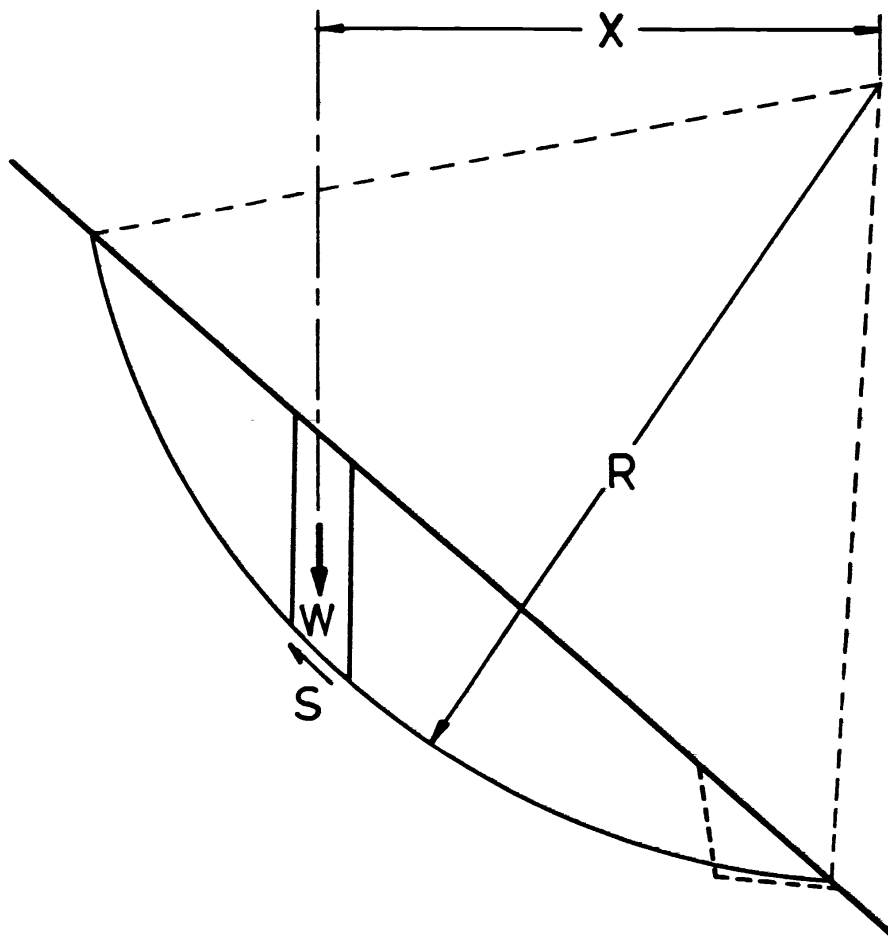
FIG. 2

The effect of these factors can perhaps best be illustrated by examining the stability of an idealized slope as shown in figure 2.

The effect on the stability of a slope of the three factors, slope, saturation and pore pressure can be readily seen from figure 2: -
