**DETAILED STUDY OF THE
21 AUGUST 2005 DEBRIS FLOW
ON THE NATURAL HILLSIDE
NEAR FEI NGO SHAN
SERVICE RESERVOIR**

GEO REPORT No. 233

Maunsell Geotechnical Services Limited

**GEOTECHNICAL ENGINEERING OFFICE
CIVIL ENGINEERING AND DEVELOPMENT DEPARTMENT
THE GOVERNMENT OF THE HONG KONG
SPECIAL ADMINISTRATIVE REGION**

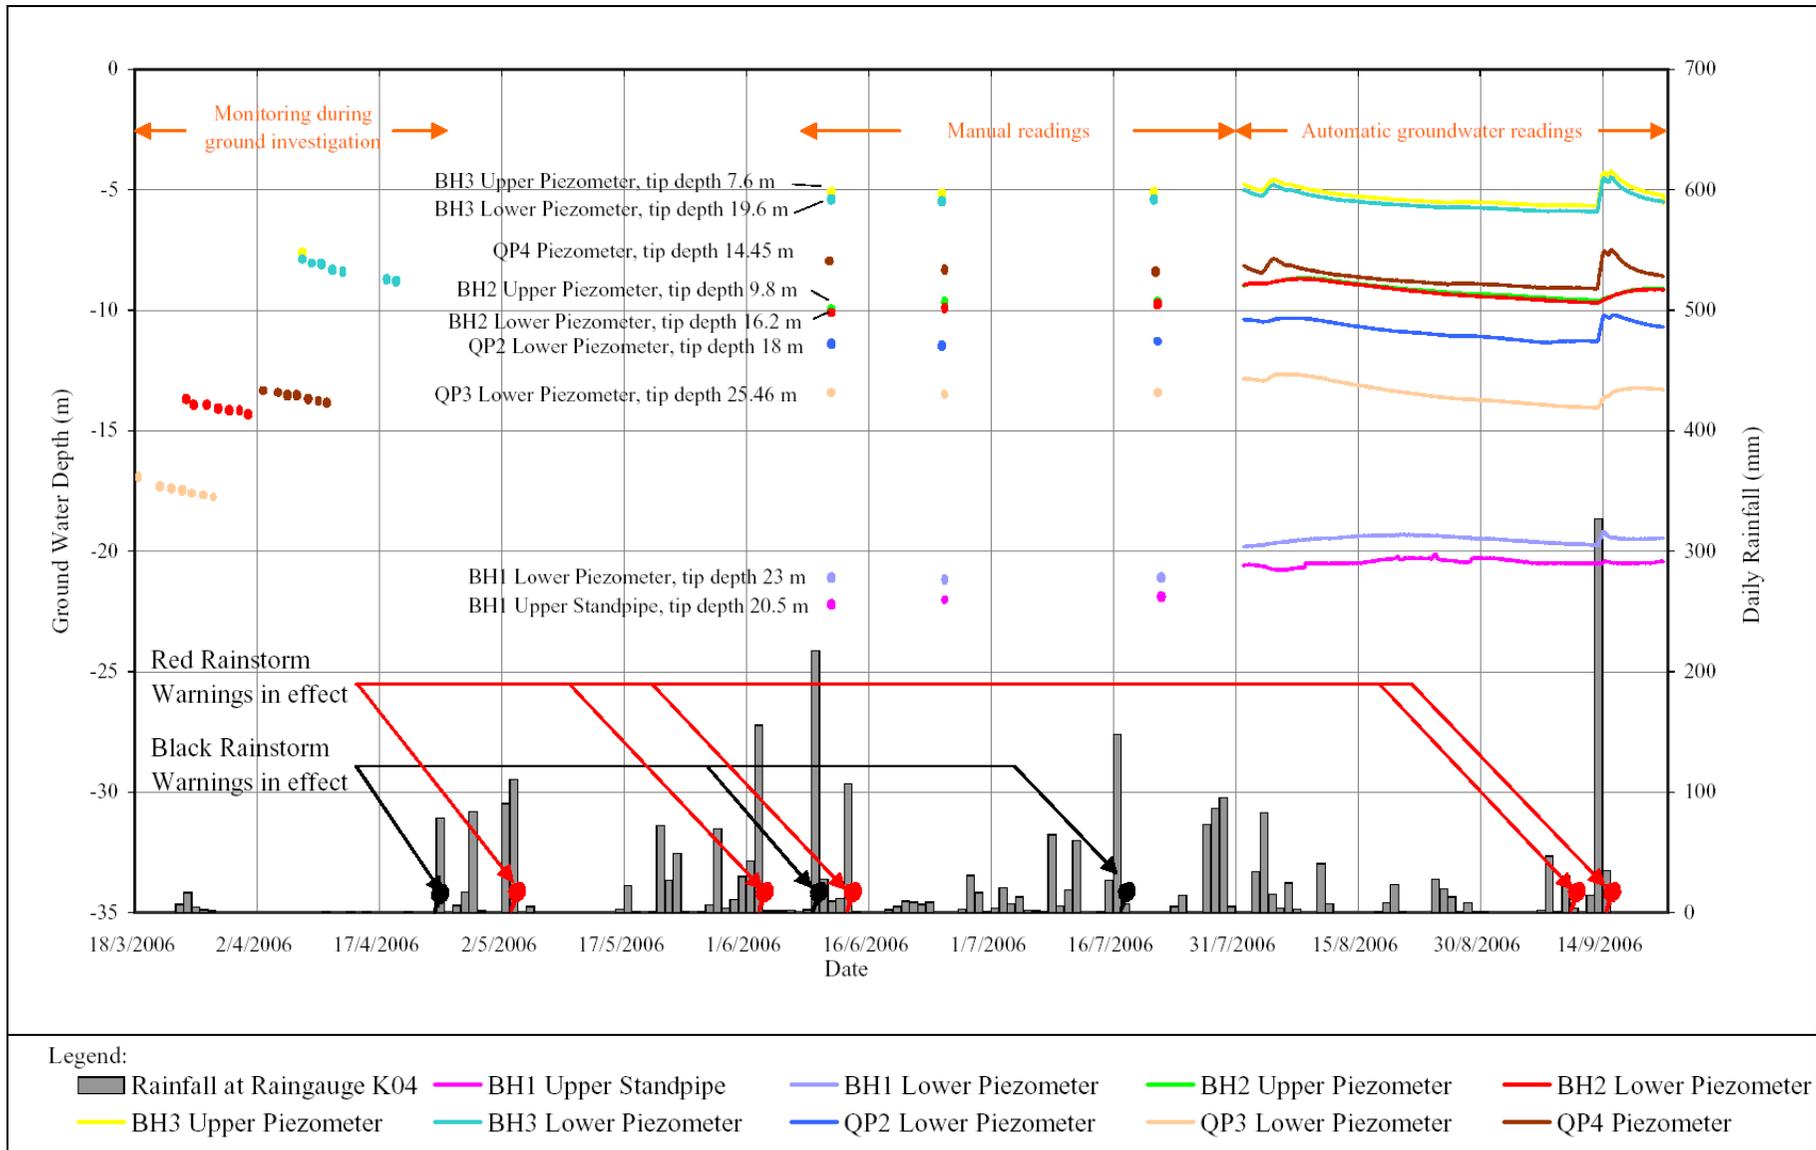
Figure 13 - Groundwater Monitoring Readings and Daily Rainfall for the Period between 18 March 2006 and 21 September 2006

Monitoring of the piezometers and standpipes installed in drillholes Nos. BH1 to BH3 and drillholes Nos. QP2 to QP4 was carried out between March 2006 and September 2006, with the use of automatic groundwater monitoring devices. The results of the groundwater level monitoring are presented in Figure 13, together with the rainfall records of the nearest GEO raingauge No. K04.

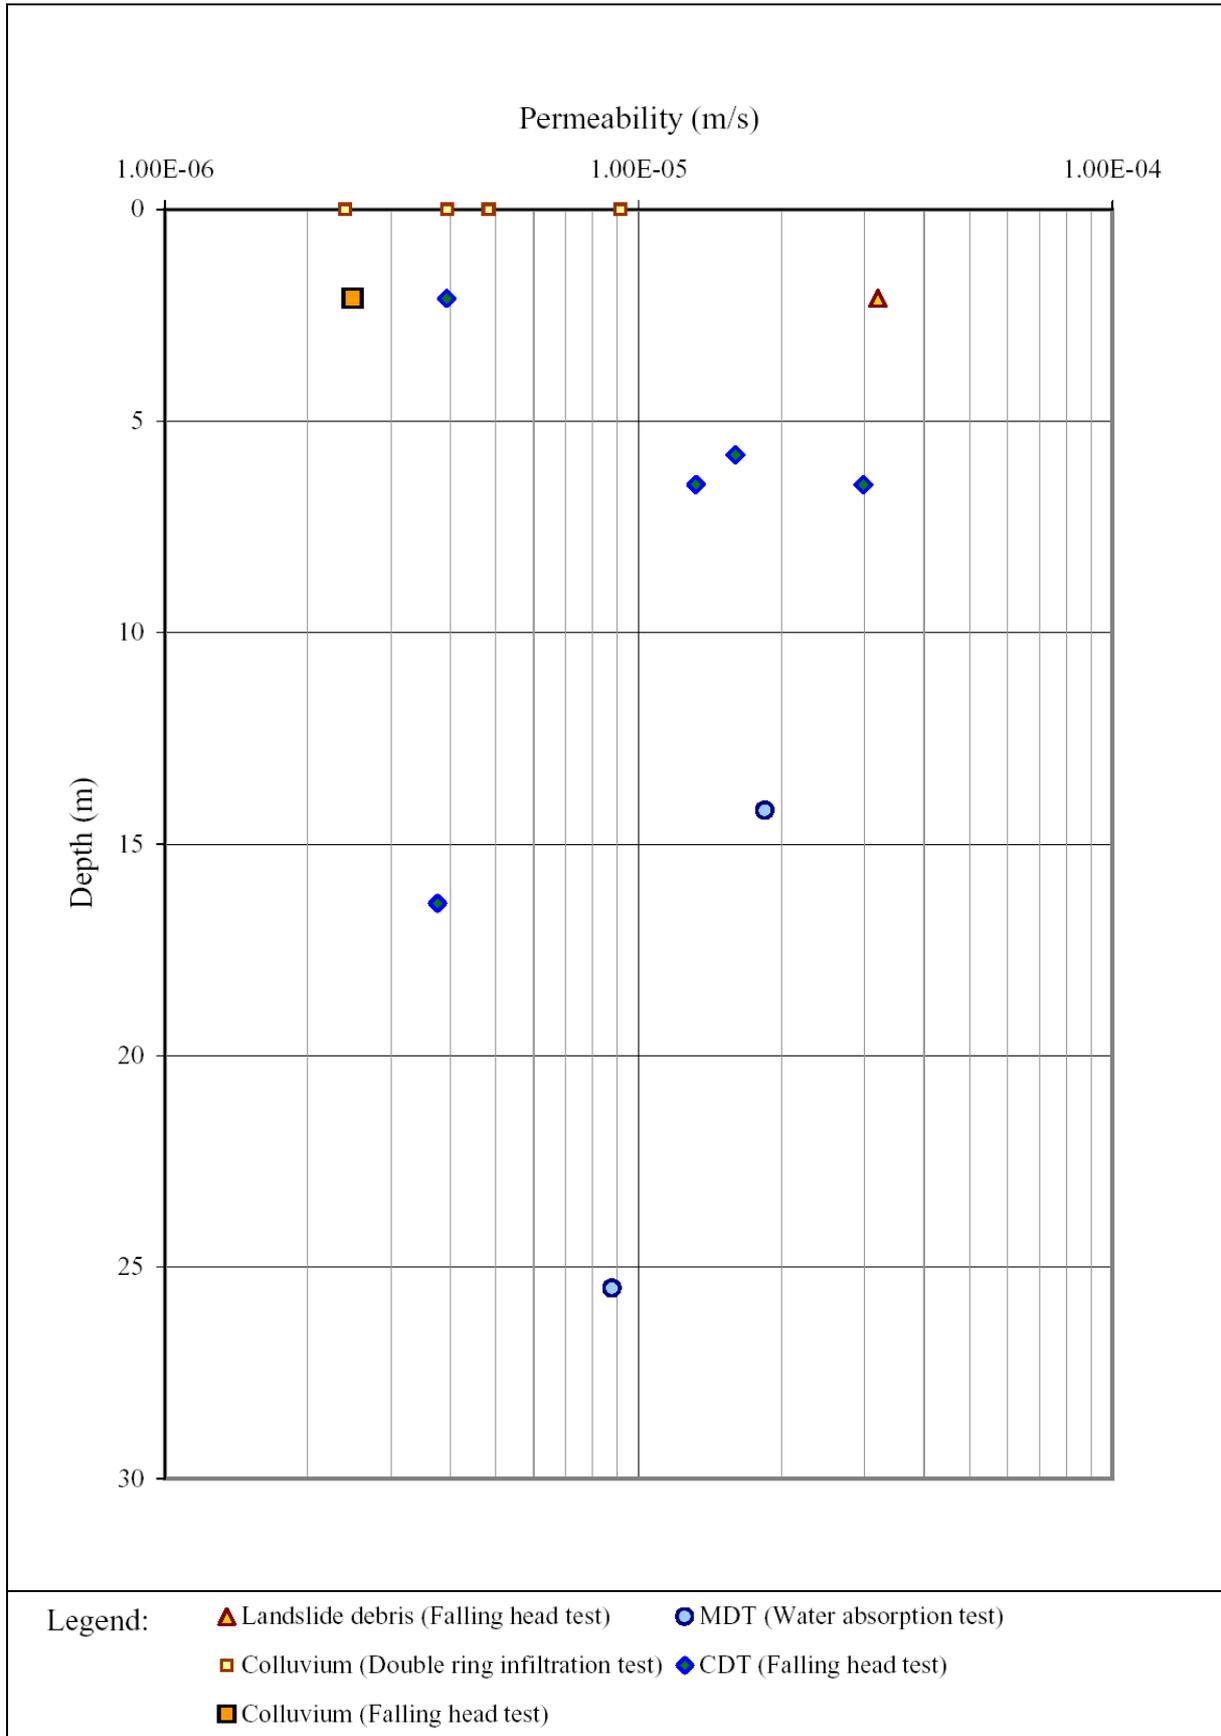
Figure 14 - Summary of Field Permeability Tests

Double-ring infiltration tests, falling head permeability tests and water absorption packer tests were carried out in the colluvium/landslide debris, CDT and moderately to highly decomposed tuff. The results of the infiltration tests (Figure 14) indicate that the infiltration

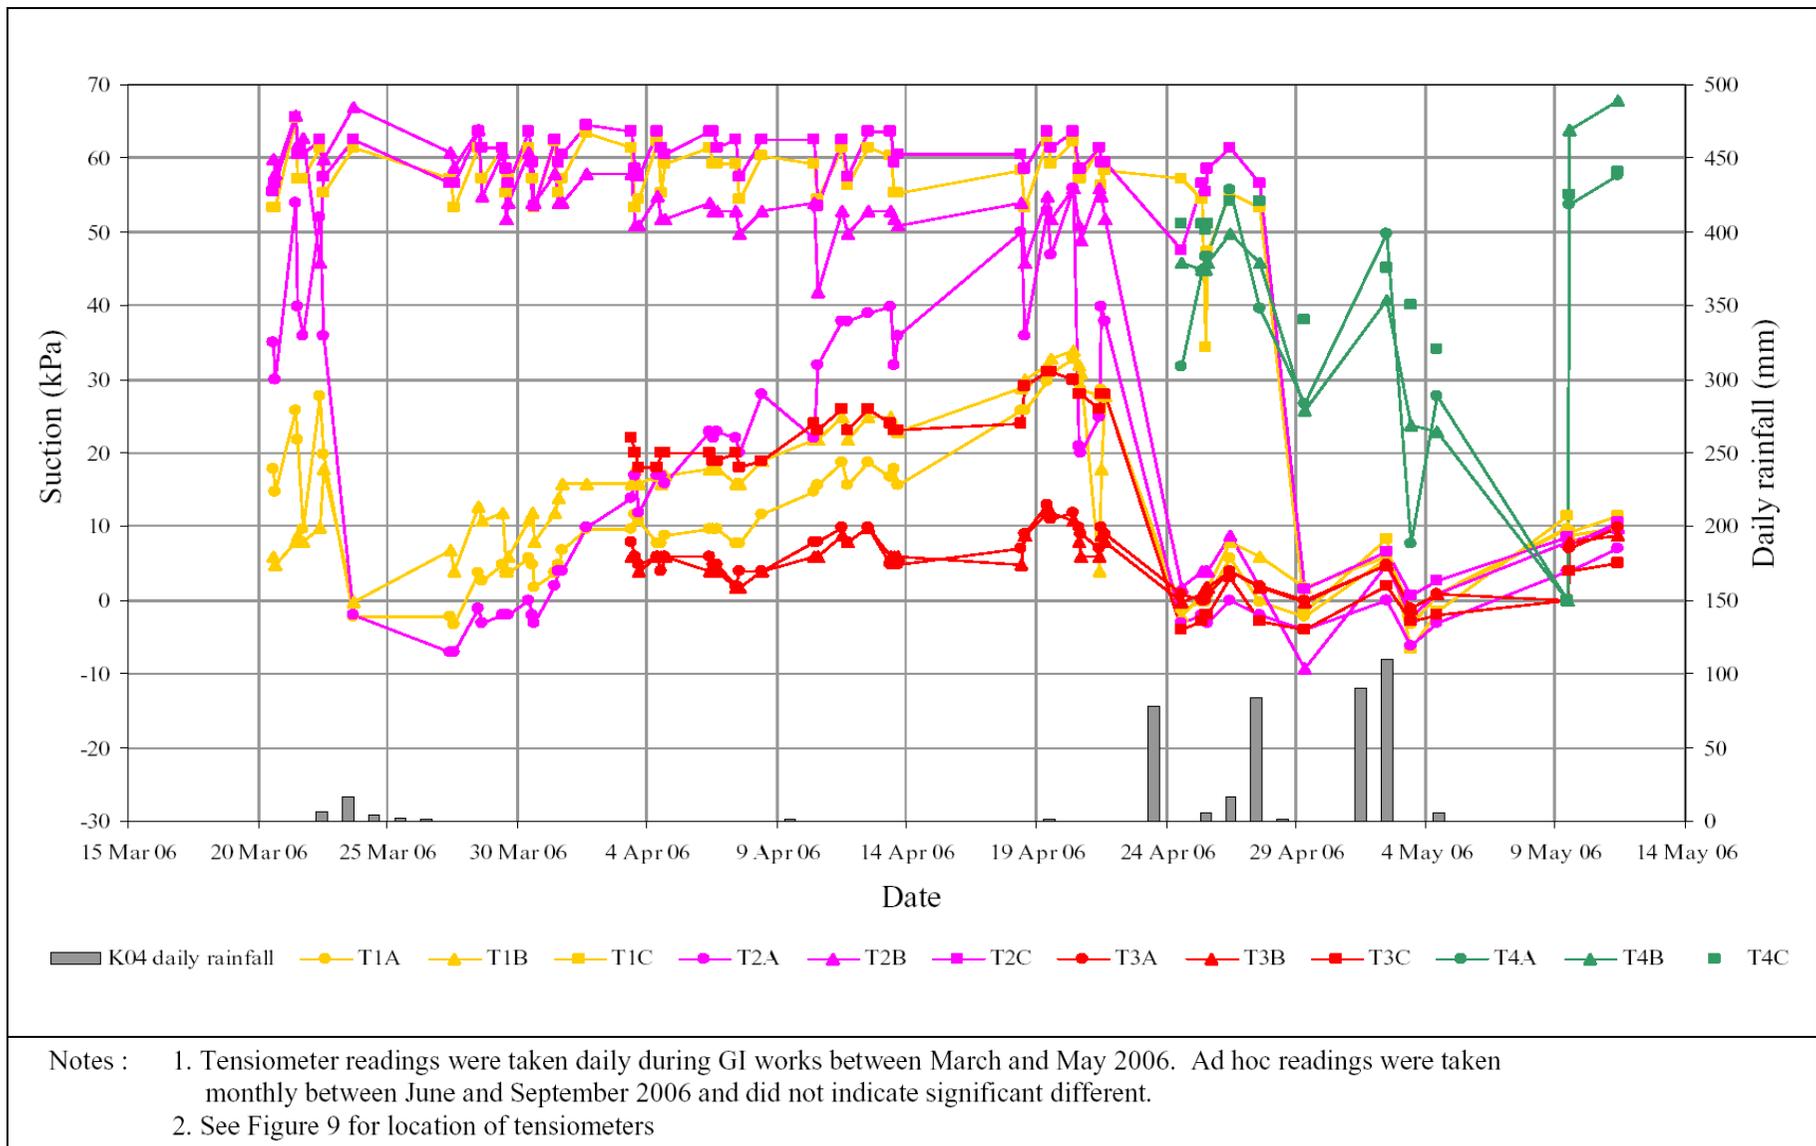
Figure 15 - Tensiometer Readings and Daily Rainfall between 20 March 2006 and 11 May 2006

The results from the monitoring of the tensiometers between 20 March and 21 September 2006 are presented in Figure 15. In general, it was observed that the tensiometers installed at 0.5 m were more responsive to rainfall than those installed at greater depths. The tensiometers installed at 2.0 m depth showed little or no variation in soil suction during and immediately following short periods of rainfall, but the suction started to drop after prolonged periods of rainfall (readings for T4A to T4C in Figure 15 refer). Based on these readings, it is apparent that loss of soil suction near the surface could occur rapidly following rainfall, whilst reductions of suction at greater depths require prolonged periods of rainfall to induce change.

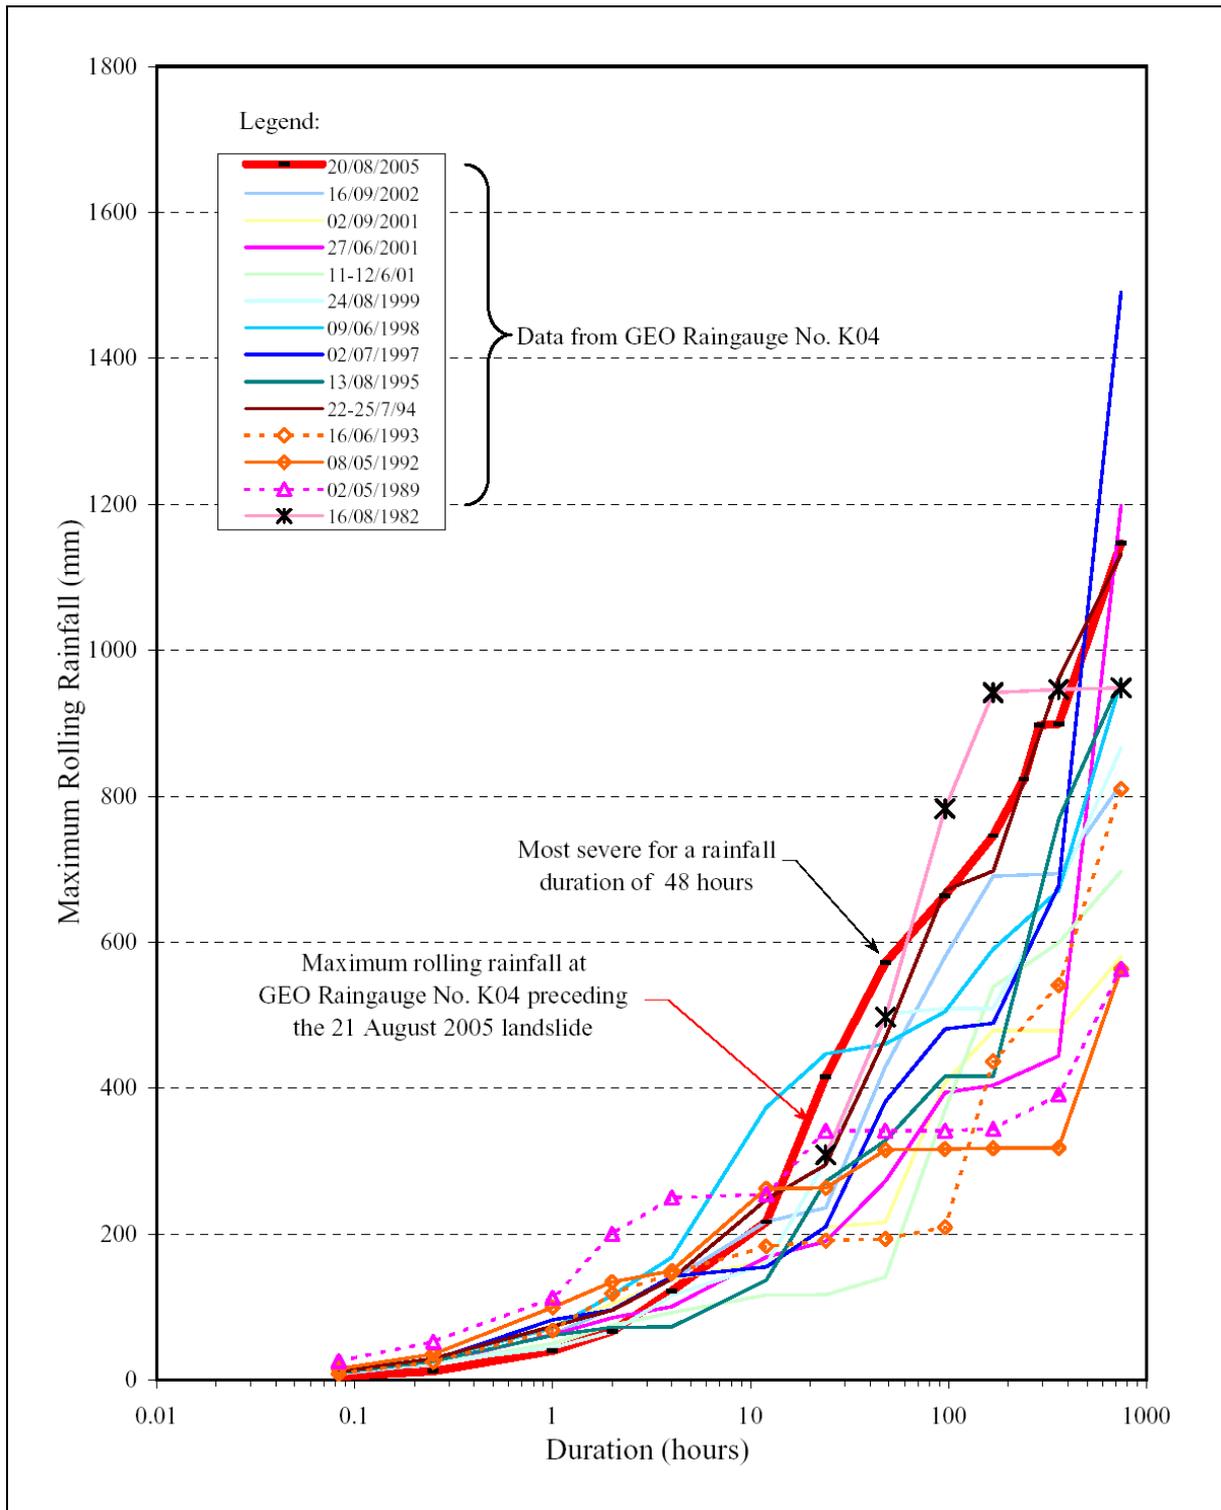
Figure 17 - Maximum Rolling Rainfall for Previous Major Rainstorms at GEO Raingauge No. K04

The maximum rolling rainfall for the August 2005 rainstorm has been compared with the past significant rainstorms recorded by raingauge No. K04 between 1980 and 2004 (Figure 17). Except for the 48-hour rainfall duration, the 20 August 2005 rainstorm is generally not as severe as the previous significant rainstorms.

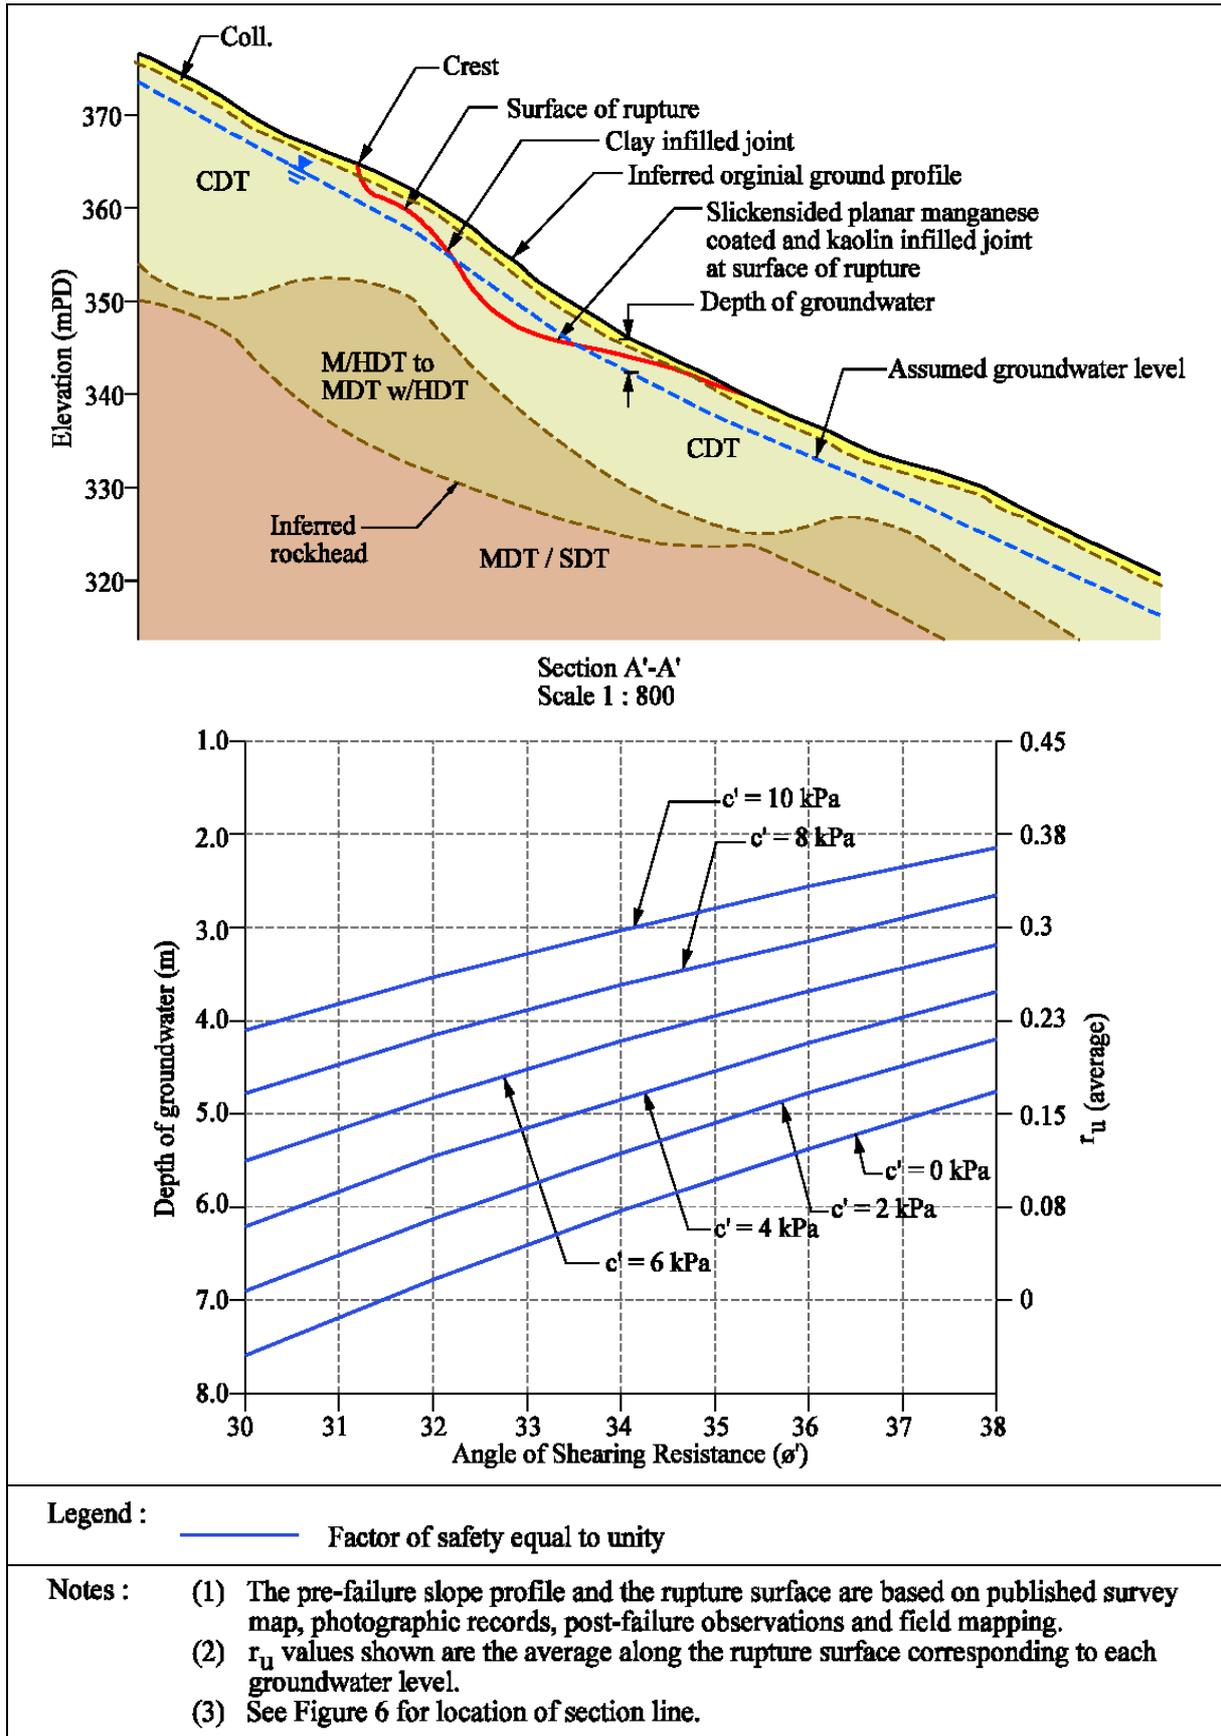
Figure 18 - Summary of Theoretical Stability Analyses

A cross-section of the source area of Landslide No. 1 and the input parameters adopted in the analyses are shown in Figure 18. The pre-failure ground profile within the failed area was established from the 1:1000 survey maps, field observations and measurements. The geological profile of the analysed failure surface was determined from field mapping and ground investigation information. Based on field mapping, the failure surface of Landslide No. 1 was in CDT with clay-infilled relict joints observed (Figure 18). A range of groundwater profiles was assumed in the analyses to simulate the possible groundwater conditions at the time of failure. It is likely that soil suction vanished in the near surface ground mass during the severe rainfall in August 2005 and therefore no suction was allowed for in the stability analysis.

The results of the analyses are presented in Figure 18 for shear strength parameters of $c' = 2$ to 10 kPa and $\phi' = 30^\circ$ to 38° . The results indicate that for the likely ranges of shear strength parameters on the failure surface, a groundwater level of about 3 m to 4.5 m below ground surface (i.e. about 2 m to 0.5 m above the rupture surface) would have been sufficient for the failure to occur. With shear strength parameters of $c' = 4$ kPa and $\phi' = 36^\circ$ for CDT that were derived from triaxial tests, a groundwater level of about 4.2 m below ground surface would have been sufficient for failure. With peak shear strength parameters of $c' = 8$ kPa and $\phi' = 33^\circ$ that were derived from direct shear tests for relict joints within the CDT, a groundwater level about 3.9 m below ground surface would have been sufficient for failure. With residual shear strength parameters of $c' = 8$ kPa and $\phi' = 31^\circ$, a groundwater level about 4.2 m below ground surface would have been sufficient for failure.

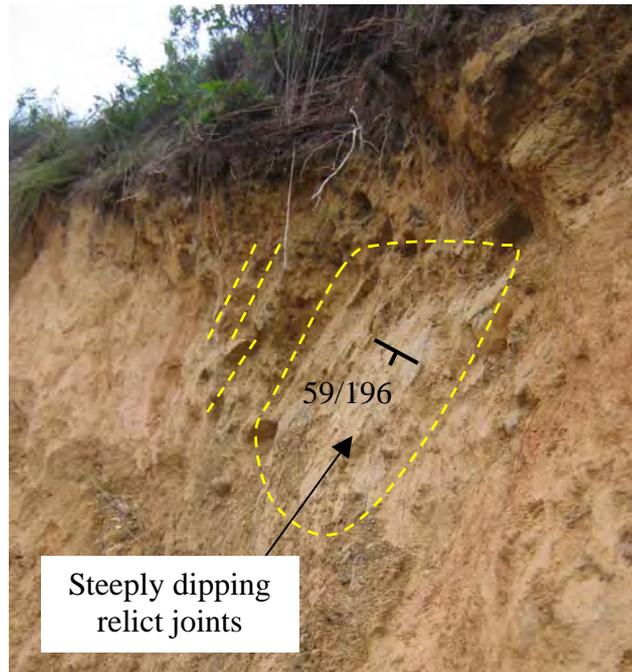
Steeply dipping
relict joints

Plate 9 - Steeply Dipping Relict Joints Forming Release Surface
at Northern Side of the Scar in the Source Area
(Photograph taken on 6 September 2005)

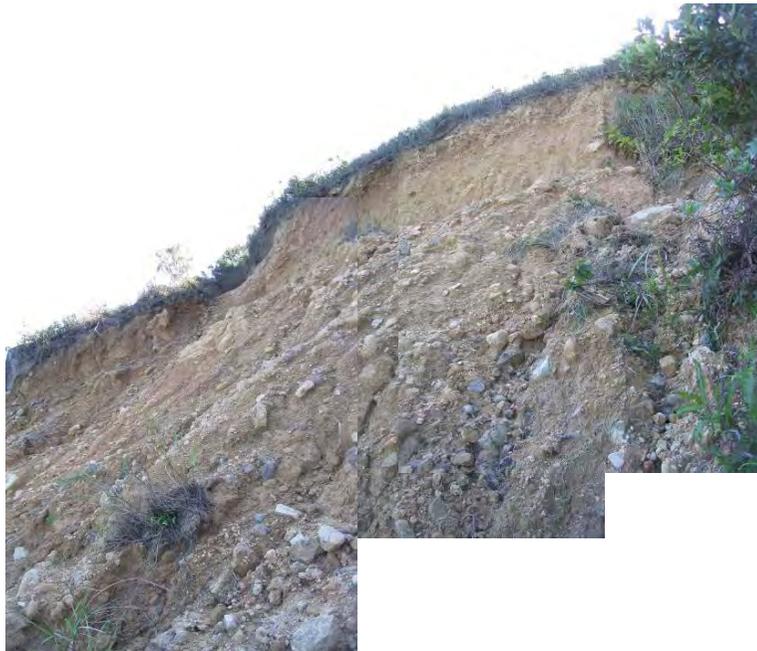
Plate 23 - General View of Landslide No. 2
(Photograph taken on 16 September 2005)

Landslide No. 2 is located uphill of Landslide No. 1. The landslide scar appeared to be fresh and the landslide probably occurred during the heavy rainfall on 20 and 21 August 2005 (Plate 23).

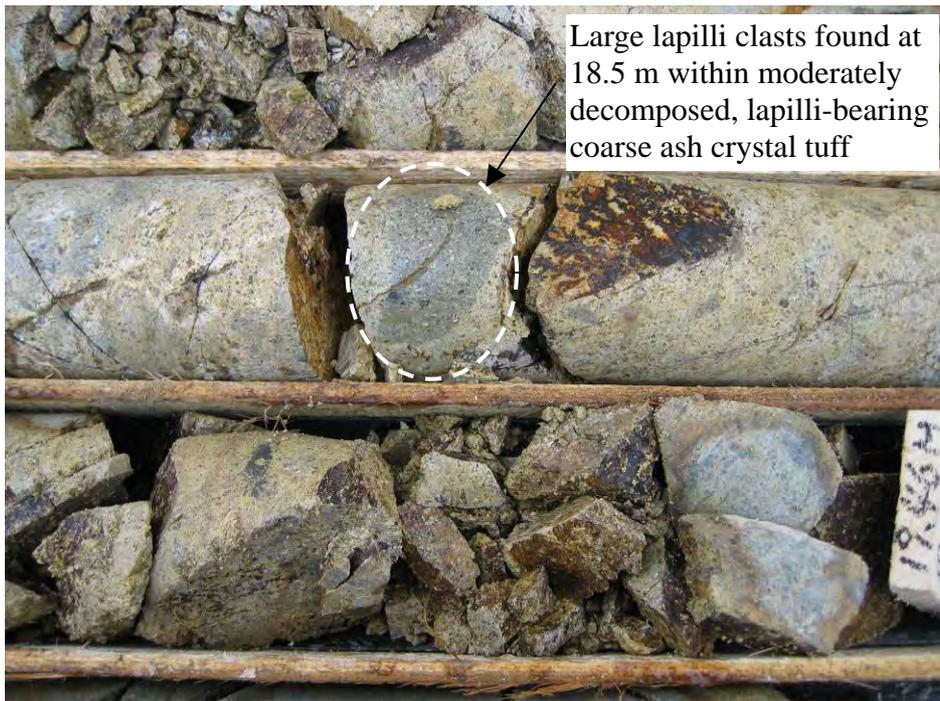
Large lapilli clasts found at 18.5 m within moderately decomposed, lapilli-bearing coarse ash crystal tuff

Plate 37 - Large Lapilli Clasts Found Locally at Drillhole No. QP4
(Photograph taken on 31 March 2006)

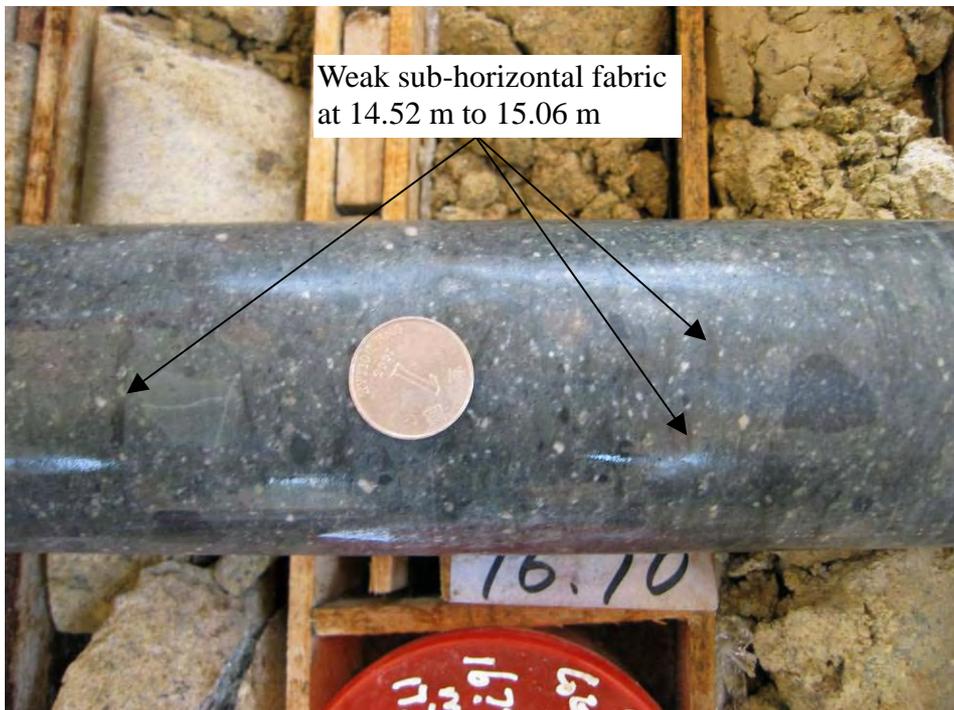
Weak sub-horizontal fabric at 14.52 m to 15.06 m

Plate 38 - Weak Sub-horizontal Fabric Observed in the Core of Moderately Decomposed Lapilli-bearing Coarse Ash Crystal Tuff from Drillhole No. BH2 (Photograph taken on 13 May 2006)

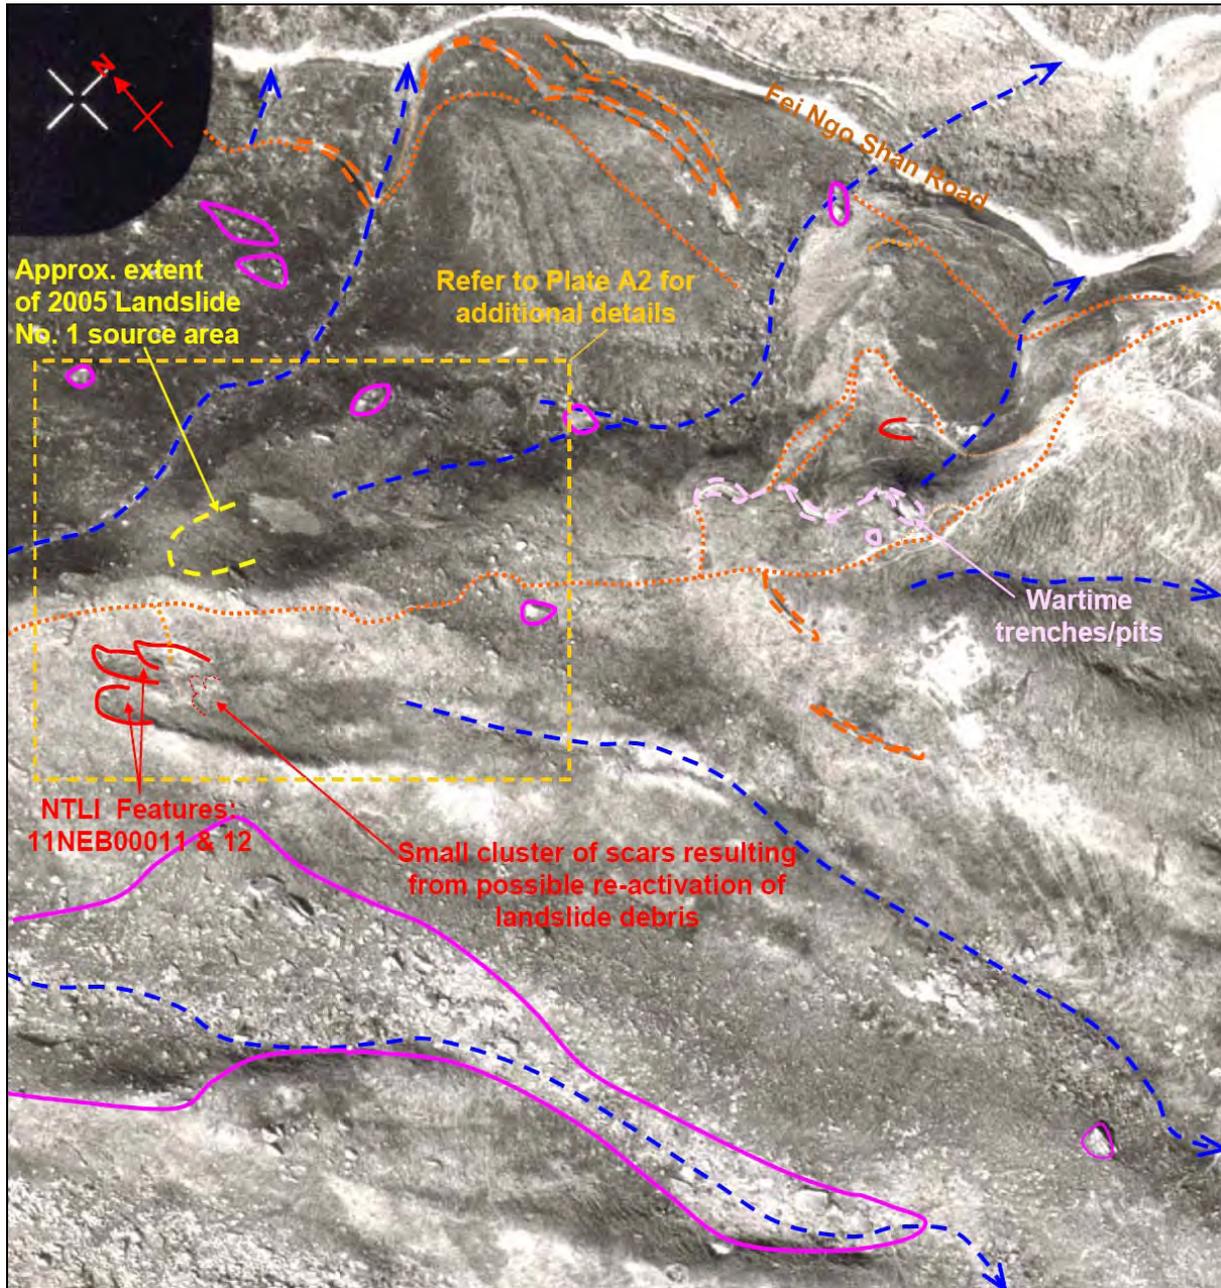
Plate A1 - Aerial Photograph Interpretation (1963 photograph)

Numerous surface boulders, moderate to large in size, are apparent within the area of natural terrain above Fei Ngo Shan Road (Plate A1). Numerous shallow failures are apparent on the hillside above Fei Ngo Shan Road. These landslides are noted to typically occur in clusters of between two and five failures and are generally located at, or near to, the head or on the bank of drainage lines. Several topographic depressions containing drainage lines / ephemeral stream channels are present on the hillside.

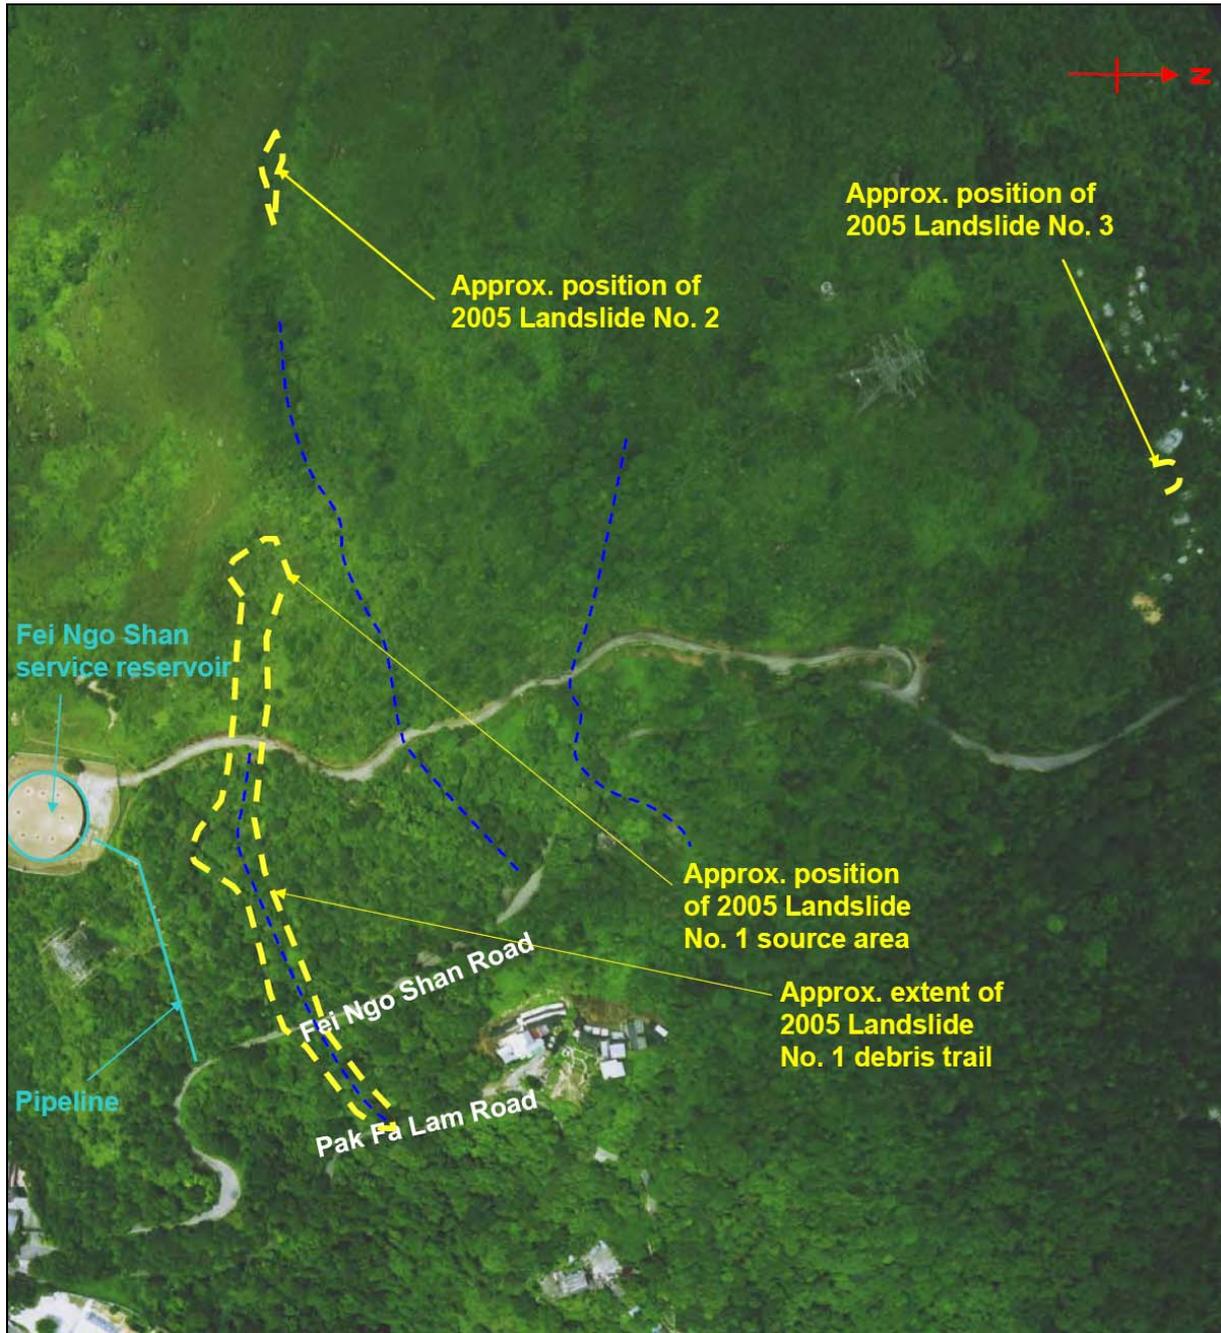
Plate A8 - Aerial Photograph Interpretation (2002 photograph)

- 2002 No significant change is visible. The landslide scar observed in 1998 was still visible in this year (Plate A8).
- 2003 Poor view due to obstruction by shadow. No significant change is visible.

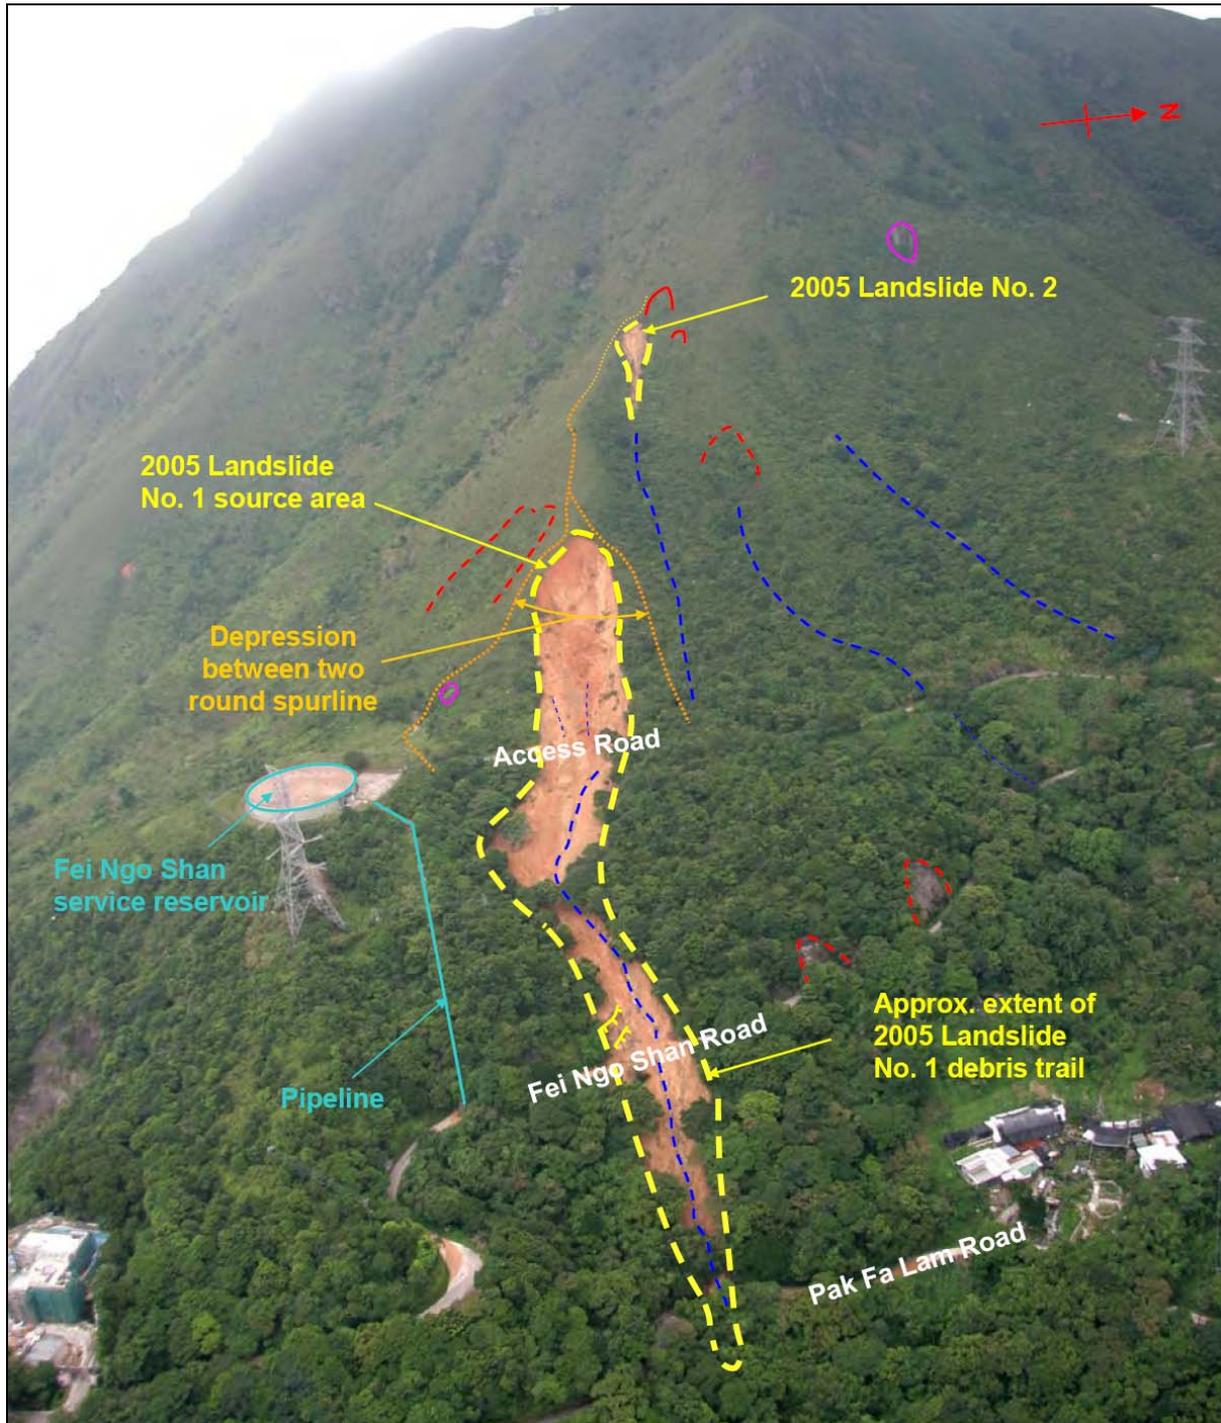
Plate A9 - Aerial Photograph Interpretation (2004 photograph)

- 2004 No significant change is visible (Plate A9).
- 2005 The photograph is an oblique aerial photograph of Landslides No. 1 and 2 taken on the day after the failure (Plate A10).

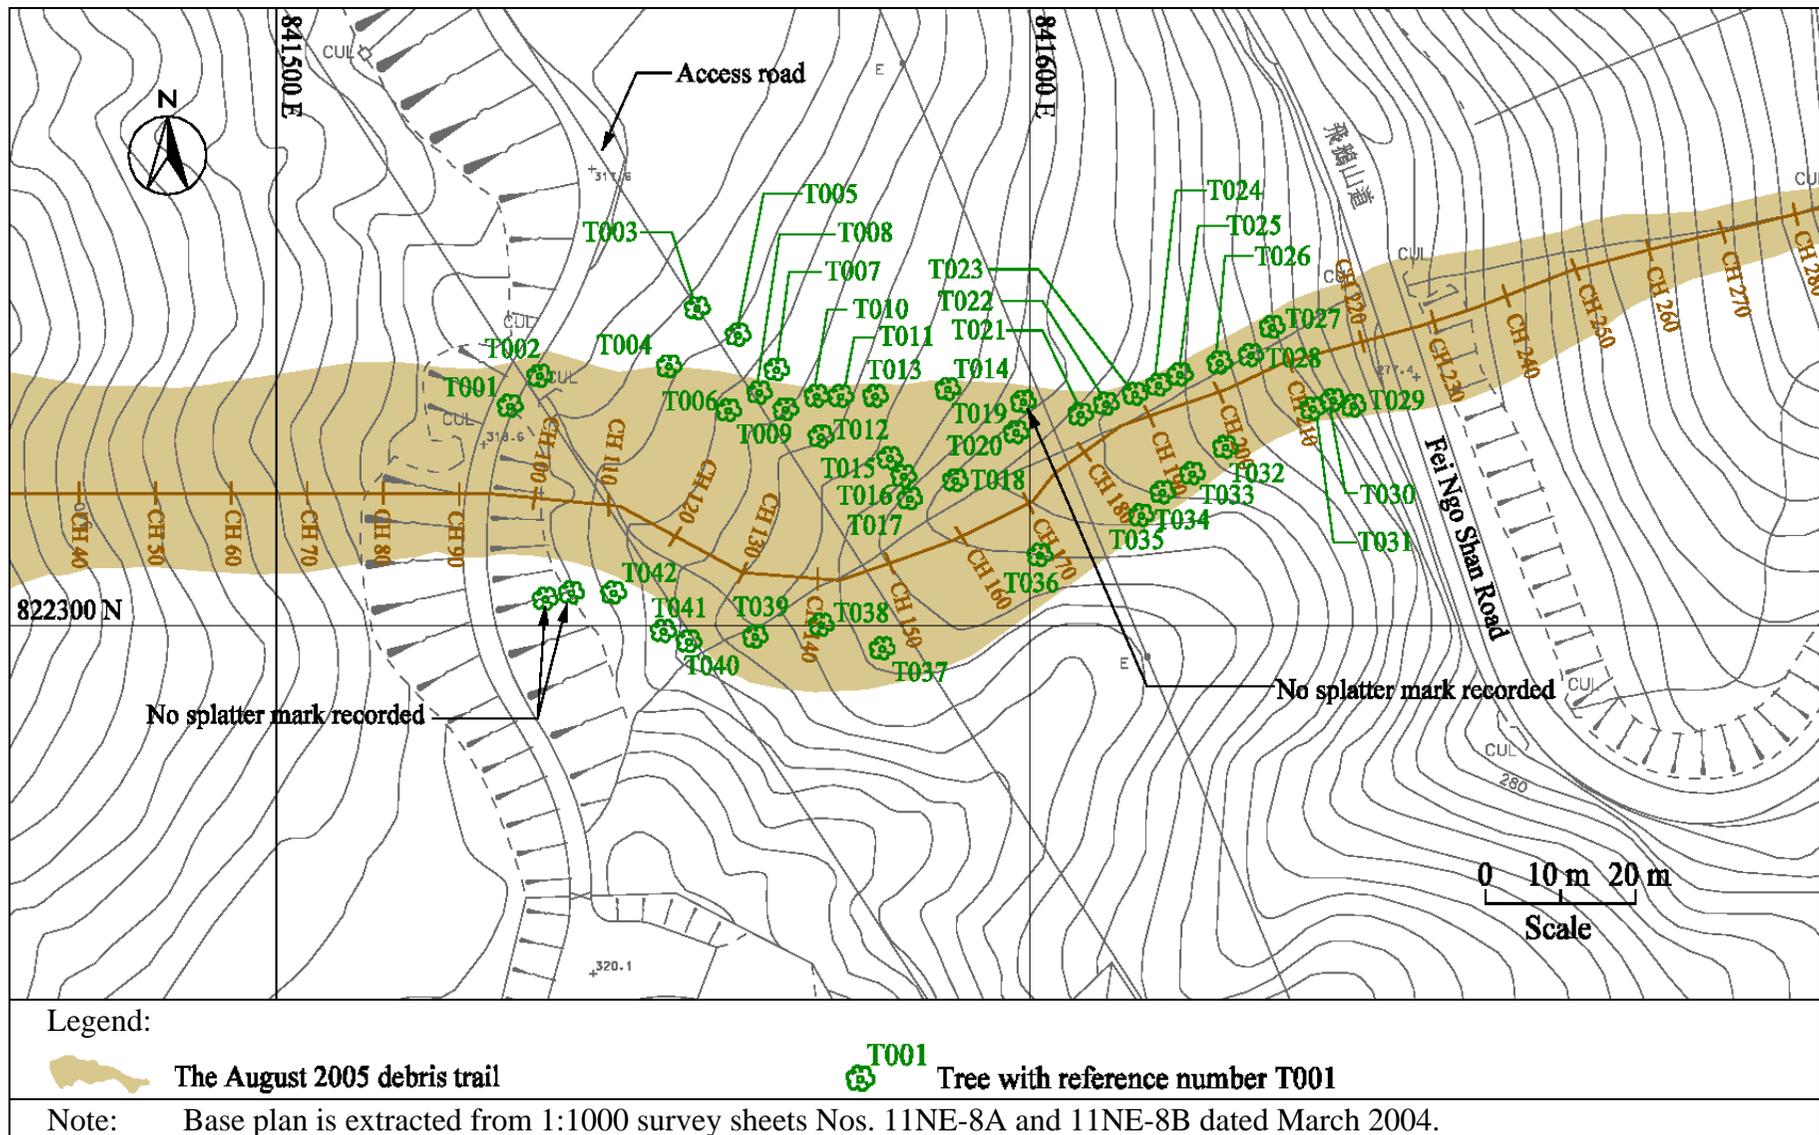
Figure B1 - Location Plan of Trees Surveyed for Debris Height and Splatter Mark

During the field inspections of Landslide No. 1, splatter marks and some remnants of landslide debris were observed reaching heights of 5.5 m on trees located on the flanks within the mid-portion of the debris trail (Figure B1). A survey was carried out on 29 and 30 March 2006 to record the maximum height of the splatter mark/landslide debris as evident on the trees along the debris trail, the findings of which are summarised in Table B1. The aim of the survey was to obtain field estimates of the possible transport mechanisms, mobility and superelevation of the landslide debris as it banked around a curve in the drainage line within the mid-portion of the landslide trail (viz. Chainages 95 to 228).
