**DETAILED STUDY OF THE
21 AUGUST 2005 DEBRIS FLOW
ON THE NATURAL HILLSIDE
NEAR FEI NGO SHAN
SERVICE RESERVOIR**

GEO REPORT No. 233

Maunsell Geotechnical Services Limited

**GEOTECHNICAL ENGINEERING OFFICE
CIVIL ENGINEERING AND DEVELOPMENT DEPARTMENT
THE GOVERNMENT OF THE HONG KONG
SPECIAL ADMINISTRATIVE REGION**

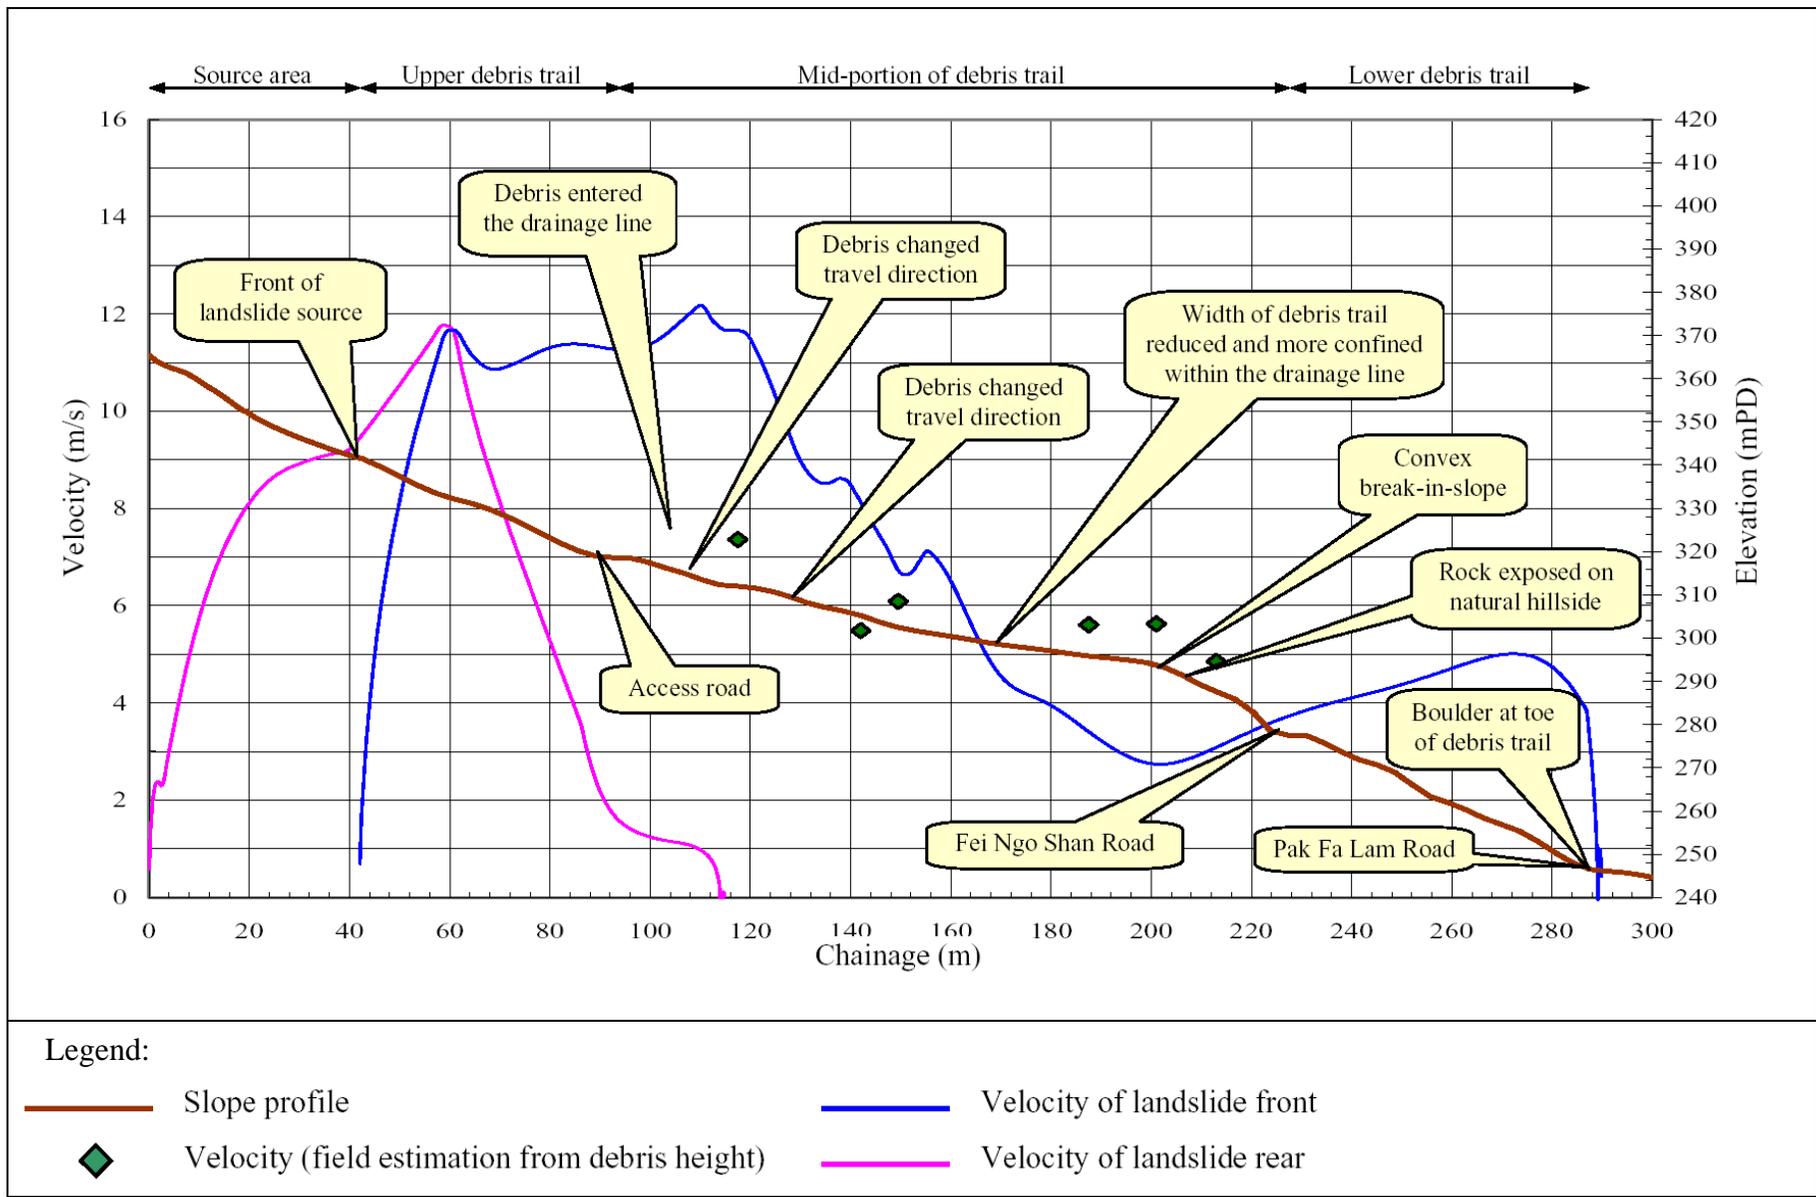
Figure C1 - Debris Velocity and Slope Profile versus Horizontal Chainage

Near Chainage 200, i.e. on the approach to Fei Ngo Shan Road, the terrain steepens and the model indicates that the velocity increased slightly to about 5 m/s as the debris flow travelled over the natural hillside before reaching Pak Fa Lam Road where it came to a halt. Based on the debris mobility model, the estimated duration from the initiation of the failure to the final deposition of materials at the debris front was about 55 seconds.

The model can provide a 'best-fit' for the debris flow event using an intermediate parameter between open-hillside failure and channelised debris flow. This appears to be primarily due to the generally broad, open hillside nature of the debris path which was only weakly channelised in a few places (channelisation ratio between 5 and 20) and the generally low angle of the debris path between Chainages 90 and 200 which resulted in most of the debris being deposited within this section. Although the correlations of the modelled debris velocity with velocities estimated from superelevation of debris marks observed in the field are not particularly close (Figure C1), it is considered that the generally broad and only partially constrained debris trail will mean that the superelevation measurements may be less representative of the actual velocities than would be the case if the debris trail were well channelised.
