**REVIEW OF  
THE 16 JULY 2006 LANDSLIDE  
ON SLOPE NO. 14NE-B/CR180  
NO. 49 PO WAH YUEN  
YUNG SHUE WAN  
LAMMA ISLAND**

**GEO REPORT No. 234**

**Fugro Scott Wilson Joint Venture**

This report presents the findings of a review of a landslide (Incident No. 2006/07/0672) that occurred on 16 July 2006 on slope No. 14NE-B/CR180, above a village house at No. 49 Po Wah Yuen, Yung Shue Wan on Lamma Island. The failure involved a shallow landslide in the soil cut slope with an estimated debris volume of about 15 m<sup>3</sup>, which was deposited on the level ground at the slope toe. Muddy water associated with the debris mound was reported to have entered the dwelling through the gap at the base of the rear door. No casualties were reported as a result of the incident.

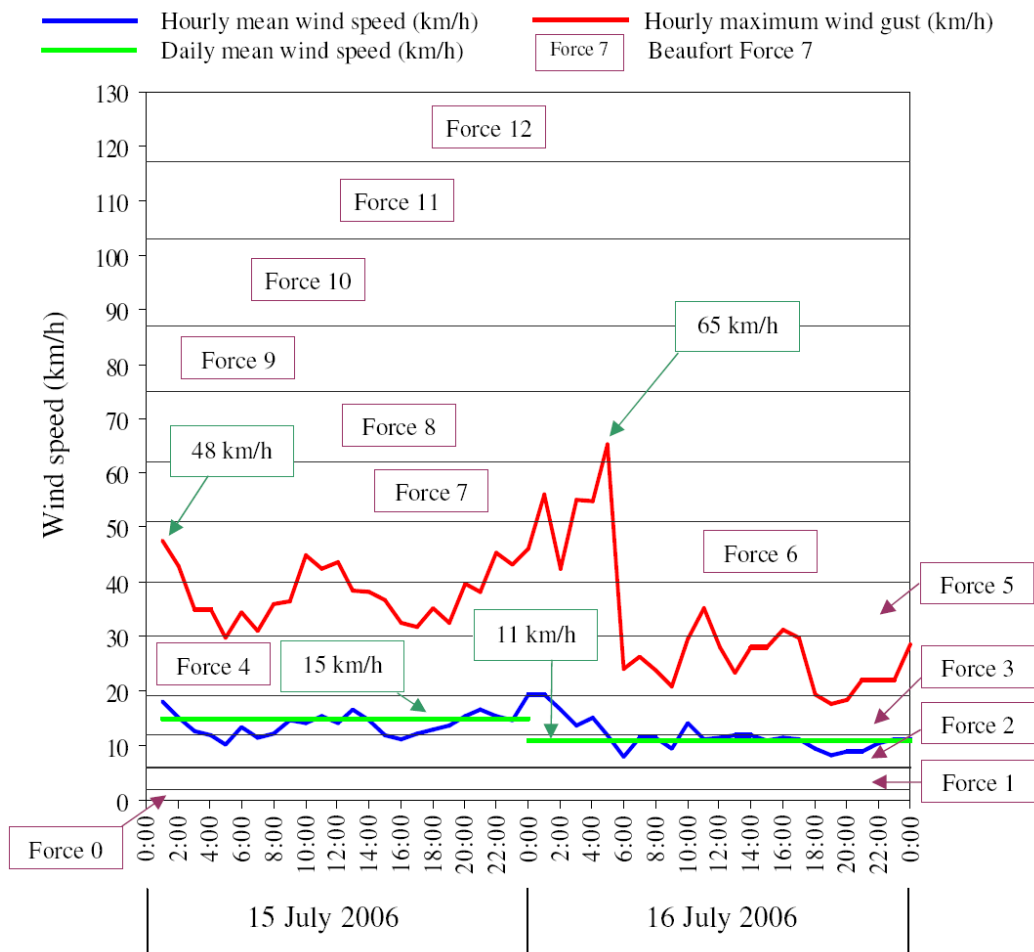
Figure 6 - Wind Speed Data Recorded at HKO Wong Chuk Hang Weather Station

The nearest HKO monitoring station to the landslide site, located at Wong Chuk Hang, about 6.8 km to the southeast of the failure, recorded mean wind speeds for 15 July and 16 July 2006 of 15 km/h and 11 km/h respectively (Figure 6), with peak wind gusts of 48 km/h and 65 km/h respectively.

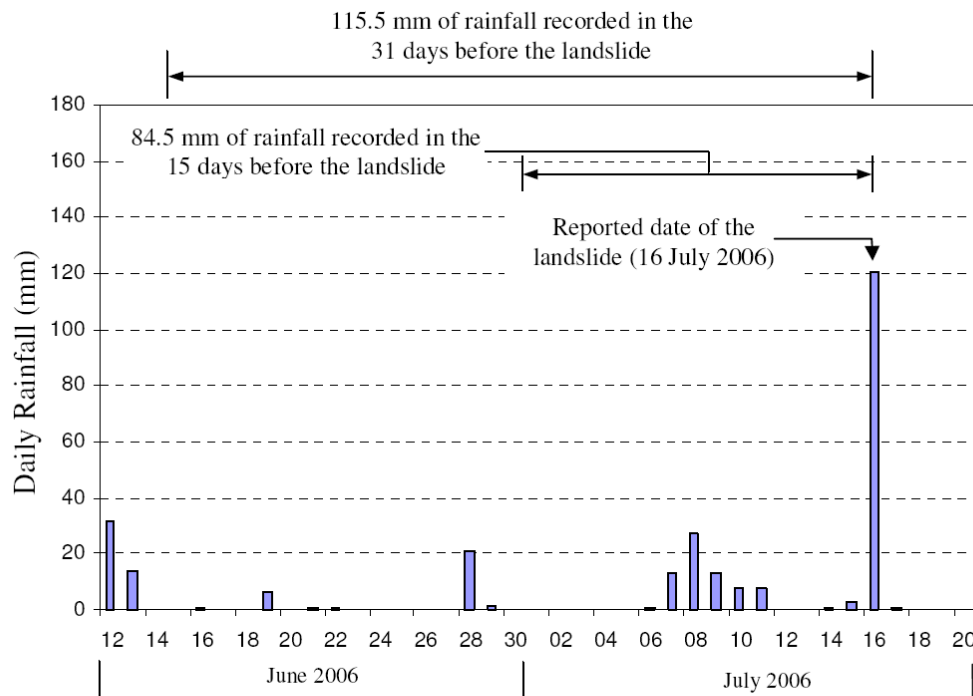
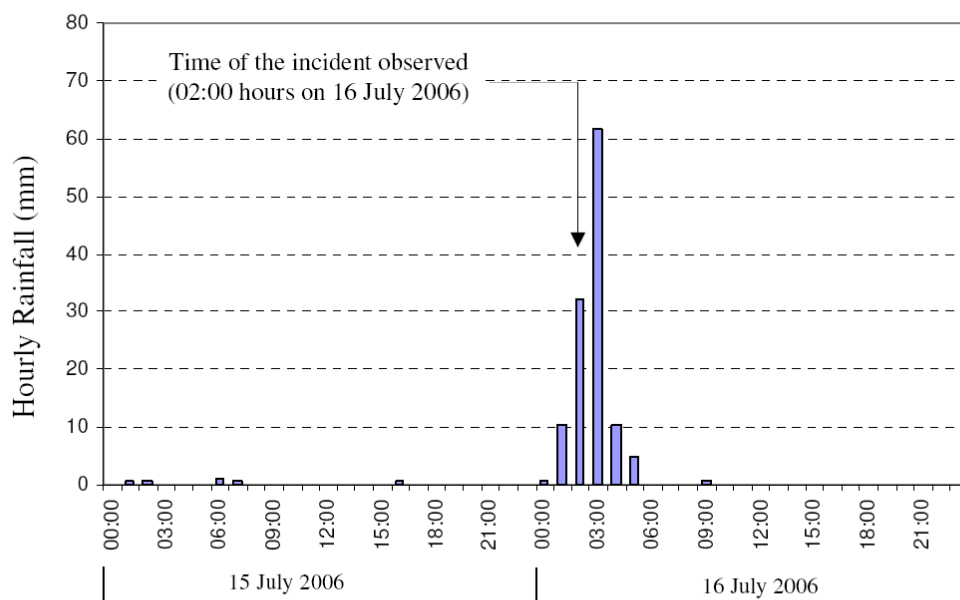
Figure 7 - Rainfall Recorded at GEO Raingauge No. N27

The daily rainfall recorded by raingauge No. N27 over the month preceding the failure, together with the hourly rainfall readings for the period between 12:00 a.m. on 15 July 2006 and 11:00 p.m. on 16 July 2006, are presented in Figure 7. The maximum 24-hour and 12-hour rolling rainfall before the failure was 13.5 mm and 11.5 mm respectively.

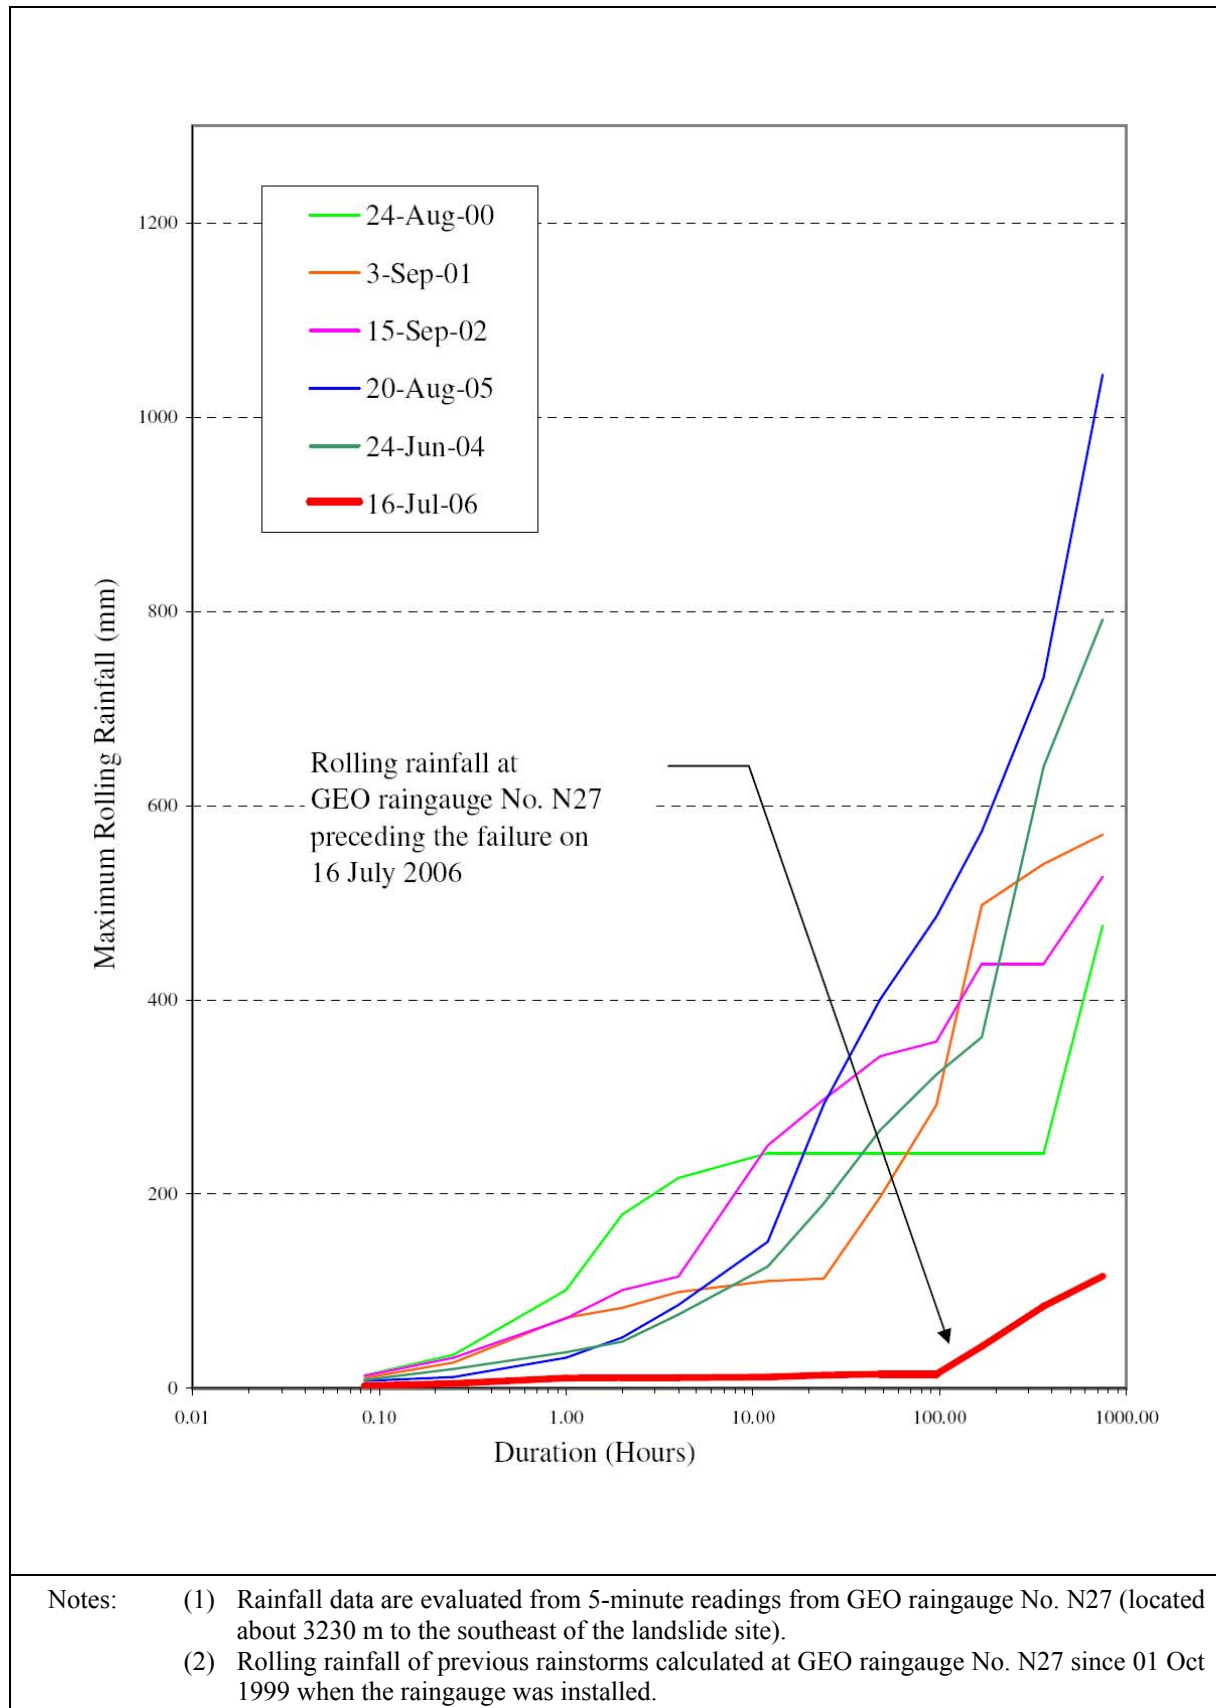
Figure 8 - Maximum Rolling Rainfall Preceding the 16 July 2006 Landslide and Selected Previous Major Rainstorms Recorded at GEO Raingauge No. N27

The maximum rolling rainfall for the rainstorm on 16 July 2006 has been compared with the past major rainstorms between 2000 and 2005 recorded by raingauge No. N27, which came into operation in 1999 (Figure 8). The maximum rolling rainfall for the rainstorm on 16 July 2006 is less severe than the previous significant rainstorms.

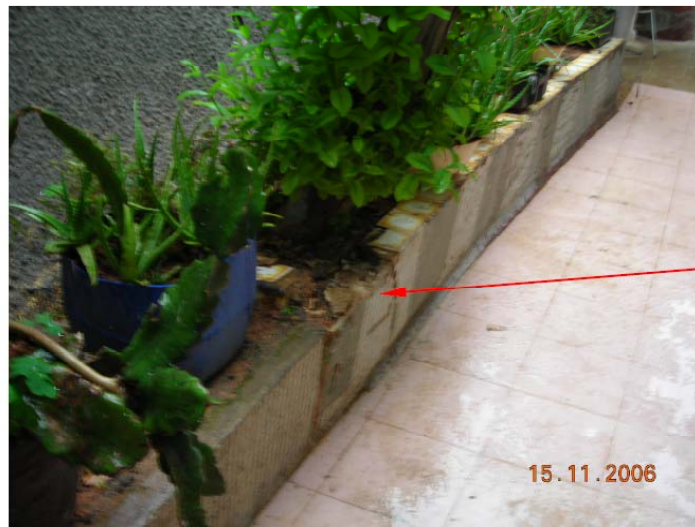
Toe planter  
wall

FSW inspected the landslide site on 15 November 2006, by which time urgent repair works (comprising the application of shotcrete to the landslide scar and surrounding slope face and reconstruction of the crest drainage channel) had been completed (Plate 5). Bulging and associated cracking were observed in the toe planter wall (Plate 6), which was assessed as pre-dating the July 2006 landslide based on the placement of ceramic tiles around the bulge on the adjacent open space at the slope toe.

Plate 6 - Close View of Toe Planter Wall Showing Bulging and Cracking  
(Photograph taken on 15 November 2006)
