**REVIEW OF THE
22 AUGUST 2005 LANDSLIDE
ON THE NATURAL HILLSIDE
ABOVE BEACON HEIGHTS,
LUNG PING ROAD, KOWLOON**

GEO REPORT No. 235

Maunsell Geotechnical Services Limited

**This report is largely based on GEO Landslide Study Report
No. LSR 13/2007 produced in December 2007**

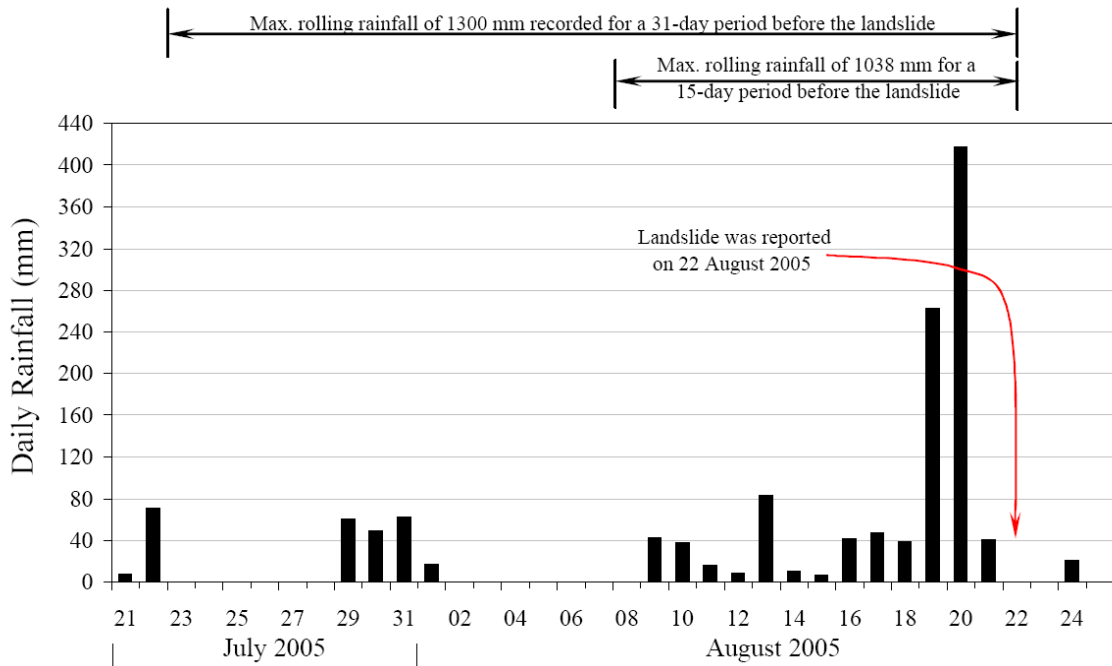
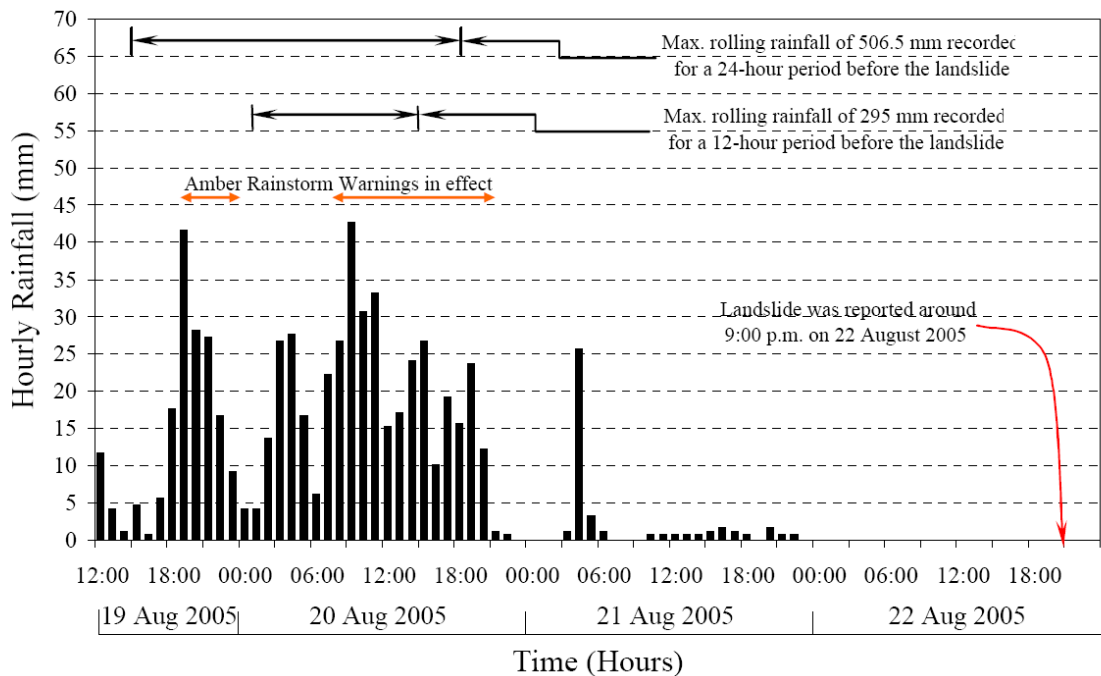
Figure 9 - Daily and Hourly Rainfall Recorded at GEO Raingauge No. K06

Rainfall data were obtained from the nearest GEO automatic raingauge No. K06, which is located approximately 1 km to the west of the August 2005 landslide on the roof of Carnation House, So Uk Estate, Cheung Sha Wan (Figure 1). The raingauge records and transmits rainfall data at 5-minute intervals to the GEO and the Hong Kong Observatory (HKO). The daily rainfall recorded by raingauge No. K06 from 21 July to 25 August 2005, together with the hourly rainfall readings for the period between 19 and 22 August 2005, is presented in Figure 9.

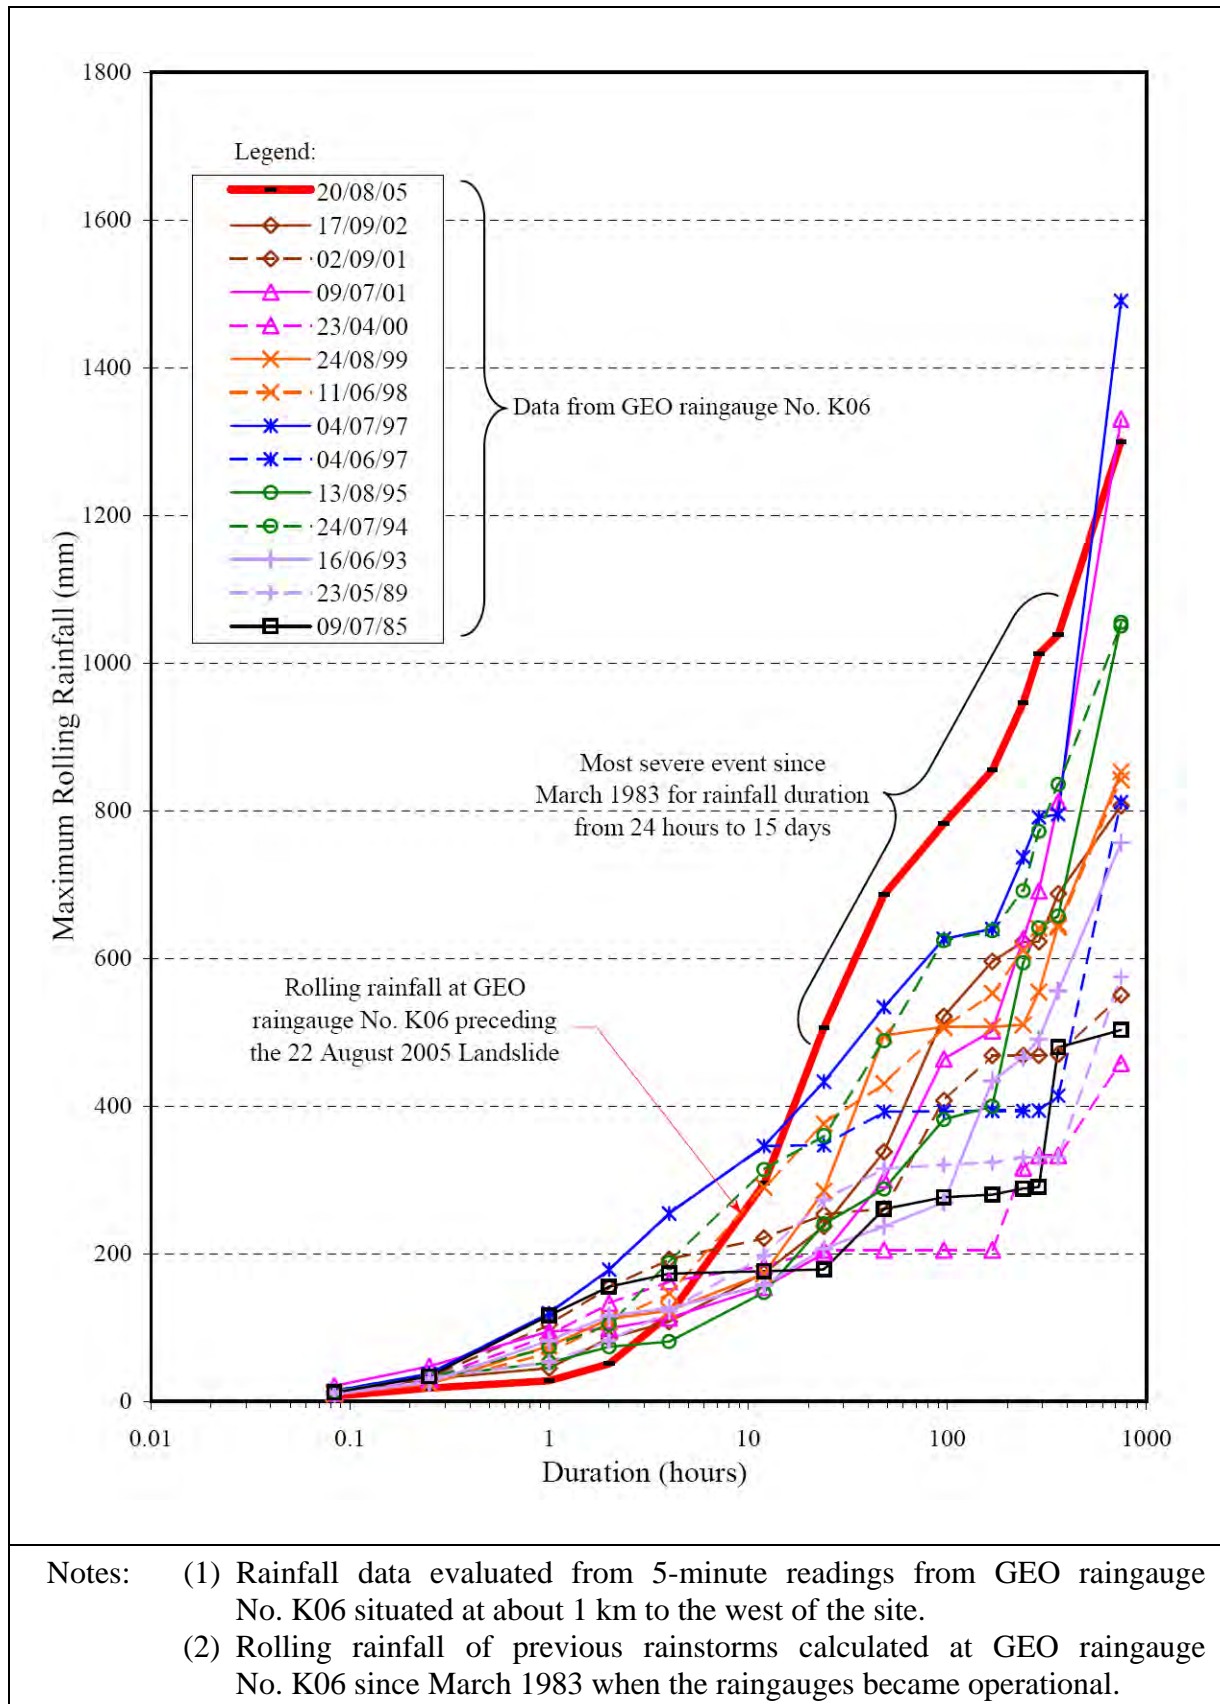
Figure 10 - Maximum Rolling Rainfall for Previous Major Rainstorms at GEO Raingauge No. K06

The maximum rolling rainfall for the August 2005 rainstorm has been compared with the past major rainstorms recorded by raingauge No. K06 between 1983 and 2004 (Figure 10). The 20 August 2005 rainstorm was the most severe for rainfall durations between 24 hours and 15 days.
