**REVIEW OF THE 2 JUNE 2006  
LANDSLIDE ON SLOPE  
NO. 7NE-D/FR58 ALONG  
MA ON SHAN TSUEN ROAD**

**GEO REPORT No. 236**

**Maunsell Geotechnical Services Limited**

**This report is largely based on GEO Landslide Study Report No. LSR 9/2007  
produced in October 2007**

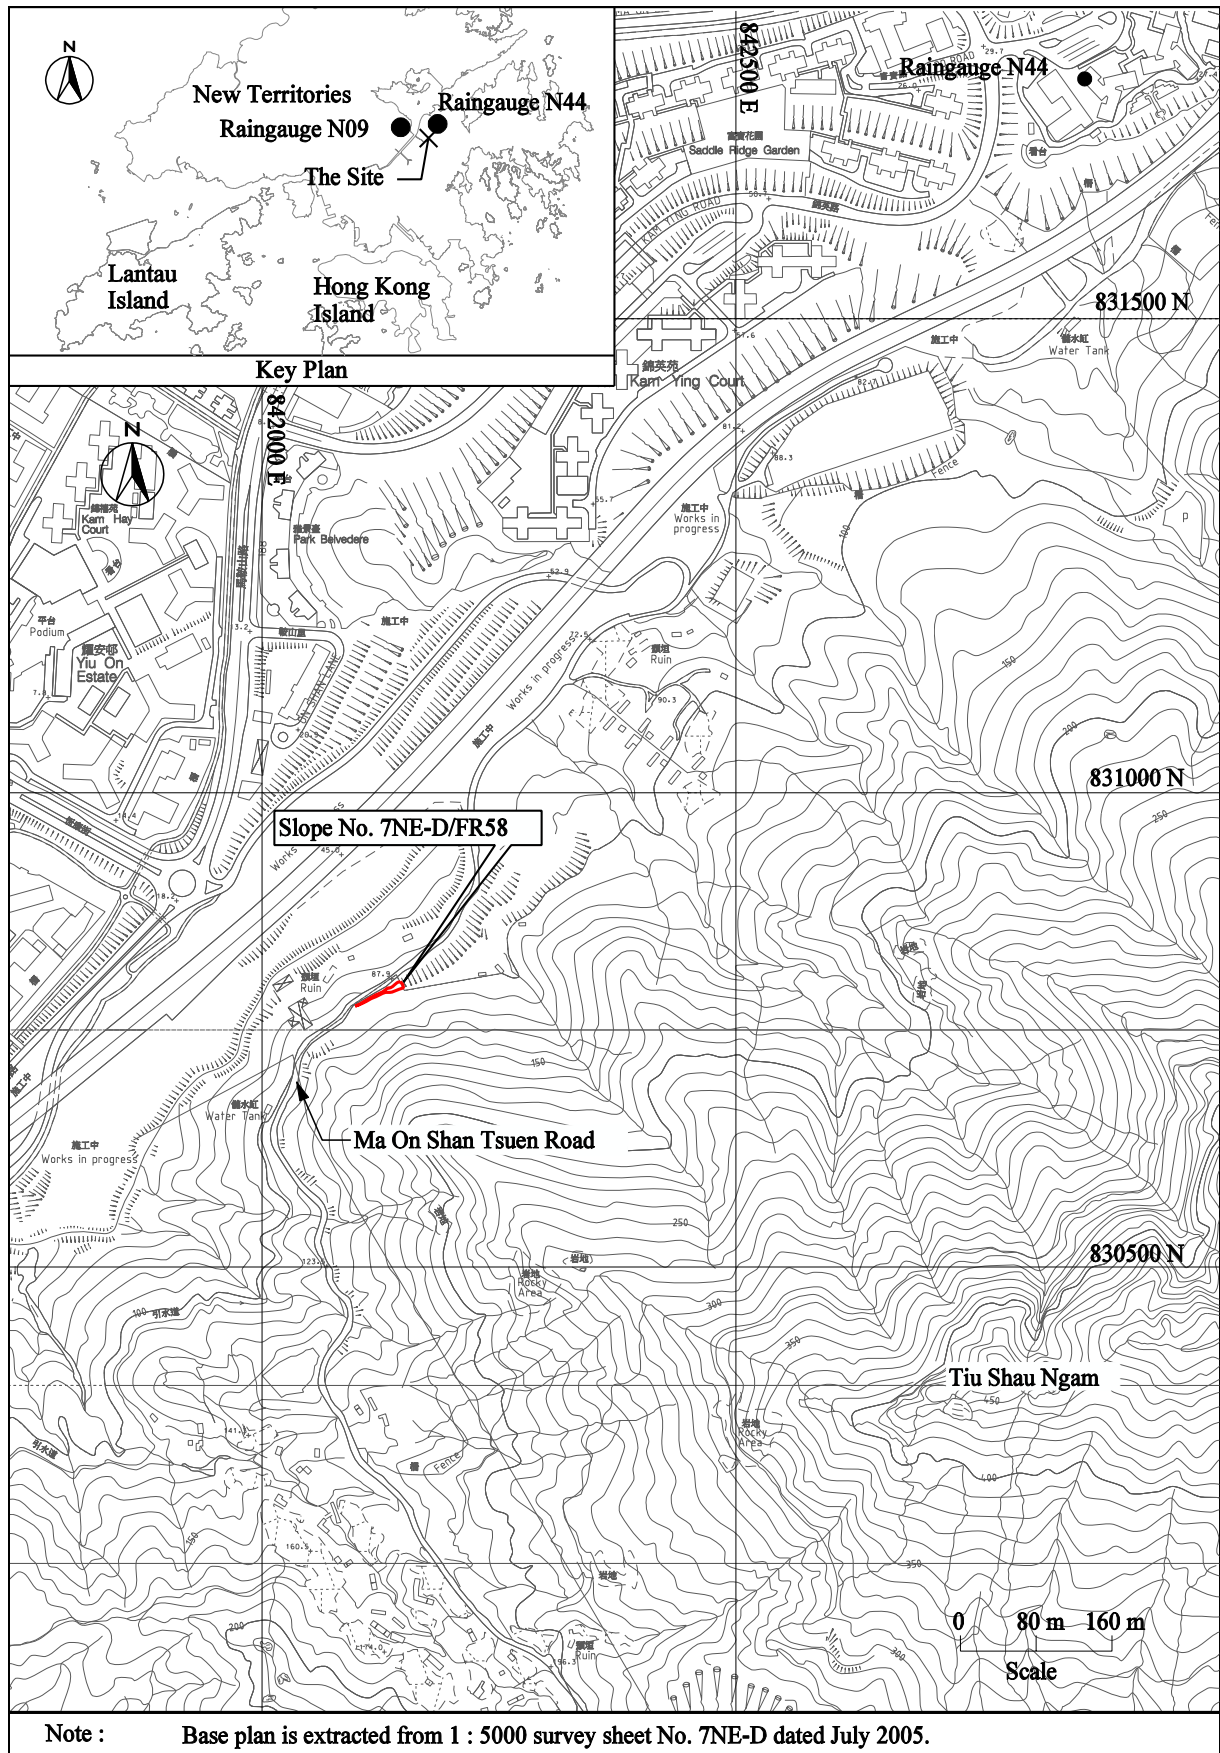
Figure 1 - Location Plan

Rainfall data were obtained from GEO automatic raingauge No. N44, which is the nearest raingauge to the study area and is located about 1.2 km to the northeast at the roof of Lee Fung House, Lee On Estate, Ma On Shan (Figure 1). The raingauge records and transmits rainfall data at 5 minute intervals to the Hong Kong Observatory and the GEO.

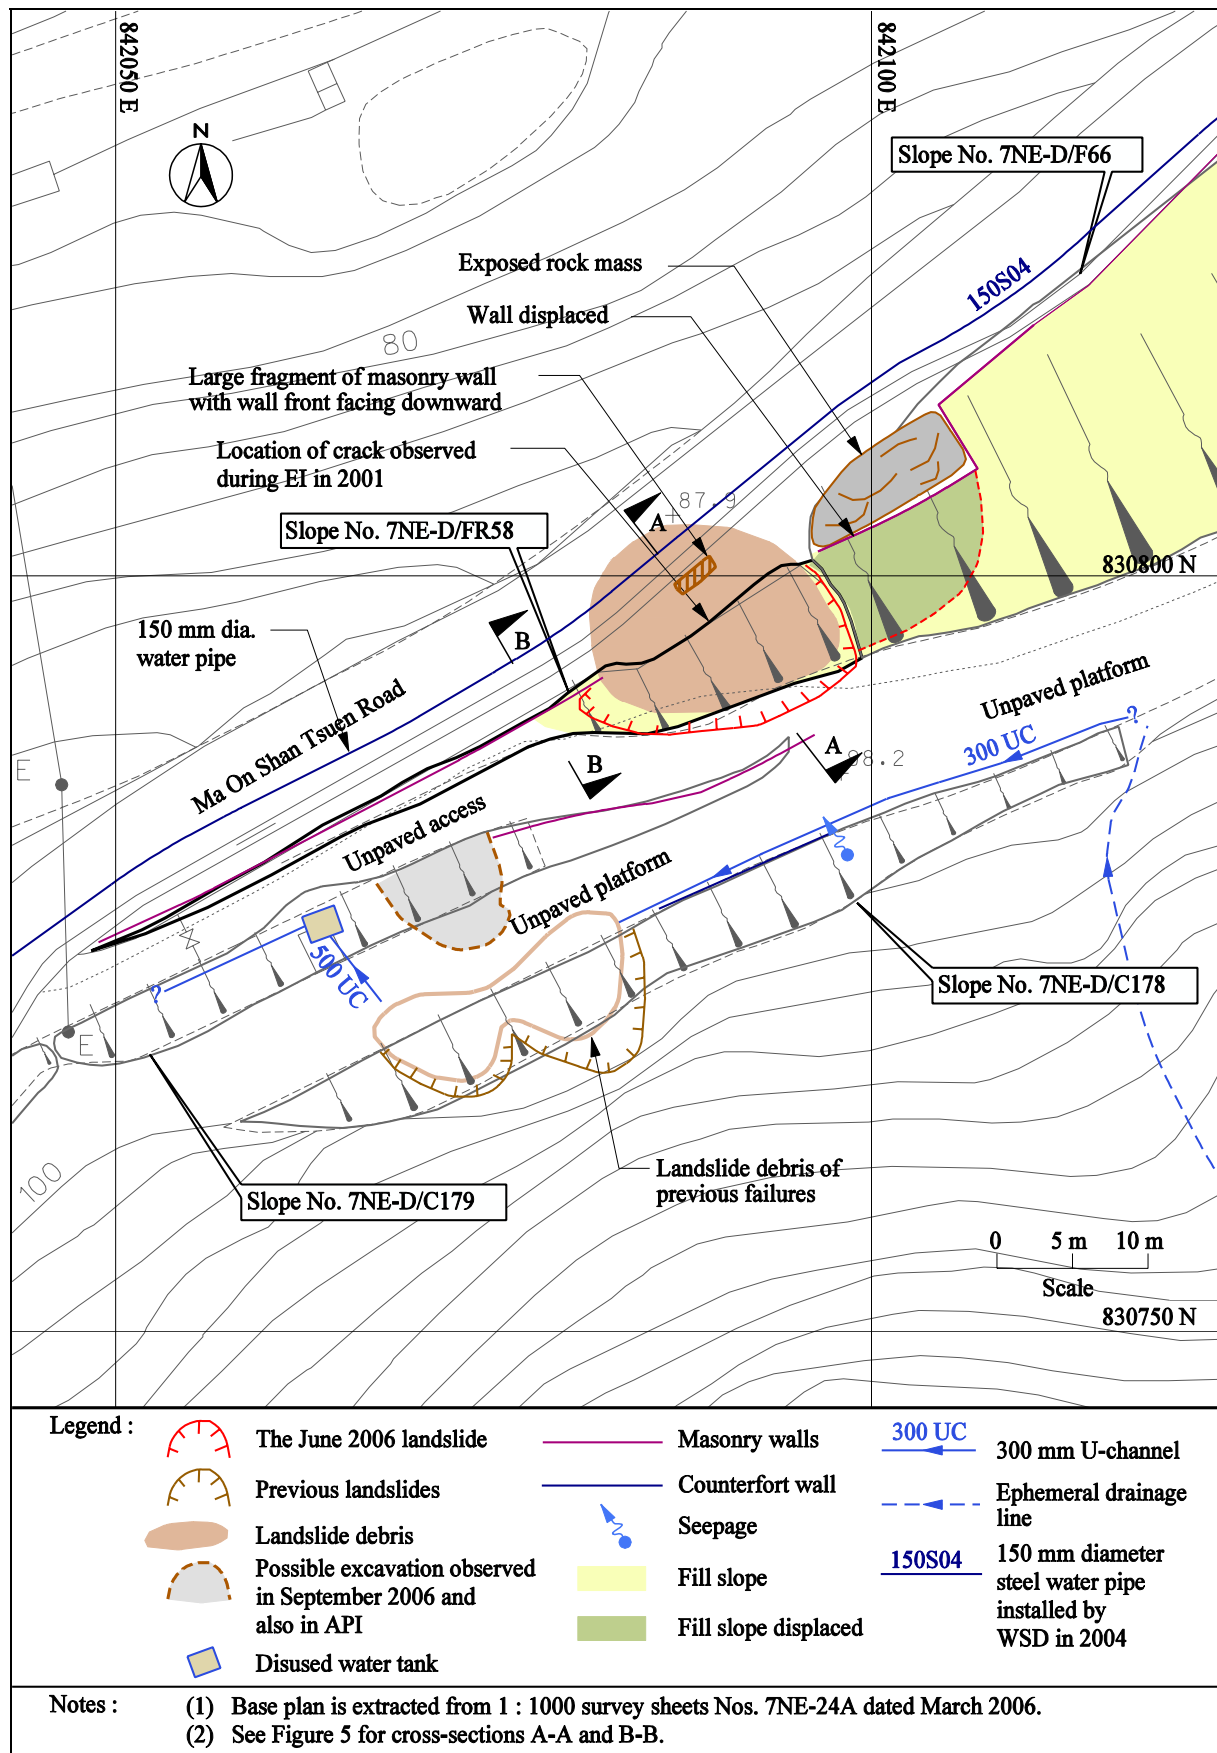
Figure 2 - Site Layout Plan and Field Observations

Lands D, the base of the masonry wall was examined by MGSL. Very few masonry blocks were observed in the central portion of the June 2006 landslide although a distinct boundary of soil/masonry block was identified near the western flank of landslide (Plate 12). Weephole probing of the portion of the unfailed masonry wall, located at about 7 m to the west of the 2006 landslide, showed that the thickness of the base of the wall in this portion was about 1.7 m to 1.9 m. The slenderness ratio of the masonry wall at this location was about 4 (Figure 5). Another 3 m high masonry wall, which rested on exposed rock mass, is located to the east of the June 2006 landslide within slope No. 7NE-D/F66 (Figure 2 and Plate 4). No signs of distress were observed on this wall.

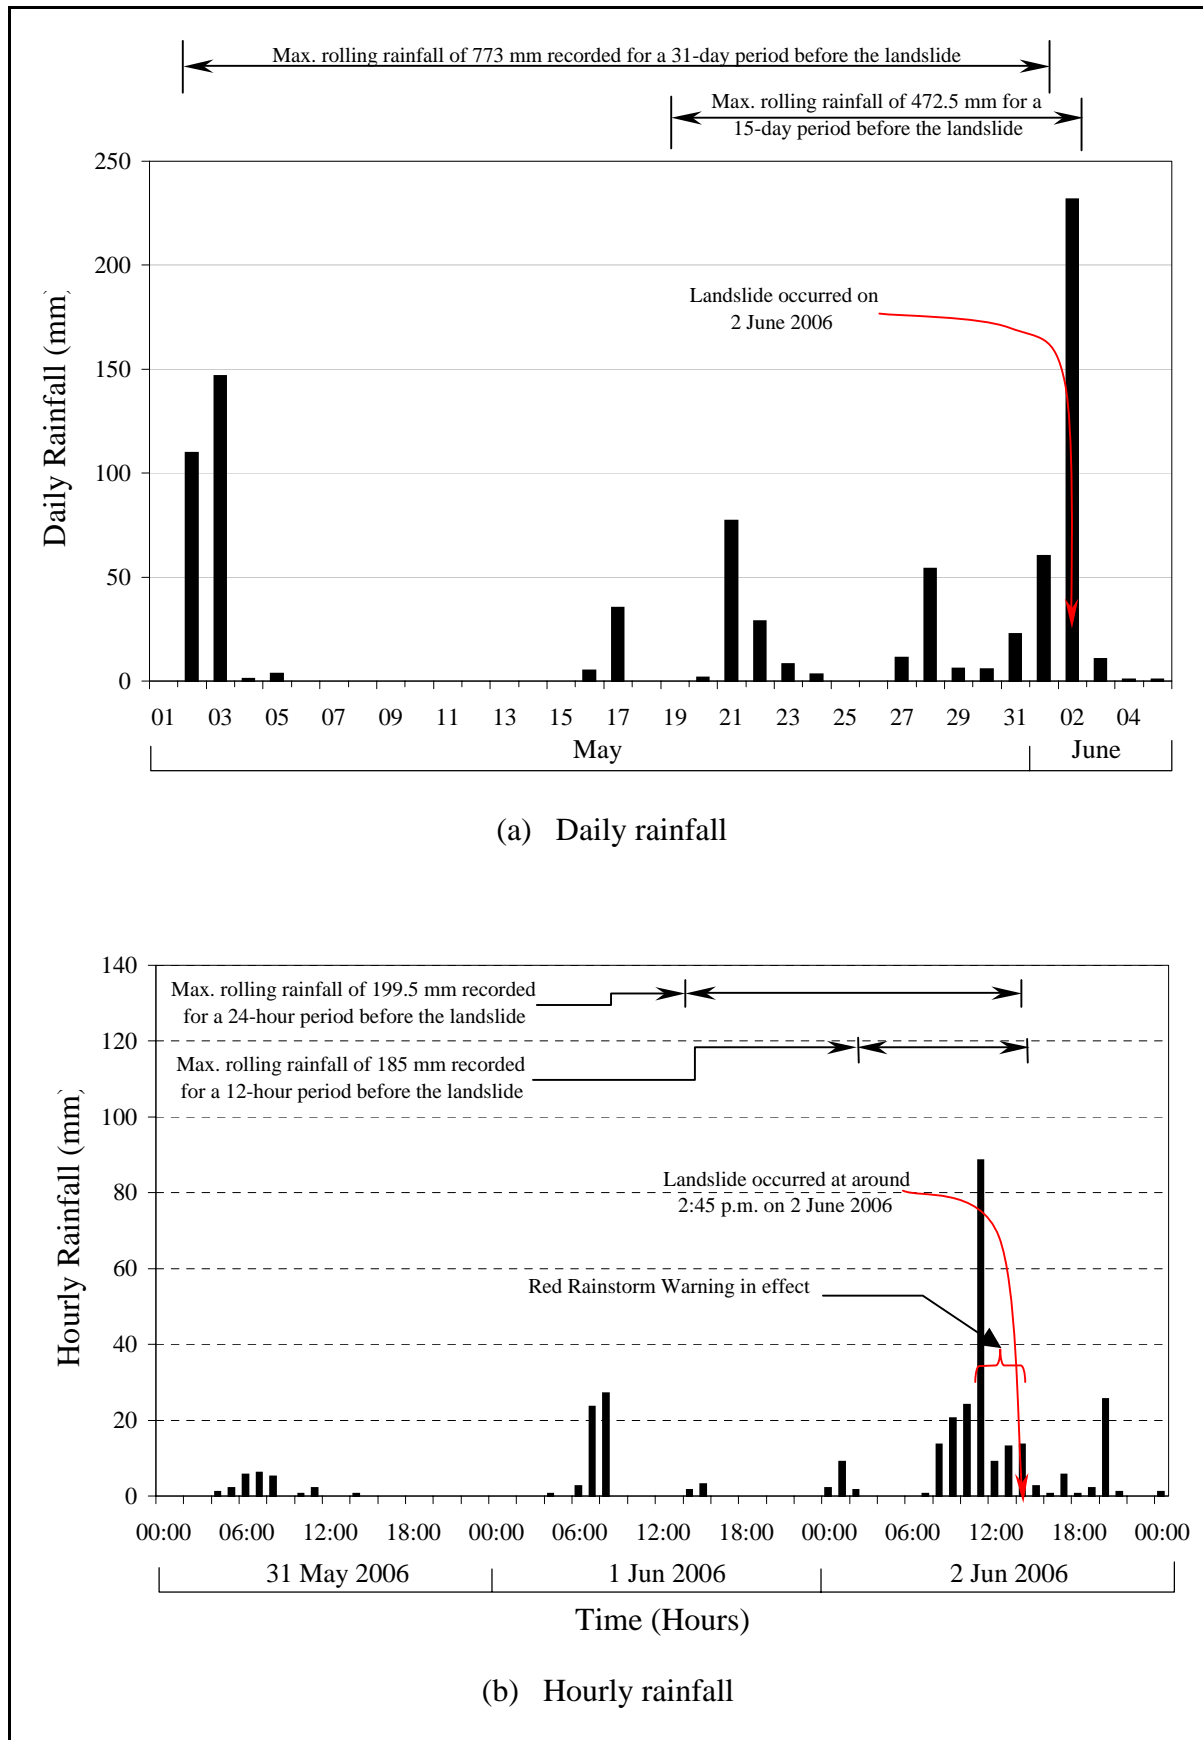
Figure 6 - Daily and Hourly Rainfall Recorded at GEO Raingauge No. N44

According to the Incident Report prepared by the GEO, the landslide occurred at about 2:45 p.m. on 2 June 2006. The daily rainfall recorded by raingauge No. N44 over the month preceding the incident, together with the hourly rainfall readings for the period between 31 May and 2 June 2006, is presented in Figure 6.

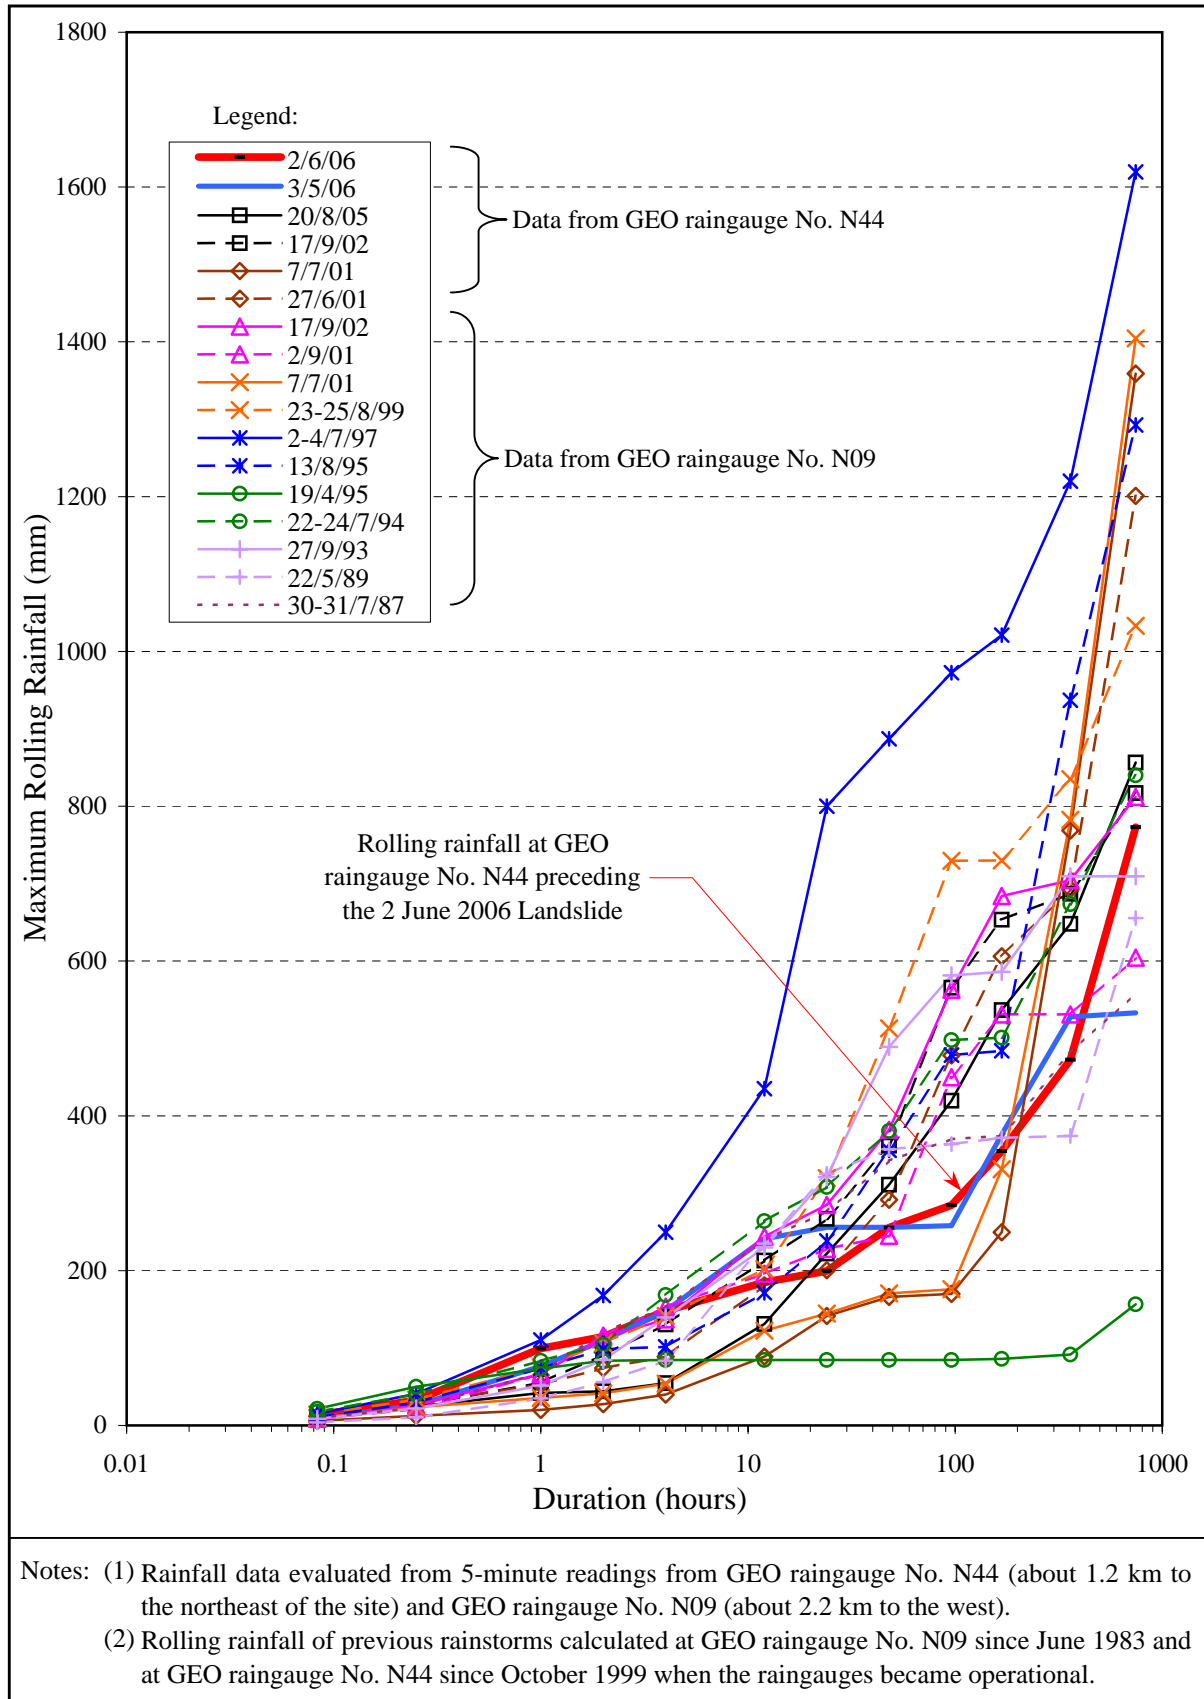
Figure 7 - Maximum Rolling Rainfall for Previous Major Rainstorms at GEO Raingauges Nos. N09 and N44

The maximum rolling rainfall for the 2 June 2006 rainstorm has been compared with the past major rainstorms recorded by raingauges Nos. N09 and N44, which came into operation in June 1983 and October 1999 respectively (Figure 7). It is noted that the 2 June 2006 rainstorm was less severe than most of the previous major rainstorms.

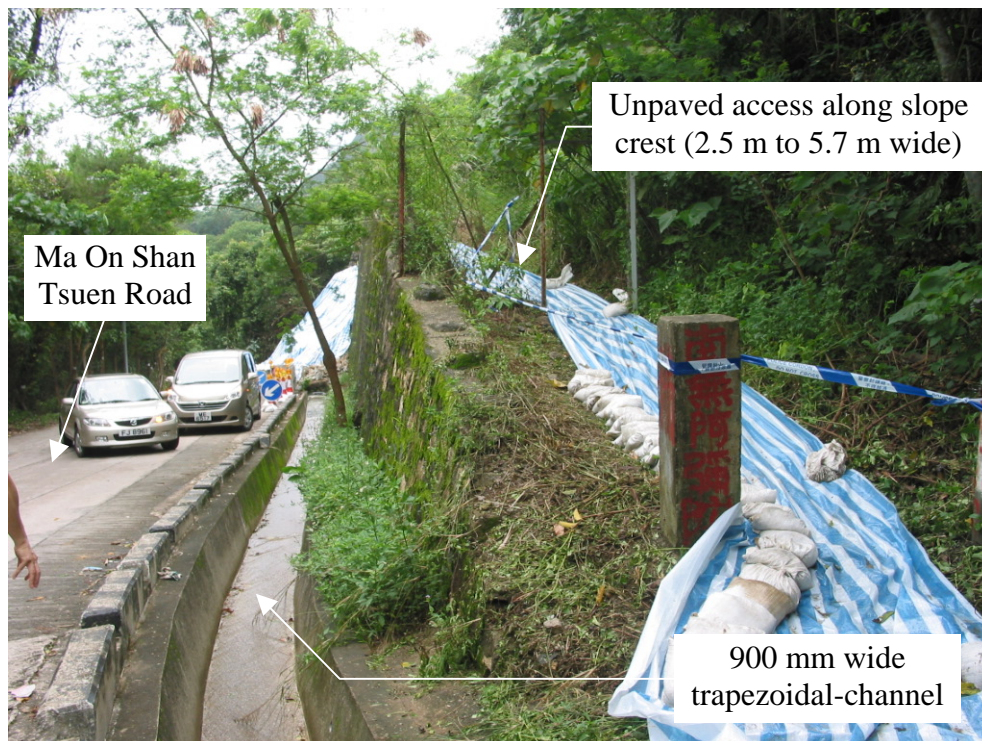
Plate 2 - View of the Access above Slope No. 7NE-D/FR58  
(Photograph taken by Lands D on 5 June 2006)

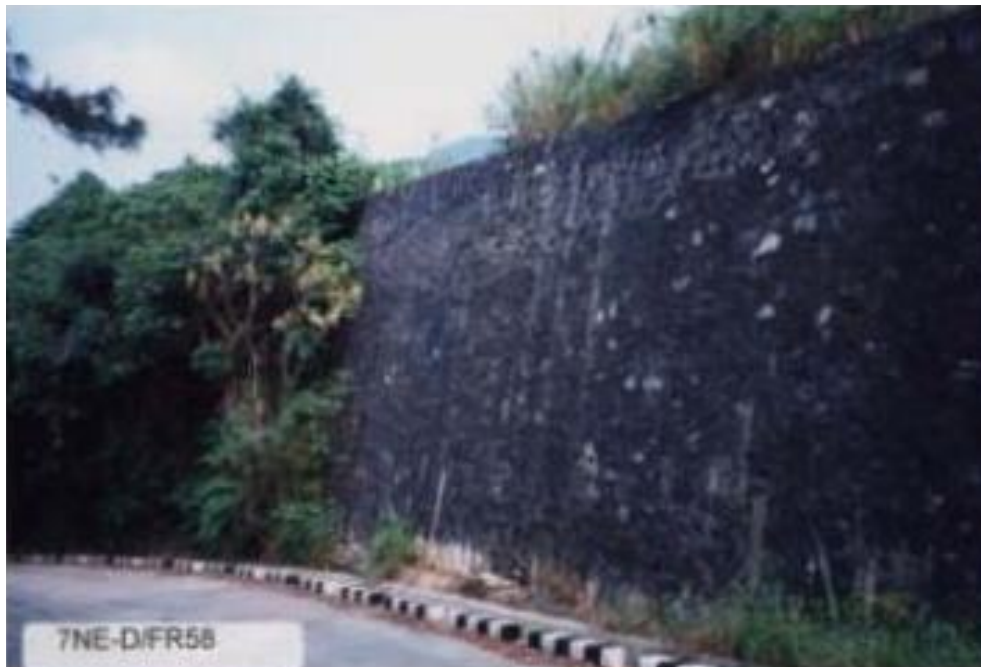
Plate 6 - View of the Failure Area of Slope No. 7NE-D/FR58 in 1997  
(Photograph taken by BCL on 17 September 1997)

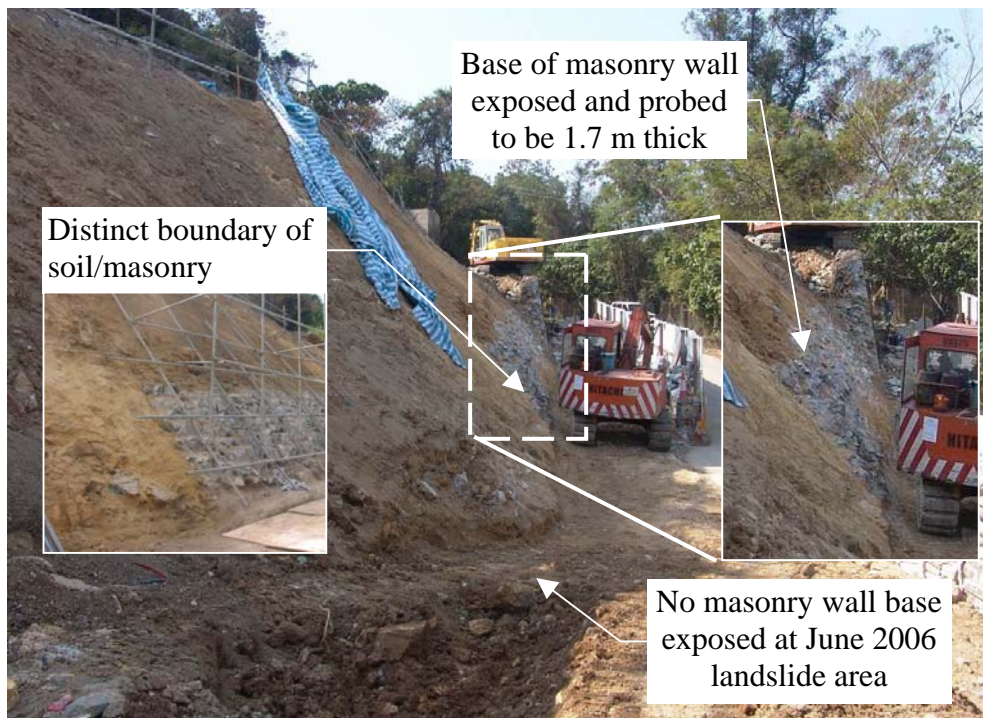
Plate 12 - View of the Masonry Wall Base during Wall Demolition  
(Photograph taken by Lands D on 31 January 2007)
