**REVIEW OF THE
9 JUNE 2006 AND
16 JULY 2006
WASHOUTS ON SLOPE
NO. 11NW-B/FR60 BEHIND
PHOENIX HOUSE,
LUNG CHEUNG ROAD**

GEO REPORT No. 238

Maunsell Geotechnical Services Limited

**GEOTECHNICAL ENGINEERING OFFICE
CIVIL ENGINEERING AND DEVELOPMENT DEPARTMENT
THE GOVERNMENT OF THE HONG KONG
SPECIAL ADMINISTRATIVE REGION**

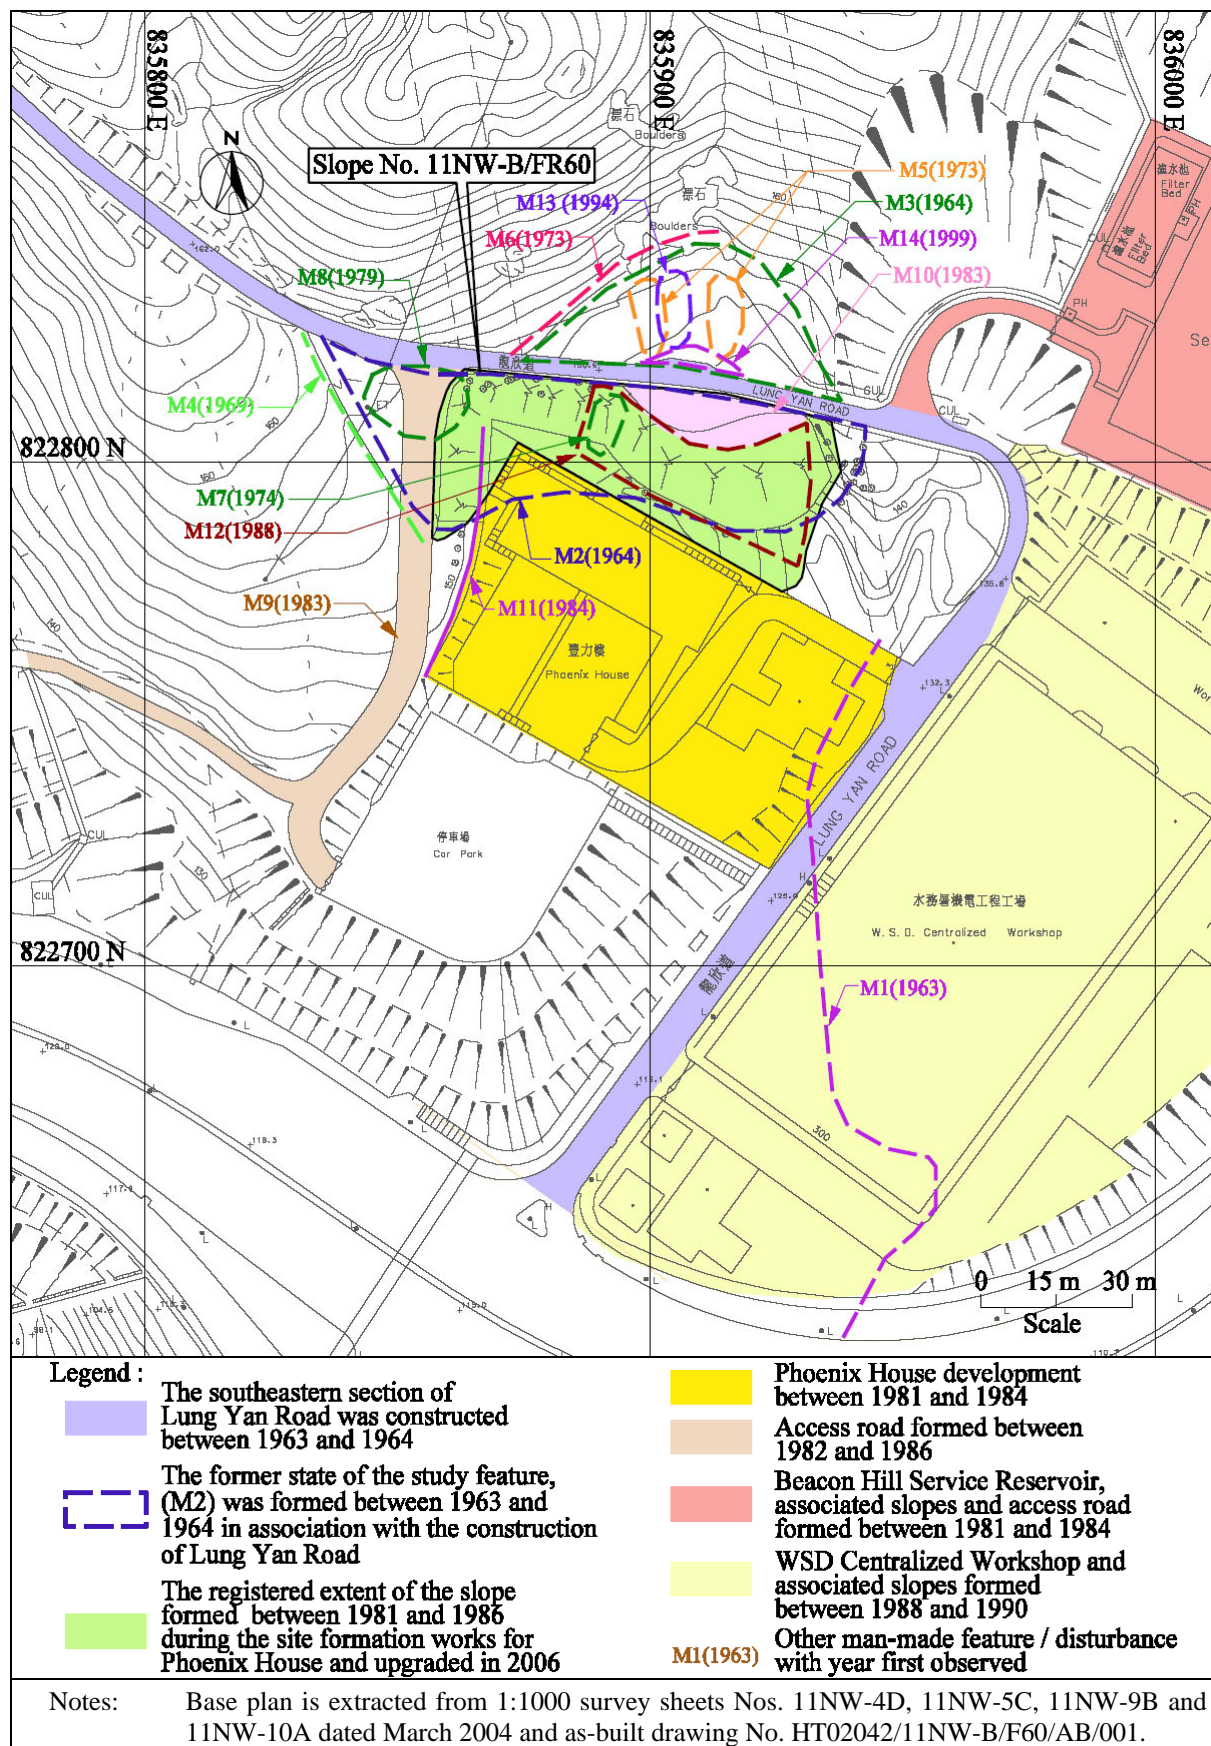
Figure 4 - Site Development History

The section of Lung Yan Road and slope No. 11NW-B/FR60 was constructed around 1964. The extent of the slope was slightly larger than the present layout (Figure 4). The

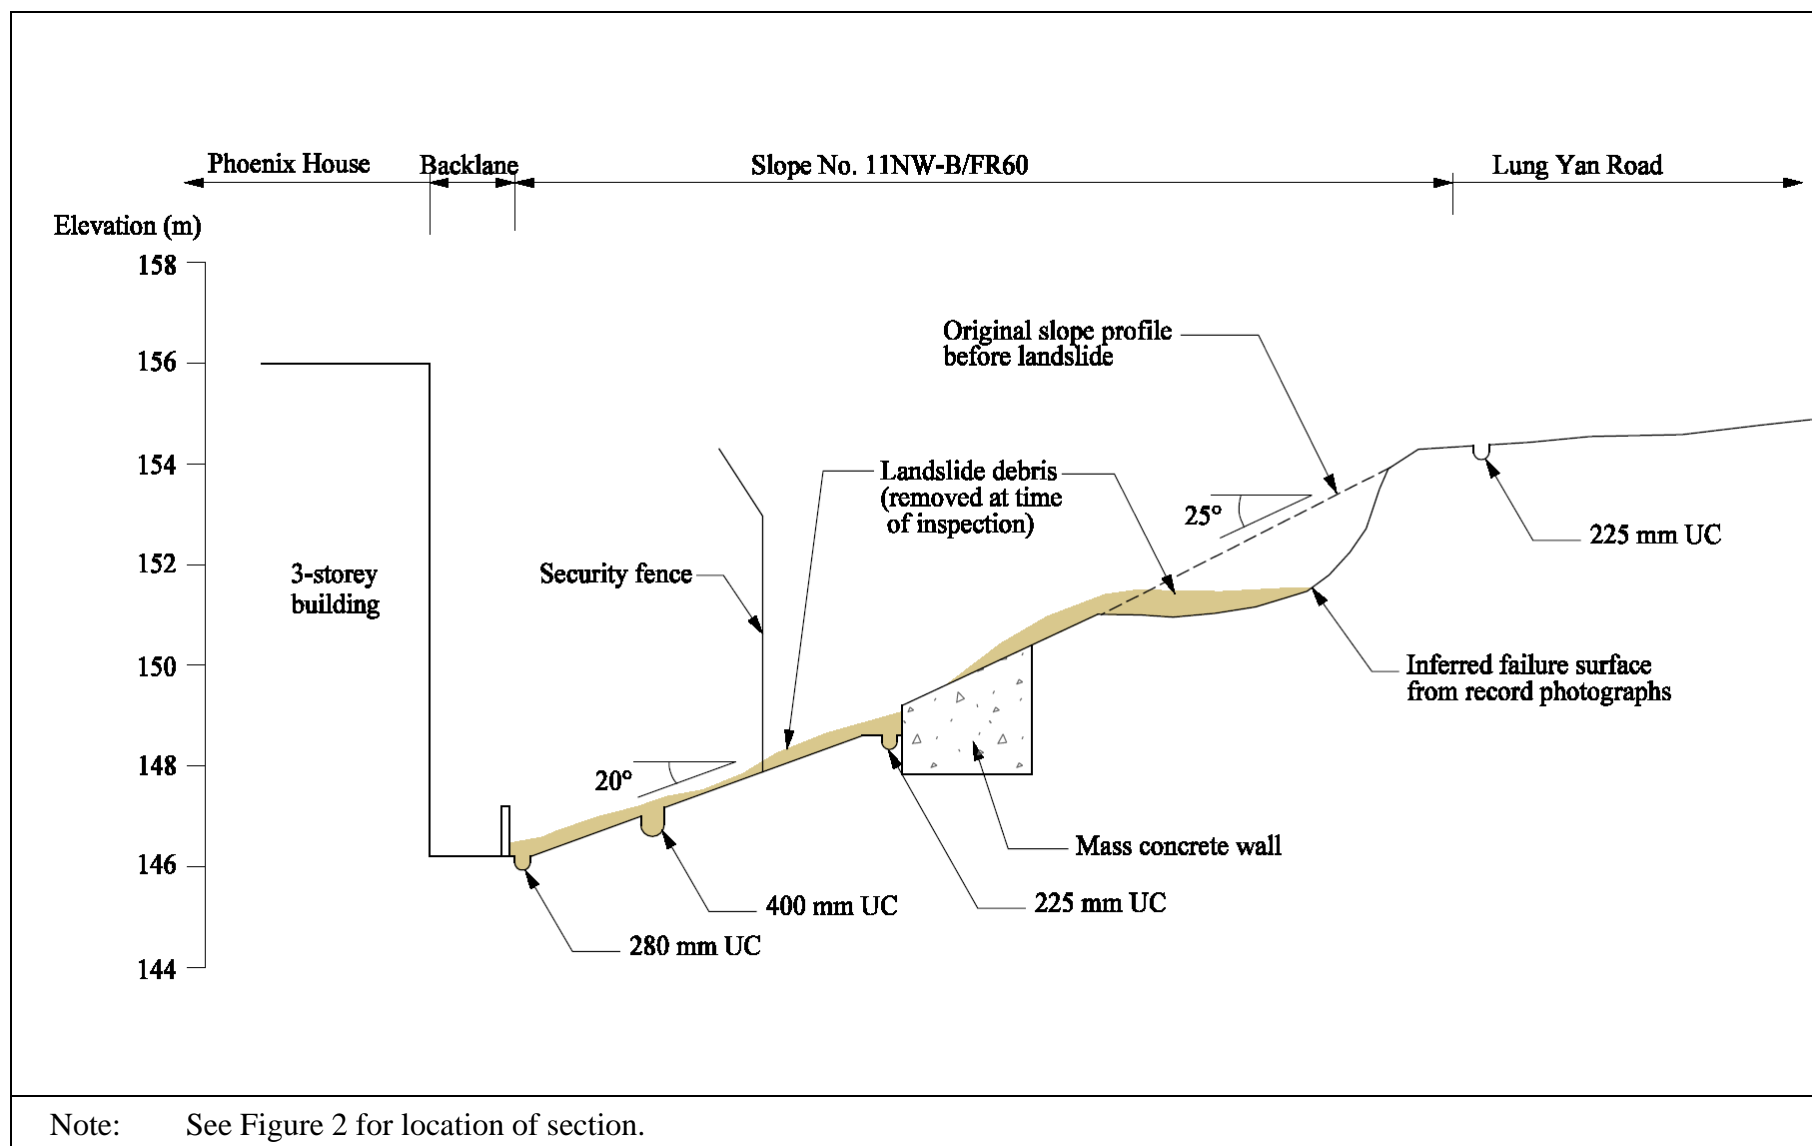
Figure 6 - Cross Section A-A

The landslide debris had been removed at the time of inspection and the landslide scar was backfilled with no-fines concrete in early August 2006 (Plate 13). Based on record photographs from Arch SD, the June 2006 washout scar was about 10 m long by 6 m wide. The depth of scar is estimated to be about 1 m to 1.5 m to the southwest of the stepped channel which was undermined, and less than 0.5 m to the northeast of the stepped channel (Figure 6 and Plate 1).

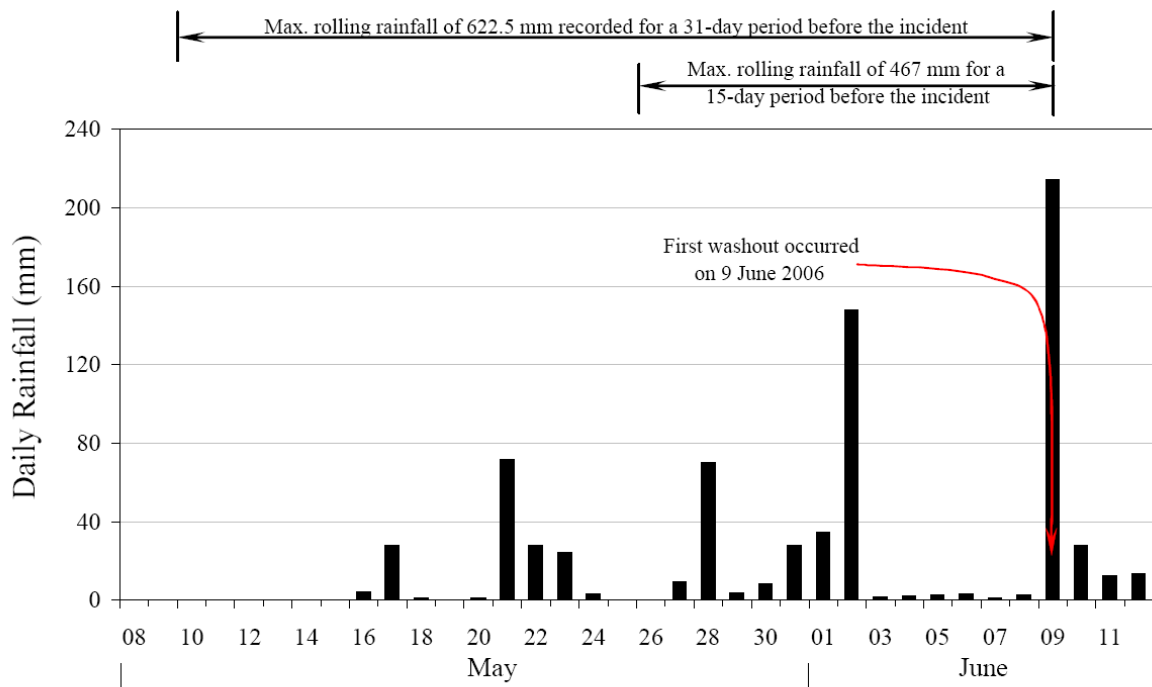
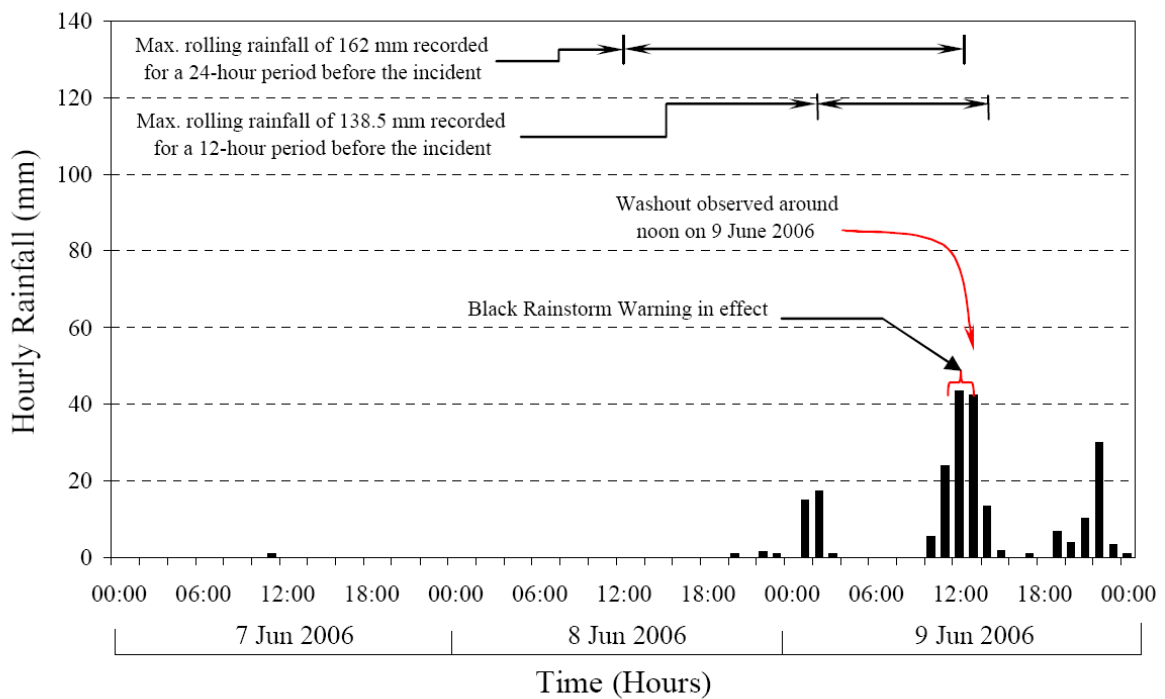
Figure 7 - Daily and Hourly Rainfall Recorded at GEO Raingauge No. K02 in June 2006

(a) Daily rainfall recorded at GEO Raingauge No. K02 between 8 May 2006 and 12 June 2006

(b) Hourly rainfall recorded at GEO Raingauge No. K02 between 7 June 2006 and 9 June 2006

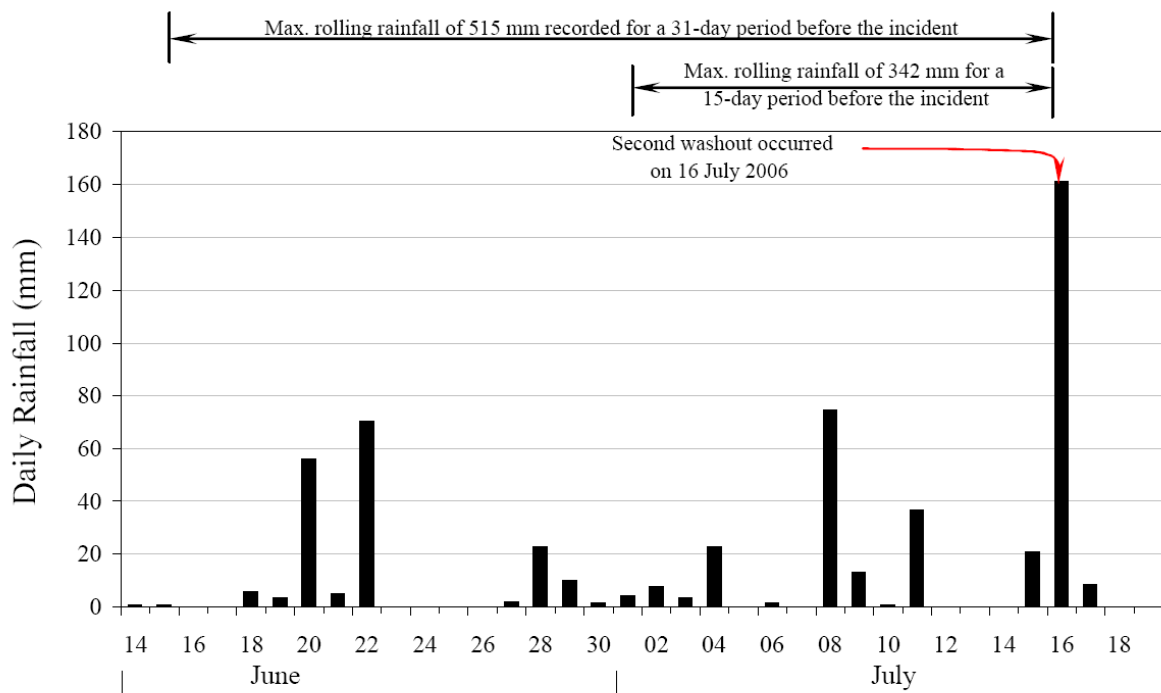
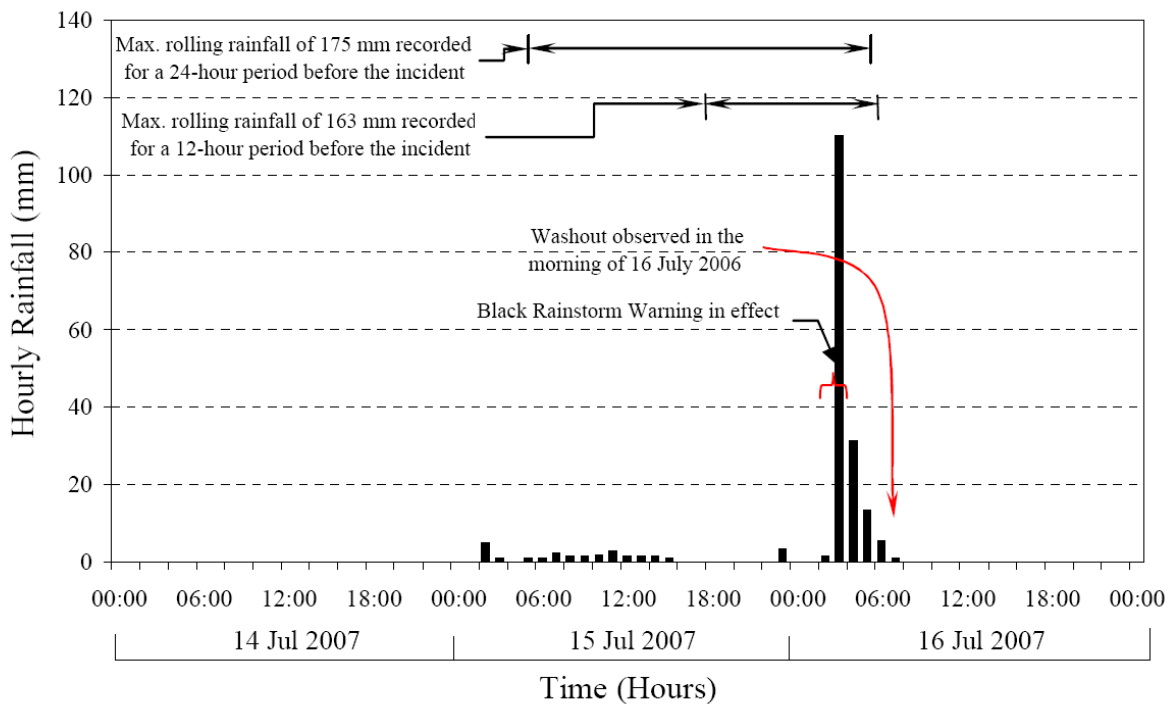
Figure 8 - Daily and Hourly Rainfall Recorded at GEO Raingauge No. K02 in July 2006

(a) Daily rainfall recorded at GEO Raingauge No. K02 between 14 June 2006 and 19 July 2006

(b) Hourly rainfall recorded at GEO Raingauge No. K02 between 14 July 2006 and 16 July 2006

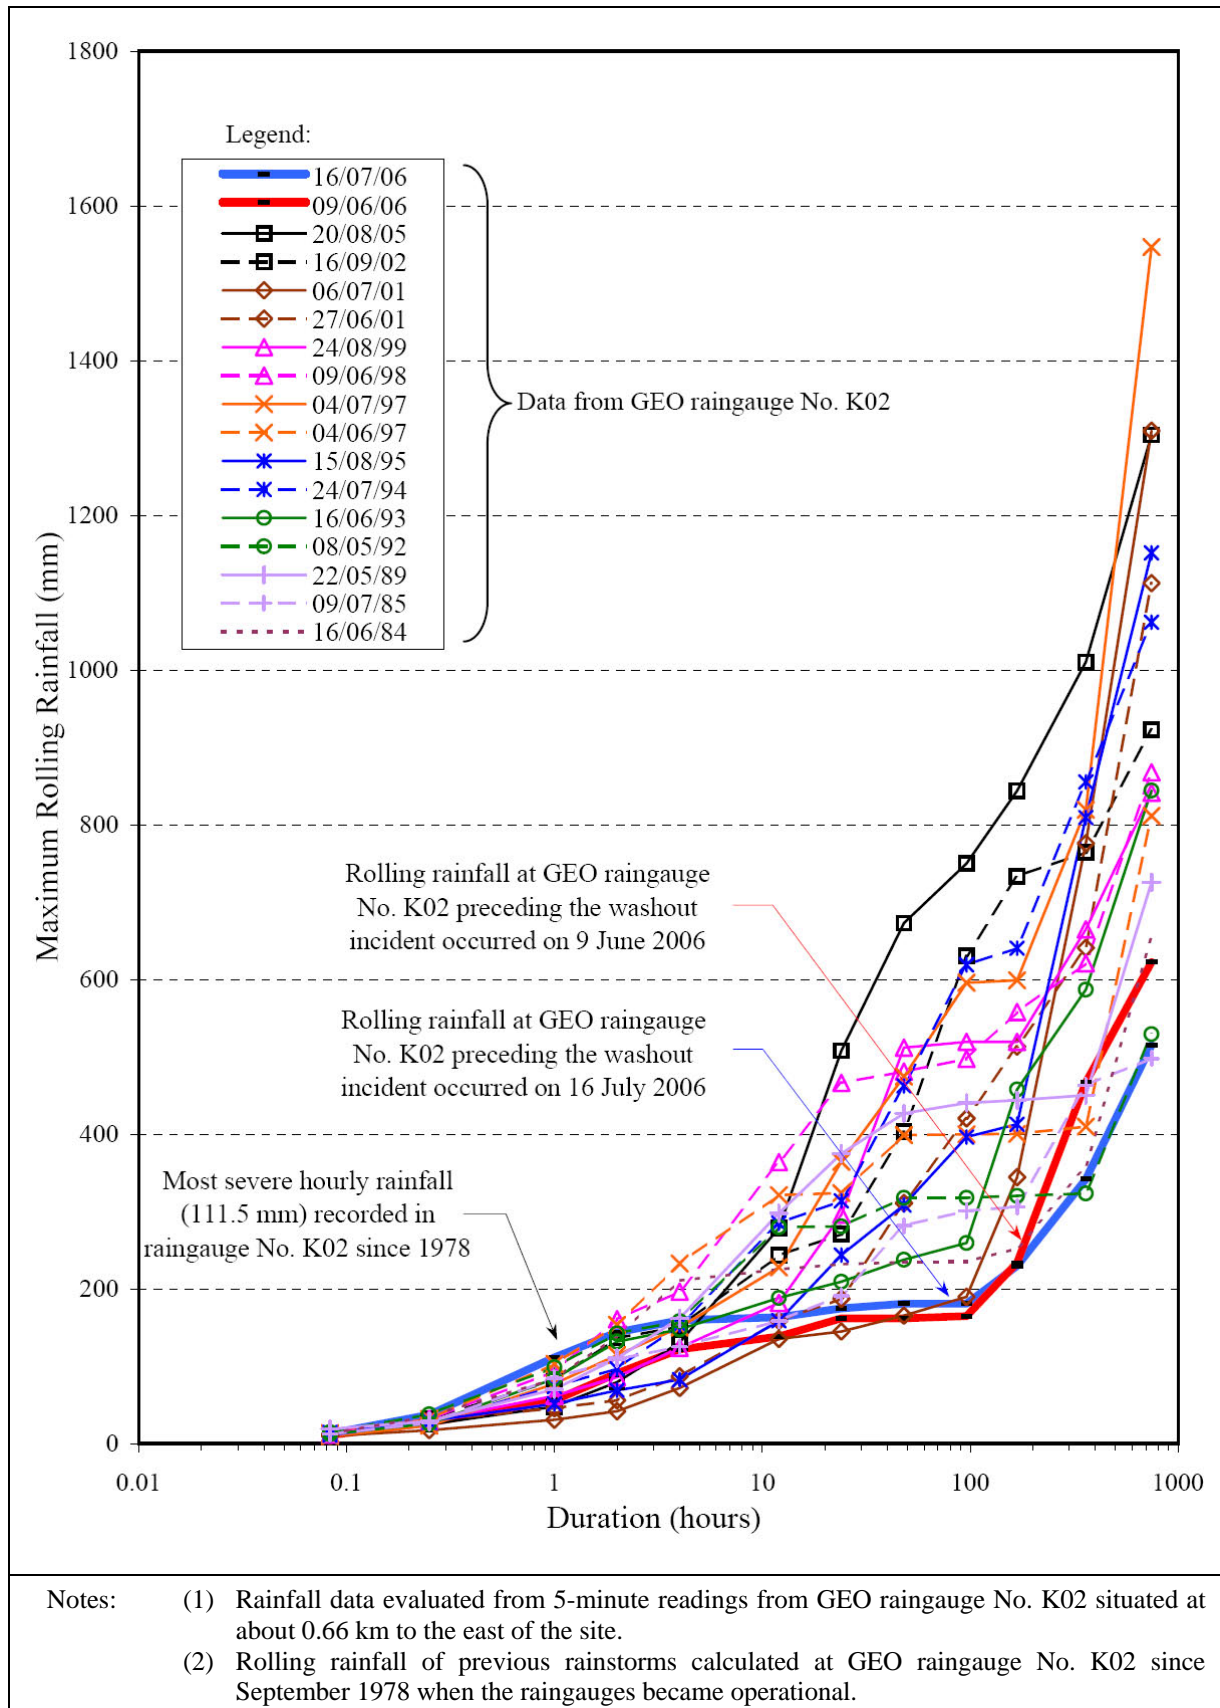
Figure 9 - Maximum Rolling Rainfall for Previous Major Rainstorms at GEO Raingauge No. K02

The maximum rolling rainfall for the 9 June 2006 and 16 July 2006 rainstorms has been compared with the previous major rainfall recorded by raingauge No. K02, which came into operation in September 1978 (Figure 9). The 9 June 2006 rainstorm is less severe than the previous major rainstorms, while the 1-hour rolling rainfall recorded on 16 July 2006 is the most severe rainfall recorded in the past 23 years.

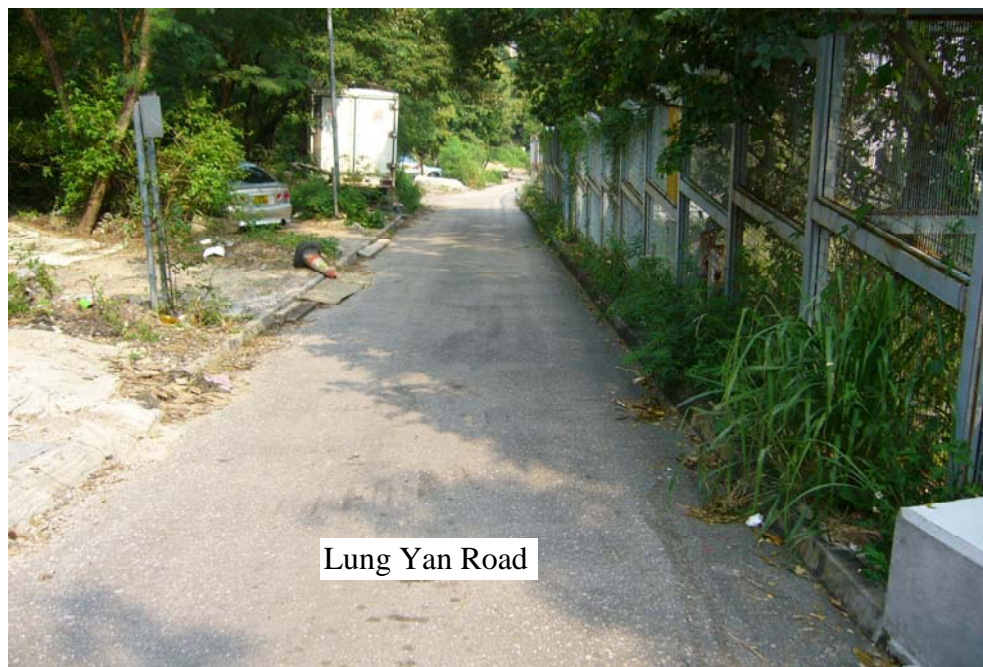
Apart from a stormwater drainage inlet to the cross-road culvert at the east end of slope No. 11NW-B/C506 (Plate 8), there is no road drainage system along a 200 m long stretch of Lung Yan Road to the west of slope No. 11NE-B/FR60. The road has a longitudinal fall of about 1 in 8 towards the crest of the washout area (Figure 1 and Plate 7). No blockage of the culvert inlet was observed at the time of inspection in August 2006. However, the outlet of the cross-road culvert is substantially blocked by the water pipes and silting was observed at the invert of the outlet (see Section 2 and Plate 9).

Plate 3 - View of Lung Yan Road along Crest of Slope No. 11NW-B/FR60 Looking Downhill
(Photograph taken on 20 September 2006)

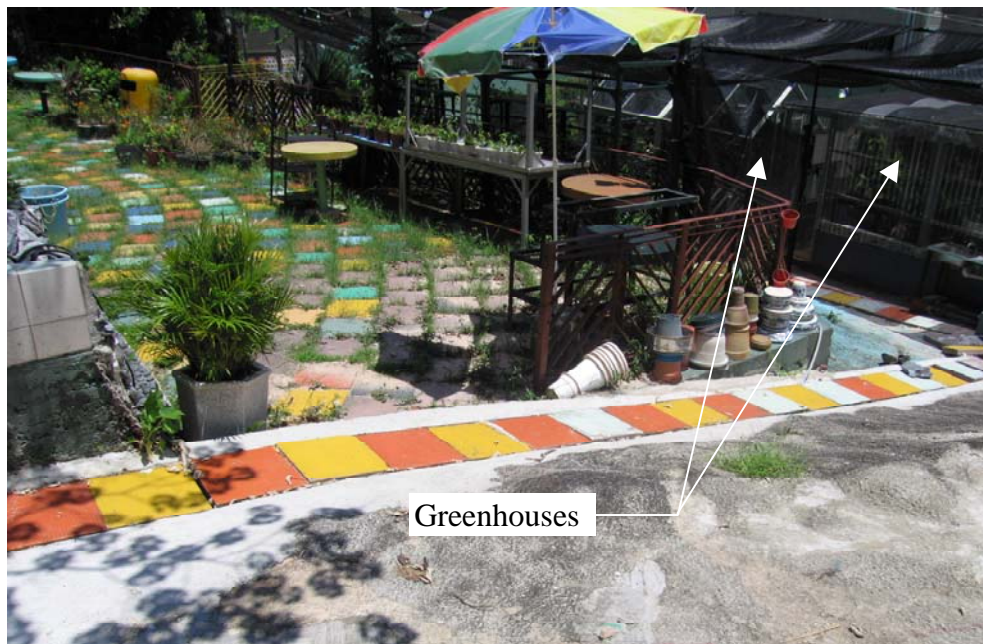
Plate 5 - View of Garden to the East of Slope No. 11NW-B/FR60 (Photograph taken by Arch SD on 20 July 2006)
